CHAPTER VI

TYPICAL APPLICATIONS OF FLOODPROOFING TECHNIQUES

A. INTRODUCTION

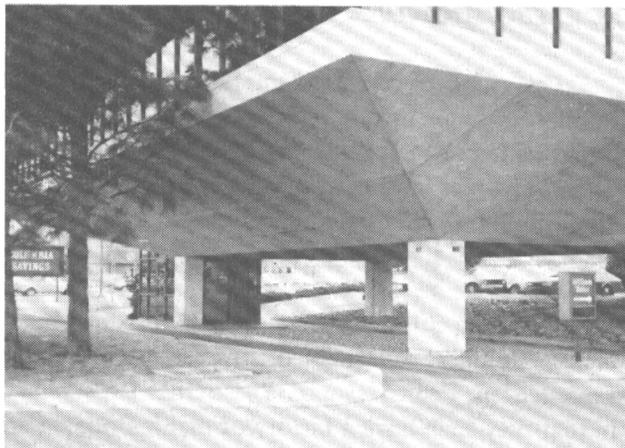
Area beneath the building provides sheltered space for automatic bank teller facility.

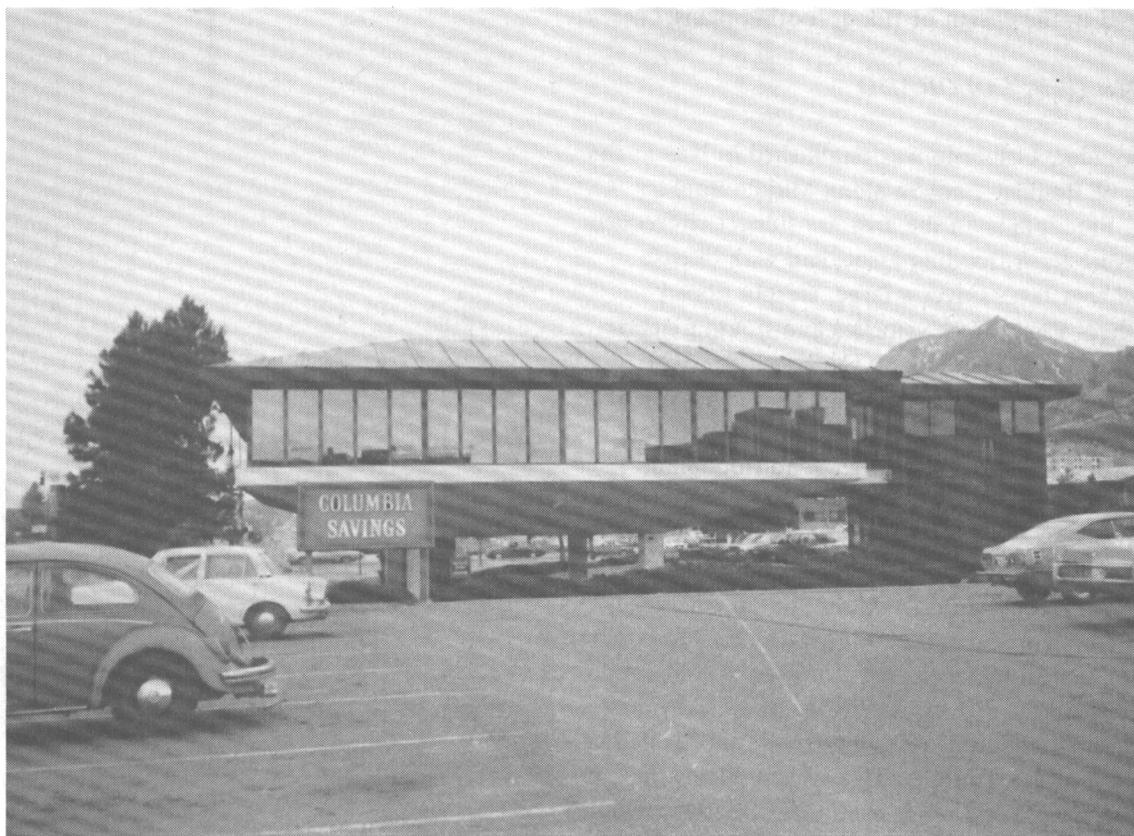
The entire structure is elevated with the exception of glass entry areas.

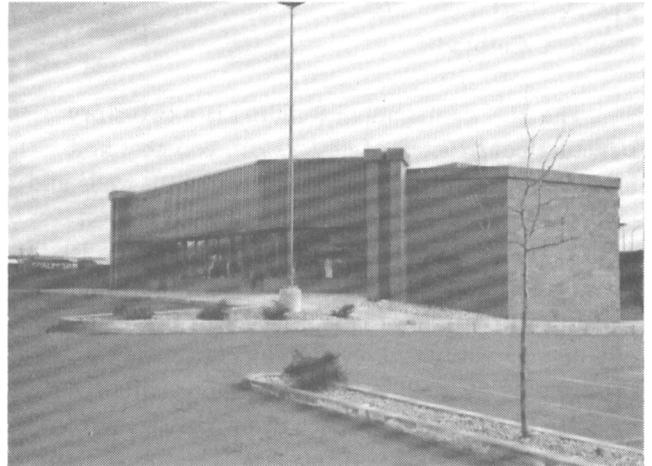
Site grading provides direct access to first floor elevation at the front of the structure.

Anticipated flood depths at the Emily Lawrence, Ltd. site were less than 3 feet, with floodwater velocities of 2 feet per second. It was determined that elevation on fill was the most cost effective and desirable floodproofing alternative for the site. The 5,500 sq. ft. brick veneer building is constructed on a concrete slab foundation. The first floor level has been elevated approximately 2.5 feet above the base flood elevation. The location of the building on the edge of the floodplain fringe allowed final grading that provides direct access to the first floor in the front of the building. A combination of grassed embankments and retaining walls were used to accommodate a relatively steep grade transition at the back of the structure. Floodproofing costs, including delivery and compaction of the fill material and additional site preparation, were approximately \$15,000 (1980).

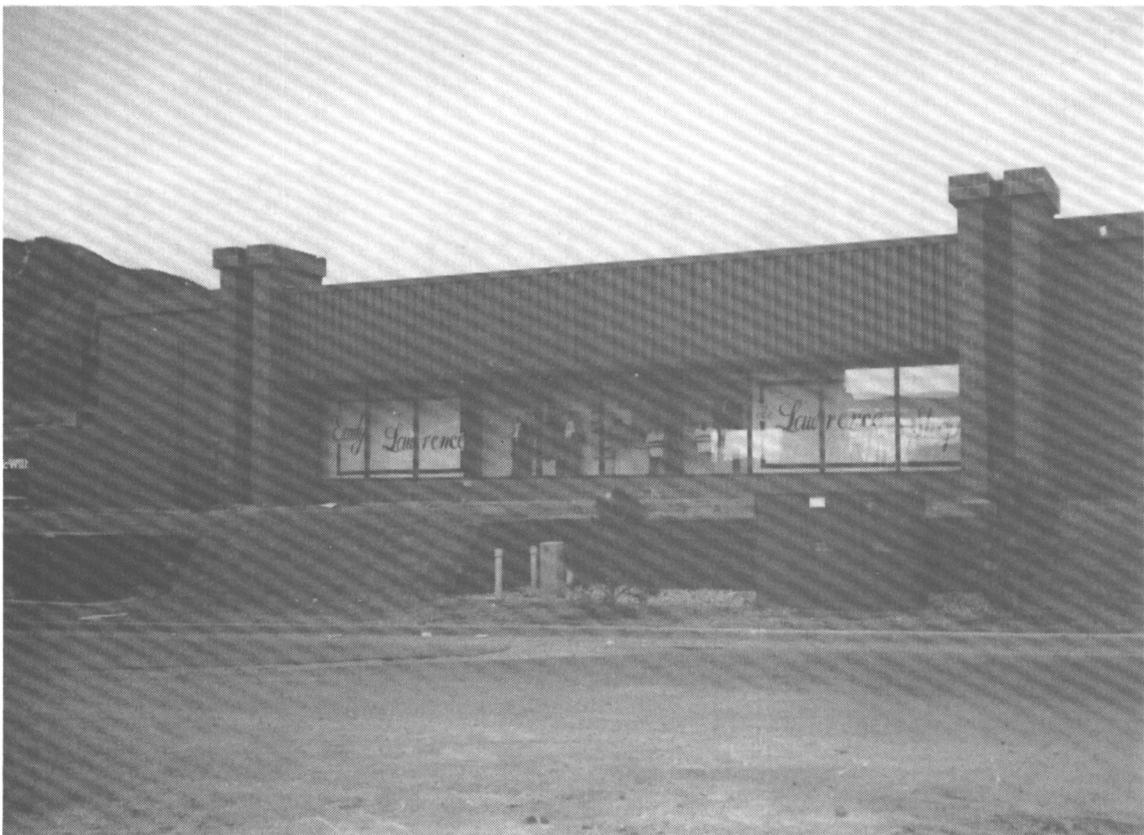
Combination of grass embankments and retaining walls to accommodate grade change at rear of the structure.

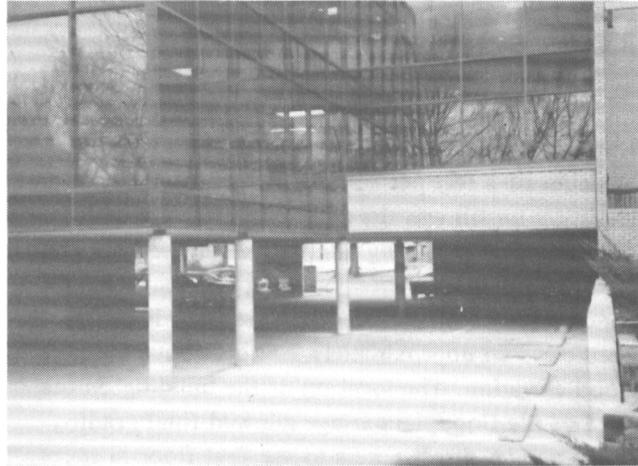
Extensive parking space has been provided beneath this elevated structure.

The JLS Professional Building is a two-story structure constructed of glass, steel, concrete and brick veneer. The building was elevated on walls and columns to provide parking space and to protect against flood damage. The first floor elevation is about 6 feet above the base flood elevation. Expected flood depths at this site are 3 feet with flow velocities of 2 feet per second. Elevation increased the cost of the building by 20-35%, however the benefits associated with parking space below the structure compensated for this cost increase. The total structure cost was approximately \$500,000 (1980). The first floor area of this building is approximately 4,750 square feet.

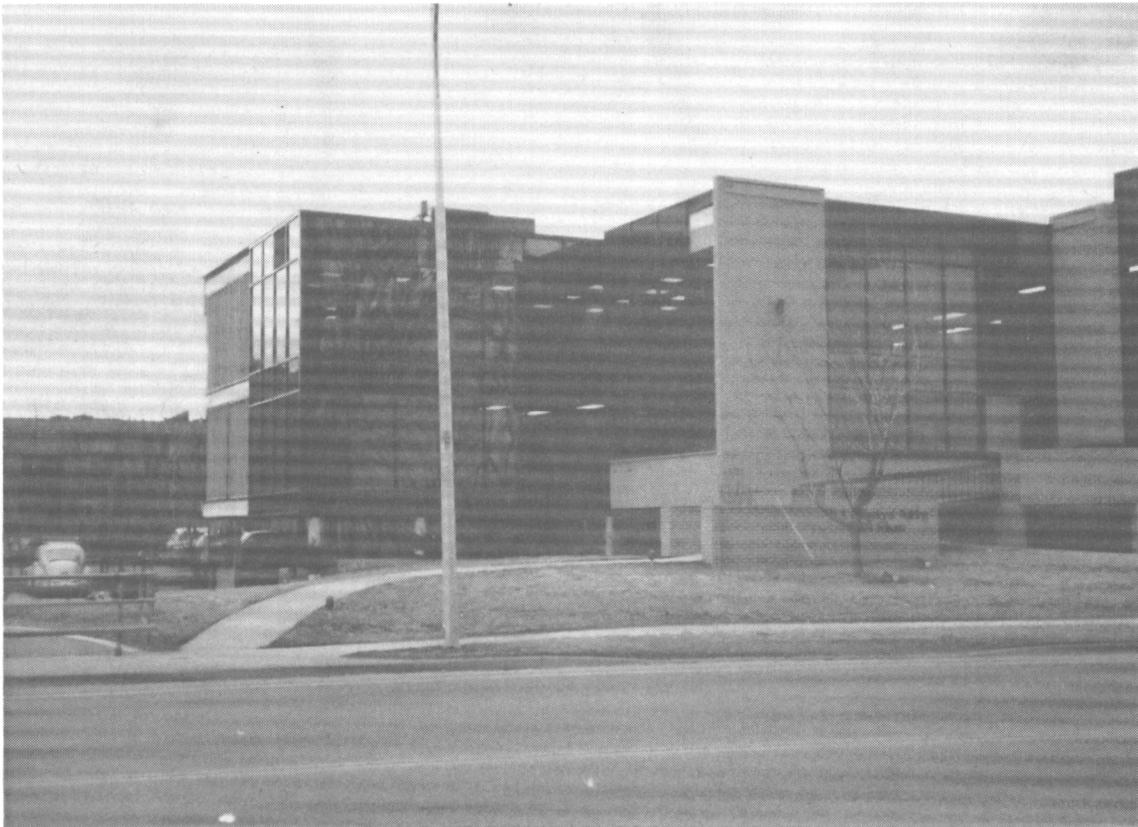
Building materials include combination of glass, steel, concrete and brick veneer.

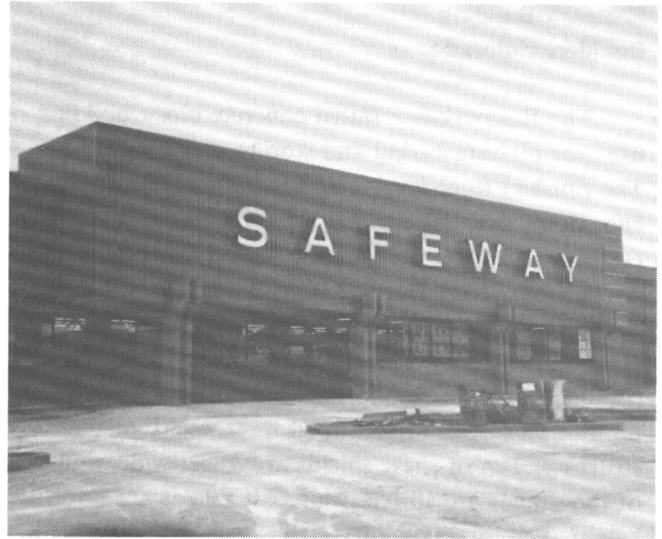
Existing Safeway Building has been retrofitted with flood shields to protect against flood depths up to 2 feet above the 1st floor elevation.

The Safeway building has a brick veneer exterior with a standing metal seam roof. All windows are located above the base flood elevation, which is approximately equal to the finished floor elevation. Therefore, flood shields only designed to protect only the doors. Flood velocities in the area are approximately 2 feet per second. The shields are equipped with a pneumatic watertight sealing system, and vary in size from 40 inches to 166 inches wide by 26 inches high. The shields are stored near the front of the store behind the shopping cart storage area where they are convenient in case of flooding. The 8 shields provided for the site were manufactured by the Presray Corporation for a total cost of \$22,650 (1981).

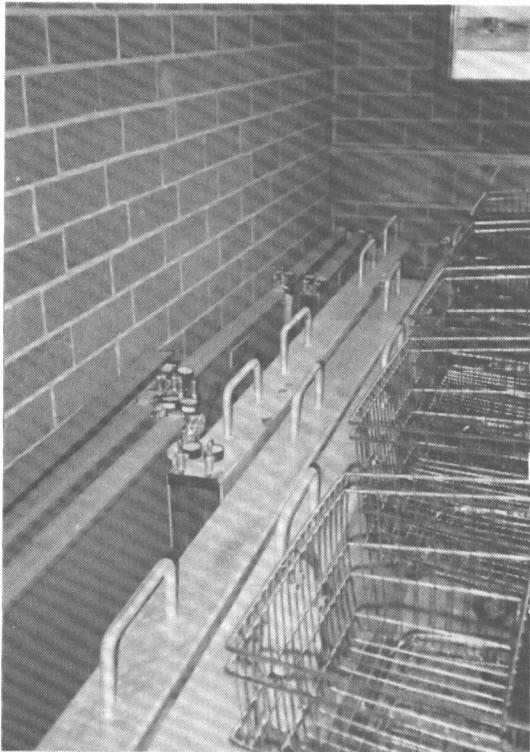
Stored flood shields (Note pneumatic seal valves).

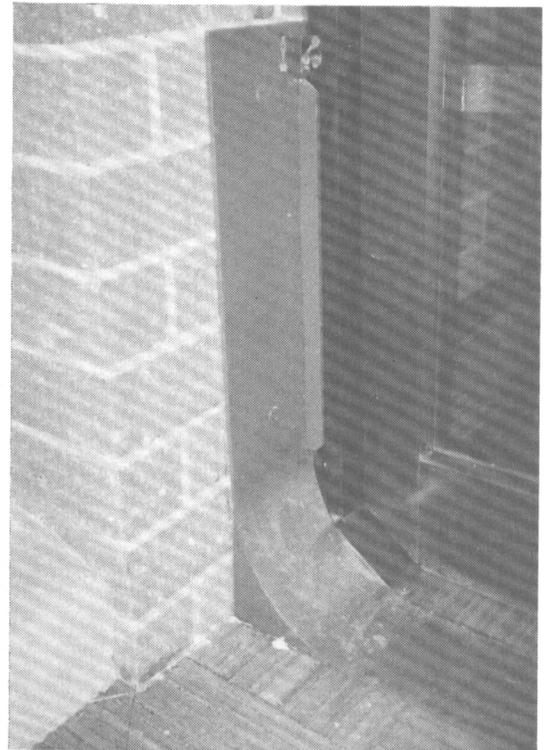
Detail of frame used for mounting shield at front door.

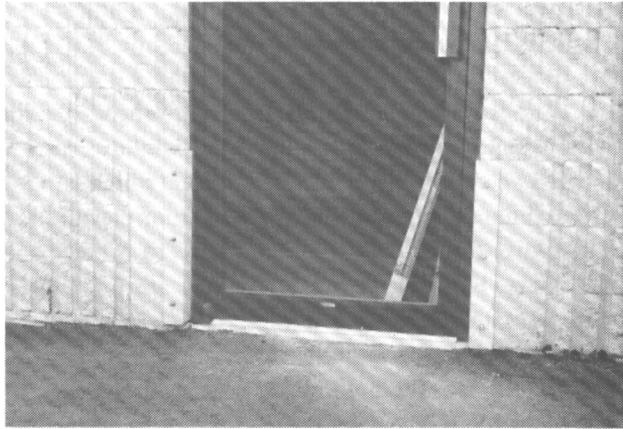
Door frames for mounting flood shields at personnel door.

The Eastpark is a fluted concrete block building used for manufacturing and storing office furniture. The finished floor level is approximately equal to the base flood elevation, and flood velocities are estimated at 2 feet per second. All windows at the site are well above the flood level; therefore only doors have been fitted with flood shields. Bolt-on shields were fabricated by a local metal working firm (Boulder Steel) to floodproof this existing structure. A total of 18 shields are required to protect the structure. Ten of these shields are 3 feet wide, and 8 of the shields are 10 feet wide. All shields are 3 feet in height. The total cost of the shields was \$3,400 (1980).

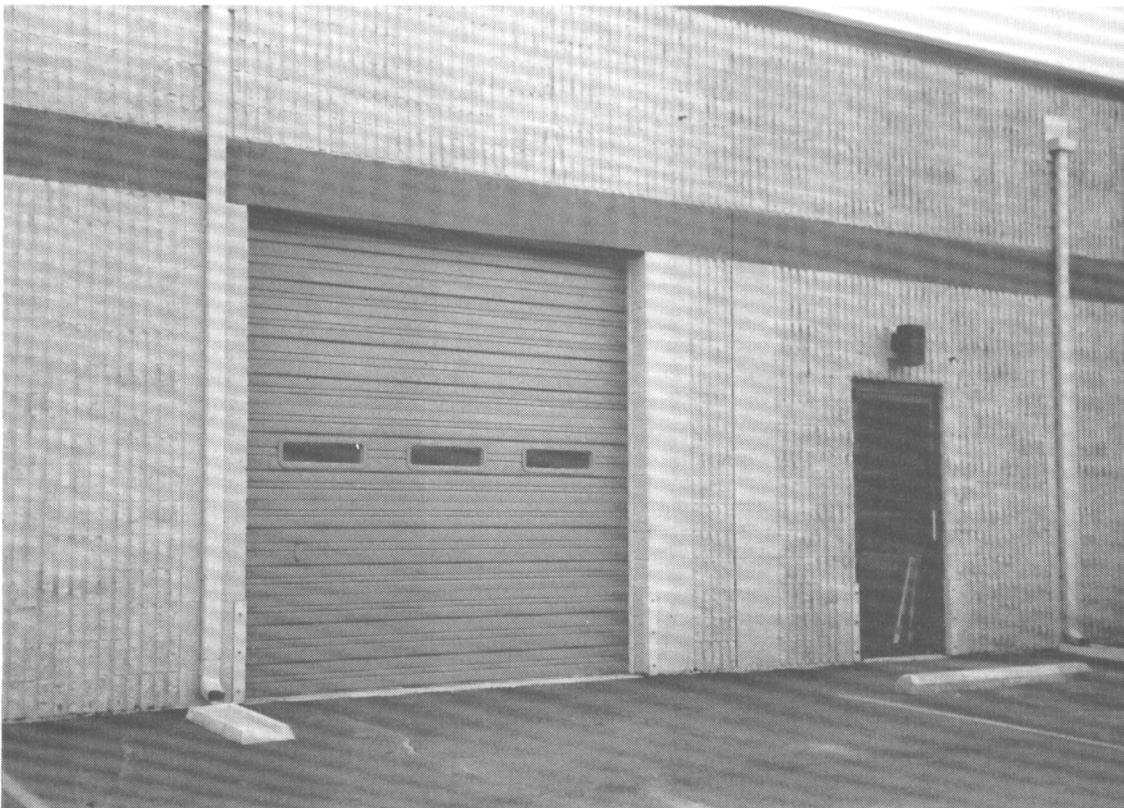
Floodproofing requires installation of 18 flood shields to protect 8 vehicular entrances and 10 personnel doors.

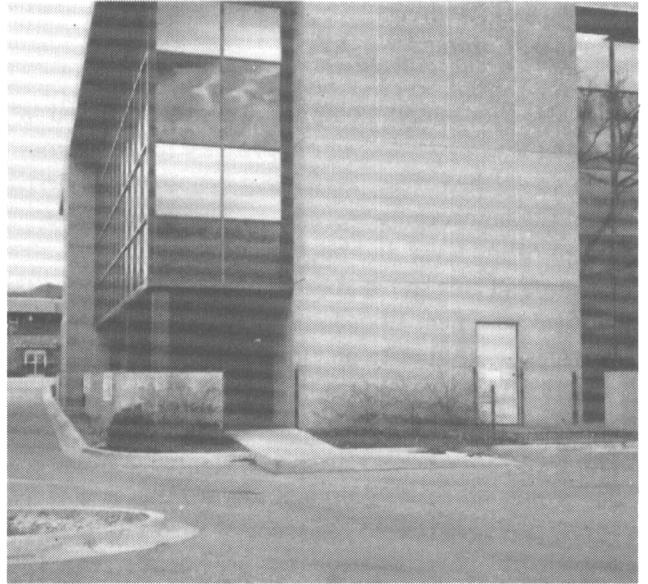
Structure can be floodproofed with a total of 5 flood shields.

The Commonwealth Office building is a three-story stuccoed precast concrete structure. The finished floor level at this site is approximately 3 feet below the base flood level. Floodproofing of this existing structure required 5 flood shields. The shields are 48 inches high and range from 3-4 feet in width. The shields are designed to withstand 3 feet of flooding depth. The shields were manufactured by Boulder Steel. The total cost of shields at this site was \$1,750 (1978).

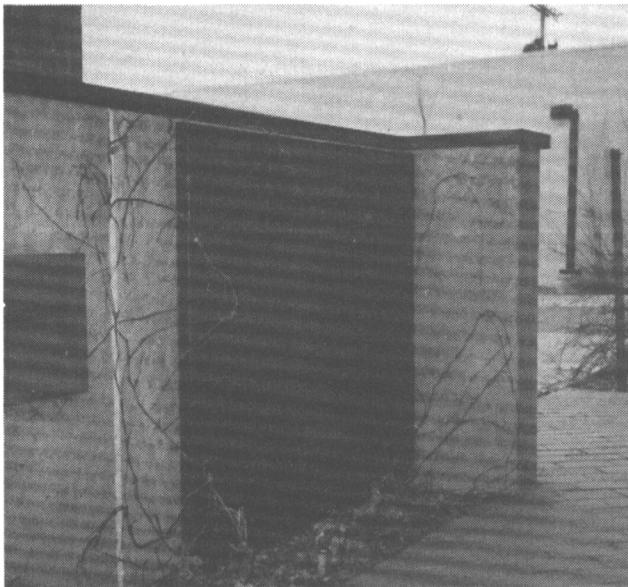
Small courtyard area is protected by combination of precast concrete wall and flood shield at door opening.

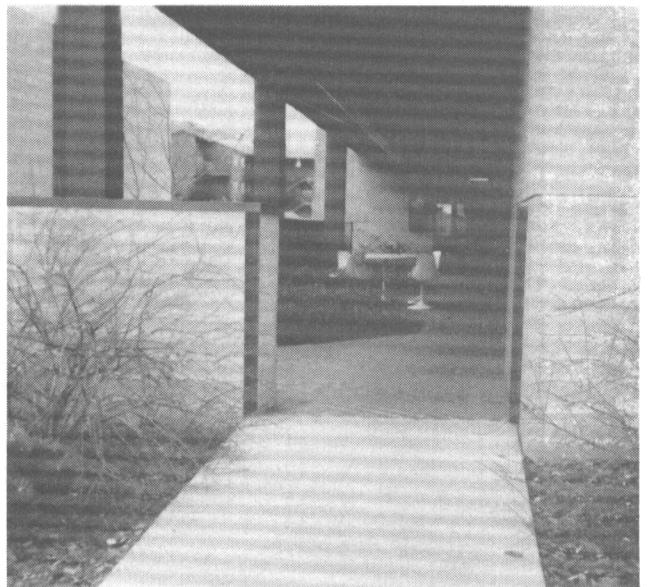
Flood shield in storage position adjacent to opening it is designed to protect.

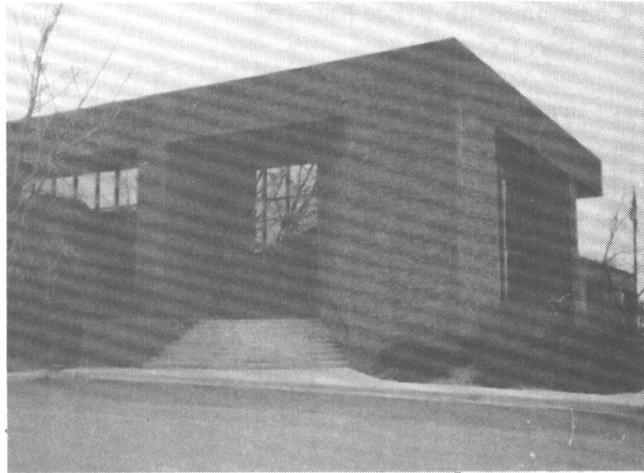
Front entrance is protected from flooding by concrete steps.

The Moore and Company building is located in an area that presented an opportunity to floodproof with an earthen levee. Secondary benefits were derived from the landscaping features incorporated in the design of the levee and building. The base flood elevation at this site is approximately 8 feet above the finished basement floor level, however the levee provides protection to an elevation 2 feet above the base flood level. Therefore, the levee protects both the basement and first floor (a total of 9,800 square feet). The three-story brick veneer building has a walkout basement that opens onto a courtyard that is enclosed by the levee. Access to the front of the building is provided by concrete steps that provide the same level of flood protection as the levee. The total cost of the levee on three sides of the building was approximately \$5,000 (1980).

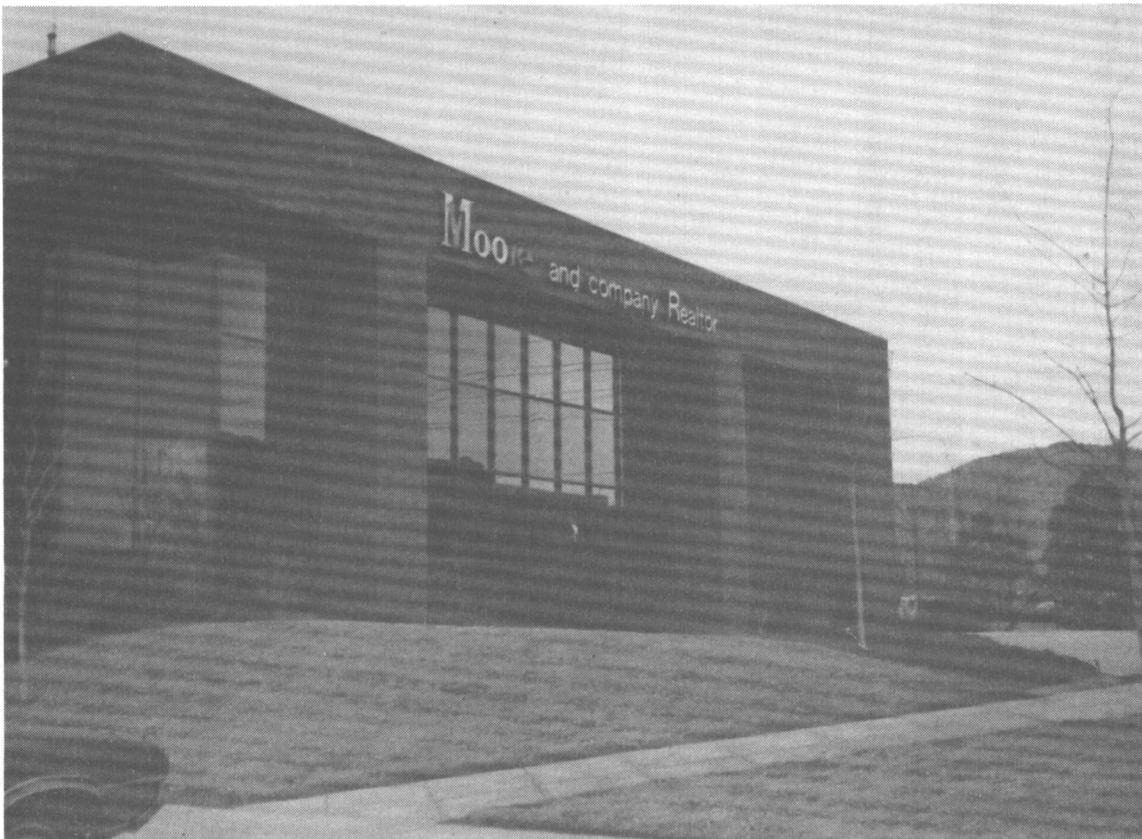
The skillful mixing ground cover and grass planting reduce the visual impact of the levee structure.

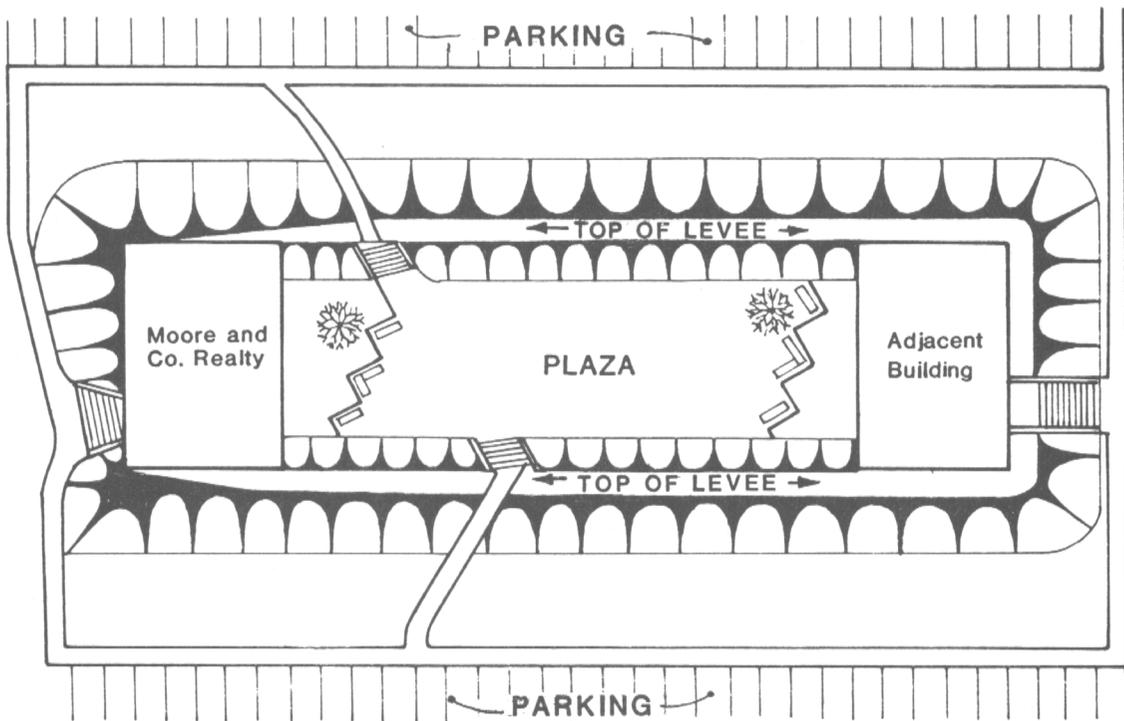
Site plan for Moore and Co. Realty. Note that levee protects two structures and provides a heavily landscaped and enclosed central plaza area.

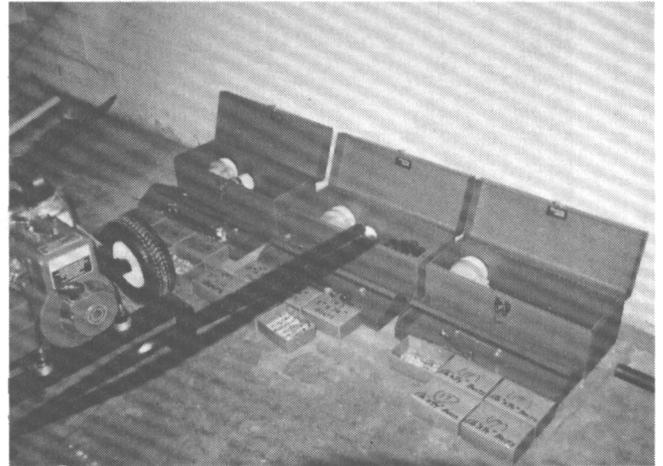
Tools, parts, and portable gas powered pumps required to install flood shields and remove any seepage that may occur.

Several locations have been designated throughout the plant for floodproofing component and equipment storage. Sandbags are stored on raised pallets that can be transported by fork lift equipment. Emergency gasoline powered pumps are also stored at these locations and a routine maintenance program assures that all systems are operational. The floodshields for individual openings are stored as close to the openings as possible and the tools for mounting them are stored at a common site.

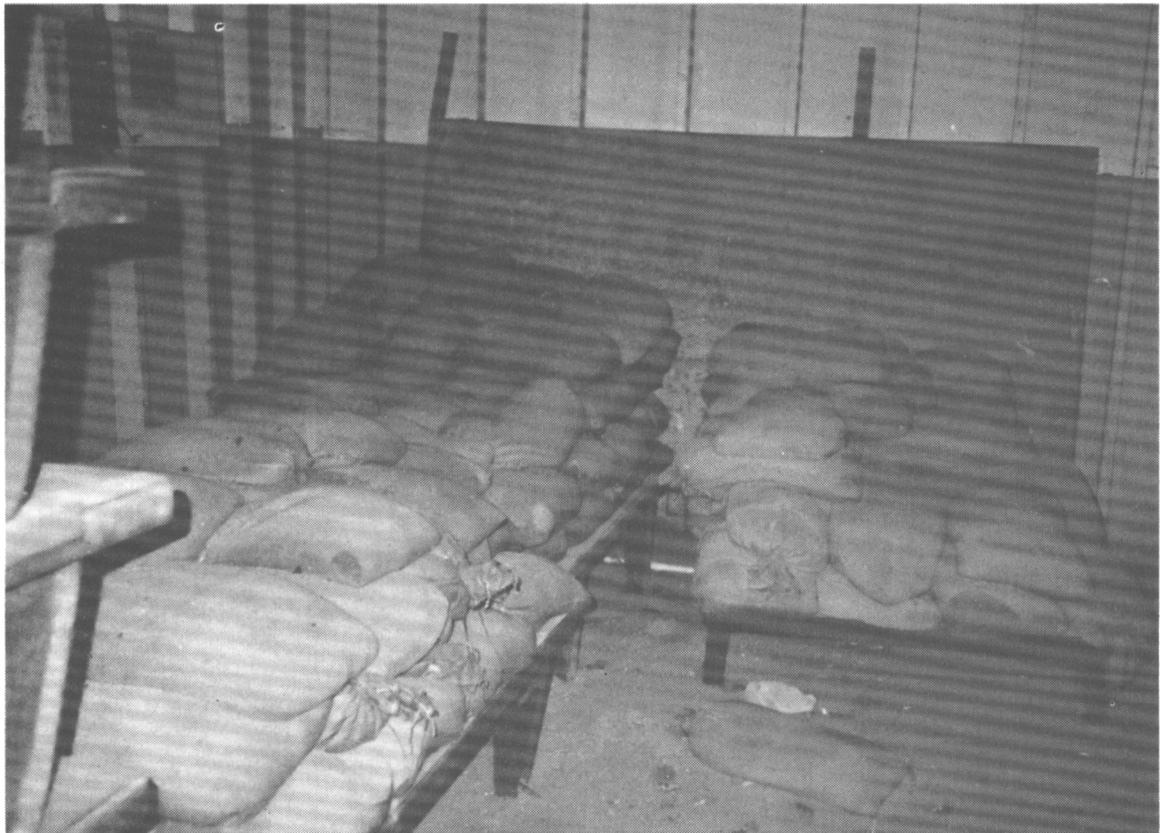
Sand bags stored on pallets that can be moved to site by fork lifts.

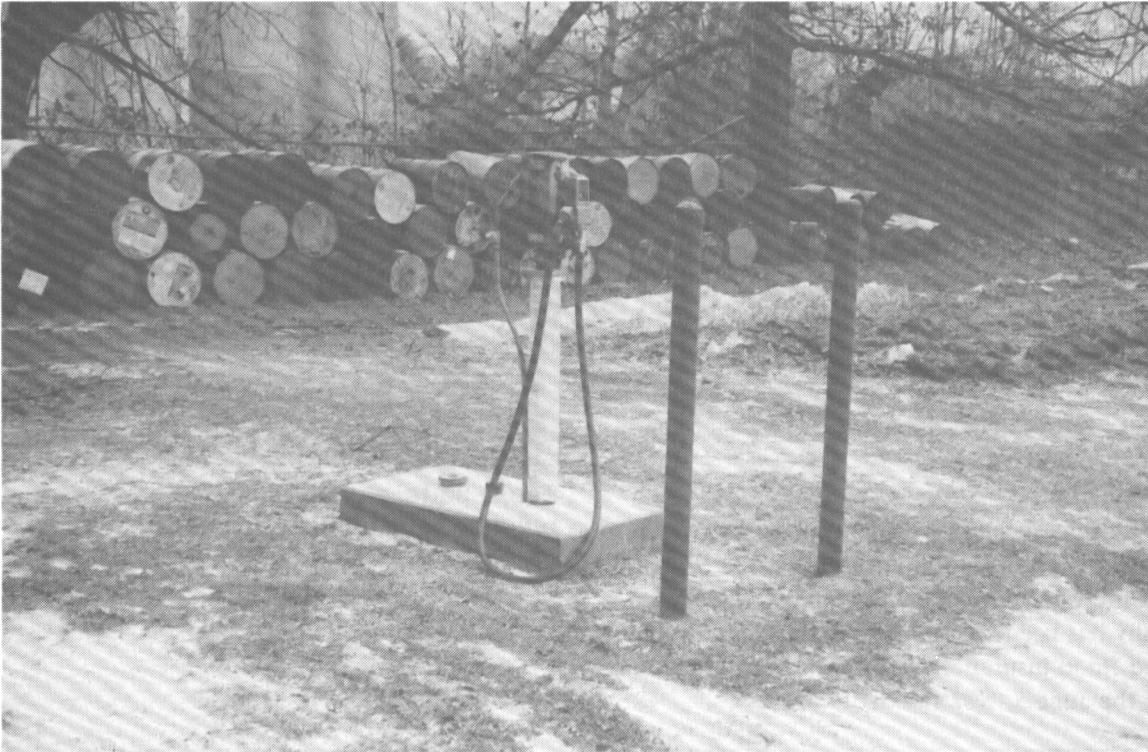
Floodproofed on-site gasoline pump to provide fuel for portable pumps and other equipment.

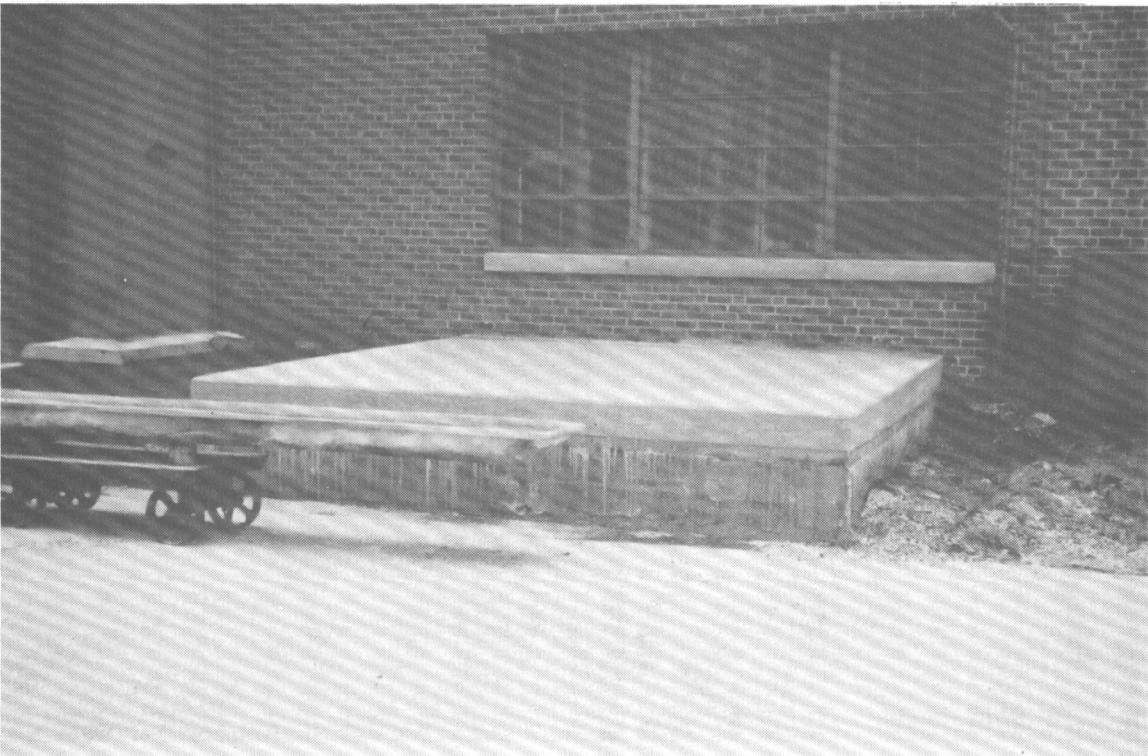
Concrete cap used to seal abandoned coal loading chute.

After some modification to the initial floodproofing plans Wallace Barnes management adopted and began to implement a floodproofing program. The selected measures included permanent closure of two coal loading bins, floodwalls designed to protect open spaces between buildings and a below-grade doorway, bolt-on flood shields to protect a total of 61 openings, and replacing an old wooden wall in one building with a 4 foot high concrete wall topped with a frame wall with metal siding. Also, a new addition to the plant was elevated above the base flood level, and a foundation drainage system was installed to relieve uplift pressure on the existing concrete slab floors.

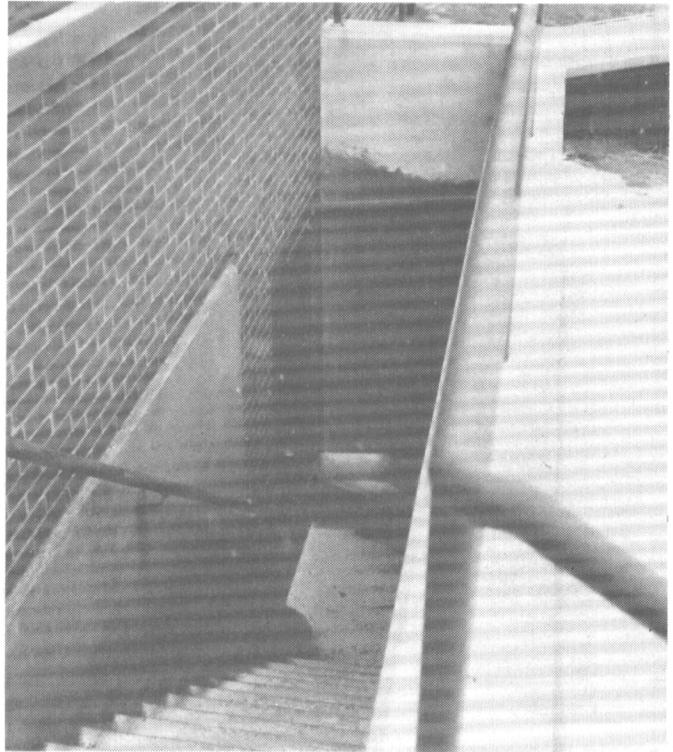
Reinforced concrete wall to protect below grade door (steps extend to top of the wall and down to Ground level).

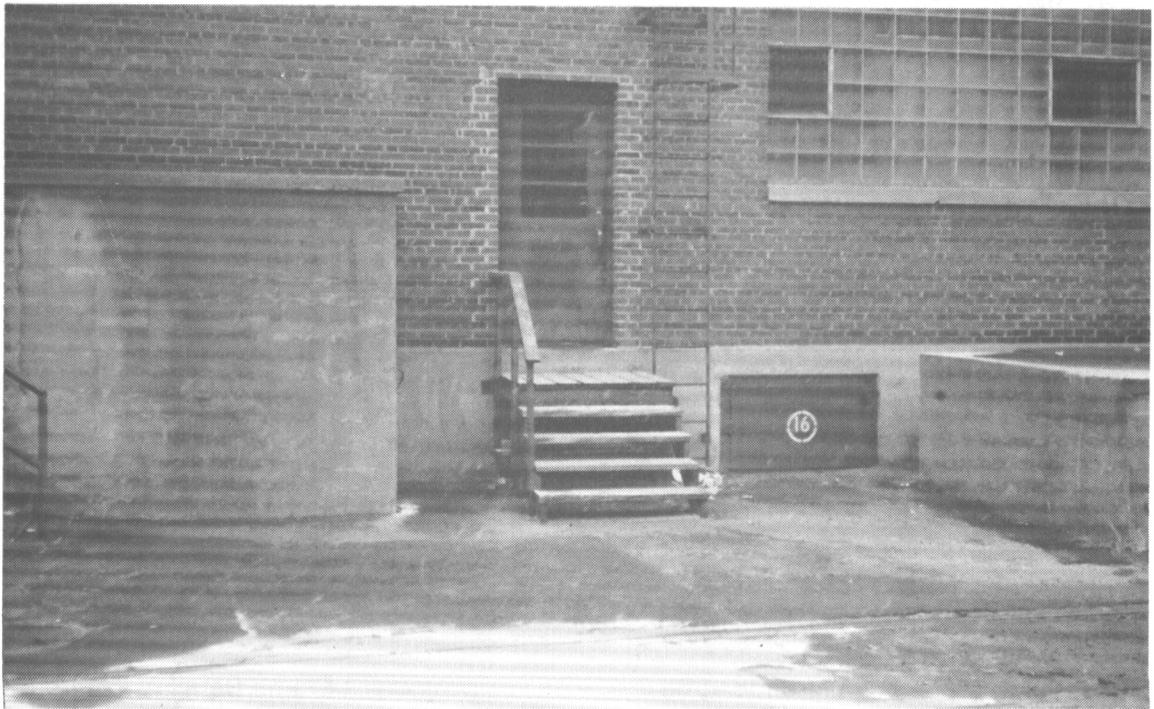
Flood shields are maintained in place over seldom-used openings.

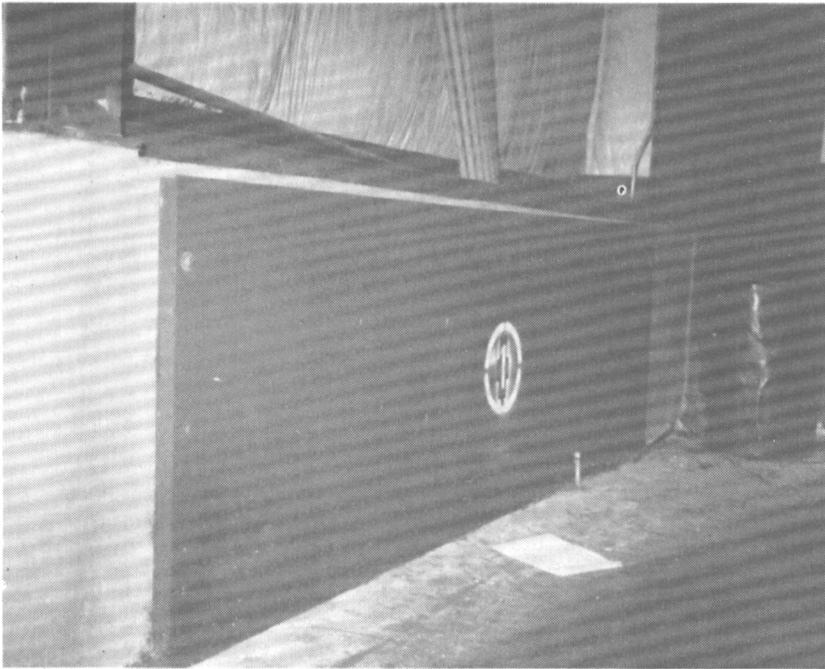
Flood shield in stored position. Can be raised to protect large loading dock door.

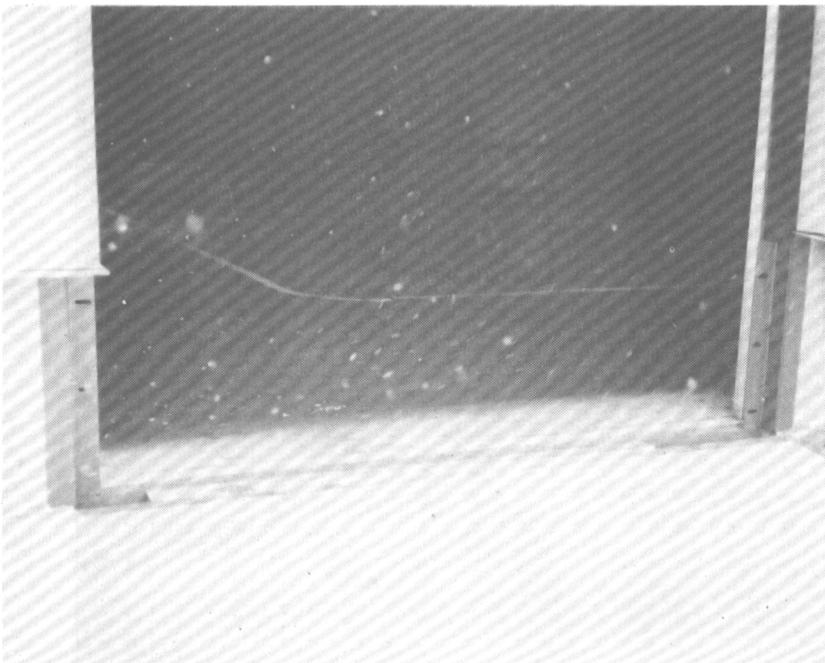
Frame for mounting flood shield on loading dock door. A 4" x 4" piece of timber is used to facilitate traffic over a slot designed to receive and seal the flood shield.

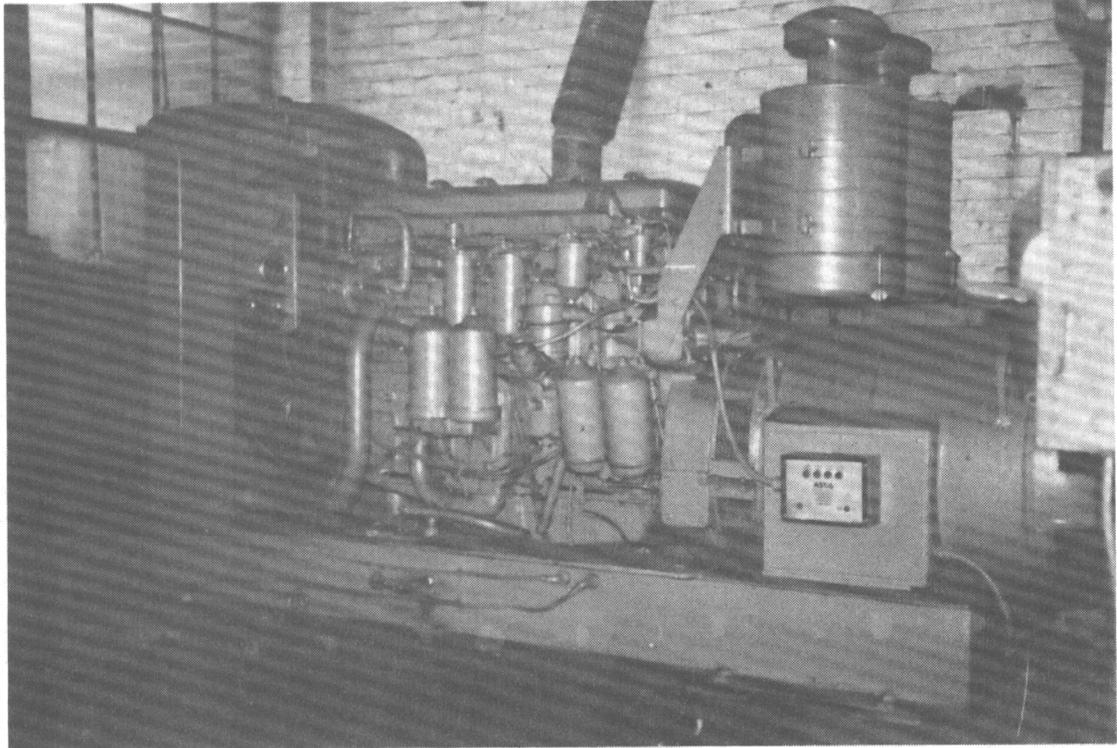
Diesel pump which can be used to dewater seepage within the plant and from a below grade collector system on the perimeter of the plant that is designed to reduce uplift forces on the floor system.

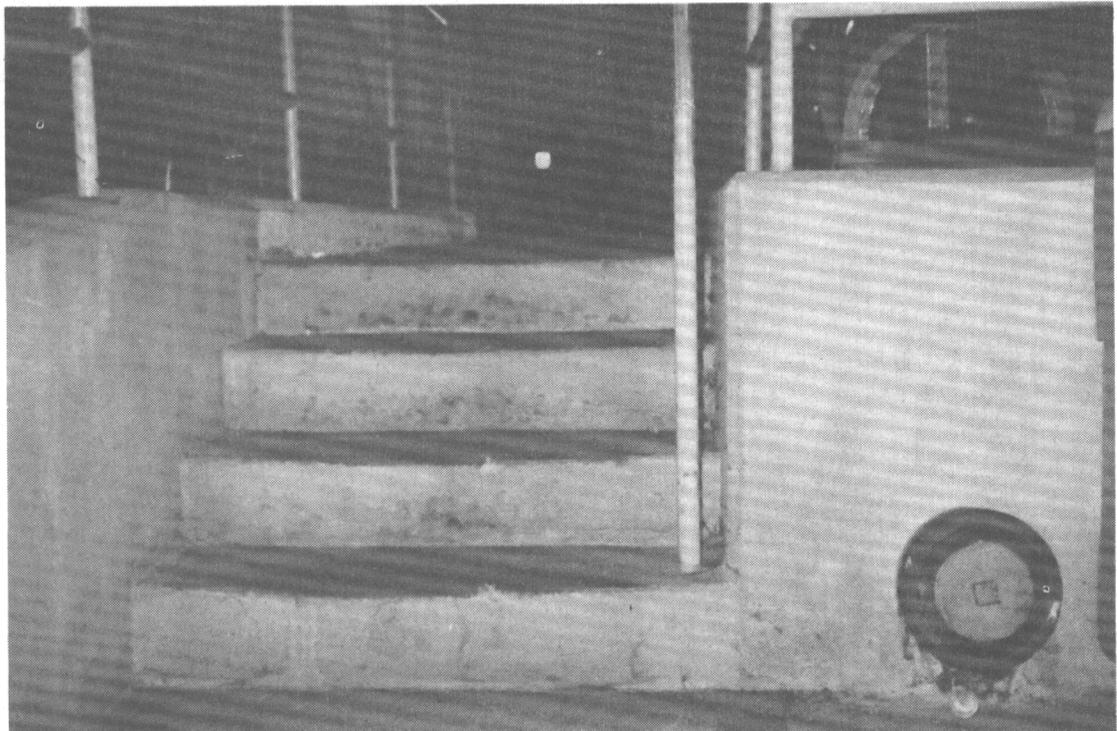
Newly constructed computerized rolling mill area has been elevated above the base flood elevation.

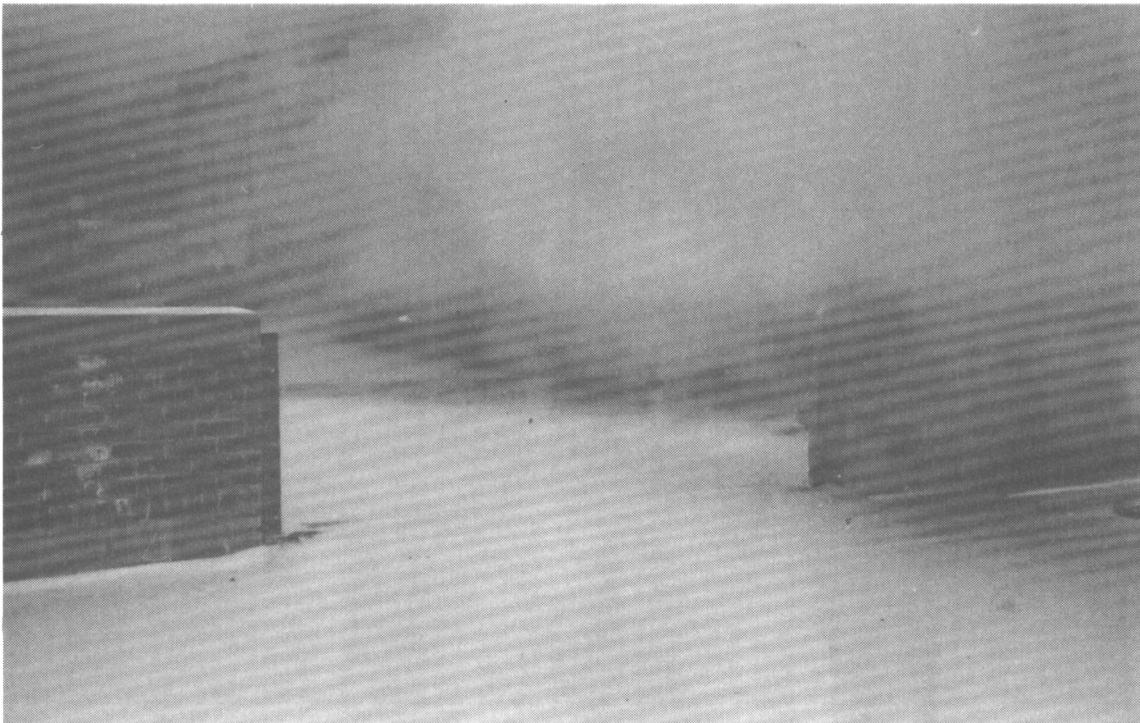
Floodwall to protect large area between two buildings.

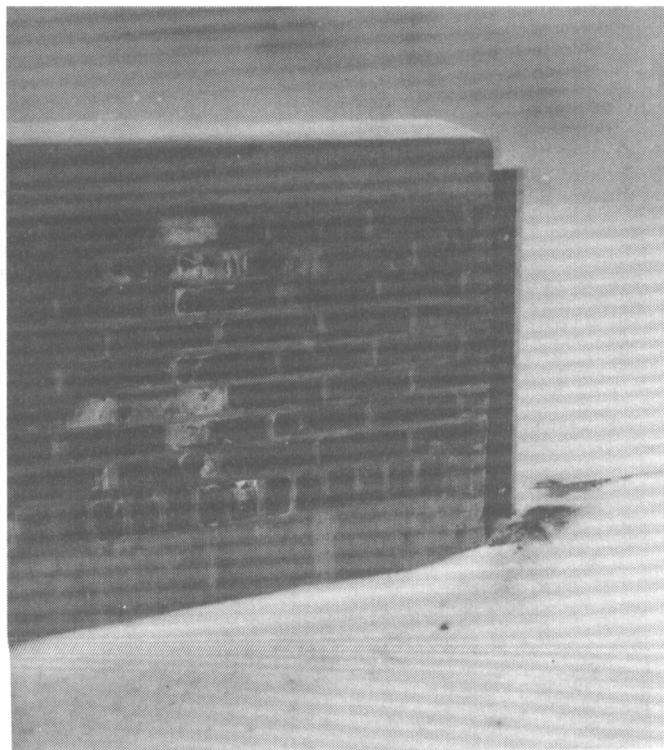
Frame for mounting flood shield at access point through floodwall.

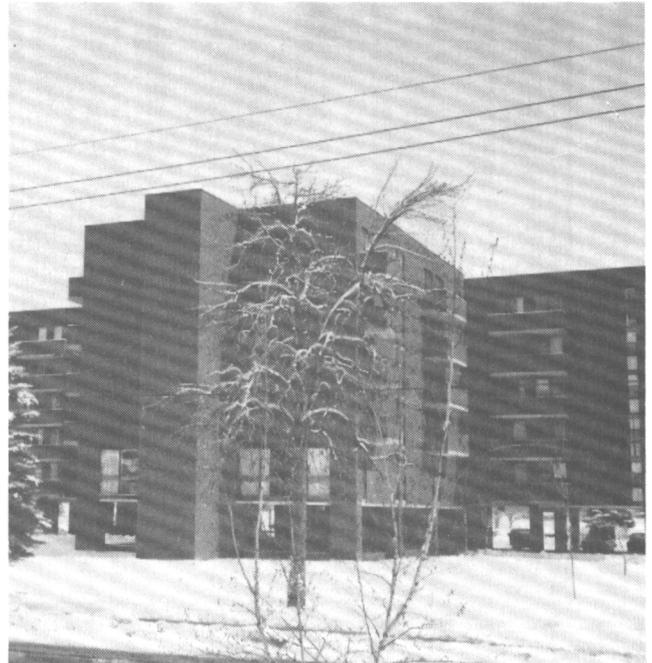
Structure elevated on columns and walls

The Kephart Plaza is a five-story cast-in-place concrete structure with a brick veneer exterior. Base flooding depth associated with the 100-year flood is approximately 9 feet. The ground elevation at the site is 557 msl and the finished floor elevation is 567 msl which places it about 1 foot above the base flood elevation. All utilities have been elevated to the first floor and access to the building is provided by stairs and an elevator. Floodproofing costs, including elevation of the utilities, was about \$100,000 (1979) or 5% of the total project cost. The open space beneath the building is utilized for parking, storage and picnic facilities. Flood warnings at this site are issued from warning sirens at a nearby fire station.

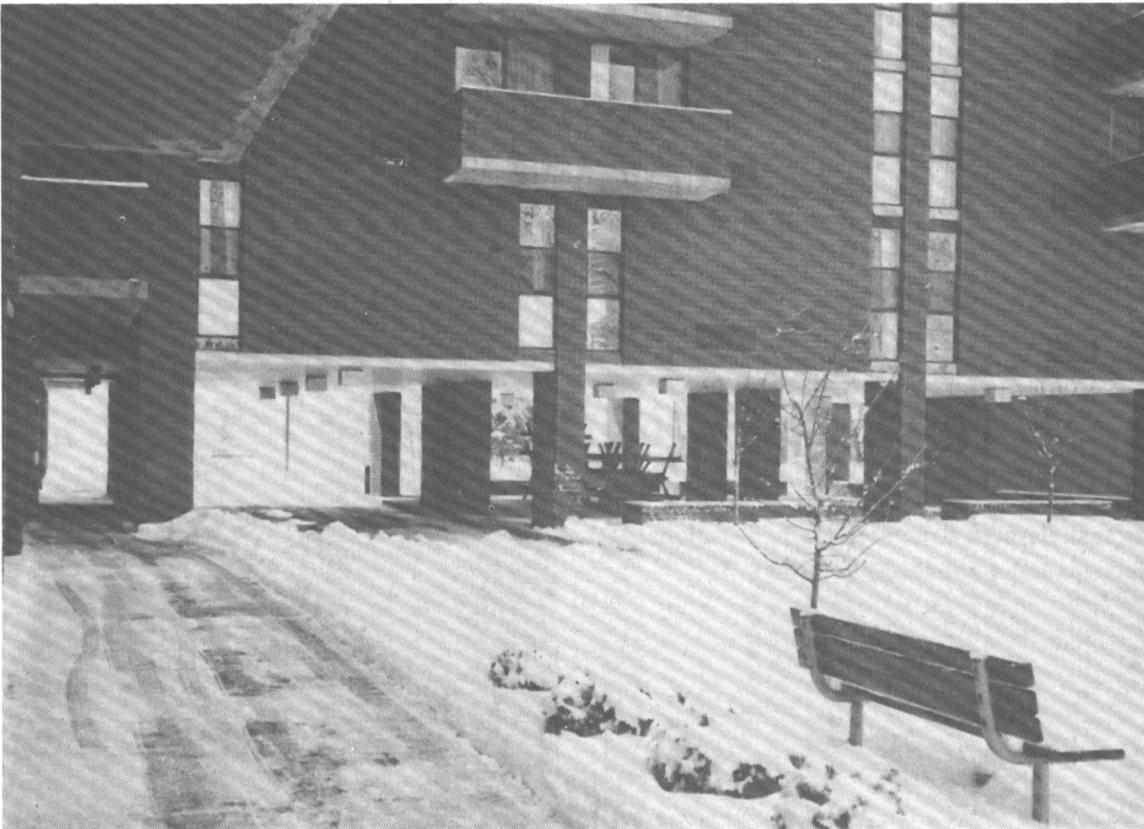
Area under the structure is used for outdoor activities and storage.

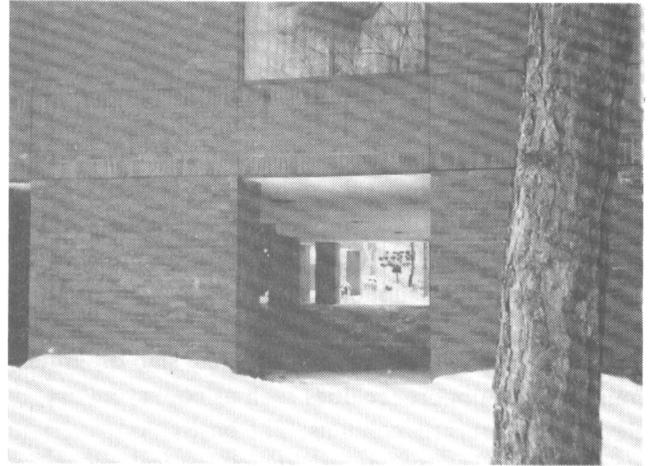
Combined use of wall and columns minimize visual impacts of 12 foot elevation height.

The Ross Library building is a 2-story cast-in-place structure with a brick veneer exterior. Because of the need in this case to reduce the impact of building placement on the floodwater depth or flow, the front and one side of the building have been elevated on walls and the balance of the structure is supported by columns. The first finished floor has been elevated approximately 12 feet, 7 feet above the base flood elevation, to reflect the severe losses that would be incurred at the library if a flood exceeded the 100-year level. The cost of elevation was approximately \$100,000 (1978).

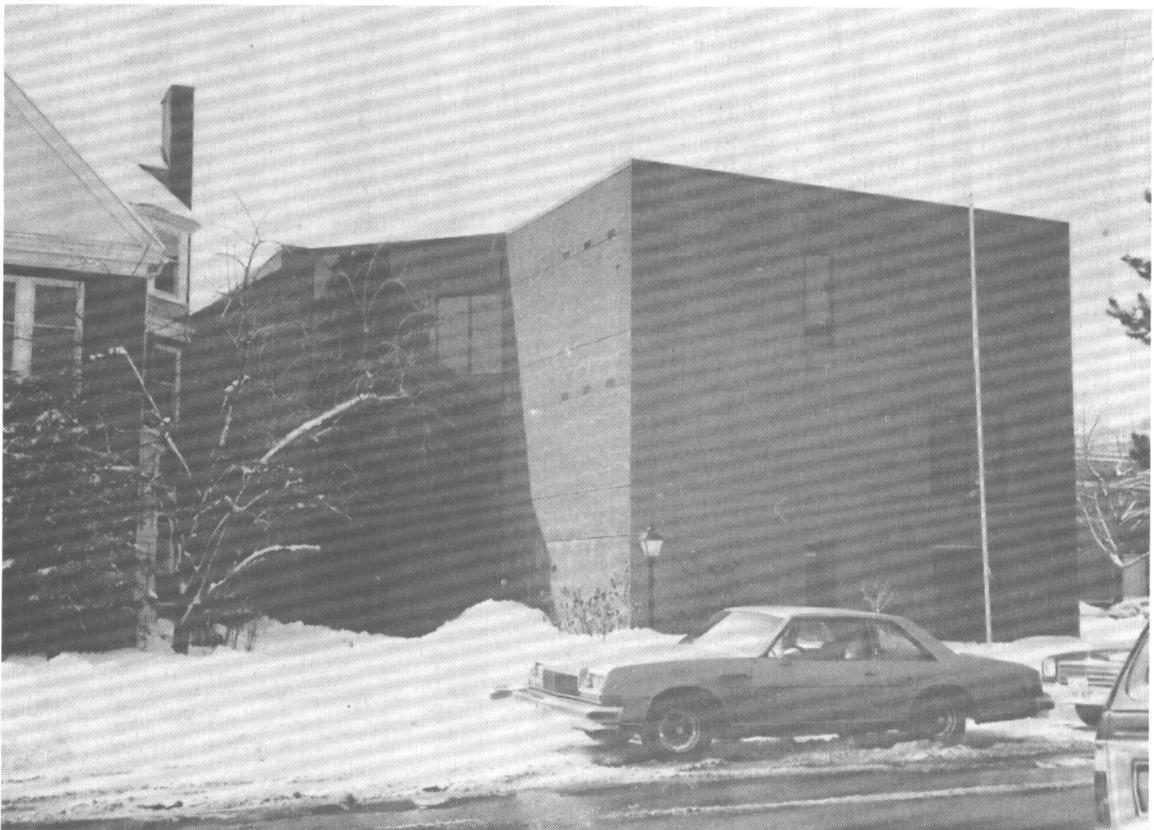
Structure has been elevated 7 feet above the base flood level in recognition of potential damage from floods that exceed the regulatory flood level.
