CHAPTER VI

TYPICAL APPLICATIONS OF FLOODPROOFING TECHNIQUES

A. INTRODUCTION

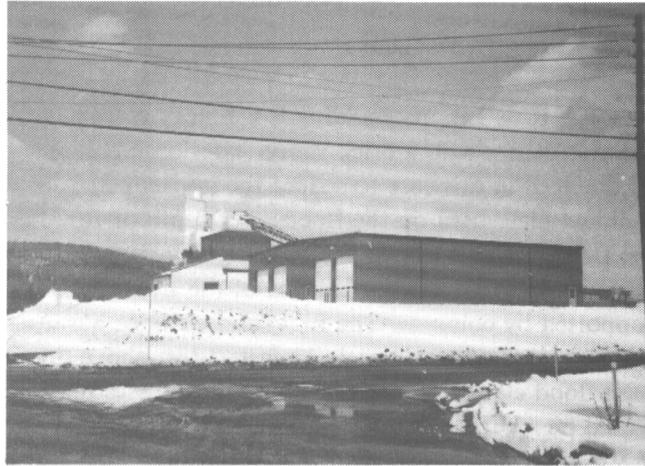
Garage structure elevated on earth fill.

The Centre Concrete Company is located in the flood fringe. Two buildings have been constructed on fill at the Centre Concrete site including a 6,150 square-foot control building and a 6,400 square-foot garage. The control building is of concrete block construction and is supported by fill which has been placed behind a concrete retaining wall. The garage is a four-bay metal building on a concrete slab-on-grade foundation. Support facilities such as conveyors are elevated on concrete columns. The base flood elevation at this site is approximately 10 feet above the original ground elevation. The cost of additional fill for the site was \$6.00 per cubic yard for a total cost of approximately \$120,000 (1981)

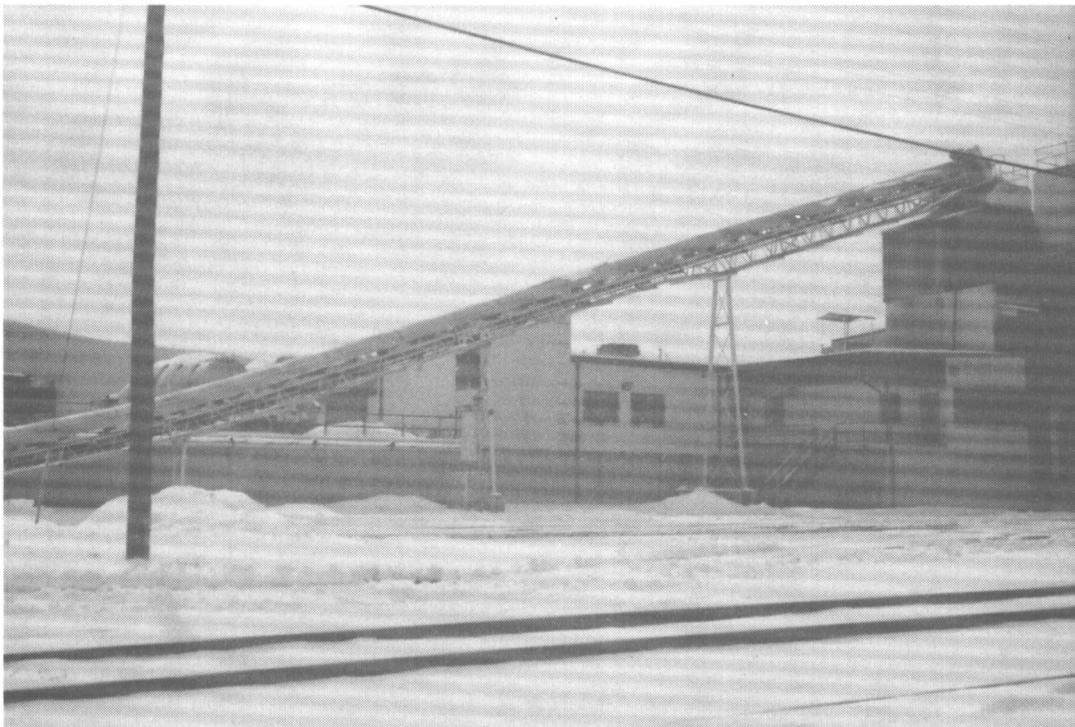
Control building is elevated on earth fill that is enclosed by concrete retaining walls. This technique minimizes space requirements because areas for slope transition are not required.

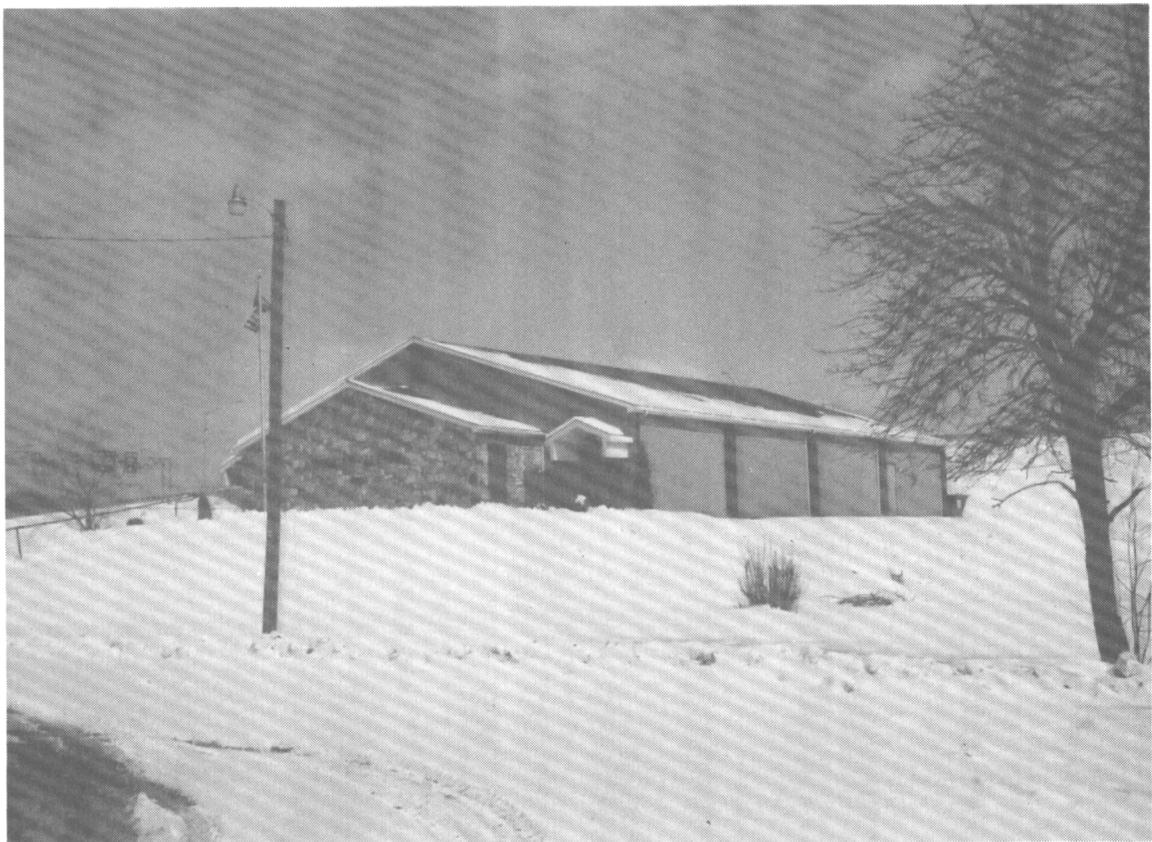
**American Legion Hall
Lock Haven, Pennsylvania**

The American Legion Hall in Lock Haven is a concrete block building that has been elevated approximately 10 feet on fill. The finished floor is located one foot above the base flood elevation. Earth fill was delivered to the site at a cost of \$2.00 per cubic yard for a total cost of \$4300 (1979), or 3% of the total building cost of \$150,000 (1979).

Structure elevated approximately 10 feet on earth fill for approximately 3% of the total project cost.
