3 NONSTRUCTURAL SURVEY PROCEDURES

NONSTRUCTURAL EXAMPLES: EARTHQUAKE DAMAGE AND UPGRADE DETAILS

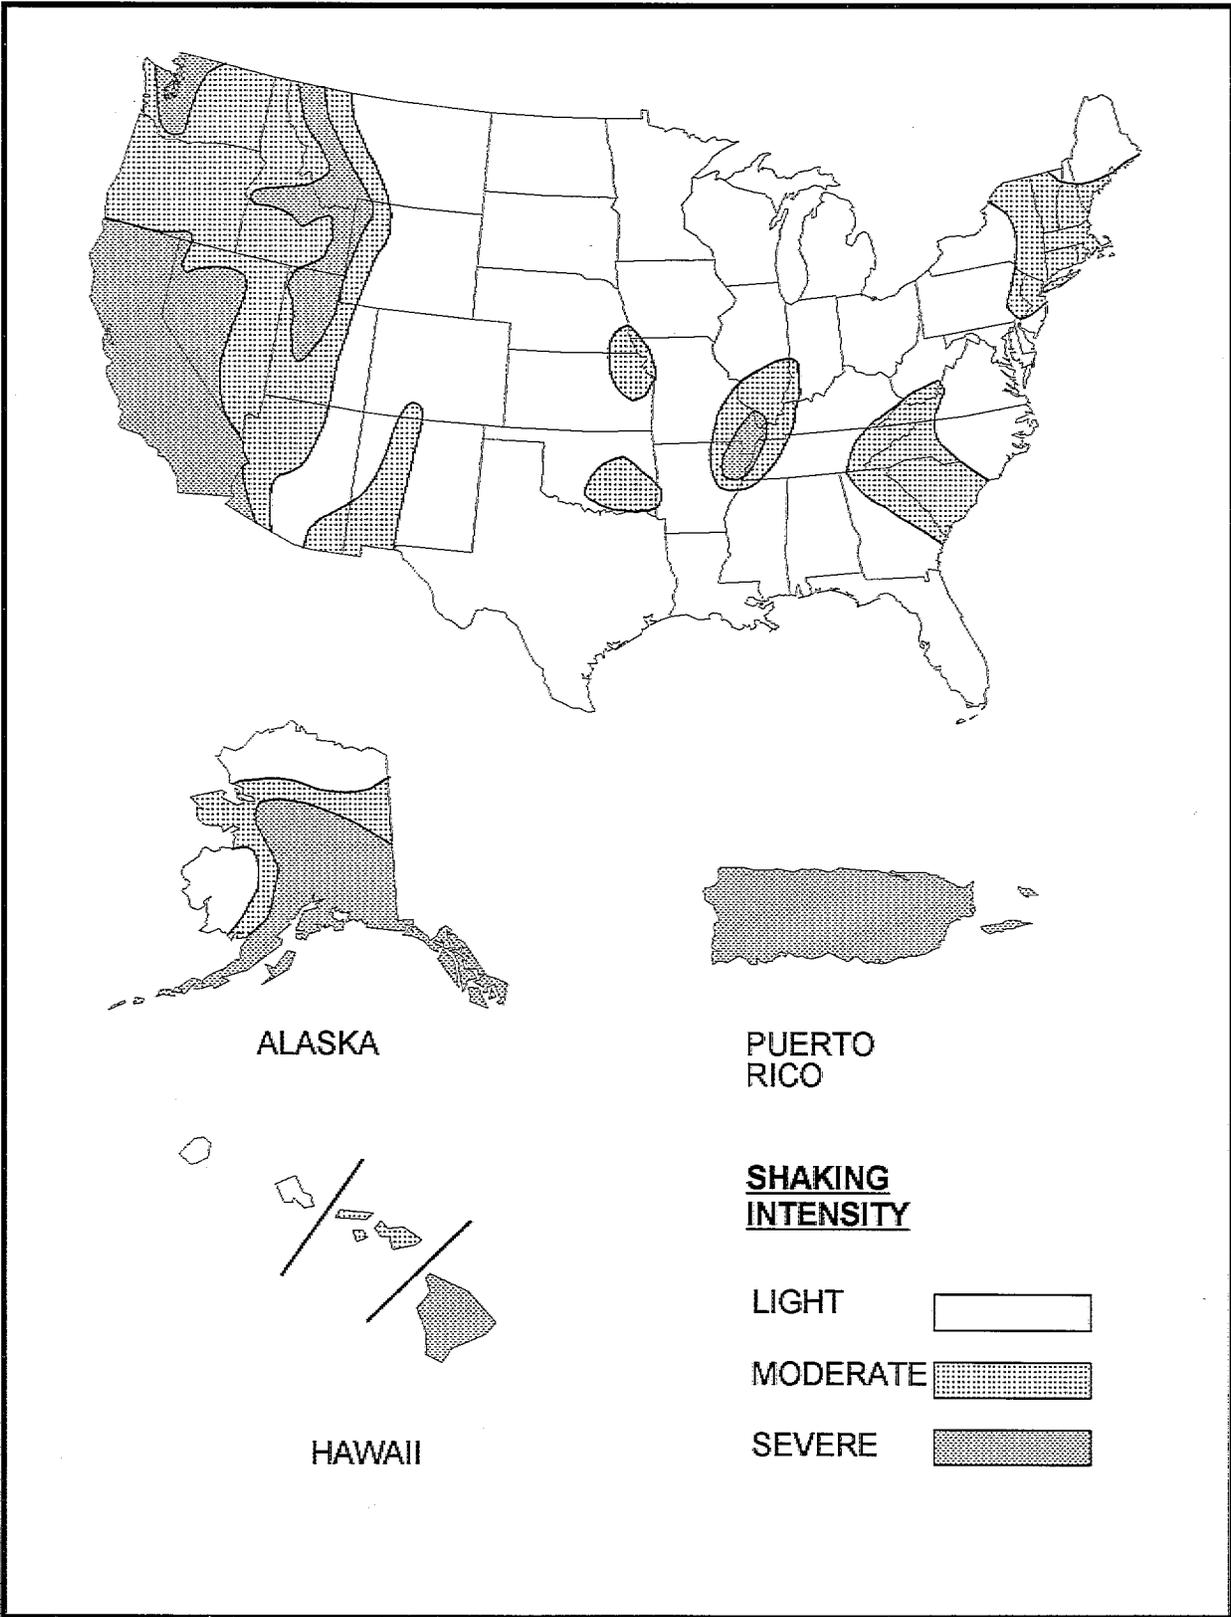
Figure 7 - Map of Probable Shaking Intensity for the United States

Note: There is approximately a 10% chance in 50 years that any given site will experience the shaking intensity shown. Map adapted from the following sources: 1991 NEHRP Recommended Provisions (primary source) and 1994 Uniform Building Code (basis for western states).

Estimating the Shaking Intensity For the purposes of this nonstructural survey, the seismic risk, or shaking intensity, for a particular geographic location may be estimated by using the seismic maps shown in Figure 7. This figure shows the areas in the United States that are likely to experience light, moderate, or severe ground shaking during a future earthquake. Some of the areas that may experience severe shaking are California; the area near New Madrid, Missouri; the islands of Hawaii, Puerto Rico, and Guam (not shown); and portions of western Washington and southern Alaska. Locations such as southern Illinois, South Carolina, and much of New England may experience moderate shaking, although most of the Continental United States east of the Rockies will likely experience light shaking.

Shaking-intensity estimates based on the seismic risk maps in Figure 7 should be adequate for items situated at or near the ground in simple, nonessential facilities. For other situations, it may be advisable to choose the next higher shaking intensity or to seek the advice of professional consultants.

for complex facilities is recommended is that the seismic risk maps in Figure 7 do not take any of these additional factors into consideration. Clearly, the complexity and detail of engineering calculations should be commensurate with the complexity and importance of the facility and the item in question.

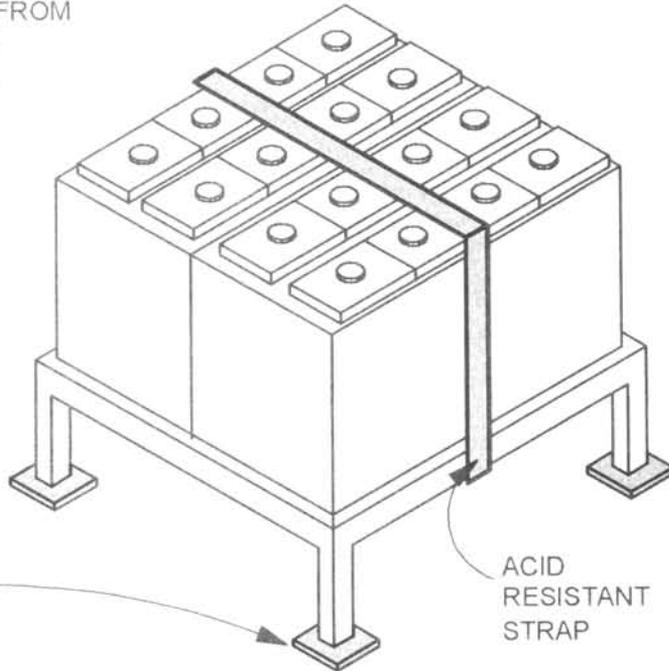
SEISMIC RESISTANT BATTERY RACKS ARE AVAILABLE FROM VENDORS THAT MAY BE BOLTED TO THE FLOOR AND/OR WALL.

BOLTED TO FLOOR.
BRACING OF LEGS
MAY BE REQUIRED.

ACID
RESISTANT
STRAP

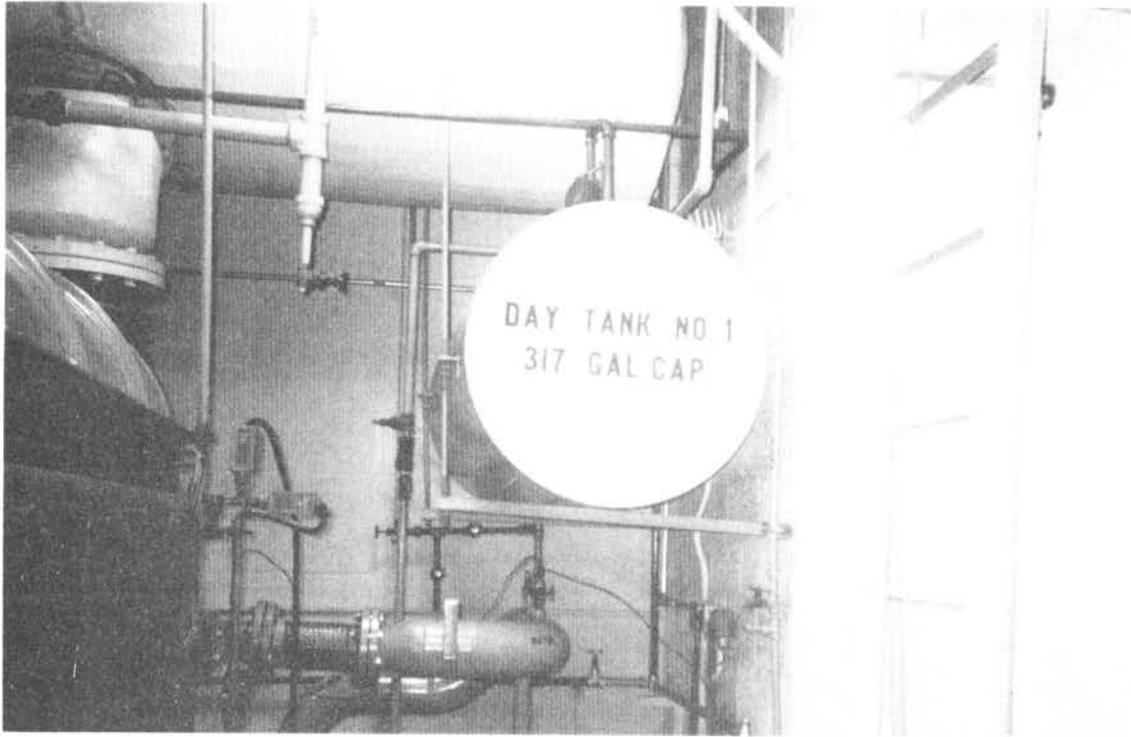
Unbraced Day Tank, Hospital, Puerto Rico
Photo Credit: Wiss, Janney, Elstner Associates, Inc.

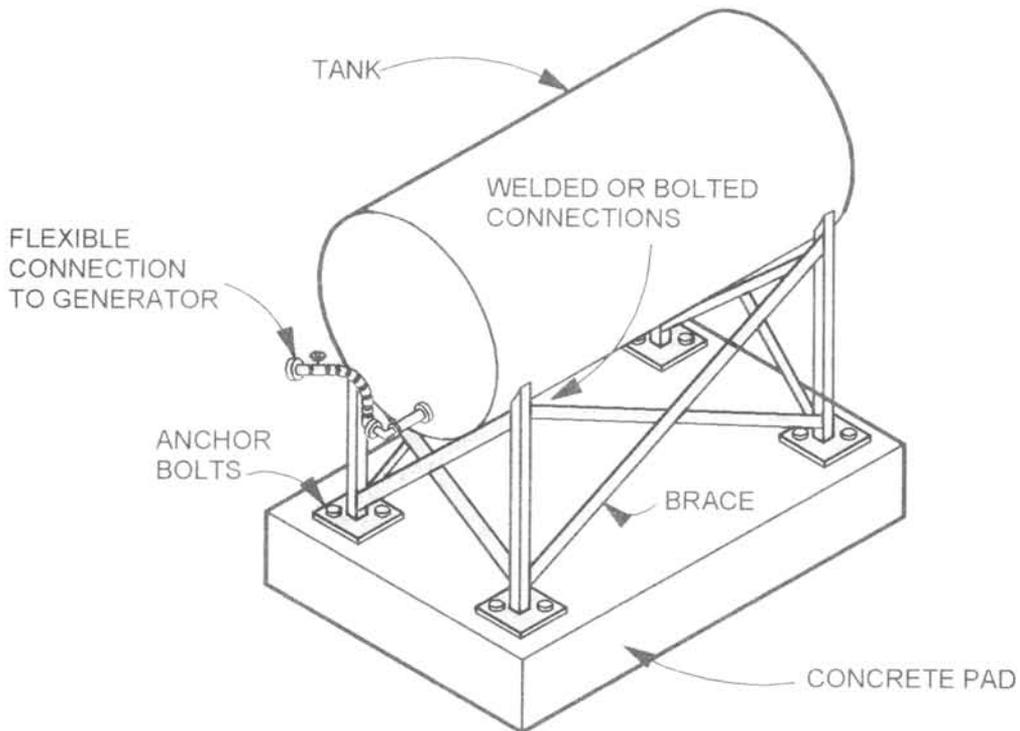
Schematic Upgrade Detail U3
Approximate Cost: \$500 - \$1000

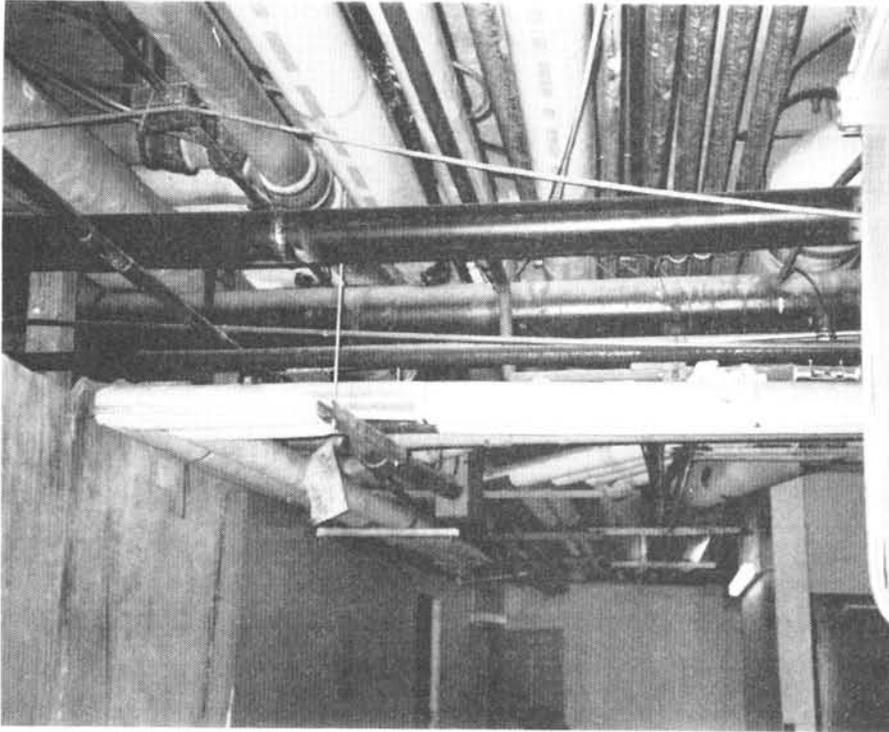
Unbraced Overhead Conduit and Pipes

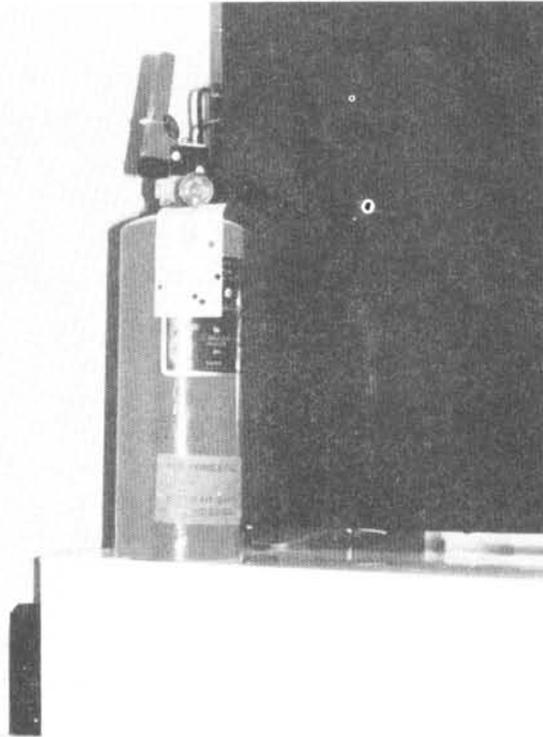
Unrestrained Extinguisher

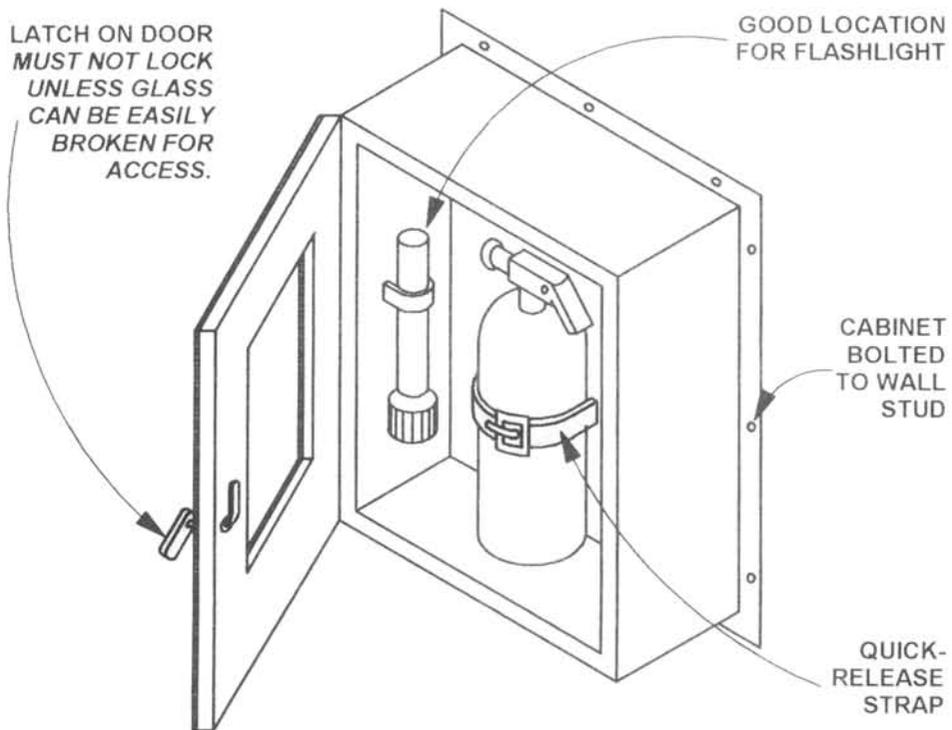
Upgrade Detail U10

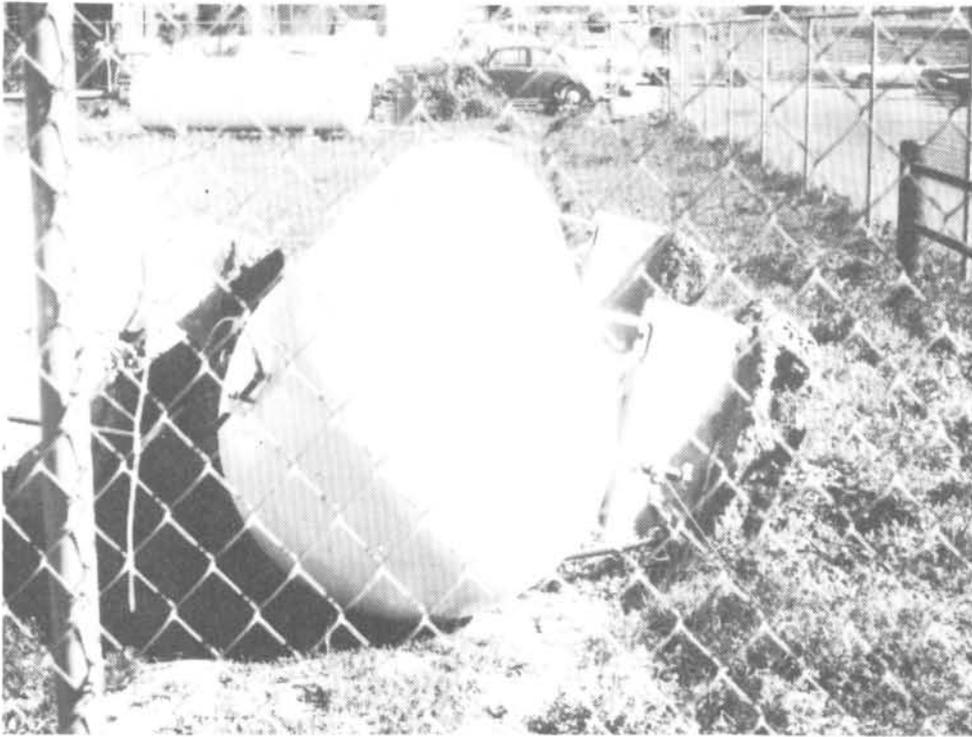
Earthquake Damage: 1971, San Fernando, California
Photo Credit: Scientific Service, Inc.

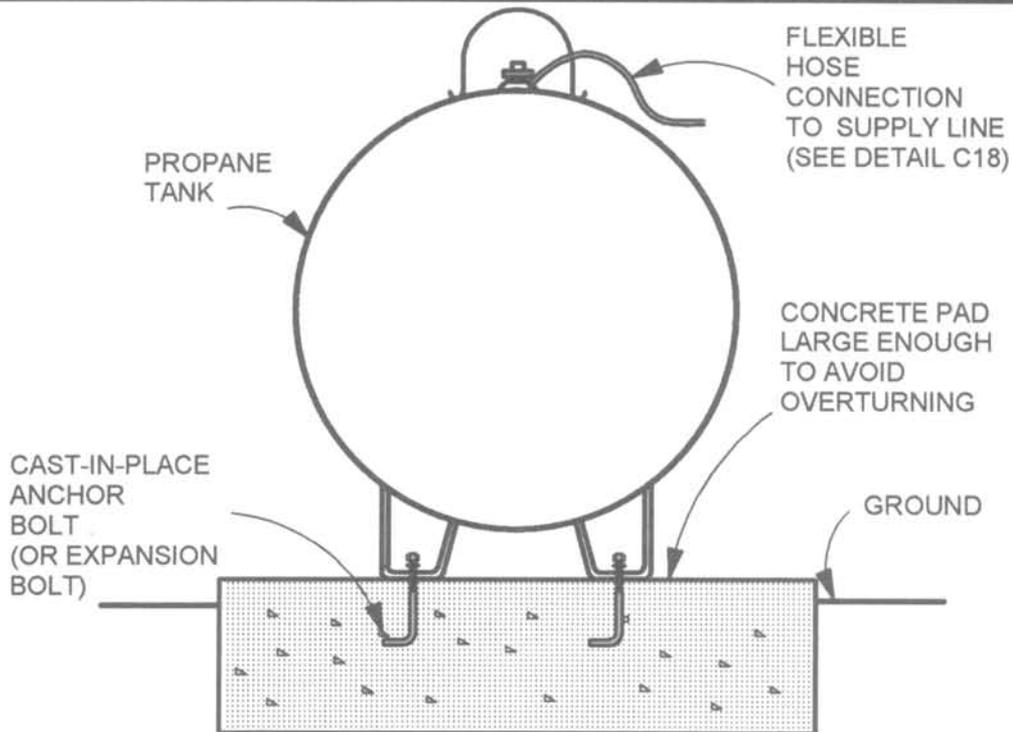
Schematic Upgrade Detail U15
Approximate Cost: \$900

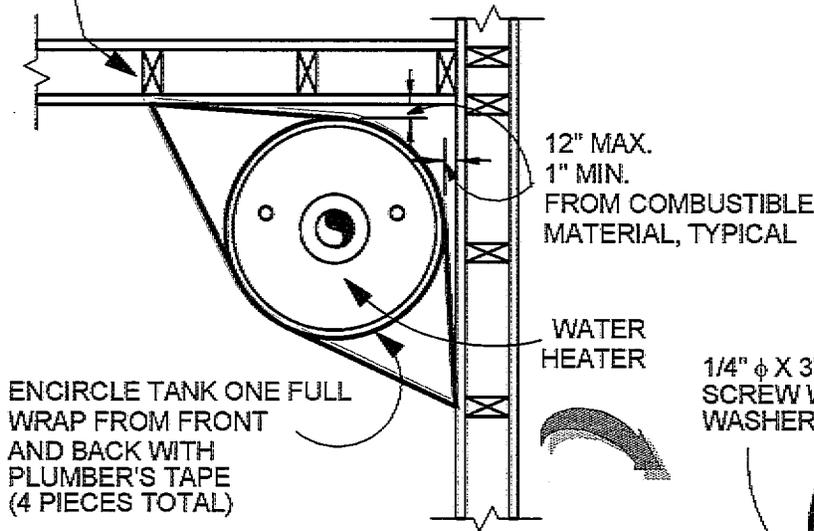
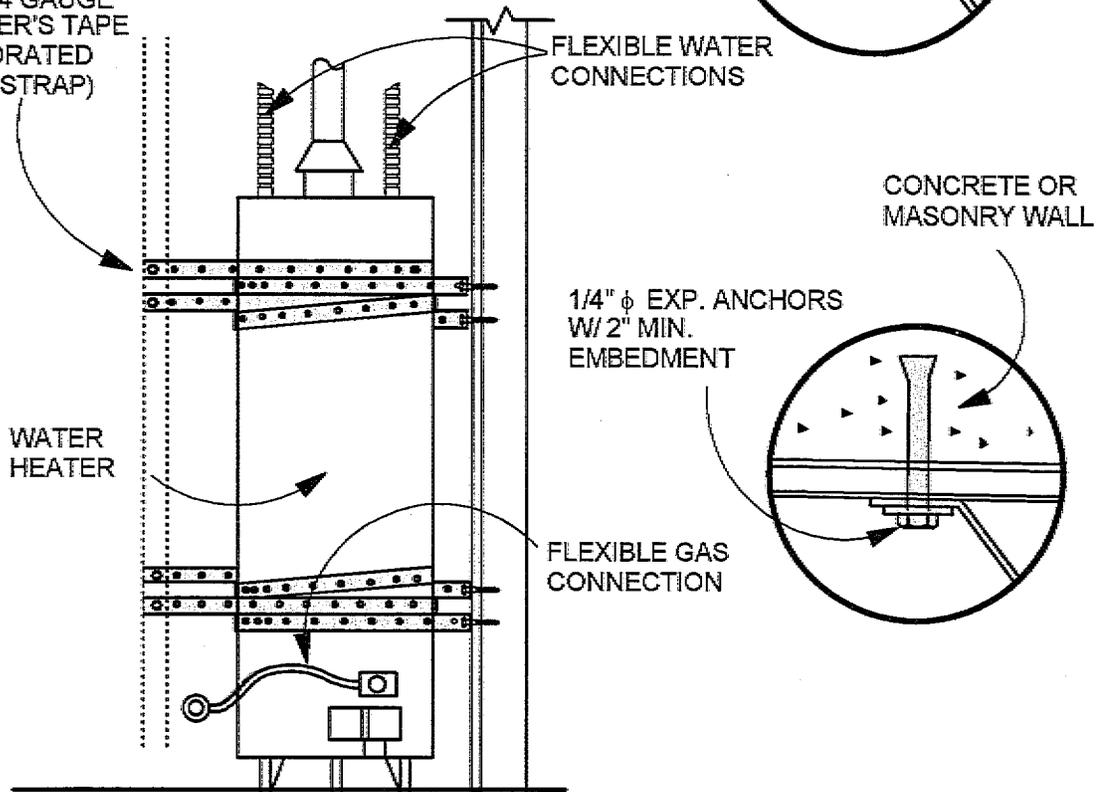
FIRST STUD NOT BEHIND HEATER

3/4" X 24 GAUGE
PLUMBER'S TAPE
(PERFORATED
METAL STRAP)

Upgrade Detail U19a

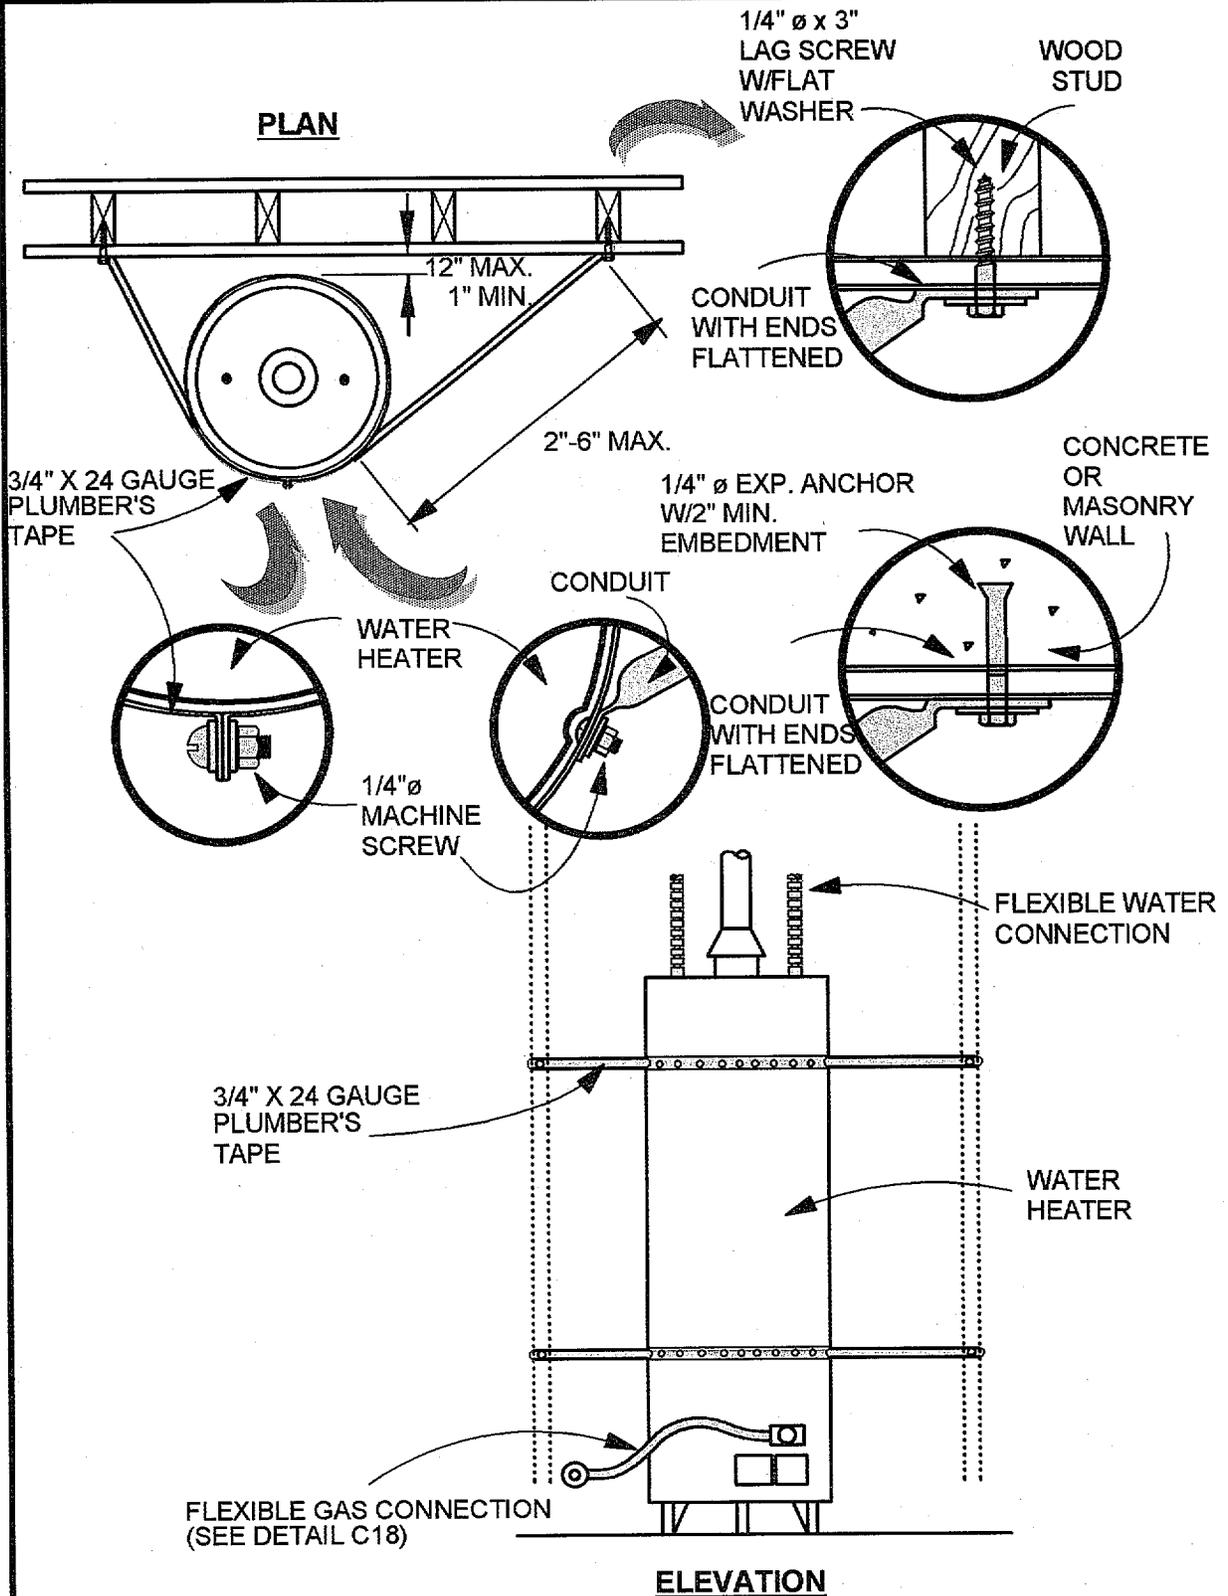
WATER HEATER: WALL INSTALLATION

Upgrade Detail U19b
Approximate Cost: \$200

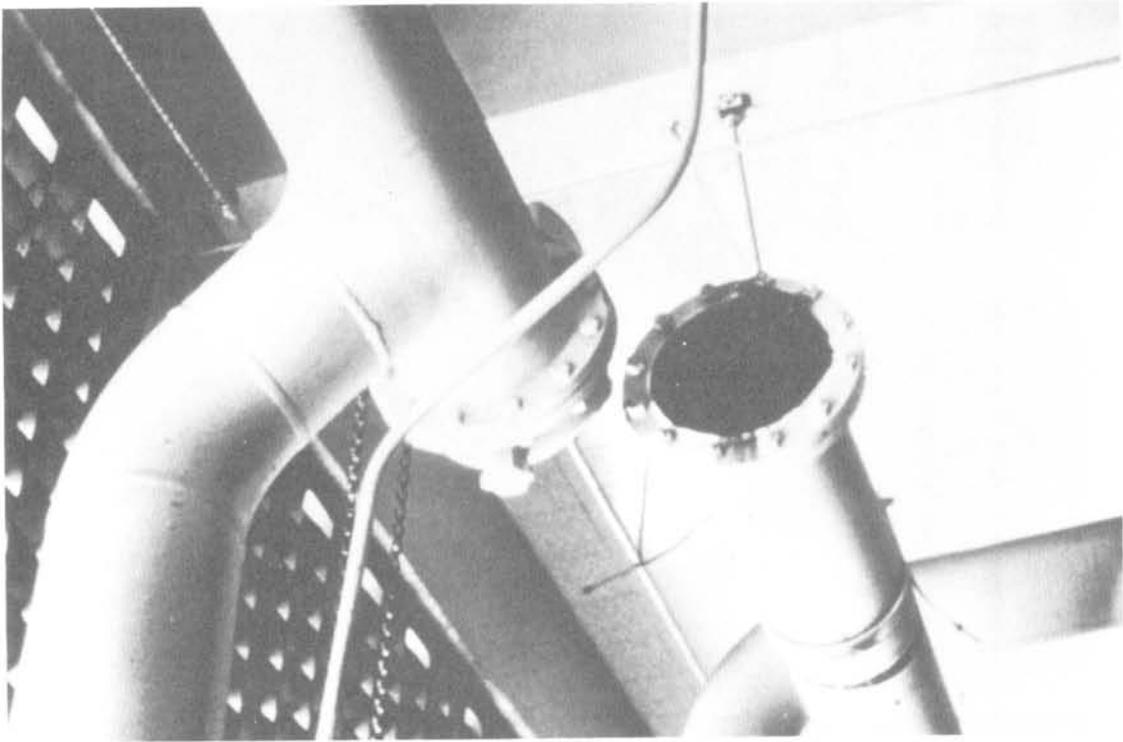
Earthquake Damage: 1971, San Fernando, California
Photo Credit: John F. Meehan

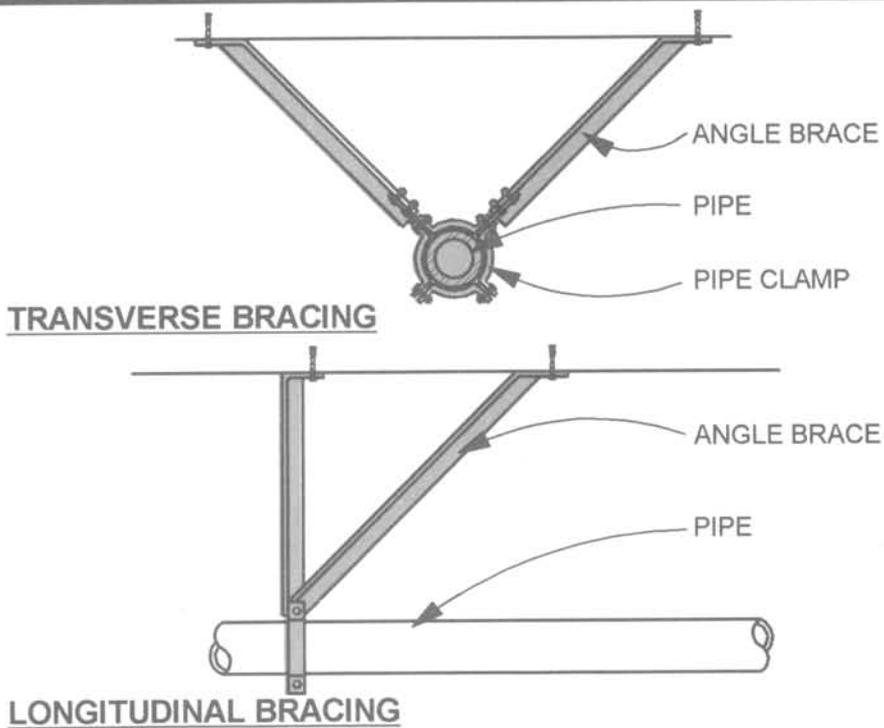
Schematic Upgrade Detail U21

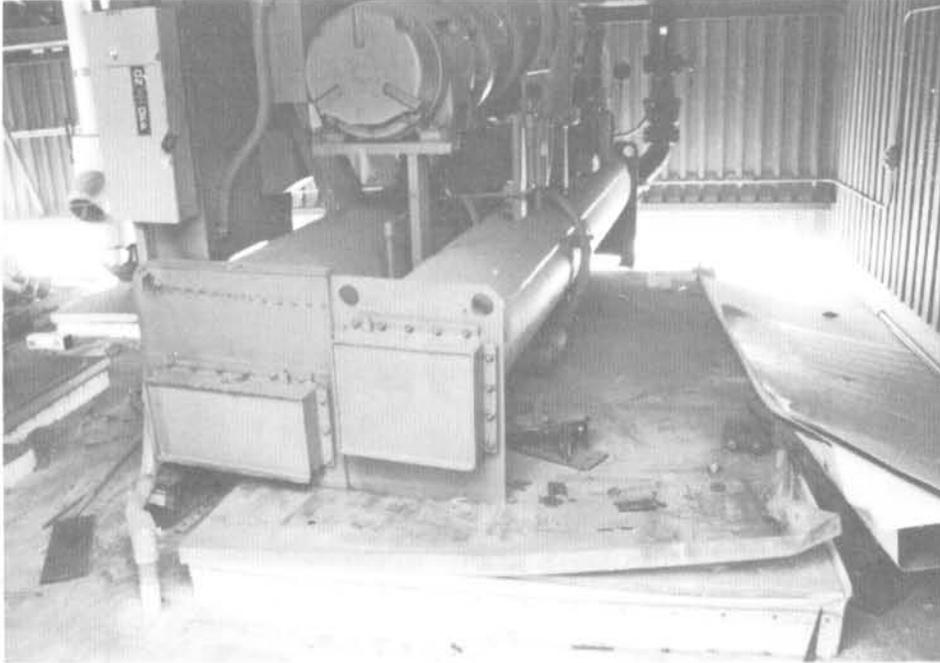
Failed chiller mounts due to insufficient uplift resistance.
Earthquake Damage: 1994, Northridge, California
Photo Credit: Wiss, Janney, Elstner Associates, Inc.

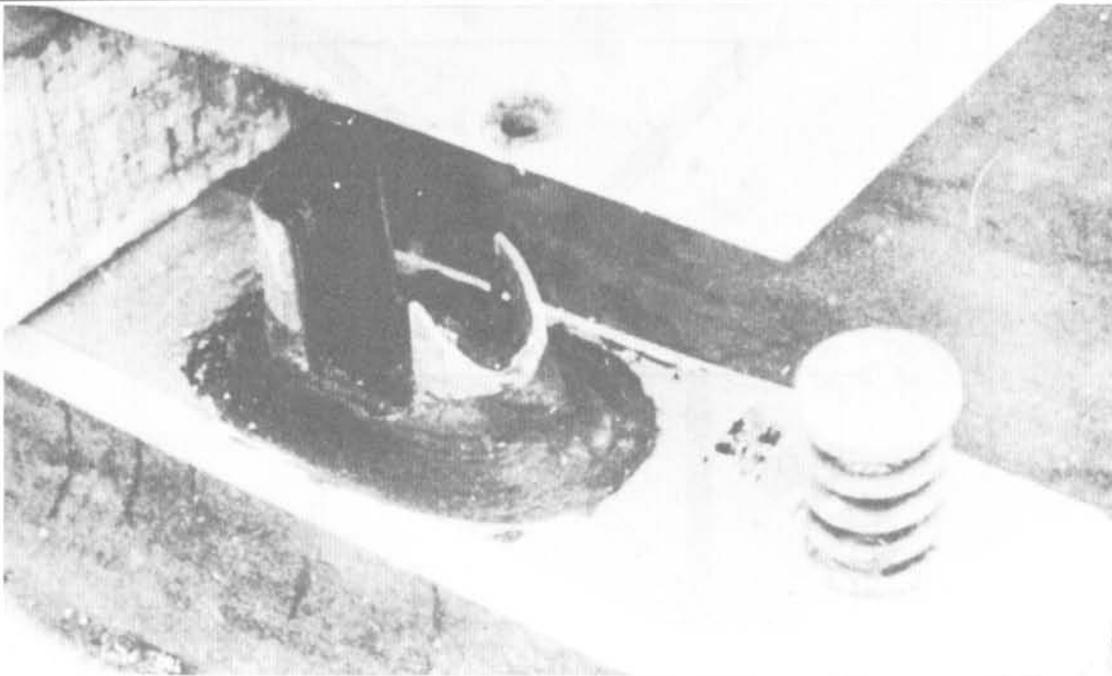
Failed chiller due mount due to insufficient shear resistance.
Earthquake Damage: 1980, Livermore, California
Photo Credit: William T. Holmes

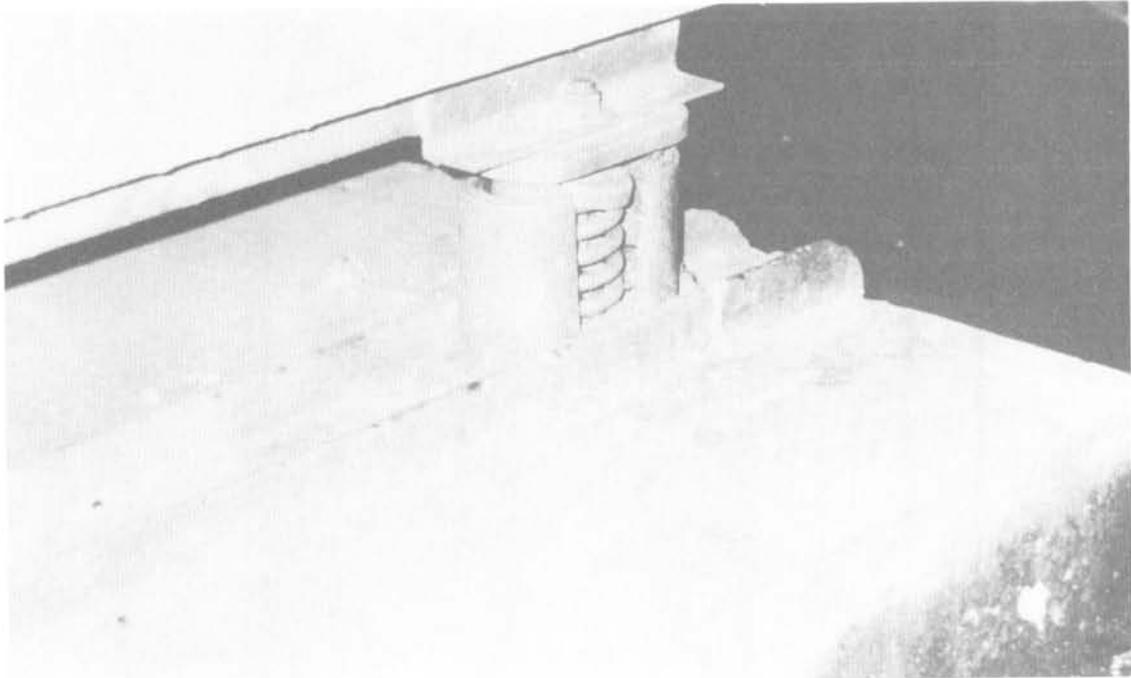
Chiller mount with no uplift resistance and insufficient shear resistance.
Photo Credit: Wiss, Janney, Elstner Associates, Inc.

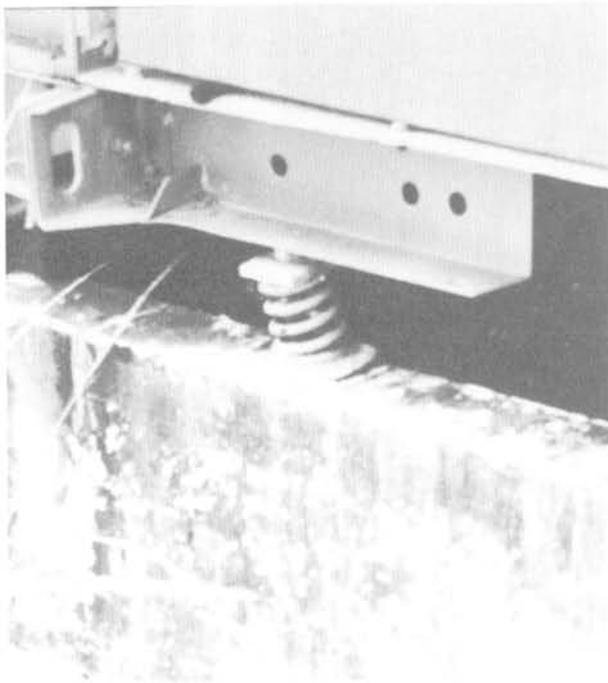
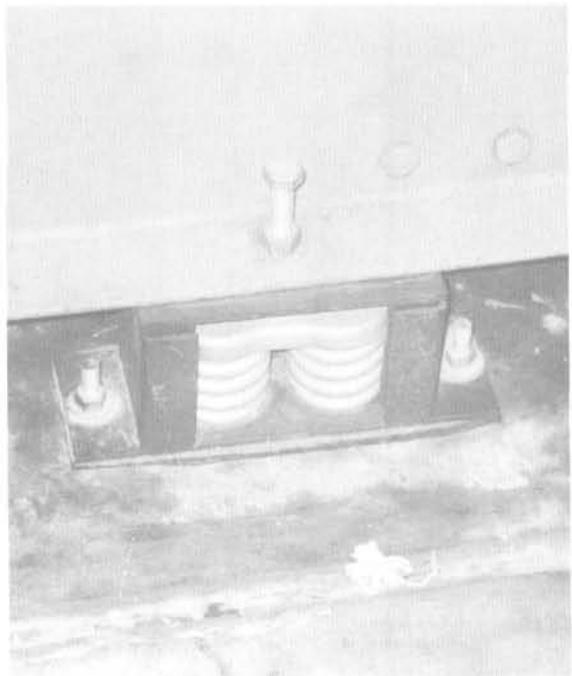
Chiller mount with no uplift resistance and insufficient or no shear resistance.
Photo Credit: Wiss, Janney, Elstner Associates, Inc.
Schematic Upgrade Detail: See Detail U32, Air Compressor

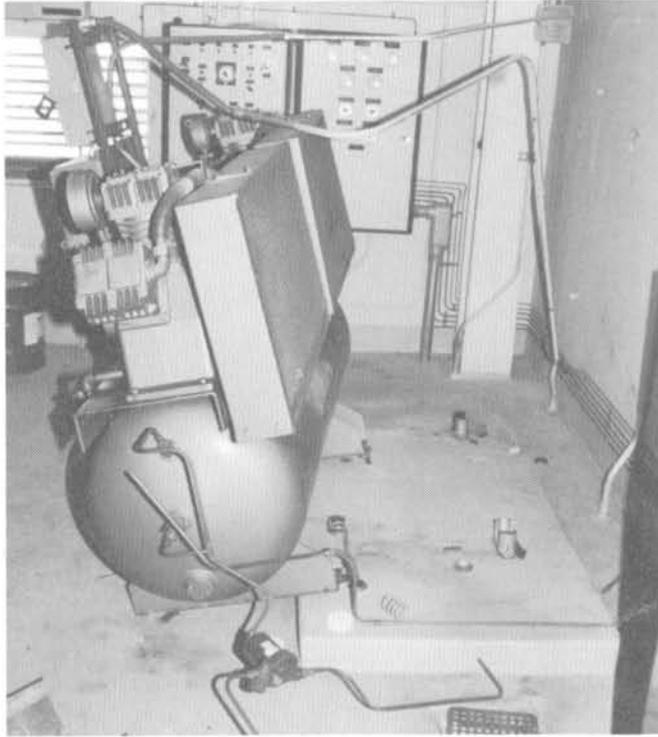
Earthquake Damage: 1994, Northridge, California
Photo Credit: Wiss, Janney, Elstner Associates, Inc.

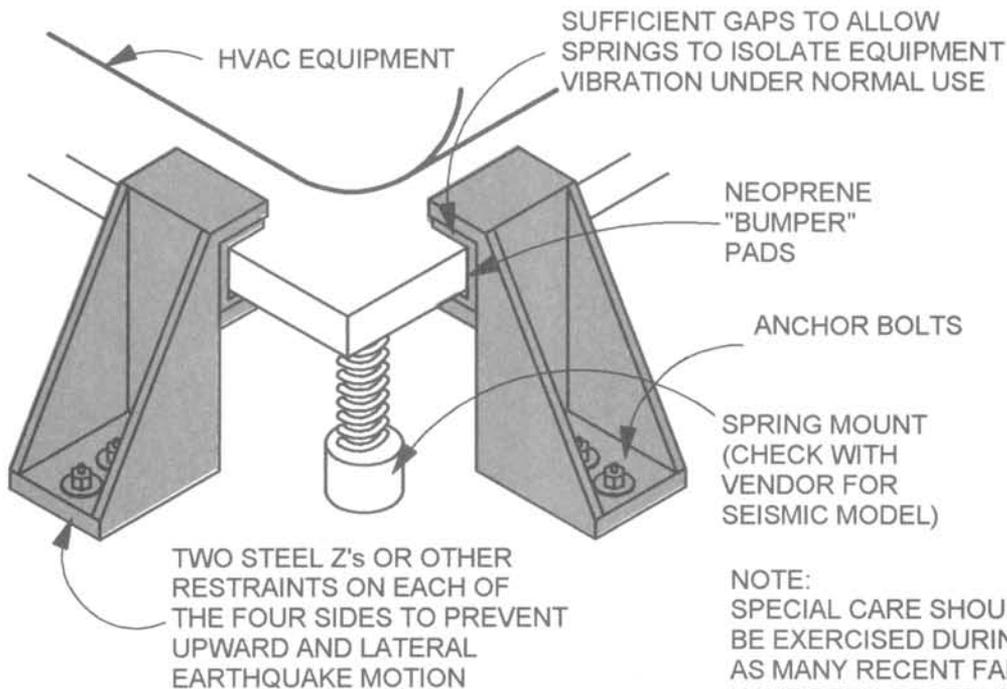
Schematic Upgrade Detail U32

Schematic Upgrade Detail: See Detail U32, Air Compressor

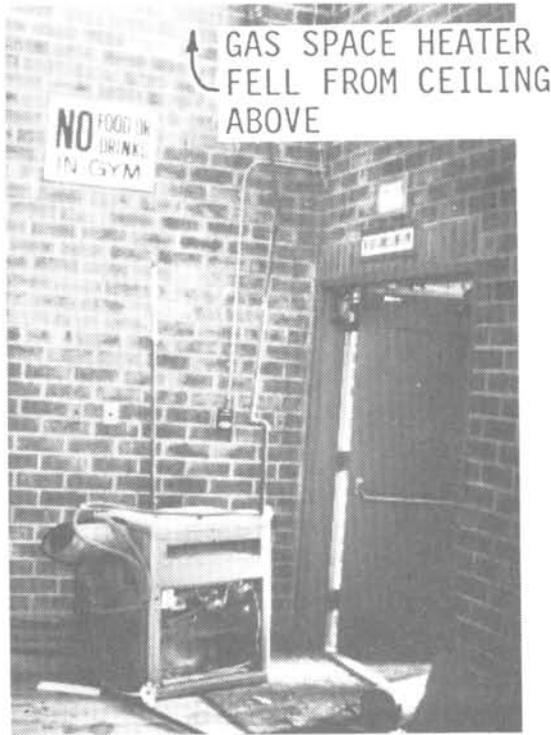
Earthquake Damage: 1971, San Fernando, California
Photo Credit: C. Wilton, Scientific Service, Inc.

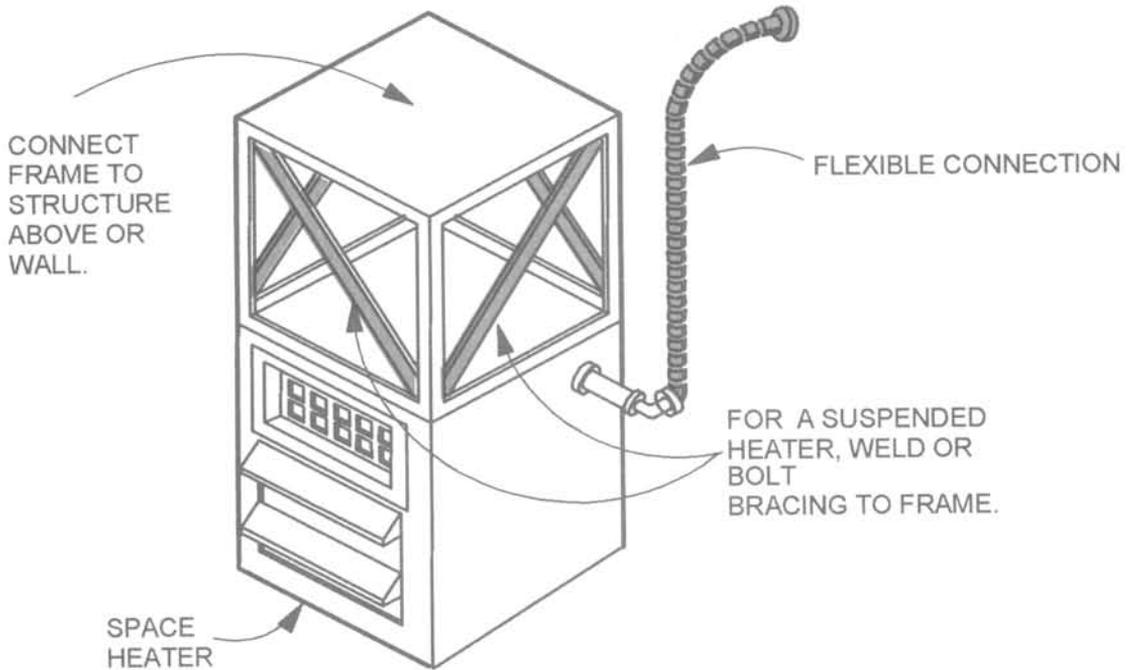
Schematic Upgrade Detail U35
Approximate Cost: \$200

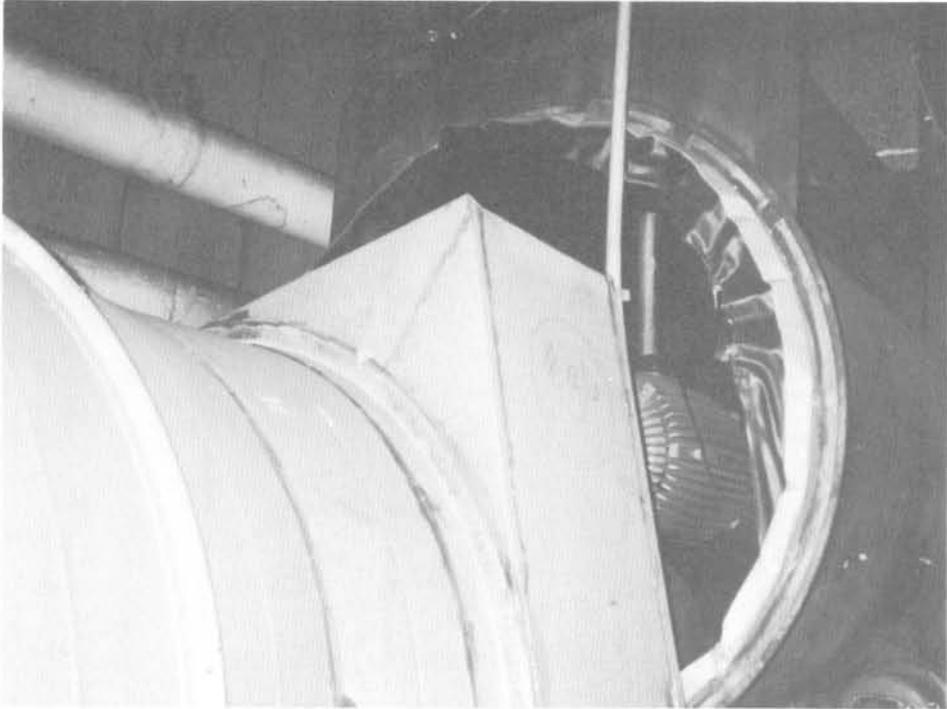
Sheet metal duct separated from fan unit.
Earthquake Damage: 1994, Northridge, California
Photo Credit: Wiss, Janney, Elstner Associates, Inc.

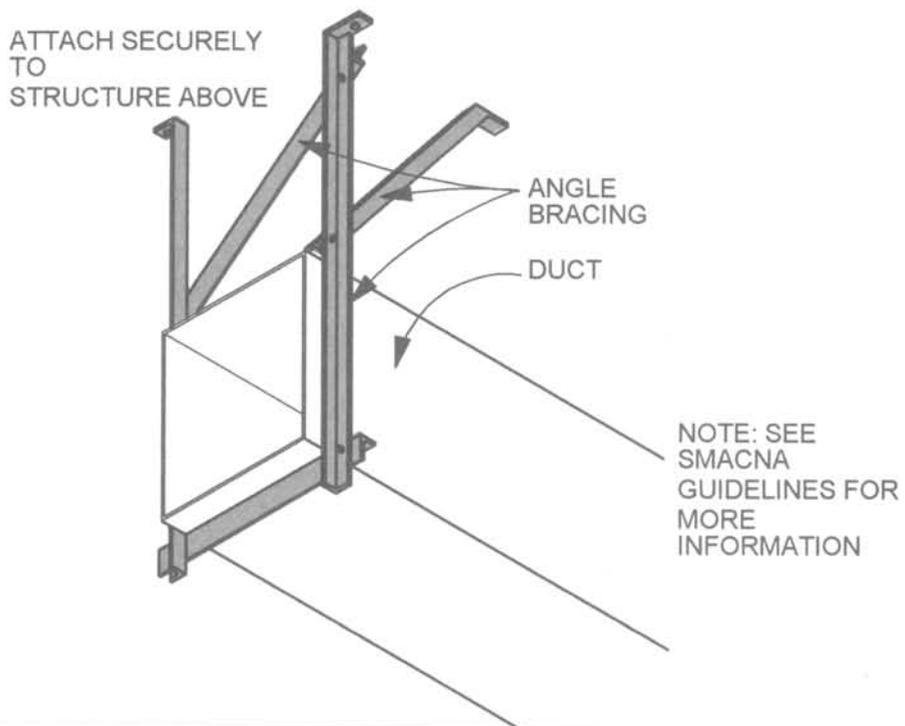
Schematic Upgrade Detail U36
Approximate Cost: \$200 - \$500 per support

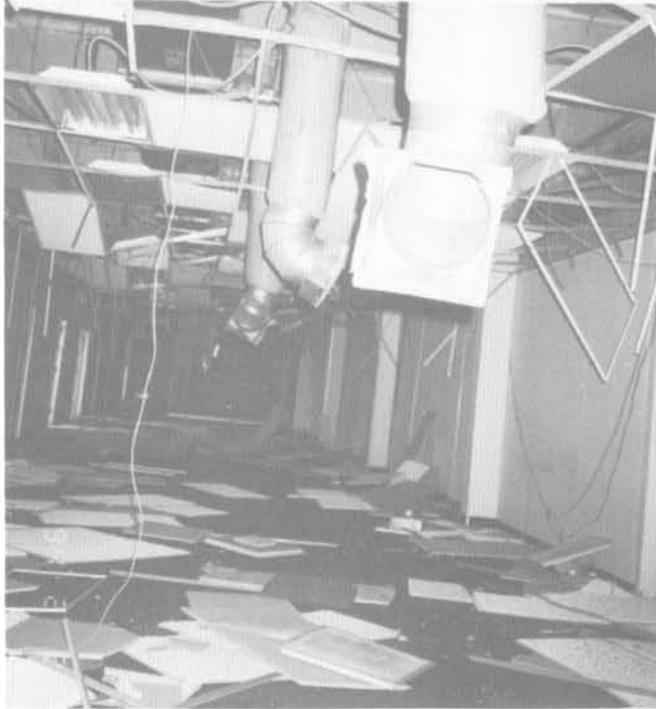
Air diffusers fell to the floor.
Earthquake Damage: 1994, Northridge, California
Photo Credit: Wiss, Janney, Elstner Associates, Inc

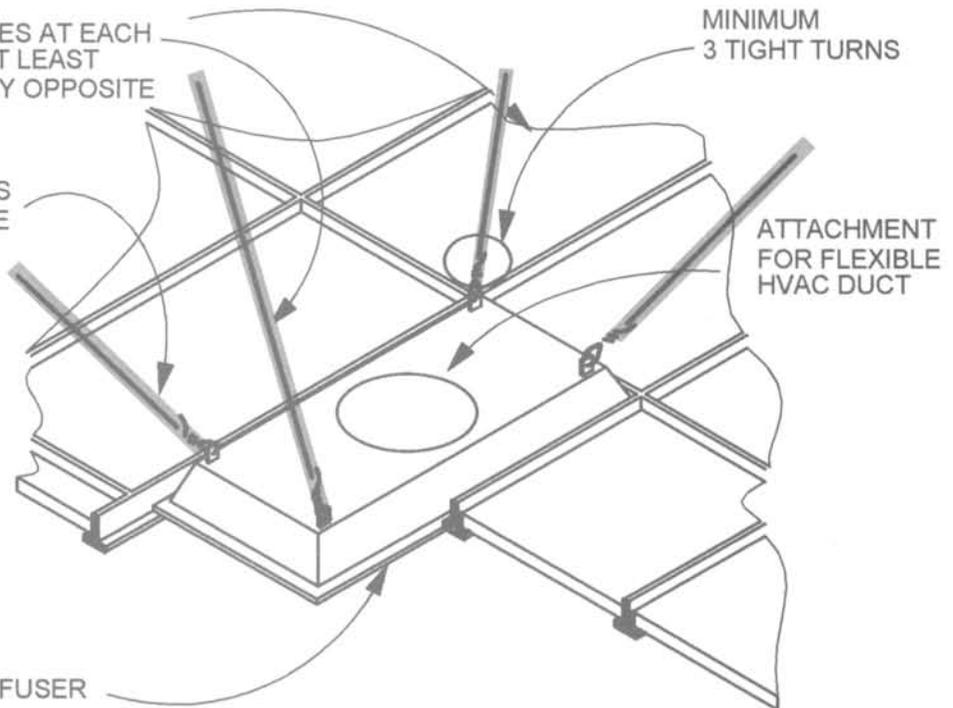
12 GAUGE WIRES AT EACH
CORNER OR AT LEAST
AT DIAGONALLY OPPOSITE
CORNERS

ATTACHMENT
FOR FLEXIBLE
HVAC DUCT

DIFFUSER

Upgrade Detail U37
