# Guidelines for Wind Vulnerability Assessments of Existing Critical Facilities

FEMA P-2062 / September 2019

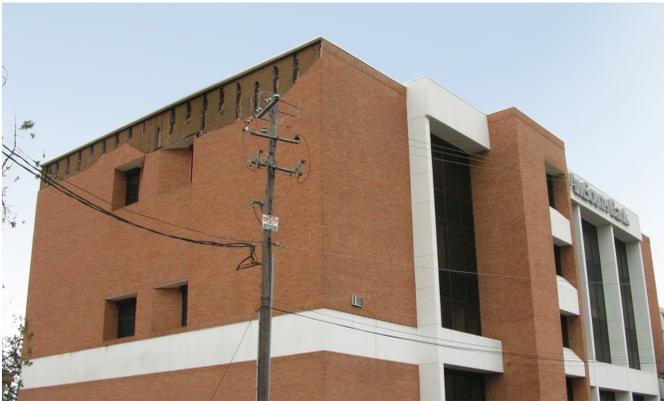
Figure 1-1:  
Brick veneer collapse due to tie corrosion.  
Hurricane Ivan (Florida, 2004) (FEMA 489)

or roof is damaged, the undamaged areas can be assessed to determine whether they are vulnerable to damage; and, if they are, the areas could be mitigated. On the building shown in **Figure 1-1**, a portion of brick veneer on one facade collapsed because of tie corrosion. If this corrosion occurred on the undamaged walls, it would be prudent to mitigate the tie corrosion on the undamaged walls instead of waiting for them to collapse during a future storm.

- **Mild impact.** The facility has no damage or only minor damage and is operational.
- **Moderate impact.** The facility is damaged and needs some repair, but most or all of the facility is functional. A few injuries to occupants may be life-threatening, but injuries are generally moderate in nature and number. The likelihood of a single life lost is low, and the likelihood of multiple lives lost is very low. Moderate impact is illustrated by **Figure 1-1**, **Figure 1-4**, and **Figure 1-5**.

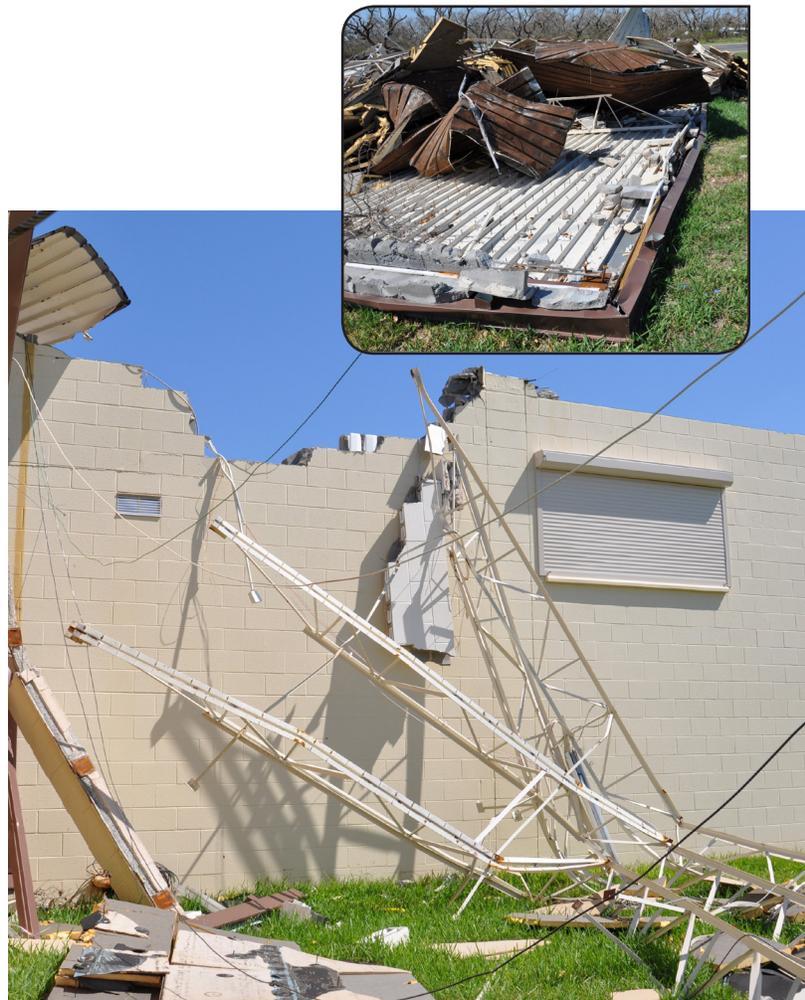
**Figure 1-2:** Much of the roof structure was blown off of this building. The steel roof deck was welded to steel joists that were supported by unreinforced concrete masonry unit (CMU)-bearing walls. The inset shows a large section of the roof assembly that was blown approximately 120 feet. The typical failure mode was uplifting of the joist bearing plates because the plate's studs were not grouted into the bond beam. There was no load path between the bond beam and the foundation. Hurricane Harvey (Texas, 2017) (FEMA P-2022)

- **Roof structure blow-off or collapse.** This type of failure typically occurs in buildings constructed before approximately 1990<sup>3</sup> or in buildings struck by a tornado (**Figure 1-2**).
- **Collapse of fire station apparatus bay doors in fire stations constructed before approximately 2000.**<sup>4</sup>
- **Glazing breakage from wind-borne debris generated by hurricanes or tornadoes.** At the hospital shown in **Figure 1-3**, 33 windows were broken, including windows in three of the eight intensive care unit (ICU) rooms and windows in other

- **Severe impact.** The facility is severely damaged and may need to be demolished. Significant collapse may have occurred. Most or all of the facility may not be functional. In facilities without a safe room or storm shelter, injuries may be life-threatening and high in number. The likelihood of a single life lost is high, and the likelihood of multiple lives lost is moderate. Severe impact is illustrated by the cover photograph, **Figure 1-2**, and **Figure 2-1**.

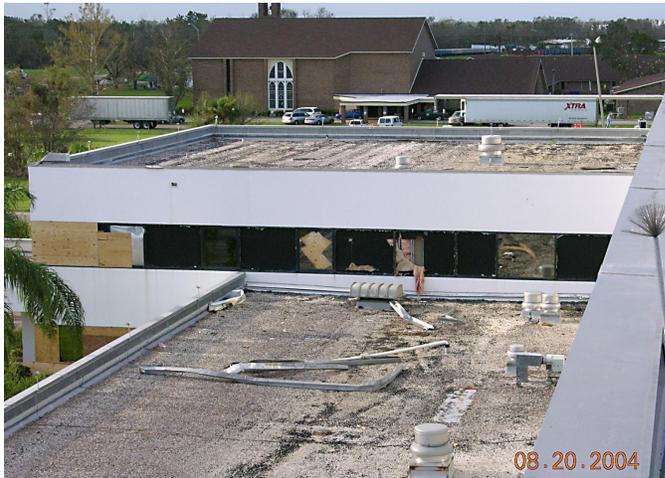
**Figure 1-3:**  
Wind-borne roof aggregate broke the glazing of this intensive care unit, requiring evacuation. Hurricane Charley (Florida, 2004) (FEMA 488)

High impact is illustrated by **Figure 1-3**, **Figure 1-6**, and **Figure 2-2**. At the six-story hospital shown in **Figure 2-2**, blow-off of metal wall panels on the elevator penthouse allowed water into the elevator equipment room, which destroyed the control

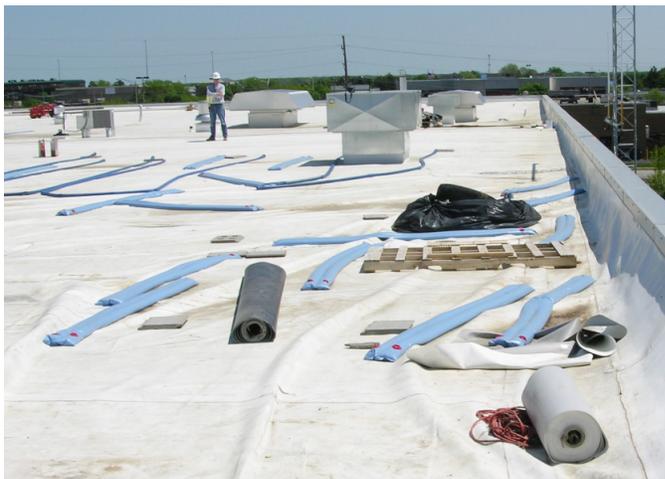
**Figure 1-4:**  
Detached roof membrane on a new police station.

- **Roof coverings.** **Figure 1-4** shows a roof membrane that was detached by winds that were well below the basic (design) wind speed. **Figure 1-5** shows a single-ply membrane that detached from the roof of a hospital in Puerto Rico. The membrane was a re-cover over a bituminous membrane. After the single-ply membrane blew off, water breached the cap sheet during the hurricane. Roof coverings are the most commonly damaged building element.
- **Rooftop equipment.** Equipment that is blown off (**Figure 1-6**) frequently leaves openings in the roof and often punctures the roof covering.

If the base flashing is mechanically attached, but the membrane is fully adhered at the roof, ballooning of the base flashing has high potential to cause lifting and peeling of the roof membrane (as shown in **Figure 1-4**).

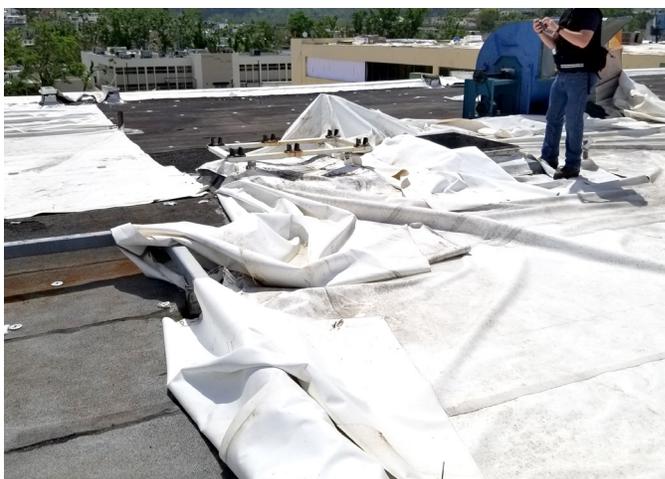
**Figure 1-5:**  
Detached roof membrane over hospital. Hurricane Maria (Puerto Rico, 2017) (FEMA P-2020)

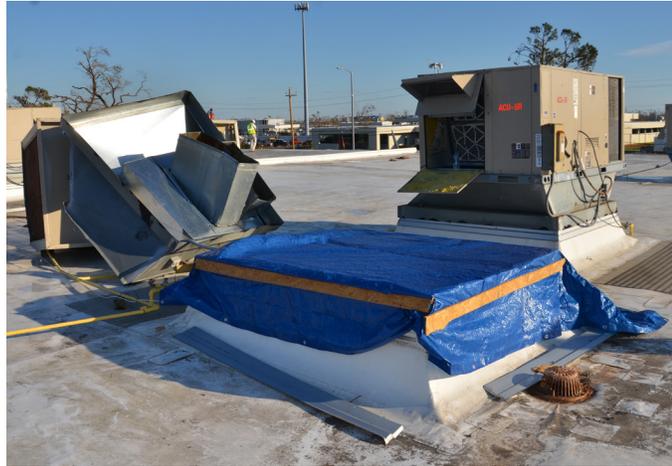
**Figure 1-6:**  
 The heating, ventilation, and air conditioning (HVAC) unit in the foreground was not fastened to the curb. A substantial amount of water entered the police station where equipment was blown off. Lack of unit attachment is very easy to detect during a wind vulnerability assessment. Hurricane Michael (Florida, 2018)

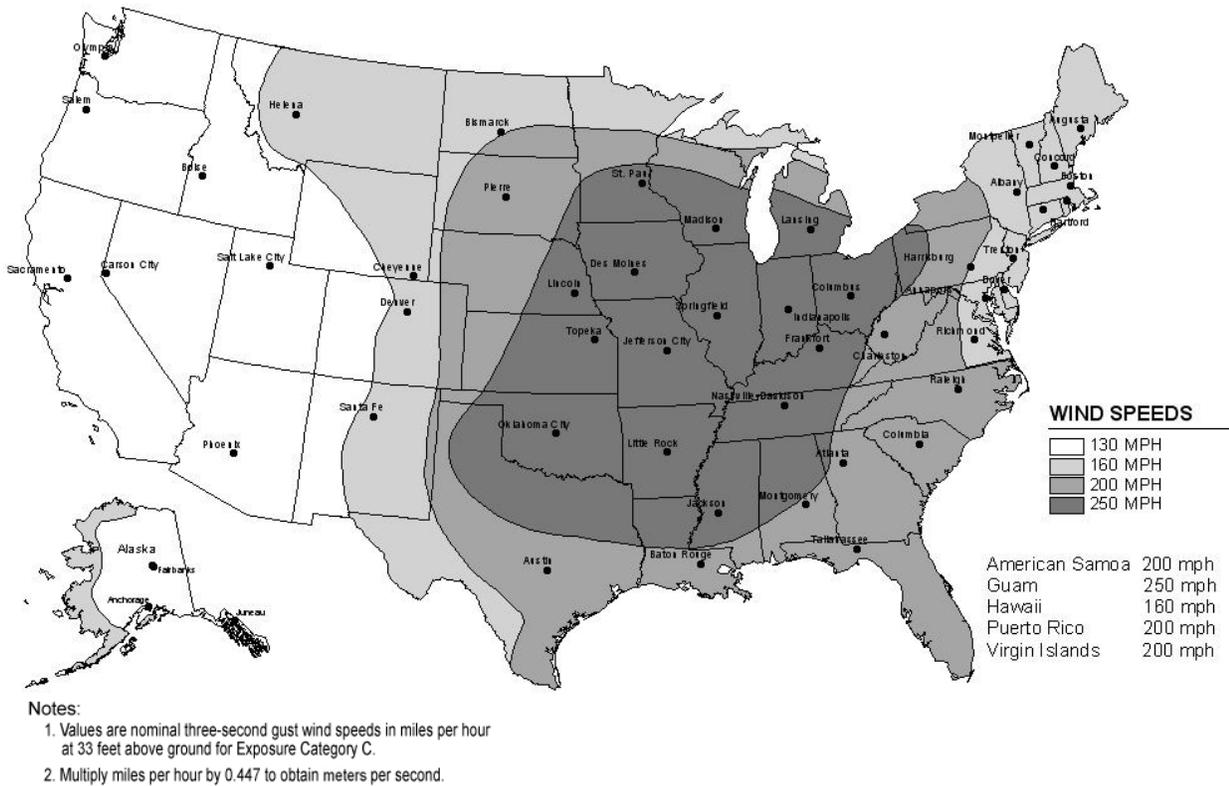
Figure 1-7: Safe room design wind speeds for tornadoes. SOURCE: ICC; USED WITH PERMISSION

- The facility is in an area where the wind speed is 200 mph or greater, in accordance with **Figure 1-7**.<sup>5</sup>
- The facility does not have a FEMA P-320-compliant or FEMA P-361-compliant safe room or ICC 500-compliant storm shelter and does not have access to such a safe room or storm shelter.

<sup>5</sup> To determine if a building site is located where the wind speed is 200 mph or greater, go to <https://hazards.atcouncil.org/>, enter the building address, and select "Tornado." A more conservative approach is to use 160 mph.

<sup>6</sup> In this manual, "tornado-prone region" refers to any area in the United States where the wind speed is 200 mph or greater, in accordance with Figure 1-7.

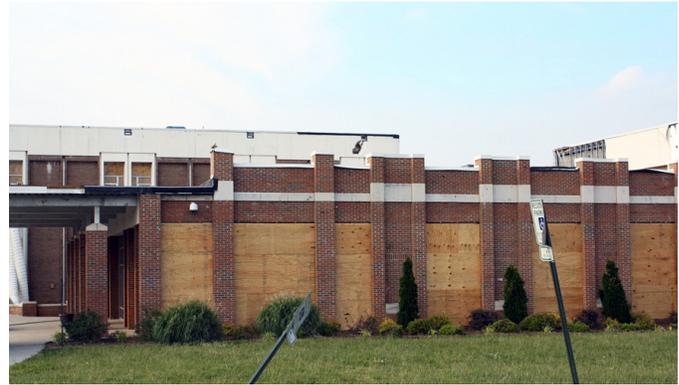
**Figure 1-8:**  
Boarded-up windows in a school after the glazing was damaged extensively in an EF1 tornado.  
Ringgold Tornado (Georgia, 2011) (FEMA P-908)

**Table 1-2** provides qualitative comparisons of main wind force resisting system (MWFRS) pressures derived from ASCE 7-16, and estimated pressures induced by EF1–EF4 tornadoes. Buildings that comply with the *International Building Code*® (IBC®) should exhibit good structural, door, and wall performance when struck by weak tornadoes (i.e., EF0 and EF1). However, damage investigations have indicated that tornado winds are more likely to generate more wind-borne debris compared to non-tornadic winds of the same speed. EF0- and EF1-rated tornadoes may generate wind-borne debris that can break unprotected glazing and puncture many types of door, wall, and roof assemblies, which can result in significant interior damage and disruption (**Figure 1-8**).

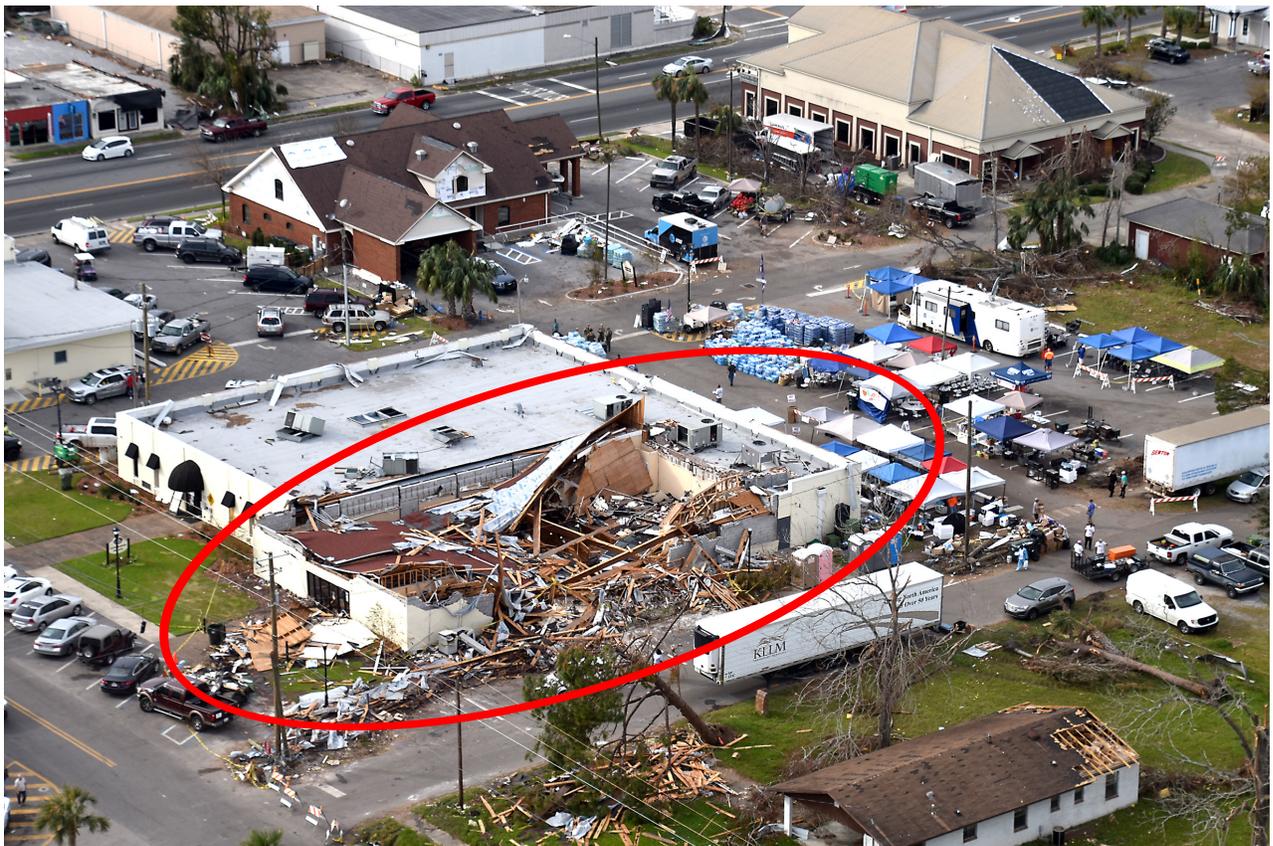
**Figure 2-1:** View of an occupied police station that collapsed during a hurricane. The building was not evacuated prior to landfall because the official in charge believed the building was safe. Hurricane Michael (Florida, 2018)

**Figure 2-1** shows damage to a building that the official in charge believed was safe. The failures at this building illustrate the importance of performing a wind vulnerability assessment for buildings that will be occupied during a hurricane. If significant vulnerabilities exist, they should be mitigated, or else the vulnerable area(s) should not be occupied during a hurricane.

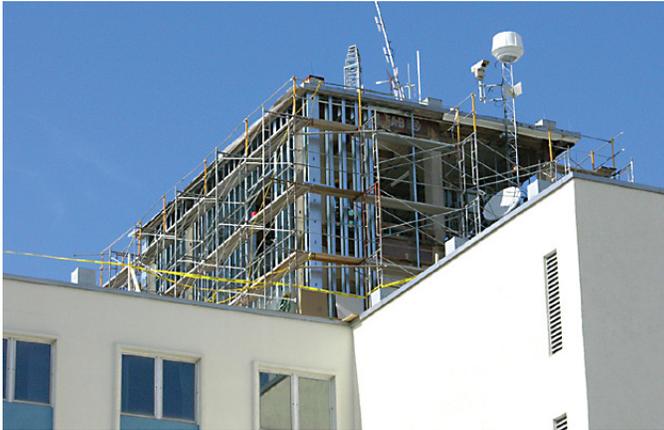
**Figure 2-2:**  
Reconstruction of the damaged walls of a hospital elevator penthouse. Hurricane Francis (Florida, 2004) (FEMA 577)

equipment. Because the elevators were not functioning, the top five floors had to be evacuated and could not be occupied until new elevator controls were installed.

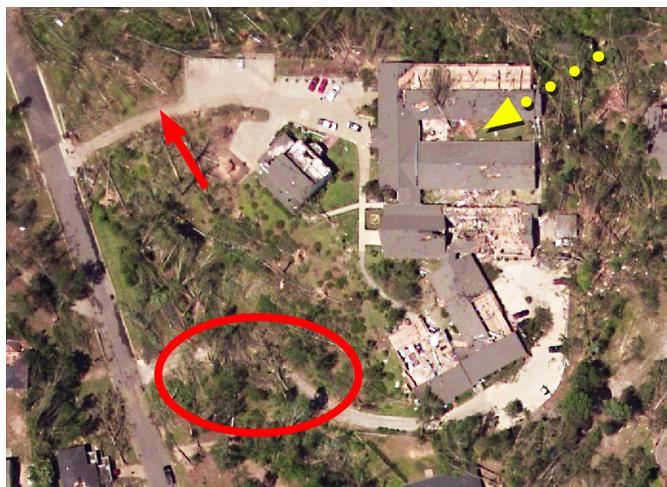
**Figure 3-1:** Both of the site egress roads were blocked by fallen trees. When this photograph was taken, the circled road had not been cleared. The other road (solid red arrow) had been cleared to evacuate the occupants. The yellow dotted arrow indicates where a tree fell on the roof (see Figure 3-2). Tuscaloosa Tornado (Alabama, 2011) (FEMA P-908)

At the nursing home shown in **Figure 3-1**, both of the site egress roads were blocked by fallen trees during a tornado. Residents were moved to portions of the building that were not badly damaged. Residents and staff were evacuated the next morning after one of the

roads had been cleared. The 68 residents and staff could not be evacuated immediately after the tornado passed because of the blockage.

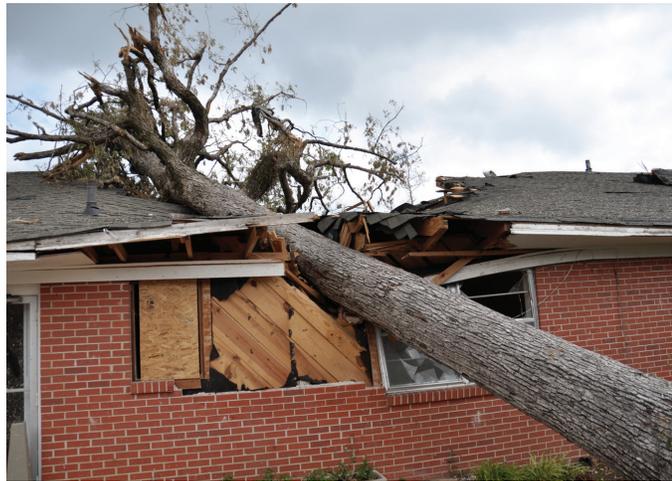
Figure 3-2:  
Tree-fall damage at the nursing home shown in Figure 3-1. Tuscaloosa Tornado (Alabama, 2011) (FEMA RA6)

Large trees, towers, and poles can crash through Metal Building Systems (formerly known as “pre-engineered metal buildings”) and wood-frame construction (**Figure 3-2**) and can rupture roof coverings and break glazing. The vulnerability assessment should include whether the site has any trees with trunks larger than 6 inches in diameter, towers, or poles that could hit the building or block egress roads if they topple.

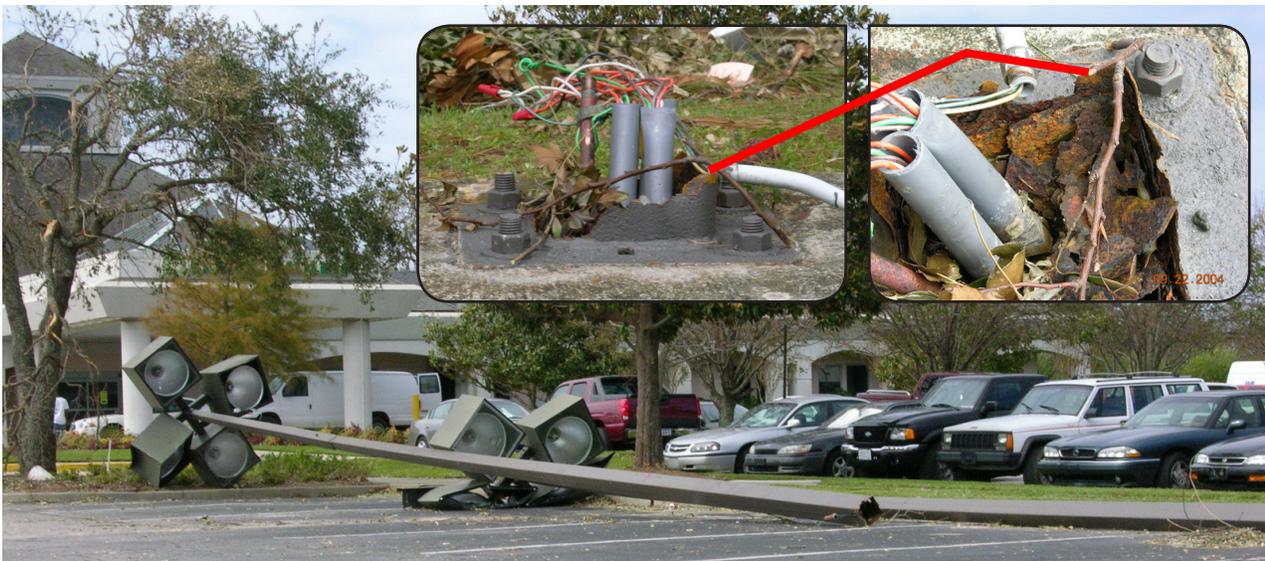
Figure 3-3: Collapsed light fixtures at a hospital. The bottom of the tubes were severely corroded (see insets). Hurricane Ivan (Florida, 2004) (FEMA 489)

**Figure 3-3** illustrates the collapse of large light fixture poles due to tube corrosion near the base plate. See Section 5.5.1.2 for information on the vulnerability assessment of light fixture poles.

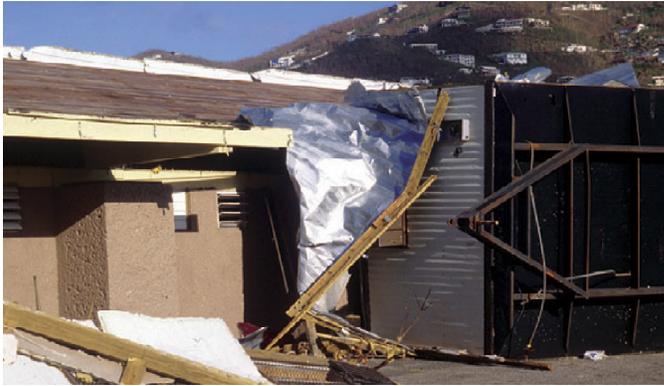
**Figure 3-4:**  
Portable classroom that became rolling debris.  
Hurricane Marilyn (U.S. Virgin Islands, 1995)  
(FEMA P-424)

Rolling debris includes portable classroom buildings, large trash receptacles, construction trailers, and vehicles. Rolling debris can block egress roads and damage buildings, and it may or may not penetrate walls or cause walls to collapse, depending on the type of exterior wall and the momentum of the debris. **Figure 3-4** shows a portable classroom that became rolling debris and hit the main school building.

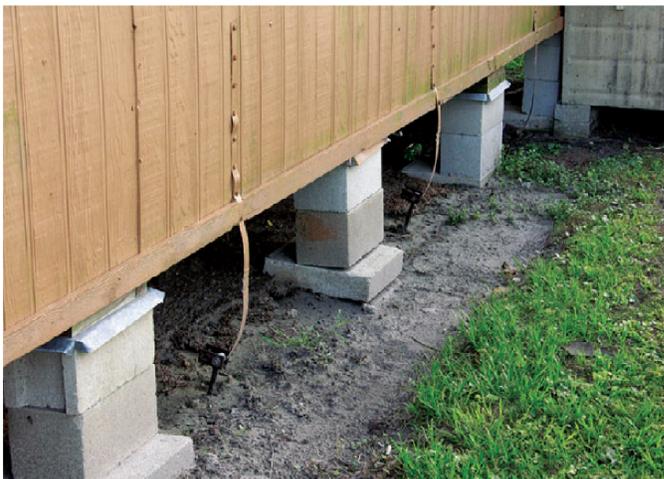
**Figure 3-5:**  
Portable classroom susceptible to being blown  
off the piers and to overturning (FEMA P-424)

The assessment should include investigation of the adequacy of the anchorage of the buildings and other structures near the critical facility that are vulnerable to becoming rolling debris, such as sheds, portable classrooms, or large trash receptacles. The portable classroom in **Figure 3-5** is susceptible to becoming rolling debris because the metal straps that connect the building to the ground anchors are not taut. **Figure 3-6** shows a portable classroom that became airborne. While the classroom could have caused significant damage, it landed in a field, rather than on the nearby school.

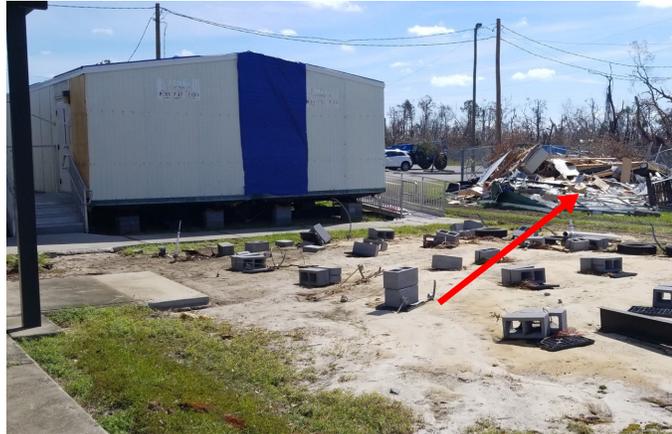
**Figure 3-6:**  
View of a destroyed portable classroom. Most of the ground anchor straps failed in tension. However, at least two anchors pulled out of the ground. Hurricane Michael (Florida, 2018)

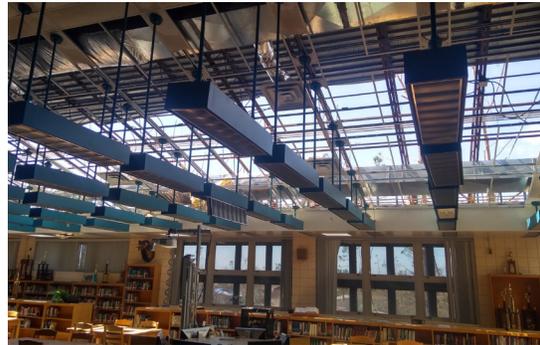
Figure 4-1: School with steel roof deck blown off. Blow-off of older steel roof decks is common. Hurricane Michael (Florida, 2018)

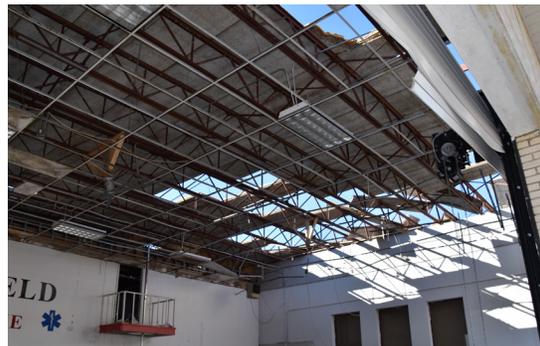
Figure 4-2: Fire station apparatus bay with displaced cementitious wood-fiber roof deck panels. Hurricane Michael (Florida, 2018)

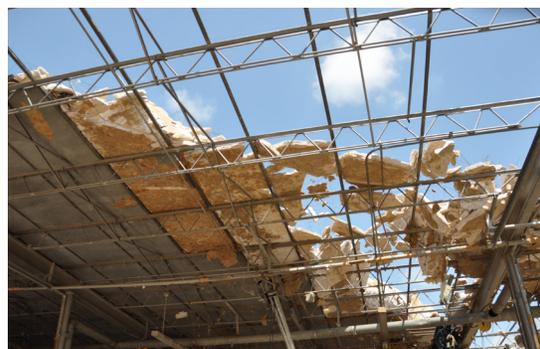
Figure 4-3: Military facility with poured gypsum roof deck blown off. Some of the bulb tees were also blown off. Tuscaloosa Tornado (Alabama, 2011)

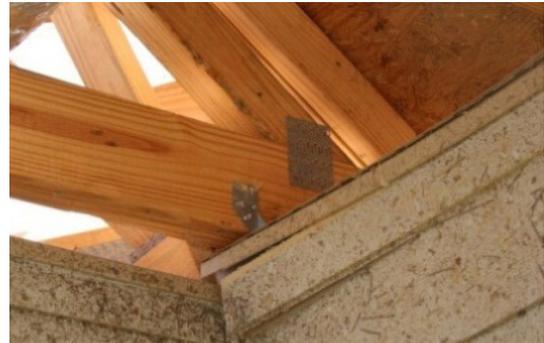
Figure 4-4: Connector used in wood-to-wood framing system

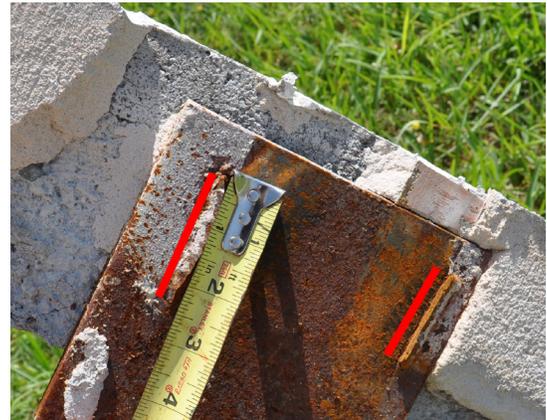
Figure 4-5: Failed welds (to left of each parallel line) that connected a joist to a bearing plate. The weld quality was marginal. Hurricane Harvey (Texas, 2017)

Vertical Load Path	Assessment Method
<p>Roof framing to exterior wall connections</p>	<ul style="list-style-type: none"> <li>• Determine the expected uplift force (demand) at the end of the roof framing member that is attached to the exterior wall or wall framing. This force is developed from appropriate roof-uplift pressures. When a load path exists, reductions in the expected uplift force from the dead load of the roof system can be considered.</li> <li>• The capacity of the connection between the roof framing member and the exterior wall must be greater than the wind uplift force on the connection.</li> </ul> <p>The connection could be:</p> <ul style="list-style-type: none"> <li>– Bolted if steel members.</li> <li>– Welded if the roof frame is steel and the wall is masonry or concrete, including precast concrete panels, with steel plates to receive the roof member.</li> <li>– Welded if the roof is precast concrete with embedded steel plates and the walls are concrete with steel plates used to receive the roof member.</li> <li>– Steel reinforcing bars if both the roof and walls are poured concrete.</li> <li>– Connected with a mechanical connector if the roof framing is wood.</li> </ul> <p>See <b>Figure 4-4</b> for a wood-to-wood framing system connector.</p> <ul style="list-style-type: none"> <li>• In a Level 2 assessment, include the use of borescopes or x-ray technology to determine the presence of embedded steel plates; presence, size, and quality of welds; and connections of steel reinforcing bars.</li> </ul> <p>See <b>Figure 4-5</b> for failed welds that connected a joist to a bearing plate.</p>

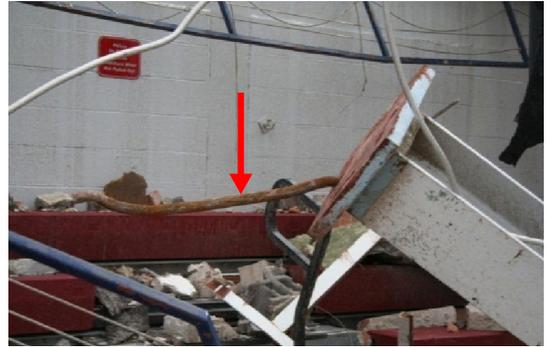
Figure 4-6: Failed column base plate with an embedded anchor bolt. Joplin Tornado (Missouri, 2011) (FEMA P-908)

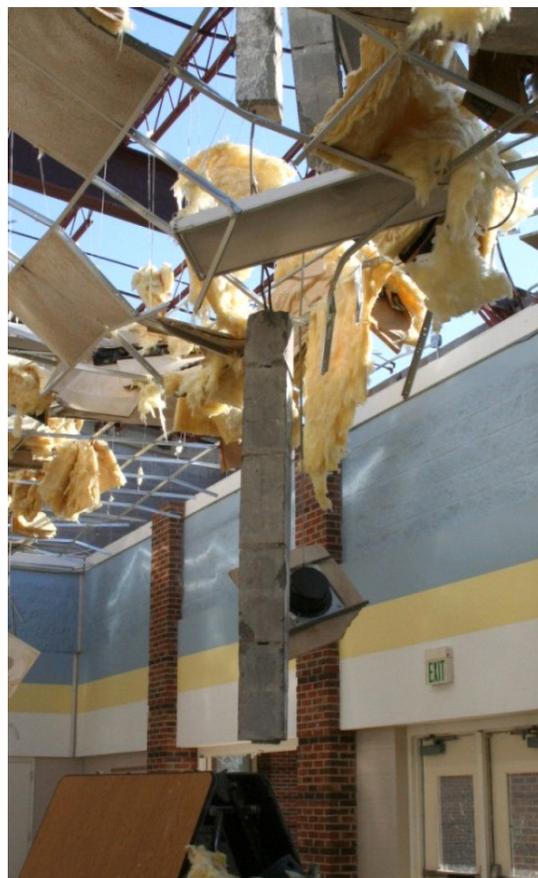
<p>C = Capacity C&amp;C = Components and cladding CMU = Concrete masonry unit</p>	<p>D = Demand MWFRS = Main wind force resisting system SEAOC = Structural Engineering Association of California</p>	<p>Figure 4-7: Masonry bond beam not secured to the MWFRS. Tuscaloosa Tornado (Alabama, 2011)</p>

Vertical Load Path	Assessment Method	
<p>Connections between beams (including masonry bond beams) and beam supports (see <b>Figure 4-7</b> of a bond beam not secured to the supporting load-bearing CMU wall)</p>	<ul style="list-style-type: none"> <li>• Use structural drawings for the assessment since this area of the structure is not visible</li> <li>• Review the notes about reinforcement in the bond beams and how the bond beams are to be tied to the wall of the MWFRS. See <b>Figure 4-7</b>. A lack of notes about the vertical tie between the steel in the bond beam and the wall may be an indication of a lack of attention to the details of the beam and wall reinforcing.                             <ul style="list-style-type: none"> <li>– For Level 2 assessments, use either a metal detector or an x-ray imaging process, if possible, to see both the locations of steel reinforcing and perhaps get an indication of the size of the steel. This nondestructive examination method should be done to determine average spacing and size of steel with some certainty.</li> </ul> </li> </ul>

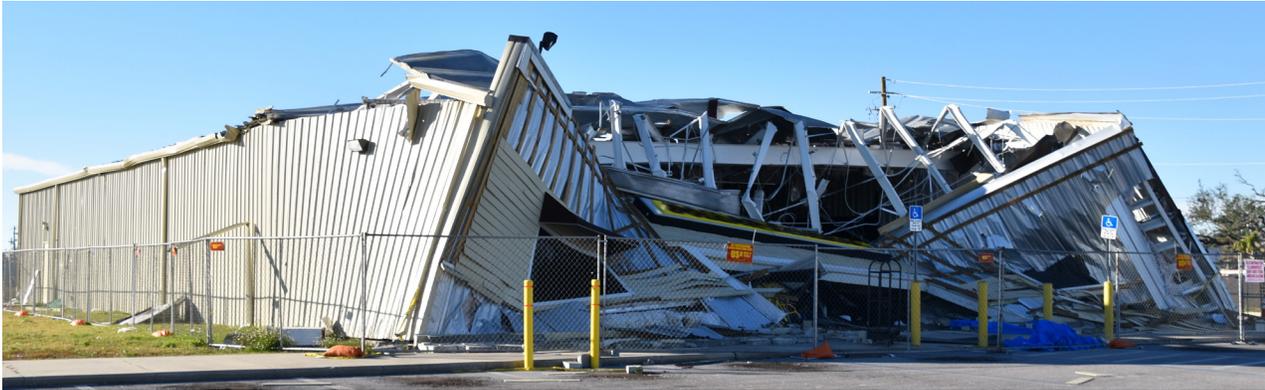
Figure 4-8: End-wall failure in a relatively new MBS. MBSs are used for many critical facilities. Hurricane Michael (Florida, 2018)

- **Steel:** Investigate corrosion, cracked welds, bent flanges or webs of steel beams, and sagging roof and floor joists. **Figure 4-8** shows end-wall failure in a relatively new metal building system (MBS).

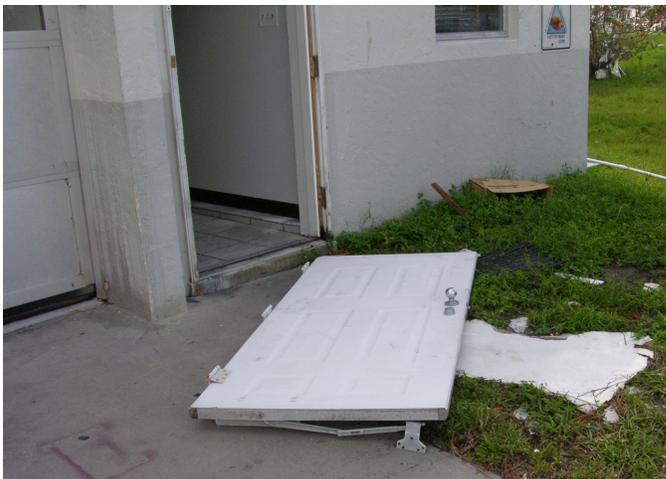
**Figure 5-1:**  
Hinge screws pulled out of the door frame at a fire station. Hurricane Charley (Florida, 2004)

Failure of personnel doors is uncommon. Personnel doors can fail because of over-pressurization or from the failure of the door latch or hinges from impact by wind-borne debris (**Figure 5-1**).

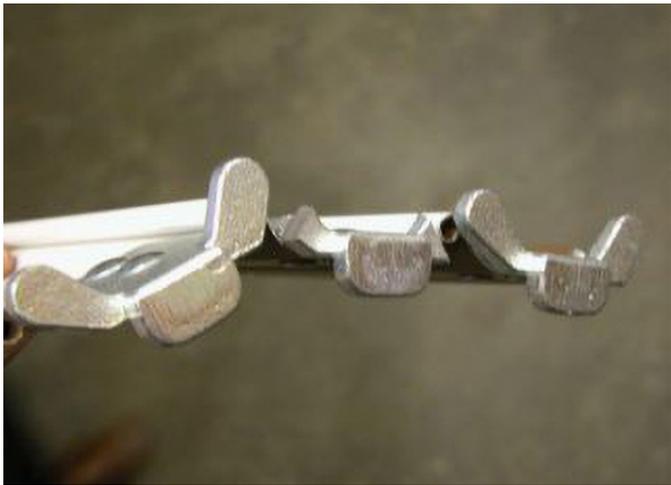
**Figure 5-2:**  
Slats with continuous endlocks and windlocks. The upward wings blocking the slats from sliding apart are endlocks. The tabs that are centered and facing down are windlocks that engage the rolling door guides for wind-rated doors.

Narrower rolling doors may have adequate resistance to wind loads because of the stiffness of the slats or curtain alone, but wider rolling doors have windlocks (**Figure 5-2**) at the edges of the curtain that hook onto the guides to keep the curtain from deflecting or bowing far enough to pull out of the guides.

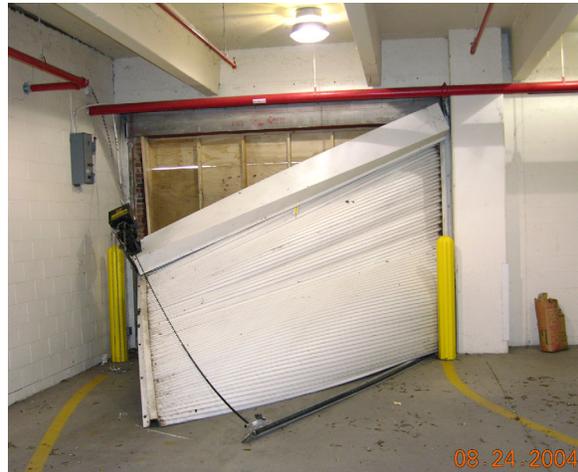
Figure 5-3:  
Failure of a rolling door at a courthouse due to inadequate edge distance of the frame's expansion bolts. Hurricane Charley (Florida, 2004) (FEMA 488)

The attachment of the door to the building also should be checked. An inadequately secured door will not achieve its wind load rating even when properly reinforced if the door cannot transfer the load to the building through a reliable connection (see **Figure 5-3**, **Figure 5-4**, and **Figure 5-5**). The rolling door in **Figure 5-3** was attached with expansion bolts into concrete. The concrete spalled at the bolt locations, which was attributed to inadequate edge distance. In **Figure 5-4**, the frame of the sectional door was adequately attached to the 2 x 6 nailer, but the nailer was inadequately attached to the wall. Most manufacturers provide guidelines for attachment, and DASMA has generic jamb attachment guidelines for general use (see DASMA TDS 161 and DASMA TDS 156). **Figure 5-5** shows rolling door failures caused by inadequate wind resistance of rough opening members.

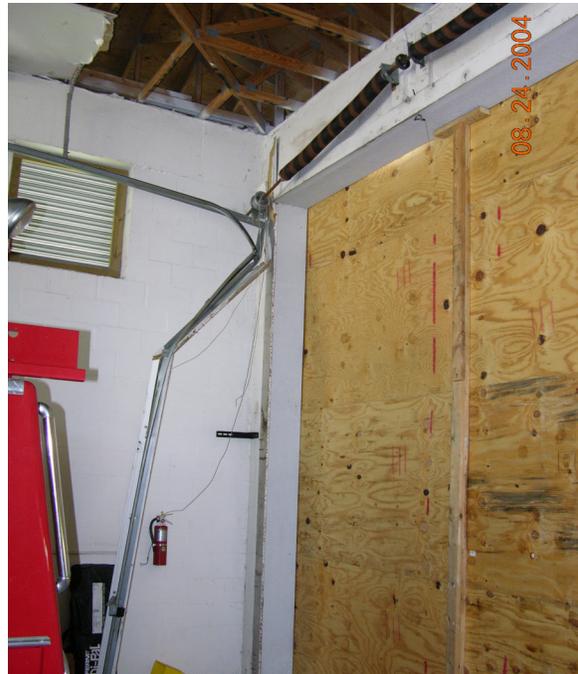
Figure 5-4:  
Failure of a fire station sectional door due to inadequate attachment of the nailer to the wall. Hurricane Charley (Florida, 2004)

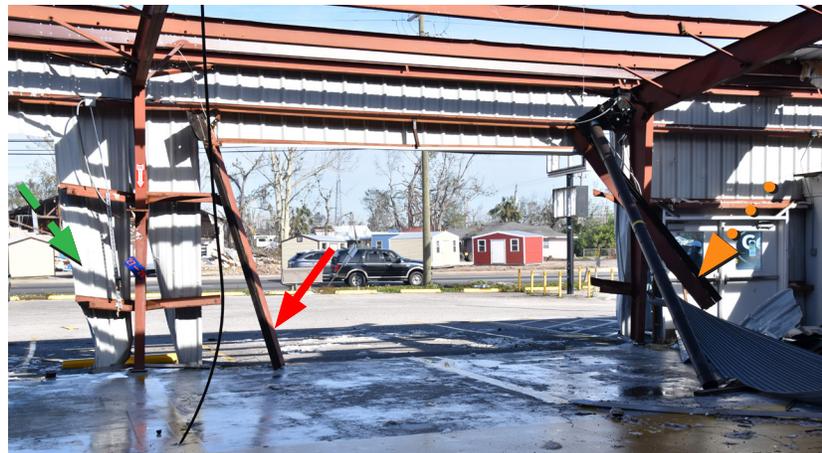
Figure 5-5:  
View of rolling door failures caused by inadequate wind resistance of rough opening members. The solid red and dotted orange arrows indicate failed rough opening jamb and header framing members. The dashed green arrow indicates a missing rough opening jamb member at an adjacent door. Hurricane Michael (Florida, 2018)

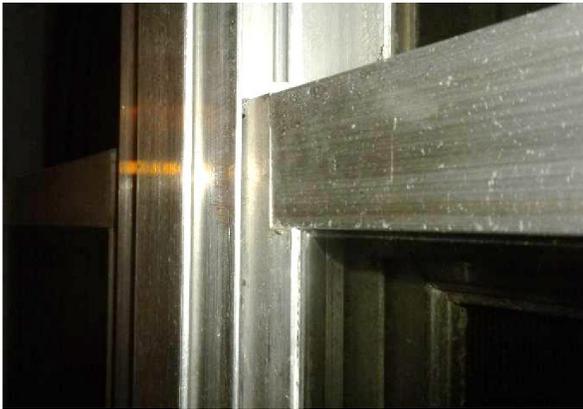
Figure 5-6: Discrete windstorm damage: Frame rotation at a window meeting rail

- **Conduct a site inspection** to determine through observation the condition of the assemblies. Sometimes research and interviews provide little information, and the site inspection is the only option for estimating performance data and current reliability. The exterior glazing should be carefully examined during the site inspection. Framing should be checked for material composition, profile measurements, condition of framing joints, evidence of construction defects, signs of wind damage, aging, and corrosion. **Figure 5-6** through **Figure 5-20** show typical examples of wind damage.

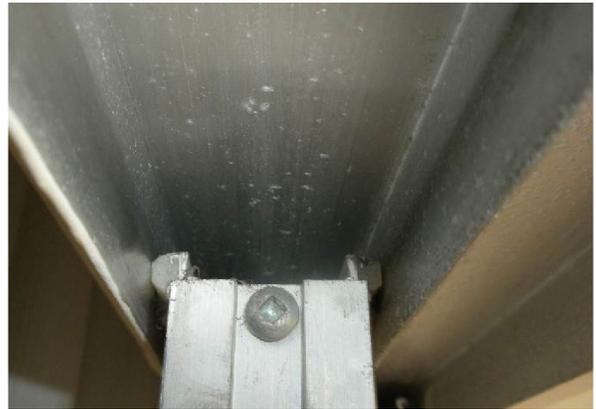
Figure 5-7: Discrete windstorm damage: Deflection at sliding door panel legs

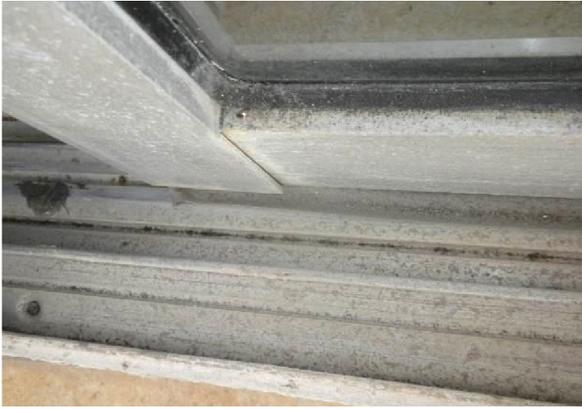
Figure 5-8: Discrete windstorm damage: Frame rotation at sliding door bottom rail

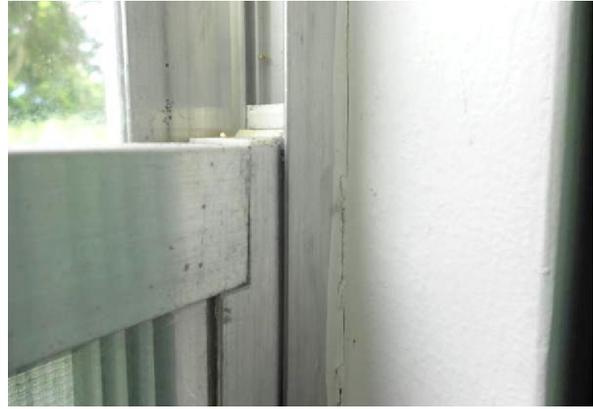
Figure 5-9: Discrete windstorm damage: Frame movement at the right jamb of window

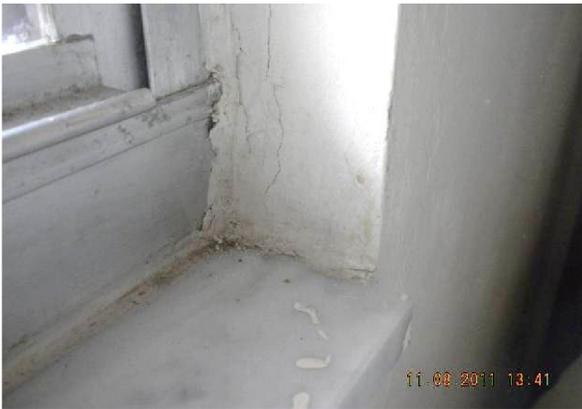
Figure 5-10: Discrete windstorm damage: Water damage at lower right corner of window

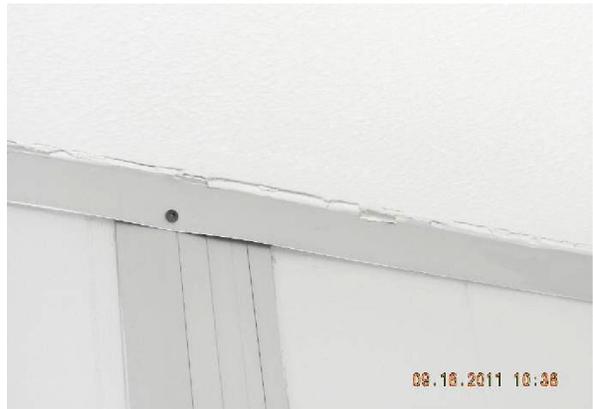
Figure 5-11: Discrete windstorm damage: Frame movement at the head

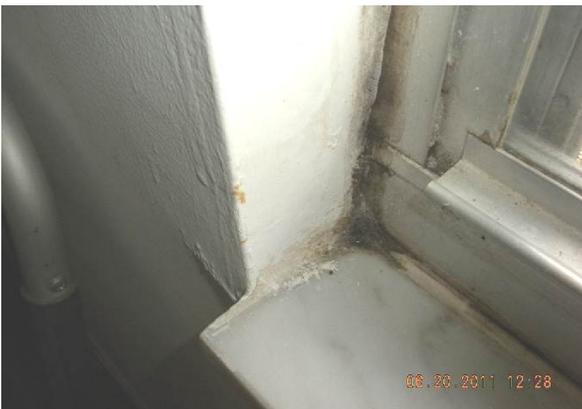
Figure 5-12: Windstorm damage: Water damage and corrosion at lower left corner of window

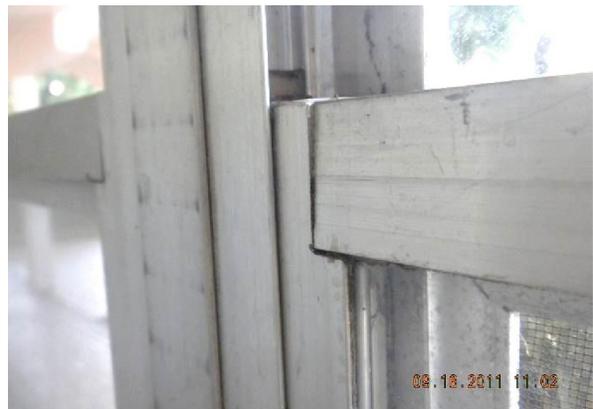
Figure 5-13: Windstorm damage: Frame rotation at a window meeting rail

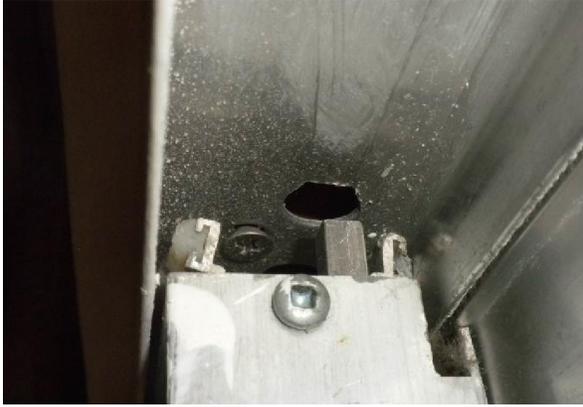
Figure 5-14: Windstorm damage: Deflection at sliding door panel legs

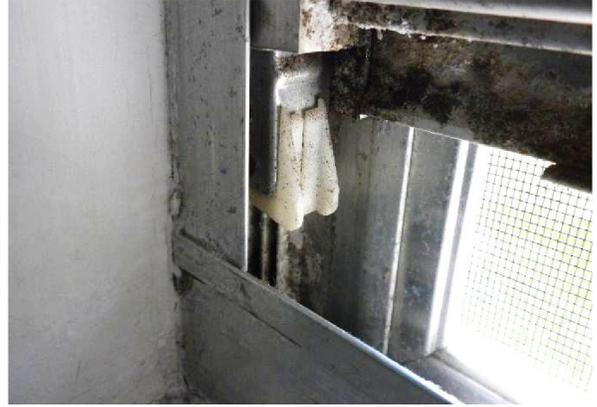
Figure 5-15: Windstorm damage: Water damage and corrosion at bottom rail of window

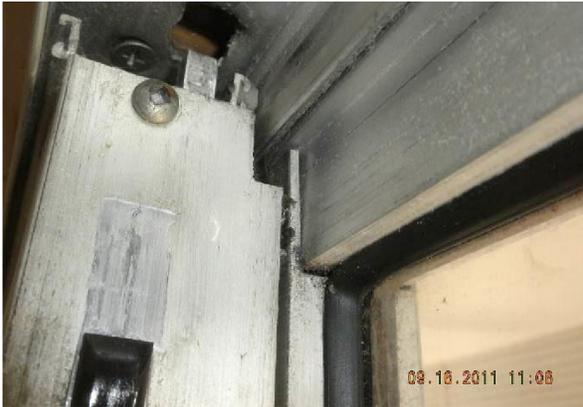
Figure 5-16: Windstorm damage: Frame rotation at sliding door top rail

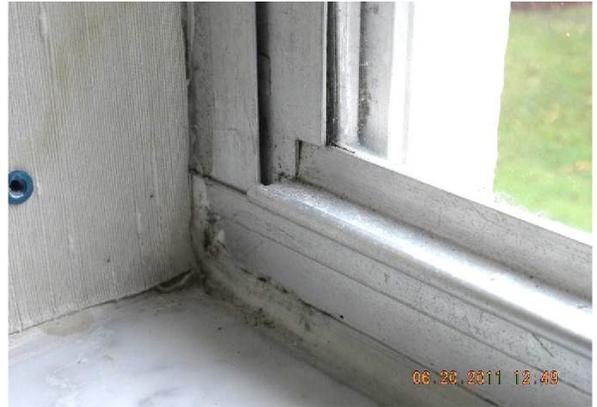
Figure 5-17: Windstorm damage: Frame rotation at a window bottom rail

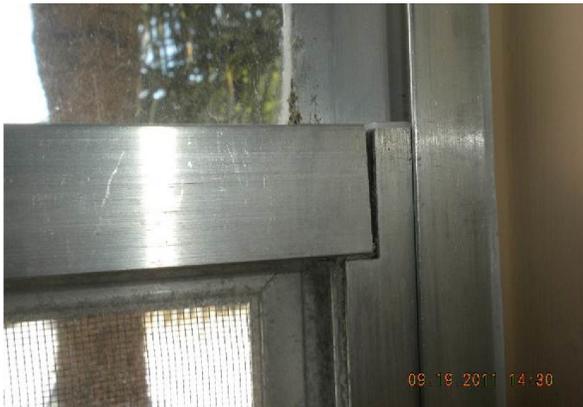
Figure 5-18: Windstorm damage: Frame separation at a window meeting rail

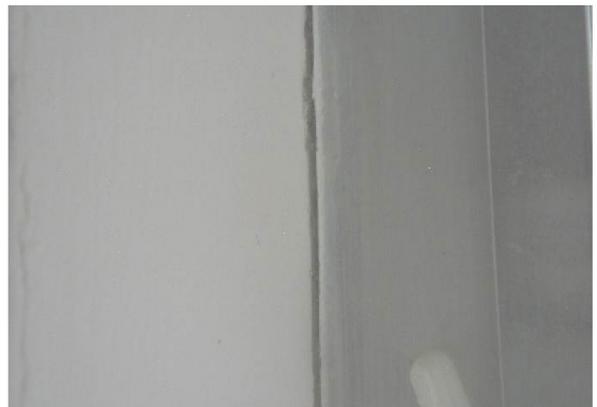
Figure 5-19: Windstorm damage: Frame movement at the left jamb of window

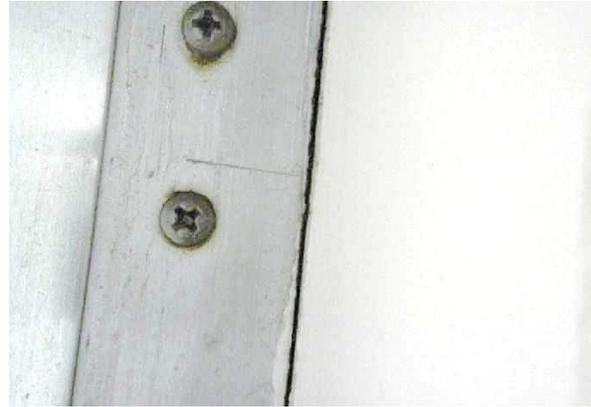
Figure 5-20:  
Windstorm damage: Frame movement at the right jamb  
of window

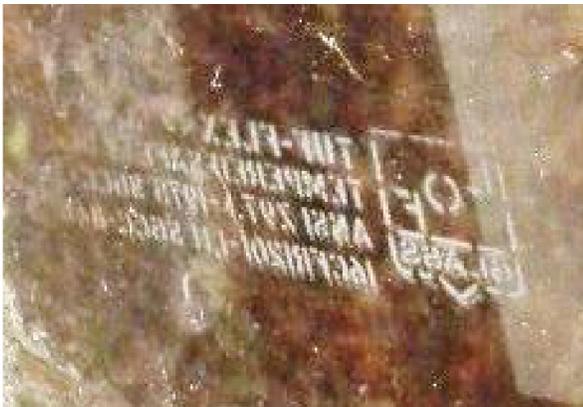
Figure 5-21: Typical glass label

- **Identify the type and treatment of the glass.** The glass may have a label (also called “bug”) that can help identify the type and treatment (**Figure 5-21**).
- **Determine whether the glass is laminated or insulated, and determine the thickness of each ply.** Glass thickness tools can be used to make these determinations.
- **Document anchor type, size, location, and condition.**
- **Determine the condition of sealants and weatherstripping** to help predict current air and water infiltration performance.
- **Check the interior finishes** around windows and skylights for evidence of water intrusion. The severity of any evidence of water leakage can be a predictor of whether the leakage is isolated or chronic. Document all observations during the site inspection with field notes and photographs. See **Figure 5-22** to **Figure 5-28**.

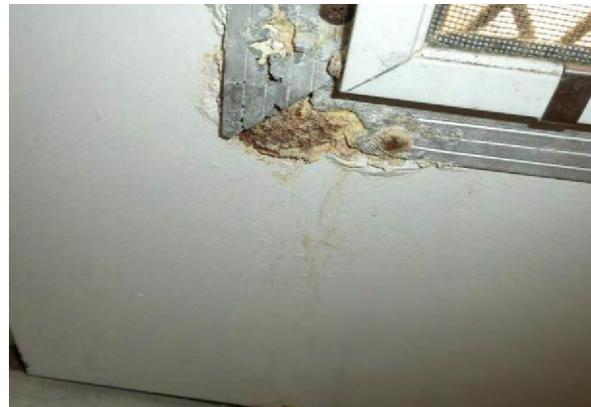
Figure 5-22: Water damage (bottom left corner of door)

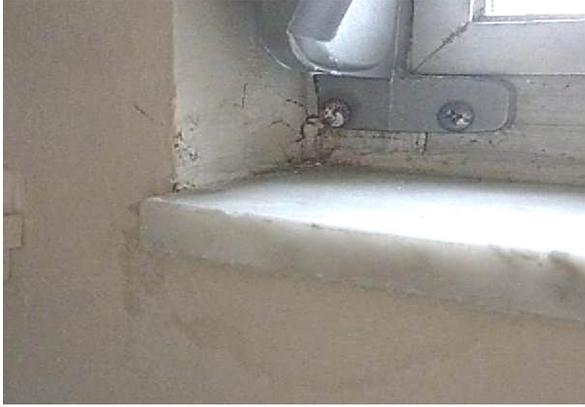
Figure 5-23: Water damage (bottom left corner of window)

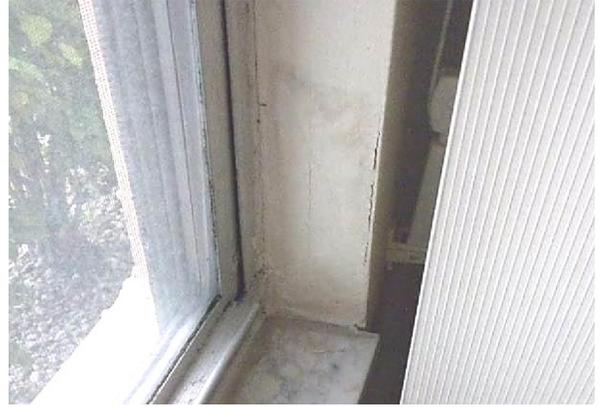
Figure 5-24: Water damage (bottom right corner of window)

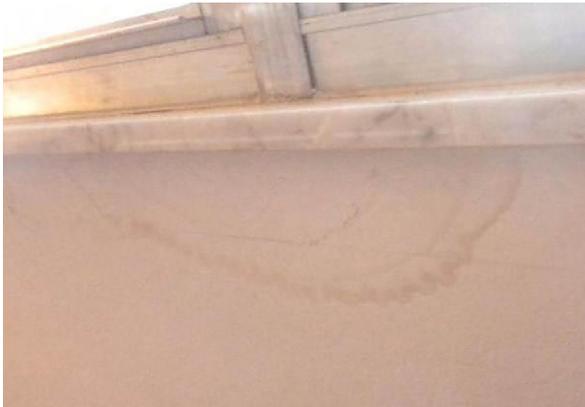
Figure 5-25: Water damage (bottom center of window)

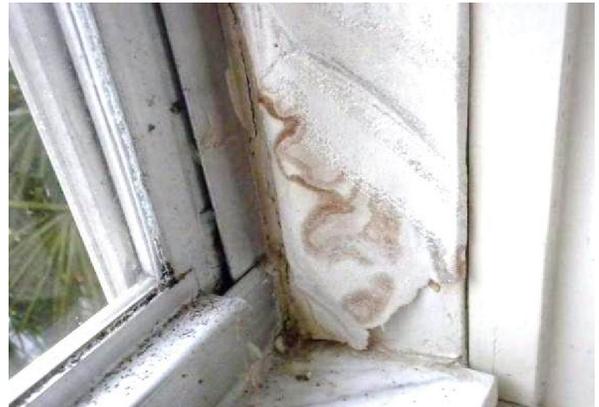
Figure 5-26: Water damage (bottom right corner of window)

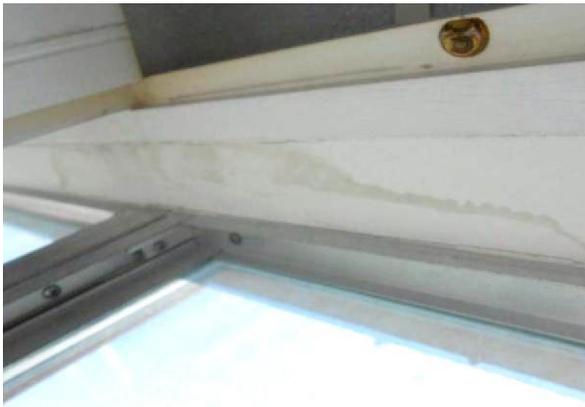
Figure 5-27: Water damage (top center of window)

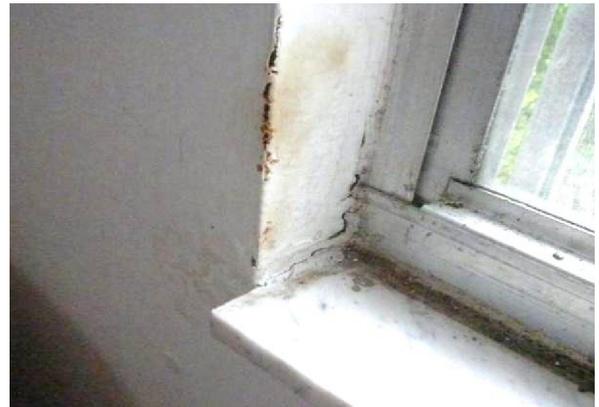
Figure 5-28: Water damage (bottom left corner of window)

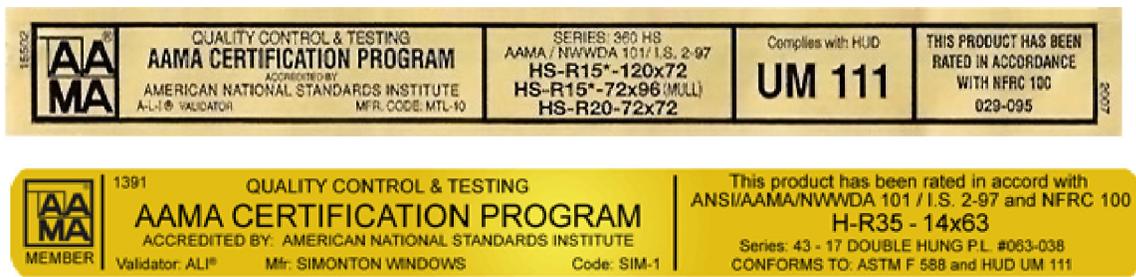
Figure 5-29: Typical AAMA labels

- If the manufacturer was not identified during the review of the project records, **check the framing for the manufacturer’s logo**. The glass fabricator, which may be identified on a glass label, is not normally the same as the window, skylight, or door manufacturer. Unfortunately, most manufacturers of older assemblies are no longer in business.
- **Check for labels that may contain performance data.** Some labels are part of an industry association certification program. The AAMA sponsors a window certification program that requires a label on every window (**Figure 5-29**).<sup>17</sup> The performance data on the label can be reconciled with industry standards for the relevant timeframe to determine the performance criteria required for certification.
