# Guidelines for Wind Vulnerability Assessments of Existing Critical Facilities

FEMA P-2062 / September 2019

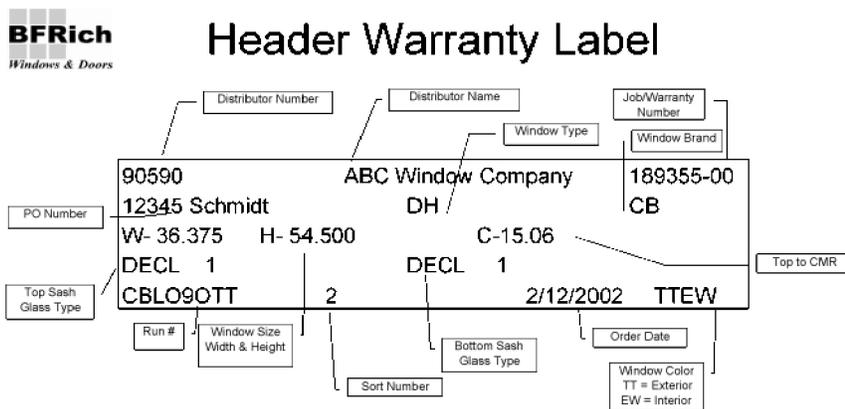
Figure 5-30: Typical manufacturer label

Miami-Dade County Product Control<sup>18</sup> and the Florida Building Commission<sup>19</sup> also have product approval programs, and product information can be obtained from them. If there is no label, sometimes hardware items have logos that indicate the manufacturer. See **Figure 5-30** to **Figure 5-32**.

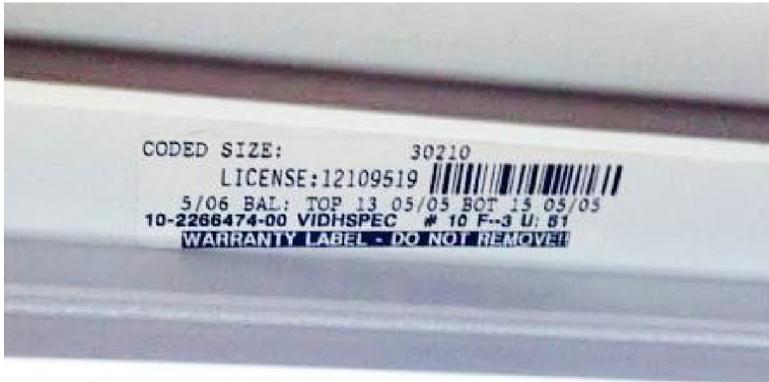
Figure 5-31:  
Typical manufacturer label on head  
of window

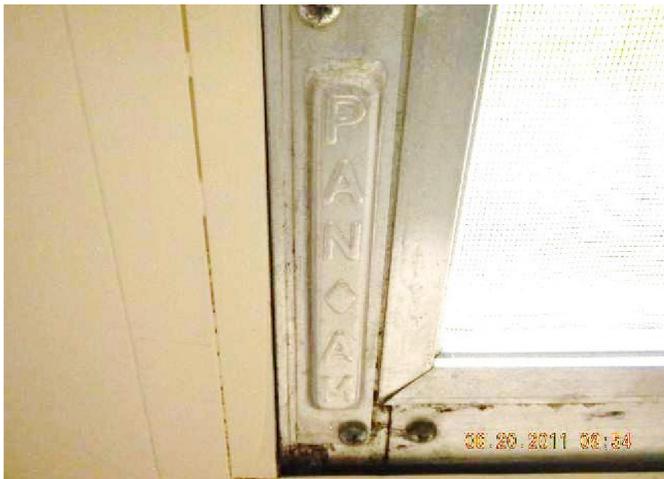
Figure 5-32:  
Manufacturer's logo on window hardware

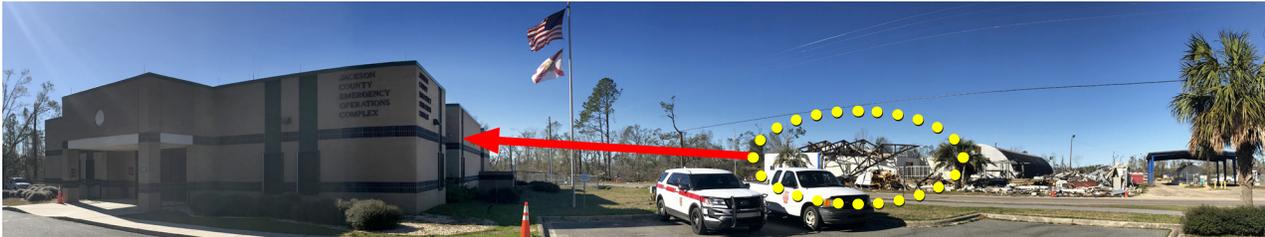
**Figure 5-33:** View of an emergency operations center (EOC) (left) that was struck by wind-borne debris from a weak building (yellow dotted oval). The debris had sufficient momentum to damage metal wall panels. Although the building was well inland of the wind-borne debris region, the glazing was protected by shutters. The hurricane’s estimated wind speed at this location was 117 mph. Hurricane Michael (Florida, 2018)

Damaging wind-borne debris has been documented to occur inland of the wind-borne debris region defined in ASCE 7-16 (**Figure 5-33**). Depending on how critical the facility is that is being evaluated and whether there is a nearby debris source such as trees or weak buildings, it may be prudent to use a speed as low as 120 mph<sup>22</sup> in lieu of the 135-mph trigger speed given above.

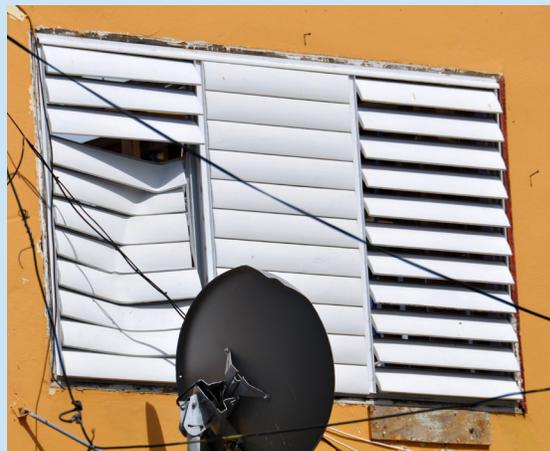
**Metal jalousie window struck by wind-borne debris. Hurricane Irma (U.S. Virgin Islands, 2017)**

Jalousies are very susceptible to wind-driven rain, even when the louvers are undamaged. Common metal jalousie louvers may be undamaged by low-momentum debris, but they can be easily breached by wind-borne debris that is common during strong hurricanes.

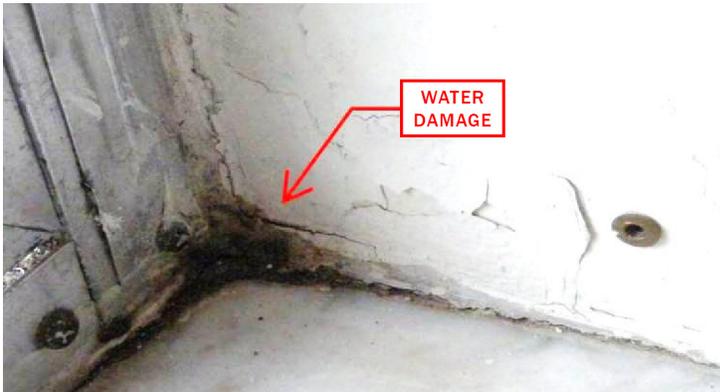
**Figure 5-34:**  
Example of a typical report photo with  
caption and arrow

- A description of all tasks performed
- A list of all materials that were reviewed
- Any unsuccessful attempts to glean information
- Any needed information that was not obtained
- Any assumptions
- Any performance data that were obtained
- Information on the manufacturer, framing type, glass type and treatment, anchors, type of operation, and hardware for any investigated windows and skylights
- The site inspection
- A description of the methodology and sampling procedure used
- Photos of all observations with descriptive captions and arrows, if needed (**Figure 5-34** to **Figure 5-40**)
- A summary of the findings and recommendations for further assessment, if any

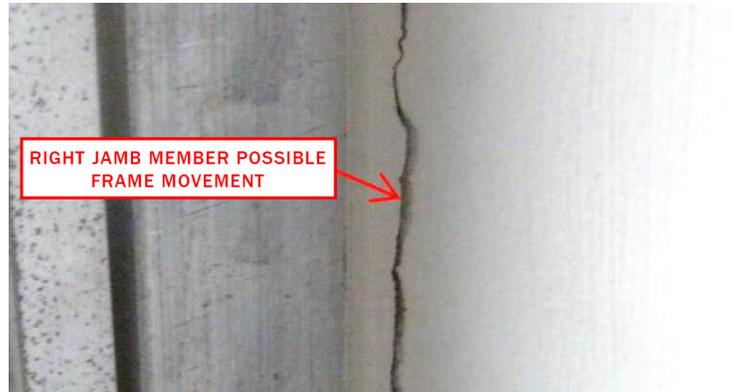
Figure 5-35:  
Example of a typical report photo with caption and arrow

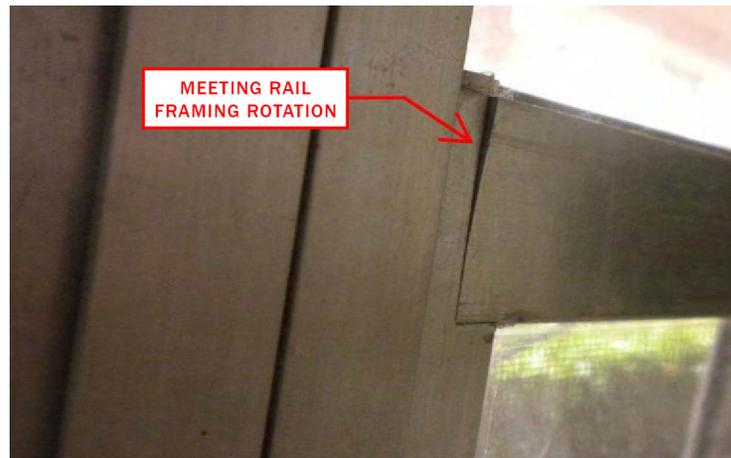
Figure 5-36:  
Example of a typical report photo with caption and arrow

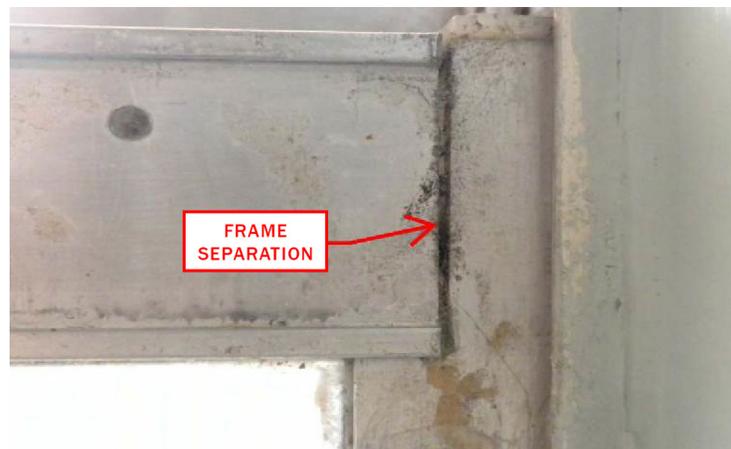
Figure 5-37:  
Example of a typical report photo with caption and arrow

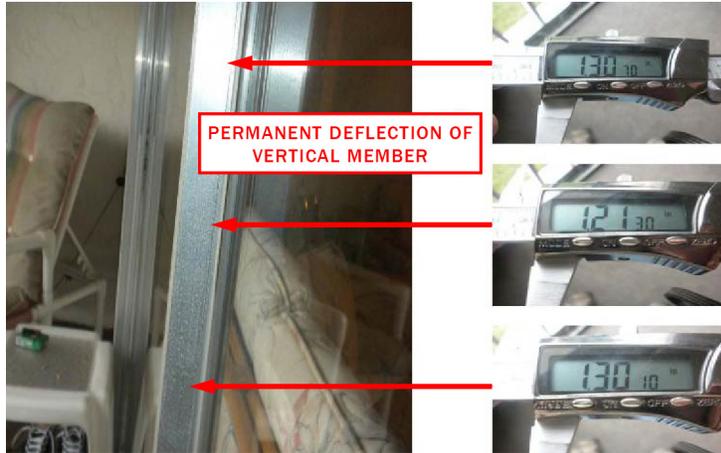
Figure 5-38:  
Example of a typical report photo with  
caption and arrows

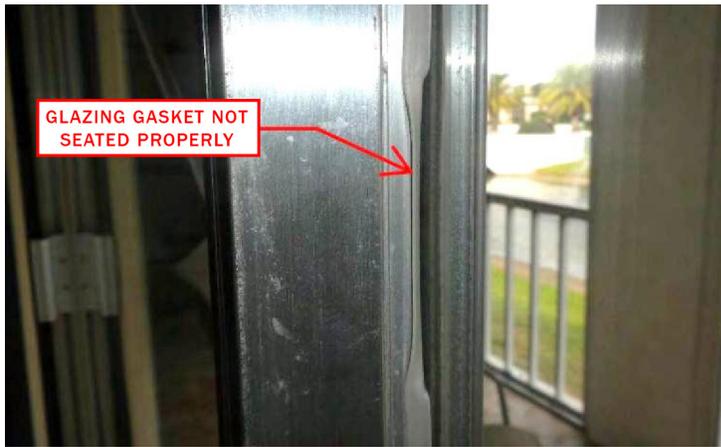
Figure 5-39:  
Example of a typical report photo with  
caption and arrow

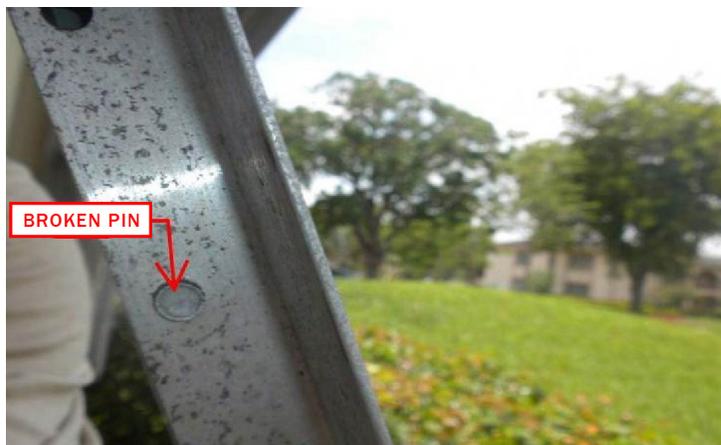
Figure 5-40:  
Example of a typical report photo with  
caption and arrow

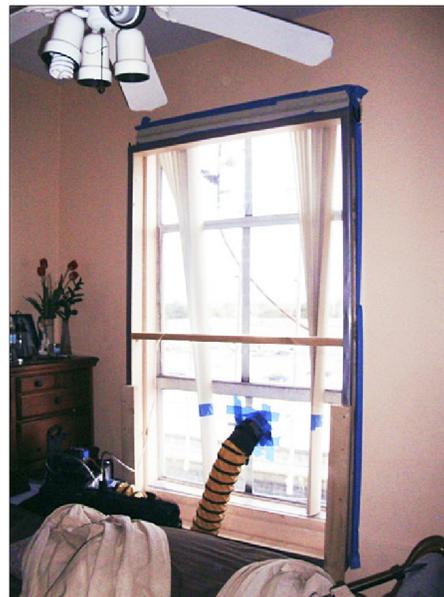
**Figure 5-41:**  
Water infiltration field testing (interior air chamber)

- **Conduct field air and water infiltration tests** to confirm current field performance. ASTM E1105-00, *Standard Test Method for Field Determination of Water Penetration of Installed Exterior Windows, Skylights, Doors, and Curtain Walls, by Uniform or Cyclic Static Air Pressure Difference* (ASTM 2015a), is the industry standard for field water infiltration testing. The test involves constructing an air chamber across the inside of the assembly<sup>24</sup> and vacuuming air from it at a specified rate, while applying water across the outside face from a uniform spray grid (see **Figure 5-41** to **Figure 5-46**). The test simulates the conditions of wind-driven rain.

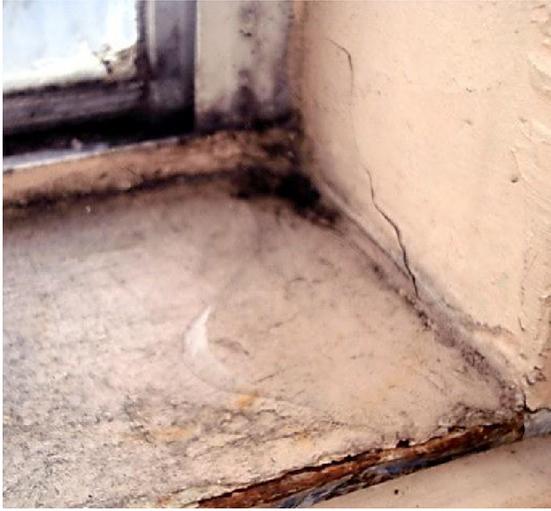
**Figure 5-42:**  
Water infiltration field testing (water leakage at lower right corner)

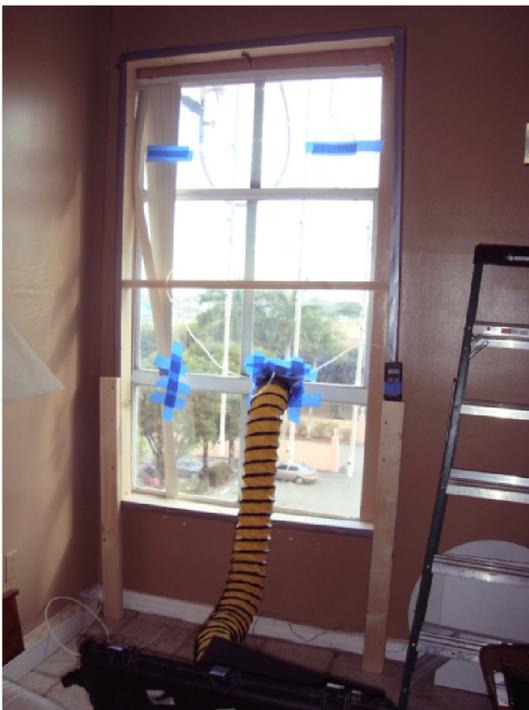
**Figure 5-43:**  
Water infiltration field testing (interior air chamber)

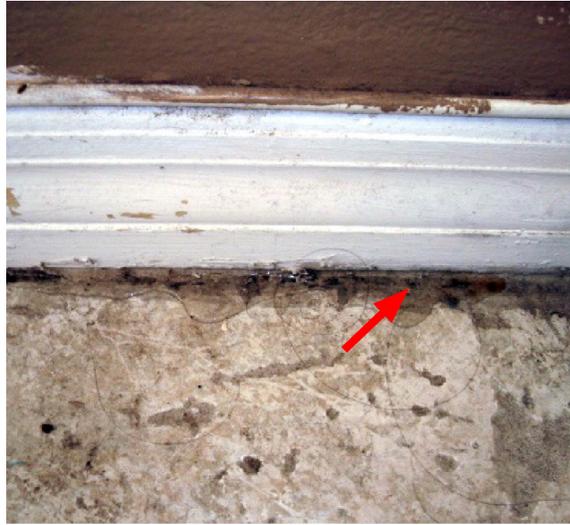
**Figure 5-44:**  
Water infiltration field testing (water leakage at bottom of window frame, solid red arrow)

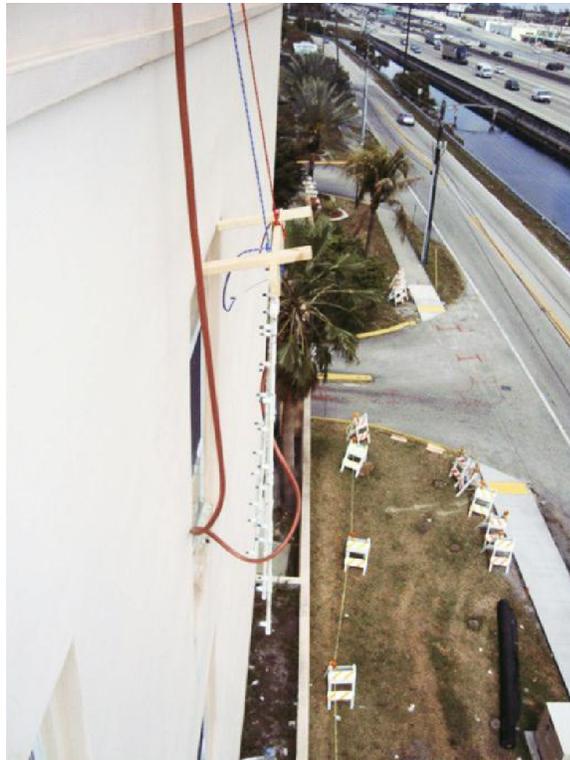
**Figure 5-45:**  
Water infiltration field testing (spray rack configuration)

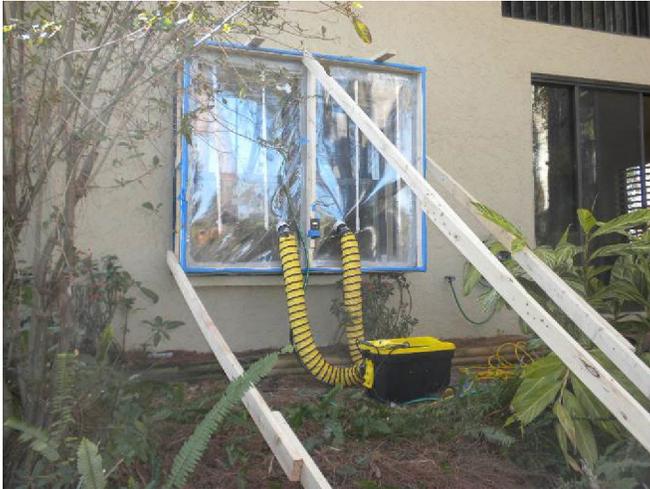
**Figure 5-46:**  
Water infiltration field testing (exterior air chamber)

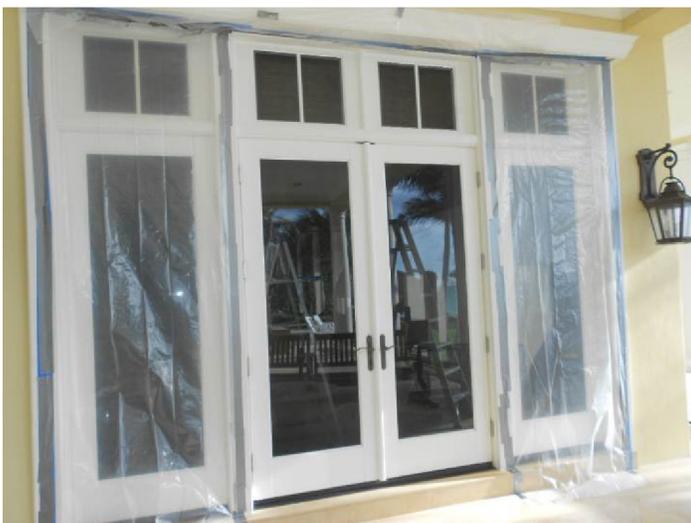
**Figure 5-47:**  
Water infiltration field testing (isolation)

AAMA 502-12 (AAMA 2012a) and AAMA 503-14 (AAMA 2014) provide guidance for setting up the test and specifying proper test pressures. ASTM E2128-17, *Standard Guide for Evaluating Water Leakage of Building Walls* (ASTM 2017e) also can provide guidance for how to investigate water leakage issues. ASTM E783-02(2018), *Standard Test Method for Field Measurement of Air Leakage Through Installed Exterior Windows and Doors* (ASTM 2002) can be used to measure field air infiltration. Field air and water testing can be very complex. The test must be set up properly to yield useful results. Isolation testing is often necessary to determine whether water entry is occurring through a window or skylight or from an adjacent wall or roof areas (**Figure 5-47** to **Figure 5-49**).

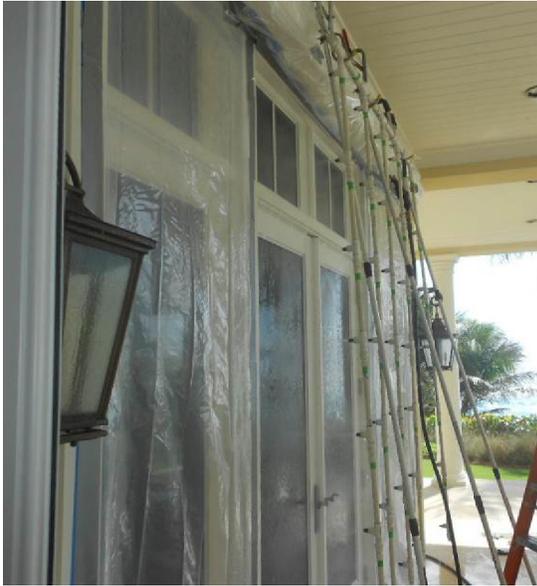
Figure 5-48:  
Water infiltration field testing (isolation)

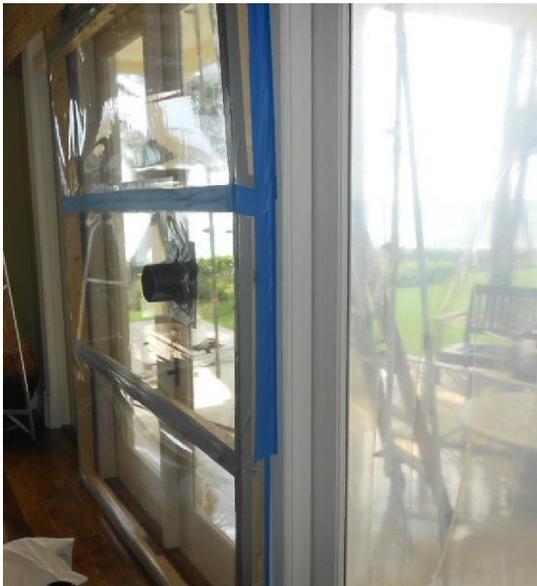
Figure 5-49:  
Water infiltration field testing (isolation)

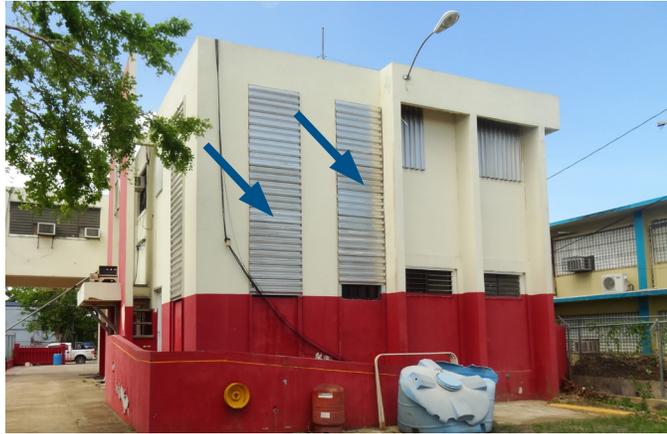
Figure 5-50:  
Metal shutters at this fire station (blue arrows)  
protected the building from wind-borne debris.  
(Puerto Rico, 2017) (FEMA P-2020)

This section addresses impact-resistant systems, including shutters and permanently mounted screens. These systems are installed to fit over glazed openings to protect the openings during a high-wind event, such as a hurricane (**Figure 5-50**).

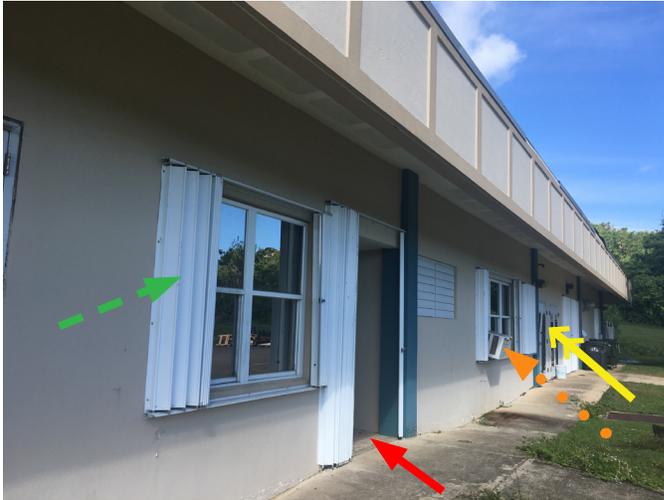
**Figure 5-51:** Successes and problems related to installation of shutter systems over glazed doors and windows at this health center, including a shutter system properly installed (green dashed arrow), a shutter system with a track missing at a glazed door (solid red arrow), a window air conditioning unit preventing a shutter being deployed (orange dotted arrow), and a pair of glazed doors without glazing protection (yellow double arrow) (Puerto Rico, 2017) (FEMA P-2020)

- **Ensure that the impact-resistant system was properly installed,** according to manufacturer standards, and has been maintained. In particular, ensure that shutters on track systems are secured appropriately to their tracks (**Figure 5-51**).

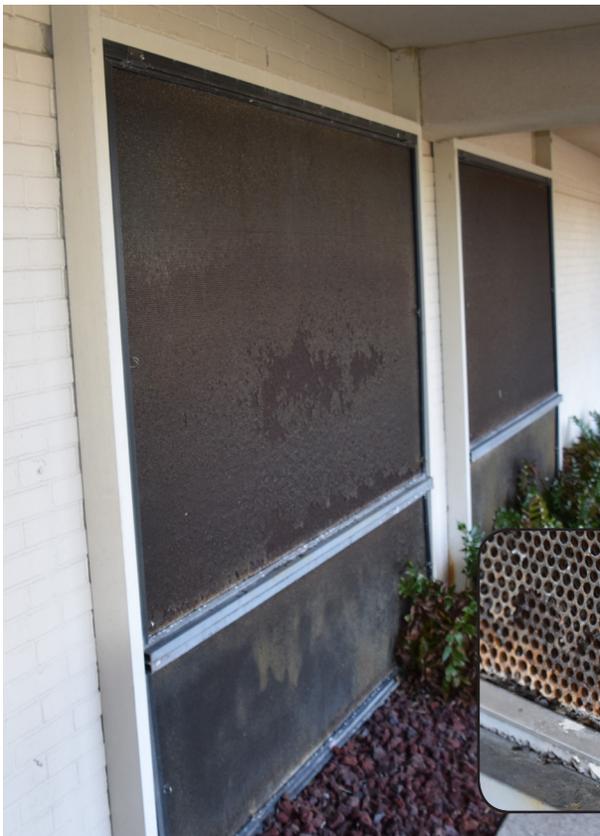
**Figure 5-52:** View of a permanently mounted screen shutter at a hospital. A portion of the screen was severely corroded; it was no longer capable of protecting the glazing.

- **Check for corrosion or other deterioration** of the shutter frame or track, fasteners, and the shutter itself (**Figure 5-52**).

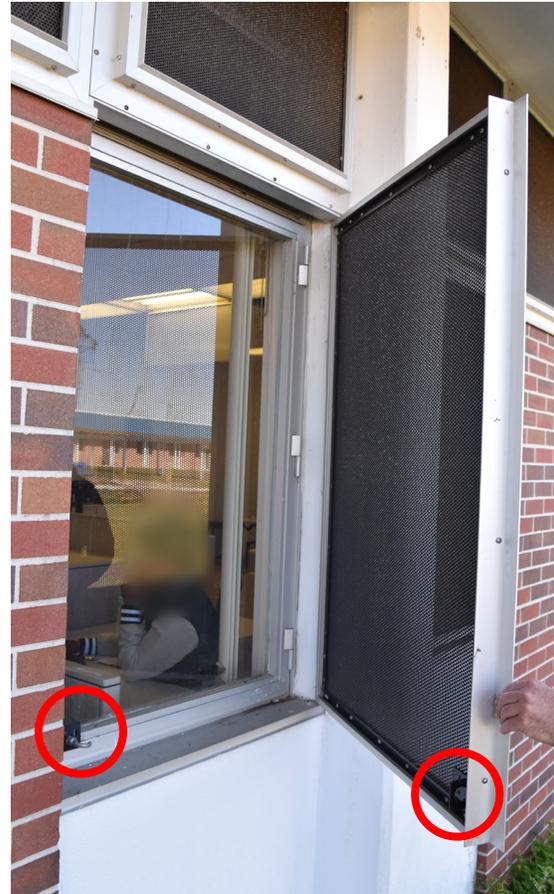
Figure 5-53:  
View of a shutter in the unlatched position. The red circles indicate the latching mechanism. Hurricane Michael (Florida, 2018)

- Permanently mounted screen shutters typically are hinged to allow access for window cleaning. At the school shown in **Figure 5-53**, several shutters unlatched during a hurricane, and at least one window was broken where a shutter unlatched. As part of the assessment, open a few shutters to evaluate the potential for unlatching during a storm.

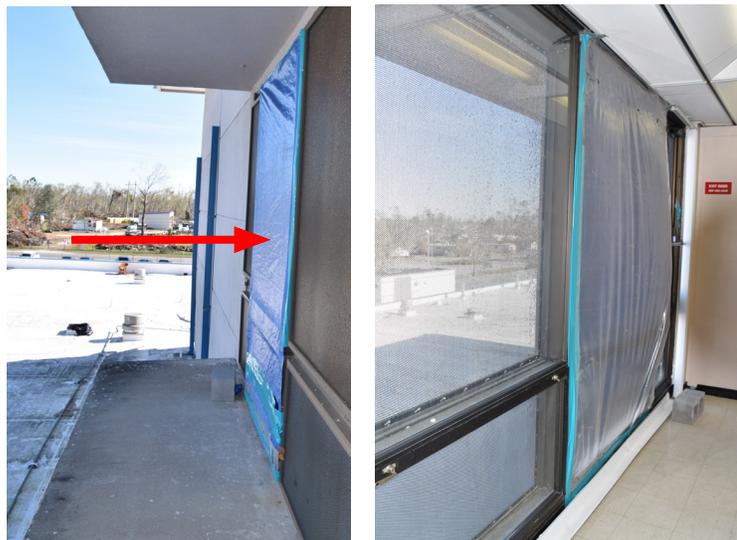
Figure 5-54:  
View of a school window that failed under positive wind pressure. The left photo is a view of windows protected by permanently mounted screen shutters. The solid red arrow indicates the primary wind direction during the hurricane. The right photo is a view of a window that failed due to positive pressure exceeding the resistance of the window frame. Hurricane Michael (Florida, 2018)

- **Ensure that the glazing assemblies protected by the impact-resistant systems have been tested** for protection against wind-driven rain, as shutters do not significantly reduce wind pressures nor wind-driven rain demand on the glazing assembly (Figure 5-54).

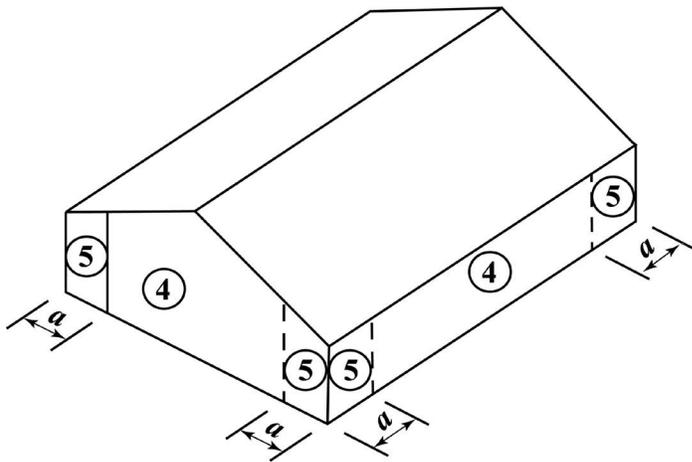
**Figure 5-55** is a schematic of the wall wind zones (Zone 4 and Zone 5) used in ASCE 7. Because wind suction pressures are higher in the corner areas of walls (Zone 5), it is important to pay additional attention to these areas when performing a vulnerability assessment. See the current edition of ASCE 7 for the width of the corner zone (Zone 5).

Figure 5-55:  
Wind zones on walls (Zone 4 and Zone 5);  $a$  = width of the corner zone. Reproduced, based on ASCE 7-16 Figure C30.3-1, with permission from ASCE.

the field of the wall (see **Figure 5-55**, Zone 4 and Zone 5). The spot check should include removing a few fasteners in order to determine their type and size and to compare the resistance provided by the fasteners with the design loads based on the current edition of ASCE 7.

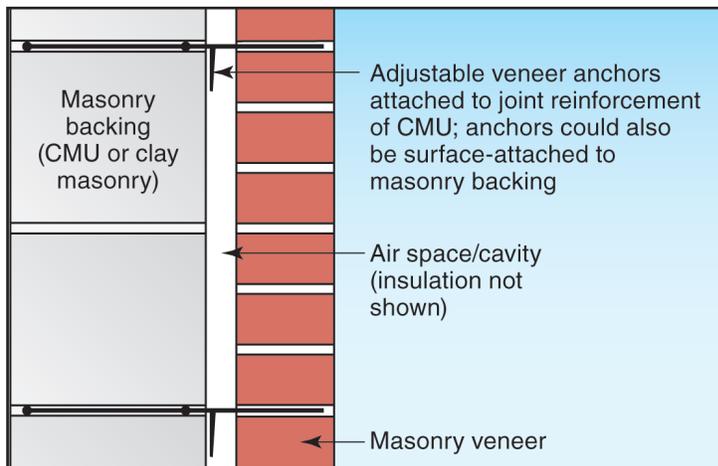
Figure 5-56:  
Masonry backing (CMU or clay masonry)

Anchored veneer is most commonly applied to backing constructed of masonry (Figure 5-56), wood framing (Figure 5-57), cold-formed metal framing (Figure 5-58), or concrete (Figure 5-59). These figures also show typical wall sections and anchor variations. More information on veneer anchored to varying backings is available in publications such as the National Concrete Masonry Association (NCMA) TEK Notes (<https://ncma.org>) and The Brick Industry Association Technical Notes ([www.gobrick.org](http://www.gobrick.org)).

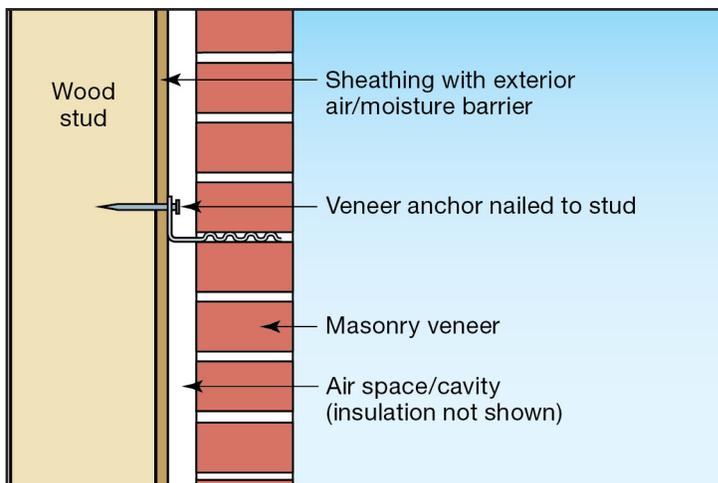
Figure 5-57:  
Wood framing backing

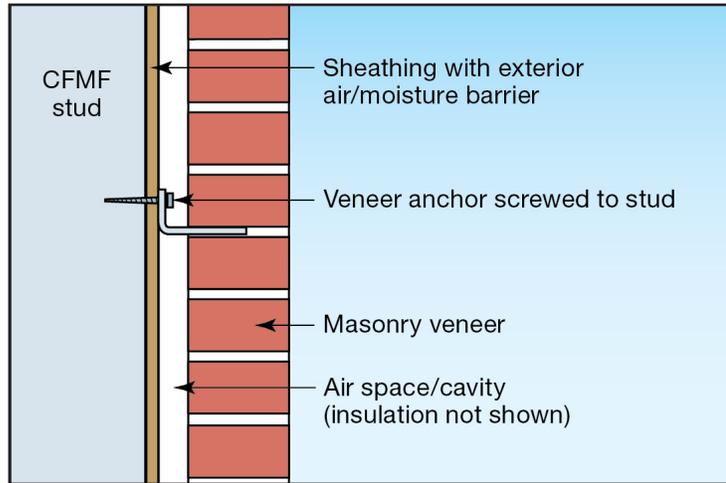
Figure 5-58:  
Cold-formed metal framing backing

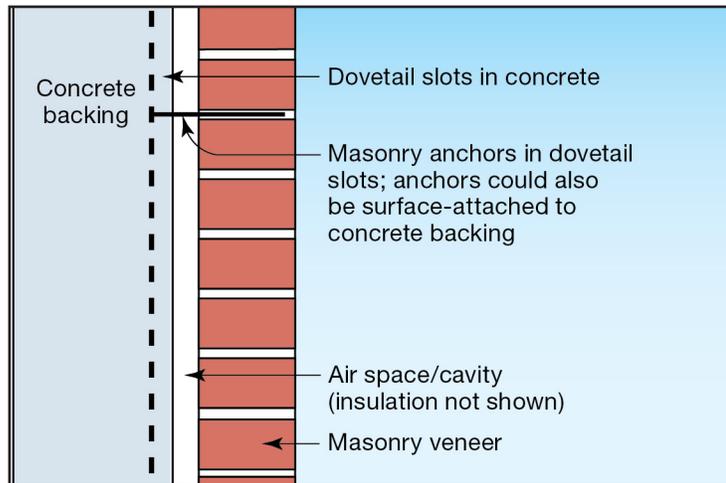
Figure 5-59:  
Concrete backing

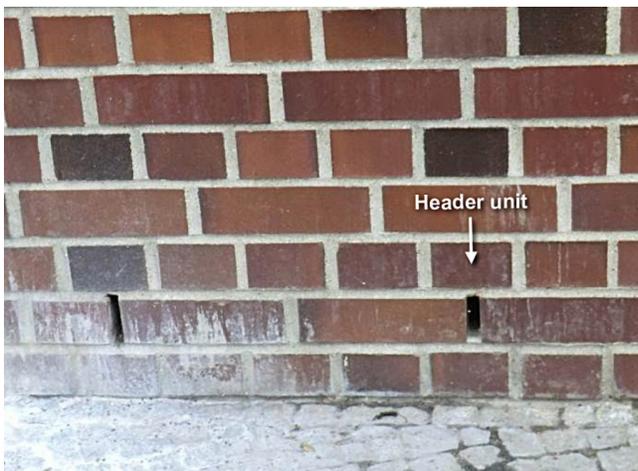
Figure 5-60:  
Weep holes, indicating a masonry veneer, even though there appear to be headers

- **Bonding pattern.** Masonry bond patterns with header bricks are unlikely to be veneer construction. These header units (units that are transverse to the wall) typically are used to bond the exterior masonry to the backing wall in solid masonry walls. However, **Figure 5-60** shows a portion of a veneer with header bricks and weep holes, indicating a brick veneer. A wall with headers and without weep holes is likely to be a solid wall and unlikely to have a veneer.

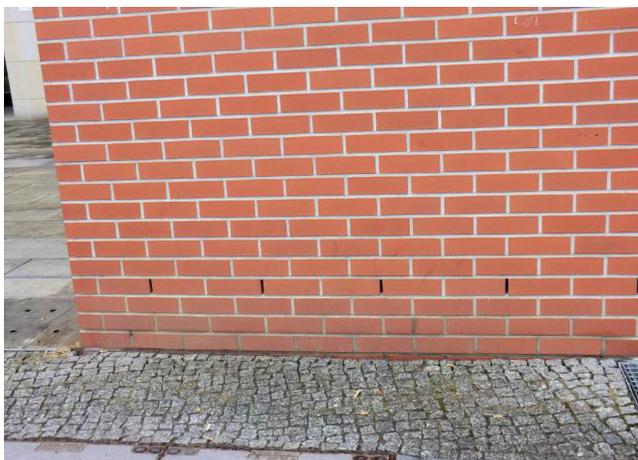
Figure 5-61:  
Weep holes, indicating a veneer with a cavity

- **Weep holes and ventilation.** Weep holes (**Figure 5-61**) generally indicate that the wall has a cavity and that the masonry facade is veneer. This figure shows the veneer in a running bond pattern, which is typical of most veneers. **Figure 5-62** shows a veneer in running bond at the corner where removals have been made. A closer view would indicate that there also are weep holes.

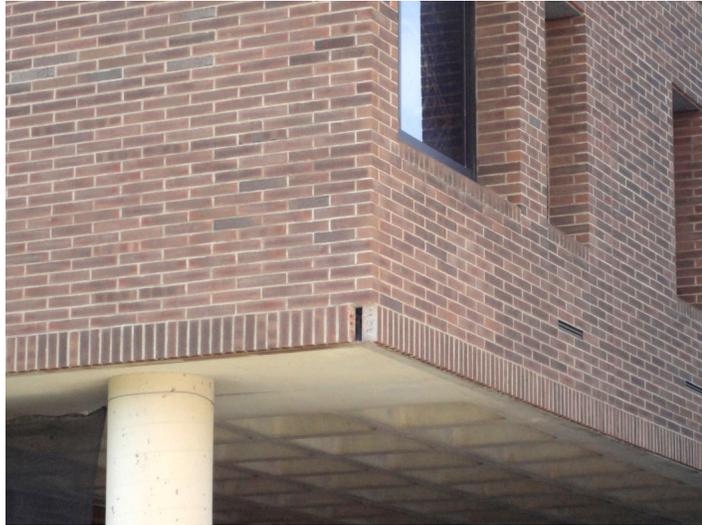
Figure 5-63:  
Metal flashing over shelf angle

- **Exposed flashing** over windows, doors, and shelf angles may indicate a veneer wall (**Figure 5-63**).

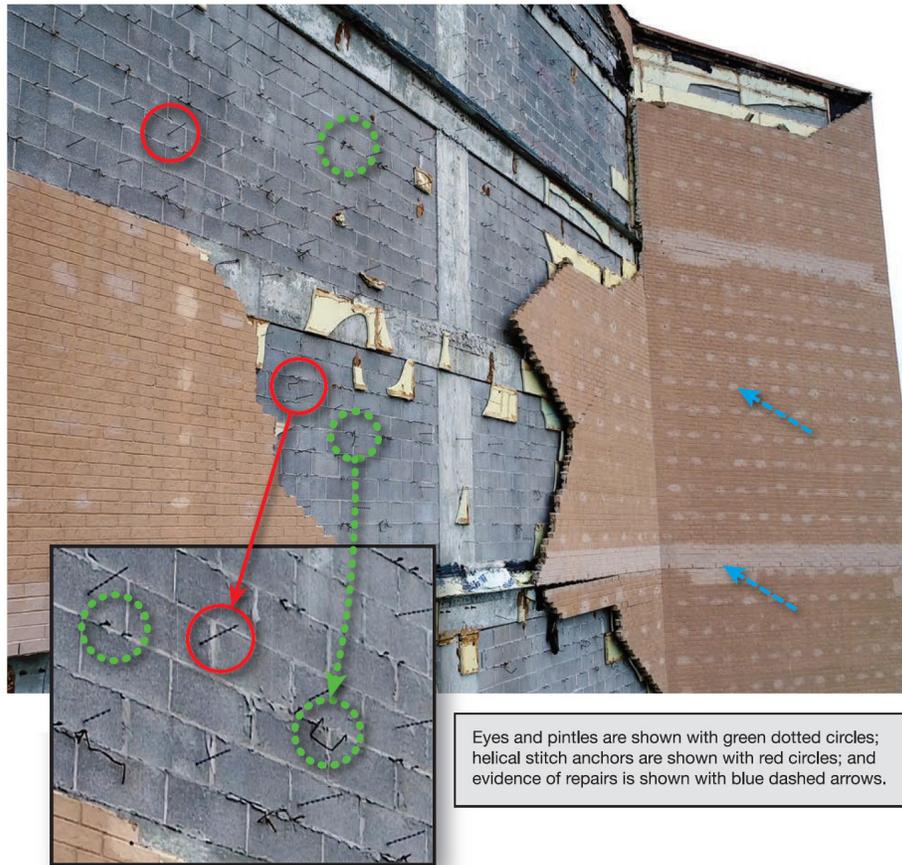
Eyes and pintles are shown with green dotted circles; helical stitch anchors are shown with red circles; and evidence of repairs is shown with blue dashed arrows.

**Figure 5-64:**  
Brick veneer failure.  
Hurricane Harvey (Texas,  
2017) (FEMA P-2022)

Veneer failure from high-wind events takes several forms. The most obvious form is full detachment and collapse (see **Figure 5-64**) and major cracking that renders the veneer unsafe to the point that it may collapse after the wind event. In some wind events, detached veneer can become wind-borne debris and can affect other structures. An additional failure is the significant water entry into the building through breaches in the moisture protection system provided by the cavity and flashings.

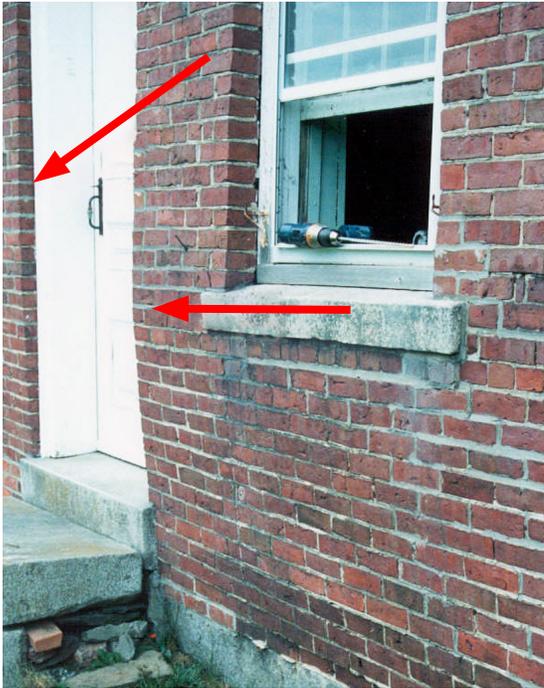
Figure 5-65:  
Bowed veneer, usually noticeable at openings

1. **Bowing of the veneer and/or structural backing.** Construction tolerances generally allow +/- ¼ inch variation over 10 feet, in either the plumbness of a wall or from a straight line. Any bowing beyond this tolerance may indicate a problem with the anchorage system.
2. **Openings.** Gaps around windows and doors are a good indicator of bowing (**Figure 5-65**).

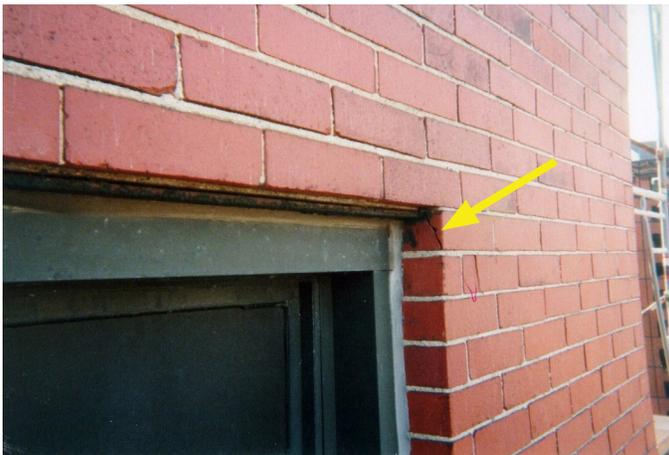
Figure 5-66:  
Deteriorated steel support and cracked  
veneer at bearing

3. **Deterioration or displacement of veneer support.** Any support deterioration must be evaluated to determine whether structural capacity has been compromised. Any displacement can be significant because it may indicate loss of support or an overstress of the anchoring system (**Figure 5-66**).

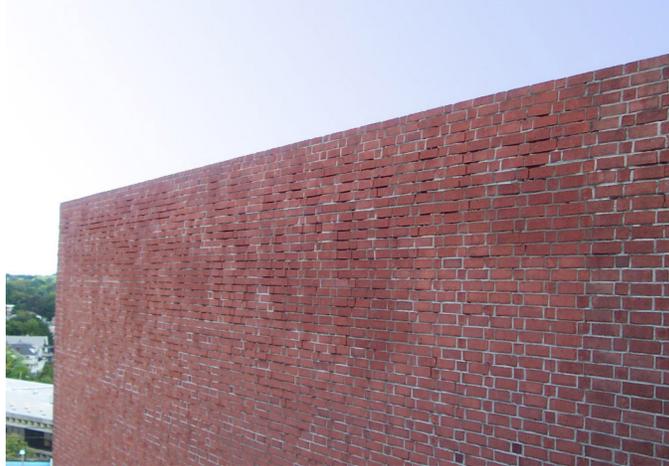
**Figure 5-67:**  
Deteriorated mortar joints

and location of the cracks are important. Cracks emanating from the corners of openings, continuous horizontal cracks (**Figure 5-67**), and diagonal cracks between openings are all examples of significant cracks that should be checked in a Level 2 assessment.

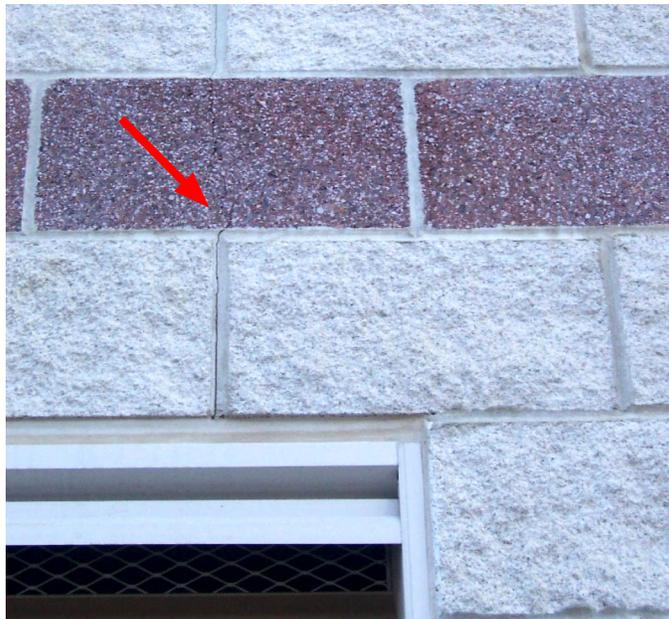
**Figure 5-68:**  
Cracks through CMU veneer and mortar

- 5. Deterioration of or cracks in masonry units.** Deterioration and cracks must be examined to determine whether: (1) the deterioration extends deeply enough into the units to affect the bond to the anchors, (2) the deteriorated unit material could become wind-borne debris in a wind event, and (3) portions of the cracked units have become dislodged from the anchors. **Figure 5-68** shows cracking in a mortar head joint of a CMU veneer that extends into the unit above. There is no cracking evident in the mortar bed joint that could affect the anchors, and there is no loose mortar or loose pieces of CMU.

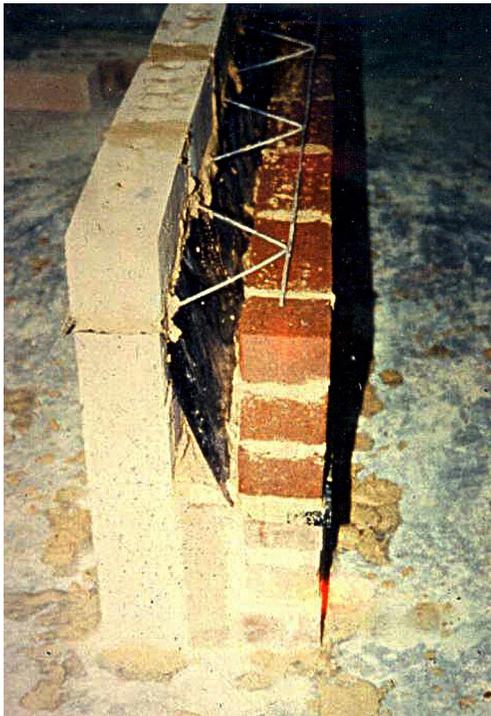
**Figure 5-69** shows a sample wall with brick veneer and joint reinforcement for anchors. The flashing is a membrane. It extends upward approximately 8 inches and is embedded in the CMU backing. Numerous industry design standards are available on proper flashing installation (IMI 2009).

**Figure 5-69:**  
Brick veneer with membrane flashing (NCMA)

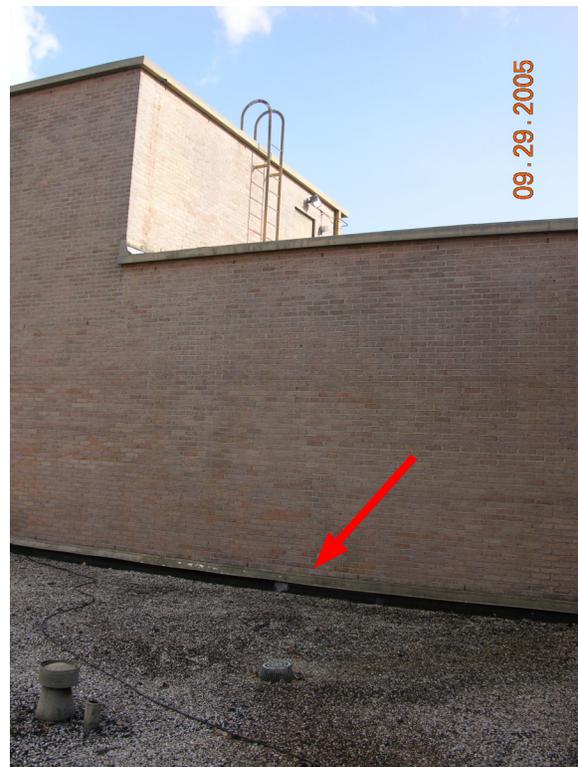
**Figure 5-70:**  
 At this hospital, water leaked inside along the base of the brick veneer walls (solid red arrow). Hurricane Katrina (Louisiana, 2005) (FEMA 577)

The weep hole spacing and height of the cavity flashing should be assessed to ensure that they are sufficient. The wall height should be considered when determining the amount of wind-driven water that may enter the cavity. For example, at the hospital shown in **Figure 5-70**, the weep holes/cavity flashing at the taller wall could experience higher water demand than the weep holes/cavity flashing at the shorter wall, depending on the direction of the wind-driven rain, the area of the wall, and the relative condition of the flashings at each location.

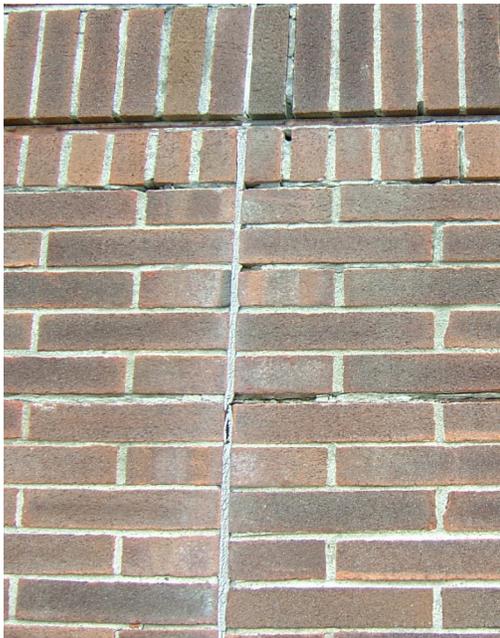
**Figure 5-71:**  
Split and deteriorated sealant

- The masonry sealant should be checked for lack of bonding to masonry or for split or missing sealant at veneer joints (**Figure 5-71**). Split sealants allow water entry. In addition, water that enters is trapped by the remaining working sealant. Sealants should be checked to determine whether they are split or debonded completely through the joints. Knowing the age and maintenance history of the building may provide data regarding the age and type of sealant used. Sealants more than 8 to 10 years old are likely to need maintenance.

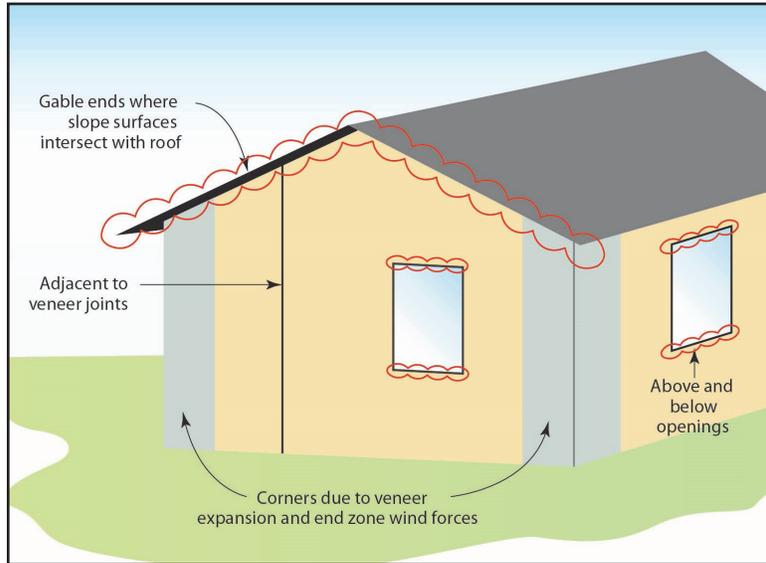
**Figure 5-72:**  
Vulnerable wind locations for veneer on gable ends

Although flashings and weep holes are most commonly associated with the base of walls, they also are required above door and window openings and at the junction of roofs and walls, as illustrated in **Figure 5-72**. The concerns for the base of walls discussed above also apply to openings. The roof-to-wall juncture introduces the following concerns that should be assessed:

Veneer in some areas of the building is more vulnerable to wind effects than veneer in other areas. The areas shown in red in **Figure 5-72** and **Figure 5-73** are the more vulnerable locations and should be examined during the visual assessment.

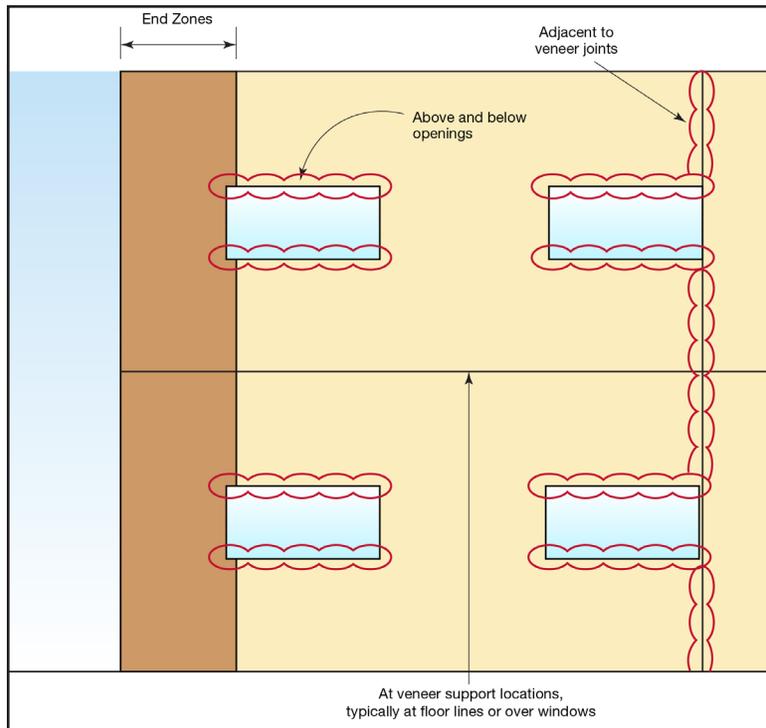
**Figure 5-73:**  
Vulnerable wind locations for veneer on multi-story elevations

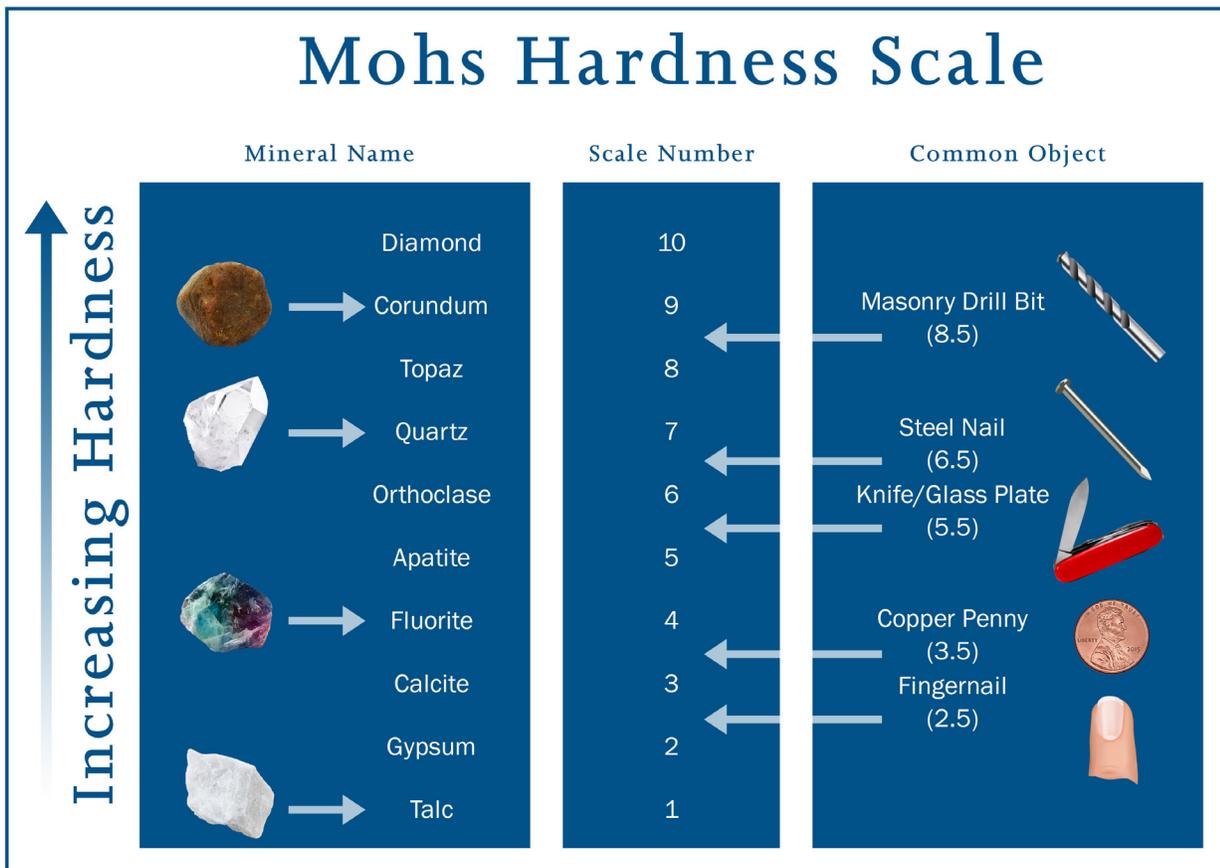
Figure 5-74: Mohs Hardness Scale (Graphic adapted from National Park Service)

- **Mortar hardness testing.** A scratch test can be used to evaluate mortar hardness based on the Mohs Scale, and this in turn can help in determining the mortar type. Even using a screwdriver to determine whether the mortar is easily scratched is valuable in assessing the type and condition of the mortar and ultimately the bond.

Without the Mohs Scale, simply scratching the mortar with a screwdriver or chipping away some mortar with a chisel can reveal some approximation of mortar strength. Mortar that is easily scratched from the joint is likely a Type O, while mortar that can be scratched, but not removed, is likely Type N. Be sure to not scratch known deteriorated mortar.

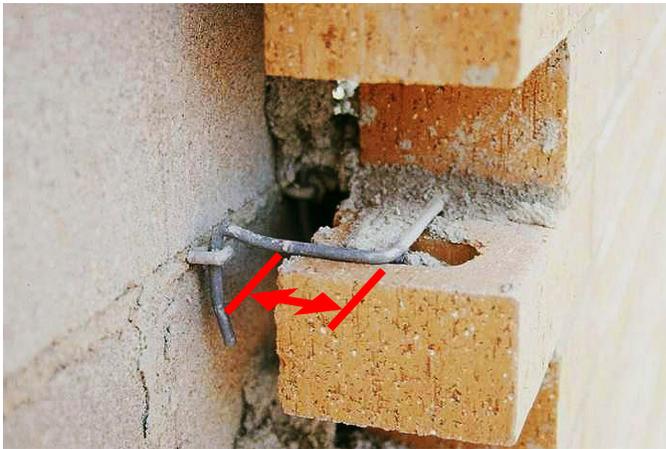
**Figure 5-75:**  
Adjustable masonry veneer anchor

**Figure 5-75** shows an adjustable anchor attached to a CMU backing using a double pintle anchor. The photograph of this improper construction was taken at a stoppage in the original construction work that resulted in a toothed (zipper) joint, which is not recommended practice. The stoppage created a vulnerable joint in the wall that may develop cracking over time. When the original work is resumed, the adjacent bricks will be pushed into the gap that was created, and the mortar will not be properly compressed. In this partial removal inspection example, note that: (1) the anchor is embedded at least 1½ inches, as required by code, (2) there is no visible corrosion, (3) the anchor is properly engaged in the pintle, and (4) the anchor is sitting on the veneer unit and not fully embedded in the mortar joint.

Although **Figure 5-75** shows an adjustable anchor that has been fairly common since the 1970s, earlier buildings, and many buildings today, use corrugated metal anchors that are attached to the backing by screws or nails (**Figure 5-76**).

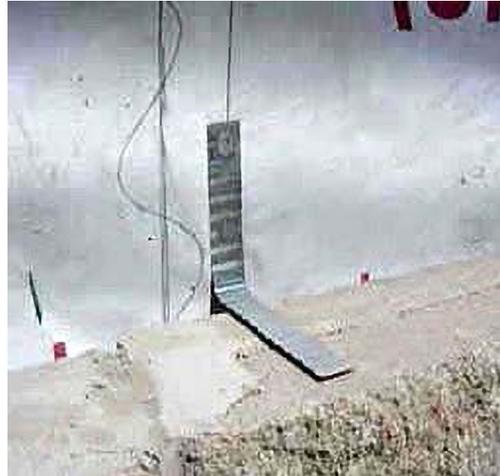
**Figure 5-76:**  
Corrugated tie screwed to backing (Photo courtesy of Heckmann Building Products, Inc.)

Some corrugated anchors of older buildings were constructed of mill-galvanized, 26-gauge metal. Mill-galvanized and 26-gauge anchors are highly vulnerable to deterioration and failure and are not approved for masonry veneers. Mill galvanizing does not provide long-term corrosion protection. By code, modern anchors are required to be 22 gauge or heavier and are either hot-dipped galvanized or stainless steel.

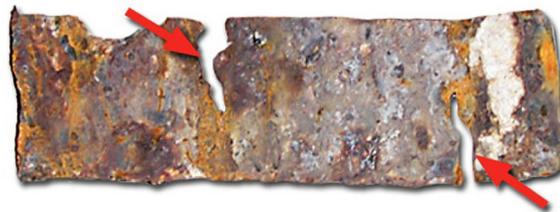
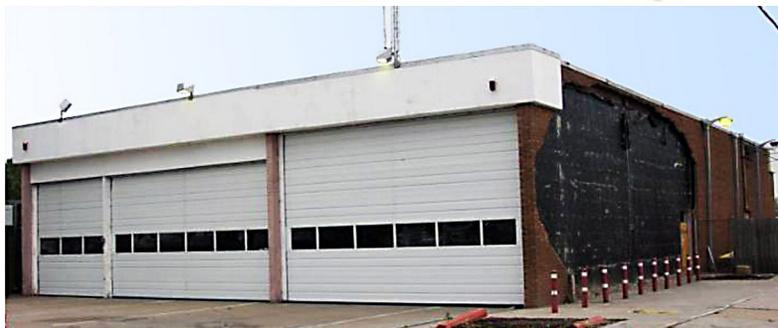
**Figure 5-77:** Brick veneer failure due to anchor corrosion. Hurricane Ike (Texas, 2008) (Top photo, FEMA P-499, Fact Sheet 5.4)

**Figure 5-77** shows brick veneer failure at a fire station that is the result of anchor corrosion. In the **Figure 5-77** inset, the metal is missing for half of the width of the anchor at two locations (red arrows). The left end of the anchor was still embedded into a CMU backup wall. The right end is where the anchor failed in tension, thus leaving a portion of the anchor embedded in the collapsed brick. Partial removal is required to identify this type of vulnerability.
