# Guidelines for Wind Vulnerability Assessments of Existing Critical Facilities

FEMA P-2062 / September 2019

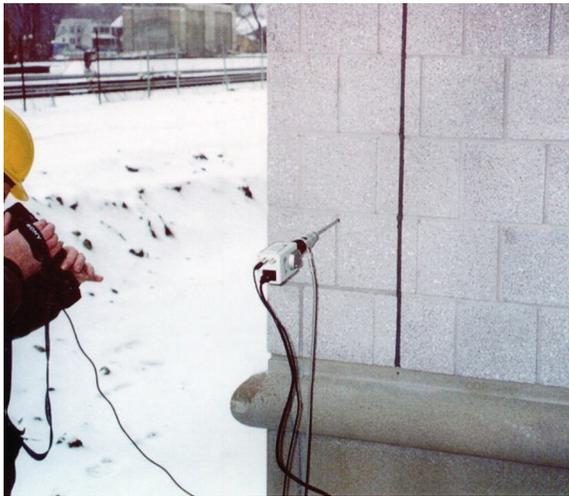
**Figure 5-78:**  
Borescope used to check the cavity of CMU veneer

- **Endoscopy using a borescope** requires partial removal or a bore hole in order to insert a borescope (**Figure 5-78**) and view the cavity behind the veneer. Endoscopy is useful in verifying the localized condition of the anchors.

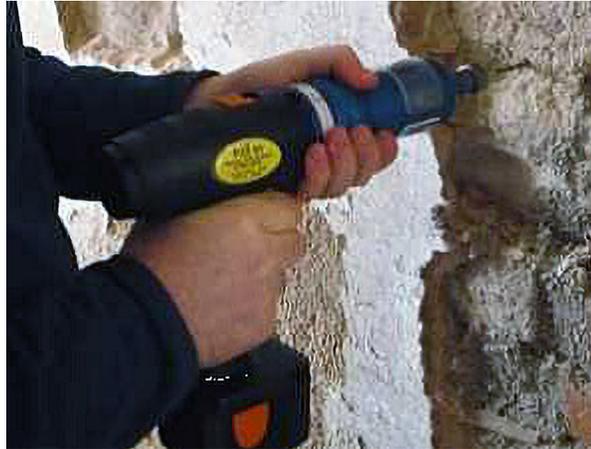
Figure 5-79:  
Drill test in mortar

- **A drill test** determines mortar strength based on drill resistance (**Figure 5-79**). Effectively, the test measures hardness and correlates to strength. It is available in Europe but, as of 2019, has not been standardized in the United States. The Windsor pin system, available commercially in the United States, is used under ASTM C803, *Standard Test Method for Penetration Resistance of Hardened Concrete* (ASTM 2018a) for hardened concrete, and is adapted for use with masonry (**Figure 5-80**). The system drives a pin into the mortar, and the pin depth then is measured and correlated to the compressive strength of the mortar.

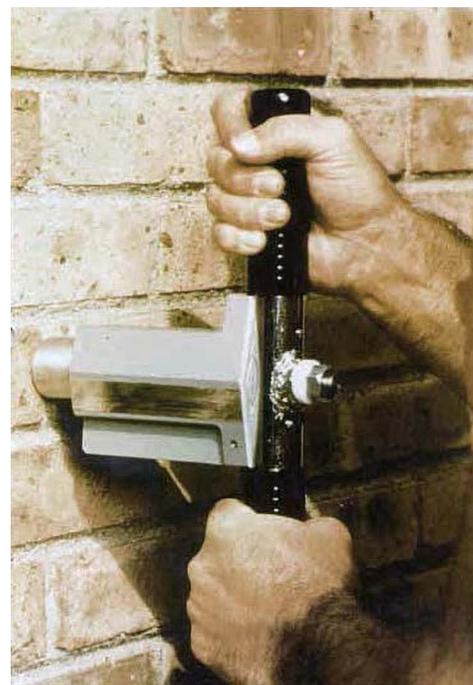
Figure 5-80:  
Windsor pin system (Photo courtesy of Qualitest International, Inc.)

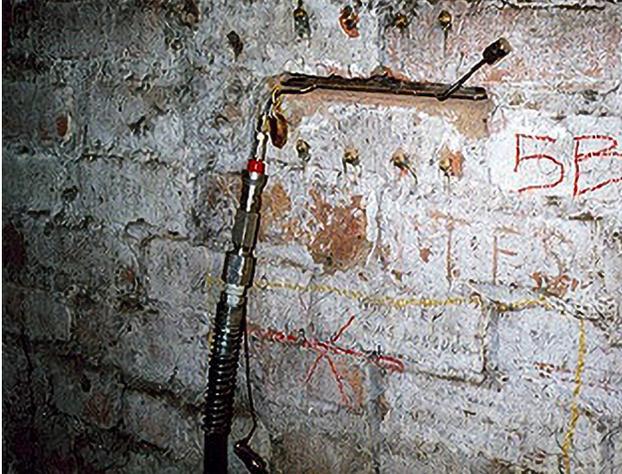
Figure 5-81:  
Flatjack in a mortar joint

- **Flatjack tests** use thin, bladder-like flatjack devices to measure the average compressive stress in a masonry veneer (**Figure 5-81**). See ASTM C1196, *Standard Test Method for In Situ Compressive Stress Within Solid Unit Masonry Estimated Using Flatjack Measurements* (2014a) and ASTM C1197, *Standard Test Method for In Situ Measurement of Masonry Deformability Properties Using the Flatjack Method* (ASTM 2014b). Although masonry veneers usually are not designed for stress, measuring the vertical stresses can be a useful diagnostic tool to determine whether stress-relieving is necessary as a repair technique. The figure shows a thin metal bladder inserted into a mortar joint, with a hose attached that connects to a hand pump and pressure gauge. Metal points are inserted into the wall above and below the joint. Initial measurements taken across the joint prior to cutting the joint, inserting the bladder, and pressurizing the joint back to its initial readings provide a means to indicate the stress in the veneer.

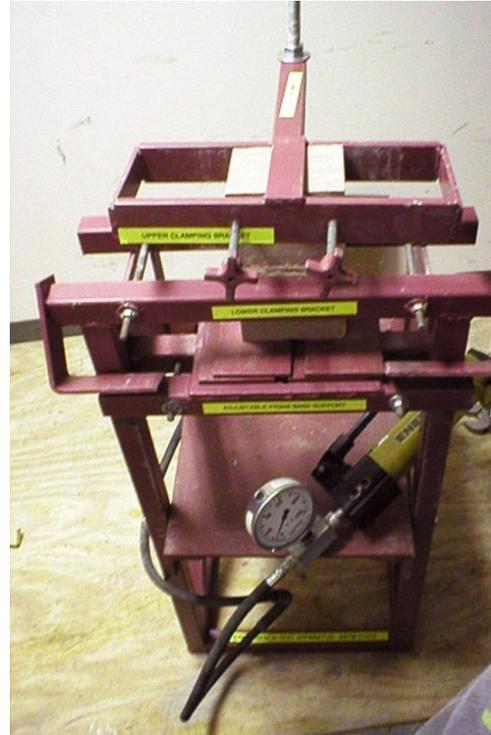
Figure 5-82:  
Bond wrench test equipment

- **A bond wrench test** requires a partial removal. See ASTM C1072, *Standard Test Method for the Measurement of Masonry Flexural Bond Strength* (ASTM 2013c). Currently, researchers test bond in the laboratory from field-extracted samples (**Figure 5-82**). An in-situ test device is still under development. These tests are used to assess the relative mortar bond to the masonry units. One representative sample per building can be selected based on the results of mortar hardness testing and drill tests. Bond values of less than 80 psi can indicate an inherent weakness that may require additional testing and evaluation.

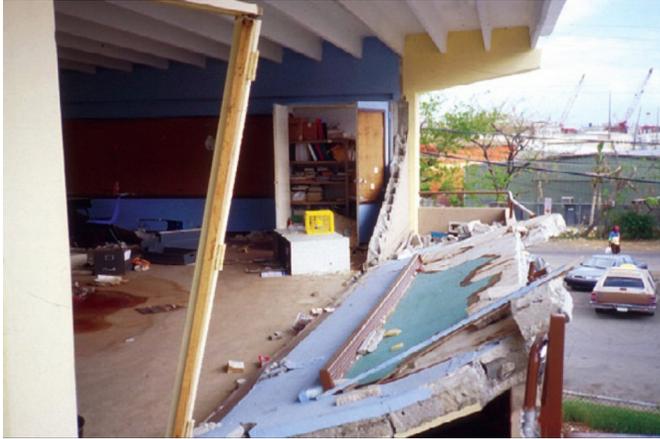
Figure 5-83:  
Collapsed unreinforced CMU wall at a school.  
Hurricane Marilyn (U.S. Virgin Islands, 1995)  
(FEMA P-424)

CMUs are used often in exterior non-load-bearing walls (**Figure 5-83**). These walls protect the interior but are subject to both positive and negative wind pressures, in-plane stresses due to sway in the MWFRS, and wind-borne debris. These walls can be damaged severely if not reinforced sufficiently to resist wind pressures and wind-borne debris. This type of wall often is used as an infill wall between concrete floors and columns, an exterior wall in steel-frame buildings, and an exterior wall for precast roof and/or floor systems (**Figure 5-83**). CMU walls may be perceived as having high wind resistance; however, when unreinforced or inadequately reinforced, this type of wall can topple, presenting a significant risk for building damage and life-safety issues.

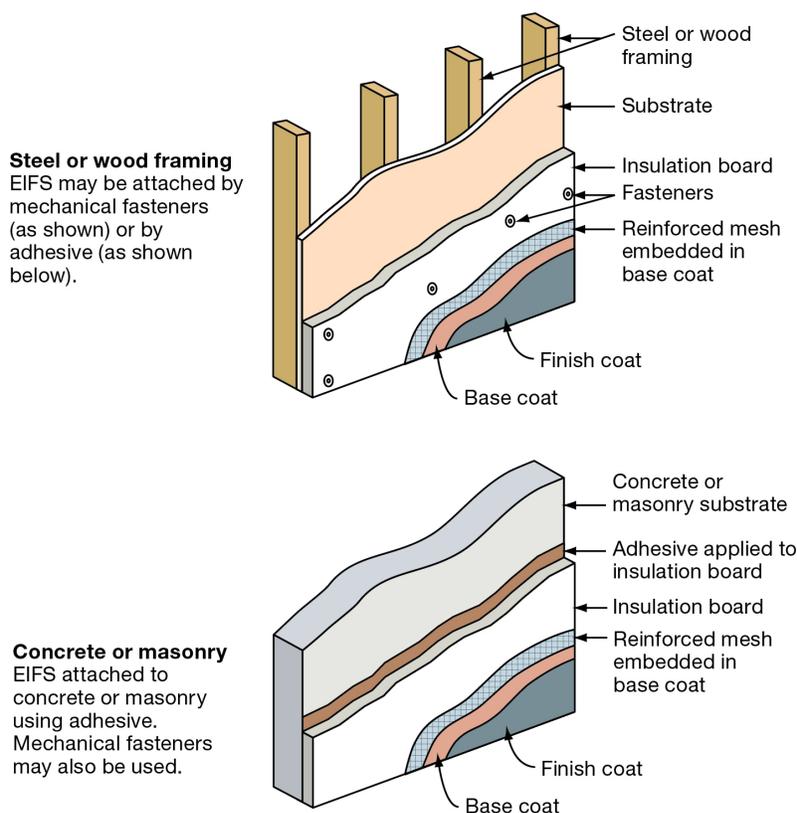
Figure 5-84: Typical polymer-based EIFS (FEMA 489)

**Polymer-based EIFS.** PB EIFS generally consists of a  $\frac{1}{8}$ - to  $\frac{3}{16}$ -inch-thick lamina composed of a mesh-reinforced base coat and a colored, textured finish coat. The base coat typically is a mixture of Portland cement and proprietary acrylic polymers, usually in a proportion of one-to-one or two-to-one. The base coat encapsulates the mesh with a thin layer of base coat material on each side and generally is considered to be the waterproofing portion of the assembly. The textured finish coat generally is considered to be the aesthetic and exposed component of the assembly. The lamina is always bonded or adhered to a rigid board foam insulation that typically is adhered to the underlying substrate using the same base coat material. **Figure 5-84** shows a typical PB EIFS.

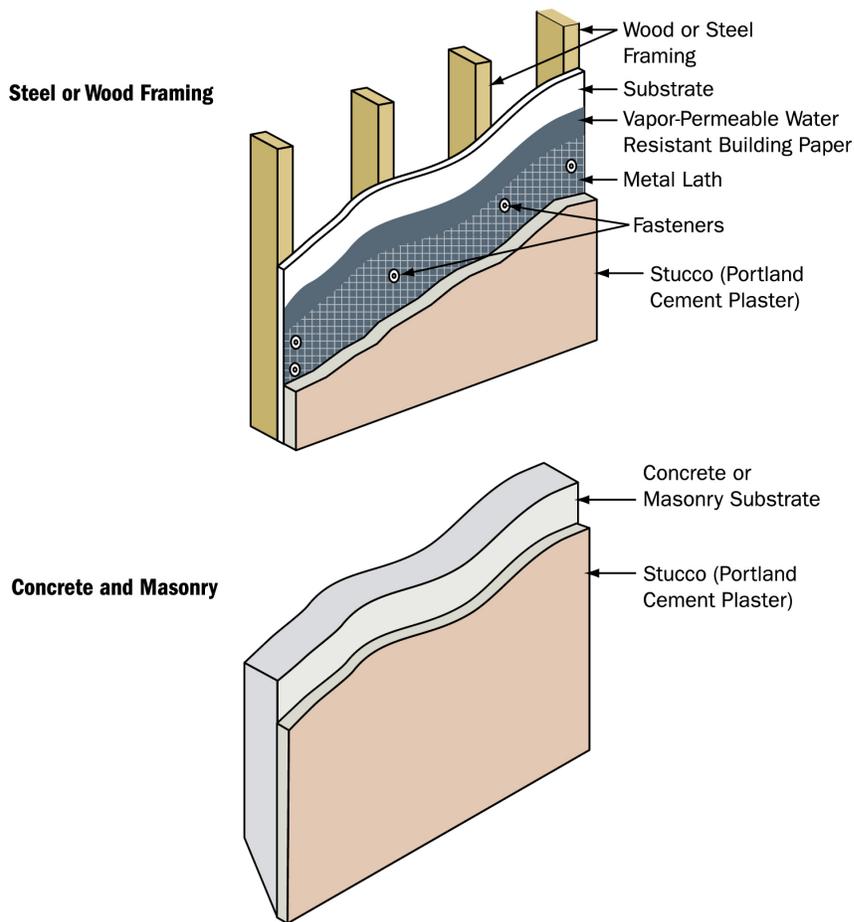
Figure 5-85: Typical PM EIFS and direct-applied traditional plaster systems (FEMA 489)

**Polymer-modified EIFS.** PM EIFS generally consists of a ¼- to ⅜-inch-thick lamina, composed of a fiber or metal mesh reinforced base coat and a colored, textured finish coat. The base coat typically is a mixture of Portland cement and proprietary acrylic polymers, usually in proportions of two-to-one or more. PM EIFS also encapsulates the mesh with a thin layer of base coat material on each side and generally is considered to be the waterproofing portion of the assembly. Likewise, the textured finish coat generally is considered to be the aesthetic and exposed component of the assembly. **Figure 5-85** shows a typical PM EIFS.

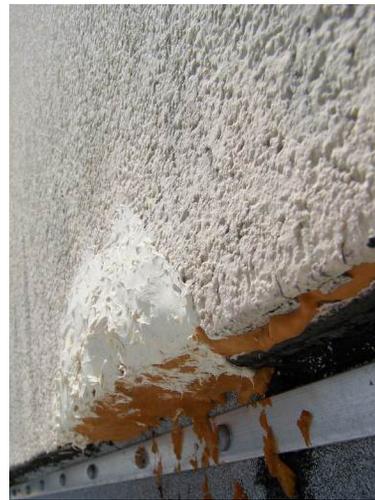
Figure 5-86:  
EIFS panel termination at base

- EIFS panel edges and terminations at openings and penetrations, at the base of the wall (**Figure 5-86**), at overhanging soffits, and against adjacent dissimilar materials, such as brick, stone, and wood
- Areas of discontinuity that often are vulnerable to water and air infiltration

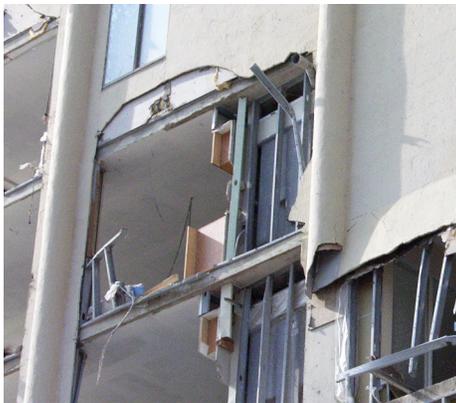
**Figure 5-87:**  
Stucco system that failed because the stud tracks were inadequately anchored to the concrete slabs. Hurricane Ivan (Florida, 2004) (FEMA 489)

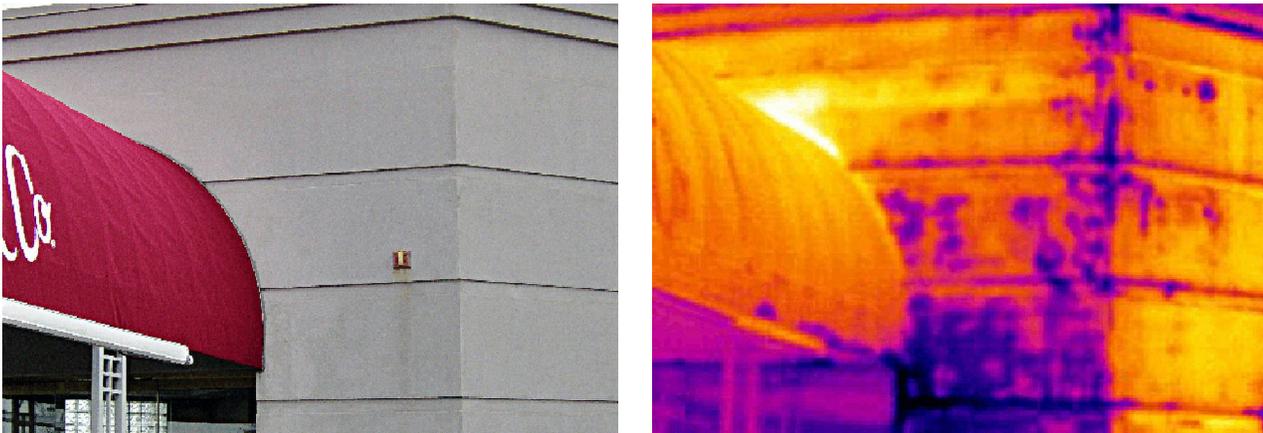
Figure 5-88: EIFS cladding (left) and infrared thermograph (right)

The purpose of using infrared thermography in a wind vulnerability assessment of EIFS is to identify any abnormal thermal patterns of infrared radiation from the building envelope. Thermal anomalies may be the result of trapped or absorbed moisture, or of energy loss from the interior through leakage of cooled or heated air, lack of insulation, inconsistent insulation, thermal bridges in the wall construction, and other reasons. See **Figure 5-88**.

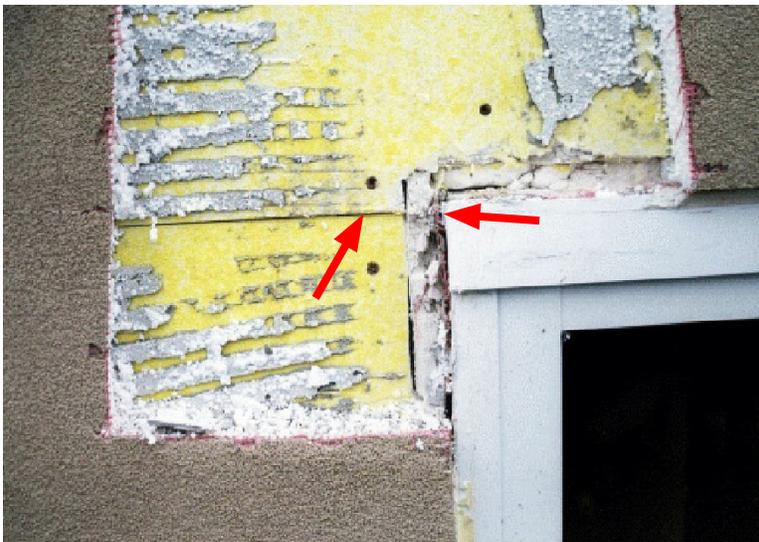
**Figure 5-89:**  
EIFS selective demolition showing alignment of sheathing with the window opening and horizontal notched trowel application of adhesive.

- Overall condition of the wall system
- Installation details, such as type of mesh, number of layers of mesh, type of foam insulation, and whether the system is adhered or mechanically attached
- In PB EIFS, the adhesion method (ribbon-and-dab or notched trowel); see **Figure 5-89**
- Qualitative evaluation of the integrity of the adhesion (assessed as the materials are manually pulled from the substrate)
- Type and thickness of the exterior sheathing substrate
- Fastener type and spacing in the exterior sheathing (this factor can affect resistance to negative wind loads)
- Any effects of past or present moisture infiltration on the substrate (e.g., water stains, corrosion, deterioration); see **Figure 5-89** and **Figure 5-90**

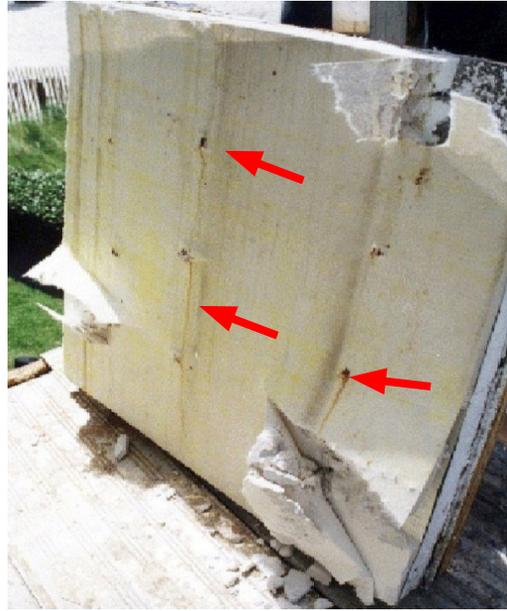
**Figure 5-90:**  
Water stains on the back of glass-faced gypsum sheathing

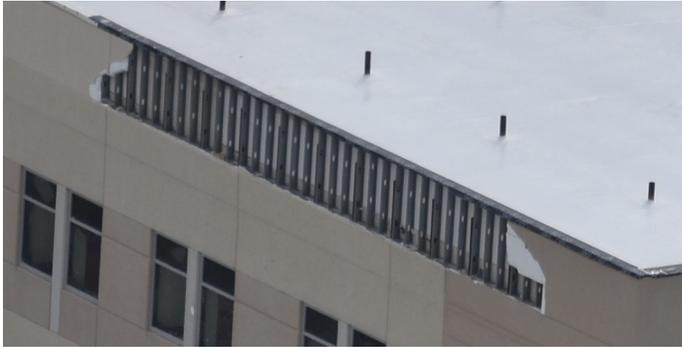
**Figure 5-91:**  
View of EIFS blow-off at a hospital addition that opened in 2010. The EIFS's gypsum board substrate blew off the metal studs. A Level 2 assessment or storm damage typically is needed to identify this type of weakness. Hurricane Michael (Florida, 2018)

about the condition, design, and workmanship of the EIFS and its anticipated performance in design wind pressures. A field pull test is the only way to evaluate wind performance and the only way to obtain quantifiable data on the resistance of the wall system to negative wind loads after the wall has been subjected to weathering (**Figure 5-91**).

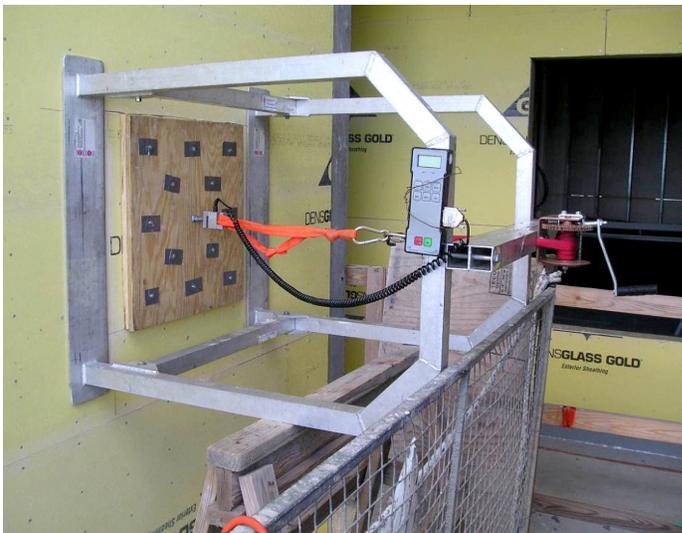
**Figure 5-92:**  
Frame used in field pull test

The equipment used in a field pull test consists of a lightweight aluminum test frame (**Figure 5-92**). The frame must be placed against a vertical exterior wall surface and supported by a scaffold or personnel positioned on either side of the test frame. The test frame is fitted with oversized contact plates, which are designed to straddle the test location and bear against the side of the building. The contact plates distribute frame reaction forces onto the wall to minimize compression of the adjacent and/or surrounding EIFS assembly or other materials.

The pull device consists of a manually operated worm-drive winch with 1-inch nylon webbing. A digital load cell with a range of 0 to 1,000 pounds is used in line between the cable and test module to measure applied force. The simulated negative pressure on the wall surface is transferred to the exterior cladding assembly via a 24-inch square, wooden panel that is adhered to the exterior cladding using a urethane adhesive. The wooden test panel is  $\frac{3}{4}$ -inch-thick plywood. A second panel is mechanically fastened to the adhered panel using twelve  $\frac{1}{4}$ -inch x  $1\frac{1}{2}$ -inch wood lag screws in a prescribed pattern in order to distribute the pressure. A  $\frac{1}{2}$ -inch-diameter hex head bolt through the center of the second panel is used as the attachment point for the digital load cell.

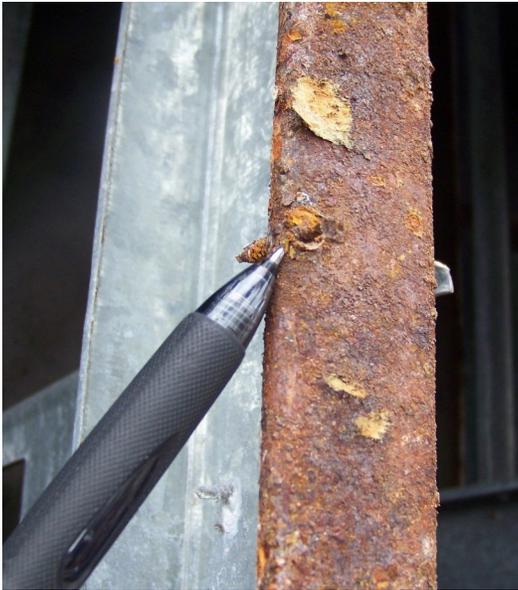
**Figure 5-93:**  
Corrosion on one face of metal stud, indicating chronic moisture

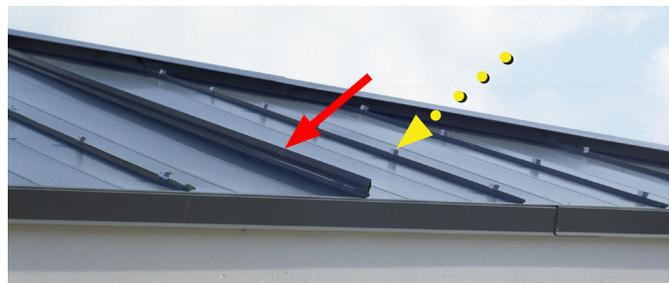
**Figure 5-94:**  
 Metal panels attached with exposed fasteners on the parapet of a school. Fastener spacing was inadequate to resist the wind load. Typhoon Paka (Guam, 1997) (FEMA P-424, 2004 edition)

- See Section 2.5.1 for information on conducting a Level 1 assessment. This should include a review of original design loads and system resistance in the historical file as well as a comparison of the historical information with design loads based on the current edition of ASCE 7. When information on the original design loads and system resistance is not available and the panels are attached with exposed fasteners (**Figure 5-94**), spot check the fastener spacing in corner areas and in

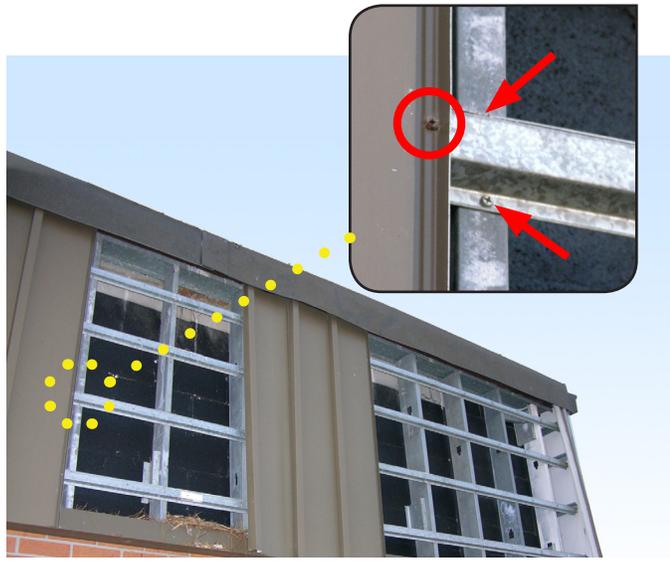
**Figure 5-96:**  
 Metal panel blow-off at a school. Without a moisture barrier over sheathing, wind-driven water blew into the school. The solid red circle indicates a concealed panel fastener. The solid red arrows indicate hat channel fasteners. Hurricane Ivan (Alabama, 2004)

Removing a panel in at least one corner area and the field of the wall is recommended to be able to determine whether there is a WRB, such as asphalt-saturated felt or housewrap, over the sheathing. As shown in **Figure 5-96**, if the metal panels blow away and there is no WRB over the sheathing, a large amount of wind-driven rain can be blown into the building.

framing member, as shown in the **Figure 5-96** inset. If fasteners occur only in the top or bottom flange, as shown in **Figure 5-98**, the hat channel can twist and create prying forces on the channel fasteners.

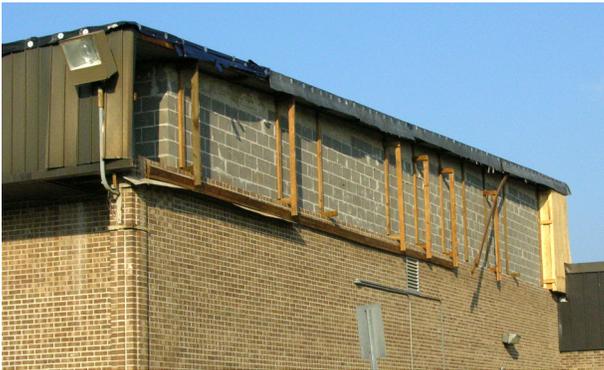
**Figure 5-97:**  
At a portion of the school shown in **Figure 5-96**, the metal panels were attached to wood framing that was inadequately attached to CMU. Hurricane Ivan (Alabama, 2004) (FEMA P-424)

- If the framing is wood (**Figure 5-97**), check the adequacy of the framing connections and the adequacy of the attachment of the framing to the building.
- If metal hat channels are present, check the attachment of the channels. Determine whether fasteners occur in the top and bottom flange at each vertical

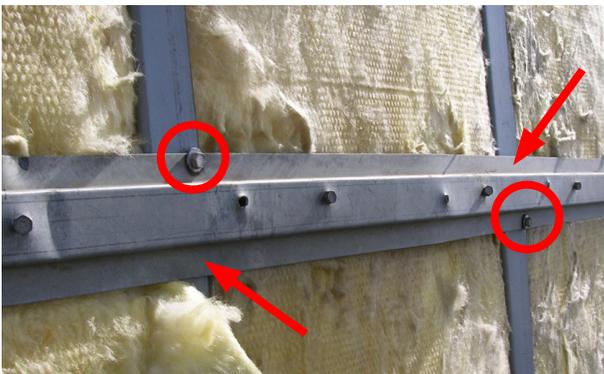
**Figure 5-98:**  
This hat channel had only one fastener at each vertical member (red circles). A fastener also should have been installed on the opposite flange (solid red arrows). At this location, the exposed fastener panels blew off, but at most blow-off areas, the hat channels blew away.

- Check fastener edge distances (**Figure 5-99**). The wall panel damage shown in **Figure 5-98** and **Figure 5-99** occurred at a power plant outside of a hurricane-prone region. The winds were well below the ASCE 7 basic wind speed.
- When the panels are removed, check for the presence of sealant or sealant tape. When actual wind speeds approach 120 mph, the potential for wind-driven rain to force in between unsealed panel laps increases.

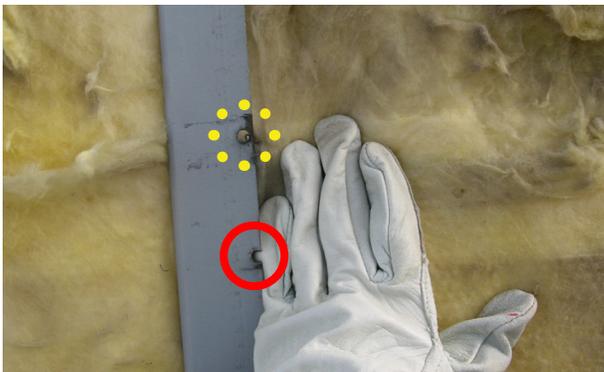
**Figure 5-99:**  
At this location, the hat channel had fasteners at the top and bottom flanges, but the fasteners were too close to the edge (solid red circle and yellow dotted circle). Nearly half of the shank of one fastener (solid red circle) did not engage the framing.

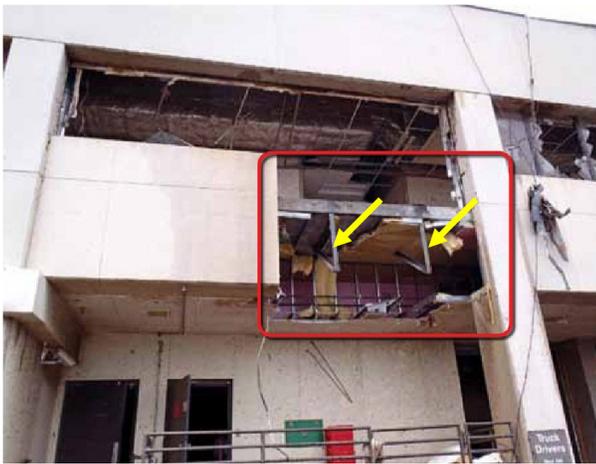
**Figure 5-100:**  
Missing precast concrete wall panel. Joplin Tornado  
(Missouri, 2011) (FEMA P-908)

Exterior cladding constructed of precast concrete is normally only a few inches thick and can be similar to the cladding shown in **Figure 5-100**. The figure shows a panel that blew off during a tornado. The vulnerability of the panels to high winds is generally in the attachment of the panels to the building frame. In the figure, the steel braces (yellow arrows), where the precast panel used to be, suggest that the panel was attached by bolts or welds.

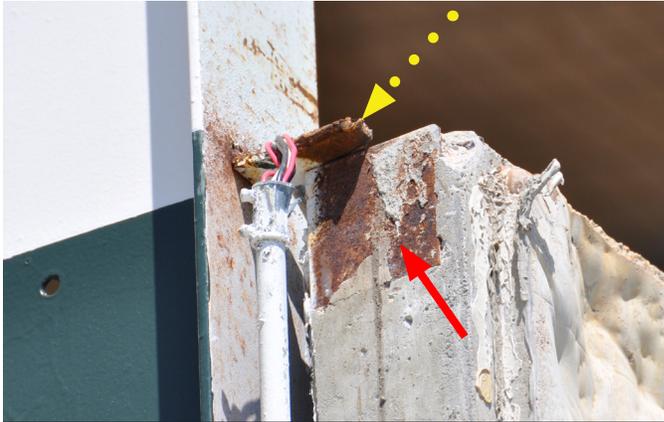
The red arrow indicates a weld plate cast into the panel. The dotted yellow arrow indicates a plate that was welded to the frame and the panel weld plate.

Figure 5-101:  
Precast panel failure at a school due to insufficient welding. Hurricane Harvey (Texas, 2017) (FEMA P-2022)

Problems with attachments involving bolts or welding include: corrosion, inadequate spacing of bolts or welds, inadequate welding (**Figure 5-101**), inadequate attachment of weld plates to the panel, and improper location of the weld plates in the panels. In coastal areas, both bolts and welds can corrode, reducing the strength of the connection. The number of bolts that were installed in the original installation may have been inadequate, or the welds may have been incomplete or inadequate. Adequate attachment of the panels to the building frame, using either bolts or welds, depends in part on the proper location of the steel plates embedded in the panels. Any shortcomings in the attachment can jeopardize the resistance of the attachment to the pressures caused by high winds.

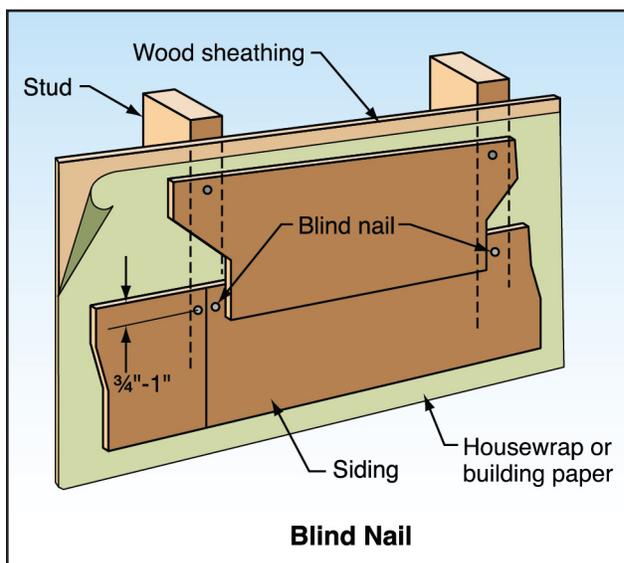
Figure 5-102:  
Blind nailing (FEMA P-499, Fact Sheet 5.3)

The typical nailing method with this siding product is called blind nailing (see **Figure 5-102**), in which the nails are driven through the product in a location that hides the nail when the next piece of siding is “lapped” on top. FEMA P-499, Fact Sheet 5.3, suggests that blind nails be kept between  $\frac{3}{4}$  inch and 1 inch away from the top edge of the siding panel and a minimum of  $\frac{3}{8}$  inch from the butt ends of the panel.

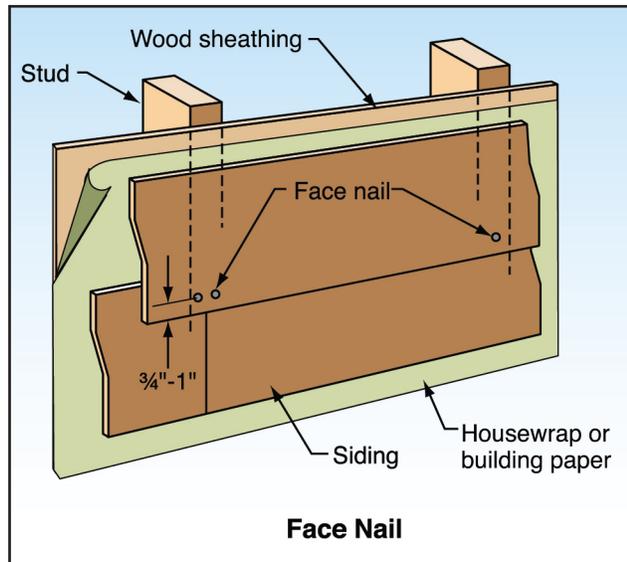
Figure 5-103:  
Face nailing (FEMA P-499, Fact Sheet 5.3)

The primary vulnerability to wind is poor attachment to the building frame. Siding also is vulnerable to bending failure when blind nailed. The product should be nailed into the wall studs to secure it properly, and in high-wind areas, nails should be placed through the face of the product, which makes the nail spacing visible (see **Figure 5-103**). In FEMA P-499, Fact Sheet 5.3, face nailing is recommended in areas where the design wind speed is 100 mph or greater unless the local building official has more restrictive requirements.<sup>41</sup> **Figure 5-104** illustrates damage to this siding when it is not face-nailed.

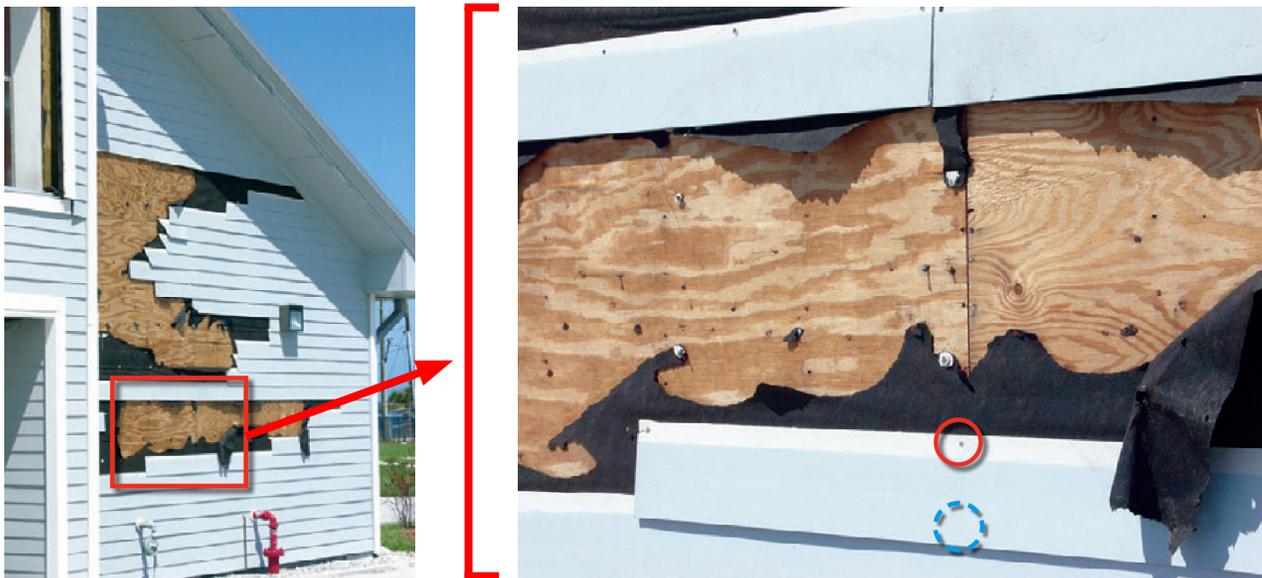
Figure 5-104: Fiber cement siding attached with blind nails (solid red circle). Because of the high design wind speed, face nails should have been used (blue dashed circle). Hurricane Francis (Florida, 2004) (FEMA P-424)

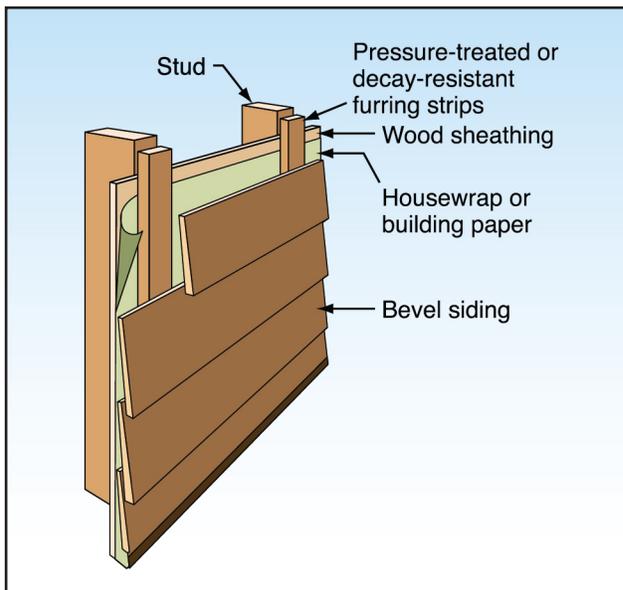
**Figure 5-105:**  
Water drainage cavity (FEMA P-499, Fact Sheet 5.3)

In coastal environments, the nails should be corrosion-resistant. Stainless steel or hot-dipped galvanized nails are considered corrosion resistant for these applications. Corrosion-resistant nails may be installed on furring strips that provide a cavity in order to facilitate drainage of water from the space between the WRB and the backside of the siding. The water drainage cavity also facilitates drying of the siding and the moisture barrier (see **Figure 5-105**). The siding manufacturer's instructions for rain screen applications in high-wind areas must be followed. The furring strips should be attached to the building framing or otherwise incorporated into the structural load path. Where this is done, siding can be attached to the furring strips, with or without penetration to the building framing, in accordance with manufacturer's instructions.

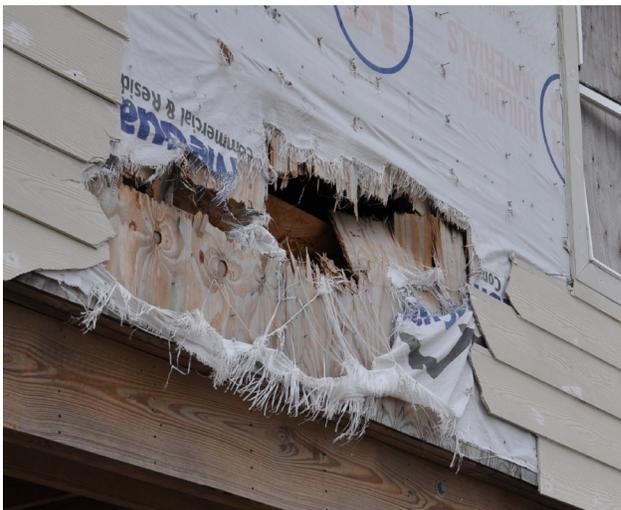
**Figure 5-106:**  
Hurricane wind-borne debris damage to fiber cement siding. The debris penetrated the plywood substrate. This siding was face-nailed. The siding blow-off likely would not have occurred, were it not for the debris impact. Hurricane Harvey (Texas, 2017)

Fiber cement siding is unlikely to resist damage from wind-borne debris in hurricanes and tornadoes, and the damage from debris can be significant (see **Figure 5-106**).

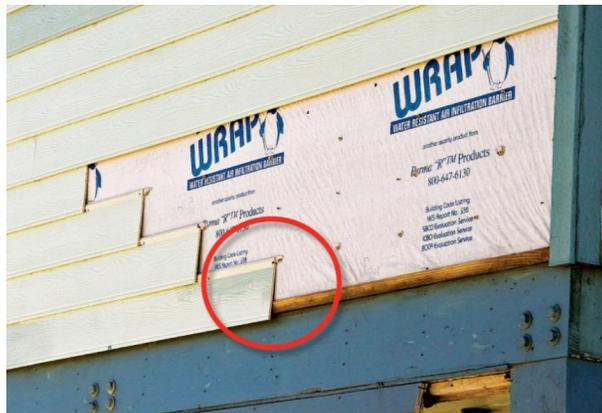
Figure 5-107:  
Exposed gap (solid red circle) (FEMA P-499, Fact Sheet 5.3)

- Check the bottom of the lowest piece of siding (see **Figure 5-107**) to determine whether it is attached to the starter section of wall sheathing. The lowest course of siding should be face-nailed to a starting spacer that is flush with the bottom of the lowest course of siding. This was not done in **Figure 5-107**.

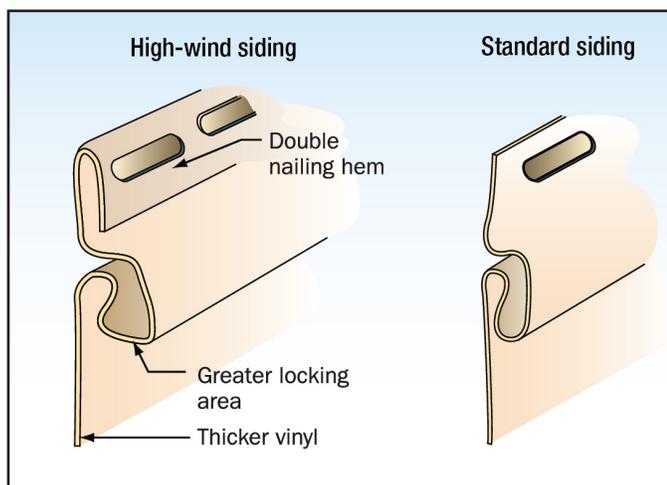
**Figure 5-108:**  
High-wind vinyl siding profile

All vinyl siding is tested and rated for different wind design pressure applications; the rating of the siding used for the building should be at least as high as the local design pressure for components and cladding. Vinyl siding that is rated for higher wind pressures may have greater overall thickness, a more robust locking mechanism, and thicker or doubled-over nail hem (see **Figure 5-108**). Even if the exact design pressure rating cannot be determined, it is often possible to determine if the siding has a higher wind rating by looking for these features.

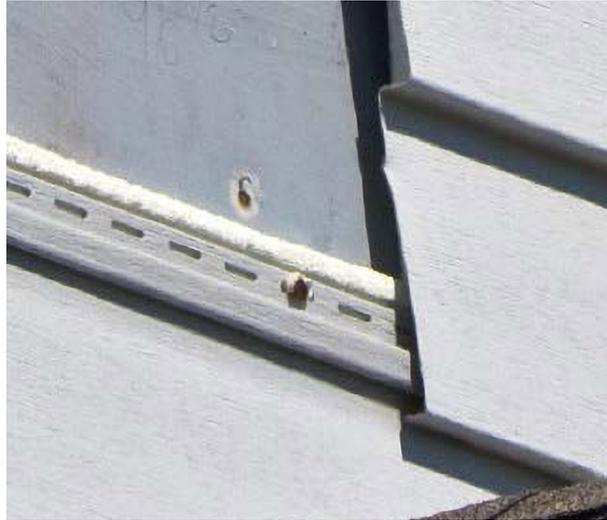
**Figure 5-109:**  
Incomplete interlocking of flanges (FEMA  
P-757)

- Check the bottom of the lowest piece of siding to determine whether it is attached to a proper starter strip used for vinyl siding.
- Spot check to ensure that the bottom of the vinyl siding is locked onto the flange on the top of the previous course. This can be determined by pulling on the bottom of the siding panels. A lack of interlocking is shown in **Figure 5-109**.

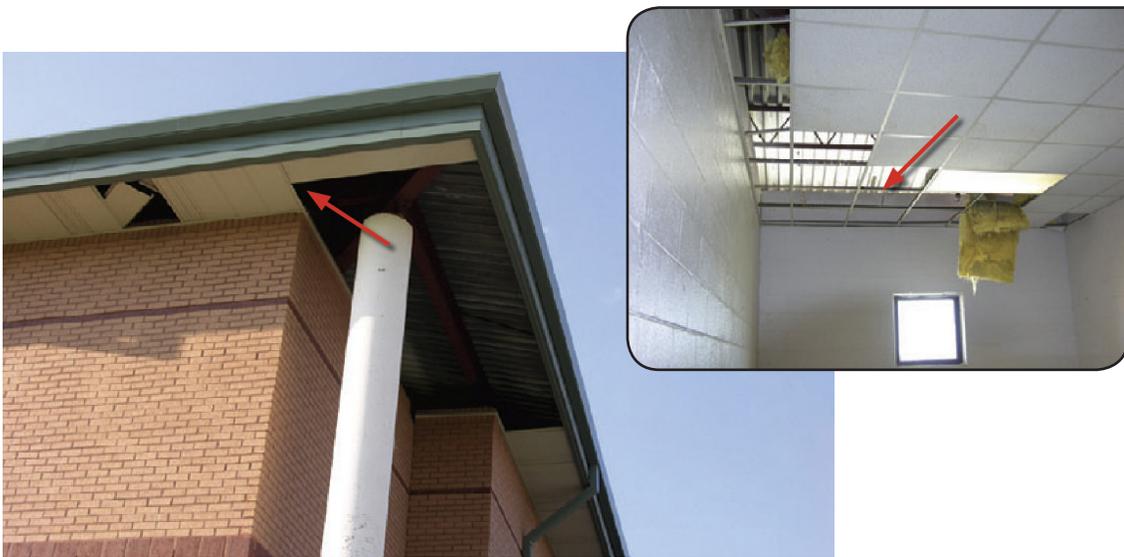
Figure 5-110: At this school, the exterior wall stopped just above the soffit (solid red arrows). After the metal soffit panels blew away, wind-driven rain blew into the attic space and saturated the fiberglass batt insulation, causing the ceiling boards to collapse. Hurricane Katrina (Mississippi, 2005) (FEMA P-424)

- Evaluate the soffit panels and framing system for resistance to both positive and negative (suction) pressures. **Figure 5-110** shows a soffit that had insufficient resistance.
- Evaluate soffits with vents for resistance to wind-driven rain.

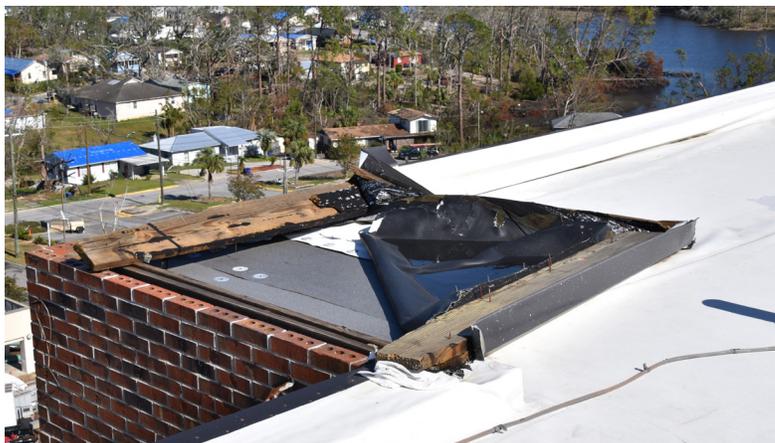
**Figure 5-111:** The nailer at this medical office building had inadequate wind resistance. It lifted and caused progressive lifting and peeling of the roof membrane. The nailer was part of the original construction, but its attachment was apparently not checked when the building was reroofed. Hurricane Michael (Florida, 2018)

- **Nailers.** Check the drawings and specifications to determine whether attachment criteria were given for nailers that occur below edge flashings and copings (see **Figure 5-111**). If so, determine whether the specified attachment is sufficient to resist current uplift loads, using a safety factor of 3 (as recommended in FEMA P-424, 543, and 577).<sup>59</sup> Field assessment of nailers is addressed in the Level 2 assessment (Section 5.4.2).

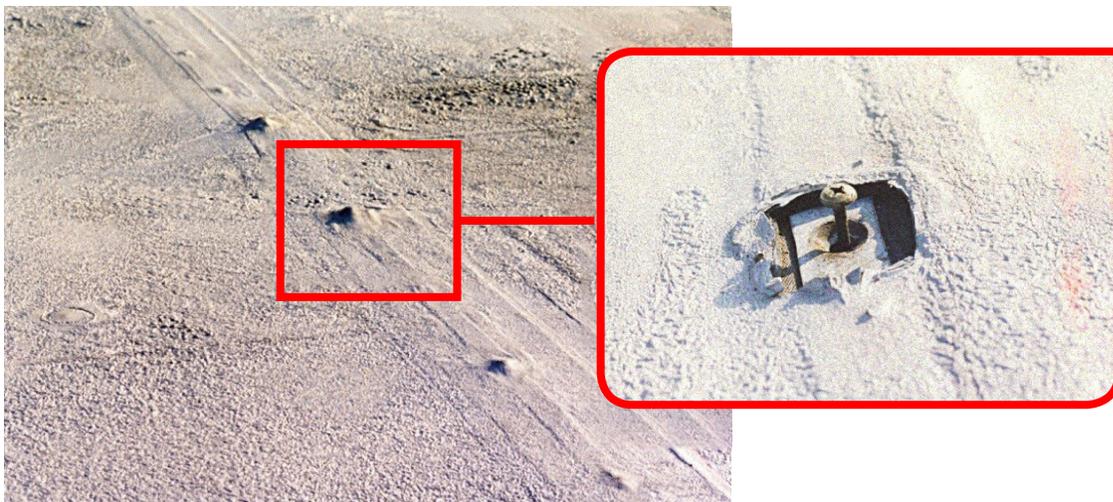
**Figure 5-112:** This mechanically attached single-ply membrane had several tented fasteners. A test cut revealed that the wood fiberboard below the membrane had compressed because it had gotten wet.

- **Observe the roof for signs of distress and detachment**, such as tented fasteners (see **Figure 5-112**) and large blisters. Walk the entire perimeter of the roof. Make one trip if the width of the perimeter zone is less than 4 feet. If the perimeter width exceeds 4 feet, make trips at intervals not exceeding approximately 4 feet. In addition, walk the field of the roof at intervals not exceeding approximately 20 feet. Be sensitive with each footfall to changes in the softness of the substrate, which could indicate wet insulation or displaced materials. Also, be sensitive to an indication of a lack of attachment of adhered roof membrane and insulation boards. For the systems that are appropriate for testing with an electrical capacitance moisture meter, a reading is recommended approximately every 10 feet while walking the roof (see **Figure 5-113**).

If signs of distress are found, normally a test cut such as the one shown in the **Figure 5-112** inset is taken to evaluate the distress.

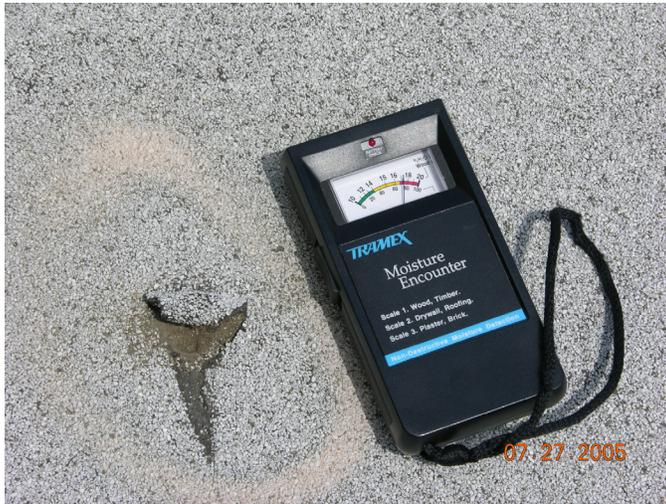
Figure 5-113:  
Electrical capacitance moisture meter shows a high reading near a damaged cap sheet.

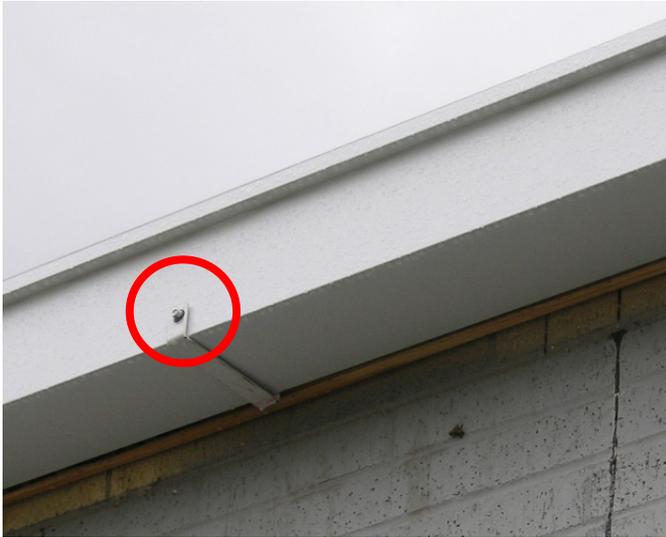
**Figure 5-114:**  
This gutter was screwed to each bracket.  
Hurricane Ike (Texas, 2008) (FEMA P-757)

- **Visually check the gutter** to see whether there is a mechanical connection or interlock between the gutter and gutter bracket (see **Figure 5-114**). If the gutter is not connected or is inadequately connected to the brackets, the gutter is susceptible to blow-off.
- **Perform the rotation tests as described above.** For some tests, place a hand on either side of a bracket. For other tests, place both hands midway between two brackets. Unfortunately, a field test method (other than hand manipulation) that can be used for a more definitive evaluation of resistance does not exist currently.
- **Evaluate the gutter load path.** The uplift and rotational wind load exerted on the gutter will be transferred to the wall, nailers, or deck, depending on the bracket design and attachment. A safety factor of 3 is recommended for gutters.

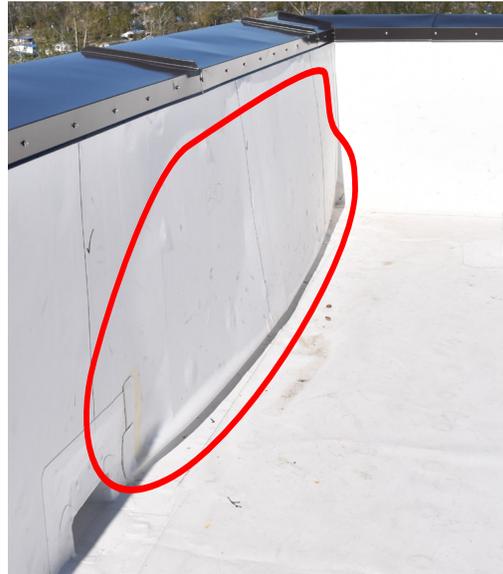
**Figure 5-115:**  
The base flashing at this medical office building remained adhered to the sheathing, but the sheathing detached from the metal studs. In this case, the roof membrane did not lift and peel. Hurricane Michael (Florida, 2018)

- **Base flashing substrate attachment and integrity:** Base flashings are often attached to wood sheathing or gypsum board that is attached to studs. Detachment of the sheathing can result in progressive lifting and peeling of the roof membrane (**Figure 5-115**). A Level 2 assessment is typically needed to evaluate attachment.

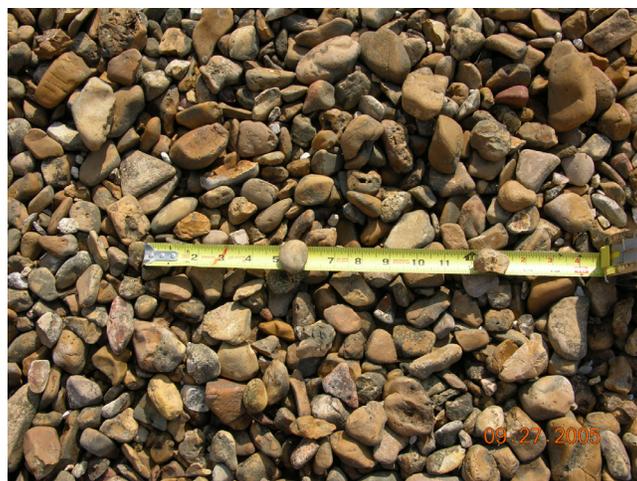
**Figure 5-116:**  
The ballasted single-ply aggregate on this hospital roof does not meet the gradation requirements in ANSI/SPRI RP-4. The undersized aggregates are more susceptible to blow-off. Hurricane Katrina (Mississippi, 2005) (FEMA 549)

- If the building is not in a hurricane-prone region and has a single-ply membrane ballasted with aggregate, pavers, or cementitious-coated insulation boards, determine whether the system (including parapet height) complies with ANSI/SPRI RP-4 2013, *Wind Design Standard for Ballasted Single-ply Roofing Systems* (ANSI/SPRI 2013) (see **Figure 5-116**).

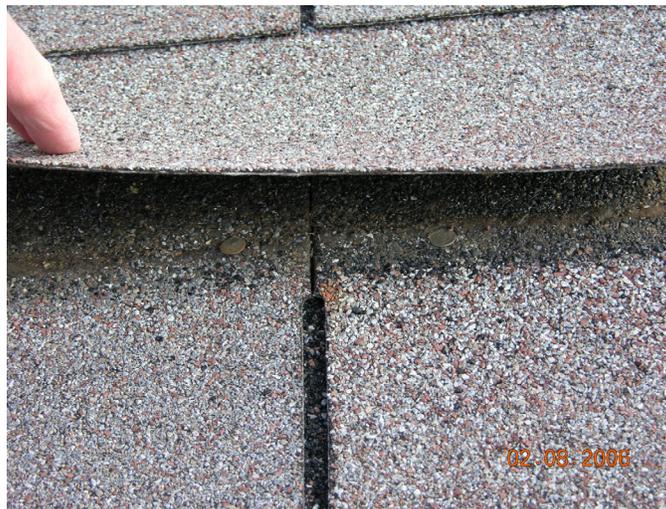
Figure 5-117:  
View of an unsealed tab on a school roof

- **Unsealed tabs.** If shingles are unsealed or partially sealed, they are vulnerable to wind damage. Spot checks for unsealed tabs are recommended at each corner zone<sup>70</sup> and at a few locations in the perimeter and ridge zones (as defined in ASCE 7) (**Figure 5-117**).

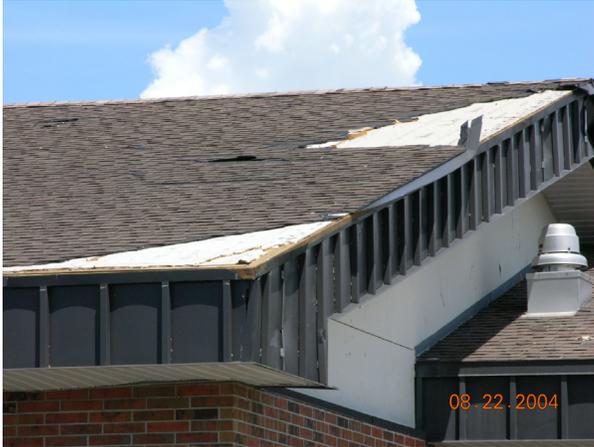
**Figure 5-118:**  
The metal drip edge at this school was not cleated or face-fastened. The vertical flange rotated and caused a progressive failure of the shingles. Hurricane Charley (Florida, 2004) (FEMA 488)

- **Eaves and rakes.** If the vertical flange of the metal drip edge along the eave or rake exceeds 2 inches, additional wind load is imparted on the flange, thereby making longer (higher) flanges more susceptible to failure, as shown in **Figure 5-118**. If the vertical flange exceeds 2 inches, try to rotate the flange as described in Section 5.4.1.1 for edge flashings and copings.

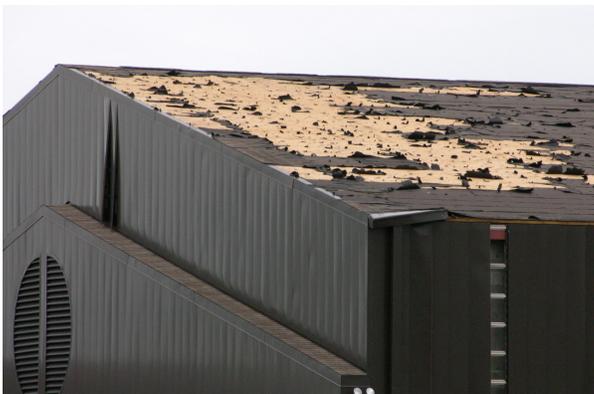
**Figure 5-119:**  
Asphalt shingle and underlayment blow-off resulted in significant water infiltration at this school. The school was being used to shelter people at the time of the blow-off. Hurricane Ivan (Florida, 2004)

- Underlayment.** Investigations of damaged roofs frequently have found that when shingles are blown off, the underlayment also is blown off (**Figure 5-119**) unless special attention is given to the design and installation of the underlayment (FEMA 489, 549, P-757). With loss of the underlayment, the building typically is susceptible to significant water infiltration. It is recommended that the assessor assume that the underlayment is susceptible to blow-off unless it is determined by destructive observation that the underlayment complies with the guidance given in FEMA P-55.

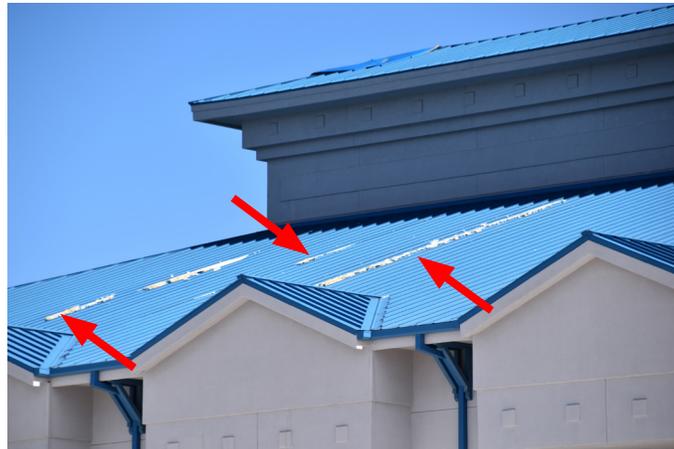
**Figure 5-120:**  
View of a few seams that opened up. In the opened condition, the panels were very susceptible to progressive failure, and they were no longer watertight. At other locations on this building, several panels were blown off. Hurricane Michael (Florida, 2018)

See Section 5.4.1 for discussion of wind-resistance testing of metal panel systems. If the historical file indicates that the system was tested in accordance with UL 580 rather than ASTM E1592, the panels may be susceptible to unlatching from concealed clips or the seams may be susceptible to opening up as shown in **Figure 5-120**.

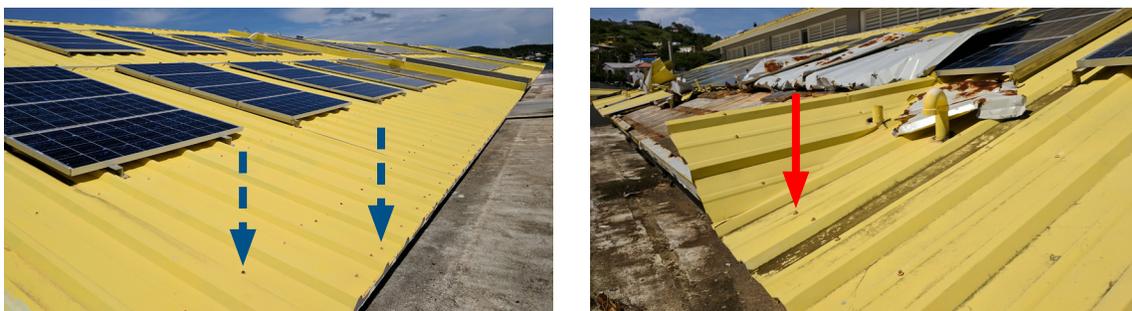
**Figure 5-121:** Metal roof panels at this school performed differently in two locations shown. In left photo, two rows of fasteners near the end of the panels (blue dashed arrows) performed better than the panels in photo on right, with only one row of fasteners that were several inches from the end (solid red arrow). (Puerto Rico, 2017) (FEMA P-2020)

- **Panels with exposed fasteners.** Determine whether the panel fasteners are screws or nails. If the fasteners are nails, they are susceptible to pull-out caused by dynamic loading of the panels. Spot check the fastener spacing in the corner,<sup>73</sup> perimeter, and field zones (as defined in ASCE 7), and determine whether the attachment is sufficient to resist current uplift loads.<sup>74</sup> See **Figure 5-121** for an example of metal panel roof performance that varied based on number and location of fasteners.
