# Guidelines for Wind Vulnerability Assessments of Existing Critical Facilities

FEMA P-2062 / September 2019

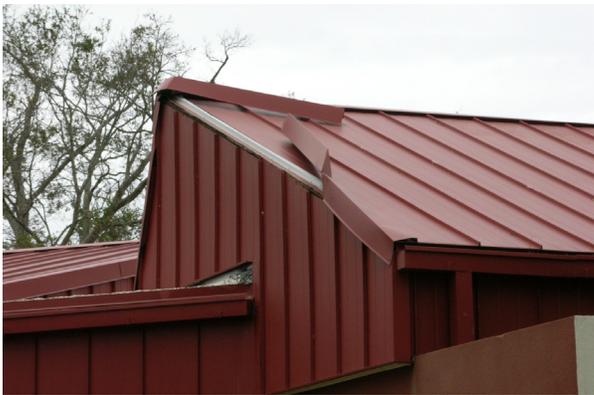
Figure 5-122:  
Rake flashing failure. Failures such as this often result in progressive lifting and peeling of the panels. Hurricane Ivan (Florida, 2004)

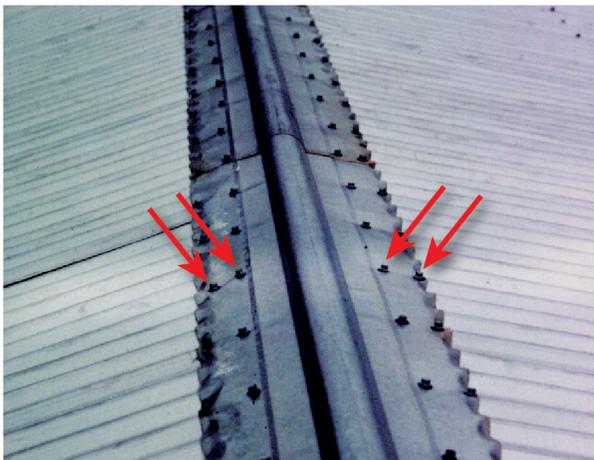
Figure 5-123:  
Well-attached ridge flashing on corrugated metal panels with two rows of closely spaced fasteners on each side of the ridge line. Hurricane Marilyn (U.S. Virgin Islands, 1995) (FEMA P-499, Fact Sheet 7.6)

- **Flashings at hips and ridges.** For flashings attached with exposed fasteners, spot check fastener spacings. Spacing should be commensurate with the design wind load, ranging from 12 inches to 3 inches on center. **Figure 5-123** and **Figure 5-124** show well-attached and inadequately attached ridge flashings, respectively.

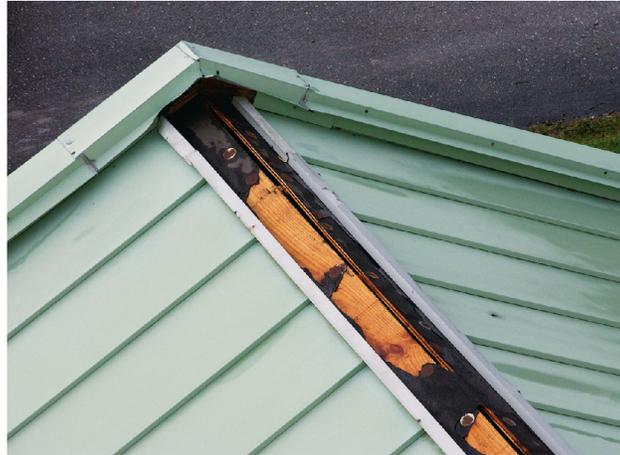
**Figure 5-124:**  
Inadequately attached ridge flashing with fasteners placed too far apart and underlayment that does not wrap over the ridge. A significant amount of water leakage can occur when ridge flashings are blown away. Hurricane Charley (Florida, 2004) (FEMA P-499, Fact Sheet 7.6)

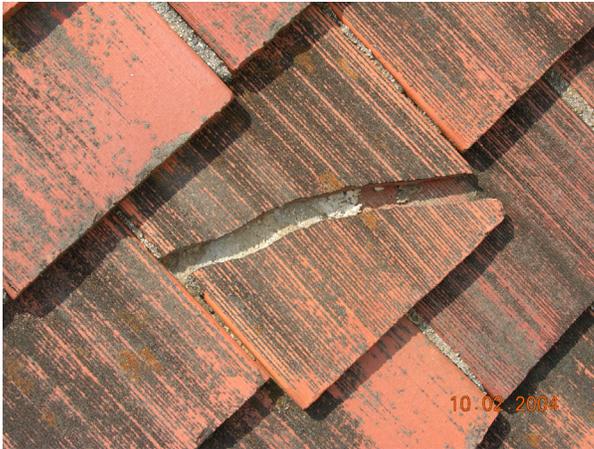
**Figure 5-125:**  
View of a broken tile. Broken fragments can become wind-borne debris that breaks other tiles. Hurricane Ivan (Florida, 2004)

- **Tile to batten and direct deck systems.** It is recommended that spot checks for tile fasteners be made at each corner zone<sup>77</sup> and at a few locations in the perimeter and ridge zones (as defined in ASCE 7). Also, spot check attachment of hip and ridge tiles, and cut field tiles adjacent to hips and valleys. Check by gently lifting on the tile. For cut tiles, also wiggle the cut tile while pulling it downslope. For direct deck systems, also spot check for tile fasteners in the field of the roof.
- **Broken or slipped tile.** Check for broken or slipped tiles (**Figure 5-125** and **Figure 5-126**).

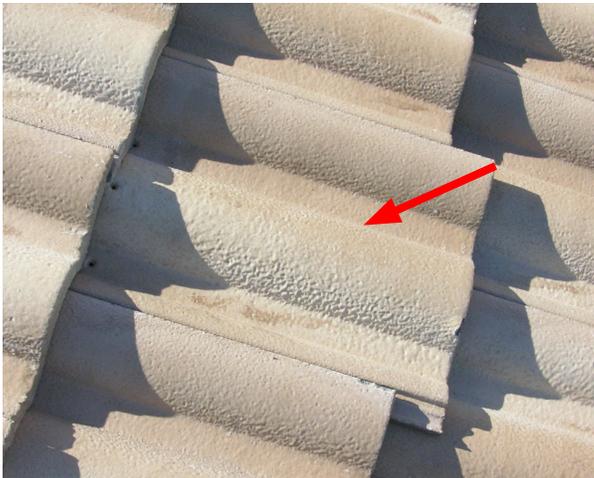
**Figure 5-126:**  
Roof with mechanically attached tiles, but because the tile shown by the solid red arrow had not been fastened, it slipped. Loose tiles such as this one are susceptible to blow-off. Hurricane Charley (Florida, 2004)

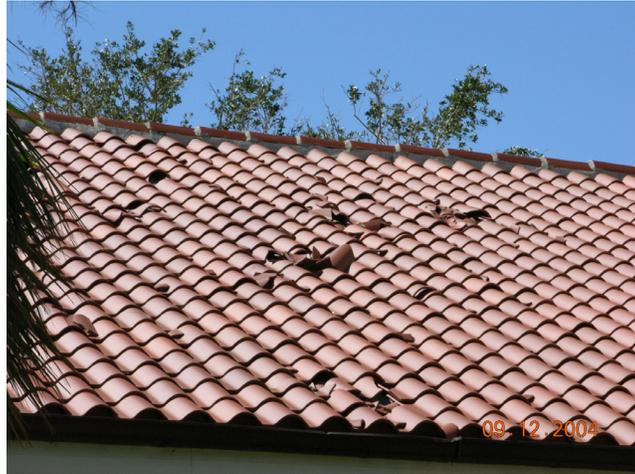
Figure 5-127:  
 Tiles on this school were broken by wind-borne debris. Hurricane Francis (Florida, 2004)

- **Wind-borne debris.** Because tile is brittle, it is often damaged by wind-borne debris. If the building is in a hurricane-prone region where the basic wind speed is greater than 135 mph,<sup>78</sup> the recommended assumptions are that the tiles may be broken by debris (**Figure 5-127**), debris may penetrate underlayment, and leakage may occur.

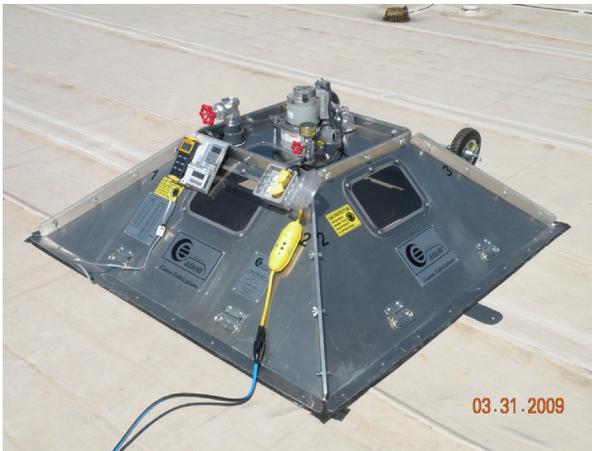
Figure 5-128:  
Field uplift test apparatus

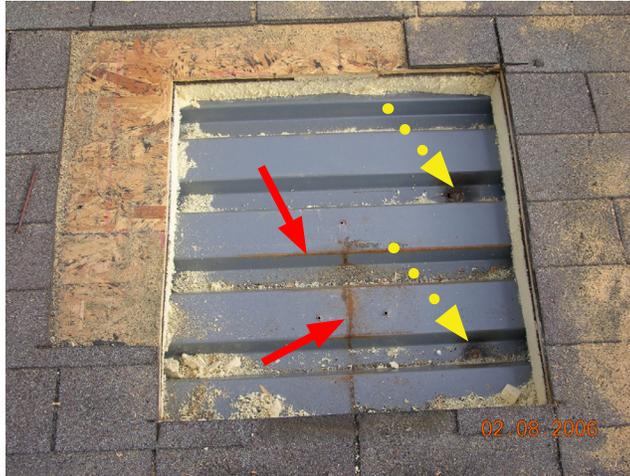
**Figure 5-129:**  
A 2-foot x 2-foot test cut on a school roof;  
superficial steel deck corrosion (solid red  
arrows) and deck welds (yellow dotted arrows)

- Perform test cuts at leakage areas if the building has a history of roof leakage. Take 2-foot x 2-foot minimum test cuts down to the deck in the leakage area(s) to assess deck integrity and attachment (see **Figure 5-129**). The number of cuts depends on several factors, including deck type, leakage history, and extent of wet insulation.

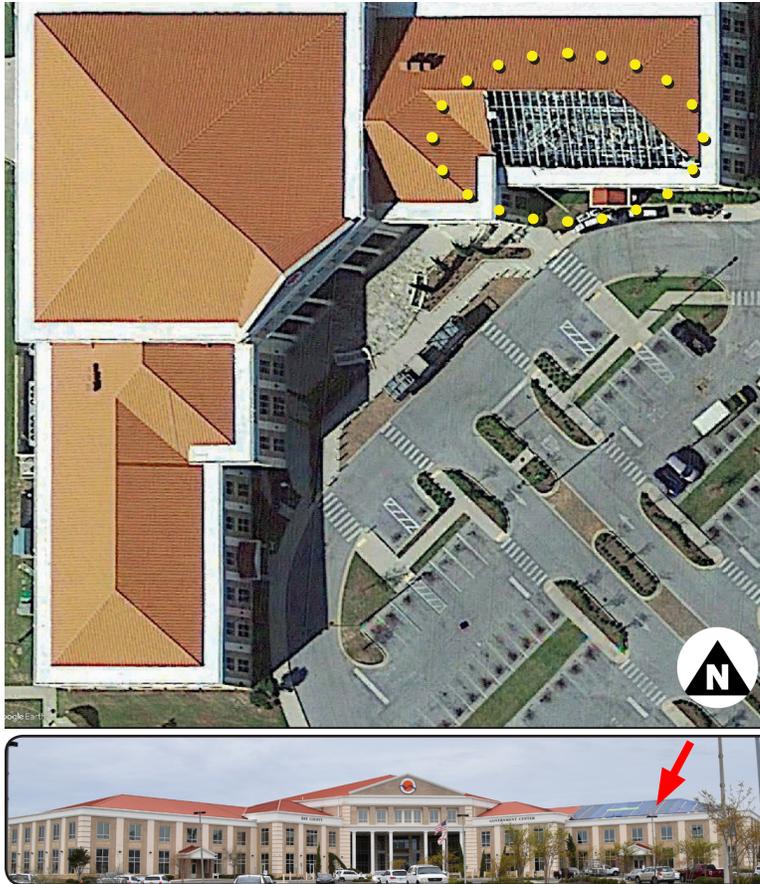
Figure 5-130:  
The metal roof panels and steel roof deck blew off at the area indicated by the yellow dotted oval. An emergency roof covering (solid red arrow) had been installed prior to shooting the inset photograph. Hurricane Michael (Florida, 2018)

**Figure 5-130** shows steel deck blow-off. Metal panels with concealed fasteners were installed over the deck. Based on observations, it appeared the lack of several contiguous deck fasteners in one or more localized areas caused the deck

blow-off. Discovering the deck vulnerability at this building would have been very expensive. Because of the expense, such an investigation would normally be limited to particularly important critical facilities.

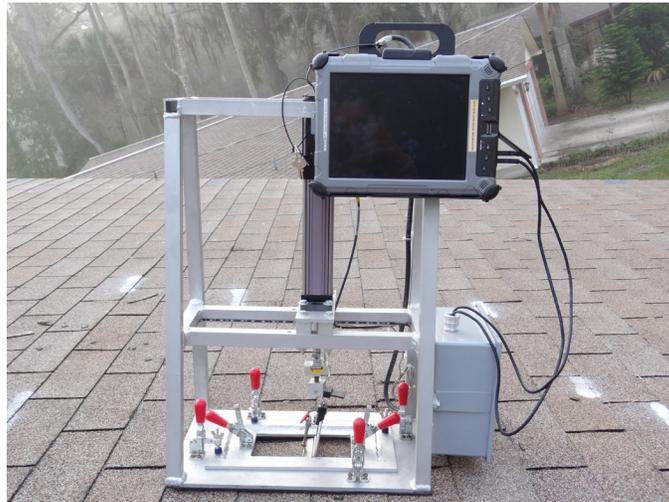
**Figure 5-131:**  
Portable mechanical uplift apparatus  
(Photo courtesy of Engineering School of  
Sustainable Infrastructure & Environment,  
University of Florida)

- Asphalt shingles. To evaluate the wind uplift resistance of existing asphalt shingle roofs, the University of Florida designed and constructed a custom portable mechanical uplift apparatus capable of performing sealant bond strength testing in accordance with the laboratory test method that is referenced in ASTM D7158 (**Figure 5-131**).<sup>86</sup> Because of the critical importance of sealant bond strength, field testing could be used to determine the bond strength of existing shingles. However, because this is a destructive test and because of the cost of conducting field uplift testing of shingles, use of this type of apparatus generally is more applicable to research projects rather than to vulnerability assessments.

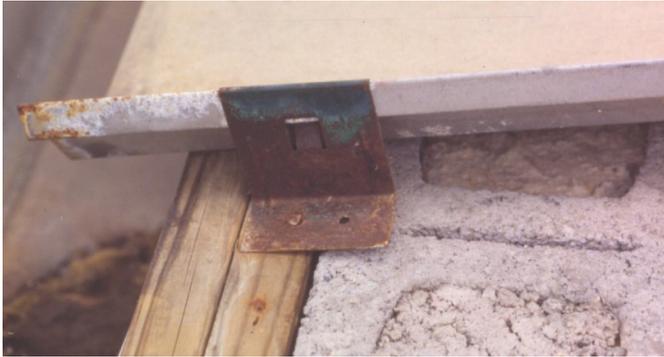
**Figure 5-132:** Panel and clip corrosion. Note that the clip was attached with a nail, which is susceptible to pull-out. Also, this clip was designed for two fasteners, but only one fastener was installed. Hurricane Marilyn (USVI, 1995)

- Metal panels. A field uplift test method does not exist currently for metal roof panel systems. If reliable information regarding the wind resistance of the system is not found in the historical file, the recommended assumption is that the system is vulnerable to wind damage or that destructive observations should be conducted, as recommended in Section 5.3.4.2. Such an investigation normally would require the services of a professional roofing contractor to assist in panel removal and replacement. Because of the expense, this investigation normally would be limited to particularly important critical facilities. As part of this type of investigation, check for fastener type and size, and for fastener and clip corrosion (**Figure 5-132**).

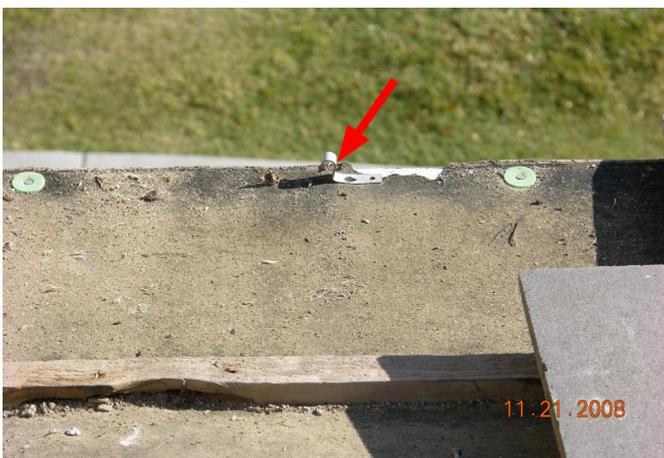
**Figure 5-133:** View along the eave after removal of several tiles. The solid red arrow shows a clip that was attached with a nail (which is susceptible to pull-out caused by dynamic loading of the tile).

In addition to field uplift testing, destructive observation (**Figure 5-133**) could be made. Such an investigation normally would require the services of a professional roofing contractor to assist in tile removal and replacement. Because of the expense, this investigation normally would be limited to particularly important critical facilities. As part of this type of investigation, check for fastener and clip corrosion.

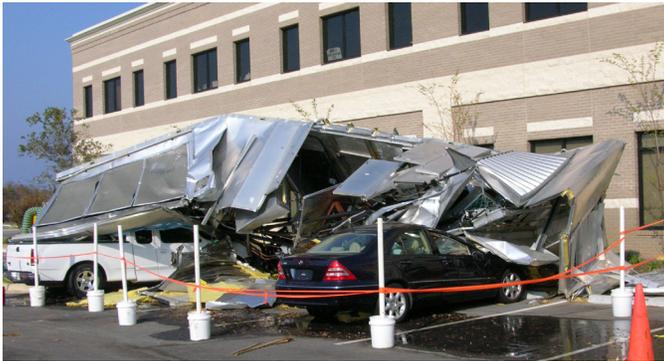
**Figure 5-134:** Although this 18,000-pound HVAC unit was attached to its curb with 16 straps, it blew off the building during Hurricane Ivan. (Florida, 2004) (FEMA P-424).

Do not assume that the dead load of the equipment is sufficient to resist the wind load (**Figure 5-134**). Calculate wind uplift and over-turning load and resistance to determine whether the dead load plus resistance provided by attachment of the equipment to the curb or stand is sufficient to resist the current wind load.

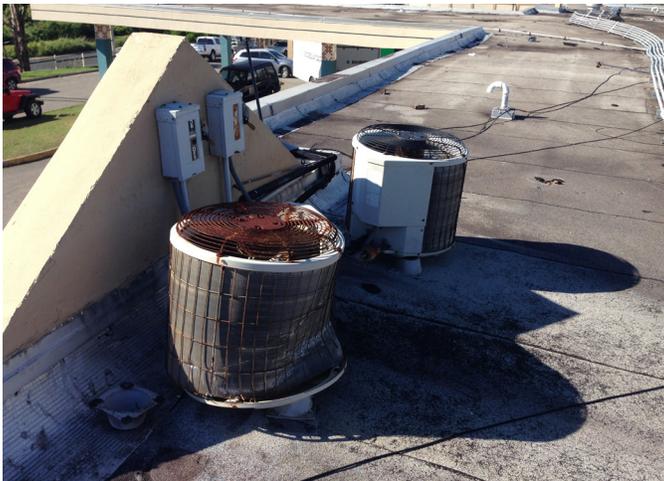
**Figure 5-135:** Condensers displaced from their stands on the roof of a health center. Hurricanes Irma and Maria (Puerto Rico, 2017) (FEMA P-2020)

- **Fans, HVAC units, relief air hoods, and condensers.** FEMA P-424, 543, and 577 provide attachment guidance. Check the attachment of the equipment to the curb or stand (see **Figure 5-134** to **Figure 5-139**).

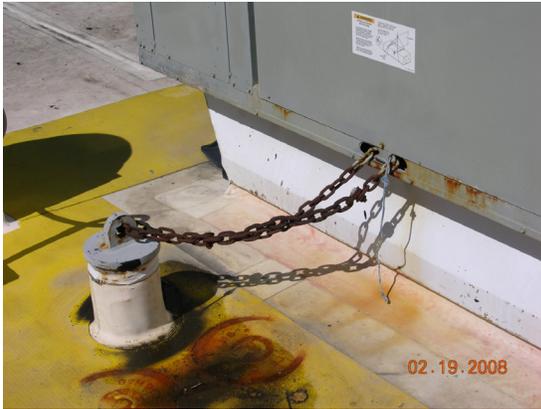
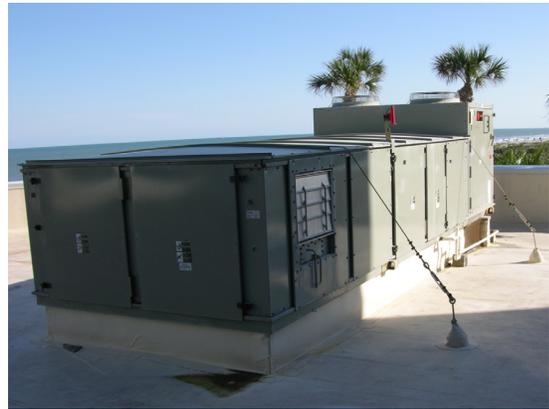
Figure 5-136: HVAC units were anchored to the structure, but the attachment was inadequate. At left, the chain between the unit and anchor post was not taut. At right, the anchor posts were 3/4-inch diameter eye bolts. Pushing at the top of the bolt moved it toward the unit. Although both units were anchored, they could lift and shift off the curb during high winds.

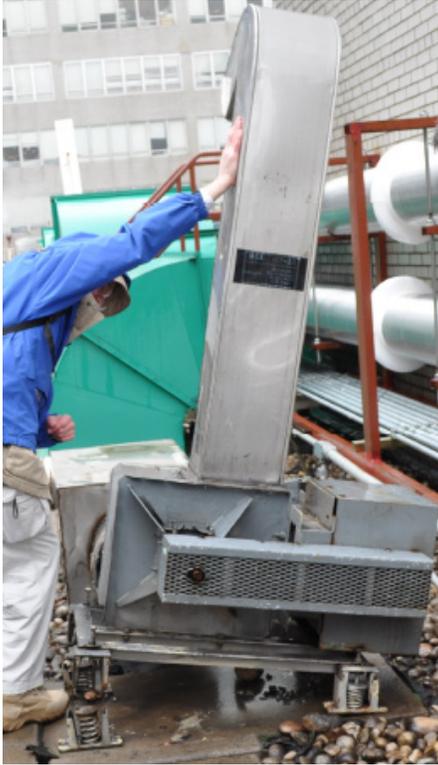
**Figure 5-139:**  
This fan had very little over-turning resistance.

For a qualitative evaluation, push and/or lift up on equipment. Experienced investigators may be able to detect a weak attachment or no attachment (see **Figure 5-139**). However, equipment may be very resistant to movement and incorrectly interpreted as having adequate wind resistance.

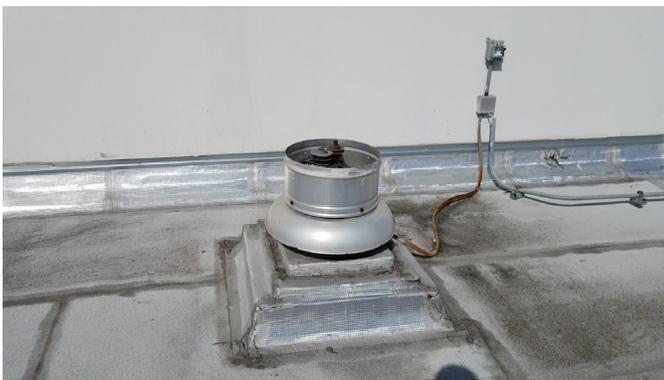
**Figure 5-140:**  
At this hospital, a fan cowling blew away, exposing the floors below to water infiltration and rainfall. Fan cowlings that blow off can cut roof membranes and cause other damage or injuries. Hurricanes Irma and Maria (Puerto Rico, 2017) (FEMA P-2020)

- **Fan cowlings.** In areas where the current basic wind speed is greater than 120 mph,<sup>91</sup> determine whether the manufacturer engineered the cowling attachment to resist the current design wind load or whether the cowling has adequate strap or cable tie-downs (see **Figure 5-140** and **Figure 5-141**)

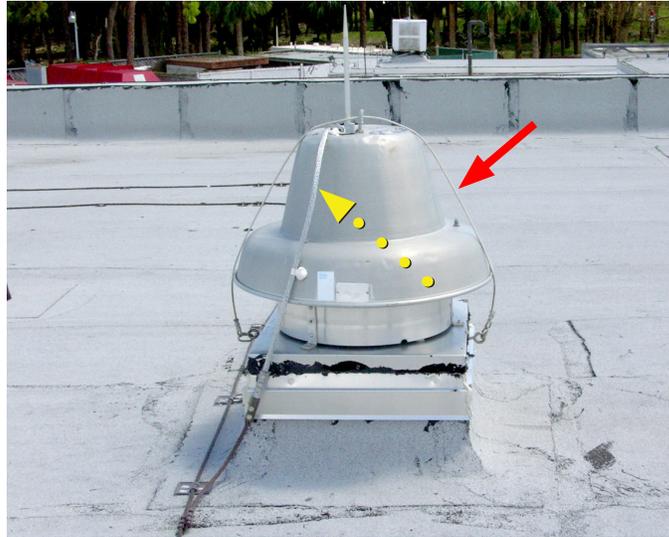
Figure 5-141:  
Cable (solid red arrow) that was anchored to the curb and the cowling at this hospital. The yellow dotted arrow indicates a lightning protection system conductor. Hurricane Frances (Florida, 2004)

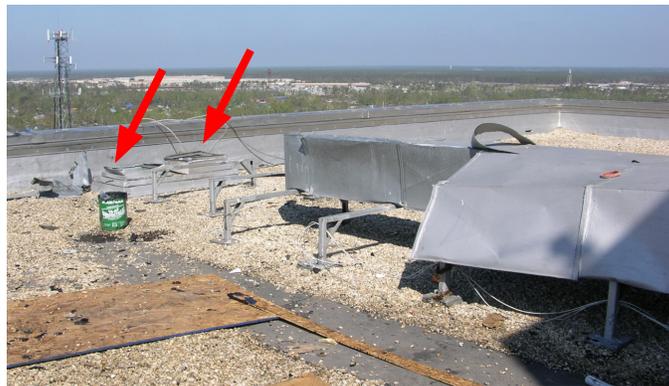
Figure 5-142:  
Duct supports that were anchored to the roof deck, but the ducts were not attached to the supports. A substantial amount of rain entered the building where the ducts penetrated the roof (solid red arrows). Hurricane Katrina (Mississippi, 2005) (FEMA 549)

- **Exposed ductwork.** Evaluate the wind resistance of the ducts, and check to determine whether the ductwork is mechanically attached to supports that are anchored to the roof deck (see **Figure 5-142**).

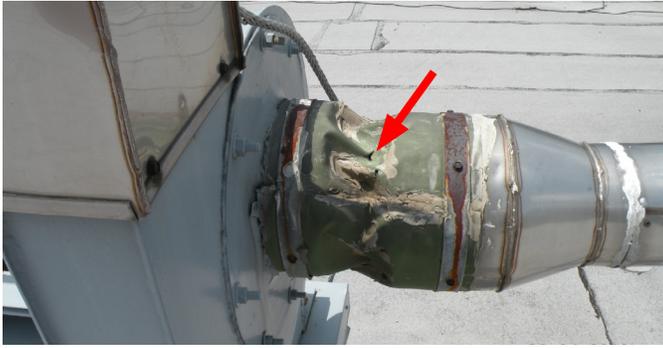
Figure 5-143:  
The flexible connectors at a hospital that tore.

- **Flexible connectors between ducts and fans.** Check the connectors for cracks or tears, which can allow water infiltration (see **Figure 5-143**). If the building is in a hurricane-prone region, the flexible connectors may be susceptible to wind-borne debris damage (see FEMA P-424 for guidance).

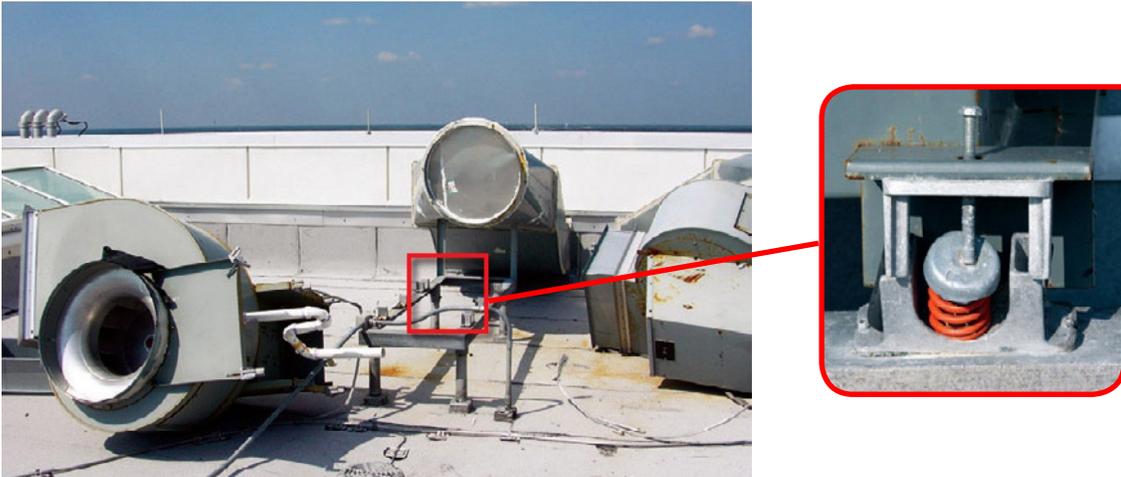
Figure 5-144: Failure of vibration isolators that provided lateral resistance, but no uplift resistance caused equipment damage. A damaged vibration isolator is shown in the inset. Hurricane Katrina (Mississippi, 2005) (FEMA P-424)

- Vibration isolators.** If vibration isolators are used to support equipment, determine whether the isolators provide uplift resistance (**Figure 5-144**), or whether cables or straps are present to provide wind resistance. If the fans are small enough, it is possible to determine whether the vibration isolator provides uplift resistance by pushing and/or lifting up on the equipment.

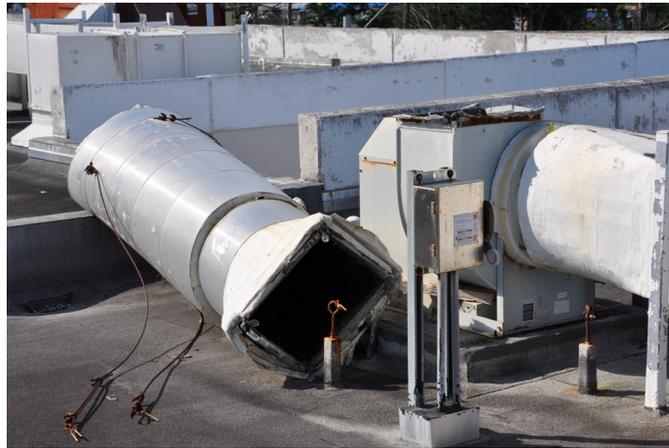
Figure 5-145:  
Exhaust stacks secured with guy-wires at this high school were toppled by high winds when the turnbuckle failed due to corrosion, leading to water intrusion in the building. Hurricanes Irma and Maria (Puerto Rico, 2017) (FEMA P-2020)

- Boiler and exhaust stacks.** Check adequacy and tautness of guy-wires (see **Figure 5-145**). If guy-wires do not exist, check the stack's wind resistance. If the stack has a rain cap, check the adequacy of the attachment (blown-off caps can cut roof membranes and cause other damage or injury).

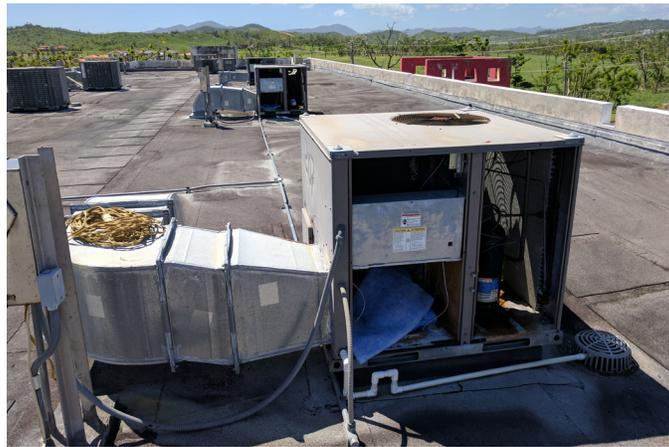
Figure 5-147:  
Inadequately attached sheet metal hood of the unit on this school roof. Blown-off hoods and enclosures can cut roof membranes and cause injuries or other damage. Hurricane Ike (Texas, 2008) (FEMA P-424)

- **Sheet metal hoods and enclosures (cabinets) on HVAC units.** FEMA P-424 provides attachment guidance for hoods. Check the adequacy of the attachment by pushing and pulling on the hood (see **Figure 5-147**). Check the method used to attach the enclosure and evaluate its adequacy.

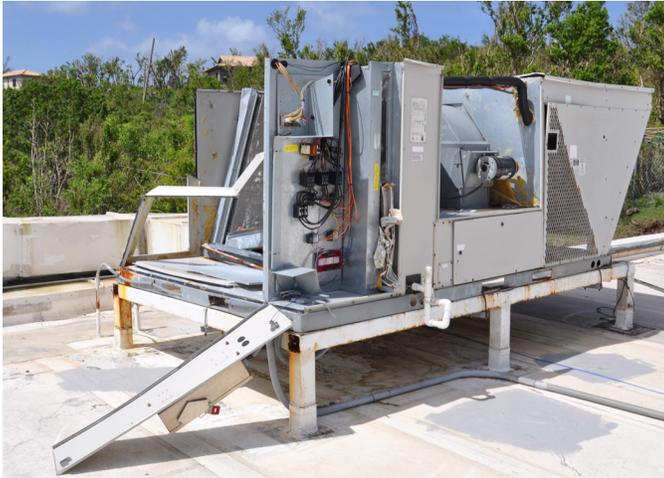
Figure 5-148:  
Blown-off unit enclosures at a medical clinic. Hurricane Irma (U.S. Virgin Islands, 2017)

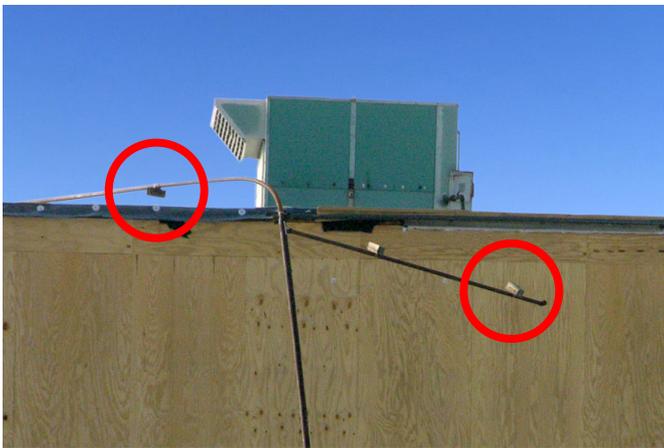
Figure 5-149:  
The gas lines serving HVAC units at this school were blown off the roof. The lines were anchored to 4-inch x 4-inch sleepers, but the sleepers simply rested on the roof membrane. Hurricane Ivan (Alabama, 2004) (FEMA 489)

- **Natural gas, electrical conduits, and condensate drain lines.** FEMA P-424 provides attachment guidance for gas and drain lines. In areas where the current basic wind speed is greater than 120 mph,<sup>92</sup> check the adequacy of the attachment (see **Figure 5-149**).

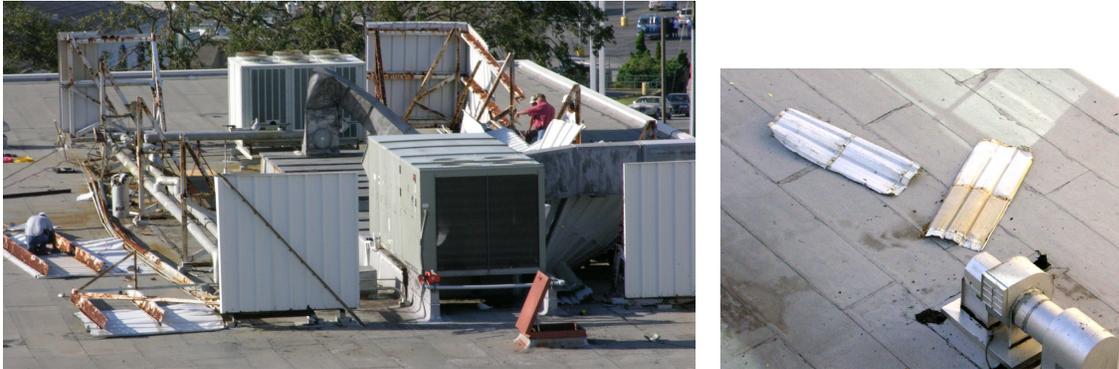
Figure 5-150: Panels that were blown off the screen. Blown-off screens can cut roof membranes and cause injuries or other damage. Hurricane Ivan (Florida, 2004) (FEMA 489)

- **Equipment screens.** If screens exist around equipment, check the adequacy of the attachment (see **Figure 5-150**). For guidance, see Chapter 4 for screen frames and the applicable section of Chapter 5 for the screen wall covering.

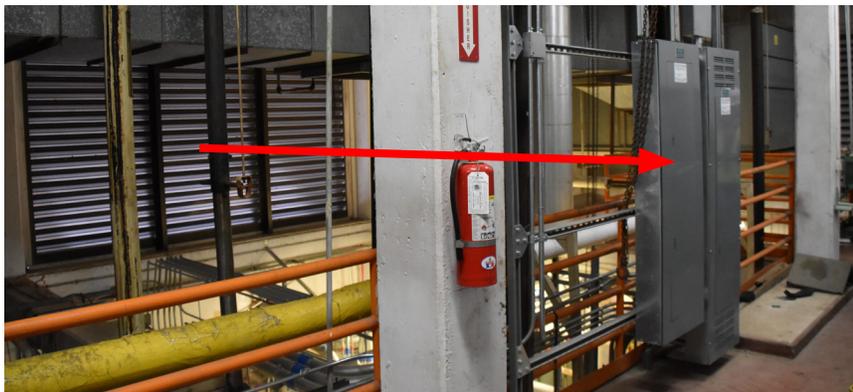
Figure 5-151: Wind-driven rain entered at louvers and wetted electrical panels, which caused the circuit breakers to trip. Hurricane Michael (Florida, 2018)

Louvers that remain open during high-wind events, such as those that provide combustion air and cooling air for fuel-fired standby or emergency generators, can increase internal pressures and can allow wind-driven rain to enter a building (see **Figure 5-151**). The size and location of louvers should be considered when determining the appropriate internal pressure coefficient GC<sub>pi</sub> used for determining wind pressures. Evaluate the wind-driven rain resistance of louvers.

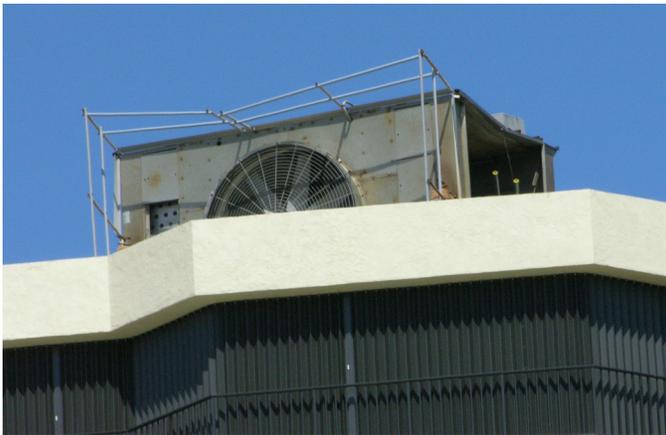
**Figure 5-152:**  
Cooling tower that was inadequately attached. Hurricane Francis (Florida, 2004)

- **Cooling towers.** Do not assume that the dead load of the cooling tower is sufficient to resist the wind load (**Figure 5-152**). Calculate wind uplift and overturning load and resistance to determine whether the dead load plus resistance provided by attachment of the cooling tower to the curb or stand is sufficient to resist the current wind load. (The cooling tower manufacturer may have wind resistance data.) The calculations should be based on the tower shipping weight (i.e., dry weight) and not on the operating weight, since it is possible for a tower to be out of service when a wind event occurs. The resistance analysis should focus on the anchors (e.g., bolts, expansion anchors, welds, or threaded rods) and the attachment points on the tower.

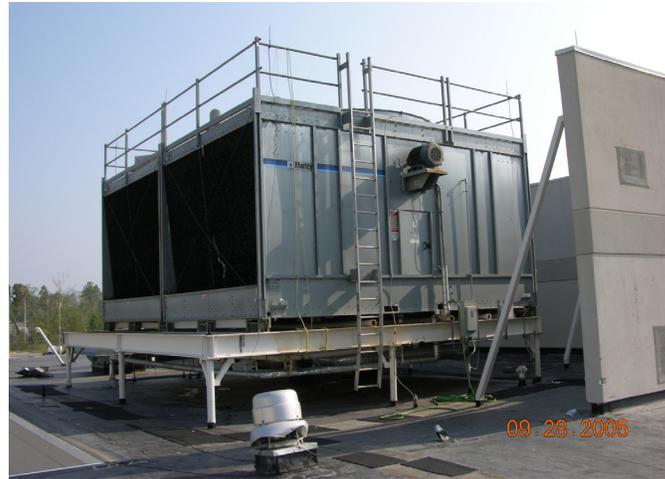
**Figure 5-153:**  
Cooling tower on the roof of a hospital with a screen wall on two sides of the tower. Although screen walls normally are intended for aesthetics, they can be designed to provide wind-borne debris protection. Hurricane Katrina (Mississippi, 2005)

missile “D” or preferably “E” (as defined in ASTM E1996-17) could be constructed to provide tower protection from horizontally traveling debris (**Figure 5-153**). However, screen walls do not provide protection from vertically traveling debris.

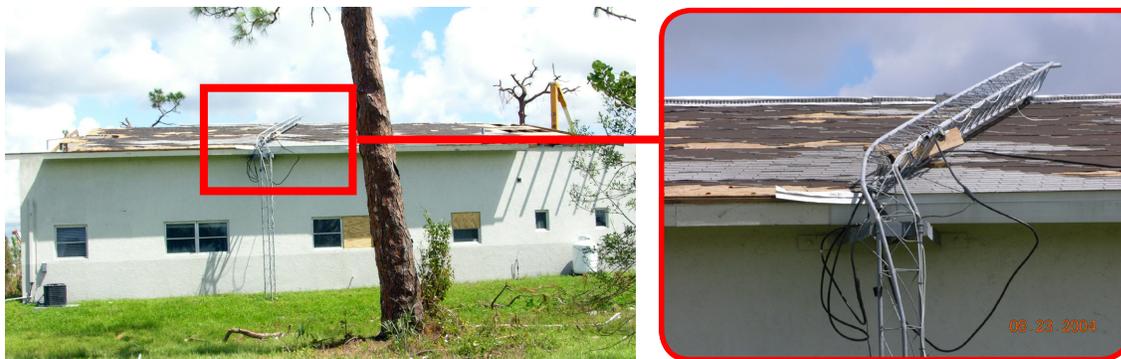
**Figure 5-154:** Mast at a fire station that collapsed onto the roof. Hurricane Charley (Florida, 2004) (FEMA 488)

- **Communications masts and towers.** Check mast/tower strength and adequacy of attachment (see **Figure 5-154** and **Figure 5-155**). If satellite dishes are mounted on the mast/tower, try to determine whether the mast/tower was designed for the additional wind load that is transferred to it. See ANSI/Telecommunications Industry Association (TIA)–222 for assessment guidance.

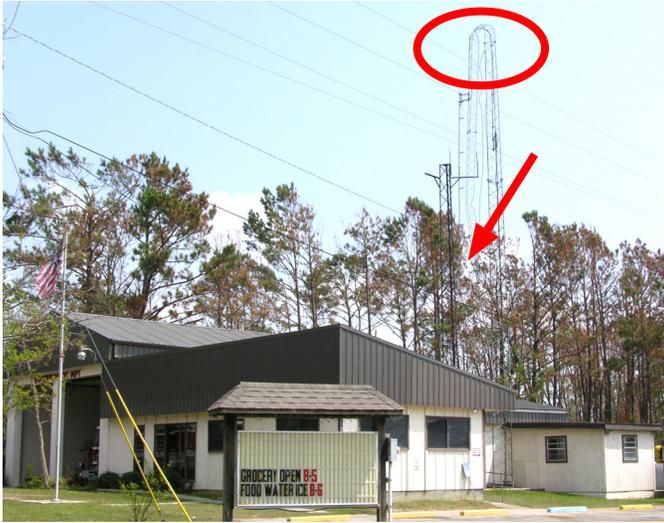
**Figure 5-155:**  
The tower at this fire station buckled (solid red oval). The top of the tower is at the end of the solid red arrow. Hurricane Katrina (Mississippi, 2005) (FEMA 549)

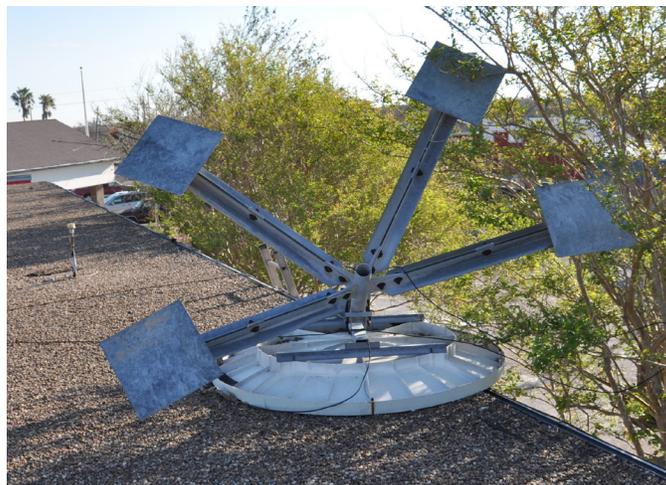
Figure 5-156:  
The satellite dish at this hospital was inadequately ballasted with CMU. Hurricane Harvey (Texas, 2017) (FEMA P-2022)

- **Check the adequacy of the attachment.** If wind resistance is provided by ballast (e.g., CMU, concrete pavers), perform calculations to verify that the ballast is sufficient (see **Figure 5-156**). For facilities in hurricane-prone regions, FEMA P-424, 543, and 577 recommend that dishes be mechanically anchored rather than ballasted.

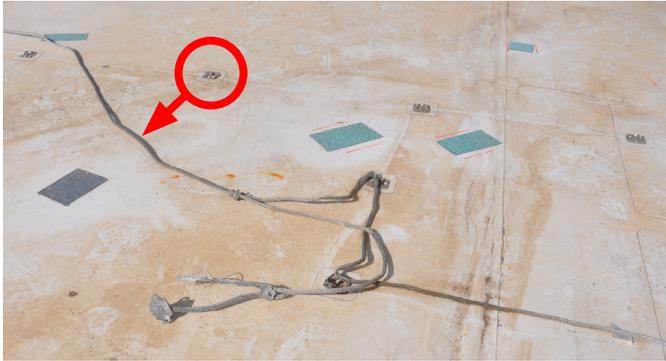
**Figure 5-157:**  
The conductor detached from the connectors (solid red circle) at an airport terminal. Several temporary patches had been made after the hurricane. Hurricane Irma (U.S. Virgin Islands, 2017)

Lightning protection systems frequently become disconnected from rooftops during hurricanes (**Figure 5-157**). Displaced lightning protection system components can puncture and tear roof membranes, thus allowing water to leak into buildings. Current lightning protection system standards do not require enhanced attachment in high-wind regions. FEMA P-424, 543, and 577 provide attachment guidance where the roof is more than 100 feet above grade or if the building is in a hurricane-prone region where the current basic wind speed is 135 mph<sup>96</sup> or greater. If these conditions exist and enhanced attachment guidance was not followed (e.g., FEMA P-424, 543, and 577), the recommended assumption is that the attachment is vulnerable to wind damage.

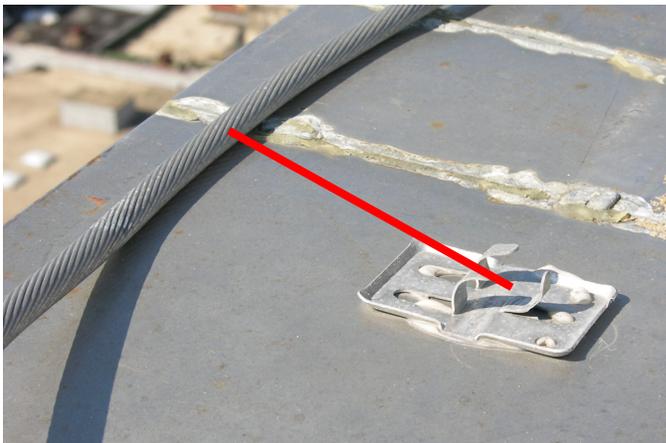
**Figure 5-158:**  
Conductor is no longer attached to the conductor connector. Hurricane Katrina (Mississippi, 2005) (FEMA 549)

- **Spot check conductor connectors** to verify that: (1) the prongs engage the conductor (see **Figure 5-158**), (2) the conductor connectors are still anchored (**Figure 5-159**), and (3) the connectors are approximately 3 feet on center. The connector problems shown in these figures are sometimes inadvertently caused by foot traffic that kicks the conductor. If conductors are attached with a looped connector (**Figure 5-160**), remove a few fasteners to determine their adequacy.
- **Spot check the air terminals** to verify that they are anchored.

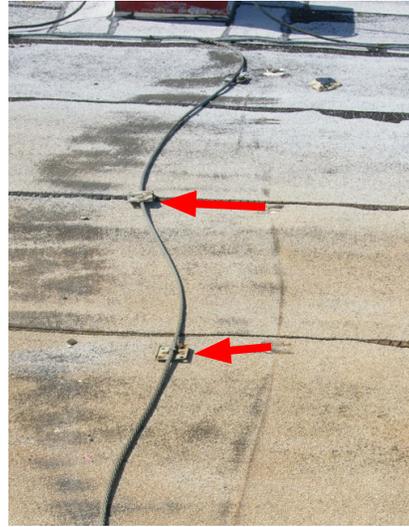
**Figure 5-159:**  
Conductor connectors on a hospital roof that debonded from the roof membrane. Hurricane Francis (Florida, 2004)

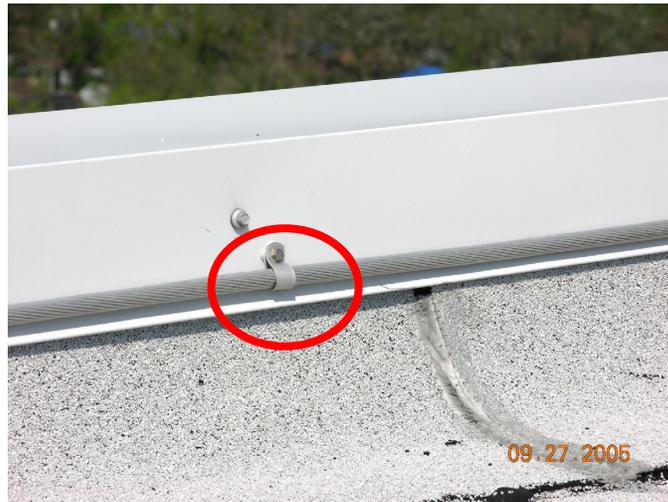
**Figure 5-160:**  
Conductor that was attached to the parapet coping with a looped connector. FEMA P-424 recommends the connectors be attached with #12 screws that have minimum 1¼-inch embedment into the parapet nailer. Hurricane Katrina (Mississippi, 2005) (FEMA 549)

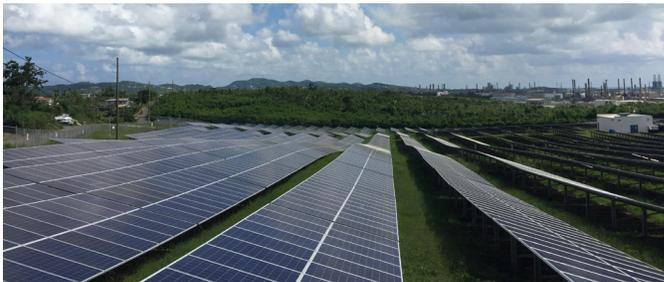
**Figure 5-161:**  
View of a ground-mounted PV array. Hurricanes Irma and Maria (USVI, 2017) (FEMA P-2021)

Solar arrays, or photovoltaic (PV) systems, typically are roof- or ground-mounted (**Figure 5-161**). The term “PV modules” (also known as “solar panels”) refers to manufactured units of solar cells that form the basic unit of a solar array (i.e., an assembly of PV modules). Modules are manufactured to be adhered to a substrate (e.g., roof covering) or supported by a rack.<sup>97</sup> The most common adhered modules are flexible thin films that are field- or factory-adhered to the roof covering; they also are referred to as “building-applied PV.” Rigid modules (e.g., crystalline PV) are attached to a support system (rack) that is ballasted or mechanically anchored to a foundation or the roof deck or deck support. Other variations exist as part of proprietary PV systems.

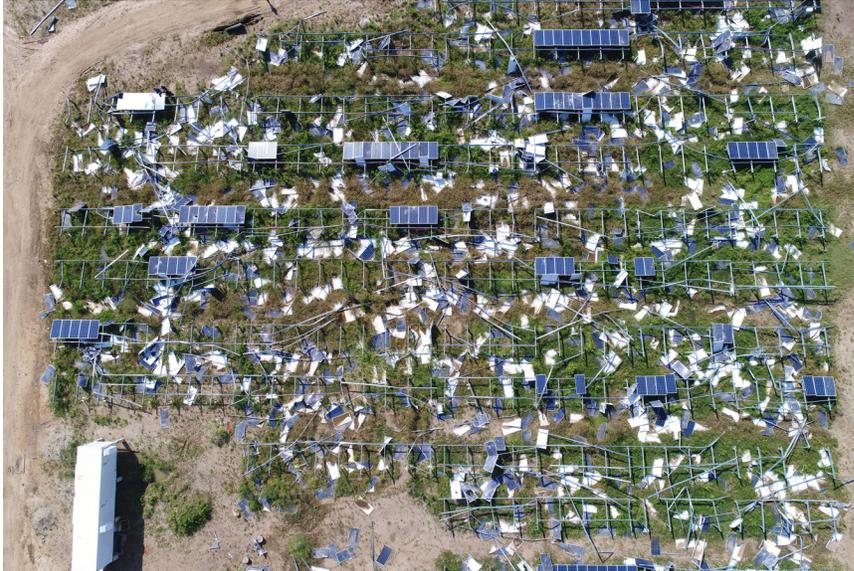
**Figure 5-162:**  
Aerial view of PV array with most panels blown off from their ground-mount supports; many structural members were damaged. Hurricanes Irma and Maria (Puerto Rico, 2017) (FEMA P-2020)

- **Spot check the interface between the PV modules and the framing system** that is used to support modules, including mechanical fasteners, snap-fit couplings, or adhesive. Perform spot checks on panel clamps with a calibrated torque wrench. Spot check the framing system fasteners and check for corrosion and fatigue cracks. Weakened or inadequately designed or installed interfaces can cause modules to blow off (see **Figure 5-162** through **Figure 5-164**).

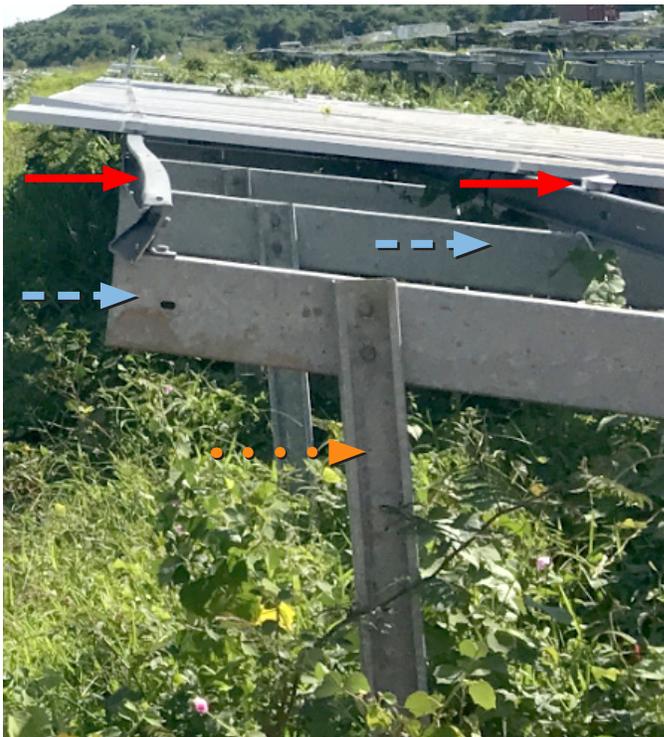
**Figure 5-163:**  
PV array support system with ground-mounted posts (orange dotted arrow), sloped beams (blue dashed arrows), and lateral rails (solid red arrows) that directly support the PV panels. Failure occurred at the panel clamps, causing some panels to be lifted off the framing system. Hurricanes Irma and Maria (Puerto Rico, 2017) (FEMA P-2020)

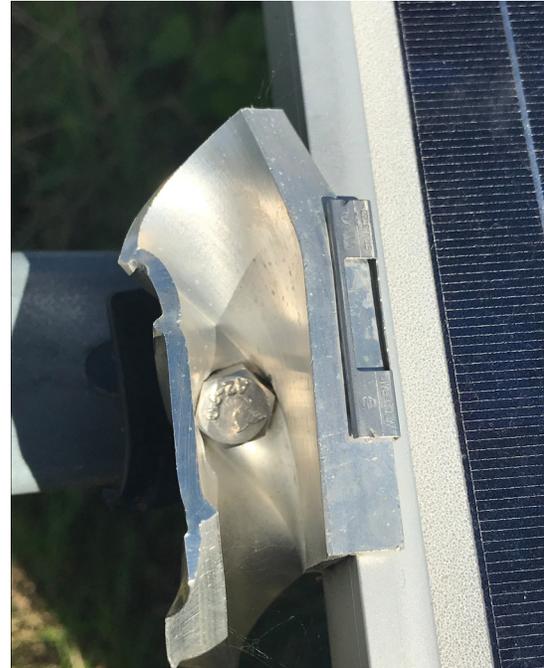
Figure 5-164:  
Deformed hat-shaped clamp still bolted to supporting lateral rail. The PV panel to the left was lifted out of position when the hat-shaped clamp could not resist the wind uplift pressures and was bent upward. Hurricanes Irma and Maria (Puerto Rico, 2017) (FEMA P-2020)

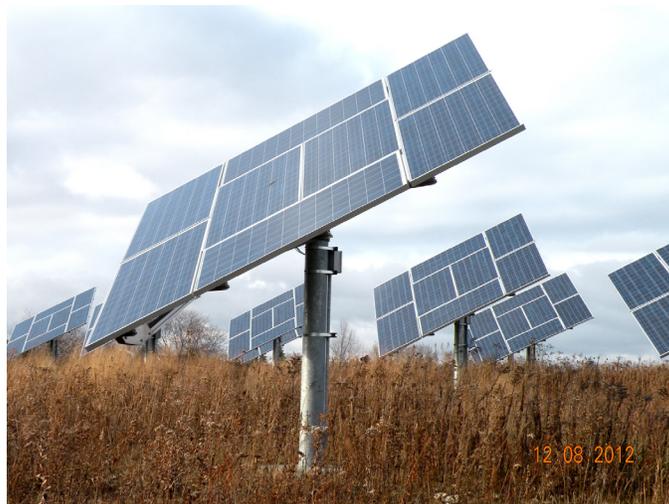
Figure 5-165:  
View of a ground-mounted PV array

- **Spot check the connections** between the framing system and the foundation (i.e., concrete footings, precast concrete sitting on grade, and piles or helical piers), including spot checking bolted connections with a calibrated torque wrench.
- **Spot check piles and helical piers** for corrosion or wood decay.
- **Natural frequency and damping.** To determine whether the panel is wobbly, push down on a corner of a panel and quickly release. Use a stopwatch to record the period of motion. Repeat this evaluation a few times. If the period of motion is approximately 3 hertz or less, wobbling induced by wind can significantly increase the wind load. **Figure 5-165** is an example of a ground-mounted PV array that may be susceptible to natural frequency problems.

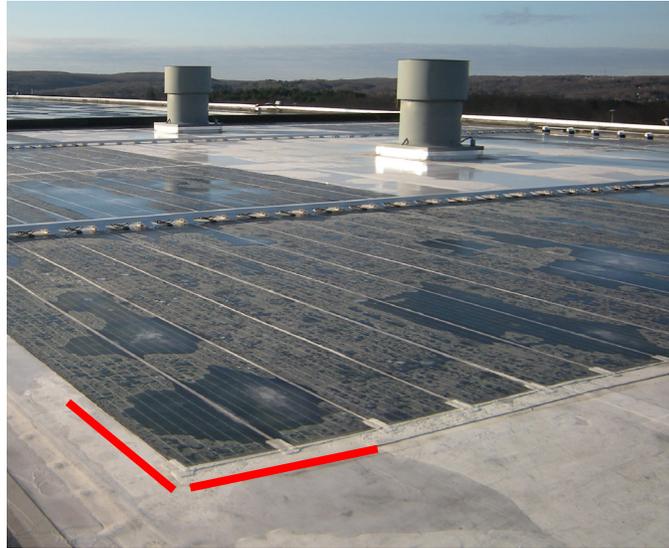
Figure 5-166:  
PV module adhered to the roof  
membrane (Photo courtesy of Phil  
Dregger, Technical Roof Services, Inc.)

- **Spot check the perimeter of the module array** to determine whether it has debonded from the roof covering. In particular, check the corner areas of the module array, as shown by the red lines in **Figure 5-166**. Perform most of the spot checks in each corner<sup>100</sup> and perimeter zone, and make a few checks in the field of the module array.

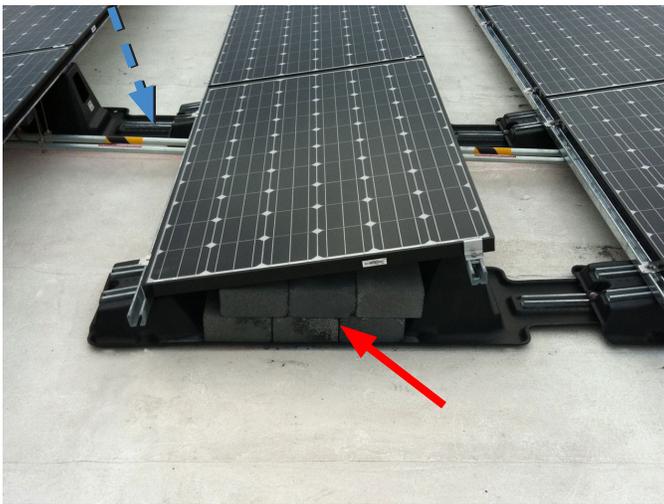
Figure 5-167:  
Racks ballasted with concrete pavers (solid red arrow). The blue dashed arrow indicates a bar that connects the rows of panels.

- **Check to see whether bars, such as those shown by the blue arrow in Figure 5-167, connect the rows of panels.** The bars allow load sharing. If bars do not occur, determine whether the bars were inadvertently not installed or if the racks have sufficient ballast without the bars.
- **Determine whether racks have shifted from their original position.**
- If CMU or concrete pavers were used for ballast, **check for displacement/toppling and freeze/thaw deterioration of the ballast.**

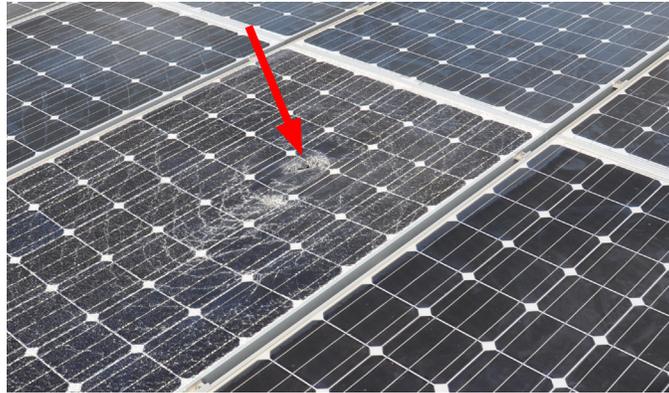
Figure 5-168:  
 PV module damaged by wind-borne debris  
 (solid red arrow). Hurricane Irma (USVI,  
 2017)

- **Check with the module manufacturer to determine whether wind deflectors are recommended.** If deflectors are recommended, verify that they were installed.
- **Determine whether the racks occur over a mechanically attached single-ply membrane.** If they do, the racks are likely to be susceptible to shifting caused by membrane ballooning during high winds. If shifting has not occurred, lack of shifting is probably due to absence of high winds rather than stability of the racks during membrane ballooning.
- **Check for wind stability of the aggregate if the roof membrane is aggregate surfaced.** Depending on factors such as aggregate gradation, basic wind speed, building height, and parapet height, aggregate can become airborne and break the PV module's film (Figure 5-168).

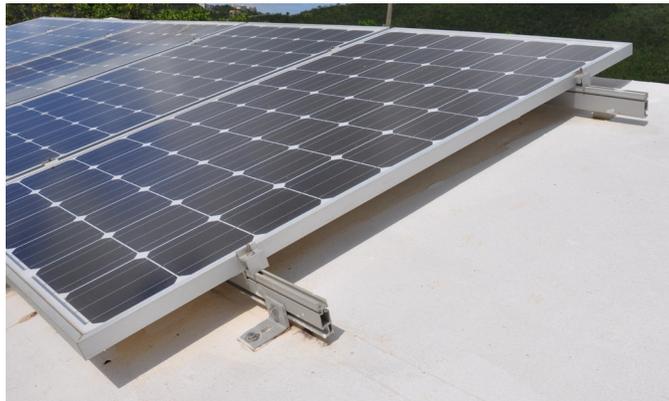
Figure 5-169:  
 PV modules attached to rails that are  
 mechanically anchored to the roof deck,  
 through the liquid-applied membrane.  
 Hurricanes Irma and Maria (USVI, 2017)

The recommended field assessment of PV modules attached to mechanically anchored racks or rails (Figure 5-169) includes the following:

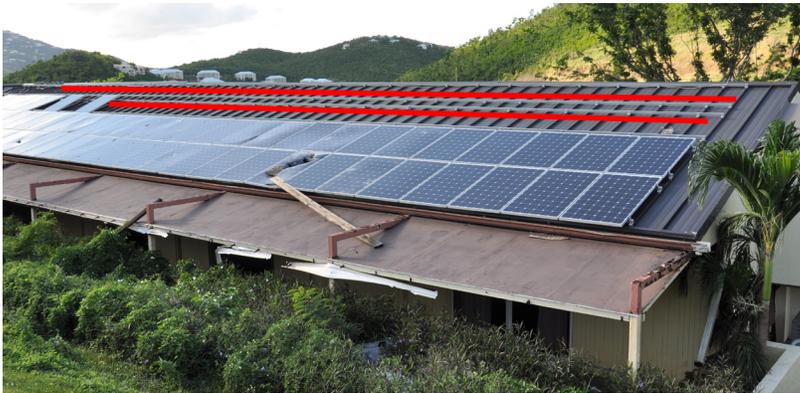
**Figure 5-170:**  
PV modules attached to rails that were attached to the metal roof ribs with external seam clamps. Several modules blew off the rails (solid red lines). In other areas, the roof panels blew off with the array. Hurricane Irma (USVI, 2017)

- **Check for wind stability of the aggregate if the roof membrane is aggregate surfaced.** Depending on factors such as aggregate gradation, basic wind speed, building height, and parapet height, aggregate can become airborne and break the PV module's film.
- PV modules may be attached to standing seam metal roof ribs with external seam clamps, or modules may be attached to rails that are attached to the ribs (**Figure 5-170**). Use of rails can result in overstressing the concealed clips that attach the metal panels. At other portions of the building shown in **Figure 5-170**, several metal panels blew off (the array was still attached to the blown-off roof panels). The recommended assumption is that metal roof panels with arrays attached to rails that are attached to the ribs are vulnerable to wind damage.

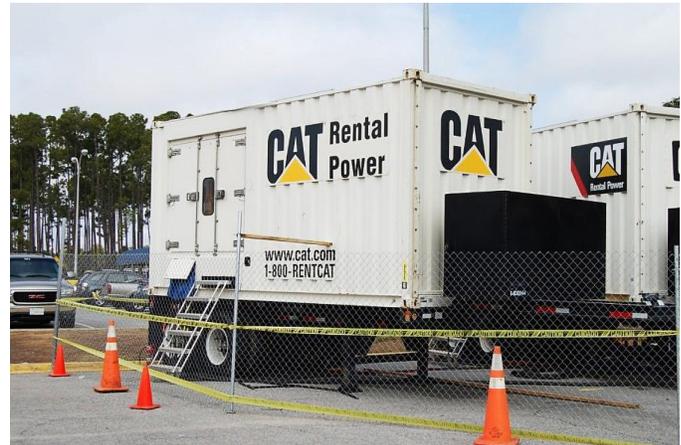
Figure 6-1:  
Trailer-mounted temporary diesel generator

- They may not be readily available during a power outage.
- They may have no protection from high winds, wind-driven rain, wind-borne debris, and lay-down hazards, which reduces their reliability during a high-wind event (see **Figure 6-1**).
- They must be located, transported to the facility, and set up.
- Cables from the generator to the building must be installed (see **Figure 6-2**).
- The existing electrical system must be electrically isolated from the utility to avoid back-feeding generator power into the utility lines. Back-feeding power can energize downed lines and injure or kill line workers trying to restore power.

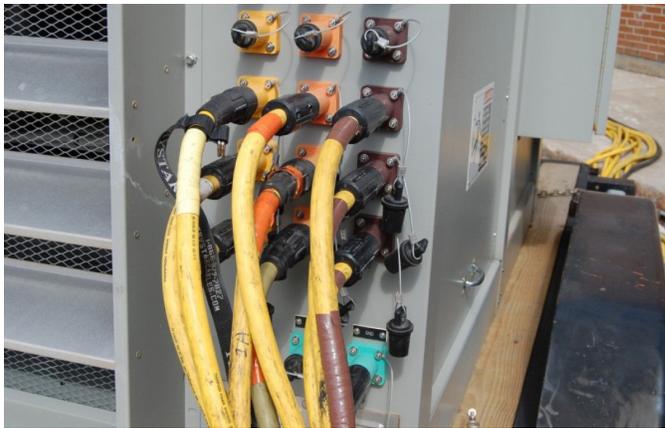
Figure 6-2:  
Temporary cables connecting generator to  
electrical service
