# Guidelines for Wind Vulnerability Assessments of Existing Critical Facilities

FEMA P-2062 / September 2019

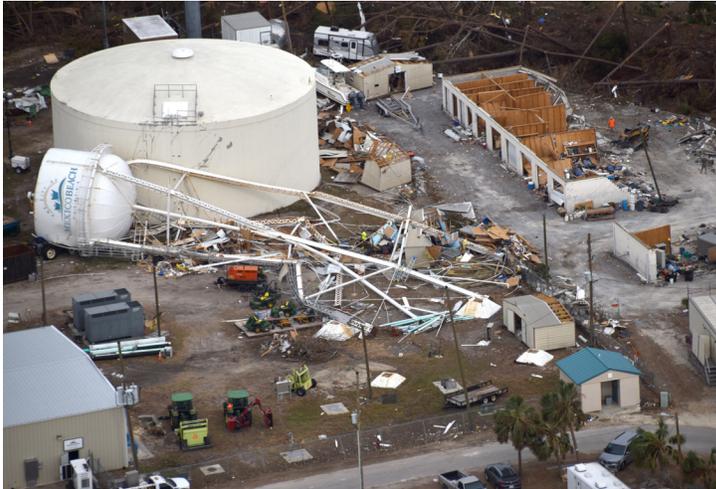
Figure 6-3:  
Topped water storage tank. Hurricane  
Michael (Florida, 2018)

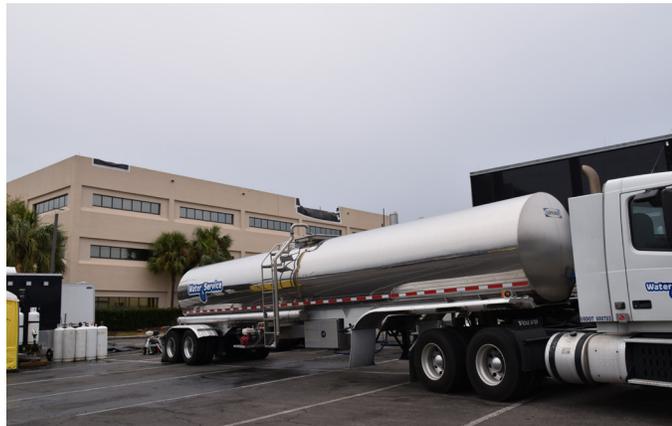
Figure 6-4:  
Water delivered to a hospital from tanker truck.  
Hurricane Michael (Florida, 2018)

- The facility is equipped with other options, such as end-user treatment systems, and whether these require power.
  - The facility is equipped with piping and connections that allow water to be delivered to the facility by tanker trucks (**Figure 6-4**).
