Seismic Retrofit Guidelines for Detached, Single-Family, Wood-Frame Dwellings

FEMA P-50-1 / June 2012

APPLIED TECHNOLOGY COUNCIL
201 Redwood Shores Parkway, Suite 240
Redwood City, California 94065
www.ATCouncil.org

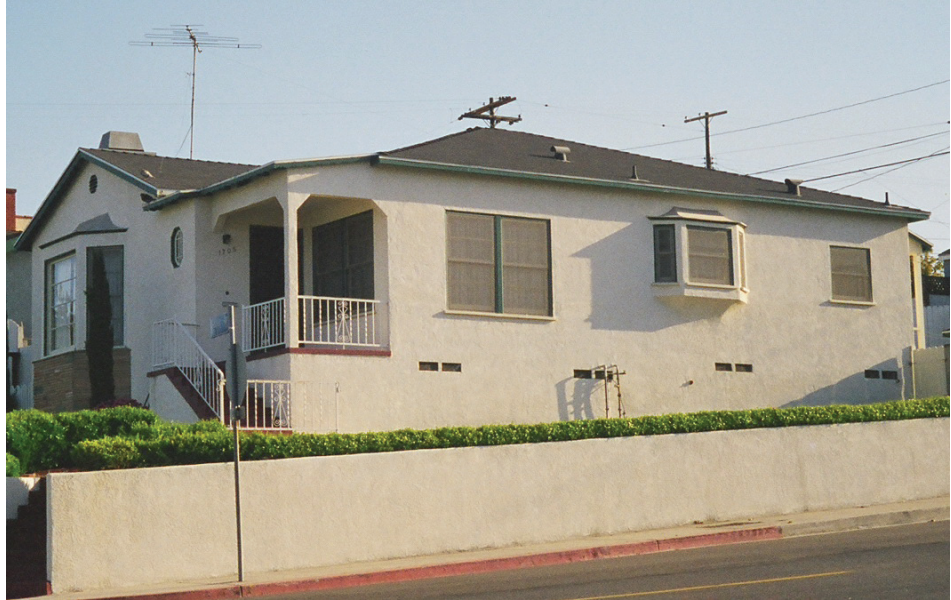
Figure 2-3 Typical one-story cripple-wall crawl-space house (from ATC, 2002).

On exterior walls, stucco, or Portland cement plaster, is applied over wire lath and building paper that has been fastened to the wood frame wall. The resulting finish has a rough appearance and is about 7/8 inch thick. Figures 2-3, 2-5, 2-8, and 2-9 show houses with stucco exteriors.

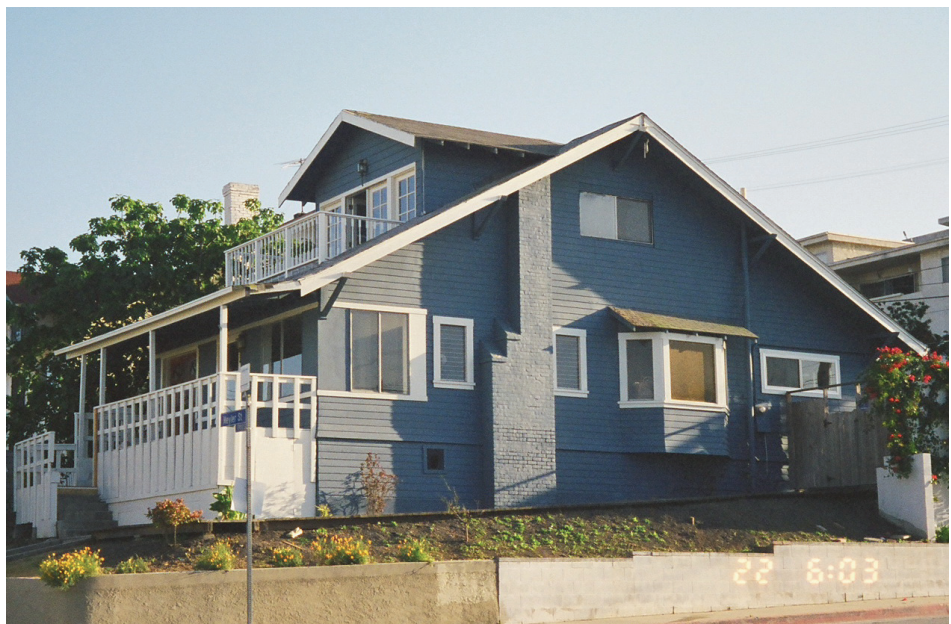
Figure 2-4 Typical older one and one-half-story cripple-wall crawlspace house (from ATC, 2002).

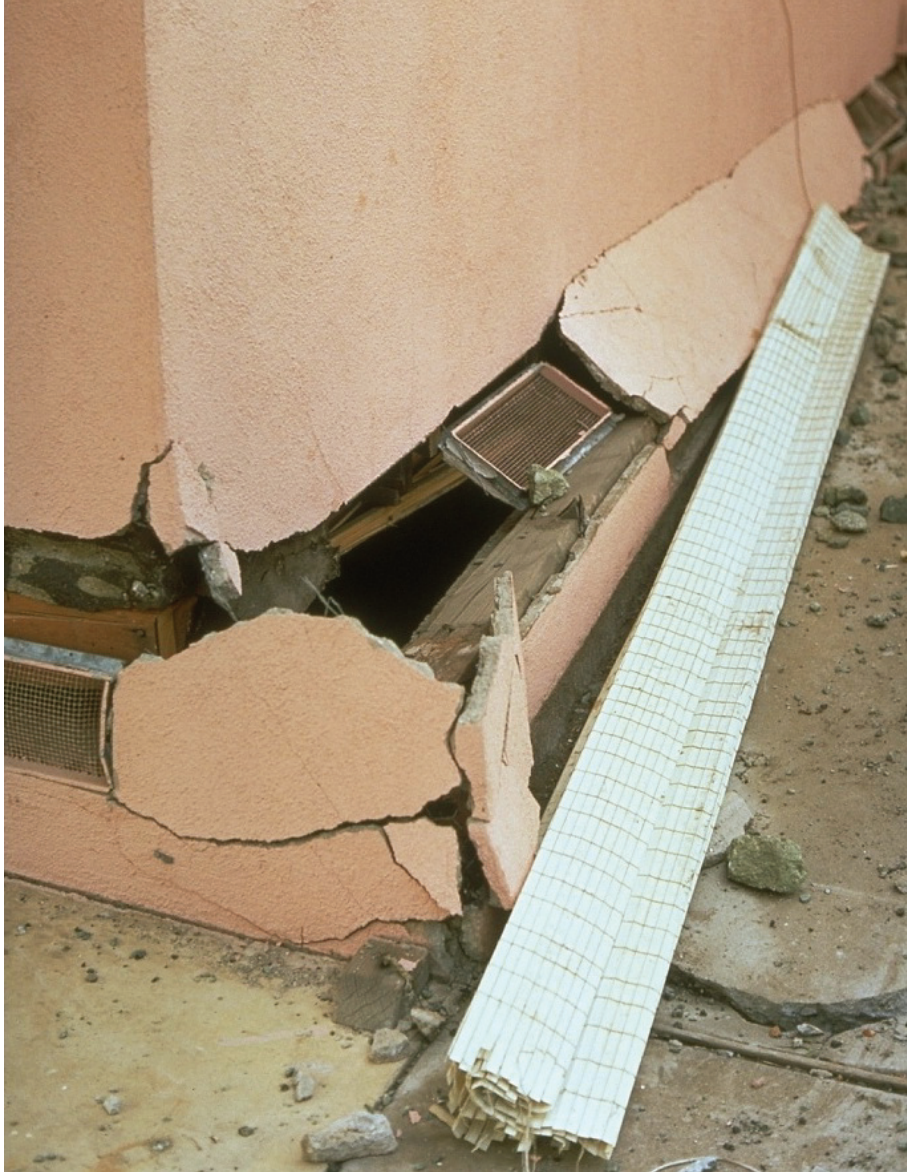
Two common seismic vulnerabilities in cripple-wall houses are the insufficient strength of the cripple wall exterior sheathing and the lack of anchor bolts between the cripple wall sill and the foundation. The exterior sides of cripple walls are usually sheathed with stucco (with or without structural sheathing underneath), sawn wood siding, exterior finish structural panel sheathing, or other material. Figure 2-5 shows typical earthquake damage to a cripple wall, due to insufficient strength of the cripple wall

Figure 2-5 Typical earthquake damage to a cripple-wall house (from ATC, 2002).

stucco-only sheathing. It is also common for the posts to shake out, leaving the beams and joists with no support.

A common seismic vulnerability in split-level houses with living spaces over the garage is inadequate strength of the walls at each side of the garage door to resist seismic forces from the house portion above. Damage that was in part initiated by this vulnerability is shown in Figure 2-19. Another common vulnerability is insufficient strength of the cripple wall under the single-story portion of the house, when present, causing damage similar to that of Figure 2-5.

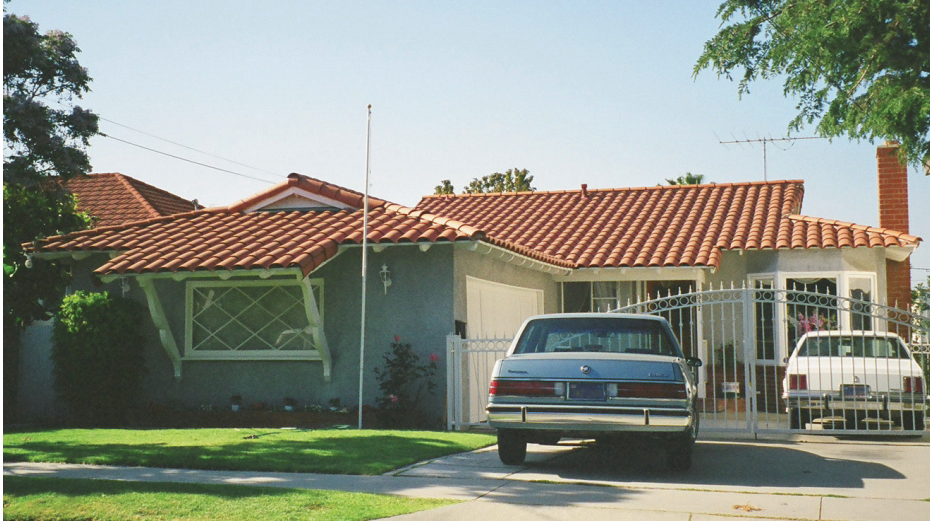
Figure 2-7 Typical one-story slab-on-grade house (from ATC, 2002).

Slate, clay, or concrete tile roofs are easily distinguished from wood or asphalt composition shingles by their appearance. Figure 2-7 shows a house with a tile roof.

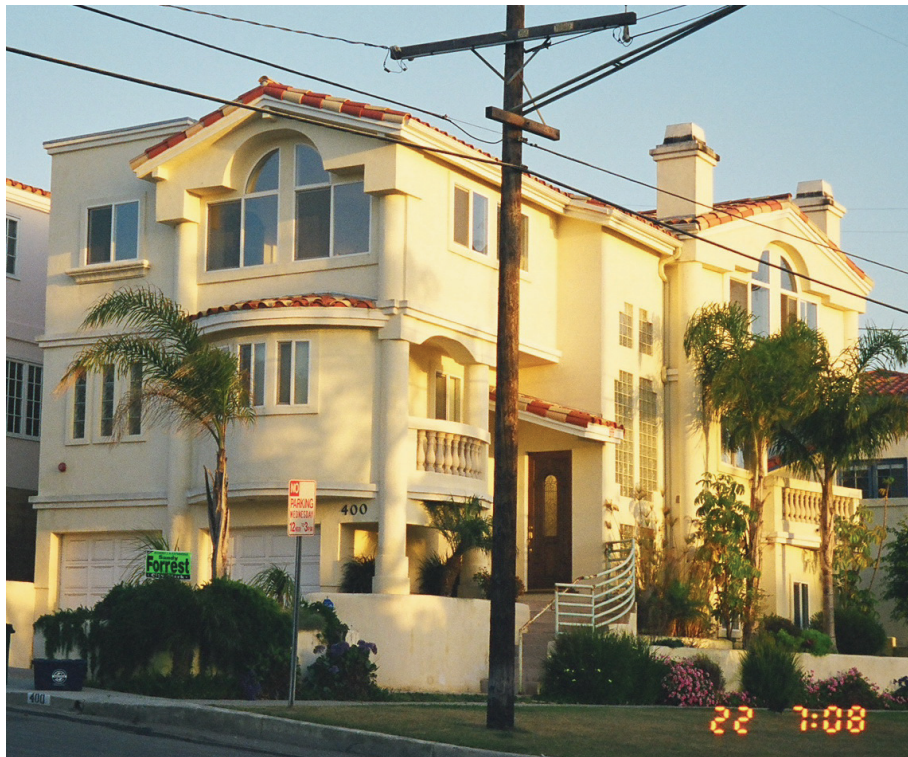
Figure 2-8 Typical three-story slab-on-grade house (from ATC, 2002).

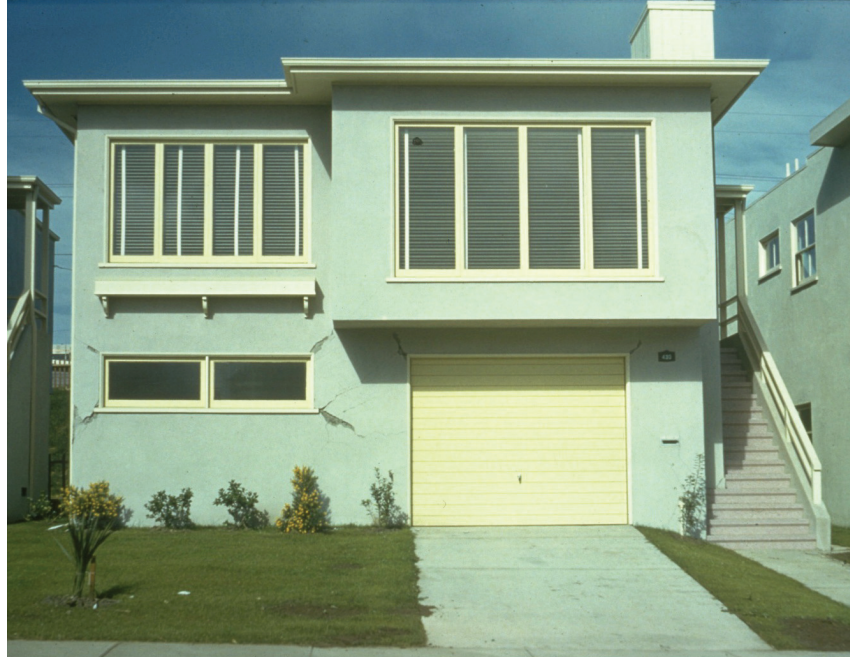
A common seismic vulnerability in some two-story and many three-story slab-on-grade houses is the insufficient lateral-force-resisting strength of the first floor exterior and interior walls due to the large number of door and window openings in these walls and the limited strength of the sheathing materials. Figures 2-9 and 2-10 show typical earthquake damage to the first-story walls.

Figure 2-9 Cracking damage at the window to stucco first-floor walls of a two-story slab-on-grade house (from ATC, 2002).

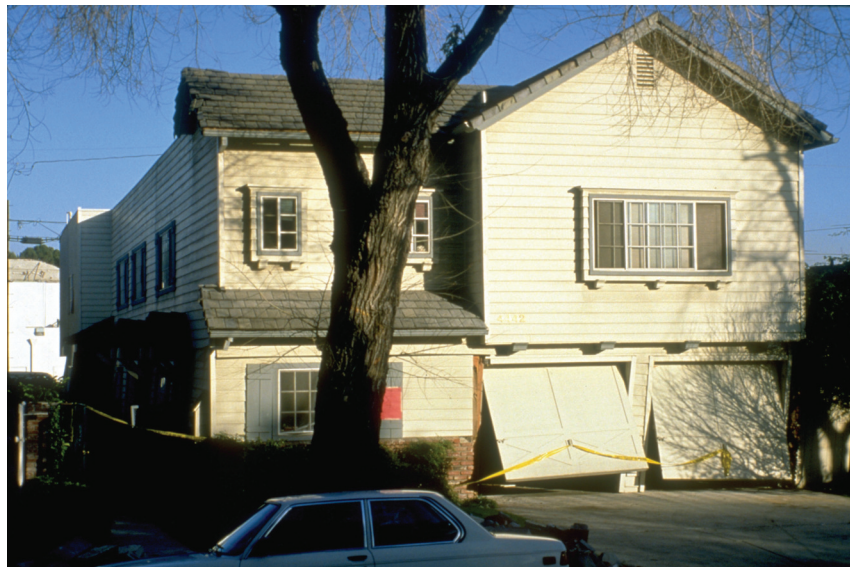
Figure 2-10 Damage and racking displacement to the right in the first floor walls of a two-story slab-on-grade house (from ATC, 2002).

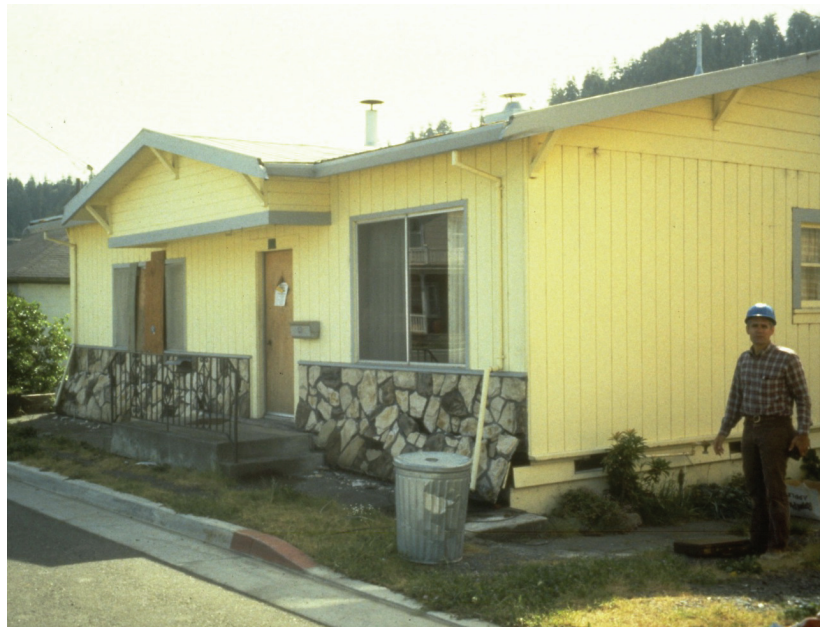
A common seismic vulnerability in basement houses is the lack of anchor bolts between the sill plate and the basement wall. Figure 2-13 shows a house of this type that was damaged in the 1992 Cape Mendocino earthquake in California as the sill plate slid along the top of the foundation wall.

Figure 2-13 Damage to a basement-type house where the sill plate slid on the top of the foundation wall (from ATC, 2002).

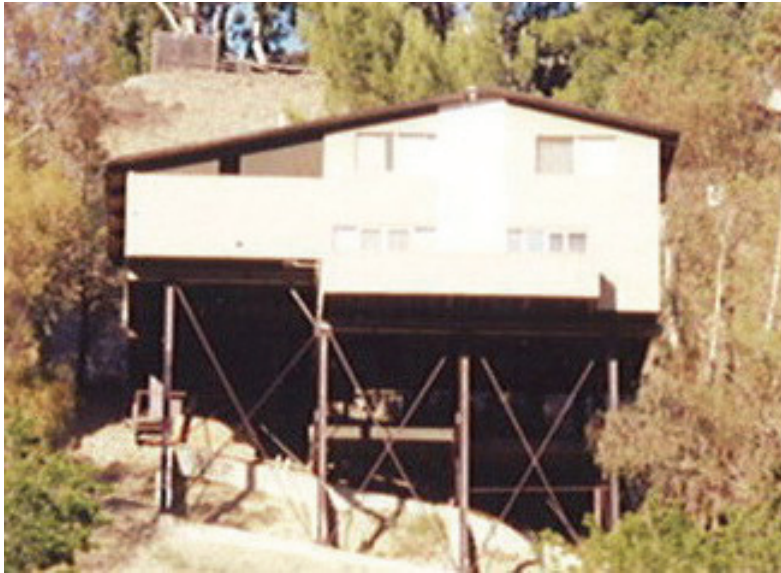
In post-and-pier foundation houses, individual footings are spaced along the house perimeter and along interior lines. These footings may be shallow foundations or deep drilled piers, and may or may not be tied together by grade beams at ground level. The footings support wood or steel posts, or masonry or concrete piers. Posts are provided with lateral-force resistance by diagonal bracing, or the width/height ratio of masonry or concrete piers providing overturning capacity. The first-floor joists and the house superstructure are supported by girders supported by the posts or piers. Figures 2-14, 2-15 and 2-16 illustrate this house configuration on sloping and flat sites, respectively.

Figure 2-14 Steel post-and-pier foundation house on sloping site (from ATC, 2002).

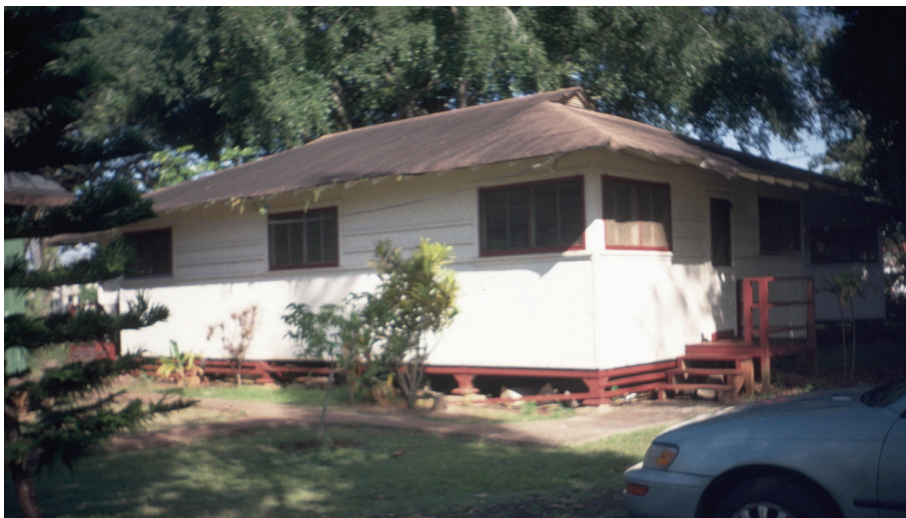
Figure 2-15 Wood post-and-pier house on flat site (from ATC, 2002).

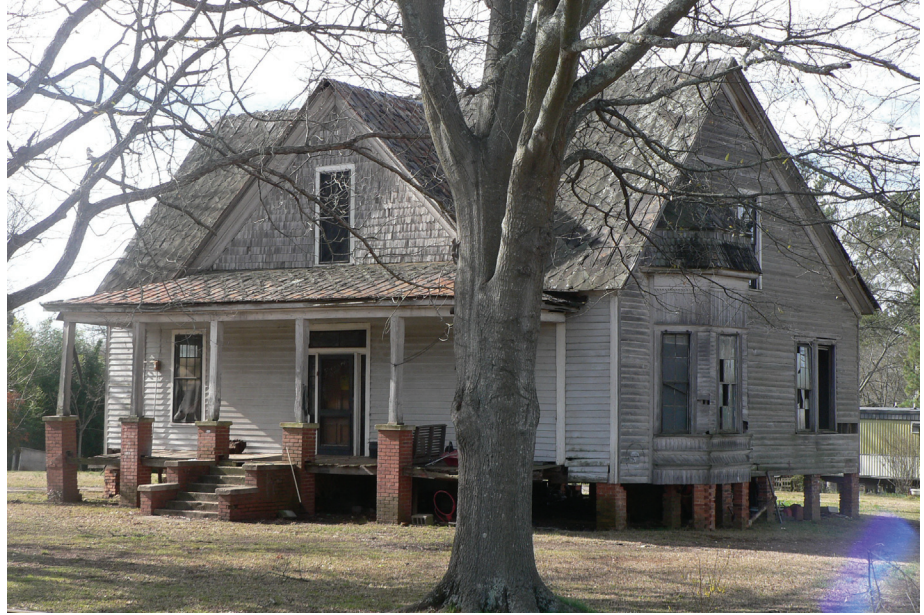
Figure 2-16 Masonry pier house on flat site (from ATC, 2002).

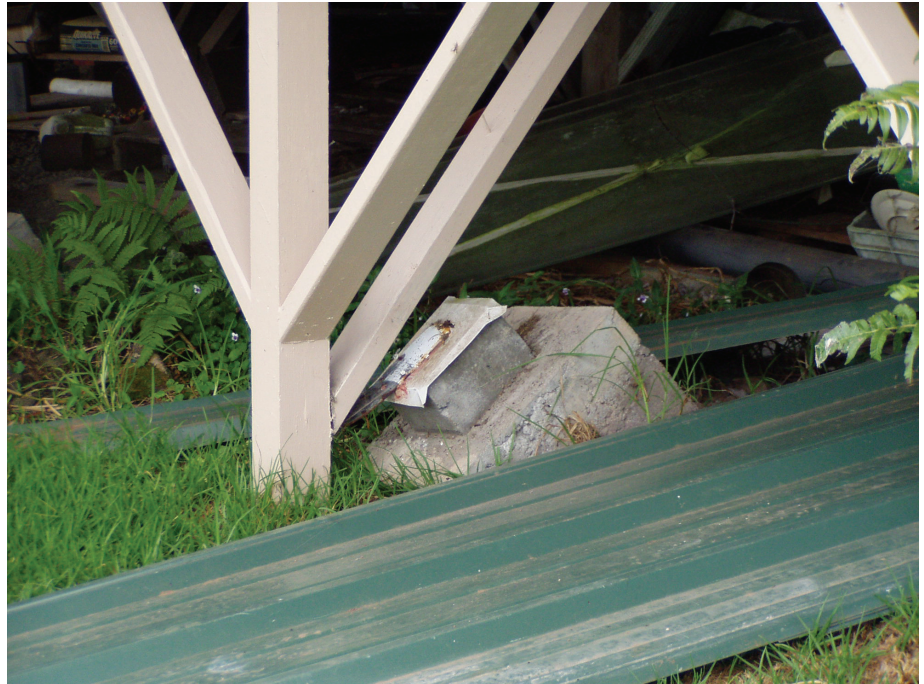
A common seismic vulnerability in post-and-pier houses is the lack of seismic-resisting strength in the post-and-pier foundation system or in the diagonal bracing system. Figure 2-17 shows earthquake damage to a post-and-pier foundation.

Figure 2-17 Earthquake-damaged perimeter post-and-pier foundation. The diagonally-braced post has overturned the shallow-founded concrete pier footing (from ATC, 2002).

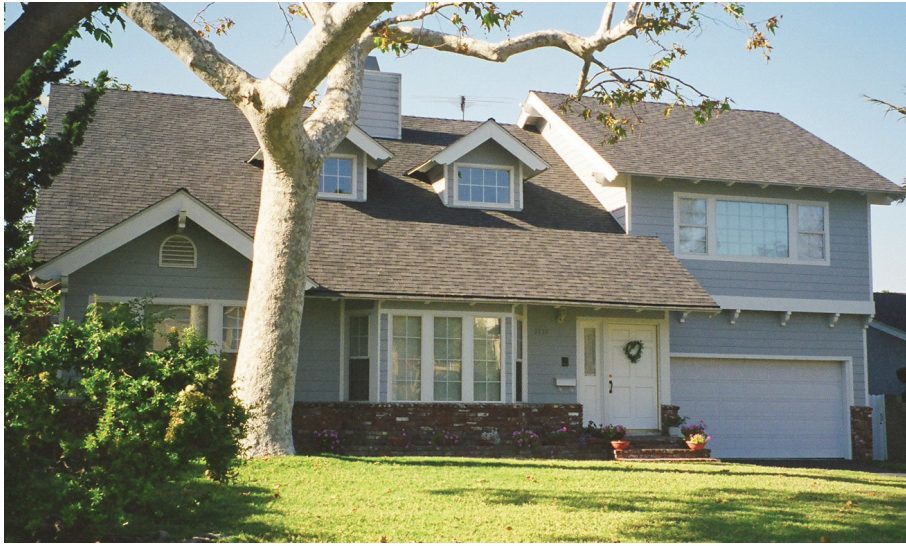
Houses where adjacent floor levels are separated by less than a full story height are usually designated split-level houses. One typical configuration is shown in Figure 2-18. The right part of the house is of two-story slab-on-grade wood-frame construction, with the garage space occupying the lower floor. The attached portion on the left side is of one-story cripple-wall construction.

Figure 2-18 Split-level house, where the section of flooring above the garage is at a lower level than the main second-floor level (from ATC, 2002).

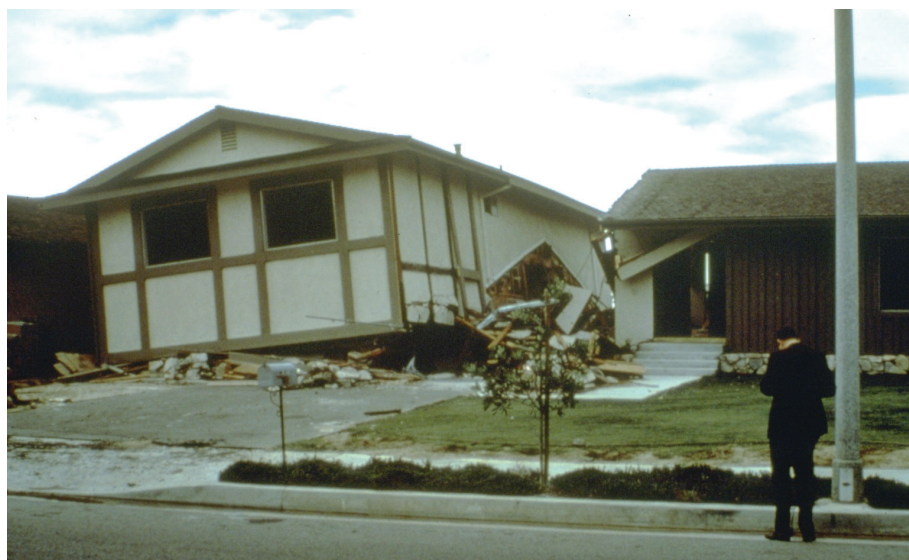
Figure 2-19 Split-level house with damage and collapse at the garage-level walls at two-story portion (from ATC, 2002).

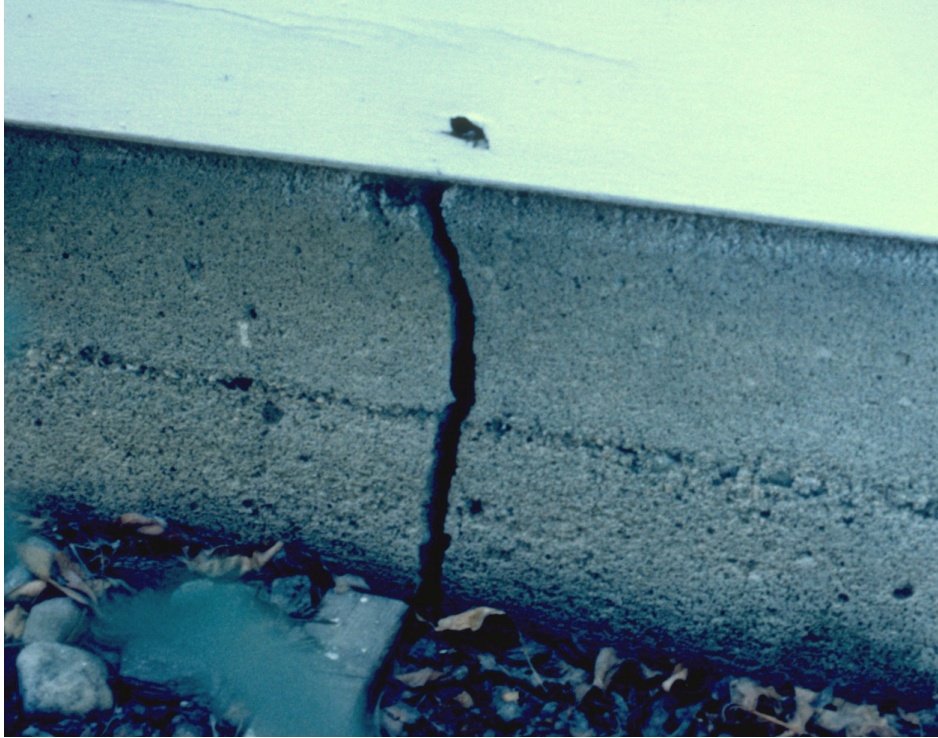
Certain foundation conditions will increase the house's vulnerability to earthquake damage. Certain cracking patterns indicate that differential settlement has occurred. Generally, cracks in foundation walls that are wider at one end indicate that the foundation stem wall on one or both sides of the crack has rotated. Occasional cracks of even width, as shown in Figure 5-1, are usually caused in unreinforced foundations by concrete shrinkage, and they do not significantly increase seismic vulnerability. A series of thinner cracks may indicate that the foundation has embedded horizontal steel reinforcement, a desirable feature.

Figure 5-1 Shrinkage crack in unreinforced concrete perimeter footing wall.

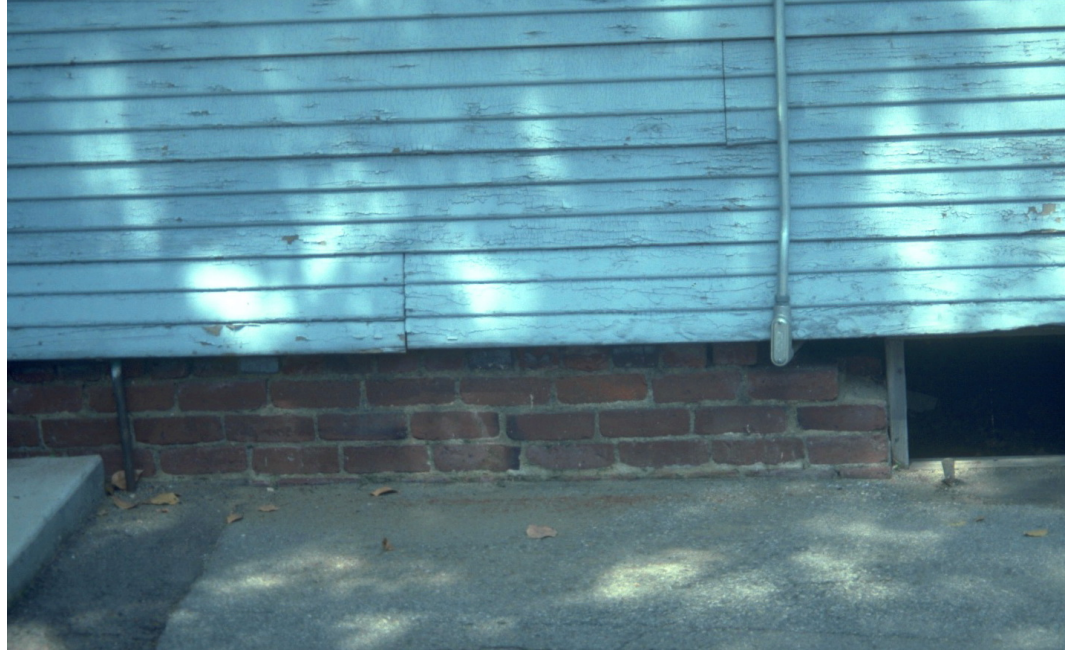
Unreinforced masonry footings and stem walls may be found. The masonry may be visible, as in Figure 5-2, or it may have been covered by a thin stucco-like coating of cement plaster. Method 1 (IEBC Cripple Wall Provisions Method), requires that the adequacy of an unreinforced masonry footing for seismic resistance be substantiated by a design professional before retrofit. This substantiation may be possible and prudent for unreinforced masonry footings and stem walls in good condition. Two preliminary evaluations should be done during the inspection to help determine whether to request this substantiation by the design professional:

Figure 5-2 Brick masonry foundation wall.

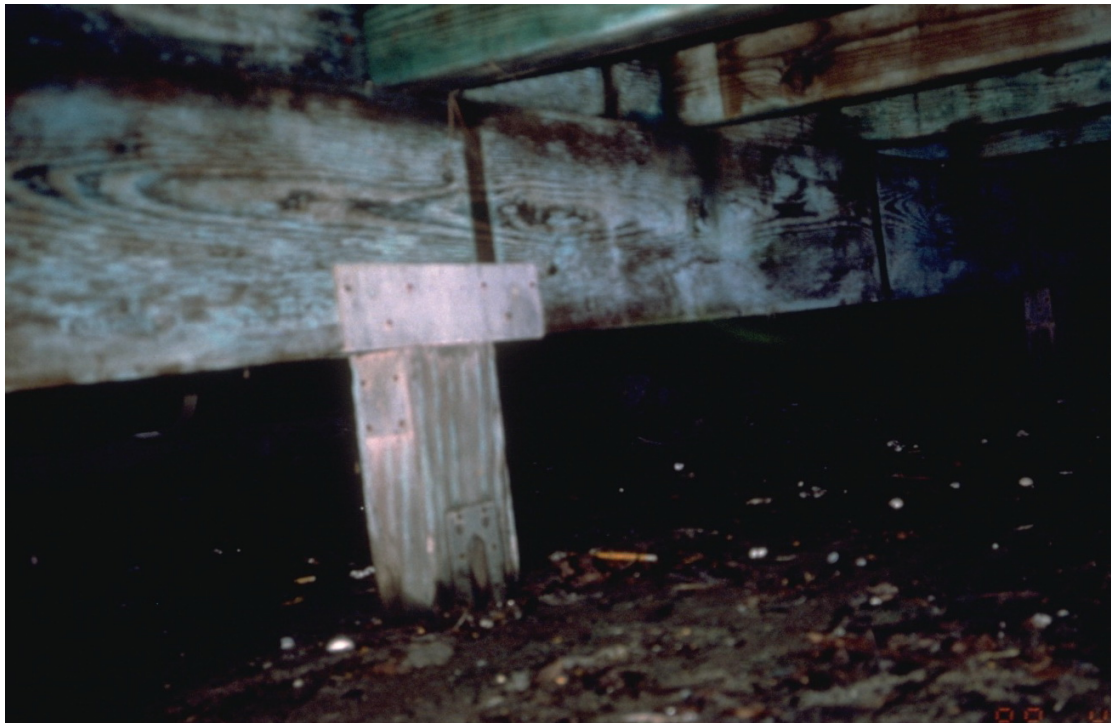
Figure 5-4 Decay of wood framing in damp crawl space.

The IBC and IRC require prescribed sizes and configurations of ventilation openings for crawl spaces. This ventilation serves to keep the moisture content of the crawl space framing below the level conducive to wood decay, as has occurred in the example shown in Figure 5-4. It is important that this ventilation be present. Retrofit sheathing should not cover these vents, unless a vent of equivalent area and cross-draft effectiveness meeting code requirements is established elsewhere.

The earthen floor of a crawl space is often damp. This is often not preventable, and usually is not a problem if proper crawl space ventilation is provided. However, standing water in crawl spaces is not desirable, and can lead to decay in the framing (Figure 5-4) and mildew in the spaces above. Proper ventilation and site drainage should be maintained to prevent standing water in crawl spaces.

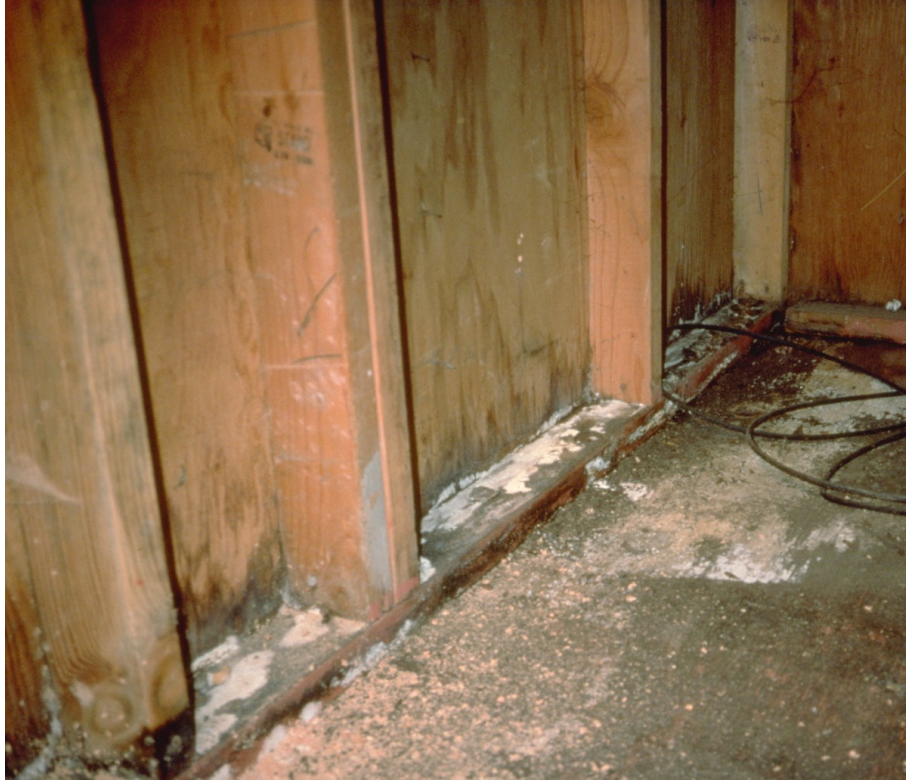
Figure 5-6 Obvious visible decay in a sill plate.

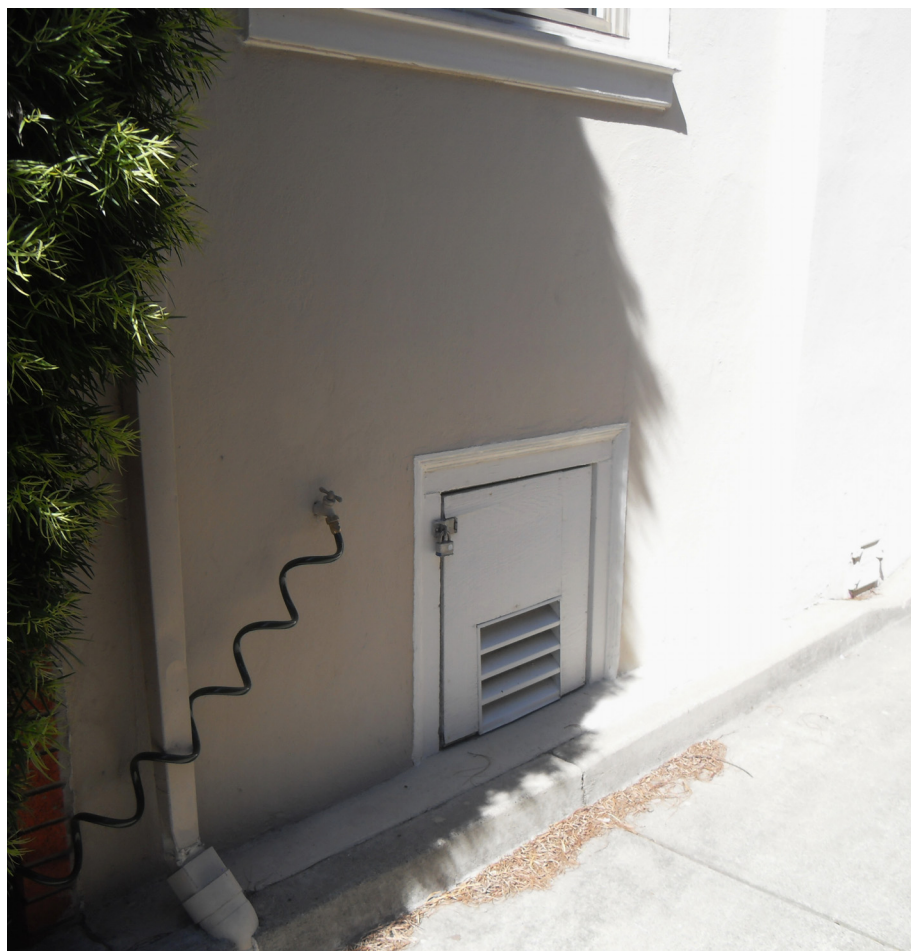
Figure 5-7 Typical crawl space access hatch.

Figure 5-7 shows a typical access hatch to a crawl space. Commonly, these small access hatches, low floor clearances, and the presence of ducts and pipes create access problems. A larger, temporary access hatch may be necessary.

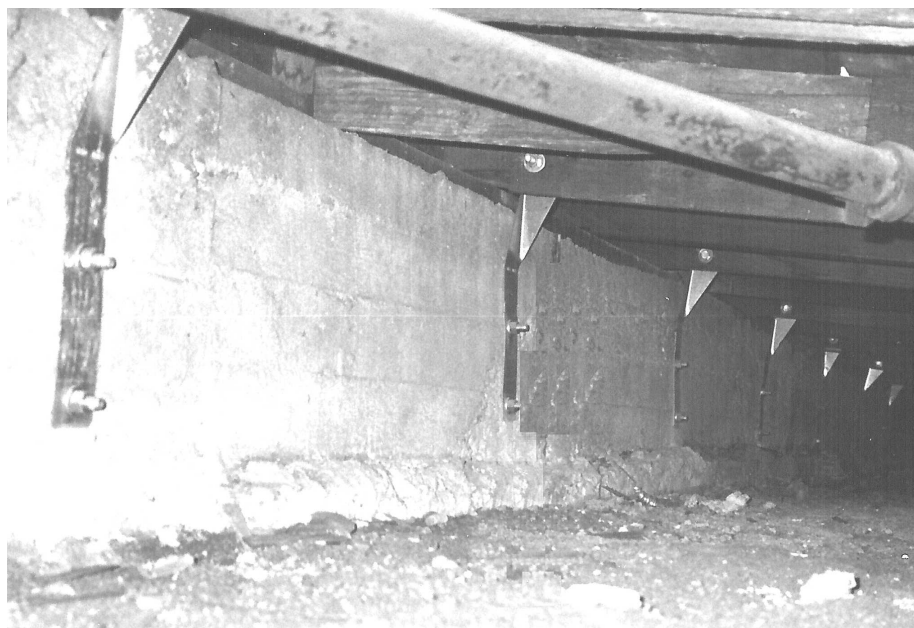
Figure 6-1 A retrofit anchor that is not appropriate for a retrofit to the IEBC Cripple Wall Provisions. Twist strap anchors between the foundation and the floor joists have insufficient strength to resist significant horizontal in-plane shear wall forces.

Twist-strap anchors (see Figure 6-1) are a type of anchor that is not suitable for sill plate anchorage. This type of anchor has good uplift capacity, but does not have sufficient shear capacity in the plane of the wall to function adequately to anchor the sill, even when placed at close spacing.

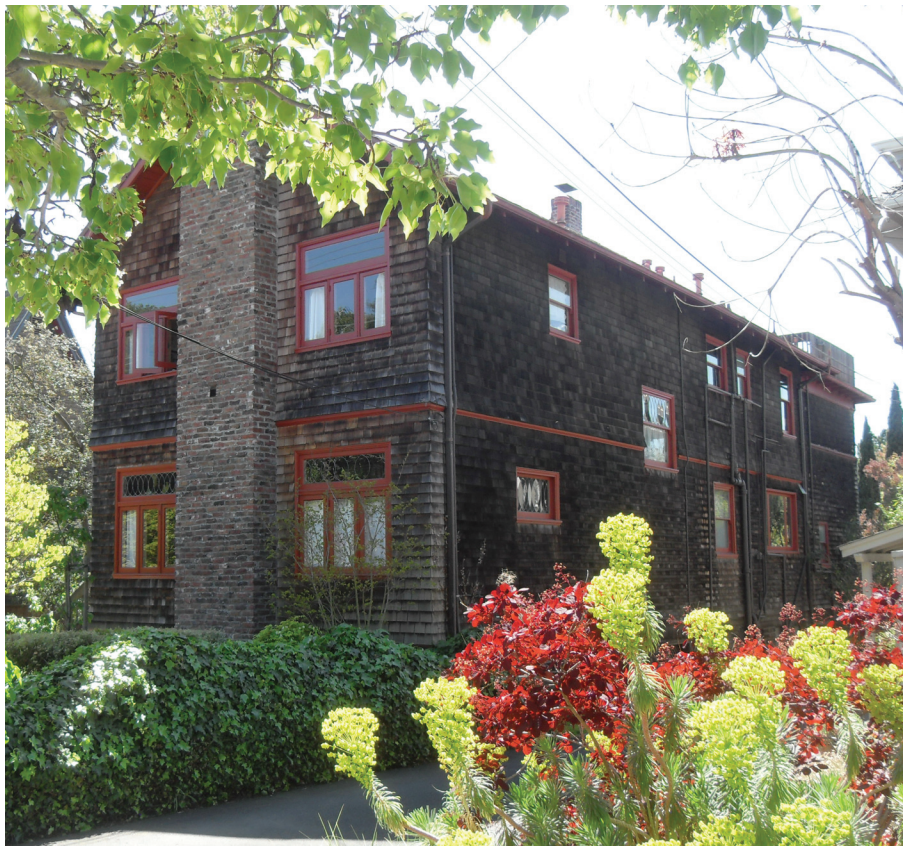
Figure 6-2 Cripple wall-type house with a narrow floor plan, with significantly shorter transverse walls than longitudinal walls (from ATC, 2002).

- *Condition 2: Narrow Floor Plans.* Figure 6-2 shows an example of a house with a narrow floor plan, in which case the length of the transverse walls is considerably less than the length of the longitudinal walls. The transverse cripple walls, rim or end-joist connections, and anchor bolt

lines in such a floor plan are more vulnerable than at the longitudinal walls because the same earthquake force must be resisted by a shorter-length wall. If the length of the transverse walls is less than about 2/3 of the length of the longitudinal walls, the Method 4 (Engineered Structural Retrofit Method) is recommended.

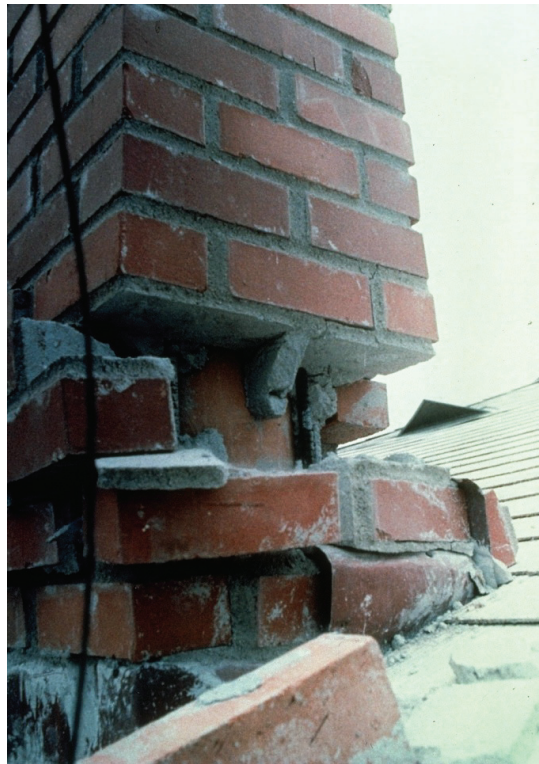
Figure 7-1 Chimney fractured at the roof line, with vertical steel reinforcement visible (from ATC, 2002).

The most common type of damage is the fracture of the cantilevered part of the chimney that extends above the roof (Figure 7-1). When this occurs, masonry debris may fall through the roof into living spaces (Figure 7-2), lie on the roof and overload it, or slide down into the yard. As exemplified in the two figures, it is much more probable that large pieces of masonry debris will break from unreinforced chimneys than from reinforced chimneys.

As shown in Figures 7-1 and 7-2, the portion of the chimney that cantilevers above the roof is vulnerable to flexural damage from earthquake accelerations.

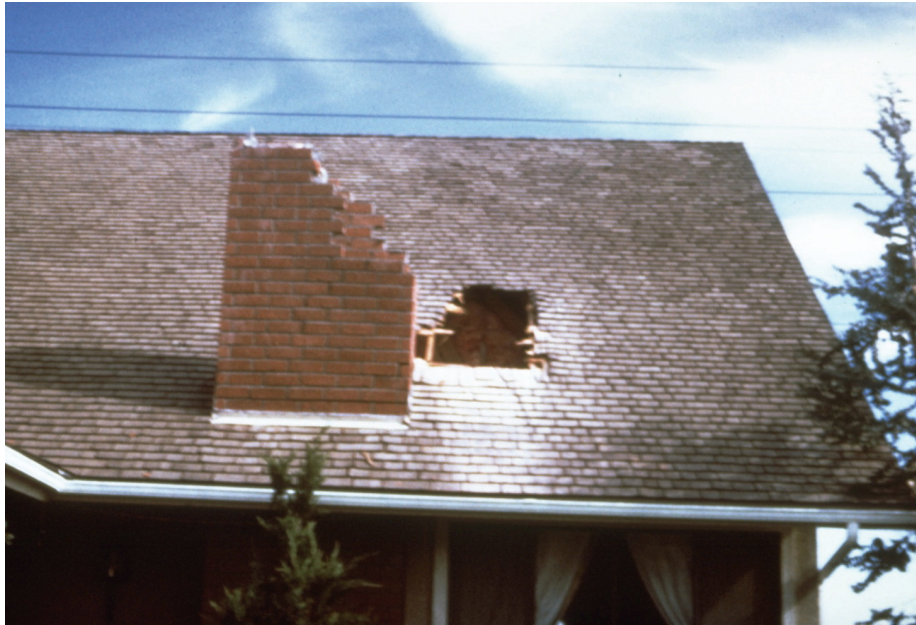
Figure 7-2 Masonry debris from an unreinforced chimney has fallen through the roof into the living spaces (from ATC, 2002).

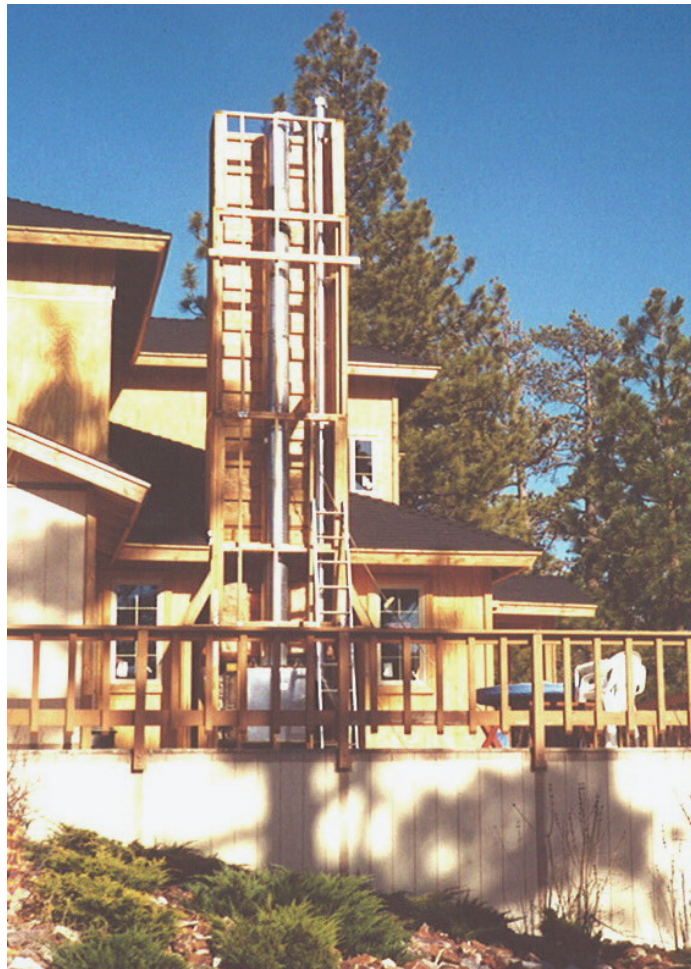
Figure 7-4 Non-masonry flue pipe with architectural enclosure.

Unfortunately prescriptive retrofit masonry chimney bracing suitable for high seismicity areas (Ground Shaking Hazard Points of 4 - 8 from Table 1 and entry F-1 on the Assessment Form) is not recommended. An engineer may be willing to design bracing for a particular chimney. Many building jurisdictions in high-seismic areas encourage the use of nonmasonry chimneys because they are much less vulnerable to earthquake damage. These chimneys have a metal double-wall flue pipe inside an architectural enclosure. This type of chimney assembly is shown in Figure 7-4.

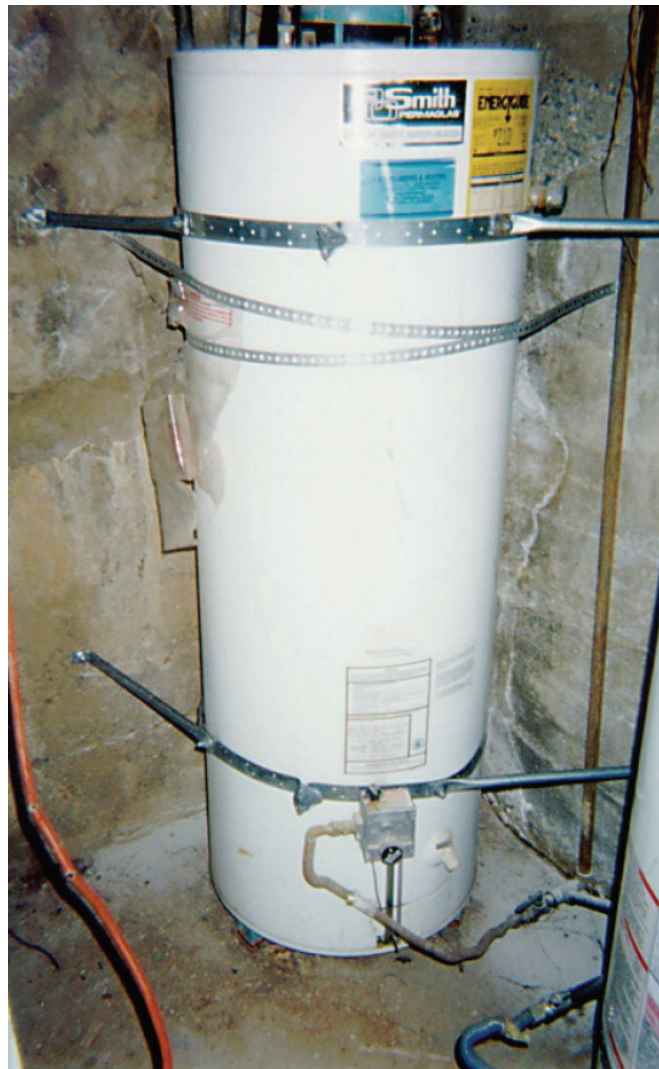
Figure 7-6 Water heater braced with straps and a V-shaped wall-mounted bracket.

There are several methods of bracing a water heater that are considered acceptable. Most involve the use of straps, spacers, and lag screws to engage the water heater and secure it to the wall framing. Other restraint methods use both straps and conduit pipe struts for bracing. Brackets between the wall and the heater can be used for spacing and to restrain motion parallel to the wall, as shown in Figure 7-6. In all bracing methods, there should be a set of braces at the top and at the bottom. Water and gas connections of flexible pipe, if allowed in your building jurisdiction, should be used to allow for movement without breaking the pipes.

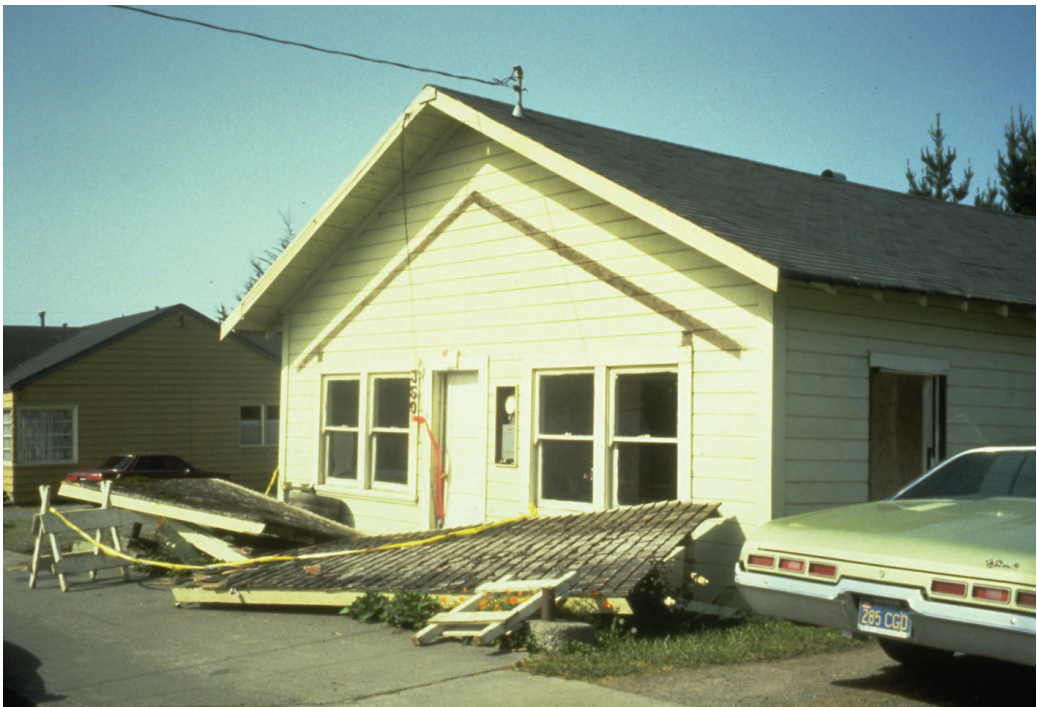
Figure 7-8 Porch roof failure (from ATC, 2002).

It is common for decks, porch floors, porch roofs, balconies and patio covers to break away from the house in an earthquake and to become dangerous falling hazards. Figures 7-8 and 7-9 show porch roof failures that luckily did not occur just as the occupants were leaving the house from the front door.

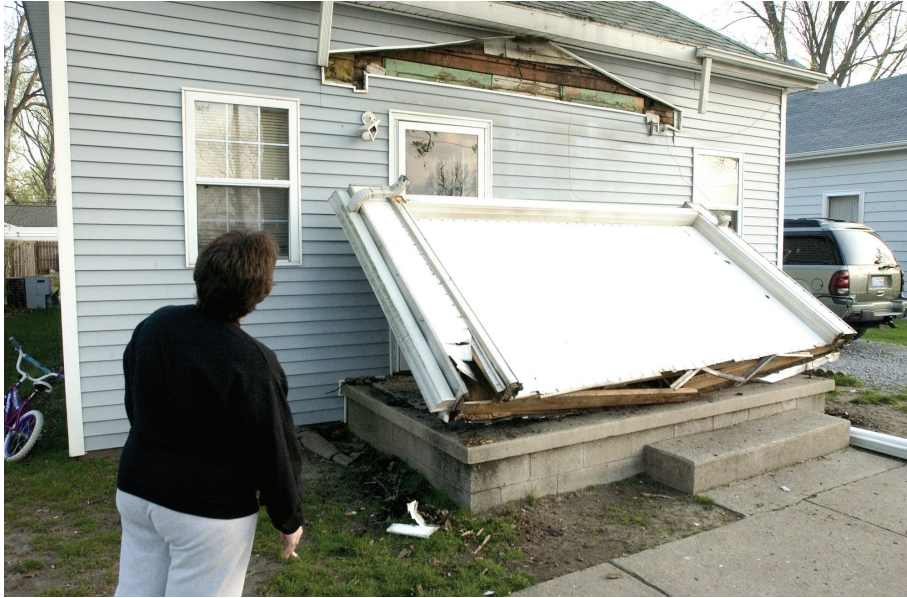
Figure 7-9 Porch roof broken off (and repositioned) in Mt. Carmel, Illinois, by the Richter magnitude 5.2 Mt. Carmel Earthquake in 2008. (Photo credit: Associated Press/Daniel R. Patmore)

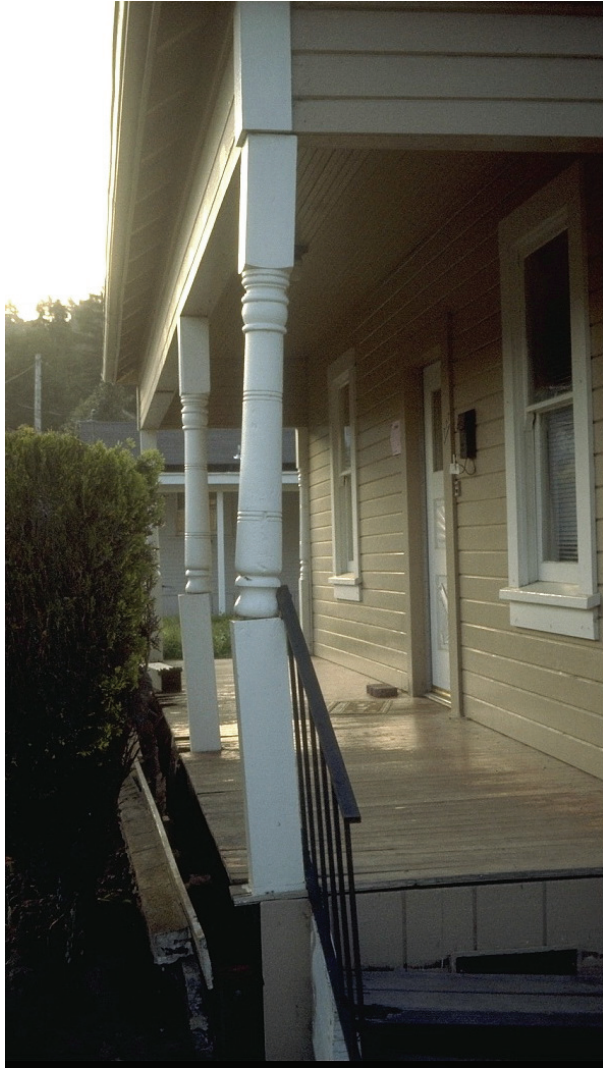
Figure 7-14 Failure of a porch roof support post by hinging at the middle (from ATC, 2002).

It is also common for porch roof support posts to shake loose or become unstable (see Figure 7-14) in an earthquake, even if the porch roof does not pull away from the house. The partial support failure shown in Figure 7-14 is due to the post having upper and lower sections, creating a mid-height hinge that makes the post potentially unstable during earthquake shaking. This post should be replaced by a continuous post or be laterally braced in both directions at the hinge.

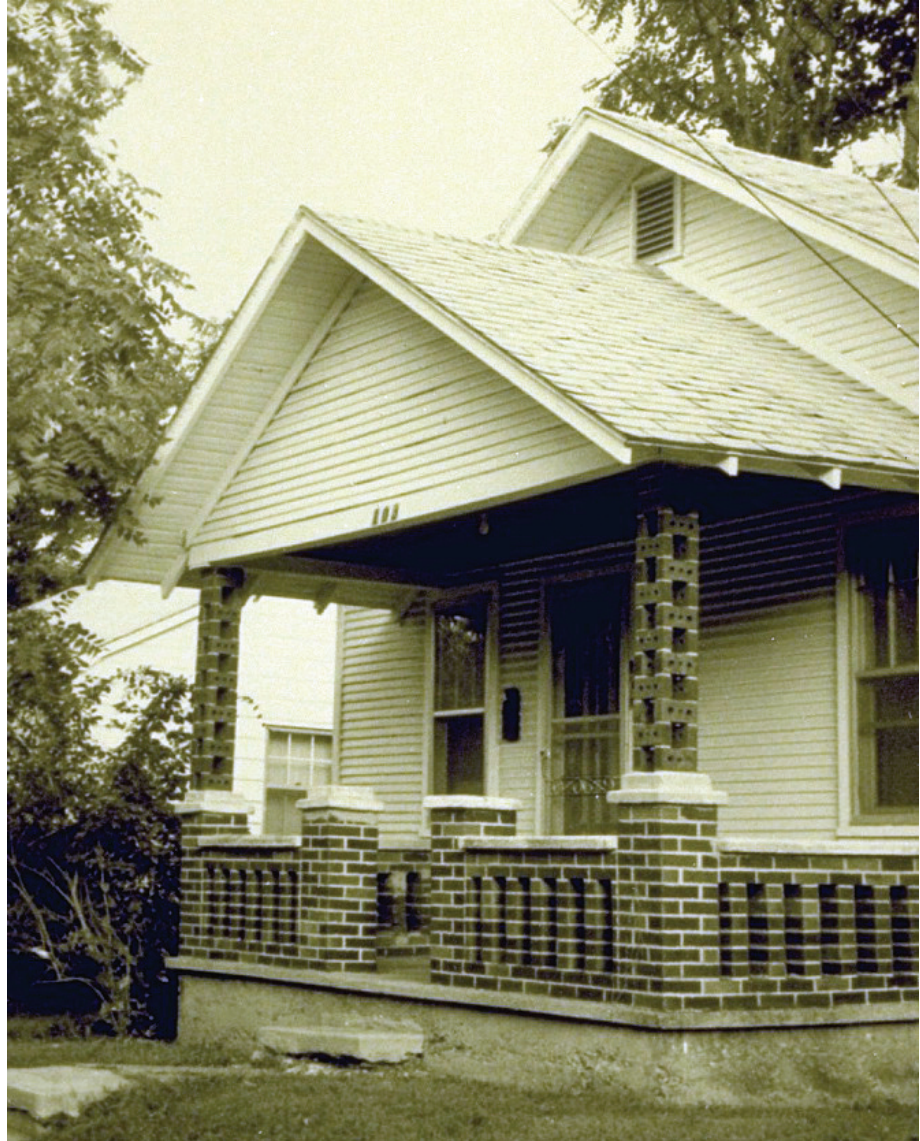
Figure 7-16 Brittle slender masonry porch support posts that will likely collapse during earthquake shaking (from ATC, 2002).

Brittle, slender, unreinforced masonry posts, such as in Figure 7-16, cannot be readily made less vulnerable to collapse from earthquake shaking. Even if the porch roof is tied to the house using the details of Figures 7-11 through 7-13, the masonry posts are vulnerable to failure, and should be replaced with adequate posts.

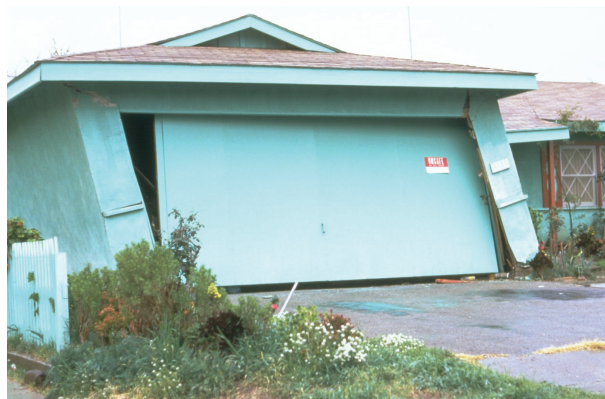
Figure 8-2 Earthquake damage at garage door opening in a one-story house (from ATC, 2002).

A homeowner may also want to address the condition of a garage door opening with narrow walls on each side, but with no second floor directly above. These narrow walls may also be inadequate for the seismic force from the garage roof, resulting in the type of failure seen in Figure 8-2.
