Seismic Retrofit Guidelines for Detached, Single-Family, Wood-Frame Dwellings

FEMA P-50-1 / June 2012

APPLIED TECHNOLOGY COUNCIL
201 Redwood Shores Parkway, Suite 240
Redwood City, California 94065
www.ATCouncil.org

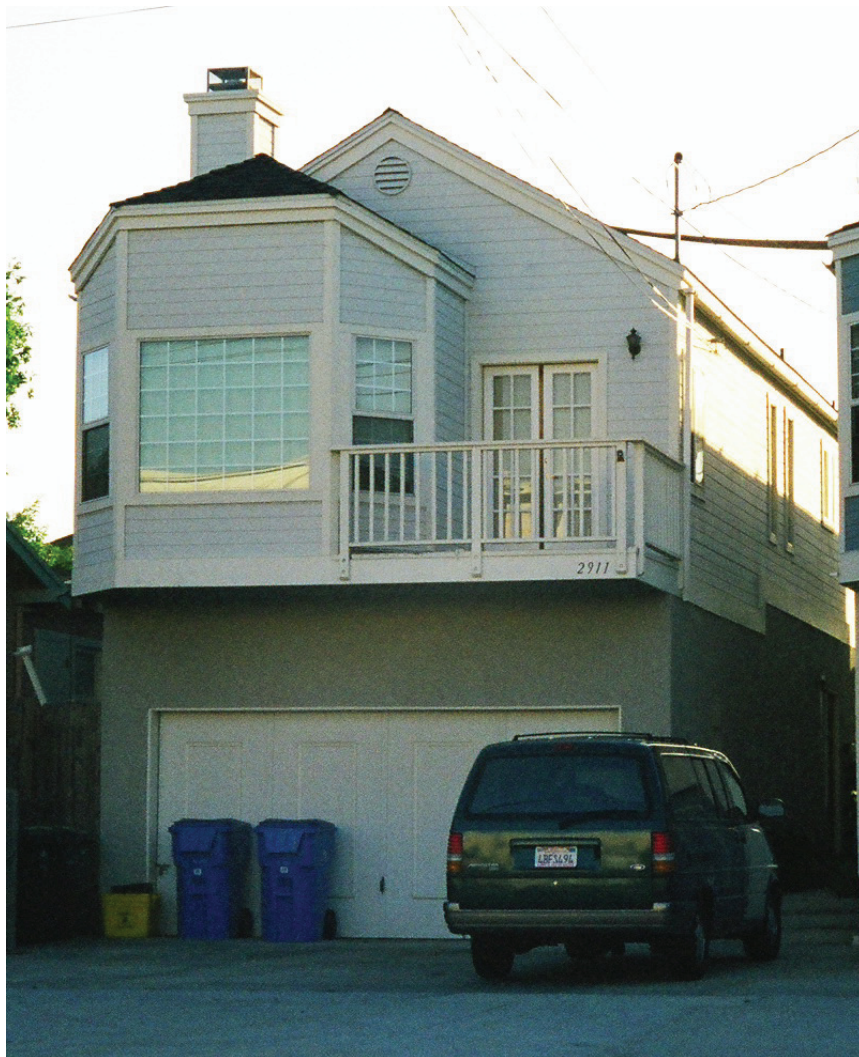
Figure 8-3 House where there appears to be insufficient wall width on each side of the garage door for effective wood structural panel shear wall sheathing (from ATC, 2002).

The engineer may find that an adequate retrofit design cannot be done with stronger narrow walls on each side of the door opening. The shear forces can exceed the capacity of available narrow walls, and the overturning forces at the base of these walls can be much larger than can be resisted by the existing foundation. Figure 8-3 shows a house configuration with very narrow walls at each side of the garage door. It appears that an effective narrow wall could not be provided at the front of the house.

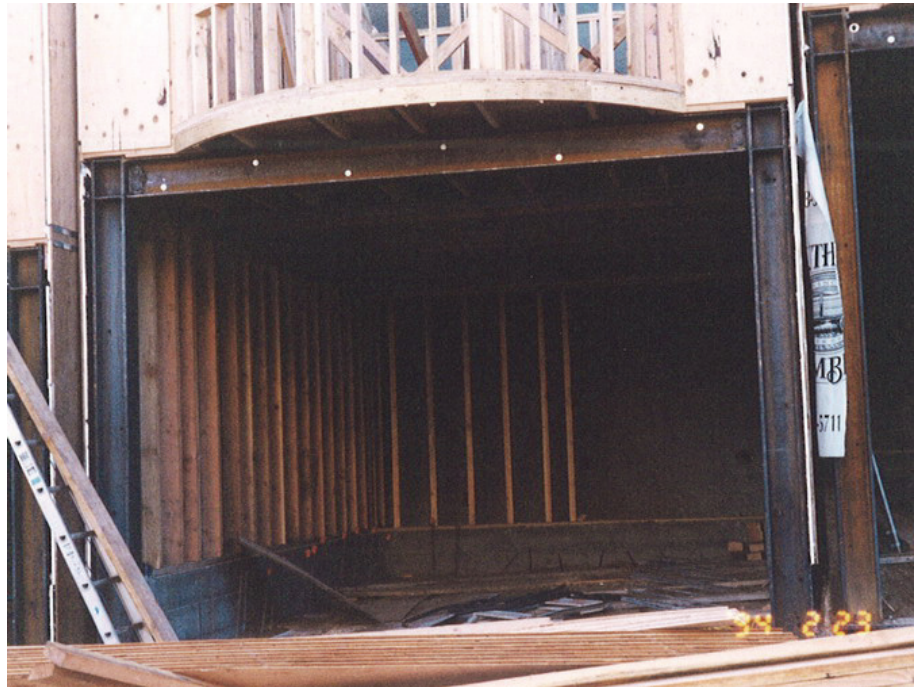
Figure 8-4 A steel moment-resisting frame at the garage opening of a row house (from ATC, 2002).

A solution to this problem is to provide a steel moment-resisting frame to withstand the lateral forces and reduce the uplift and overturning forces to the foundation. This solution may or may not require a new foundation beneath the frame columns. Steel moment-resisting frames are available commercially in many heights and widths, and are constructed so that field welding is not required. An example of a steel frame around the garage opening of a narrow row house is shown in Figure 8-4. A successful frame design by an engineer will address the considerations of transferring vertical and lateral loads into the frame; frame strength, stiffness, and stability; and transferring vertical and lateral loads from the frame into the foundation.

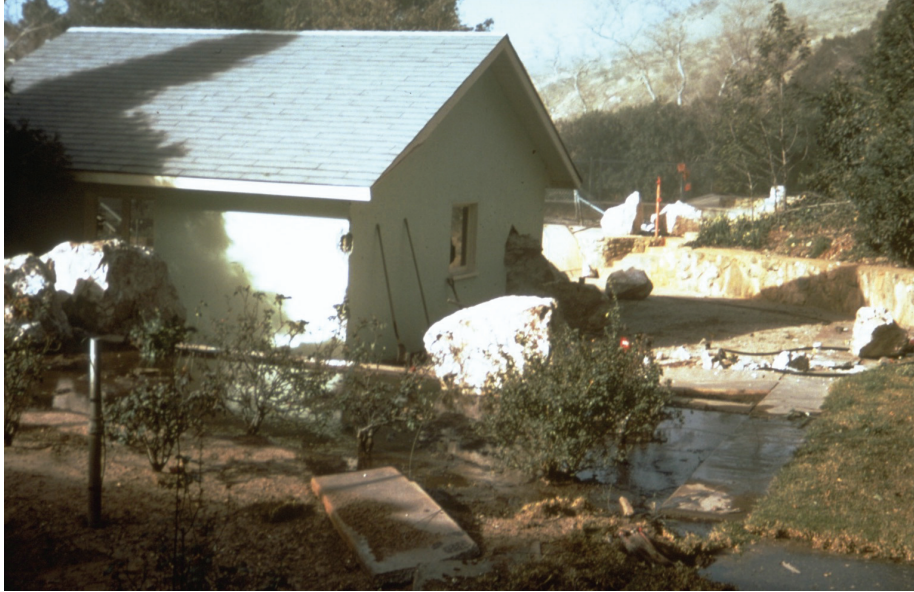
Figure 8-7 Boulder that was shaken loose from the slope above by an earthquake and came to rest against a house (from ATC, 2002).

The stability of natural features at the site may also be of concern. Figure 8-7 shows a boulder that was shaken from the slope above in an earthquake and came to rest against a house.

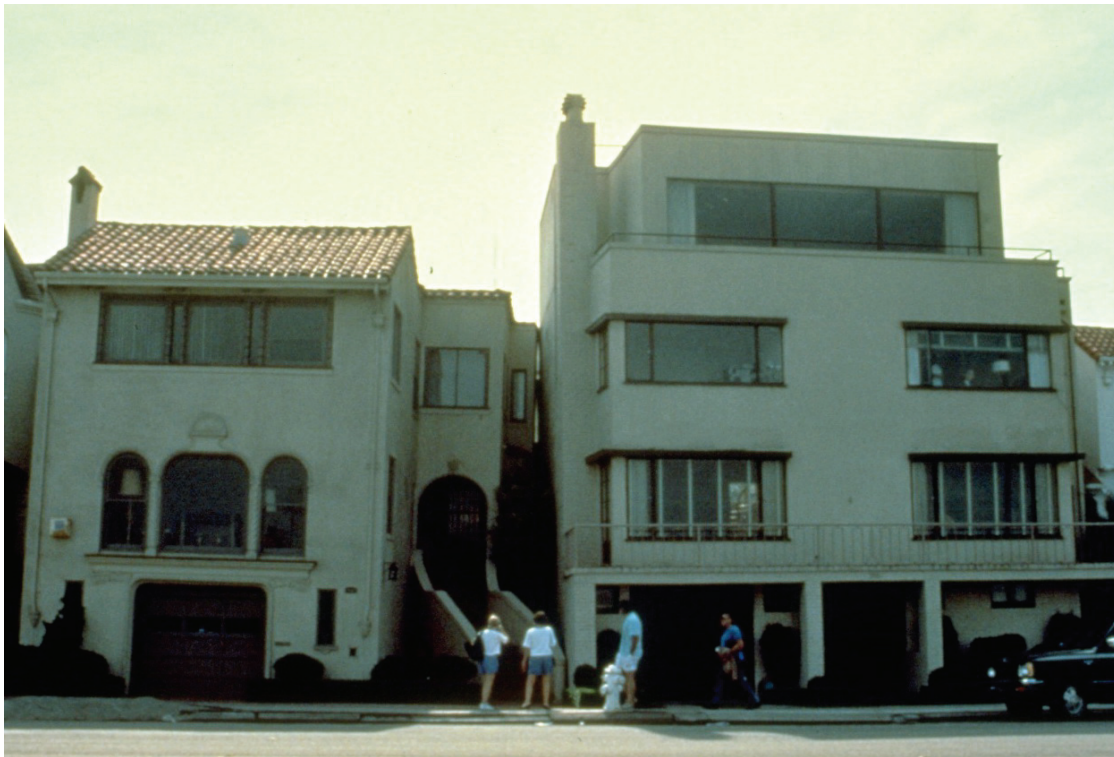
Figure 8-8 Differential settlement of two houses caused by liquefaction along their common property line (from ATC, 2002).

Liquefaction can occur in sandy soils below the water table if the soils are not at their most dense compaction. When the earthquake shakes the soil, it becomes more compacted. This displaces the water between the sand grains, and the displaced water flows upward toward the building foundations or the surface. At building foundations, it creates a temporary “quick” condition, allowing the foundation to sink down. Figure 8.8 shows two houses that settled differentially and came to lean against each other when liquefaction occurred along their common property line.
