# Simplified Seismic Assessment of Detached, Single-Family, Wood-Frame Dwellings

FEMA P-50 / May 2012

APPLIED TECHNOLOGY COUNCIL  
201 Redwood Shores Parkway, Suite 240  
Redwood City, California 94065  
[www.ATCouncil.org](http://www.ATCouncil.org)

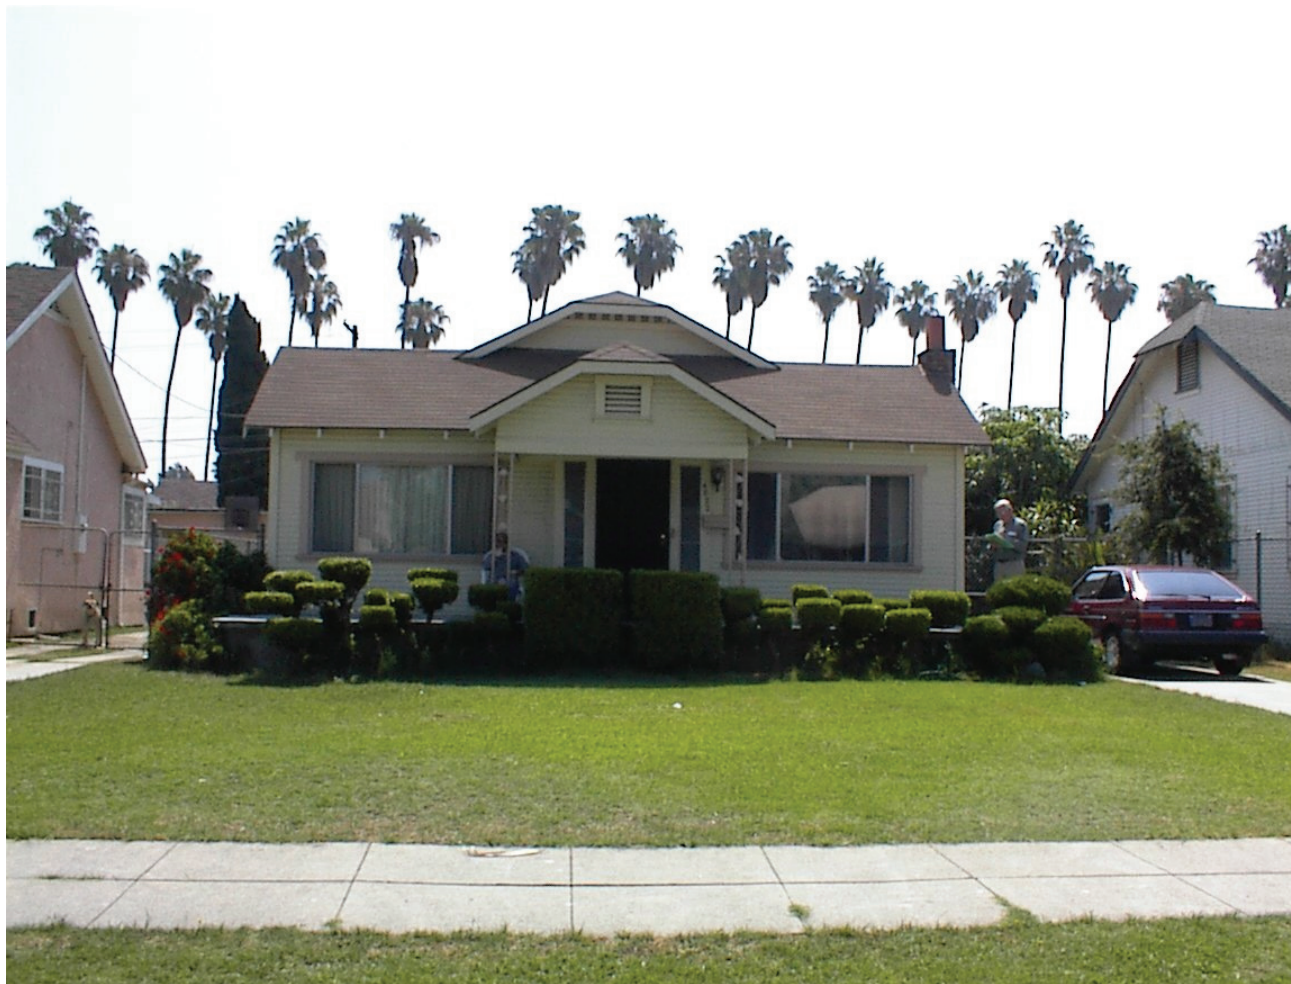
This house in southern Los Angeles was built prior to 1977 but was seismically rehabilitated after the 1994 Northridge earthquake.

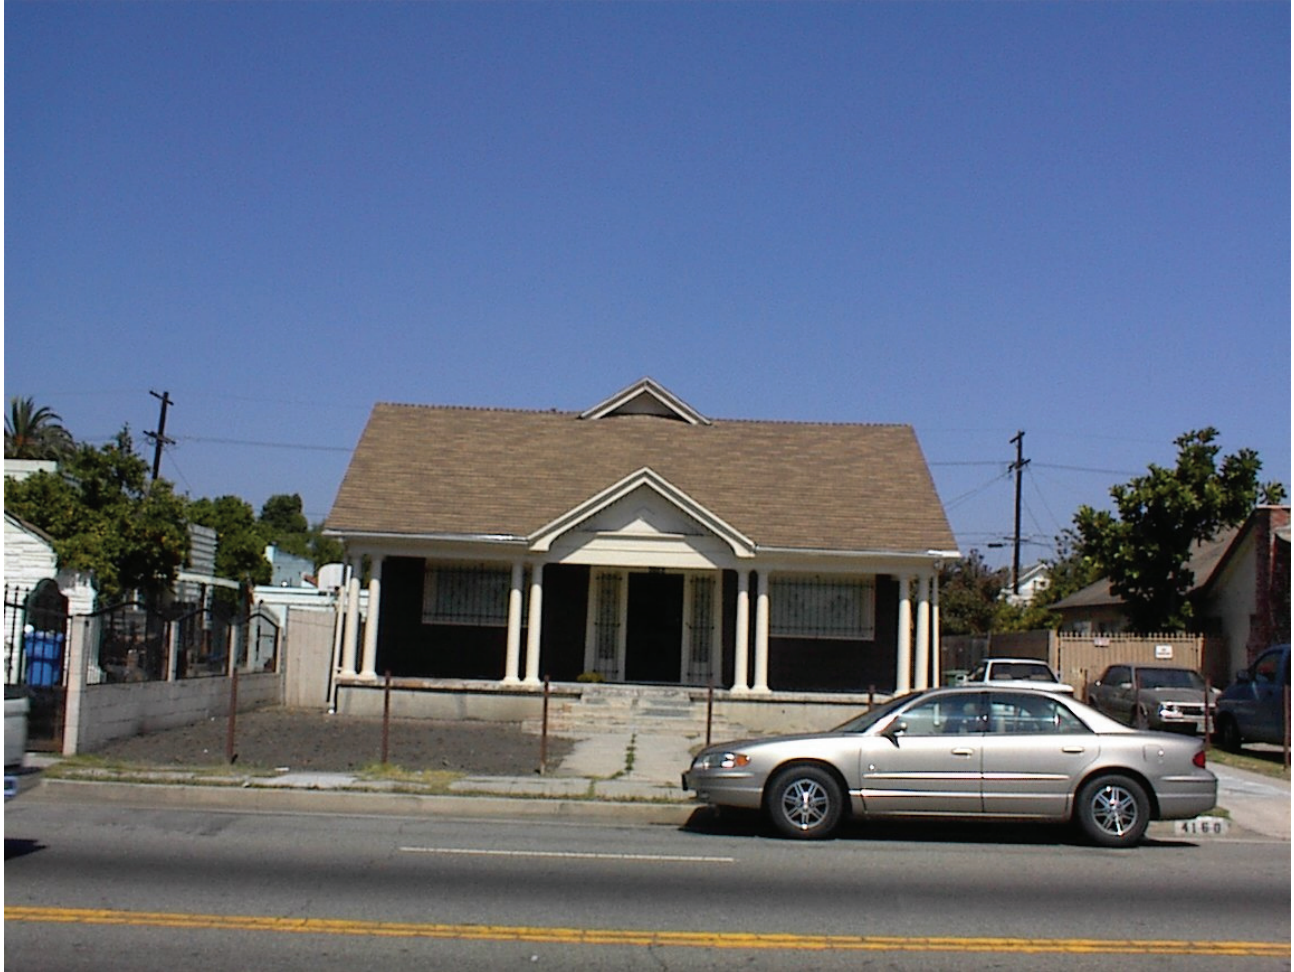
This single-story home has a raised floor supported by an unbraced cripple wall. Additionally, the cripple wall is not bolted to the foundation.

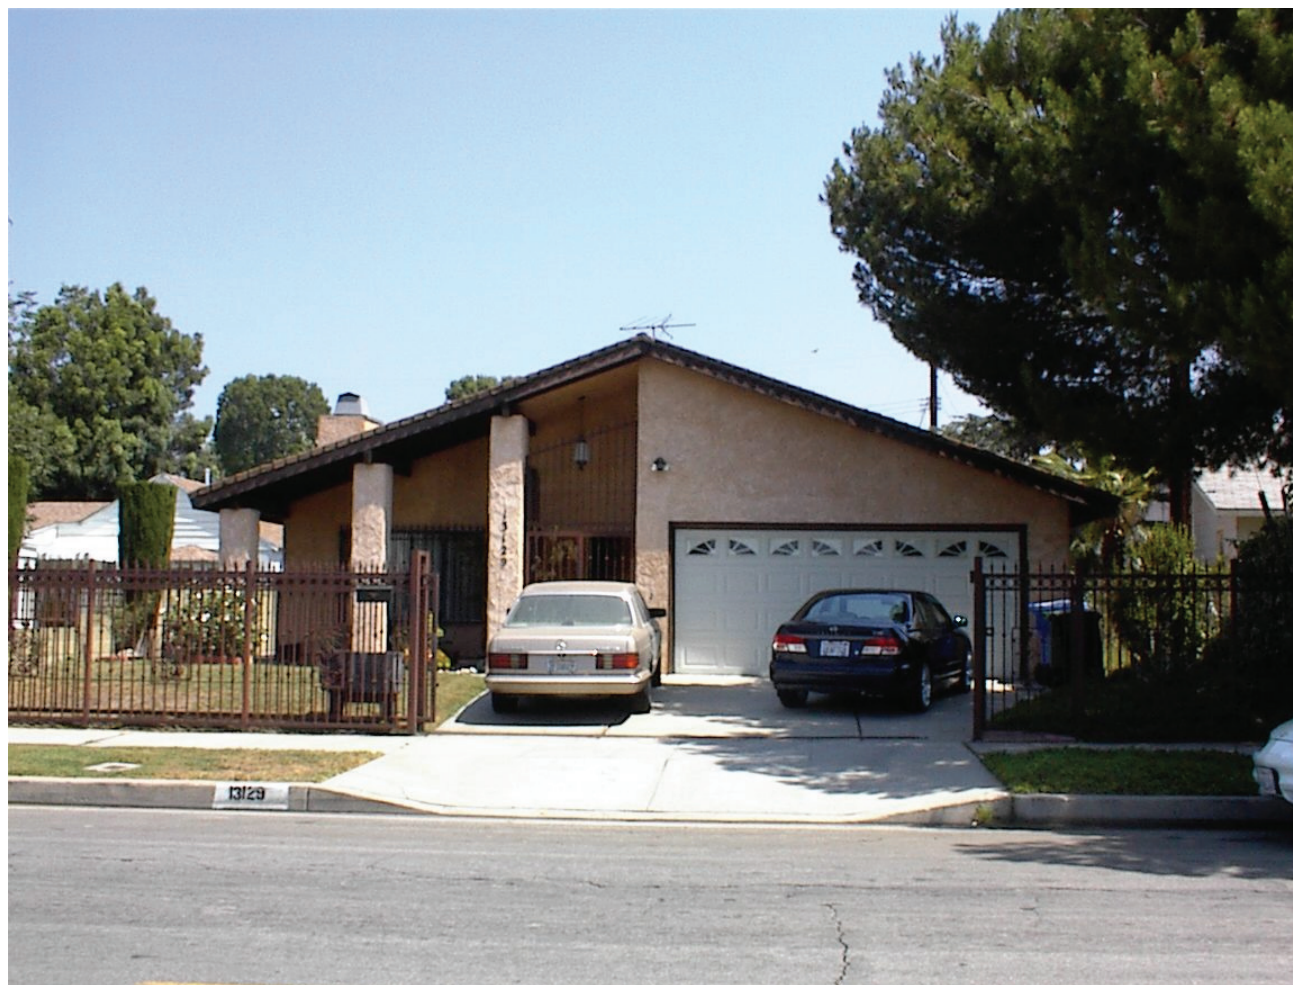
This house is located in the Panorama City area of Los Angeles. Because of the slab-on-grade floor construction, it received no penalties in the foundation section of the form. The house was built after 1977, and received relatively low penalties on the other sections of the form.

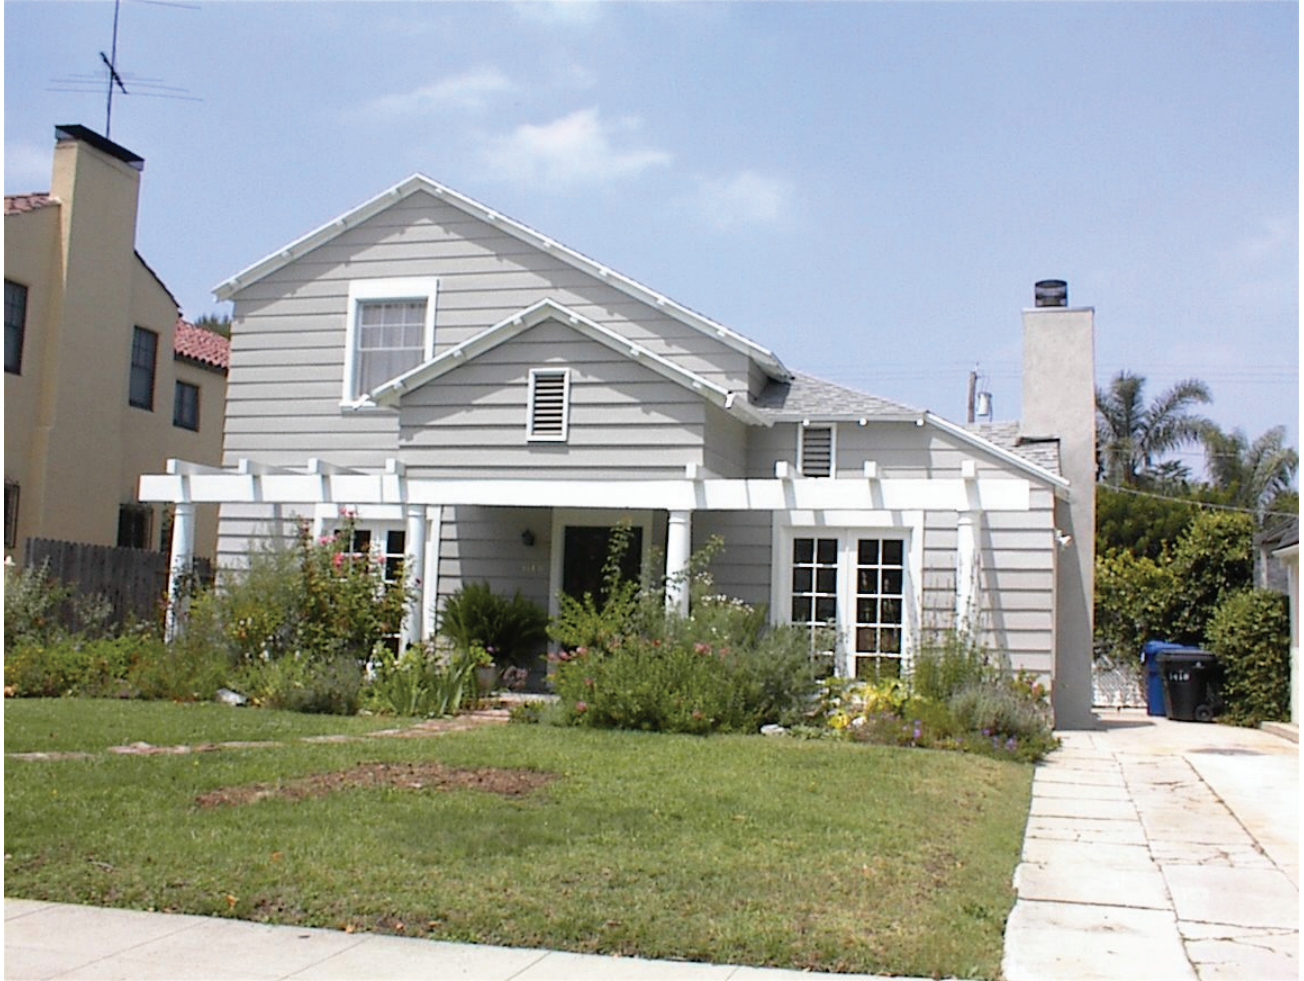
This dwelling received a penalty for the split-level floor diaphragms. However, it scored reasonably well in most sections, especially Local Site Conditions, and it is equipped with an earthquake activated gas shut-off valve.

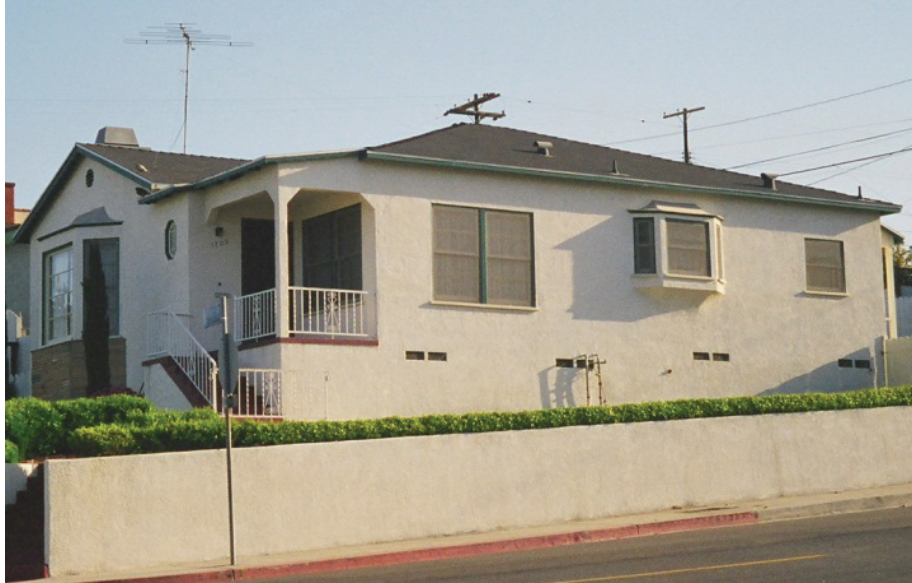
Figure C-2 Typical one-story cripple-wall crawl-space house (from ATC, 2002a).

Cripple-wall dwellings are typically one- and two-story structures (Figures C-2 and C-3) with a perimeter foundation of unreinforced or reinforced concrete, brick masonry, or concrete block. The perimeter foundation typically comprises a stem wall supported by a wider footing. The stem wall

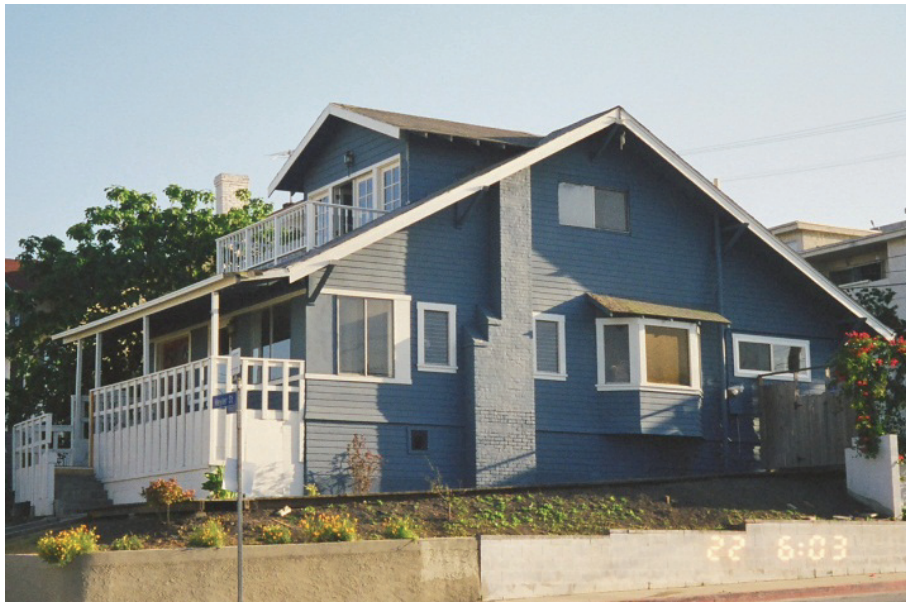
Figure C-3 Typical older one and one-half-story cripple-wall crawl-space house (from ATC, 2002a).

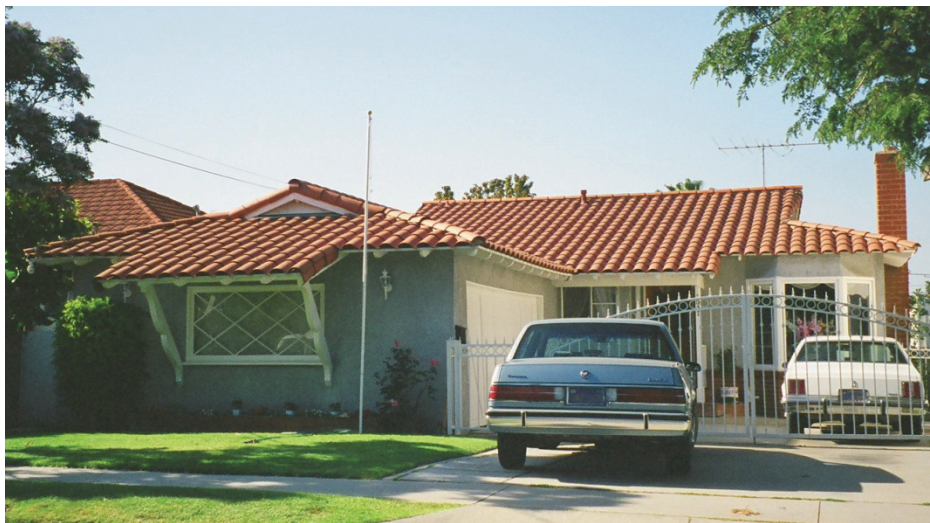
Figure C-6 Typical one-story slab-on-grade house (from ATC, 2002a).

Slab-on-grade dwellings (see example in Figure C-6) have foundations formed by cast-in-place concrete slabs that lie directly on leveled soil. Most of the foundation consists of a ground floor concrete slab of about four-inch

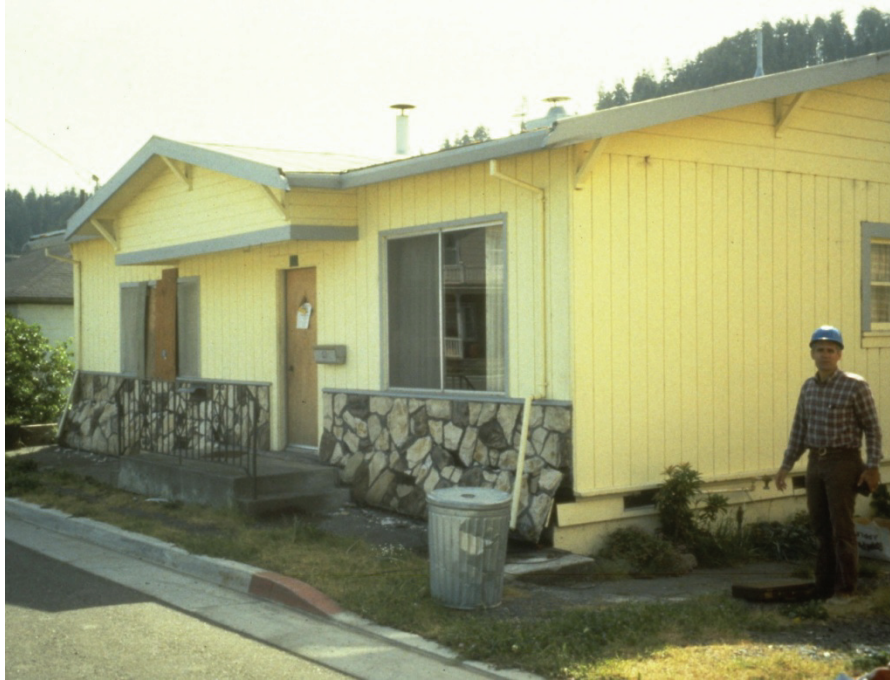
Figure C-10 Damage to a basement-type dwelling where the sill plate slid on the top of the foundation wall (from ATC, 2002a).

A common seismic vulnerability in basement and foundation stem wall dwellings is the lack of anchor bolts between the sill plate and the basement wall [Form item A-5]. A dwelling of this type that was damaged in the Cape Mendocino earthquake of 1992 is shown in Figure C-10; in this case the sill plate slid along the top of the basement wall.

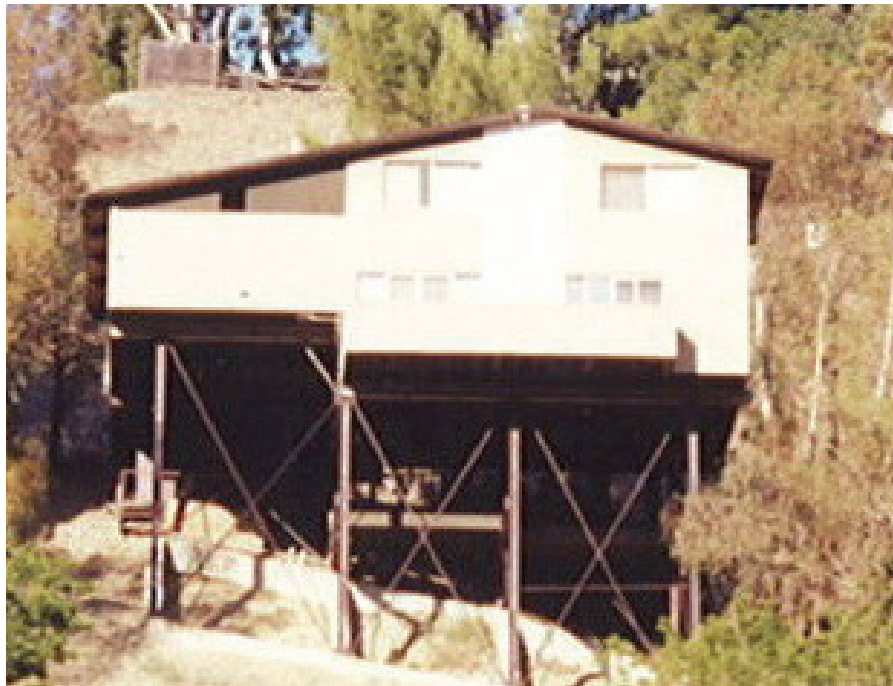
Figure C-11 Post-and-pier foundation house on sloping site (from ATC, 2002a).

Dwellings with post-and-pier foundation can be located either on sloping sites (Figure C-11) or flat sites (Figure C-12). Dwellings of this type have

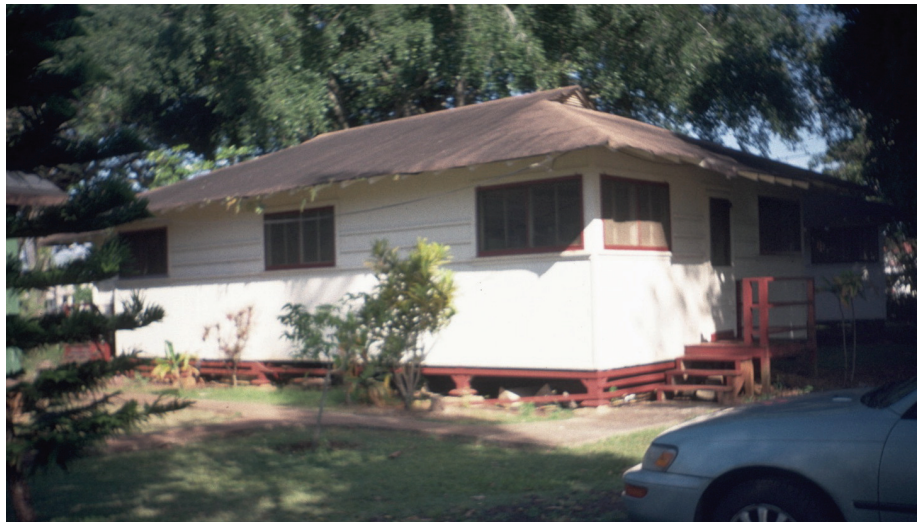
Figure C-12 Post-and-pier house on flat site (from ATC, 2002a).

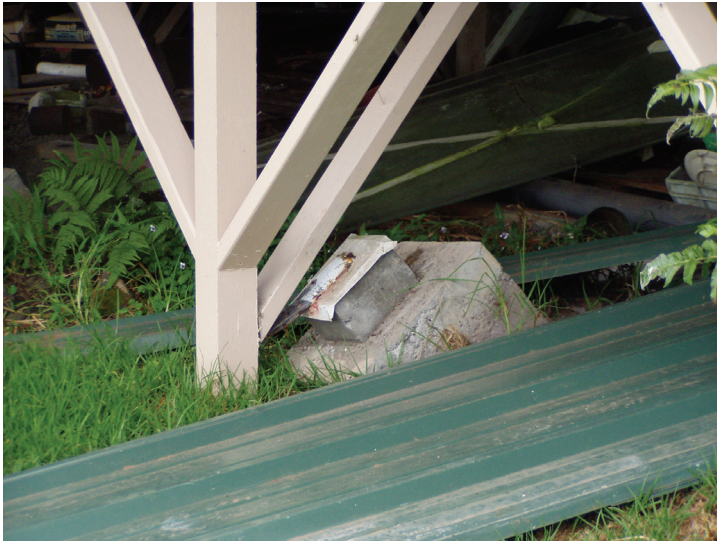
Figure C-13 Earthquake-damaged perimeter post-and-pier foundation (from ATC, 2002a). The diagonally braced post has slid off the pier footing.

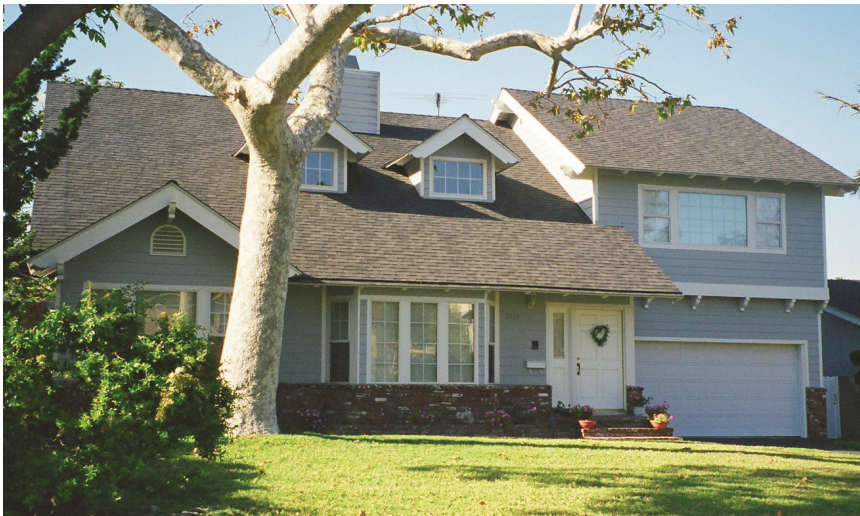
Figure C-14 Split-level house, where the section of flooring above the garage is at a lower level than the main second-floor level (from ATC, 2002a).

Dwellings where adjacent floor levels are separated by less than a full-story height are usually designated split-level dwellings. One typical configuration is shown in Figure C-14. The right part of the dwelling is of two-story slab-on-grade wood-frame construction, with the garage space occupying the lower floor. The attached portion on the left side is of one-story cripple-wall construction. Other split-level dwellings may have all slab-on-grade ground floors at different elevations, and may not have living spaces over the garage. These dwellings may be on either flat or sloped sites. On flat sites, the two lower levels may be at nearly the same elevation.

A common seismic vulnerability in split-level dwellings with living spaces over the garage is inadequate strength of the walls at each side of the garage door to resist seismic forces from the dwelling portion above [Form item B-4]. Damage that was in part initiated by this vulnerability is shown in Figure C-14. Another common vulnerability is insufficient strength of the cripple wall under the single-story portion of the dwelling, when present, causing damage similar to that of Figure C-5 [Form item B-8]. This configuration is also penalized under form item B-1, split-level floor construction.

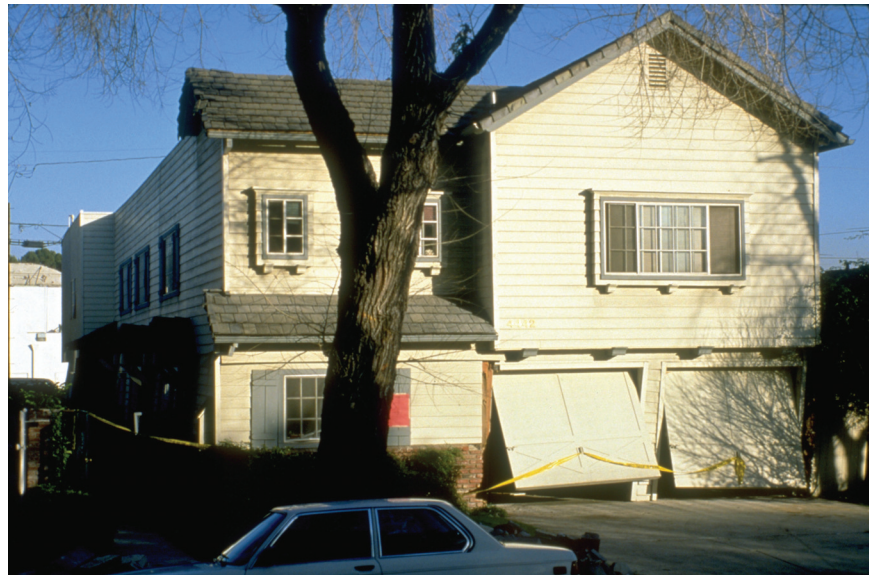
Figure C-16 Damage and racking displacement in the first floor walls (from ATC, 2002a).

A common seismic vulnerability in dwellings is the insufficient lateral-force-resisting strength of the first floor exterior and interior walls due to the large number of door and window openings in these walls [Form item B-2] and the limited strength of the sheathing materials [Form item B-5]. Typical earthquake damage to the first-story walls is shown in Figures C-15 and C-16.
