Risk-Informed Decision Making to Prioritize Rehabilitation of South Carolina's High Hazard Potential Dams

National Dam Safety Program Technical Seminar | February 13 & 14

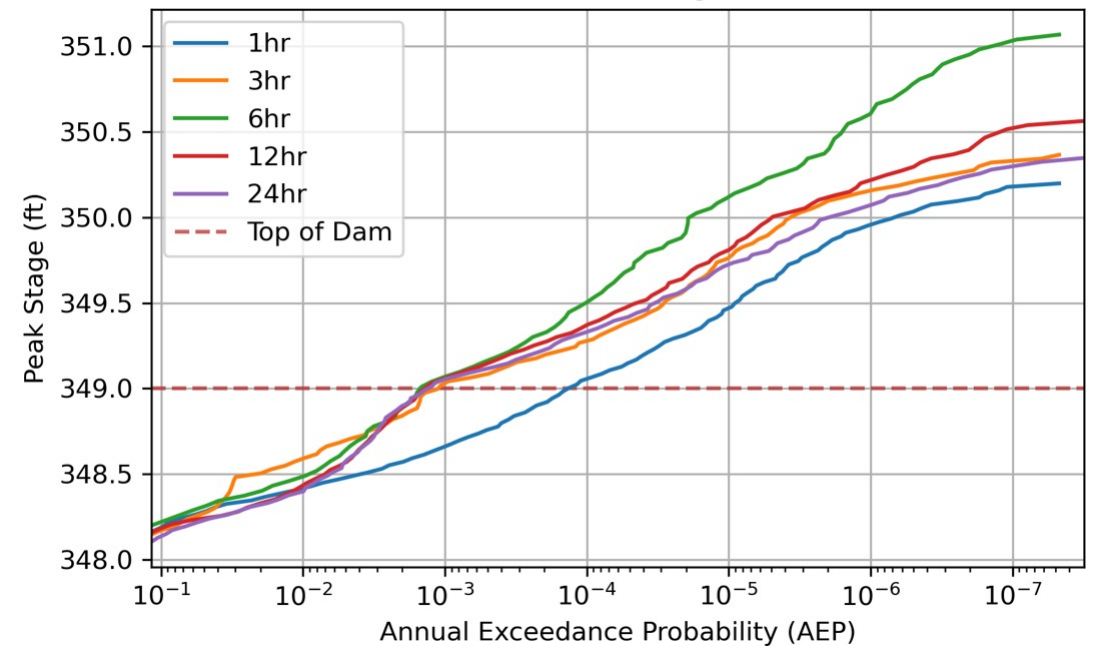
1. Gathered spillway and topographical information
 - a. Spillway size, dam and watershed characteristics, elevations
 - b. Upstream dam studies
2. Performed advanced Hydrologic and Hydraulic modeling (Research Triangle Institute) using Rainfall Runoff Frequency Tool (RRFT)
3. Developed hydrologic hazard curves: Stage frequency, Depth duration, duration above crest, inflow volume

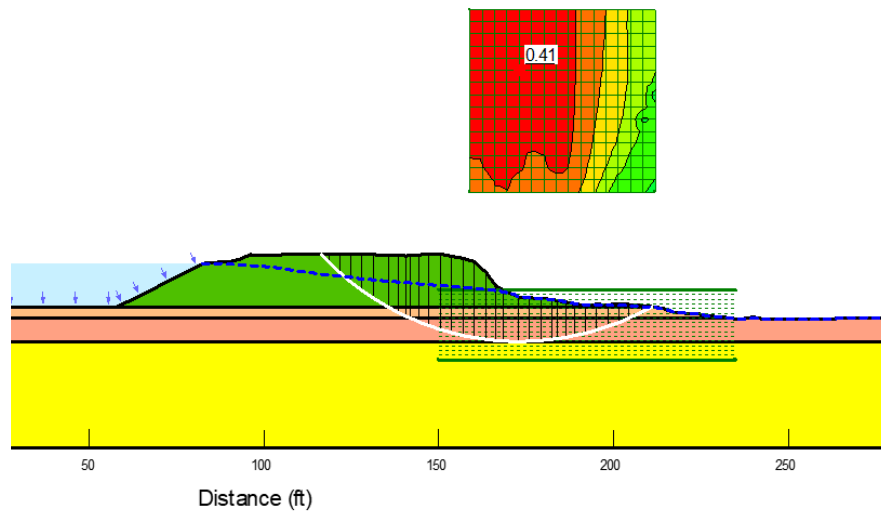
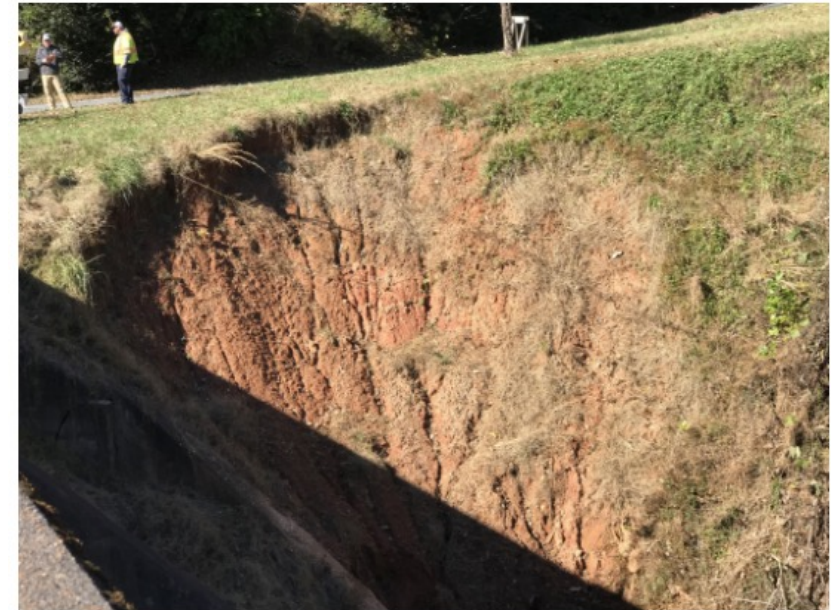
1. Geotechnical analyses
 - a. Generalized seepage and stability analyses
 - b. Seismic hazard analyses – Liquefaction and seismic deformations
 - c. Pseudo-Static stability & Post Earthquake Stability

West Abutment Slough

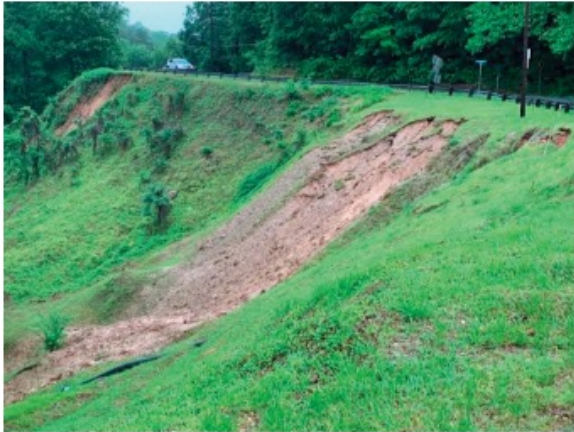
Figure 1-4 – Slough 1 (4/20/2020 S&ME Site Visit)

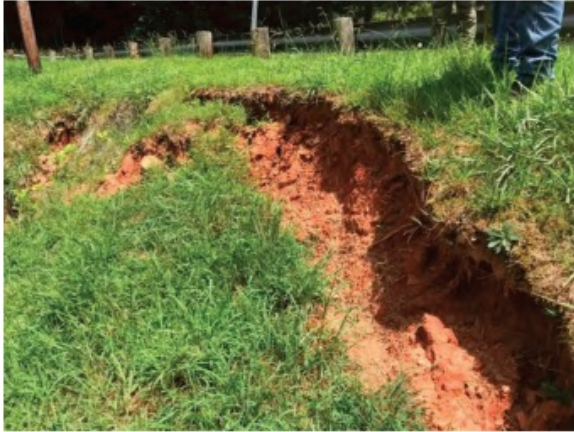
Figure 1-5 – Upper Scarp at Slough 1 (7/22/2020 S&ME Site Visit)

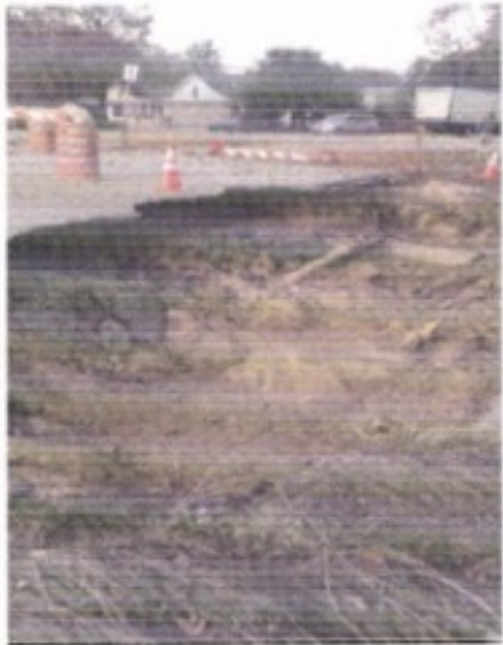
Figure 2 - Erosion of Eastern Dam Section

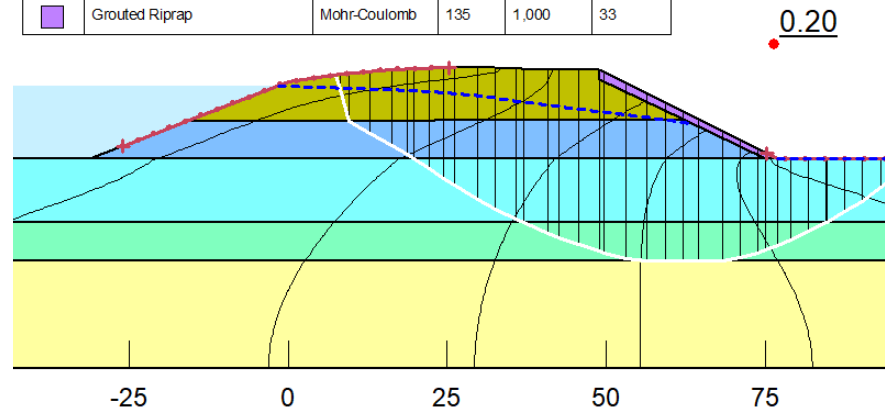
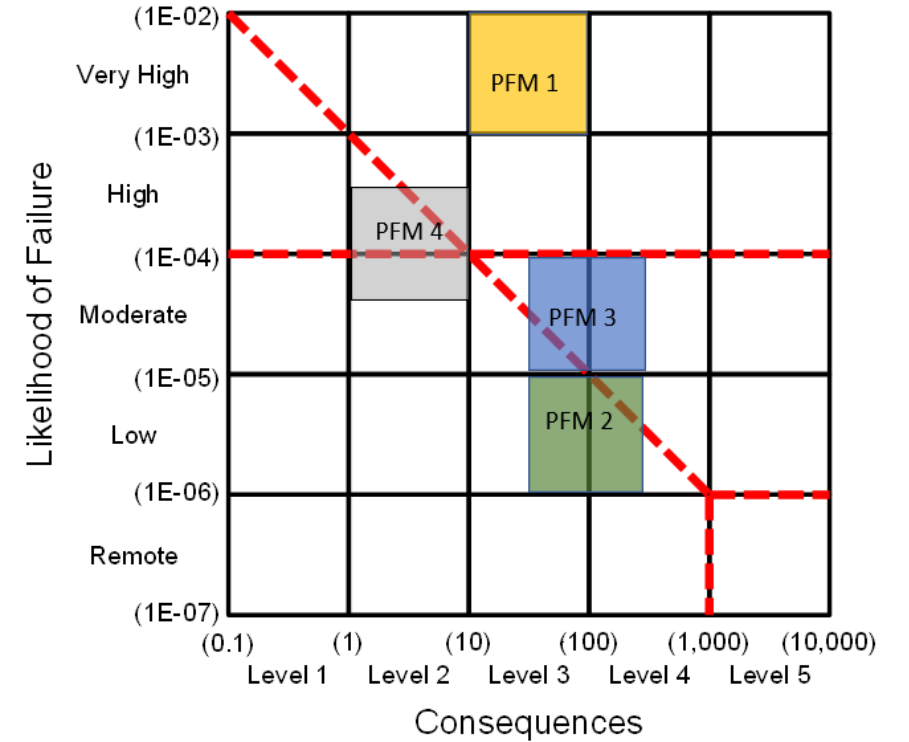
Color	Name	Slope Stability Material Model	Unit Weight (pcf)	Effective Cohesion (psf)	Effective Friction Angle (°)
Yellow	1. SM/SC (Fill)	Mohr-Coulomb	115	0	31
Blue	1. SM/SC (Fill) (SSL)	Mohr-Coulomb	115	55	0
Cyan	2. SC/SM (Alluvium) (SSL)	Mohr-Coulomb	120	100	0
Light Yellow	3. SM/SP-SM (Alluvium)	Mohr-Coulomb	120	0	32
Light Green	3. SM/SP-SM (Alluvium) (SSL)	Mohr-Coulomb	120	100	0
Purple	Grouted Riprap	Mohr-Coulomb	135	1,000	33

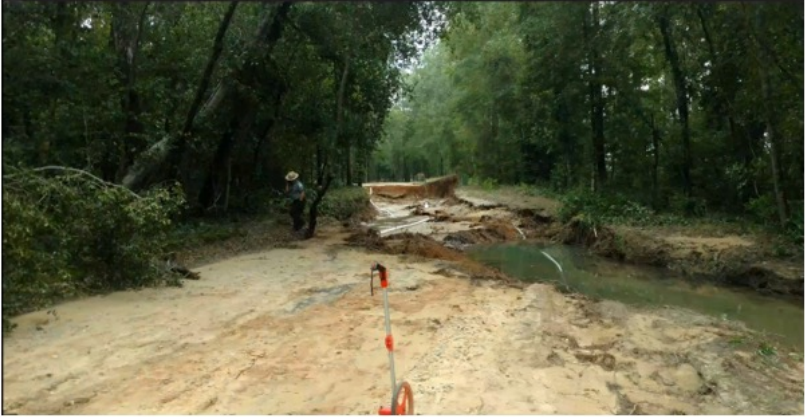
Figure 7 – 2018 Damage Photos showing scour along access road

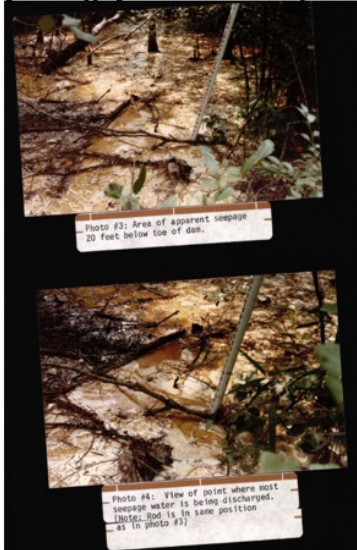
Figure 2 - Photographs from 1981 LRCC Inspection

Earthfill Dam (Continued)
 C. Downstream Slope
 (1) Seepage: check the embankment slope, toe, abutment contacts; denote the amount and location on schematic diagram.
 A significant amount (10 gal/min estimated) of apparent seepage was observed approximately 20 feet below the toe of the dam. (See photo #3 and #4 and the attached schematic diagram)
