6.3 ARCHITECTURAL COMPONENTS

6.3.1 EXTERIOR WALL COMPONENTS

6.3.1.2 ANCHORED VENEER

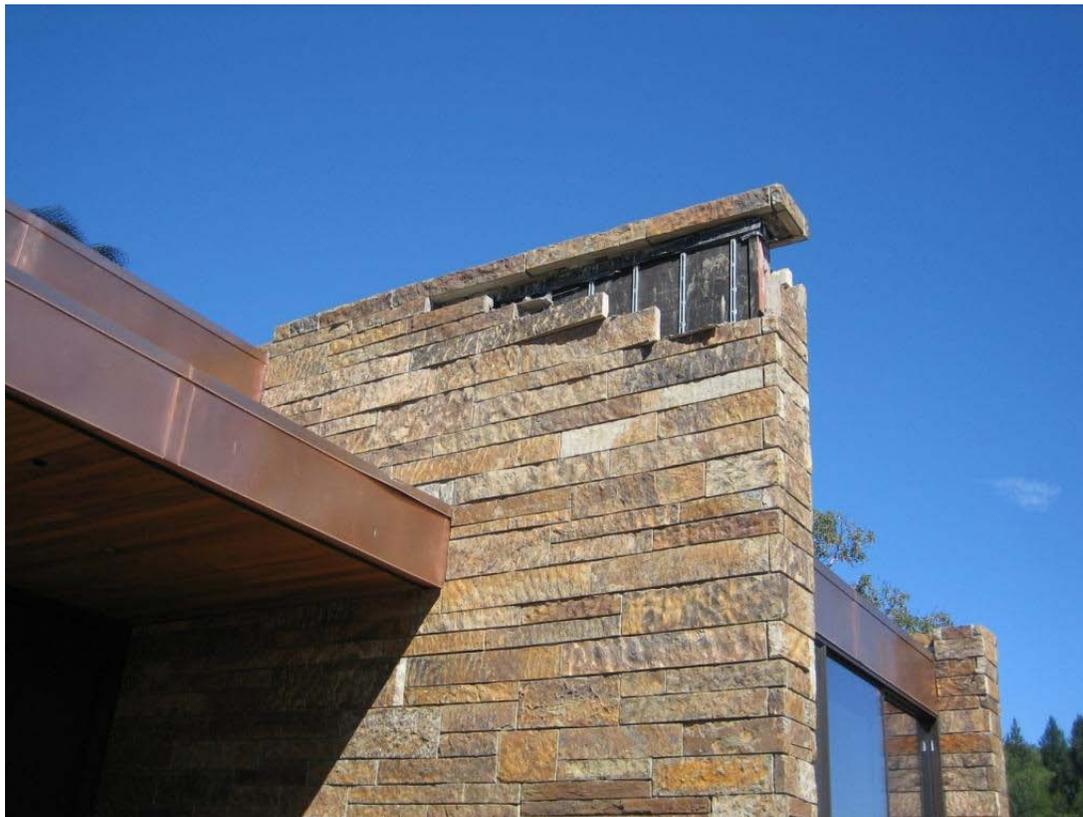
Figure 6.3.1.2-1 Fallen sandstone veneer as a result of a magnitude-4.4 earthquake in northern California. Post-earthquake investigation revealed missing dovetail anchors, missing pencil rods, and weak stone-to-mortar bond (Photo courtesy of Simpson Gumpertz and Heger).

- Anchored veneers and their connections may be damaged by inertial forces and by building distortion; units located at corners and around openings are particularly vulnerable.
- Rigid connections may distort or fracture if they do not have sufficient flexibility to accommodate the seismic drift; veneer units may crack, spall, or become completely dislodged and fall.
- Deterioration or corrosion of the mechanical connections is a significant concern; corroded connections may fail prematurely. Maintaining watertightness at joints is important for the longevity of the anchors.

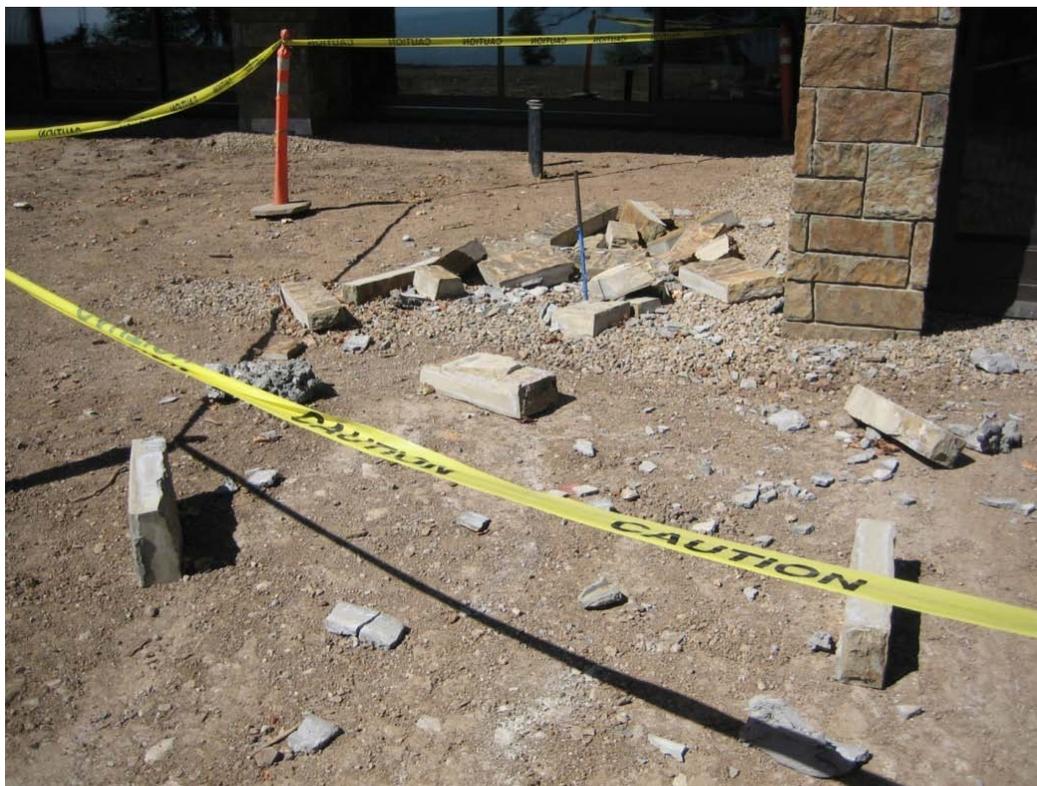
Figure 6.3.1.2-2 Fallen sandstone veneer as a result of a magnitude-4.4 earthquake (Photo courtesy of Simpson Gumpertz and Heger).

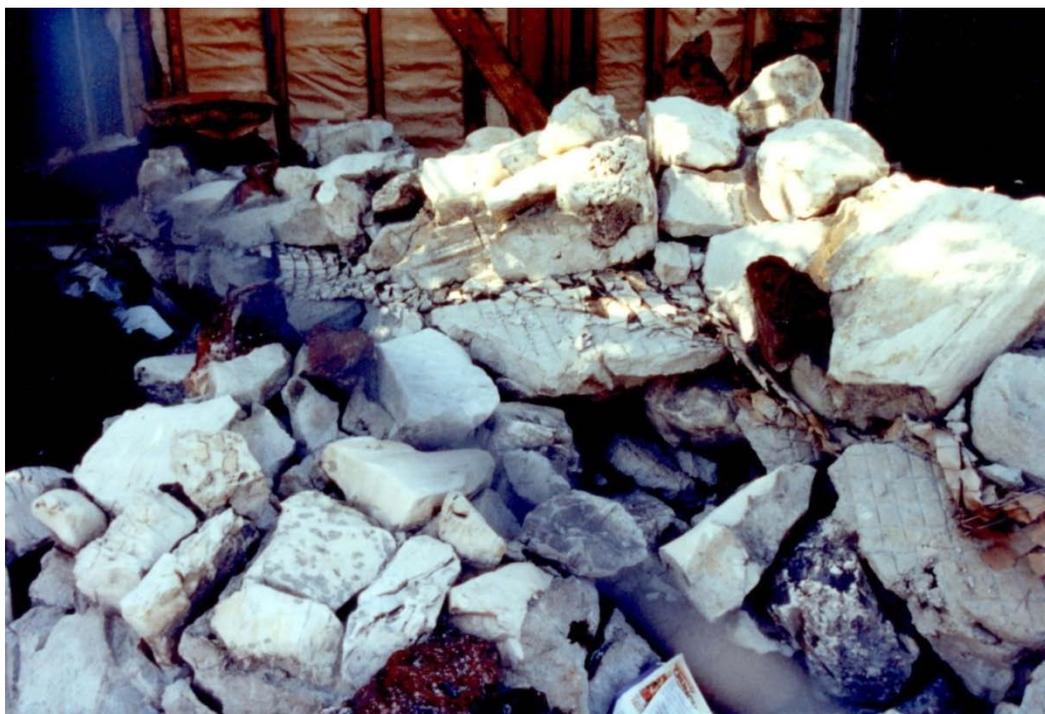
Figure 6.3.1.2-3 Rubble from failed anchored veneer as a result of the 1994 Northridge Earthquake (Photo courtesy of Robert Reitherman).

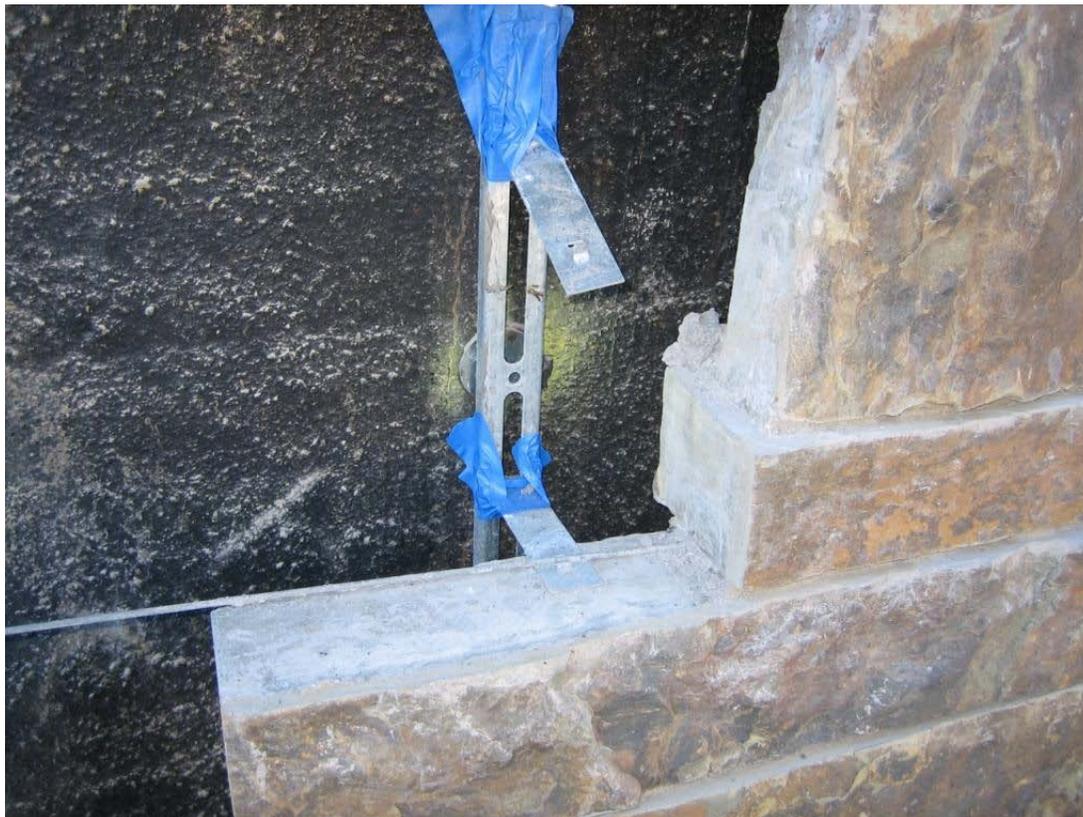
Figure 6.3.1.2-4 Installation of stone veneer showing anchorage to steel dovetail clips which are fastened to steel studs bolted to the grouted reinforced masonry wall behind (Photo courtesy of Simpson Gumpertz and Heger).

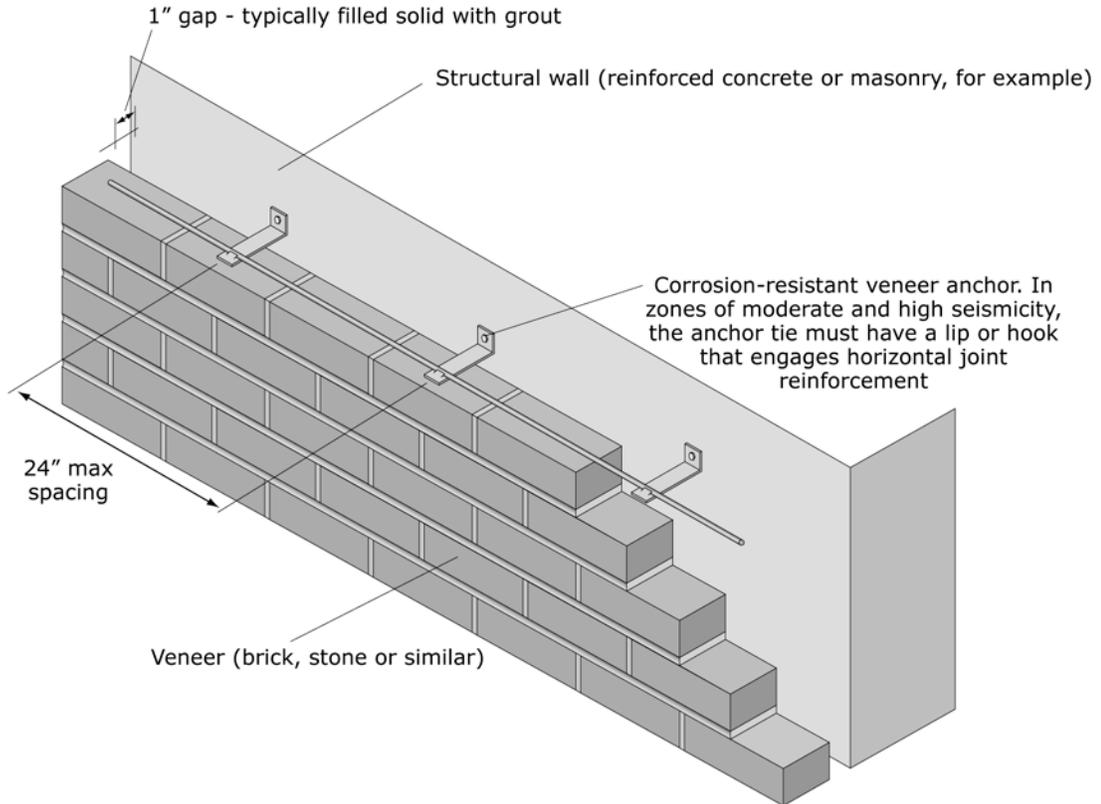
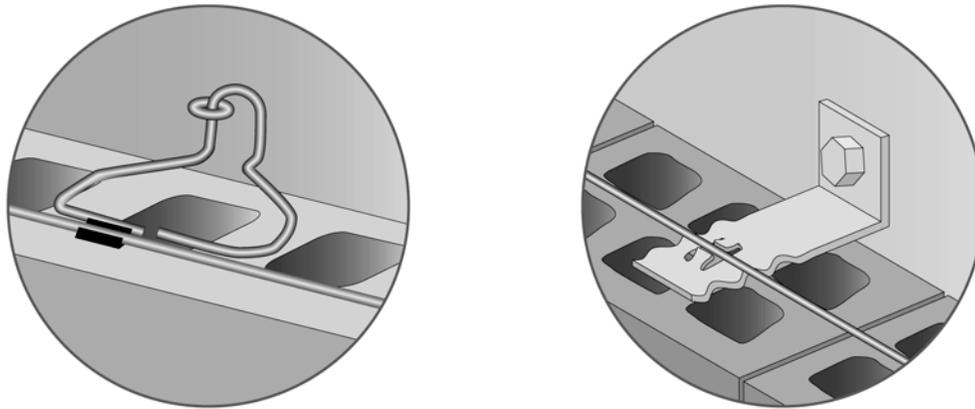
Figure 6.3.1.2-5 Anchored veneer (ER).

Examples of veneer anchors. There are many proprietary types available

- There are many vendors who supply veneer anchors; these are typically metal wires or clips with a positive attachment to the structural backing that are embedded in the veneer mortar bed. The seismic version of these anchors requires an additional horizontal wire placed in the mortar bed and attached to the anchor. Some examples of these seismic veneer anchors are shown, others can be found online.
