Design Guide

for Improving Hospital Safety
in Earthquakes, Floods, and High Winds

FEMA 577 / June 2007

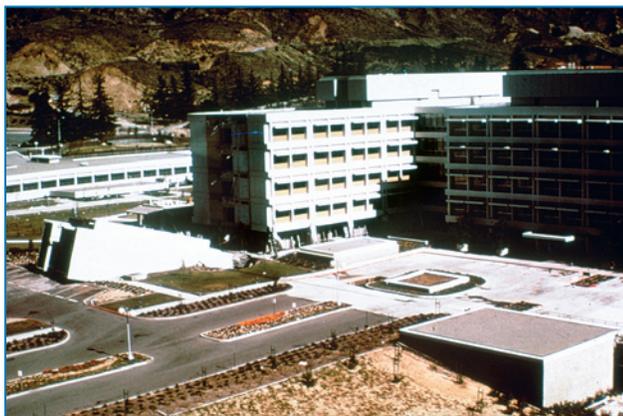
Olive View Hospital After the 1971 Magnitude 6.7 San Fernando Earthquake

The new Olive View hospital building shown on the cover performed well during the 1994 Northridge earthquake. This quake, of the same magnitude as the 1971 San Fernando Earthquake that nearly collapsed the original building, caused no serious damage. Built in 1970, the Medical Treatment and Care Building of the Olive View Hospital complex was designed to meet the earthquake provisions of building codes in place at that time. The hospital incurred heavy damage (at left) during the 1971 earthquake and was subsequently rebuilt to stricter design and construction standards.
