# Techniques for the Seismic Rehabilitation of Existing Buildings

**FEMA 547 – October 2006**

Rutherford & Chekene (R & C) Consulting Engineers (Subconsultant) under contract with National Institute of Standards and Technology (NIST).

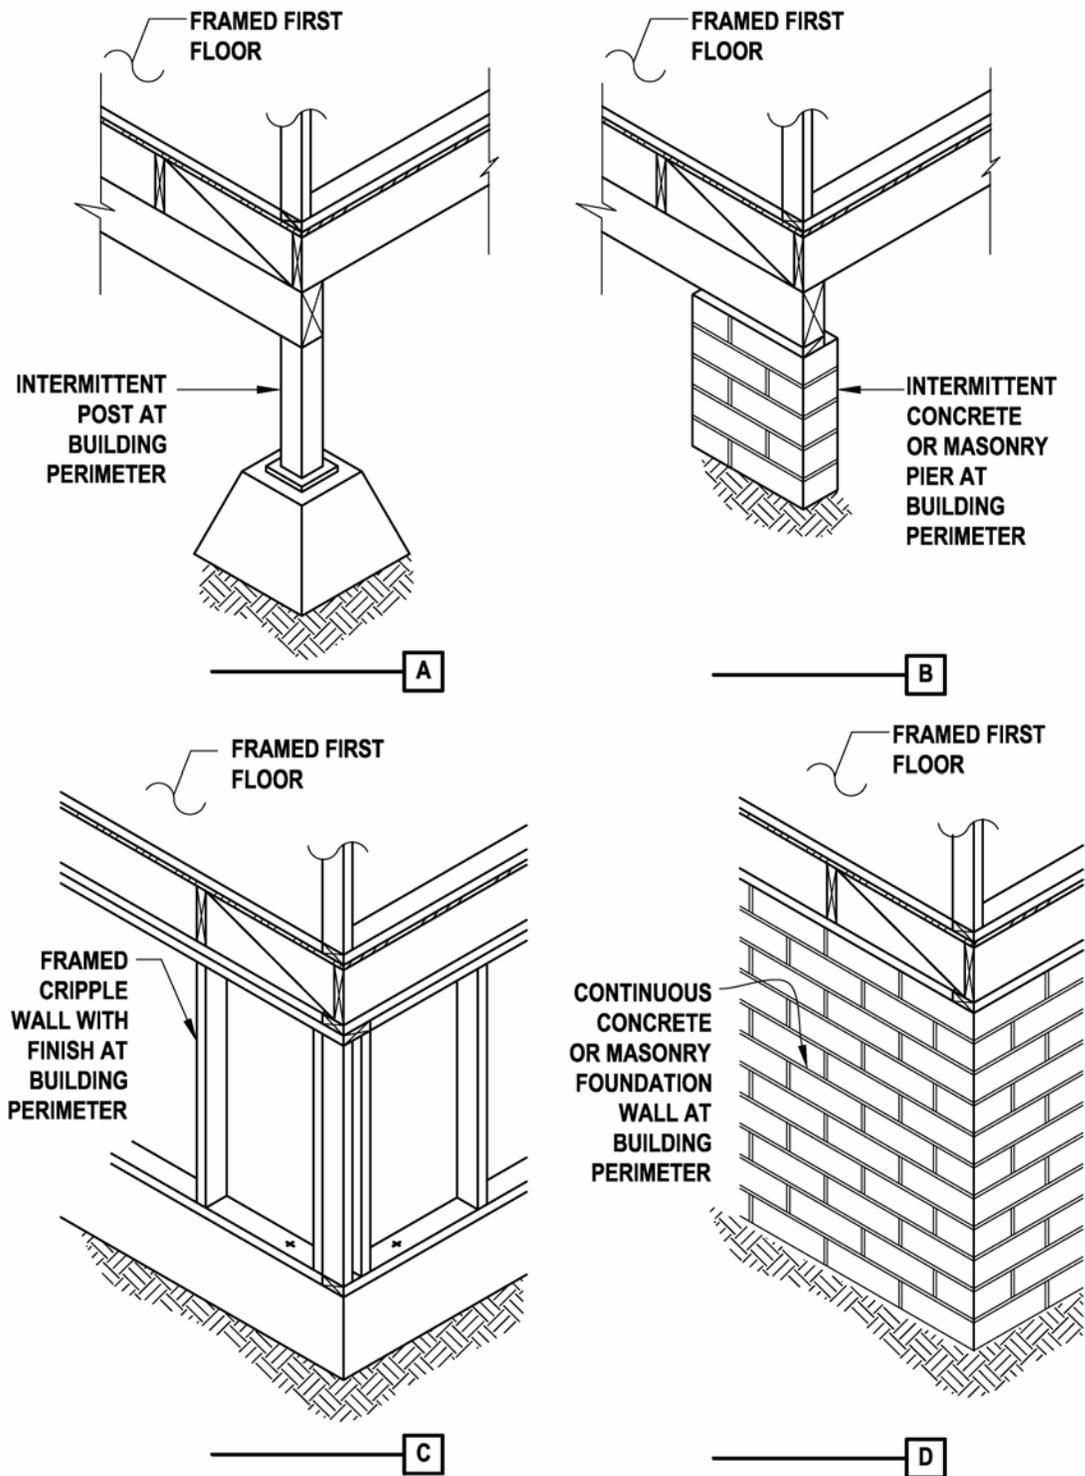
Figure 5.1-2: Systems Between First Framed Floor and Grade – Level Lot Sites

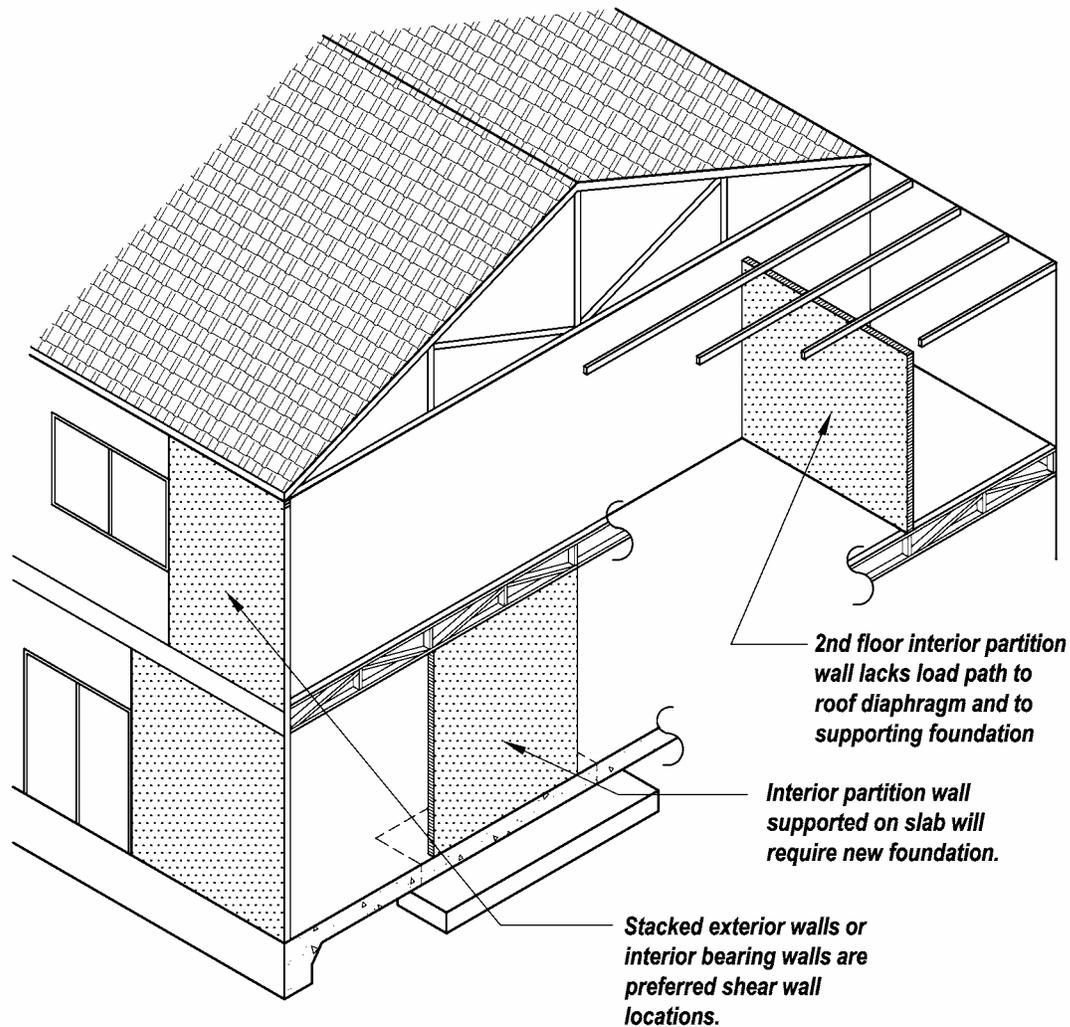
**Figure 5.4.1-2: Preferred and Less Preferred Shear Wall Locations**

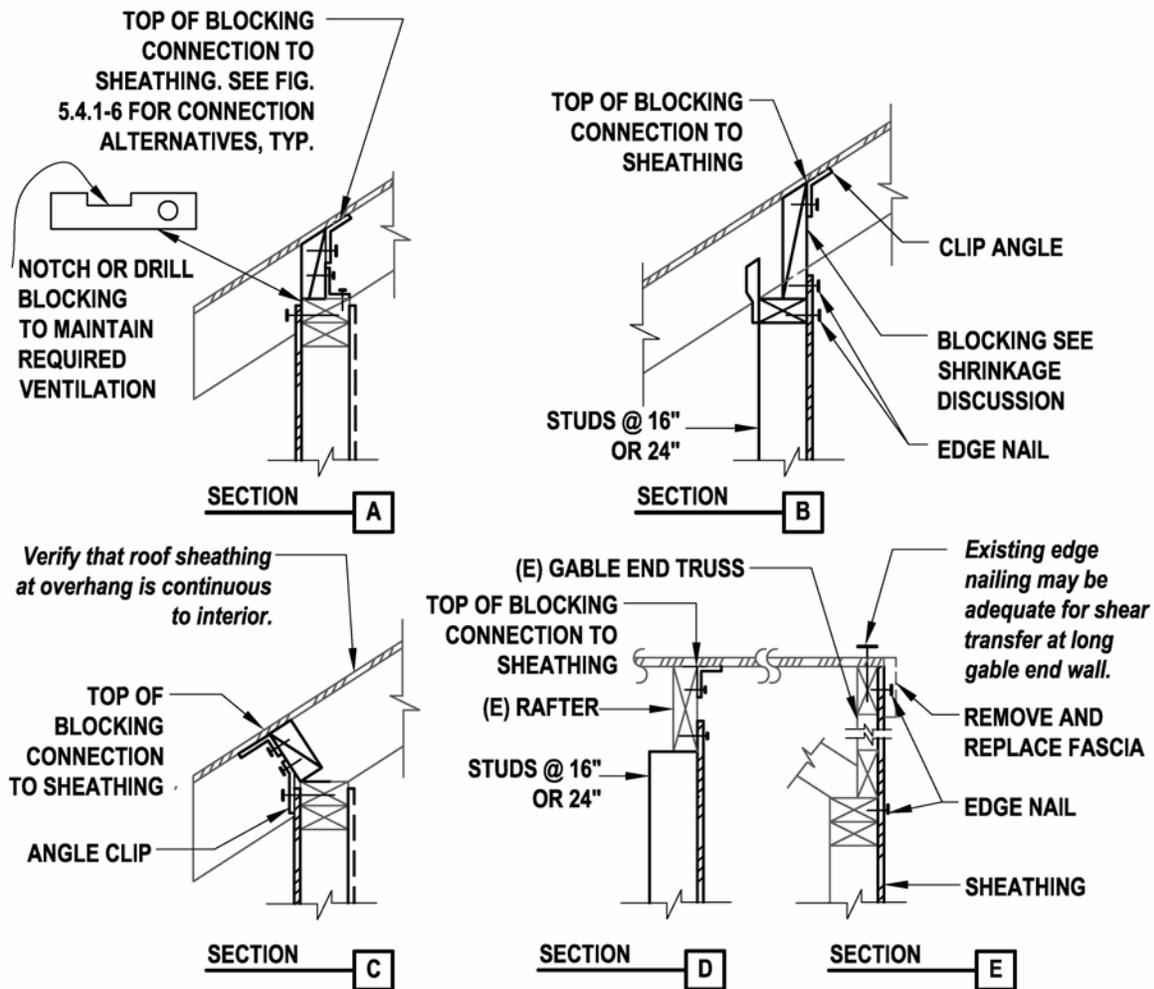
Figure 5.4.1-5 shows a series of top of shear wall details where the shear is being transferred from a roof diaphragm into the top of the wall. Since most diaphragms in residential construction are not blocked, the unit capacity of the new shear wall is likely to be higher than the unit

Figure 5.4.1-5: Load Path from Roof Diaphragm to Top of Shear Wall

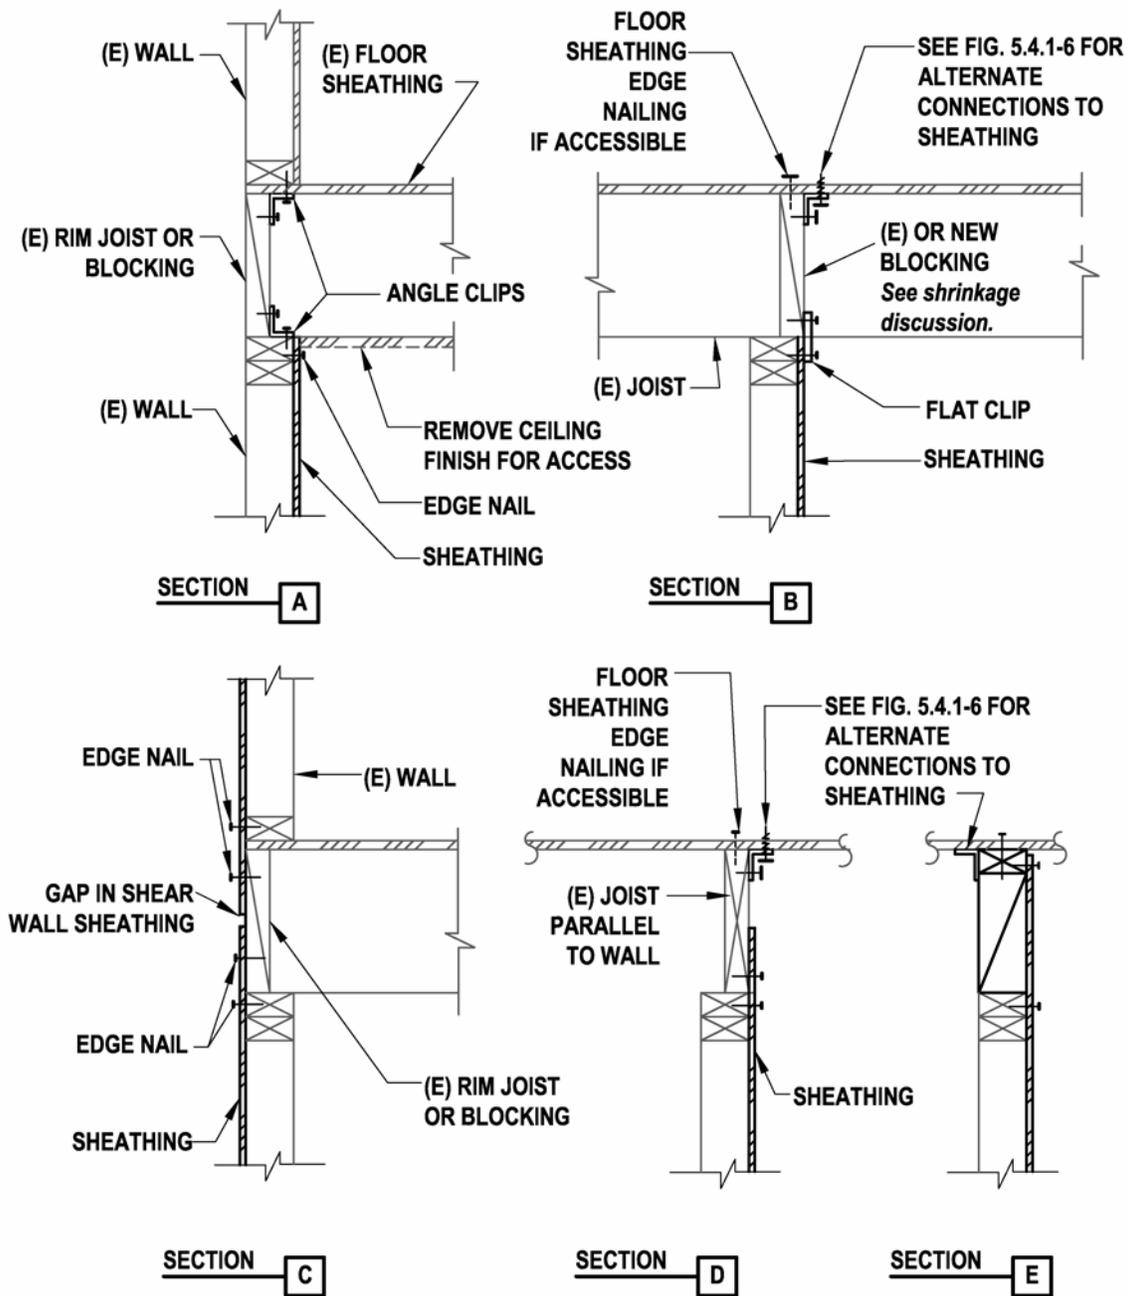
**Figure 5.4.1-7: Load Path From Floor Diaphragm to Lower Story Shear Wall**

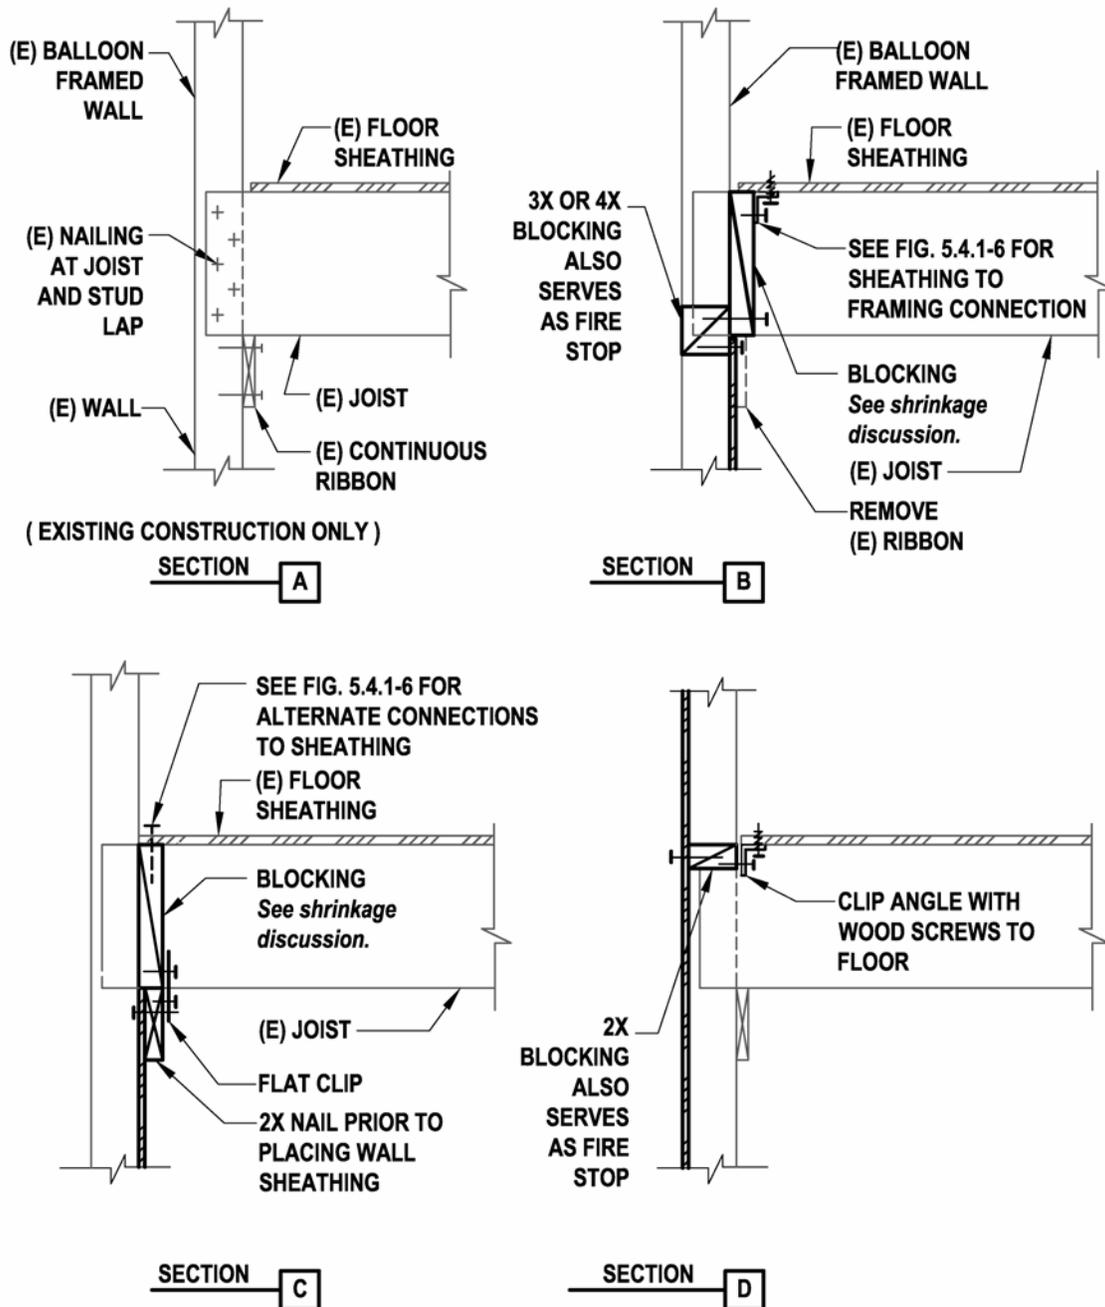
**Figure 5.4.1-8: Load Path From Floor Diaphragm to Lower Story Shear Wall – Balloon Framing**

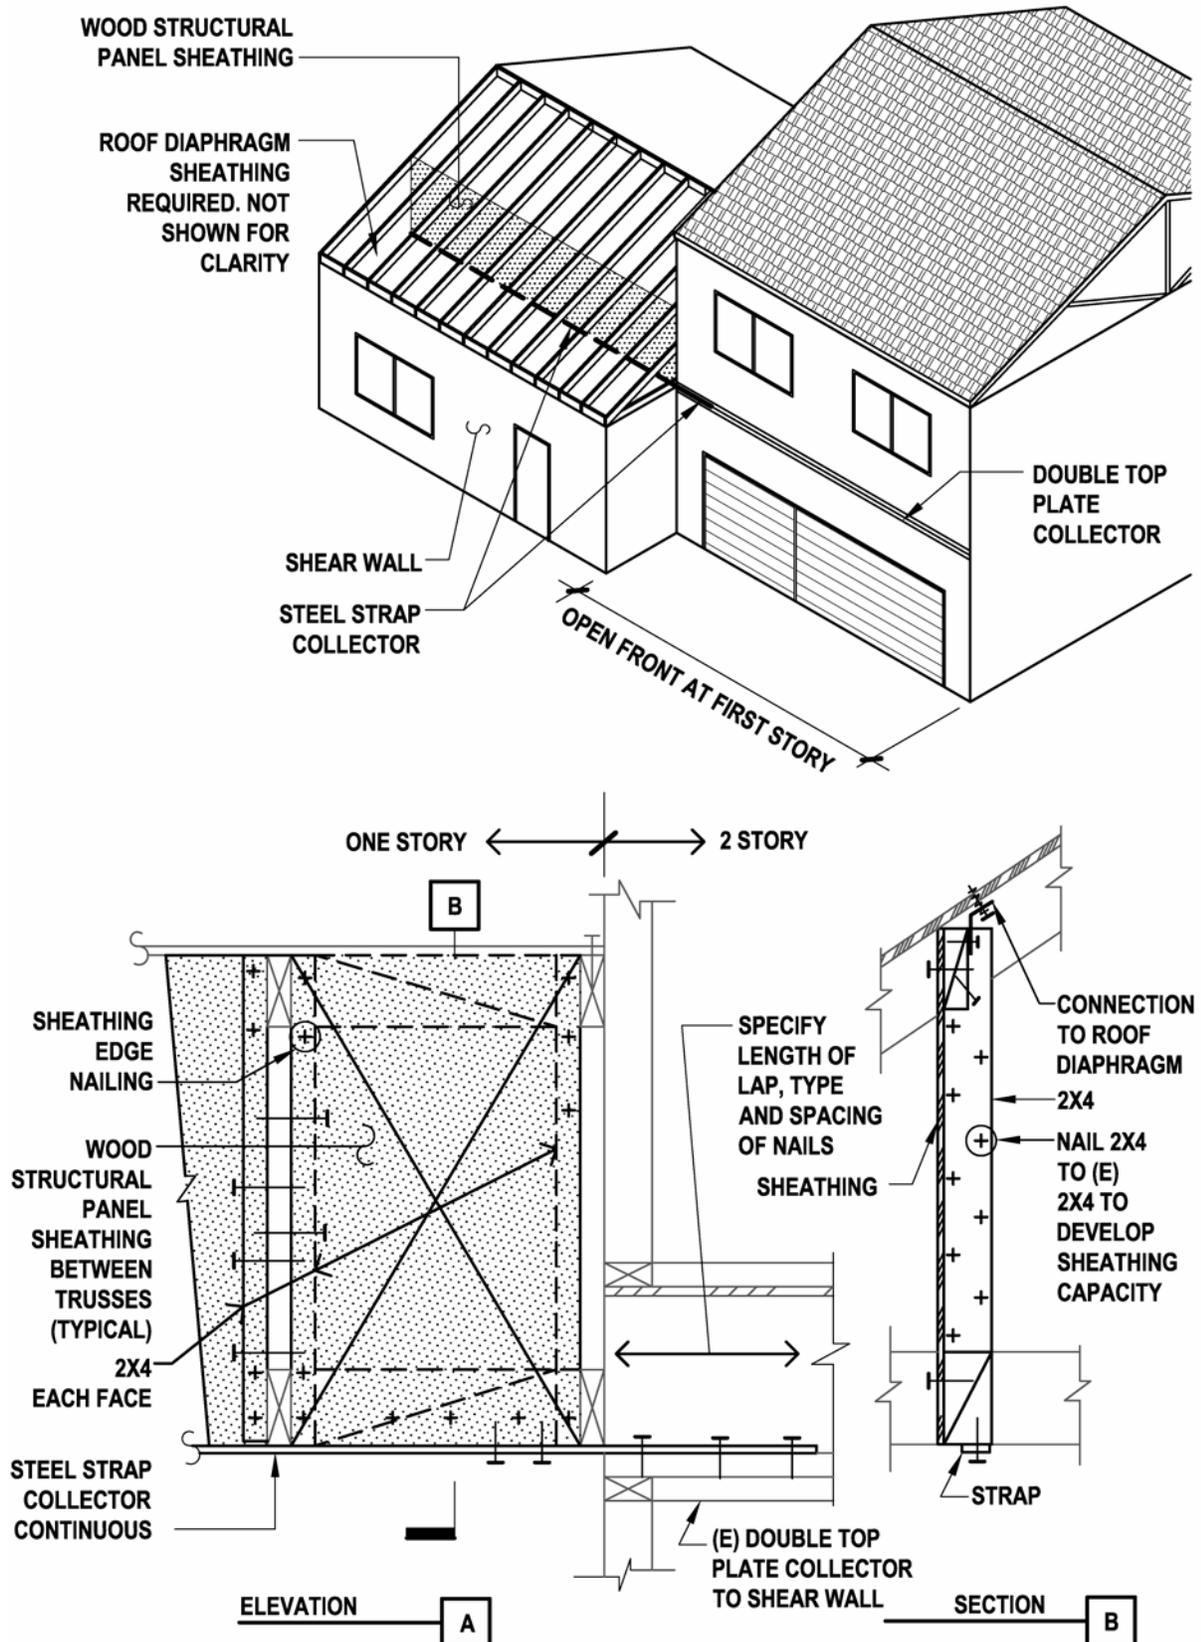
Figure 5.4.2-1 shows one of several possible methods of providing a collector. In the illustrated approach, a steel strap ties the top plates from the garage open-front to wood structural panel sheathed infill panels between the roof trusses in the one-story portion of the building. The infill panels transfer the load from the truss bottom chord up to the roof diaphragm, where loads can be carried to the shear walls. In Figure 5.4.2-1, a vertical eccentricity exists between the collector

Figure 5.4.2-1: Collector from Garage Open Front to Adjacent Dwelling

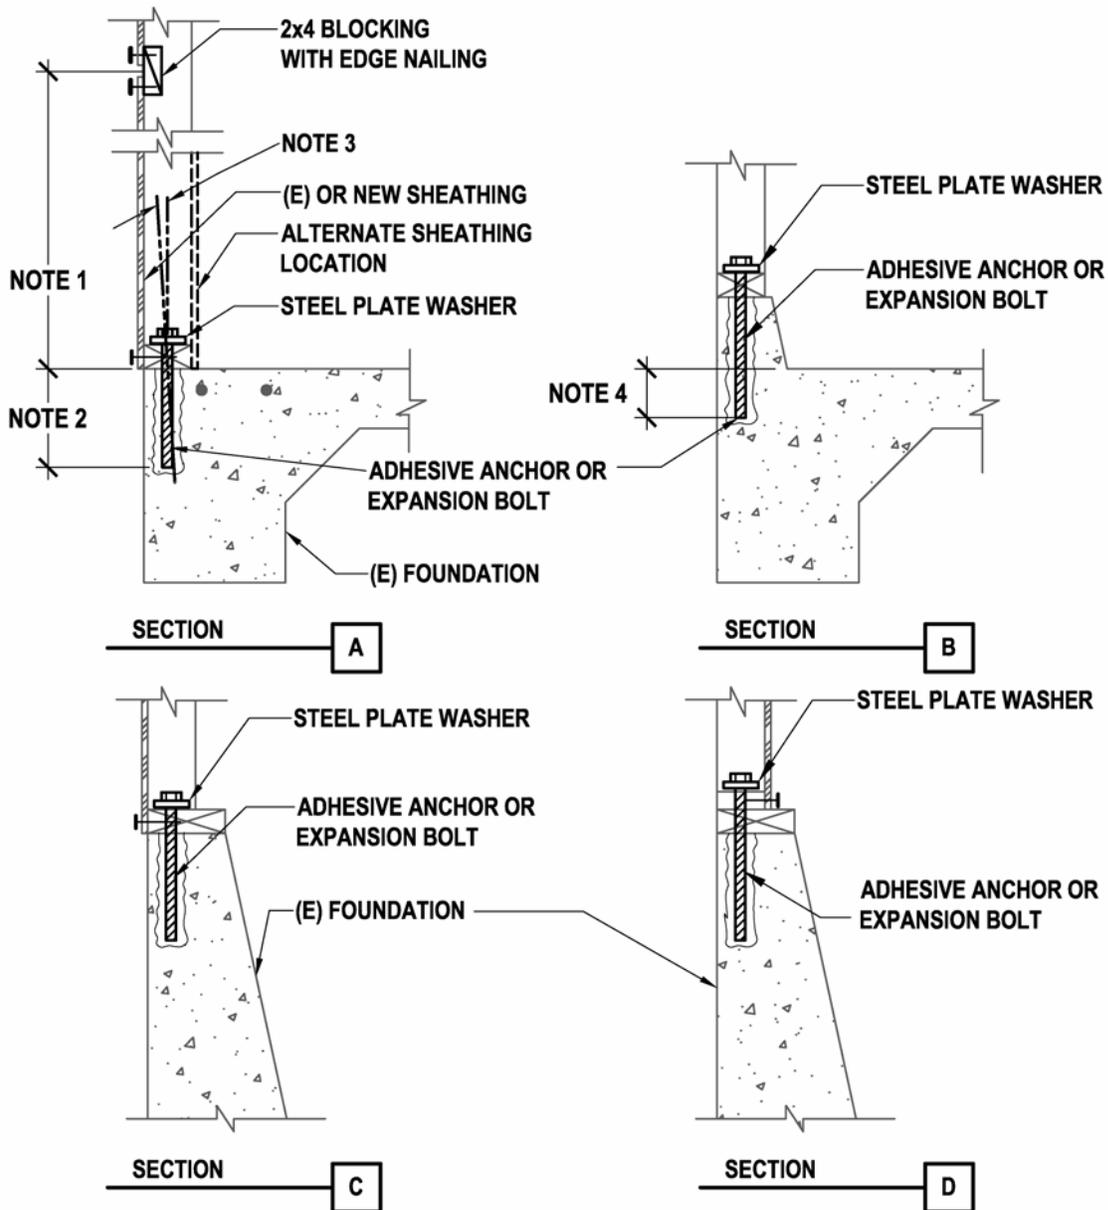
**Figure 5.4.3-2: Added Anchor Bolt at Existing Partially Grouted Concrete Masonry Foundation**

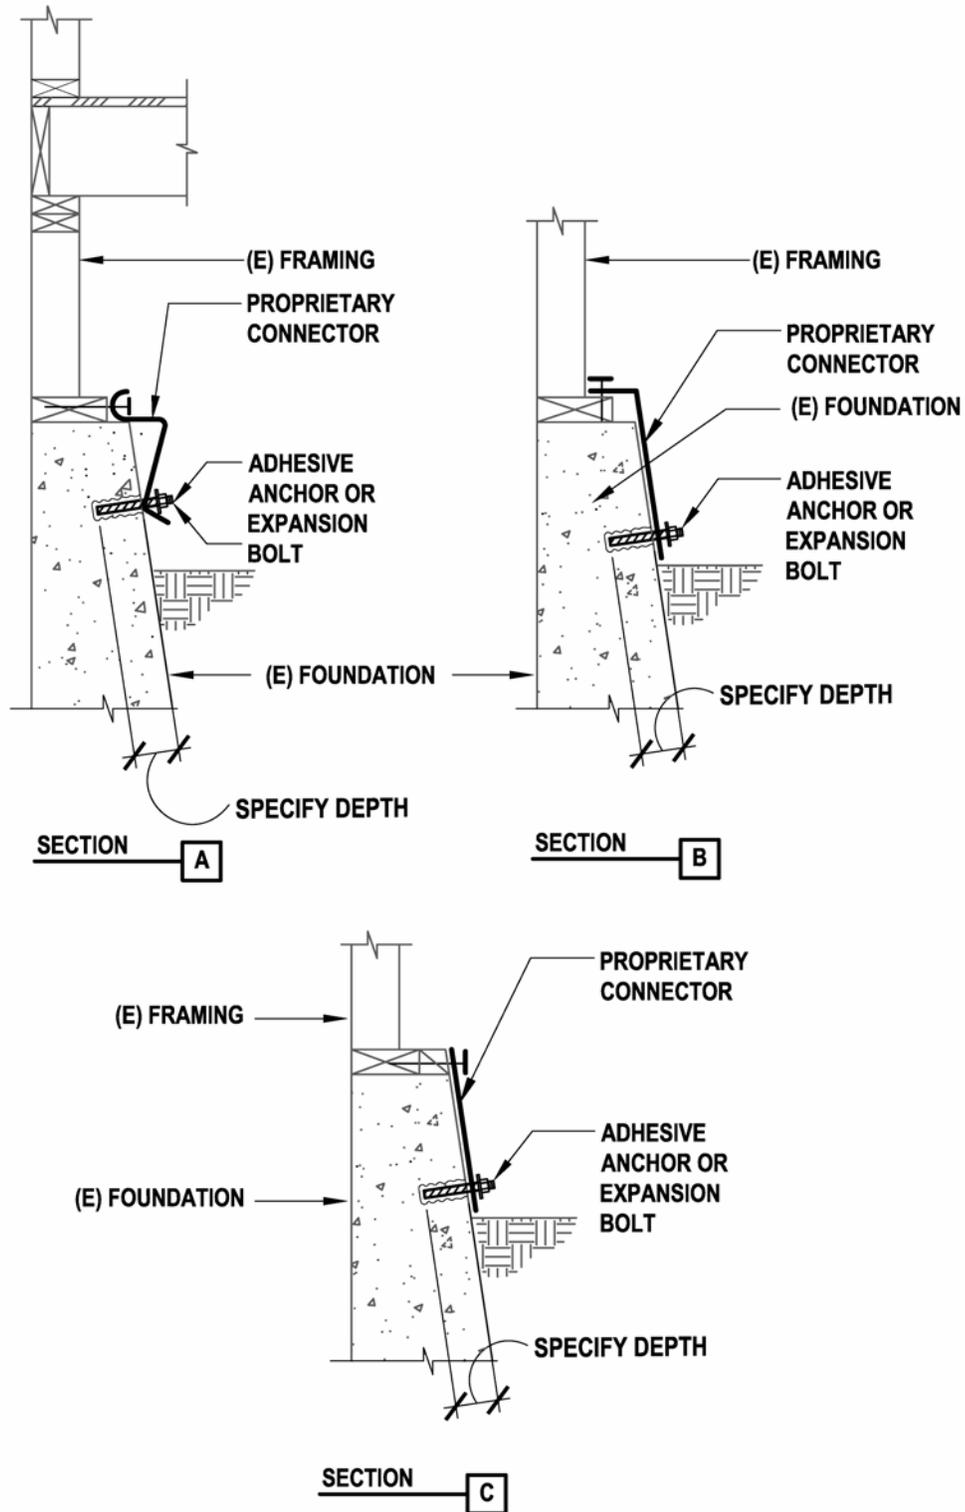
Figure 5.4.3-3: Anchorage to Existing Foundation Using Proprietary Connectors

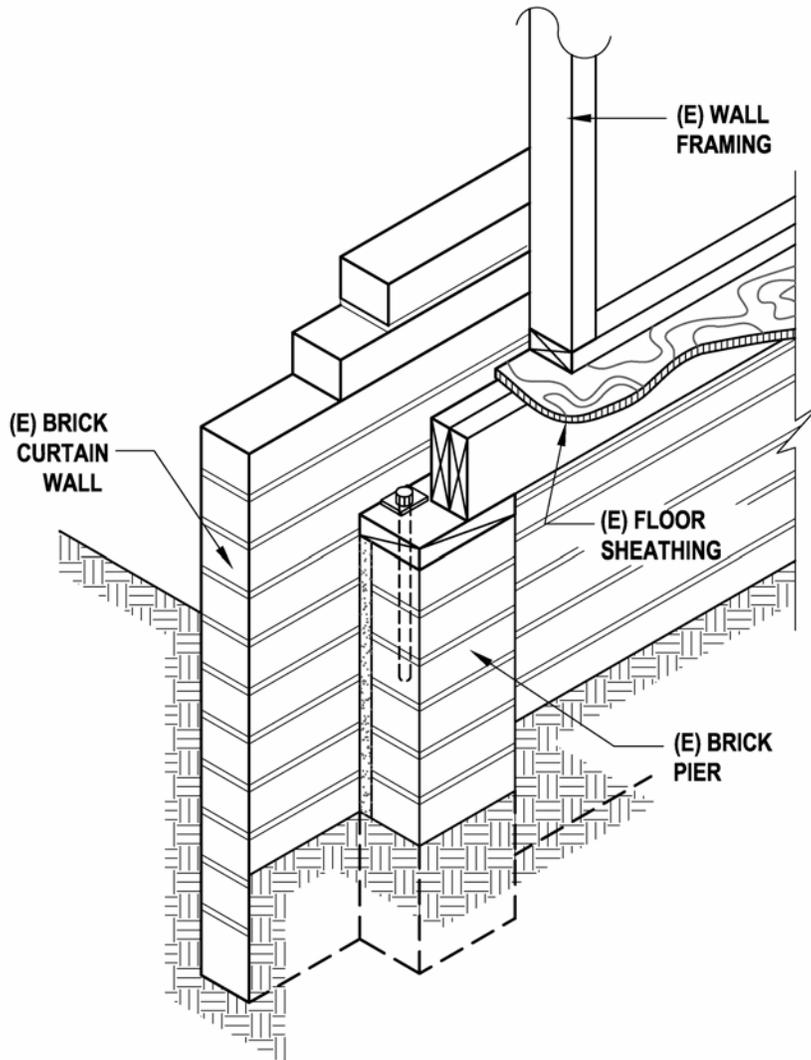
**Figure 5.4.3-4: Pier and Curtain Wall Foundation System with Inadequate Load Path Between Shear Walls and Foundation**

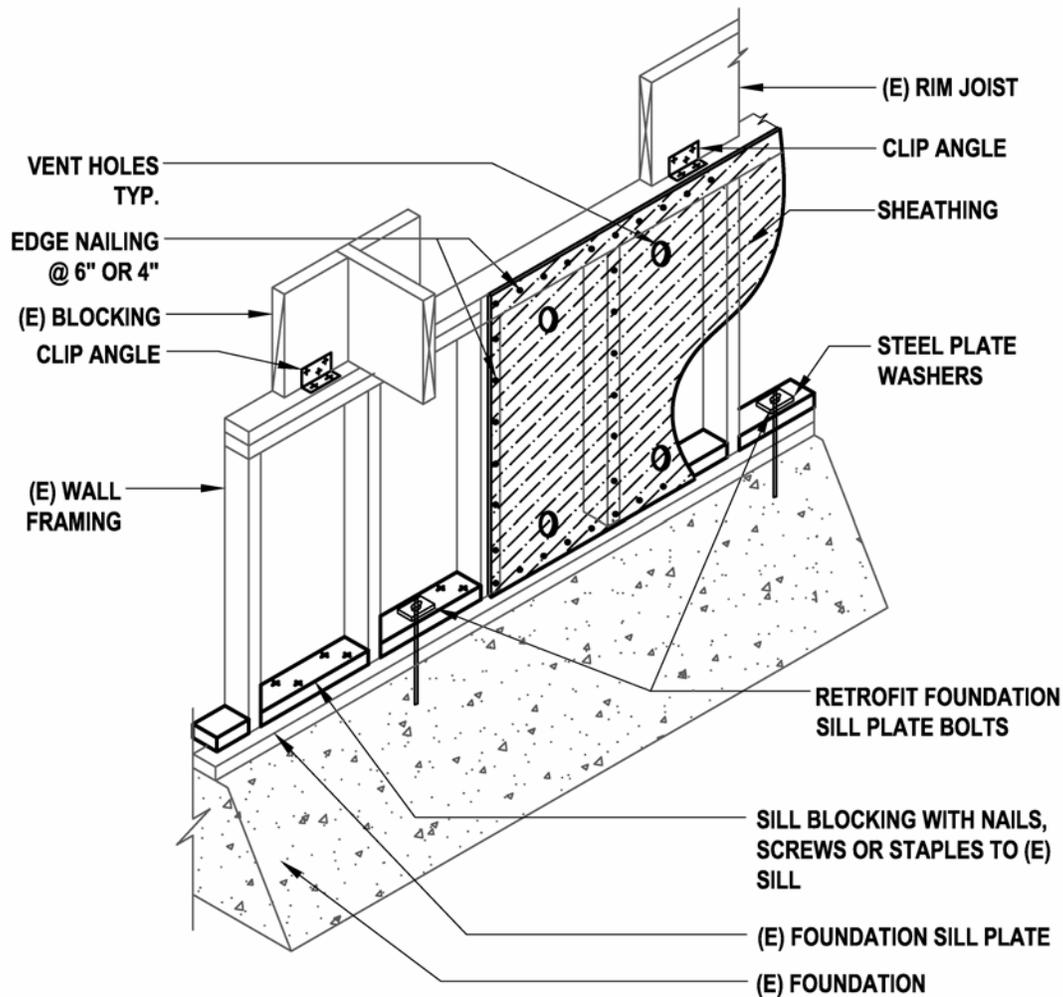
Where cripple walls are 14 inches tall or less, wood structural panel sheathing may no longer provide reliable bracing of the studs, and splitting of the studs becomes a more significant concern. For this configuration, use of solid blocking between studs is recommended in lieu of sheathing.

**Figure 5.4.4-1: Cripple Wall Enhancement**

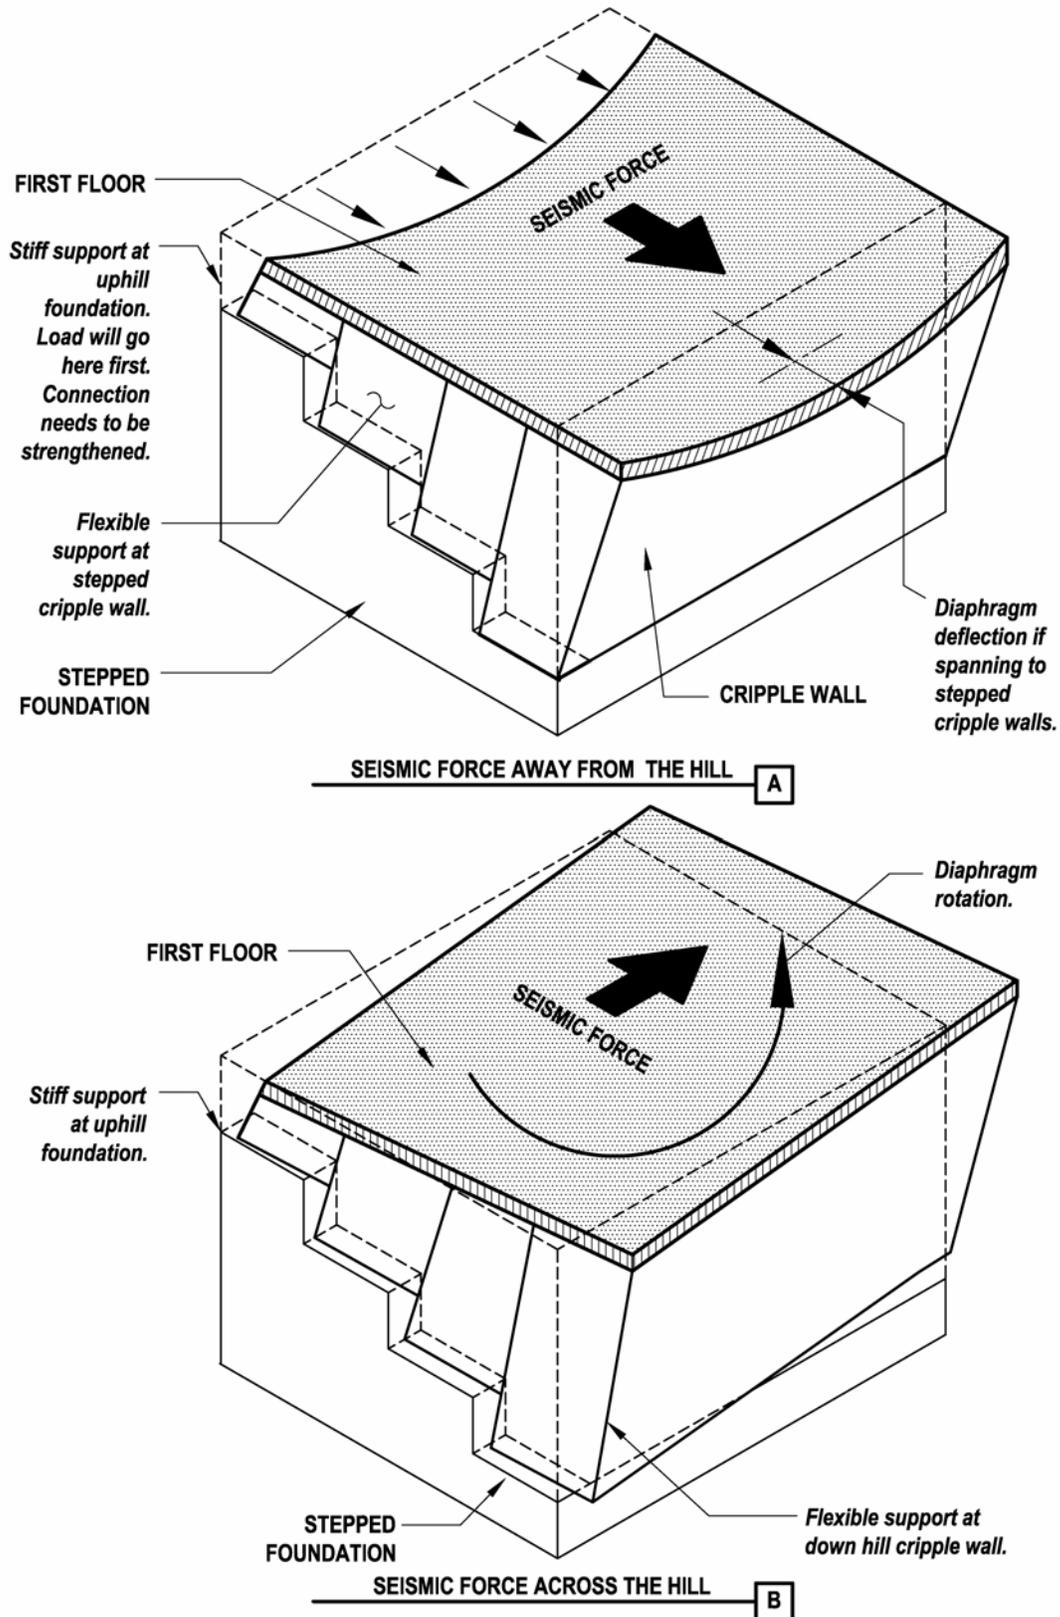
**Figure 5.4.5-1: Hillside Home Response to Seismic Forces**  
*Adapted from Von Winterfeldt, Roselund and Kitsuse (2000)*

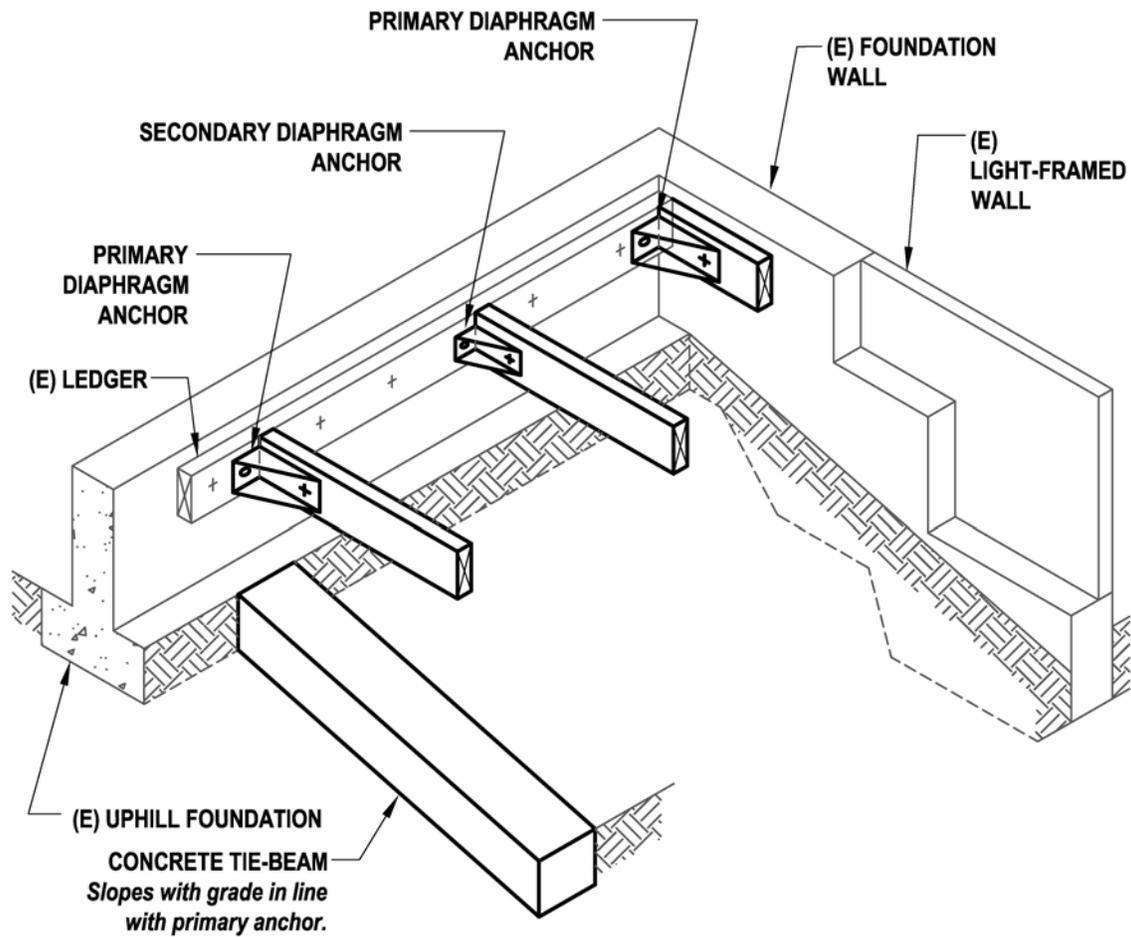
*Note. Diaphragm anchor prevents existing ledger from pulling off at uphill foundation.*

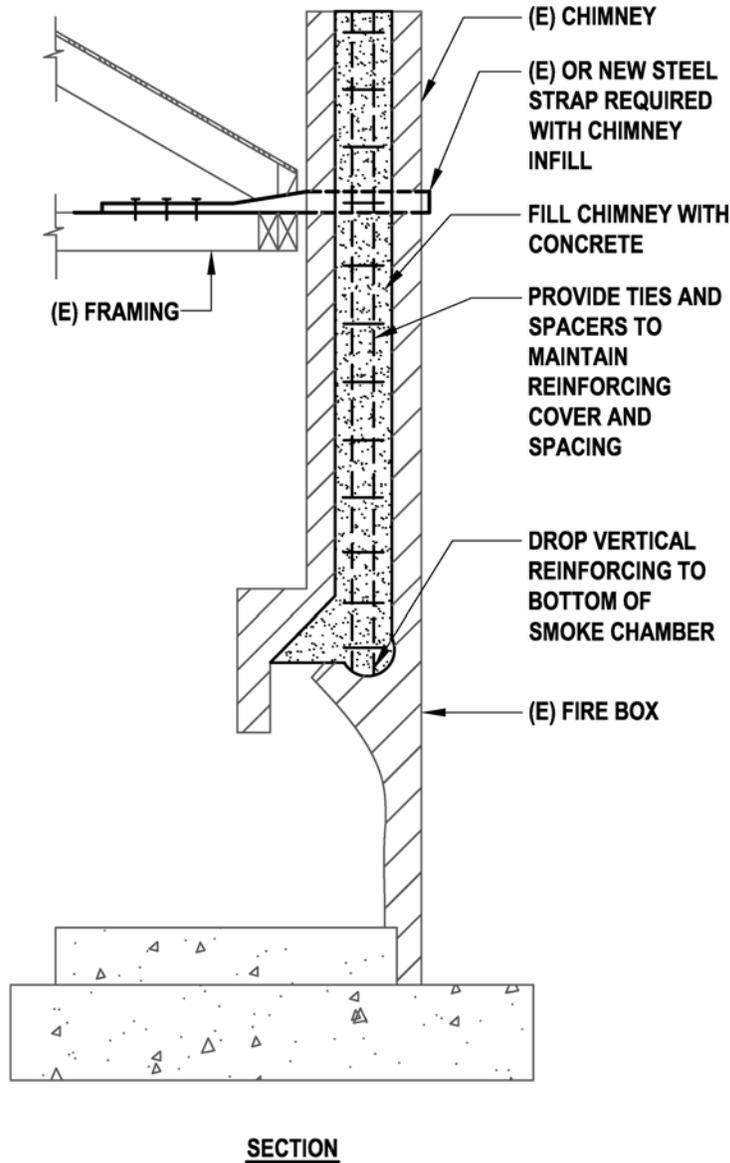
stiffness continuity at the commonly seen weak points (roof line and transitions in width). Filling the chimney may reduce, but is unlikely to eliminate damage. This rehabilitation measure is most often used for buildings of historical significance where there is a strong desire to maintain the current appearance. In some cases the height of very tall chimneys are reduced prior to filling with concrete. Use on chimneys already in poor condition due to deterioration or foundation movement is not recommended. Placement of grout between the flue liner and masonry is also recommended where this grout is completely missing or has significant gaps.

Figure 5.4.6-1: Infill and Bracing of Masonry Chimney

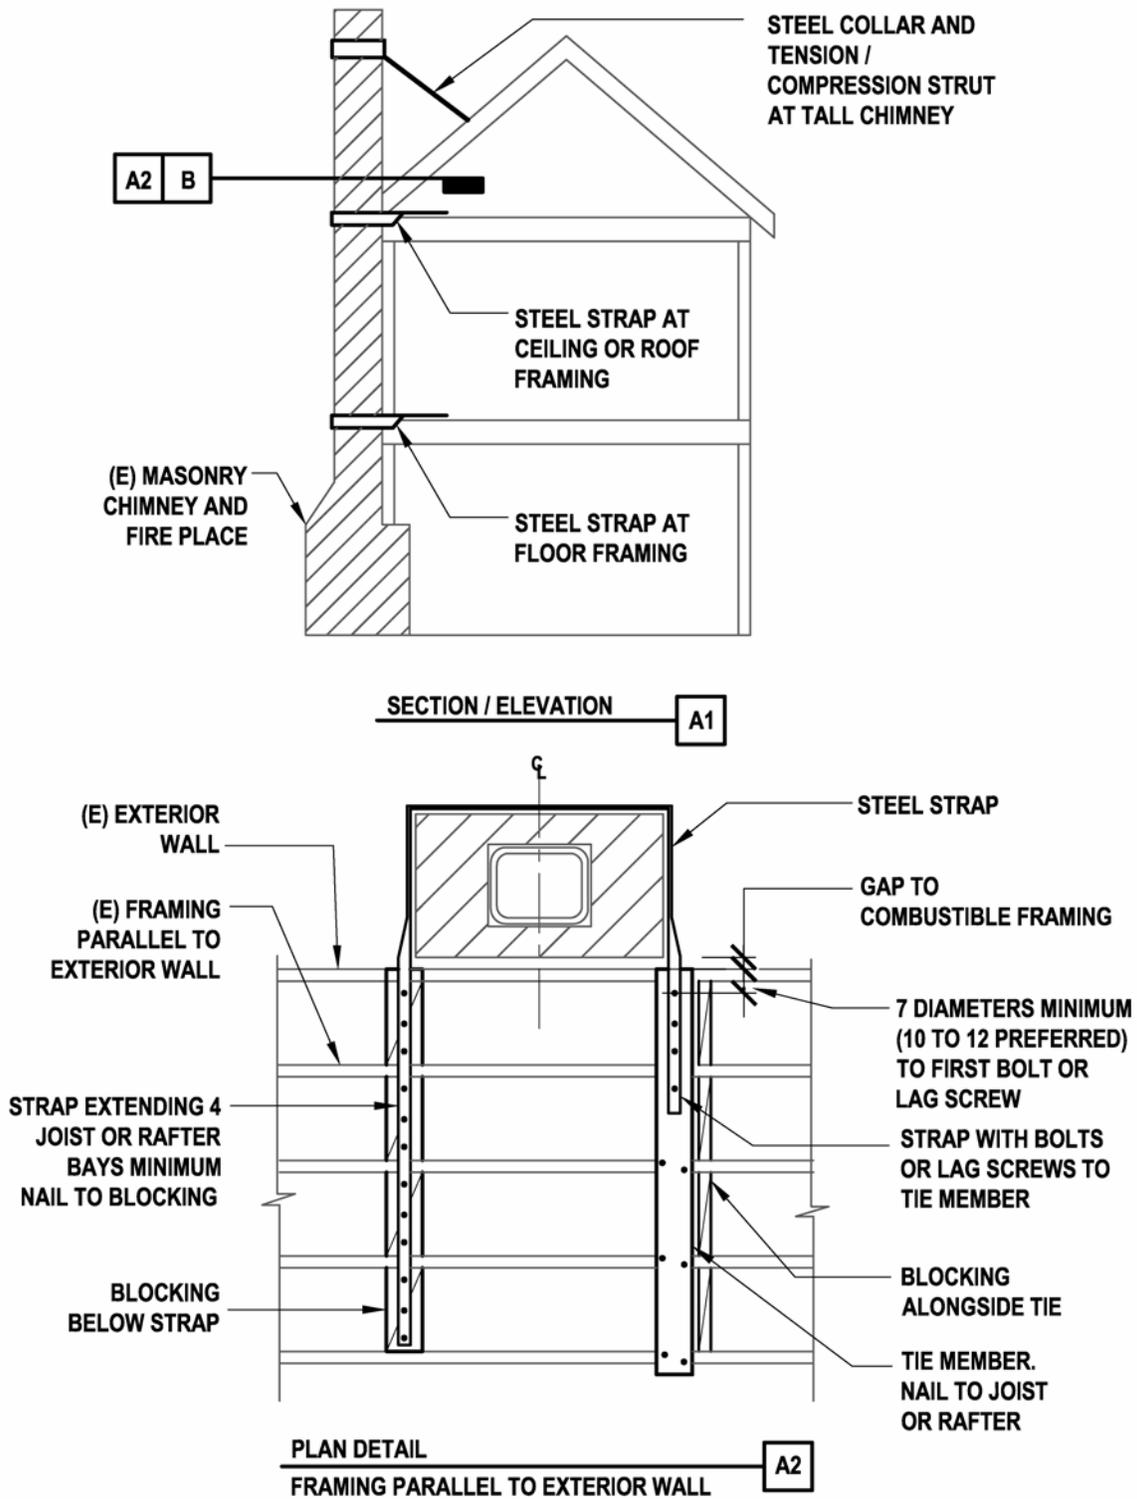
Anchorage of a strap or other tie to an existing masonry chimney should be avoided where possible and otherwise approached with caution. Expansion anchors cause splitting tensile stresses that can result in cracking of the masonry. Adhesive anchors change properties under elevated temperatures that might be experienced during use of the chimney.

Figure 5.4.6-2A: Bracing of Masonry Chimney

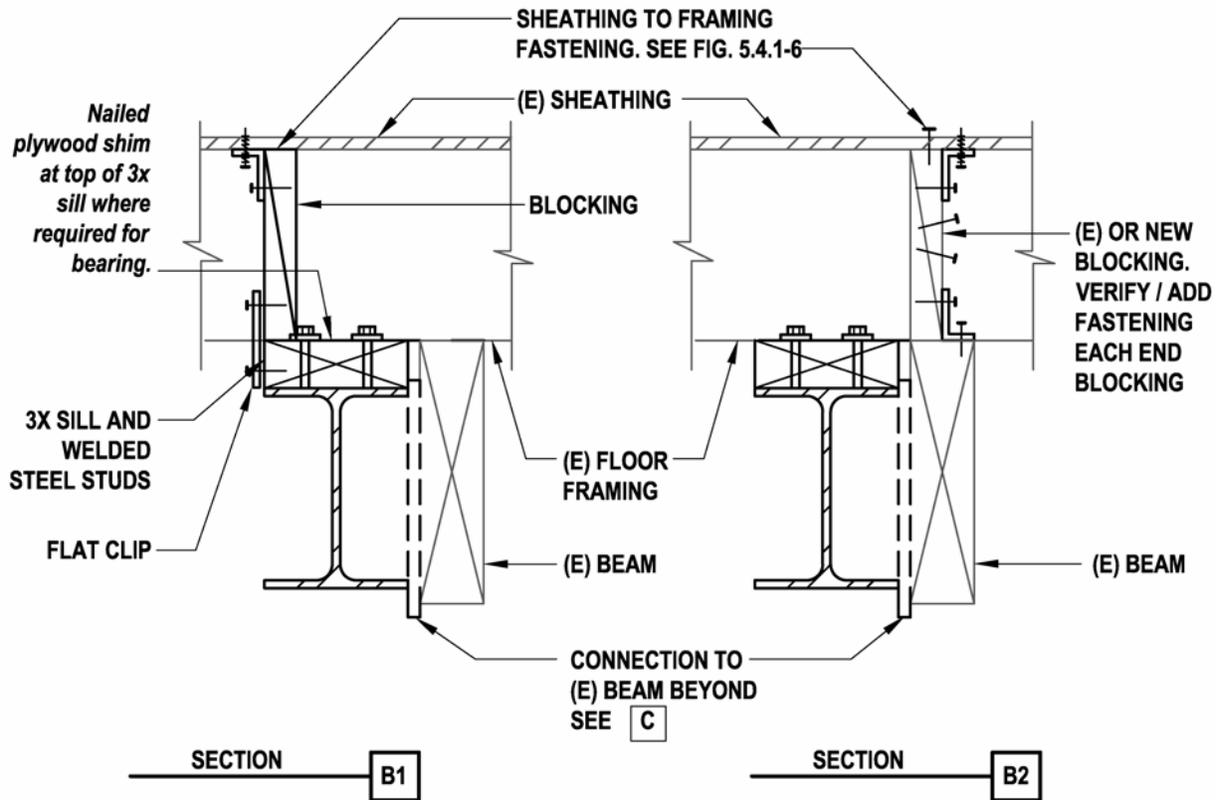
**Figure 6.4.1-1B: Shear Transfer Between Moment Frame Beam and Diaphragm**

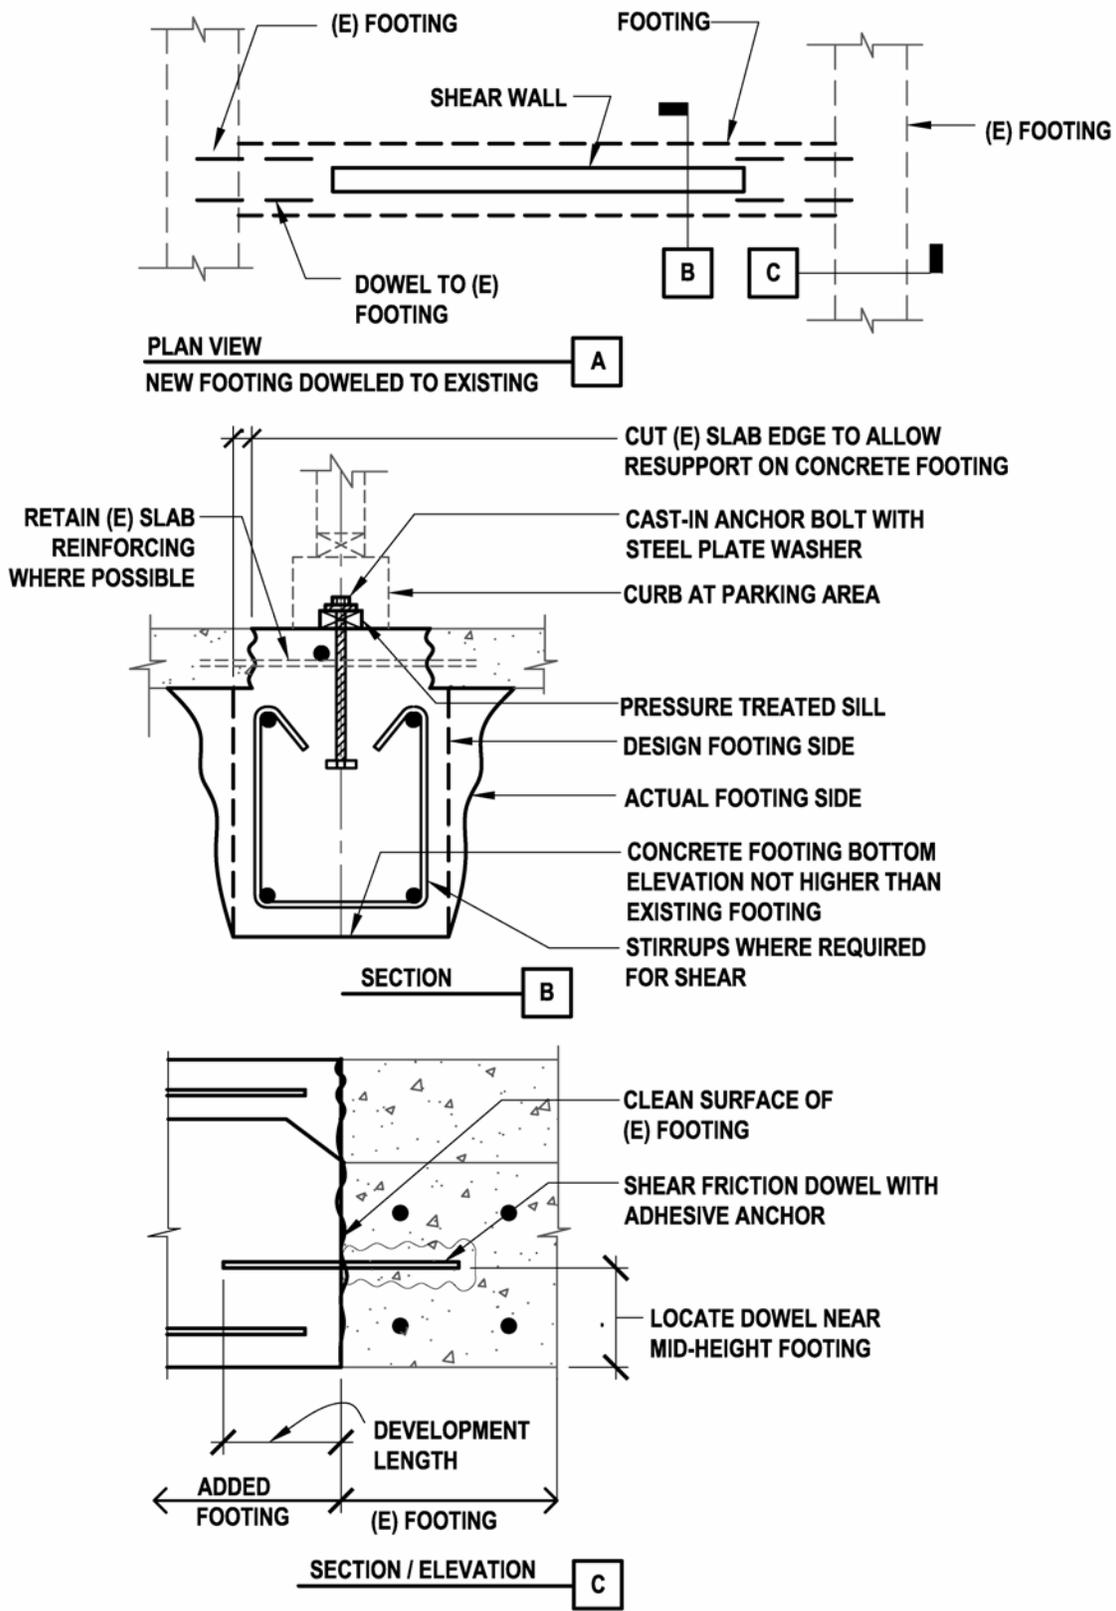
Figure 6.4.2-2: Added Shear Wall Supported by New and Existing Footings

Figure 6.4.2-1 shows a shear wall located so that it can use the dead load carried by a building column to resist uplift at the left hand side and an existing bearing wall foundation at the right
