# Techniques for the Seismic Rehabilitation of Existing Buildings

**FEMA 547 – October 2006**

Rutherford & Chekene (R & C) Consulting Engineers (Subconsultant) under contract with National Institute of Standards and Technology (NIST).

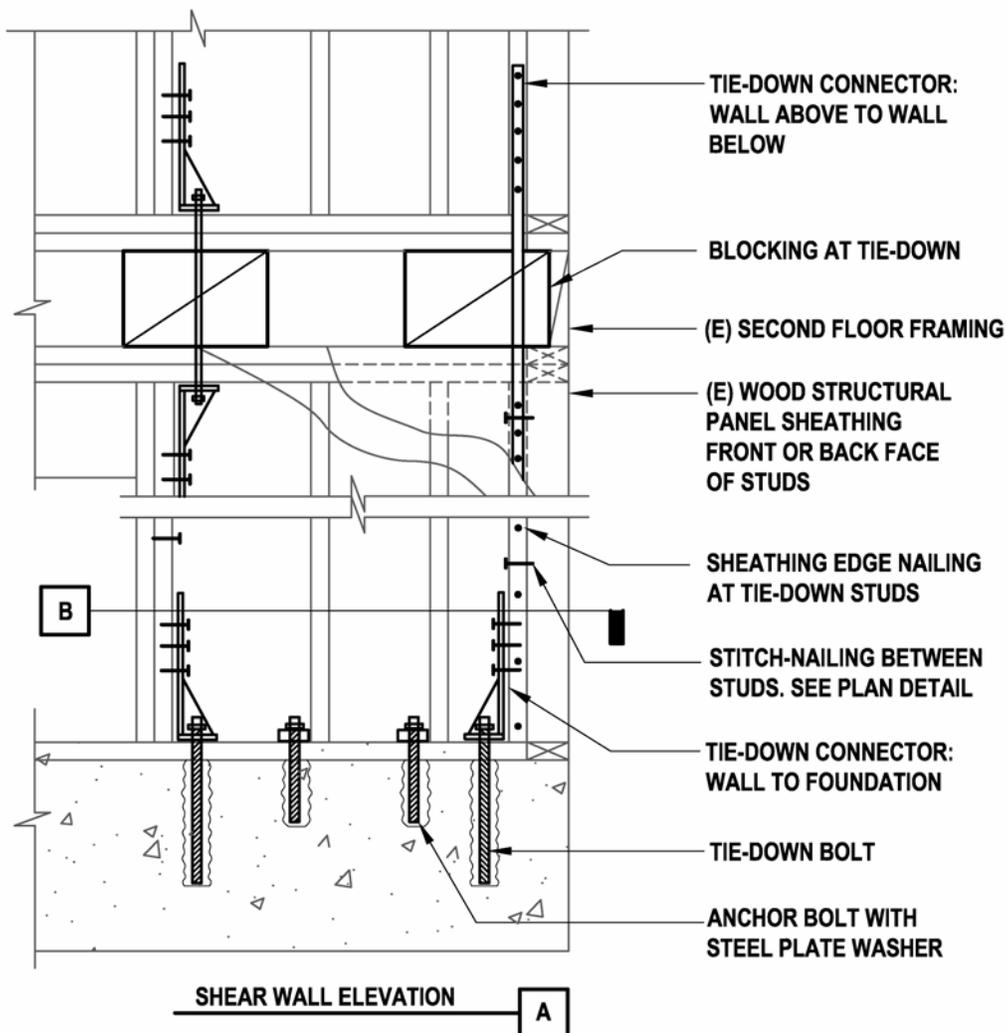
Figure 6.4.4-1A illustrates a shear wall elevation with commonly used tie-down connectors for a slab-on-grade condition. Figure 6.4.4-1B illustrates fastening to develop a load path between the tie-down connector and the shear wall sheathing edge nailing. For sheathing and framing conditions other than those shown, similar fastening must be provided to complete the load path.

**Figure 6.4.4-1A: Shear Wall Elevation with Enhanced Overturning Detailing**

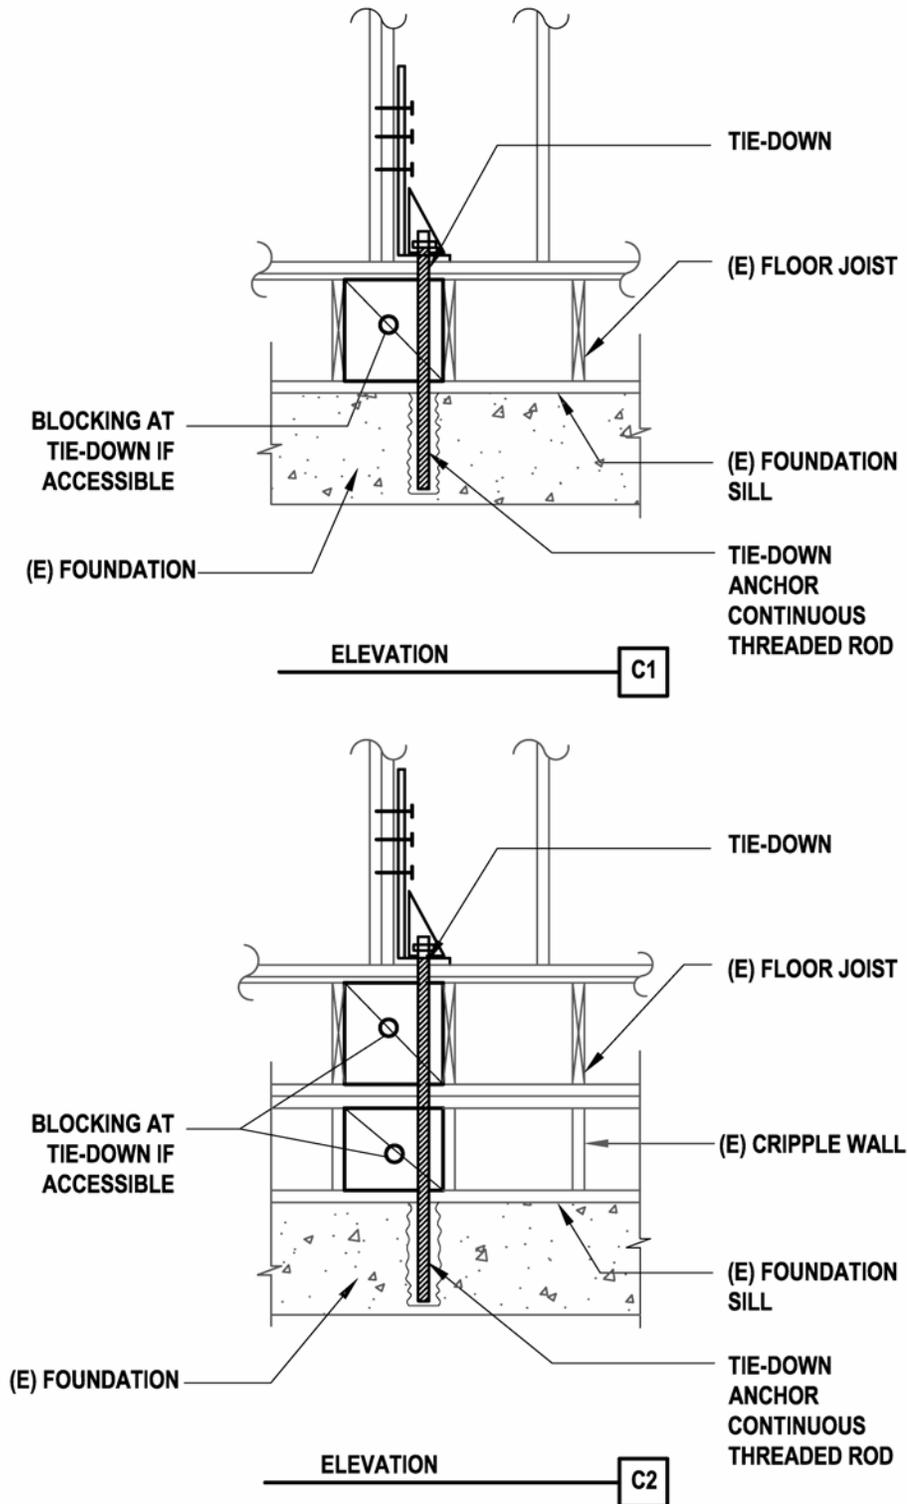
Figure 6.4.4-1C: Tie-down Details at Alternate Base Conditions

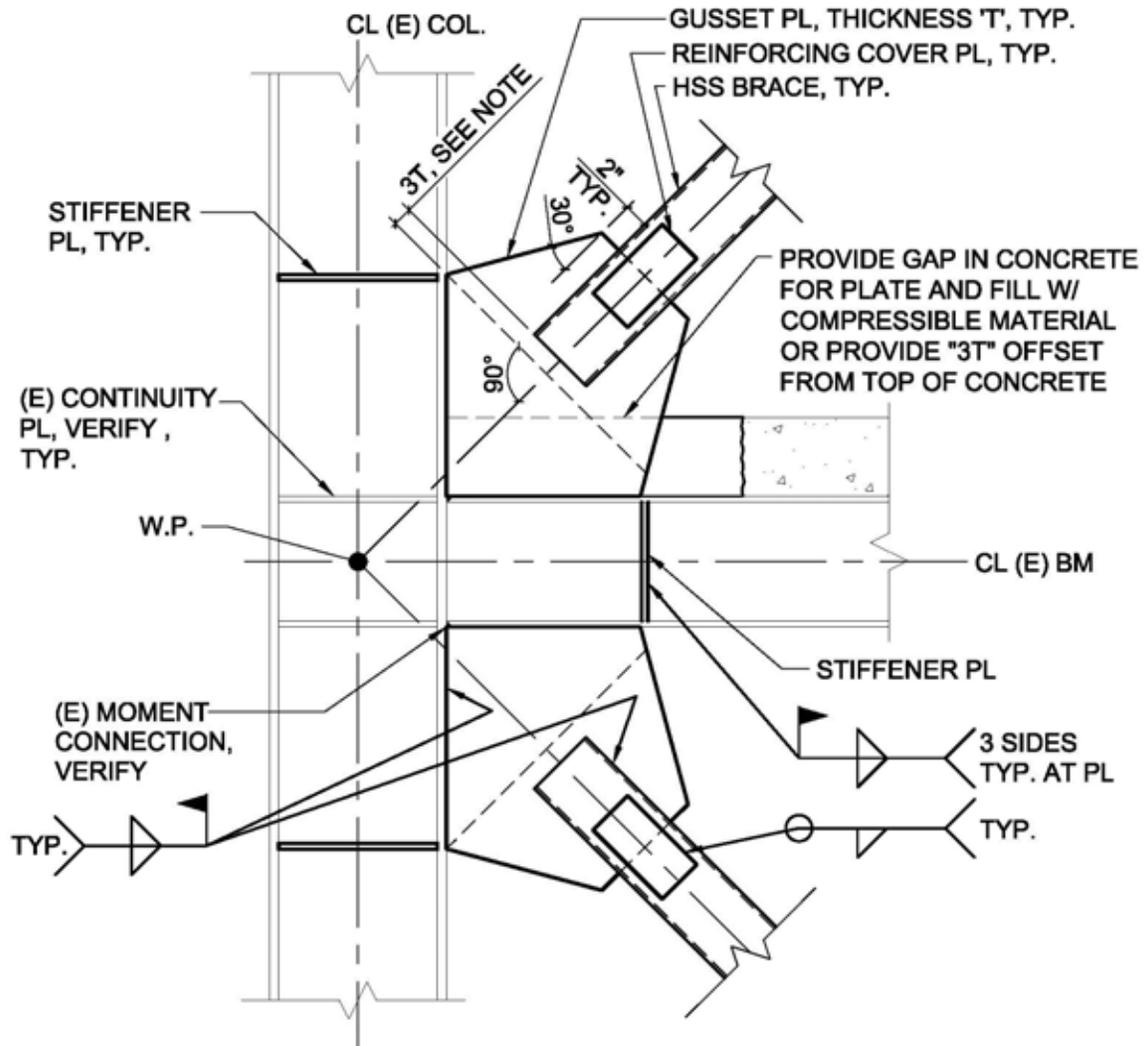
**Note:**  
AISC recommends  $2T$  to allow for restraint-free plastic rotations.  
 $3T$  is shown here to accommodate overcutting of HSS slots.

**Figure 8.4.1-1: HSS Brace at Existing Beam-Column Connection in SCBF**

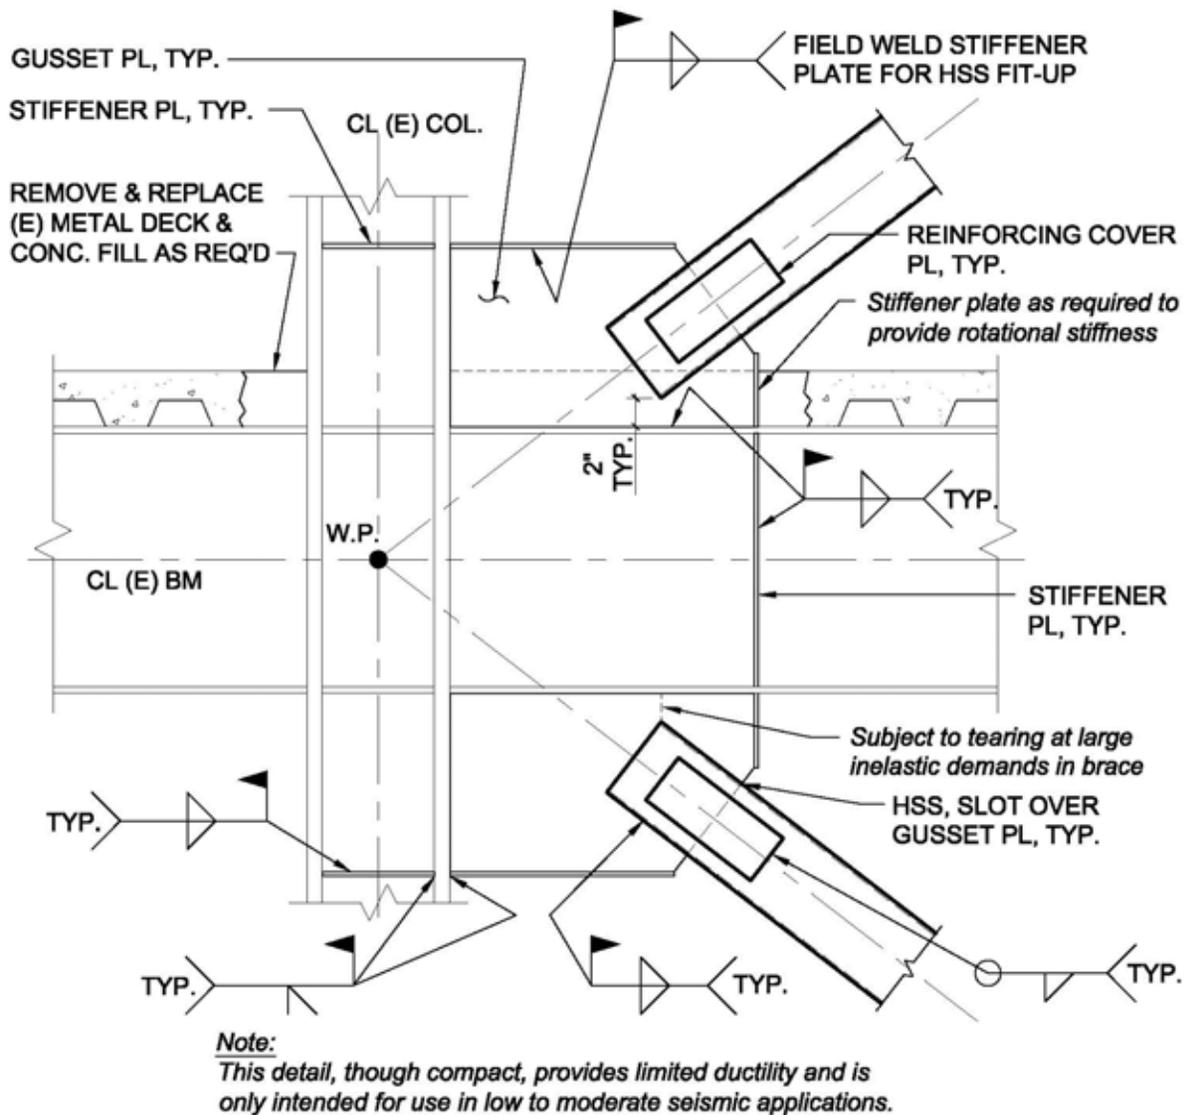
**Figure 8.4.1-2: HSS Brace at Existing Beam-Column Connection in Ordinary CBF**

For low to moderate seismic applications, Figure 8.4.1-2 shows a more compact connection. An example of a W-shape used as a brace and welded directly to the beam and column is shown in Figure 8.4.1-3. The two latter connections do not allow for restraint-free plastic rotations out-of-plane and should be used primarily in situations where in-plane buckling of the braces govern or

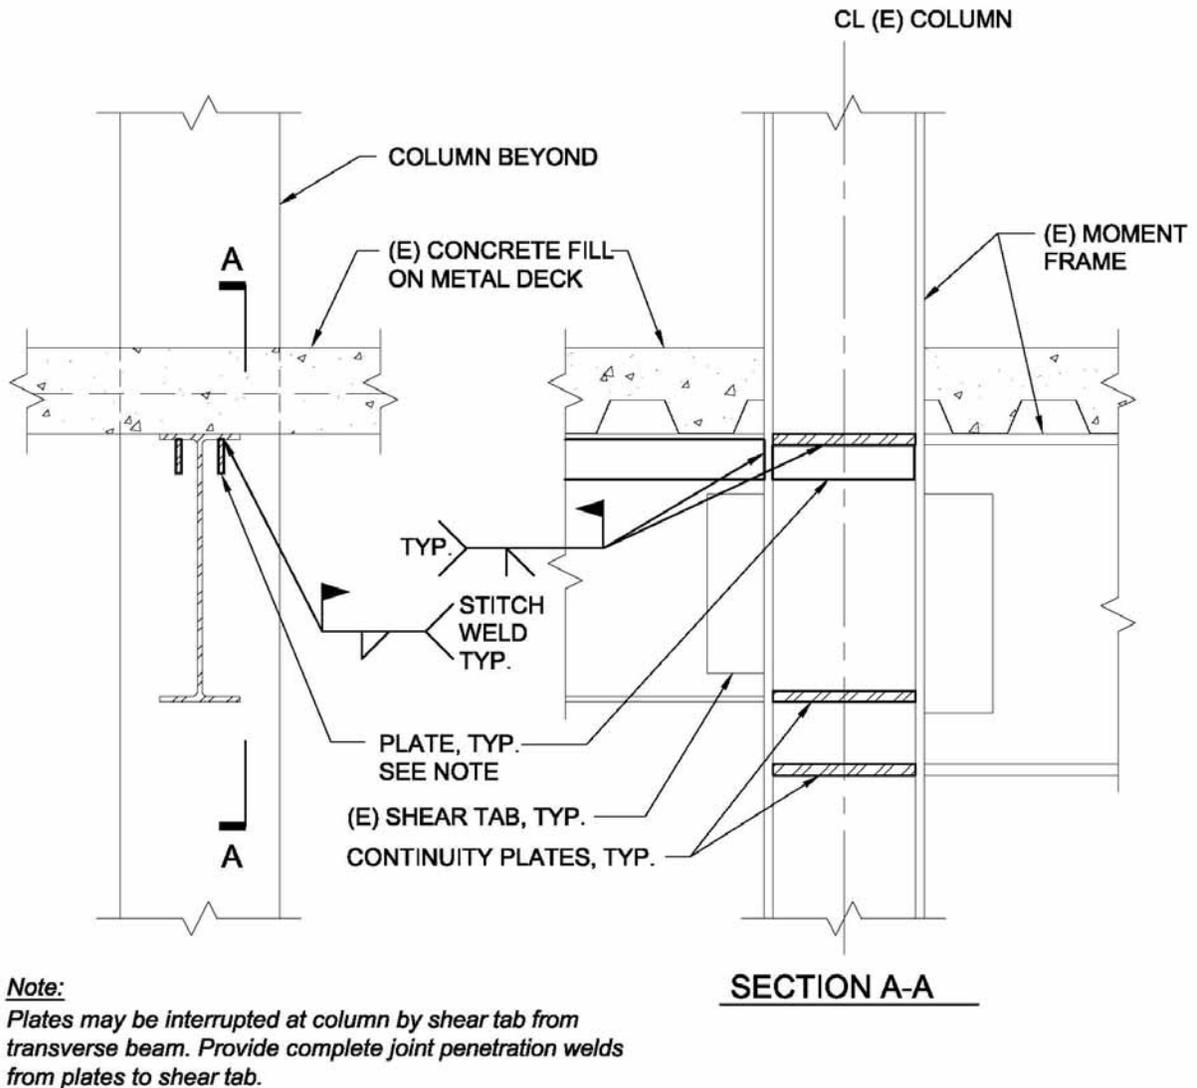
Figure 8.4.4-1: Plate Collectors at Existing Beam

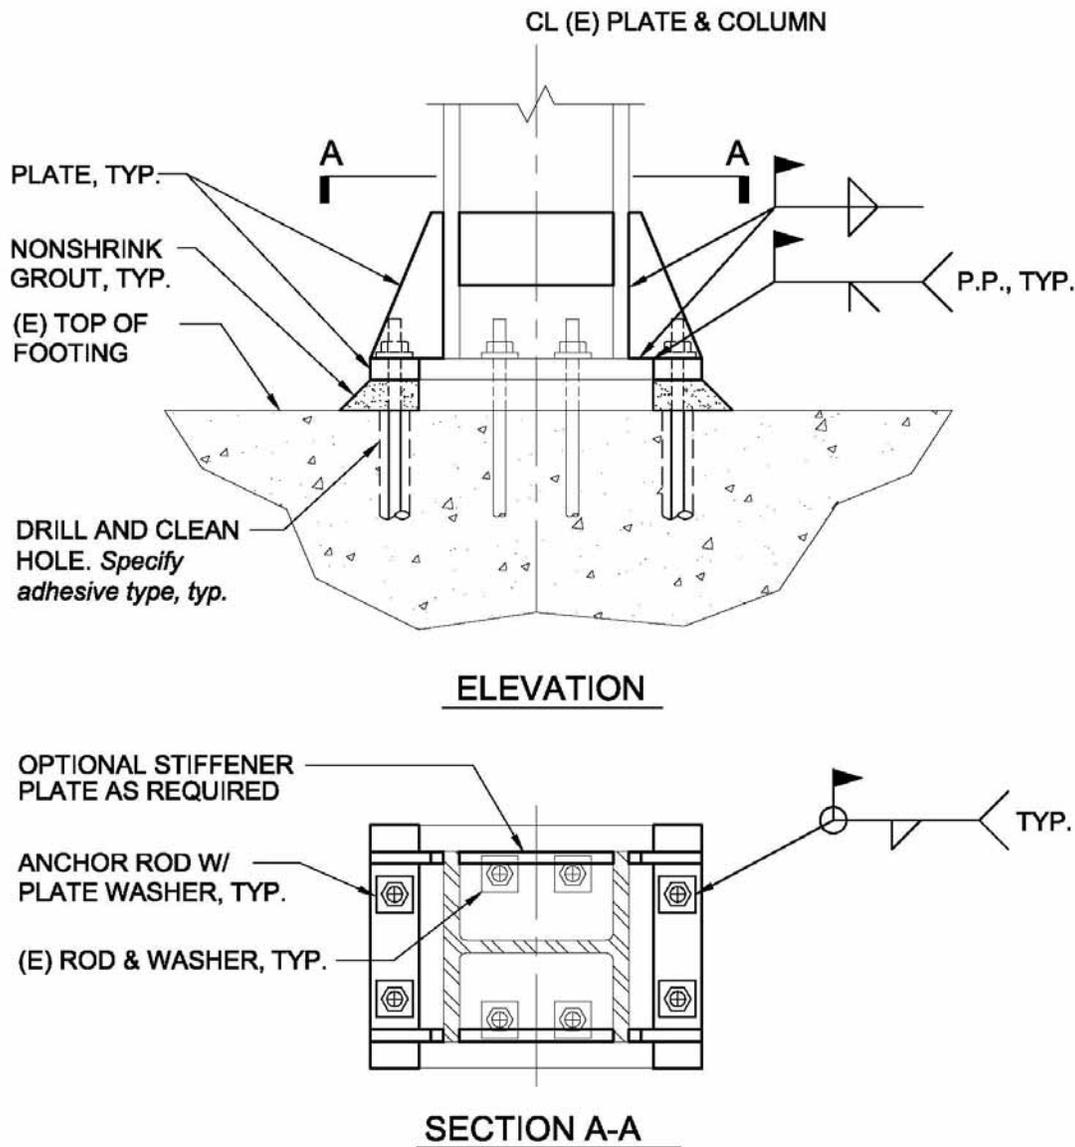
hole large enough in an existing footing to accommodate a bolt head or nut, manufacturers of grouts and adhesives sometimes limit the size of the hole for a given rod diameter in which its product can be used as an infill. In this case, the tensile force has to be developed entirely through bond. For bond development, the rod has to be threaded or some other means of mechanical anchorage has to be provided along the rod. Anchor rods are not typically used to transfer shear to the foundation because the mechanism for shear transfer is difficult to define and still subject to debate. If unavoidable, several factors should be considered, including bending of the rod through the oversized hole in the base plate and shear and tension interaction on the rod. If the column shear force is being distributed between both new and existing rods, note that the holes for the existing rods are likely to be oversized and welded plate washers should be verified or provided.

Figure 8.4.5-1: Modified Base Plate to Increase Uplift Capacity

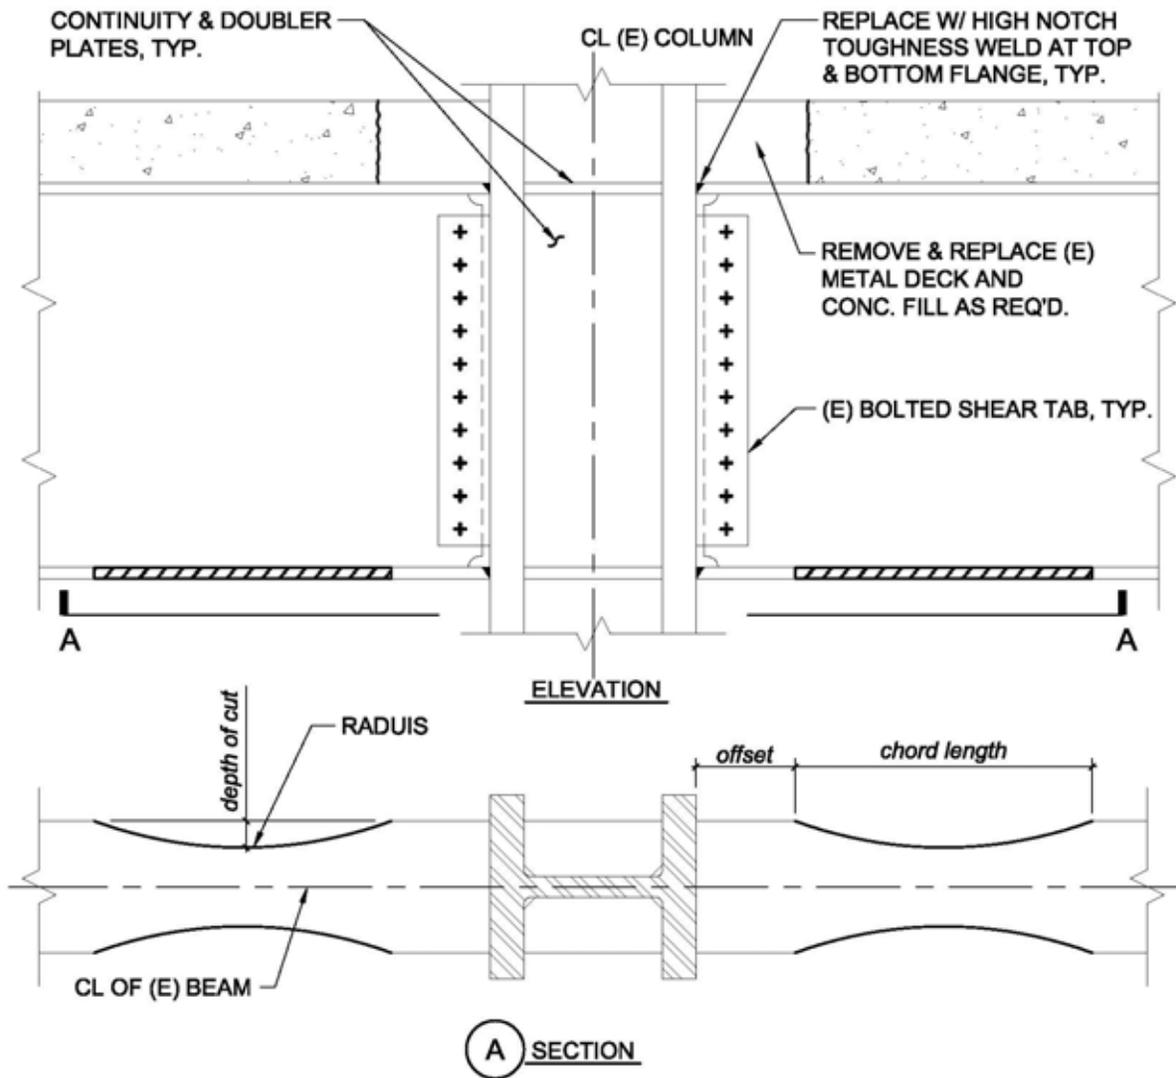
length of the cut should also be long enough to control the inelastic strains along the RBS. The radius of the cut is a function of its depth and the chord length. See *AISC Design Guide 12* for specific recommendations and guidelines for selecting these dimensions.

**Figure 8.4.6-1: Reduced Beam Section at Bottom Flange of Existing Beam**  
*(adapted from AISC Design Guide 12)*

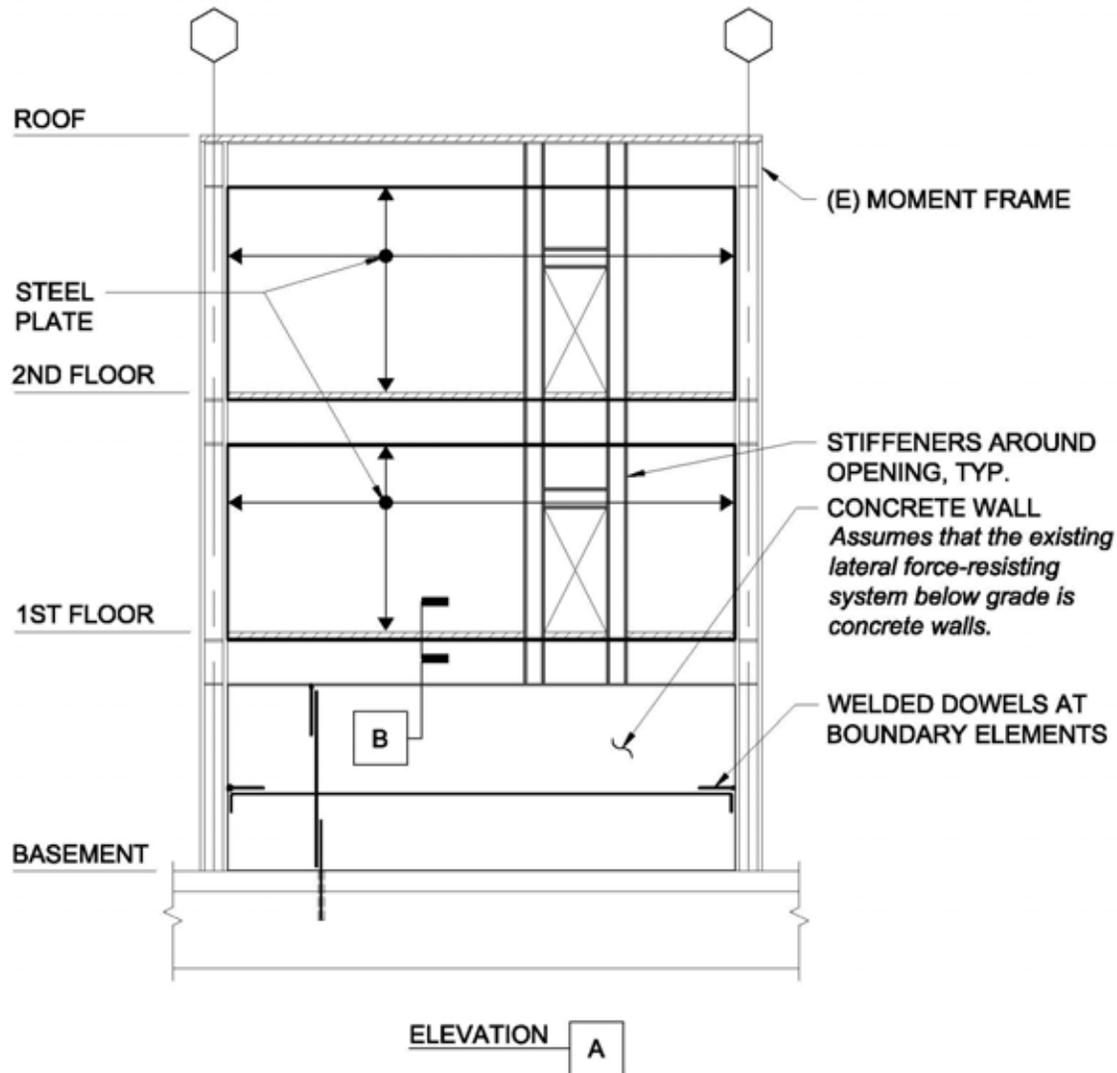
**Figure 8.4.8-1A: Unstiffened Steel Plate Shear Wall**

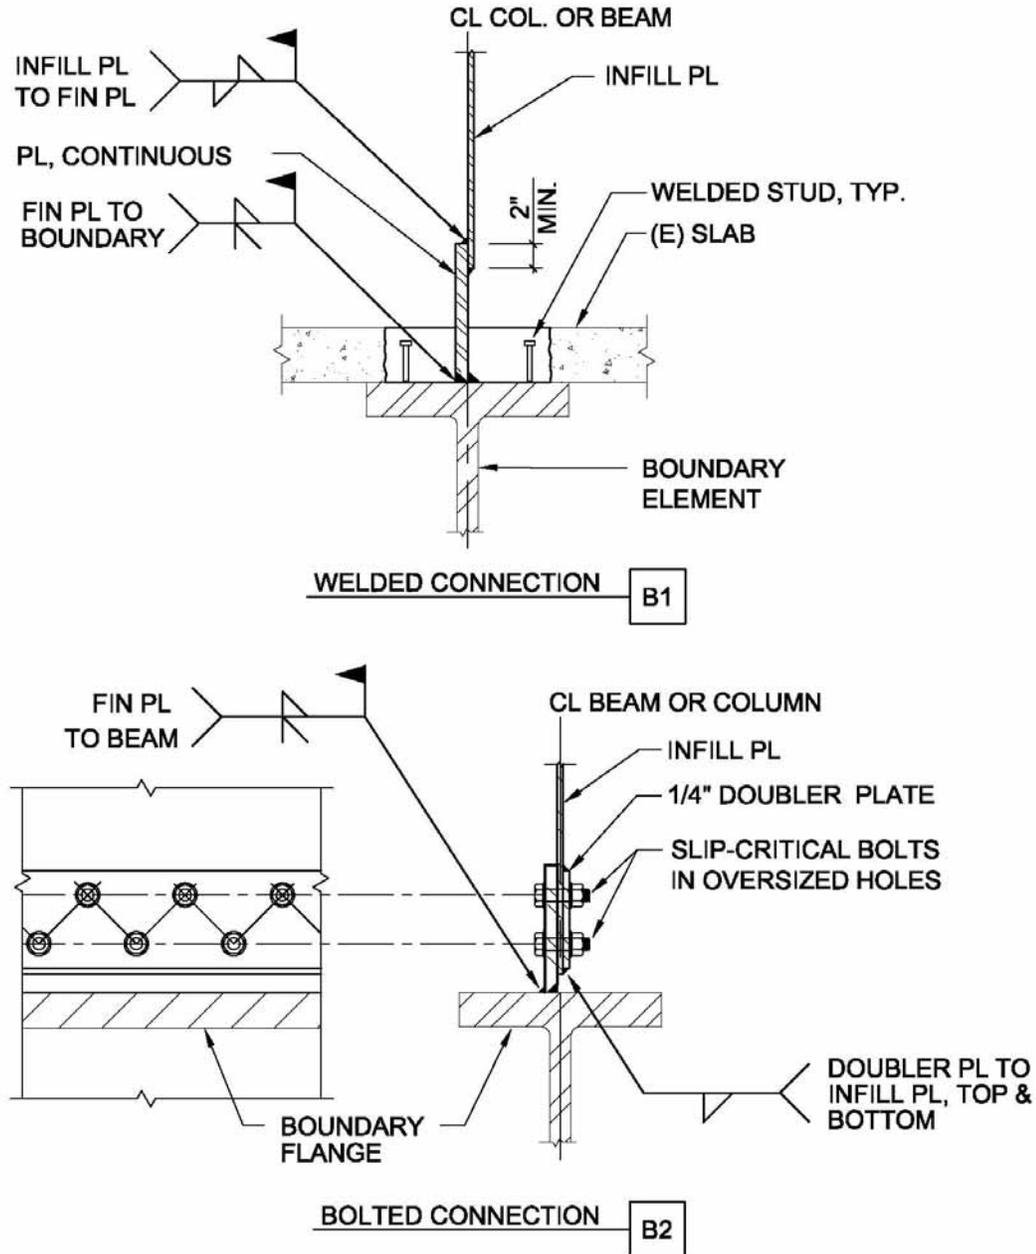
**Figure 8.4.8-1B: Fin Plate Connection Options**

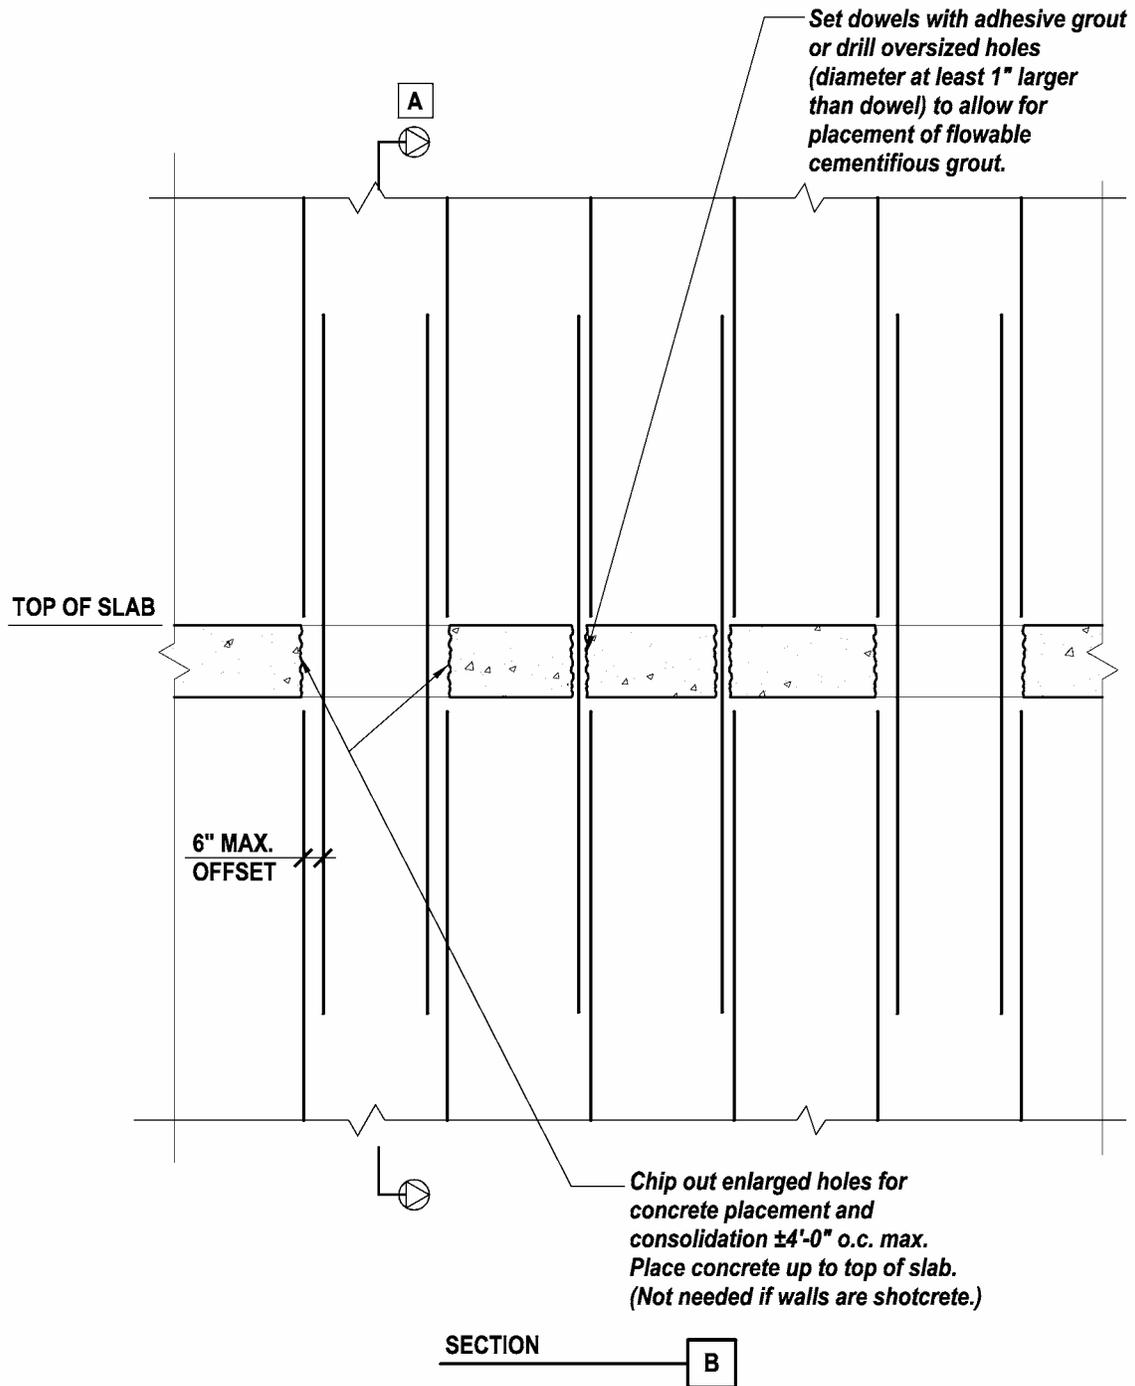
**Figure 12.4.2-1B: Concrete Wall Connection to Concrete Slab – Partial Elevation View**

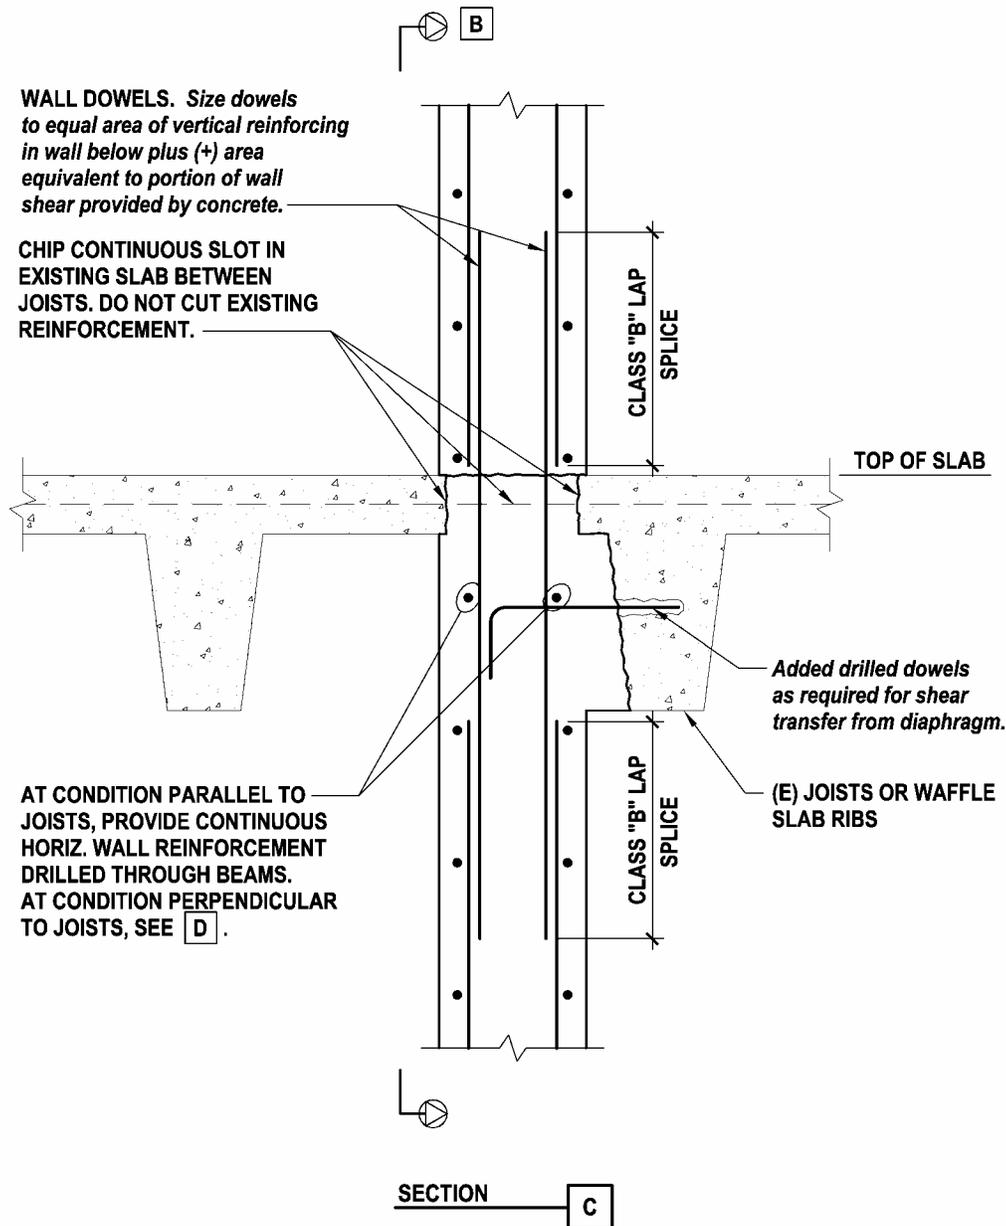
**Figure 12.4.2-1C: Connection of Concrete Wall to Concrete Joists or Waffle Slab**

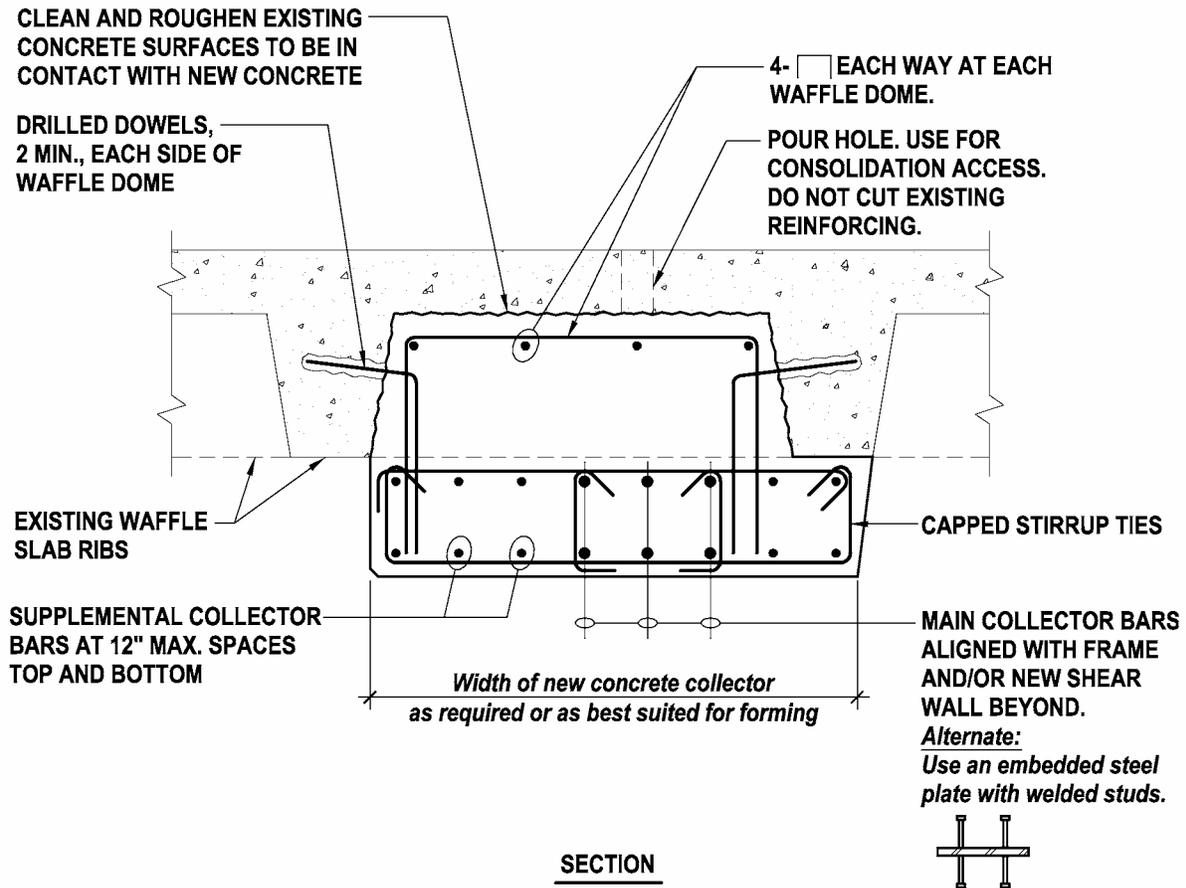
**Figure 12.4.3-2: Concrete Collector at Waffle Slab**

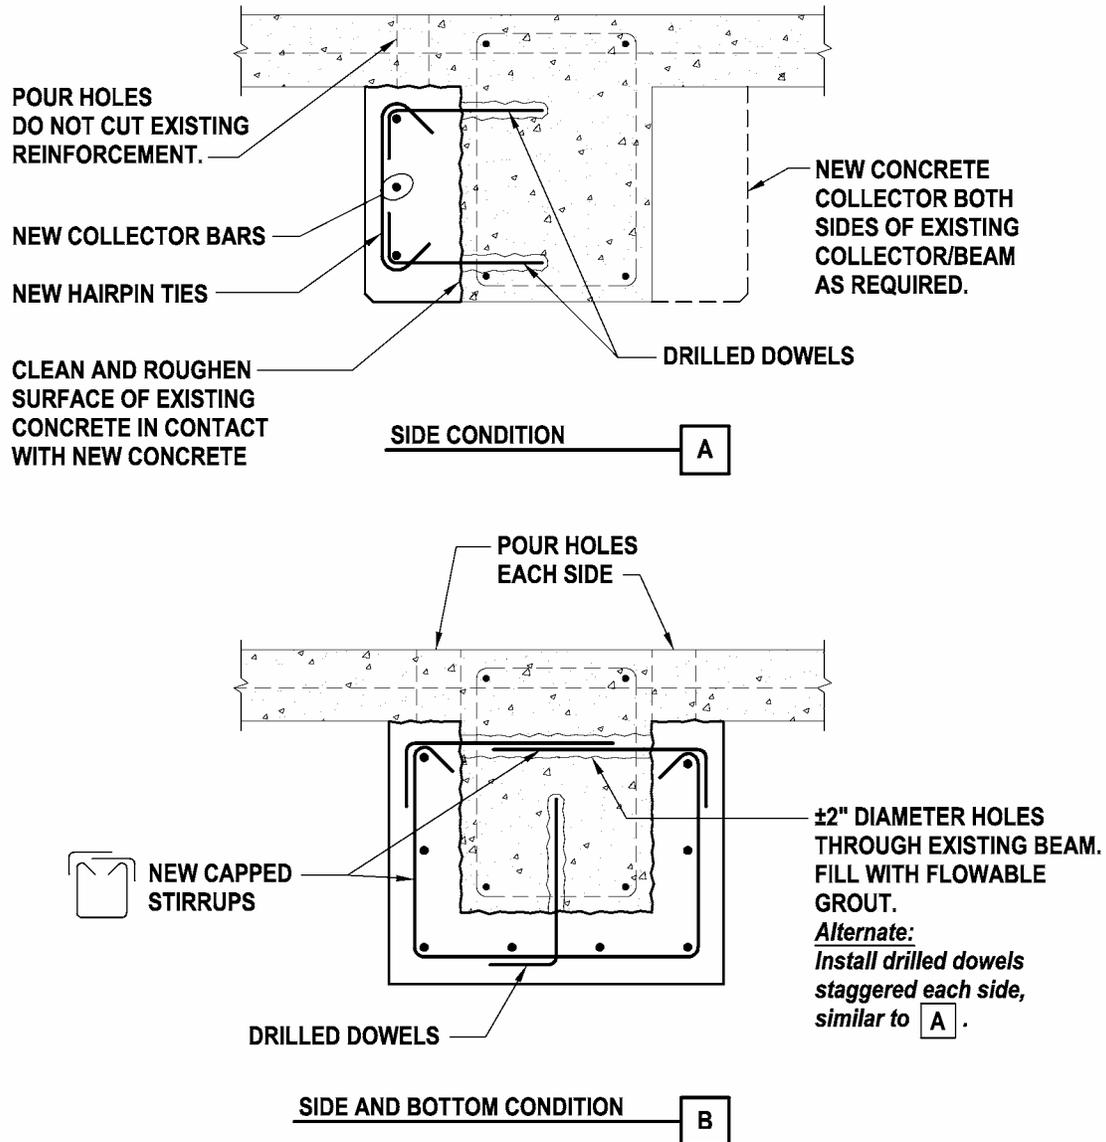
**Figure 12.4.3-3: Concrete Collector at Existing Beam**

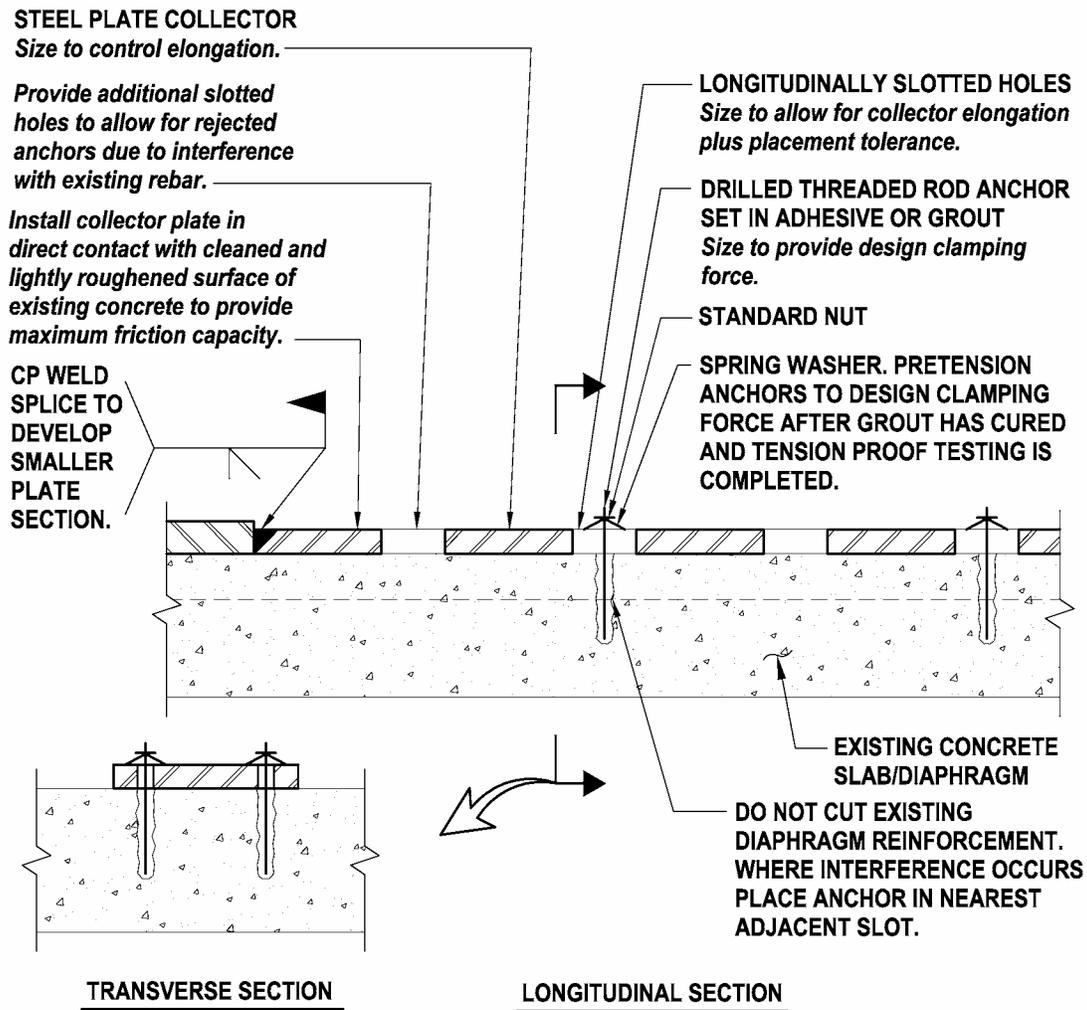
**Figure 12.4.3-4: Steel Plate Collector**

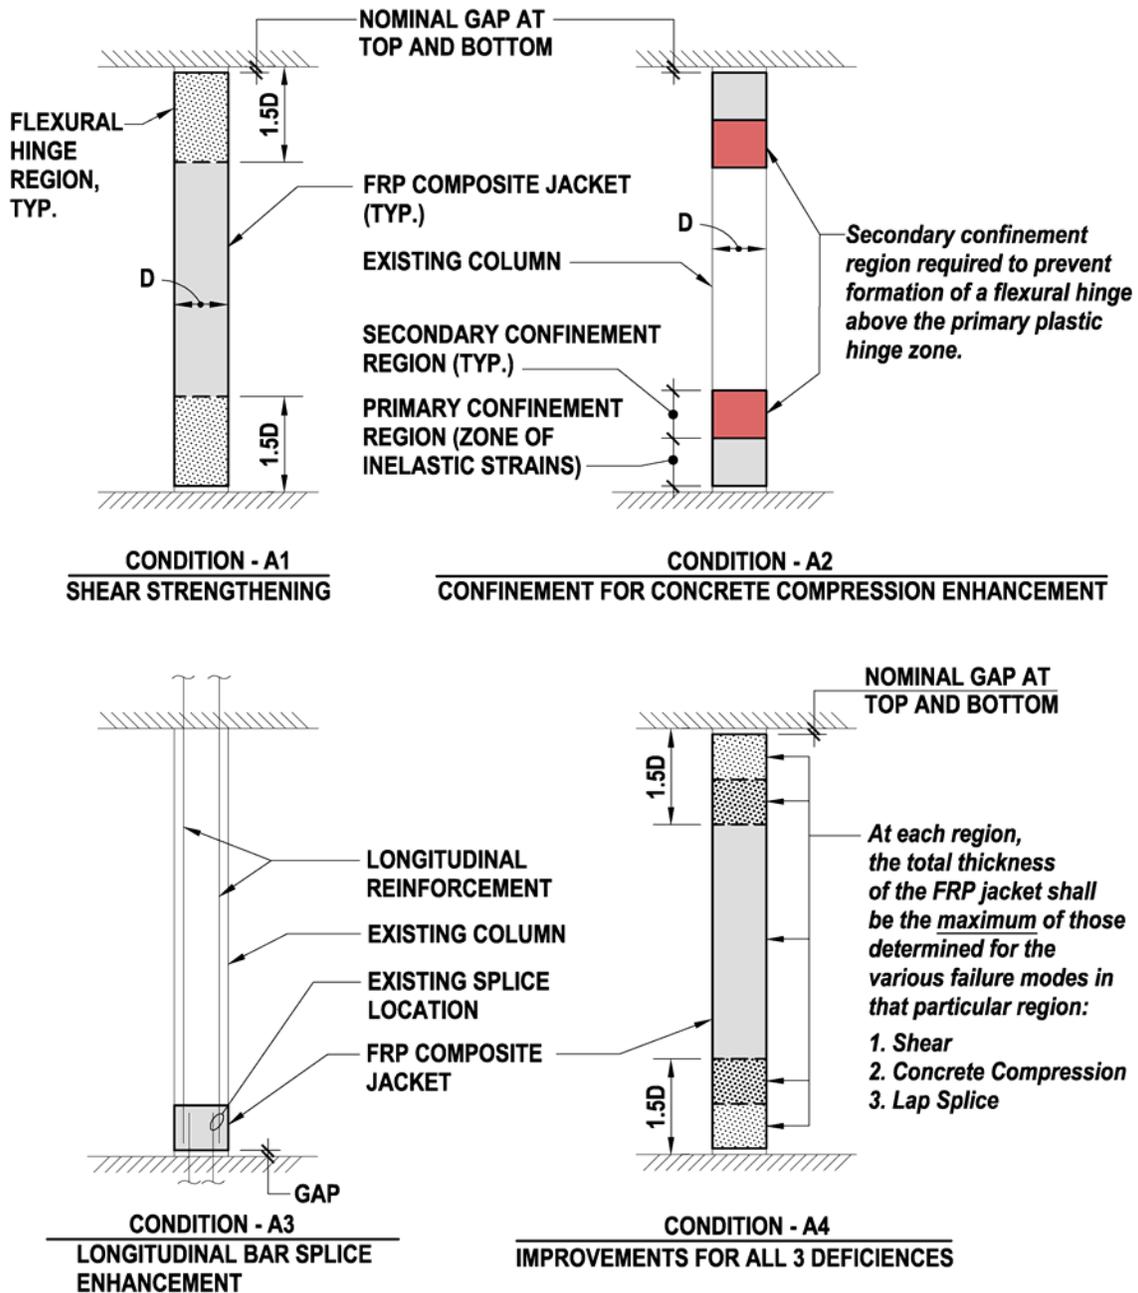
Figure 12.4.4-1A: Seismic Retrofit of Columns Using FRP Composites

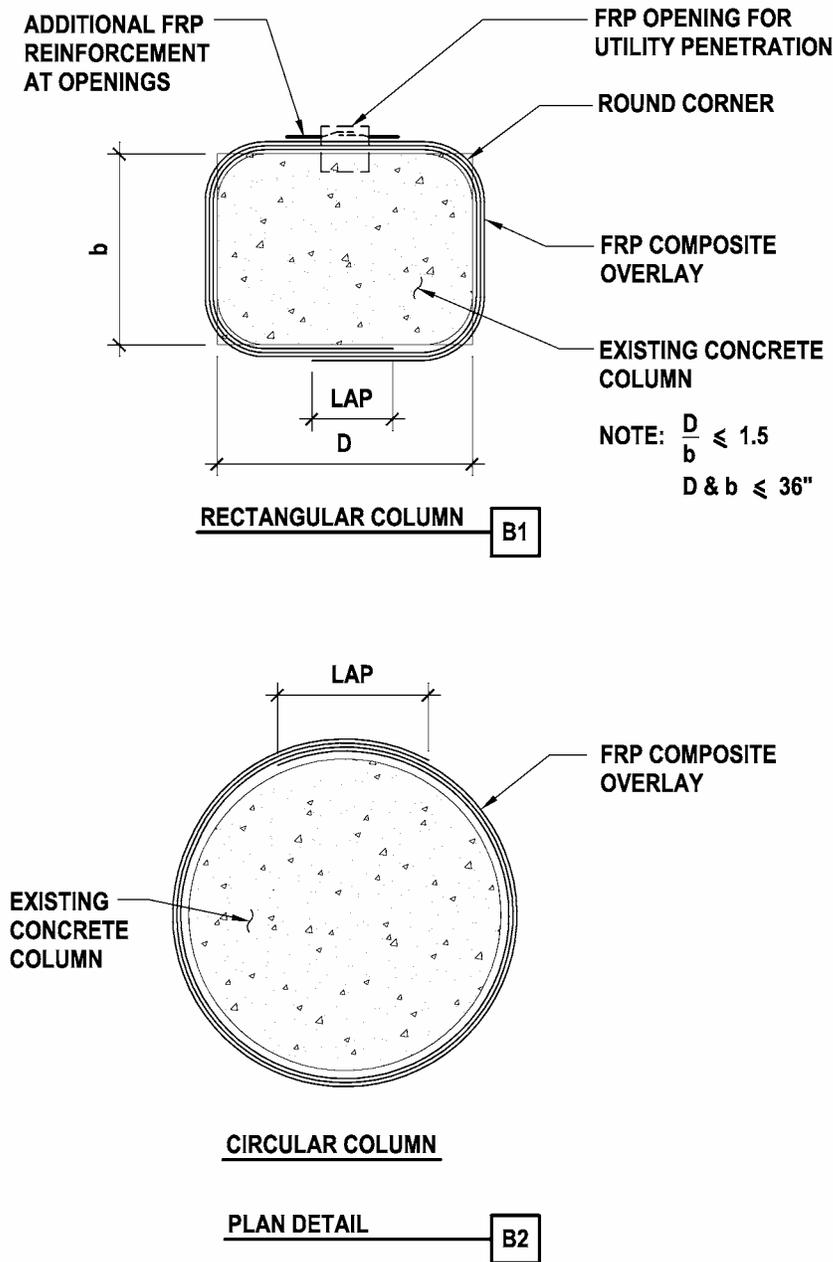
**Figure 12.4.4-1B: Seismic Retrofit of Columns Using FRP Composites**

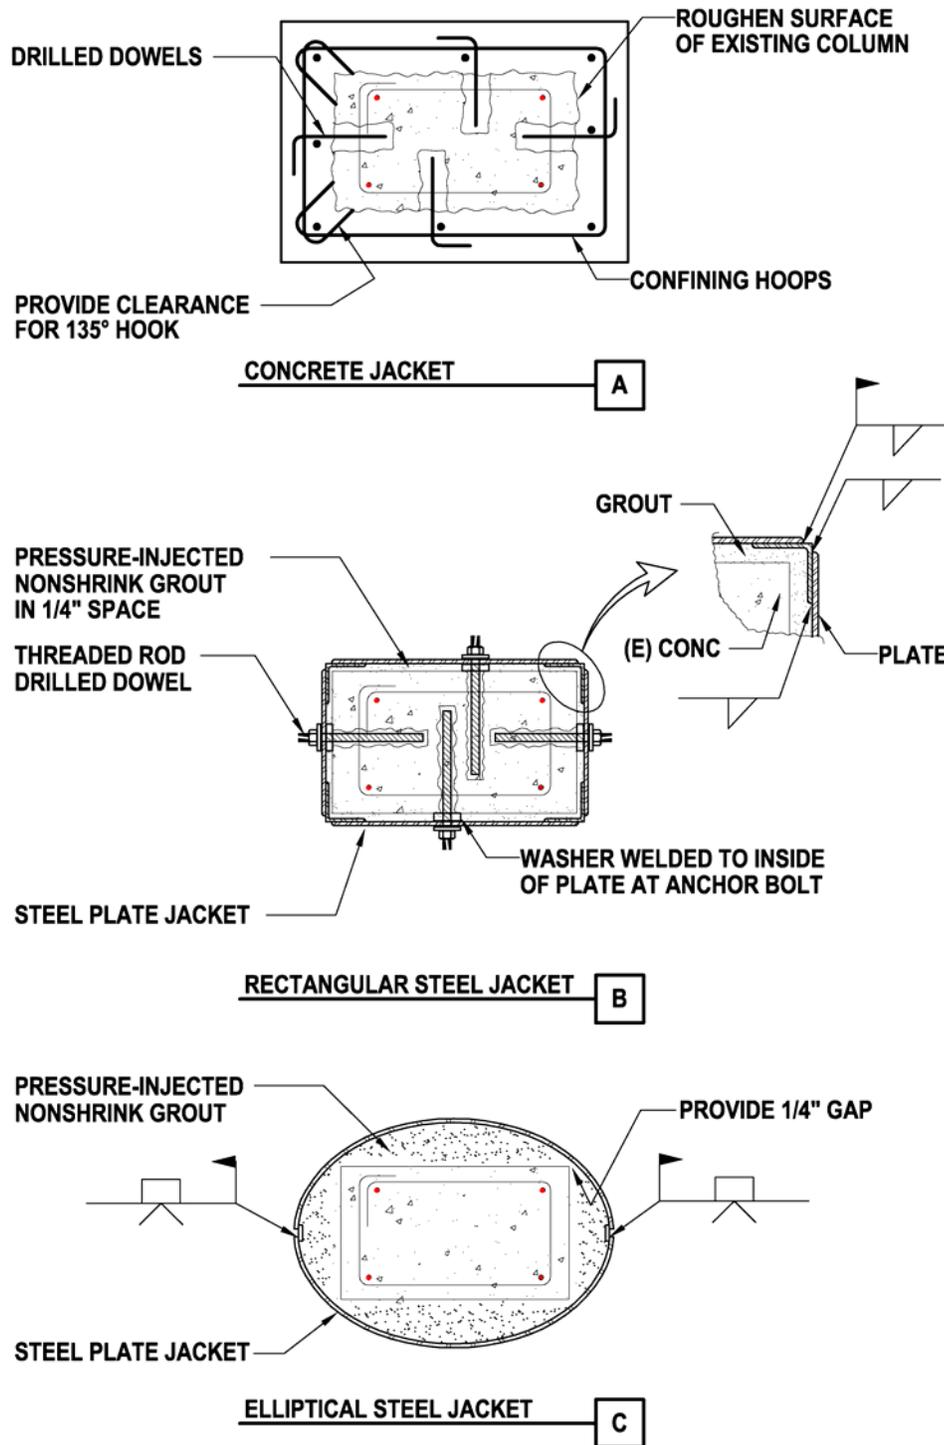
Figure 12.4.5-1: Concrete and Steel Overlays for Concrete Columns

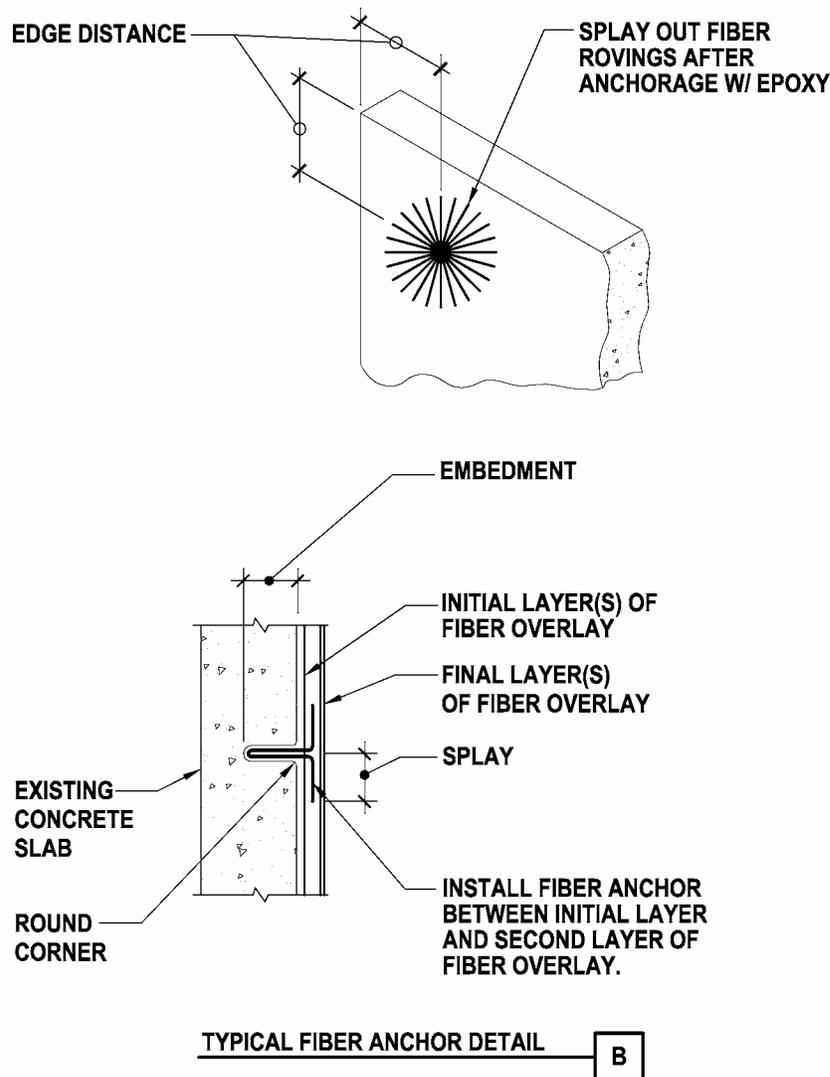
**Figure 13.4.1-1B: Fiber Anchor Details**
