# Techniques for the Seismic Rehabilitation of Existing Buildings

**FEMA 547 – October 2006**

Rutherford & Chekene (R & C) Consulting Engineers (Subconsultant) under contract with National Institute of Standards and Technology (NIST).

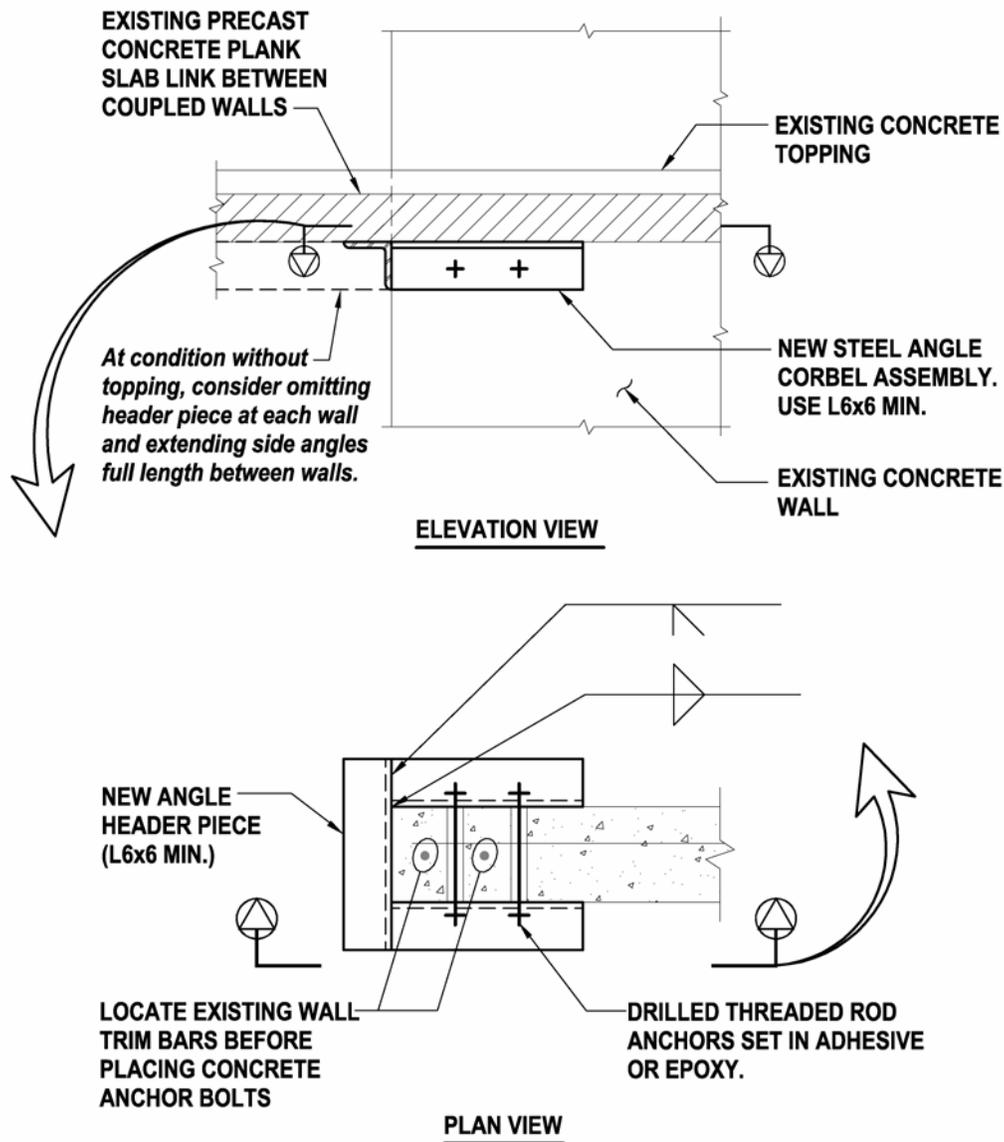
**Figure 13.4.2-1: Typical Corbel at Linking Slab**

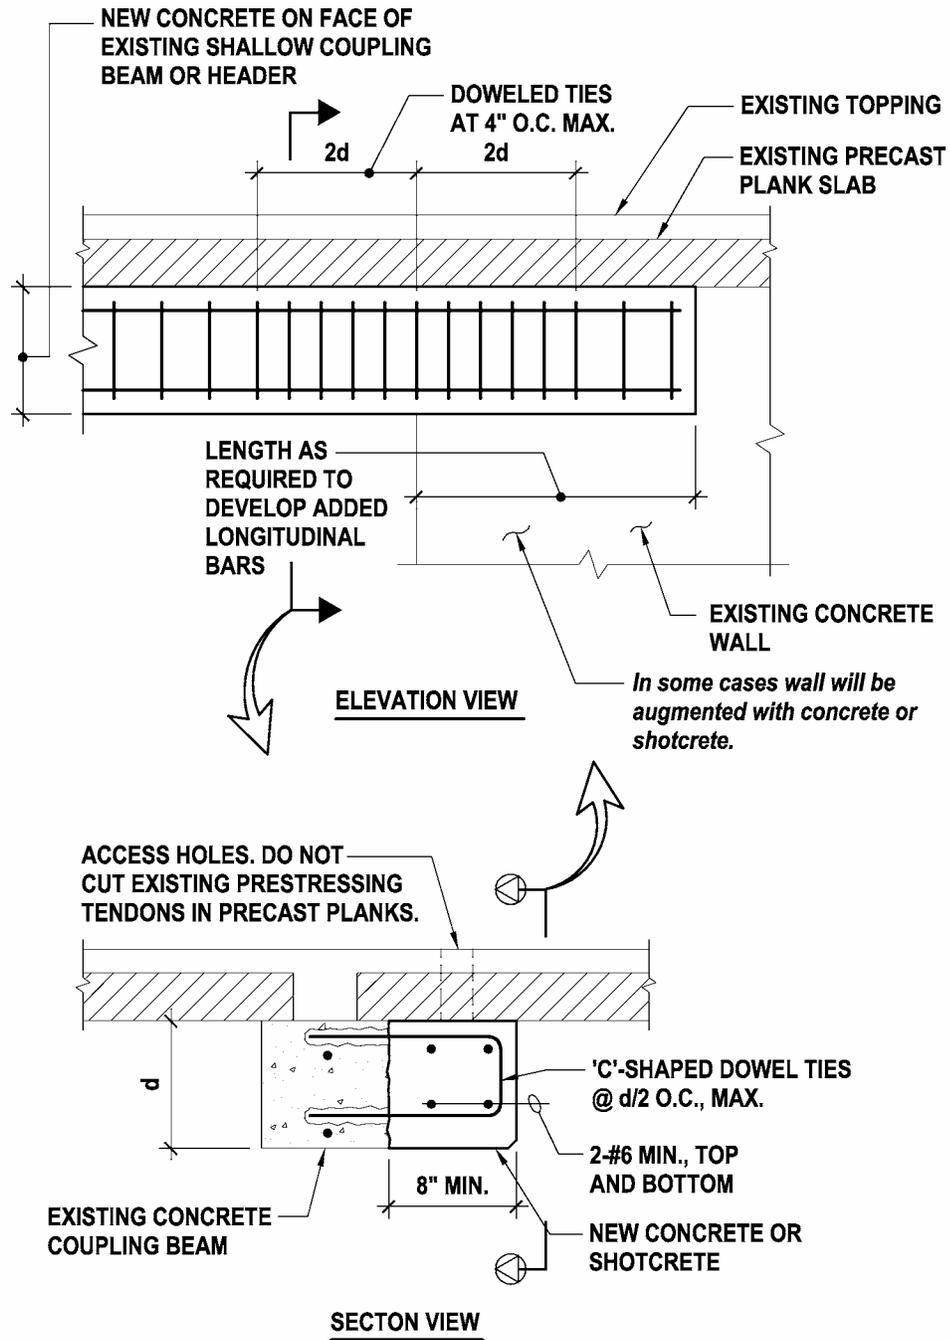
**Figure 13.4.2-2: Typical Strengthening of Shallow Coupling Beam**

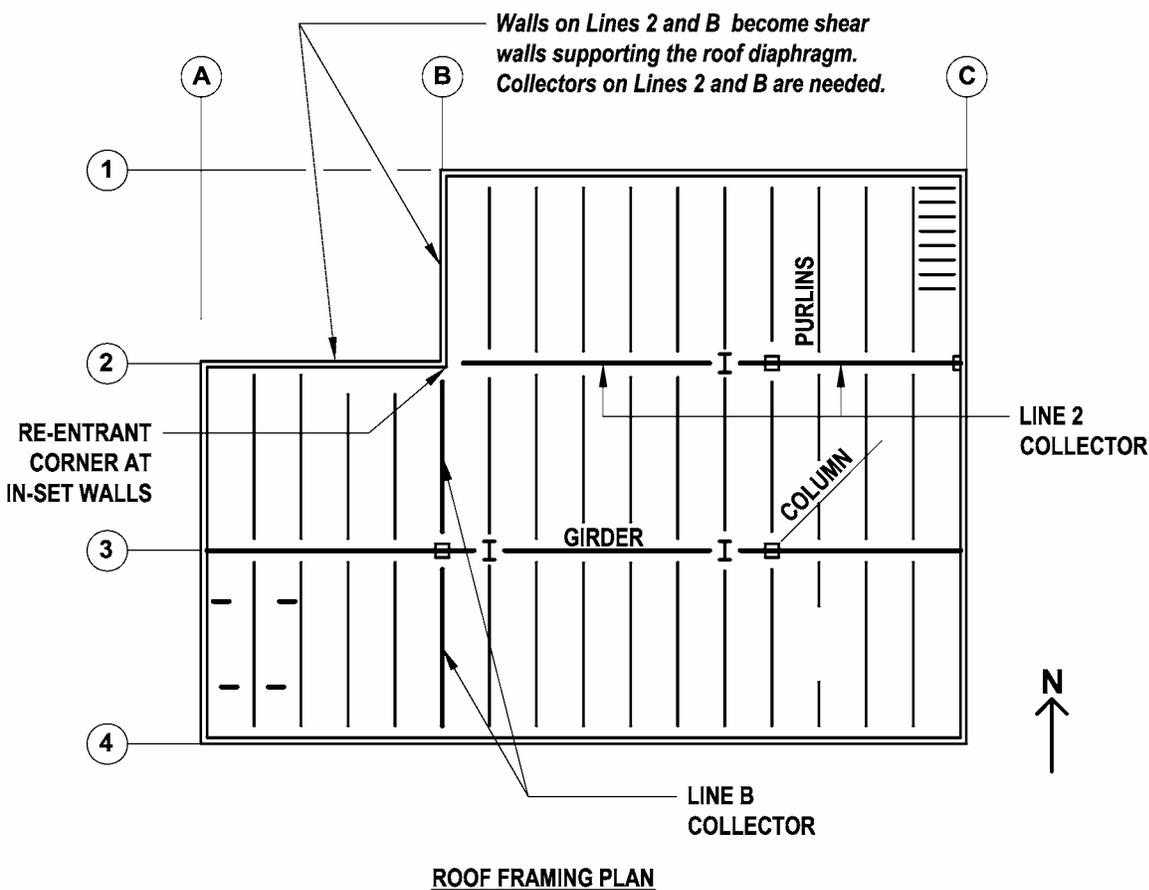
**Figure 16.3-1: Plan of PC1 Building with Re-entrant Corner at In-set Panels**

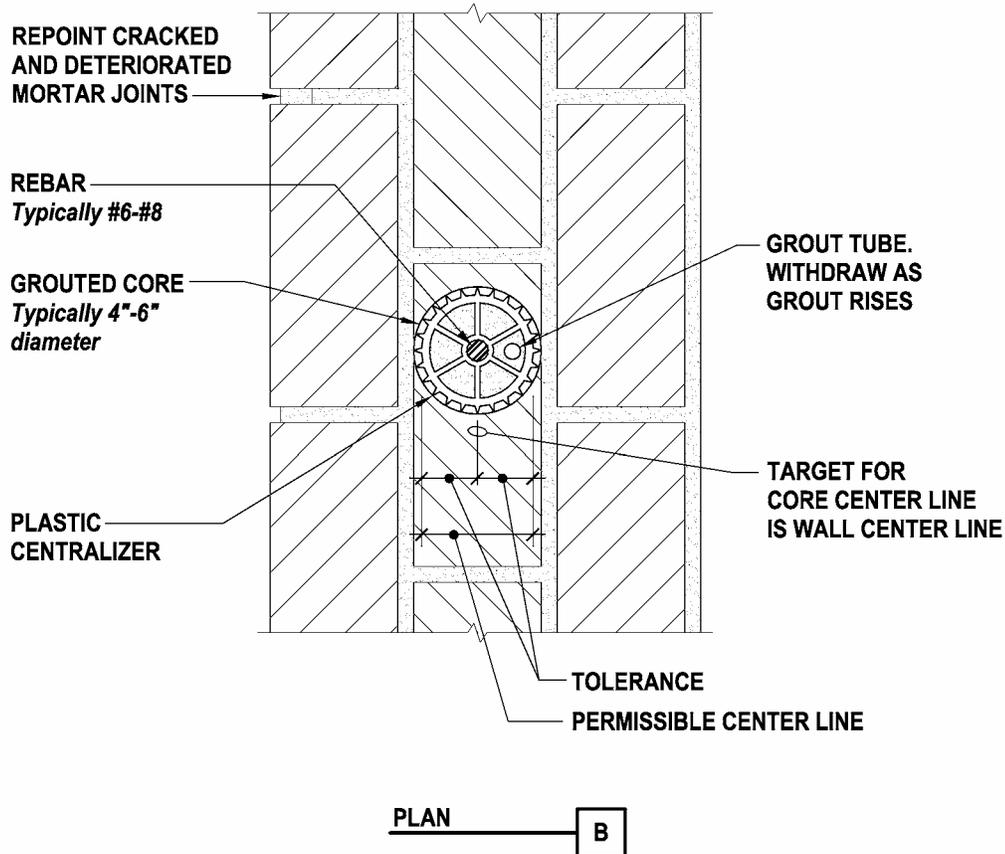
**Figure 21.4.4-1B: Plan Detail of Reinforced Core in Masonry Wall**

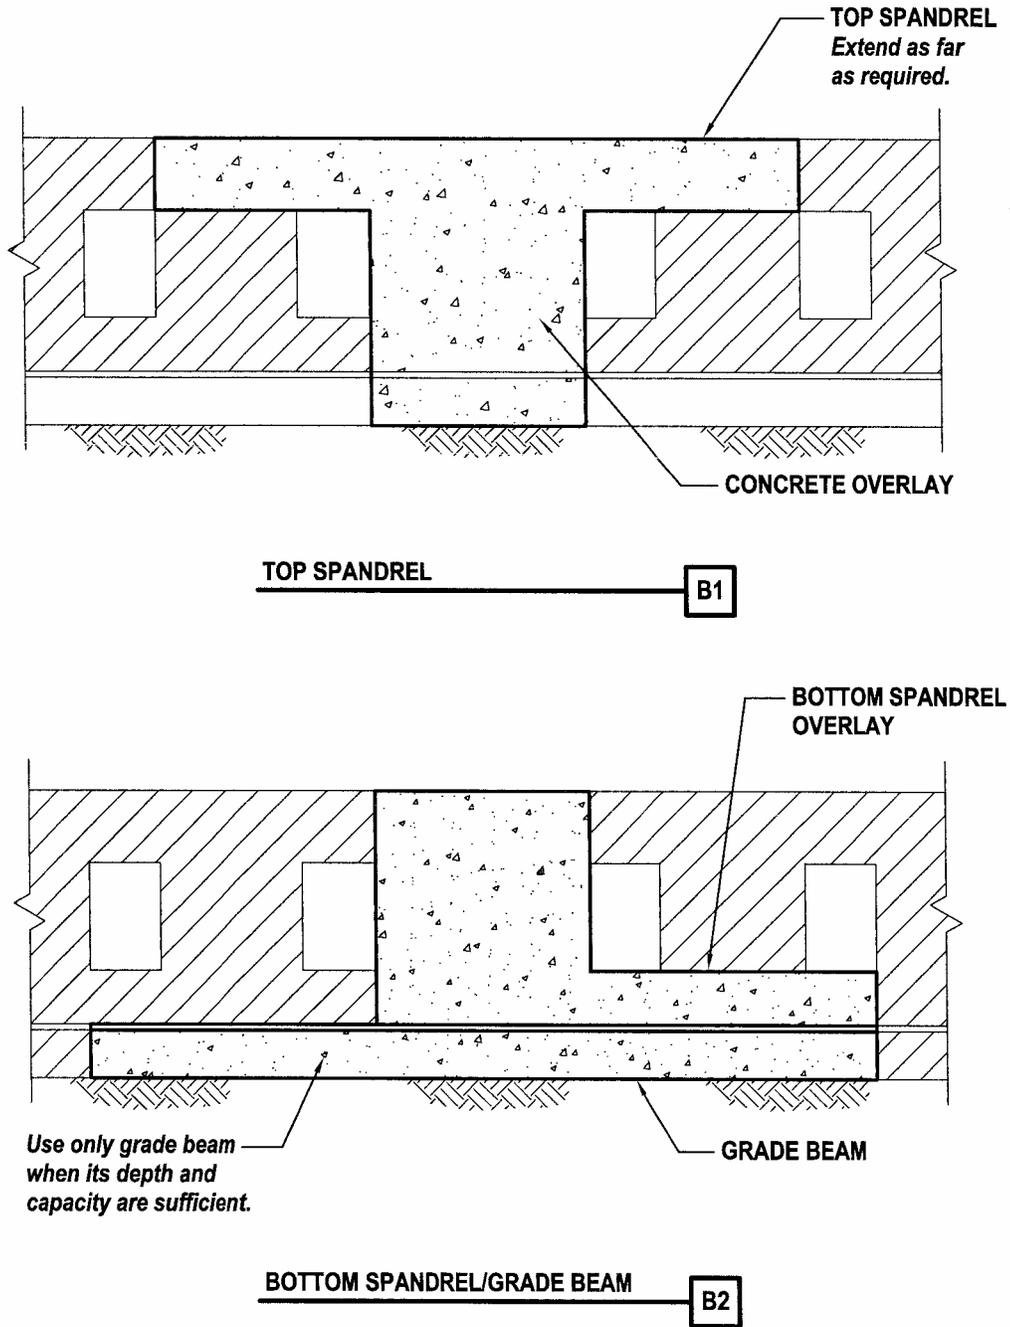
**Figure 21.4.5-2B: Alternatives to Distribute Overturning Loads in Concrete Overlay**

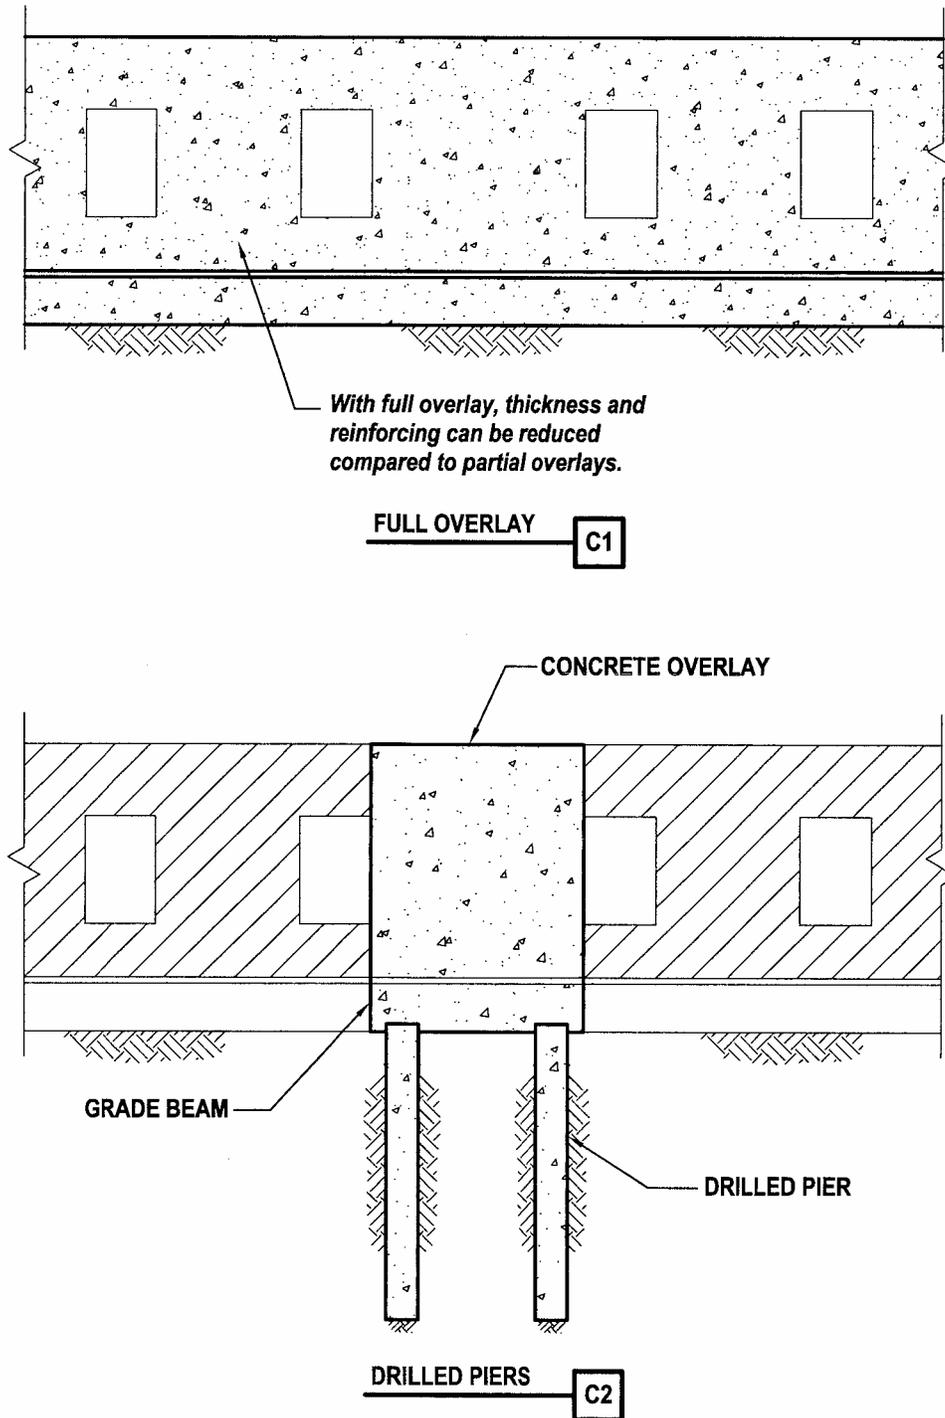
Figure 21.4.5-2C: Alternatives to Distribute Overturning Loads in Concrete Overlay

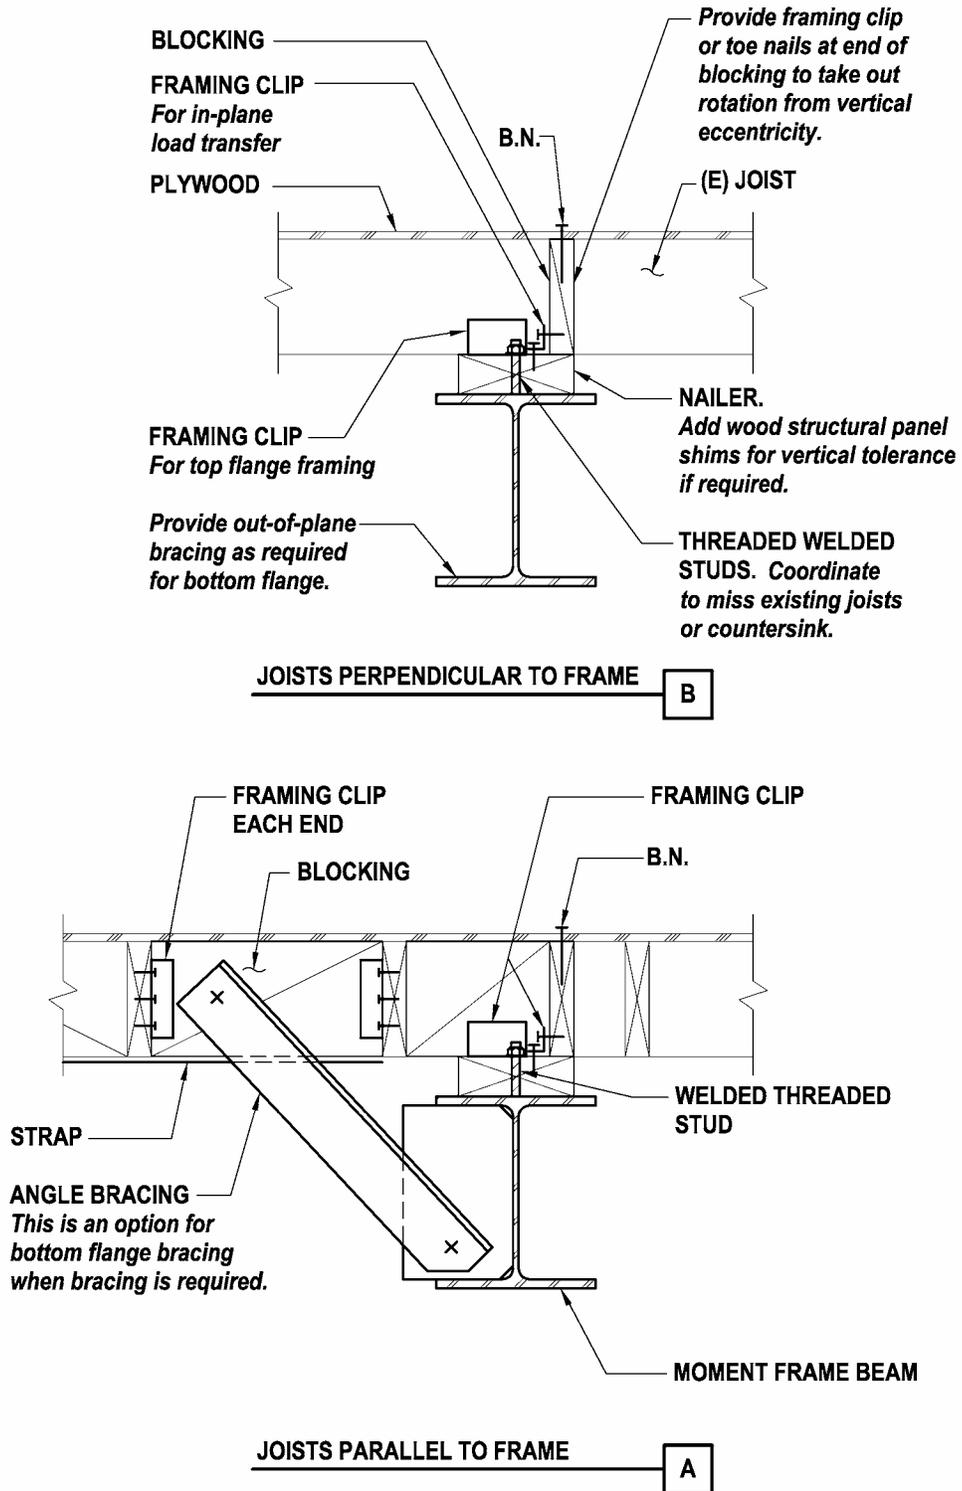
Figure 21.4.9-2: New Interior Steel Moment Frame to an Existing Wood Floor

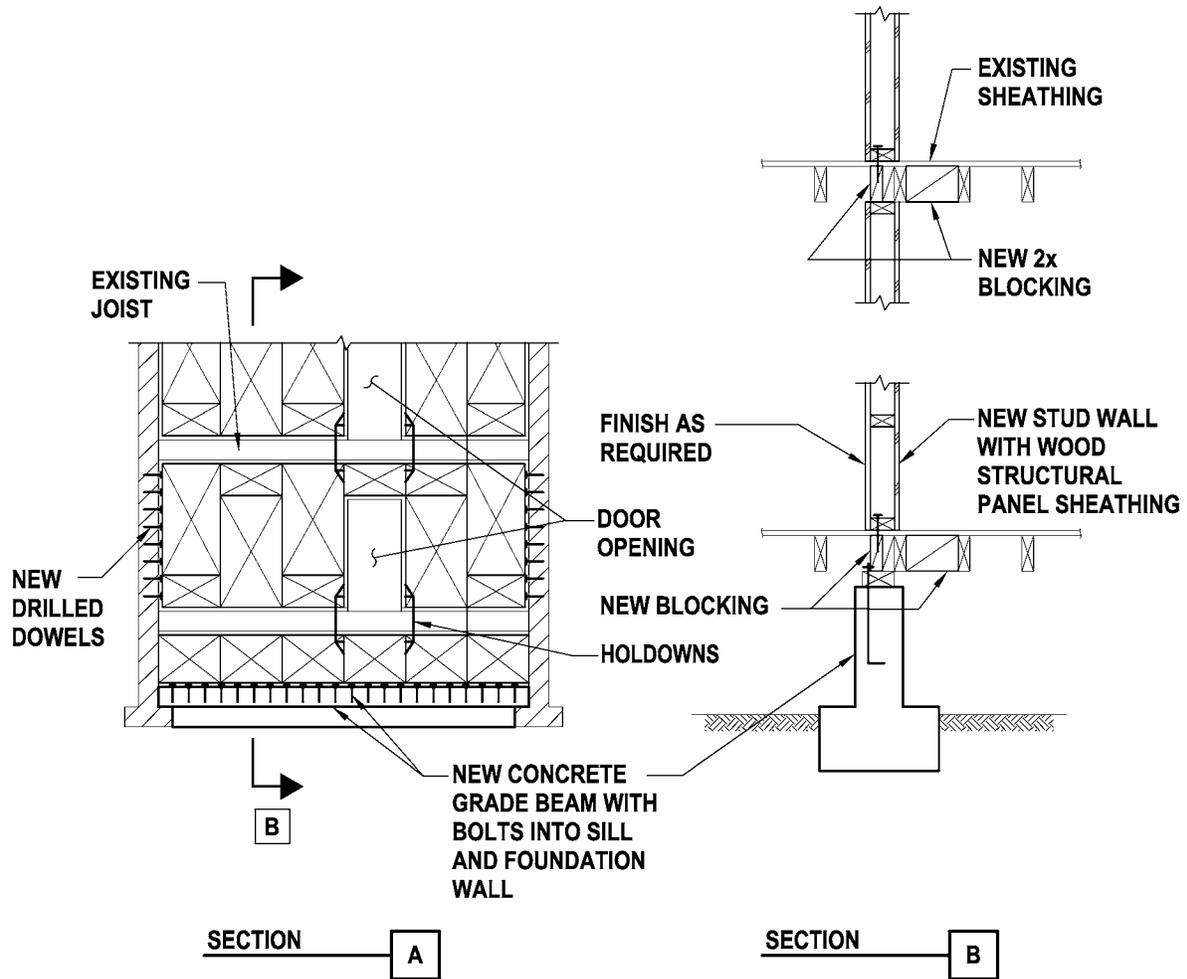
Figure 21.4.10-2: Add New Crosswalls

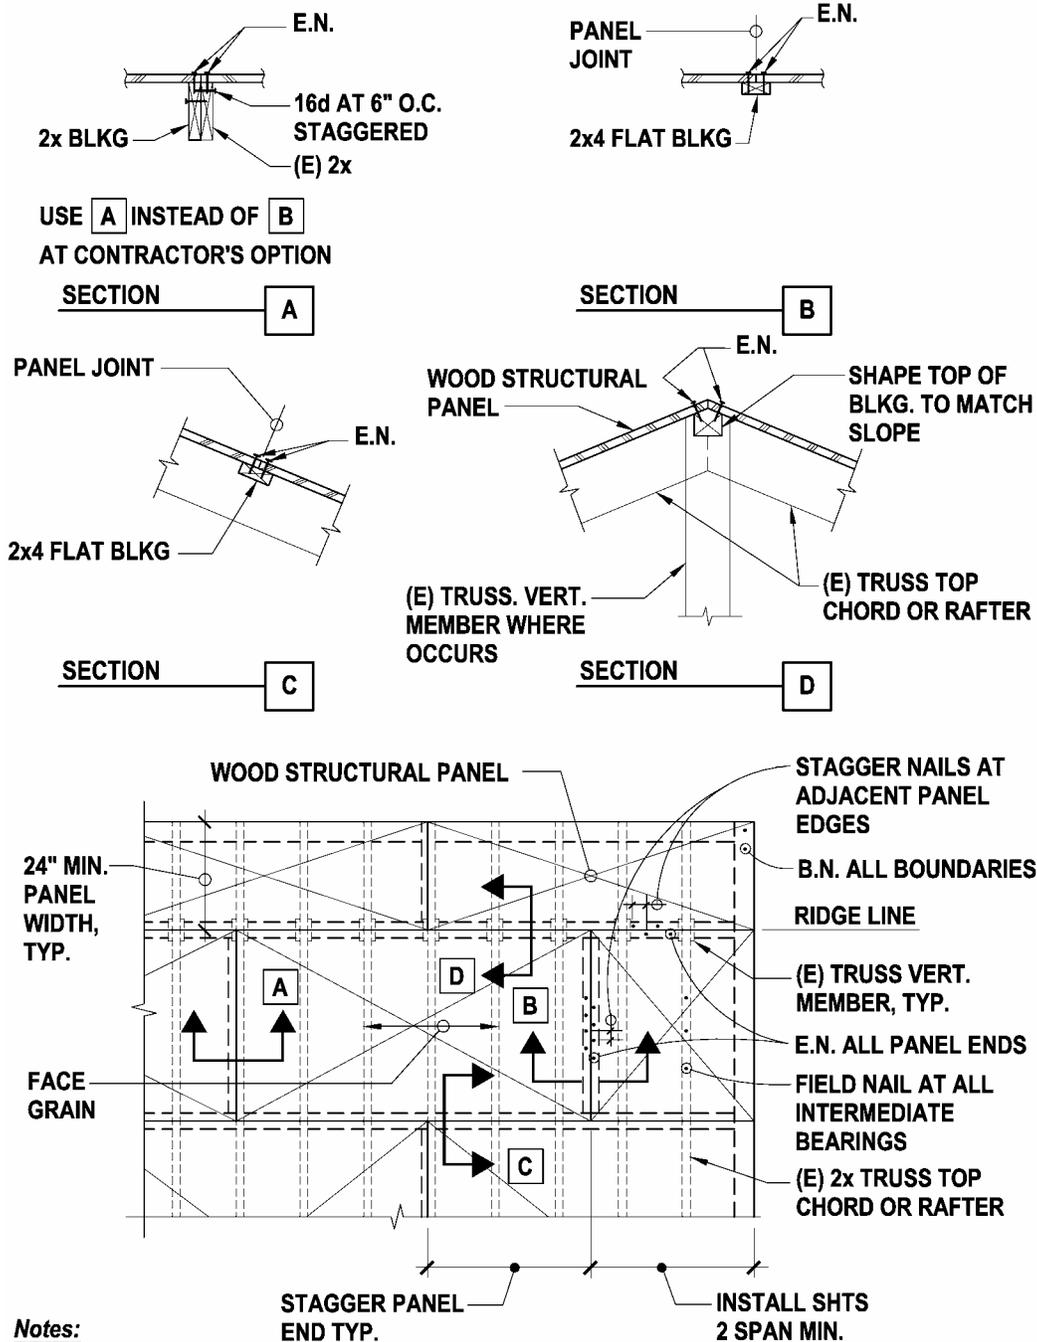
Figure 22.2.1-1: Remove and Replace Existing Wood Sheathing with Wood Structural Panel at a Roof

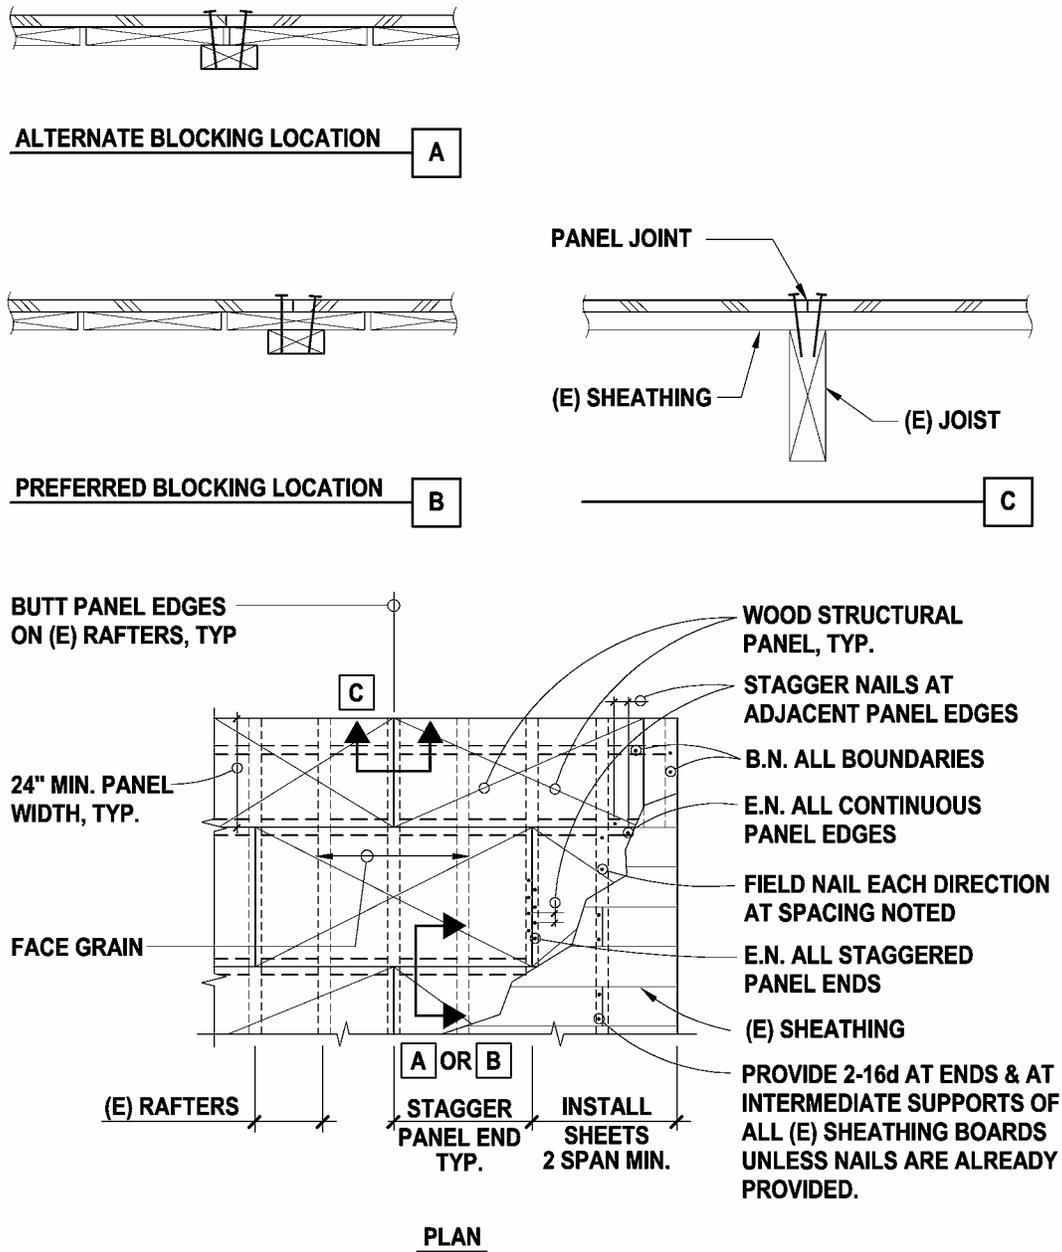
Figure 22.2.1-2: Wood Panel Overlay with Blocking Over Existing Sheathing

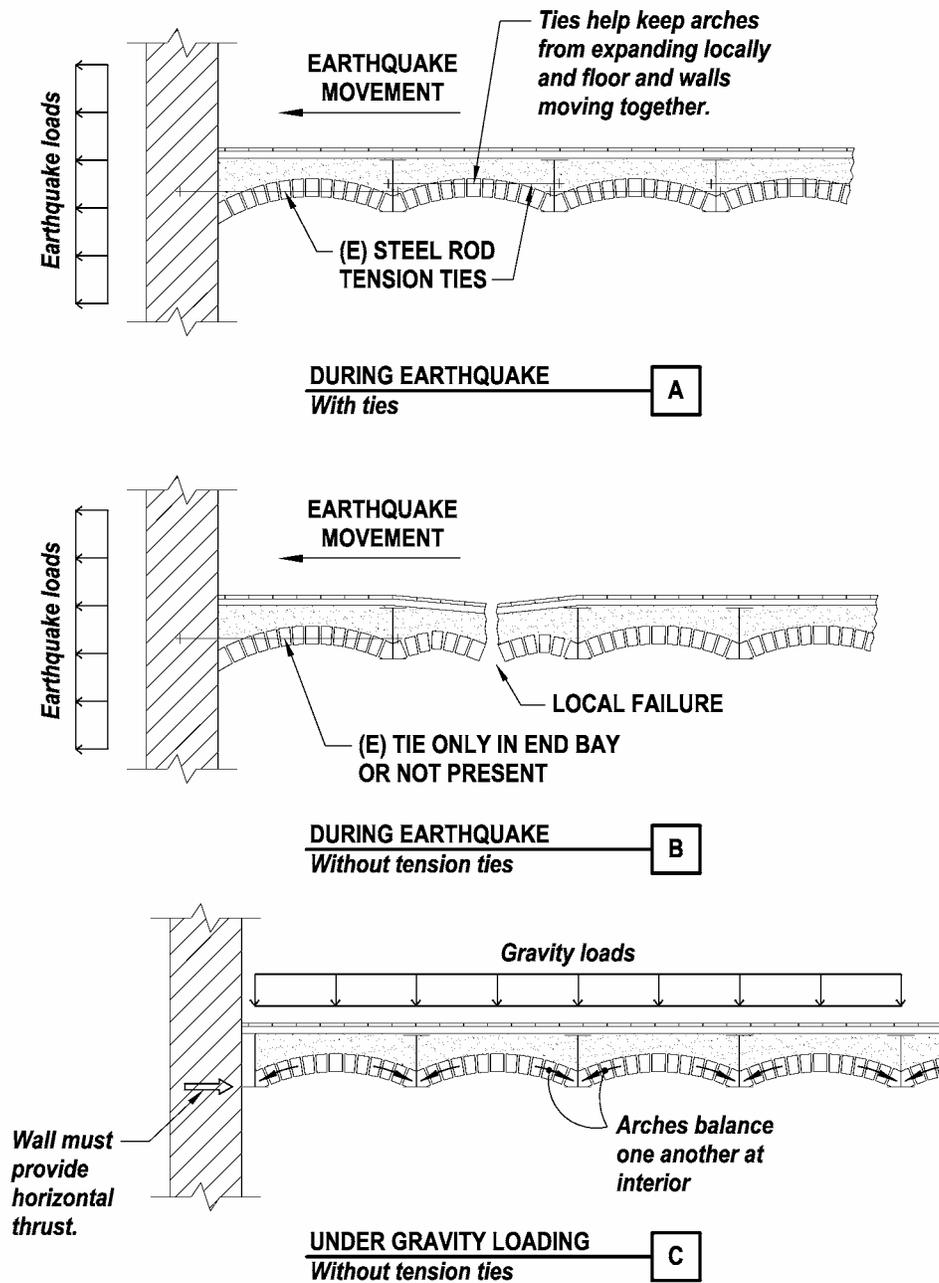
Figure 22.2.8-1: Failure Scenarios for Masonry Flat Arch Floors

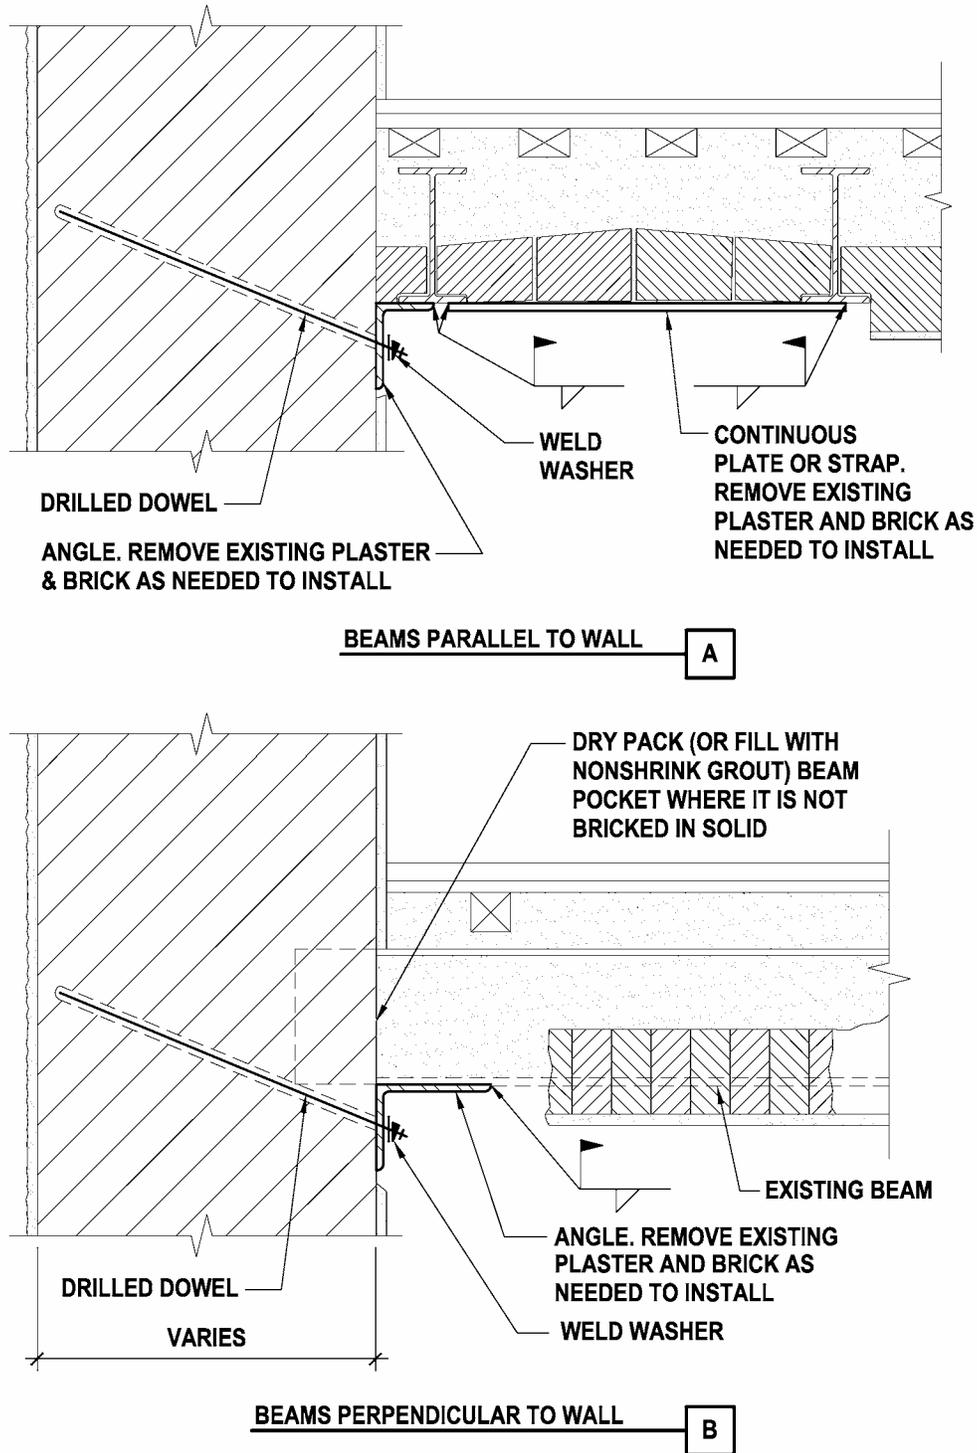
**Figure 22.2.8-2: Add Wall-to-Diaphragm Ties and Chord for Masonry Flat Arch Floor - Access from Below the Floor**

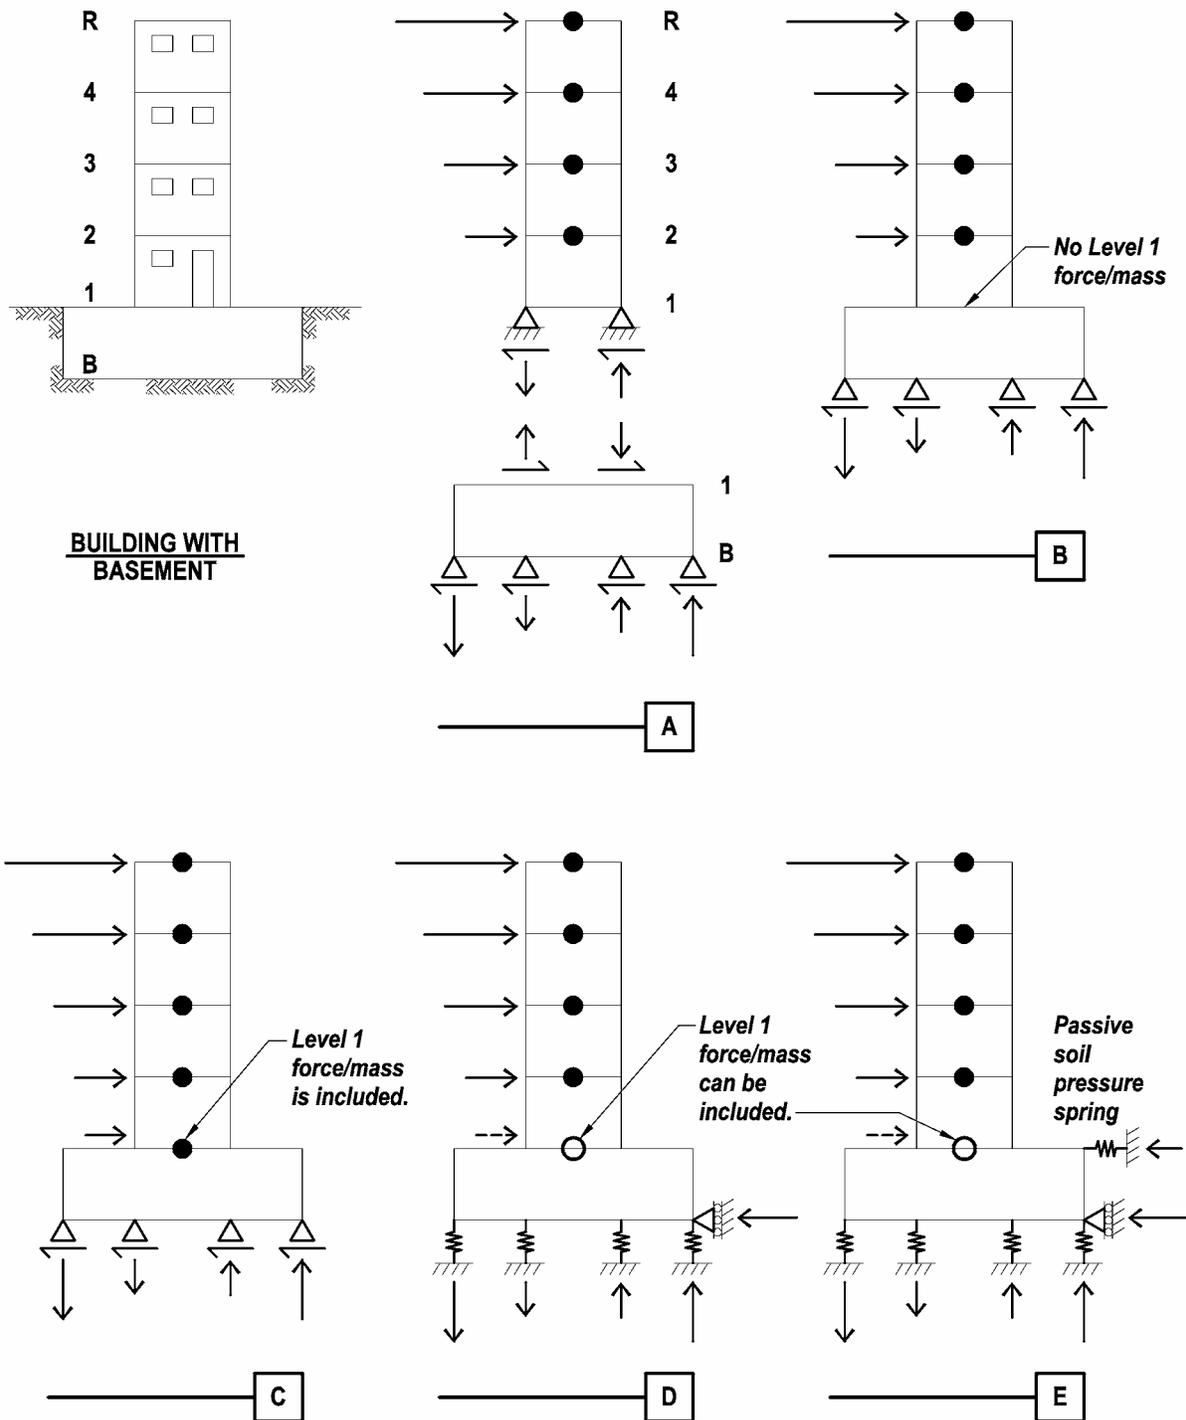
Figure 23.4-1: Modeling Approaches for Buildings with Basements

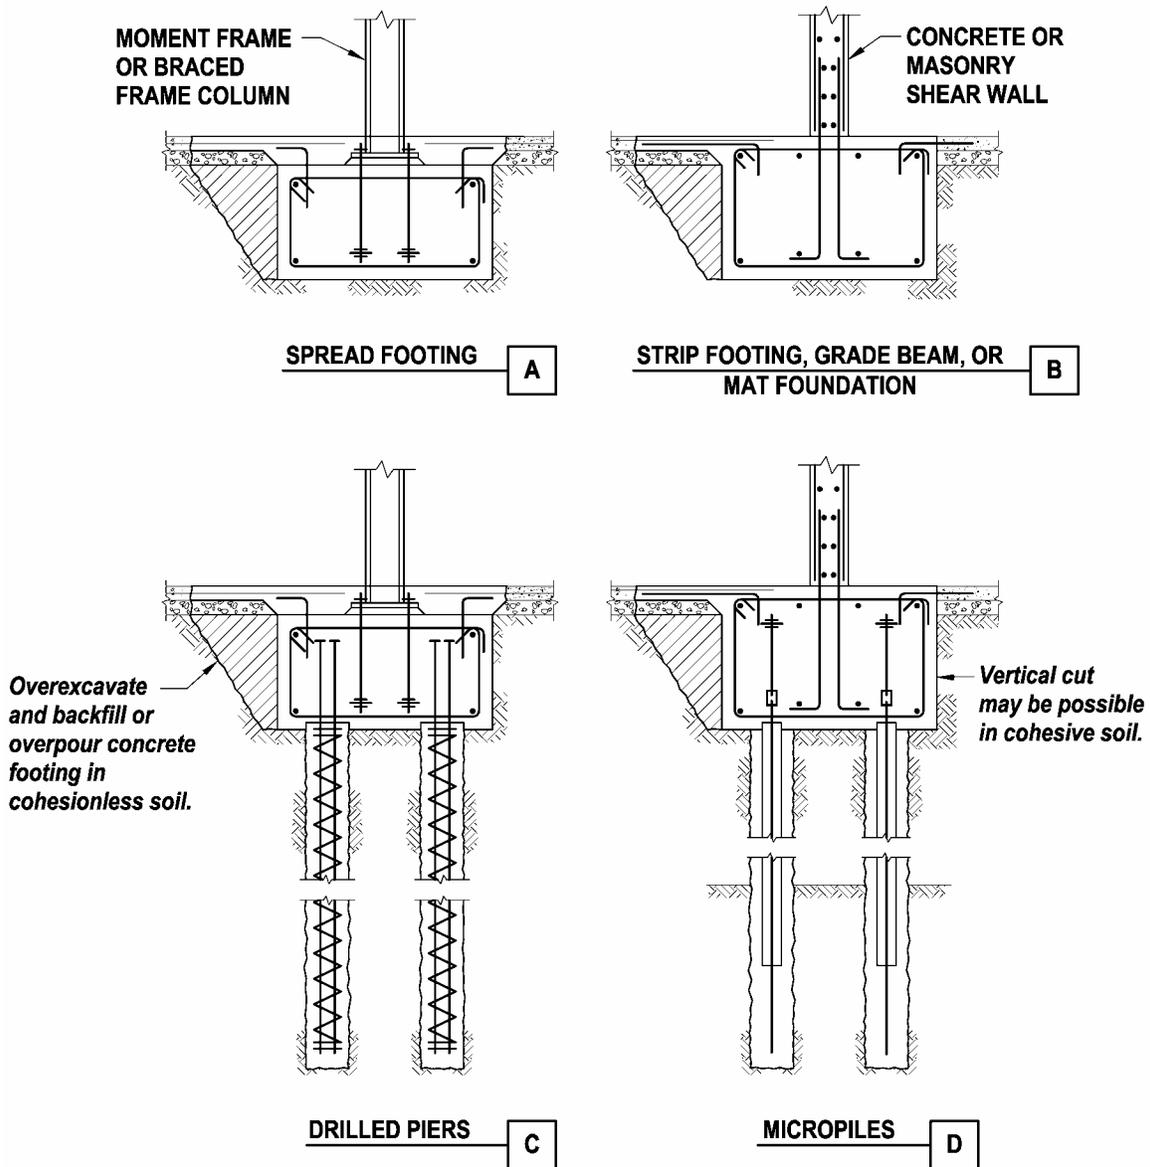
**Figure 23.6.1-1: Types of New Foundations Commonly Used in Seismic Rehabilitation**

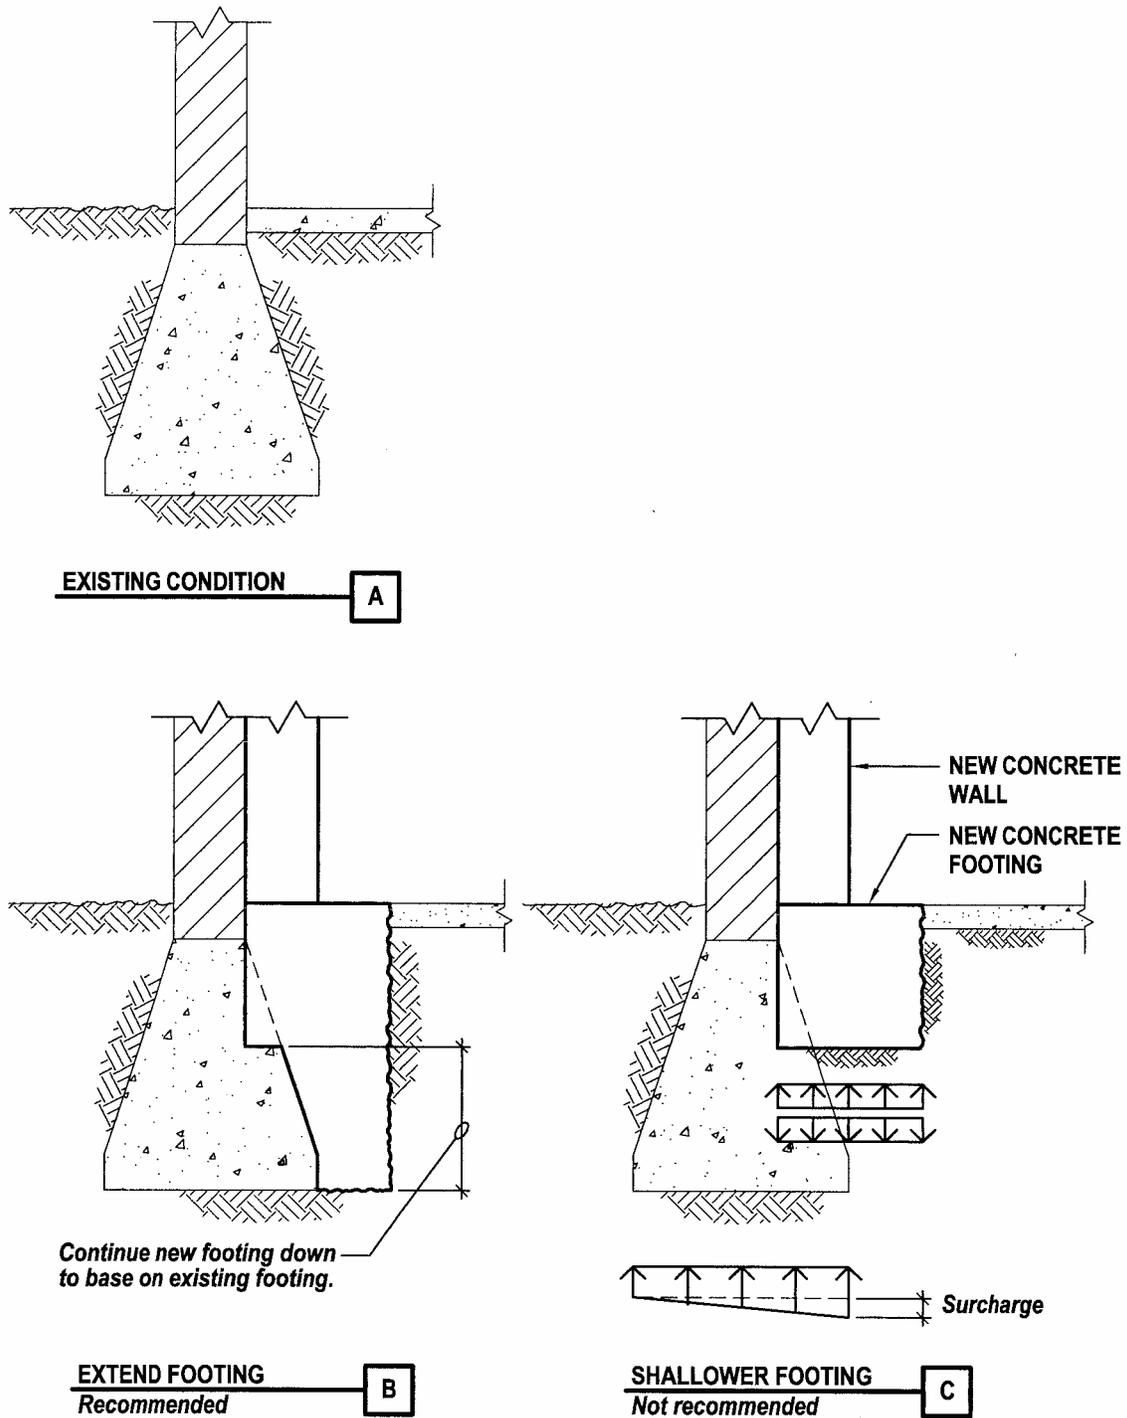
**Figure 23.6.2-3: New Shallow Footing Does Not Need to be as Deep as Existing Shallow Footing**

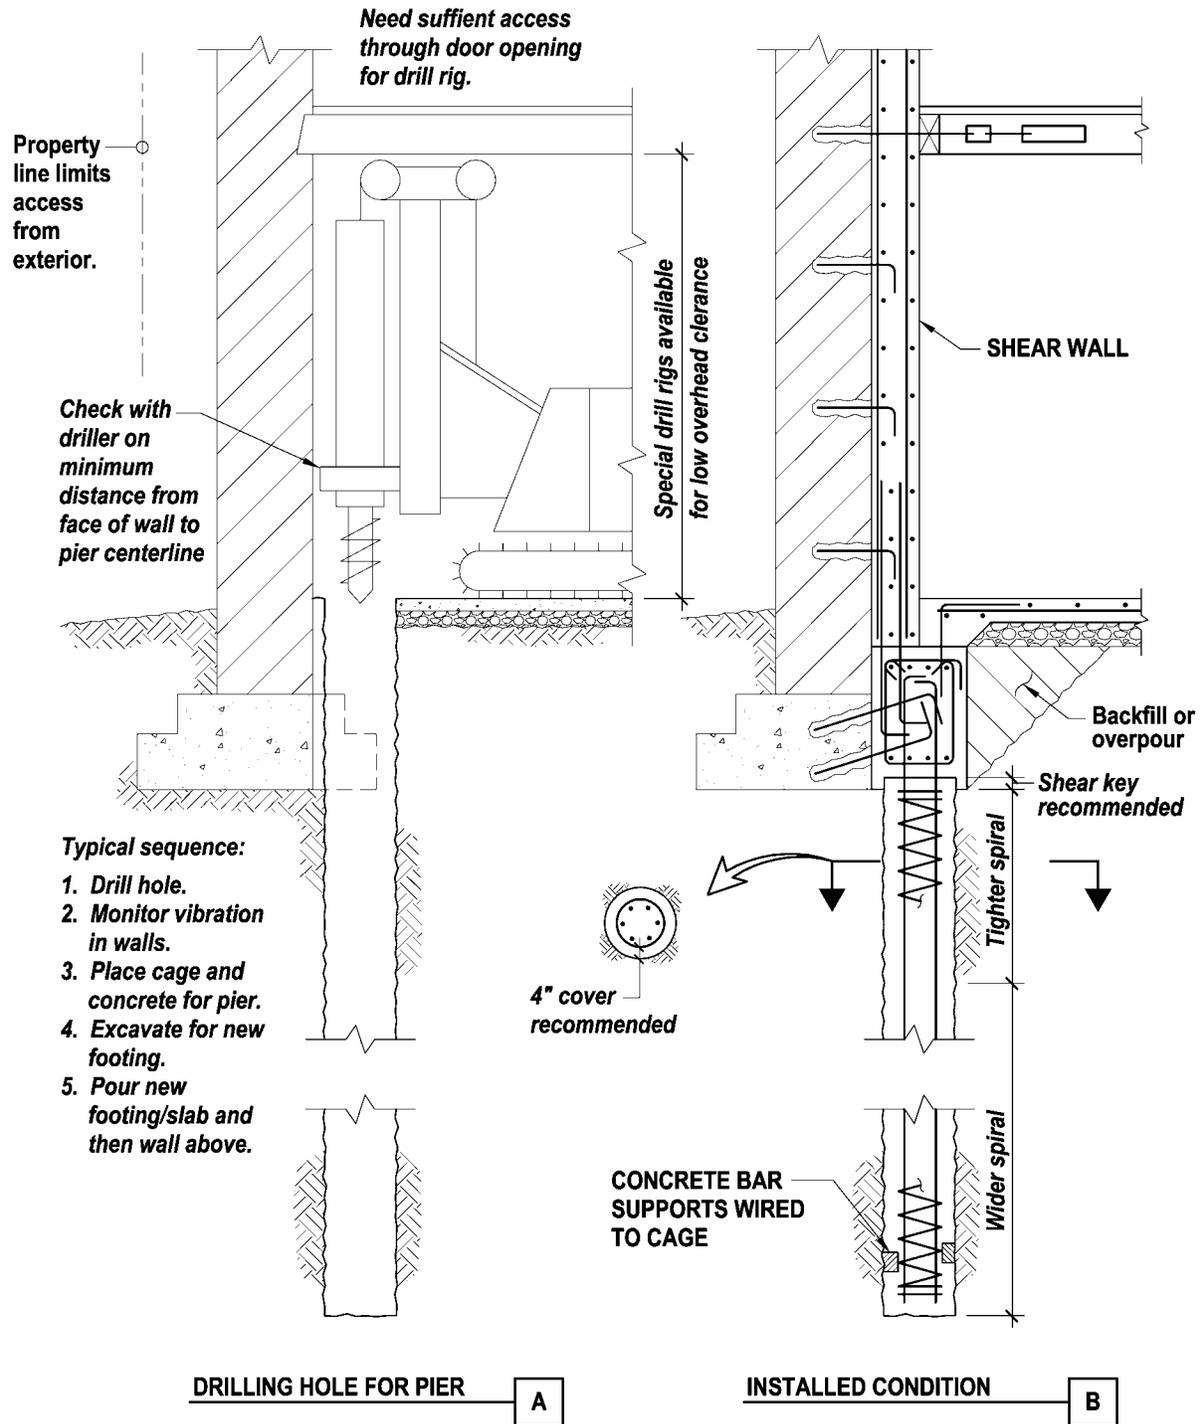
Figure 23.6.4-1: New Drilled Pier Next to Existing Strip Foundation

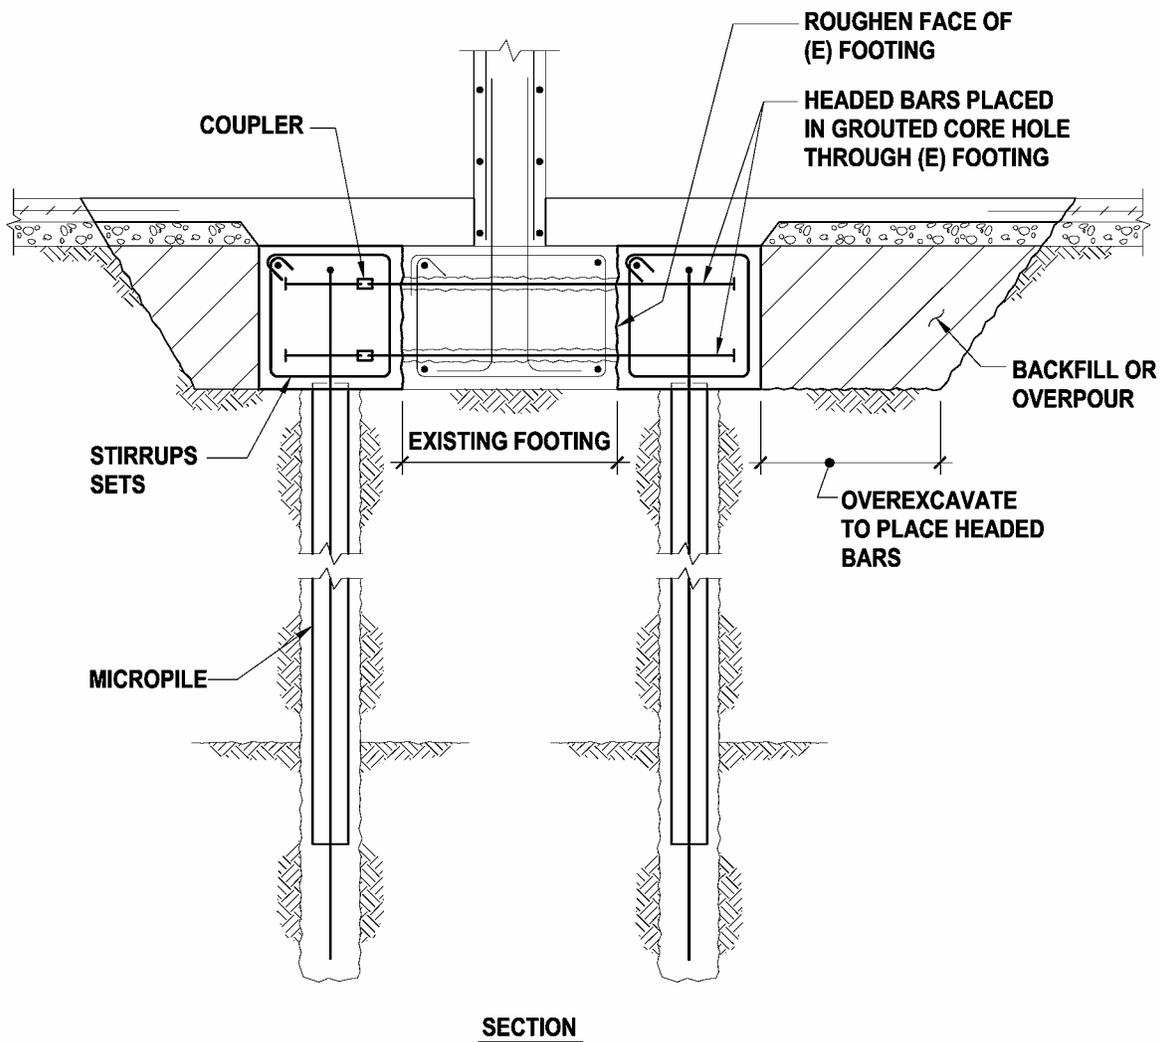
**Figure 23.7.2.-1: Micropile Enhancement to Existing Strip Footing**
