# Techniques for the Seismic Rehabilitation of Existing Buildings

**FEMA 547 – October 2006**

Rutherford & Chekene (R & C) Consulting Engineers (Subconsultant) under contract with National Institute of Standards and Technology (NIST).

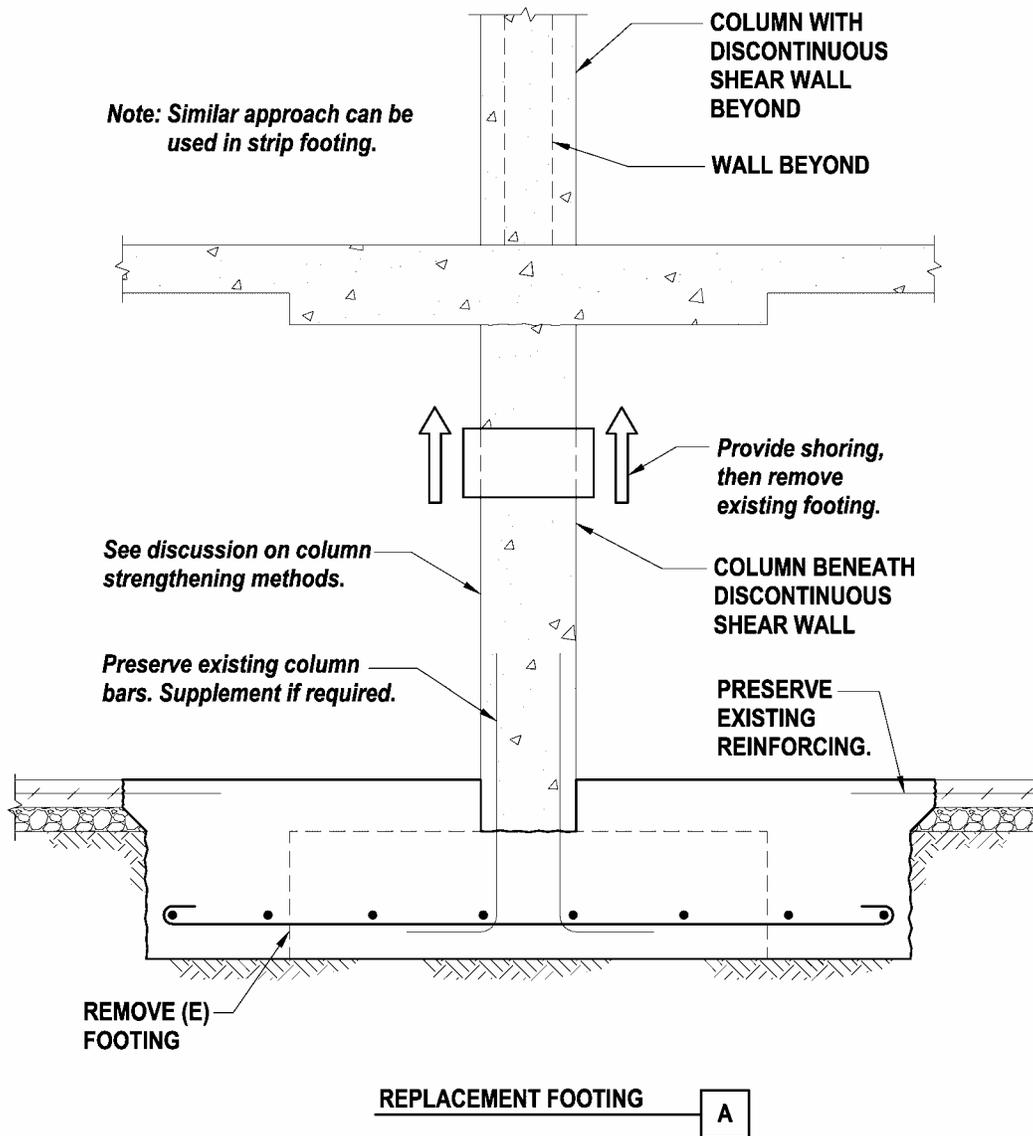
**Figure 23.7.3-2: Replace Existing Spread Footing**

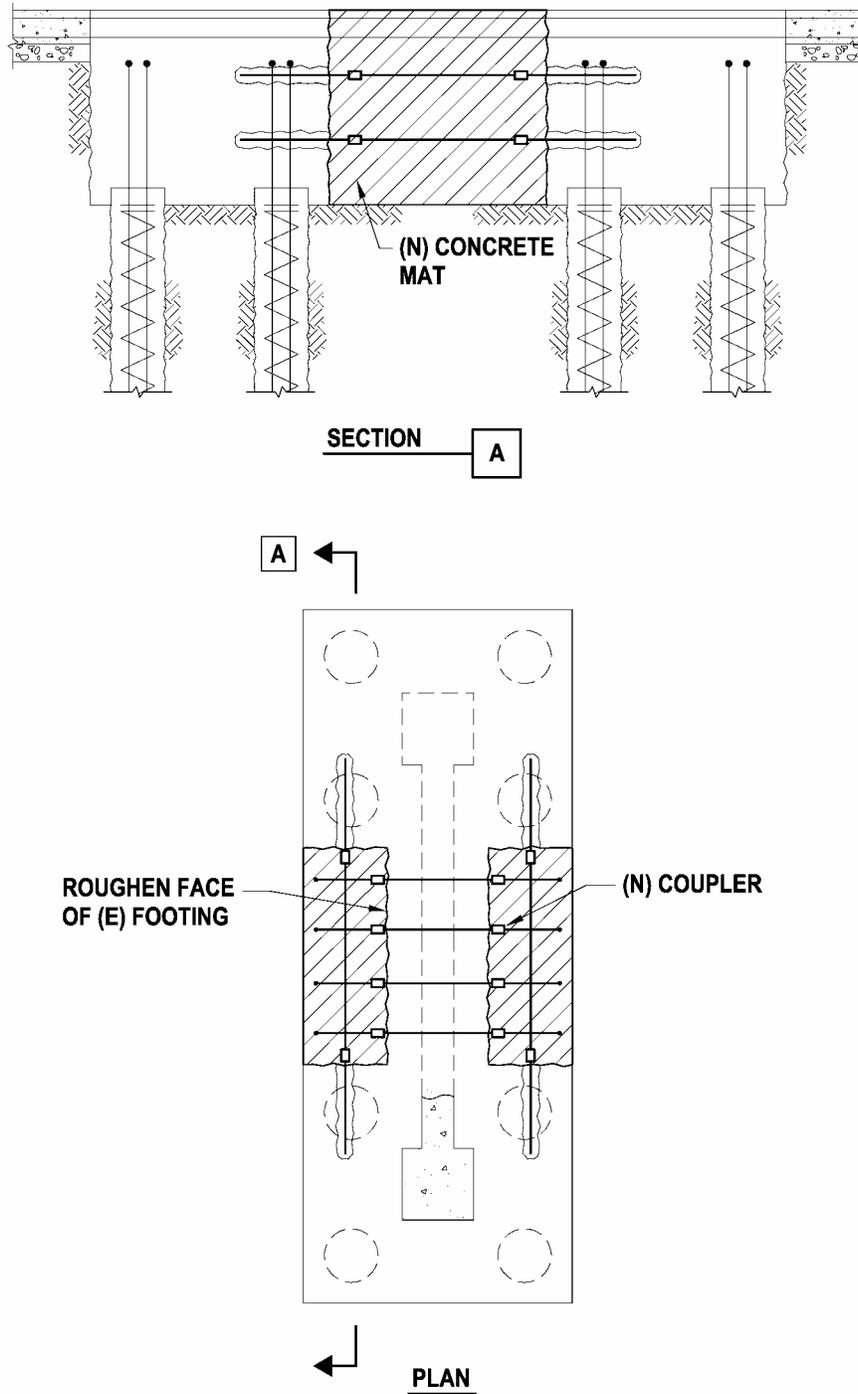
Figure 23.8.2-1: New Mat Foundation Between Existing Drilled Piers

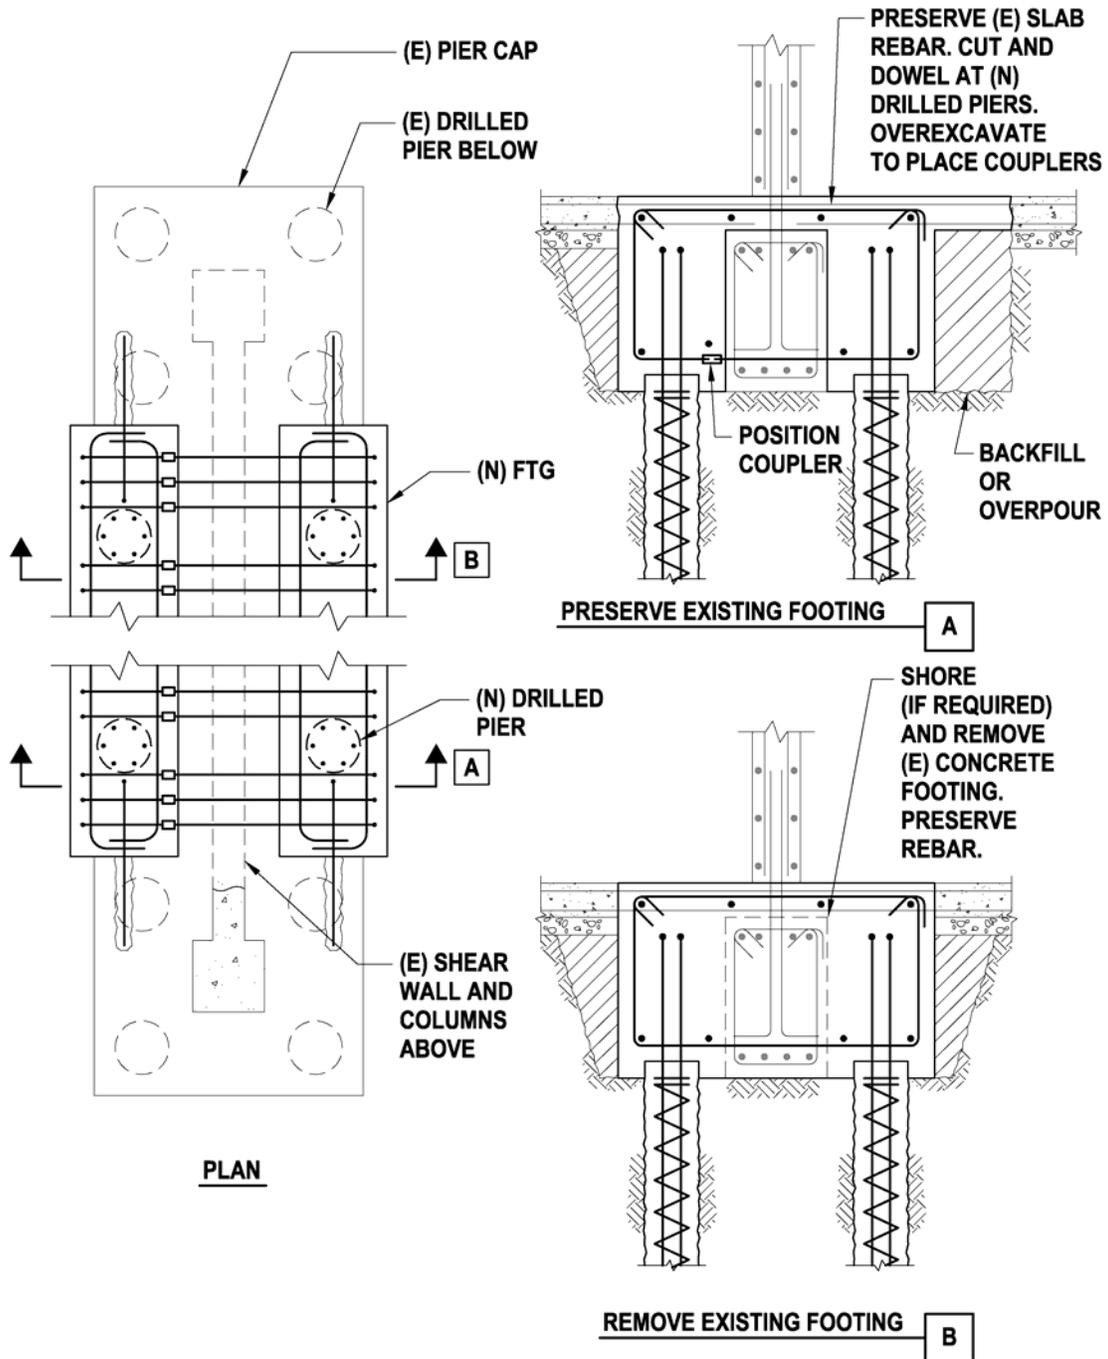
Figure 23.8.3.-1: Adding Drilled Piers to an Existing Drilled Pier Foundation

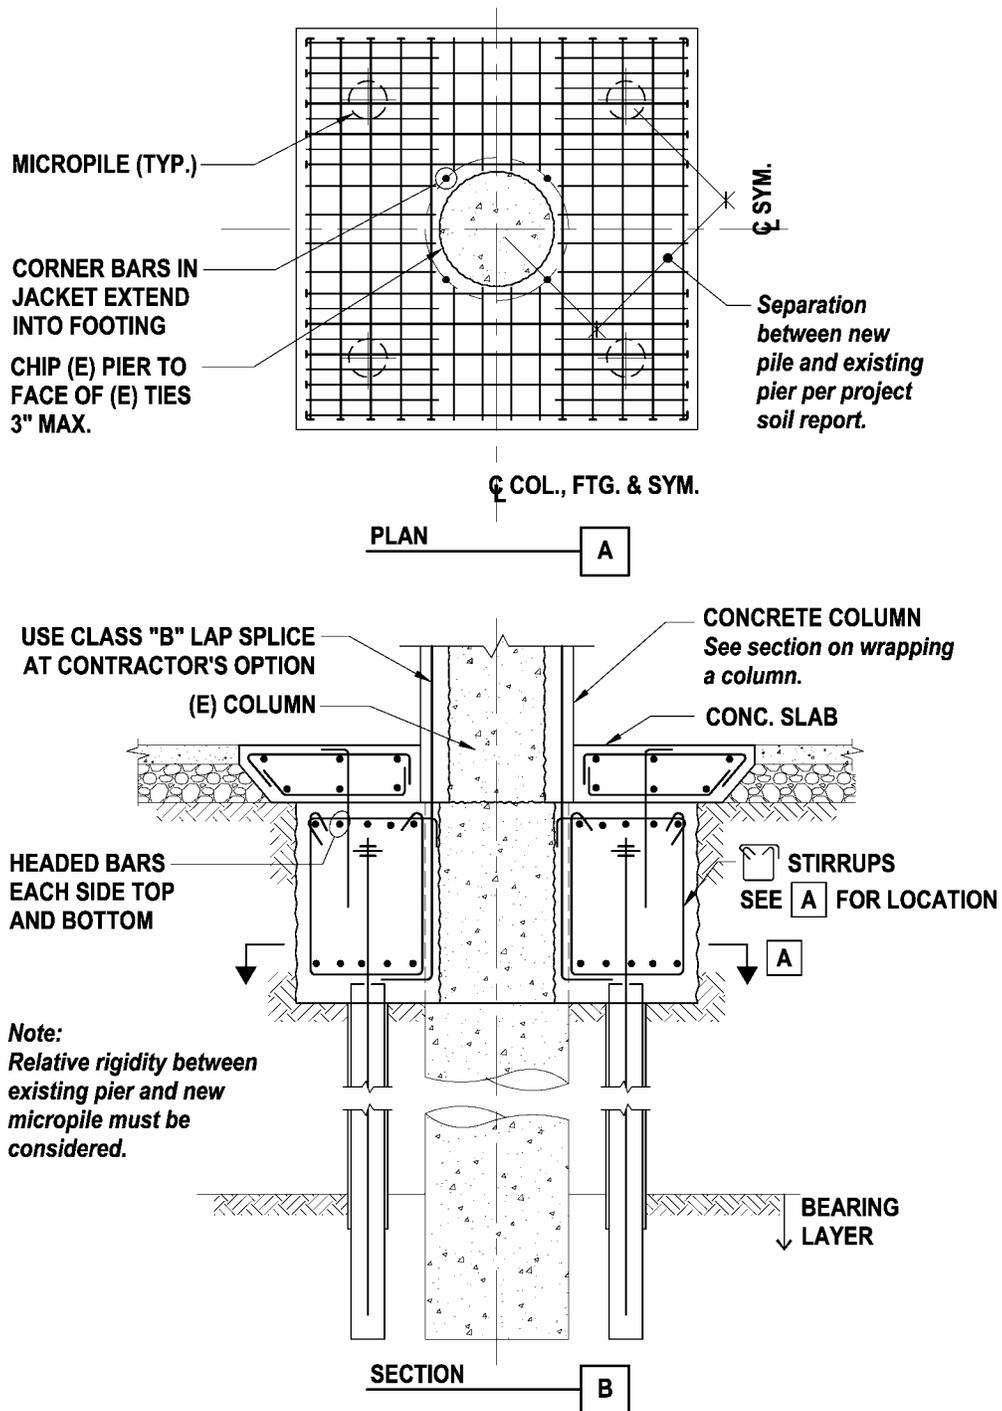
Figure 23.8.4.-1: Micropile Enhancement of an Existing Drilled Pier Footing

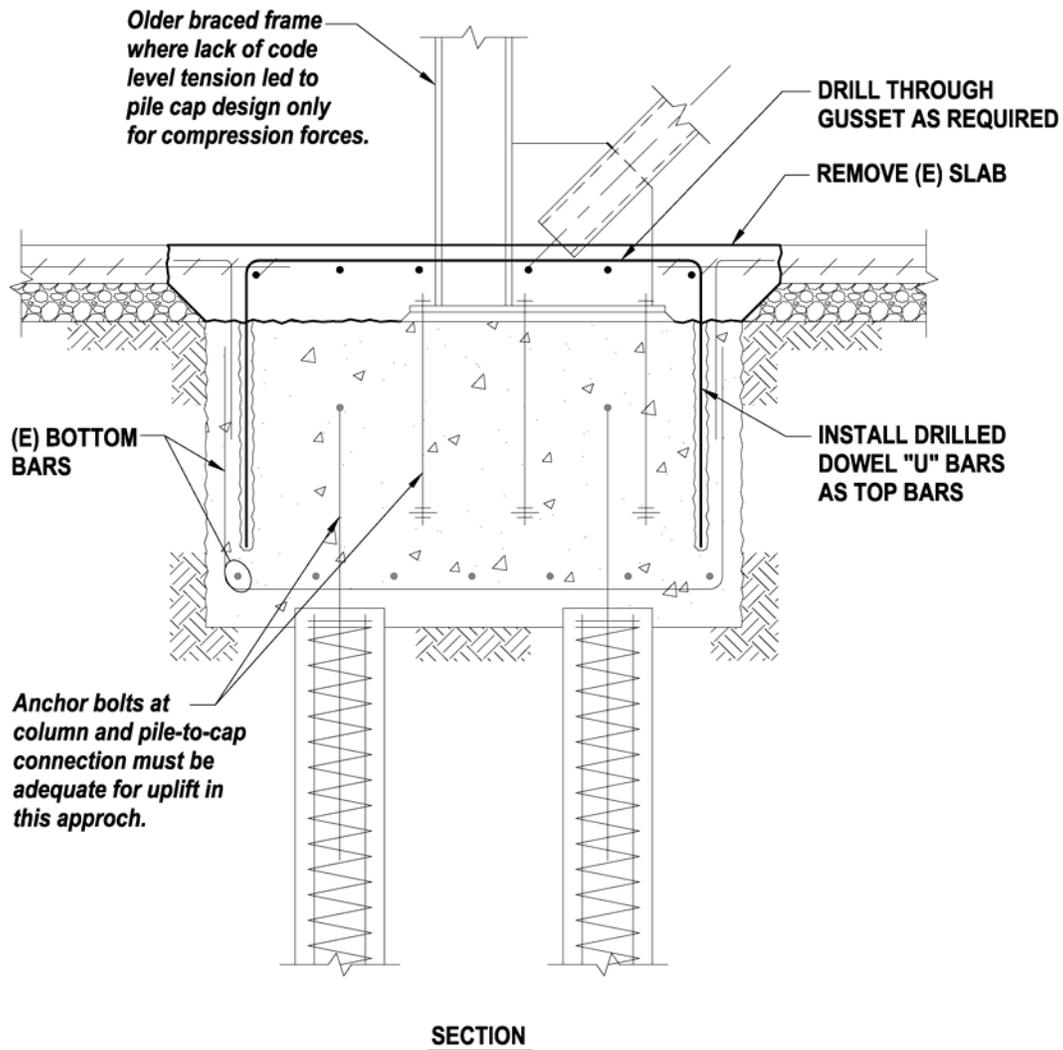
**Figure 23.8.5-1: Adding Top Bars to an Existing Pile Cap**

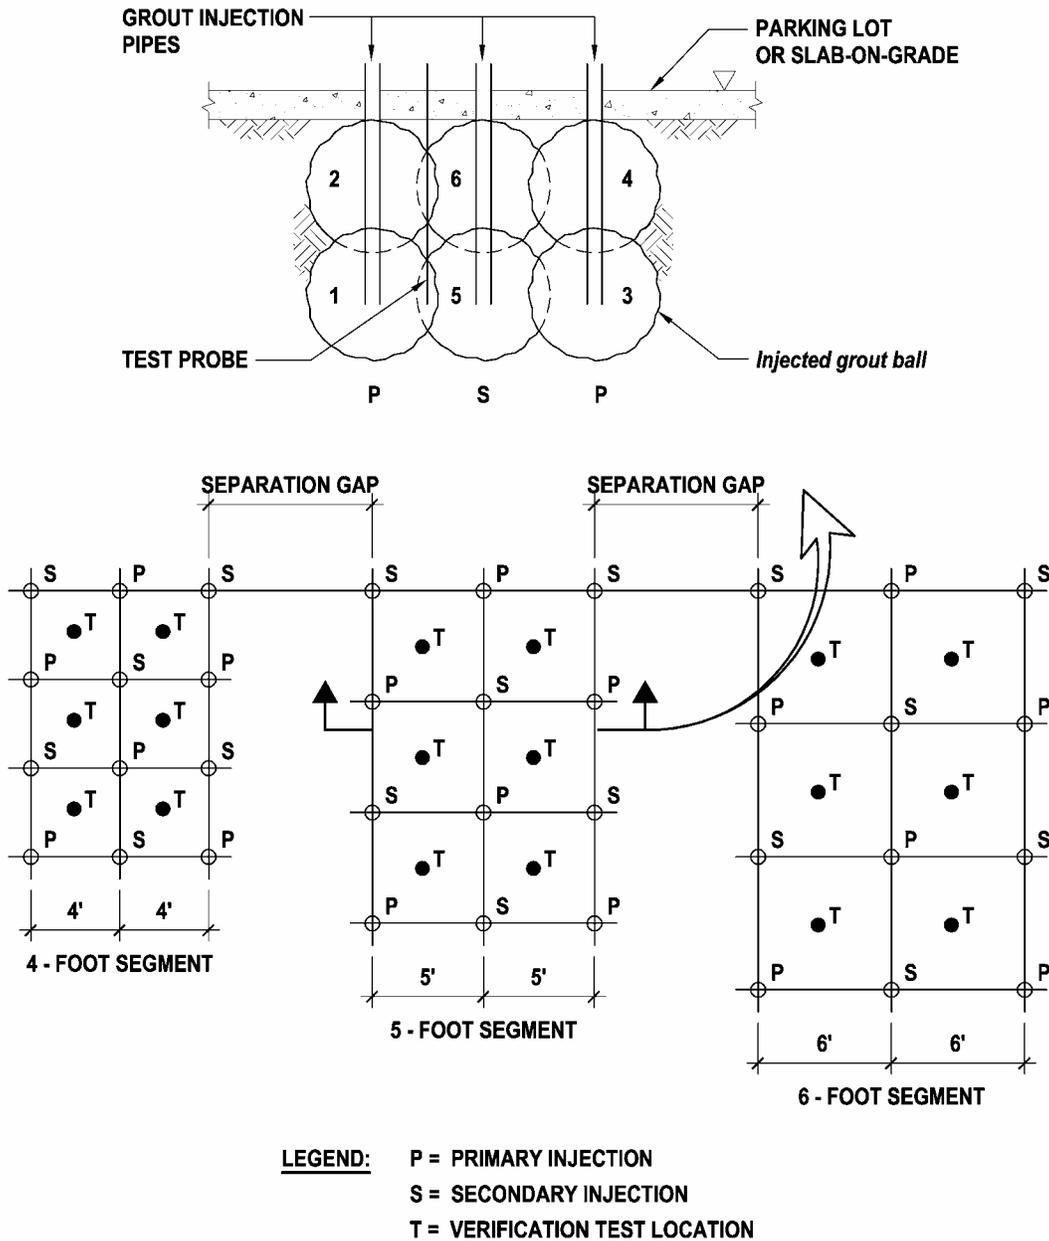
**Figure 23.9.2-1: Compaction Grouting Under Existing Shallow Foundations – Pilot Test Program**

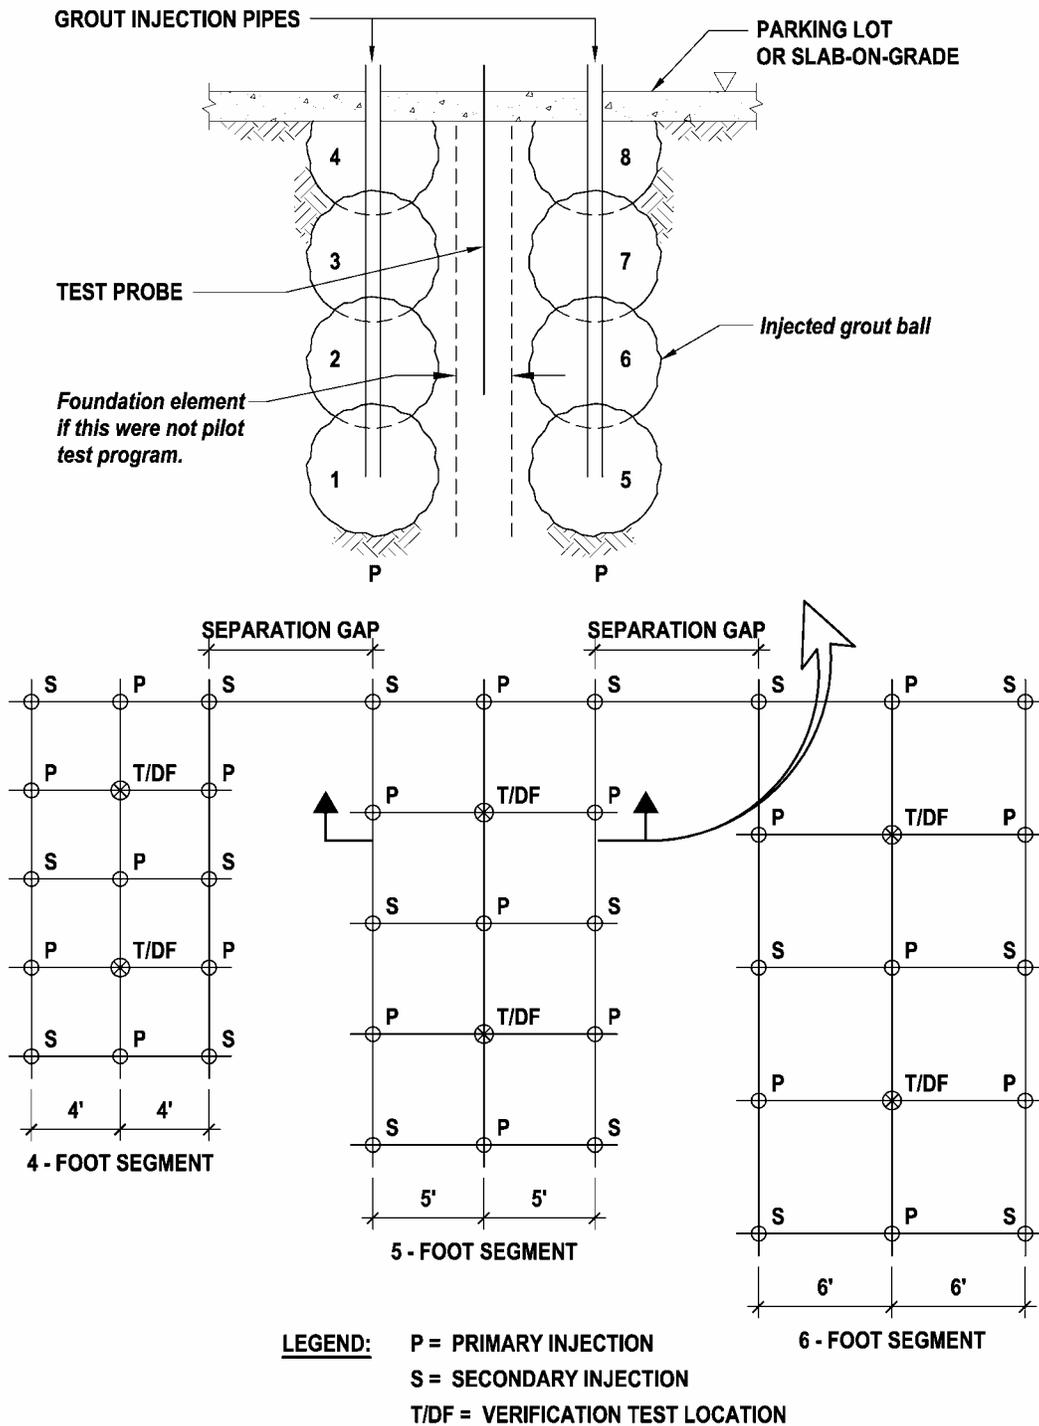
**Figure 23.9.2-2: Compaction Grouting Under Existing Deep Foundations – Pilot Test Program**

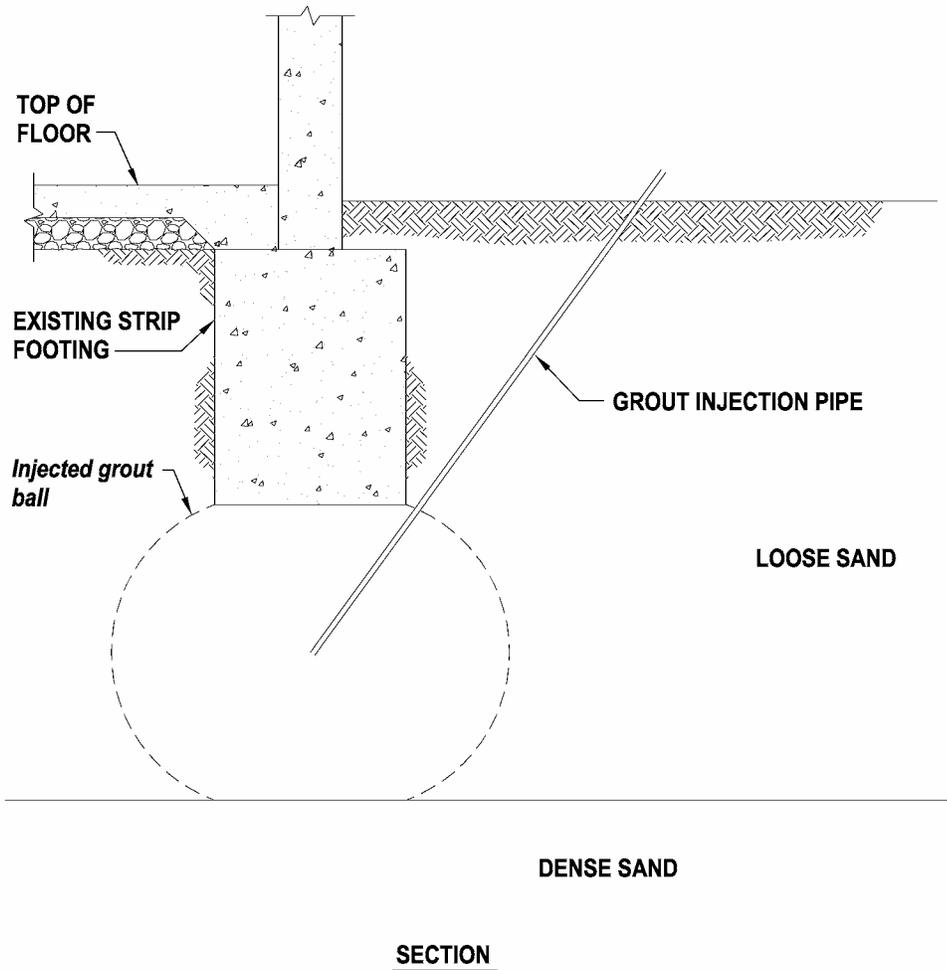
**Figure 23.9.3-1: Permeation Grouting of Loose Sand Under Existing Shallow Foundation**

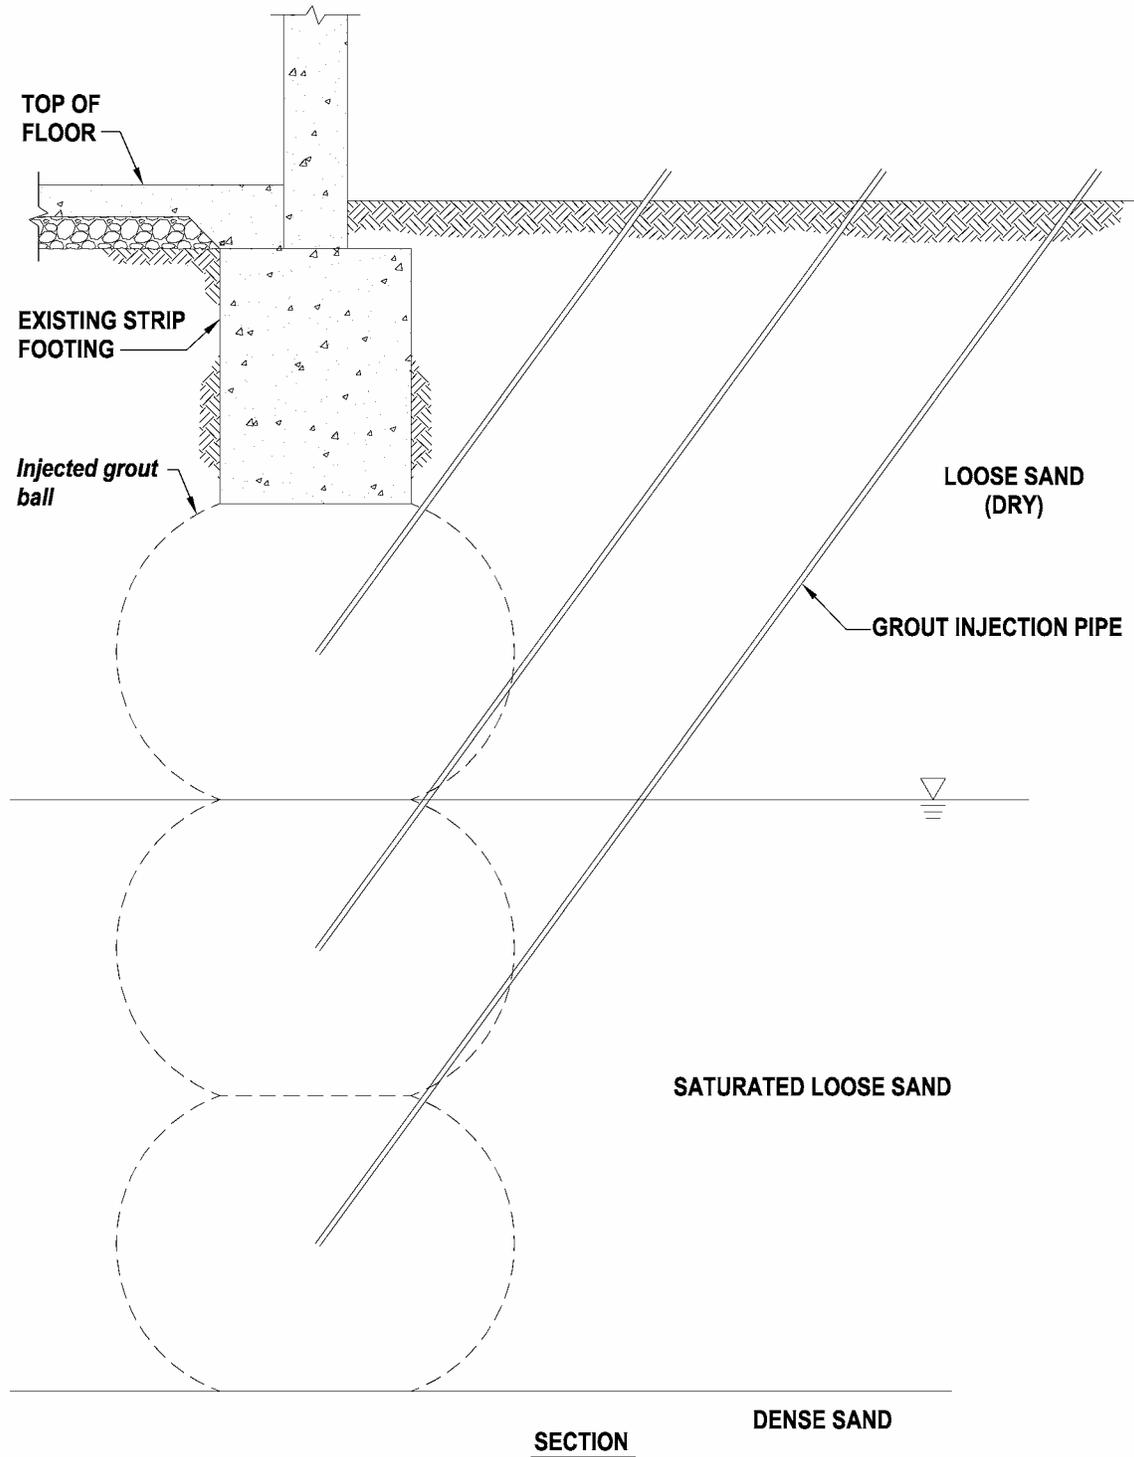
**Figure 23.9.3-2: Permeation Grouting of Liquefiable Layer Under Existing Shallow Foundation**

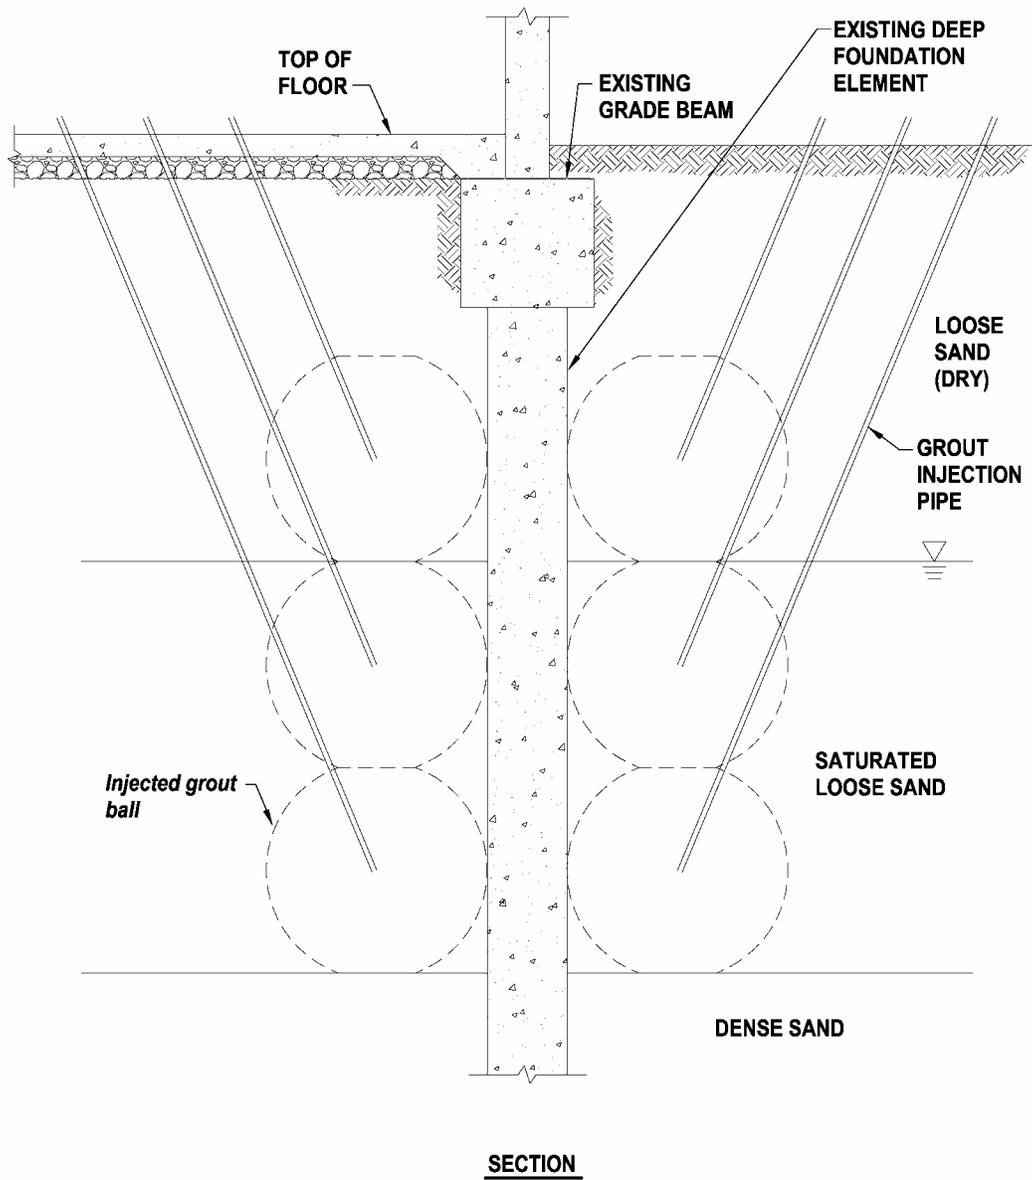
**Figure 23.9.3-3: Permeation Grouting of Liquefiable Layer Around Existing Deep Foundation**

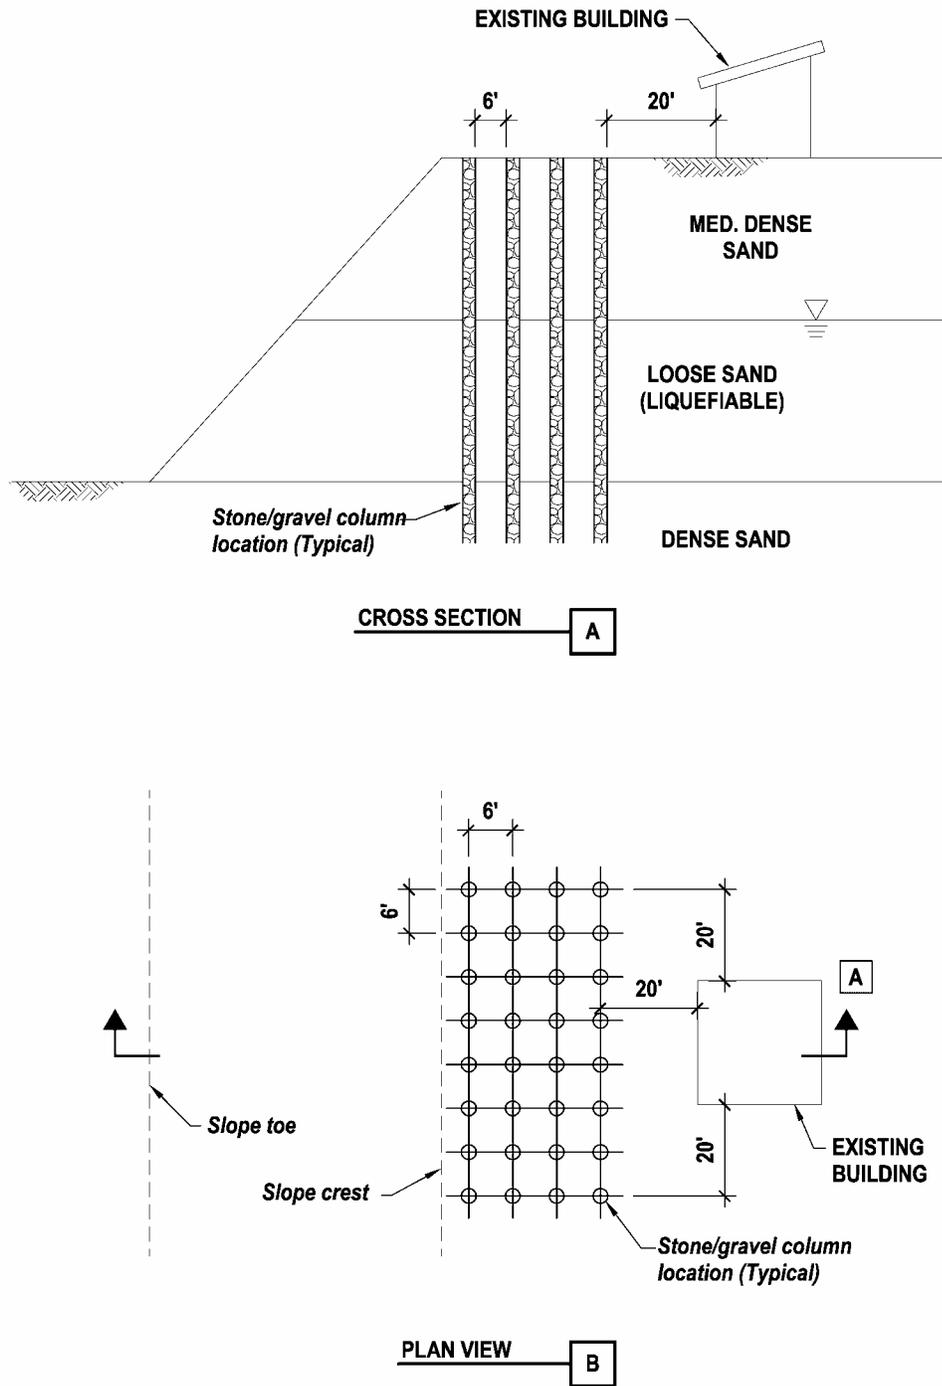
Figure 23.10.3-2: Mitigation Measure for Lateral Spreading – Stone/Gravel Column

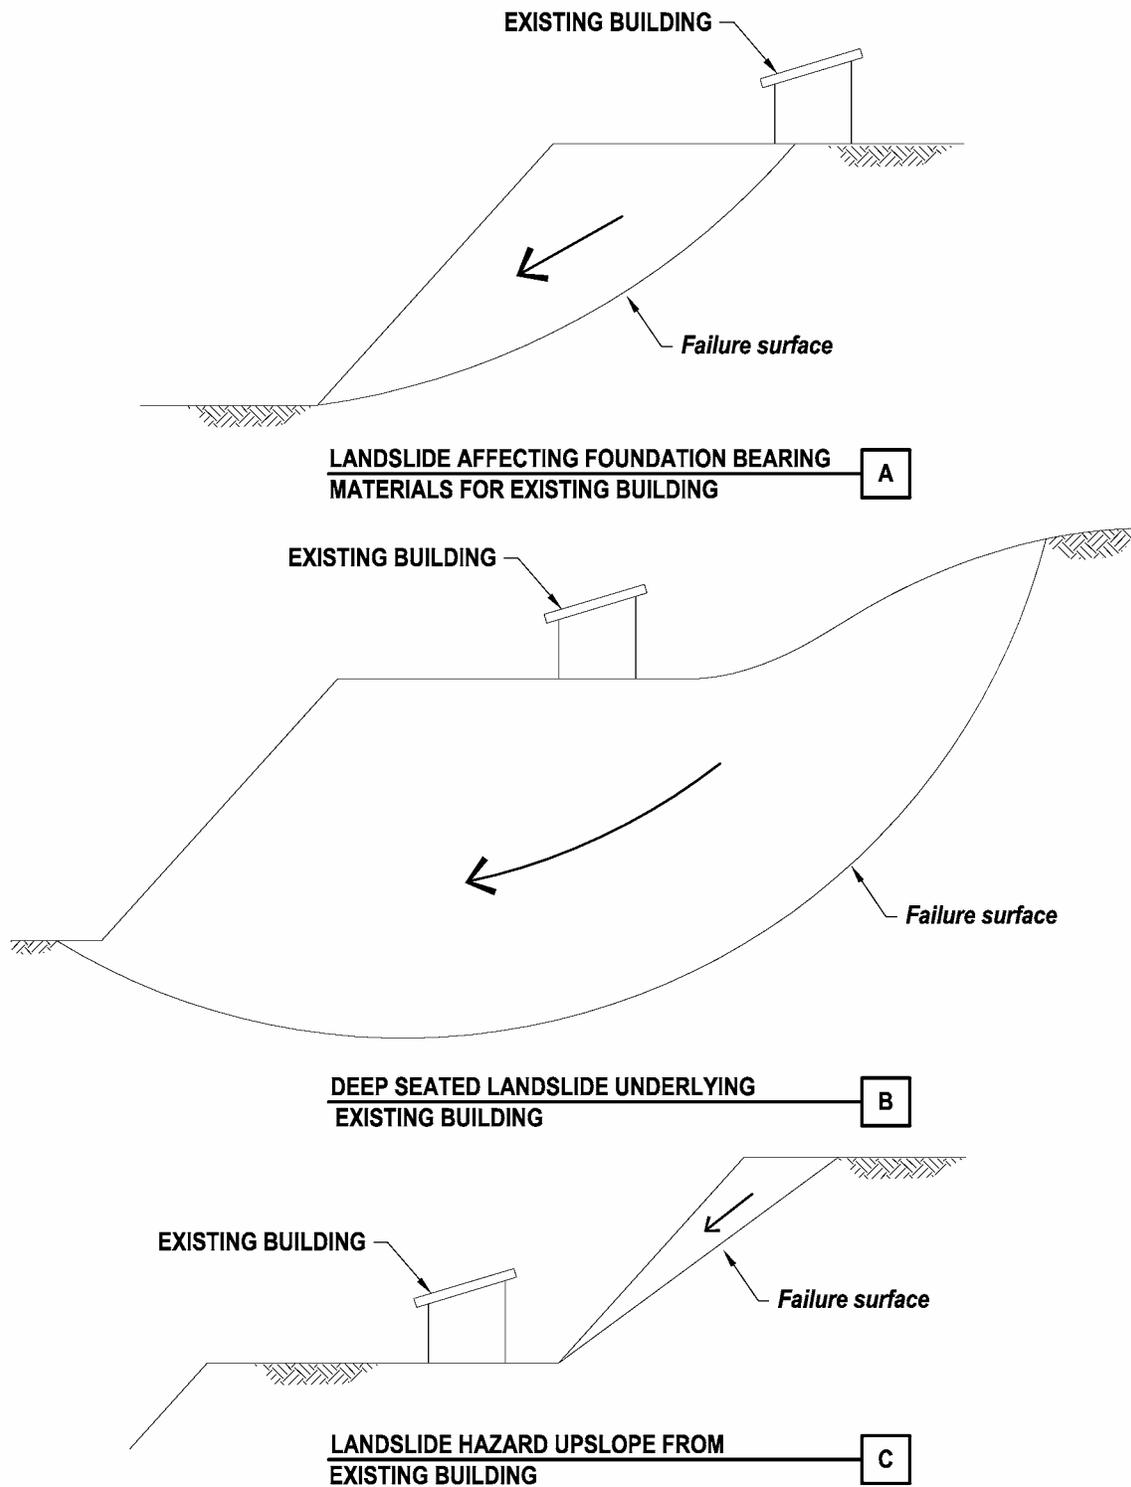
Figure 23.10.4-1: Landslide Hazards

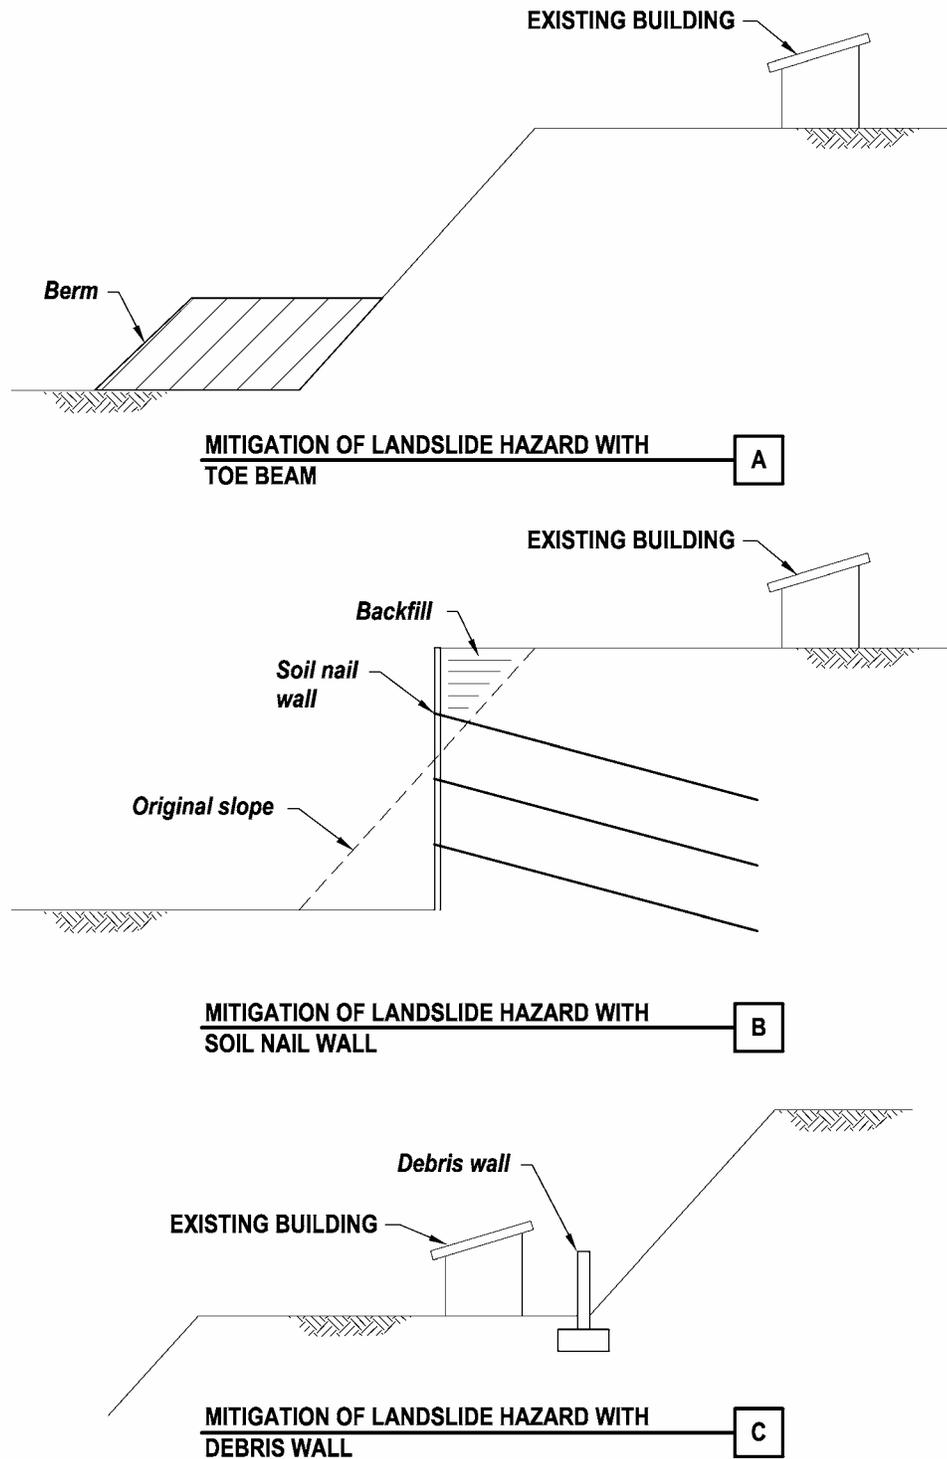
Figure 23.10.4-2: Mitigation of Landslide Hazards

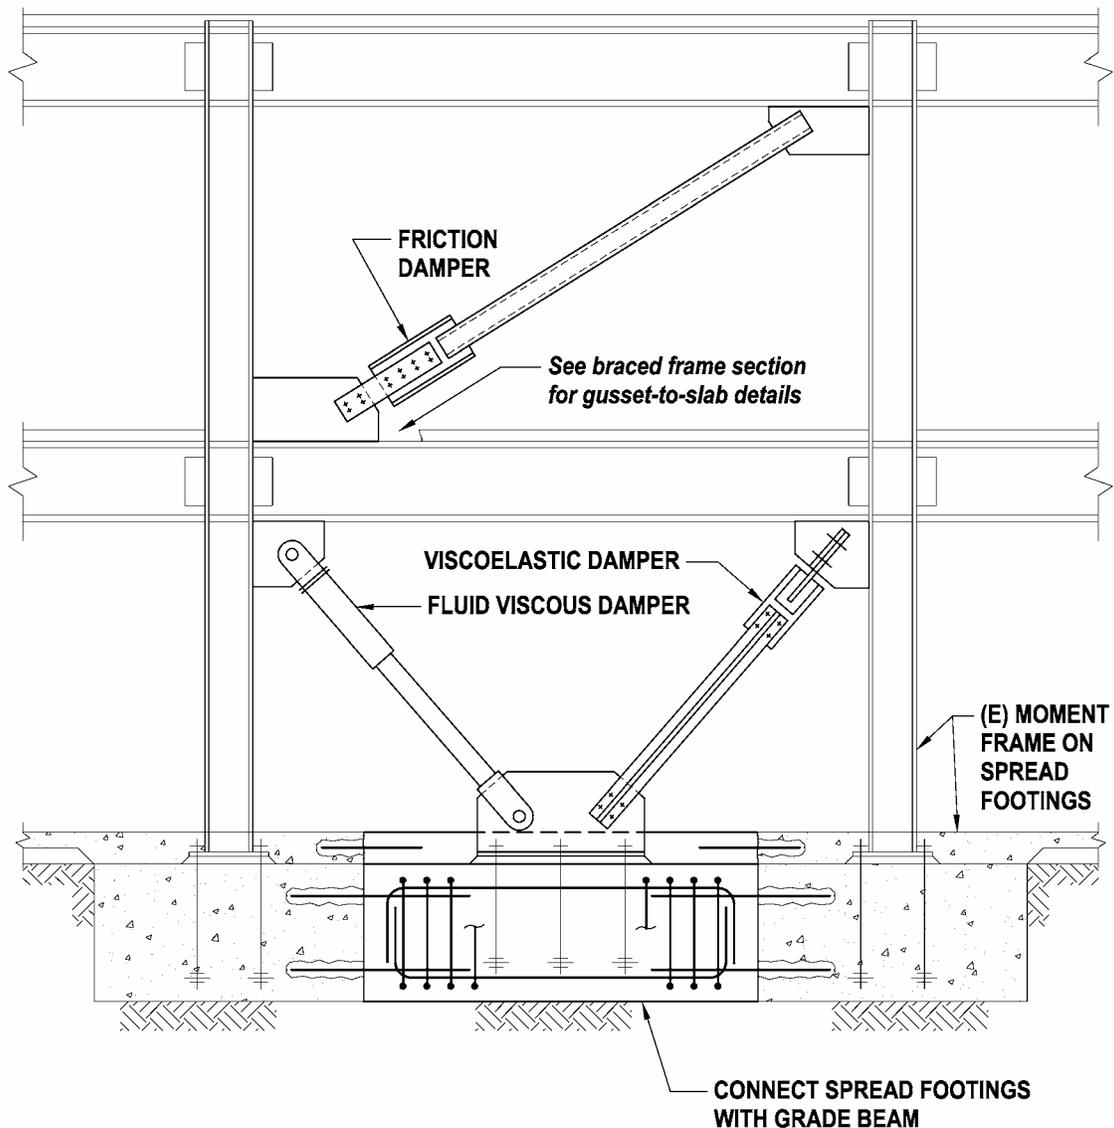
**Figure 24.4-1: Damper Alternatives for Rehabilitating an Existing Moment Frame**

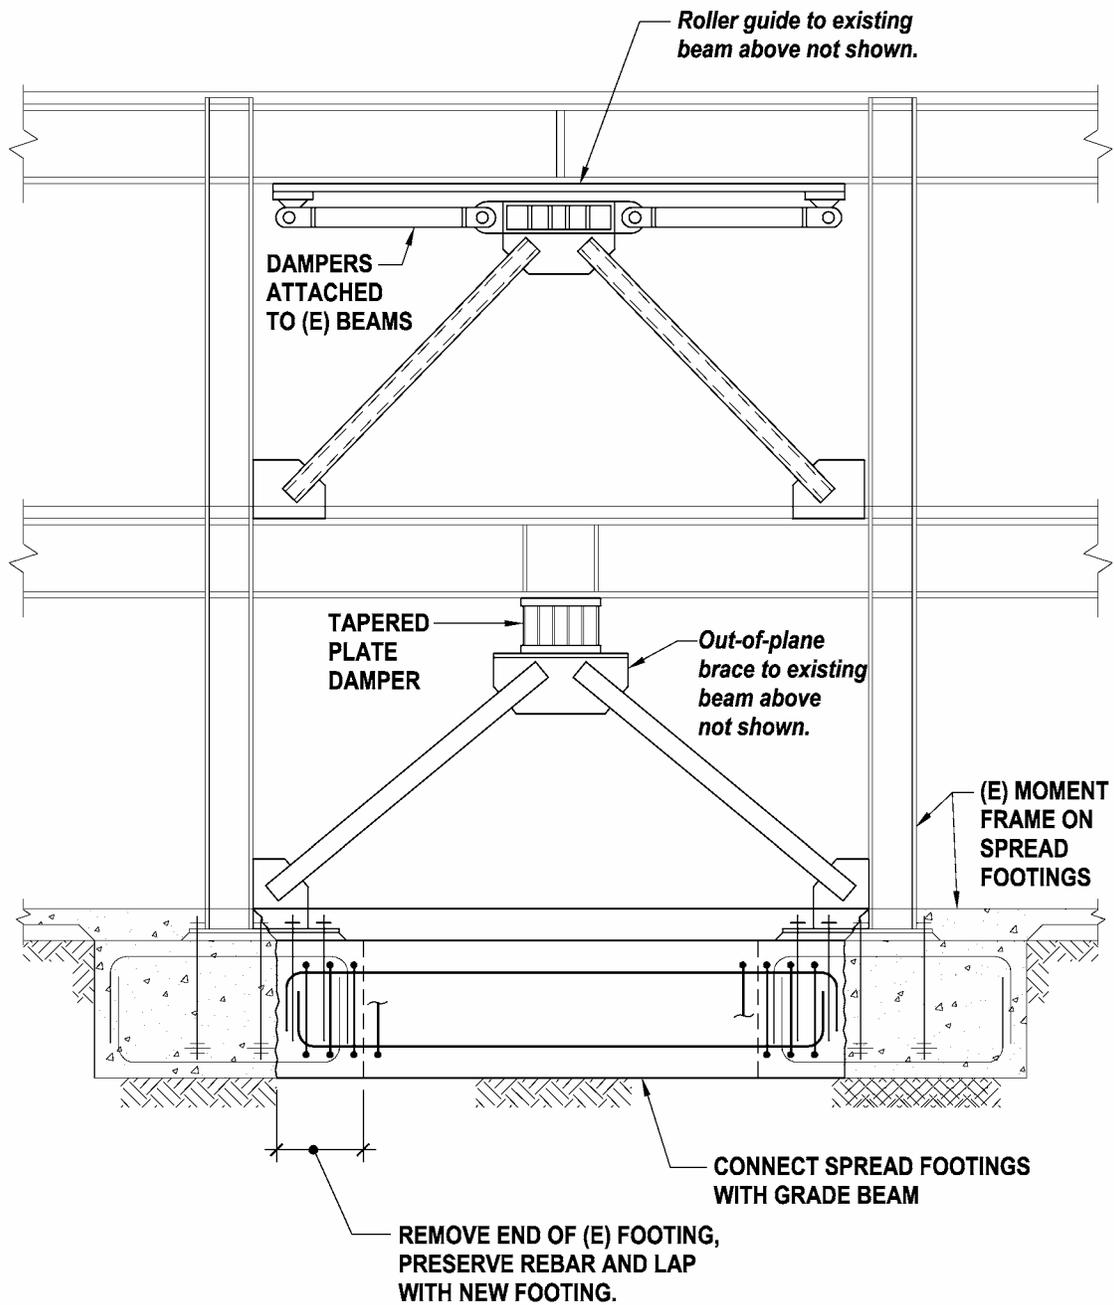
**Figure 24.4-2: Additional Damper Alternatives for Rehabilitating an Existing Moment Frame**
