Collocation Impacts on the Vulnerability of Lifelines During Earthquakes with Applications to the Cajon Pass, California

**Collocation Impacts on the
Vulnerability of Lifelines During
Earthquakes with Applications to the
Cajon Pass, California**

Submitted to the Federal Emergency Management Agency
Washington, D.C.

INTECH Inc.
11316 Rouen Dr.
Potomac, MD 20854-3126

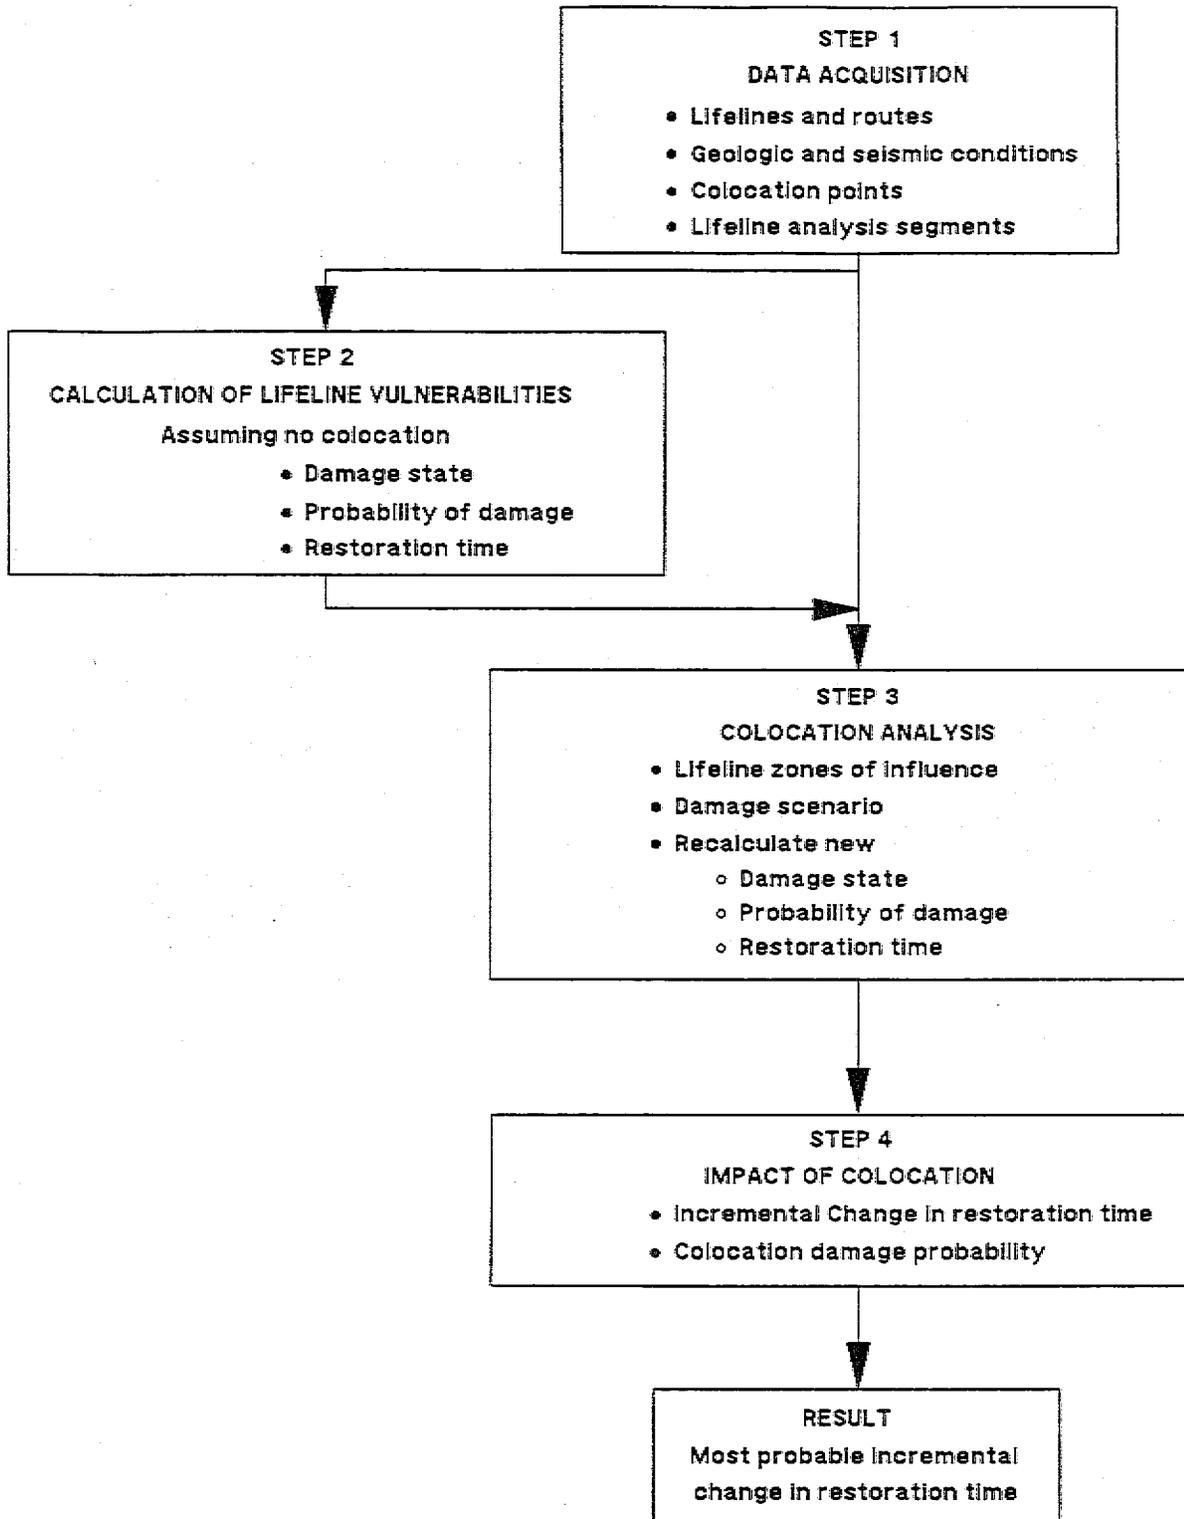
Figure 1, FLOW CHART OF THE ANALYSIS METHOD

Figure 1 shows a four step approach that can be used to analyze any lifeline under at-risk conditions (e.g., an natural or manmade disaster condition). However, the present study only develops the detailed information needed to analyze earthquake conditions. The steps are:

FLOW CHART OF ACTIVITIES FOR CALCULATING COLOCATION-INDUCED LIFELINE VULNERABILITIES DURING EARTHQUAKES

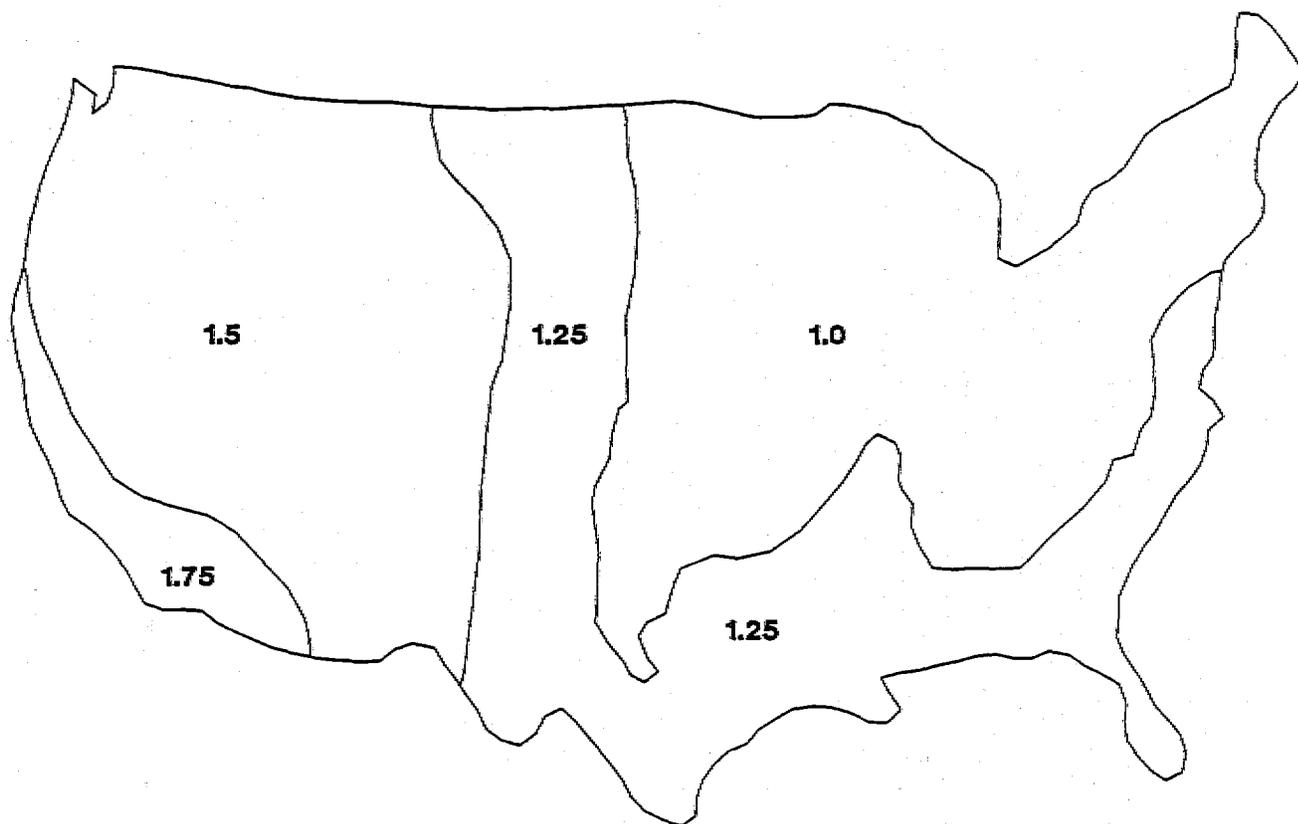
Figure 2, THE "ATTENUATION PARAMETER k" FOR USE IN CALCULATING EARTHQUAKE SHAKING INTENSITY

APPROXIMATE PATTERN OF ATTENUATION CHARACTERISTICS (k-VALUE DISTRIBUTION) THROUGHOUT THE CONTERMINOUS UNITED STATES

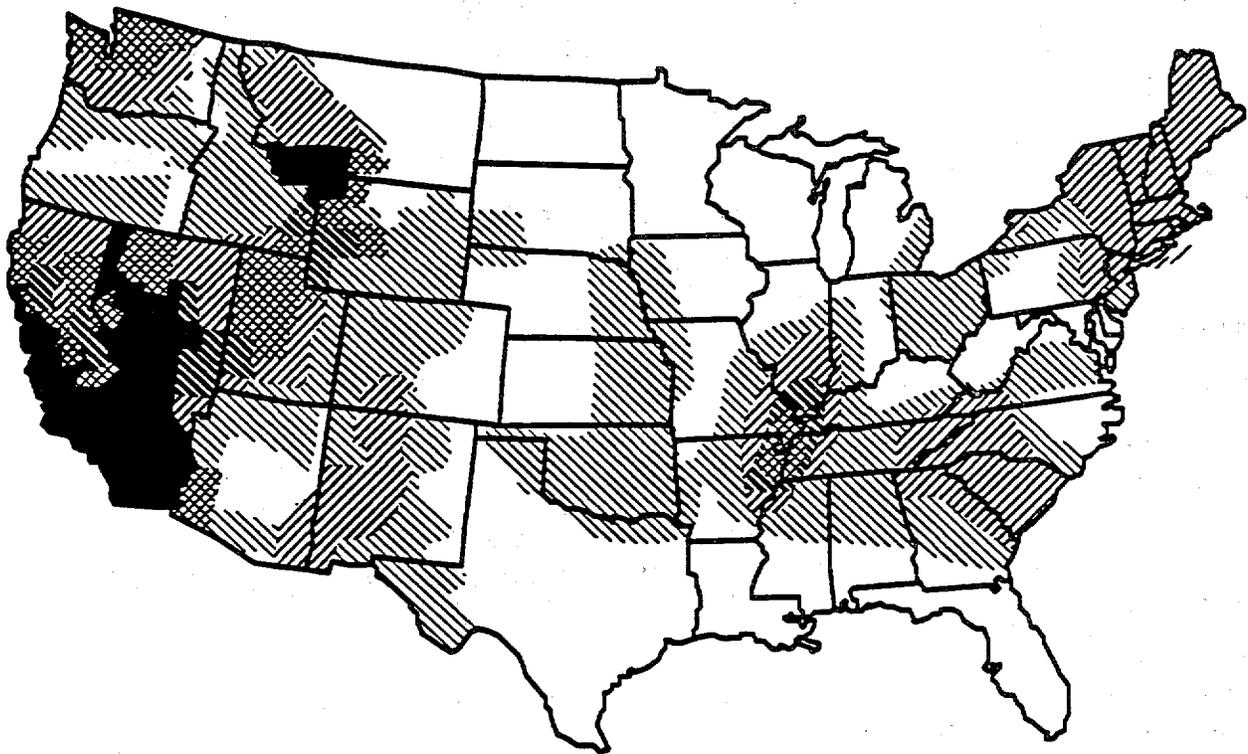
Figure 3, MAP OF U.S. SEISMIC HAZARD REGIONS

NEHRP Seismic Map Areas (ATC, 1978; BSSC, 1988).

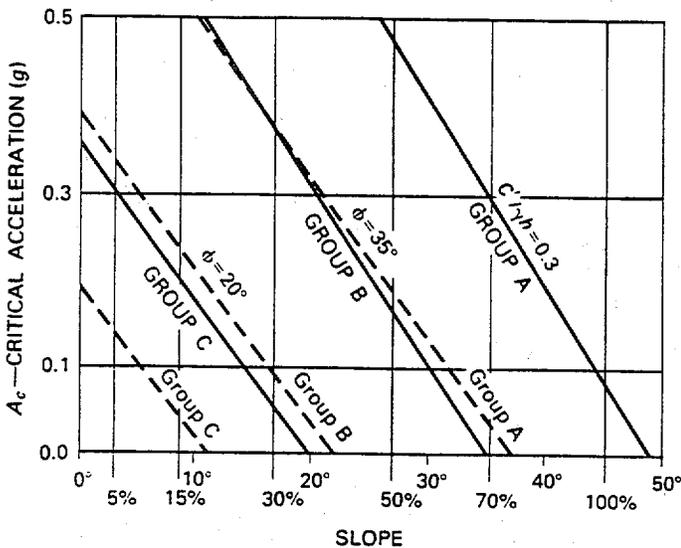
Wilson and Keefer⁽¹⁴⁾ have also developed an analysis for saturated and dry slopes. They use a 35 degree friction angle for sands, sandstones, and crystalline rocks, and 20 degrees for clayey soils and shales. They present a graph of the critical acceleration as:

Plots of critical acceleration (A_c) versus slope steepness for three sets of lithologies: group A, strongly cemented rocks (crystalline rock and well-cemented sandstone); group B, weakly cemented rocks (sandy soil and poorly cemented sandstone); group C, argillaceous rocks (clayey soil and shale). The cohesion factor, $c'/\gamma h$, for group A assumes values of $c' = 300$ pfs, $\gamma = 100$ pcf, and $h = 10$ ft. The angle of internal friction (ϕ) (peak strength, undrained conditions) is 35° for sands, sandstone, and crystalline rocks and 20° for clayey soils and shales. The solid lines depict dry slope materials, and the dashed lines depict saturation from the slide plane to the surface.

Either the Legg formula or the Wilson graph is acceptable for determining the critical acceleration, it's numeric value will be used in the Legg tables discussed below.

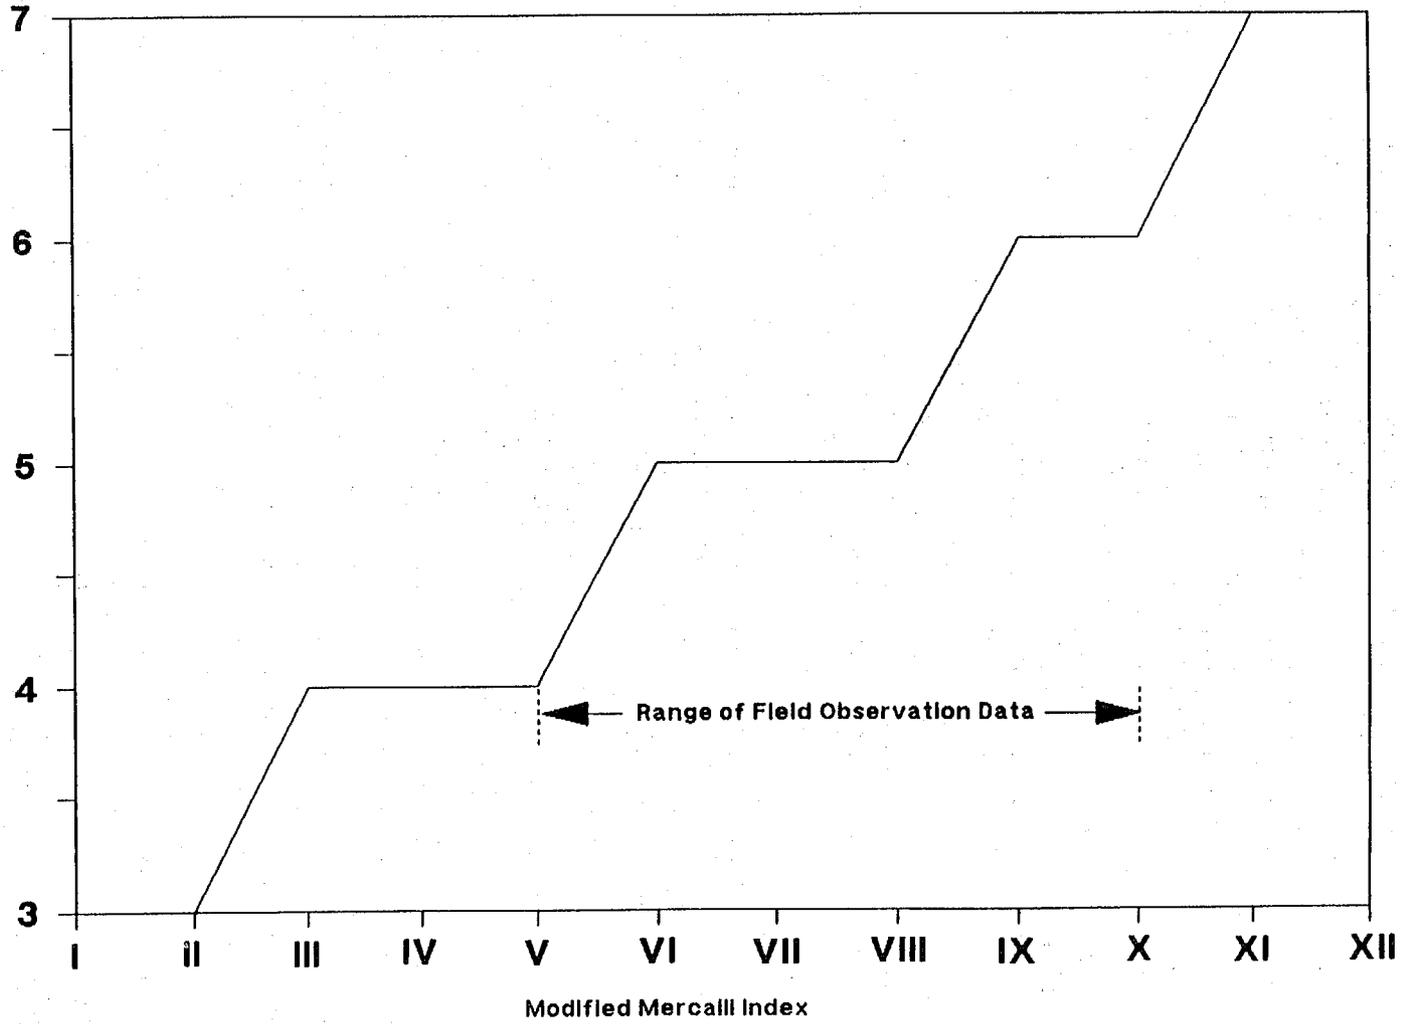
Figure 4

LIQUEFACTION INDUCED DAMAGE

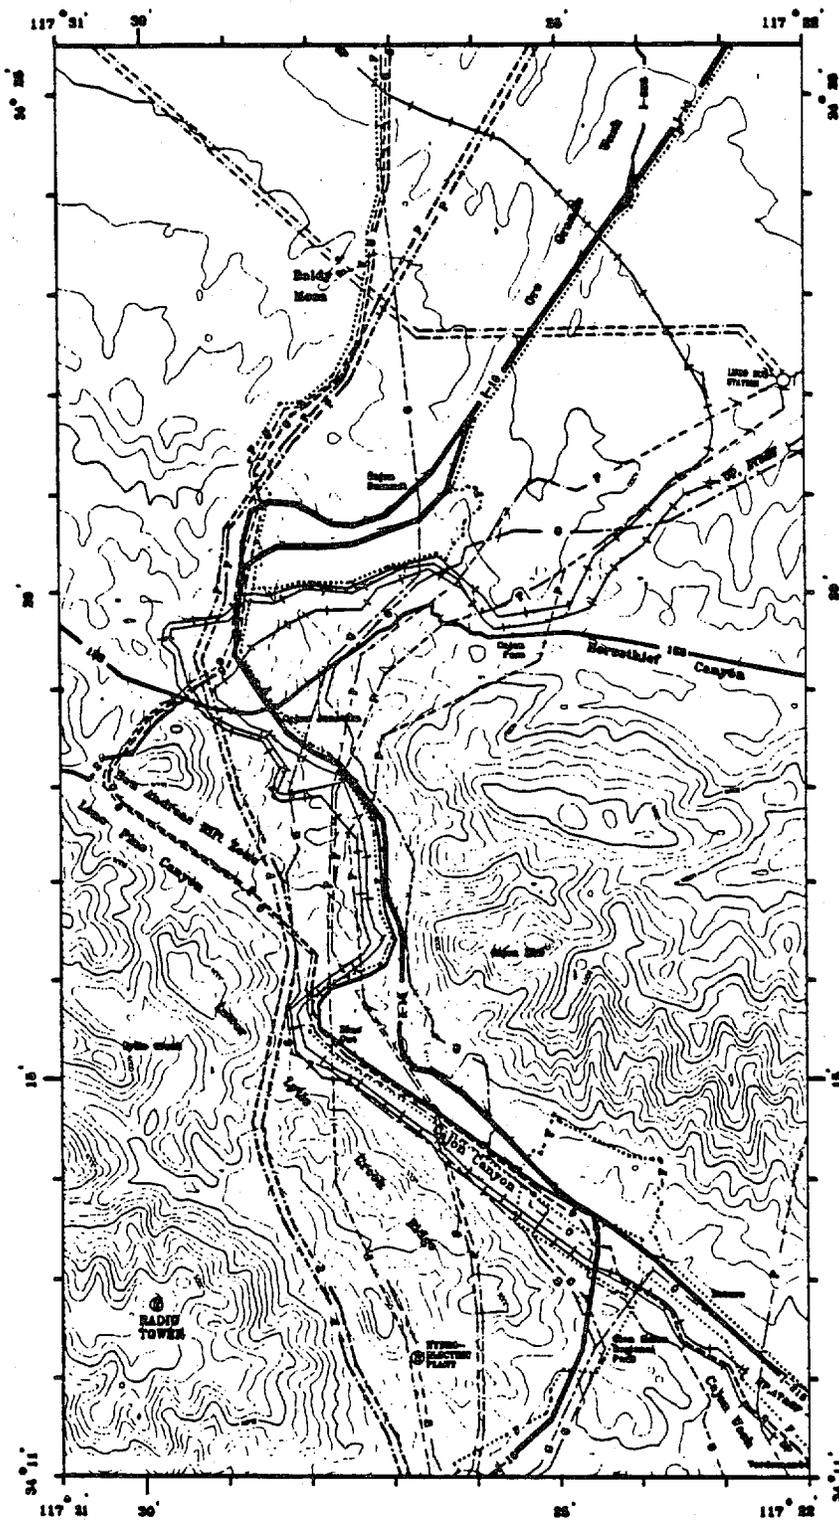
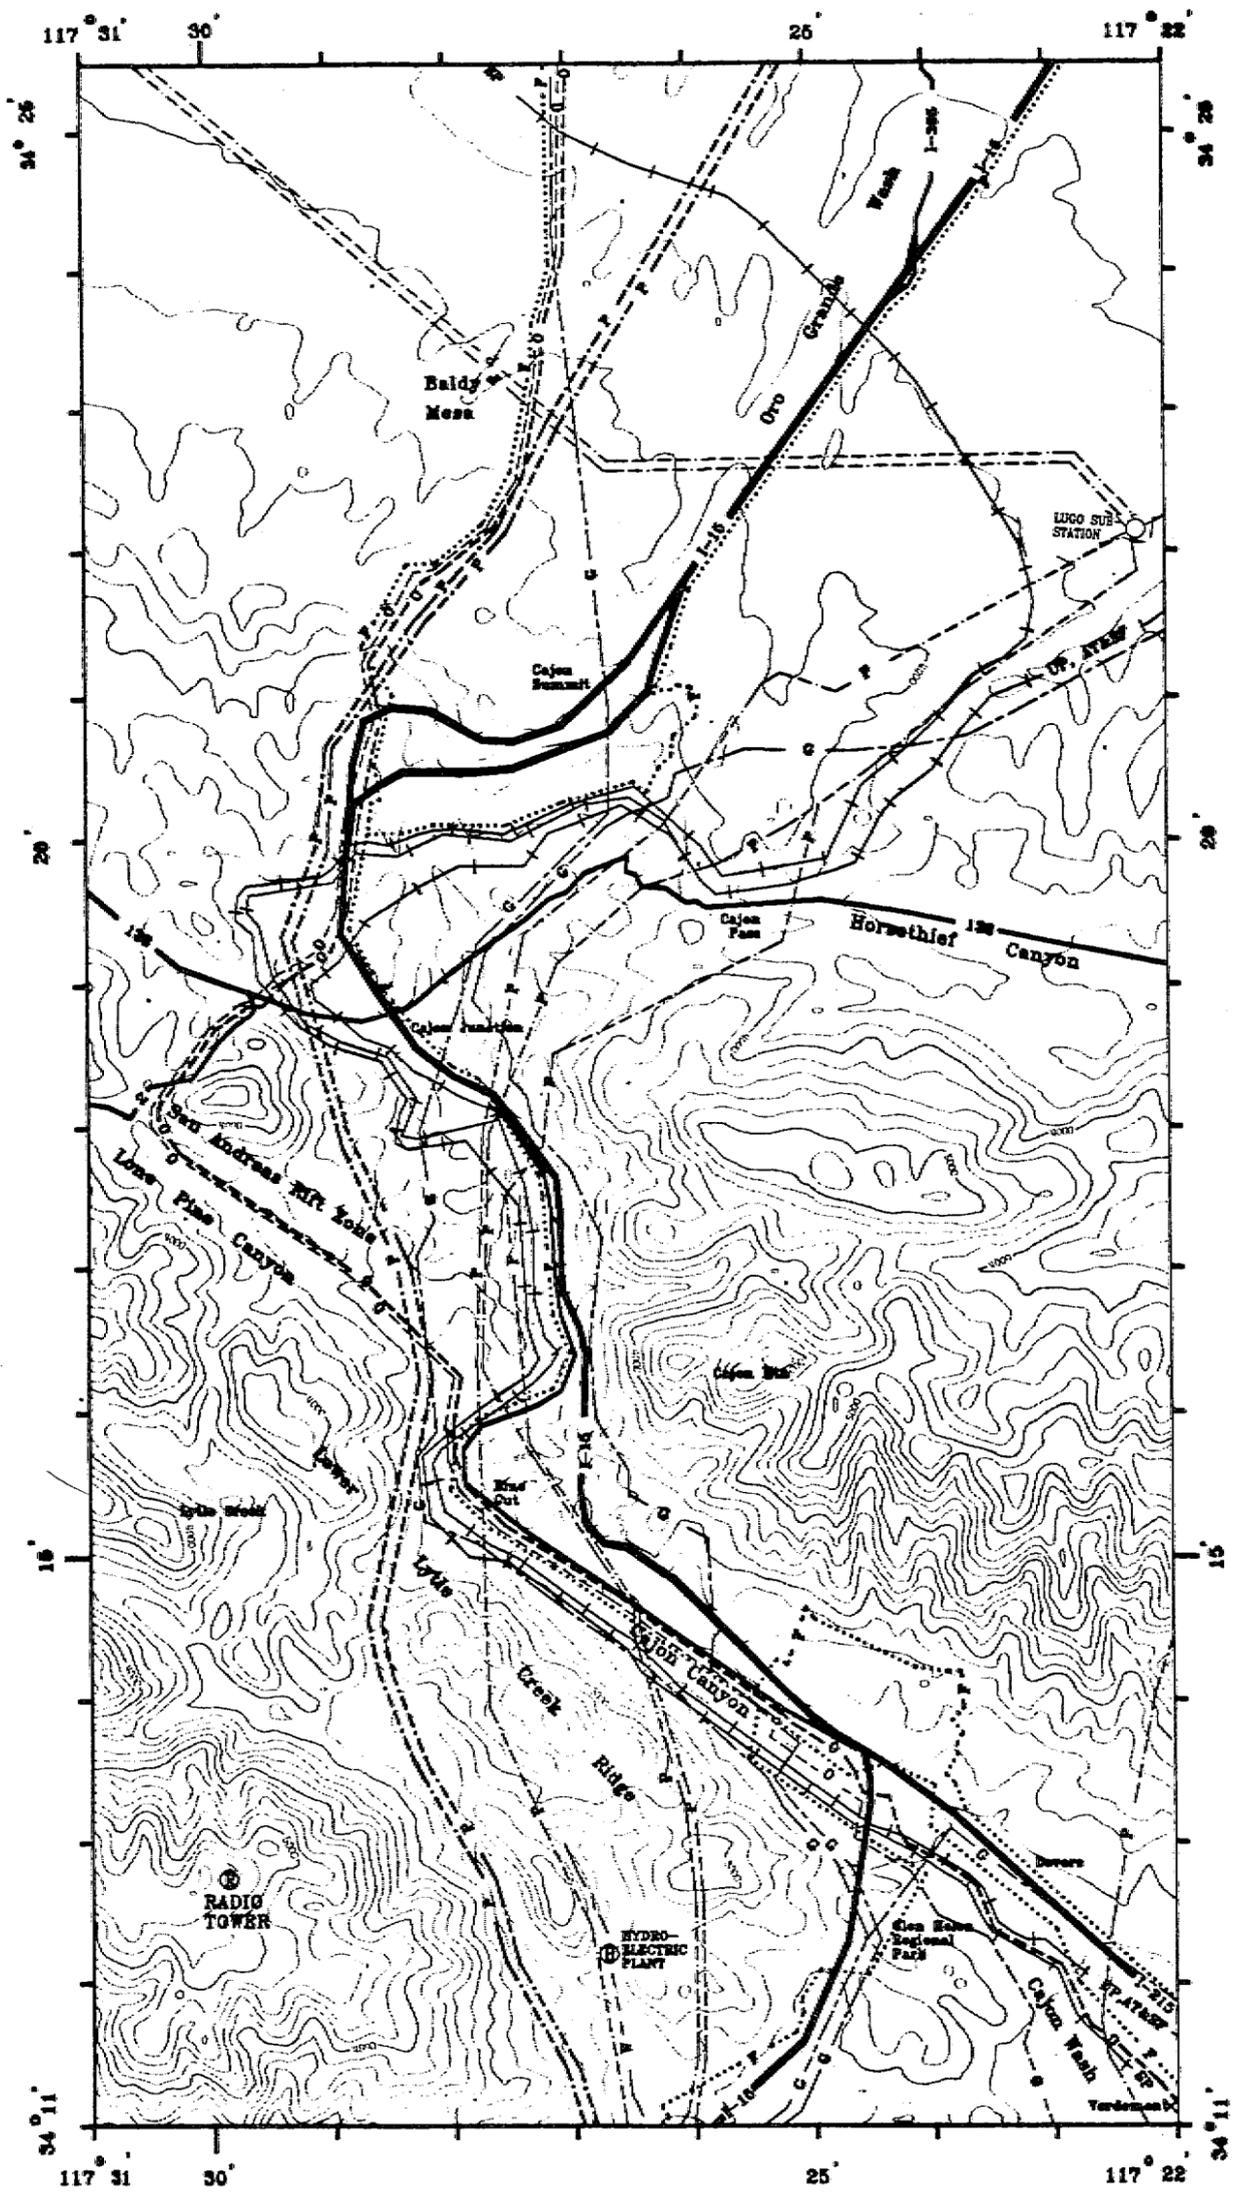
Figure 6, A COMPOSITE OF THE LIFELINE ROUTES AT CAJON PASS

Figure 6 is a plot of the communication, electrical power transmission, natural gas pipelines, petroleum products pipelines, railroad, and highway lifelines overlaid upon the U.S. Geological Survey's quadrangle map of the study area. Figure 6 shows several important items. First, the Pass is crowded with the lifelines traveling in a general north-south orientation through the middle of the study area. Second, the lifelines are clearly routed in a utility corridor. Since the bed of the Pass varies from about 0.5 miles near Blue Cut (which is located in about the center of the figure) to over several miles wide at most other regions, topology requirements alone would not require the observed congestion. The conclusion reached was that routing criteria such as aesthetic, cost, land use, and environmental considerations have had the controlling impact on the lifeline routing decisions.

There are especially congested areas near the intersection of Highways I-15 and I-215 in the southeast corner of the study area, near Blue Cut in the center portion of the study areas, and south and separately north of the intersection of Highway I-15 and State Highway 138. In addition, there are crowded areas for several of the lifeline systems, for example, near the railroad summit of Cajon Pass where natural gas pipelines, fiber optic lines, and the railroads are closely located. Also in the northern portion of the study area it is crowded where the two petroleum product pipelines and two fiber optic conduits parallel one set of high voltage power lines and also along Baldy Mesa Road where the two petroleum

FIGURE 6, A COMPOSITE OF THE LIFELINE ROUTES AT CAJON PASS

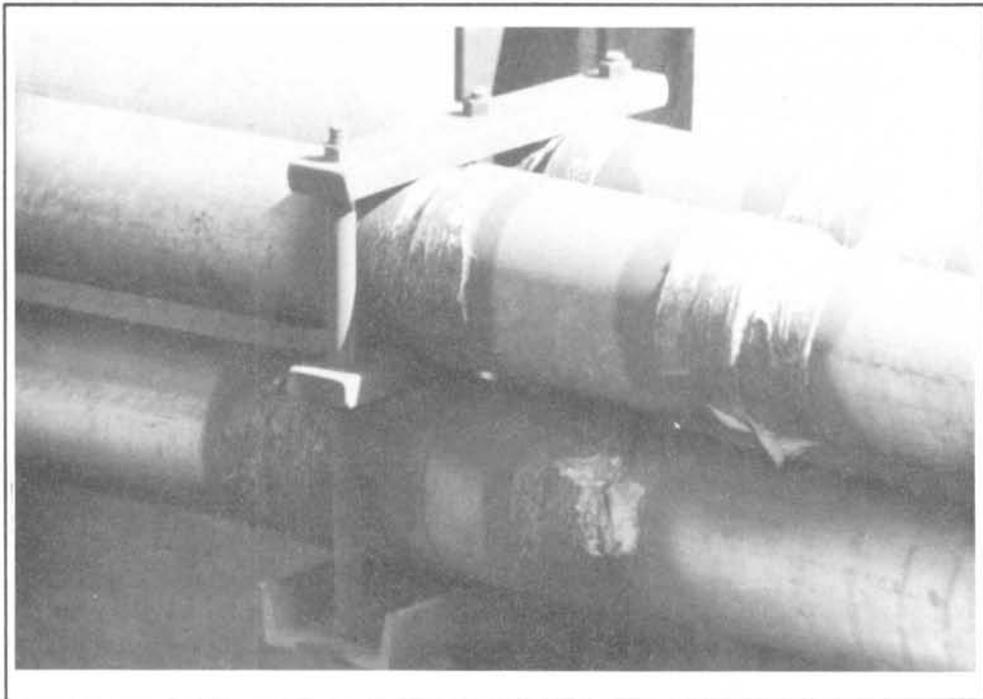
Figure 11 Details Of The Fiber Optic Conduits Of Figure 10

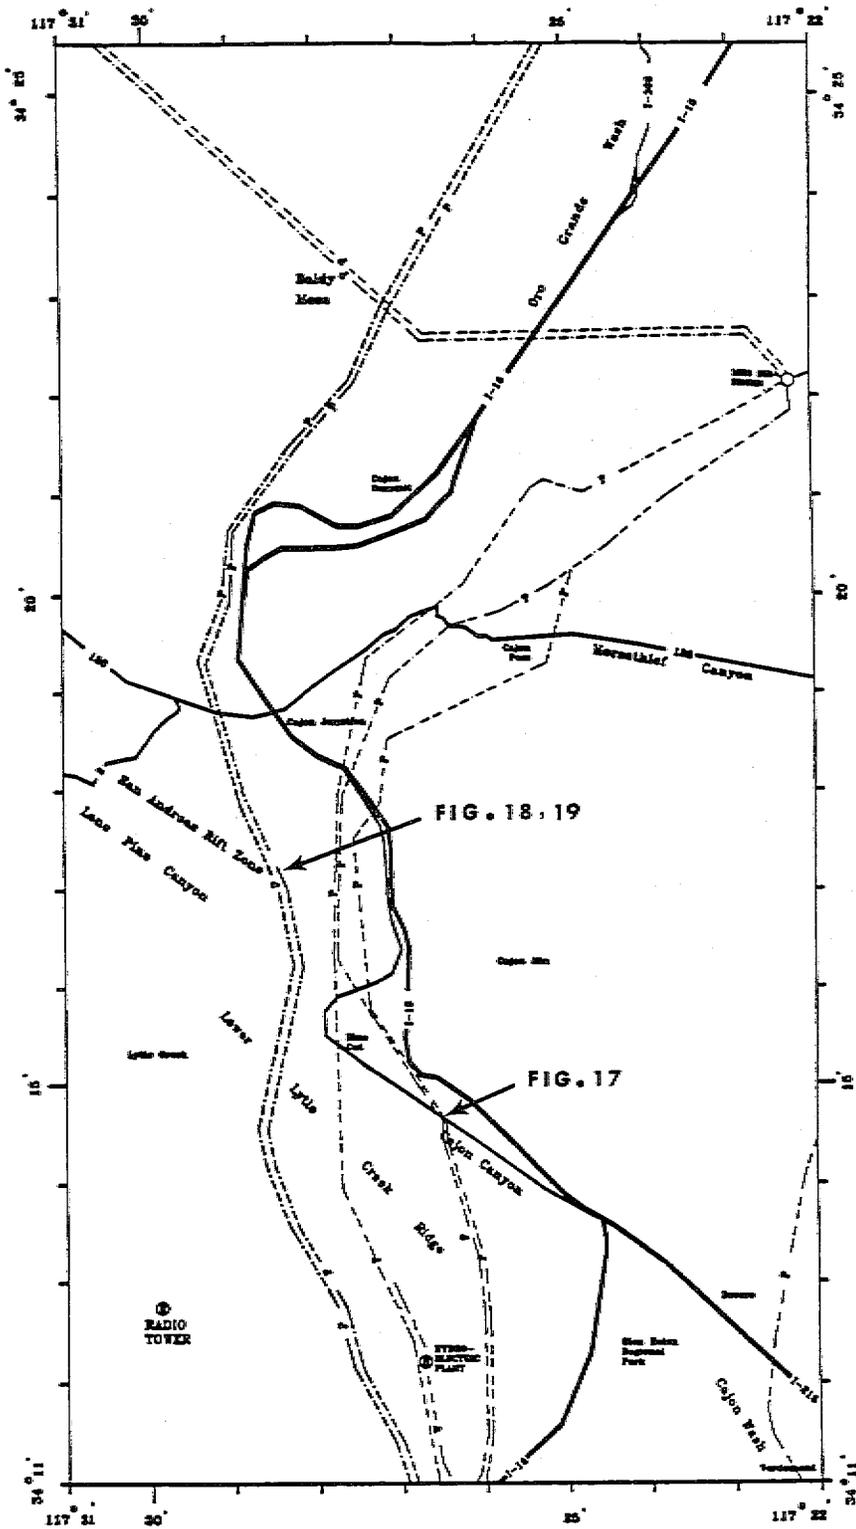
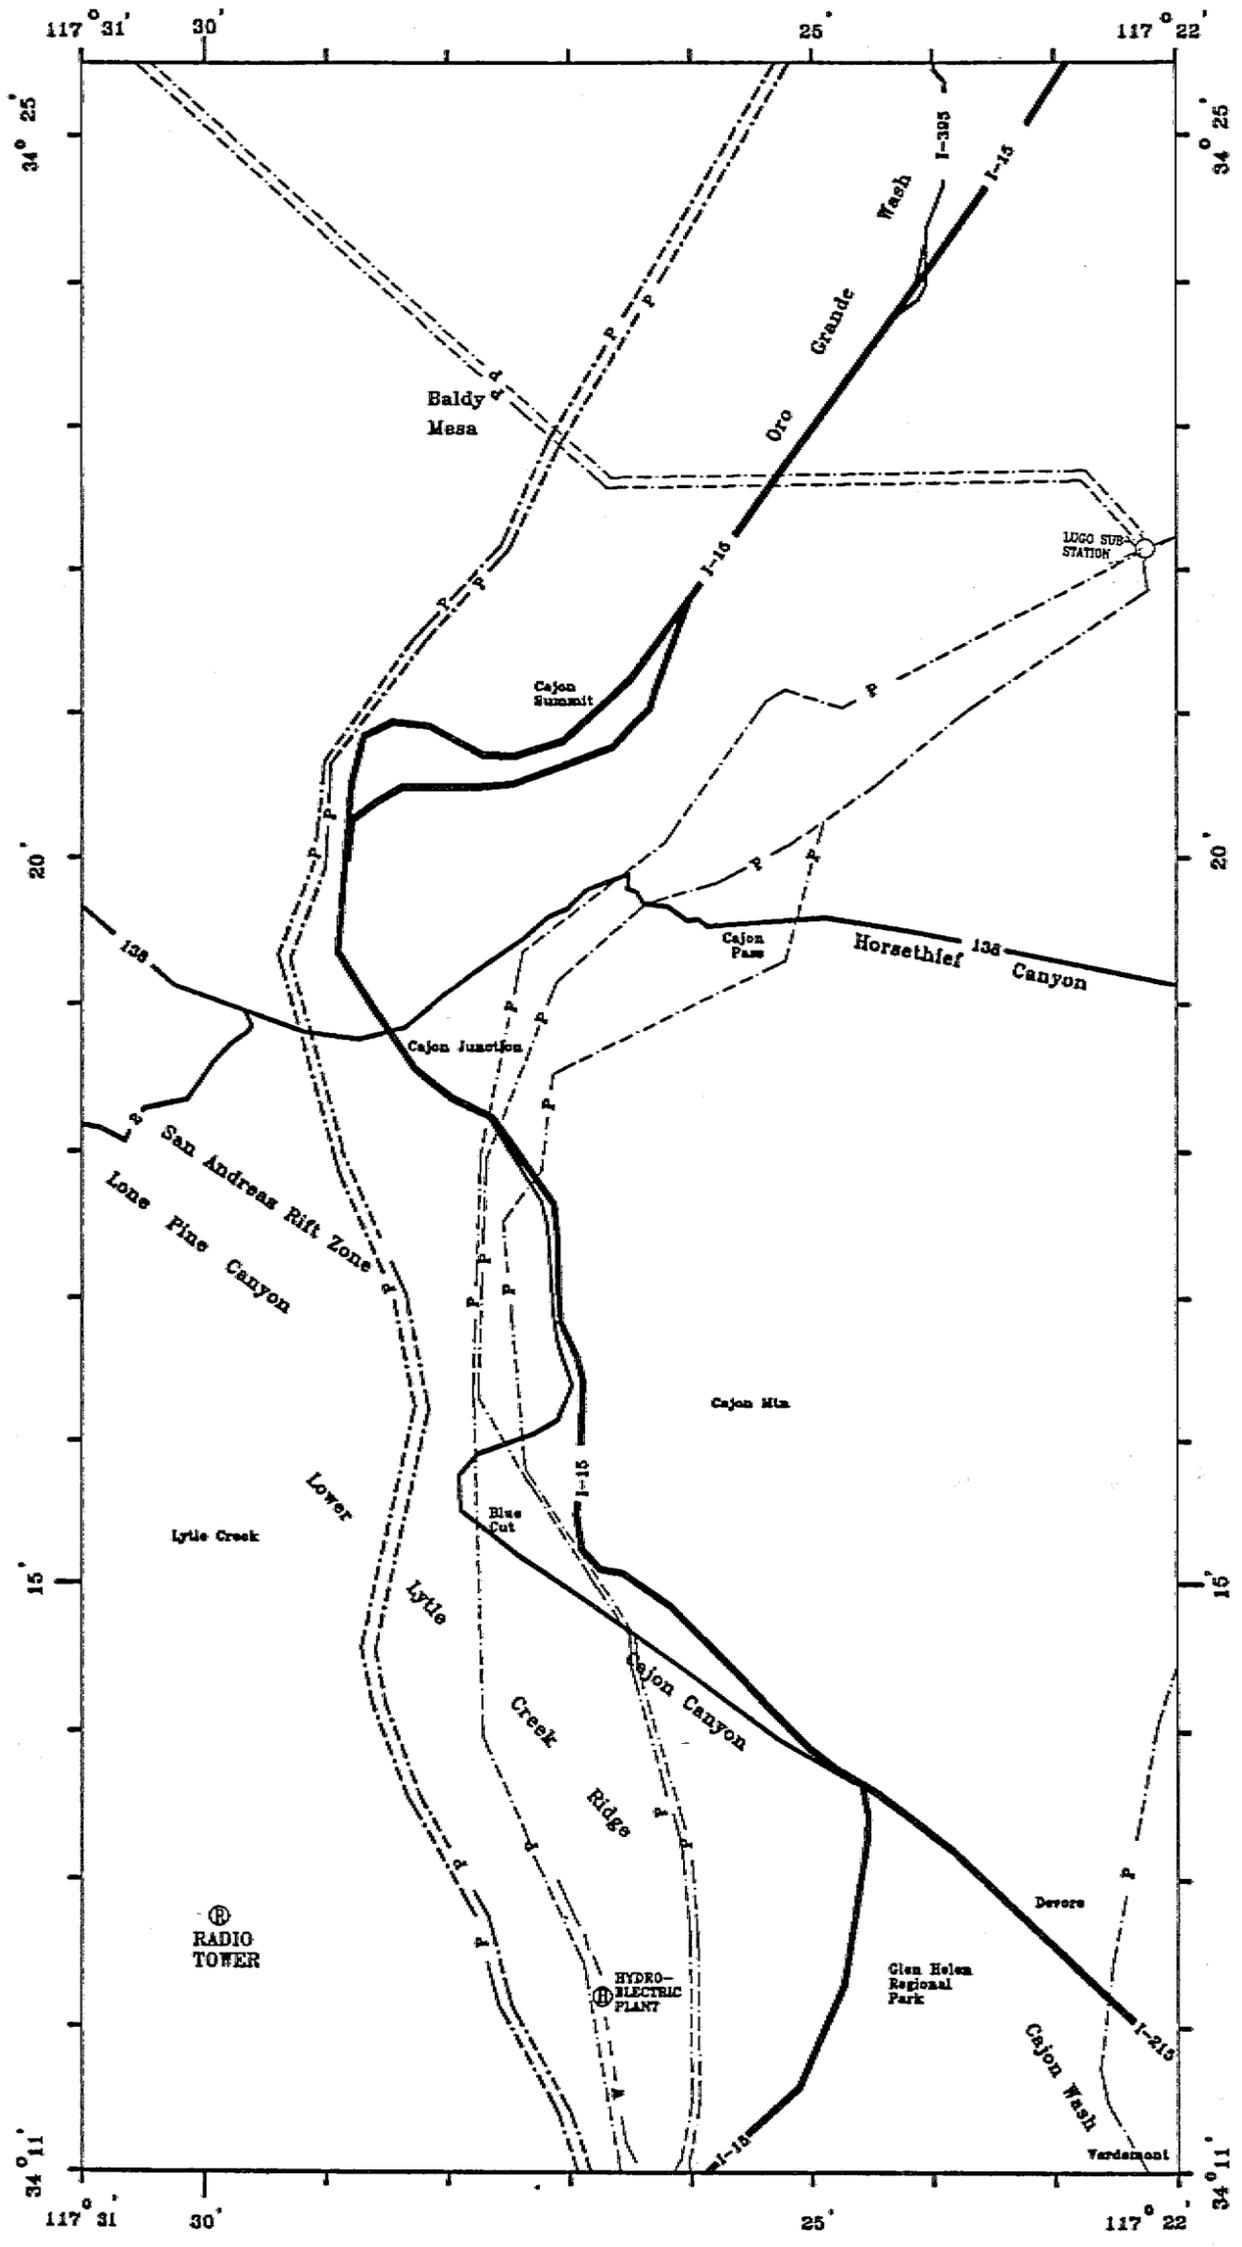
Figure 16, ELECTRIC POWER LIFELINE ROUTES

The electric power lifeline systems include a major transmission system substation at Lugo in the northeast corner of the study area, a hydroelectric generation station in Lytle Creek Canyon, and four major high voltage transmission systems. The hydroelectric station is not collocated with any of the lifeline components of interest to this study. Although the substation is collocated with two of the high voltage transmission systems, component failures in the substation are not expected to lead to transmission line failures, and visa versa. The transmission lines are not expected to have any failures at the shaking intensity expected at Lugo

FIGURE 16, ELECTRIC POWER LIFELINE ROUTES

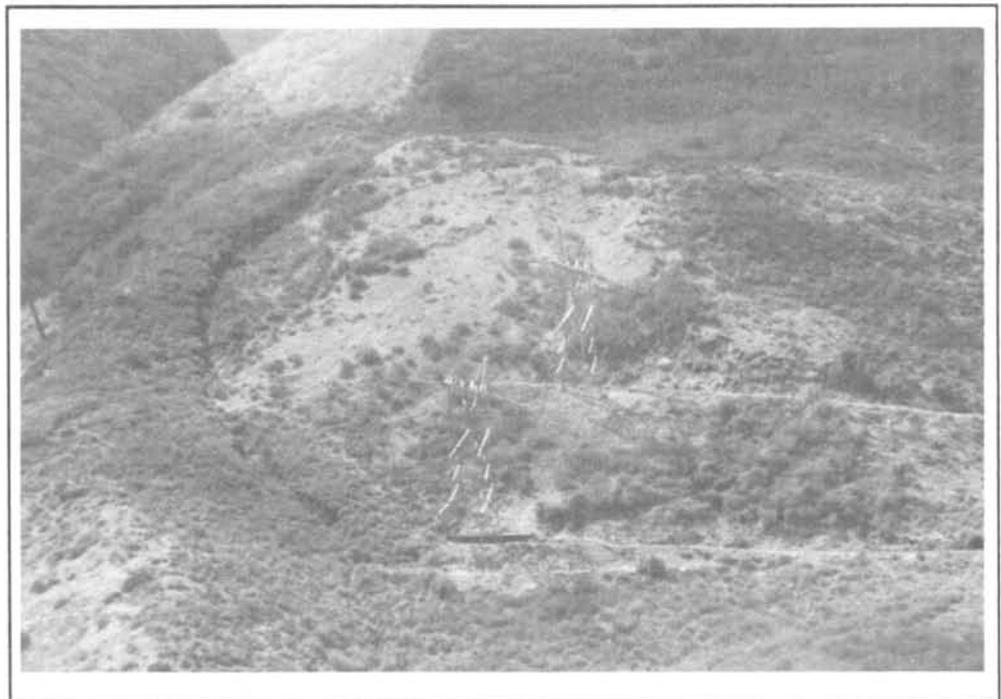
Figure 17 A Landslide Scar With Power Towers In The Slide Area

Transmission lines often traverse more rugged areas, and as such they are susceptible to landslide damage. Figure 17 shows two transmission towers located in an old landslide scar (the original towers were damaged in the landslide). This location is an important collocation site, as a buried natural gas transmission pipeline and the railroad tracts are located just below the slide area. Figure 18 shows the location of two high voltage power transmission tower systems, a buried natural gas transmission pipeline (shown by a surface marker), and the 8- and 14-inch buried petroleum products pipelines (also shown by a surface marker).

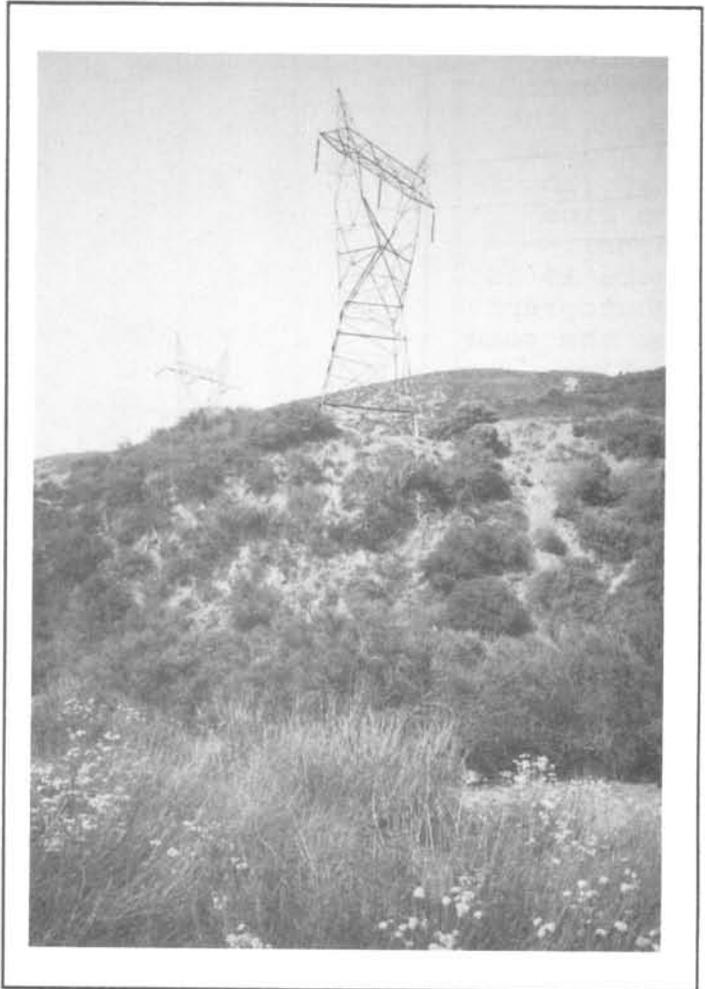
Figure 19 Power Tower At A Ravine Edge In The San Andreas Fault Rift Zone

This location is in the fault rift zone of the San Andreas fault (in Lone Pine Canyon). Figure 19 is a photograph from the same location looking in the opposite direction. It shows a transmission tower located at the edge of a steep ravine where it is subject to possible landslide failure.

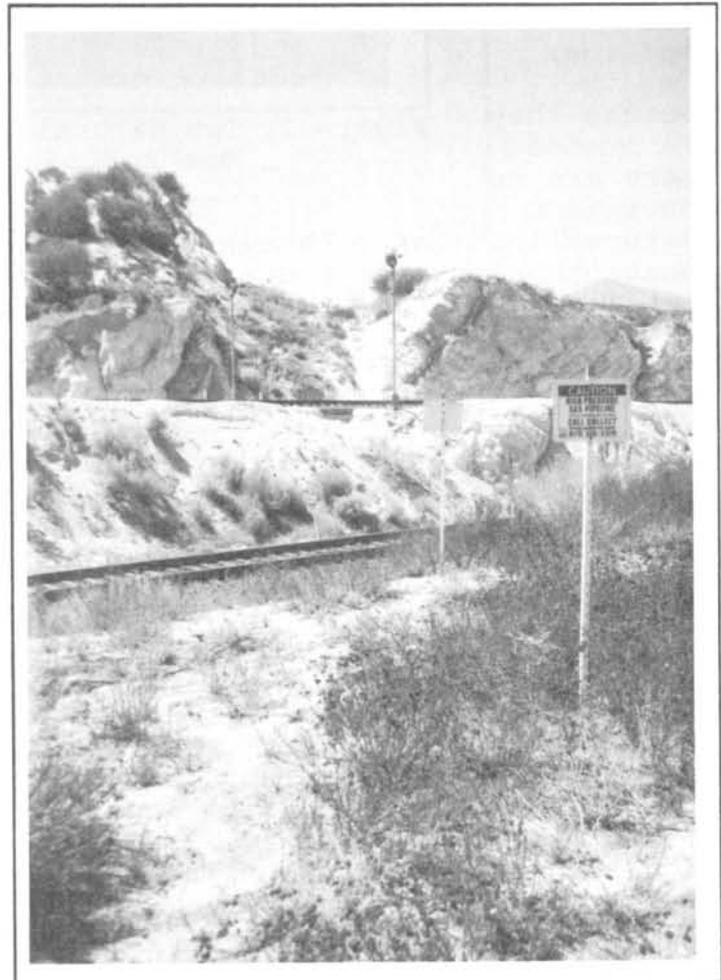
Figure 23 Natural Gas Pipeline Crossing Under Railroad Beds

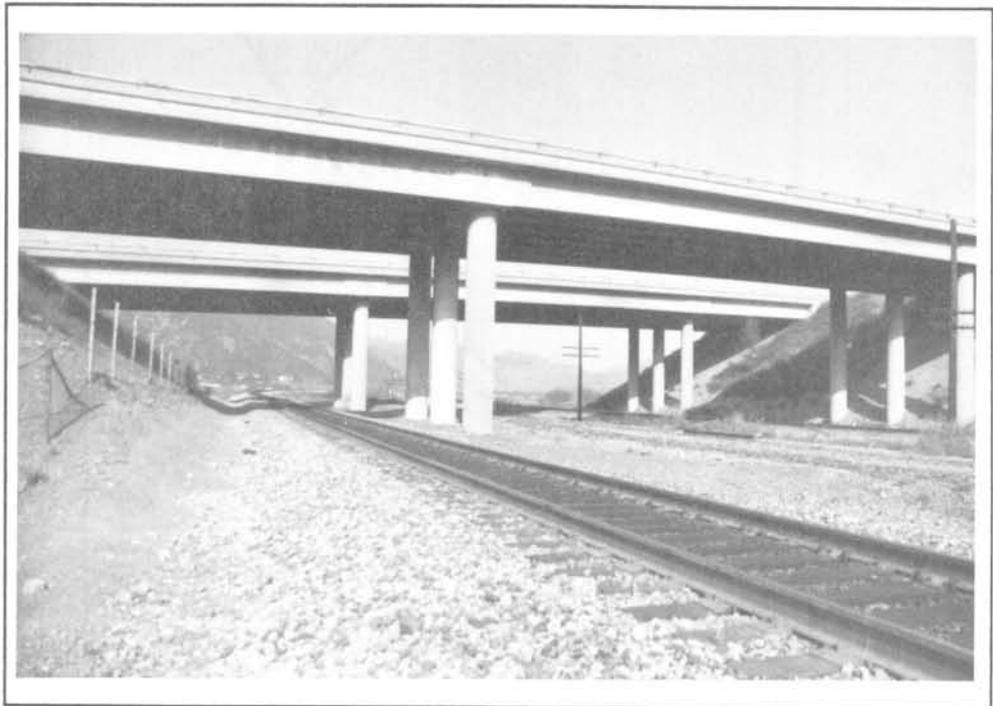
Figure 25 I-15 Bridge Over The Railroads In Cajon Wash

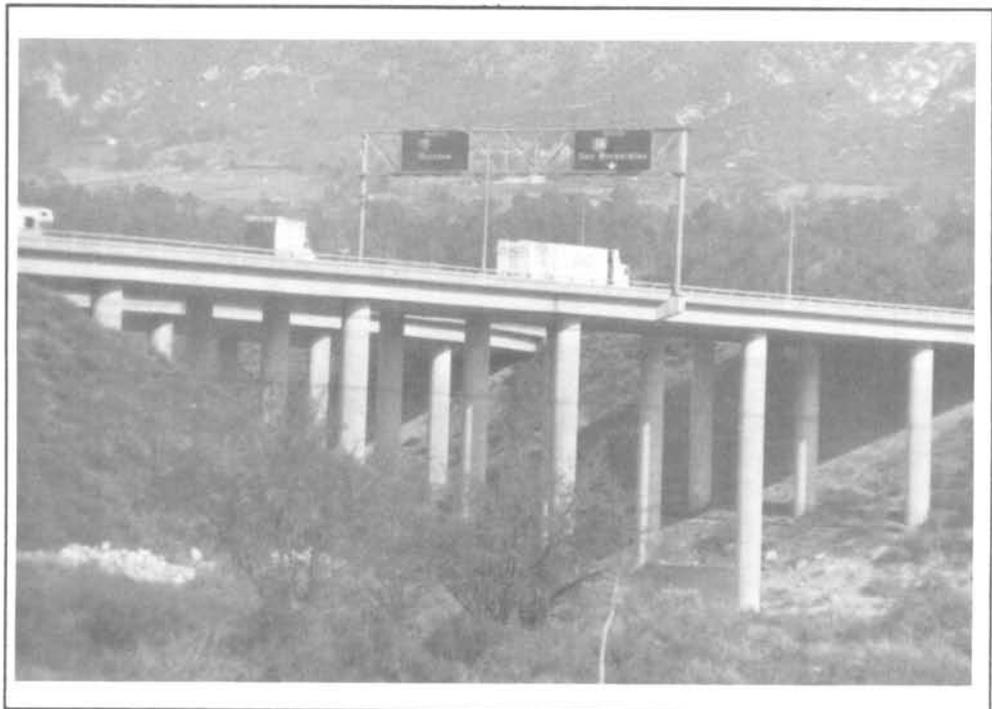
Figure 26 I-15 Bridge Over Cajon Wash

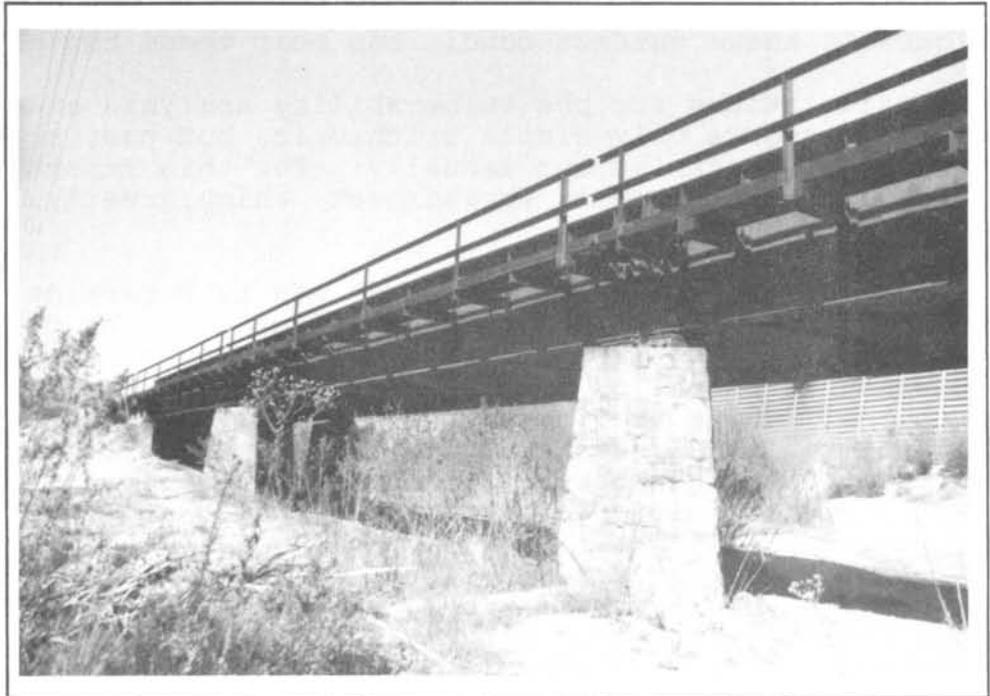
Figure 30 Santa Fe Railroad Rubble Masonry Pier Bridge

There is one bridge on the Santa Fe railroad just south of the I-15 truck weighing station which is founded on rubble masonry piers on sandy soil with a high water table (Figure 30). Loss of one or more spans is anticipated. That is contrasted to the Union Pacific railroad bridge at the

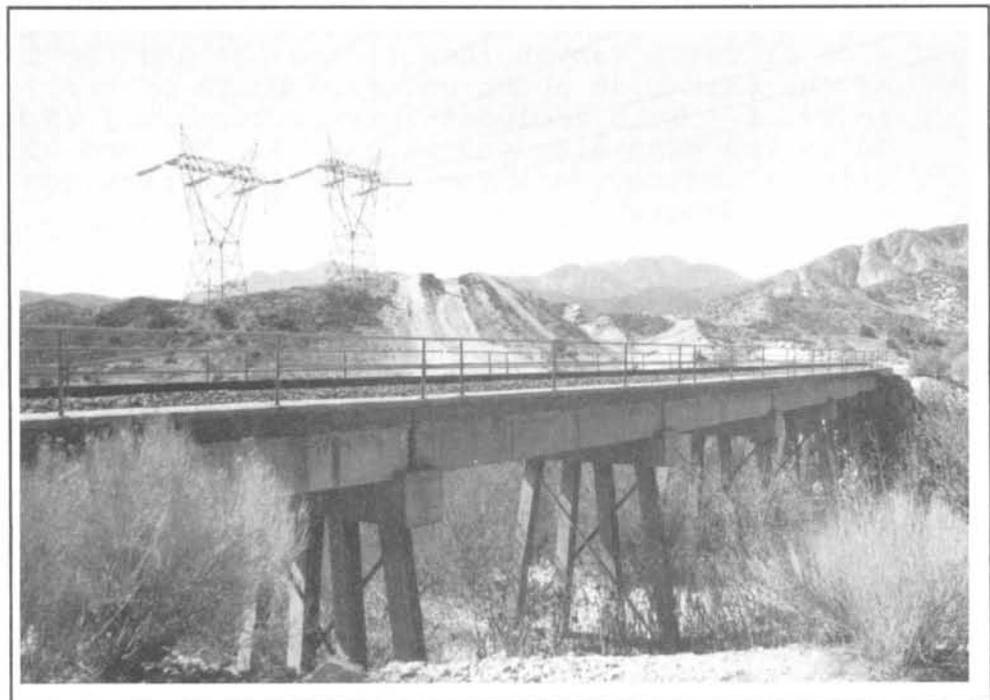
Figure 31 Union Pacific Railroad Bridge With Power Lines Overhead

same location (Figure 31) which has steel column, pile piers. Figure 14 shows surface conditions near these two bridges.
