Collocation Impacts on the Vulnerability of Lifelines During Earthquakes with Applications to the Cajon Pass, California

**Collocation Impacts on the
Vulnerability of Lifelines During
Earthquakes with Applications to the
Cajon Pass, California**

Submitted to the Federal Emergency Management Agency
Washington, D.C.

INTECH Inc.
11316 Rouen Dr.
Potomac, MD 20854-3126

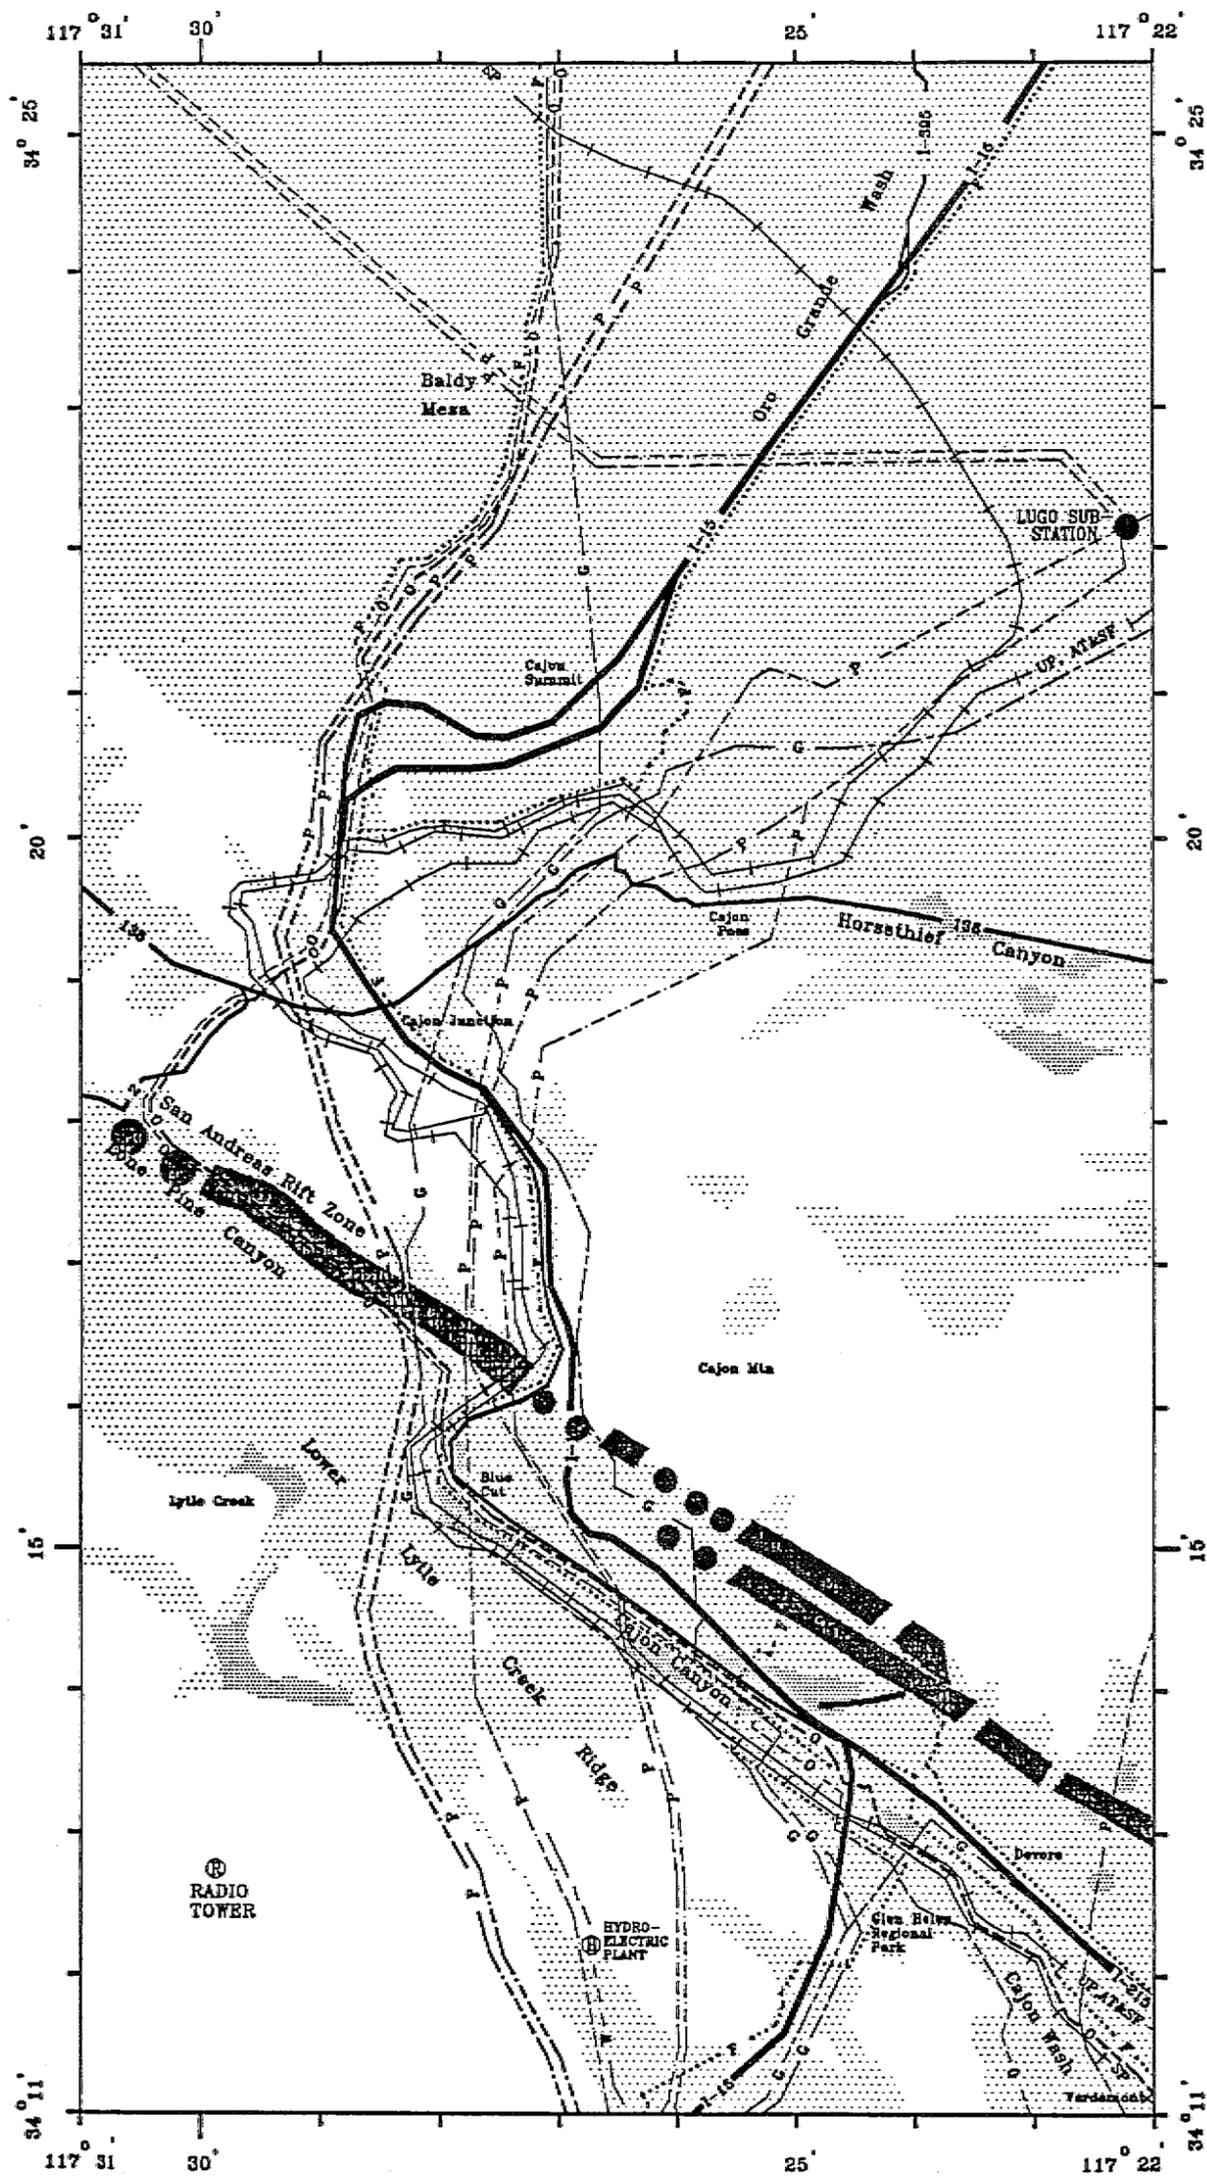
Figure 8, LIFELINE ROUTES WITH EARTHQUAKE SHAKING INTENSITY, AND POTENTIAL LANDSLIDE AND LIQUEFACTION AREAS

Figure 8 shows that many of the conditions of high MMI value, landslide, and liquefaction overlap. This is important to note because the lifeline components in the study area (with the exception of some bridges) are not very sensitive to shaking damage. MMI values of VIII generally would only cause damage state

FIGURE 8, LIFELINE ROUTES WITH SHAKING INTENSITY AND POTENTIAL LANDSLIDE AND LIQUEFACTION AREAS
