## Improved Drainage Washes Away Flood Worries

### Full Mitigation Best Practice Story

#### *Bayamon Municipio, Puerto Rico*

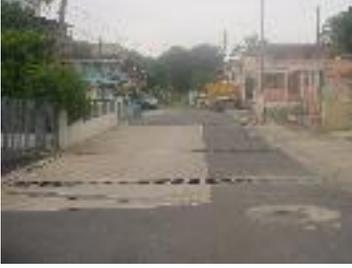
Aboveground view of water retention tank.

In 2002, the Flood Mitigation Assistance program awarded funds for the improvement of the existing storm sewer. This program is funded through flood insurance premiums to carryout projects that will reduce flood insurance claims. The Municipality of Bayamon upgraded 1,003 feet of the existing storm water system, including the installation of two additional storm water drains. In addition, a water-retention tank was constructed to control rapid water build-up in the area and provide subsequent slow discharge to a nearby creek.

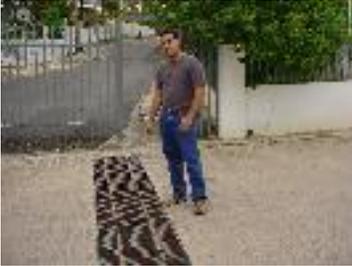
Nelson Irizarry points to the water retention tank.
