Simple Actions Yield Significant Results

Full Mitigation Best Practice Story

Yabucoa Municipio, Puerto Rico

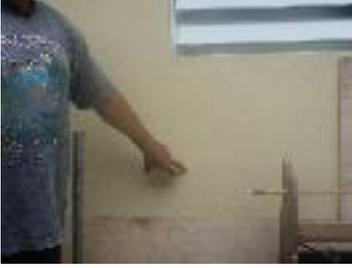
Jesus Rosado points to the height of floodwaters.

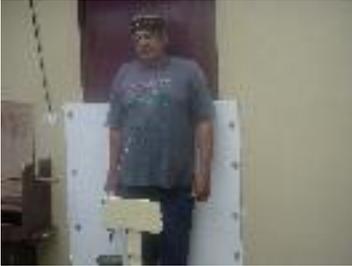
Rosado in front of one of the floodgates he installed.

First, Rosado constructed a floodgate for each doorway. The floodgates consist of a wooden board cut to cover the bottom half of all doorways, thereby blocking water from coming into the home. Once in place, a sealant is applied around the borders to prevent water from seeping through. The boards are mounted with screws, allowing for their removal once the floodwaters have receded. Rosado also decided to reduce the size of his windows, making sure that all openings were well above flood levels.

- Homeowner constructed floodgates consisting of a wooden board cut to cover the bottom half of all doorways, thereby blocking water from coming into the home. Once in place, a sealant is applied around the borders to prevent water from seeping through. The boards are mounted with screws, allowing for their removal once the floodwaters have receded.
- Furthermore, Rosado mitigated the home's electrical system.
- Since 1996, the Rosado residence has not sustained any damages due to rain events, while other homes in the same neighborhood continue to be impacted.
