Mitigation Project Protects Allegany Water Line

Full Mitigation Best Practice Story

Allegany County, New York

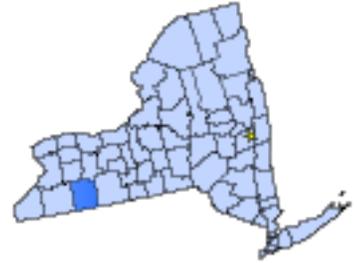
Severe storms and flooding in the spring of 2000 caused the rupture of a water main that crosses under Houghton Creek in the Town of Caneadea. The main carries water from the town's filtration plant to its water tower, supplying Houghton College and town residents.

In addition to repairing the damaged pipe to its pre-disaster condition, the project involved construction of an emergency overflow bypass, upstream from the area where the pipe ruptured, to divert stream flows during high water incidents.

As a result, officials said, since the pipe was repaired it has performed without incident on several occasions, including three additional declared disaster events.
