Hurricane Mitigation Protects Plaquemines Parish Home

Full Mitigation Best Practice Story

Plaquemines Parish, Louisiana

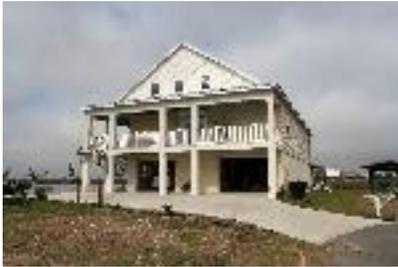
Post-Katrina Myrtle Grove Marina Estates Home

Shortly after Hurricane Katrina, the Lawrences headed home to survey the damage. Gayle Lawrence's first thought as they approached their home was "at least it's still standing." The couple was pleased to discover as they got closer that there was actually very little damage at all.

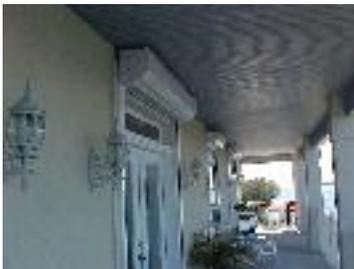
Installed hurricane shutters on doors and windows

To provide superior wind and impact resistance, a 7-inch thick concrete wall reinforced with 5/8-inch steel rebar was poured at the ground level. Walls in the living area were upgraded using 6-inch studs, instead of the standard 4-inch, to provide extra strength. A local building code also mandates the attachment of horizontal wood blocks between the studs to reinforce the walls and to prevent the whipping effect that high winds can cause. Storm shutters were also installed to protect the doors and windows throughout most of the home. One of the decorative windows that did not have storm shutters broke during Katrina, which is clear evidence of the protection that storm shutters provide.

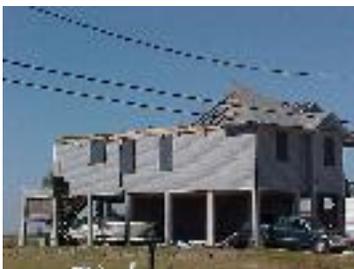
Myrtle Grove Marina Estates home damaged by Hurricane Katrina
