## Home Elevations Work: Rebuild Higher and Stronger

### Full Mitigation Best Practice Story

#### *Terrebonne Parish, Louisiana*

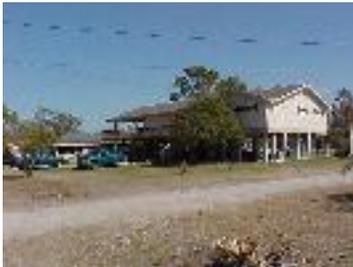
The Lukes' elevated home was not damaged by flooding during Hurricane Rita.

Darlene and Wiltz Luke elevated their home along Grand Caillou Road after suffering damage during several storms. Although the local building code required their home to be elevated five feet, the Lukes chose to raise their home by nearly nine feet so they could use the space underneath for a parking and recreational area. Such uses, as well as limited storage and stairs and stairwells for access to the elevated structure, are permitted in spaces below the Base Flood Elevation (BFE). The BFE is the average floodwater depth for a flood event that has an estimated one percent chance of occurring during any given year; buildings constructed to this standard are expected to sit above the floodwater and avoid damage during all but the most severe inundations. Elevation of the Luke home, a 2,700-square-foot house on a concrete slab, was completed in 2004. The family was able to live in their home during a month of ground preparations, but they had to vacate during the two months it took to physically raise the house.

The cost of raising the Luke home along with the underlying slab was much greater than the cost of raising a structure of the same size without a slab. The Lukes elevated their home with the assistance of HMGP funding; their out-of-pocket expenses were reduced because they were only responsible for 25 percent of the cost of the mitigation project. In addition, they were able to apply for Increased Cost of Compliance (ICC) coverage, which is part of a standard flood insurance policy. When an insured building is declared substantially damaged by flood (meaning that the repair costs would be 50 percent or greater than the pre-damaged market value of the structure), ICC coverage will pay up to \$30,000 to bring the building into compliance with State or community floodplain management laws or ordinances by elevating, floodproofing, demolishing, or relocating the building. The Luke's home remains covered under the National Flood Insurance Program (NFIP), and their premium has been reduced by more than two-thirds – from \$1,000 to \$300 per year – since completion of the home elevation.

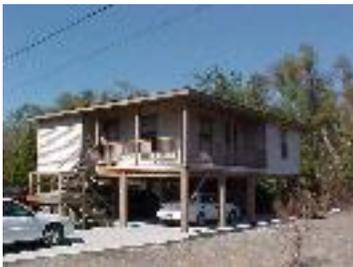
Rita Verdin's elevated home in Houma, Louisiana, was not damaged by flooding during Hurricane Rita.

About four miles south of the Lukes' home, Rita Verdin's home on Shrimpers Row also escaped damage from the six feet of water that Hurricane Rita brought into her neighborhood. She elevated her home as it was being built in 1986. Although required by the local building code to elevate to three and a half feet, Verdin chose to elevate to a height of eight and a half feet above grade so that the space underneath the home could be used for parking. She elevated her home on eight-inch by eight-inch treated wood beams, but recommends the use of steel-reinforced concrete pylons to minimize long-term maintenance and to avoid termite and rot problems that affected her support beams. Verdin's brother's home across the street also escaped water damage from the most recent storm. He elevated his home by about ten feet in 2003 after being flooded by Hurricane Lili.
