Multi-Hazard Protection for Historic Home

Full Mitigation Best Practice Story

Napa County, California

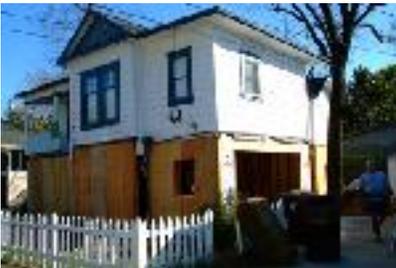
Elevated house with shear walls in Napa, California.

Although his house had never flooded, Mr. Faulk decided to hire a contractor in December 2005 to elevate it an additional four feet. The contractor raised the house in 14-inch intervals, installing railroad tie cribs one level at a time until the structure was nine feet above the ground. A new concrete slab replaced the old deteriorated foundation and slab. The contractor engineered the first level framing to allow for open spaces for a new garage, and strengthened the structure to conform to City of Napa building codes for seismic hazard mitigation. All of the structural elements were connected in a continuous load path with ties, hangers, and foundation bolts.

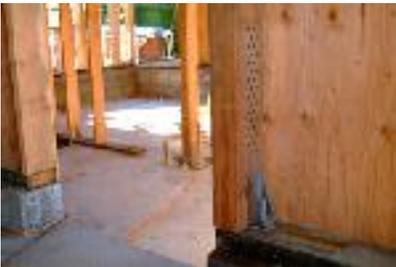
Construction detail.

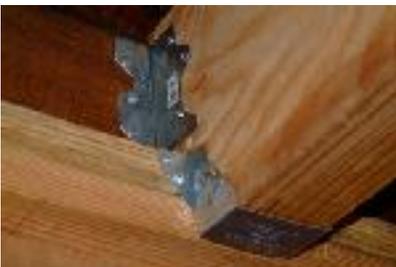
Construction detail.

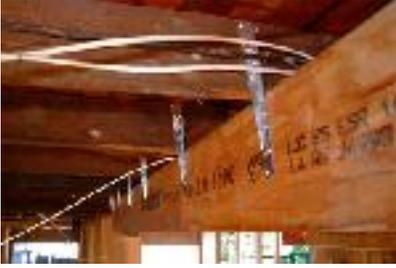
Construction detail.
