# Designing for Earthquakes

A Manual for Architects

*FEMA 454 / December 2006*

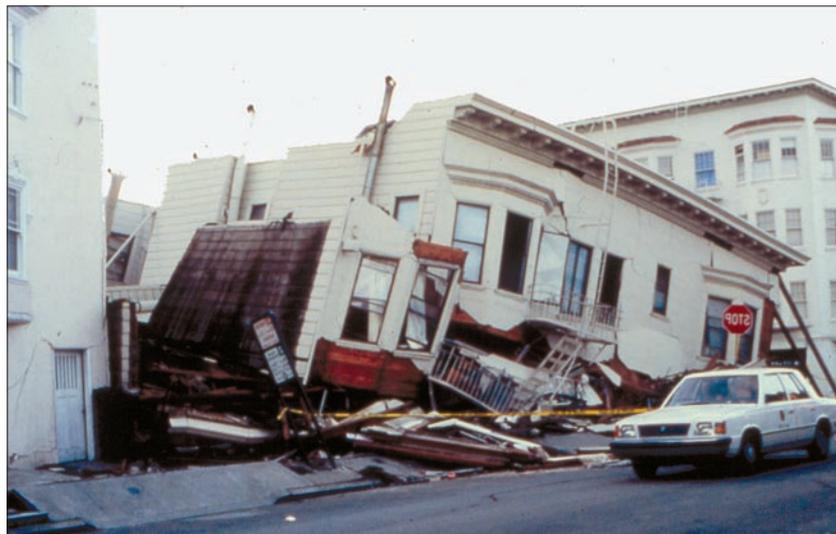
Collapsed apartment house in the Marina District of San Francisco, caused by a combination of amplified ground motion and a soft story.

ground motion at the site (Figure 1-2). The United States does not rate very high in deadly earthquakes compared to other countries. In the entire history of the United States, the estimated number of earthquake-related deaths is only about 3,100, of which some 2,000 are accounted for by the 1906 San Francisco quake.

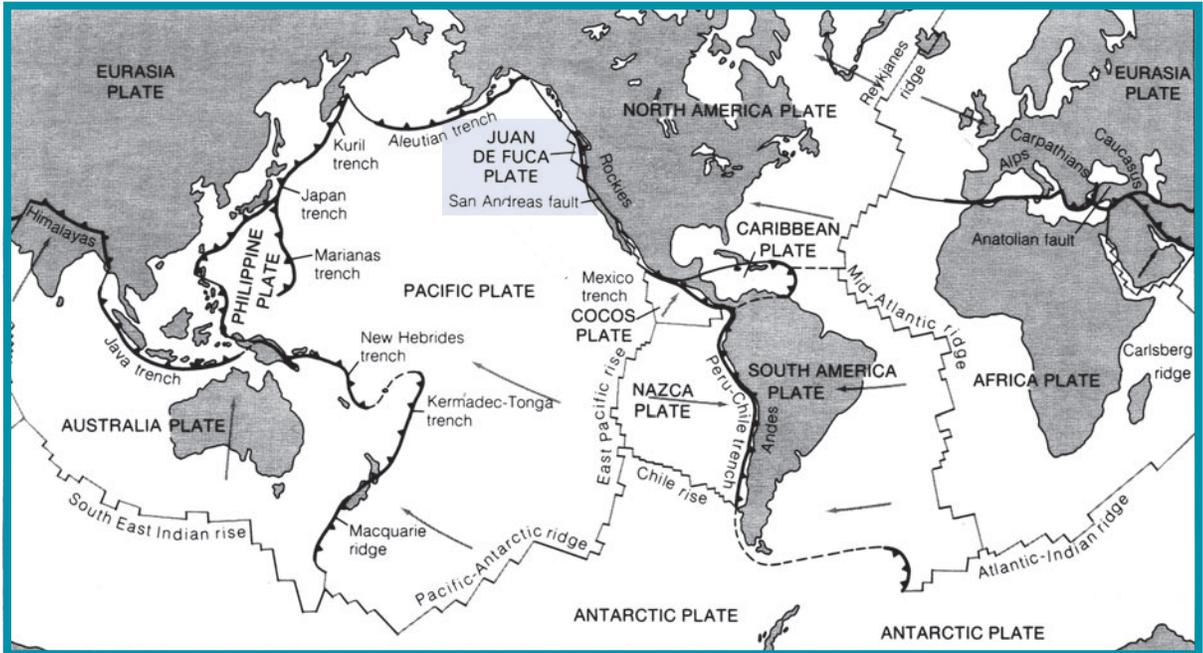
Figure 2-2: The major tectonic plates, midoceanic ridges, trenches and transform faults.

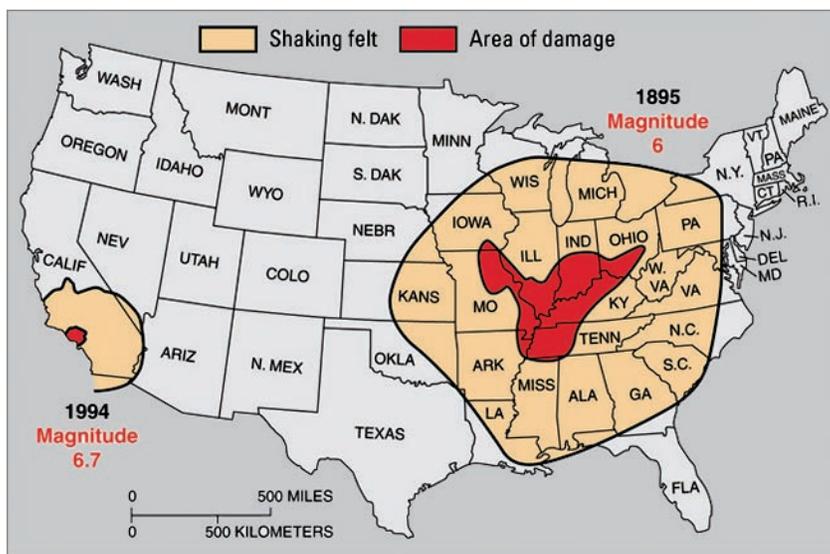
Figure 2-6: Map comparing curves of MMI 3 (shaking felt) and MMI 8 (area of damage) for the magnitude 6.7 1994 Northridge, California, earthquake and a magnitude 6 near New Madrid, Missouri, in 1895. Although the difference in magnitude implies an 11-fold difference in scalar seismic moment, the areas of shaking intensity for the smaller earthquake are substantially larger due to differences in seismic wave attenuation in the non-tectonic region of New Madrid compared to the western U.S. (discussed in section 2.6.1).

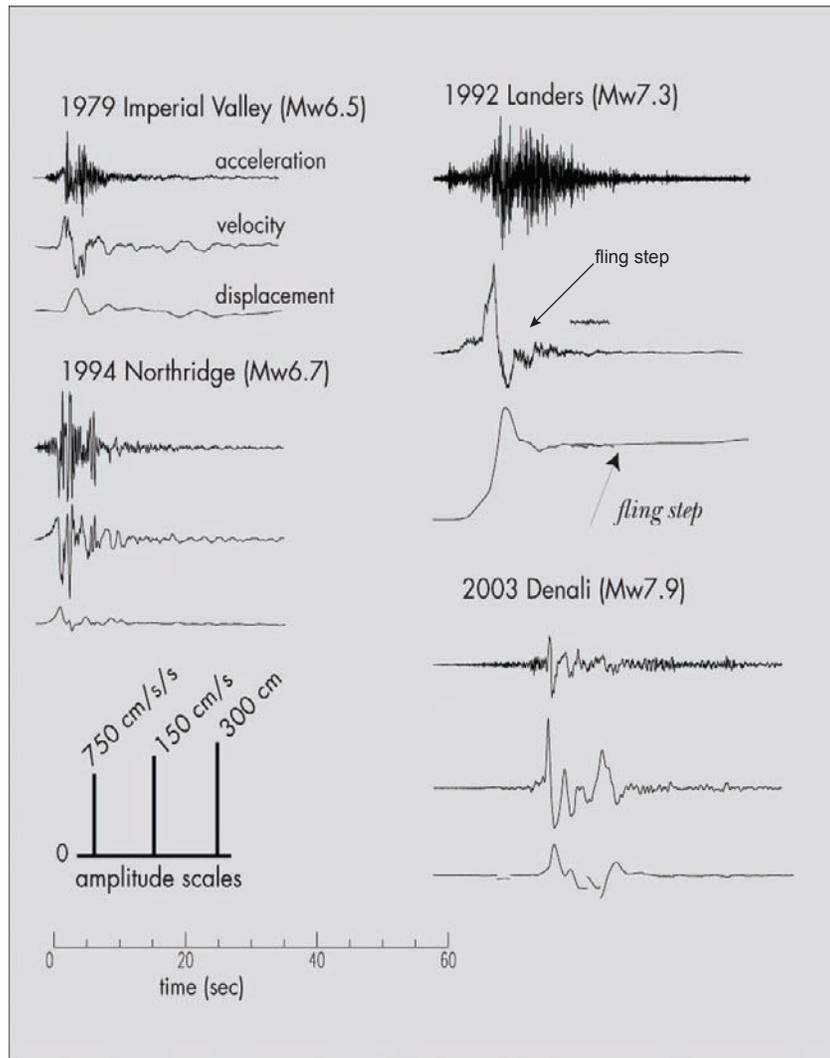
Figure 2-9: Examples of near-fault, large amplitude seismograms (time-histories).

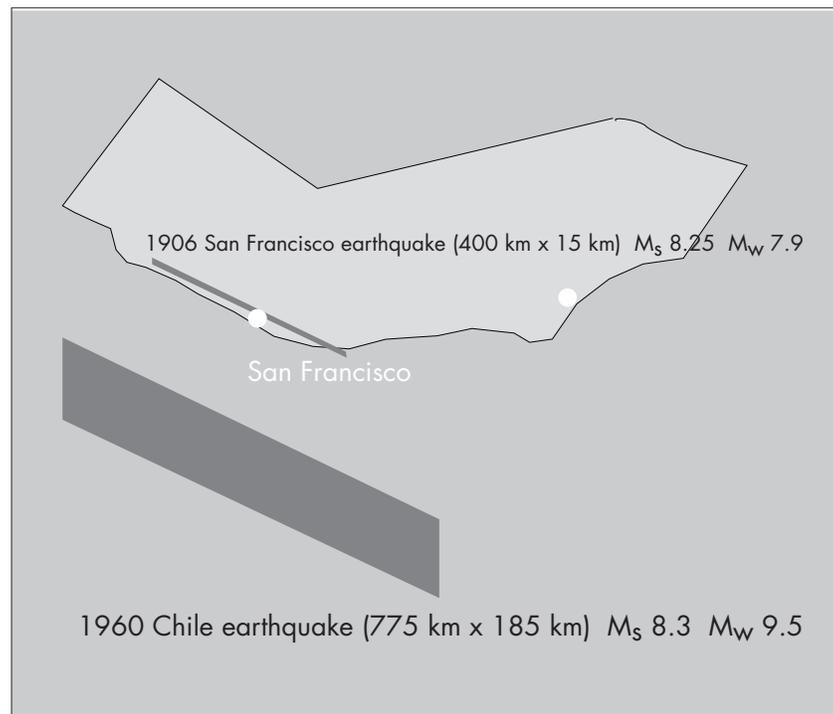
Figure 2-10: Two earthquakes may have equal magnitudes but be distinctly unequal in other respects.

The 1906 San Francisco, California, earthquake ruptured rock over a shorter length and shallower depth - only about 1/25 the area - as the 1960 Chilean earthquake. Although the surface wave magnitudes are the same, the moment magnitude for these two earthquakes (Table 2-1) are distinctly different. A sketch of the outline of California is shown for scale.

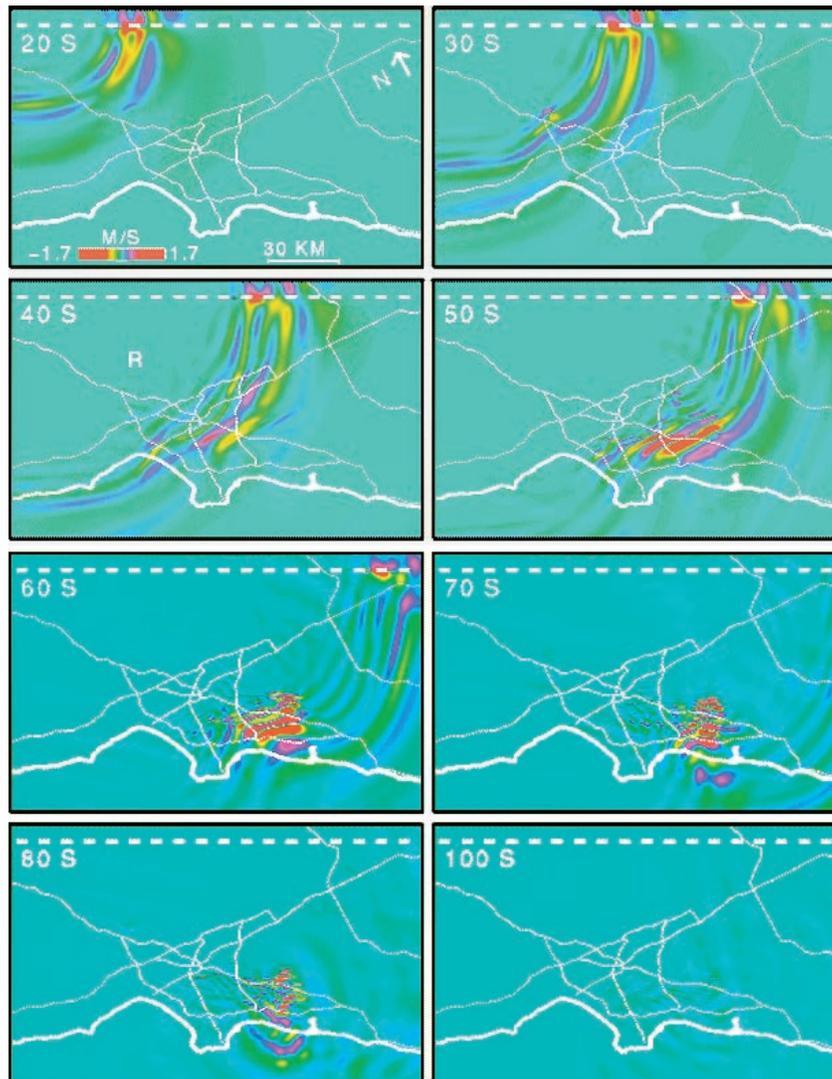
Figure 2-11: Aerial snapshots of a simulated wave propagation in the Los Angeles area.

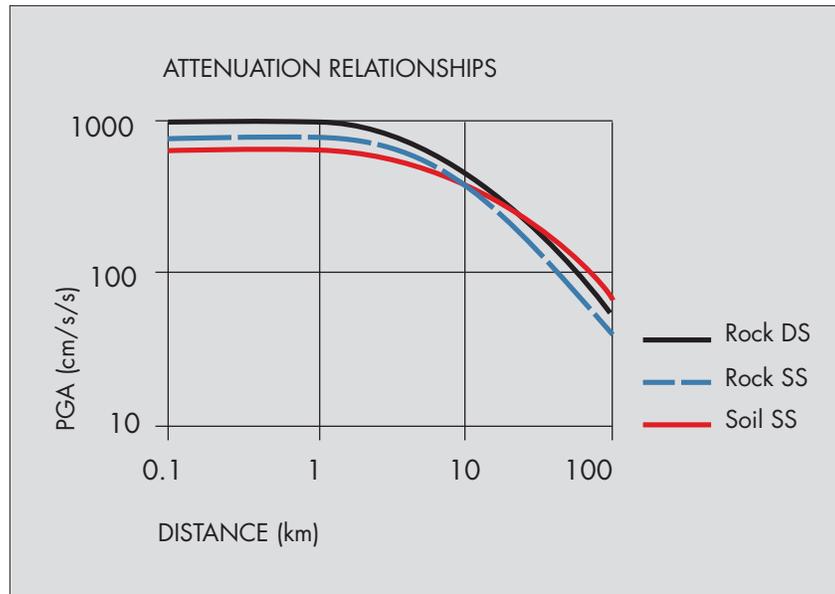
Figure 2-12: Examples of attenuation curves for a  $M_w7$  earthquake obtained by data regression, illustrating the effects of a **site** type: rock (blue dashed) vs. deep soil (red), and **event** type: strike-slip fault (blue dashed) vs. reverse fault (black)

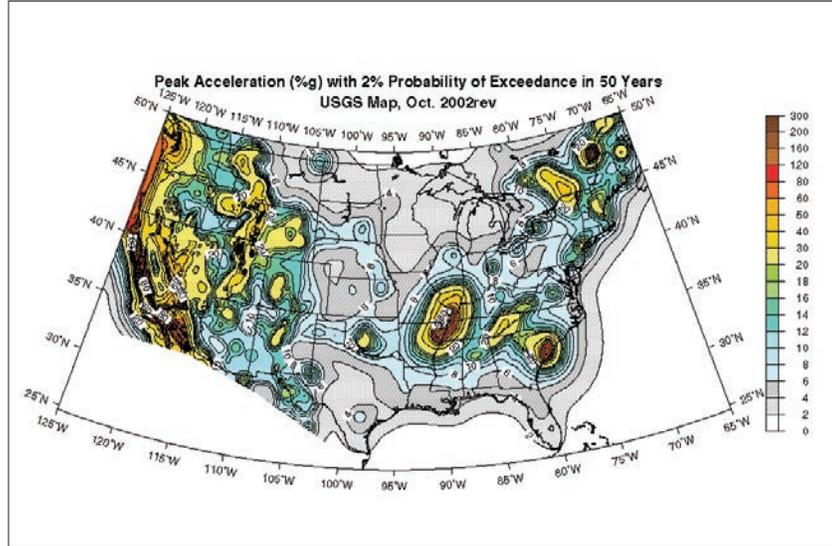
Figure 2-13: Spectral Acceleration values in %g with a 2% Probability of Exceedance in 50 years for the coterminous United States. The color scale to the right relates to the %g values.

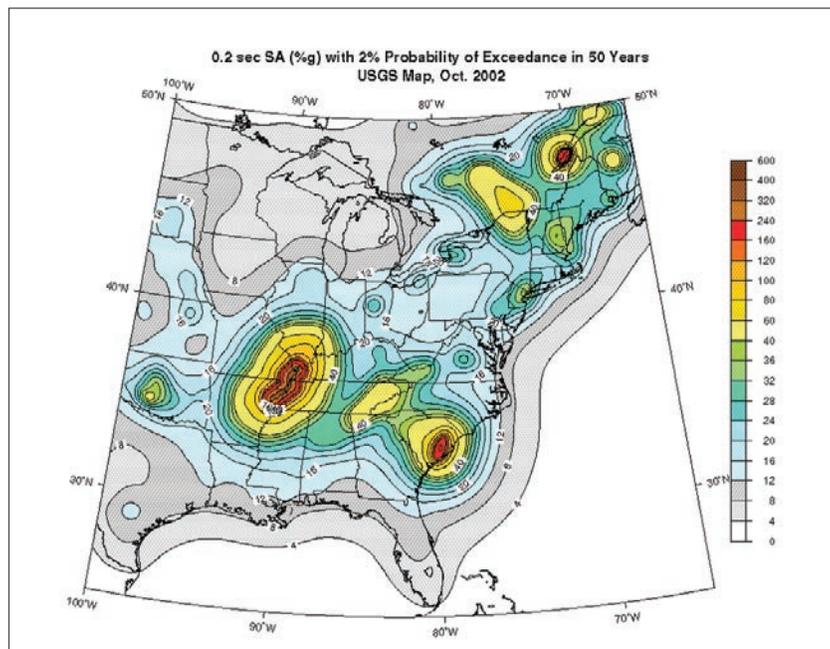
Figure 2-14: 0.2 second (short) period Spectral Acceleration values in %g with a 2% Probability of Exceedance in 50 years for Central and Southern United States.

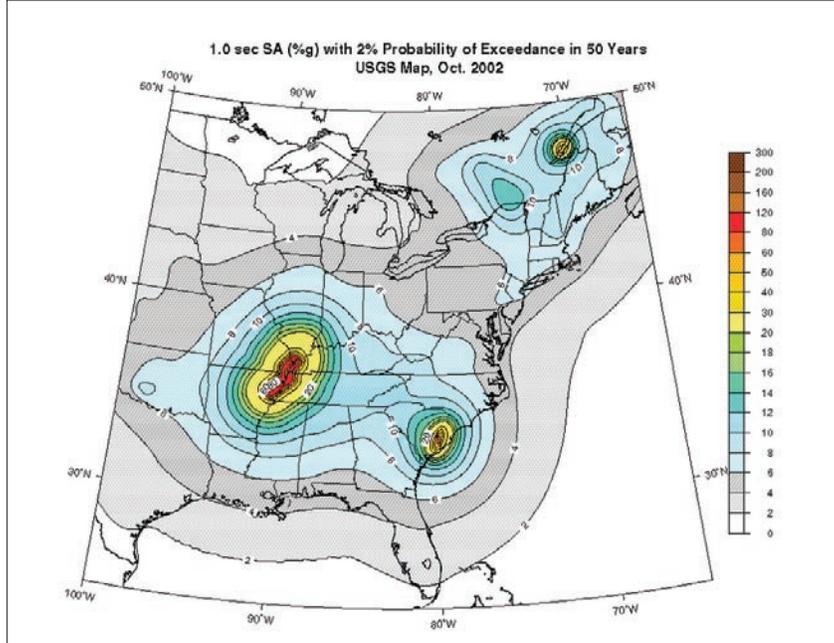
Figure 2-15: 1.0 second (long) period spectral acceleration values in %g with a 2% probability of exceedance in 50 years for central and southern United States.

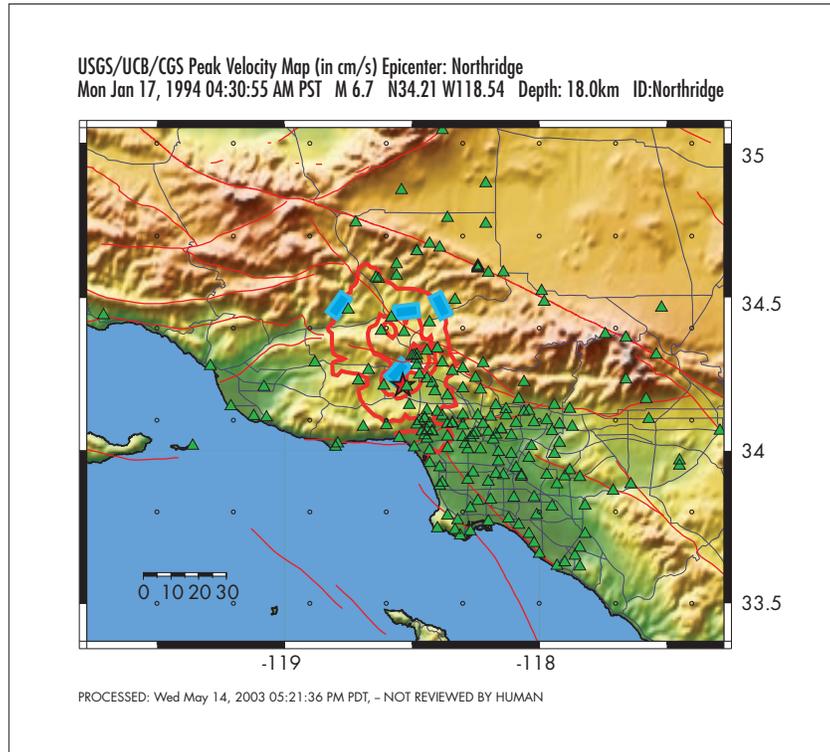
Figure 2-16: Example of a peak ground velocity (PGV) ShakeMap for the 1994  $M_w=6.7$  Northridge earthquake.

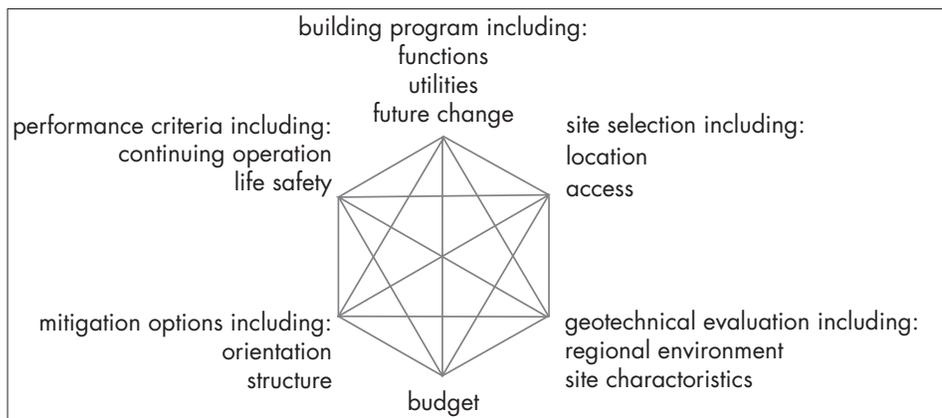
Figure 3-1: Interrelationships of performance expectations, building program and site characteristics.

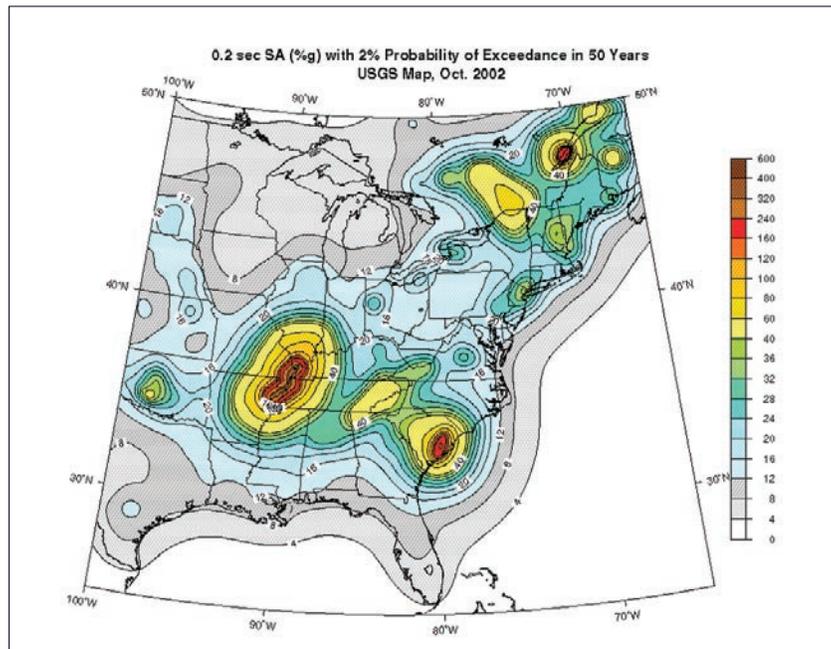
Figure 3-2: USGS Map of 0.2 sec spectral acceleration with a 2% Probability of Exceedance in 50 Years

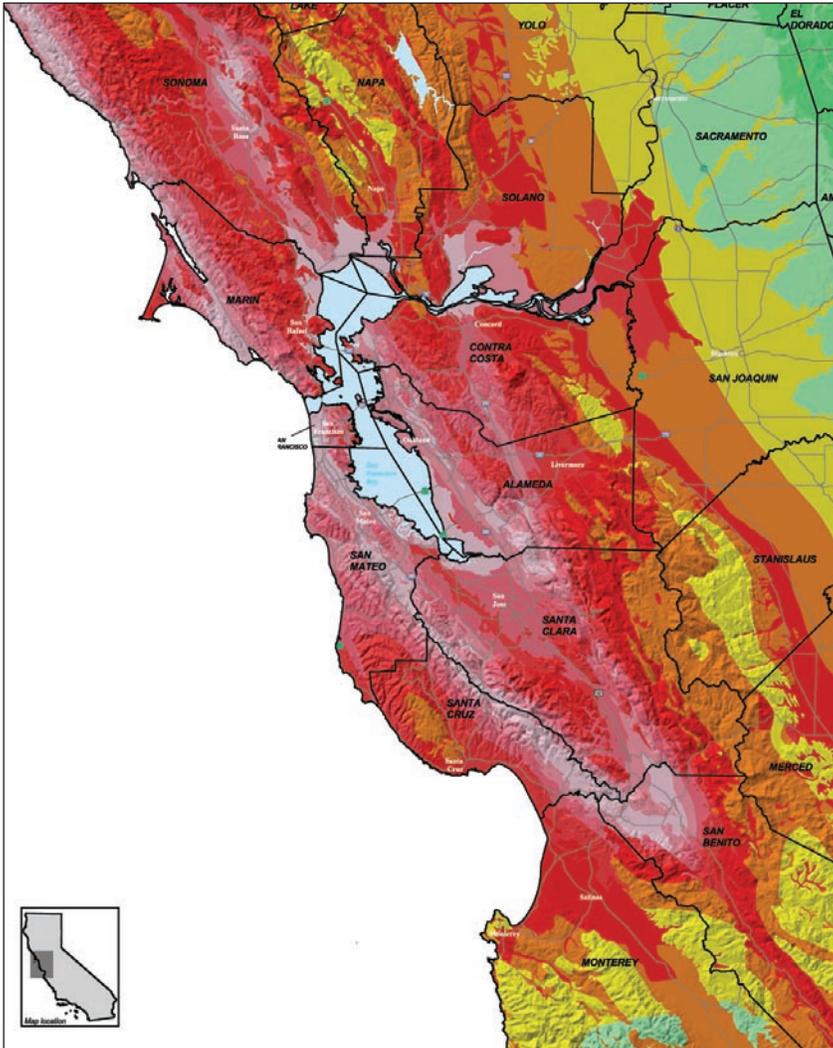
Figure 3-3: USGS and CGS Map of Relative PGA with a 2% Probability of Being Exceeded in 50 Years

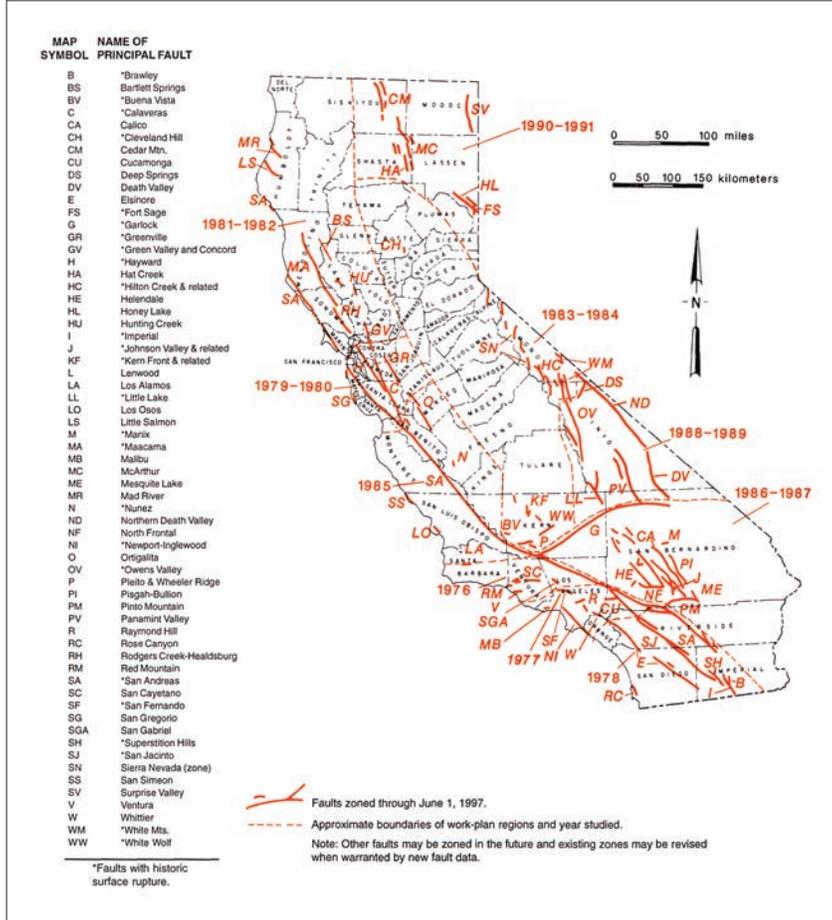
Figure 3-7  
Principal Active Fault Zones in California  
SOURCE: CGS, SPECIAL PUBLICATION 1999

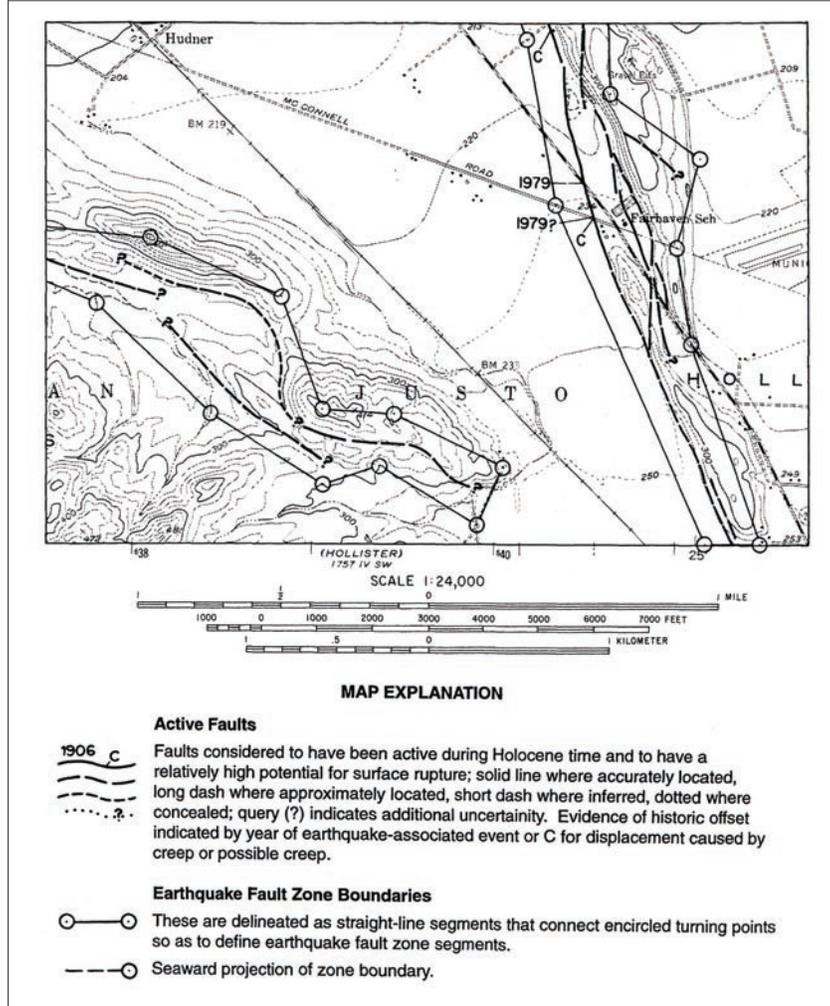
Figure 3-8: Alquist Priola Special Studies Zone (Earthquake Fault Zone).

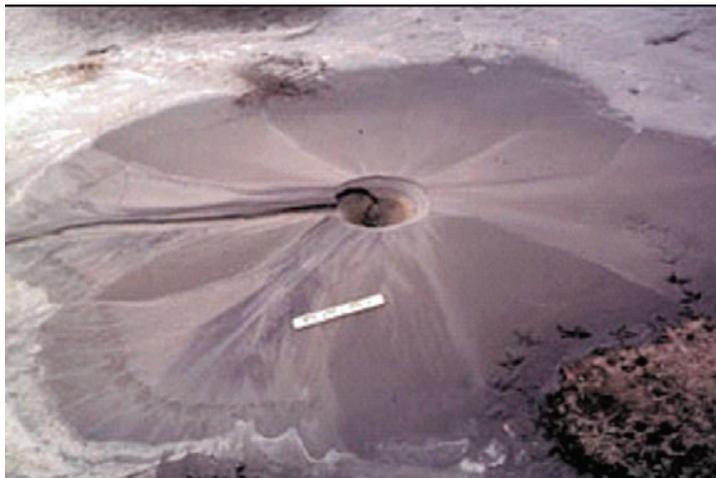
Figure 3-11: Sand Boil.

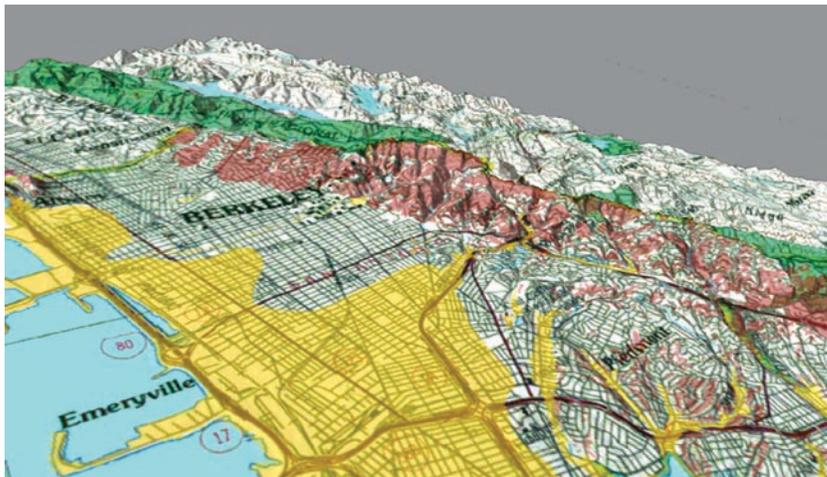
Figure 3-12: 3-D image of Liquefaction and Landslide Hazard Zone Map for Berkeley and Emeryville. Yellow indicates liquefaction, which is related to soil type and proximity to ground water.

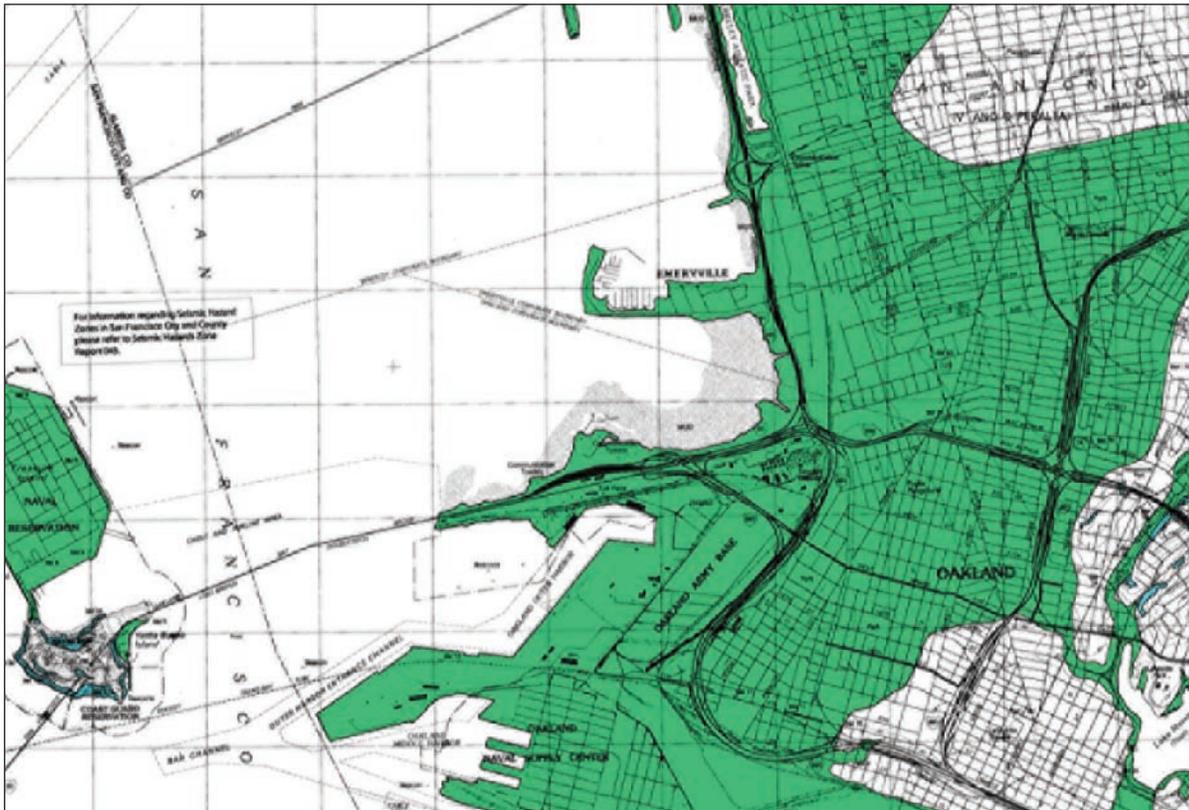
Figure 3-13: Liquefaction Hazard Zone Map for West Oakland and Emeryville.

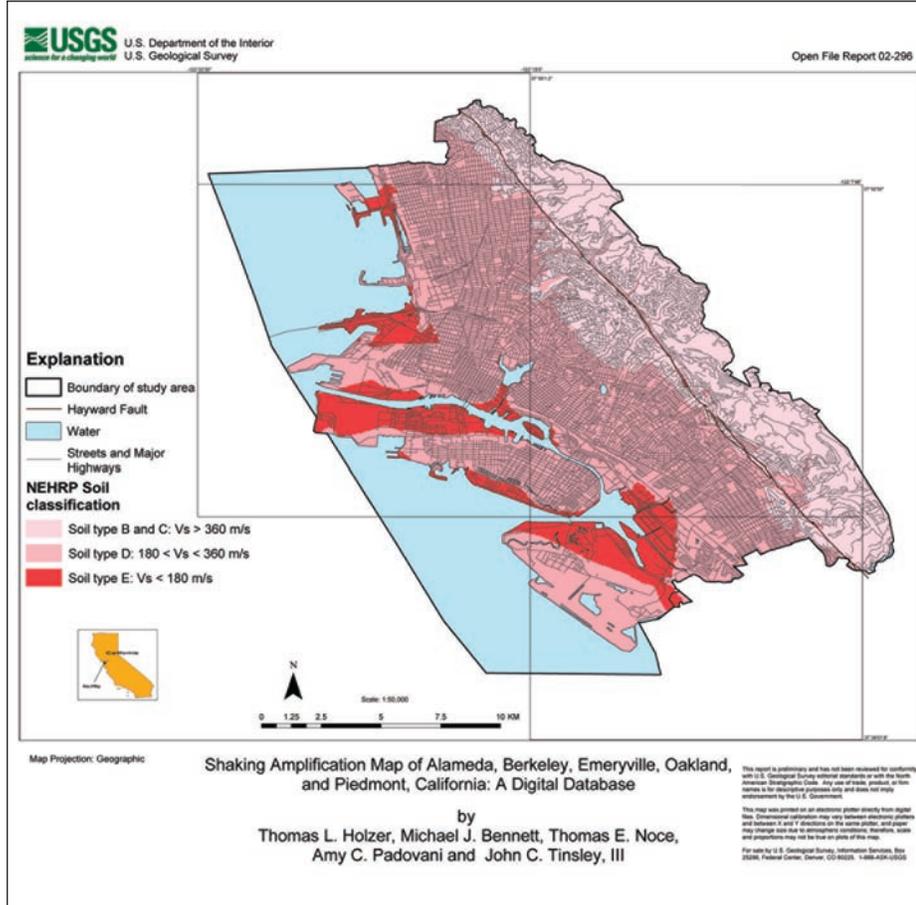
Figure 3-15: USGS Shaking Amplification Map of Alameda, Berkeley, Emeryville, Oakland and Piedmont, California. SOURCE: USGS (HOLZER ET AL.)

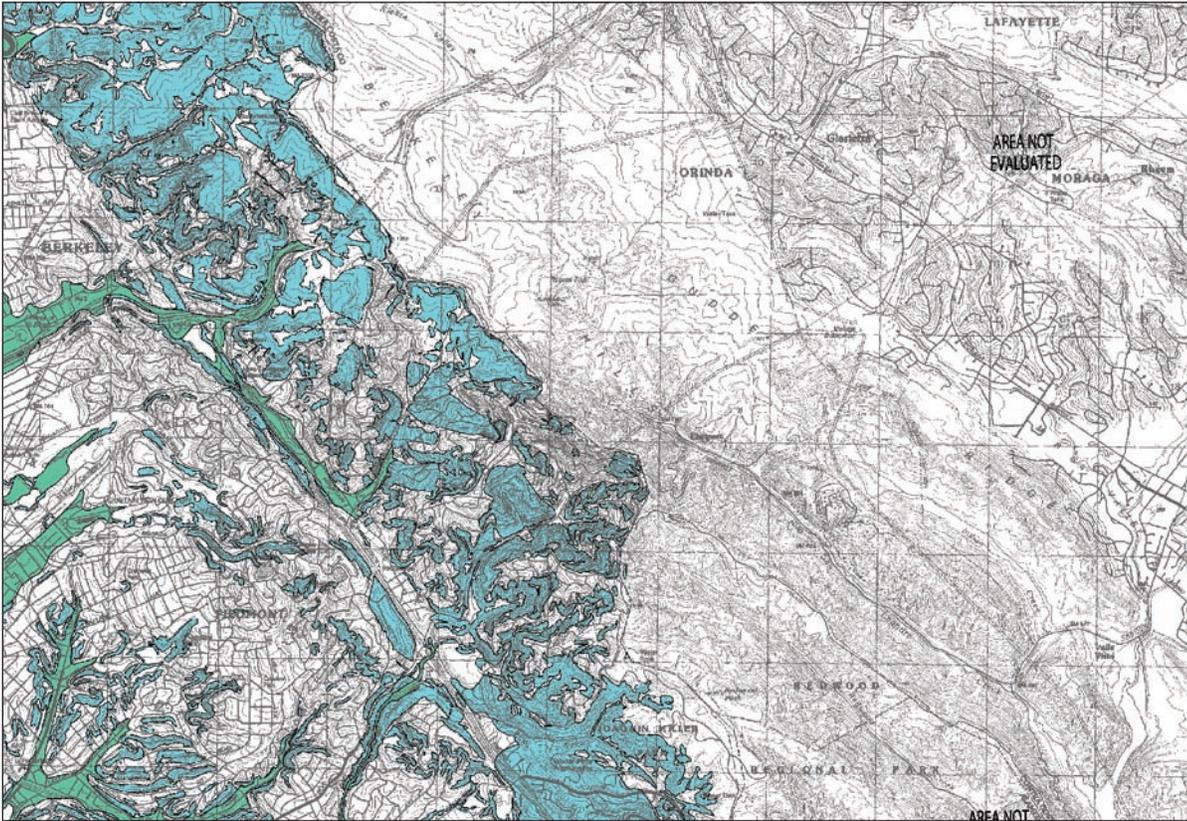
Figure 3-16: Landside Hazard Zones for Berkeley and Oakland, California. Blue areas are those that are susceptible to earthquake-caused landslides.

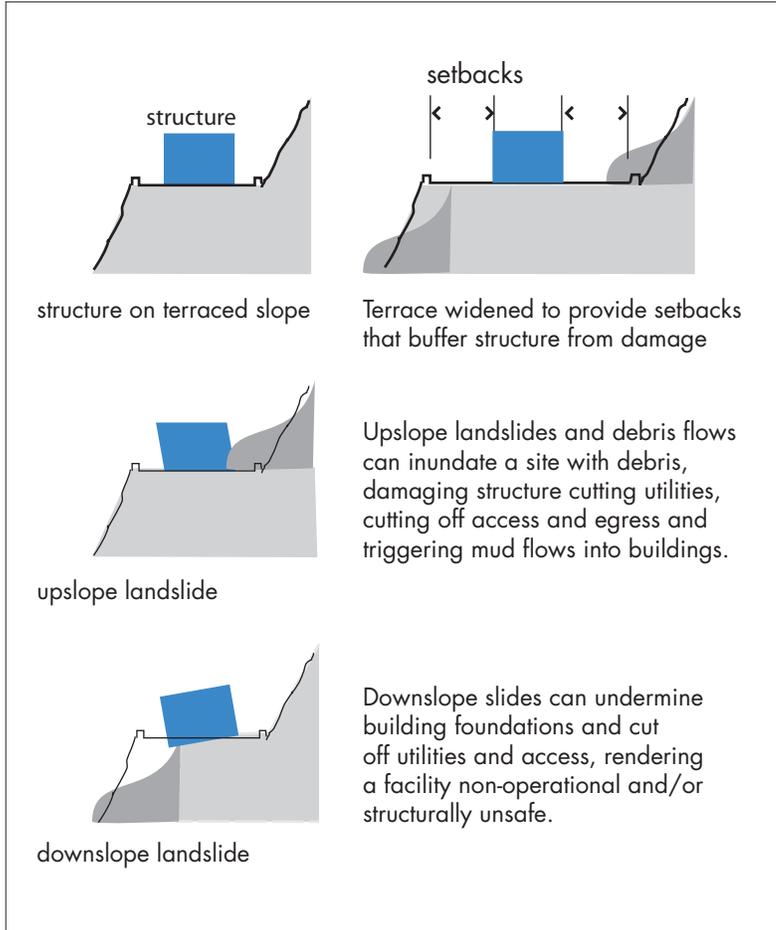
Figure 3-17  
The effect of upslope and downslope landslides.

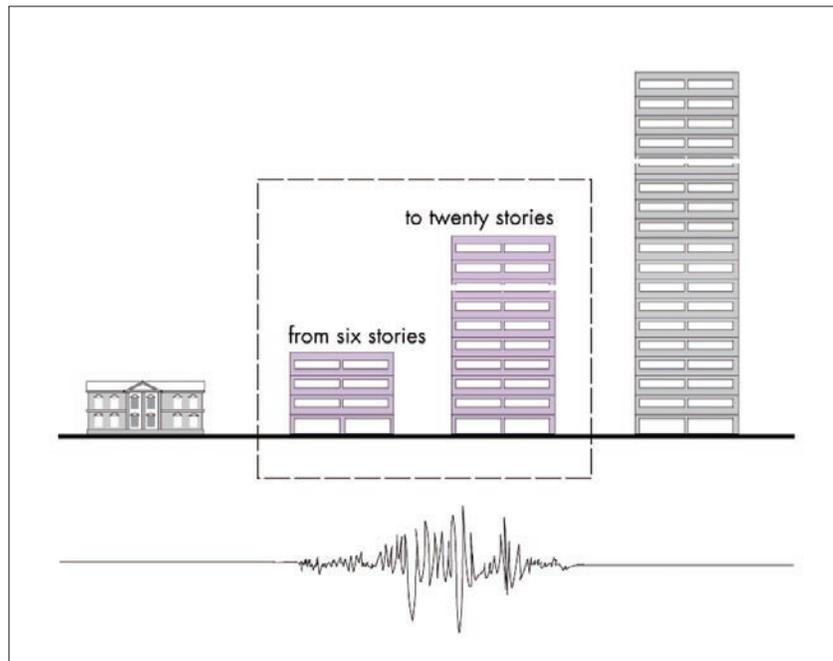
Figure 4-5: The vulnerable group: Mexico City, 1985. The periods of buildings in the 6 to 20 story range resonated with the frequency content of the earthquake.

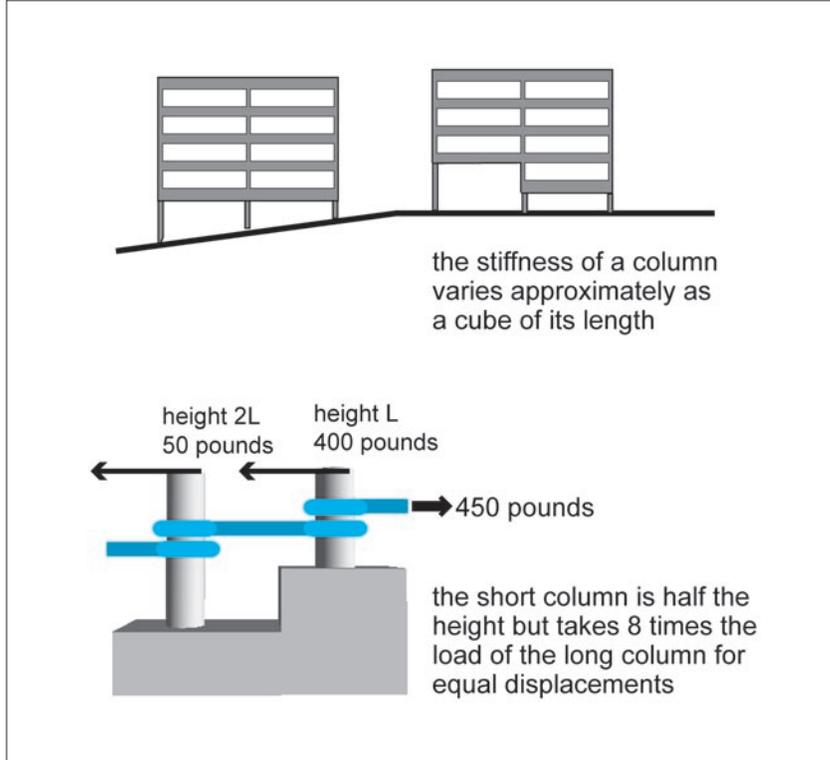
Figure 4-15: The short column problem.

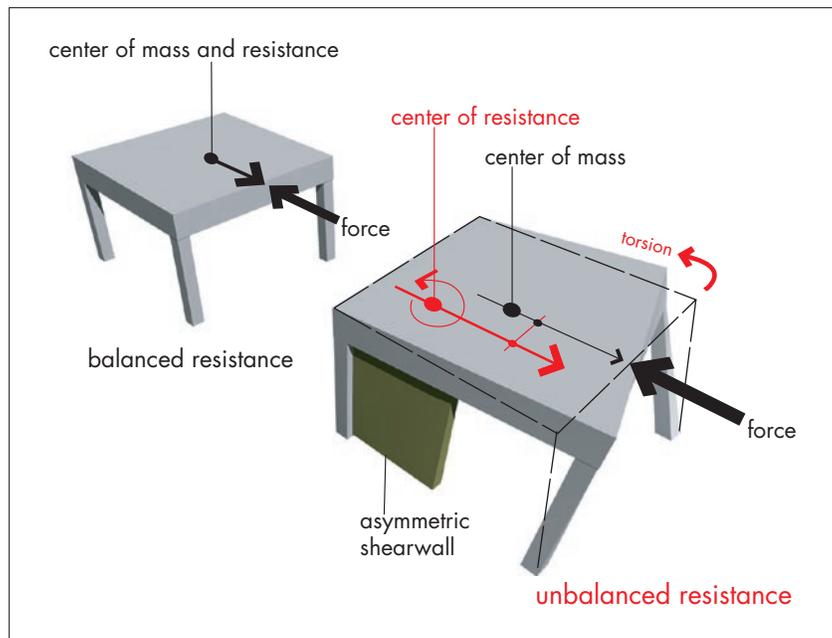
Figure 4-17  
Torsional forces.

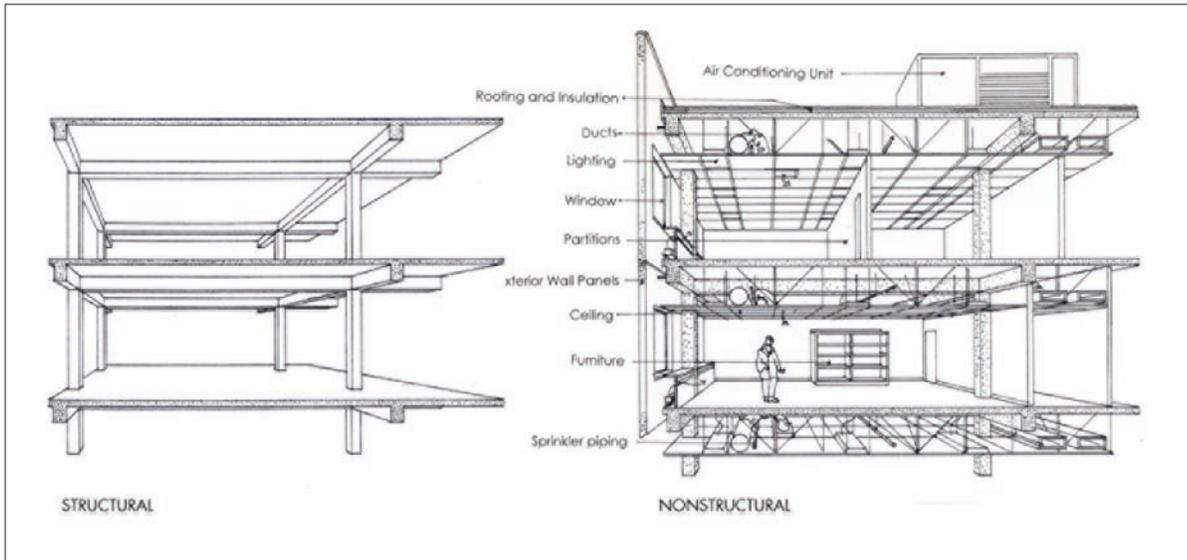
Figure 4-18: Structure (left), nonstructural components and systems (right).

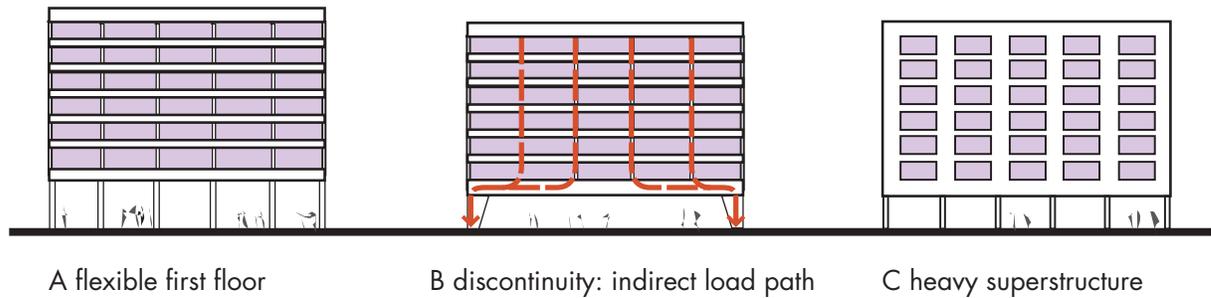
Figure 5-8: Three types of soft first story.

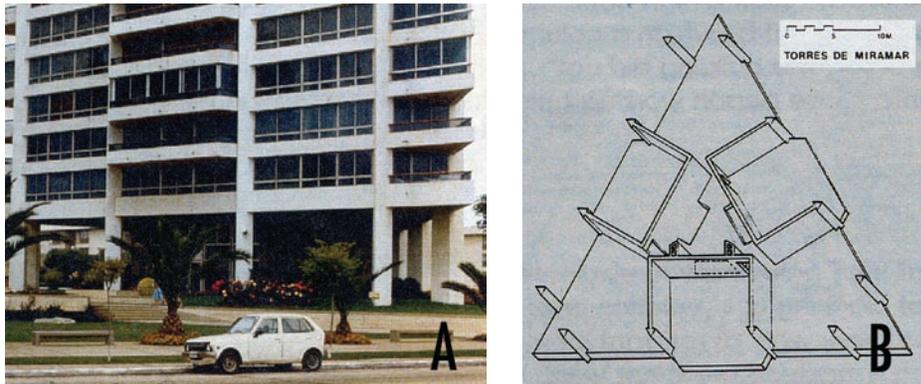
Figure 5-12: This apartment house appears to have a soft first story (Figure 5-12A), but the lateral force-resisting system is a strong internal shear wall box, in which the shear walls act as party walls between the dwelling units (Figure 5-12B). The architect achieved a light and elegant appearance, and the engineer enjoyed an optimum and economical structure.

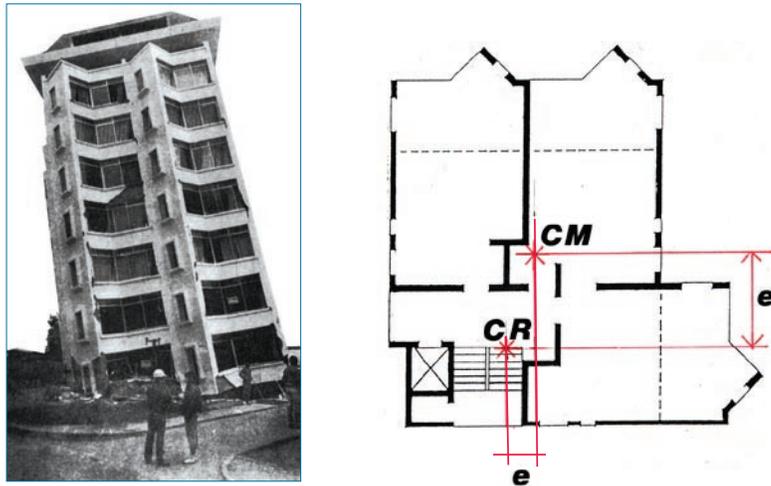
Figure 5-16: Left, the building after the earthquake. Right, typical floor plan showing the Center of Mass (CM), Center of Resistance (CR), and Eccentricity (e) along the two axes. PHOTO SOURCE: EERI

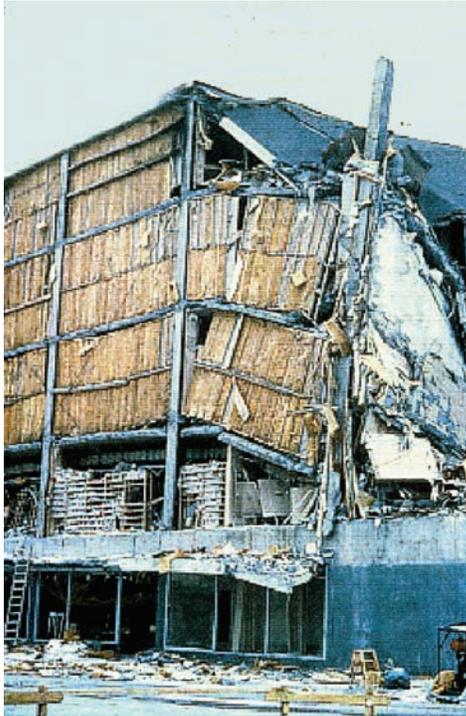
Figure 5-18: Penney's store, Anchorage, Alaska, earthquake, 1964. Left: Damage to the store: loss of perimeter precast panels caused two deaths. Right: Second-floor plan, showing unbalanced perimeter resistance. SOURCE: JAMES L. STRATTA

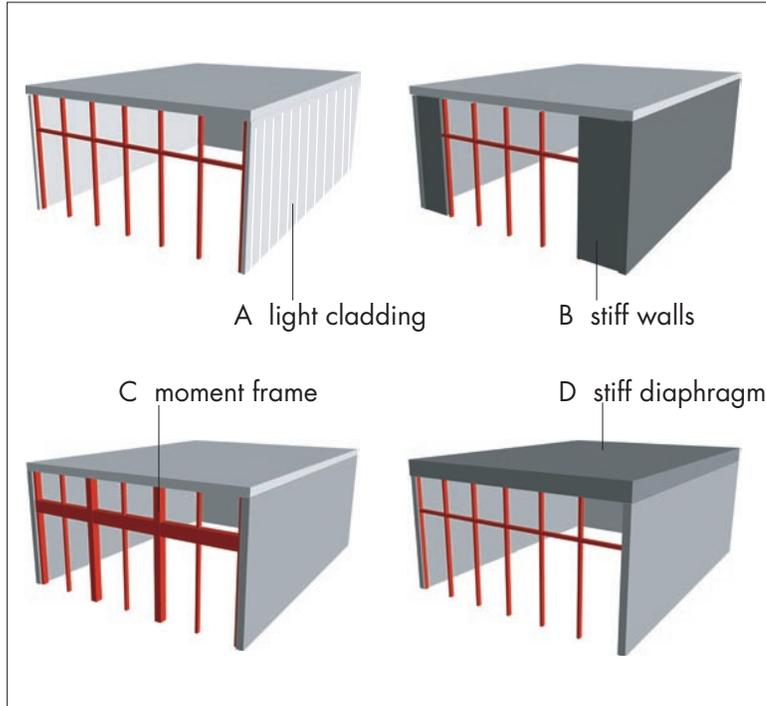
Figure 5-19  
Some solutions  
to store-front type  
unbalanced-perimeter-  
resistance conditions

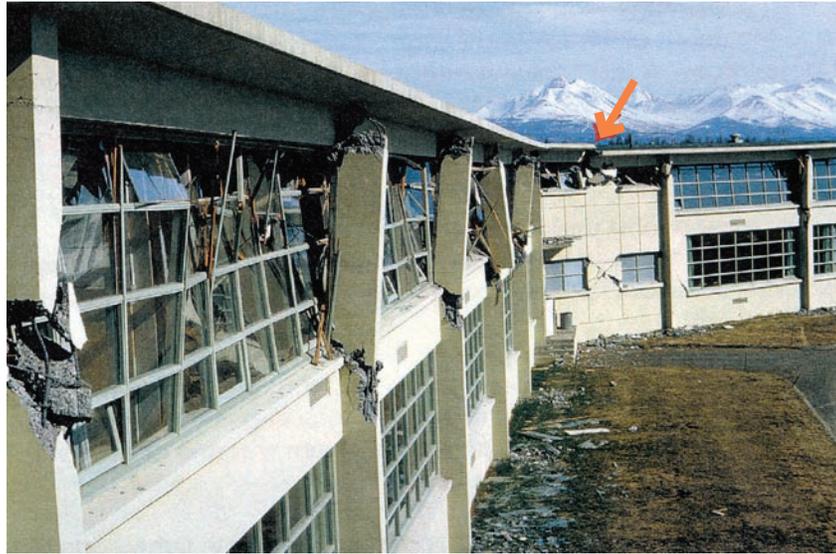
Figure 5-22: West Anchorage High School, Alaska earthquake, 1964. Stress concentration at the notch of this shallow L-shaped building damaged the concrete roof diaphragm.

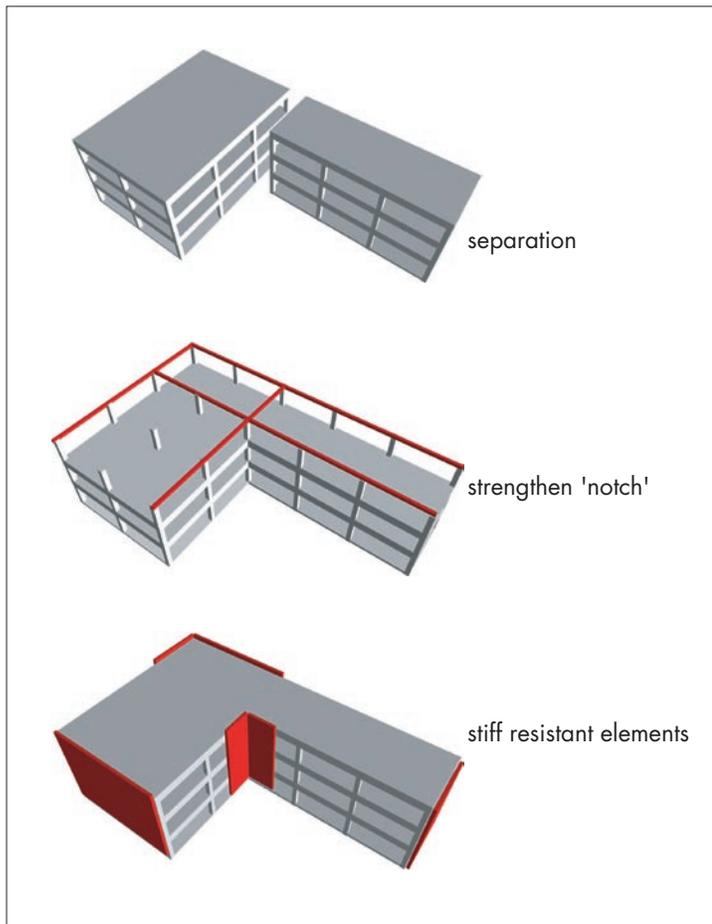
Figure 5-23  
Solutions for the re-entrant-  
corner condition.

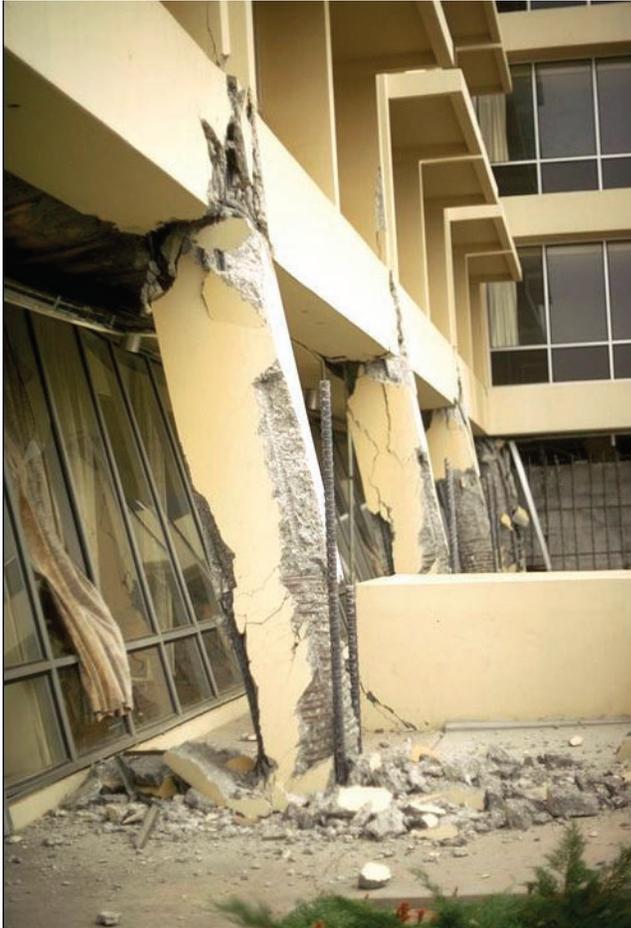
Figure 6-4: Sylmar, 1971, Damage to engineered building at Olive View Medical Center.

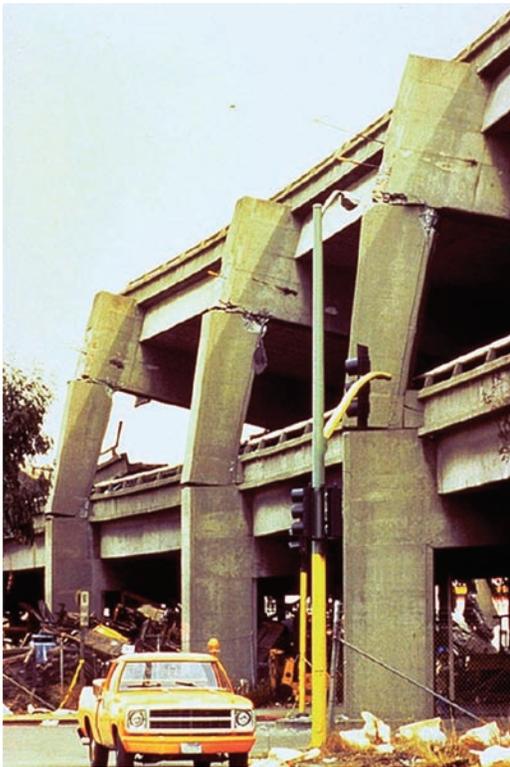
Figure 6-6: San Francisco, 1989, elevated highway support bents, an example of failure of engineered structures.
