# Designing for Earthquakes

A Manual for Architects

*FEMA 454 / December 2006*

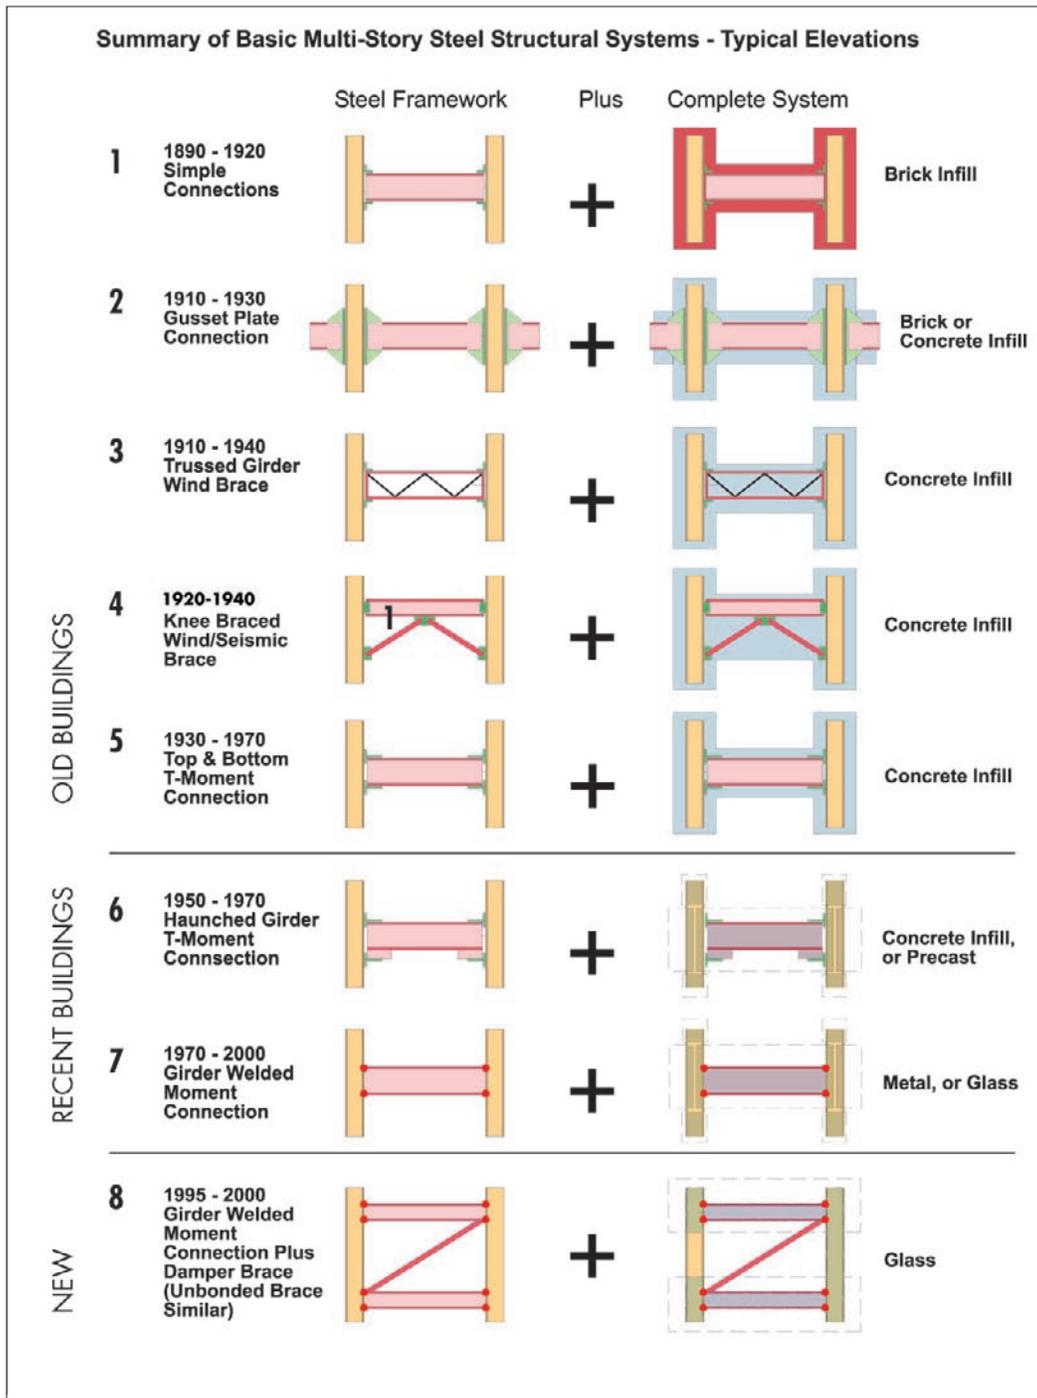
Figure 7-2: Steel building frameworks.

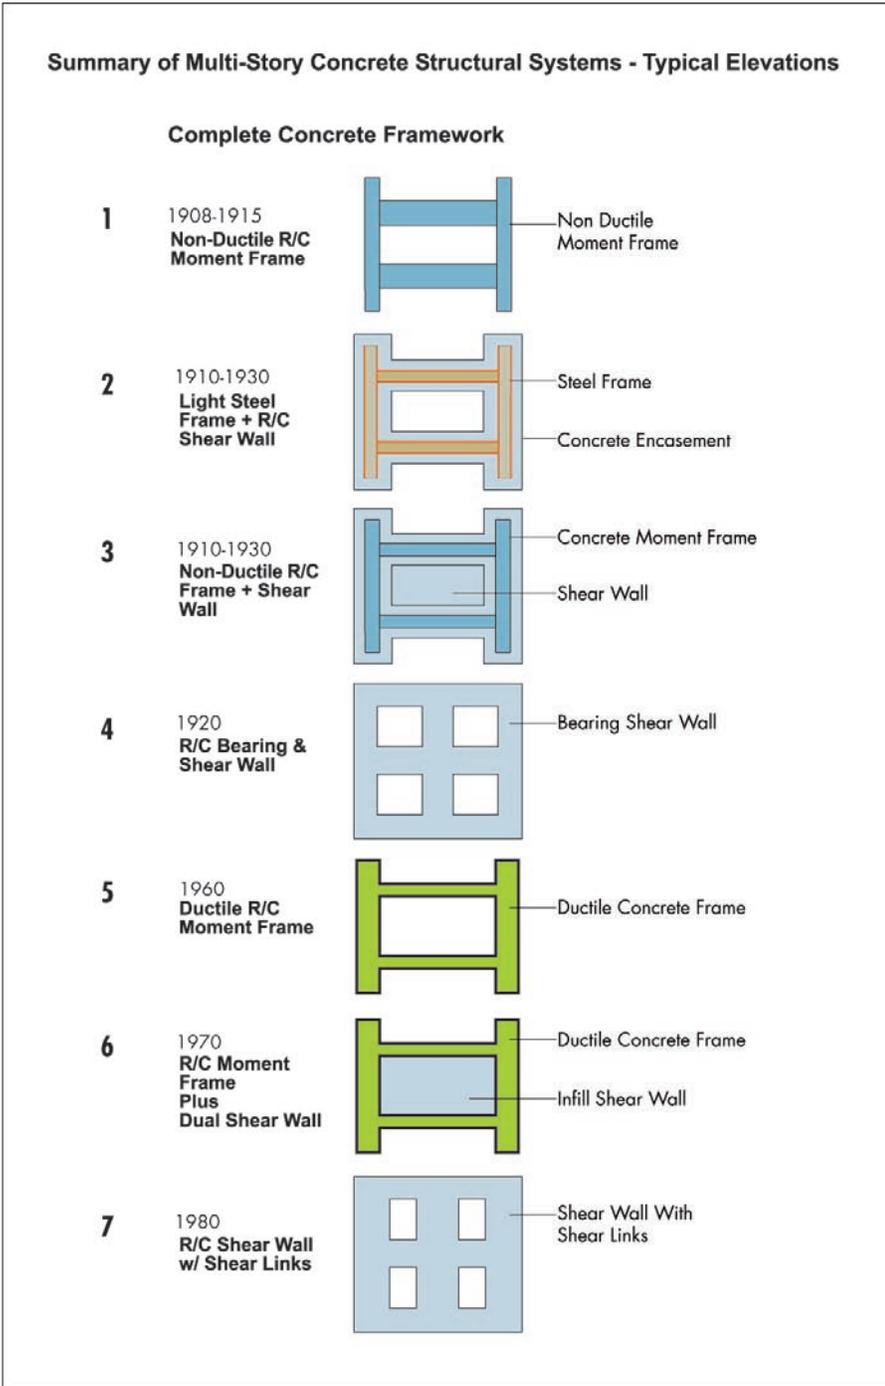
Figure 7-3: Concrete building frameworks

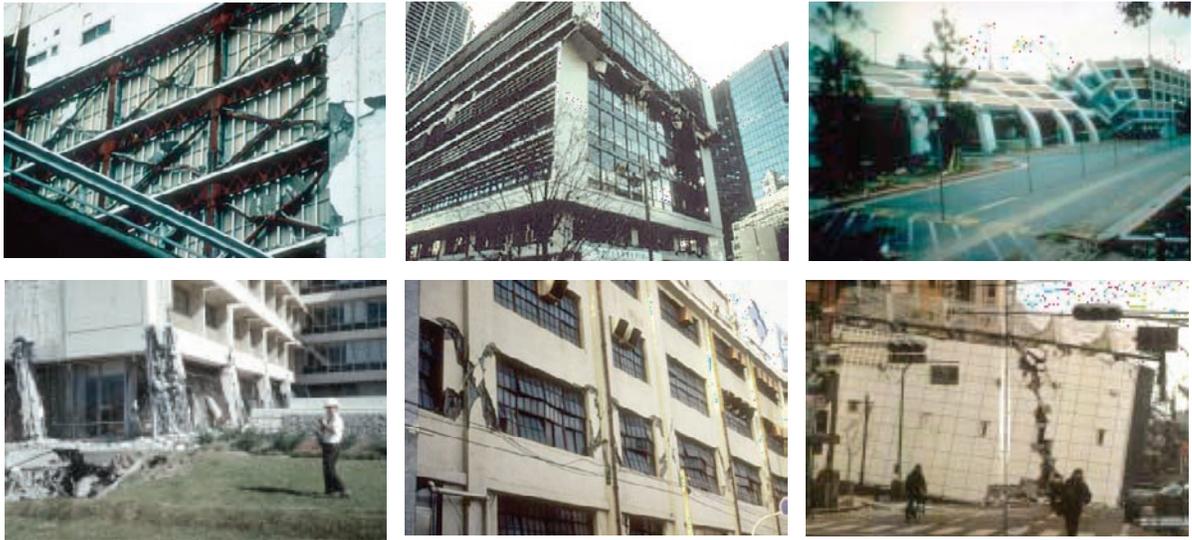
Figure 7-12: Examples of typical earthquake damage.

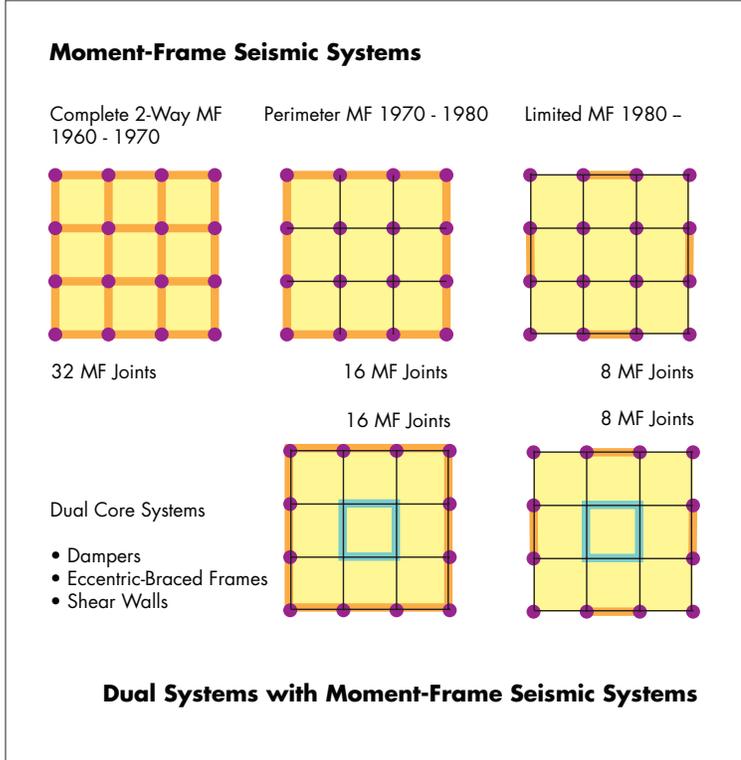
Figure 7-18: Single and multiple system concepts.

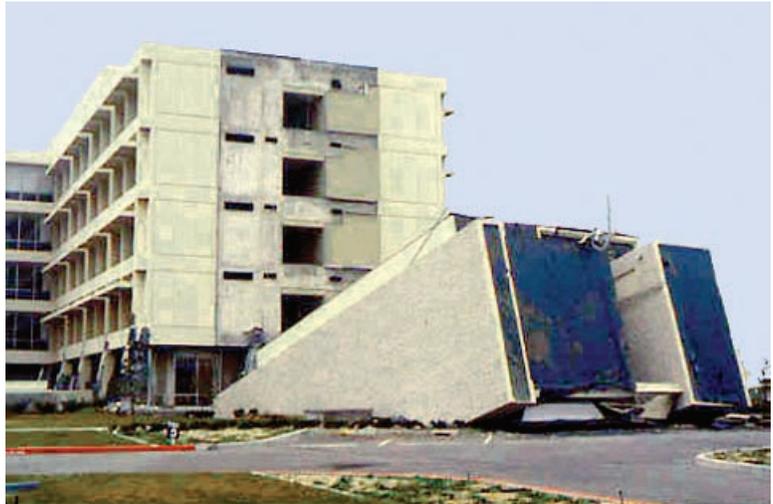
Figure 8-2: Olive View Hospital. A brand new facility that was damaged beyond repair in the 1971 San Fernando earthquake due to a shaking intensity that exceeded what was expected at the site and a design that, although technically complying with code at the time, contained several structural characteristics now considered major deficiencies. The lateral system contained nonductile concrete frames, discontinuous shear walls, and a significant weak story.

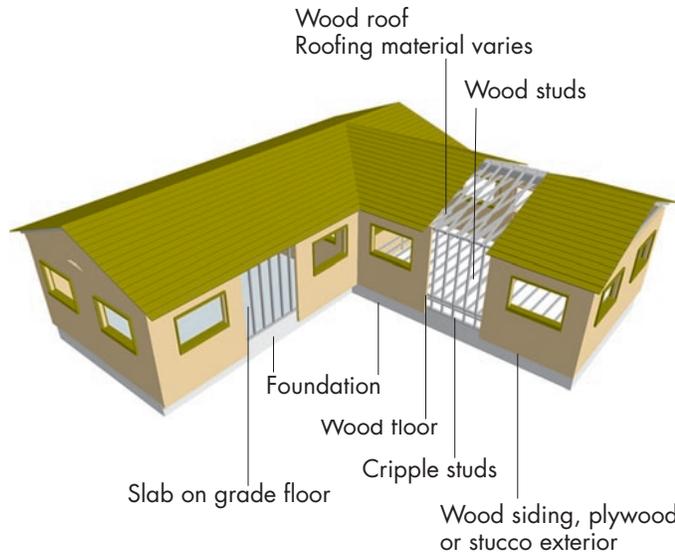
These buildings are generally single-family dwellings of one and two stories. Floor and roof framing consists of wood joists or rafters supported on wood studs spaced no more than 24 inches apart. The first floor may be slab on grade or wood raised above grade with cripple stud walls and post-and-beam supports. Lateral support is provided with shear walls of plywood, stucco, gypsum board, and a variety of other materials. Most often there is no engineering design for lateral forces.

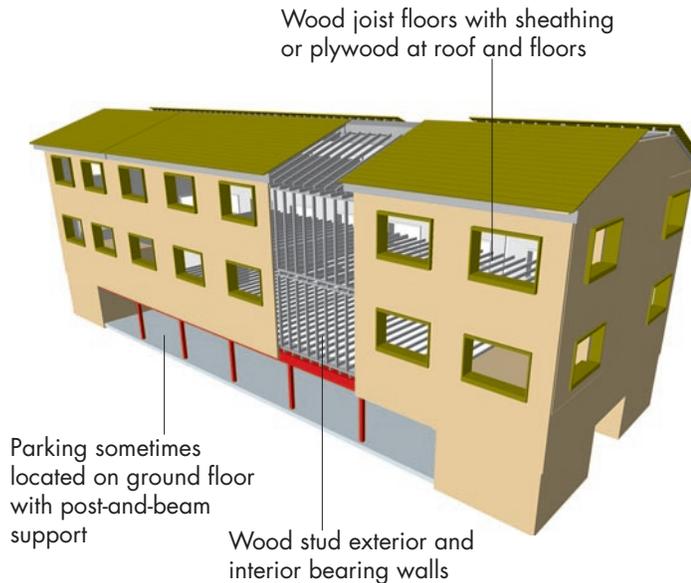
These buildings are framed with the same systems as W1 buildings but are most often multiple-story large residential-type structures, and, unless very old, are engineered. A common seismic deficiency is the tuck-under parking at the ground story that creates a soft or weak story. This building type is also often built on top of a one story concrete parking structure.

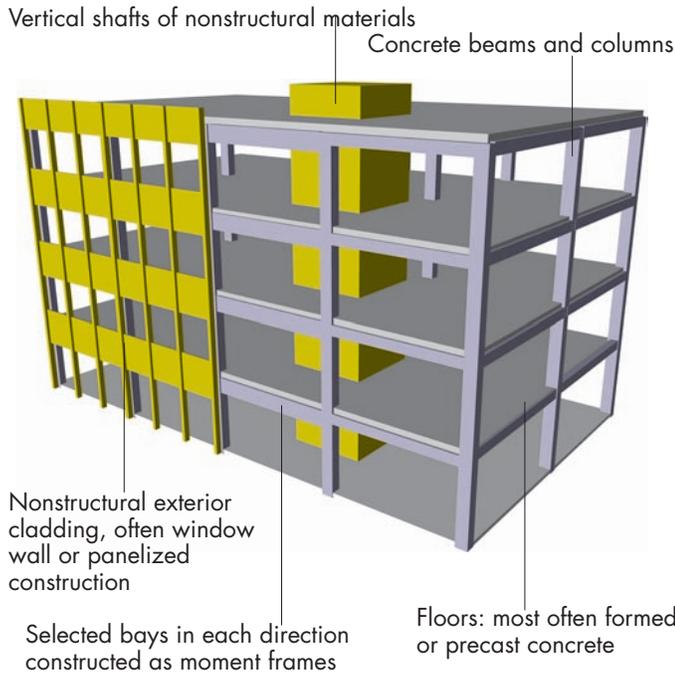
These buildings consist of concrete framing, either a complete system of beams and columns or columns supporting slabs without gravity beams. Lateral forces are resisted by moment frames that develop stiffness through rigid connections of the column and beams placed in a given bay. Moment frames may be developed on all framing lines or only in selected bays. It is significant that no structural walls are required. Floors are cast-in-place or precast concrete. Buildings with concrete moment frames could be used for most occupancies listed for steel moment frames, but are also used for multifamily residential buildings.

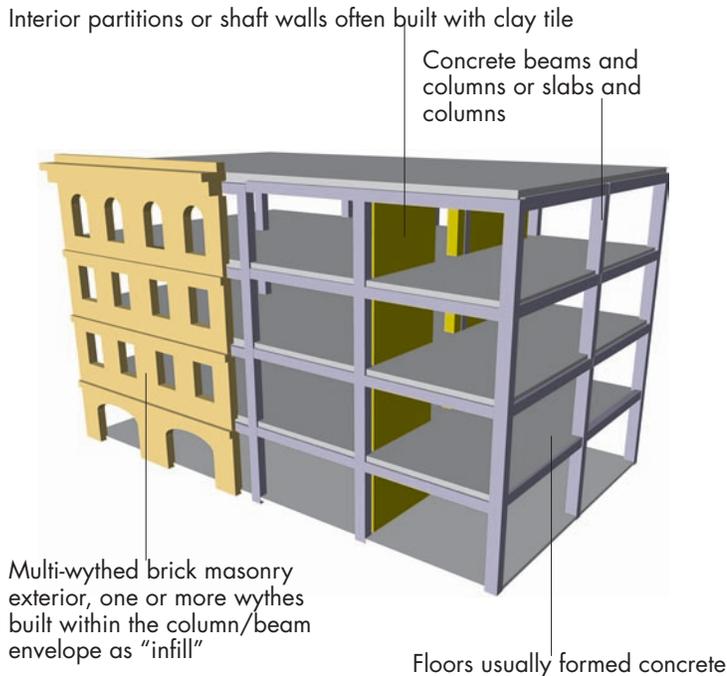
These buildings consist of concrete framing, either a complete system of beams and columns or columns supporting slabs without gravity beams. Exterior walls and possibly some interior walls are constructed of unreinforced solid clay brick, concrete block, or hollow clay tile masonry infilling the space between columns and beams. Windows and doors may be present in the infill walls, but to act effectively as shear-resisting elements, the infill masonry must be constructed tightly against the columns and beams. The building type is similar to S5, but is more often used for industrial and warehouse occupancies.

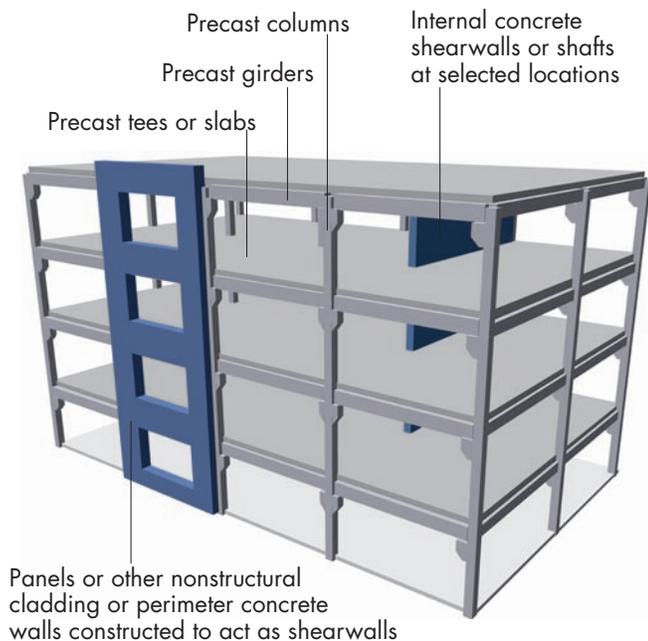
These buildings consist of concrete columns, girders, beams and/or slabs that are precast off the site and erected to form a complete gravity-load system. Type PC2 has a lateral force-resisting system of concrete shear walls, usually cast-in-place. Many garages have been built with this system. The building type is most common in moderate and low seismic zones and could be used for many different occupancies in those areas.

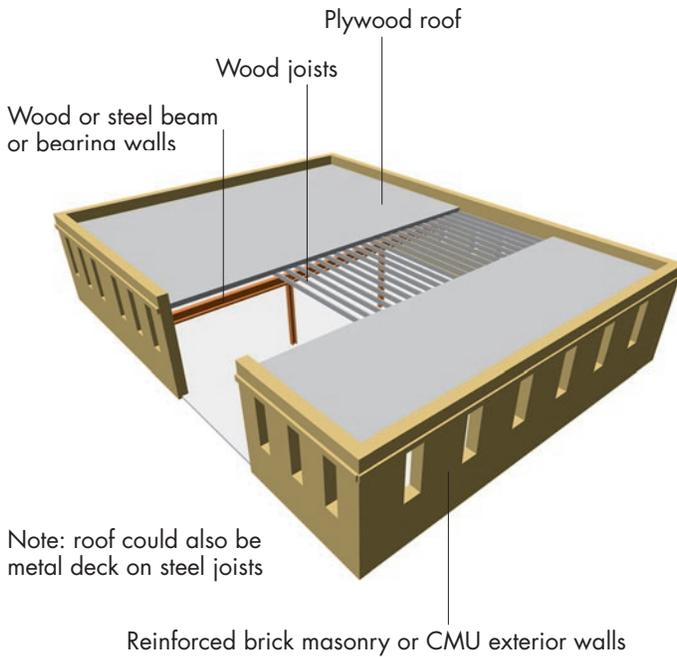
These buildings take a variety of configurations, but they are characterized by reinforced masonry walls (brick cavity wall or CMU) with flexible diaphragms, such as wood or metal deck. The walls are commonly bearing, but the gravity system often also contains post-and-beam construction of wood or steel. Older buildings of this type are generally small and were used for a wide variety of occupancies and are configured to suit. Recently, the building type is commonly used for one-story warehouse-type occupancies similar to tilt-up buildings.

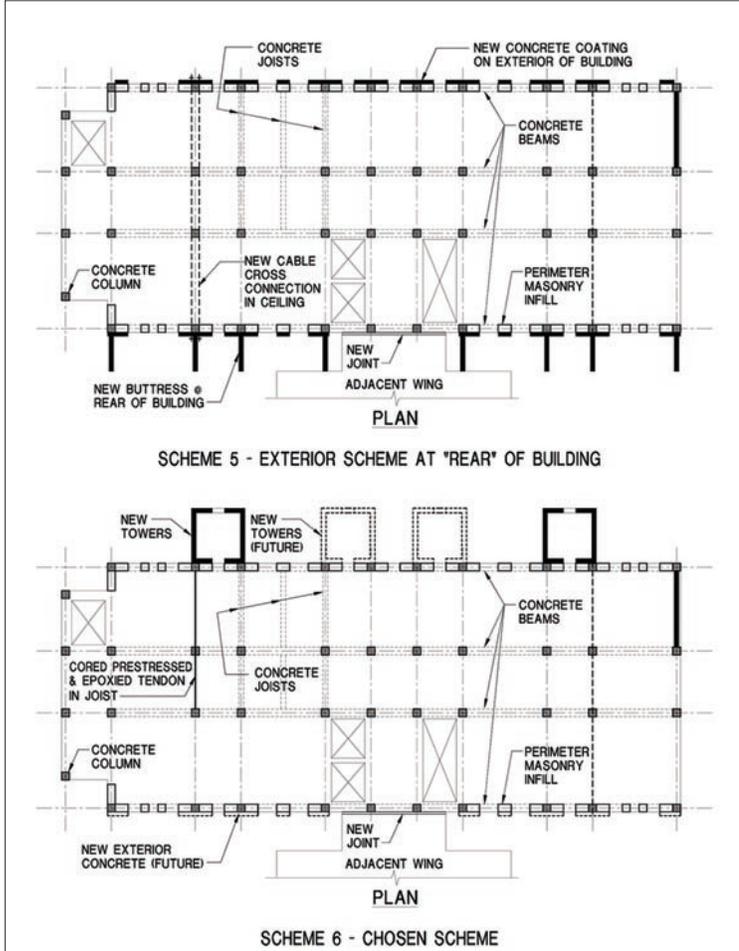
Schemes 1 and 2 required a complete lateral system in both buildings because of the separation installed at the wing intersection, which also caused difficult exiting issues. Schemes 3 and 4 were therefore developed, providing a strong inter-tie between wings and taking advantage of several new lateral elements to provide support to both wings. Scheme 3 featured new concrete towers as shown. Although the outside location was considered advantageous from a disruption standpoint, the towers closed windows and caused disruption to mechanical services. Scheme 4 was similar to 3, but eliminated the towers. Schemes 3 and 4 had less construction cost than 1 and 2, but disruption, in terms of phasing, caused essentially the same total downtime.

Figure 8-9c: Example of effect of non technical issues on retrofit schemes.
