Elevation Near Blanco River Survives Historic Flood

HAYS COUNTY, TX – On May 24, 2015, floodwater from the Blanco River overwhelmed numerous Texas cities. The record floods left residents homeless, structures damaged and claimed several lives.

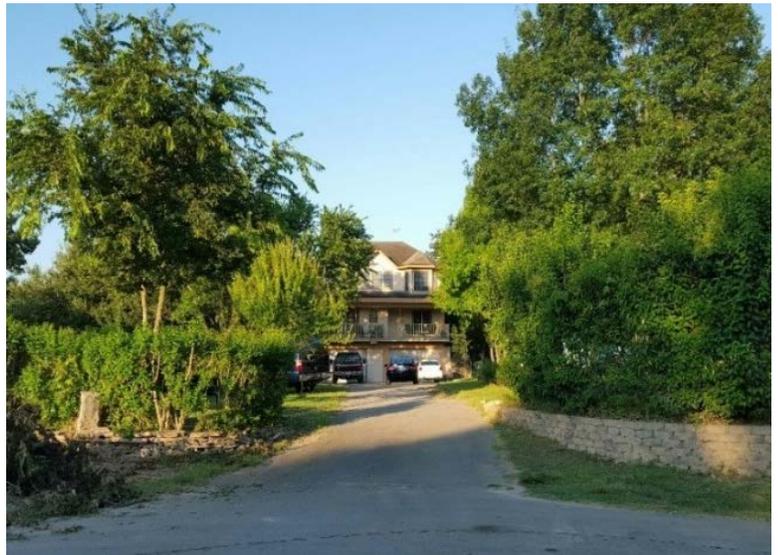
Juan Ponce’s home escaped flood damage after Memorial Day weekend flood in 2015
(Photo by Bonnie Hanchett)

Ponce’s 2,100-square-foot, two-story house is situated at the end of a tree-lined street. The house is designed with a retaining wall at the entrance that added a distinctive look to the landscape.

The home is elevated on 15 steel and concrete posts that are embedded seven feet into the ground. Underneath the house is a concrete slab reserved for parking vehicles and storage.

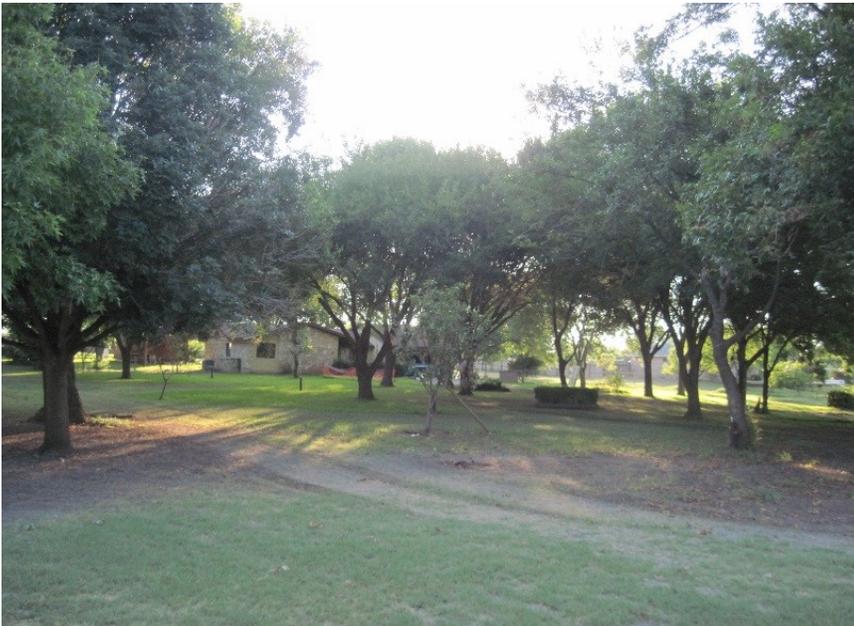
Neighbor's house on Bogie Drive received 7 ft. of water
(Photo by Bonnie Hanchett)

They looked directly across the street and saw their neighbor’s house submerged in nine feet of water. Next door, the floodwaters had risen up to seven feet. The entire neighborhood was covered with water. They were astonished.

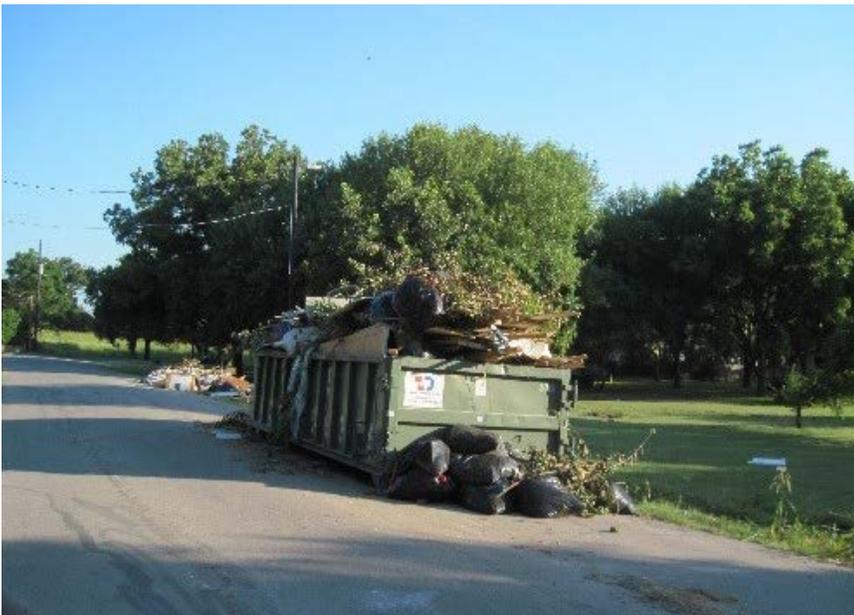
Nearly three months after the historic event, all of the houses on Bogie Street are still vacant except for Ponce’s house. However, signs of recovery and rebuilding can be seen throughout the area. Dumpsters lining the street are filled with trash, damaged insulation, along with discarded sheetrock and carpet.

Bogie Drive is lined with debris as residents recover
(Photo by Bonnie Hanchett)
