Designing for Earthquakes

A Manual for Architects

FEMA 454 / December 2006

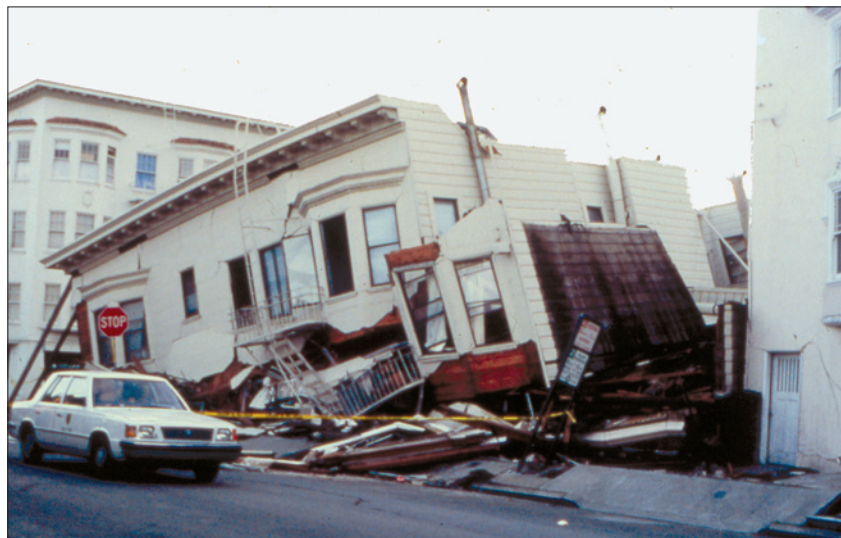
Collapsed apartment house in the Marina District of San Francisco, caused by a combination of amplified ground motion and a soft story.

ground motion at the site (Figure 1-2). The United States does not rate very high in deadly earthquakes compared to other countries. In the entire history of the United States, the estimated number of earthquake-related deaths is only about 3,100, of which some 2,000 are accounted for by the 1906 San Francisco quake.

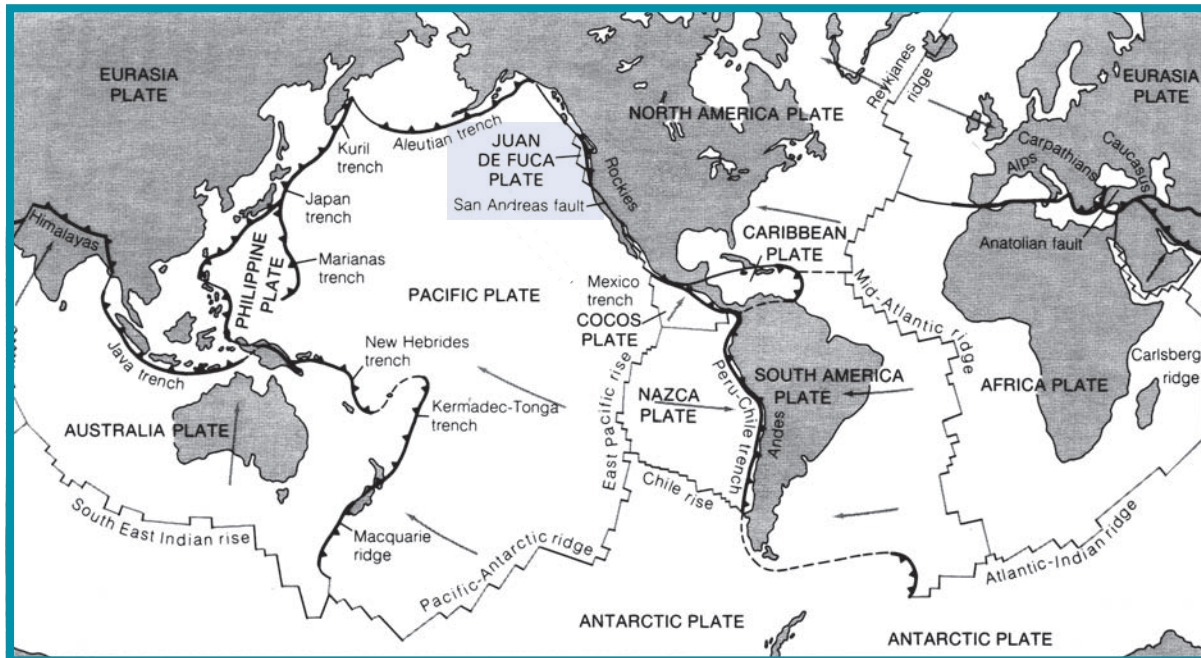
Figure 2-2: The major tectonic plates, midoceanic ridges, trenches and transform faults.

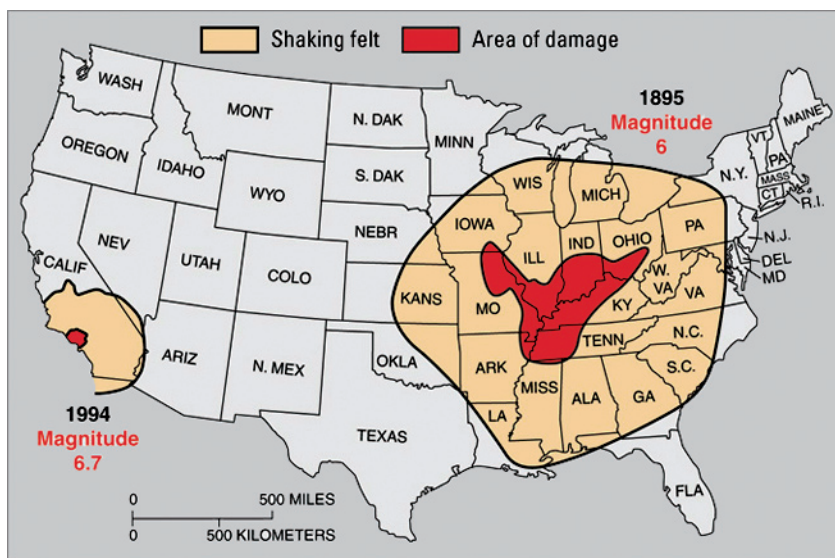
Figure 2-6: Map comparing curves of MMI 3 (shaking felt) and MMI 8 (area of damage) for the magnitude 6.7 1994 Northridge, California, earthquake and a magnitude 6 near New Madrid, Missouri, in 1895. Although the difference in magnitude implies an 11-fold difference in scalar seismic moment, the areas of shaking intensity for the smaller earthquake are substantially larger due to differences in seismic wave attenuation in the non-tectonic region of New Madrid compared to the western U.S. (discussed in section 2.6.1).

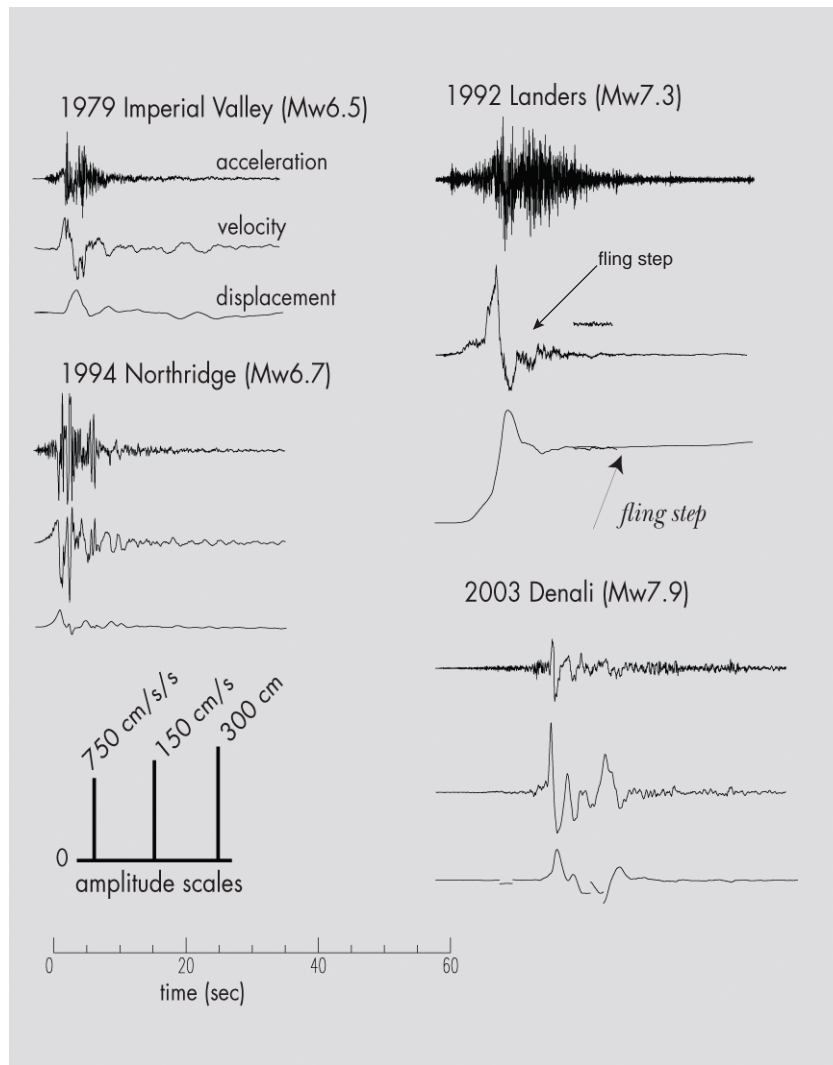
Figure 2-9: Examples of near-fault, large amplitude seismograms (time-histories).

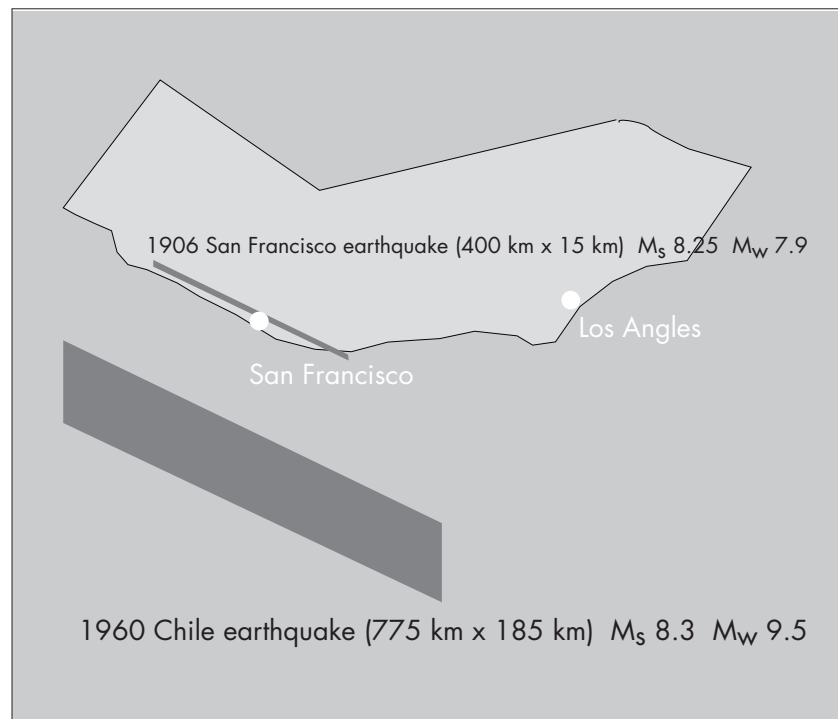
Figure 2-10: Two earthquakes may have equal magnitudes but be distinctly unequal in other respects.

The 1906 San Francisco, California, earthquake ruptured rock over a shorter length and shallower depth - only about 1/25 the area - as the 1960 Chilean earthquake. Although the surface wave magnitudes are the same, the moment magnitude for these two earthquakes (Table 2-1) are distinctly different. A sketch of the outline of California is shown for scale.

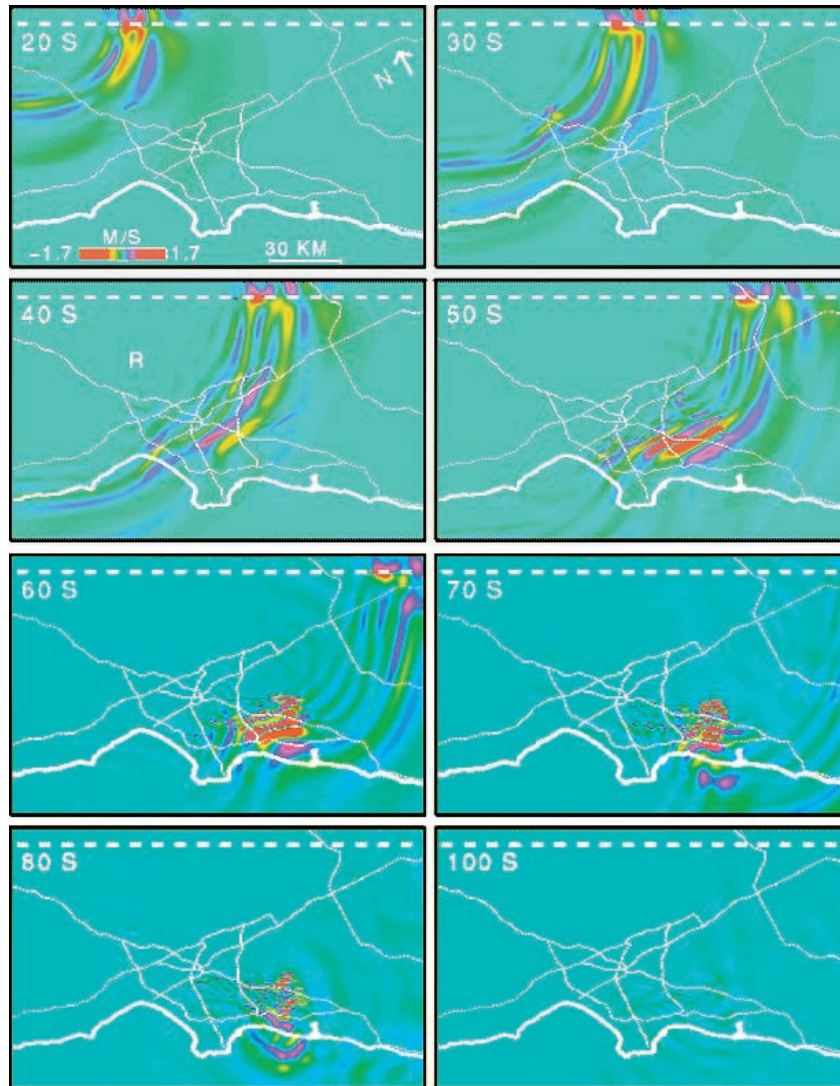
Figure 2-11: Aerial snapshots of a simulated wave propagation in the Los Angeles area.

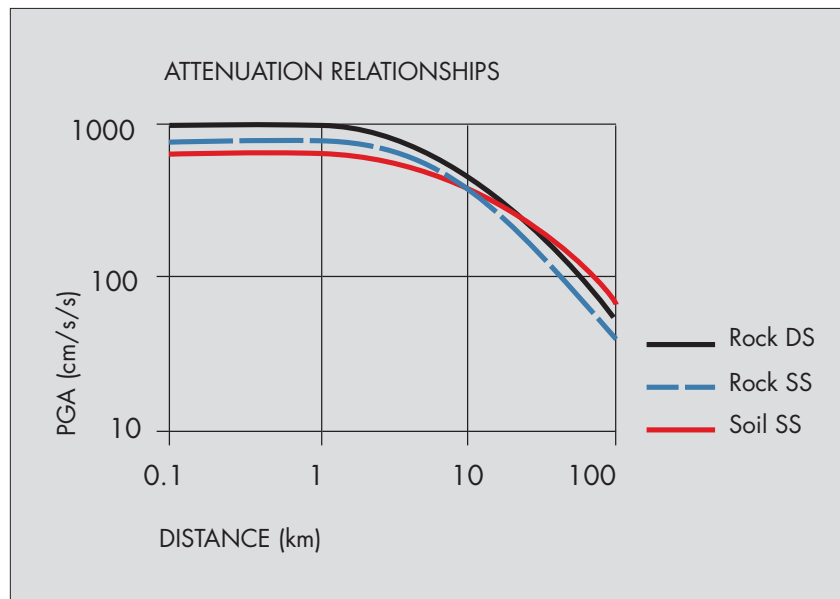
Figure 2-12: Examples of attenuation curves for a $M_W 7$ earthquake obtained by data regression, illustrating the effects of a **site** type: rock (blue dashed) vs. deep soil (red), and **event** type: strike-slip fault (blue dashed) vs. reverse fault (black)

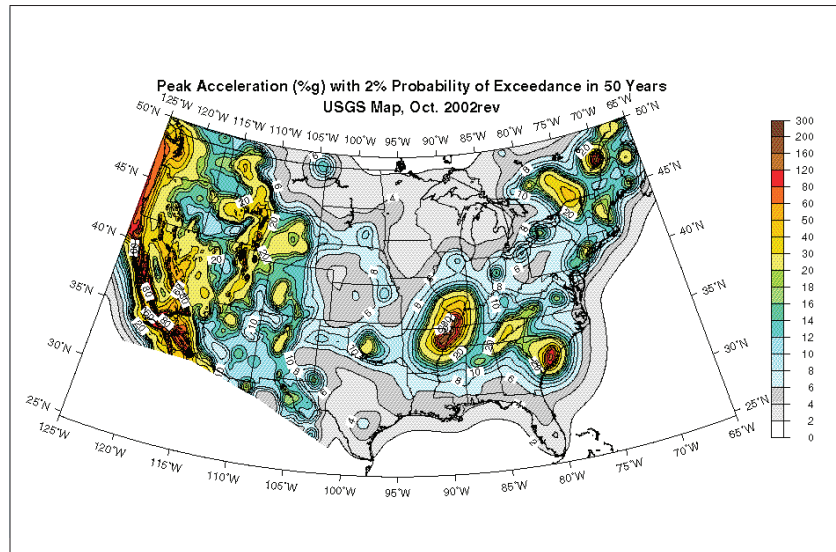
Figure 2-13: Spectral Acceleration values in %g with a 2% Probability of Exceedance in 50 Years for the coterminous United States. The color scale to the right relates to the %g values.

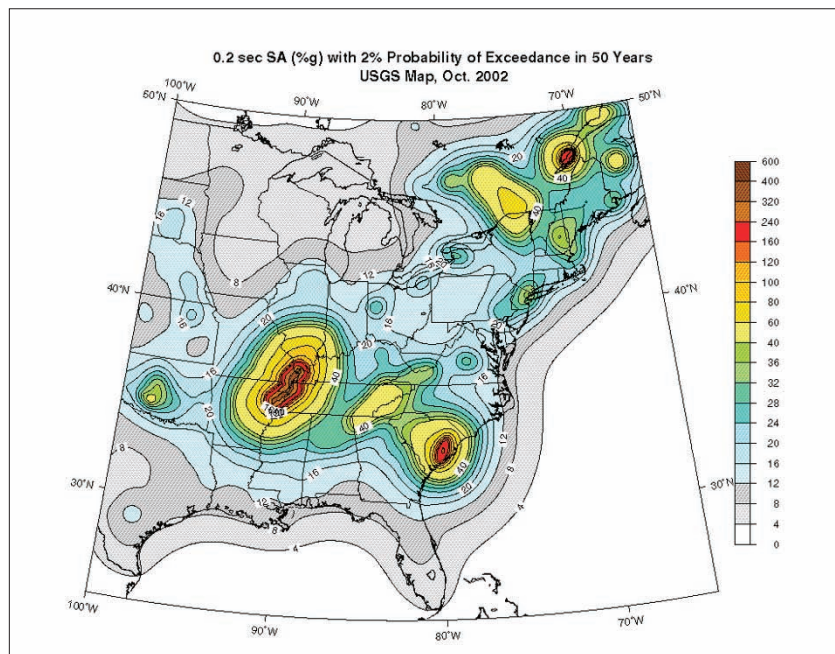
Figure 2-14: 0.2 second (short) period Spectral Acceleration values in %g with a 2% Probability of Exceedance in 50 years for Central and Southern United States.

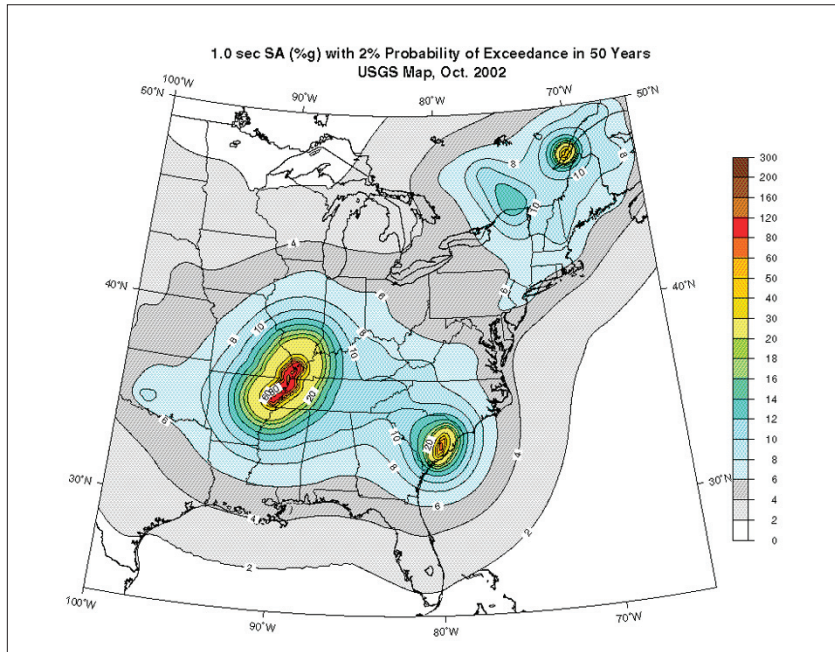
Figure 2-15: 1.0 second (long) period spectral acceleration values in %g with a 2% probability of exceedance in 50 years for central and southern United States.

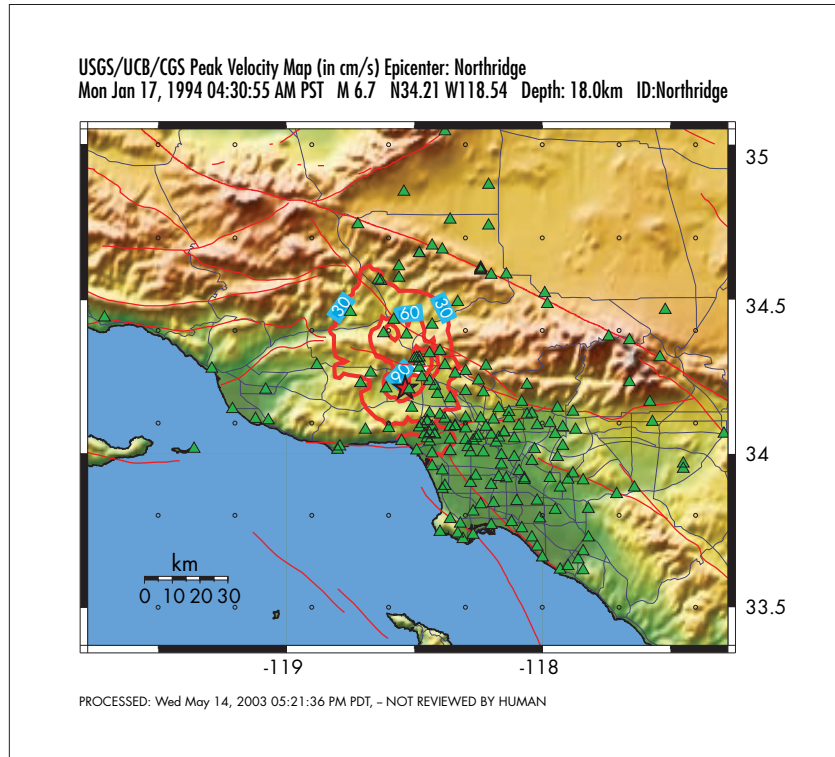
Figure 2-16: Example of a peak ground velocity (PGV) ShakeMap for the 1994 $M_W=6.7$ Northridge earthquake.

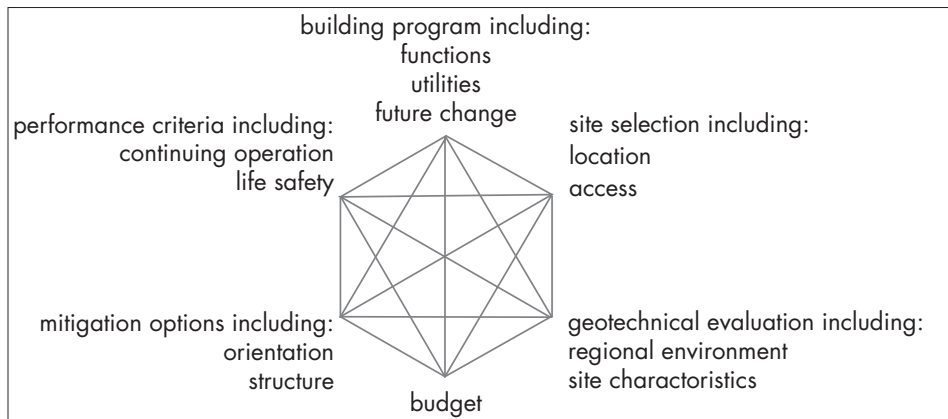
Figure 3-1: Interrelationships of performance expectations, building program and site characteristics.

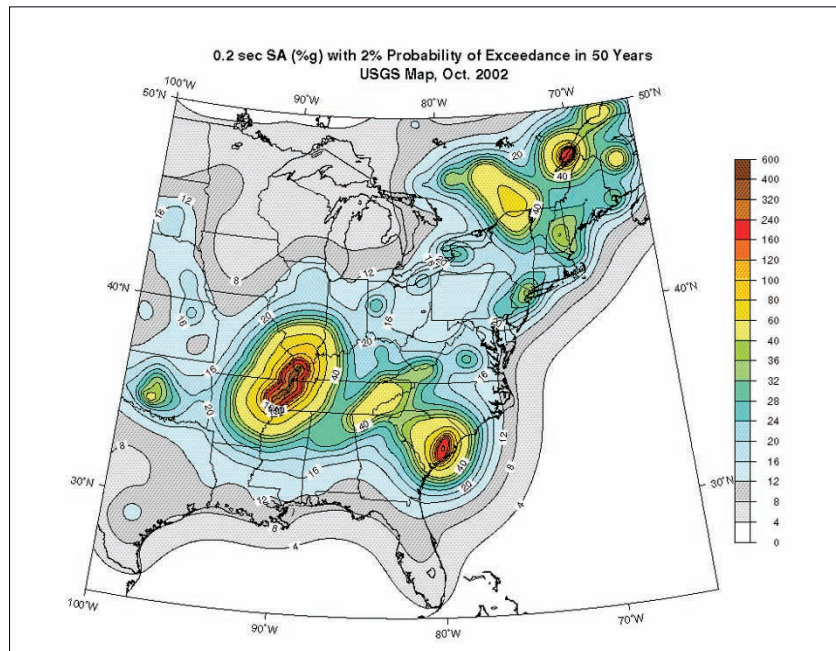
Figure 3-2: USGS Map of 0.2 sec spectral acceleration with a 2% Probability of Exceedance in 50 Years

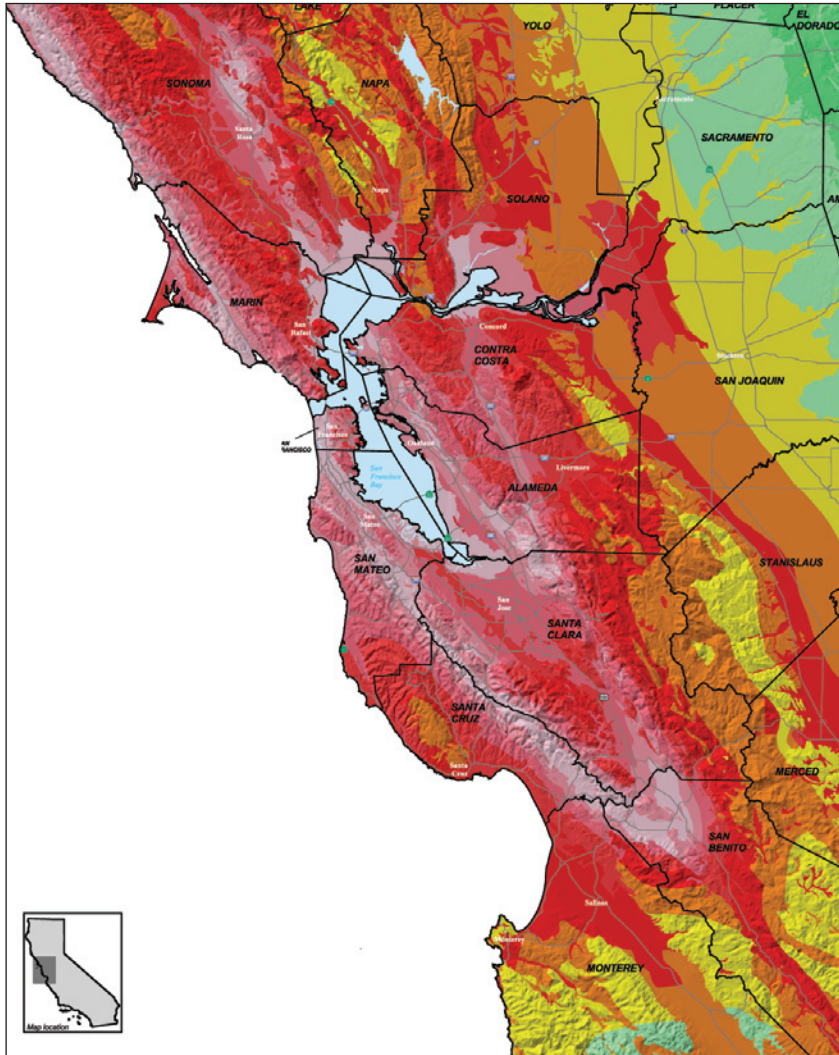
Figure 3-3: USGS and CGS Map of Relative PGA with a 2% Probability of Being Exceeded in 50 Years

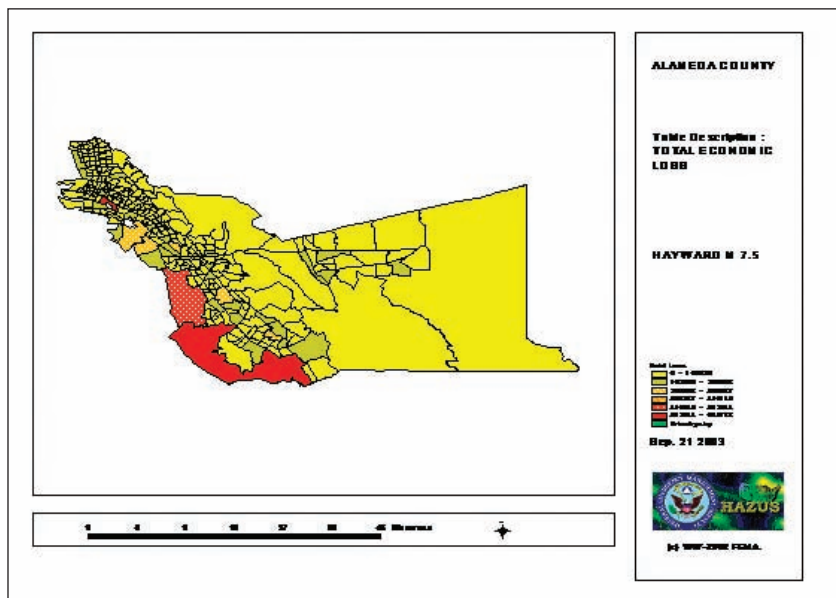
Figure 3-5
HAZUS Estimate of Total
Economic Loss by Census
Tract

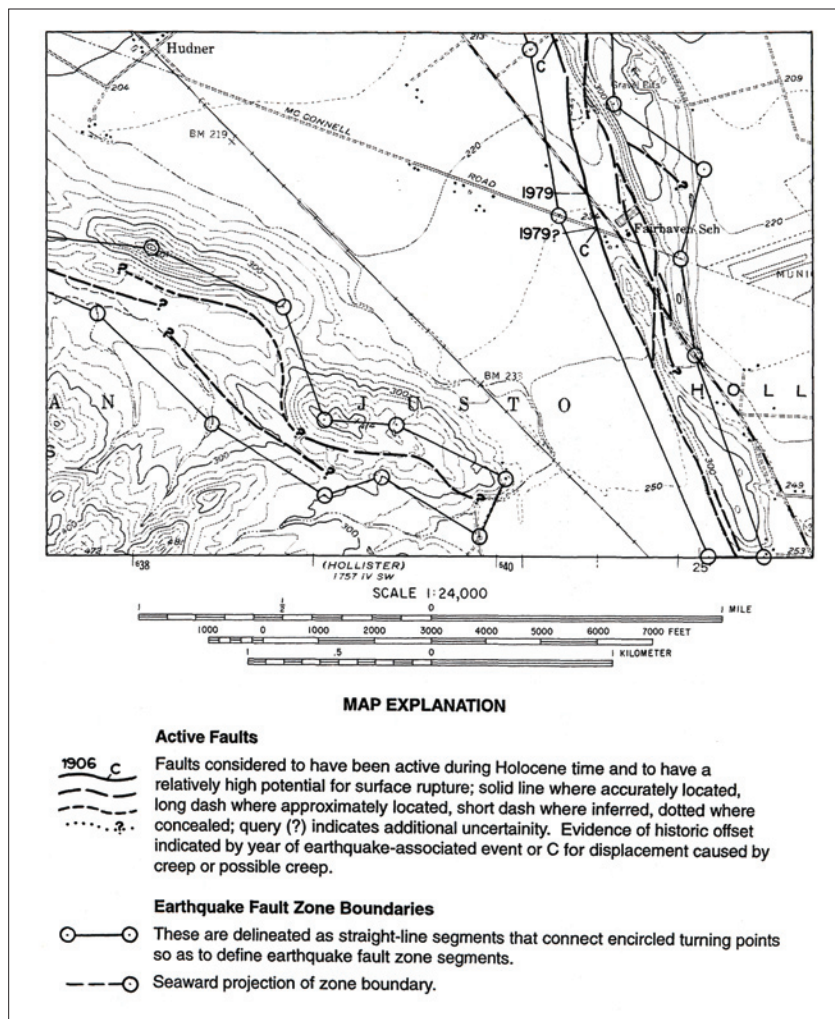
Figure 3-8: Alquist Priola Special Studies Zone (Earthquake Fault Zone).

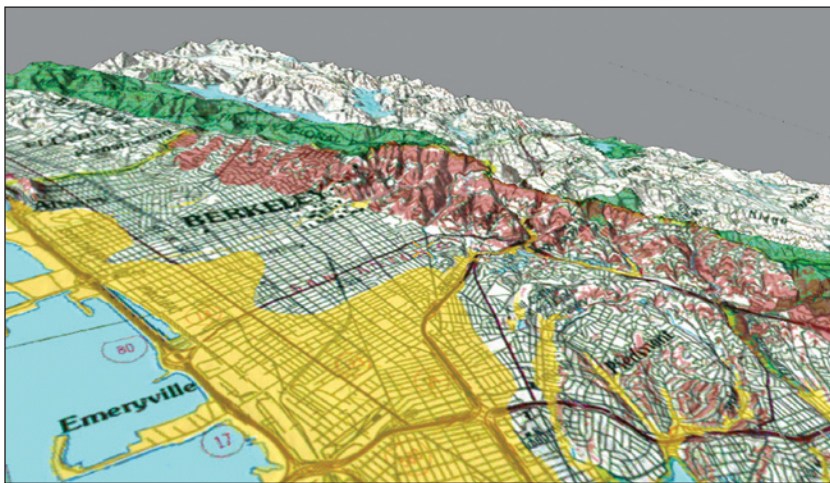
Figure 3-12: 3-D image of Liquefaction and Landslide Hazard Zone Map for Berkeley and Emeryville. Yellow indicates liquefaction, which is related to soil type and proximity to ground water.

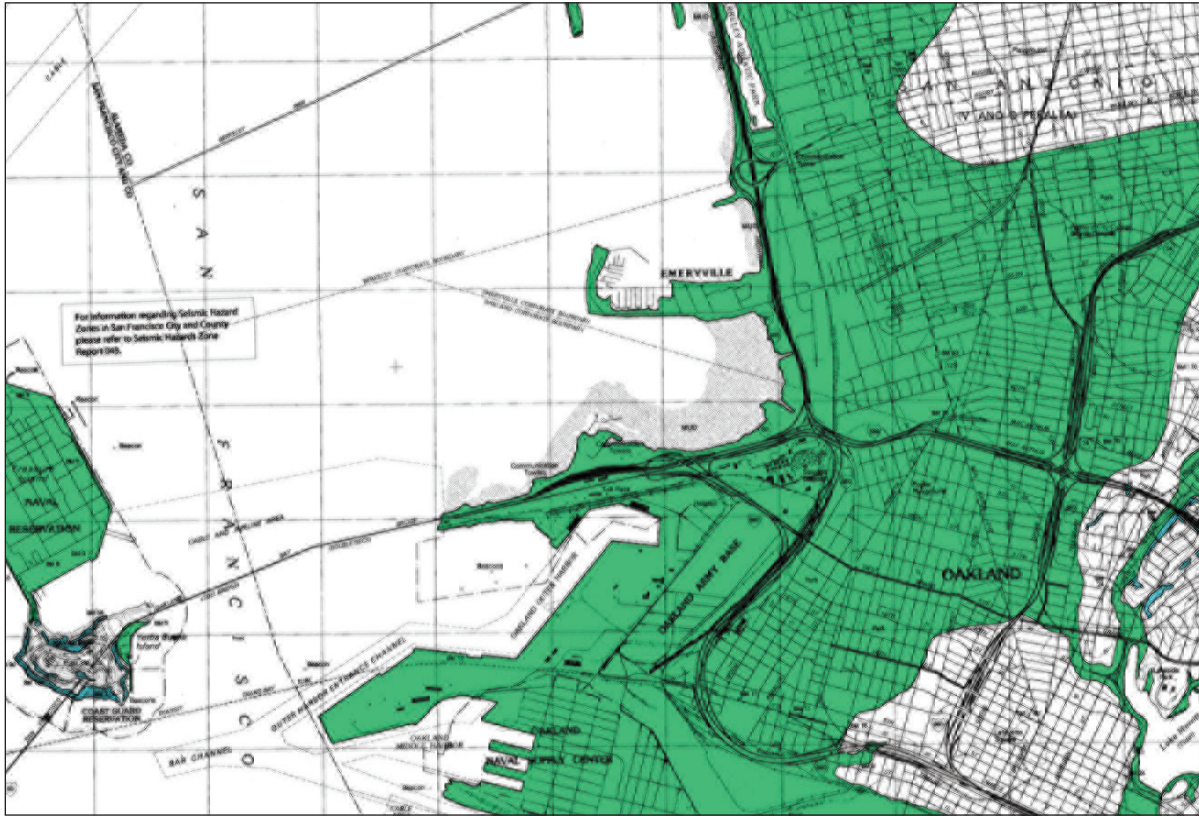
Figure 3-13: Liquefaction Hazard Zone Map for West Oakland and Emeryville.

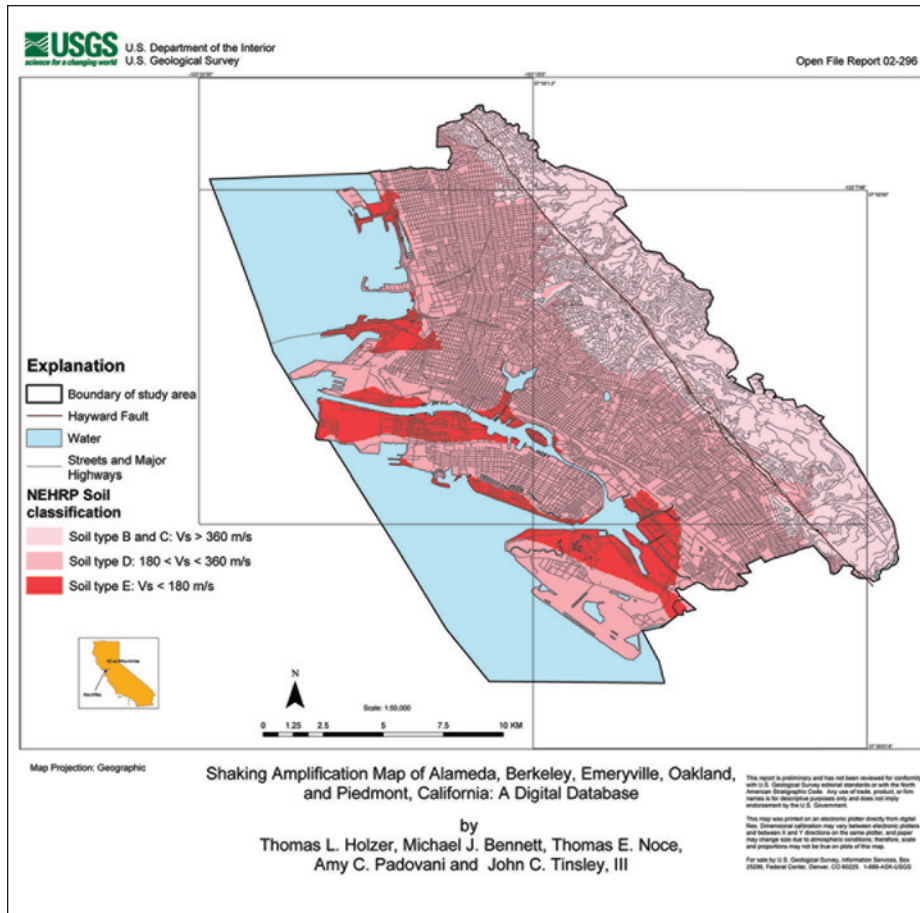
Figure 3-15: USGS Shaking Amplification Map of Alameda, Berkeley, Emeryville, Oakland and Piedmont, California. SOURCE: USGS (HOLZER ET AL.)

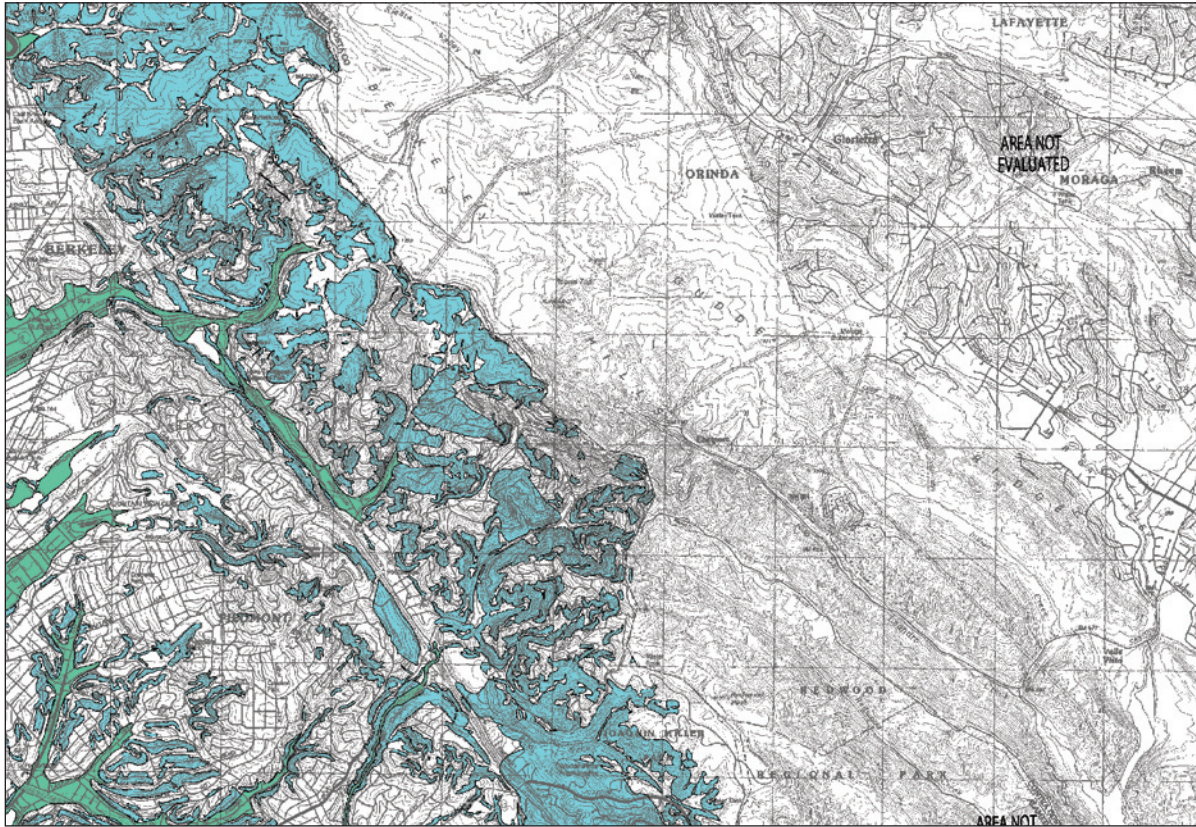
Figure 3-16: Landslide Hazard Zones for Berkeley and Oakland, California. Blue areas are those that are susceptible to earthquake-caused landslides.

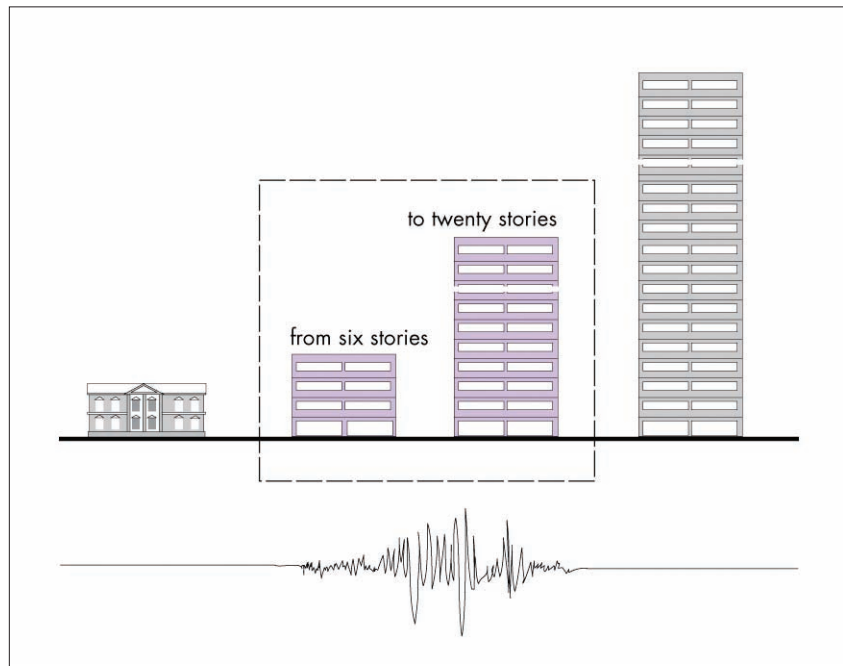
Figure 4-5: The vulnerable group: Mexico City, 1985. The periods of buildings in the 6 to 20 story range resonated with the frequency content of the earthquake.

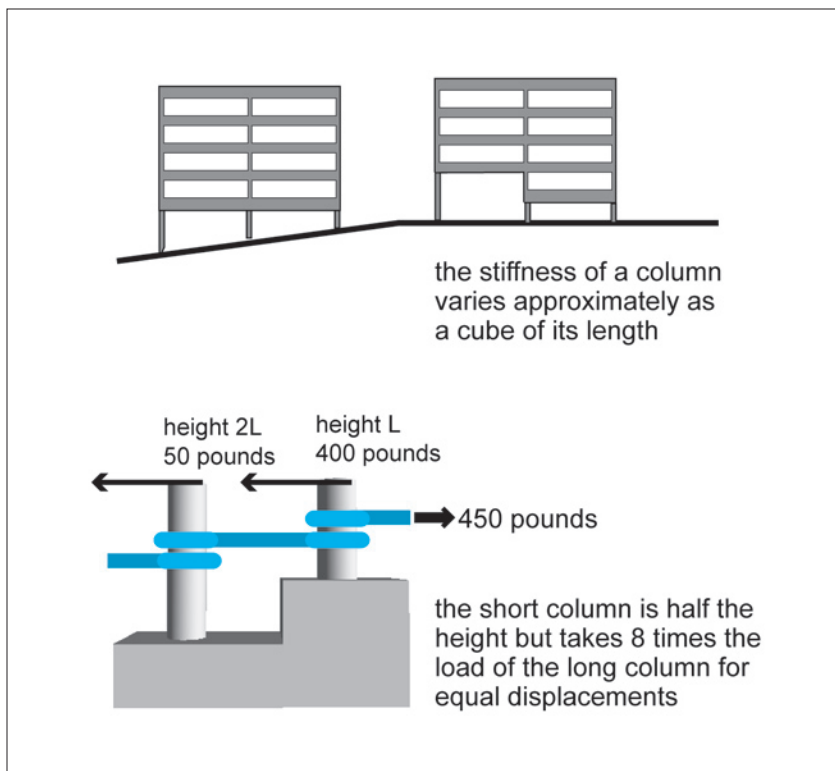
Figure 4-15: The short column problem.

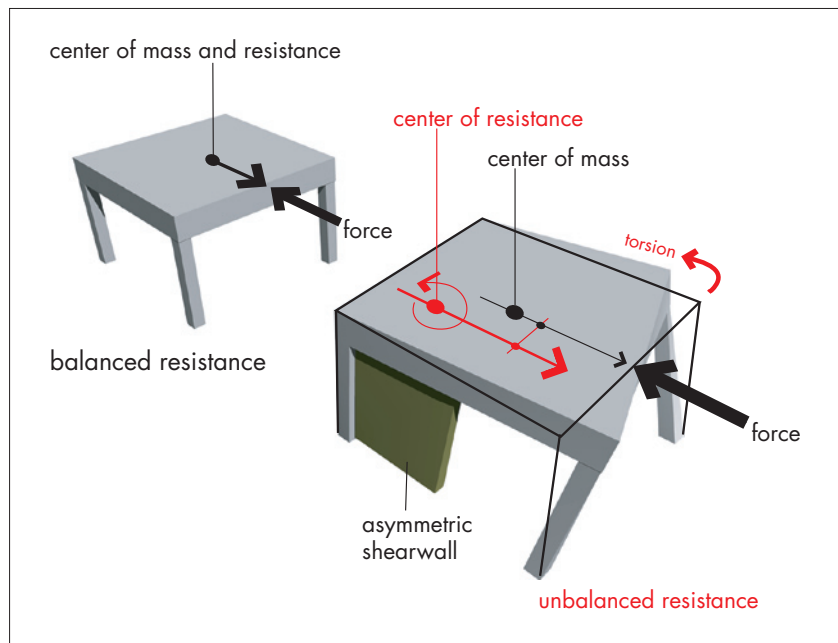
Figure 4-17
Torsional forces.

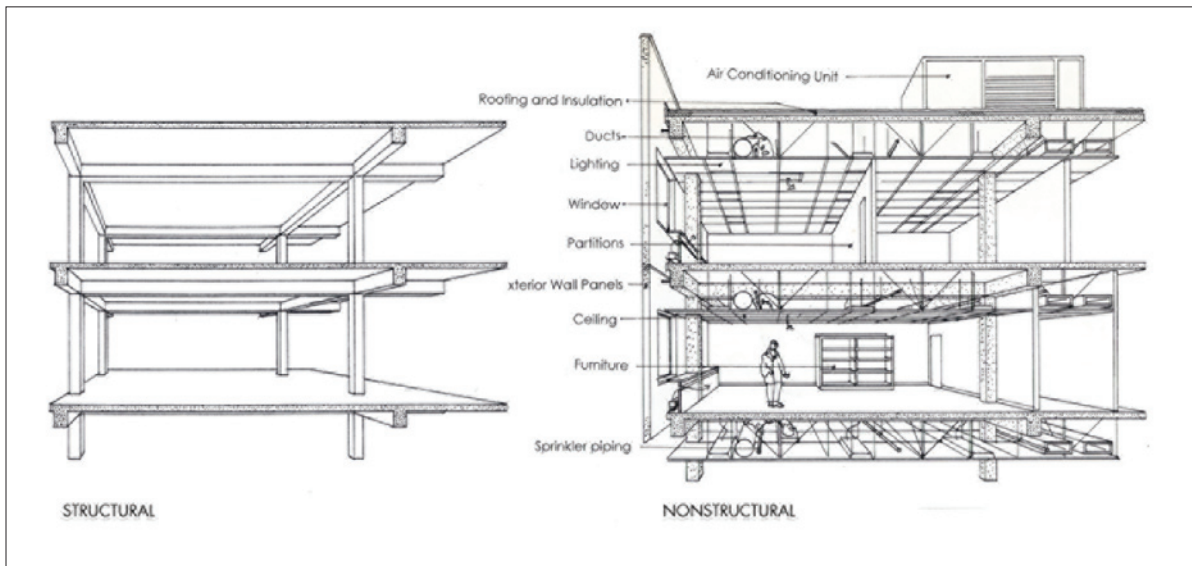
Figure 4-18: Structure (left), nonstructural components and systems (right).

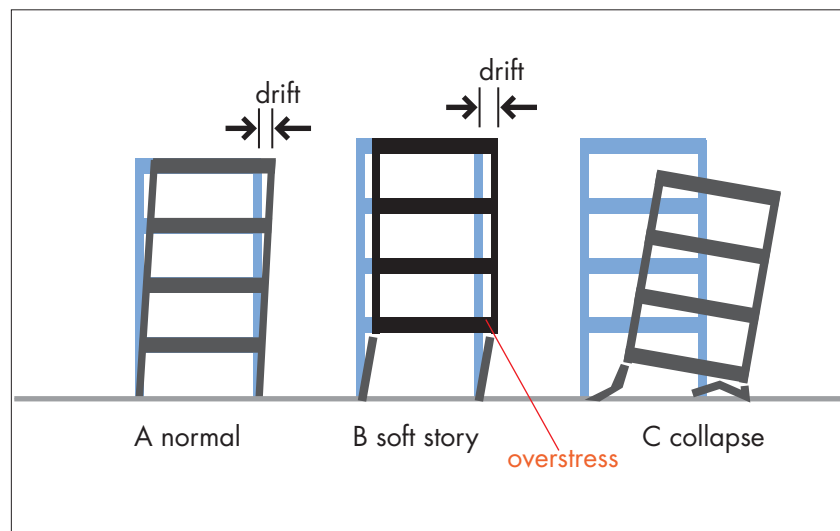
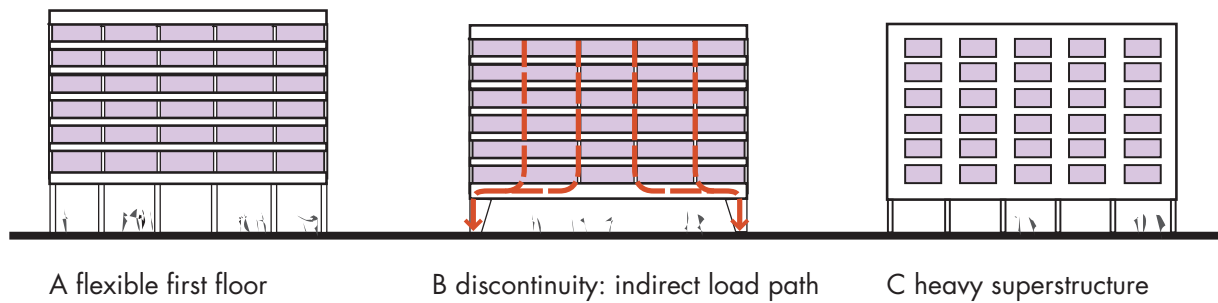
Figure 5-8: Three types of soft first story.

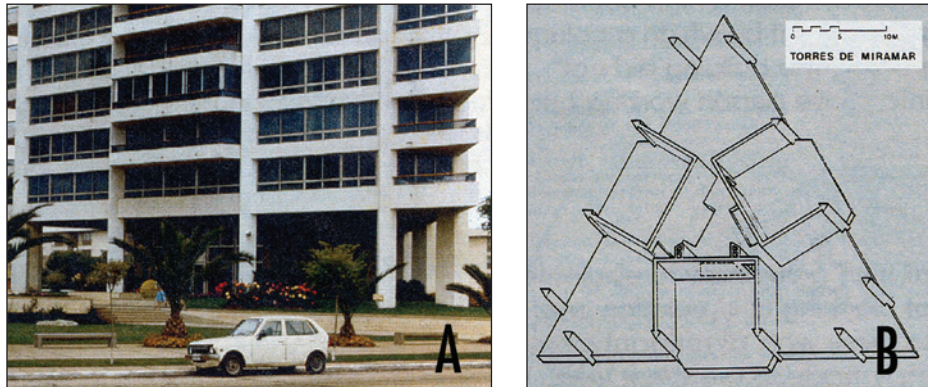
Figure 5-12: This apartment house appears to have a soft first story (Figure 5-12A), but the lateral force-resisting system is a strong internal shear wall box, in which the shear walls act as party walls between the dwelling units (Figure 5-12B). The architect achieved a light and elegant appearance, and the engineer enjoyed an optimum and economical structure.

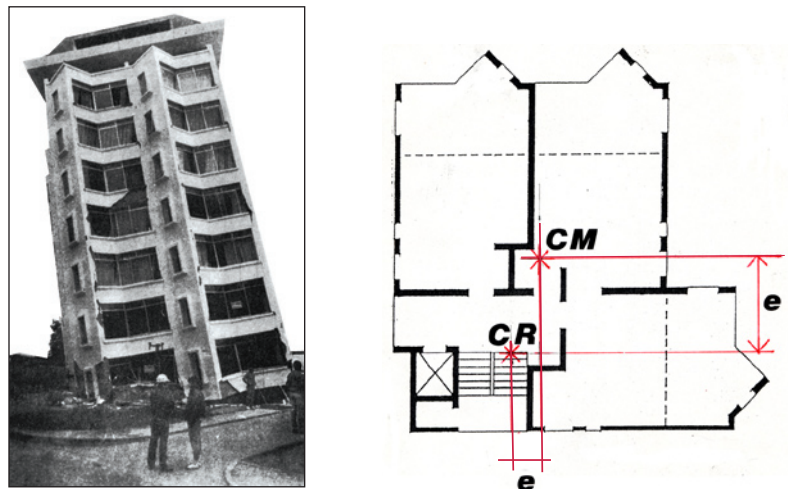
Figure 5-16: Left, the building after the earthquake. Right, typical floor plan showing the Center of Mass (CM), Center of Resistance (CR), and Eccentricity (e) along the two axes. PHOTO SOURCE: EERI

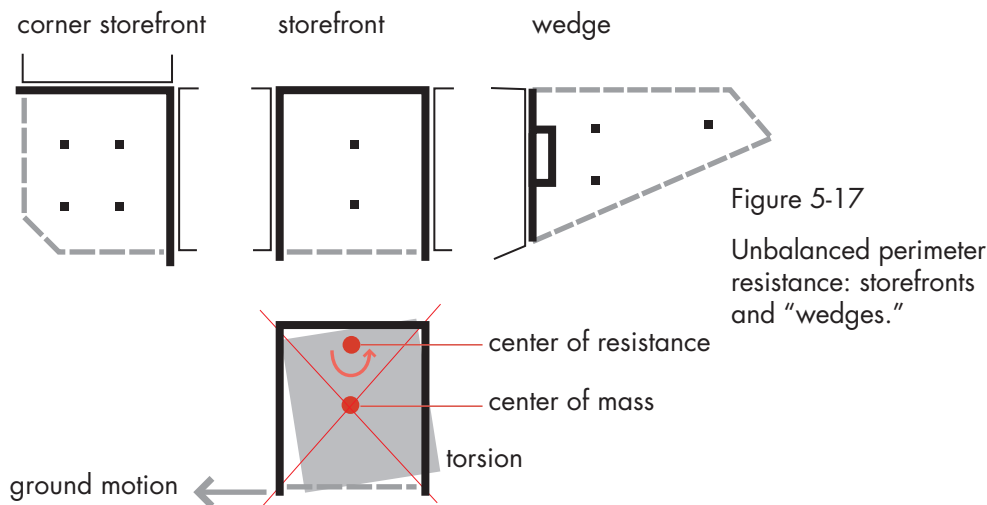
A common instance of an unbalanced perimeter is that of open-front design in buildings, such as fire stations and motor maintenance shops in which it is necessary to provide large doors for the passage of vehicles. Stores, individually or as a group in a shopping mall, are often designed as boxes with three solid sides and an open glazed front (Figure 5-17).

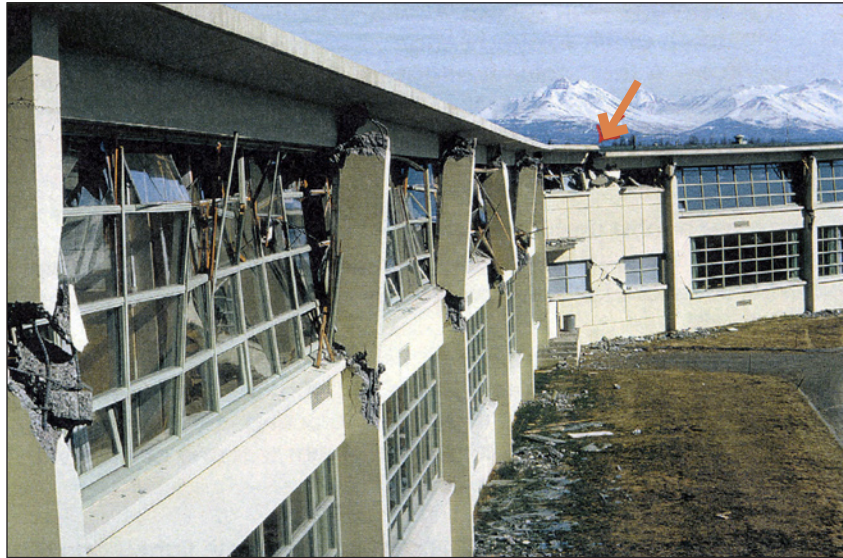
Figure 5-22: West Anchorage High School, Alaska earthquake, 1964. Stress concentration at the notch of this shallow L-shaped building damaged the concrete roof diaphragm.

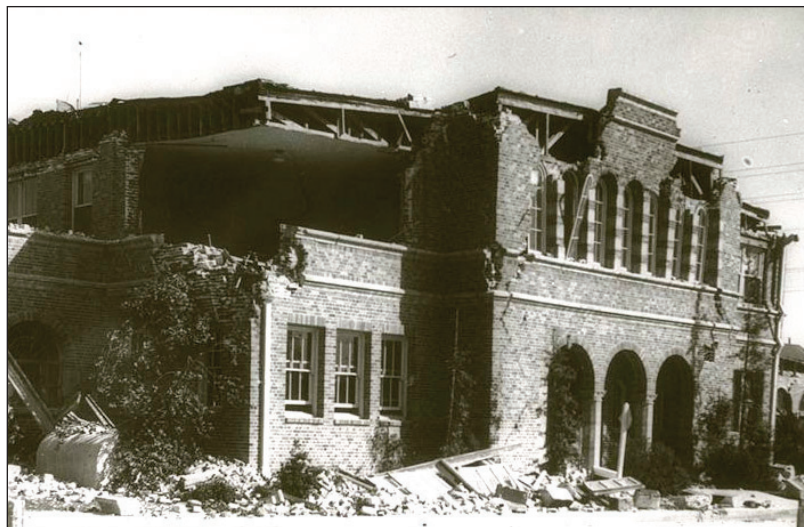
Figure 6-3: Long Beach, 1933, Alexander Hamilton Junior High School.

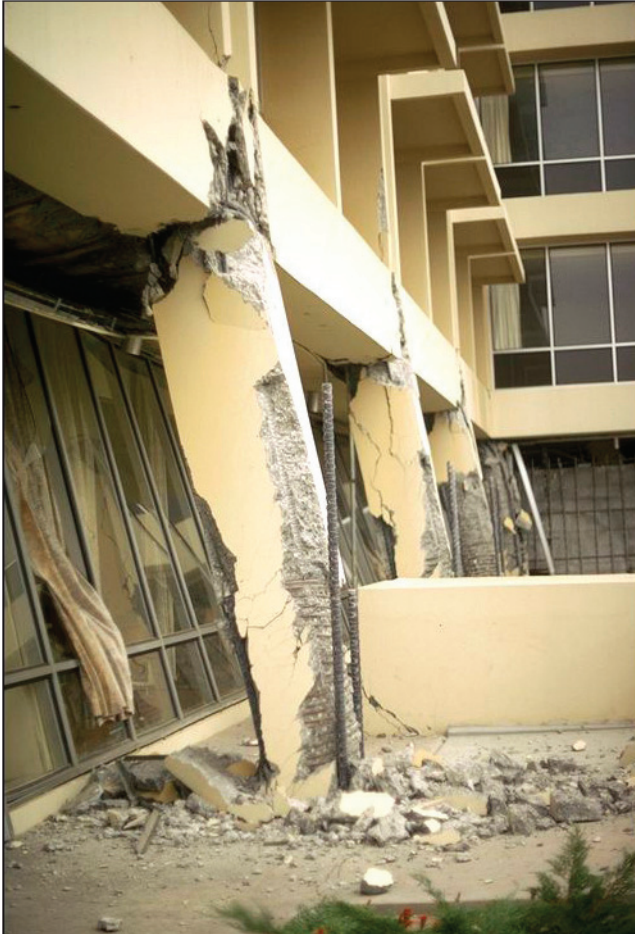
Figure 6-4: Sylmar, 1971, Damage to engineered building at Olive View Medical Center.

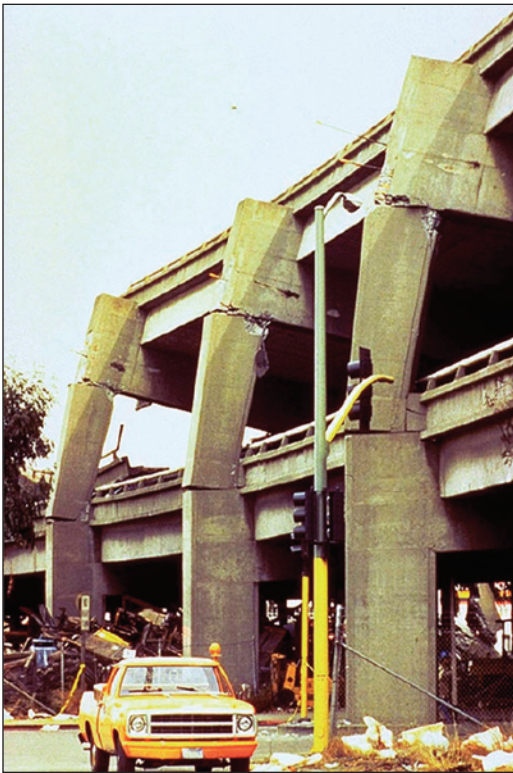
Figure 6-6: San Francisco, 1989, elevated highway support bents, an example of failure of engineered structures.

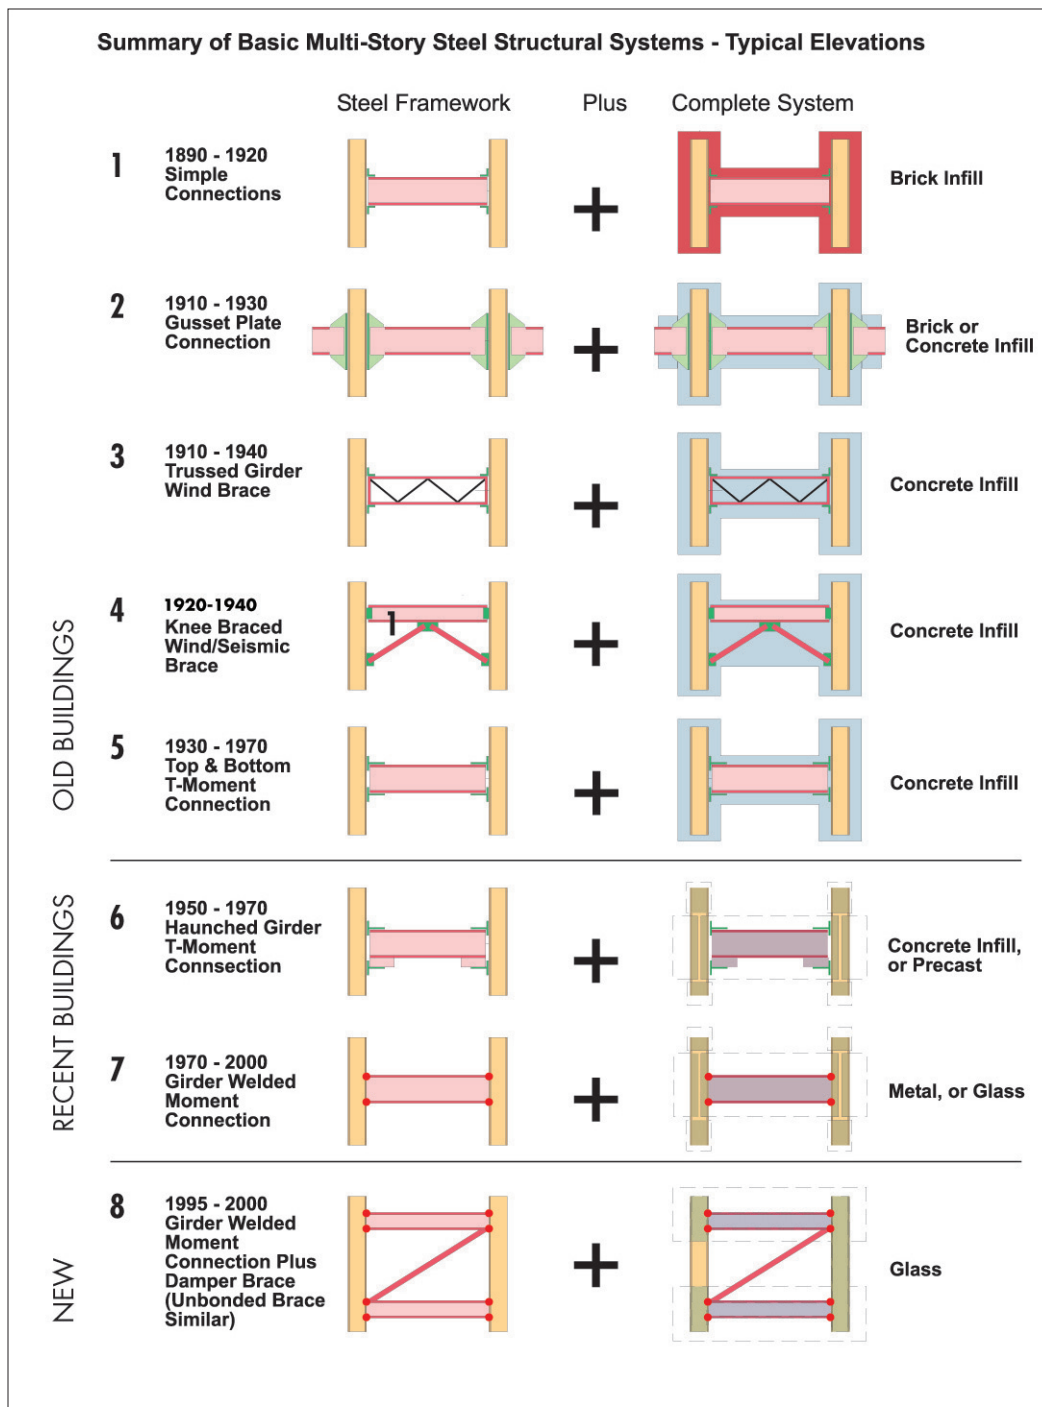
Figure 7-2: Steel building frameworks.
