Designing for Earthquakes

A Manual for Architects

FEMA 454 / December 2006

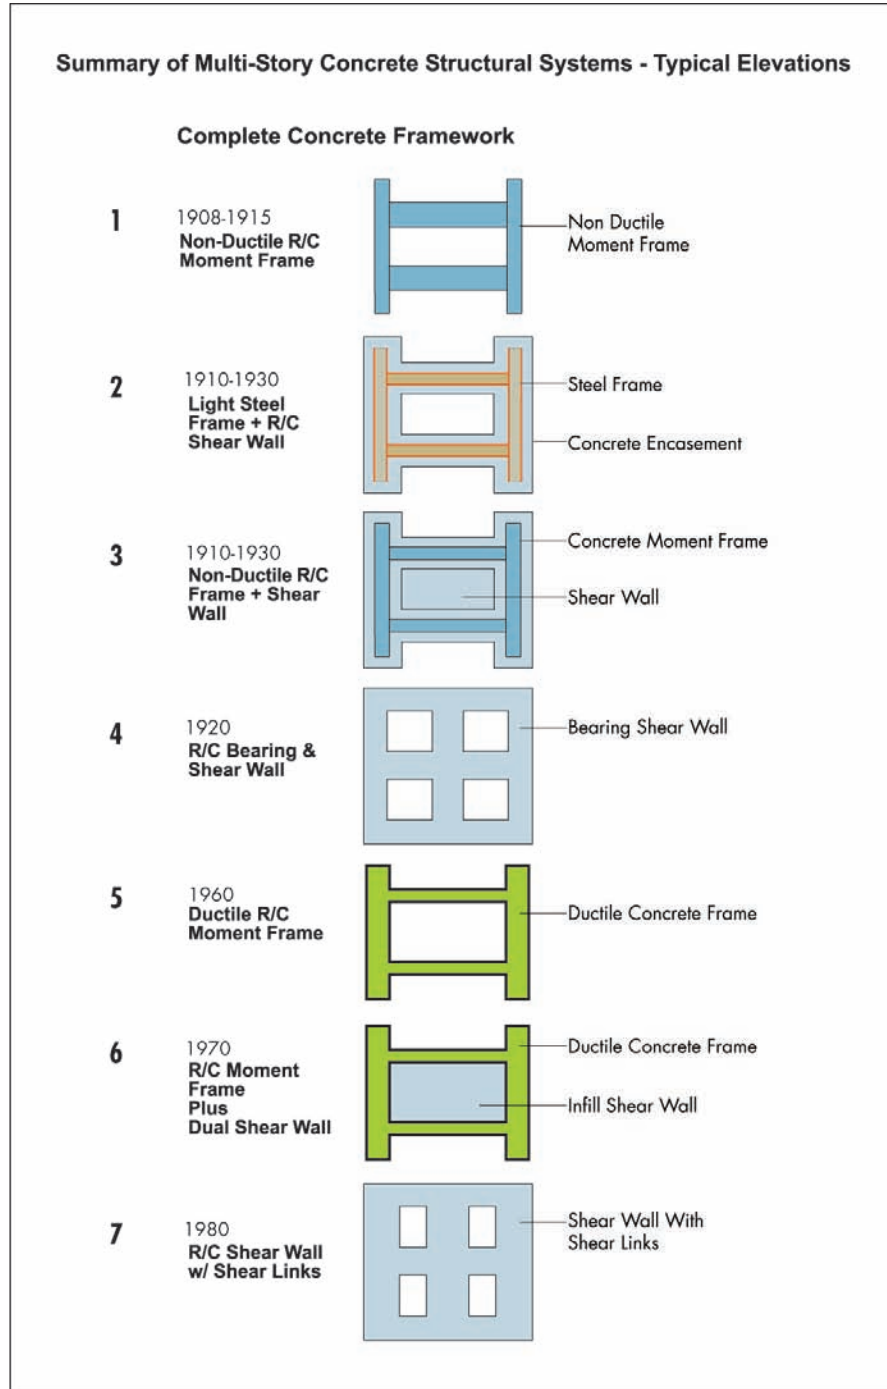
Figure 7-3: Concrete building frameworks

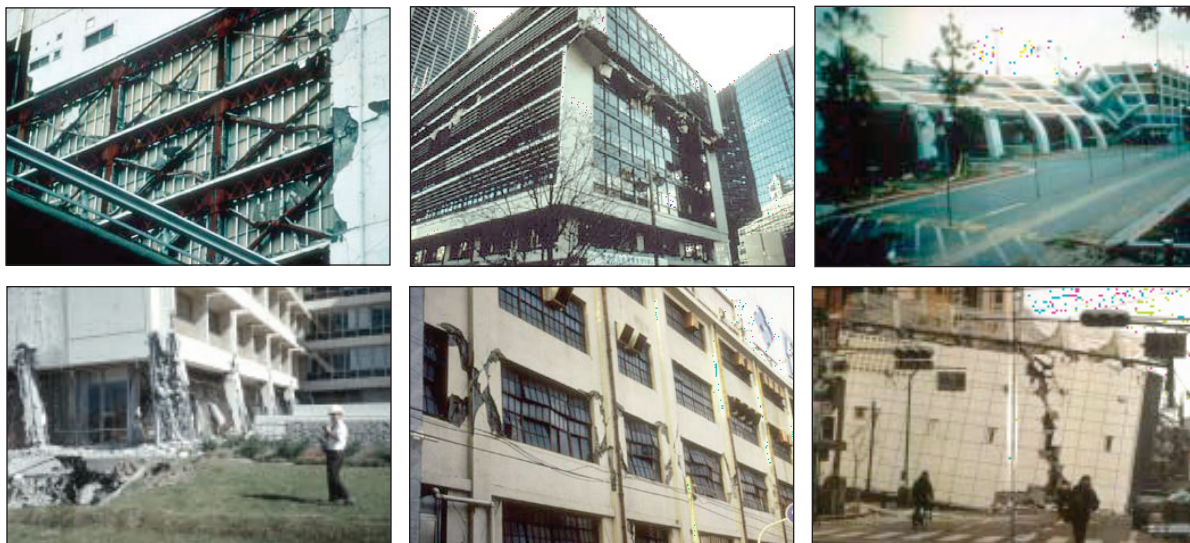
Figure 7-12: Examples of typical earthquake damage.

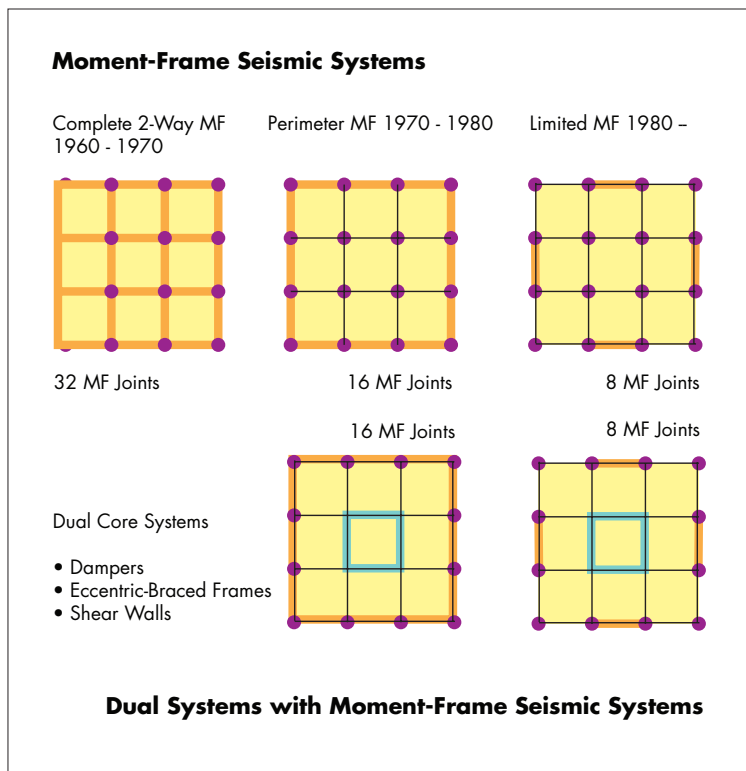
Figure 7-18: Single and multiple system concepts.

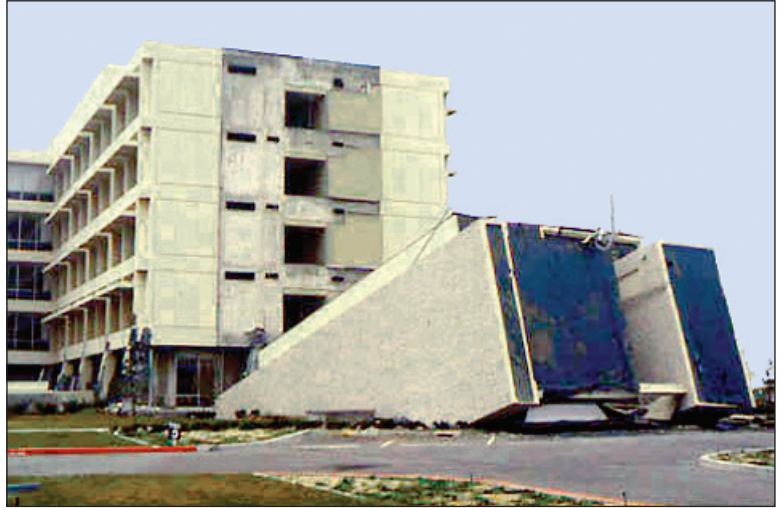
Figure 8-2: Olive View Hospital. A brand new facility that was damaged beyond repair in the 1971 San Fernando earthquake due to a shaking intensity that exceeded what was expected at the site and a design that, although technically complying with code at the time, contained several structural characteristics now considered major deficiencies. The lateral system contained nonductile concrete frames, discontinuous shear walls, and a significant weak story.

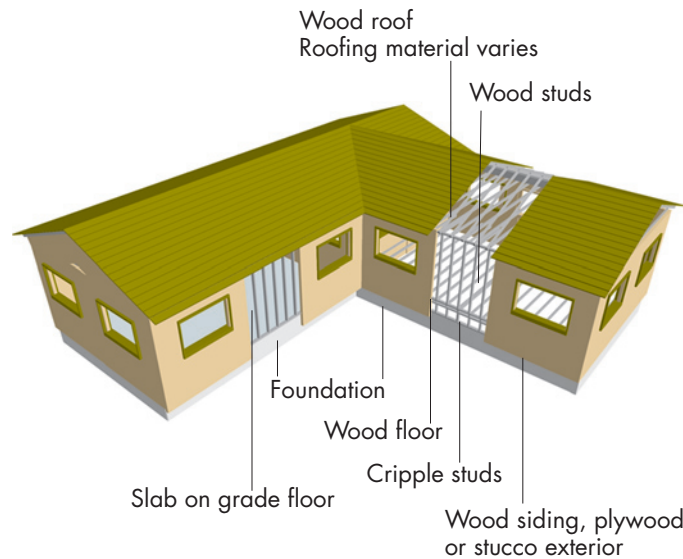
These buildings are generally single-family dwellings of one and two stories. Floor and roof framing consists of wood joists or rafters supported on wood studs spaced no more than 24 inches apart. The first floor may be slab on grade or wood raised above grade with cripple stud walls and post-and-beam supports. Lateral support is provided with shear walls of plywood, stucco, gypsum board, and a variety of other materials. Most often there is no engineering design for lateral forces.

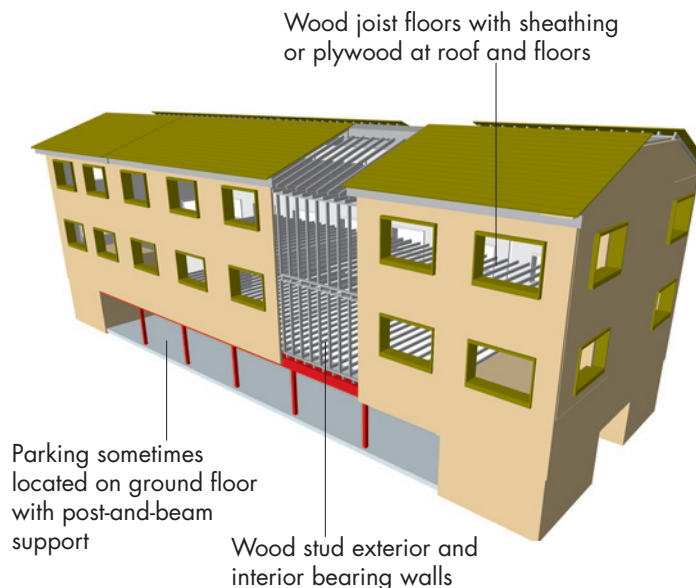
These buildings are framed with the same systems as W1 buildings but are most often multiple-story large residential-type structures, and, unless very old, are engineered. A common seismic deficiency is the tuck-under parking at the ground story that creates a soft or weak story. This building type is also often built on top of a one story concrete parking structure.

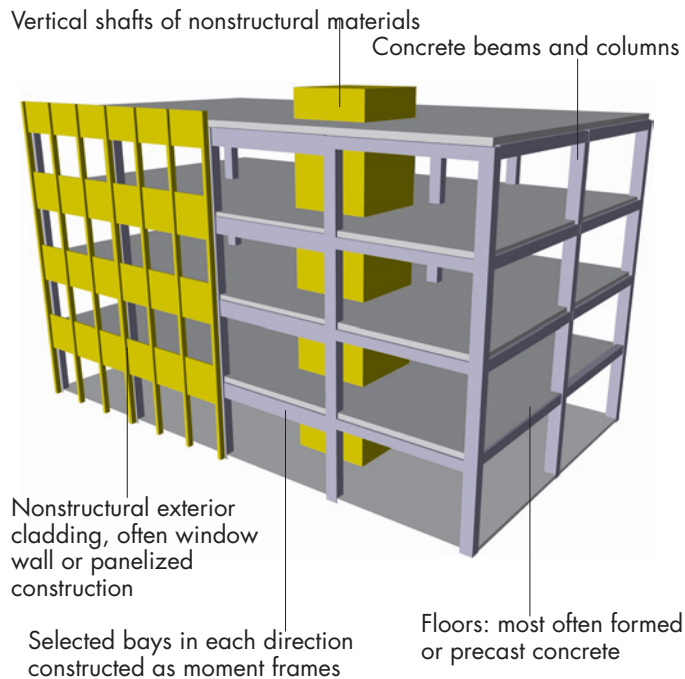
These buildings consist of concrete framing, either a complete system of beams and columns or columns supporting slabs without gravity beams. Lateral forces are resisted by moment frames that develop stiffness through rigid connections of the column and beams placed in a given bay. Moment frames may be developed on all framing lines or only in selected bays. It is significant that no structural walls are required. Floors are cast-in-place or precast concrete. Buildings with concrete moment frames could be used for most occupancies listed for steel moment frames, but are also used for multistory residential buildings.

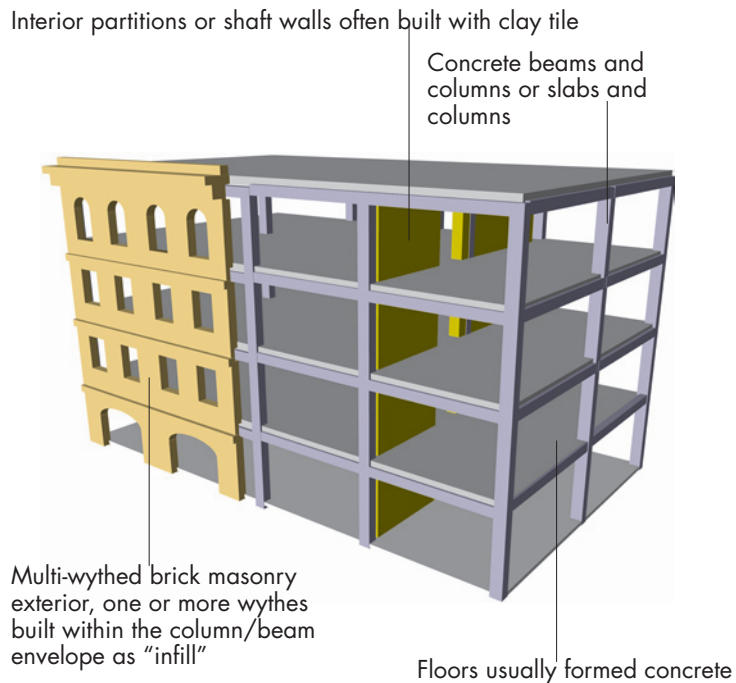
These buildings consist of concrete framing, either a complete system of beams and columns or columns supporting slabs without gravity beams. Exterior walls and possibly some interior walls are constructed of unreinforced solid clay brick, concrete block, or hollow clay tile masonry infilling the space between columns and beams. Windows and doors may be present in the infill walls, but to act effectively as shear-resisting elements, the infill masonry must be constructed tightly against the columns and beams. The building type is similar to S5, but is more often used for industrial and warehouse occupancies.

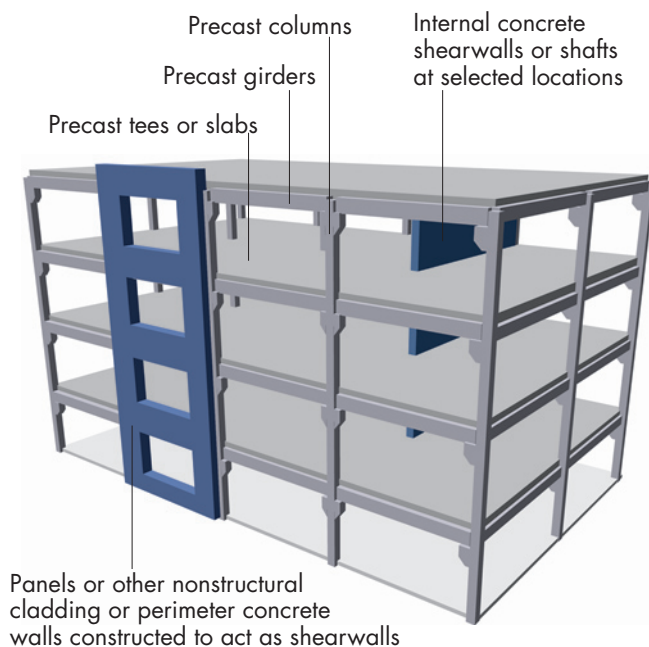
These buildings consist of concrete columns, girders, beams and/or slabs that are precast off the site and erected to form a complete gravity-load system. Type PC2 has a lateral force-resisting system of concrete shear walls, usually cast-in-place. Many garages have been built with this system. The building type is most common in moderate and low seismic zones and could be used for many different occupancies in those areas.

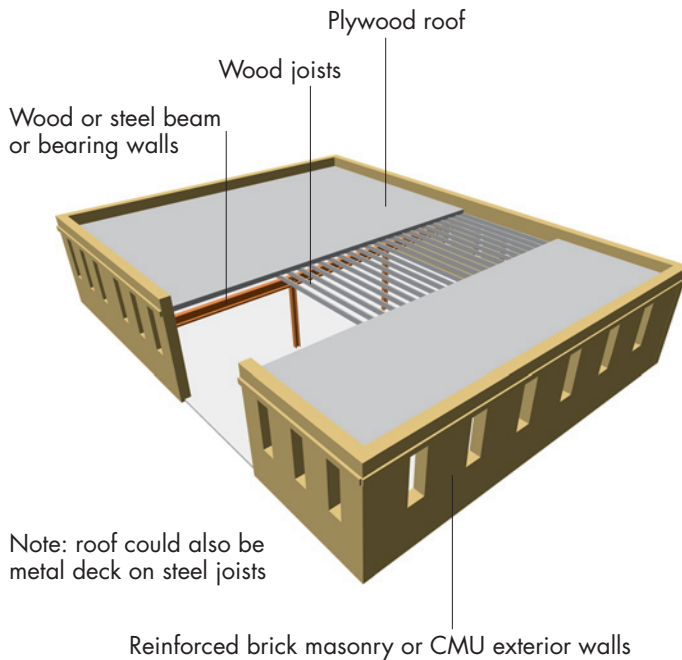
These buildings take a variety of configurations, but they are characterized by reinforced masonry walls (brick cavity wall or CMU) with flexible diaphragms, such as wood or metal deck. The walls are commonly bearing, but the gravity system often also contains post-and-beam construction of wood or steel. Older buildings of this type are generally small and were used for a wide variety of occupancies and are configured to suit. Recently, the building type is commonly used for one-story warehouse-type occupancies similar to tilt-up buildings.

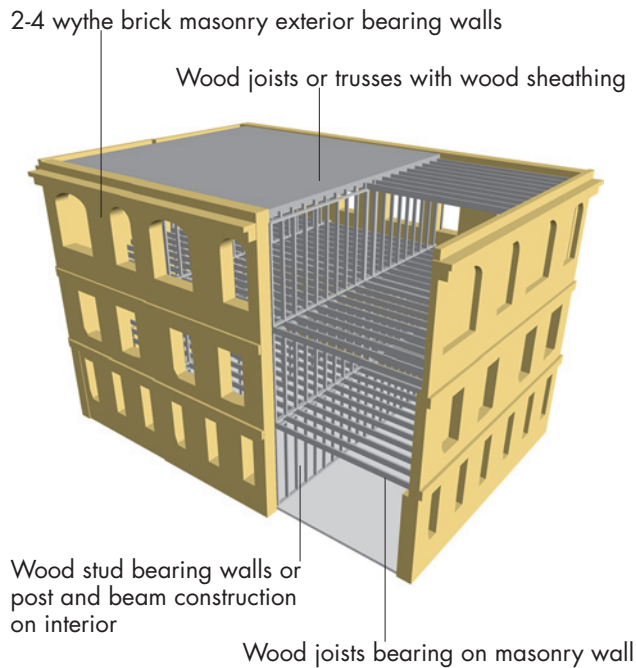
This building consists of unreinforced masonry bearing walls, usually at the perimeter and usually brick masonry. The floors are wood joists and wood sheathing supported on the walls and on interior post-and-beam construction or wood-stud bearing walls. This building type is ubiquitous in the U.S. and was built for a wide variety of uses, from one-story commercial or industrial occupancies, to multistory warehouses, to mid-rise hotels. Unfortunately, it has consistently performed poorly in earthquakes. The most common failure is an outward collapse of the exterior walls, caused by loss of lateral support due to separation of the walls from the floor/roof diaphragm.

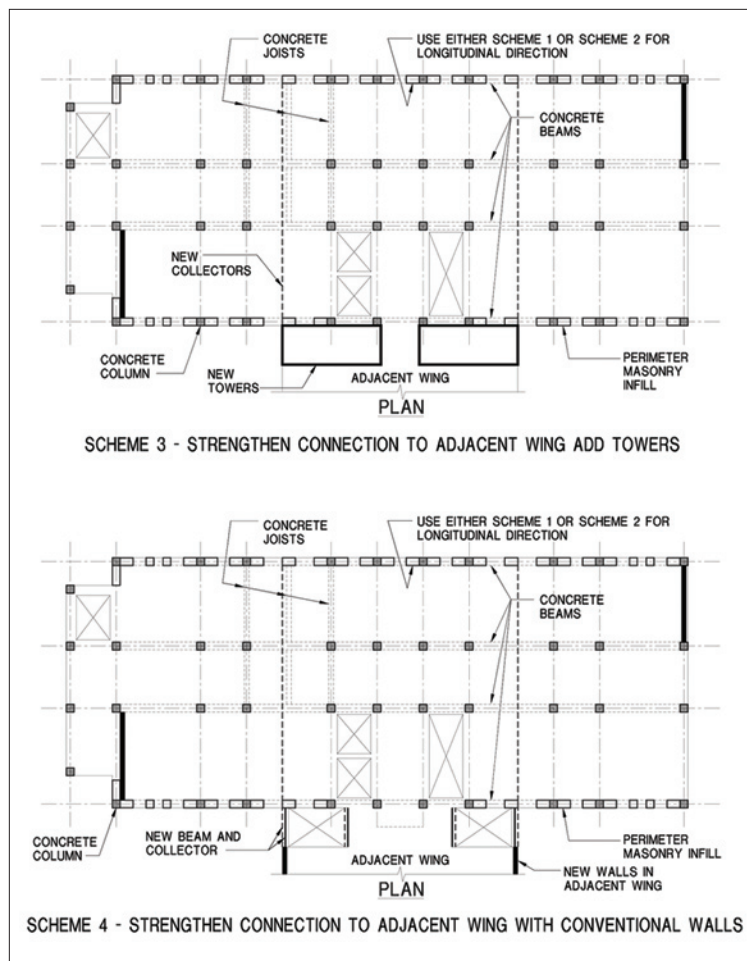
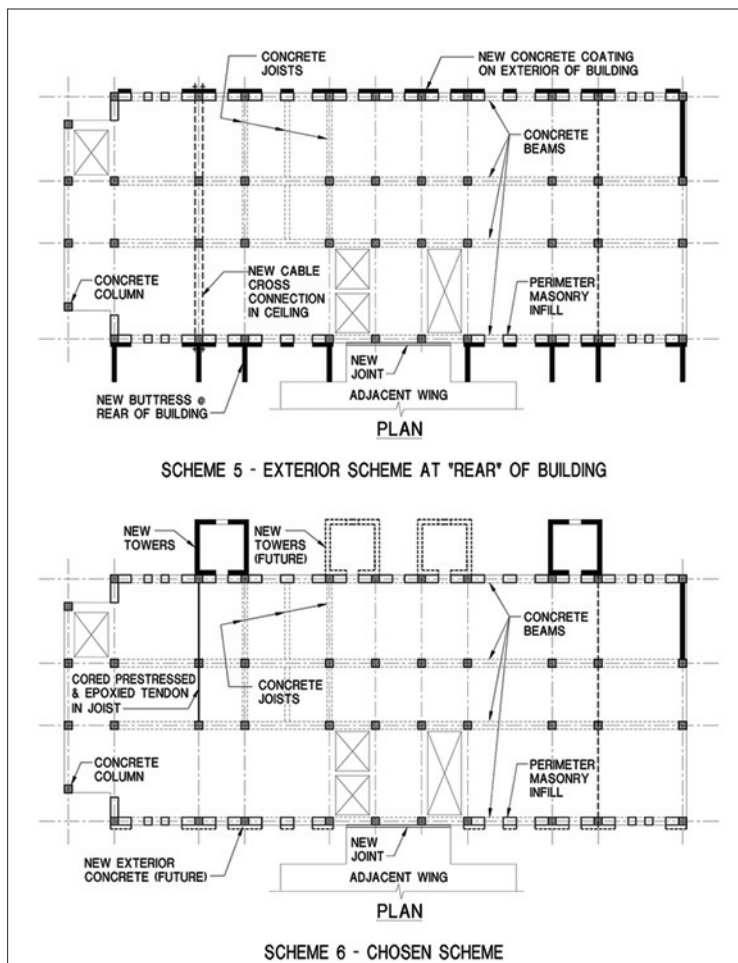
Schemes 1 and 2 required a complete lateral system in both buildings because of the separation installed at the wing intersection, which also caused difficult exiting issues. Schemes 3 and 4 were therefore developed, providing a strong inter-tie between wings and taking advantage of several new lateral elements to provide support to both wings. Scheme 3 featured new concrete towers as shown. Although the outside location was considered advantageous from a disruption standpoint, the towers closed windows and caused disruption to mechanical services. Scheme 4 was similar to 3, but eliminated the towers. Schemes 3 and 4 had less construction cost than 1 and 2, but disruption, in terms of phasing, caused essentially the same total downtime.

Figure 8-9c: Example of effect of non technical issues on retrofit schemes.

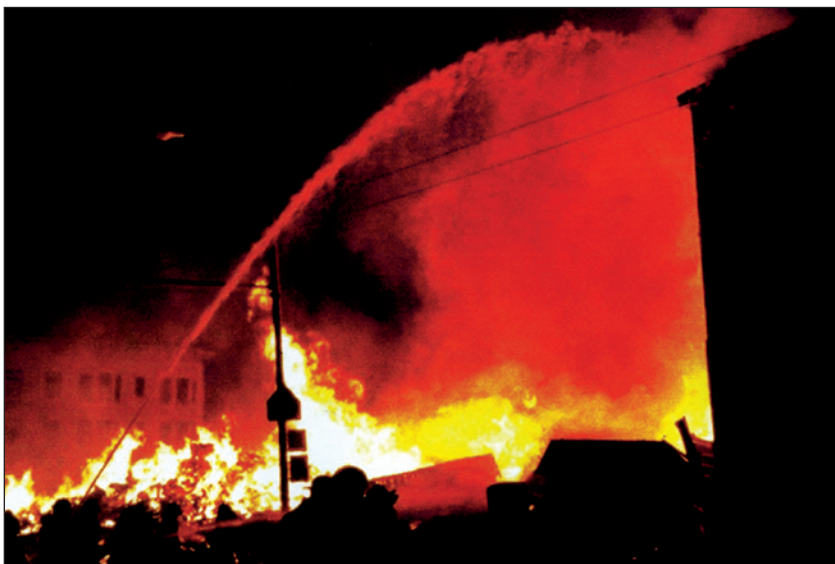
Figure 10-1
Earthquake and Fire,
Marina District, Loma
Prieta, 1989.
