Mitigation Prevents Community Isolation

Full Mitigation Best Practice Story

Yabucoa Municipio, Puerto Rico

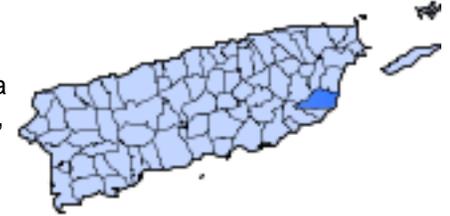
Yabucoa, PR - During any heavy rain event, almost 10,000 residents of Barrio Guayabota and Barrio Quebradilla in Yabucoa faced the possibility of losing the road at Coquí Bridge, which is their connection with downtown Yabucoa and other communities. If this road got damaged or destroyed, it meant a 30-kilometer detour to get assistance or provisions.

Natividad Ruiz was born and raised in Barrio Guayabota and has endured this situation many times. “Just last year, as soon as it started raining heavily, we would worry about how much time we had left before our community would be isolated,” said Ruiz. The floodwaters would scour the creek bank and cause washout of the road.

The FEMA Public Assistance Program normally funds repair of public infrastructure to pre-existing conditions. However, in this case, it was clear that future rains would again damage the road and bridge approach. Thus, after the November 2003 flooding event, a mitigation measure was undertaken, which involved the installation of gabions (rock filled wired baskets) in areas eroded by floodwaters. The gabions were later covered with earth.

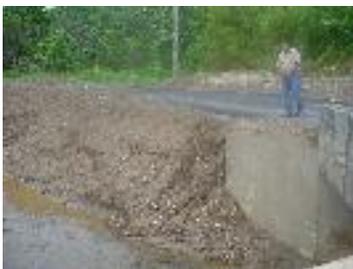
Gabions installed to prevent future erosion.
