Nobles Cooperative Electric: Power Up in Nobles County

Full Mitigation Best Practice Story

Nobles County, Minnesota

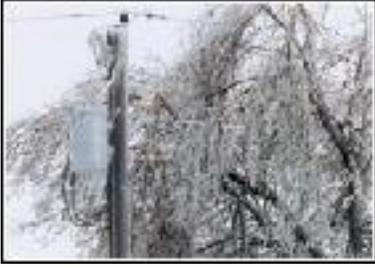
Downed power lines was the result of the 1998 ice storm

Hazard Mitigation Grant Program (HMGP) funds gave NCE the opportunity to mitigate against continuing power outages occurring in the Buffalo Ridge area. The co-op implemented a \$741,295 hazard mitigation project, converting 36.4 miles to underground line.
