Anchoring Code Defends Home from Katrina's Winds

Full Mitigation Best Practice Story

Washington Parish, Louisiana

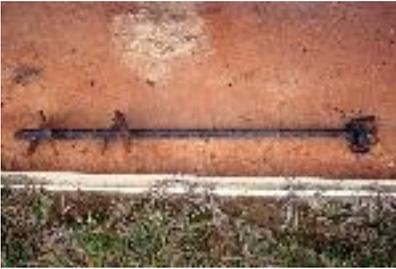
Ground anchor.

In order bring his home into compliance with Washington Parish’s current anchoring standards, Mr. Passman followed the recommendations of a structural engineer. The engineer evaluated Mr. Passman’s property and advised him to replace several inches of topsoil with dense clay. The engineer then instructed Mr. Passman to secure his home on thicker, heavier concrete foundation pads, and to fasten it with many more steel straps and auger-style ground anchors than he had been required to use in the past.

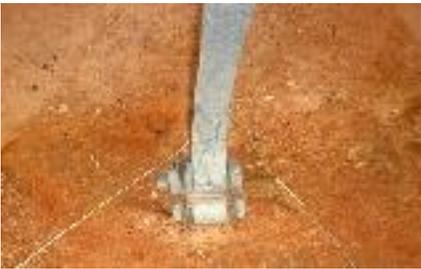
Steel strap.

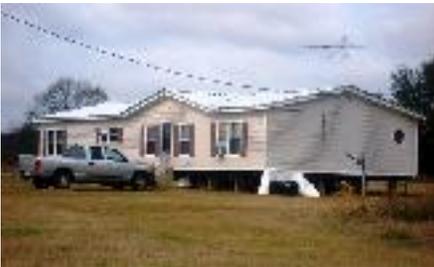
The Passman home standing strong after Katrina.

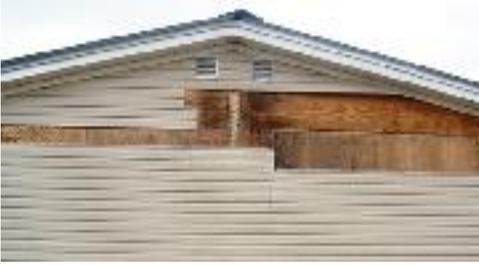
Hurricane Katrina caused tremendous wind damage in the Franklinton area. The storm blew apart trailers, tore roofs from houses, and knocked down trees by the acre. The Passmans’ residence did sustain exterior damage, but it was minor in comparison with the devastation suffered by many other manufactured homes in the area.

Siding and roof damage.
