A Dream Comes True: Mitigated Haven in Mississippi

Full Mitigation Best Practice Story

Jackson County, Mississippi

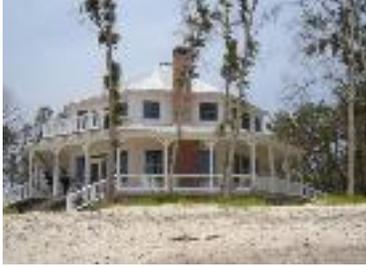
Beachside view of Charlotte Lamar's House in Ocean Springs, MS.

Eight pressure-treated wood pilings were positioned at the corners of the octagonal structure, embedded 15 feet in the ground, and connected to the roof. The design of the roof aids in its wind resistance; its pitch equalizes downward pressure from high winds. The entire house is tied together with metal brackets and hurricane straps that help distribute wind loads by providing a continuous load path from the roof to the foundation. The home, built of cedar, stands approximately 22 feet above sea level and is located in Zone C where there is no regulation to elevate above the Base Flood Elevation. Therefore, Ms. Lamar elevated her house by choice, basing her decision on historical events, such as Hurricane Camille. Following fourteen months of construction, she gazed toward the Gulf from the second floor deck of her new home.

The tidal surge rose two feet on Ms. Lamar's property, but missed her house by three feet because of the additional elevation incorporated into her home's construction. The force of the tidal surge destroyed the air conditioning and heating ductwork beneath the house; saltwater invaded the floor vents and left mud on the floors of the house; and the 102 mile-per-hour winds and rain damaged a window, allowing water into the house. However, compared to other beachfront homes, Ms. Lamar's house sustained minimal damage.

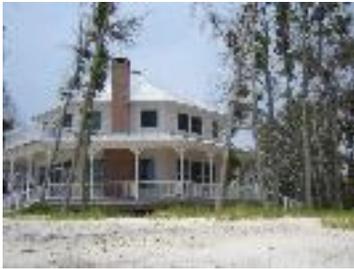
Beachside view of Charlotte Lamar's House in Ocean Springs, MS.

Hurricane Katrina damaged the contemporary house nextdoor to Charlotte Lamar's house.
