FEMA

Homemade Floodgates Succeed Octogenarian and Blacksmith Collaborate

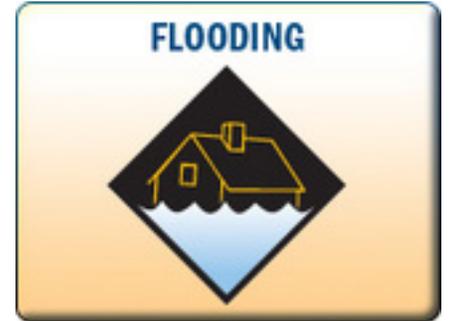
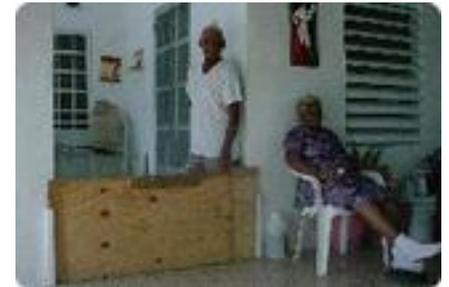
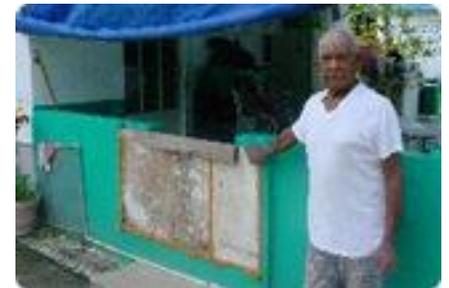
“I thought of two metal slots, one on each side of the door, to slide a wood panel through them. Then, foam sealant is sprayed all the way around the panel, between the metal slot and the floor,” explained Flores. A friend of his, who is a blacksmith, created and attached custom-made metal slots to every outside doorway. The wood panels are three and a half feet tall, and the couple tries to keep them at hand. “We are two aging persons . . . we need the floodgates to be comfortably low: high enough to remain safe, but low enough to step over them. And it’s easier to move if they are lighter instead of heavier,” Flores explained.
