FEMA

Only House Left Standing: Building Code Saves House

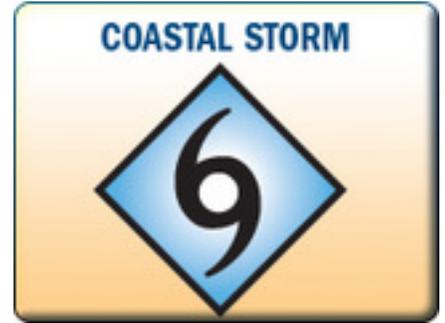
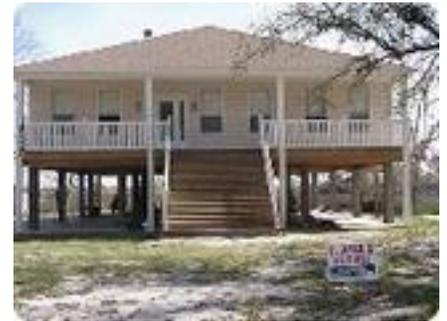
Photo Caption: The Harris' house was the only one in their neighborhood standing after Hurricane Katrina. They used ICC funds to elevate their house, exceeding the 13.1-foot requirement.

There is connectivity in the Harris' house from the foundation to the roof. The posts that support the house were connected to other structural components using the proper size galvanized bolts and hurricane straps. Hurricane straps can be used to connect the top of the wall to the roof as well as connect the bottom of the wall and flooring to the post. Harris credits the large posts and the connectivity method of construction for saving his house from serious hurricane damage.
