Hillsboro Cabin

Won't Log Any More Floods

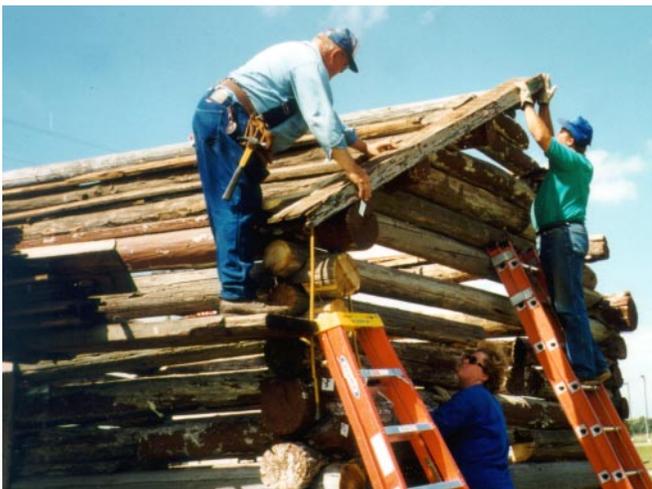
So in June 1998, he and five other townspeople took the log house apart the same way it had been built—piece by piece—carefully numbering each of the 61 logs so that it could be correctly reconstructed.

Duane Nysveen (left) gets help taking apart the cabin log by log. Photo courtesy Shirley Nysveen.

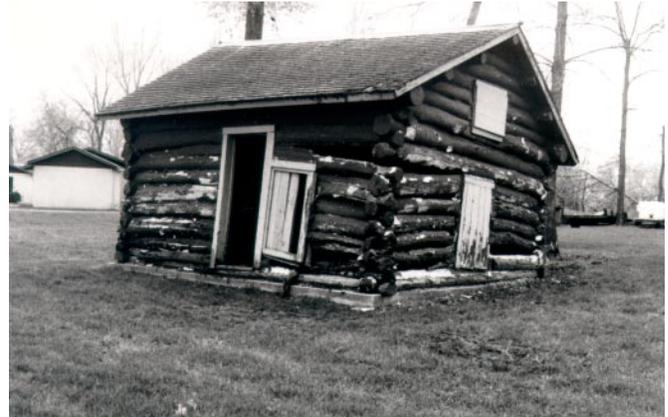
More often than not, the cabin flooded too. Parts of it began to rot. When the area was hit with record flooding and a late blizzard in the spring of 1997, the damage caused by both water and ice was even worse.

The city's park district owned the structure and used it to store park equipment. Although the city had "mucked out" the structure many times before, the '97 flood had caused some serious structural damage. Historic preservationists wanted to move the cabin to protect an important piece of the area's history.

Furthermore, the structure—which flooded twice more after the '97 event—was so damaged that it couldn't be moved intact. Instead, it would need to be dismantled, moved and then reconstructed.

After the '97 flood, the cabin had deteriorated even further. FEMA file photo.

To replace the flood-damaged logs—about 20 percent of the whole structure—Nysveen went to rural electric cooperatives and got old, weathered high-voltage power line poles that looked strikingly like the original timbers. Mortar, rather than the original dirt-and-cow-manure paste, was used to fill the spaces between the logs. A new roof was added, the lone window was rebuilt and a new front door was put on.

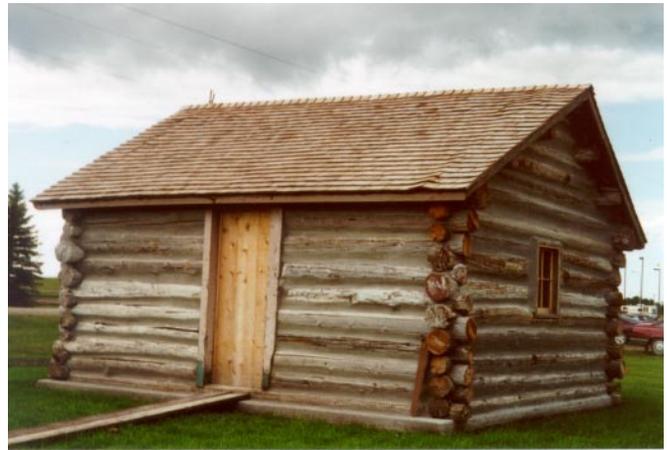
"First we built up the site so there wouldn't be any water problems and then we built a concrete base," Duane said. "We wanted to get the cabin up enough so we were sure it would stay dry."

Newly reconstructed outside the floodplain, the cabin now has a chance to live high and dry. Photo courtesy Shirley Nysveen.
