Reducing the Risks of Nonstructural Earthquake Damage – A Practical Guide

FEMA E-74 / December 2012

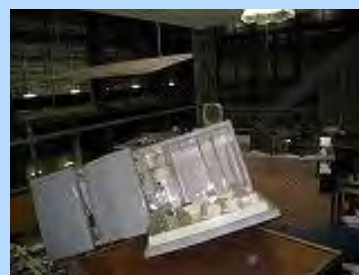
Figure 2-1 Result of shaking table test on room contents (from 01, 2008 test)

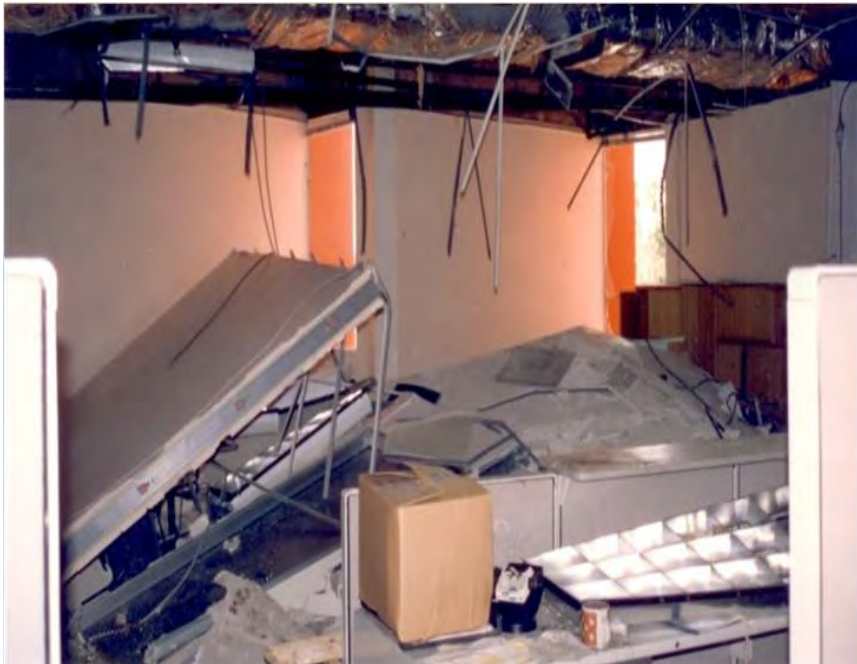
Figure 2.4.1-1 Failure of office partitions, ceilings, and light fixtures in the 1994 Northridge Earthquake (FEMA 74, 1994).

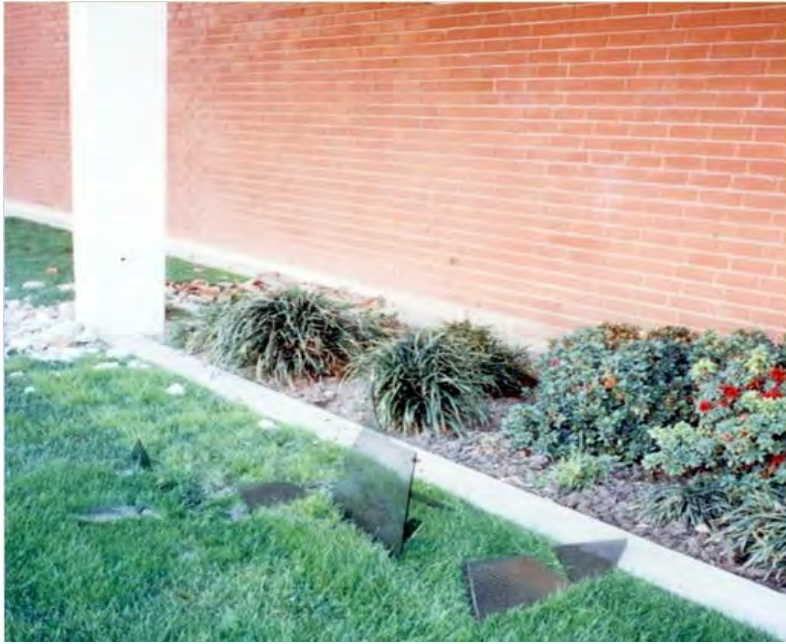
Figure 2.4.1-2 Shards of broken untempered glass that fell several stories from a multistory building in the 1994 Northridge Earthquake. Failures of this type can be very hazardous, especially if glazing is located above exit ways (FEMA 74, 1994).

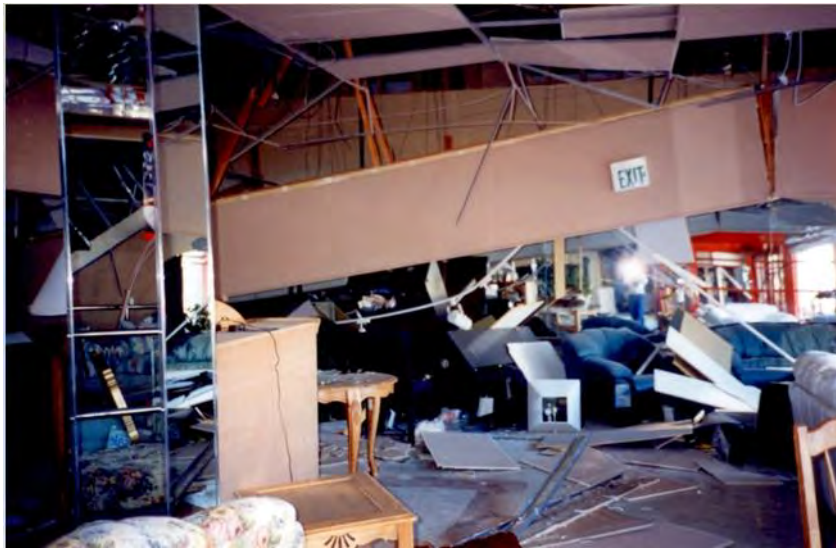
Figure 2.4.1-3 Failure of suspended ceilings and light fixtures in a furniture store (FEMA 74, 1994).

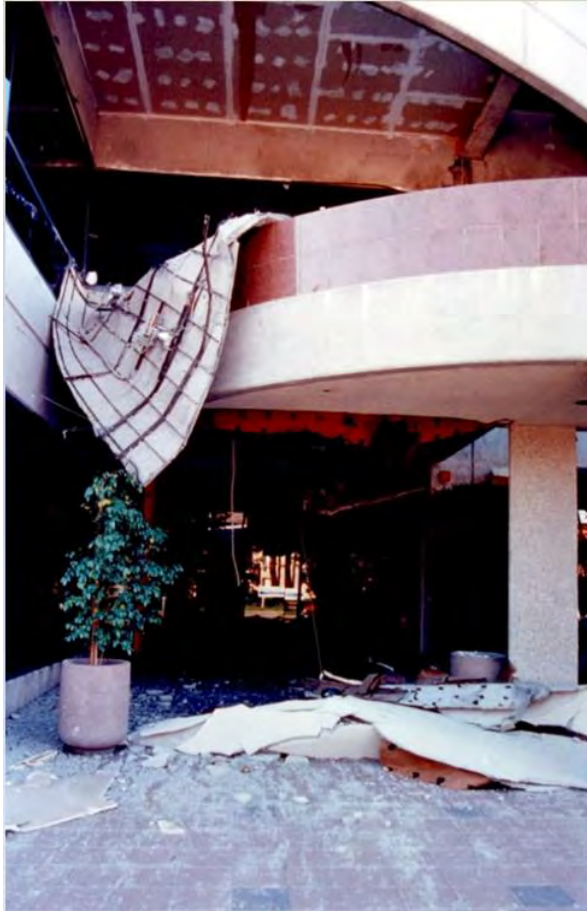
Figure 2.4.1-4 Failure of heavy stucco soffit at building entrance in the 1994 Northridge Earthquake (FEMA 74, 1994).

Heavy suspended ceilings and soffits can be damaged during earthquakes, sometimes causing heavy and dangerous material to fall and injure people below. Figure 2.4.1–2 shows a failed stucco soffit above a building entrance damaged in the 1994 Northridge Earthquake. During the 1989 Loma Prieta Earthquake, the proscenium arch ceiling at the Geary Theatre in San Francisco fell and covered the first six rows of seats in the auditorium; the theater was not in use at the time and no one was injured (Ding, 1990).

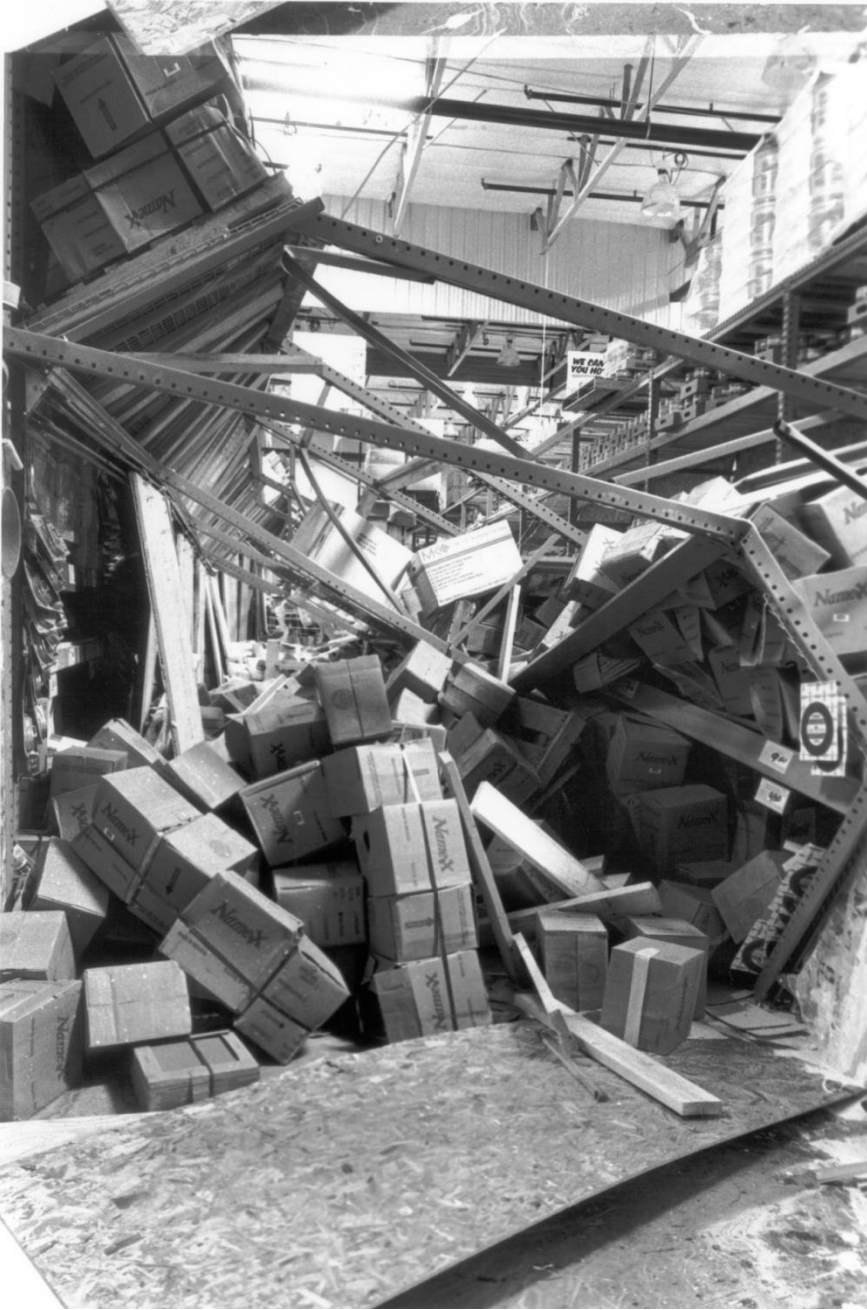
Figure 2.4.1-5 Damage to overloaded racks during the 1994 magnitude-6.7 Northridge Earthquake (FEMA 460, 2005).

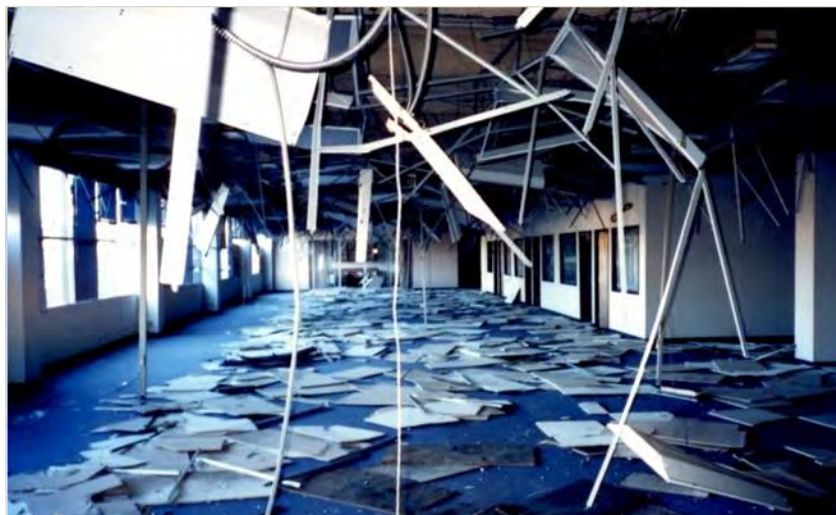
Figure 2.4.2-1 Complete loss of suspended ceilings and light fixtures in the 1994 Northridge Earthquake (FEMA 74, 1994).

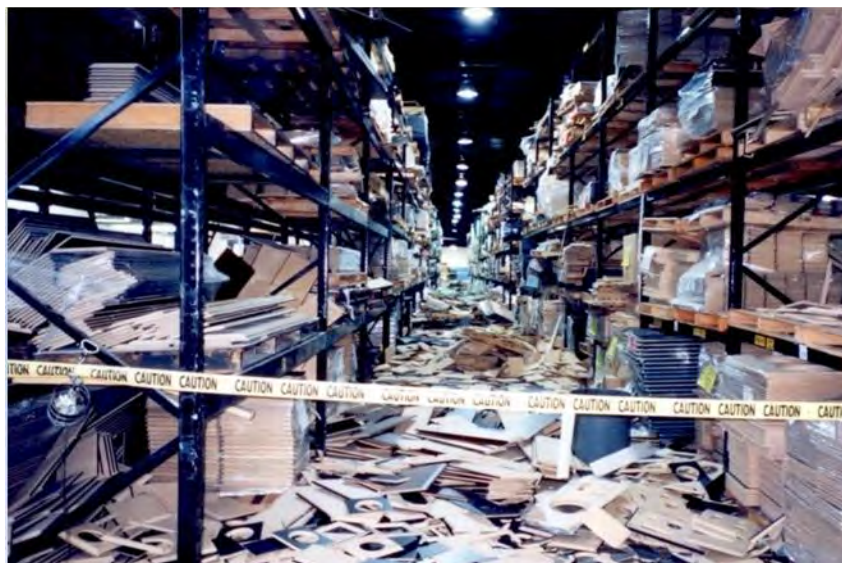
Figure 2.4.2-2 Damage to inventory on industrial storage racks in the 1994 Northridge Earthquake (FEMA 74, 1994).

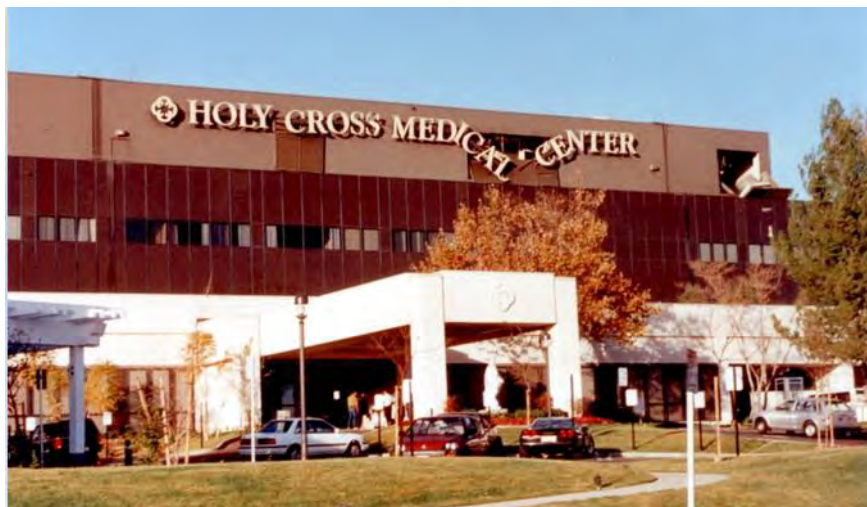
Figure 2.4.3-2 HVAC damage at Holy Cross Medical Center in Sylmar in the 1994 Northridge Earthquake. Damage to signage and louvers was caused when suspended fans in the mechanical penthouse swung and impacted the louver panels. HVAC service outage caused the temporary evacuation of patients (FEMA 74, 1994).

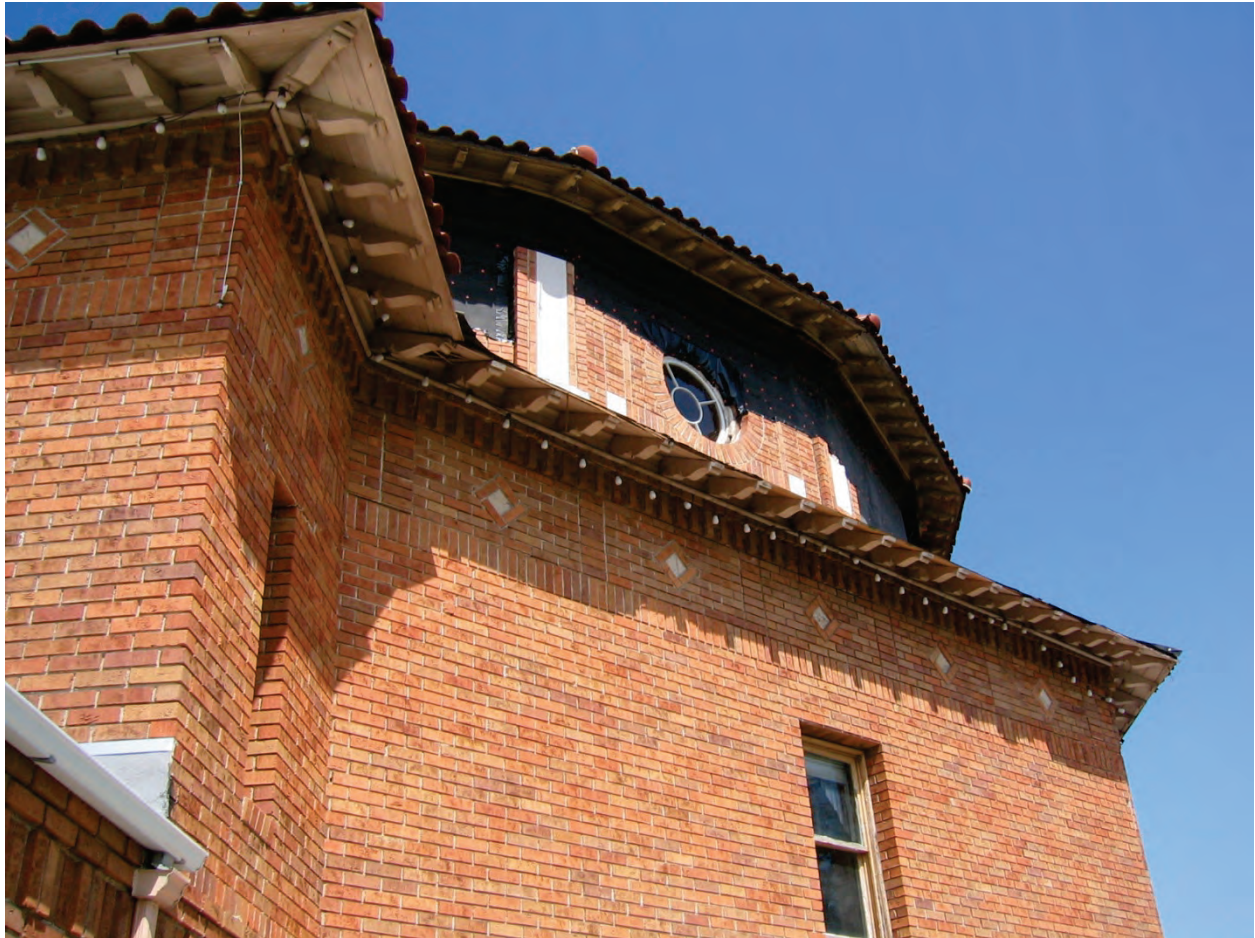
Figure 6.3.1.1-1 Failure of adhered masonry veneer at the Atascadero City Hall in the 2003 magnitude-6.5 San Simeon Earthquake (Photo courtesy of Mike Mahoney, FEMA).

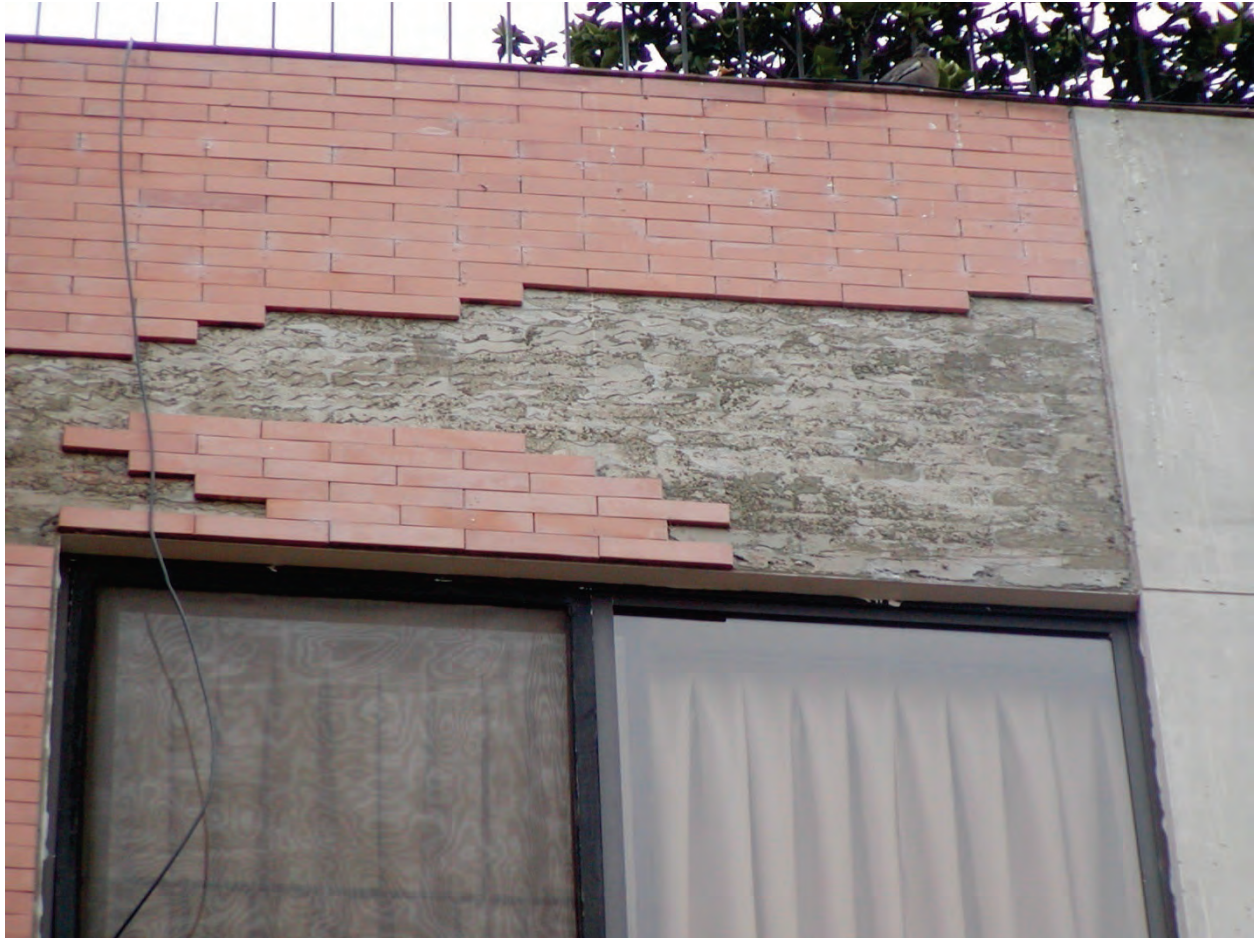
Figure 6.3.1.1-2 Close-up of failed adhered veneer. (Photo courtesy of Eduardo Fierro, BFP Engineers).

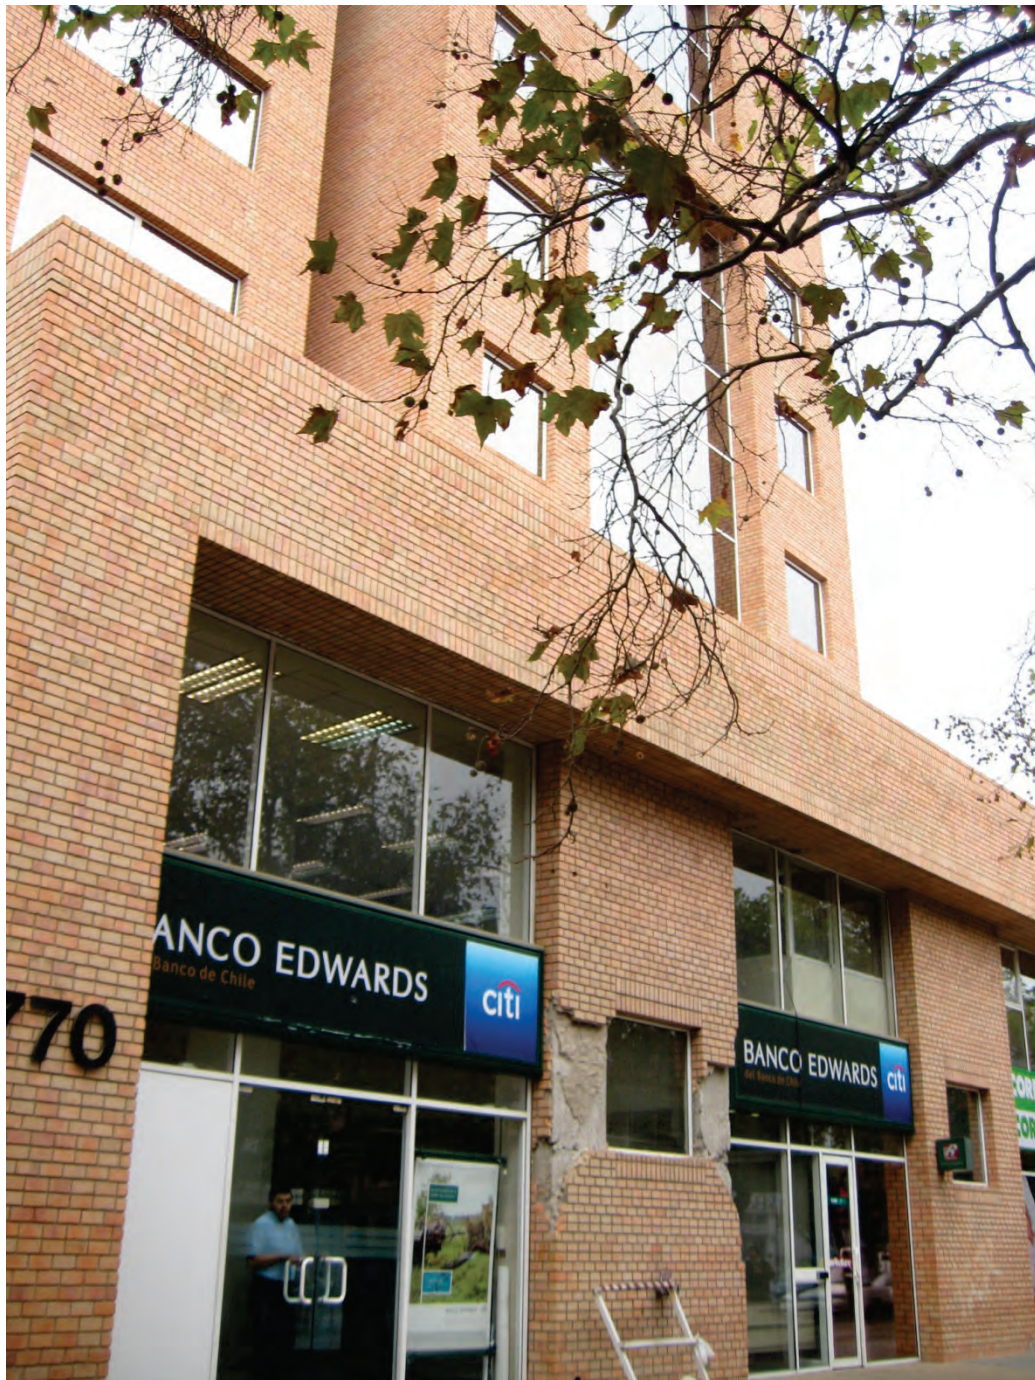
Figure 6.3.1.1-3

Cracked and spalled adhered veneer reveals incipient structural damage to concrete piers in Viña del Mar following the 2010 magnitude-8.8 Chile Earthquake. In this case, the areas of structural and nonstructural damage coincide; the adhered veneer remained intact over portions of the shear wall that did not deform significantly (Photo courtesy of Santiago Pujol, Purdue University).

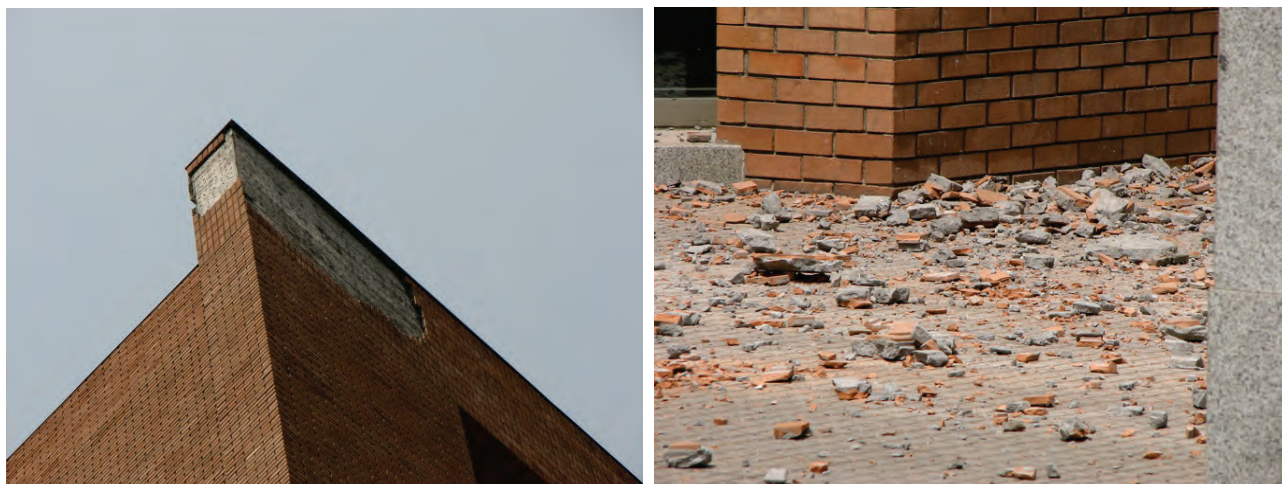
Figure 6.3.1.1-4 Failed adhered veneer fallen from parapet in Santiago following the 2010 magnitude-8.8 Chile Earthquake. (Photos courtesy of Antonio Iruretagoyena, Rubén Boroscheck & Associates)

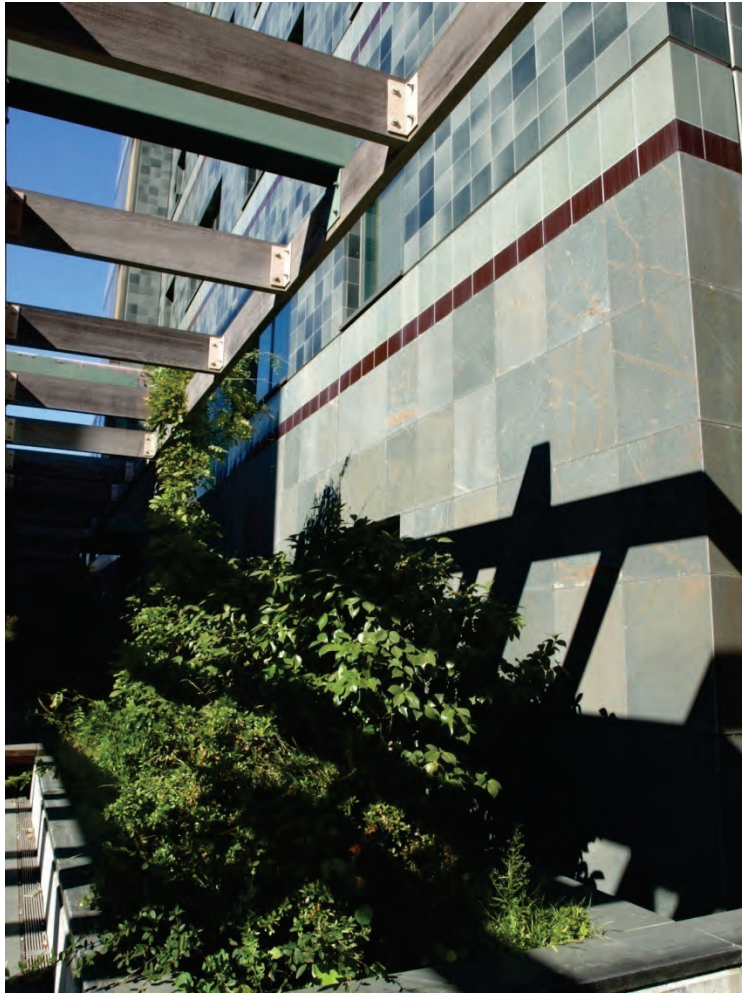
Figure 6.3.1.1-5 Landscaping strip restricts pedestrian access adjacent to adhered veneer façade. Larger units used within lower 6 feet; smaller units used above (Photo courtesy of Cynthia Perry, BFP Engineers).

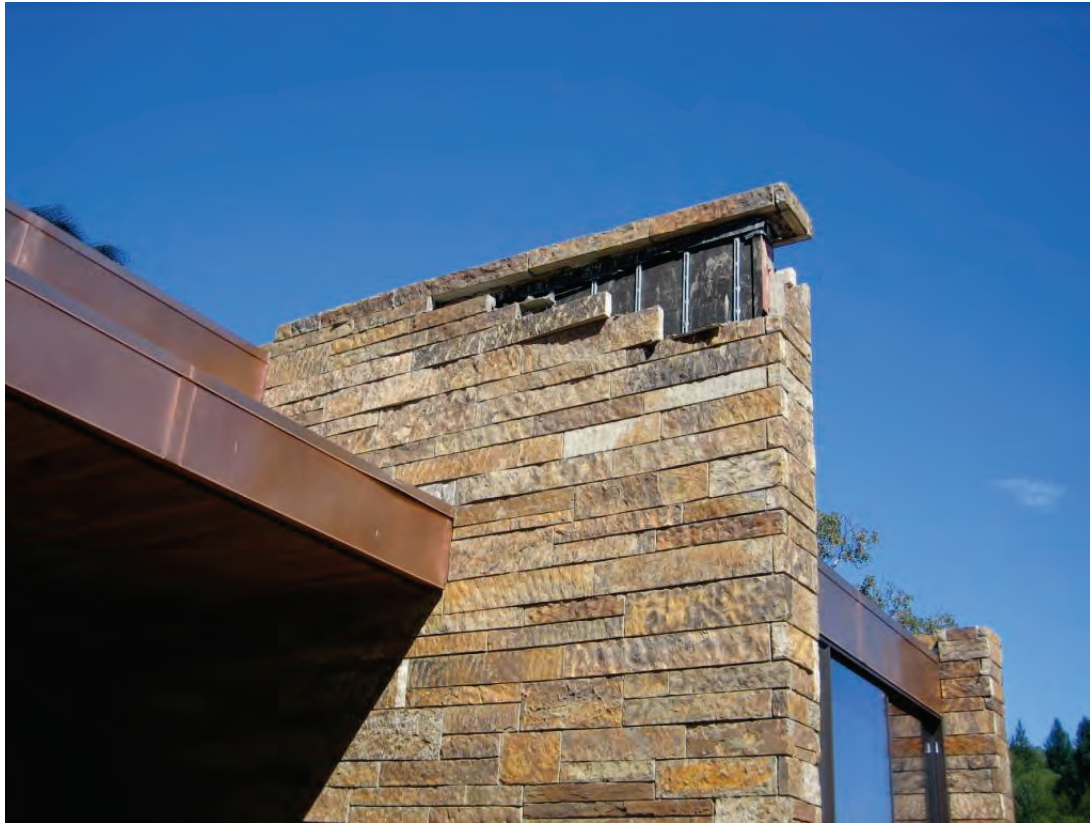
Figure 6.3.1.2-1 Fallen sandstone veneer as a result of a magnitude-4.4 earthquake in northern California. Post-earthquake investigation revealed missing dovetail anchors, missing pencil rods, and weak stone-to-mortar bond (Photo courtesy of Simpson Gumpertz and Heger).

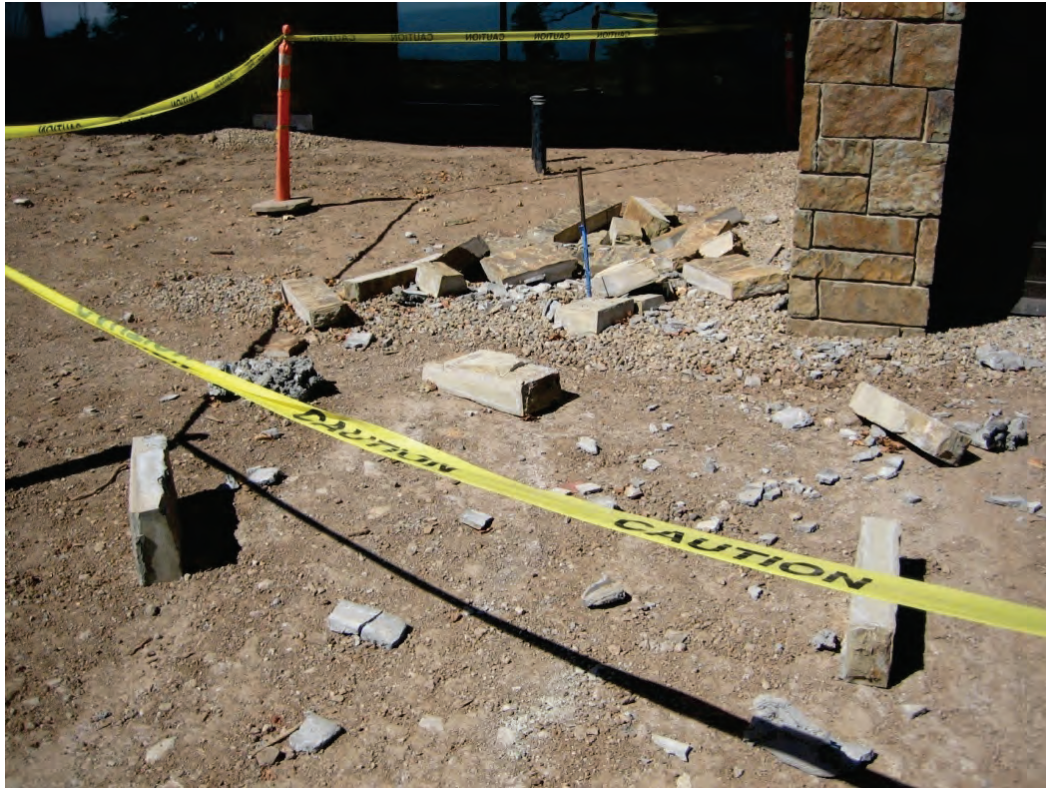
Figure 6.3.1.2-2 Fallen sandstone veneer as a result of a magnitude-4.4 earthquake (Photo courtesy of Simpson Gumpertz and Heger).

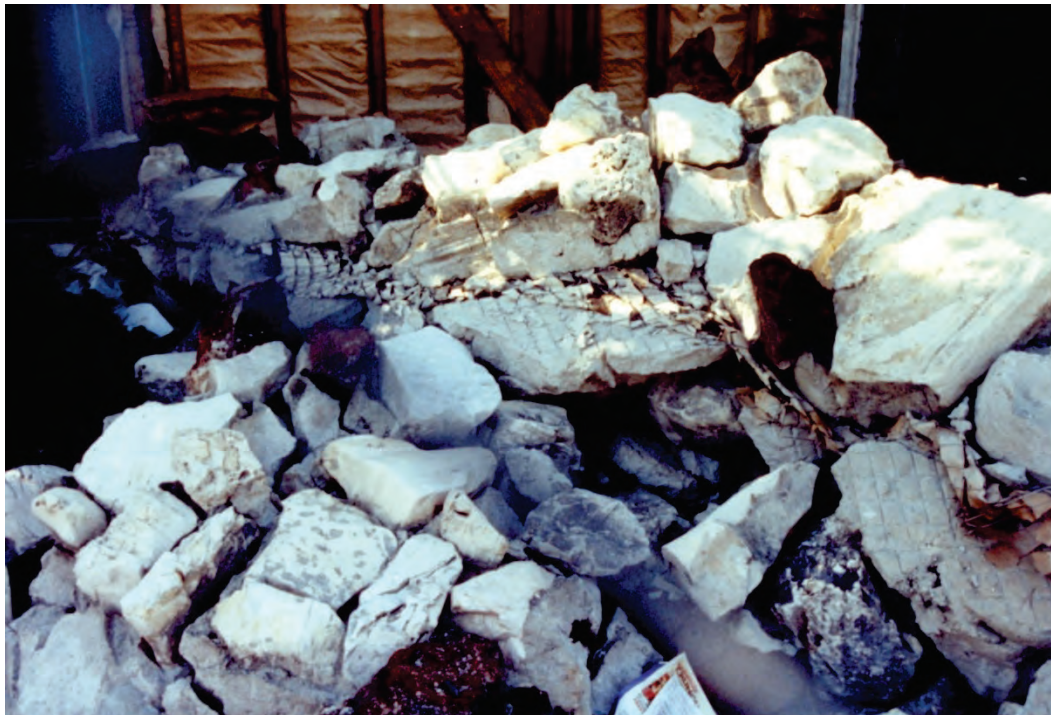
Figure 6.3.1.2-3 Rubble from failed anchored veneer as a result of the 1994 Northridge Earthquake (Photo courtesy of Robert Reitherman).

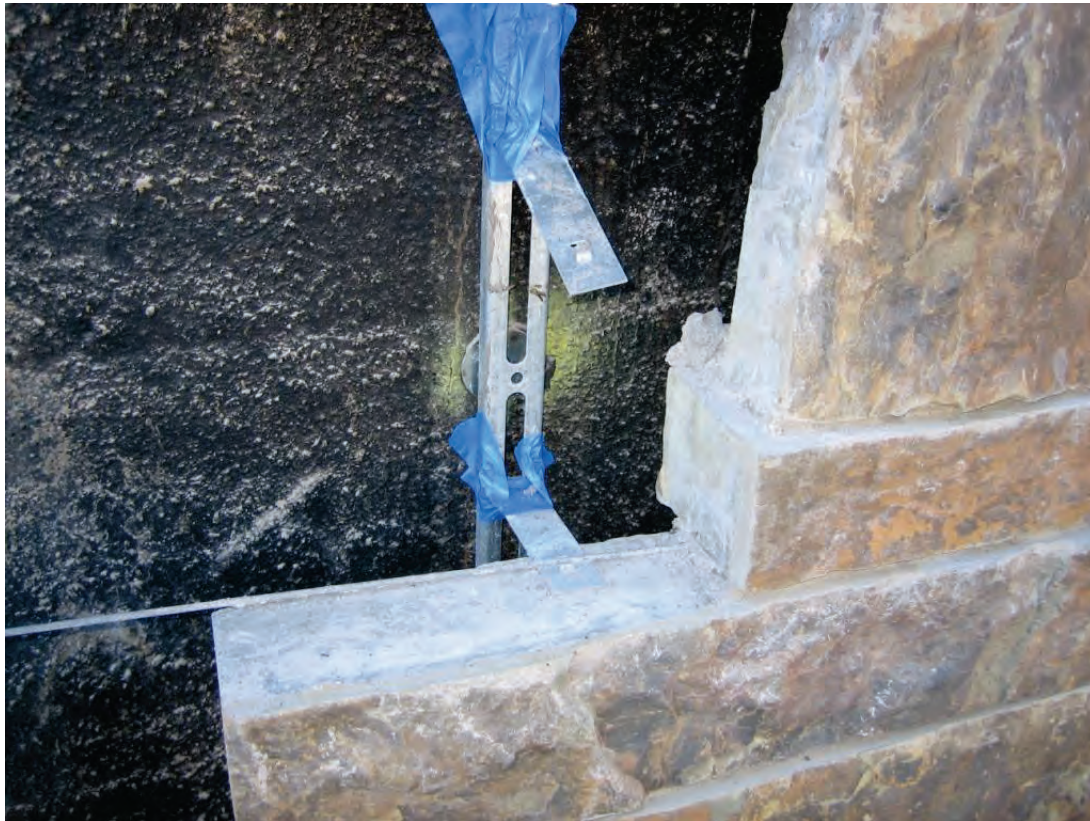
Figure 6.3.1.2-4 Installation of stone veneer showing anchorage to steel dovetail clips which are fastened to steel studs bolted to the grouted reinforced masonry wall behind (Photo courtesy of Simpson Gumpertz and Heger).

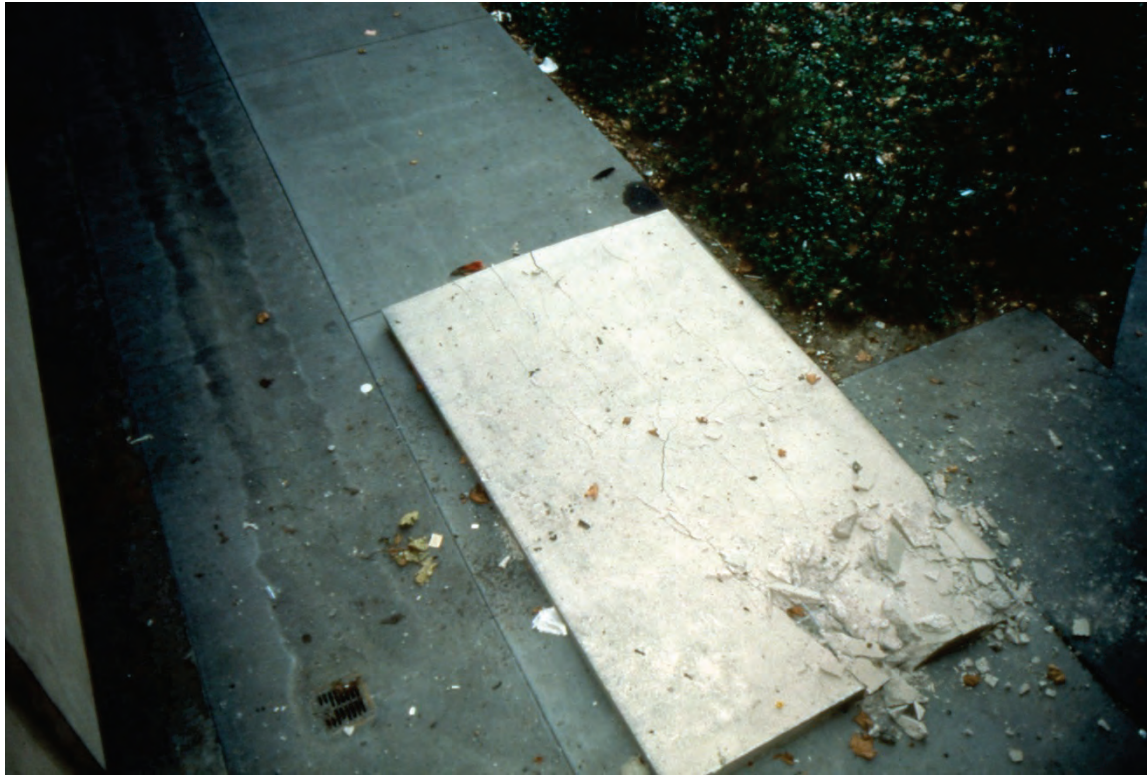
Figure 6.3.1.3-1 Failure of precast panel at parking garage that resulted in fatality in the 1987 magnitude-5.9 Whittier, California earthquake (Photo courtesy of Degenkolb Engineers).

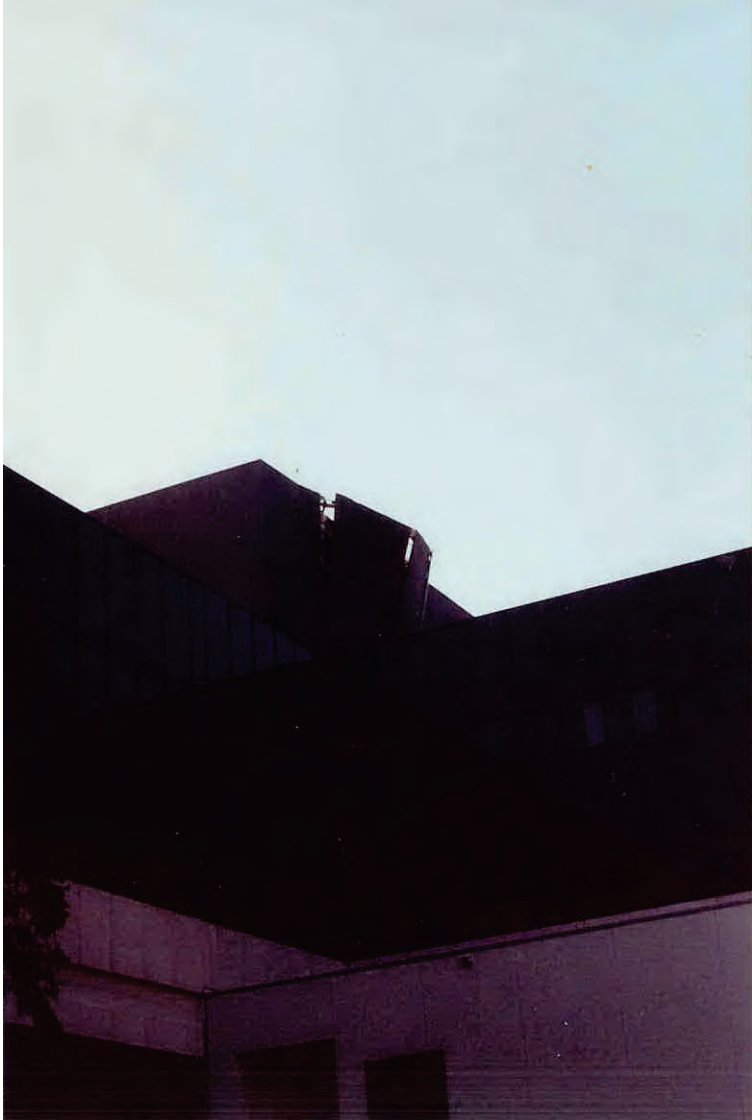
Figure 6.3.1.3-2 Precast panel failure at the top floor of a hospital in the 1994 magnitude-6.7 Northridge Earthquake (Photo courtesy of OSHPD).

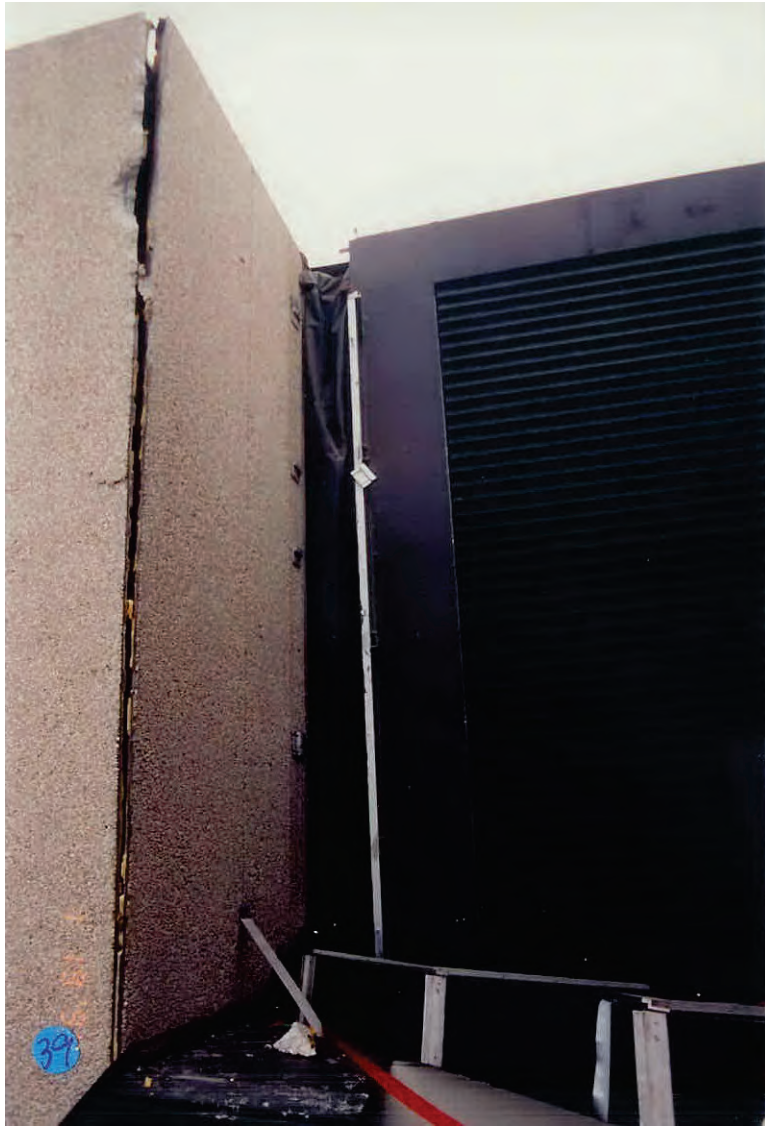
Figure 6.3.1.3-3 Precast panel damage at a building corner in the 1994 Northridge Earthquake
(Photo courtesy of OSHPD).

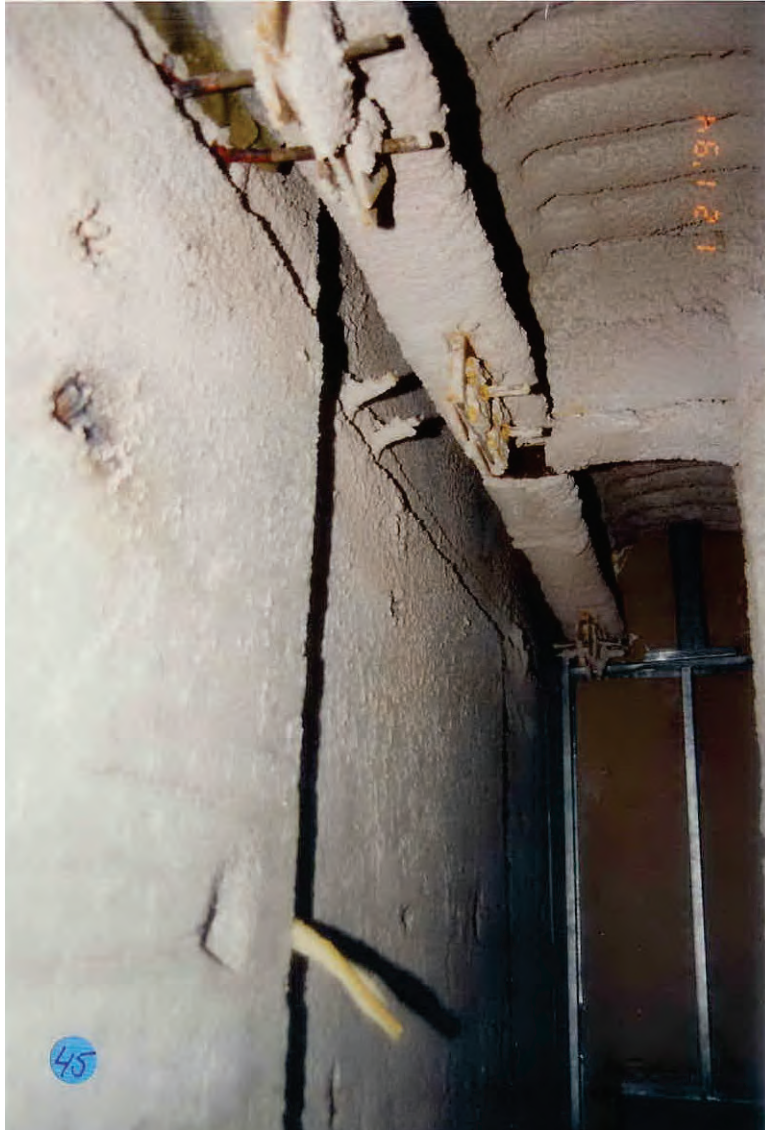
Figure 6.3.1.3-4 Interior view of precast panel showing response of three sets of push-pull connections in the 1994 Northridge Earthquake (Photo courtesy of OSHPD).

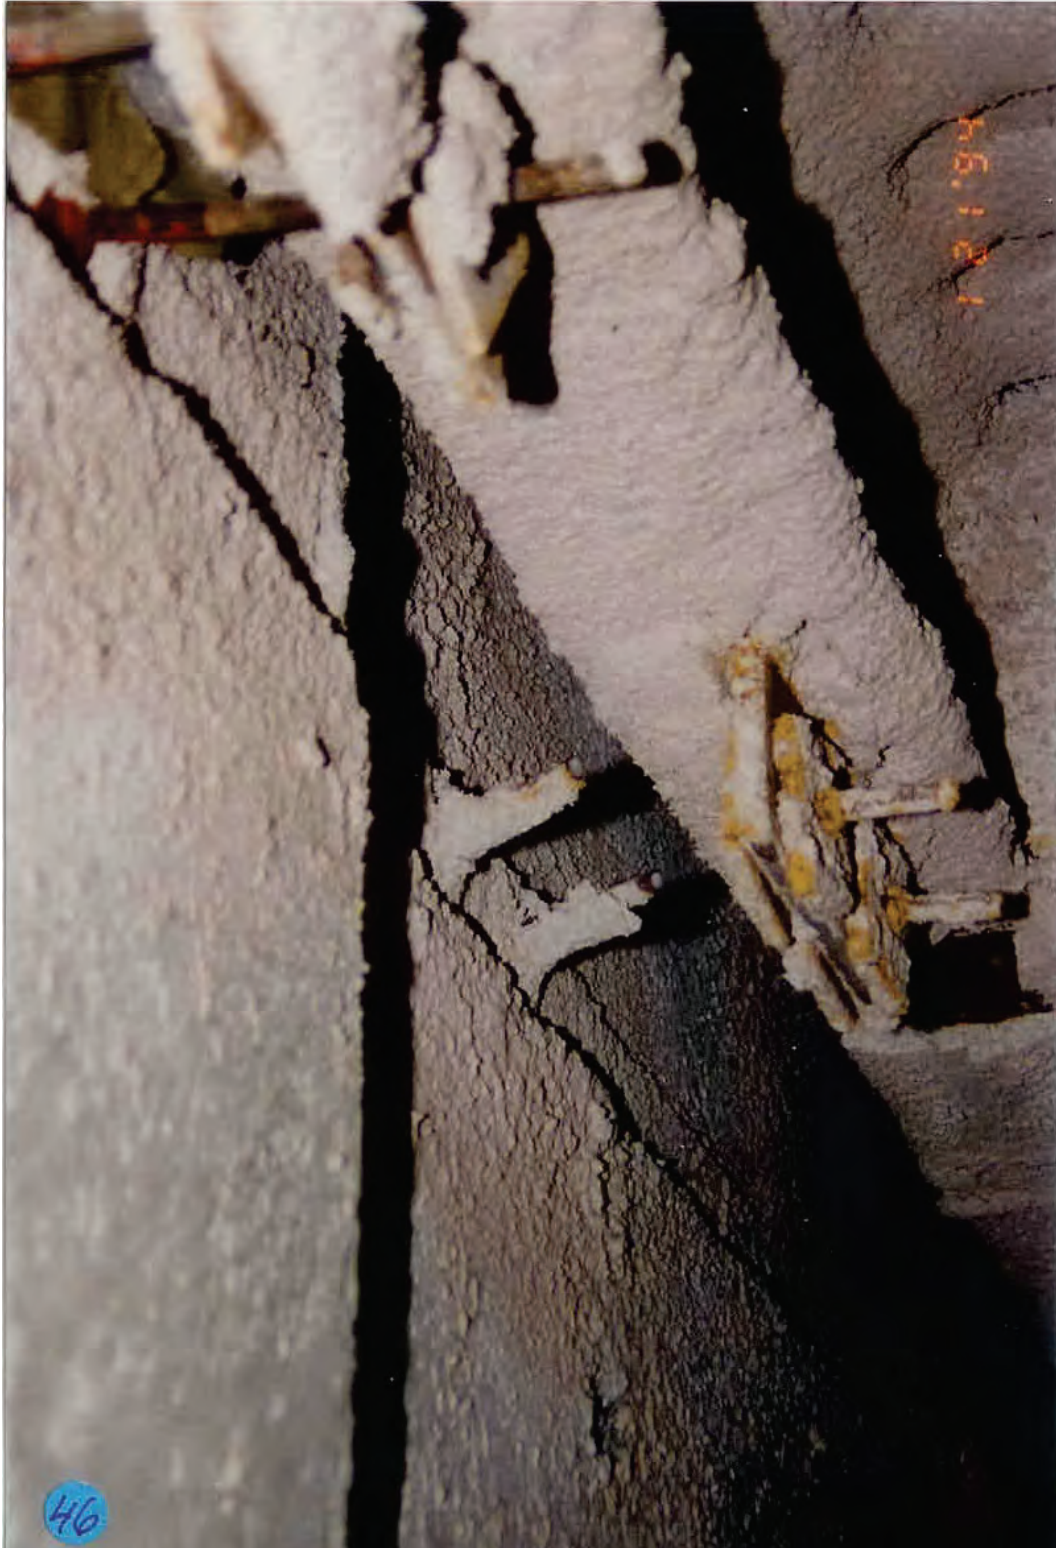
Figure 6.3.1.3-5 Close-up photo of two fractured connection bolts in a prefabricated panel in the 1994 Northridge Earthquake; corrosion of the rods may have contributed to the failure. (Photo courtesy of OSHPD).

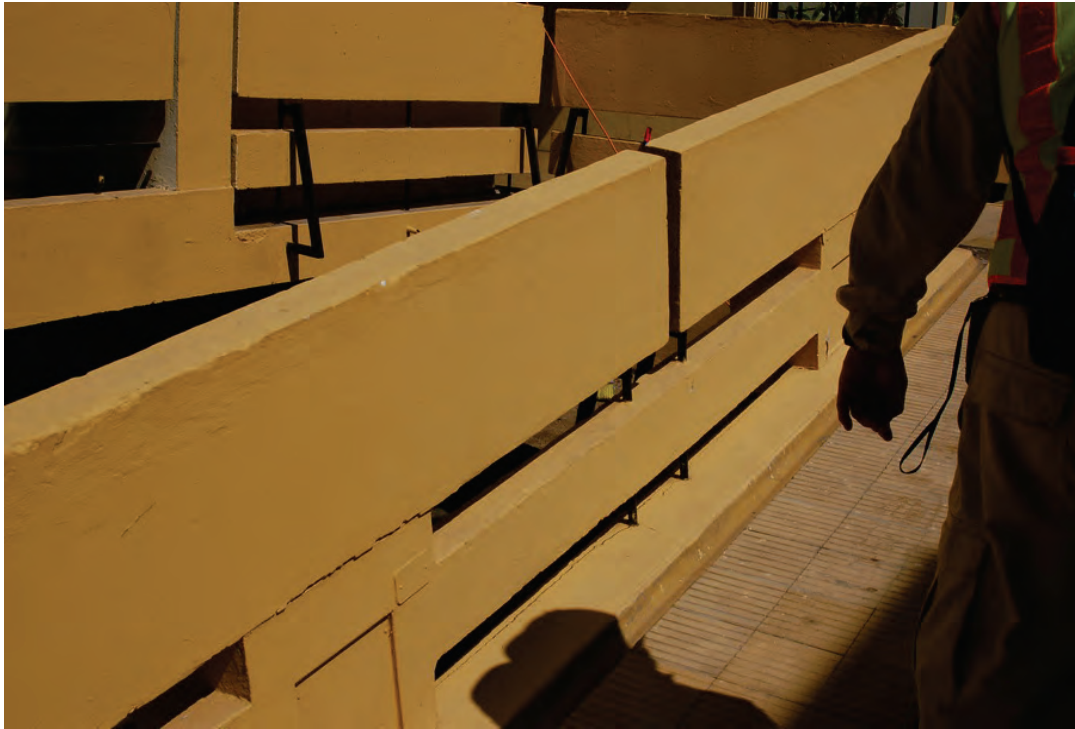
Figure 6.3.1.3-6 Residential building with precast concrete corridor and balcony railing panels. Some panels were damaged and subsequently many were removed to prevent falling. Location in Rancagua, Chile 154 miles northeast of the epicenter; estimated PGA of 0.3g during the 2010 magnitude-8.8 Chile Earthquake (Photo courtesy of Antonio Iruretagoyena, Rubén Boroscchek & Associates).

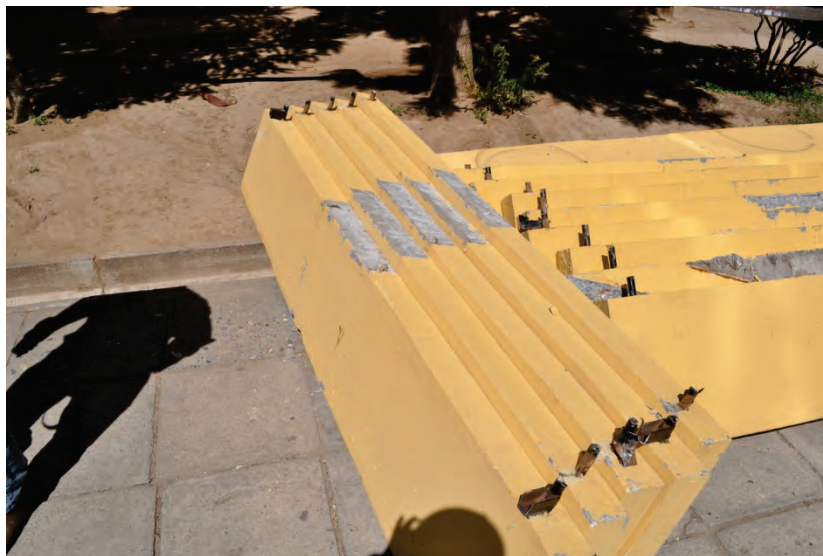
Figure 6.3.1.3-7 Numerous precast panels removed to prevent falling; detail from residential building in Rancagua, Chile above. These panels had a bearing seat at the center and supported on steel dowels at either end (Photo courtesy of Eduardo Fierro, BFP Engineers).

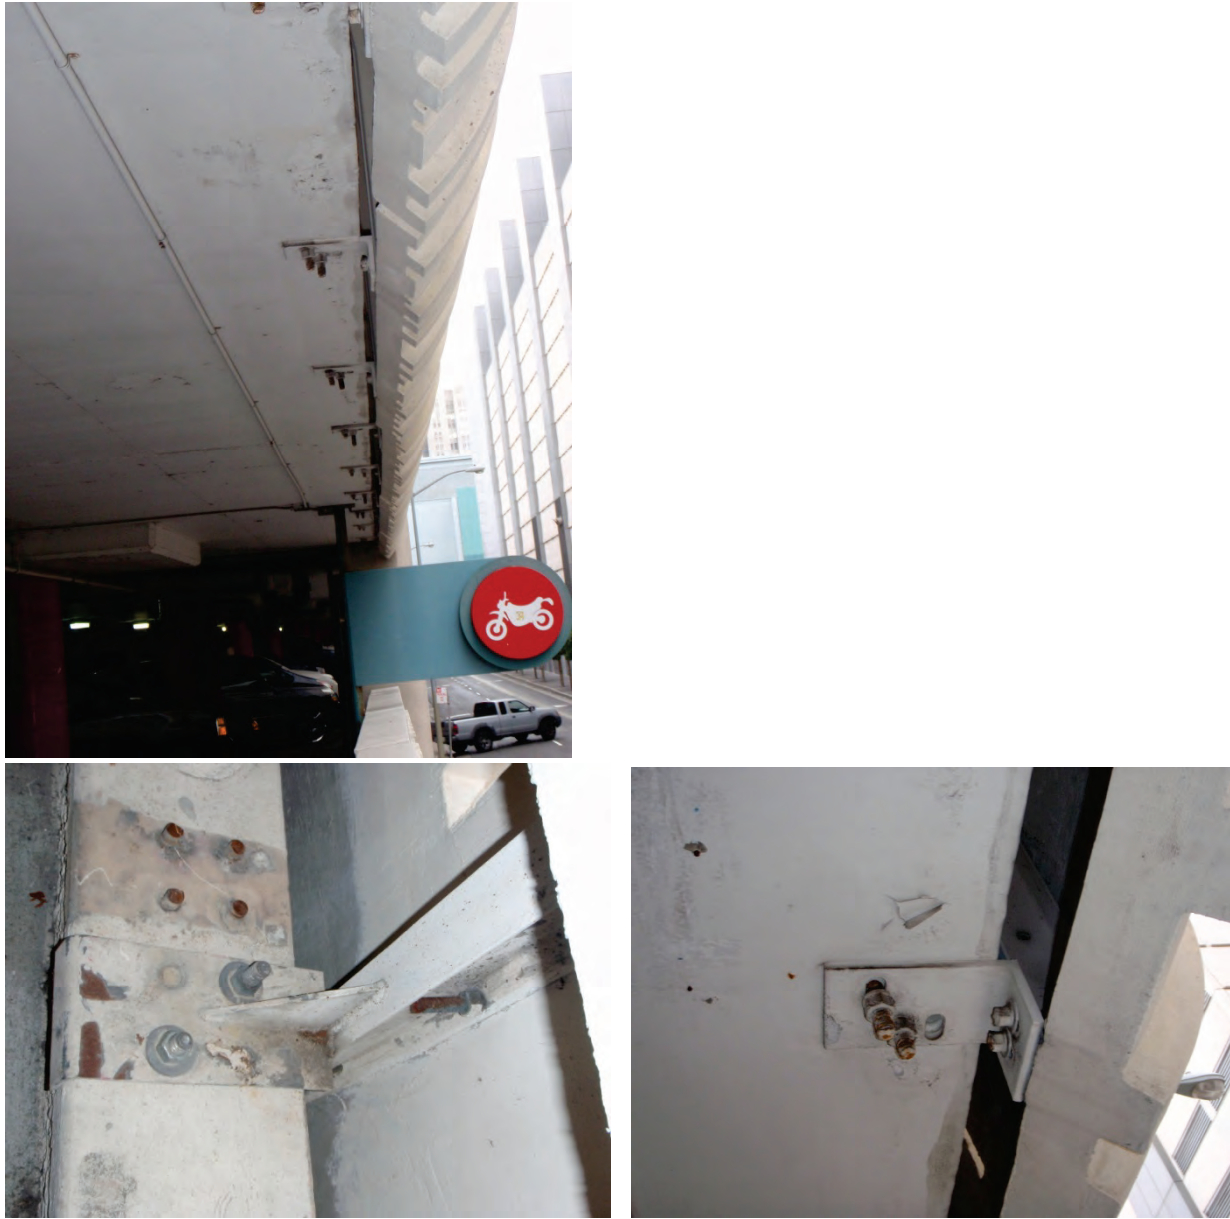
Figure 6.3.1.3-9 Precast spandrel panel in San Francisco parking garage supported by bearing connections near top of panel (left) and slotted connections at bottom of panel (right); panels have four connections each. The remnants of a previous nonductile connection detail are visible in the photo at left (Photo courtesy of Cynthia Perry, BFP Engineers).

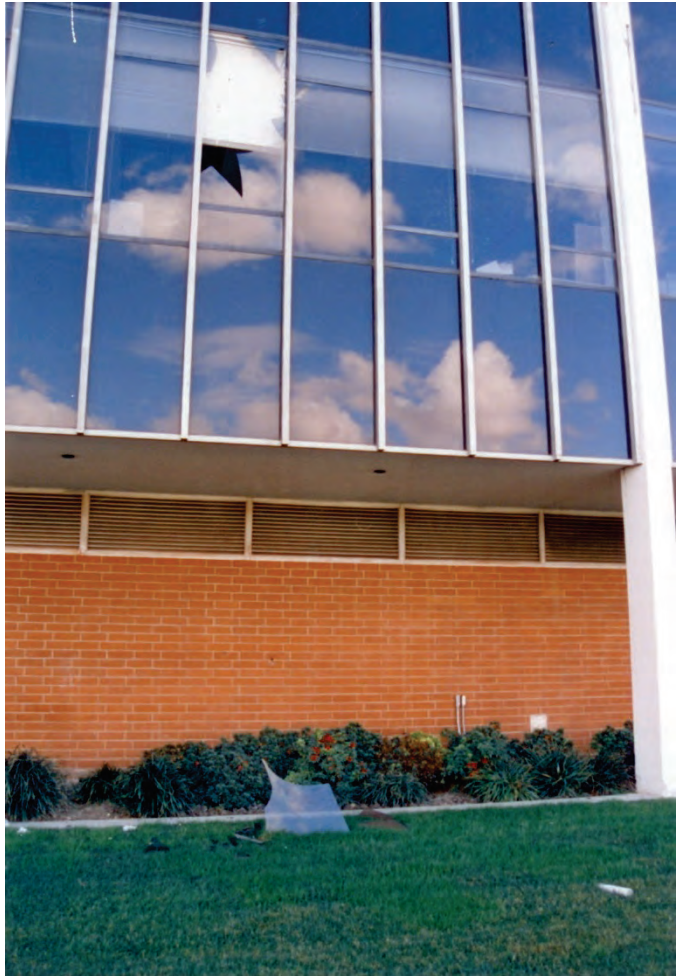
Figure 6.3.1.4-1 Shard of broken untempered glass that fell several stories from a multistory building in the 1994 Northridge Earthquake (Photo courtesy of Wiss, Jenney, Elstner Associates).
