Reducing the Risks of Nonstructural Earthquake Damage – A Practical Guide

FEMA E-74 / December 2012

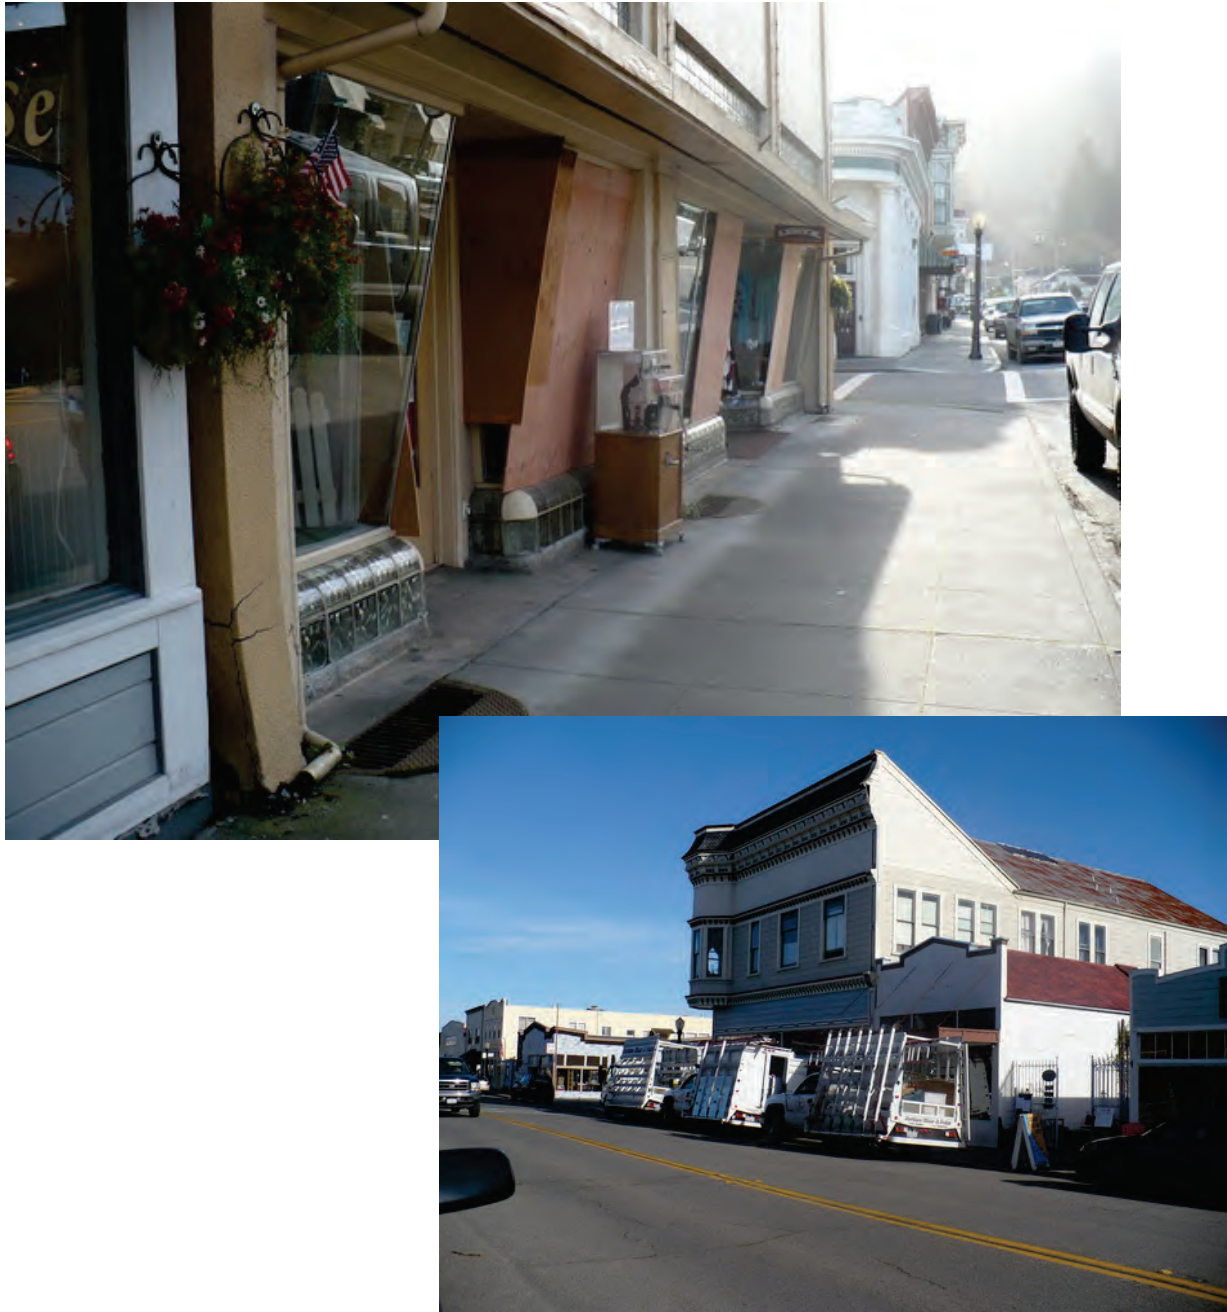
Figure 6.3.1.4-2 Scenes in Ferndale, California following the 2010 magnitude-6.5 Eureka Earthquake. 50% of the glazing on Main Street was cracked (Photos courtesy of Bret Lizundia, Rutherford & Chekene).

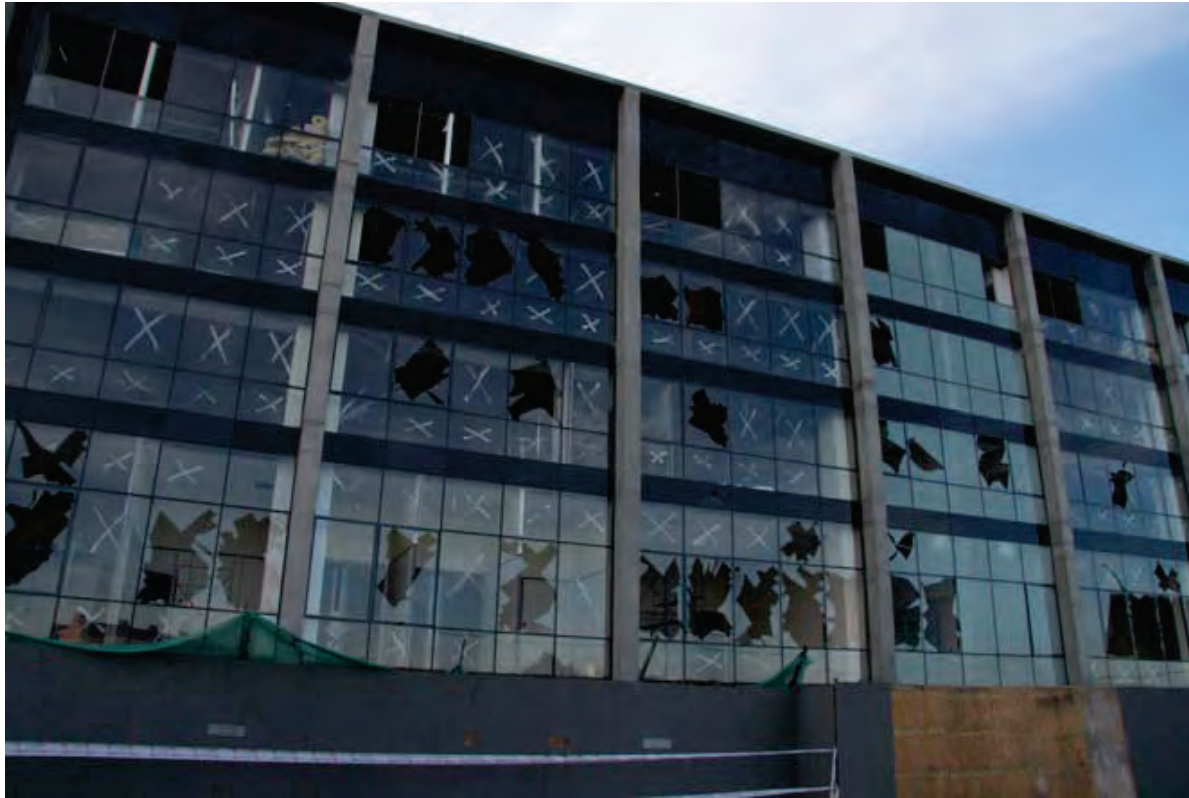
Figure 6.3.1.4-3 Glazing damage was observed in many residential and commercial buildings and hospitals throughout central Chile following the 2010 magnitude-8.8 Chile Earthquake (Photo courtesy of Eduardo Miranda, Stanford University).

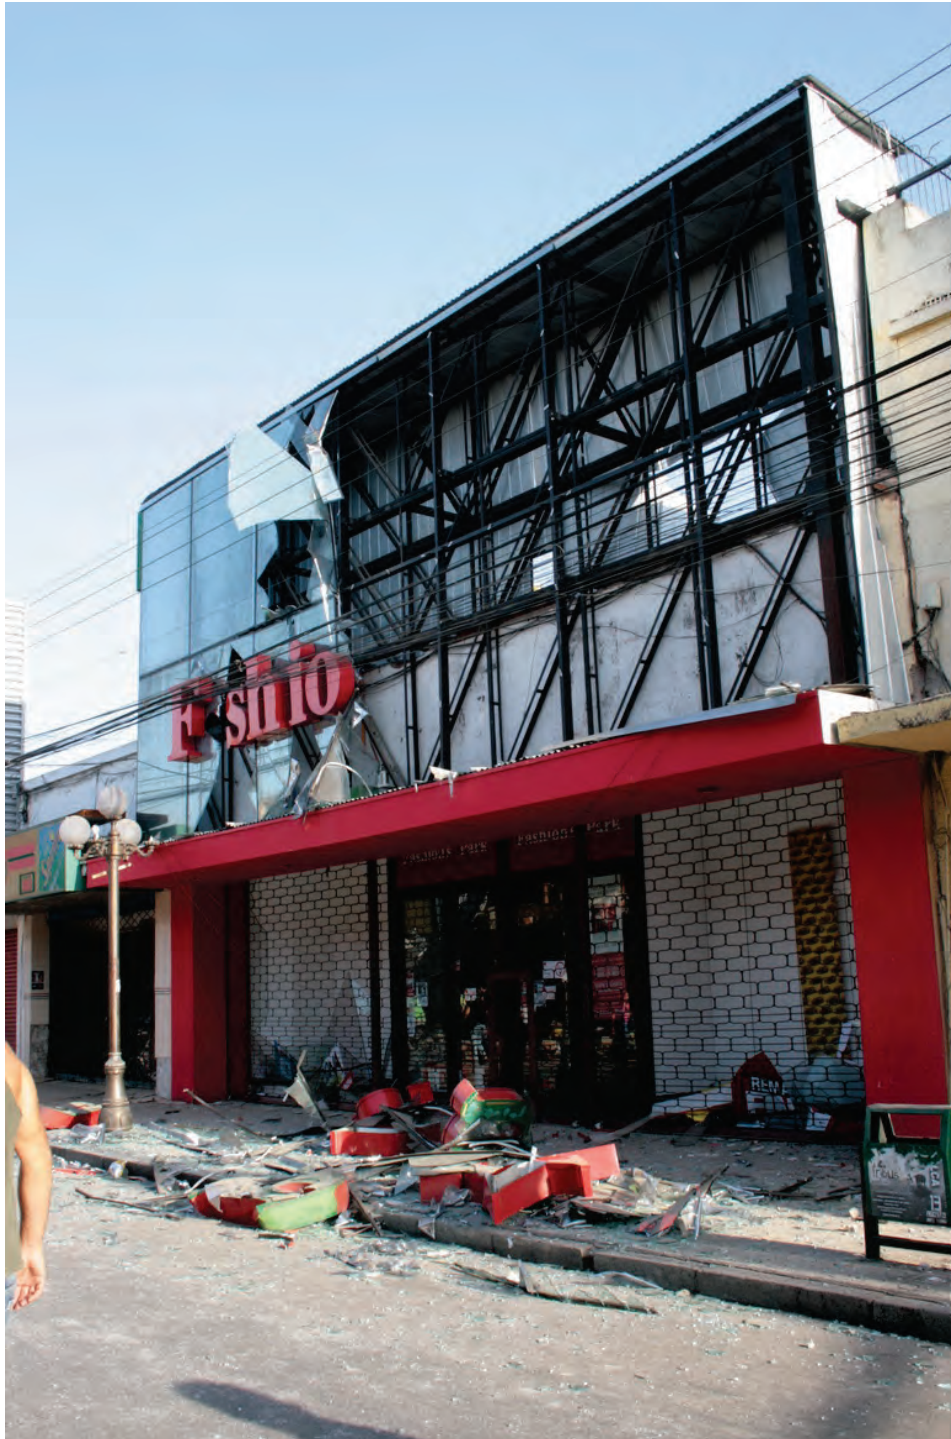
Figure 6.3.1.4-4 Glazing damage, due in part to pounding with the structure at right during the 2010 Chile Earthquake (Photo courtesy of Antonio Iruretagoyena, Rubén Boroscheck & Associates).

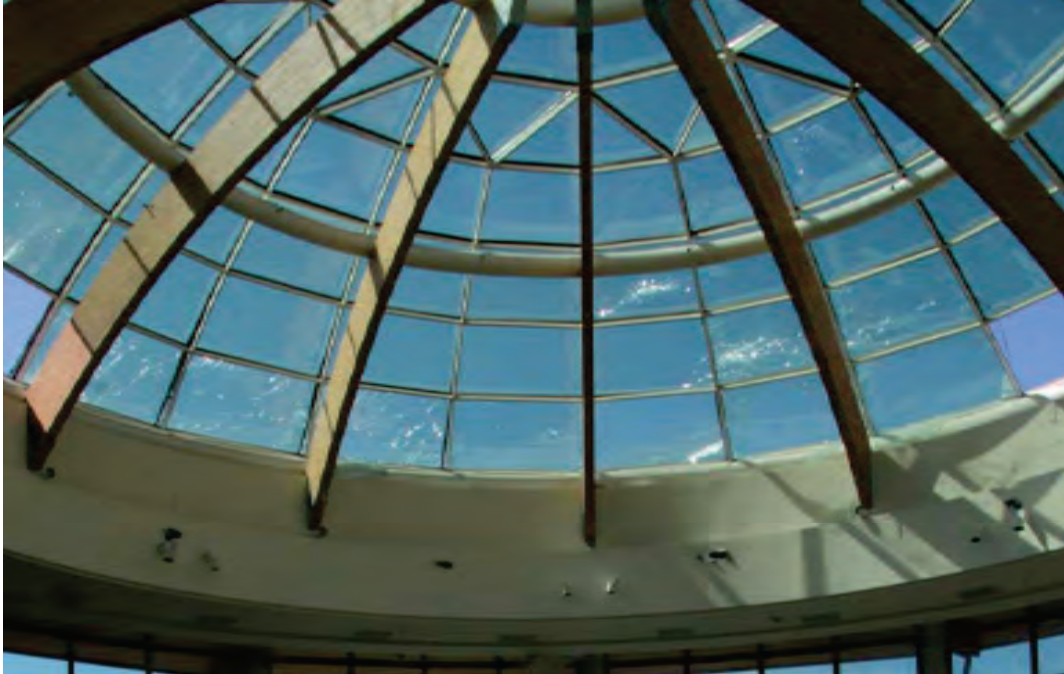
Figure 6.3.1.4-5 Overhead glazing damage from the 2010 Chile Earthquake (Photo courtesy of Eduardo Miranda, Stanford University).

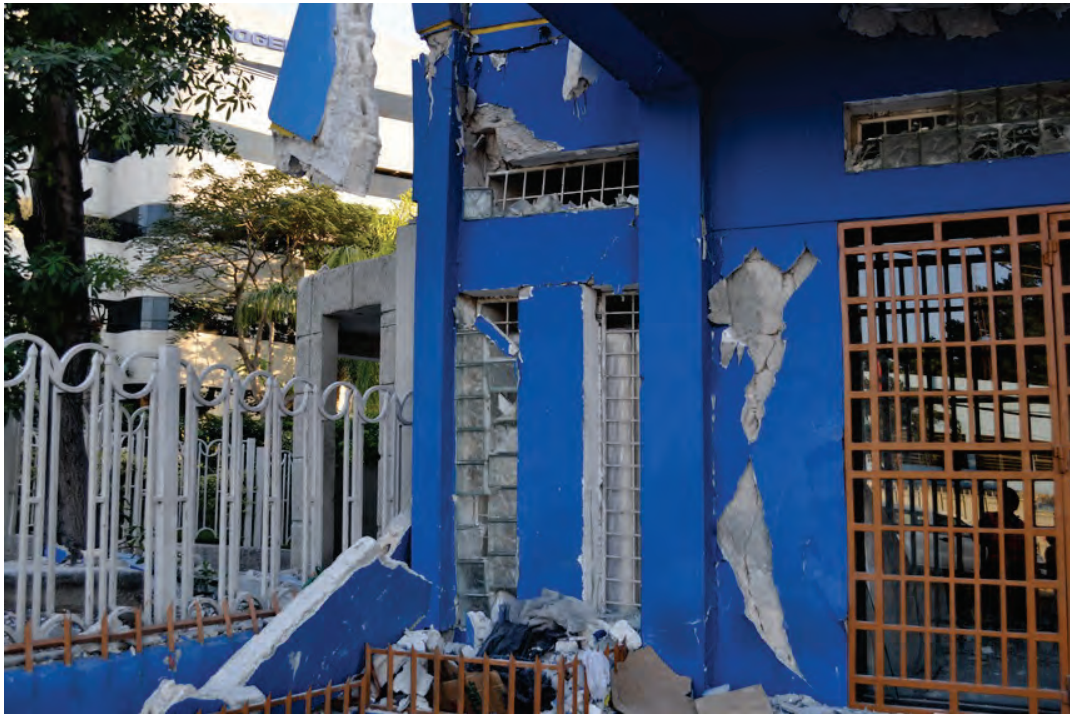
Figure 6.3.1.5-1 Damage to glass block in building with reinforced concrete frame and concrete masonry infill in the magnitude-7 2010 Haiti Earthquake (Photo courtesy of Eduardo Fierro, BFP Engineers). Note some blocks failed at rigid mortar joints and stayed in the frame, others fell out of the frame, and others broke in place. This building also suffered structural damage.

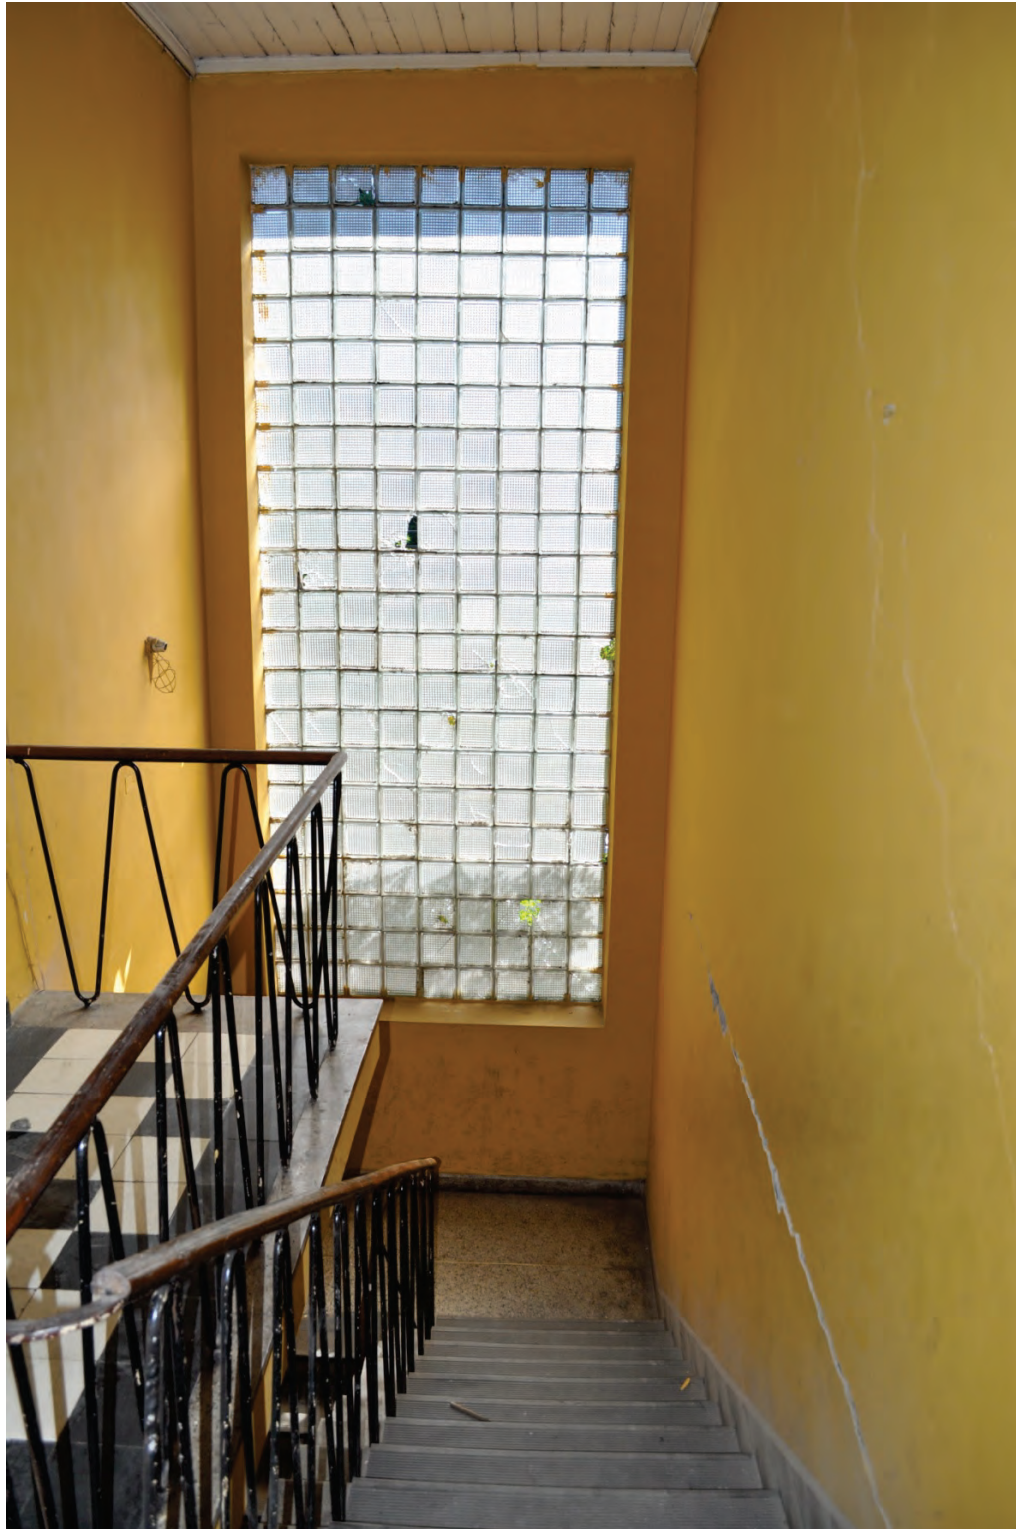
Figure 6.3.1.5-2 Damage to glass block with rigid mortar on all sides and in all joints in the 2010 Chile Earthquake (Photo courtesy of Eduardo Fierro, BFP Engineers). About 25% of the glass block units are cracked or broken but entire panel will need to be removed and replaced.

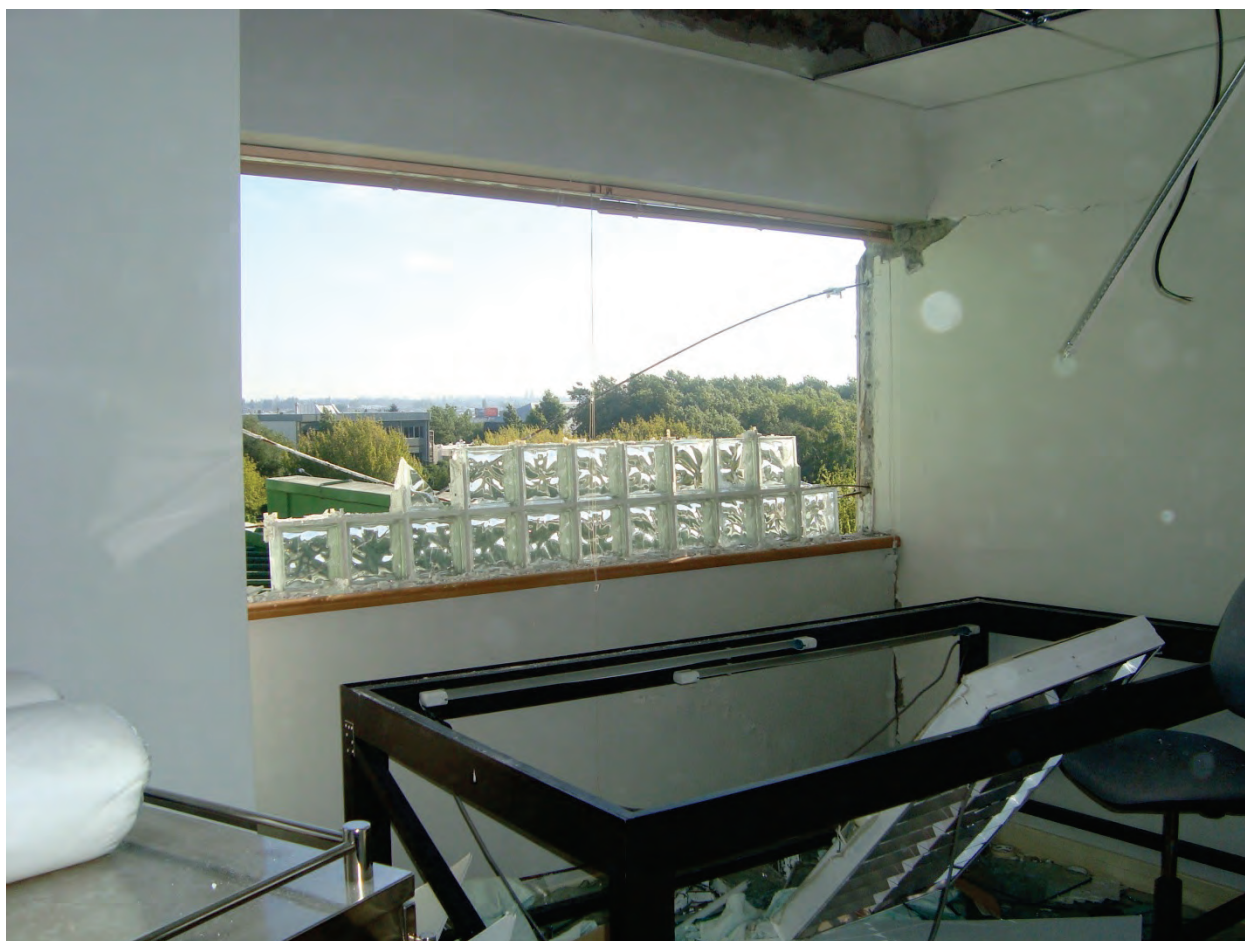
Figure 6.3.1.5-3 Damaged glass block panel from the Los Angeles Hospital in the 2010 Chile Earthquake; relatively new hospital building that had to be evacuated for repairs (Photo courtesy of Bill Holmes, Rutherford & Chekene). Blocks were installed with steel reinforcing bars in the top and bottom horizontal joints.

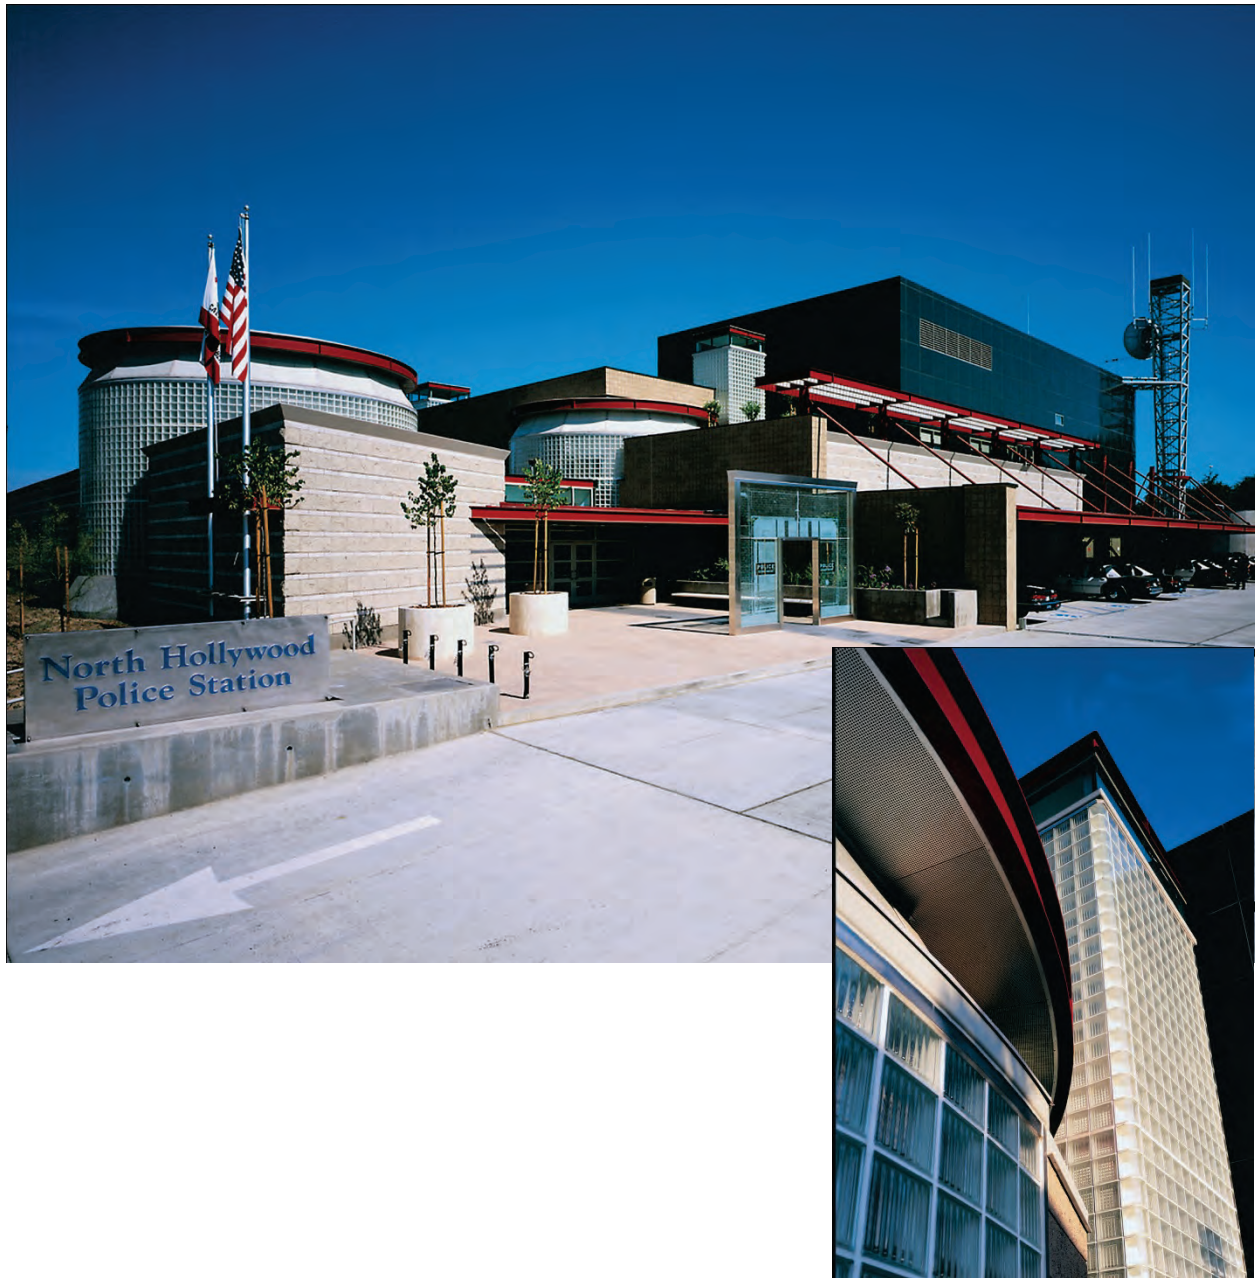
Figure 6.3.1.5-4 Use of glass block panels for select exterior and interior walls at the North Hollywood Police Station in California, utilizing standard details provided by Pittsburgh Corning Glass (Photo courtesy of Pittsburgh Corning Corporation).

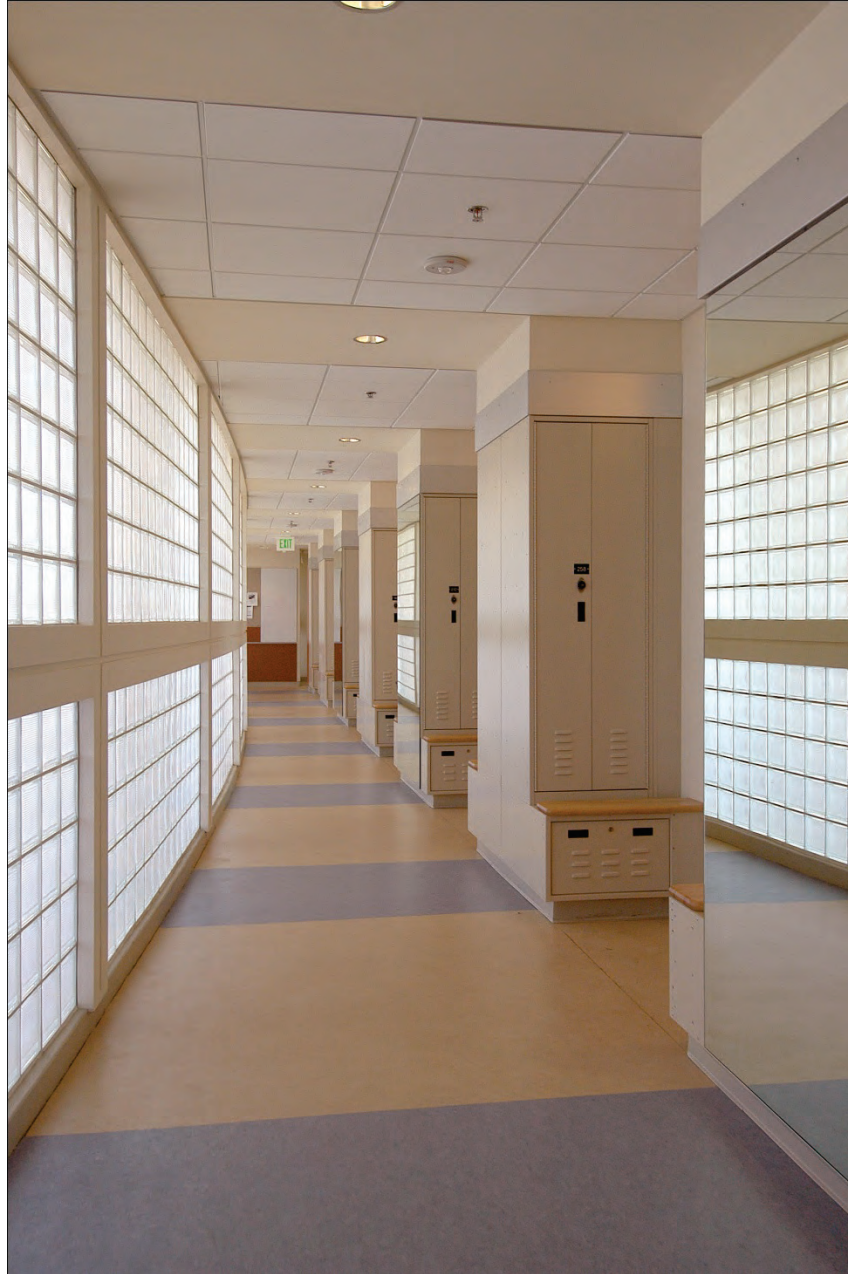
Figure 6.3.1.5-5 Glass block panels divided into numerous subpanels at the Chula Vista Police Headquarters, California (Photo courtesy of Pittsburgh Corning Corporation). In addition, the nonbearing glass block panel partition wall is isolated from seismic movement of the building structure.

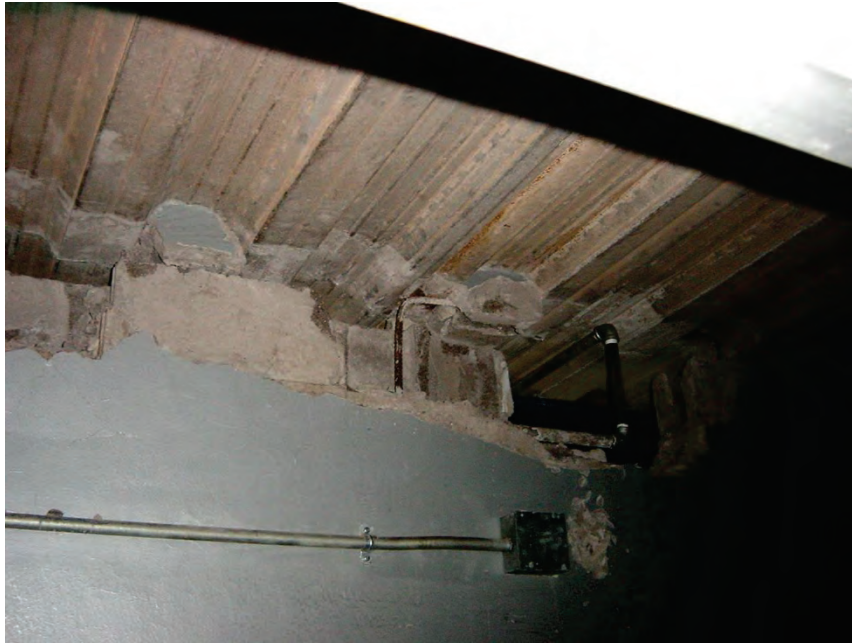
Figure 6.3.2.1-1 Damage along the top of a reinforced concrete masonry unit partition built flush with soffit of metal deck at an industrial facility in the 2001 magnitude-8.4 Peru Earthquake (Photo courtesy of Eduardo Fierro, BFP Engineers).

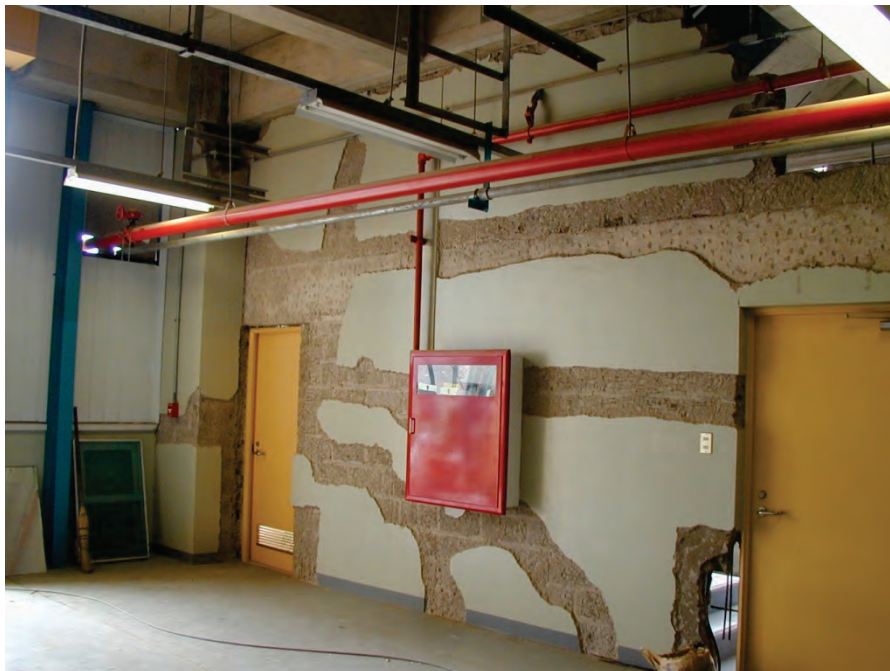
Figure 6.3.2.1-2 Damage to reinforced concrete masonry partition used to support fire protection cabinet and piping in the 2001 Peru Earthquake; loose stucco and masonry were removed prior to photo (Photo courtesy of Eduardo Fierro, BFP Engineers).

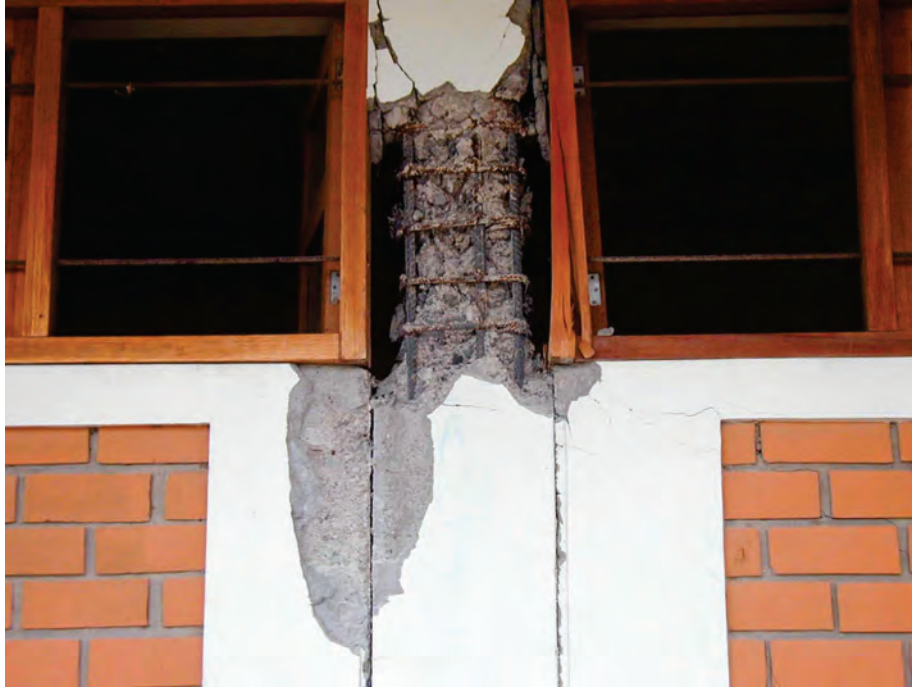
Figure 6.3.2.1-3 Damage to structural column (“captive column”) due to restraint caused by partial height masonry wall in the 2001 Peru Earthquake (Photo courtesy of Eduardo Fierro, BFP Engineers).

Where partitions are built tight against structural columns, there is a potential for the masonry wall to unintentionally create a “captive column” thereby changing the intended earthquake response of the building. A structural engineer is needed to evaluate the implications of such conditions.

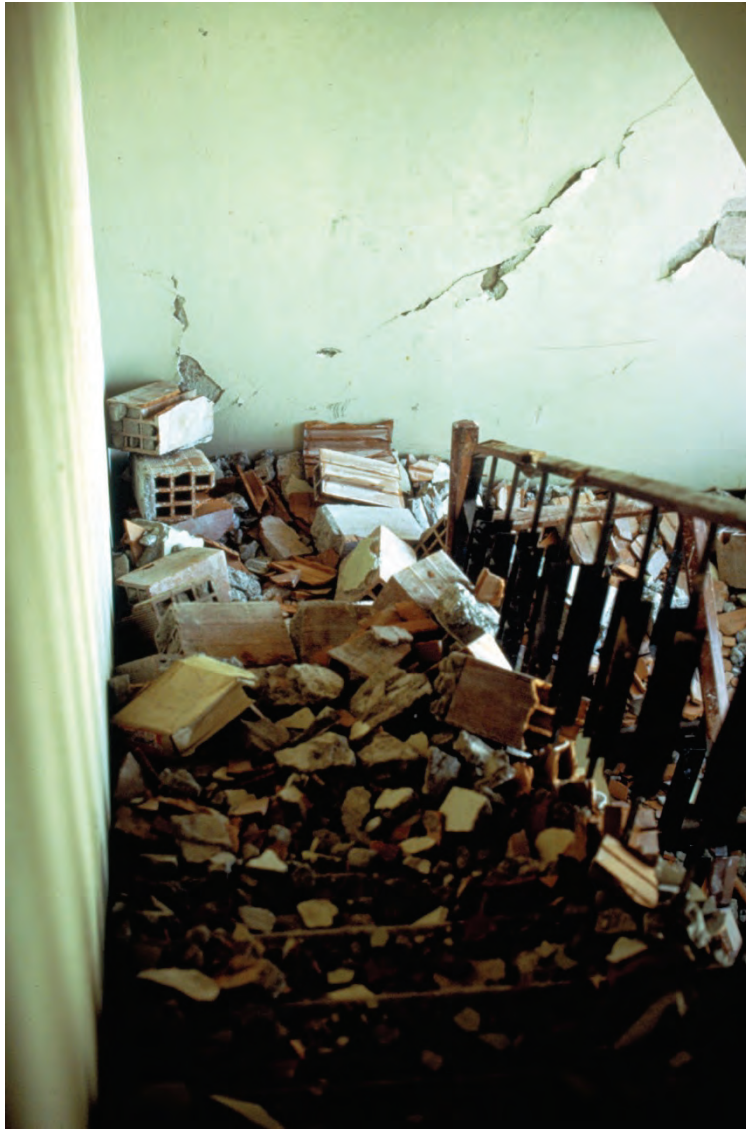
Figure 6.3.2.1-4 View of stairway in the Banco Central Building, Managua, Nicaragua after the 1972 magnitude 6.2 Managua Earthquake. Most of the stairs were covered with debris that resulted from the failure of the hollow tile partitions surrounding the stairs (Photo courtesy of PEER Godden Collection, No. J94).

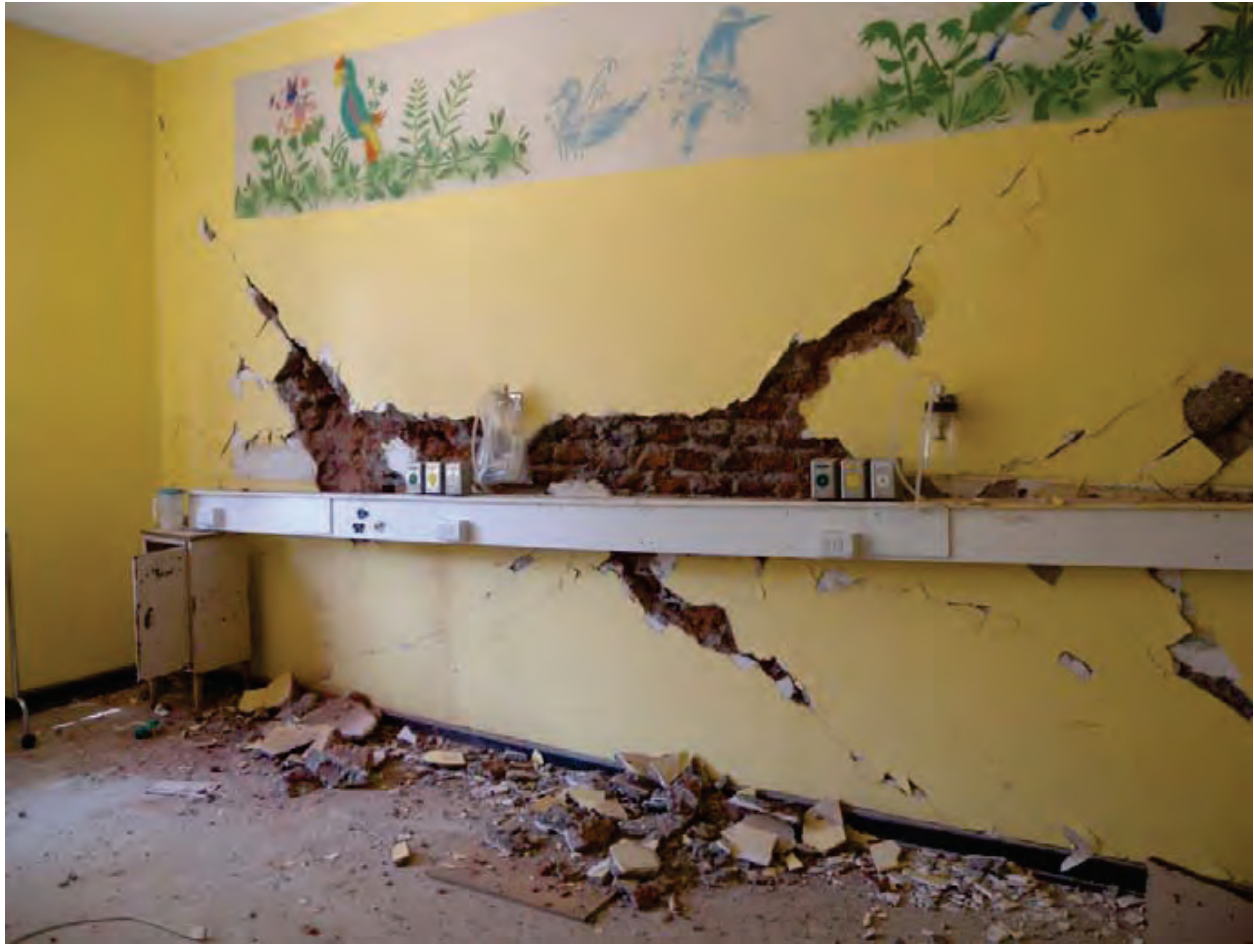
Figure 6.3.2.1-5 Damage to unreinforced brick partitions in patient rooms, and other mostly nonstructural damage, resulted in the evacuation of the Felix Bulnes Hospital in Santiago in the 2010 magnitude-8.8 Chile Earthquake (Photo courtesy of Gilberto Mosqueda, University of Buffalo, SUNY).

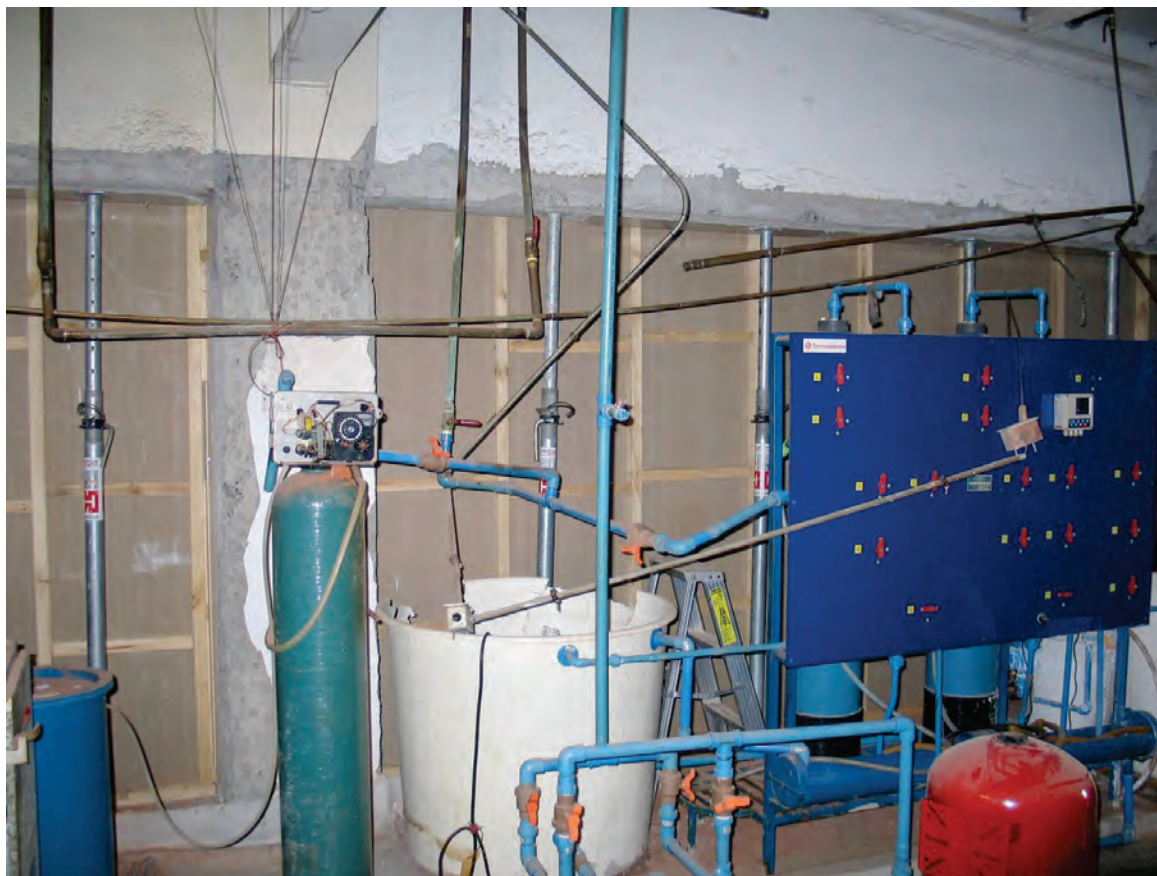
Figure 6.3.2.1-6 An infill masonry wall collapsed onto the distilled water equipment spilling two 150 gallon containers; water leaked past the perimeter edge of the floor slab into the operating room suite below resulting in the closure of 3 of 6 the operating rooms. Replacement gypsum board partition seen in photo. Hospital built in 2005 in Los Angeles, Chile. Damage from the 2010 Chile Earthquake (Photo courtesy of Bill Holmes, Rutherford & Chekene).

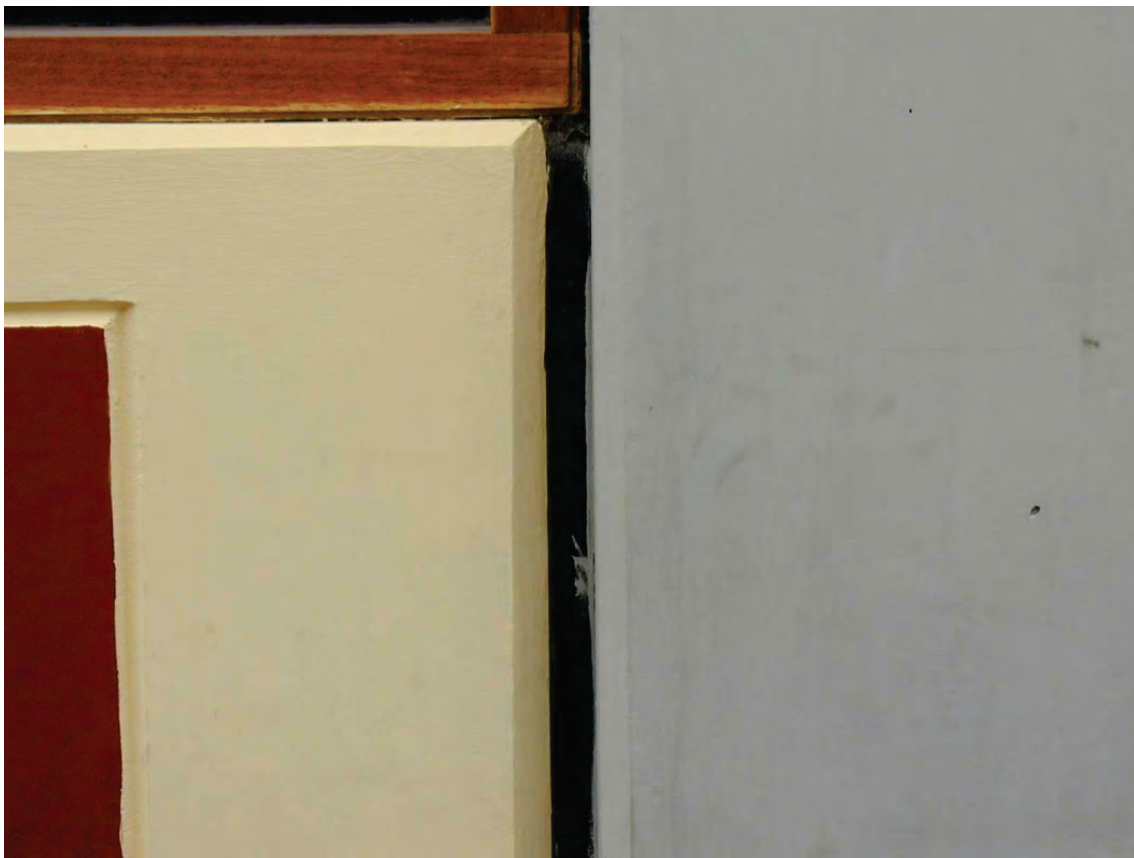
Figure 6.3.2.1-7 Detail of isolation joint to prevent creation of “captive column” condition
(Photo courtesy of Eduardo Fierro, BFP Engineers).

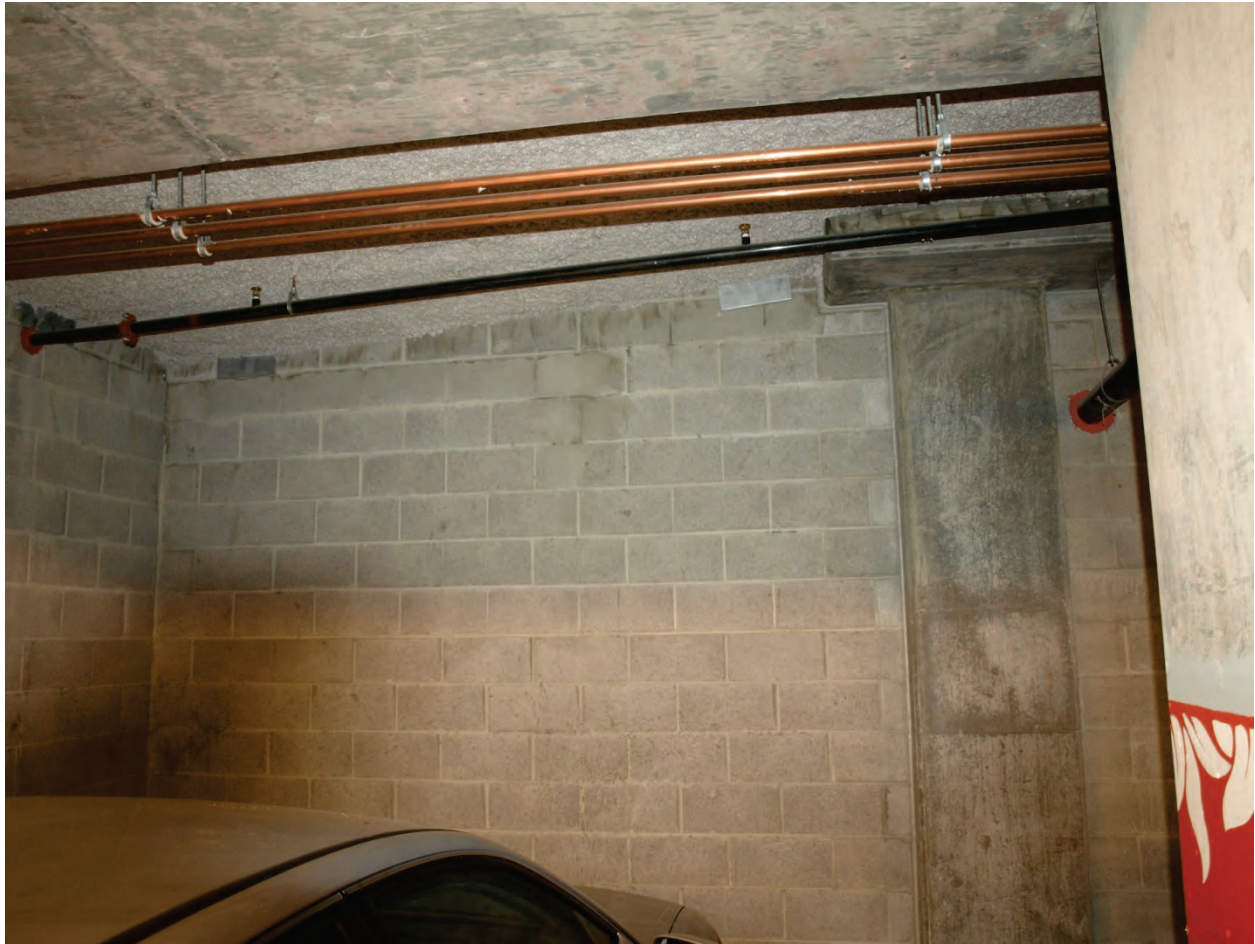
Figure 6.3.2.1-8 Full-height concrete masonry unit walls detailed with steel clip angles (3 angles visible in photo). Configuration shown includes perpendicular walls, sloping ramp above, and column with column capital. Although wall detailed with sealant joints along edges of column and column capital, it is not clear that the concrete frame can move independently of these CMU walls (Photo courtesy of Cynthia Perry, BFP Engineers).

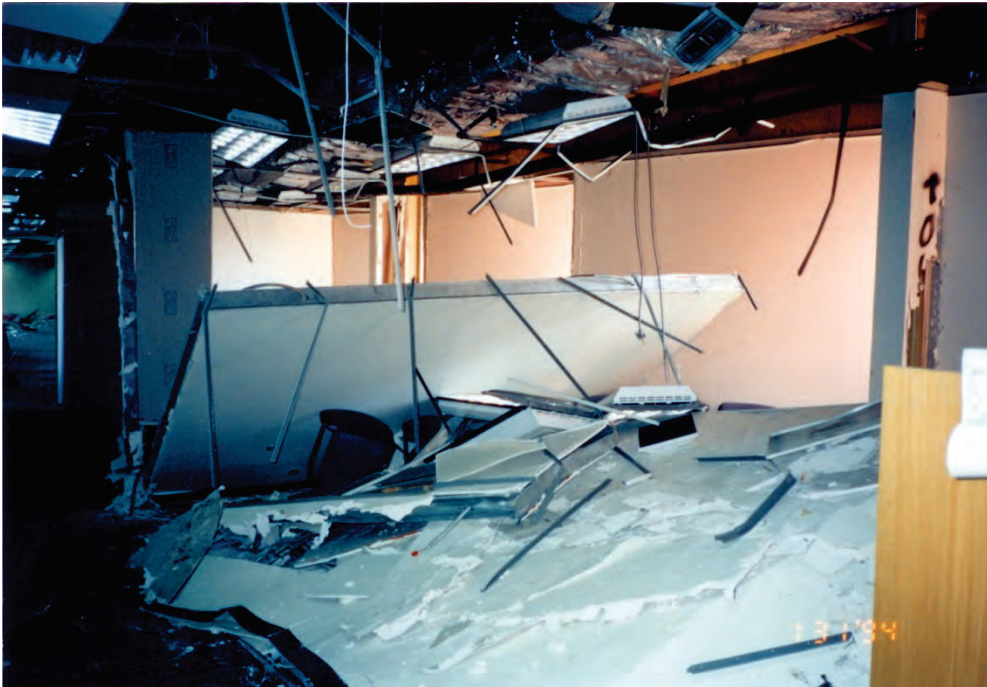
Figure 6.3.2.2-1 Out-of-plane failure of inadequately braced partial height metal stud partitions in the 1994 Northridge Earthquake (Photo courtesy of Wiss, Janney, Elstner Associates).

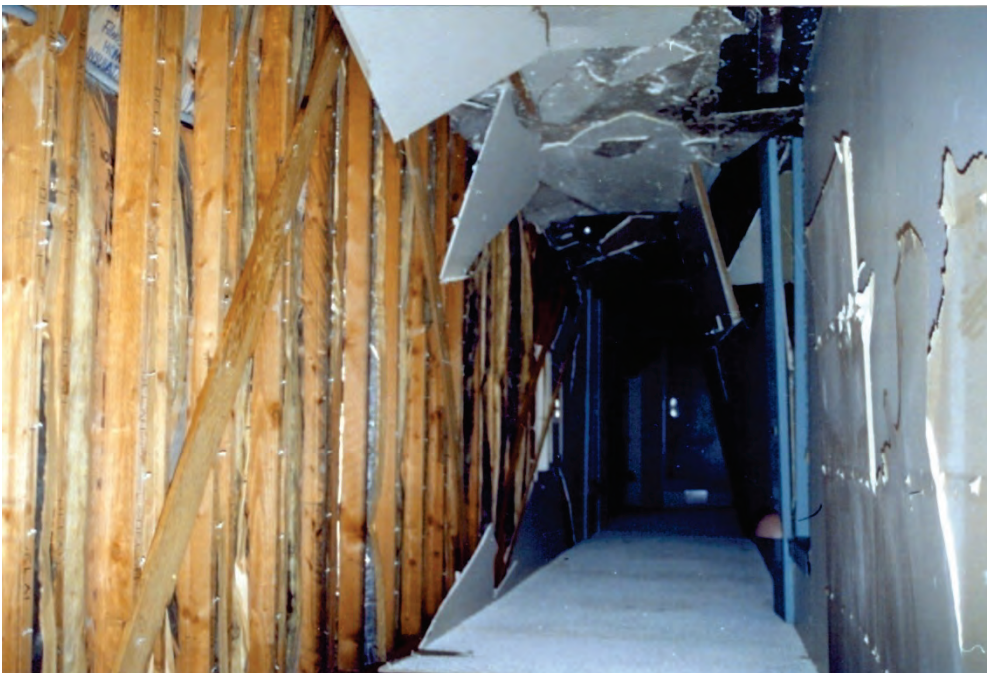
Figure 6.3.2.2-2 In-plane damage to wood stud wall spanning floor-to-floor caused by differential movement between the two floors in the 1994 Northridge Earthquake (Photo courtesy of Wiss, Janney, Elstner Associates).

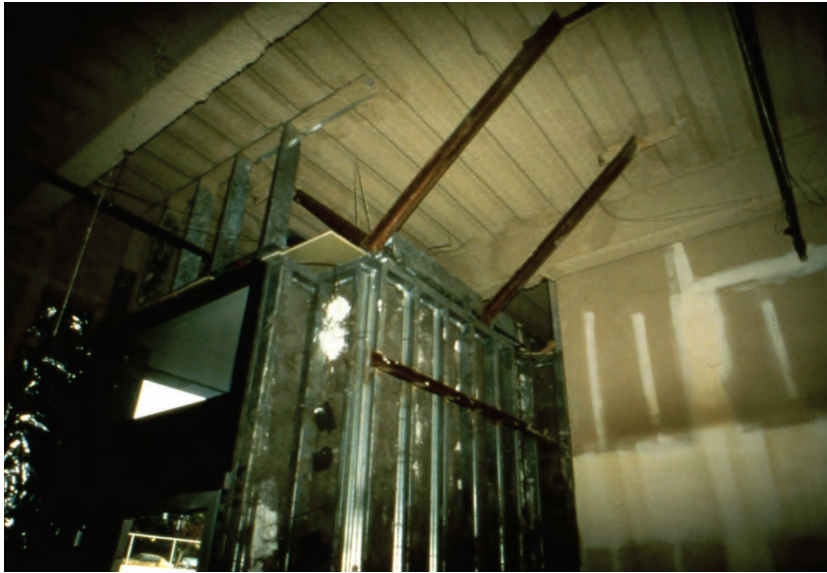
Figure 6.3.2.2-4 Bracing of partial height stud partition (Photo courtesy of Degenkolb Engineers).

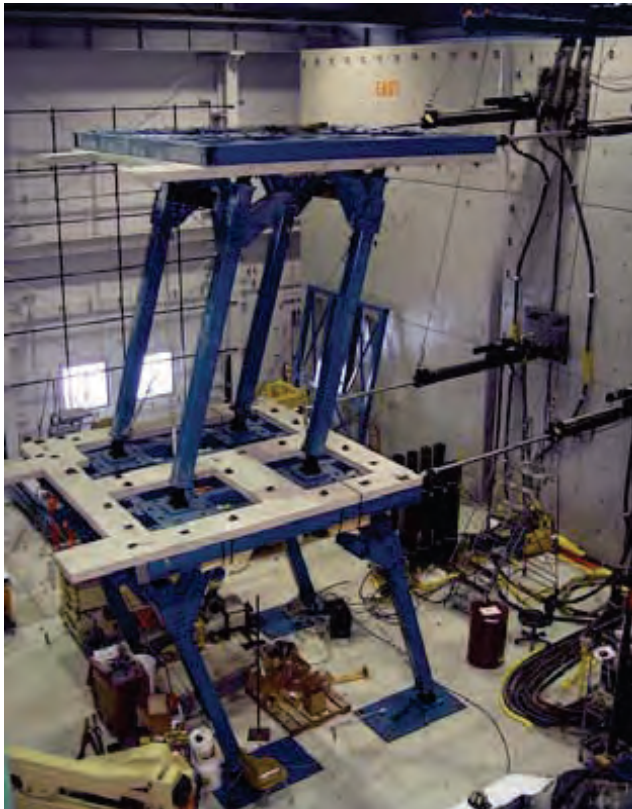
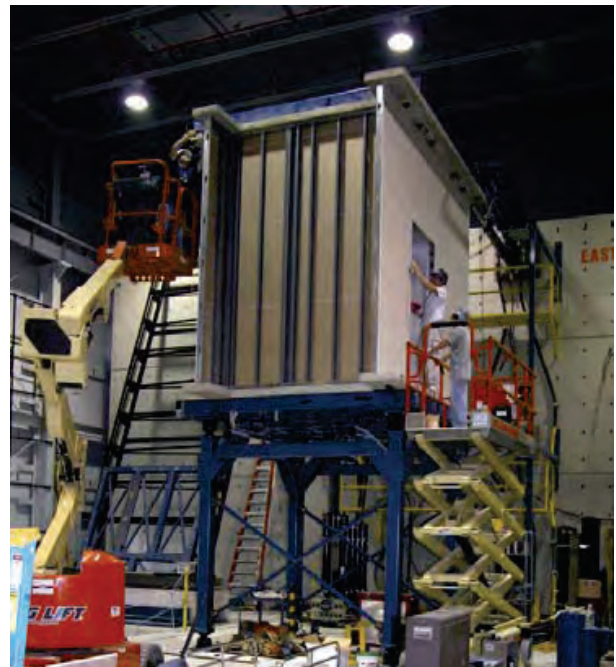
Figure 6.3.2.2-5 Two-story nonstructural component simulator at the University of Buffalo, SUNY shown at left. Preparation for dynamic testing of stud partitions for the NEES Nonstructural Project shown at right. Tests such as these improve understanding of the seismic behavior of nonstructural components (Photos courtesy of University of Buffalo, SUNY).

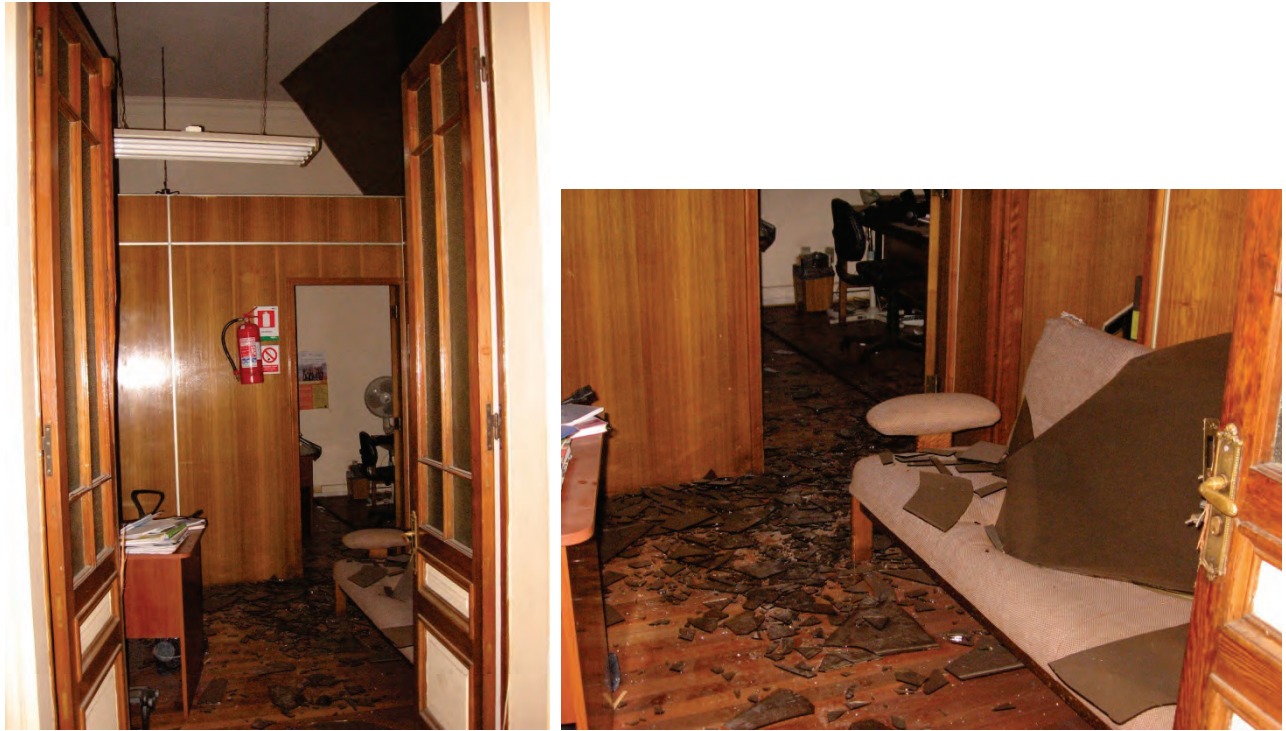
Figure 6.3.2.3-1 Glass shards fallen from the top of partial height office partitions in the reception area during the magnitude-8.8 2010 Chile Earthquake (Photo courtesy of Rodrigo Retamales, Rubén Boroschek & Associates).
