Reducing the Risks of Nonstructural Earthquake Damage – A Practical Guide

FEMA E-74 / December 2012

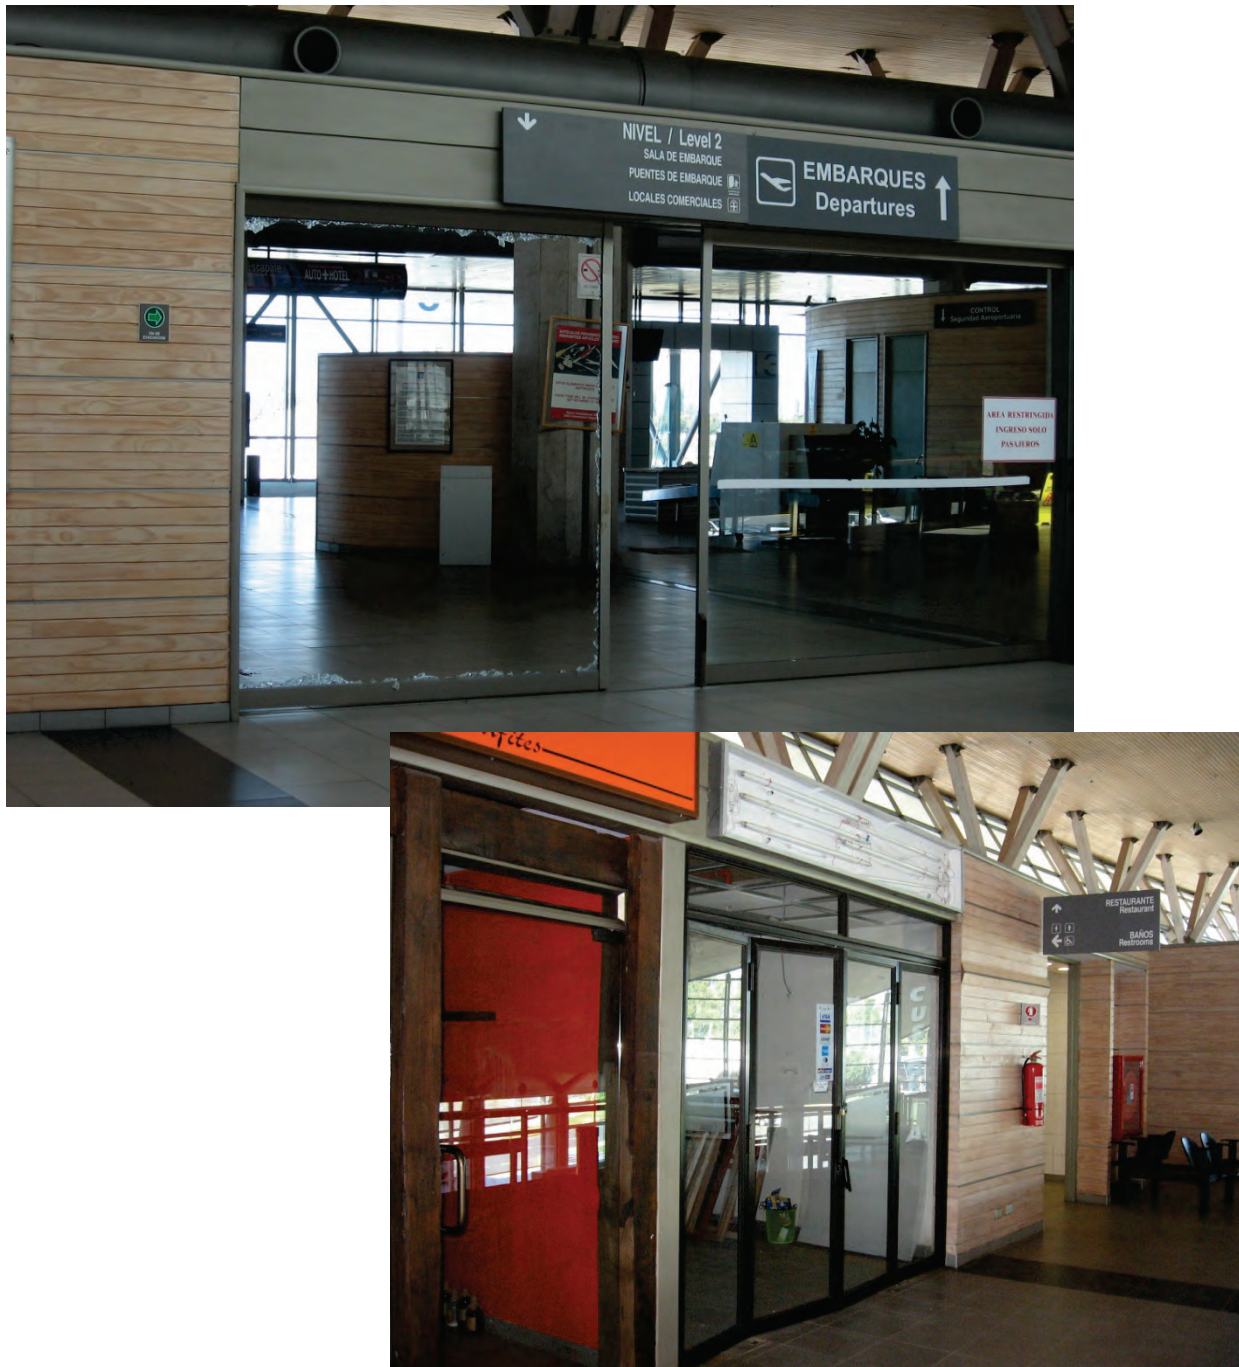
Figure 6.3.2.3-2 Damage to glazed doors at the Concepción airport in the 2010 Chile Earthquake. In the top photo the glazing in the sliding glass door shattered; in the lower photo the glass is intact but the door frames are misaligned (Photos courtesy of Rodrigo Retamales, Rubén Boroschek & Associates).

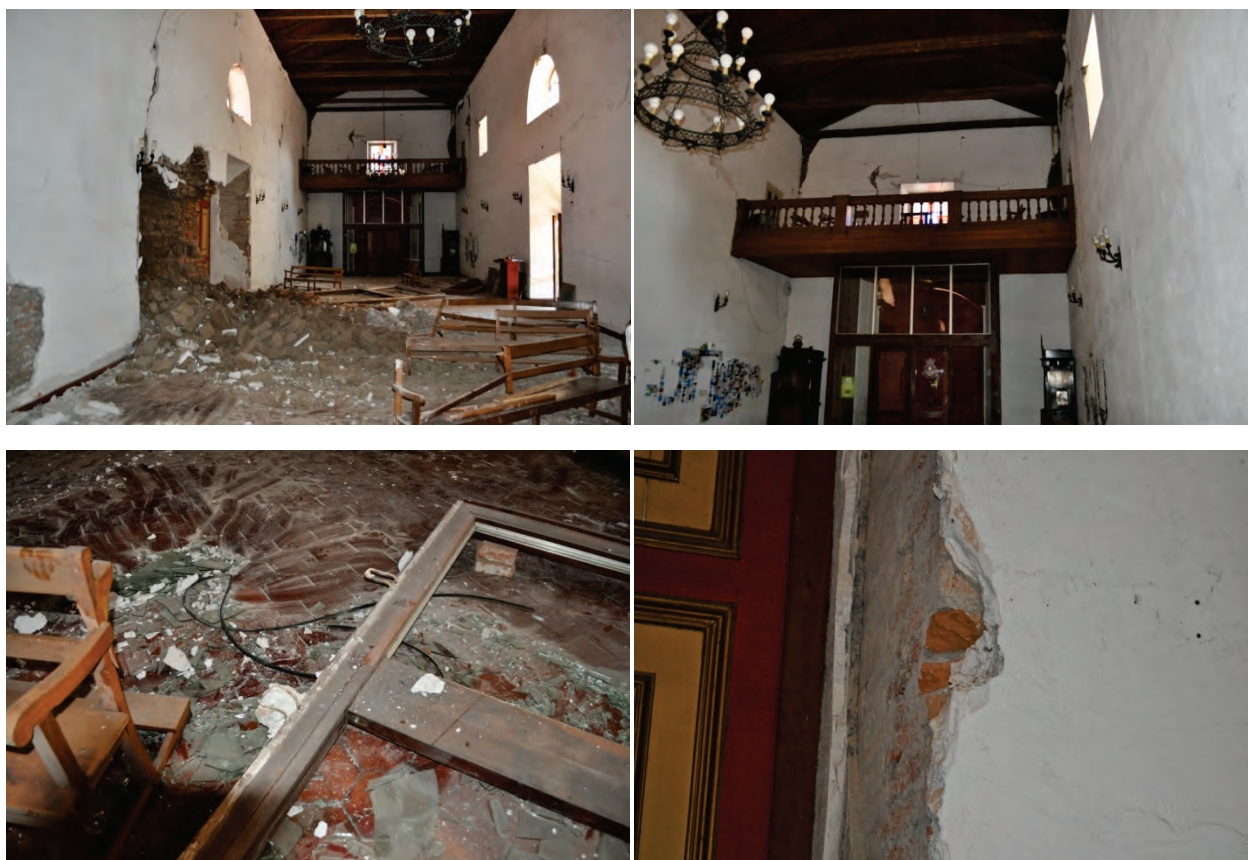
Figure 6.3.2.3-3 Failed wood framed glazing assembly in the 2010 Chile earthquake (Photo courtesy of Eduardo Fierro, BFP Engineers). The wood framing was held in place by metal or rebar brackets embedded in the masonry wall. The adobe wall on the left of the door collapsed and the brackets on the right side pulled out of the brick masonry wall (lower right). The glazing assembly at the rear entrance of the chapel was anchored overhead to the wood balcony framing and was undamaged.

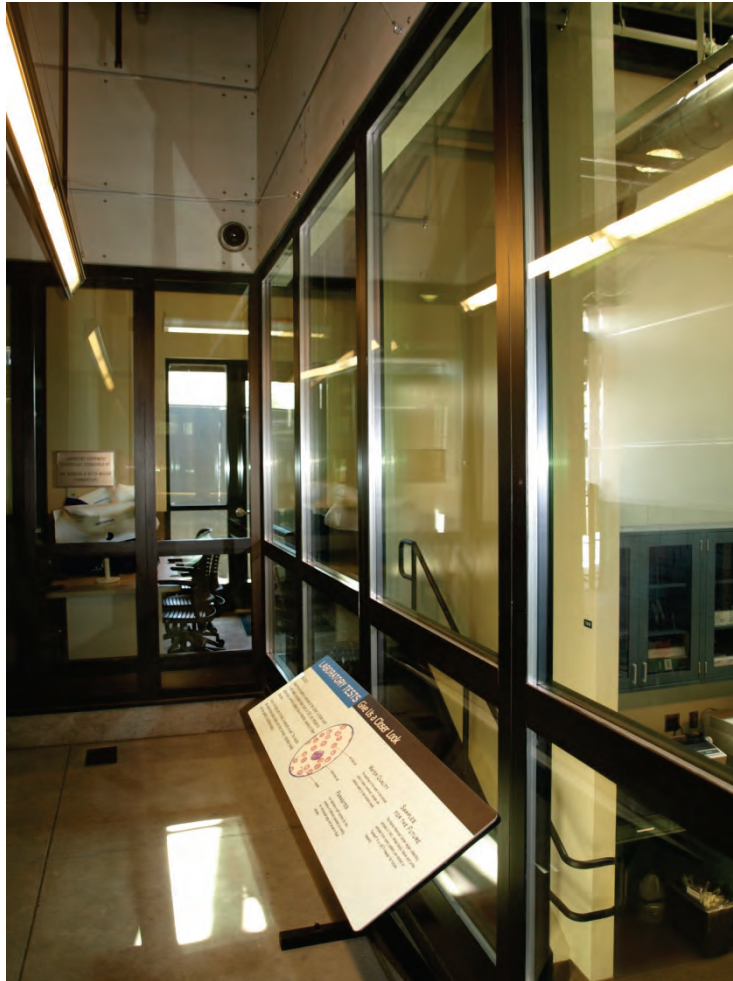
Figure 6.3.2.3-4 Glazed partition supported at base with slip track at top; partition above glazing suspended and braced from above. Glazing subdivided into relatively small panels with ample clearance at mullions (Photo courtesy of Cynthia Perry, BFP Engineers).

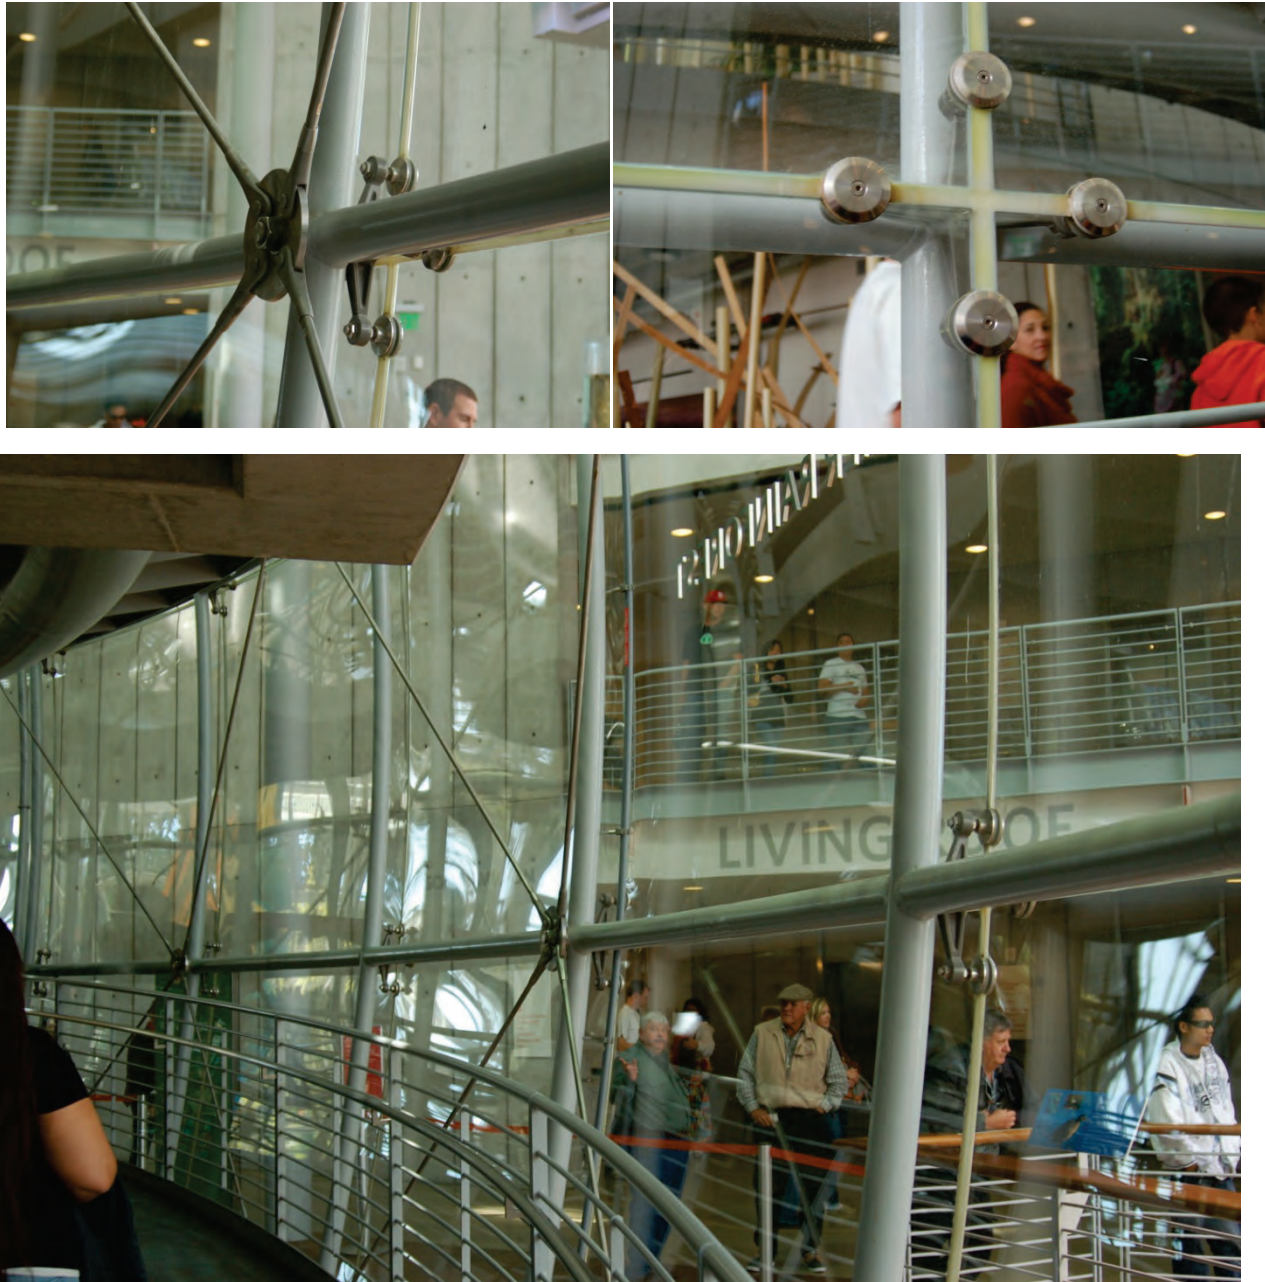
Figure 6.3.2.3-5 Specialized glazing details for glass dome using specialty hardware, such as large sealant joints required to accommodate thermal movement and seismic deformations at the California Academy of Sciences, San Francisco, California (Photos courtesy of Cynthia Perry, BFP Engineers).

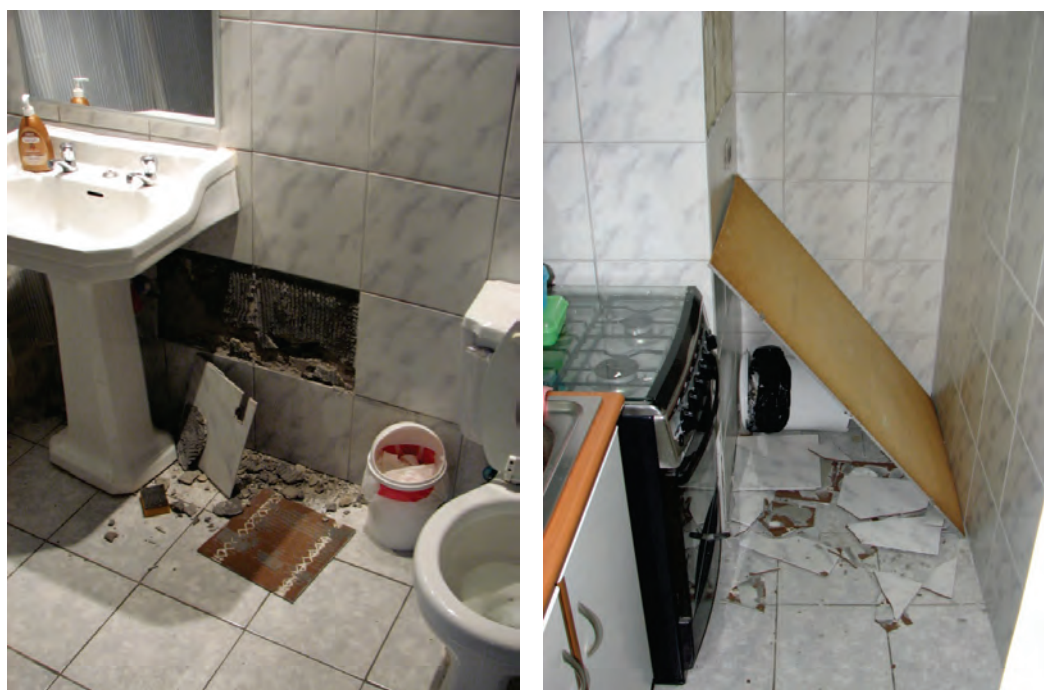
Figure 6.3.3.1-1 Damage to adhered tile veneer in residential bathroom and kitchen in the 2010 magnitude-8.8 Chile Earthquake (Photo courtesy of Antonio Iruretagoyena, Ruben Boroschek & Associates). Tile is adhered to CMU infill partitions.

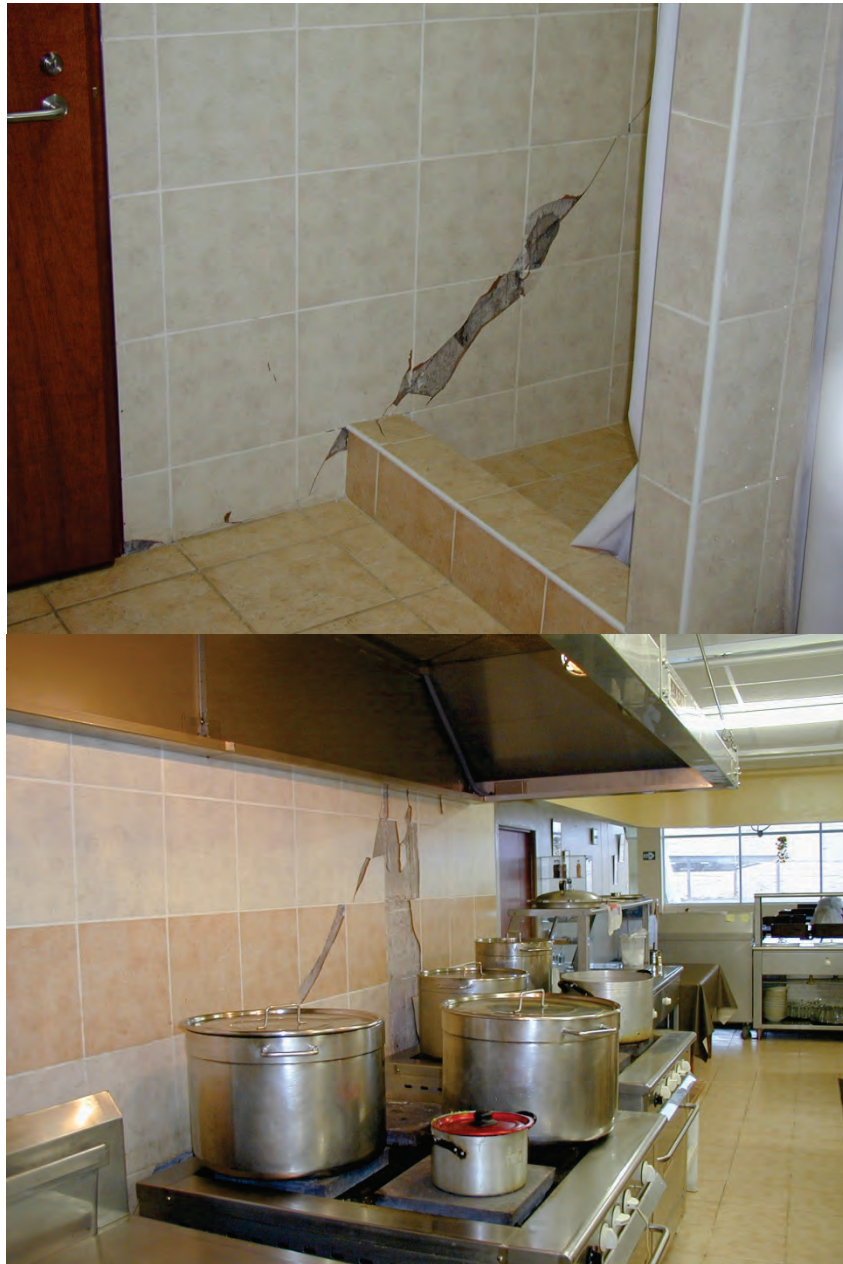
Figure 6.3.3.1-2 Damage to adhered tile veneer in locker room and kitchen at industrial facility in the 2001 Peru Earthquake (Photo courtesy of Eduardo Fierro, BFP Engineers). Tile was adhered to CMU partitions which were built integral with the concrete frame. While only a limited number of tiles were broken, equipment had to be disconnected and many tiles removed to repair cracks in the wall and facilitate the repair of the veneer.

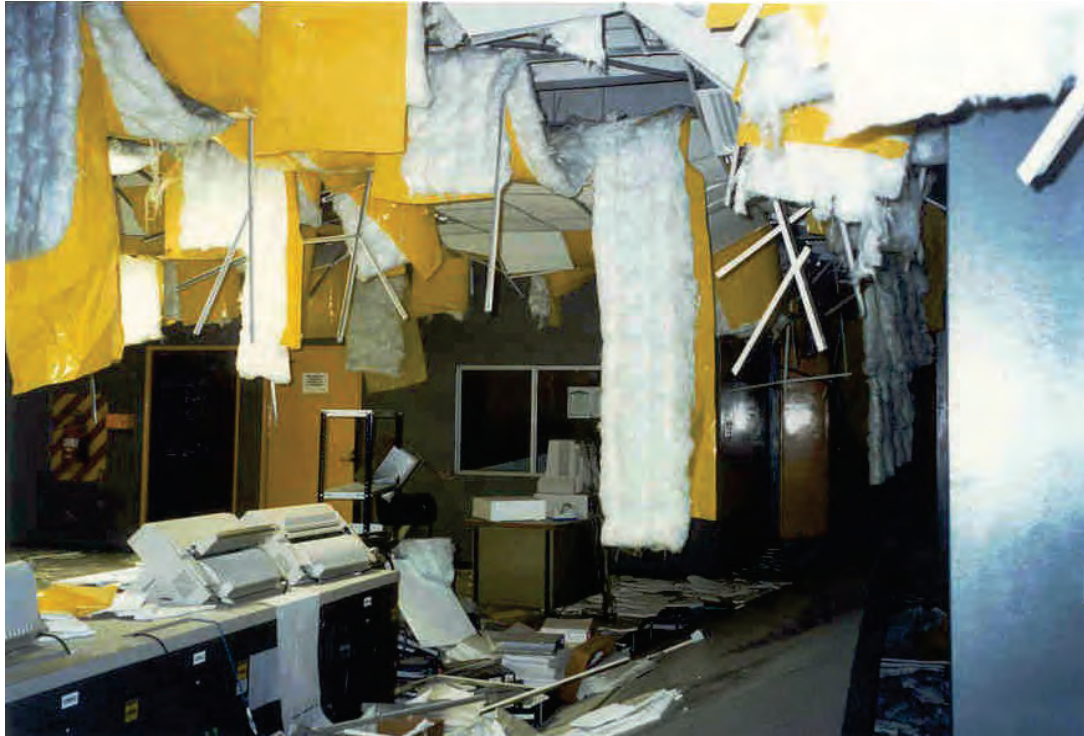
Figure 6.3.4.1-1 Failure of suspended ceiling system including lights, air diffusers, and insulation in control room of an industrial plant in the 2001 magnitude-8.4 Peru Earthquake (Photo courtesy of BFP Engineers).

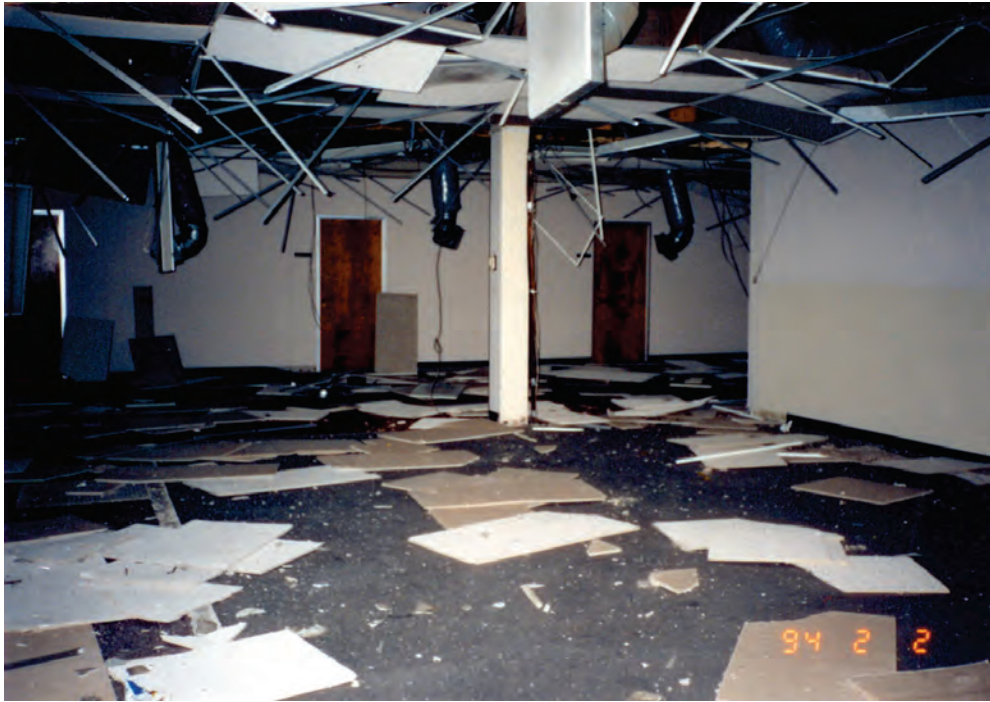
Figure 6.3.4.1-2 Failure of suspended ceiling system including lights and air diffusers in the 1994 Northridge Earthquake (Photo courtesy of Wiss, Janney, Elstner Associates).

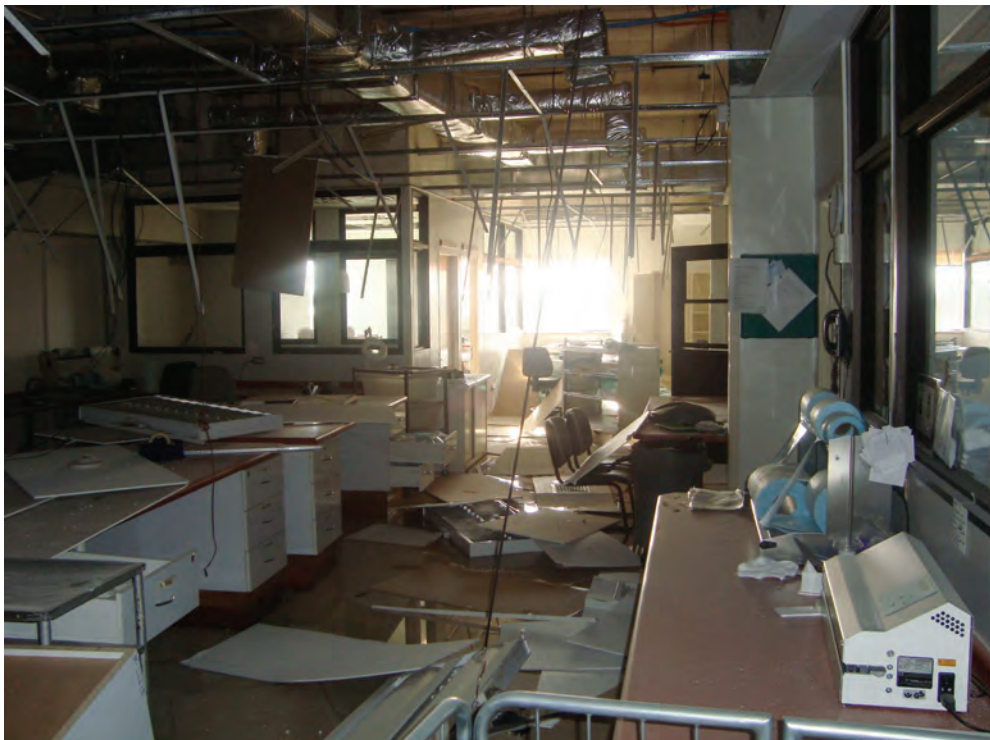
Figure 6.3.4.1-3 Generalized failure of ceiling grid, tiles, lights, and diffusers at the Los Angeles Hospital in the 2010 magnitude-8.8 Chile Earthquake (Photo courtesy of Bill Holmes, Rutherford & Chekene).

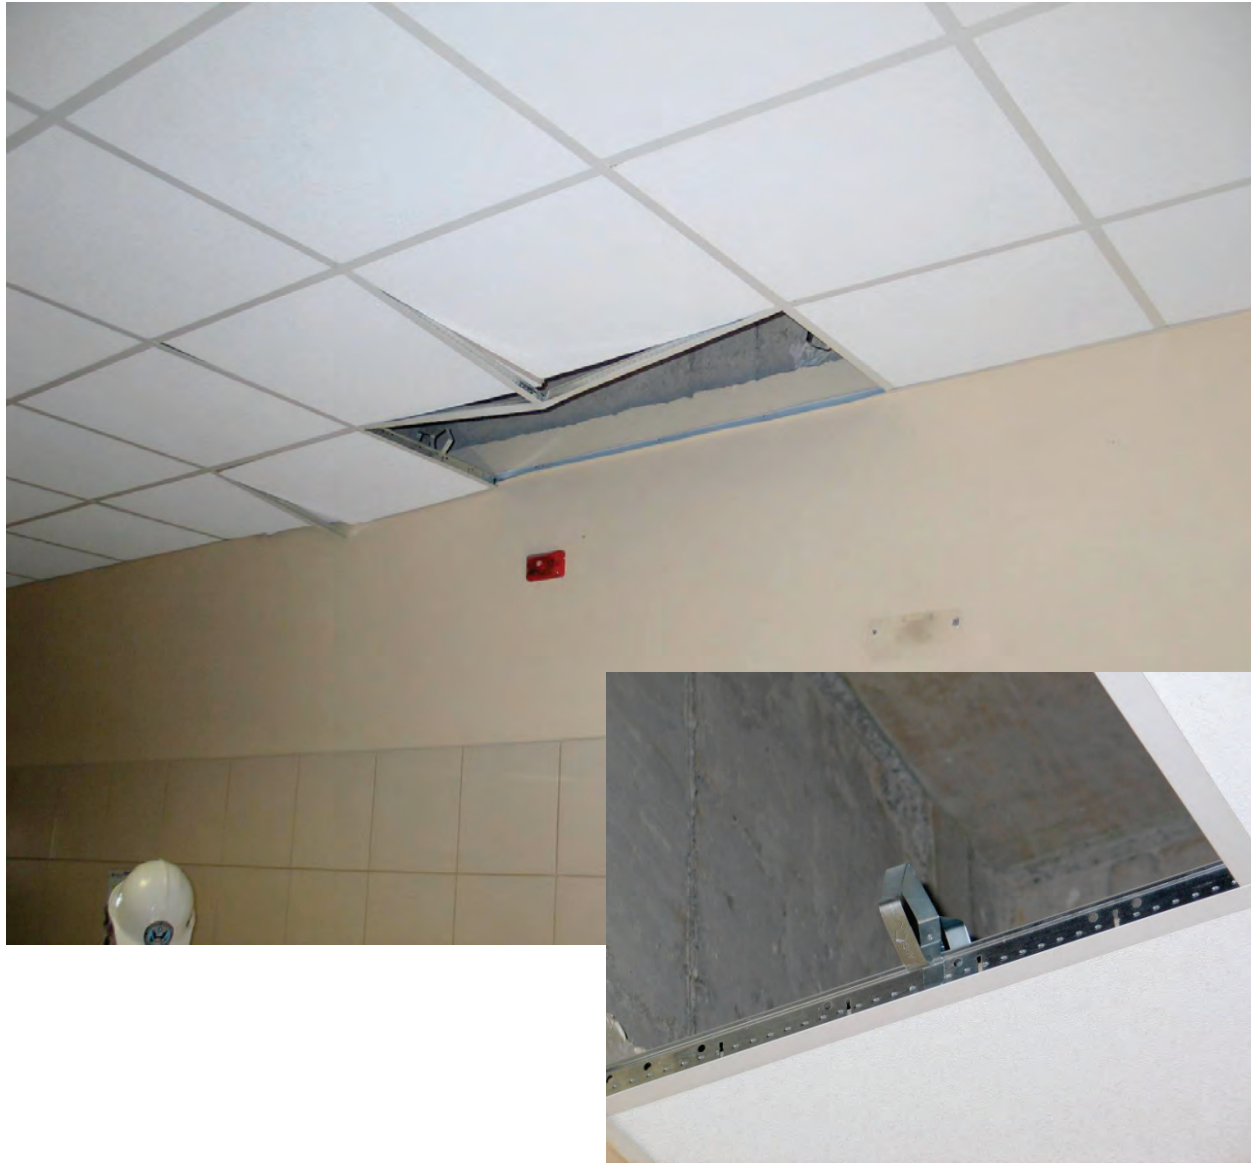
Figure 6.3.4.1-4 Fallen ceiling tiles at Talca Hospital in the 2010 Chile Earthquake, in spite of the use of clips as shown in detail at right. Most ceilings observed in Chile did not have seismic detailing (Photos courtesy of Bill Holmes, Rutherford & Chekene).

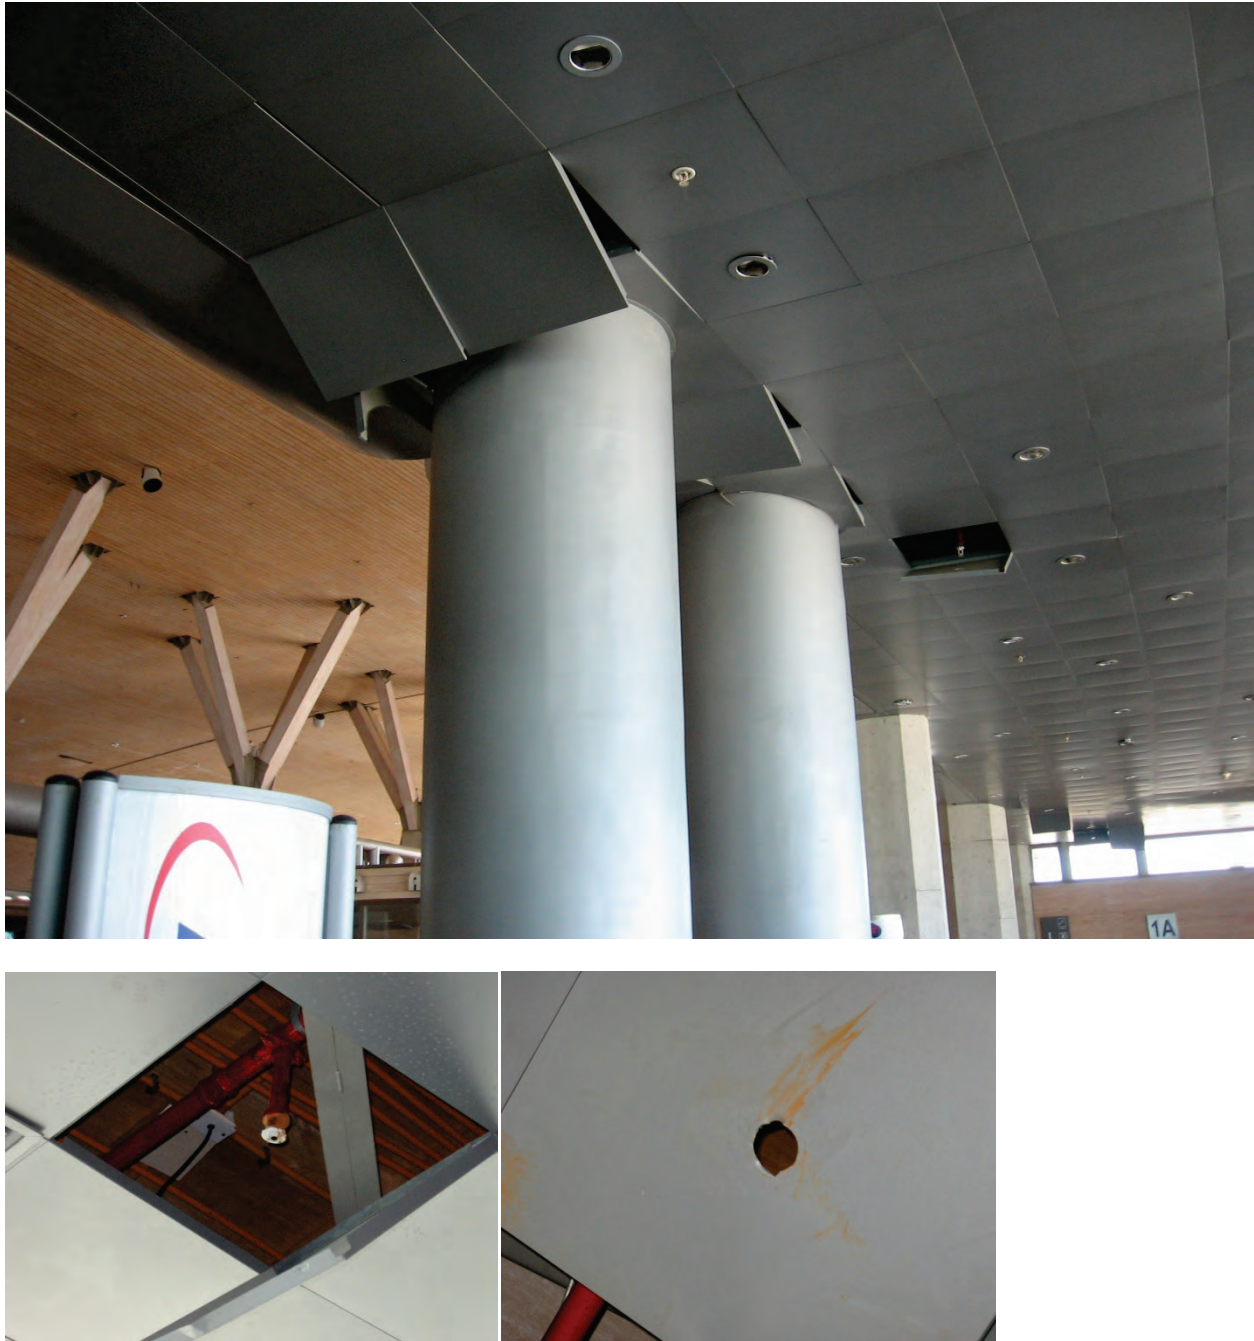
Figure 6.3.4.1-5 Damage to suspended metal panel ceiling system and fire sprinklers at Concepción airport, primarily at far end and around column obstructions in the 2010 Chile Earthquake (Photos courtesy of Rodrigo Retamales, Rubén Boroschek & Associates). The metal panel was strong enough to fail the sprinkler head shown at lower left.

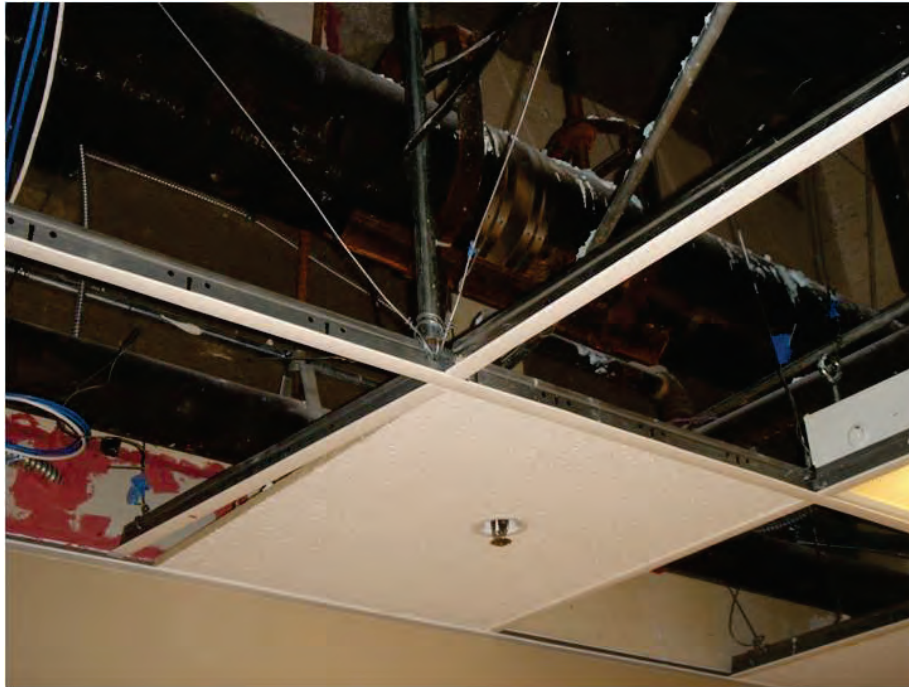
Figure 6.3.4.1-6 Compression struts and diagonal splayed wires are used to limit the movement of suspended acoustic tile ceilings. Per ASTM E580, this type of bracing assembly is required for ceiling areas larger than 1000 sq. ft. in Seismic Design Category D,E, and F (Photo courtesy of Maryann Phipps, Estructure).

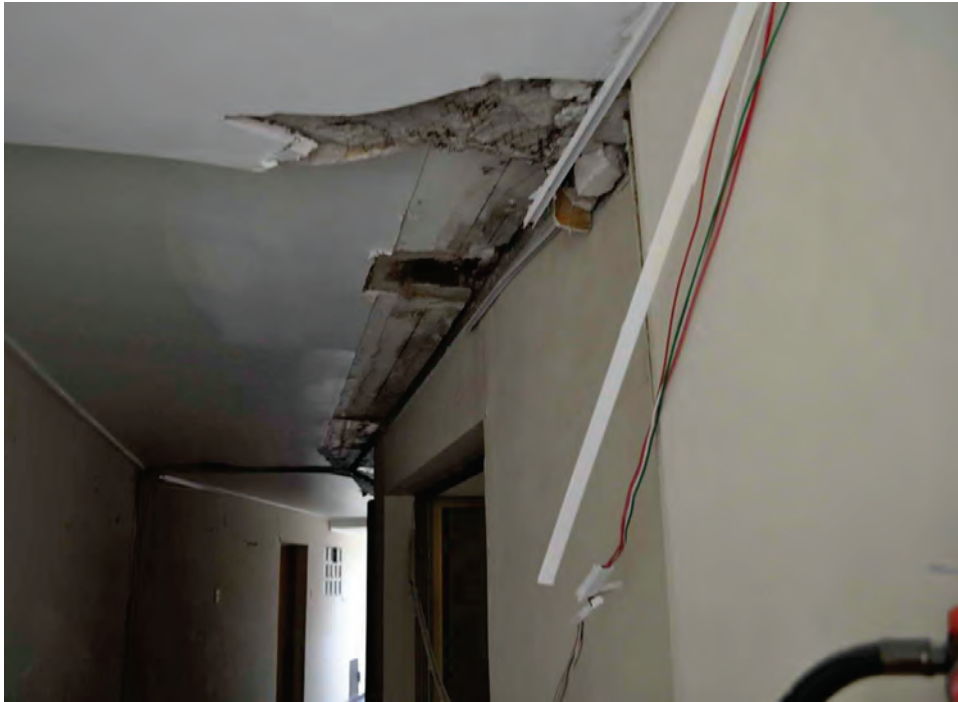
Figure 6.3.4.2-1 Damage to metal lath and plaster ceiling applied to the underside of the concrete slab in 10-story residential building in the 2010 magnitude-8.8 Chile Earthquake (Photo courtesy of Eduardo Fierro, BFP Engineers). The damage occurred due to pounding at the interface between two wings of the structure.

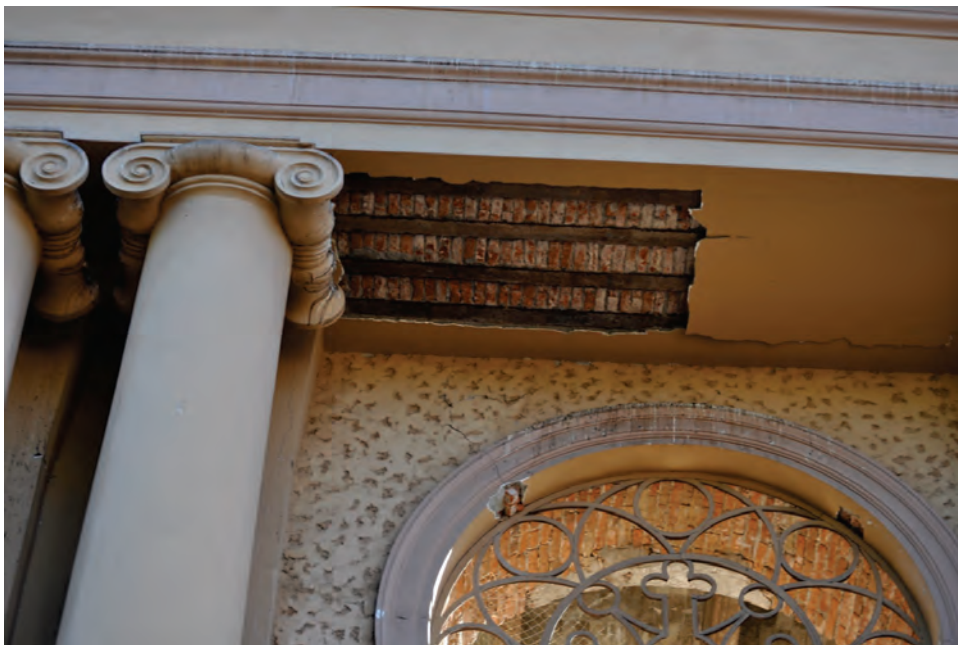
Figure 6.3.4.2-2 Damage to stucco soffit of historic church in the 2010 Chile Earthquake (Photo courtesy of Eduardo Fierro, BFP Engineers). Stucco applied directly to the underside of the slab above without furring; portion at left has fallen, portion at right delaminated.

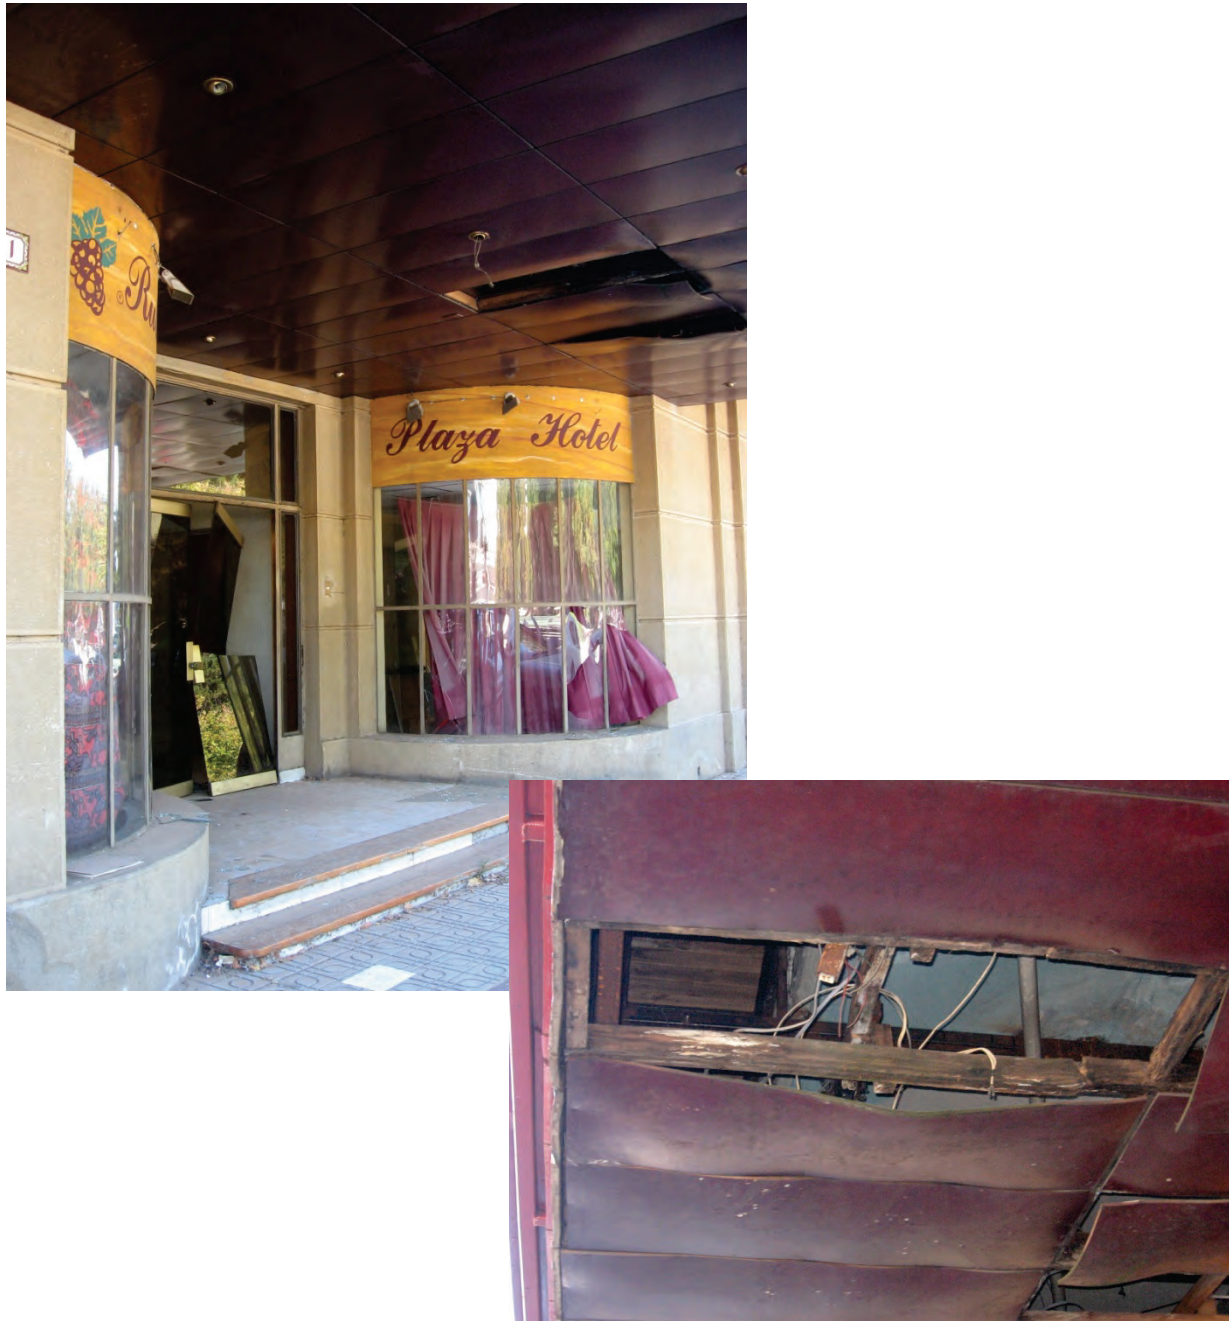
Figure 6.3.4.2-3 Damage to soffit paneling and wood framing at hotel in the 2010 Chile Earthquake; panels and wood framing show signs of prior water damage and deterioration. Note also damage to storefront glazing and glass doors (Photos courtesy of Rodrigo Retamales, Rubén Boroschek & Associates).

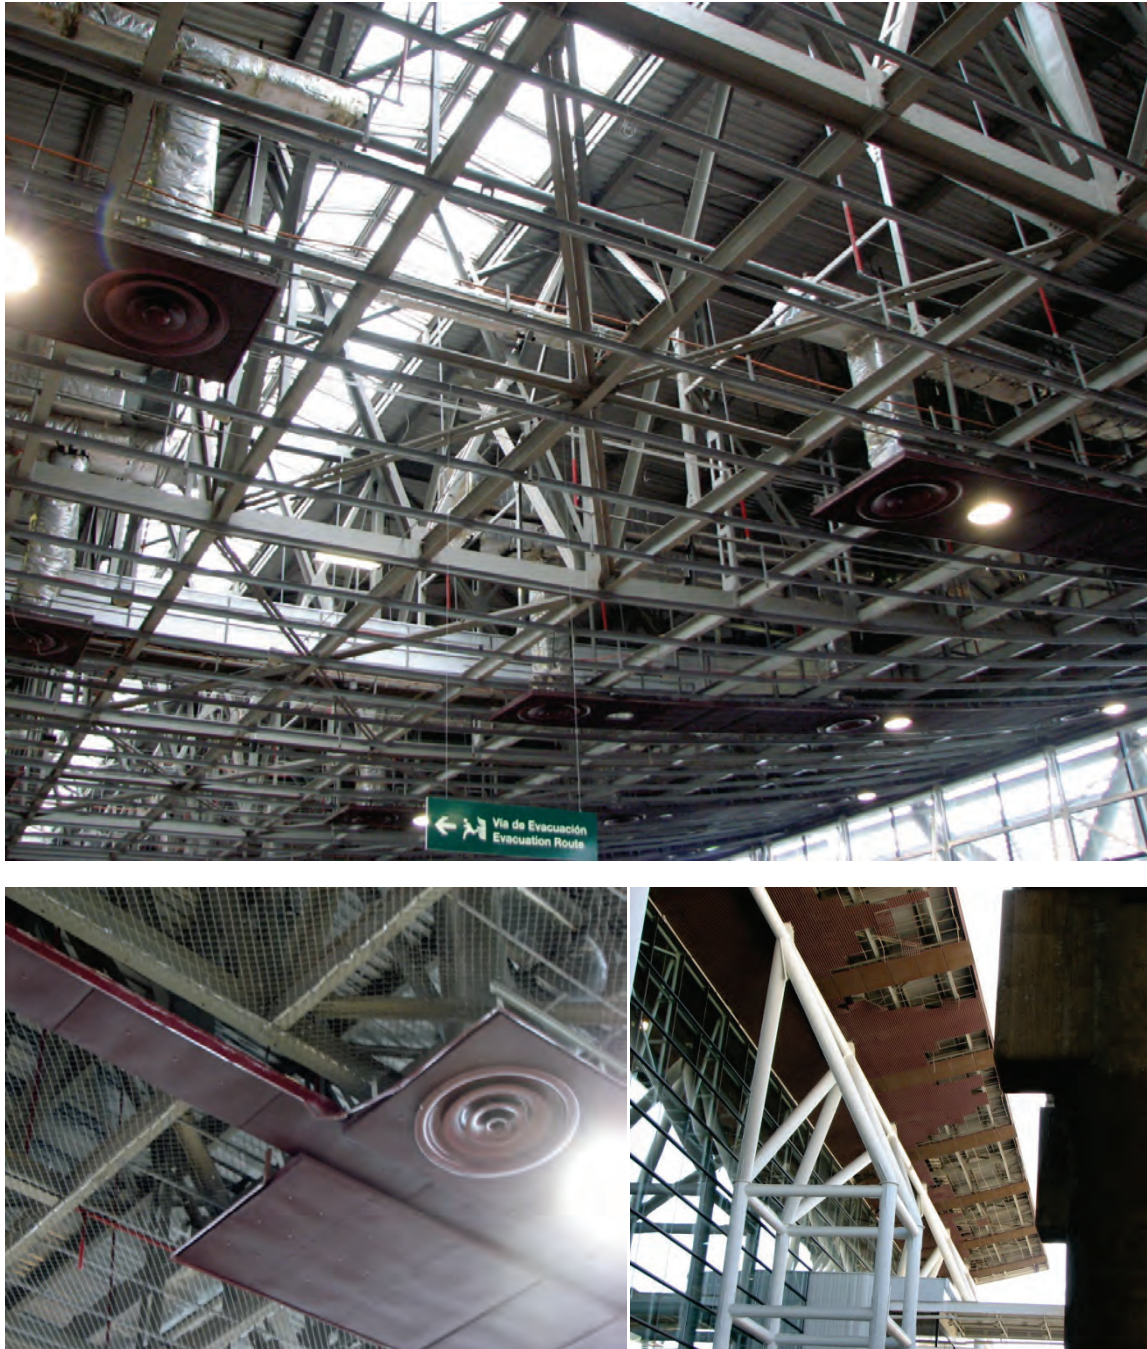
Figure 6.3.4.2-5 Extensive failure of ceiling in the main terminal of the Santiago airport in the 2010 Chile Earthquake. Metal panels with lights and diffusers hung from furring on short metal tabs; these remained in place but detail at lower left shows they also sustained some damage. Furring channels still in place throughout ceiling but majority of lightweight ceiling panels and much of the cross furring came down as shown at lower right photo of exterior soffit with same system (Photos courtesy of Antonio Iruretagoyena, Rubén Boroscchek & Associates).

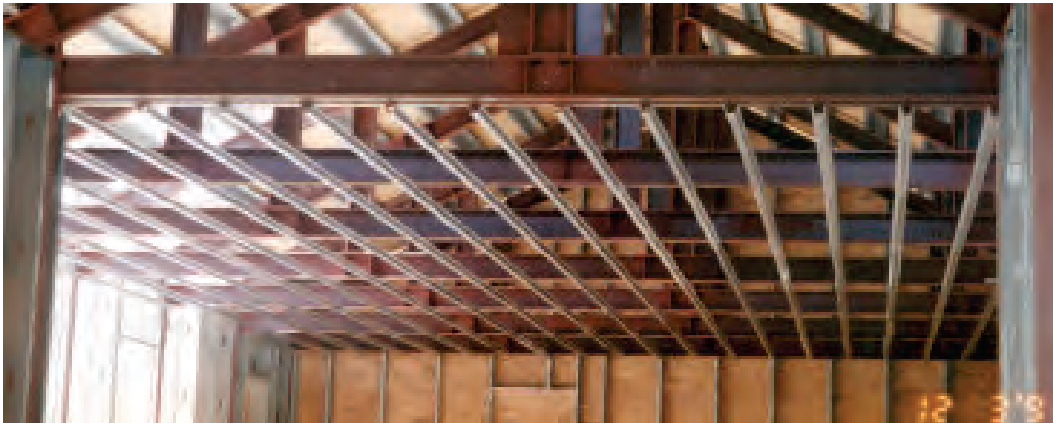
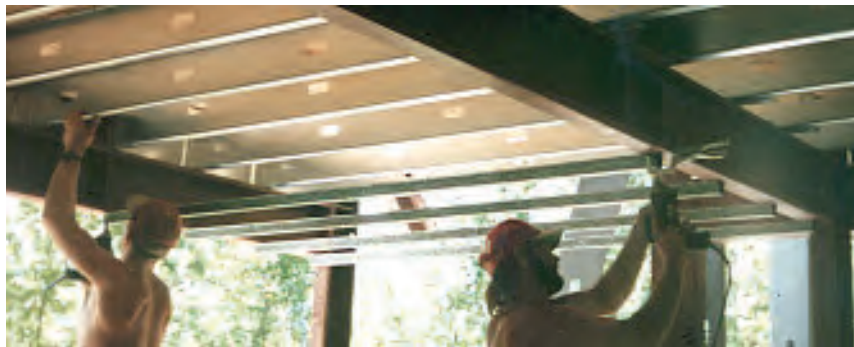
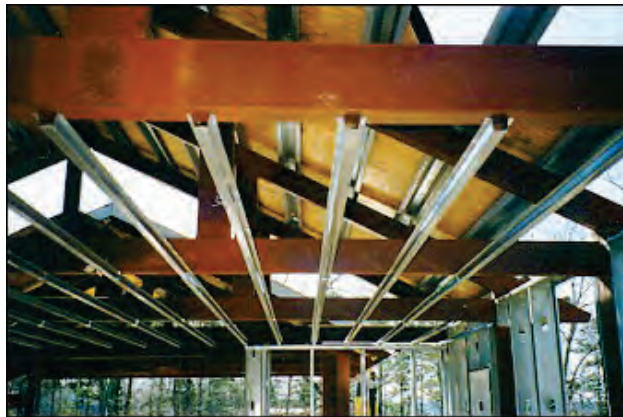
Figure 6.3.4.2-6 Mitigation examples with 1-1/2" hat channels at 16" on centers screwed in place with #12 self drilling screws and furring strips ready to receive gypsum board (Photo courtesy of Excalibur Steel). No special seismic details are required for this type of ceiling where the gypsum board is well secured directly to furring strips.

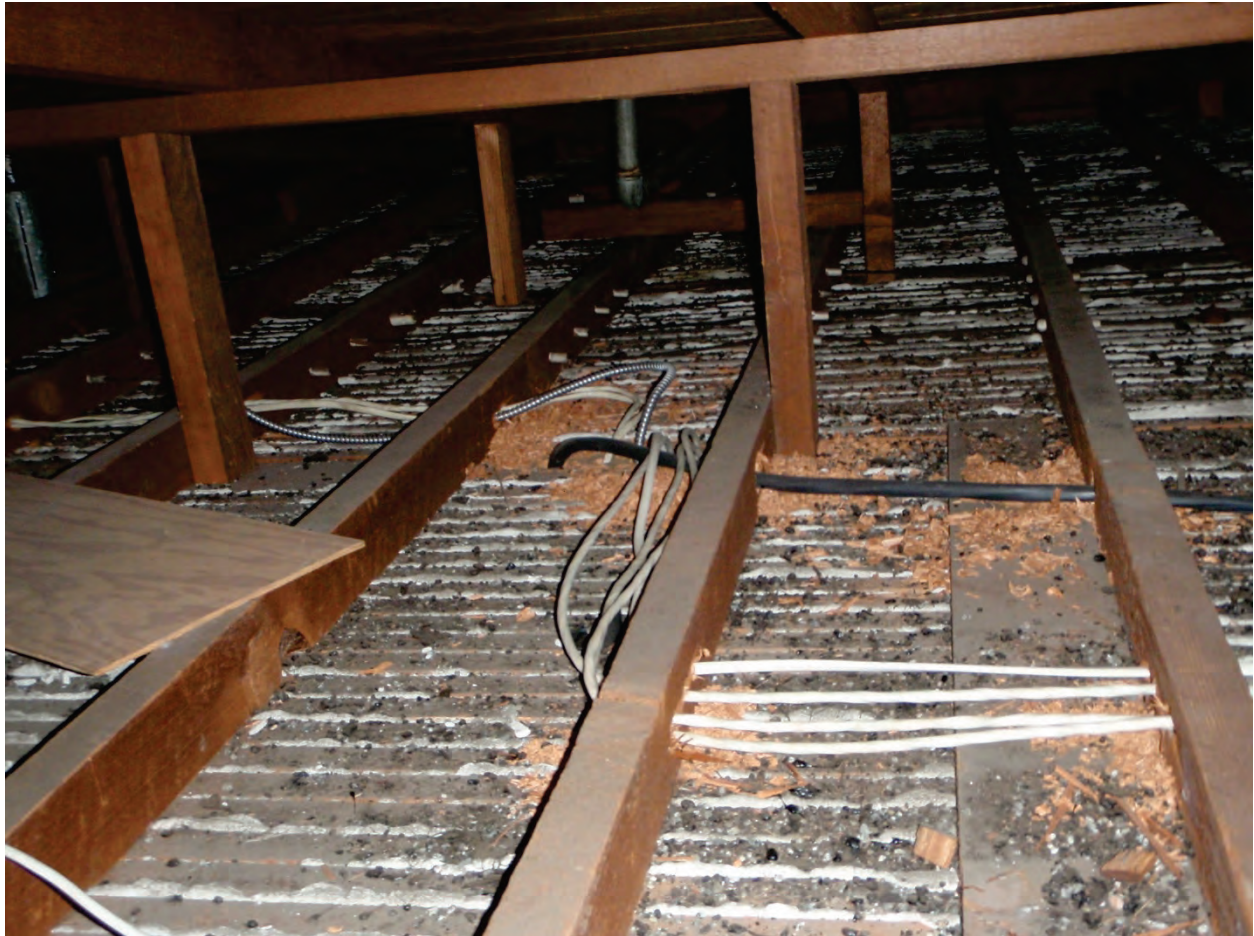
Figure 6.3.4.2-7 View of typical wood lath and plaster ceiling from the 1920's from above (Photo courtesy of Cynthia Perry, BFP Engineers). The wood lath is well nailed to the underside of the ceiling joists. This type of ceiling typically remains intact during an earthquake but may require crack repair and painting. Where the plaster has delaminated from the lath due to age or water leakage, wood strips could be installed from below as in Figure 6.3.4.2-8.

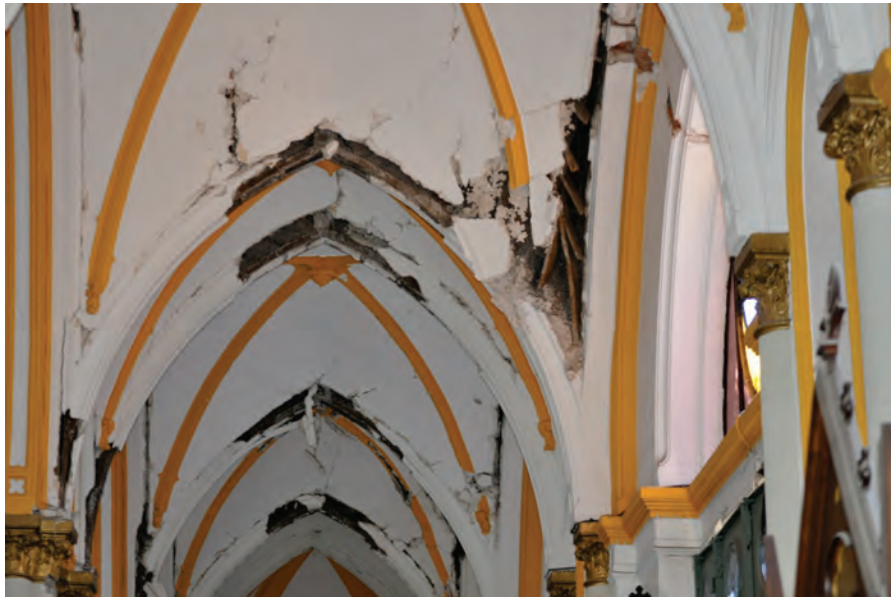
Figure 6.3.4.3-1 Damage to ornate wire lath and plaster ceiling in the 2010 magnitude-8.8 Chile Earthquake (Photo courtesy of Eduardo Fierro, BFP Engineers). Wire lath is attached to arches or to wood furring suspended from the roof framing.

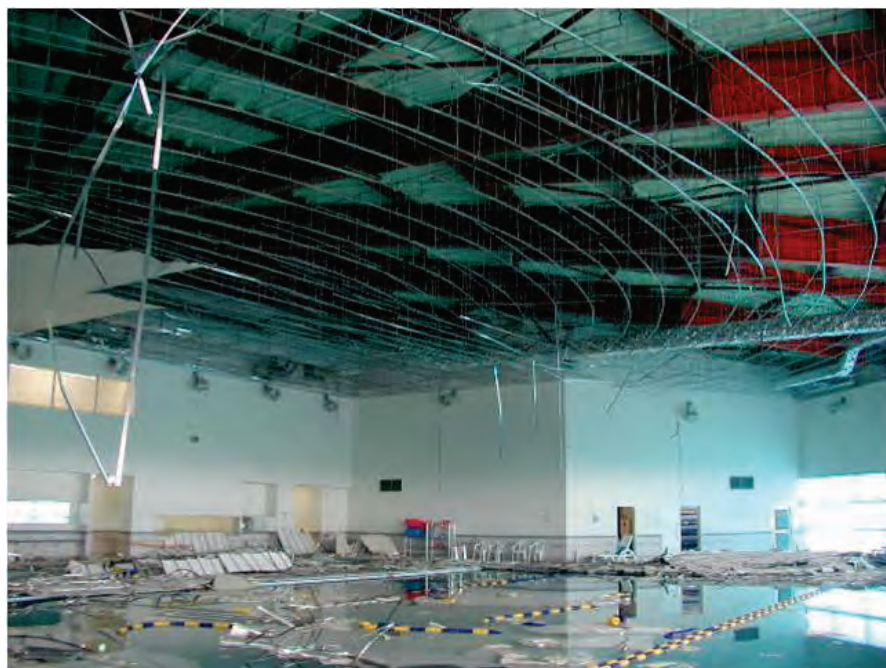
Figure 6.3.4.3-2a Complete collapse of a large suspended gypsum board ceiling over a swimming facility in Japan (Photo courtesy of Shojiro Motoyui, Tokyo Institute of Technology). This type of failure has been replicated on the E-defense shake table and occurs when the U-shaped clip holding the cross furring (M-bar) to the main runners (channel) opens into a V-shape and drops the furring grid. This type of failure is not common in the U.S.

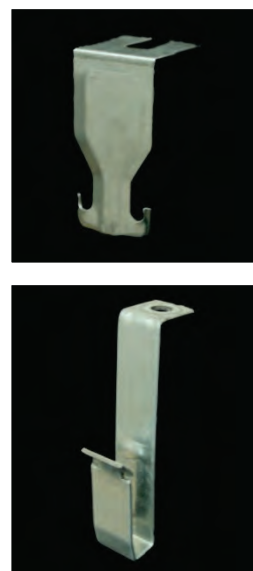
Figure 6.3.4.3-2b Schematic view of Japanese drywall ceiling grid. These ceilings are also typically installed with lateral bracing and 200mm edge clearance. Clip shown at lower right opens when the M-bar slides back and forth relative to the main runner, particularly those located near a diagonal brace. This type of clip is not common in the U.S (Source: "Dynamic characteristics of Japanese style of ceiling," Motoyui, S., Satoh, Y., and Kawanishi, T. *Proceedings 7CUEE & 5ICEE*, March 2010).
