Reducing the Risks of Nonstructural Earthquake Damage – A Practical Guide

FEMA E-74 / December 2012

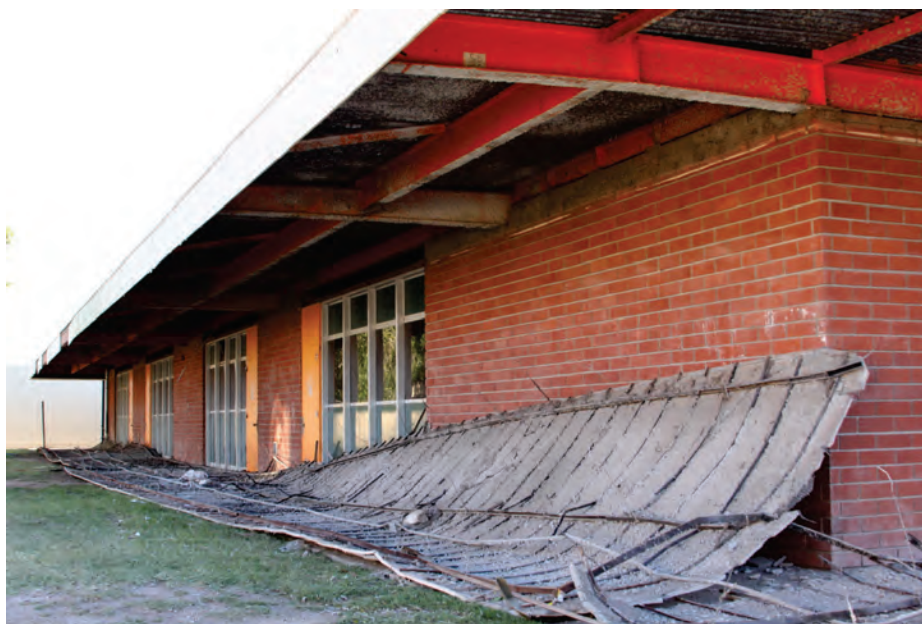
Figure 6.3.4.3-3 Collapse of exterior soffit at Jefferson Elementary School in Calexico in the 2010 Baja California Earthquake; approximately 1200 sq ft of soffit collapsed at this school built in the 1960's (Photo courtesy of Baja Earthquake Reconnaissance Team, Earthquake Engineering Research Institute (EERI), published in the EERI July 2010 Newsletter).

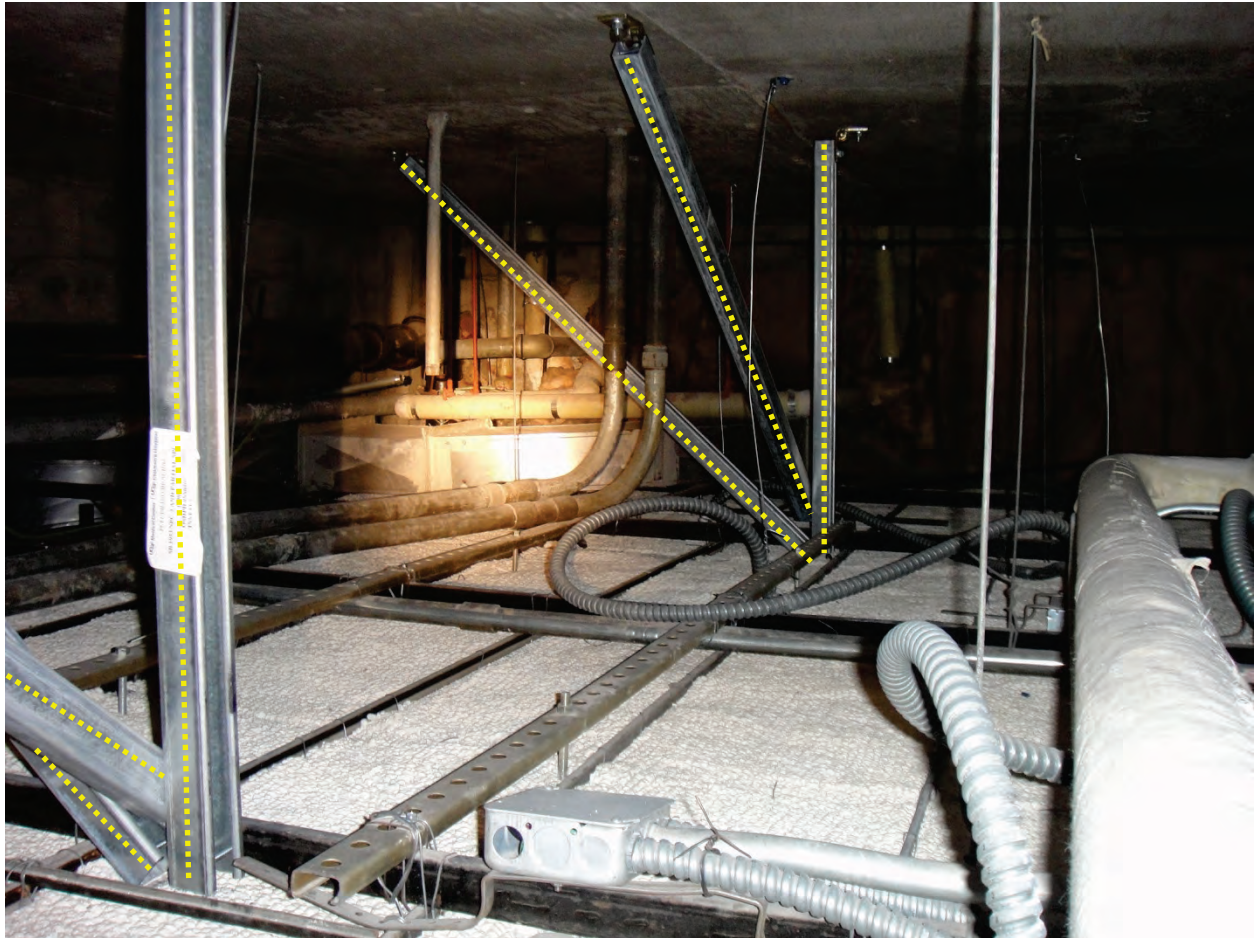
Figure 6.3.4.3-4 Details of suspended and braced plaster ceiling,. Rigid bracing and compression posts (highlighted) are provided at 6 ft by 8 ft on center. Note cross furring saddle tied to black channel (main runner) from below; supplementary framing for lights runs parallel to cross furring and saddle tied to main runner from above (Photo courtesy of Maryann Phipps, Estructure).

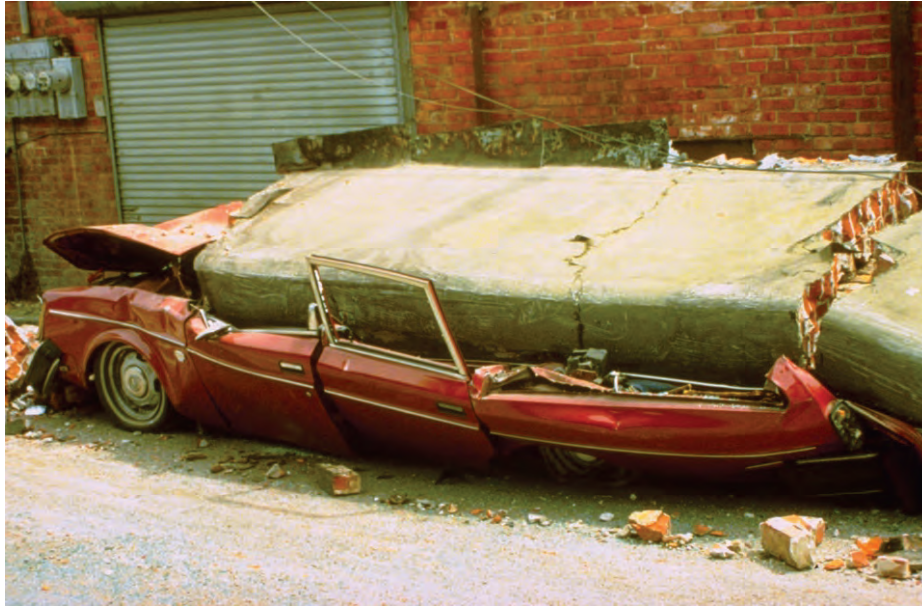
Figure 6.3.5.1-1 URM parapet fell and smashed two cars in the 1992 magnitude-7.2 Petrolia Earthquake. A parapet at same location in Ferndale, California failed in 1906 and killed two cows (NGDC, 2009).

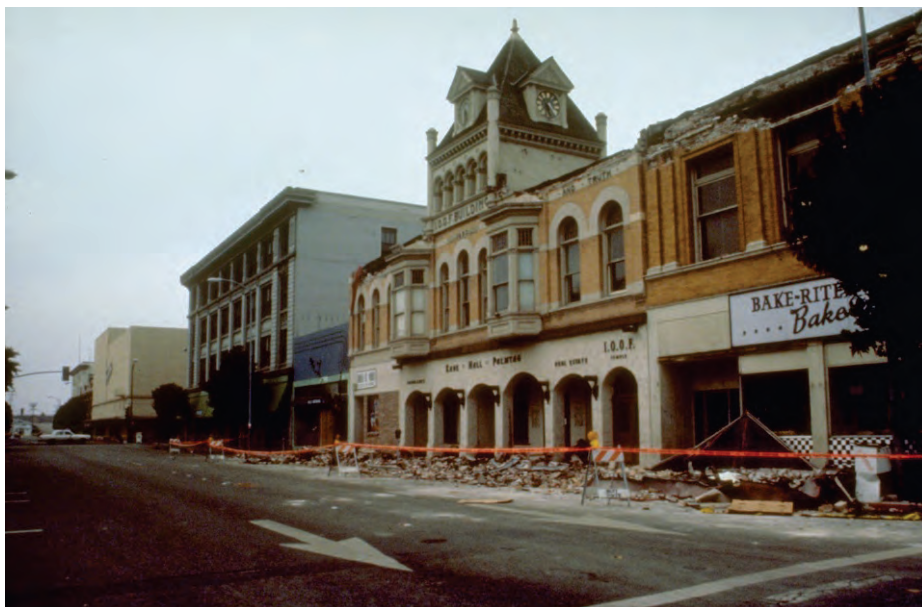
Figure 6.3.5.1-2 Unreinforced masonry parapet failures along Beach Street, Watsonville in the 1989 magnitude-6.9 Loma Prieta Earthquake (NGDC, 2009).

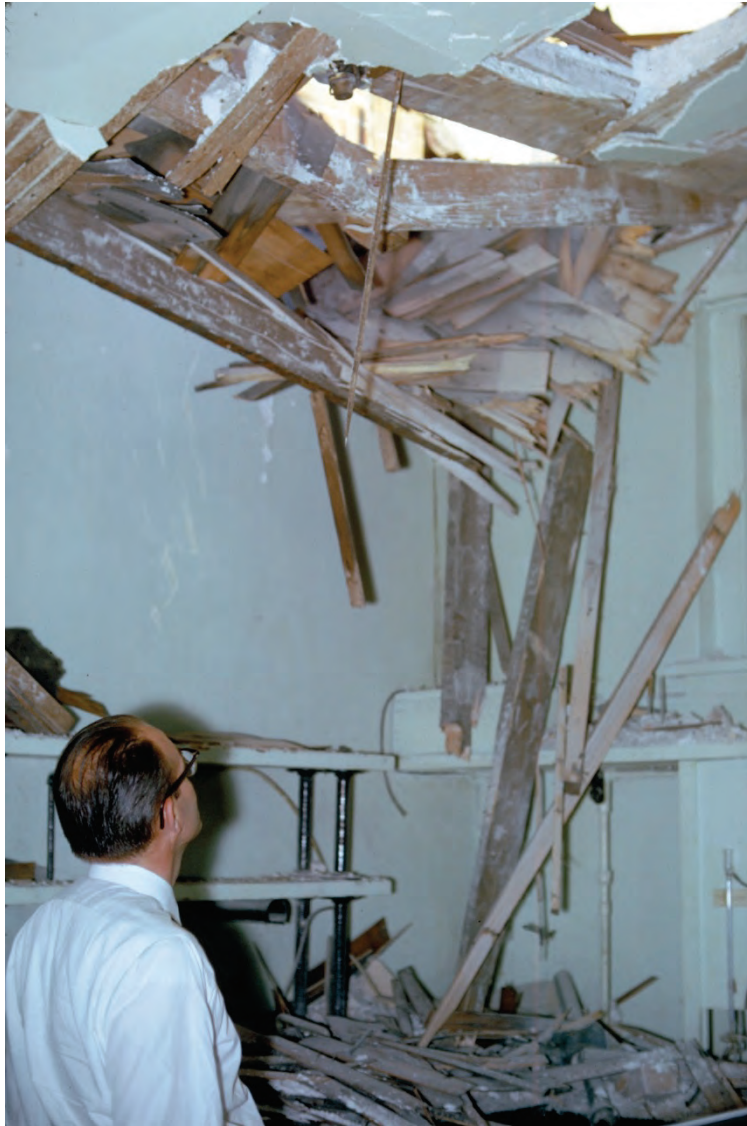
Figure 6.3.5.1-3 Damage to roof framing caused by failure of overhanging brick masonry during the 1962 magnitude-5.8 Cache Valley, Utah earthquake (Photo courtesy of PEER Steinbrugge Collection, No. S828).

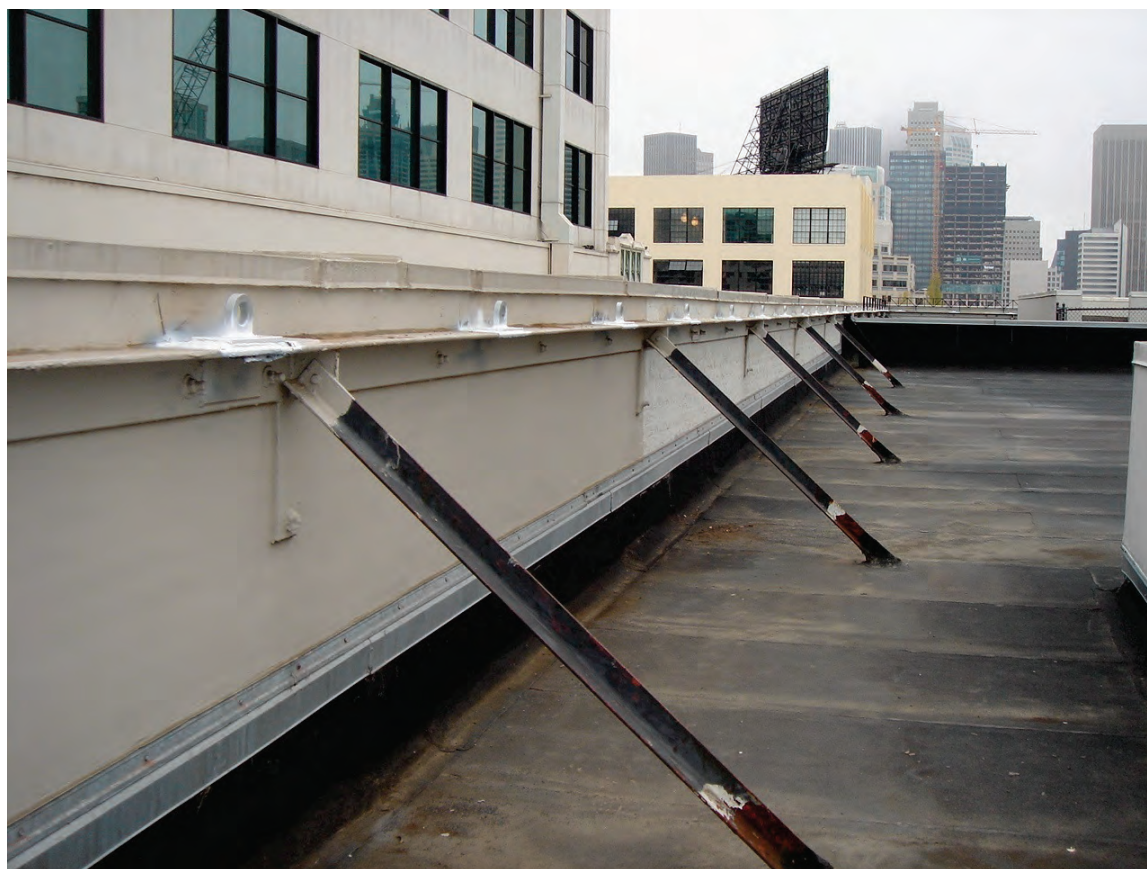
Figure 6.3.5.1-4 Bracing of URM parapet (Photo courtesy of Maryann Phipps, Estructure).

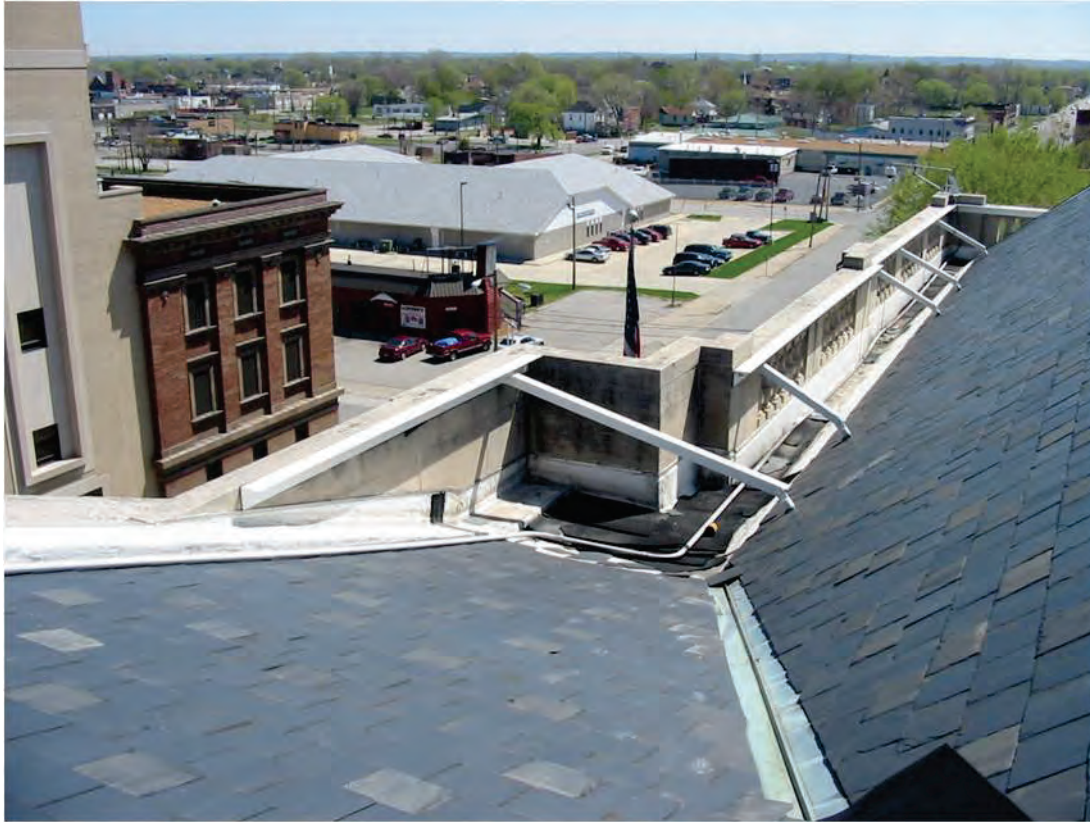
Figure 6.3.5.1-5 Bracing of unreinforced masonry parapet (Photo courtesy of Degenkolb Engineers).

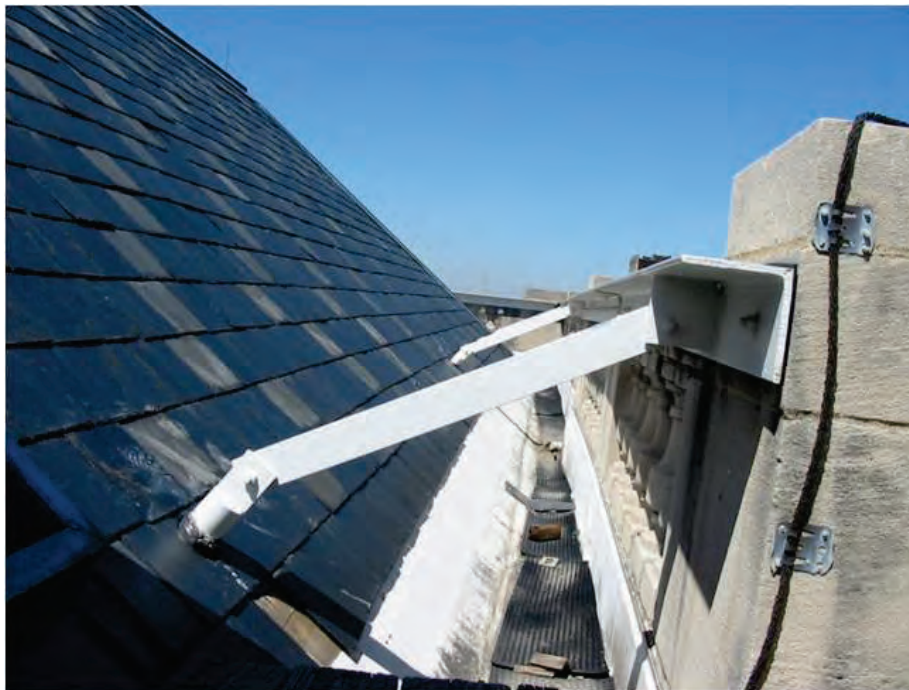
Figure 6.3.5.1-6 Close-up of parapet bracing (Photo courtesy of Degenkolb Engineers).

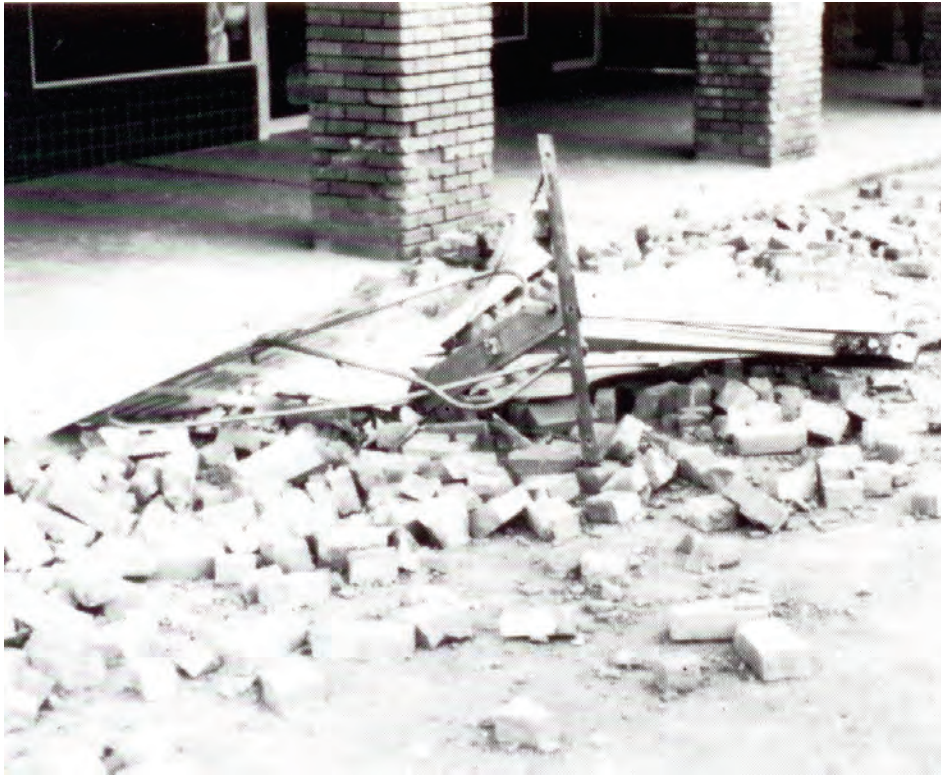
Figure 6.3.6.1-1 Failure of commercial sign in the 1979 Imperial Valley, California earthquake (Photo courtesy of Robert Reitherman).

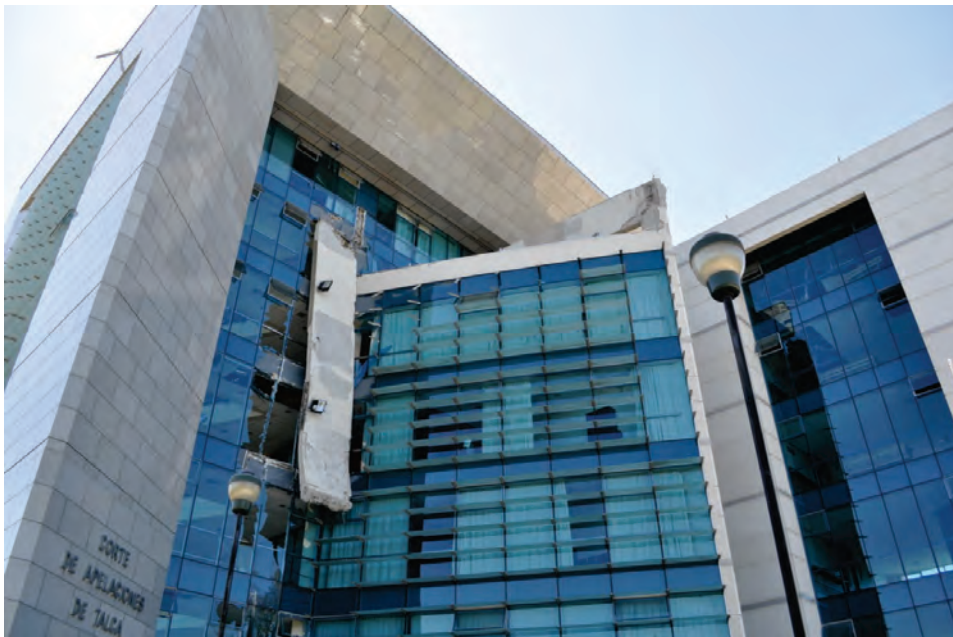
Figure 6.3.6.1-2 Reinforced concrete appendage dangling from connection on one side; impact damaged the curtain wall and created a serious hazard above the entrance of the Corte de Apelaciones de Talca in the 2010 magnitude-8.8 Chile Earthquake (Photo courtesy of Eduardo Fierro, BFP Engineers).

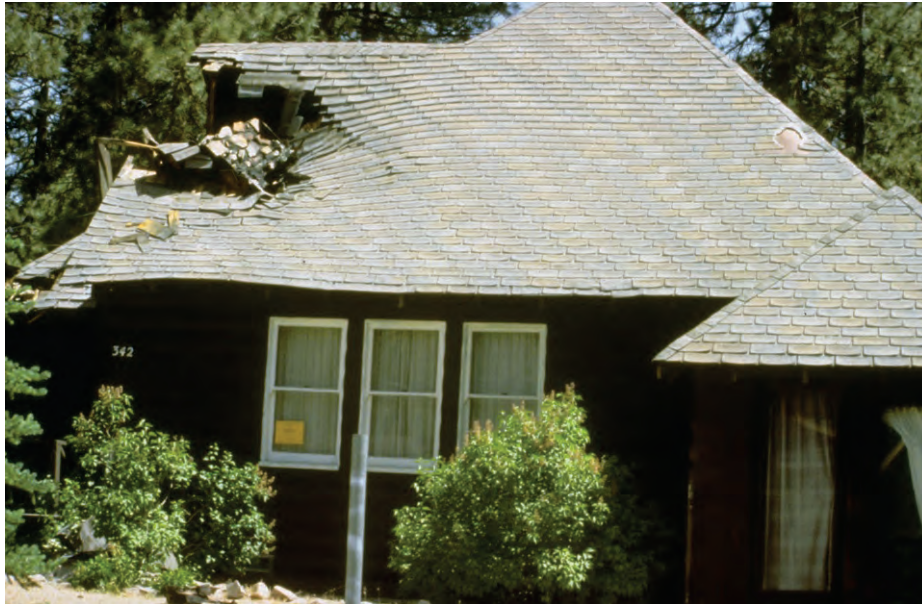
Figure 6.3.7.1-1 Chimney collapsed and fell through the roof; approximately 2,600 chimneys were destroyed in the 1992 Big Bear City, California earthquake (NGDC, 2009).

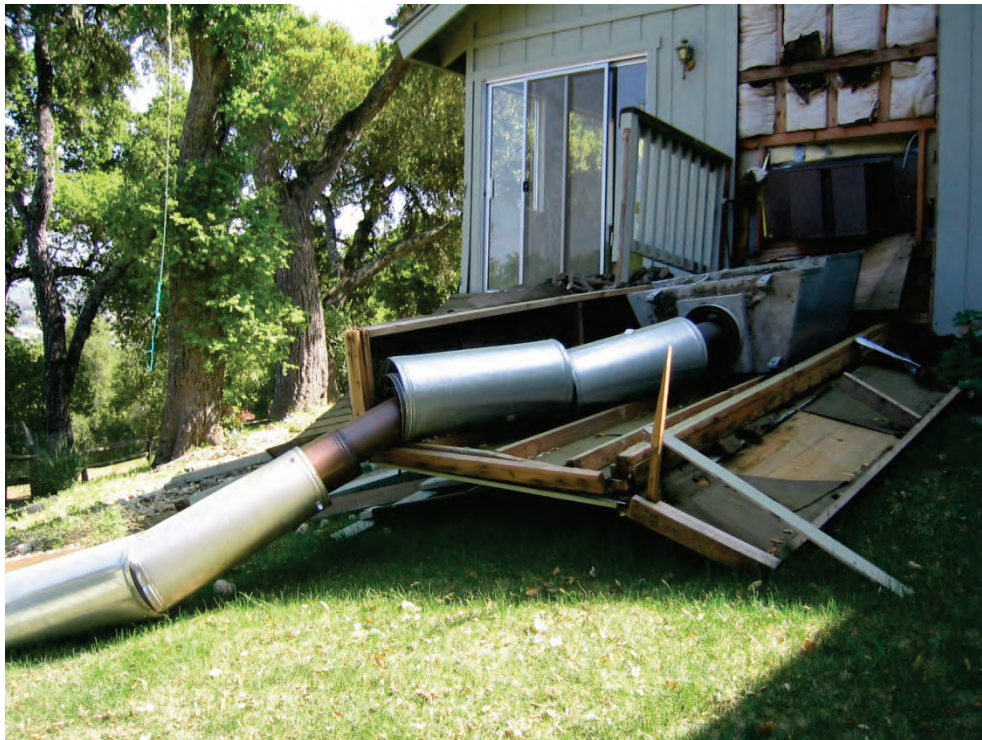
Figure 6.3.7.1-2 Residential metal flue in wood frame chimney that failed in the 2003 magnitude-6.5 San Simeon earthquake. The house fell off its cripple wall, pushing over the chimney (Photo courtesy of Michael Mahoney).

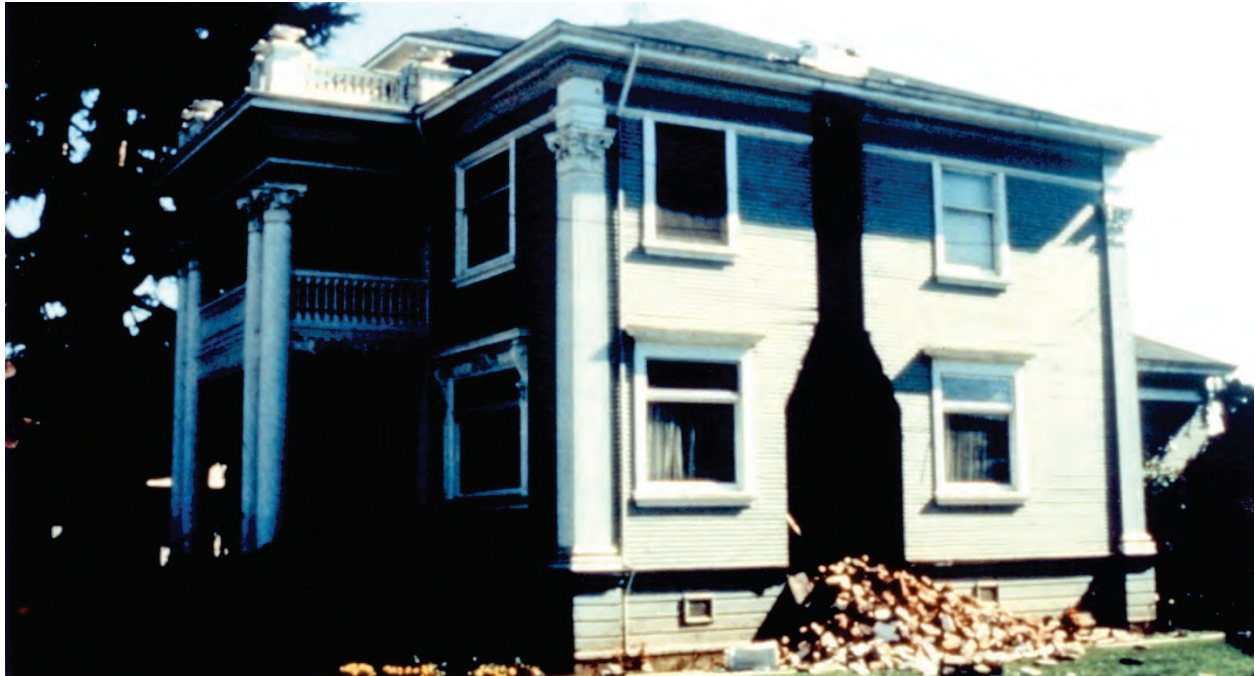
Figure 6.3.7.1-3 Chimney collapse (Photo courtesy of Earthquake Engineering Research Institute).

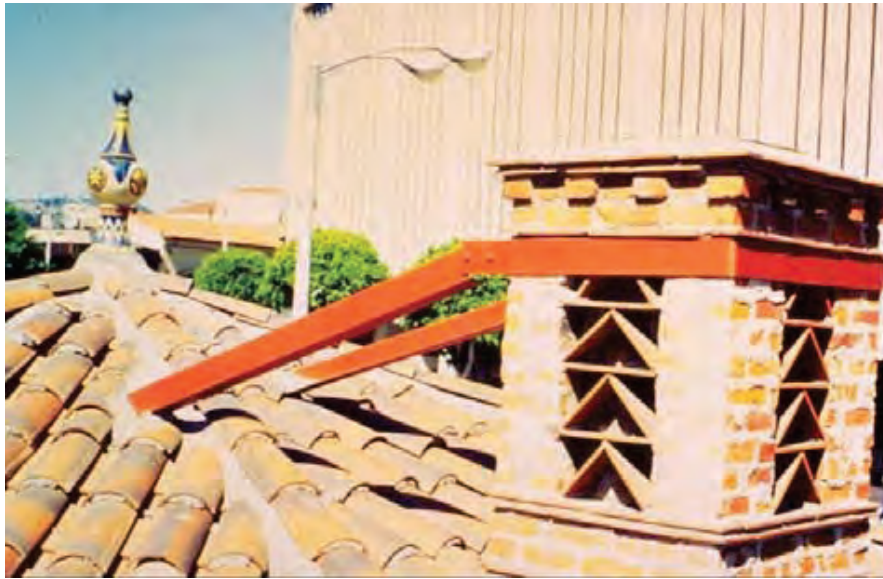
Figure 6.3.7.1-4 Braced chimney (FEMA, 2004).

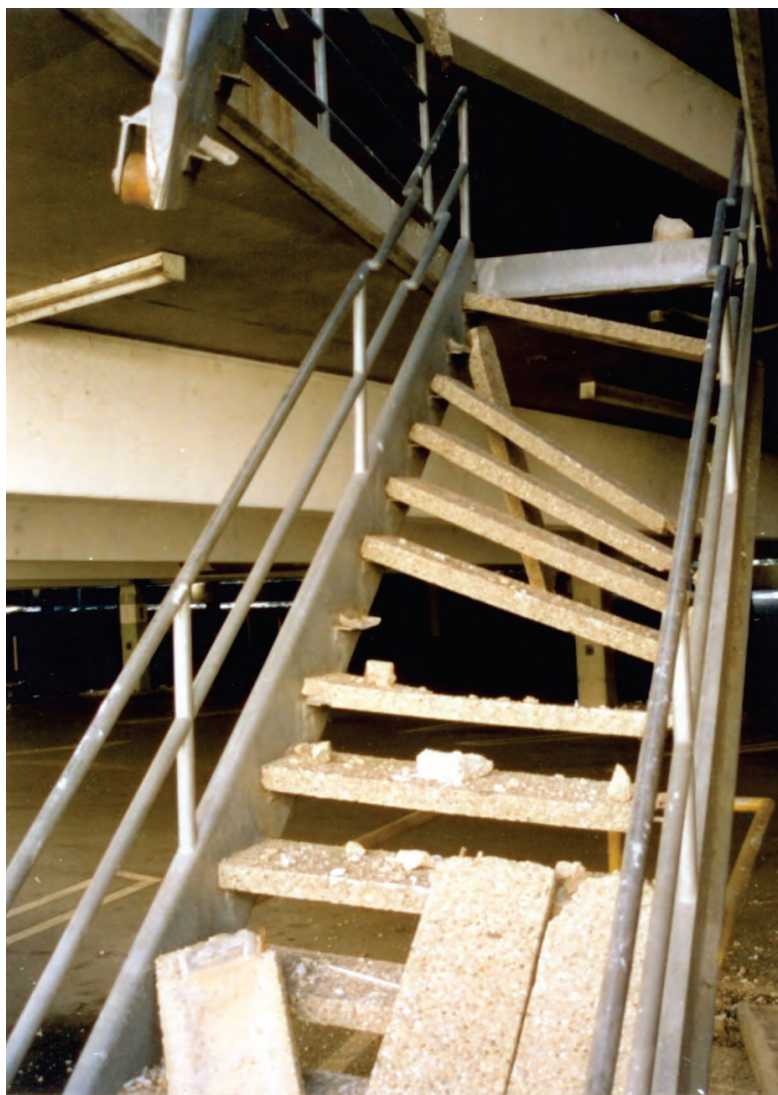
Figure 6.3.8.1-1 Stairway damaged by drift in the 1994 magnitude-6.7 Northridge, California earthquake (Photo courtesy of Wiss, Jenney, Elstner Associates).

- Single run stairs with steel stringers as shown in Figure 6.3.8.1–1, not detailed with slip connections, will provide stiff resistance to drift which could cause buckling of the stringers or failure of the connections.

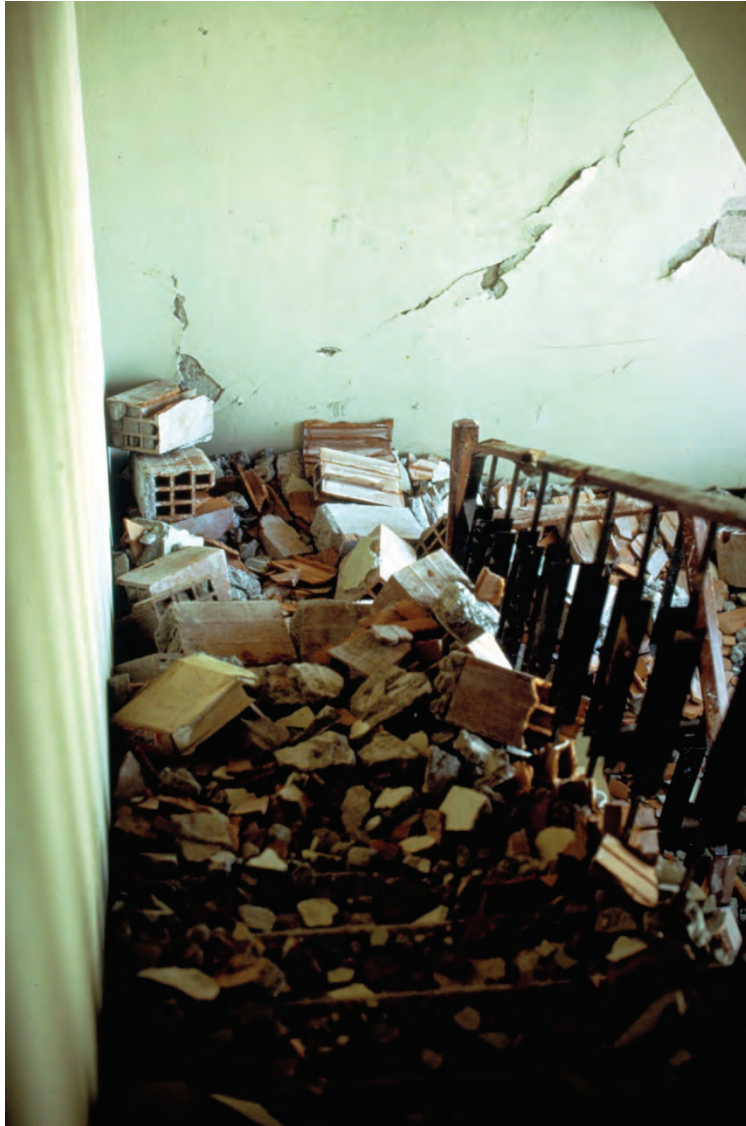
Figure 6.3.8.1-2 View of stairway in the Banco Central Building, Managua, Nicaragua after the 1972 magnitude-6.2 Managua Earthquake. Most of the stairs were covered with debris that resulted from the failure of the hollow tile partitions surrounding the stairs. This photograph highlights the need to not only prevent direct damage to stairway framing and connections, but also to protect against damage to surrounding walls (Photo courtesy of PEER Godden Collection, No. J94).

- Wooden stairs are generally in smaller, stiff buildings and have inherent flexibility in connections. Damage to wooden stairs has not been common, although configurations which provide direct bracing between floors (e.g., a straight run from ground to first floor) should be provided with a slip connection.
- The walls surrounding a stairway may be damaged during an earthquake causing debris to fall into the stairwell and rendering the stairs unusable. Brittle materials such as brick, hollow clay tile, or glass are particularly vulnerable and may create falling and debris hazards in stair enclosures as shown in Figure 6.3.8.1–2.

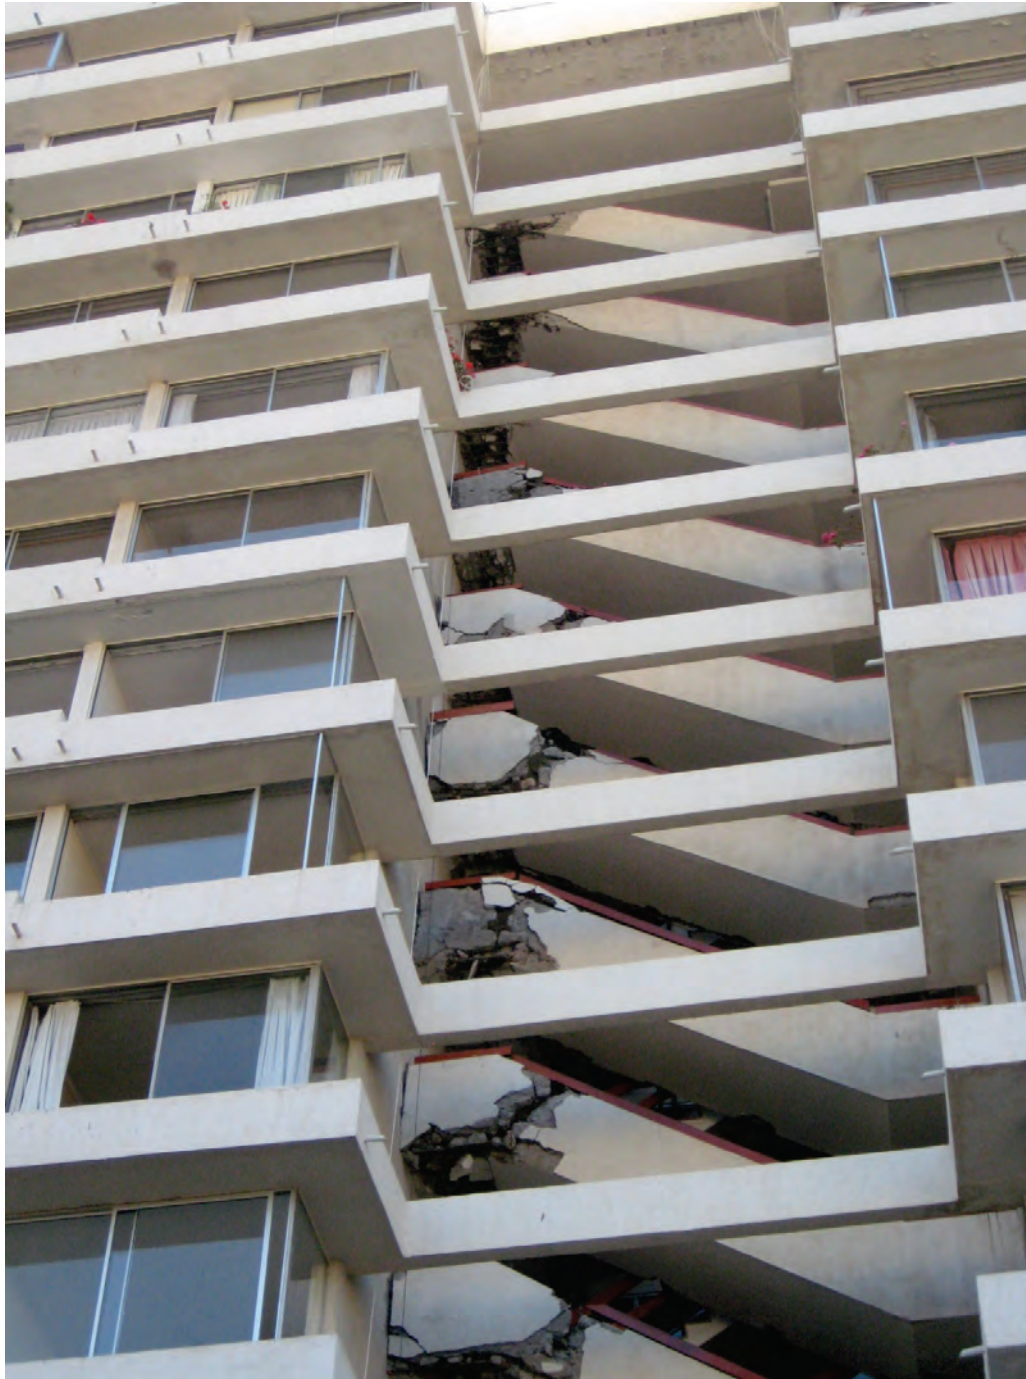
Figure 6.3.8.1-3 Stairs damaged up the full height of this apartment building in Viña del Mar in the 2010 magnitude-8.8 Chile Earthquake (Photo courtesy of Santiago Pujol, Purdue University). The stairs were rigidly attached at adjacent floors and behaved like diagonal braces although they were neither designed nor detailed to function as structural braces.

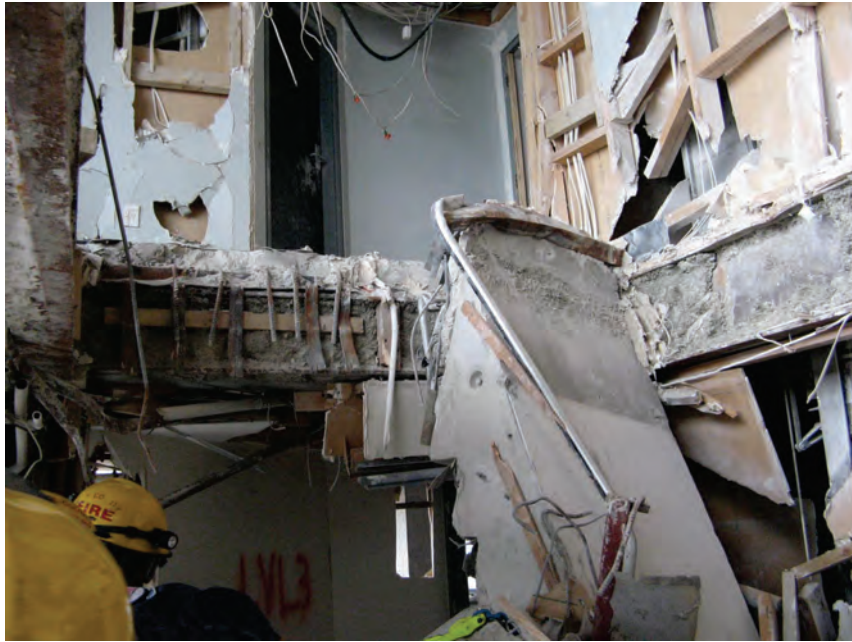
Figure 6.3.8.1-4 Stair support condition at Forsyth-Barr Building in Christchurch, New Zealand. Precast stair runs have completely pulled off supports and collapsed into stairwell (Photo courtesy of Des Bull, Holmes Consulting Group).

- When one end or both ends of the stair have slip or sliding connections, the design differential movement could be exceeded causing failure of the connection and perhaps collapse of the stair as shown in Figures 6.3.8.1–4 and 6.3.8.1–5.

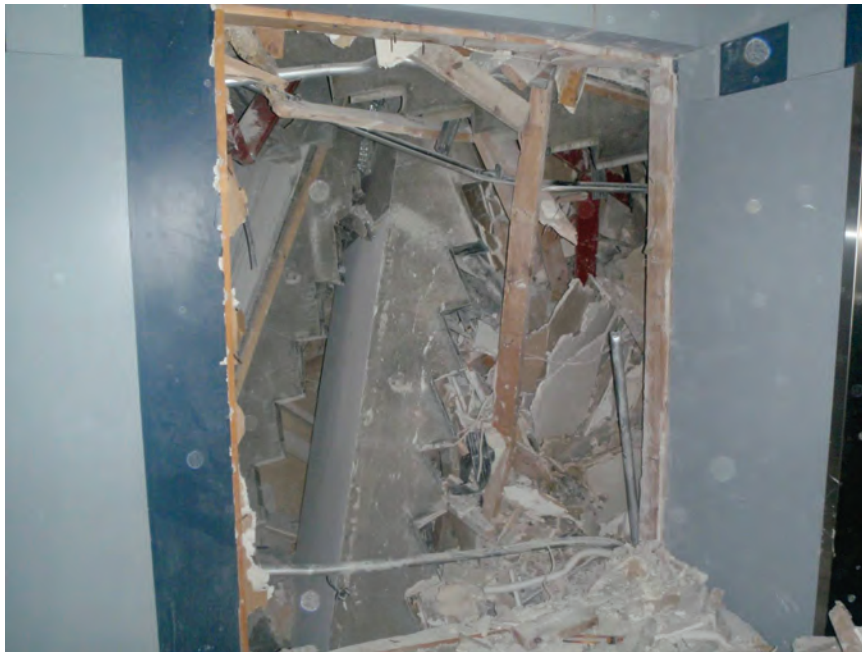
Figure 6.3.8.1-5 One story precast stair units stacked up at base of stairwell after falling off the sliding end supports and collapsing into stairwell (Photo courtesy of Des Bull, Holmes Consulting Group).

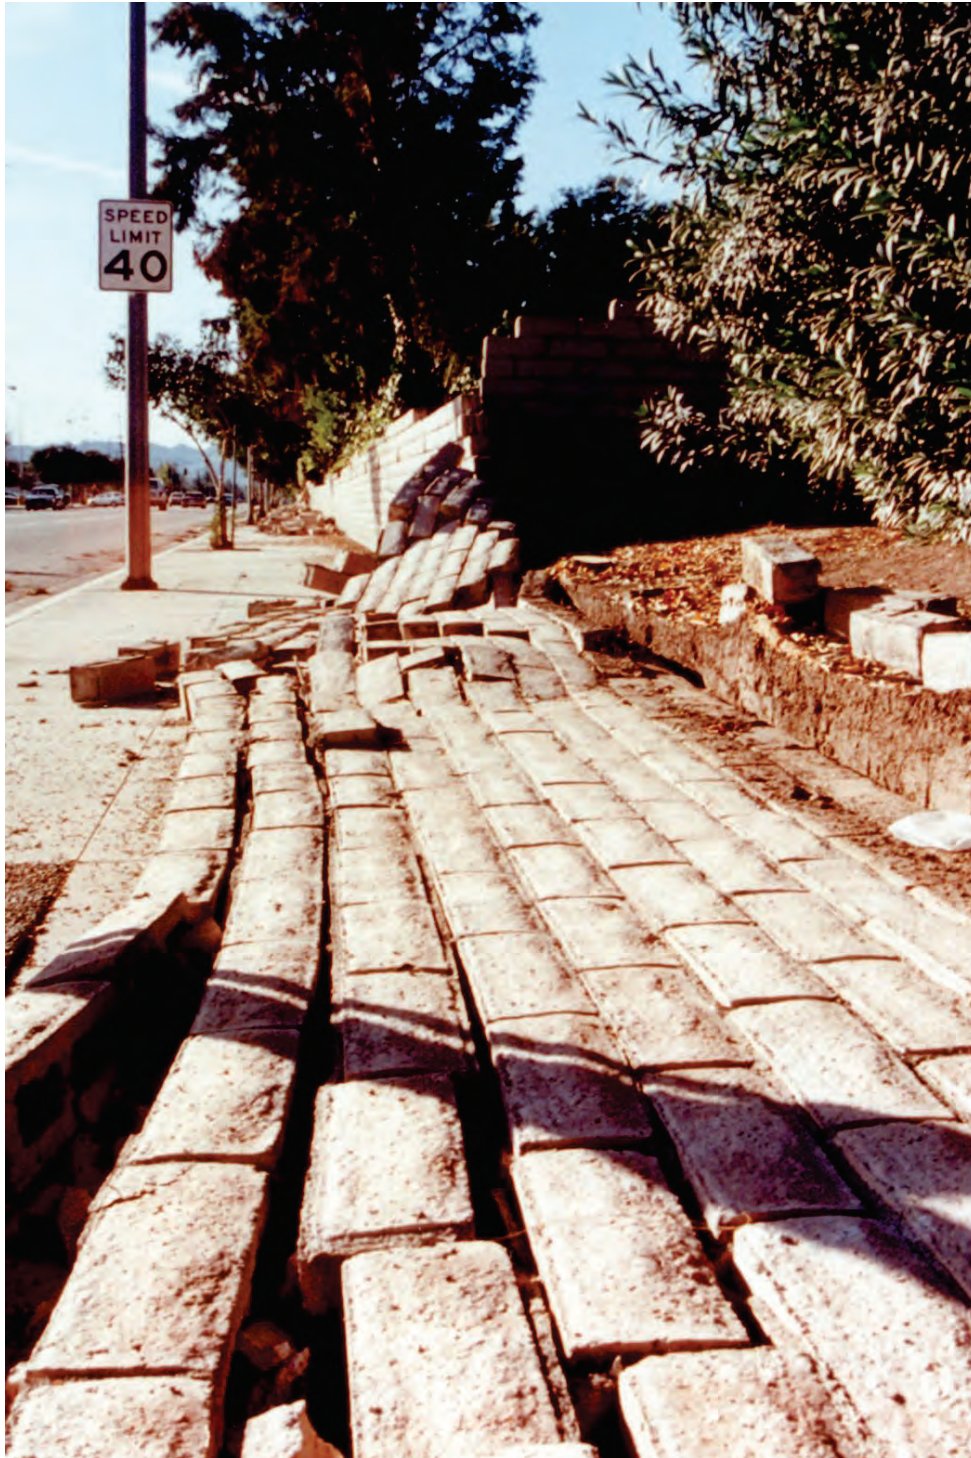
Figure 6.3.9.1-1 Collapse of freestanding CMU walls covering much of the sidewalk in the 1994 magnitude-6.7 Northridge Earthquake (Photo courtesy of Robert Reitherman). The rubble reveals that the wall was unreinforced.

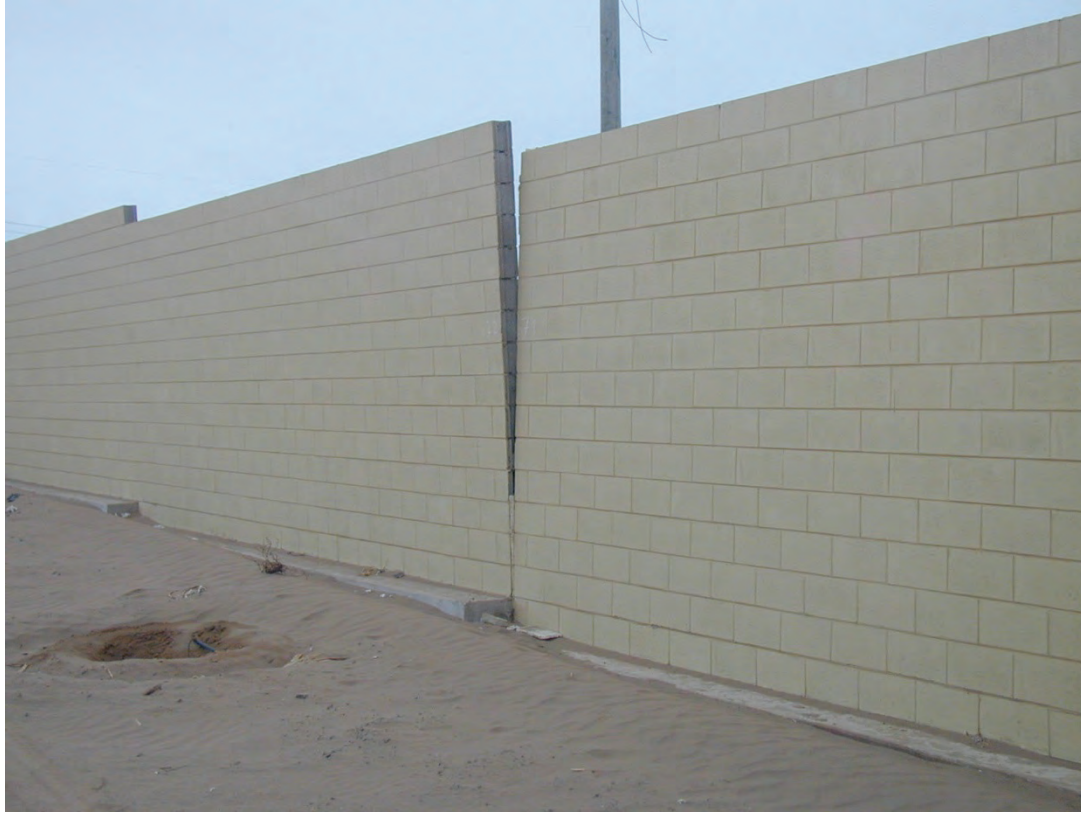
Figure 6.3.9.1-3 Damage to reinforced masonry boundary fence at industrial facility in Southern Peru; out-of-plane movement at construction joint in wall without sufficient reinforcing for the level of shaking experienced at this location in the 2001 magnitude-8.4 Peru Earthquake (Photo courtesy of Eduardo Fierro, BFP Engineers). Additional boundary steel or reinforced concrete boundary columns located either side of construction joints would improve the performance of this type of fence.

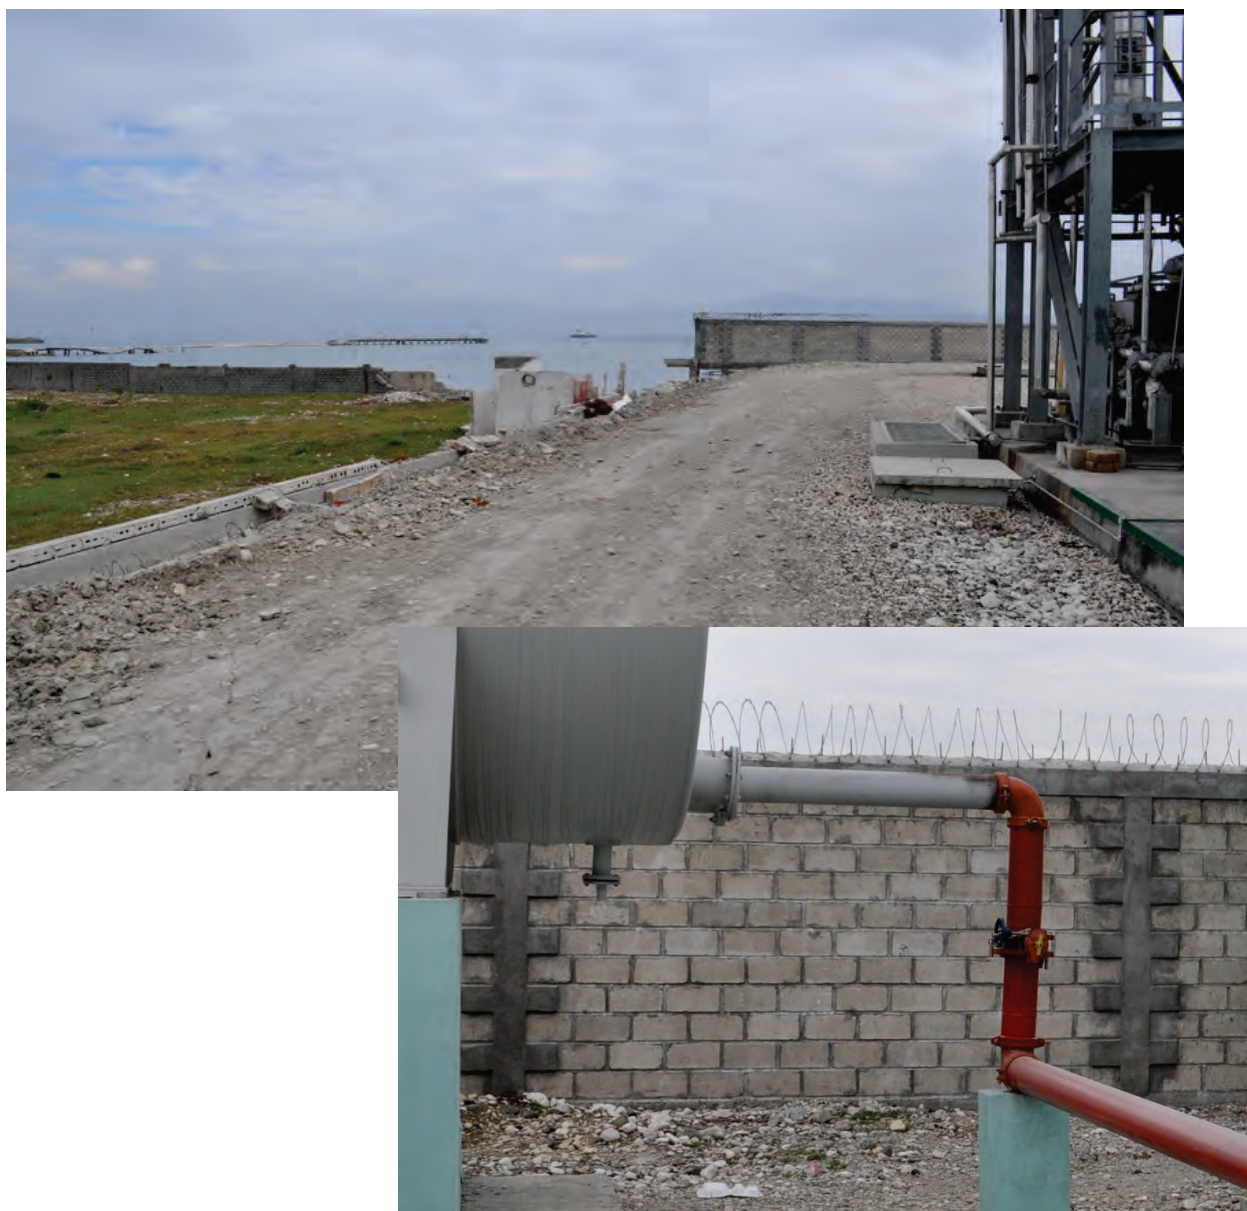
Figure 6.3.9.1-4 Photo at top shows complete collapse of poorly detailed confined masonry fence in foreground; partial collapse of poorly detailed confined masonry fence in distance at left; no damage to well detailed confined masonry fence in distance at right in the 2010 Haiti Earthquake. Close-up view of well-detailed confined masonry fence in bottom photo with concrete columns and bond beam at top (Photos courtesy of Eduardo Fierro, BFP Engineers). Fences in foreground and at right formed the security perimeter at an electric power plant in Port-au-Prince.

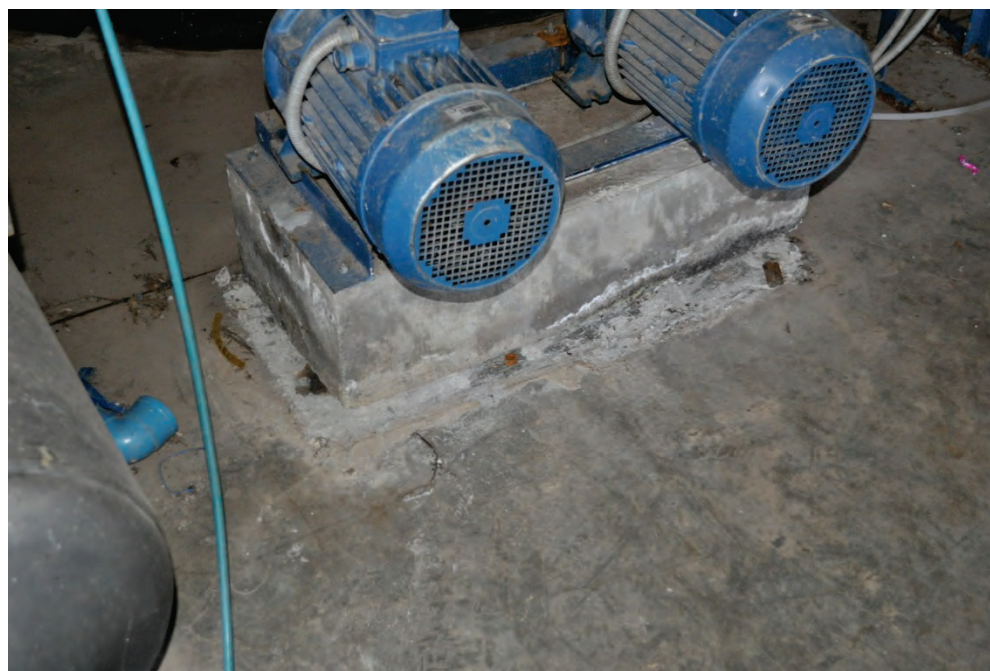
Figure 6.4.1.1-2 Pumps with rigid anchorage to housekeeping pad in the 2010 magnitude-8.8 Chile Earthquake; housekeeping pad not anchored to base slab and slid horizontally several inches (Photo courtesy of Eduardo Fierro, BFP Engineers).

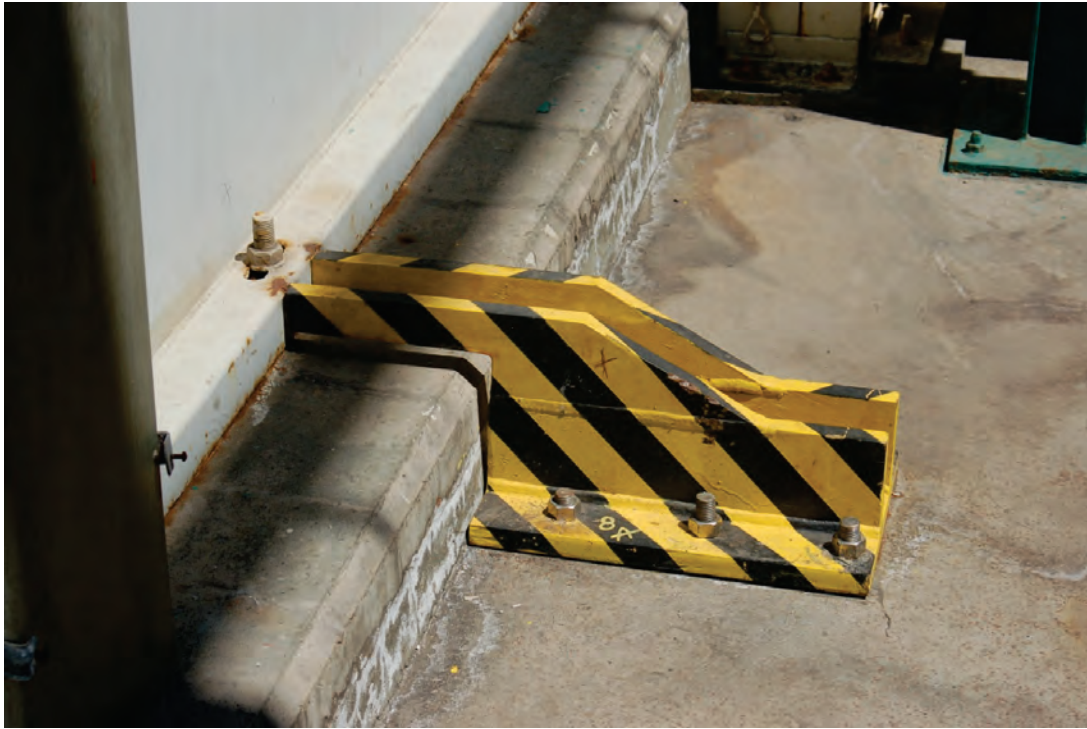
Figure 6.4.1.1-3 Added lateral capacity provided for skid-mounted equipment added following the 2001 Peru Earthquake (Photo courtesy of Eduardo Fierro, BFP Engineers).

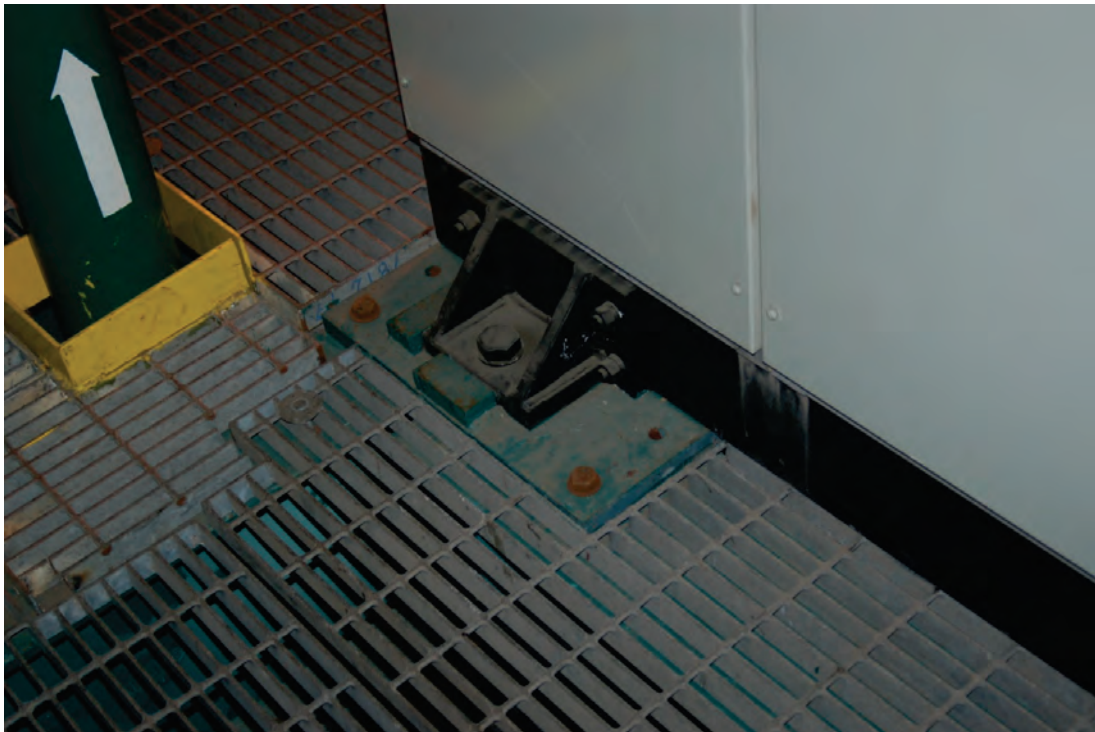
Figure 6.4.1.1-4 Bolted connection to steel skid with added shear lugs (Photo courtesy of Eduardo Fierro, BFP Engineers).
