Reducing the Risks of Nonstructural Earthquake Damage – A Practical Guide

FEMA E-74 / December 2012

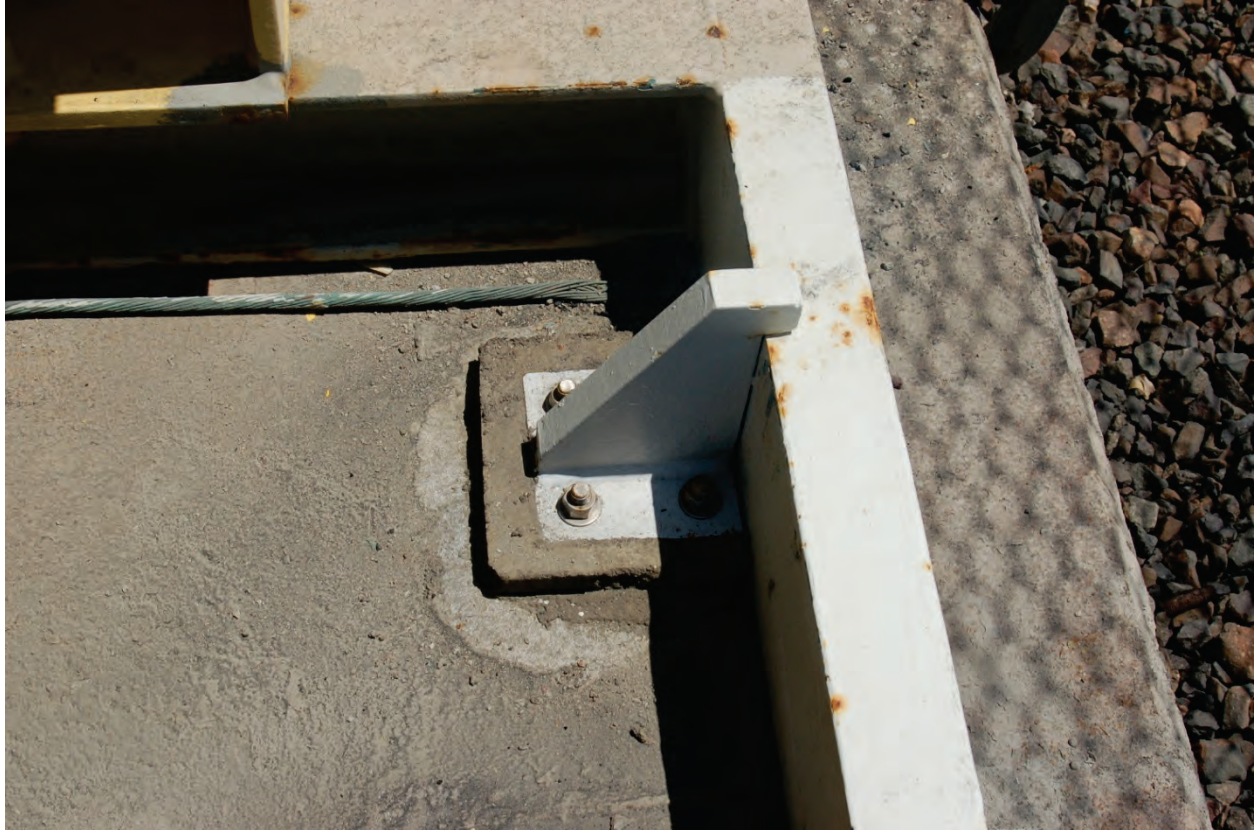
Figure 6.4.1.1-5 Alternate detail for skid mounted equipment (Photo courtesy of Eduardo Fierro, BFP Engineers).

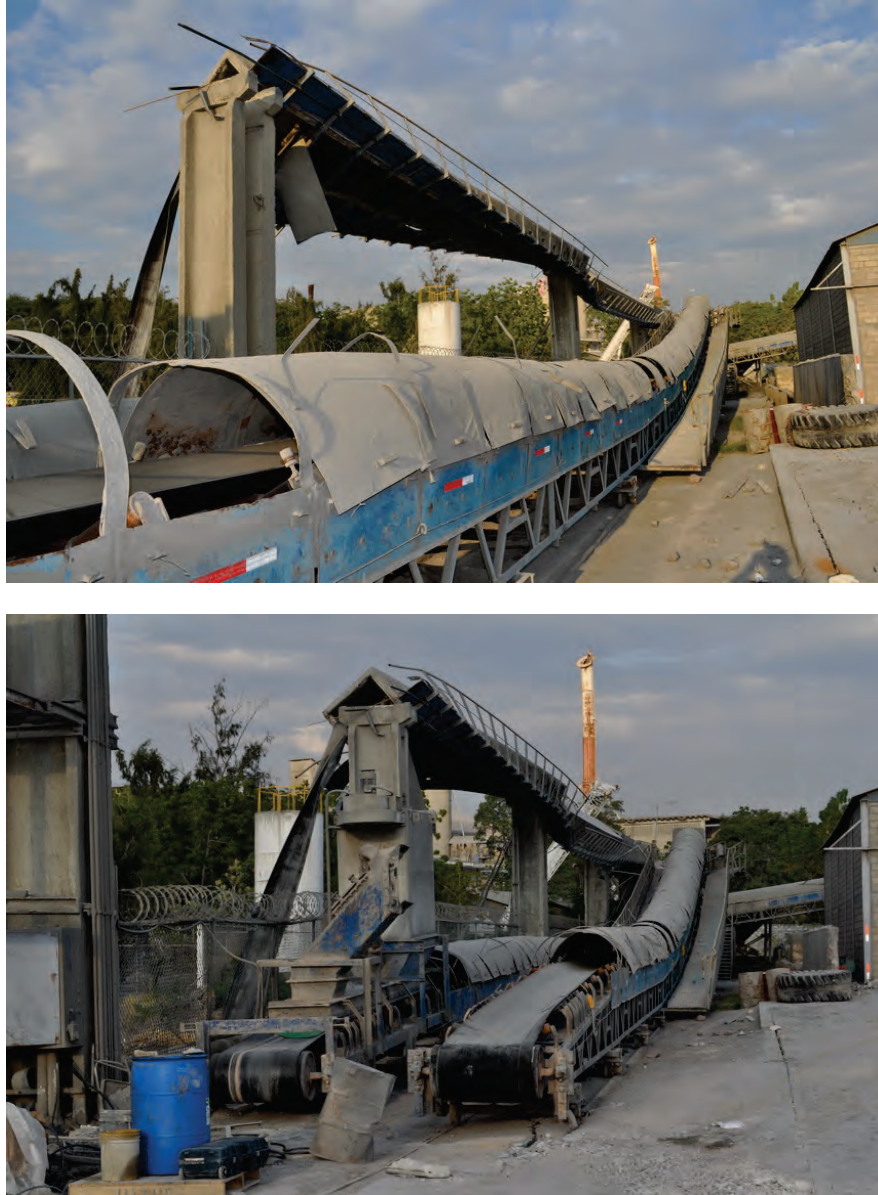
Figure 6.4.1.2-1 Damage to conveyors and equipment at a cement plant in the 2010 magnitude-7 Haiti Earthquake (Photos courtesy of Eduardo Fierro, BFP Engineers).

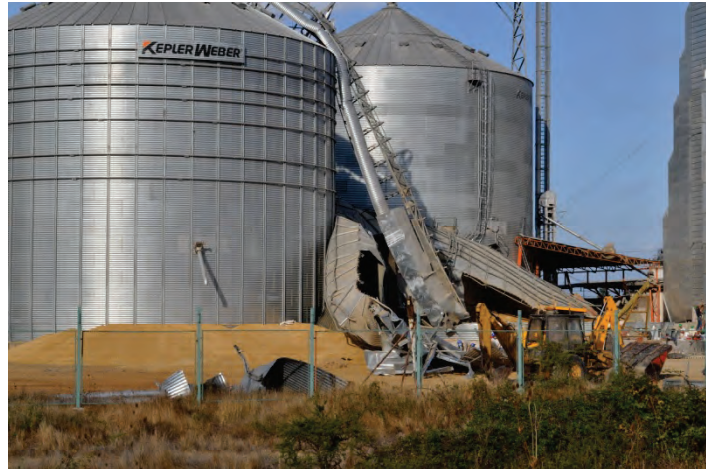
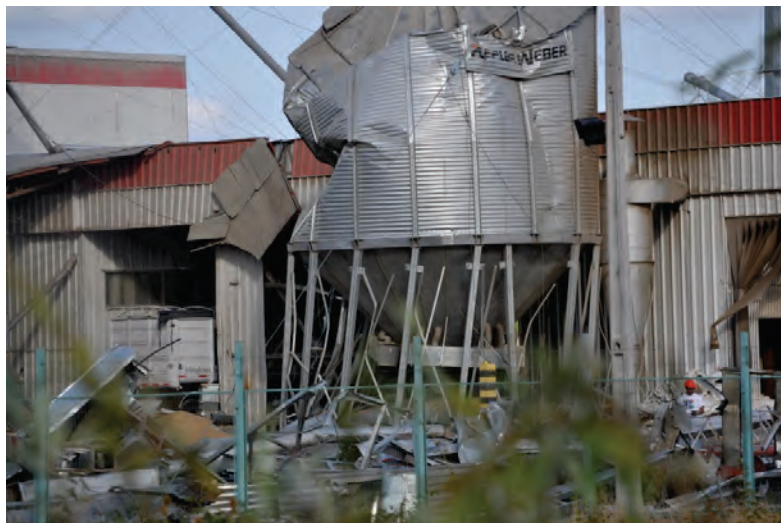
Figure 6.4.1.2-2 Damage to silos, conveyors and equipment at a grain operation in the 2010 magnitude-8.8 Chile Earthquake (Photos courtesy of Eduardo Fierro, BFP Engineers).

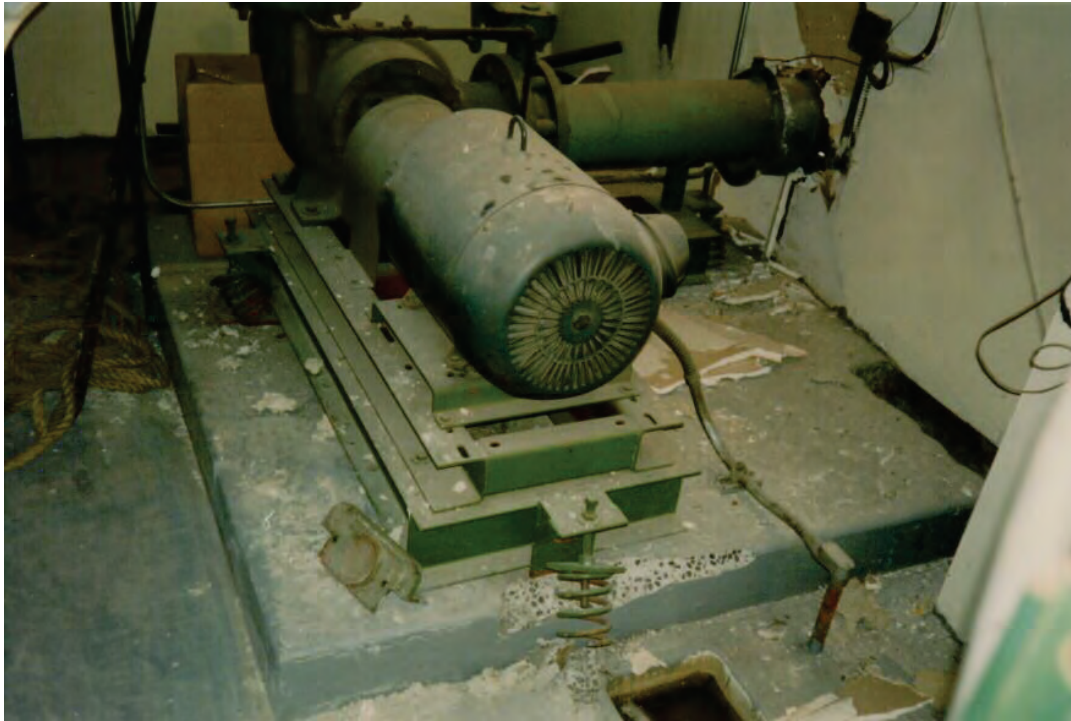
Figure 6.4.1.3-2 Failure of pump mounted on three vibration isolators and damage at wall penetration (Photo courtesy of Mason Industries).

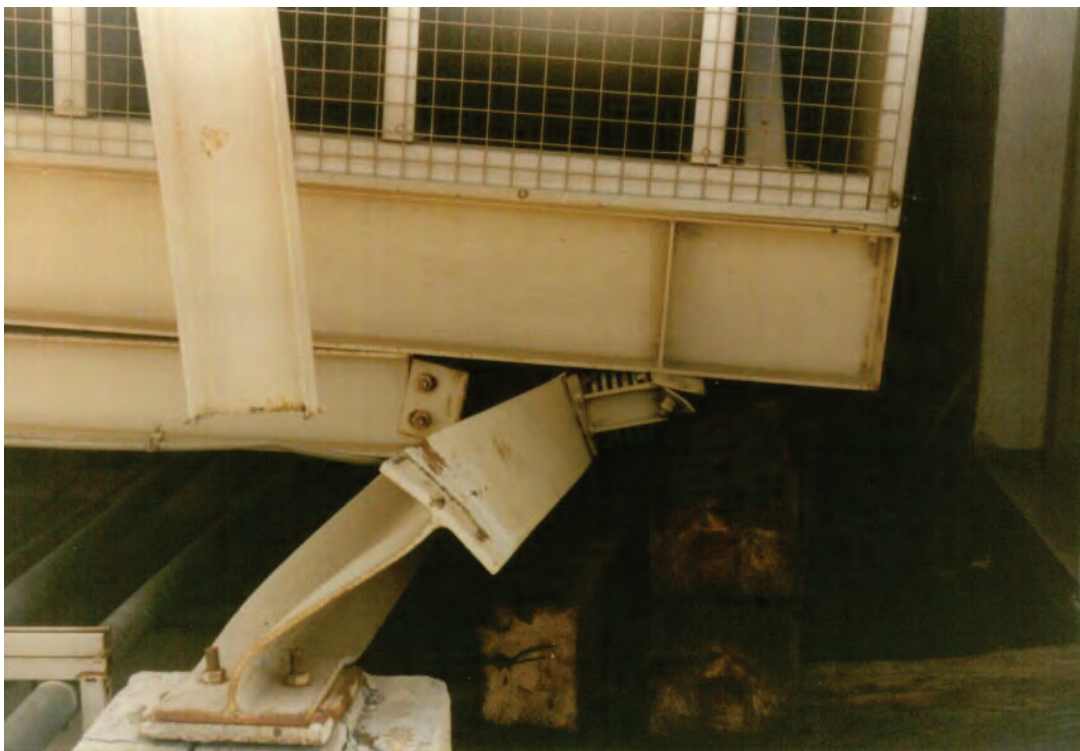
Figure 6.4.1.3-3 Failure of an entire support assembly including vibration isolators (Photo courtesy of Mason Industries).

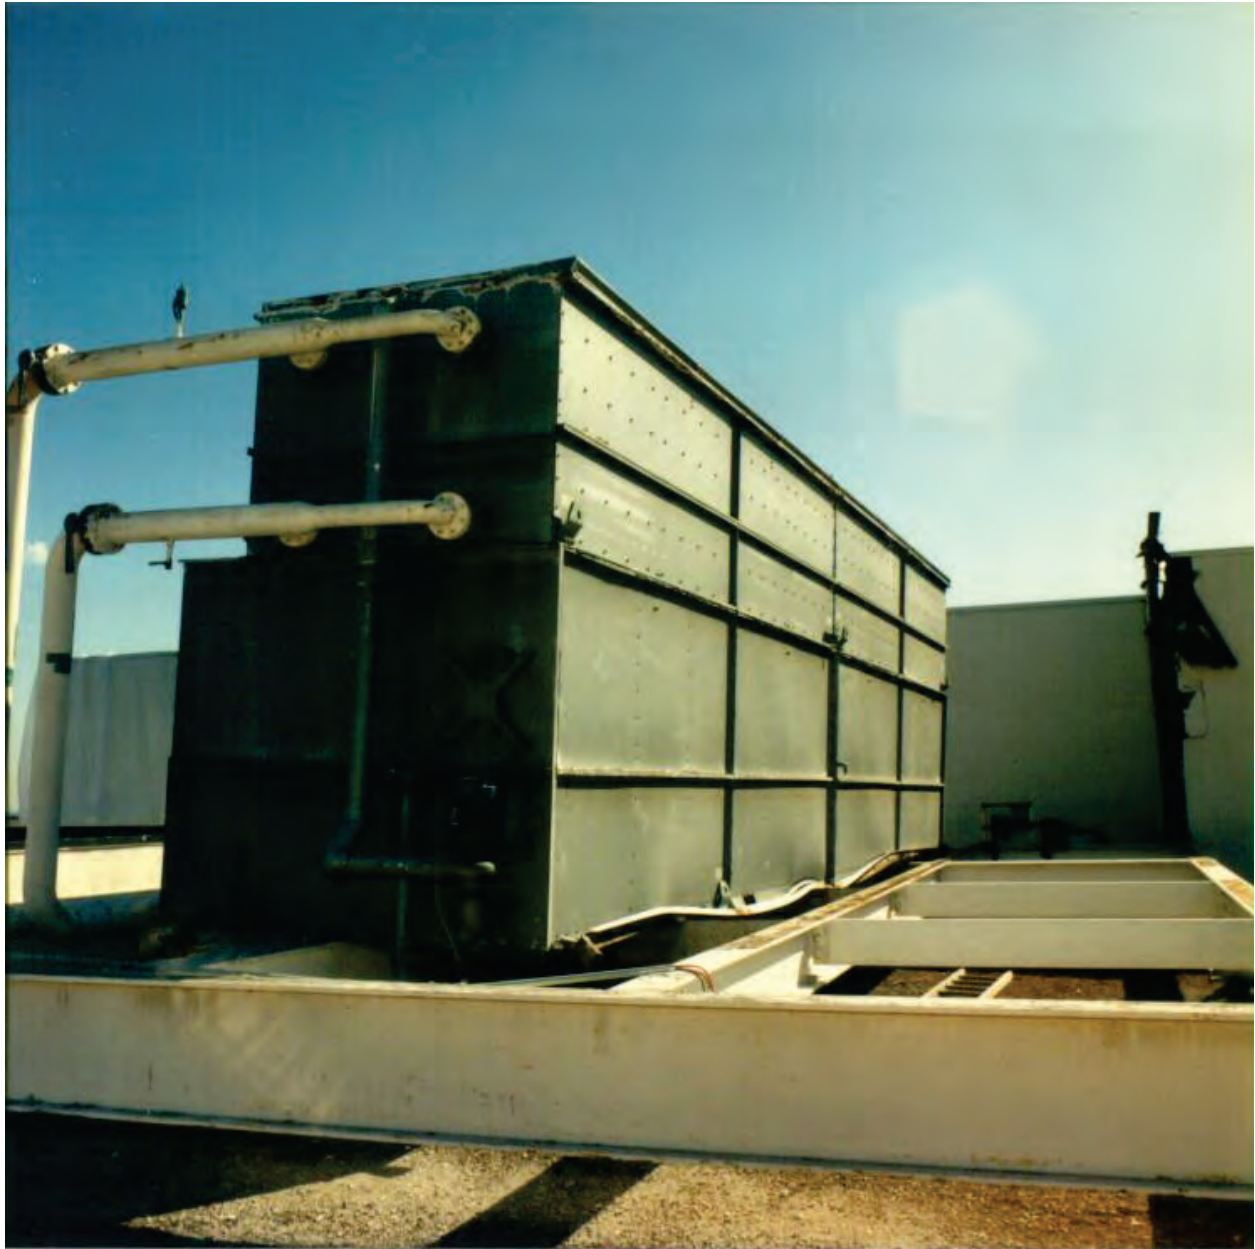
Figure 6.4.1.3-4 Rooftop equipment on isolators collapsed onto skid (Photo courtesy of Mason Industries).

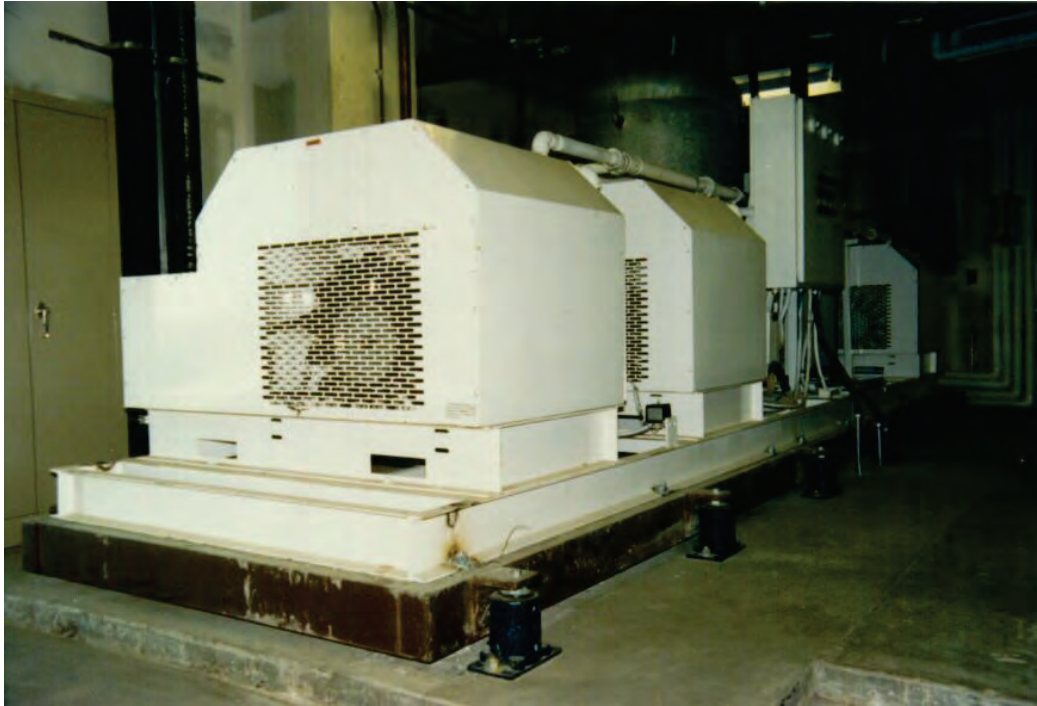
Figure 6.4.1.3-5 Restrained springs used to support heavy equipment (Photo courtesy of Mason Industries).

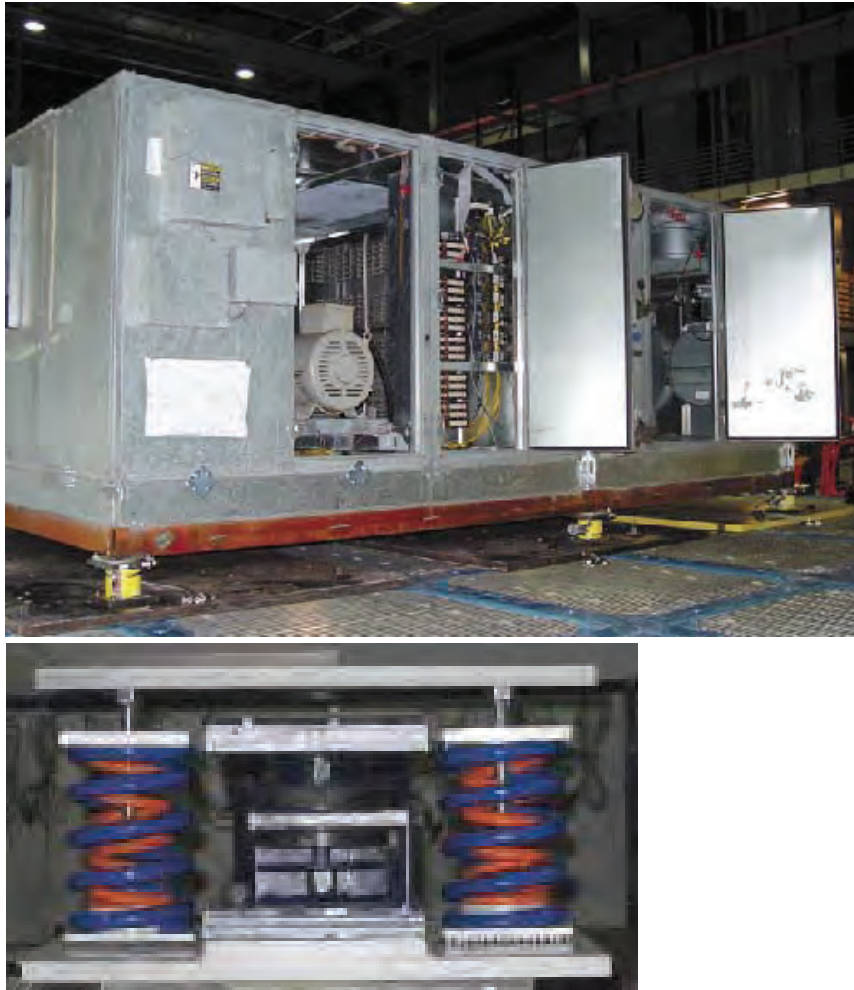
Figure 6.4.1.3-7 Seismic shake table testing of an air-handler unit and vibration isolation restraint system as part of the MCEER-ASHRAE project (Photos courtesy of André Filiatrault, MCEER).

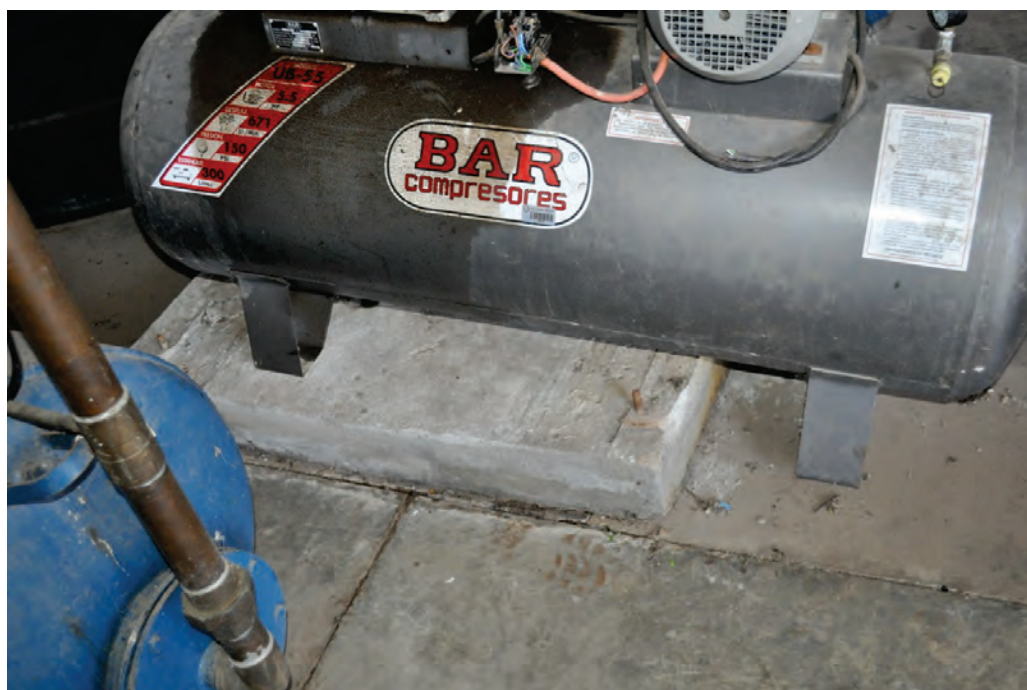
Figure 6.4.1.4-1 Poorly anchored compressor jumped off the undersized anchor bolts in the 2010 magnitude-8.8 Chile Earthquake (Photo courtesy of Eduardo Fierro, BFP Engineers).

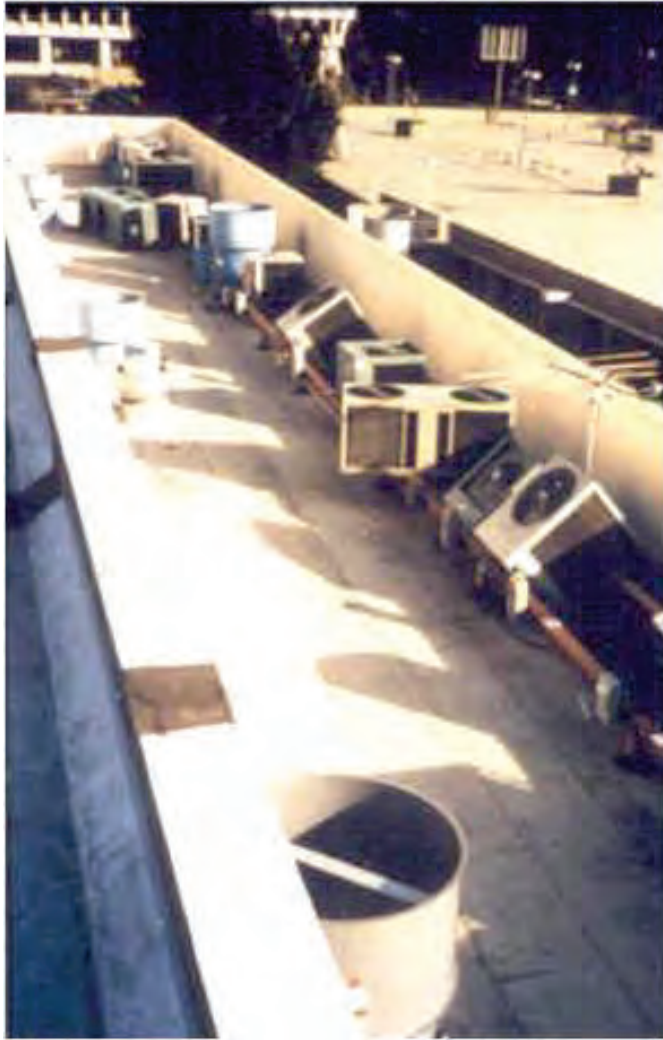
Figure 6.4.1.4-2 Unanchored rooftop units thrown off their supports during an earthquake (Photo courtesy of Maryann Phipps, Estructure).

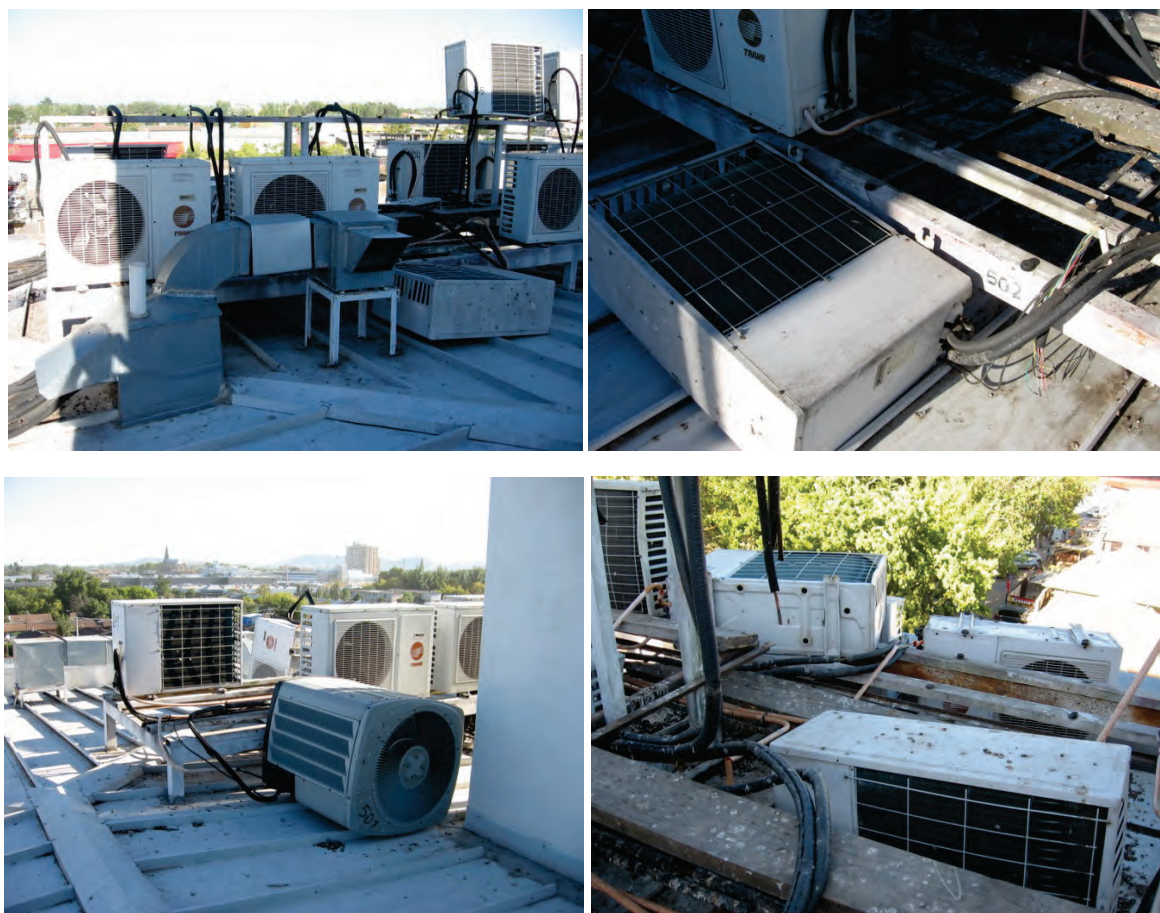
Figure 6.4.1.4-3 Numerous poorly anchored rooftop units toppled in the 2010 Chile Earthquake (Photos courtesy of Rodrigo Retamales, Rubén Borosc hek & Associates).

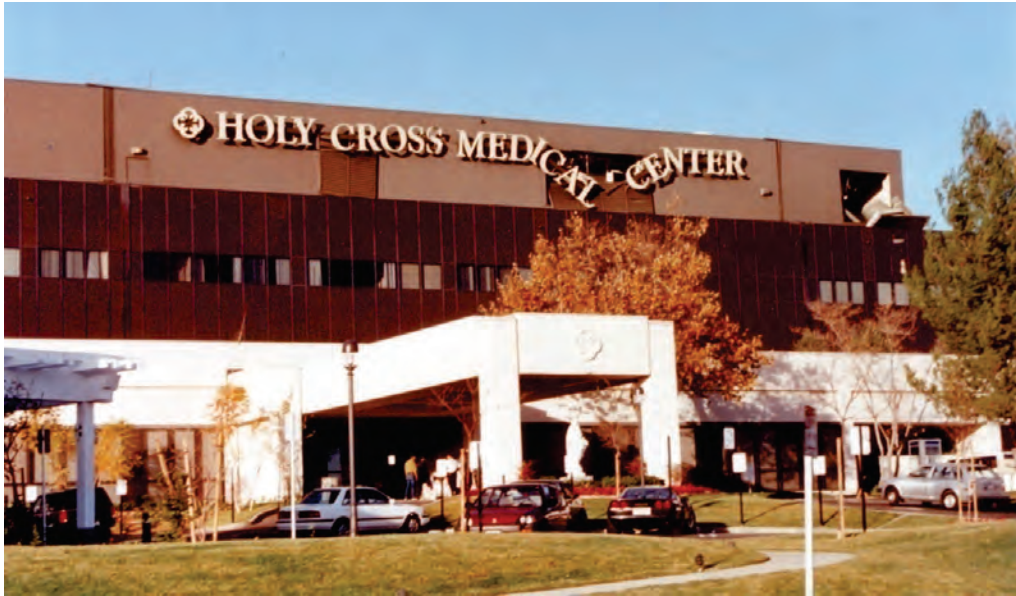
Figure 6.4.1.5-1 Damage to suspended HVAC, signs, and louvers was caused when suspended fans in the mechanical penthouse swung and impacted the louver panels. Holy Cross Medical Center in Sylmar, as a result of the 1994 magnitude-6.7 Northridge Earthquake (Photo courtesy of Robert Reitherman).

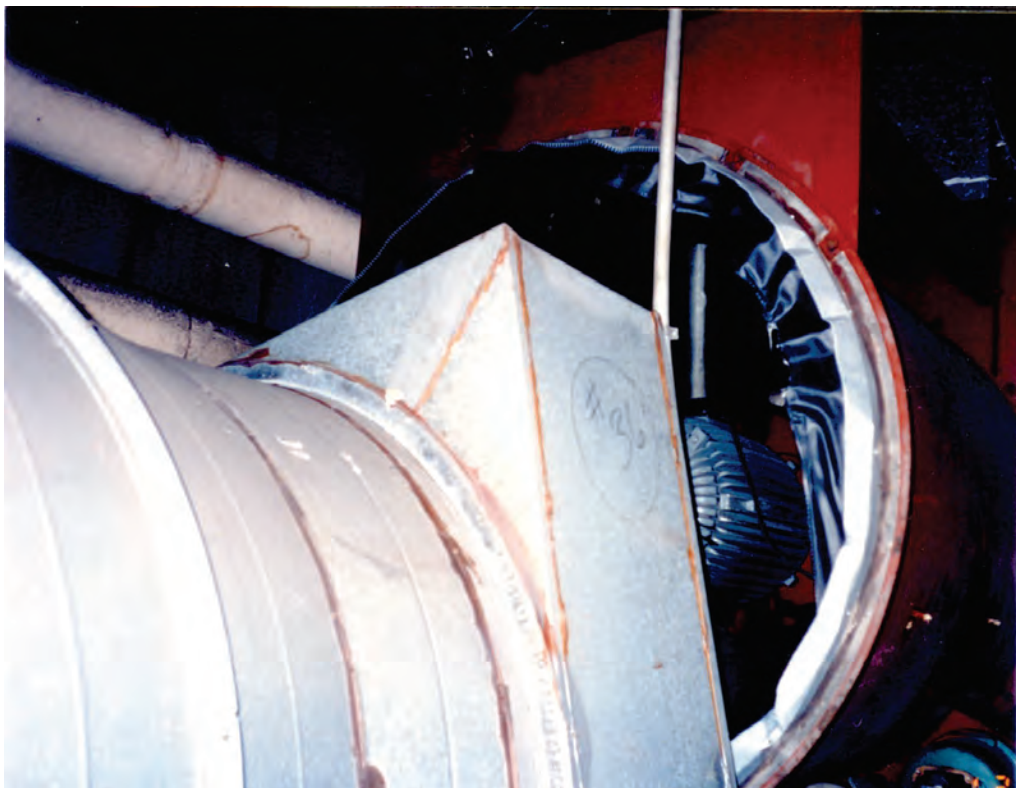
Figure 6.4.1.5-2 Sheet metal duct separated from suspended fan unit (Photo courtesy of Wiss, Jenney, Elstner Associates).

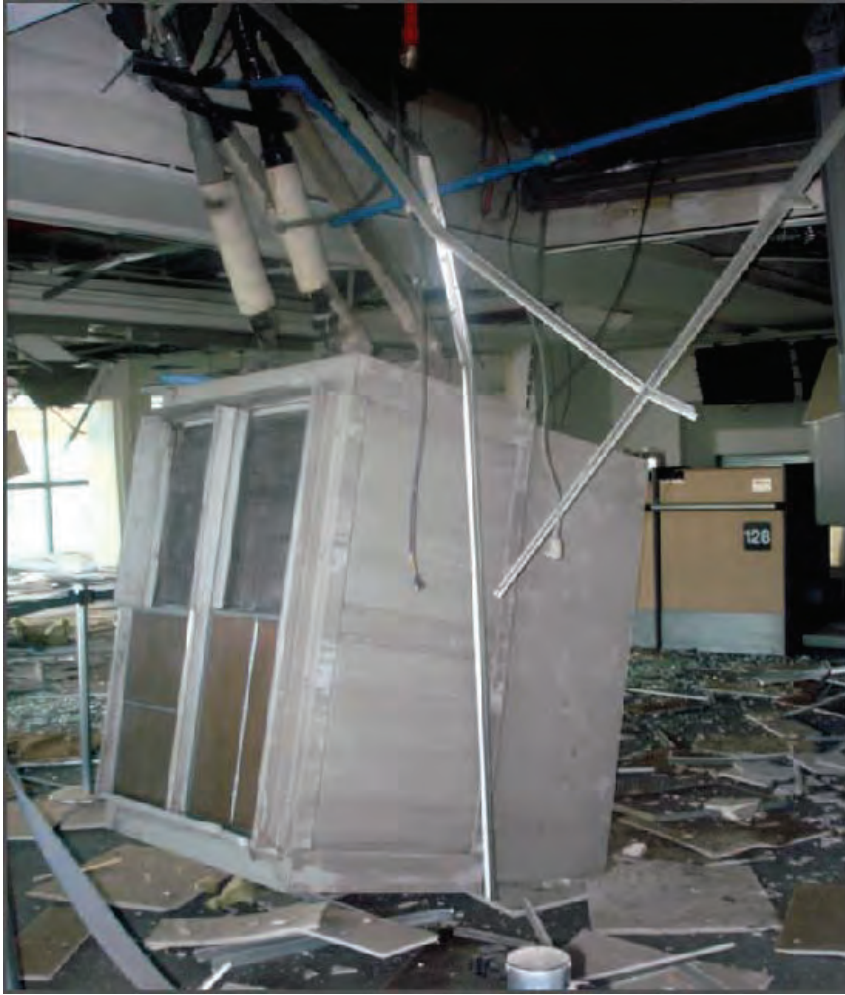
Figure 6.4.1.5-3 Suspended HVAC equipment came down at the Santiago airport terminal in the 2010 magnitude-8.8 Chile Earthquake (Photo courtesy of Gokhan Pekcan).

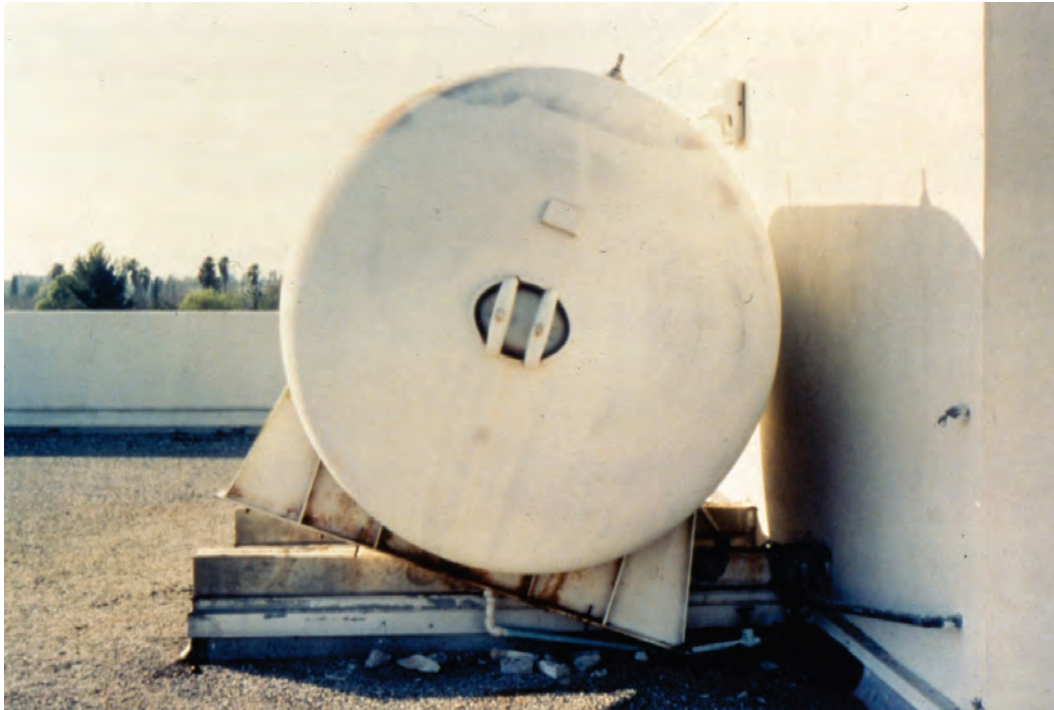
Figure 6.4.2.1-1 Tank shifted off support curb, Granada Hills Hospital in the 1994 magnitude-6.7 Northridge Earthquake (Photo courtesy of OSHPD).

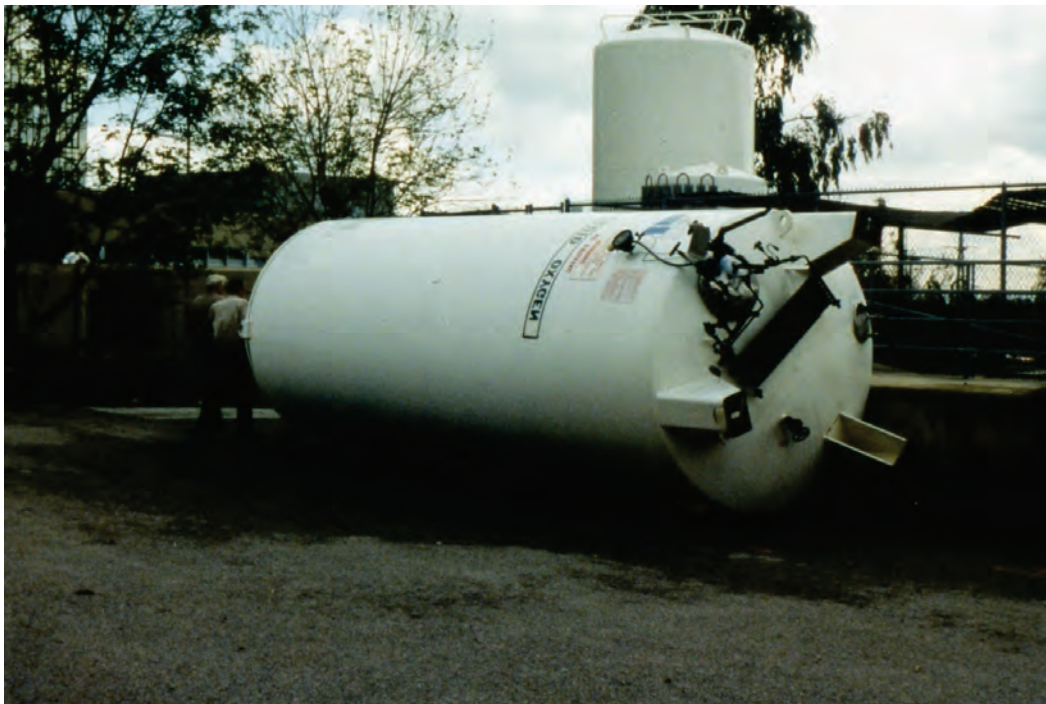
Figure 6.4.2.1-2 A vertical tank at hospital overturned due to inadequate anchorage in the 1994 Northridge Earthquake (Photo courtesy of OSHPD).

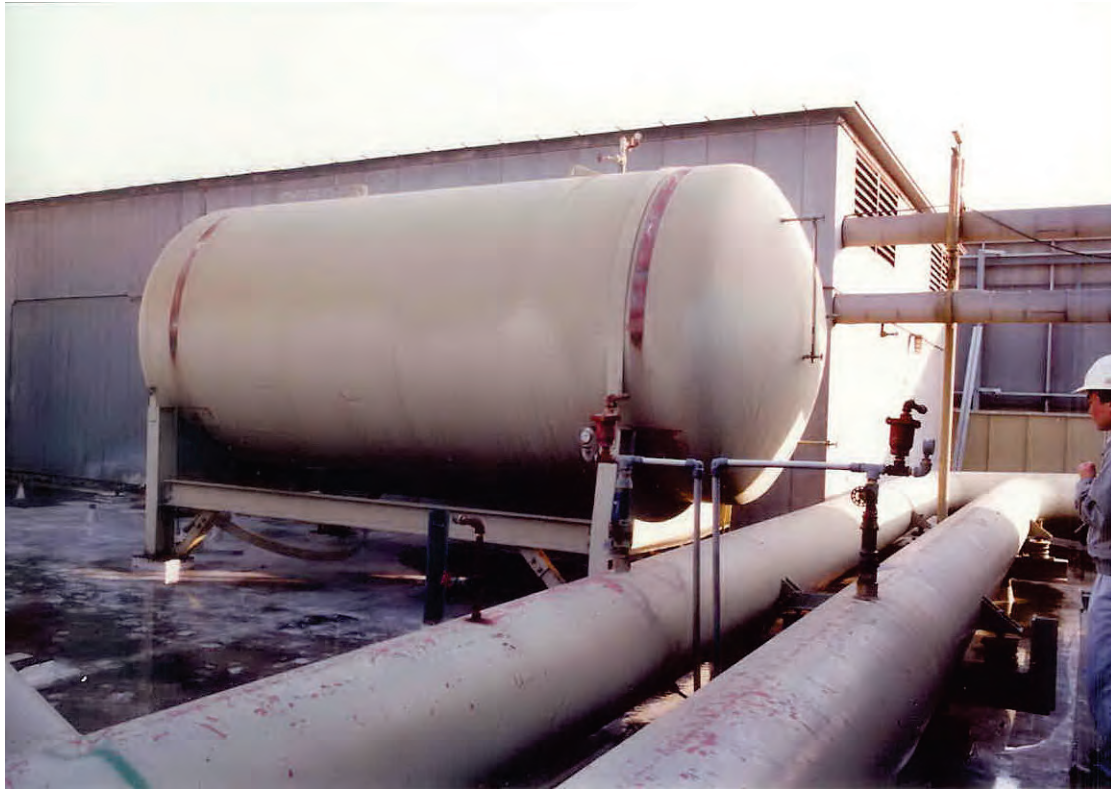
Figure 6.4.2.1-3 Horizontal tank strapped to structural support frame on hospital roof; one strap failed and tank slid six inches in the 1994 Northridge Earthquake (Photo courtesy of OSHPD).

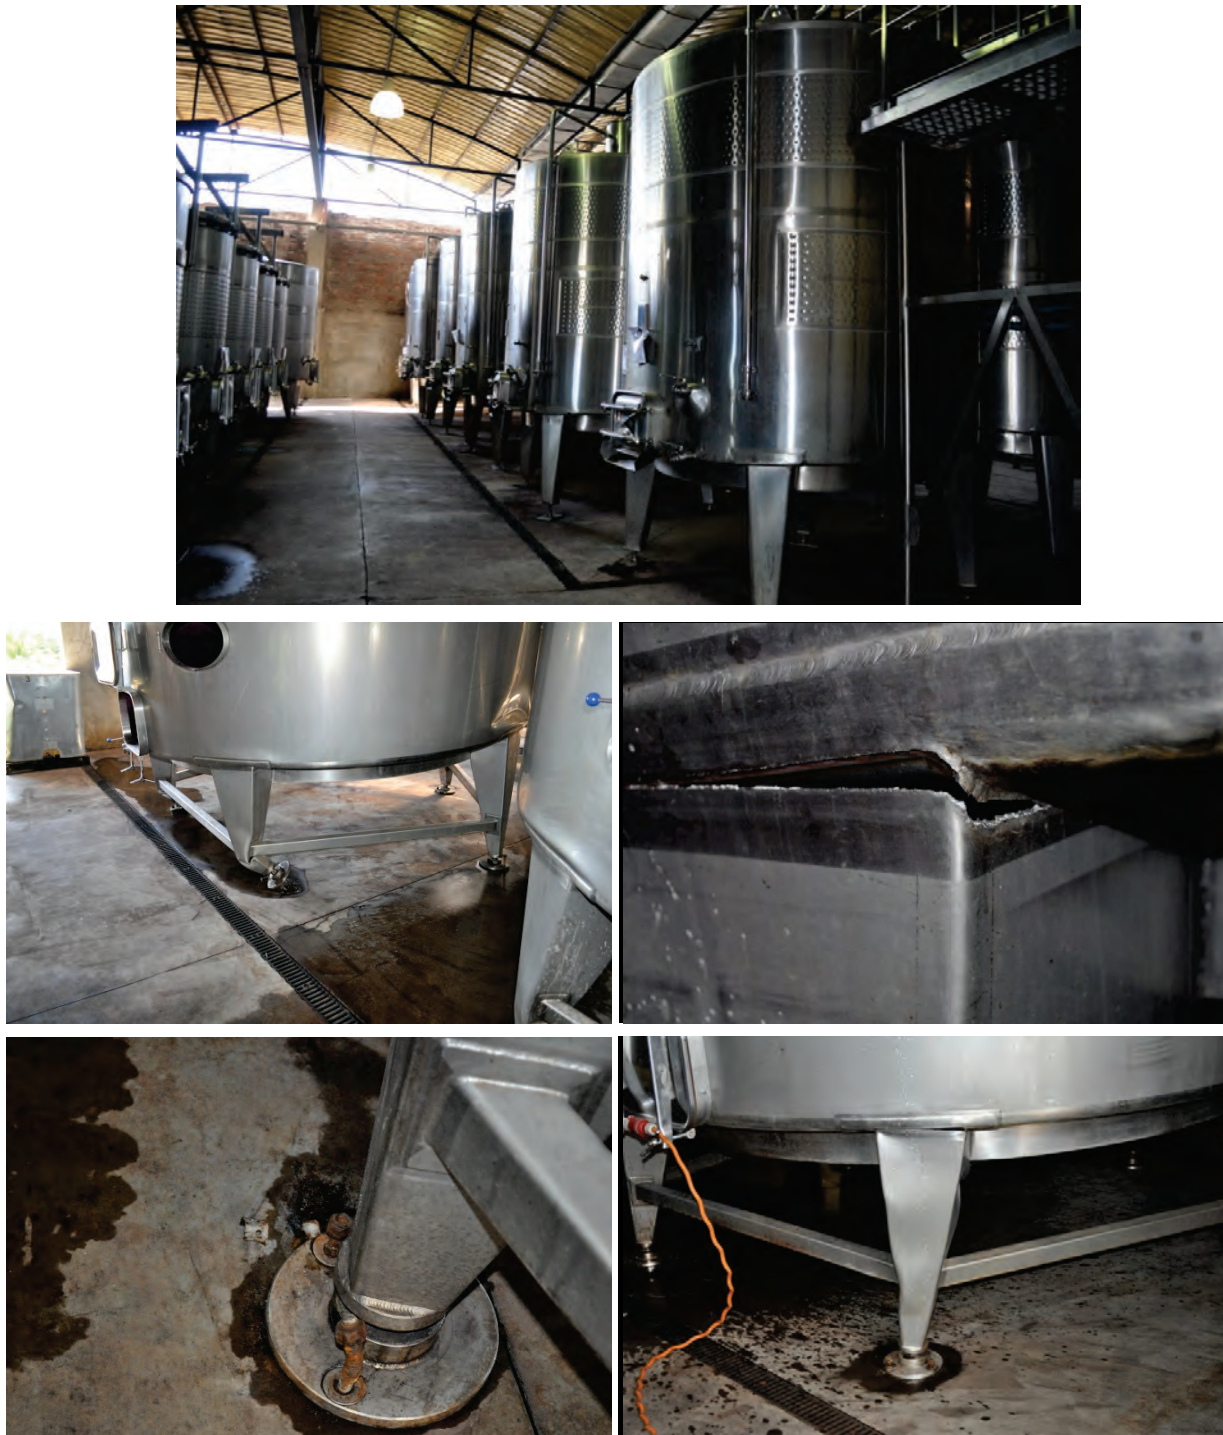
Figure 6.4.2.1-4

Wineries suffered extensive damage in the 2010 magnitude-8.8 Chile Earthquake with many barrels of wine spilled. This winery had damage to anchored tanks; tank anchorage failed, legs buckled, welds tore, anchor bolts pulled up, etc. The tank legs all have leveling bolts at the bottom, creating a weak zone between the bottom of the leg and the anchor plate. Similar unanchored tanks in this facility shifted position but were undamaged (Photos courtesy of Eduardo Fierro, BFP Engineers).

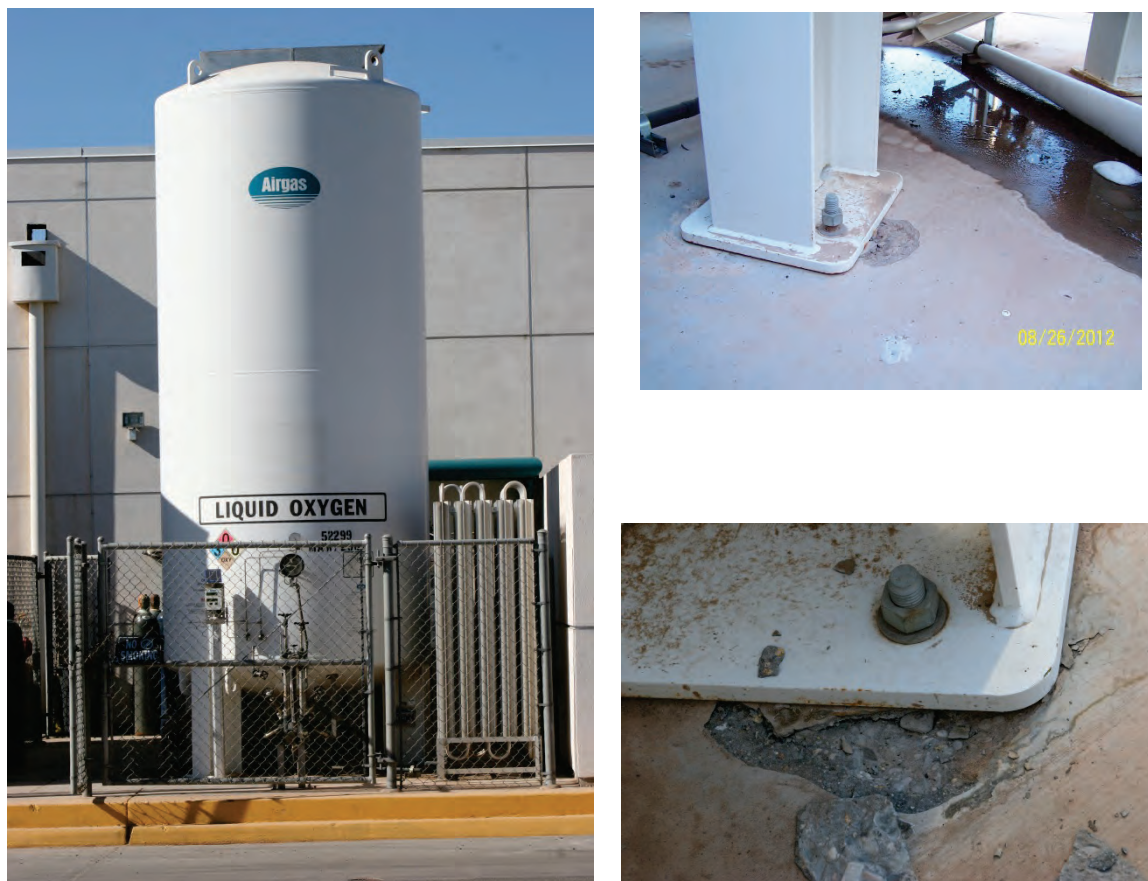
Figure 6.4.2.1-5 Damage to tanks at the Pioneer Memorial Hospital at the 2012 Brawley Earthquake (Photo courtesy of Chris Tokas, OSHPD)

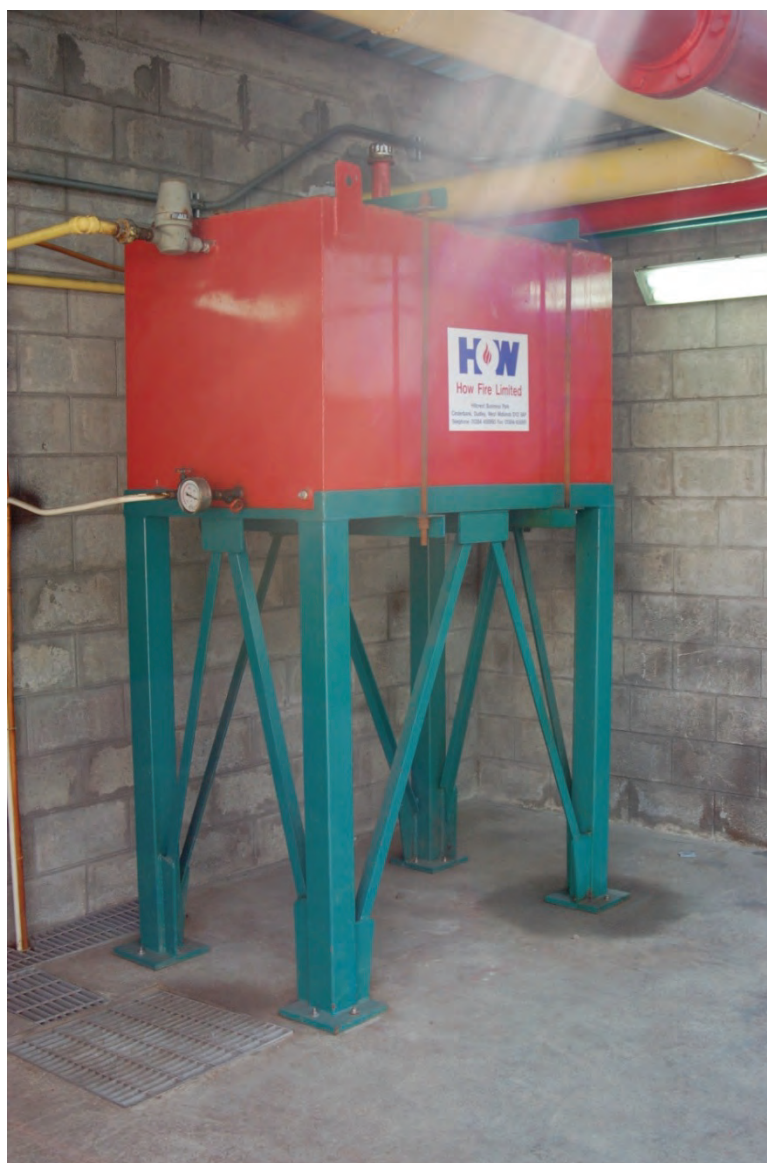
Figure 6.4.2.1-6 Braces added to four sides of tank support structure (Photo courtesy of Eduardo Fierro, BFP Engineers).

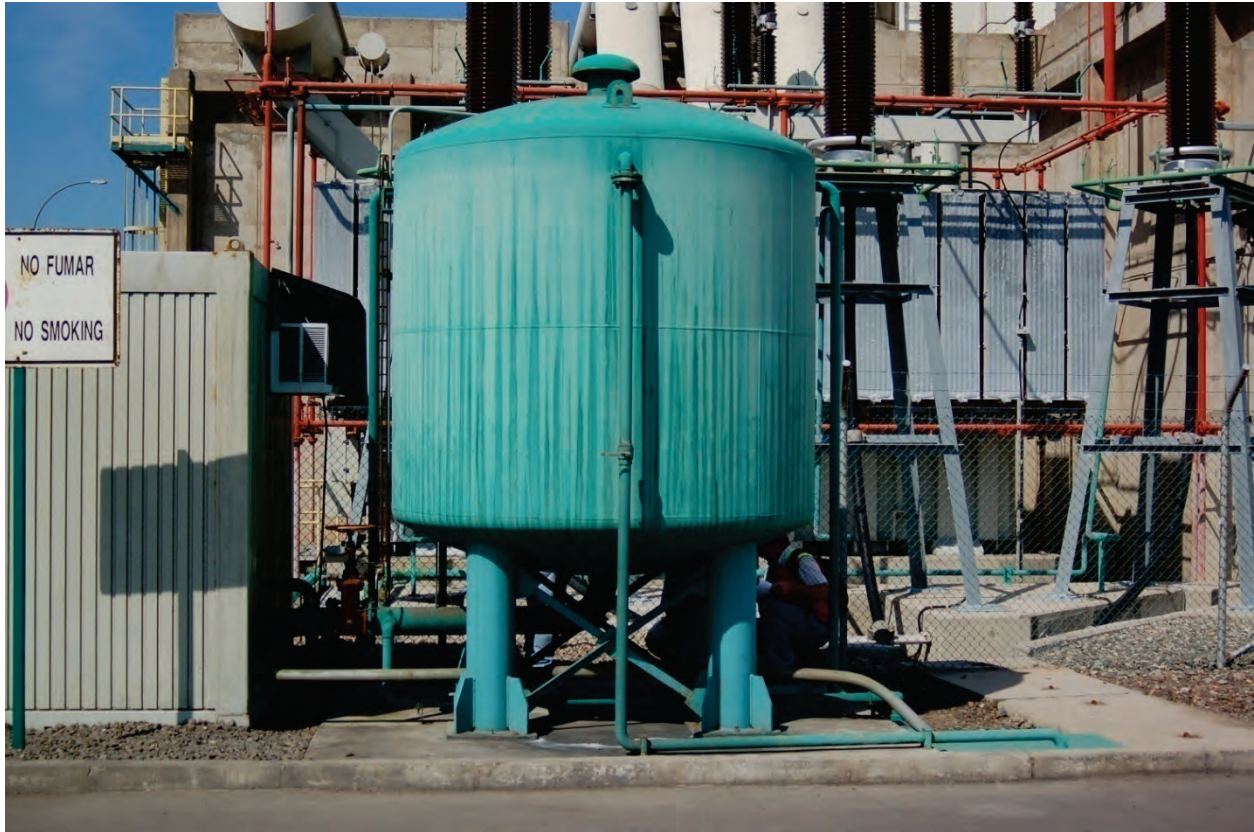
Figure 6.4.2.1-7 Gusset plates and cross bracing added at base of vertical tank on four legs following the 2001 magnitude-8.4 Peru Earthquake (Photo courtesy of Eduardo Fierro, BFP Engineers).

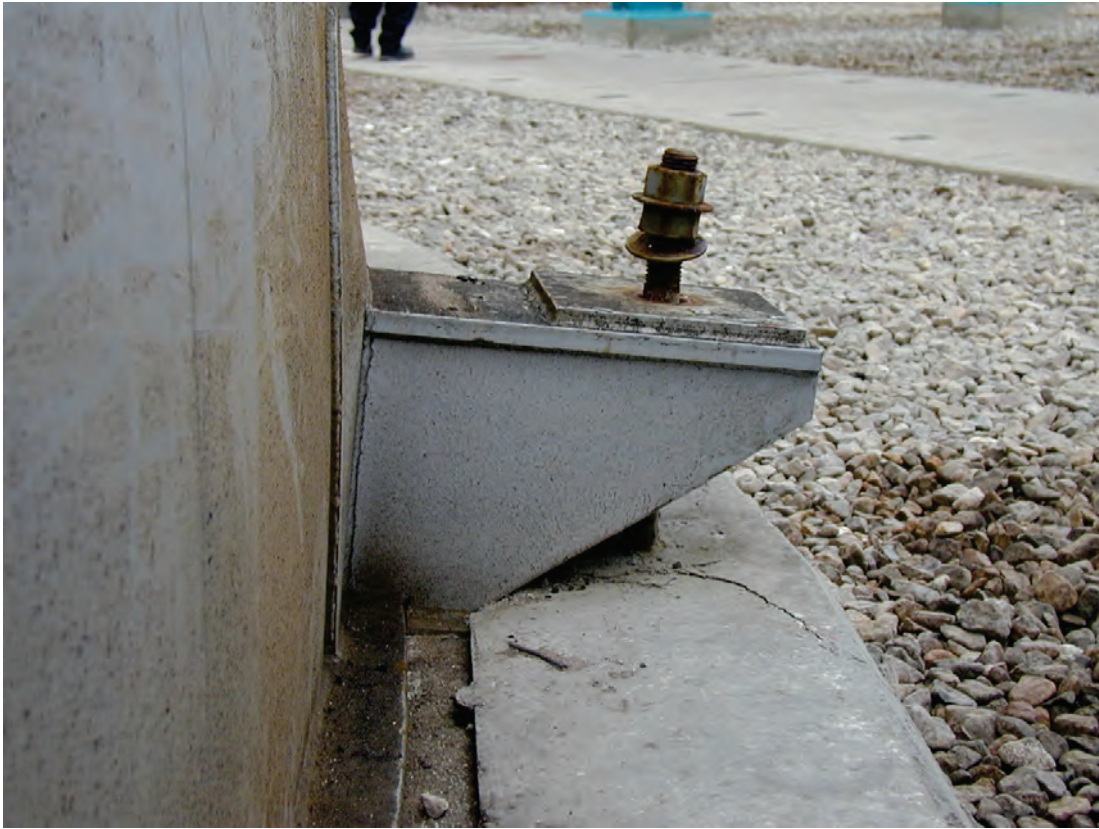
Figure 6.4.2.2-1 Damage to ductile connection at base of a 5000 cubic meter diesel fuel tank in the 2001 magnitude-8.4 Peru Earthquake. All eight connections were damaged; damage included bolt elongation, deformation of tank wall, and cracked concrete pad (Photo courtesy of Eduardo Fierro, BFP Engineers).

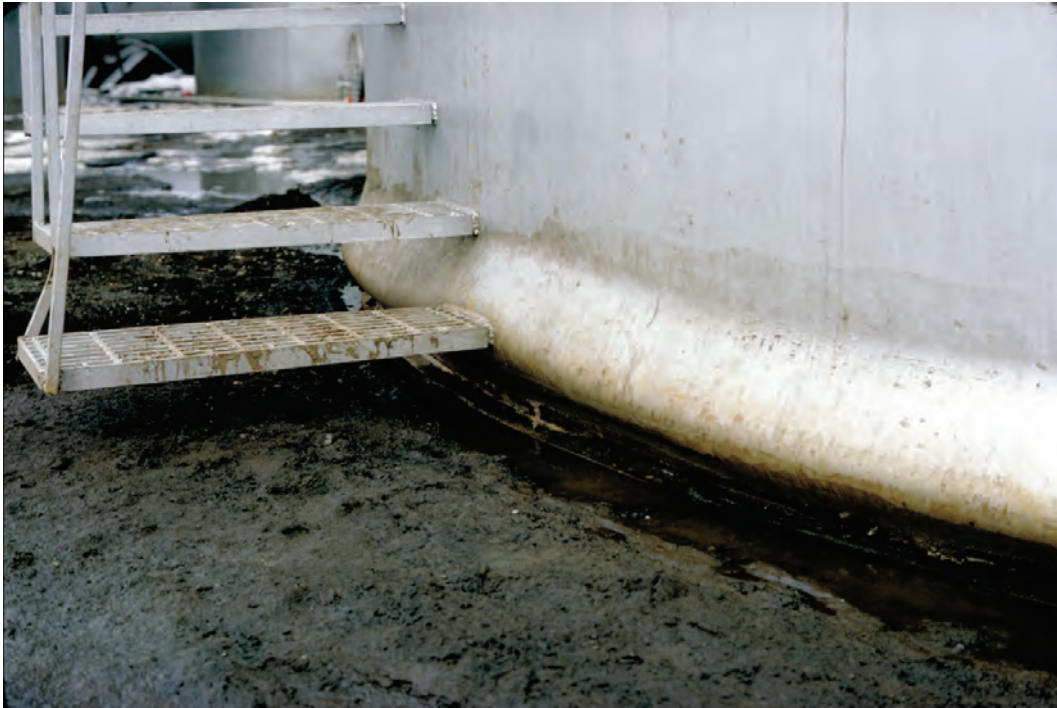
Figure 6.4.2.2-2 Tank with “elephant’s foot” buckle at the base in the 1964 magnitude-9.2 Anchorage, Alaska earthquake (Photo courtesy of PEER, Steinbrugge Collection, No. S2508)

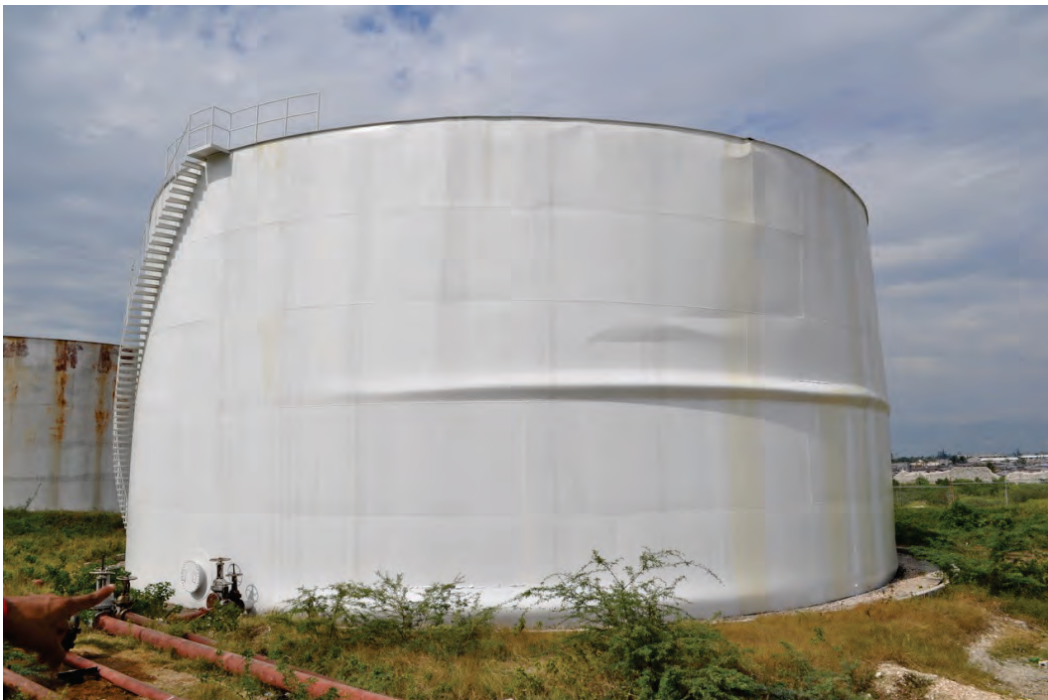
Figure 6.4.2.2-3 Tank with “elephant’s foot” and “elephant knee” in Port-au-Prince in the 2010 magnitude-7 Haiti Earthquake (Photo courtesy of Eduardo Fierro, BFP Engineers).
