Reducing the Risks of Nonstructural Earthquake Damage – A Practical Guide

FEMA E-74 / December 2012

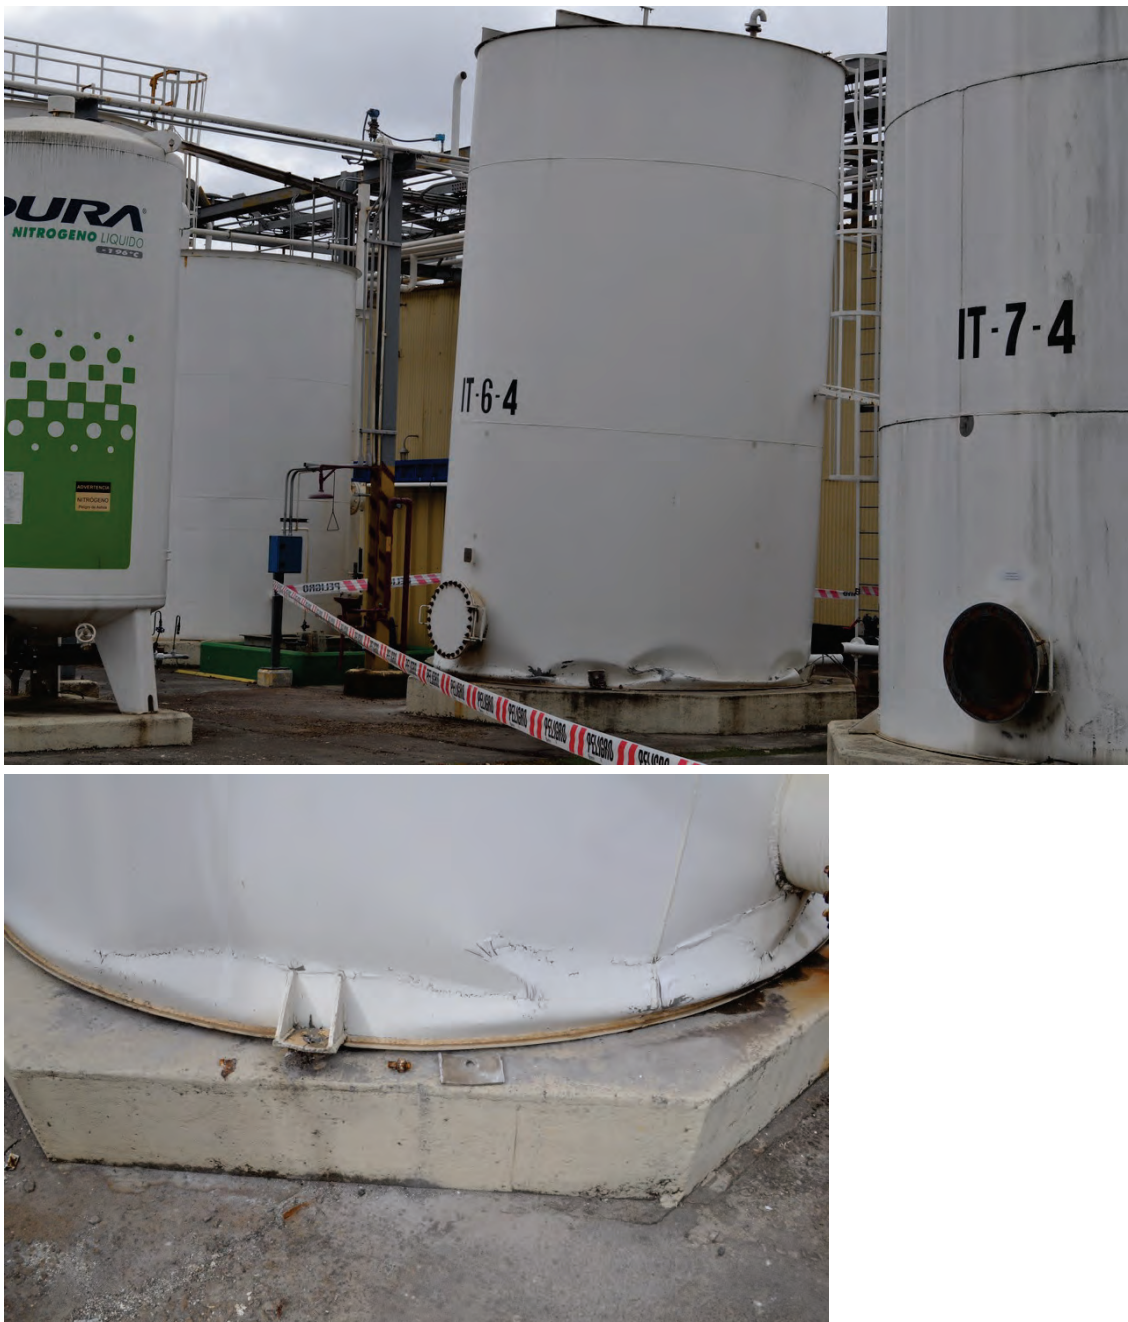
Figure 6.4.2.2-4 Anchored tank damaged at base when anchorage failed; tank slid and ruptured attached piping in 2010 magnitude-8.8 Chile Earthquake (Photo courtesy of Eduardo Fierro, BFP Engineers).

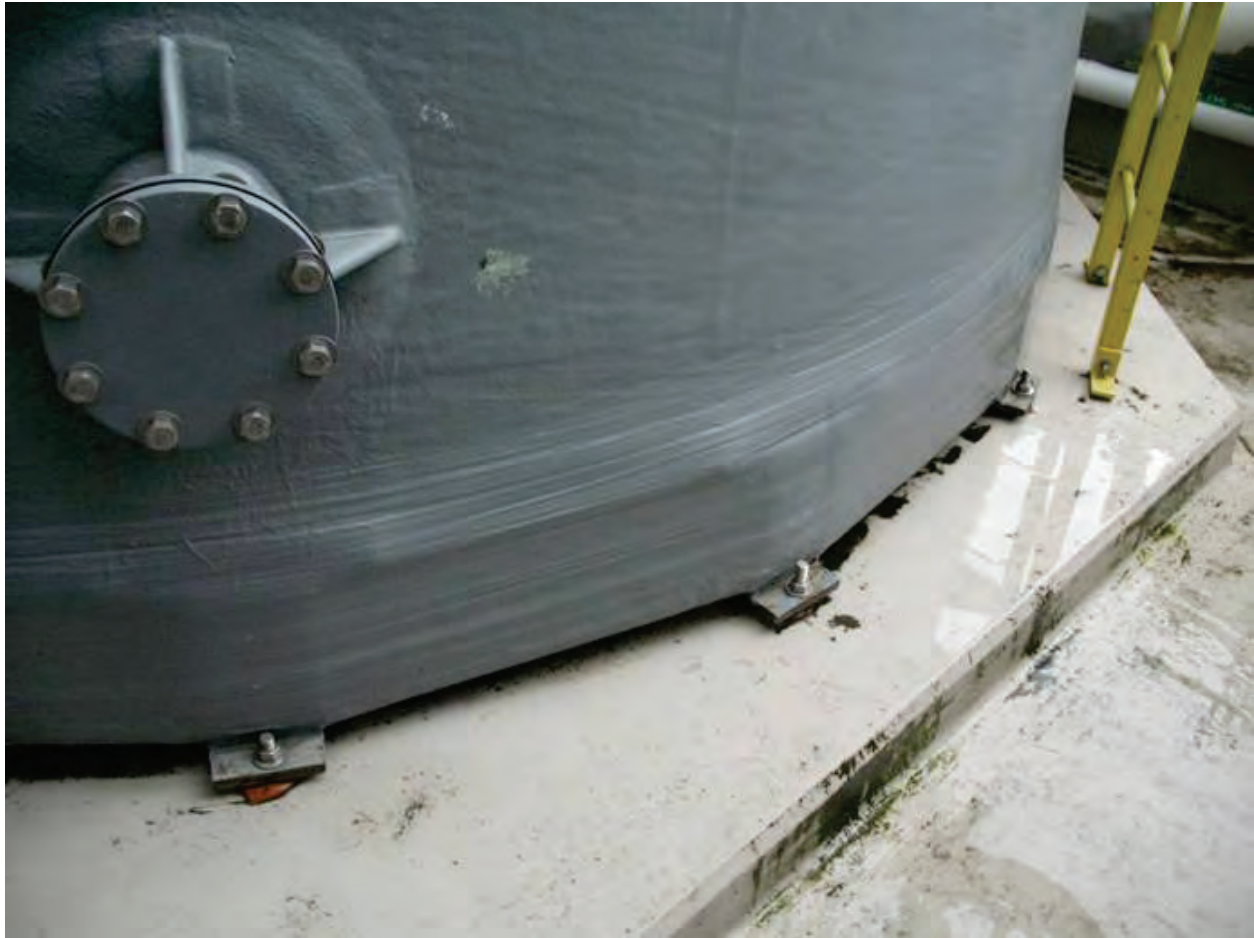
Figure 6.4.2.2-6 Anchors at base of fiberglass reinforced plastic tank (Photo courtesy of Jeffrey Soulages, Intel).

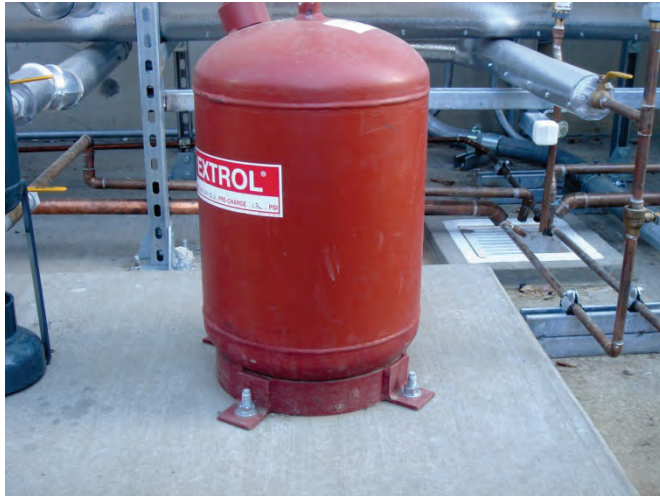
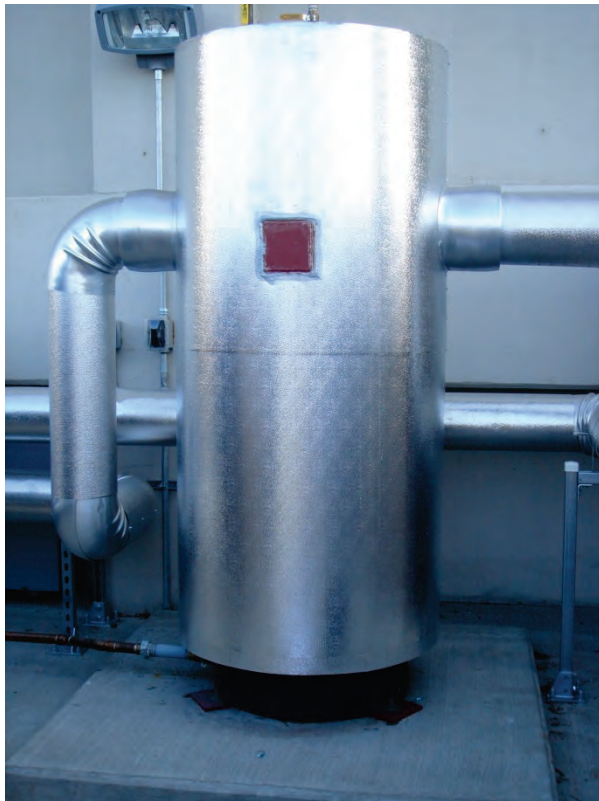
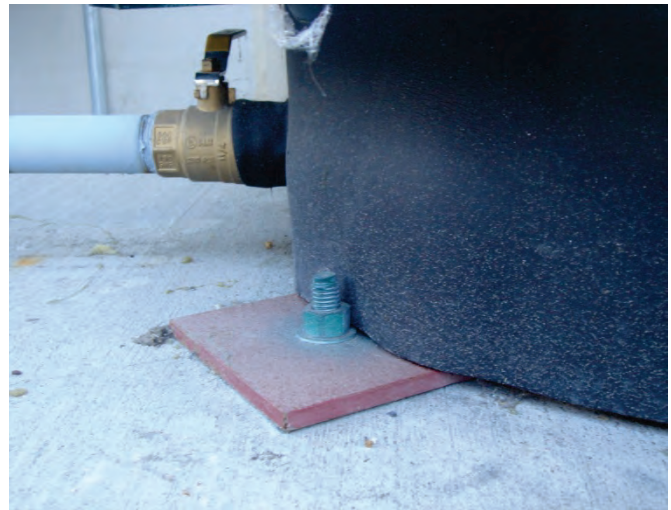
Figure 6.4.2.2-7 Examples of rigid base anchorage for small circular tanks (Photos courtesy of Maryann Phipps, Estructure).

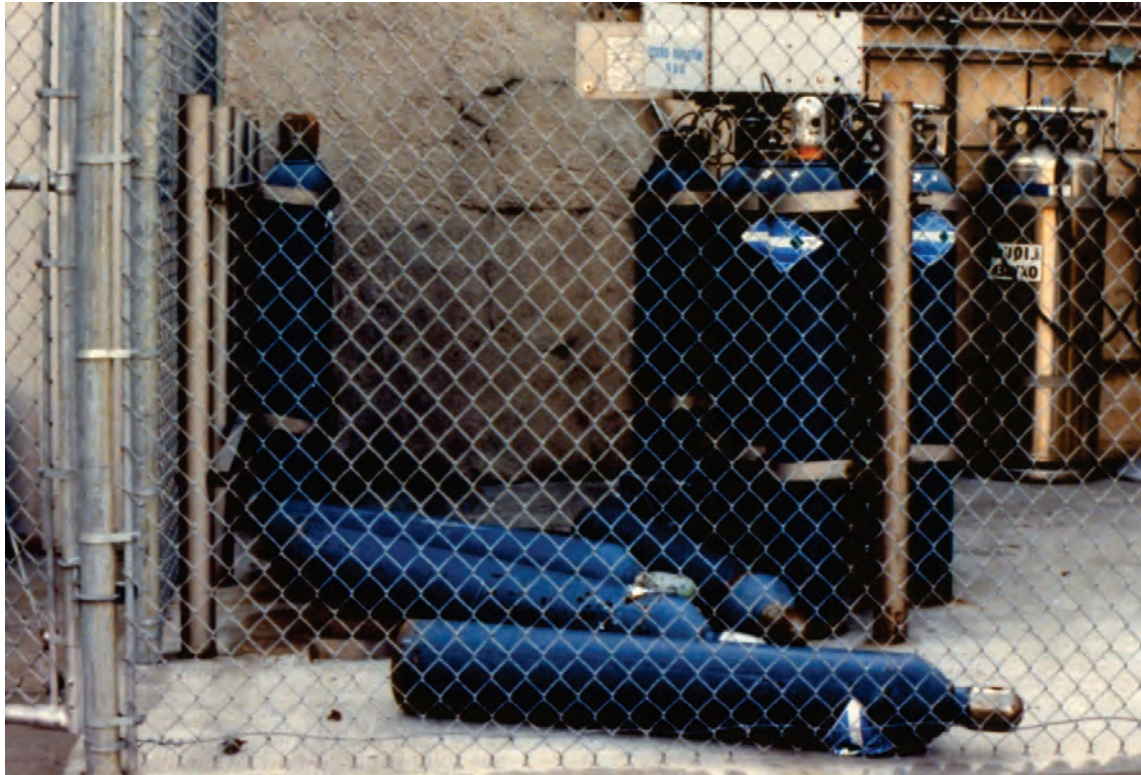
Figure 6.4.2.3-1 Unanchored tanks inside fenced enclosure in the 1994 magnitude-6.7 Northridge Earthquake (Photo courtesy of OSHPD).

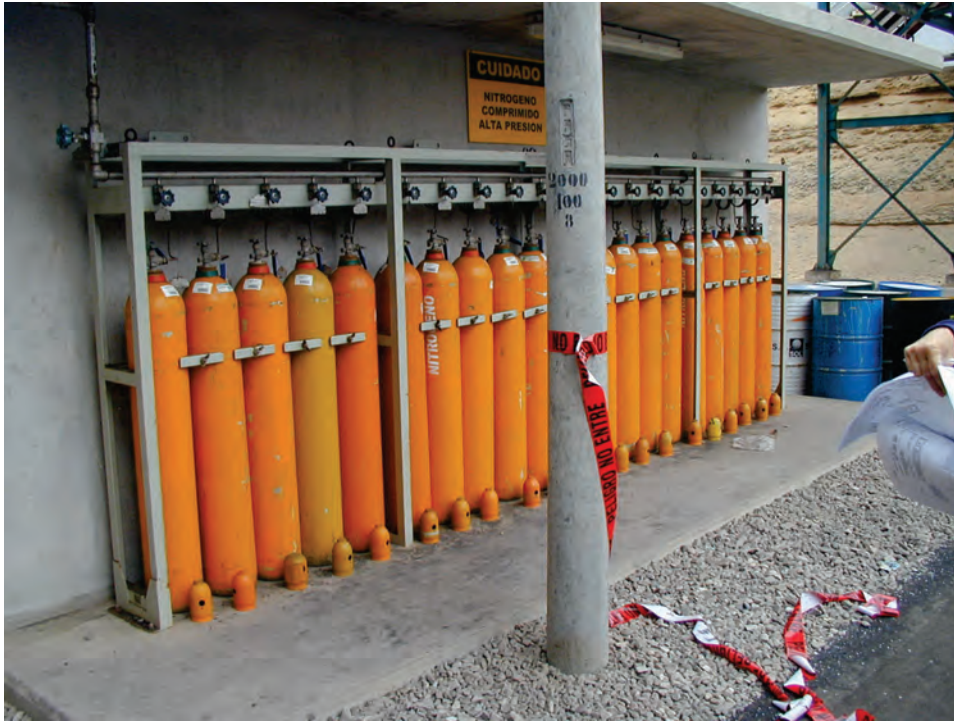
Figure 6.4.2.3-2 Gas cylinder anchorage with attached gas lines undamaged in the 2001 magnitude-8.4 Peru Earthquake (Photo courtesy of Eduardo Fierro, BFP Engineers).

- Wall restraint detail shown at top of Figure 6.4.2.3-8 is a non-engineered detail for tank storage; this detail does not provide sufficient restraint for tanks attached to piping.
- Engineered details with additional restraints are required for tanks attached to piping; see corral detail at bottom of Figure 6.4.2.3-7 or scheme shown in Figures 6.4.2.3-2 and 6.4.2.3-3.

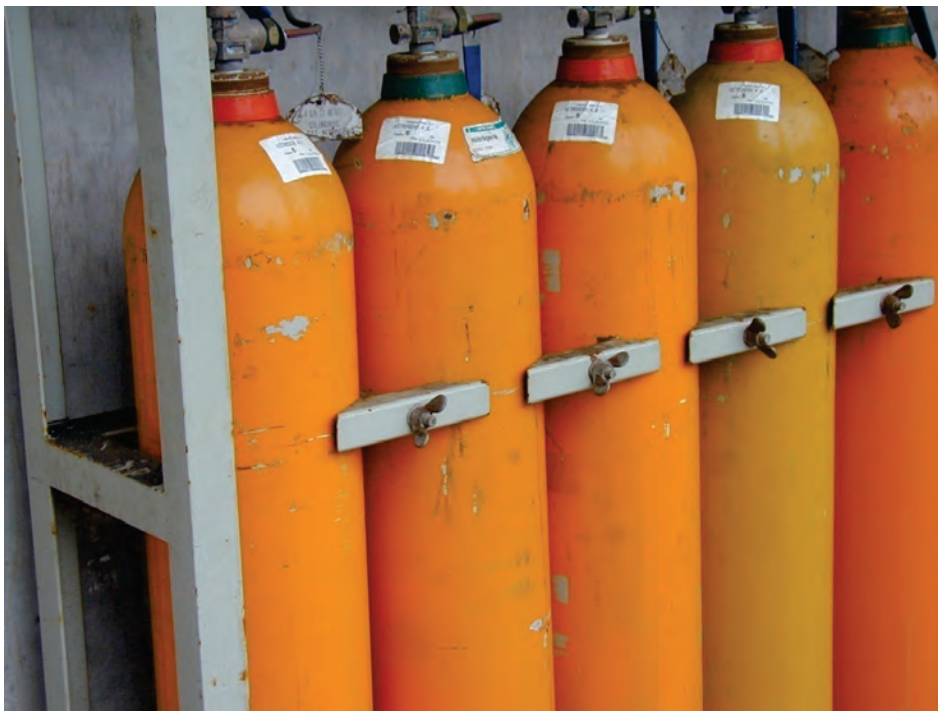
Figure 6.4.2.3-3 Detail of undamaged gas cylinder installation (Photo courtesy of Eduardo Fierro, BFP Engineers).

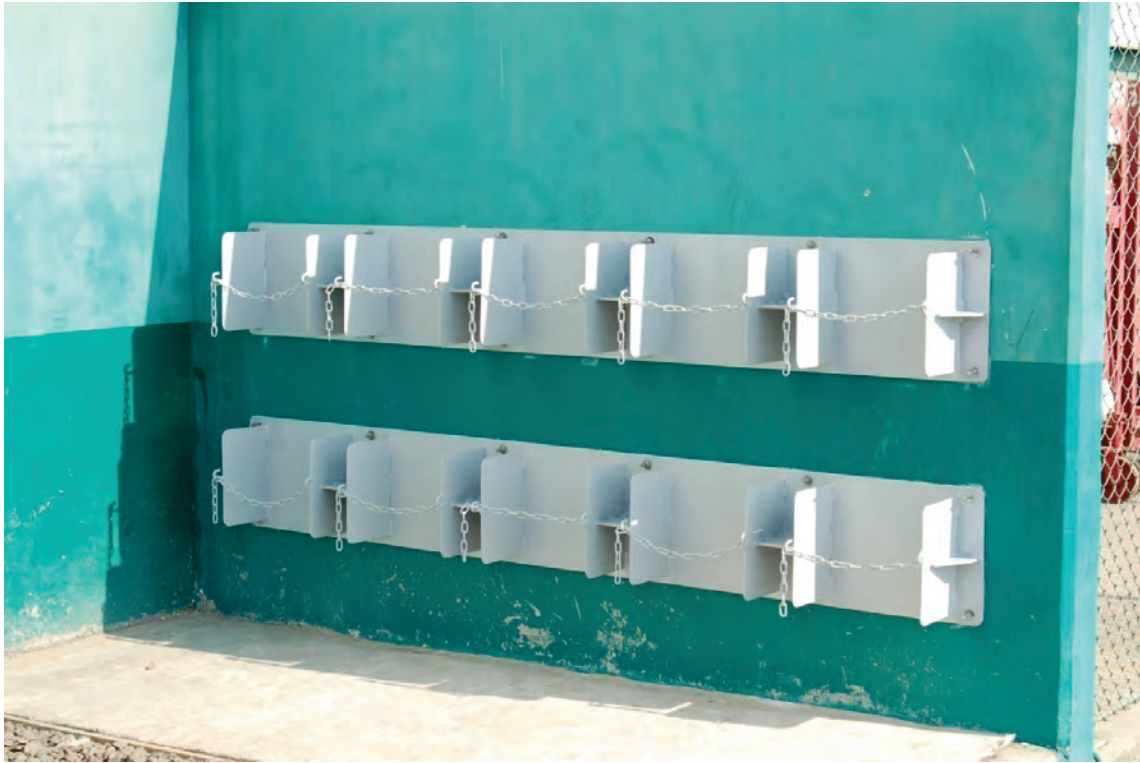
Figure 6.4.2.3-4 Wall-mounted cylinder restraints upgraded with stiffener plates following the 2001 Peru Earthquake(Photo courtesy of Eduardo Fierro, BFP Engineers).

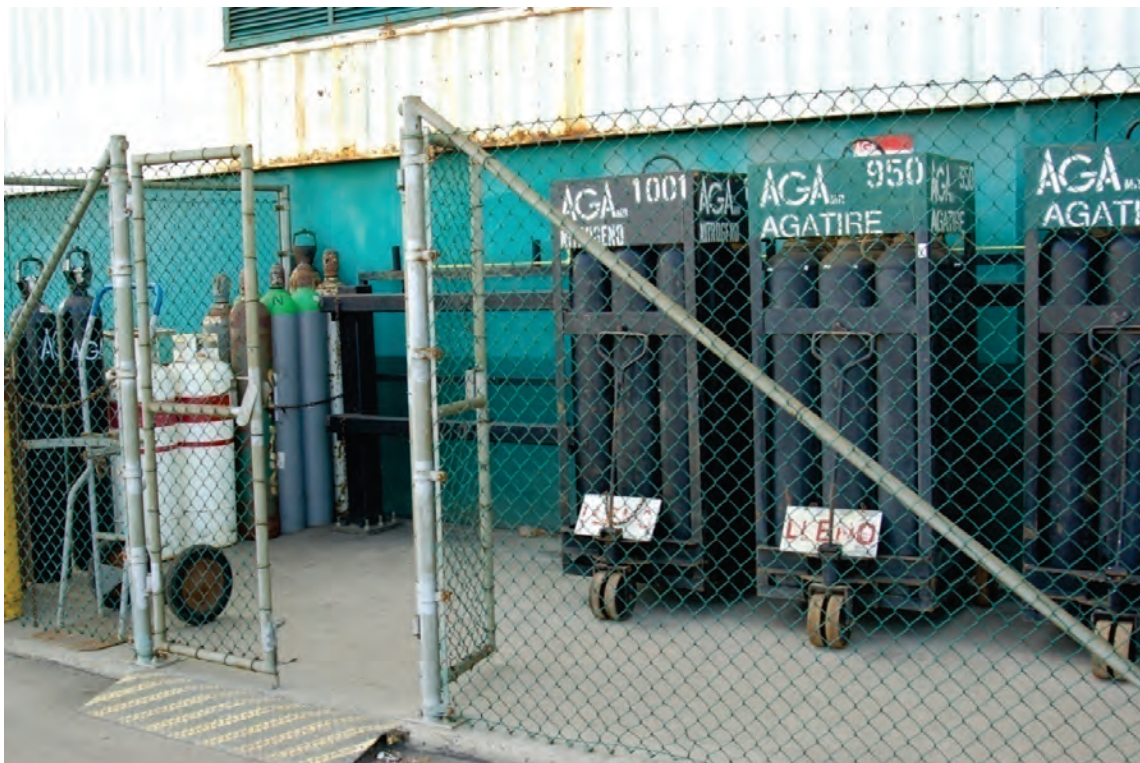
Figure 6.4.2.3-5 Steel tube supports for mobile gas cylinder carts (Photo courtesy of Eduardo Fierro, BFP Engineers).

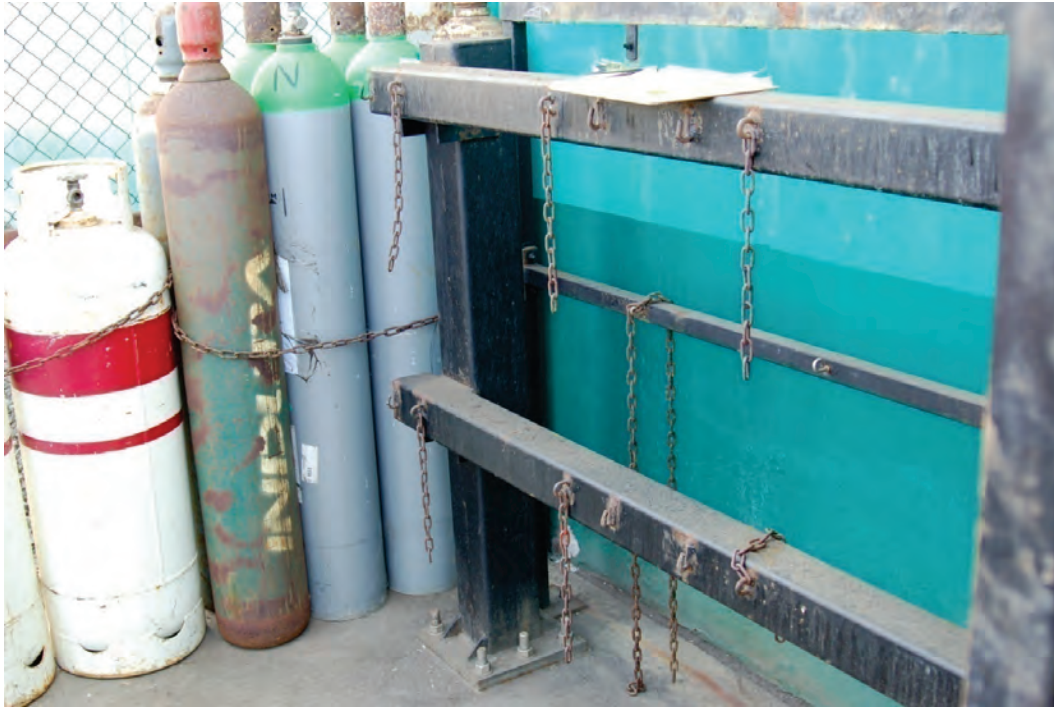
Figure 6.4.2.3-6 Detail of steel tube supports and chains (Photo courtesy of Eduardo Fierro, BFP Engineers).

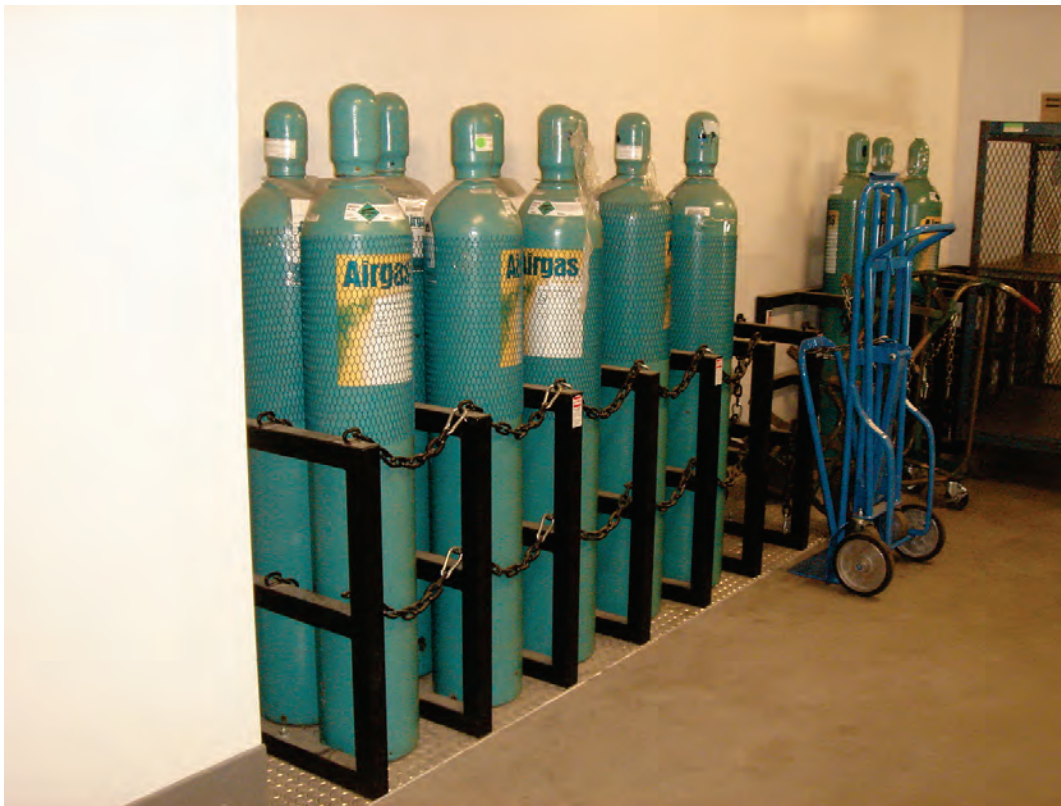
Figure 6.4.2.3-7 Detail of enclosures for airgas tanks in a hospital; chains attached with quick release hooks (Photo courtesy of Maryann Phipps, Estructure).

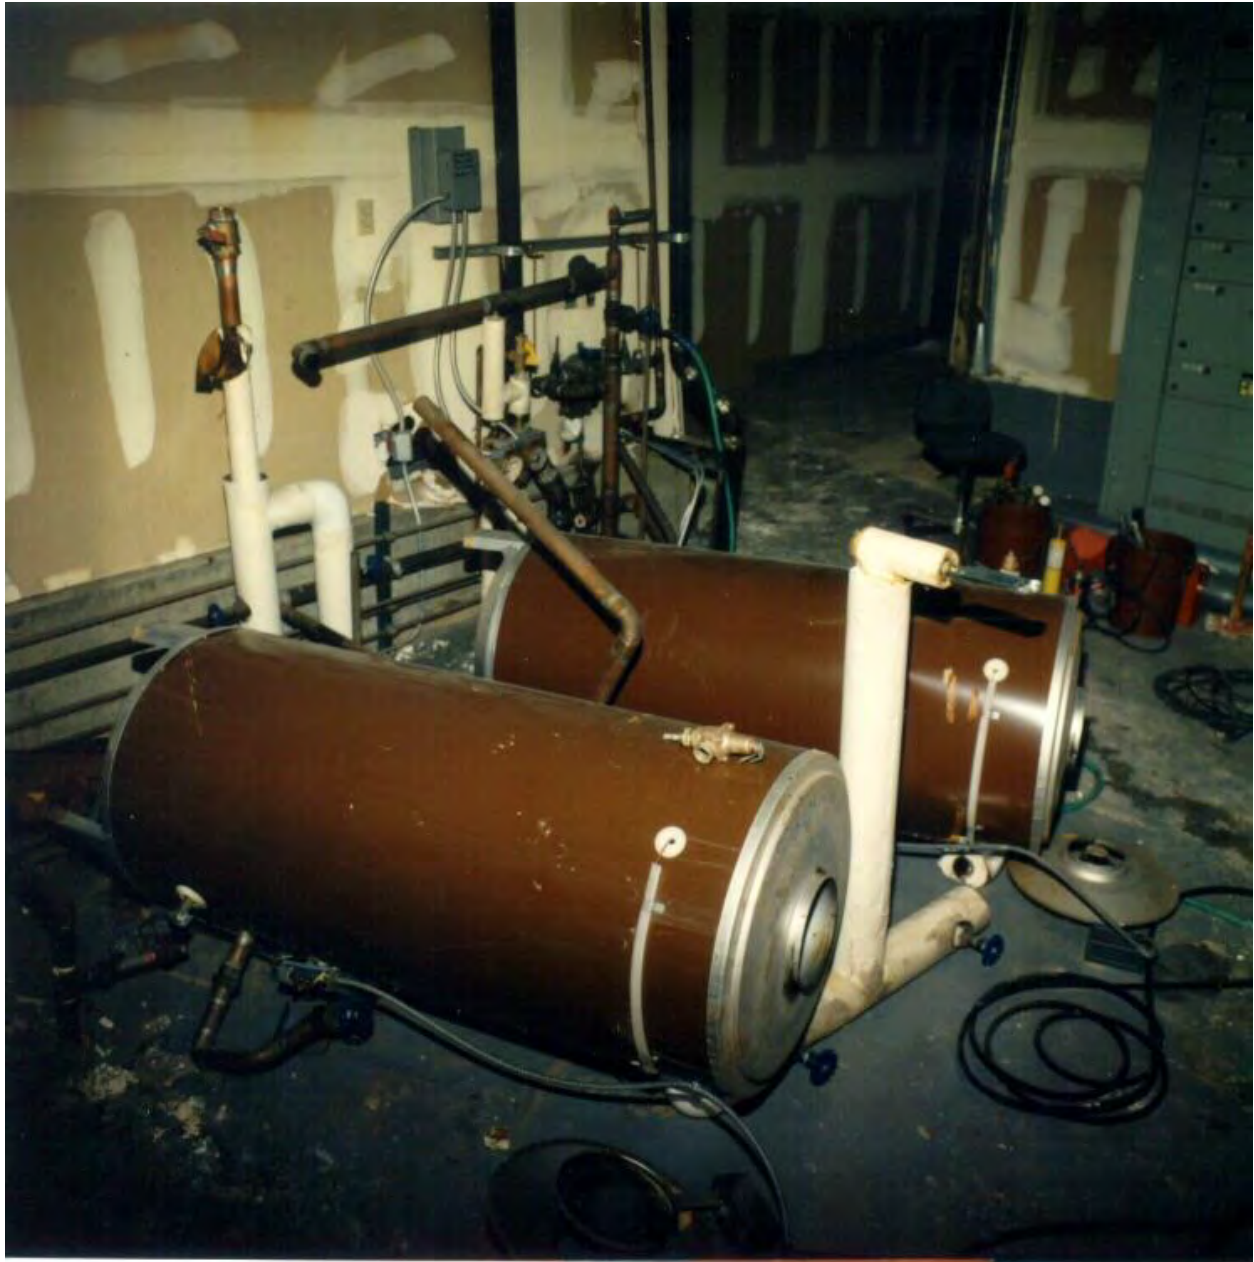
Figure 6.4.2.4-1 Unanchored water heaters overturned (Photo courtesy of Mason Industries).

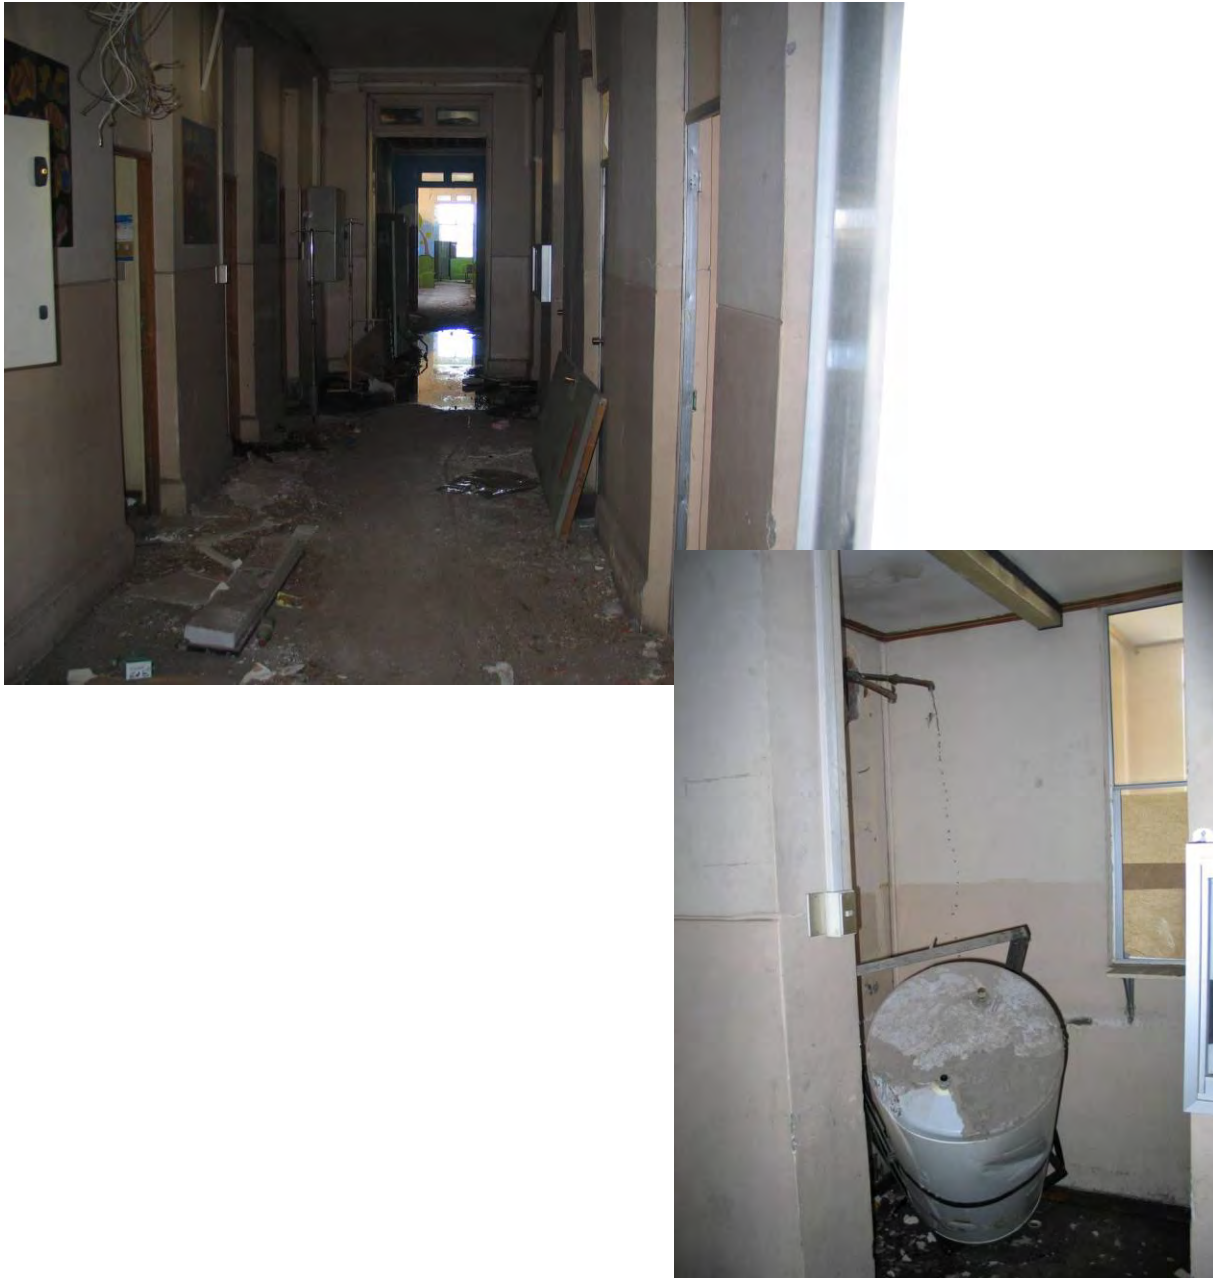
Figure 6.4.2.4-2 Water damage at the Talca Hospital in the 2010 magnitude-8.8 Chile Earthquake; water leaking from tank at right. This building was closed due to nonstructural damage, dominated by water damage (Photos courtesy of Bill Holmes, Rutherford & Chekene).

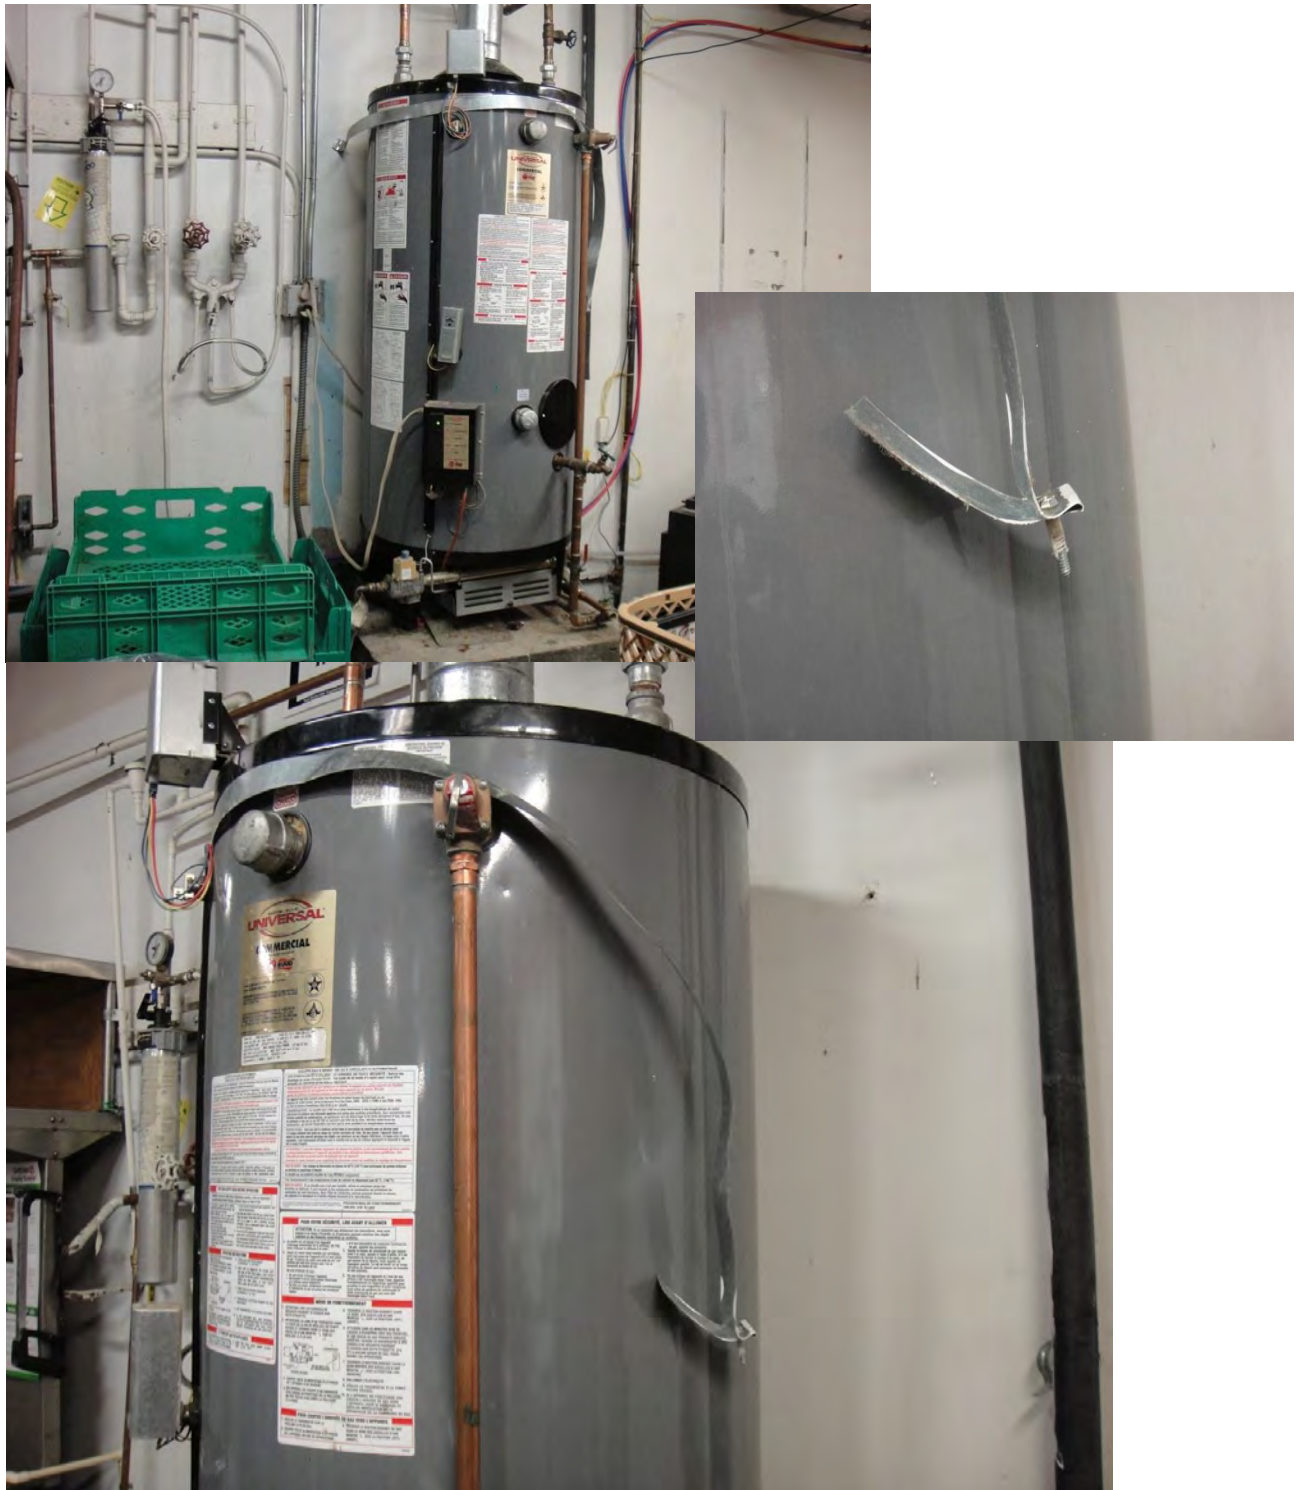
Figure 6.4.2.4-3

Damaged water heater in the 2010 magnitude-6.5 Eureka Earthquake. The water heater strap pulled out from the supporting concrete wall as a result of inadequate anchorage. The tank moved sufficiently to break interconnected water lines which were rigidly connected to the tank.

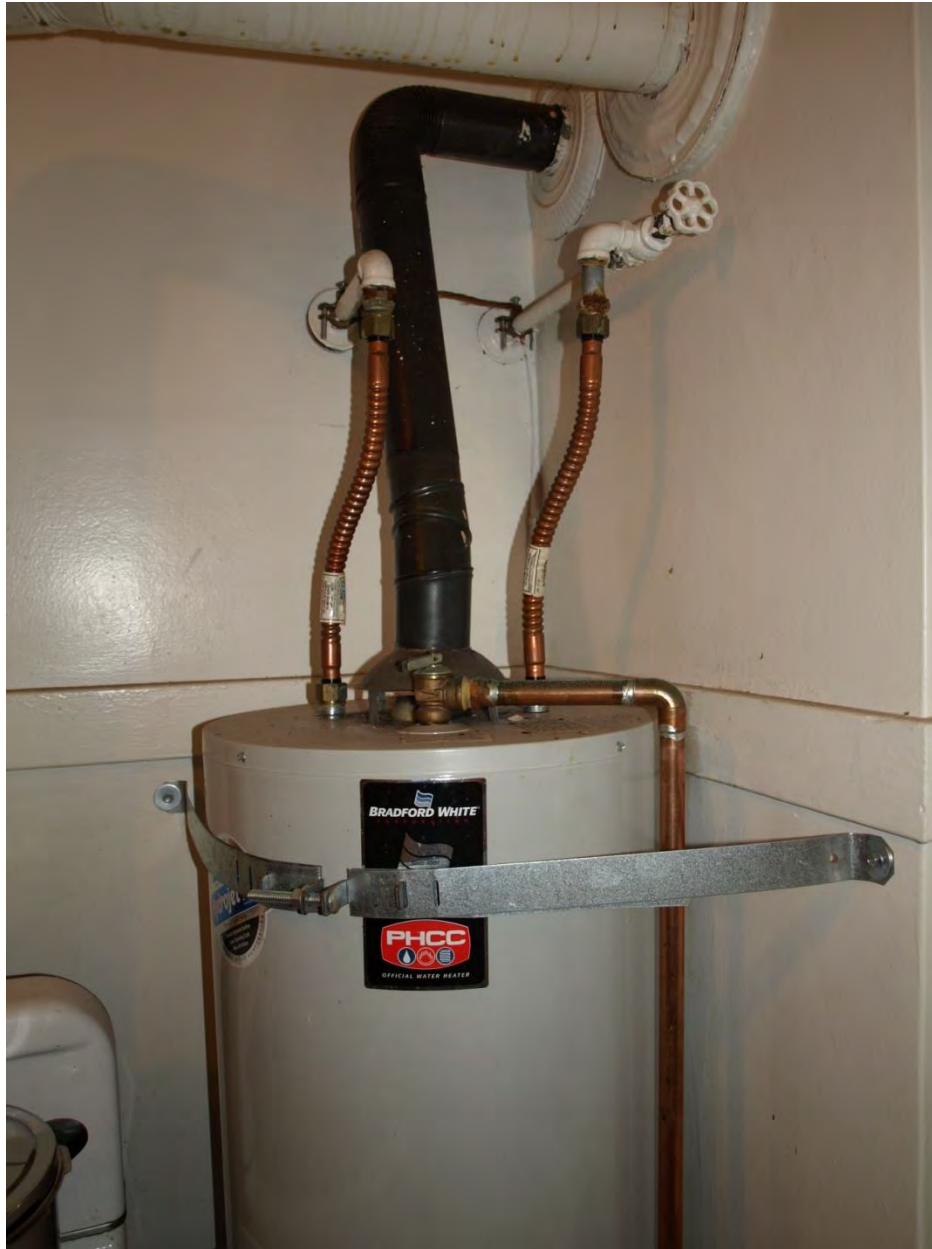
Figure 6.4.2.4-4 Corner installation using a commercially available strap; note flex copper tubing for water hook up (Photo courtesy of Cynthia Perry, BFP Engineers).

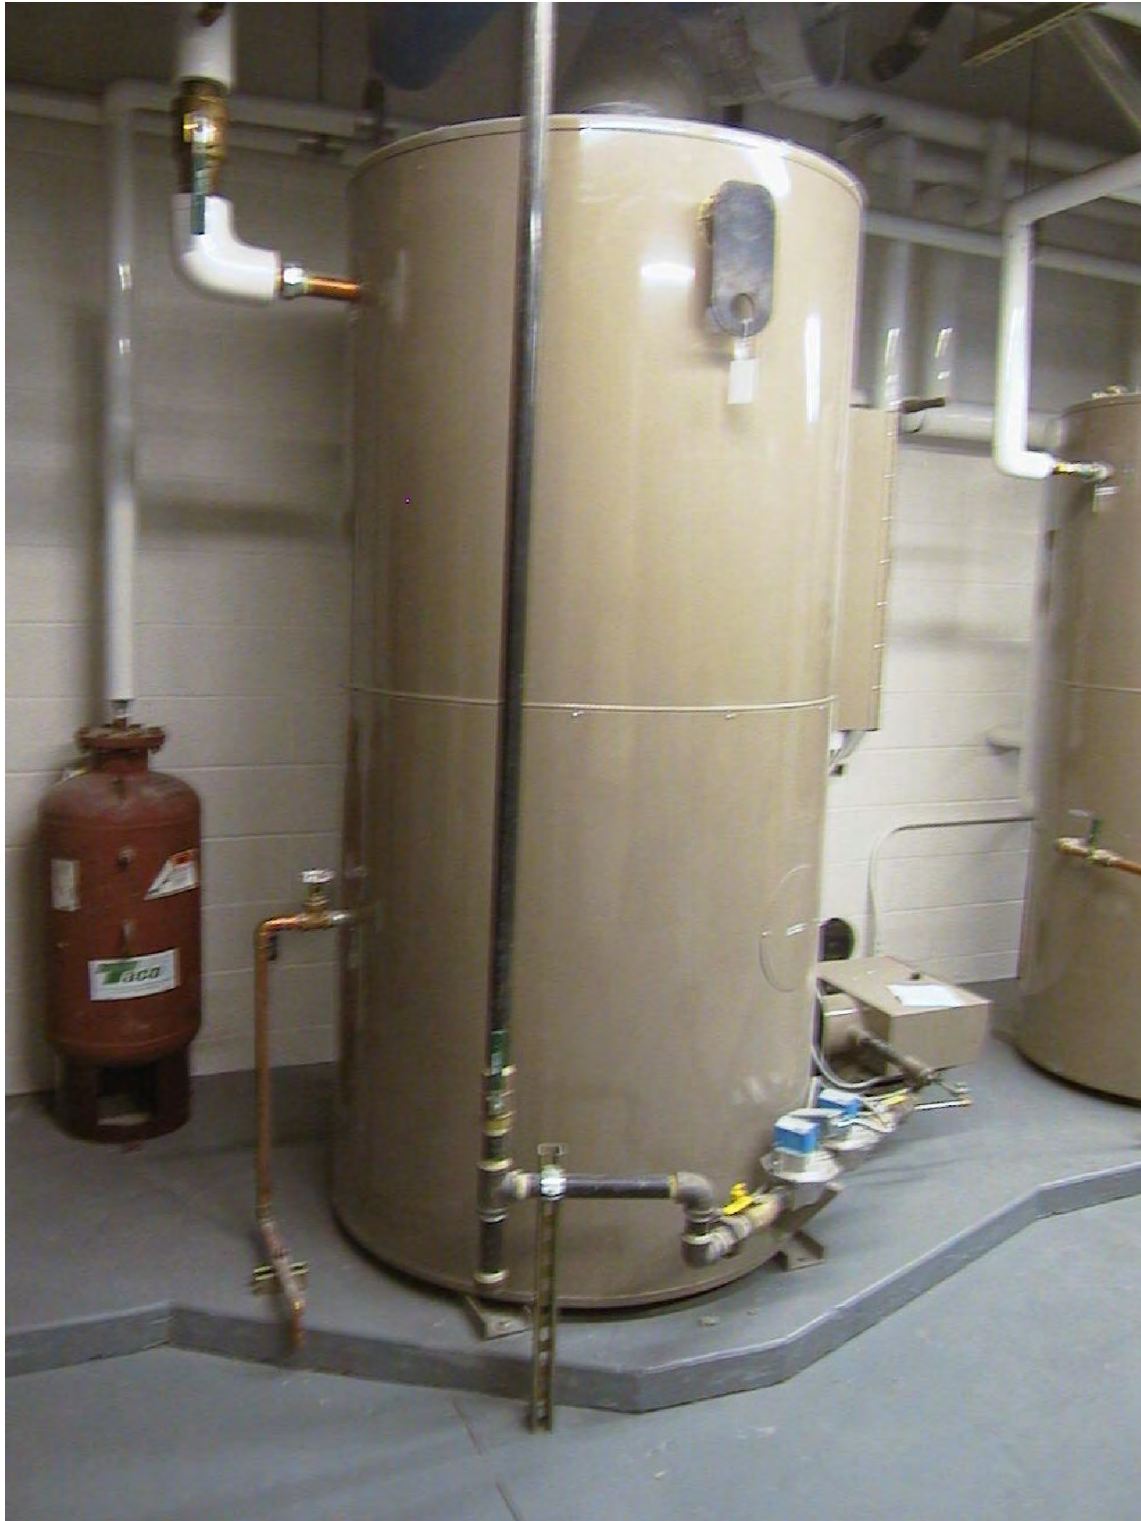
Figure 6.4.2.4-5 Base-mounted water heater located in a school; equipment supplied with metal base for mounting (Photo courtesy of EQE for the Salt Lake City School District).

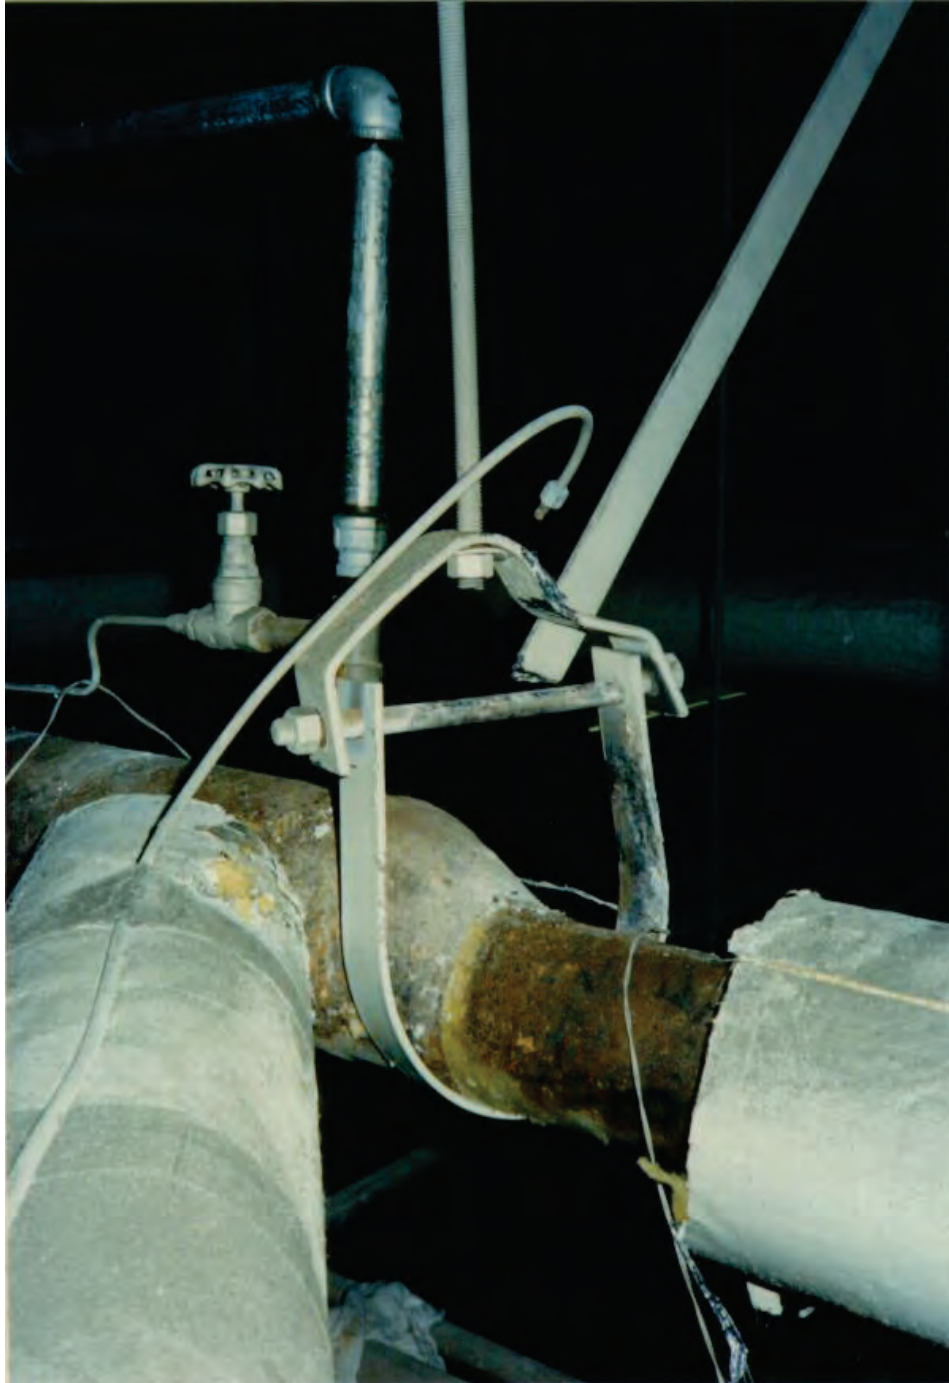
Figure 6.4.3.1-3 Pipe brace failed at connection in 1994 Northridge Earthquake; insulation removed prior to photo (Photo courtesy of Mason Industries).

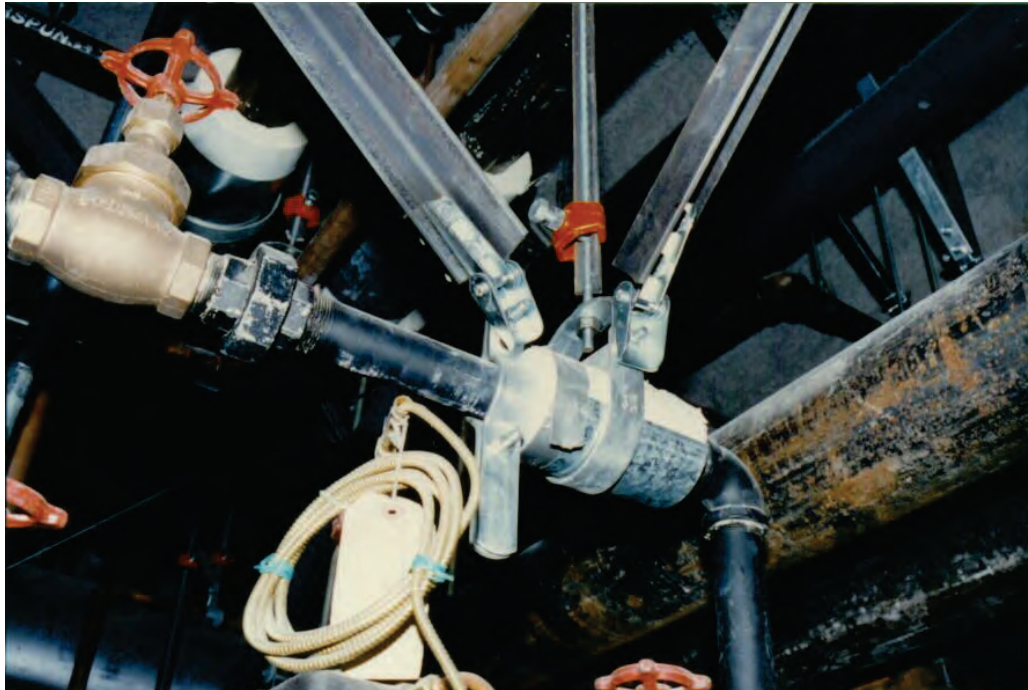
Figure 6.4.3.1-5 Pipe clamp supports with transverse and longitudinal angle braces; note pipe clamp for longitudinal brace in direct contact with pipe (Photo courtesy of Mason Industries).

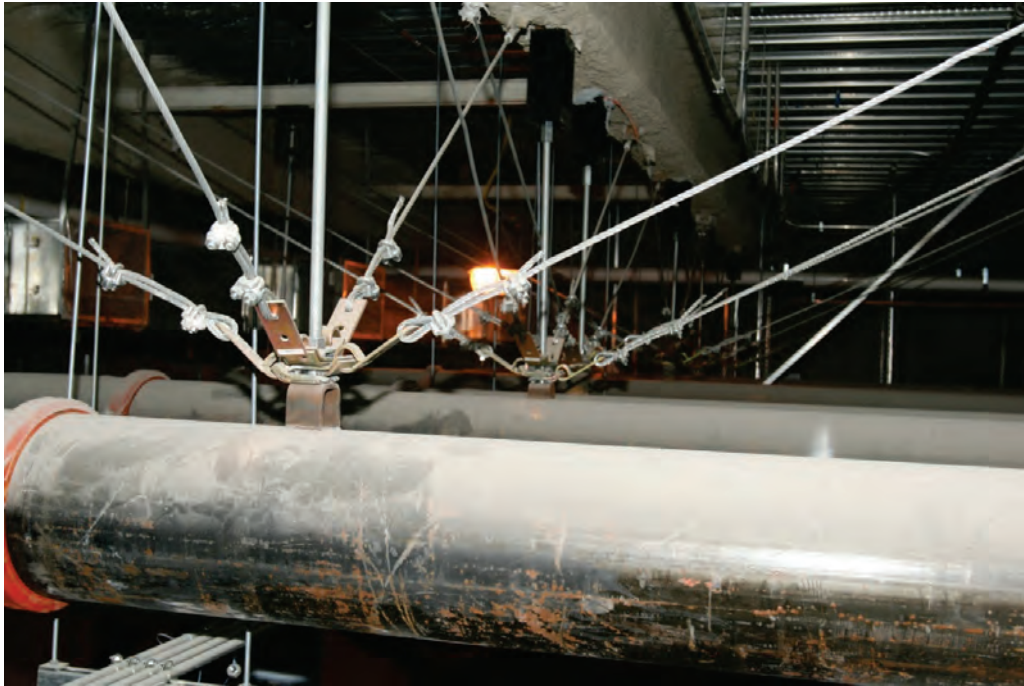
Figure 6.4.3.1-6 All-directional cable bracing of suspended piping (Photo courtesy of ISAT).

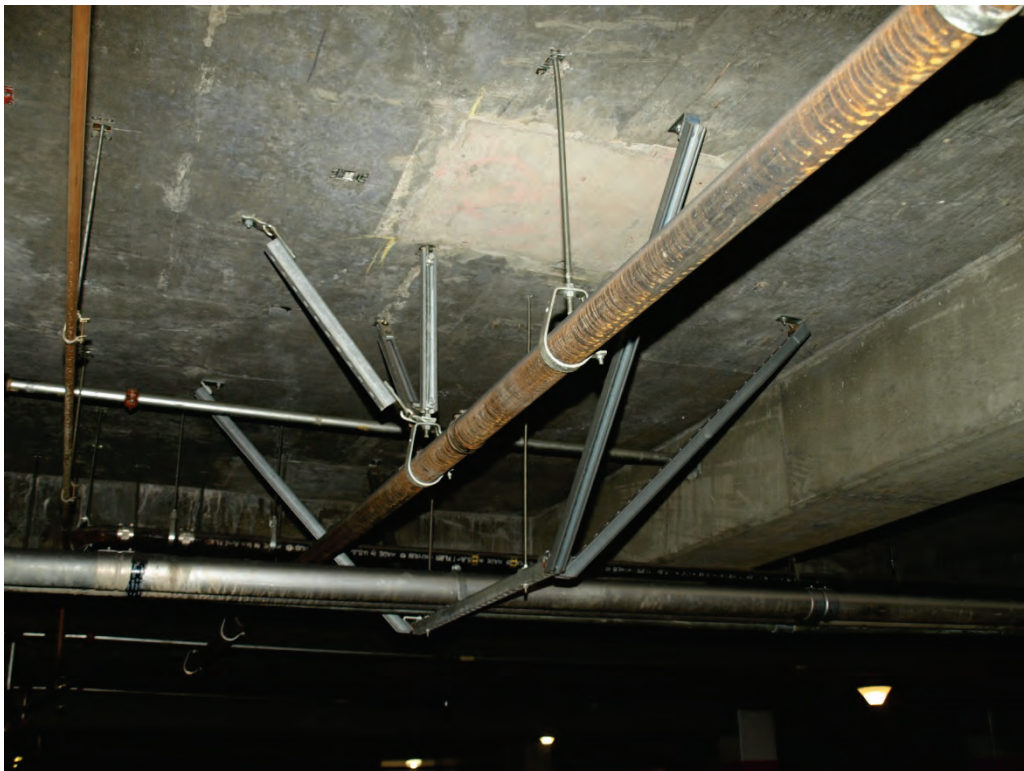
Figure 6.4.3.1-7 Transverse bracing with J-hanger and strut at the restraining bolt. Note that longitudinal brace shown is ineffective because the J-hanger can slip along the length of the pipe; a pipe clamp or equivalent is required for a longitudinal brace (Photo courtesy of Cynthia Perry, BFP Engineers).

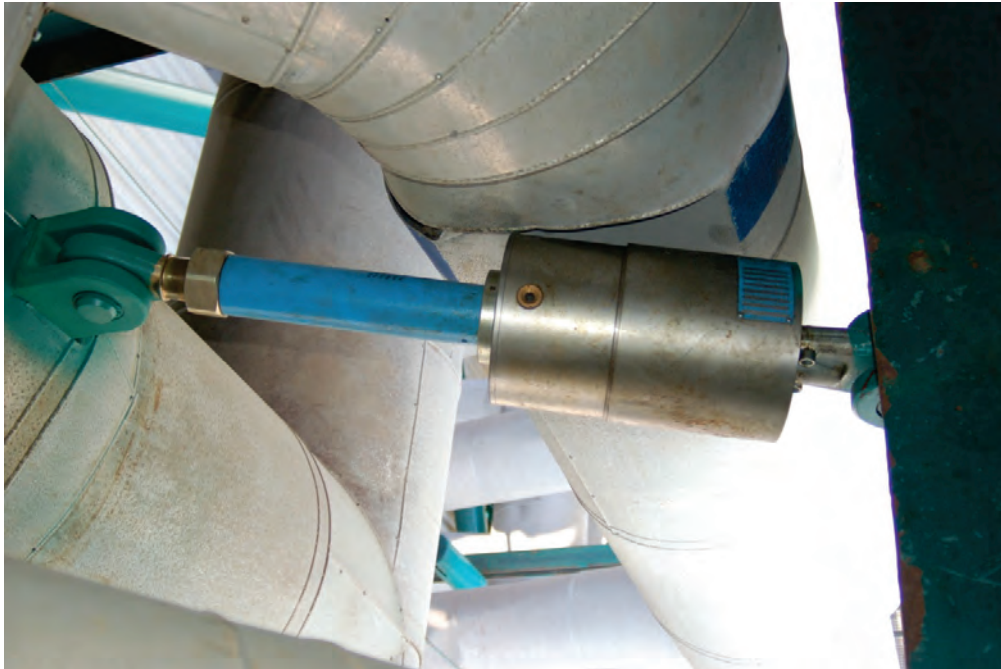
Figure 6.4.3.1-8 Viscous damper used as restraint on large insulated pipe (Photo courtesy of Eduardo Fierro, BFP Engineers).
