Reducing the Risks of Nonstructural Earthquake Damage – A Practical Guide

FEMA E-74 / December 2012

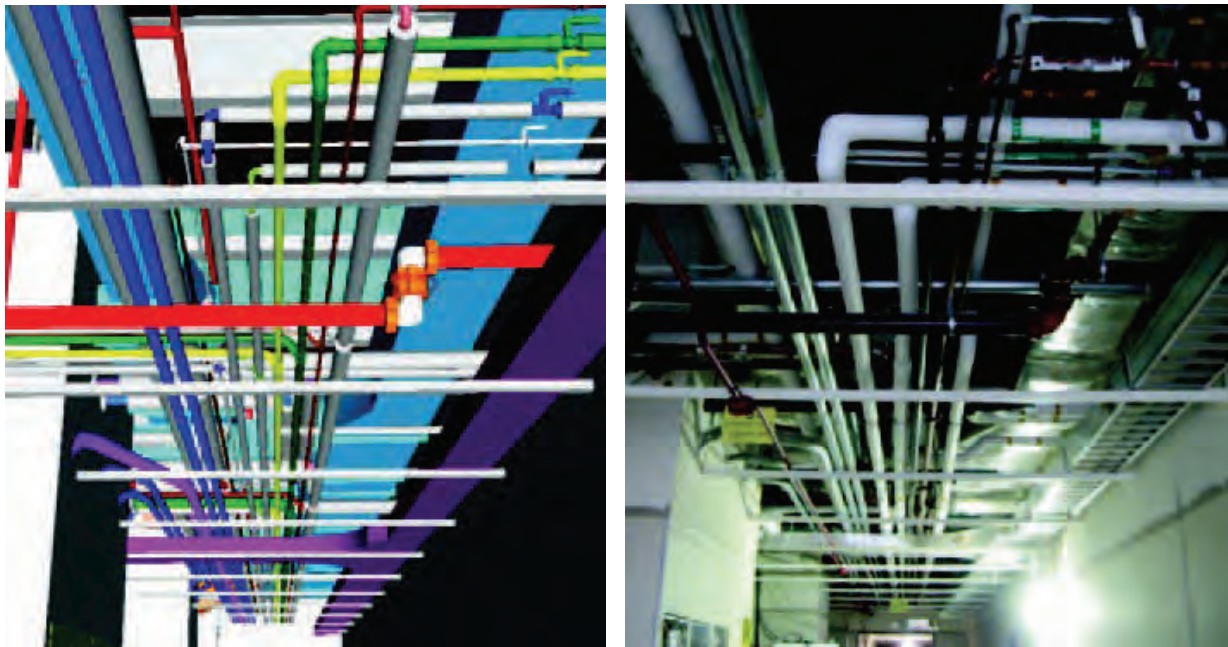
Figure 6.4.3.1-9 Example of BIM Model (left) compared to installed piping (right) (Photo and image courtesy of ISAT).

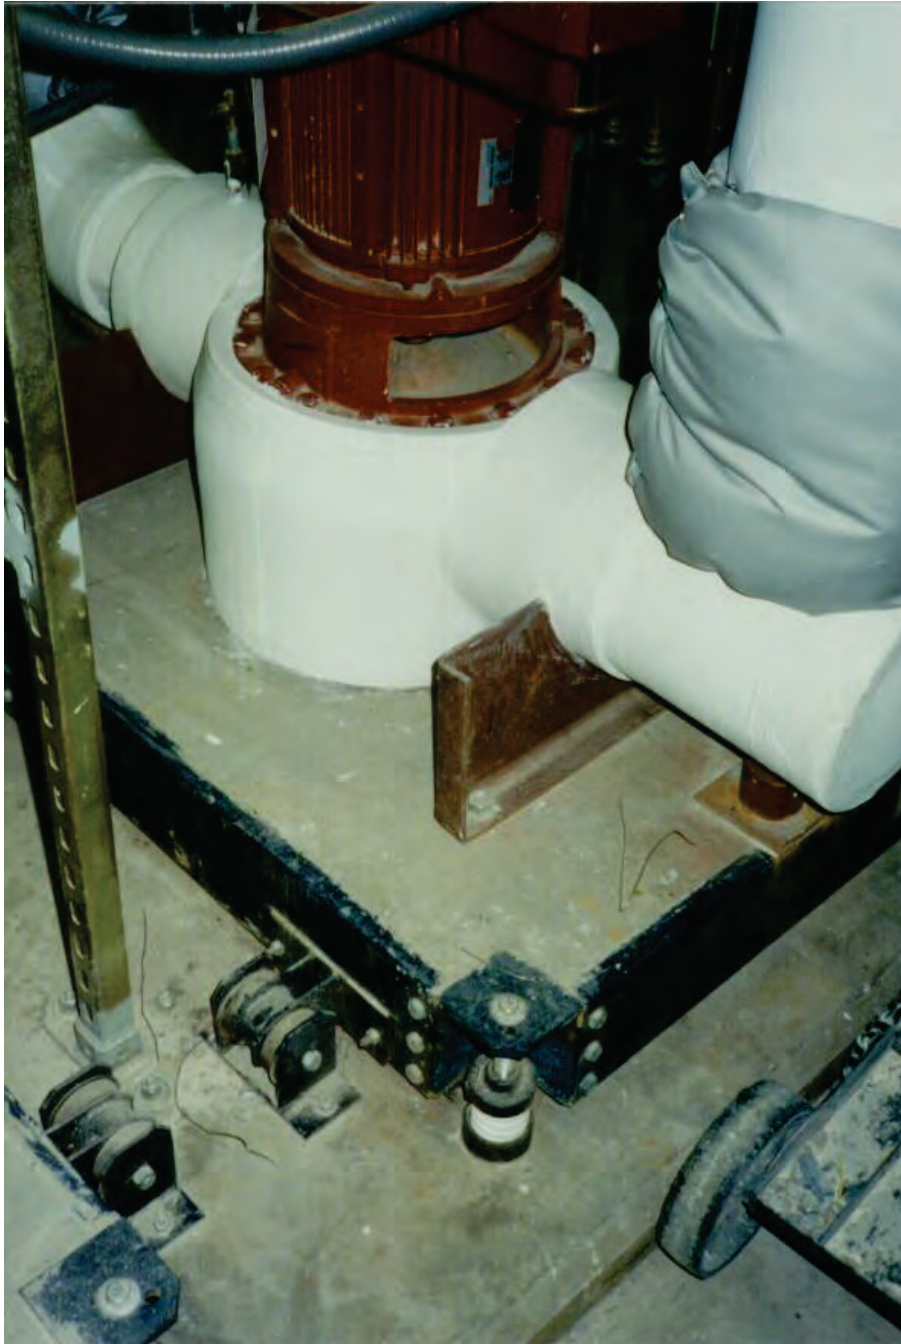
Figure 6.4.3.2-1 Inline pump mounted on independent concrete inertia pad with vibration isolation and seismic snubbers (Photo courtesy of Mason Industries).

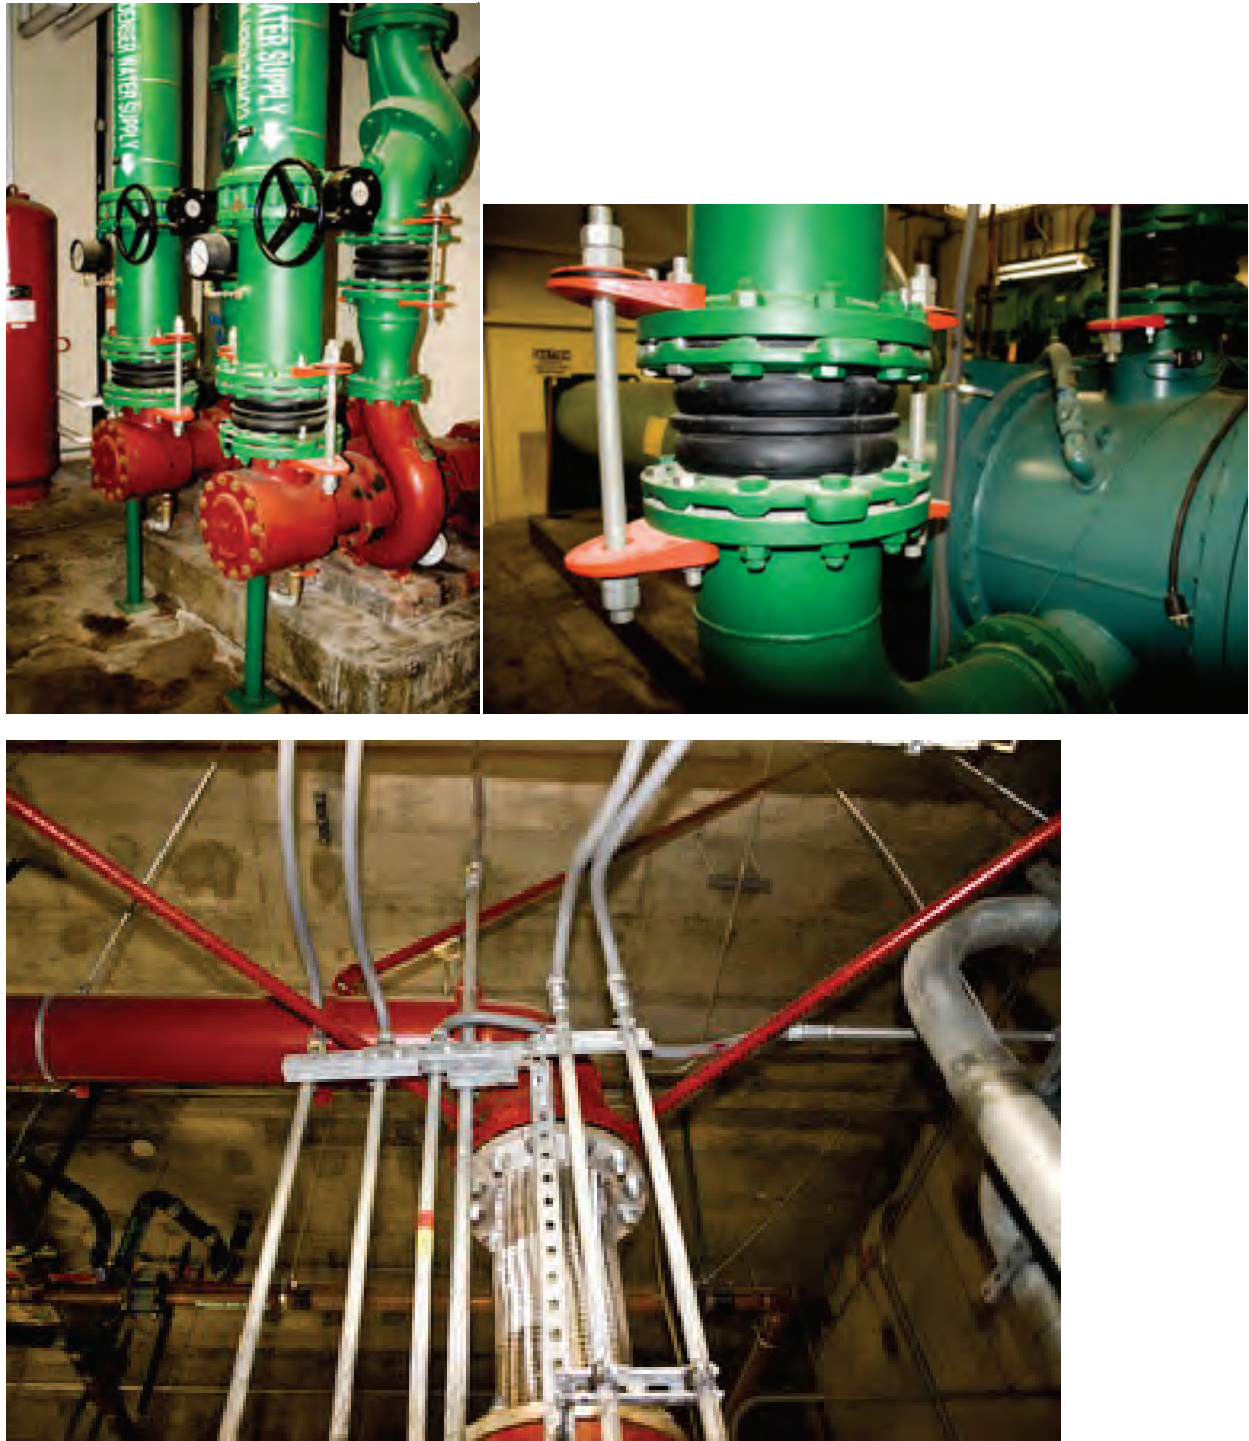
Figure 6.4.3.3-2 Examples of flexible couplings that performed well in the 2010 magnitude-7 Haiti Earthquake; the building suffered relatively minor damage (Photo courtesy of Tom Sawyer, Engineering News Record).

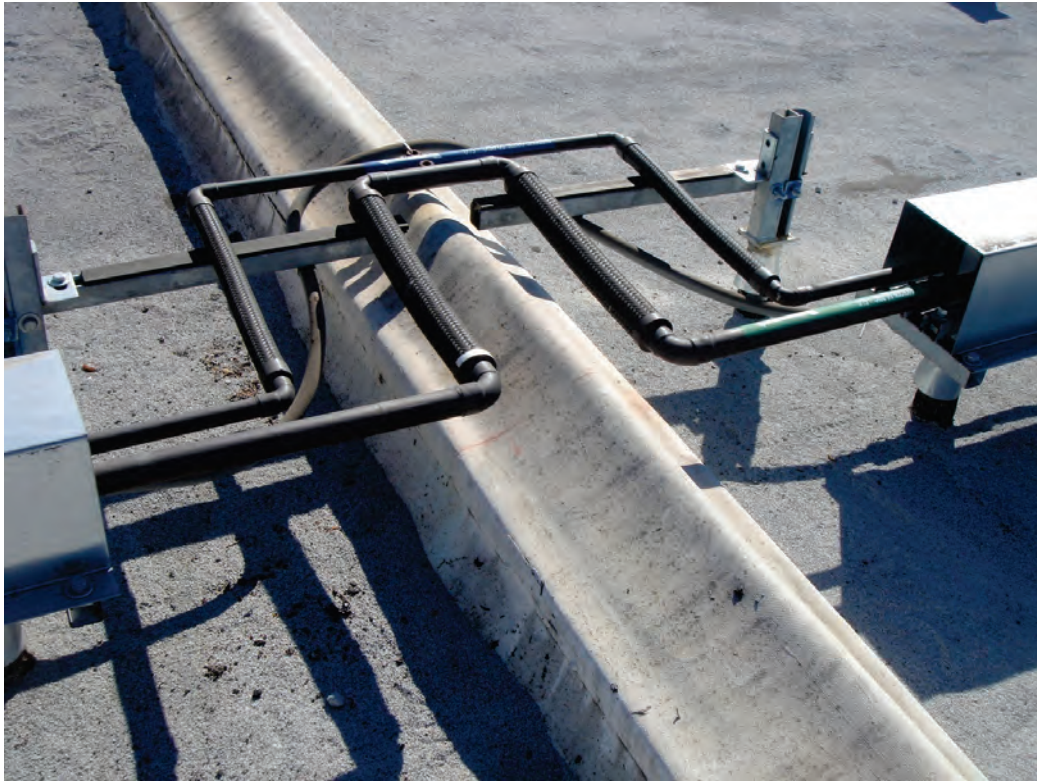
Figure 6.4.3.3-4 Flexible pipe connections at rooftop expansion joint (Photo courtesy of Maryann Phipps, Estructure).

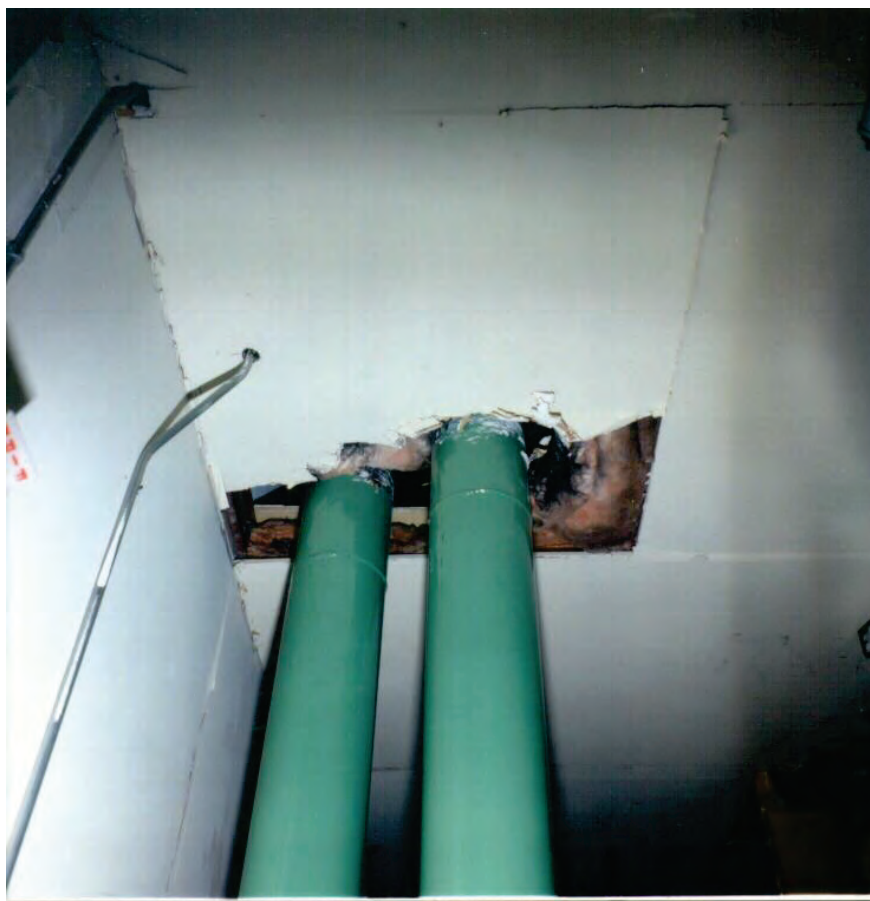
Figure 6.4.3.4-1 Movement of unbraced risers damaged ceiling finishes and insulation in the 1994 magnitude-6.7 Northridge Earthquake (Photo courtesy of Mason Industries).

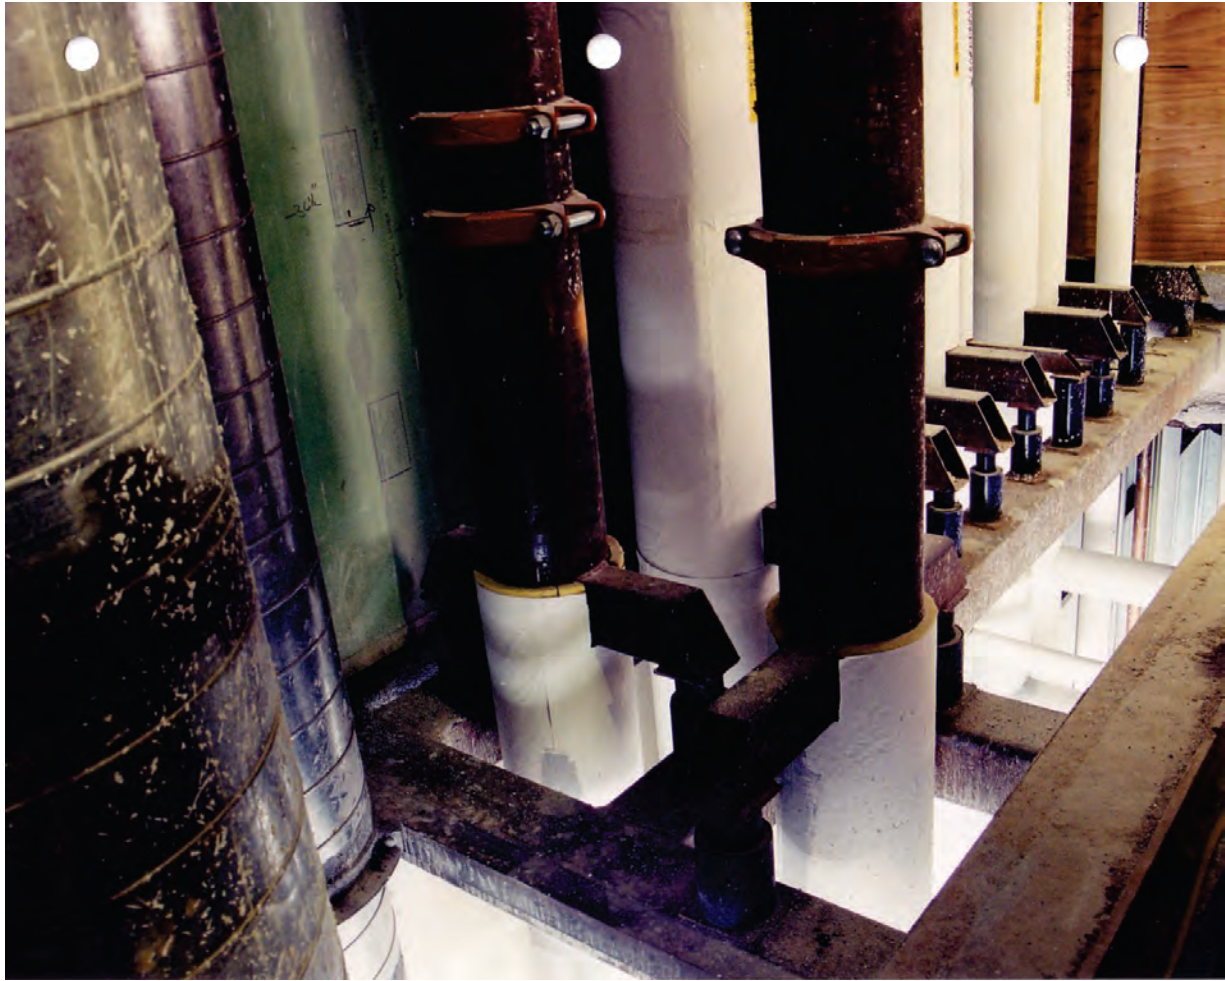
Figure 6.4.3.4-2 Riser supports provide lateral restraint with vertical sliding guides that allow thermal movement; restraint hardware consisting of tube sections is welded to either side of pipe (Photo courtesy of Mason Industries).

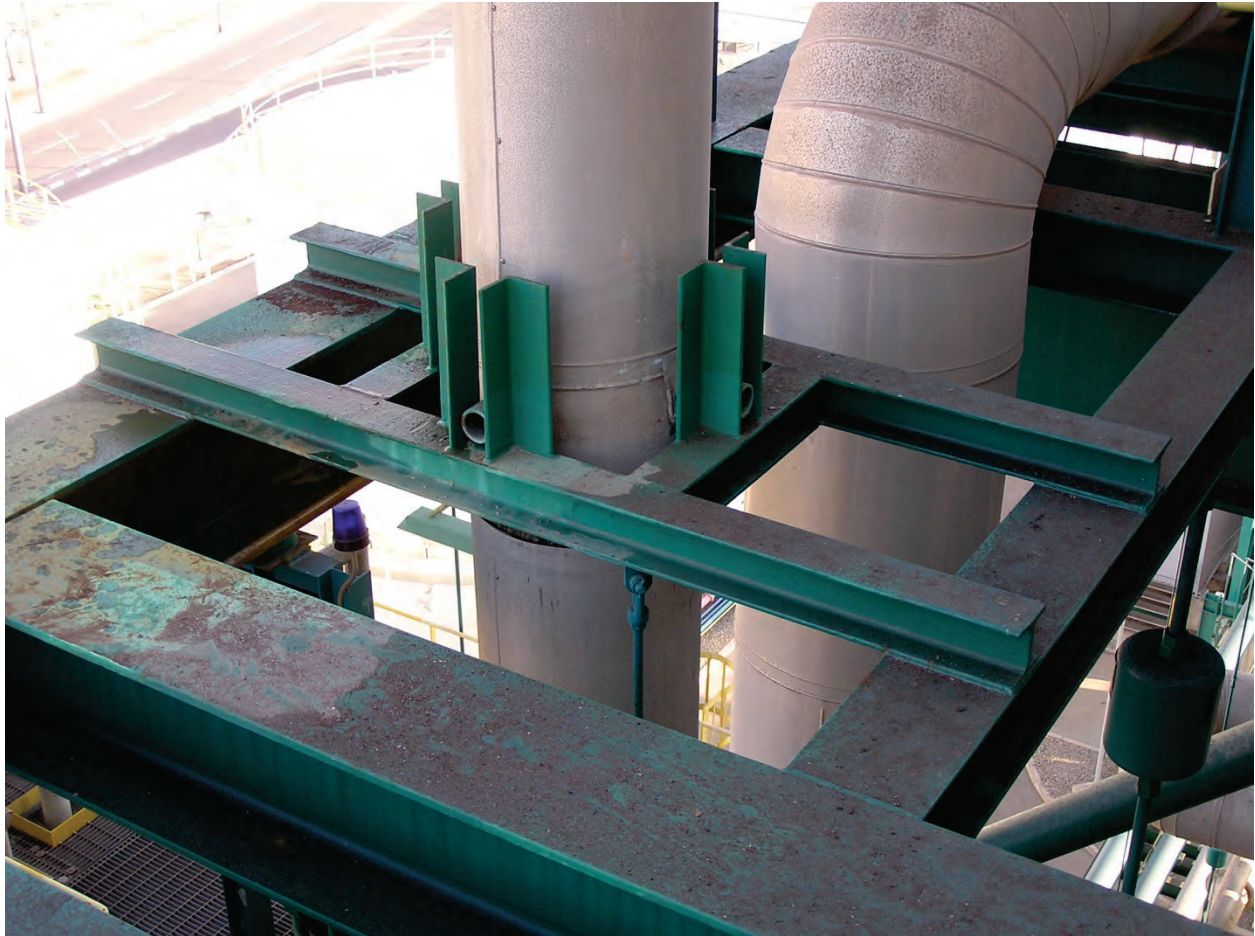
Figure 6.4.3.4-4 Insulated boiler pipe risers with welded lugs (small pipe sections) which travel vertically in guides providing lateral seismic restraint (Photo courtesy of Eduardo Fierro, BFP Engineers).

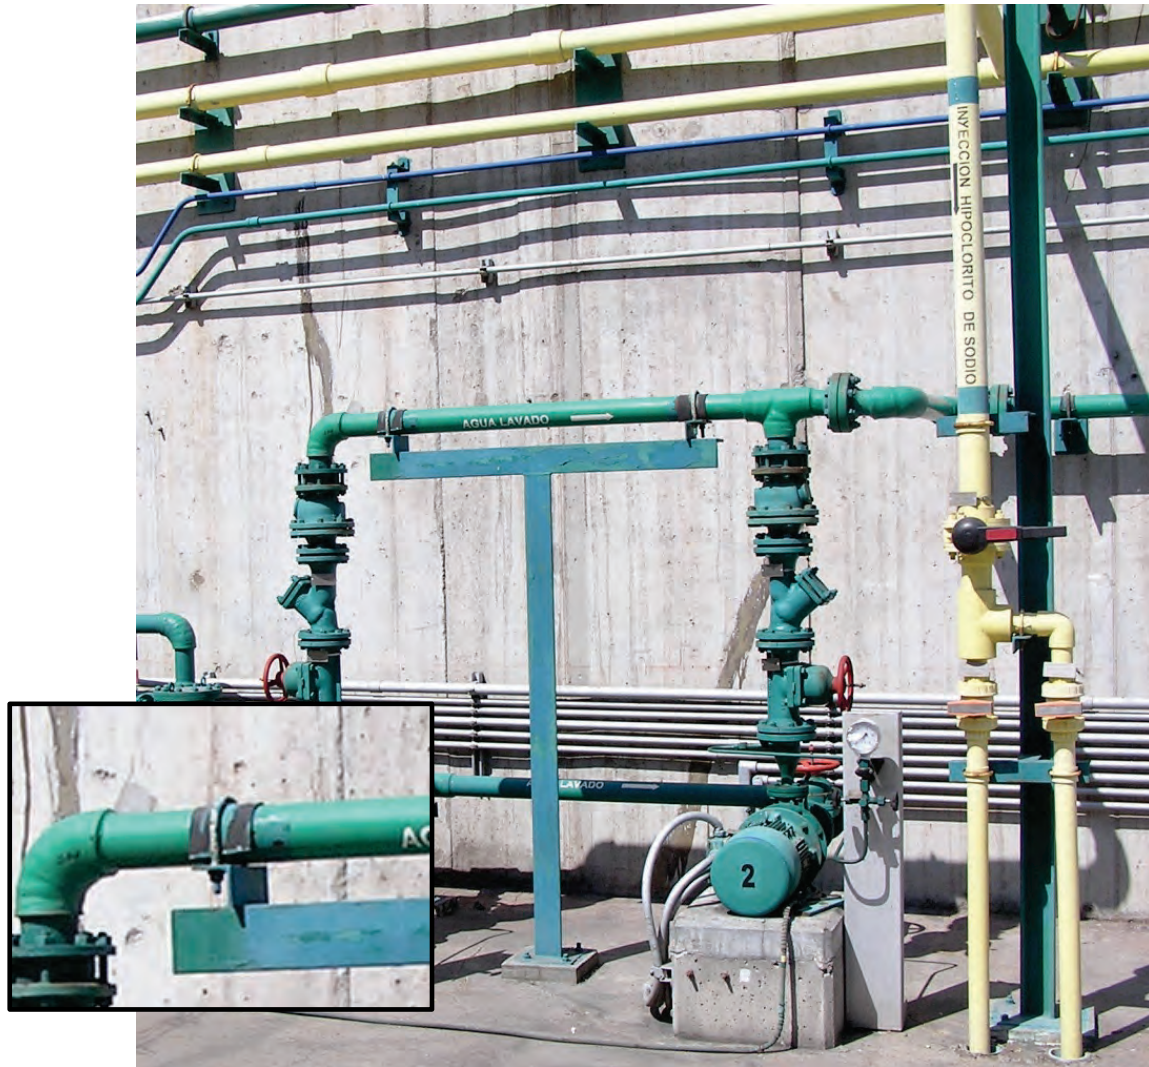
Figure 6.4.3.5-1 Pipe and support assembly seem intact but photo shows evidence of longitudinal movement of the pipe in the U-bolts (Photo courtesy of BFP Engineers). A rubber pad was installed between the U-bolt and pipe in order to increase the friction coefficient, but was not sufficient to provide longitudinal restraint.

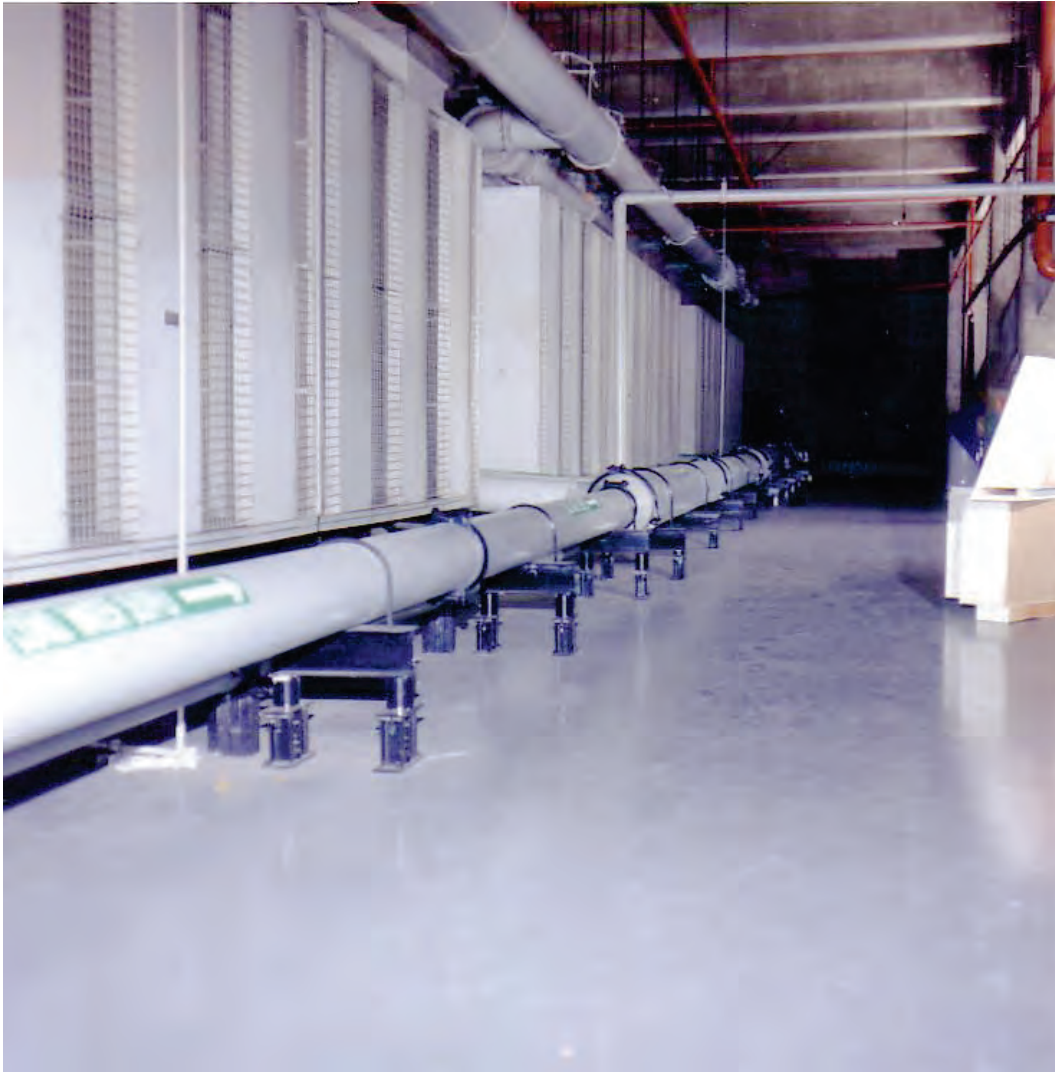
Figure 6.4.3.5-3 Floor-mounted supports for insulated pipe with vibration isolation (Photo courtesy of Mason Industries).

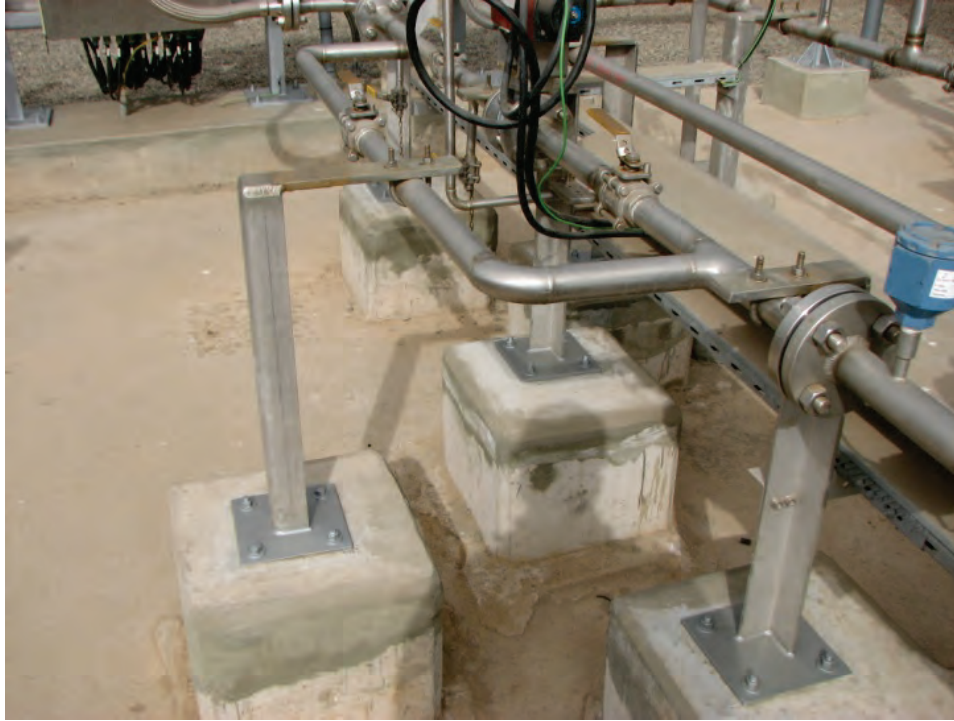
Figure 6.4.3.5-4 Floor/ground-mounted supports for industrial piping in Chile; piping undamaged in the 2010 magnitude-8.8 Chile Earthquake. Pipe supports include concrete pedestal, base plate, and built-up welded support stand. (Photos courtesy of Antonio Iruretagoyena, Rubén Boroschek & Associates).

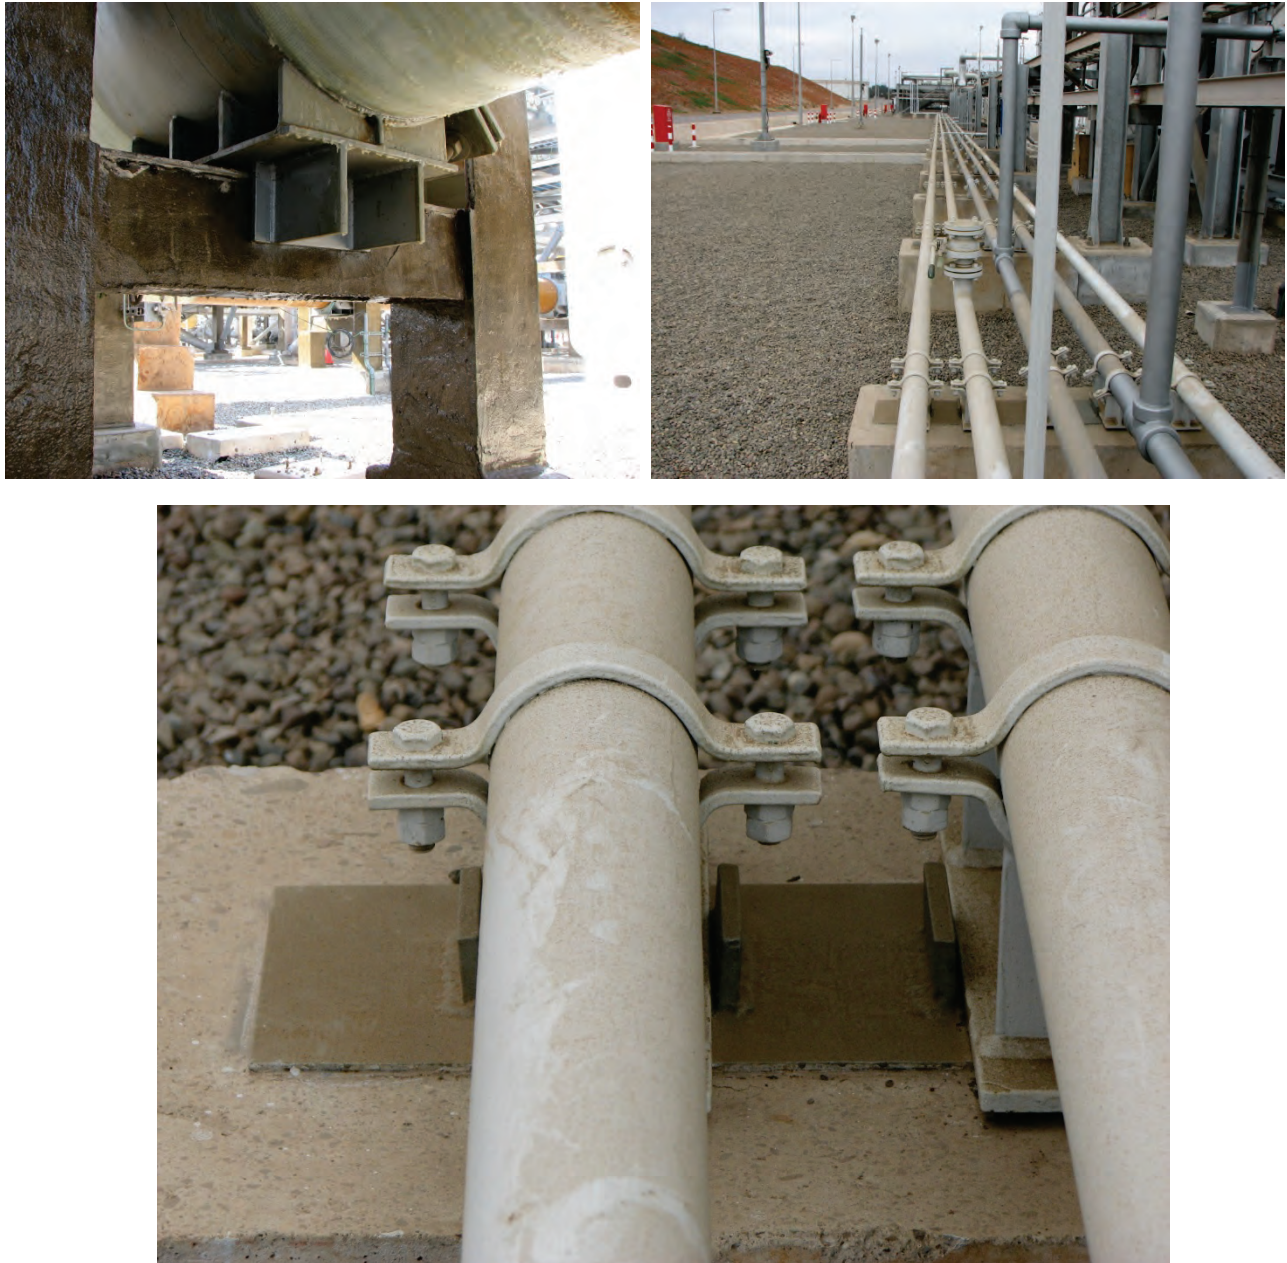
Figure 6.4.3.5-5 Floor-mounted supports for industrial piping in Chile; piping undamaged in the 2010 Chile Earthquake. The Chilean Industrial Code (Norma Chilena 2369) requires that shear forces be resisted by shear keys as shown; lower photo is detail of piping at upper right (Photos courtesy of Antonio Iruretagoyena, Rubén Boroschek & Associates).

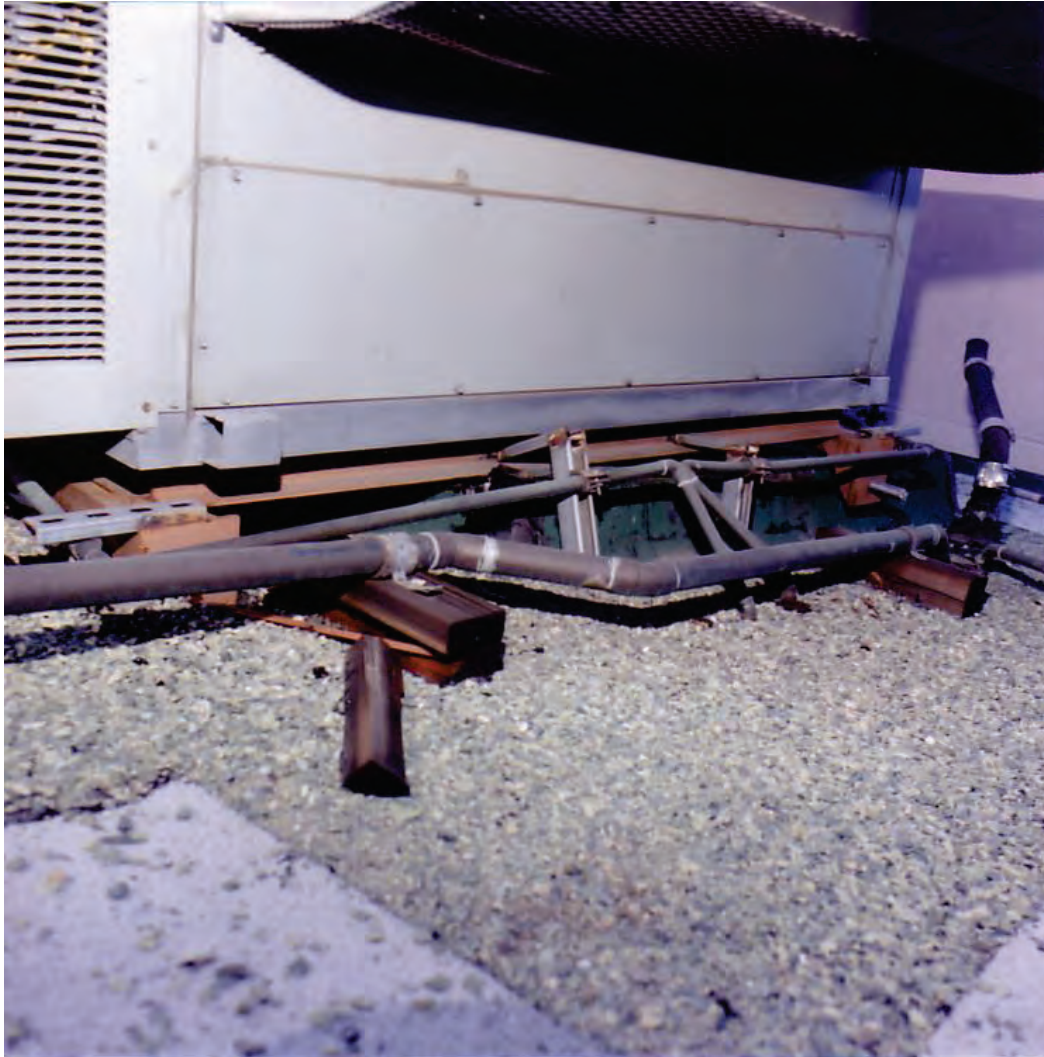
Figure 6.4.3.6-1 Damaged supports and piping on roof-mounted HVAC unit in the 1994 magnitude-6.7 Northridge Earthquake (Photo courtesy of Mason Industries). Both the roof-mounted wood sleepers and strut supports failed.

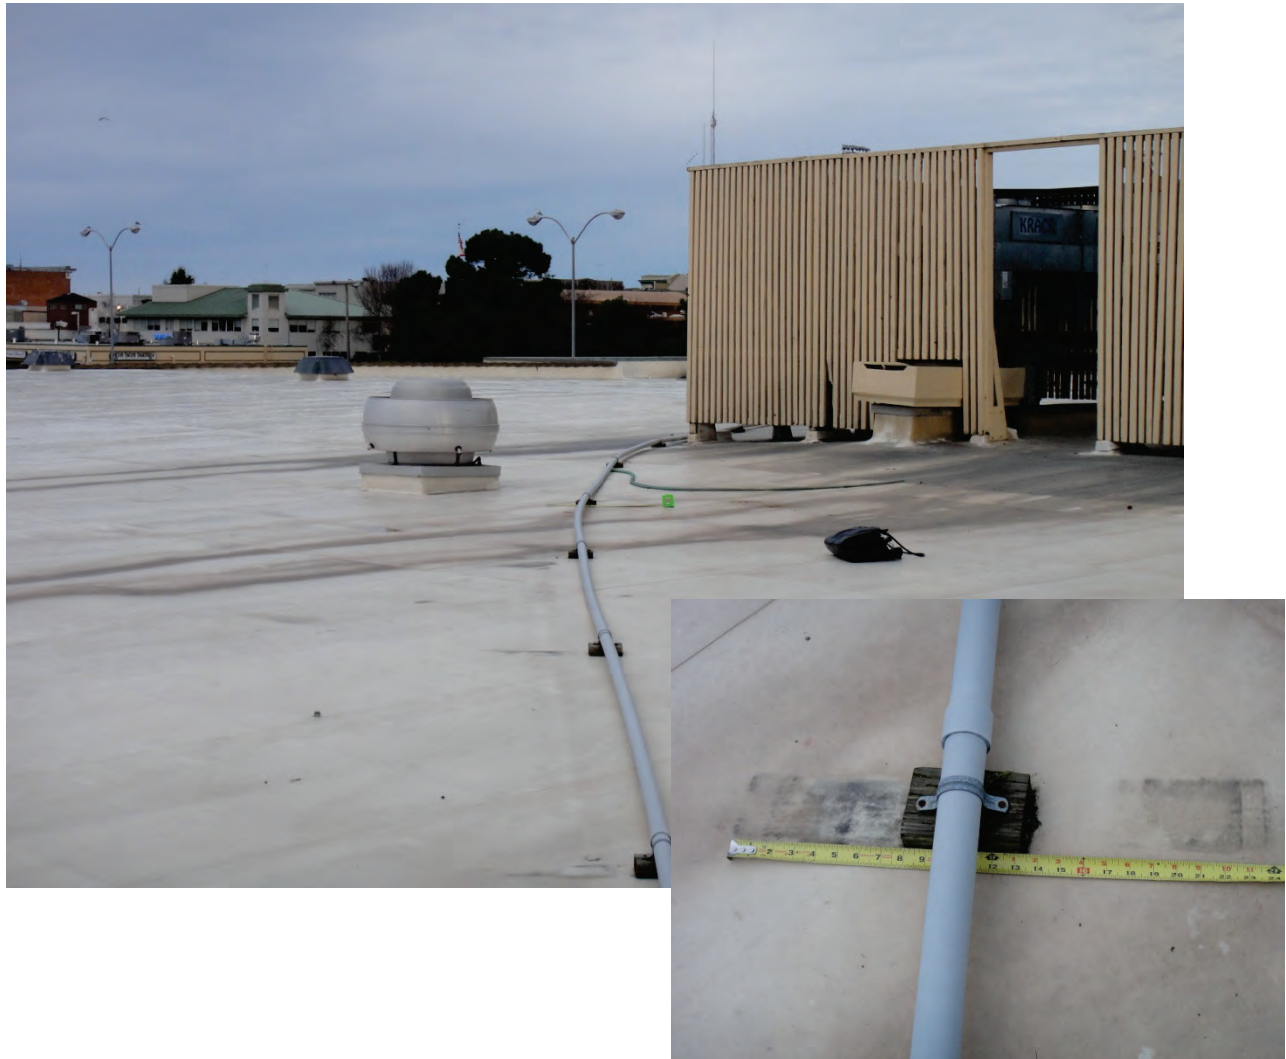
Figure 6.4.3.6-2 Unrestrained wood sleepers on roof-mounted piping slid a foot in either direction in 2010 magnitude-6.5 Eureka Earthquake (Photos courtesy of Maryann Phipps, Estructure).

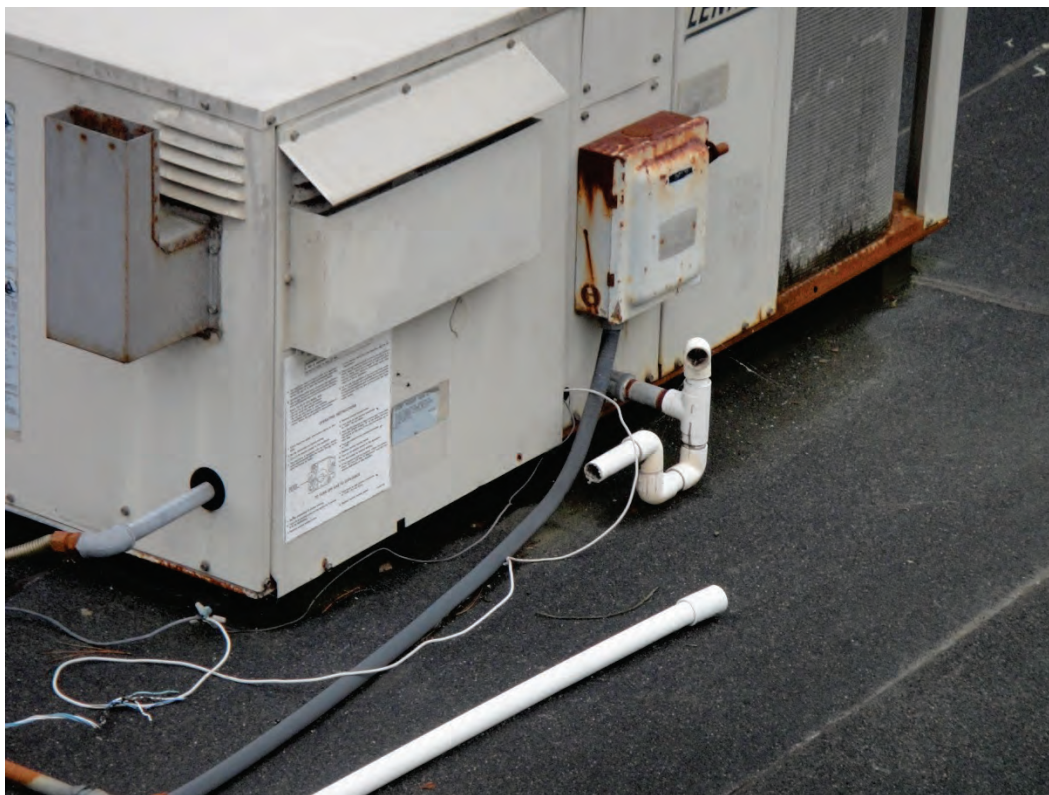
Figure 6.4.3.6-3 Unrestrained roof-mounted piping broke at the connection to the equipment in the 2010 Eureka Earthquake. Piping mounted on wood sleepers should typically be restrained to the roof, not free to slide (Photo courtesy of Maryann Phipps, Estructure).

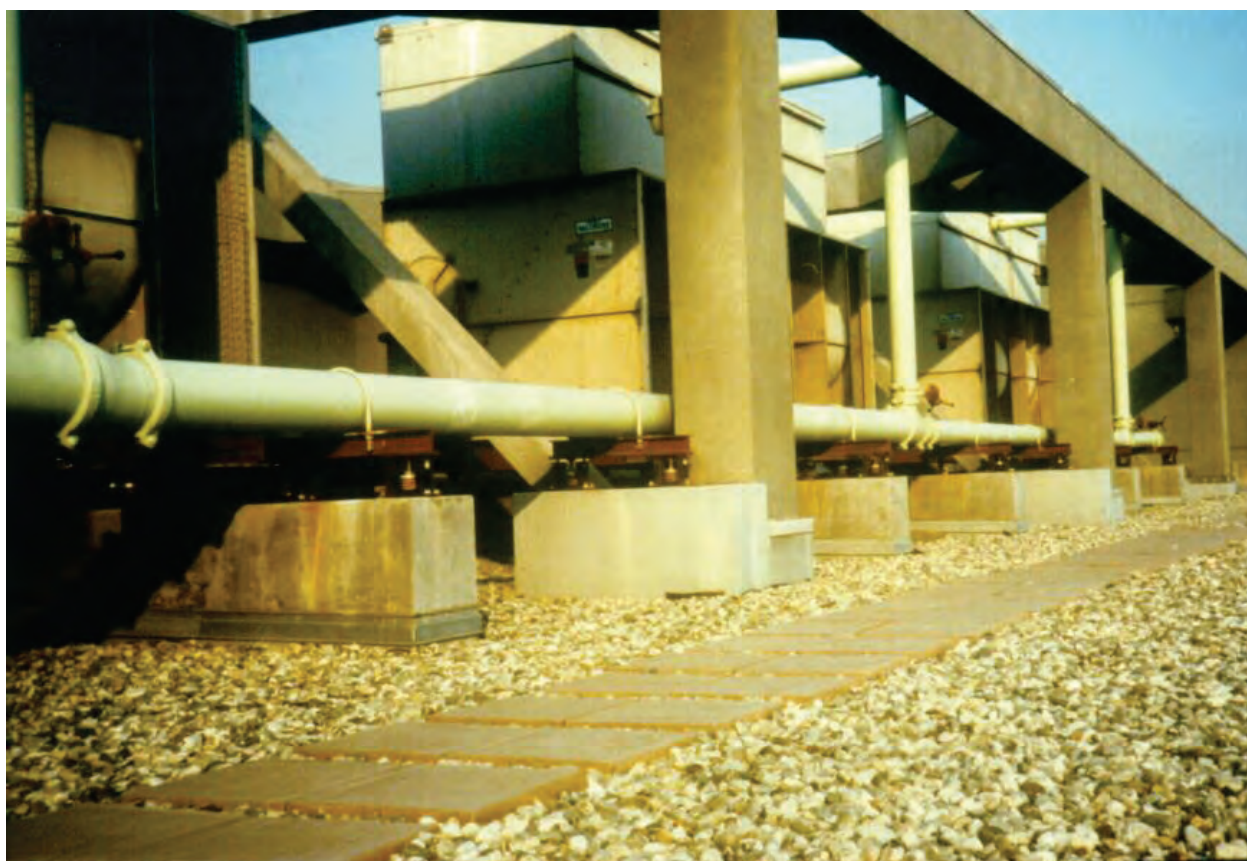
Figure 6.4.3.6-4 Roof-mounted supports with vibration isolation (Photo courtesy of Mason Industries).

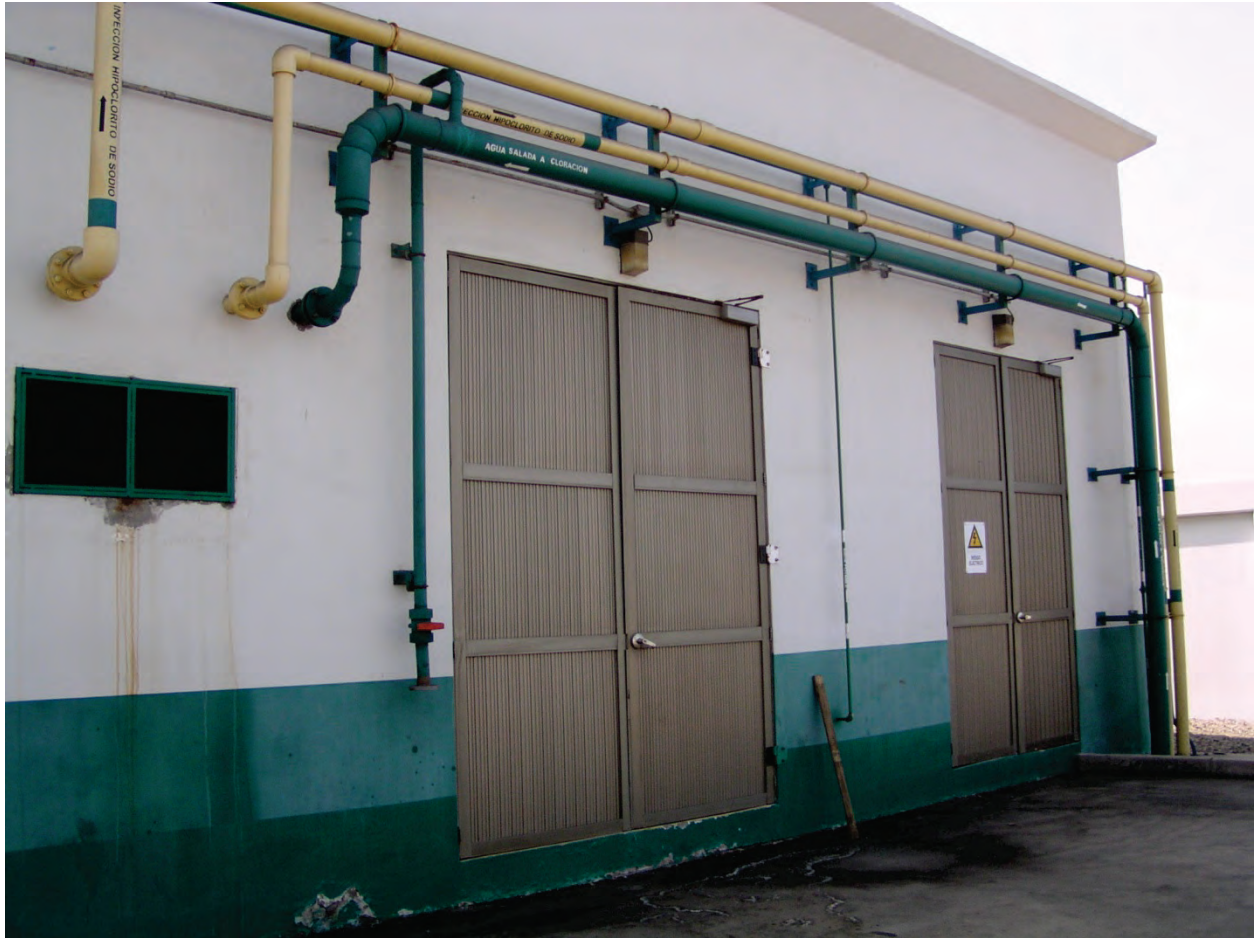
Figure 6.4.3.7-1 Wall-mounted supports for horizontal and vertical pipe runs with exterior exposure. Photo shows minor damage at wall penetration of green pipe and minor movement at some U-bolts, but restraints generally performed well (Photo courtesy of Eduardo Fierro, BFP Engineers). Note that lateral restraint near an elbow can be used to provide longitudinal restraint for a perpendicular pipe run.

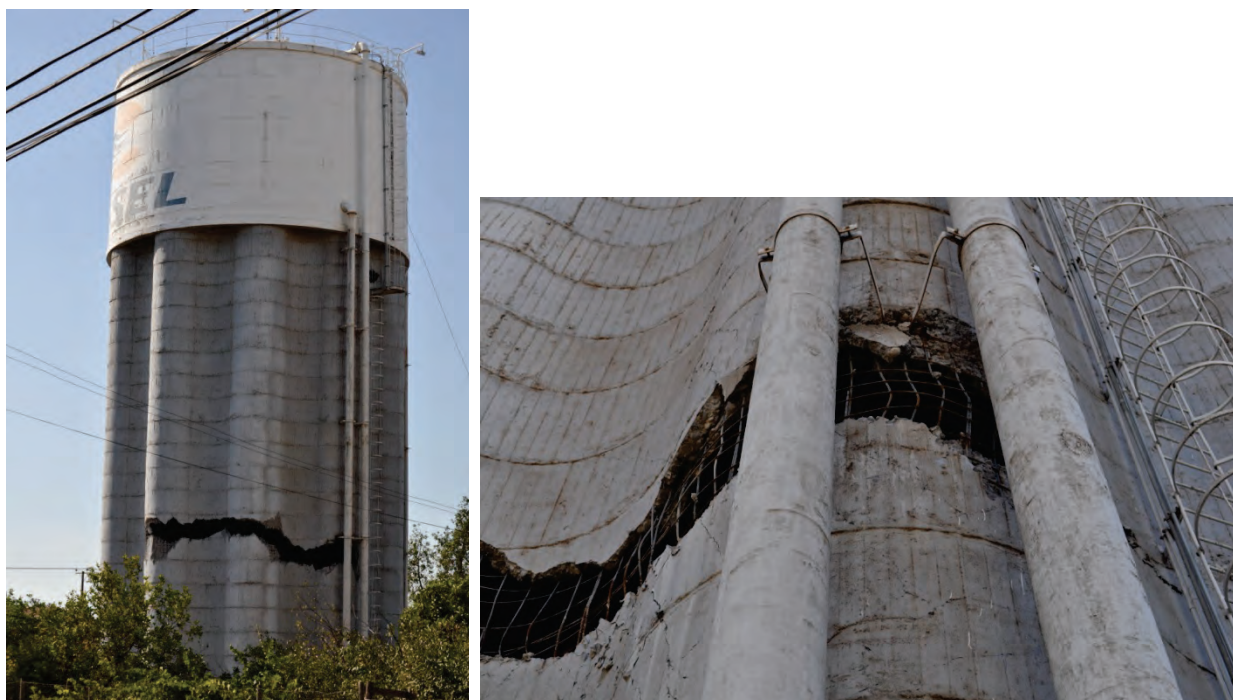
Figure 6.4.3.7-2 Pipe supports attached to wall of damaged silo (Photo courtesy of Eduardo Fierro, BFP Engineers). In spite of structural damage to silo, cast-in-place pipe supports were still intact and the piping did not fall.

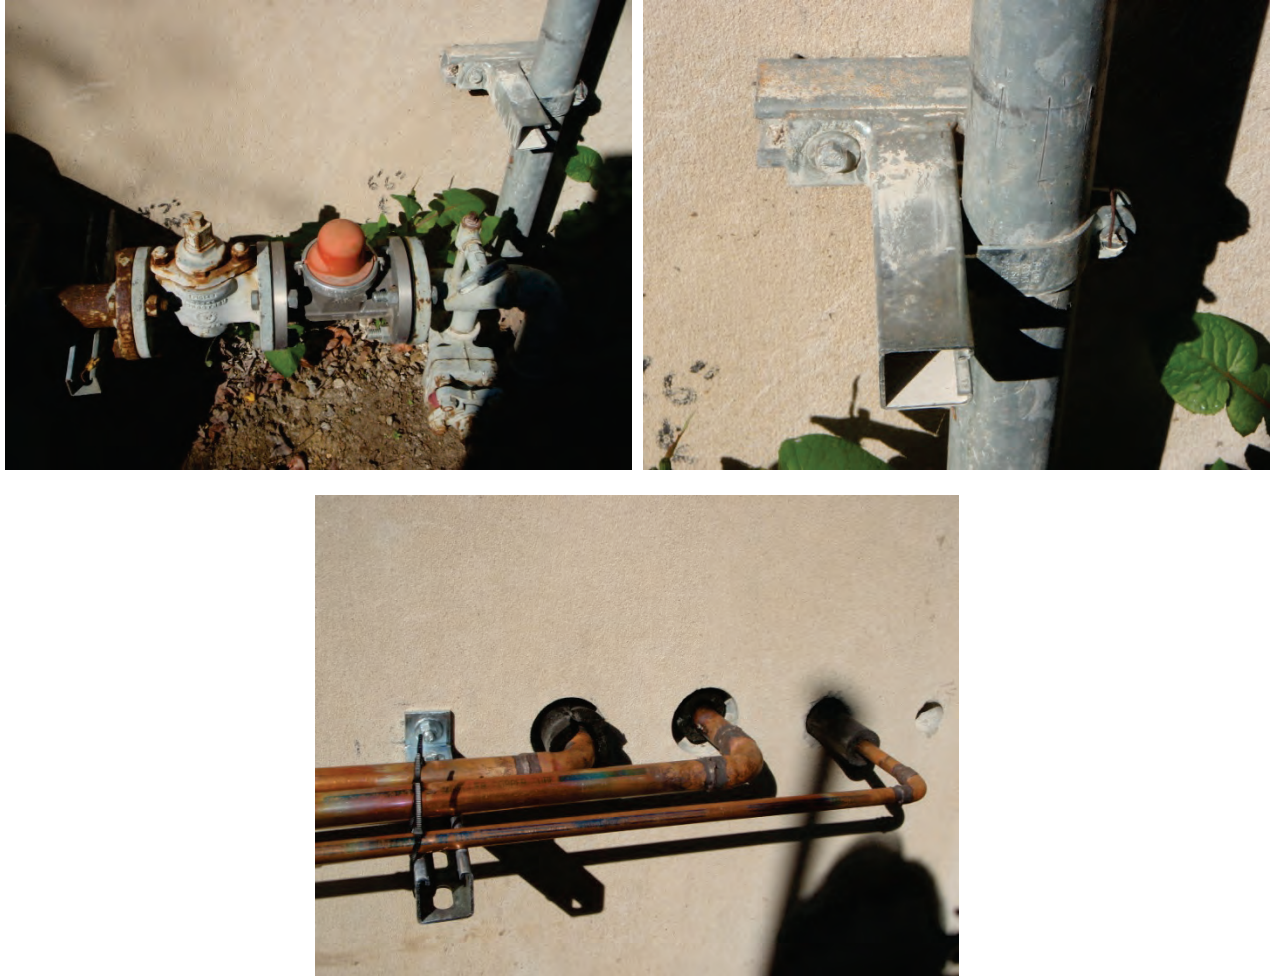
Figure 6.4.3.7-3 Wall-mounted pipe restraint examples using standard strut shapes and connectors (Photo courtesy of Cynthia Perry, BFP Engineers). Bottom view still under construction; pipes temporarily attached with plastic ties.

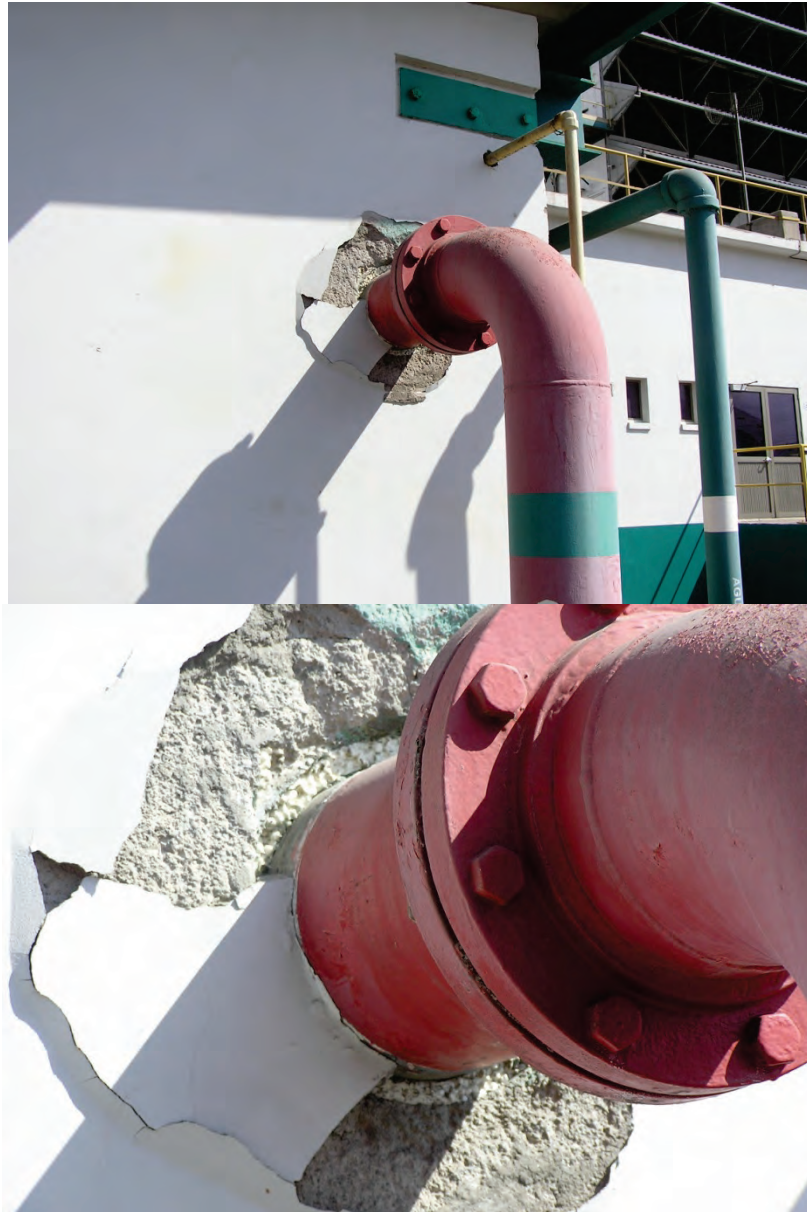
Figure 6.4.3.8-2 Exterior stucco damage at wall penetration for fire protection piping in the 2001 magnitude-8.4 Peru Earthquake (Photos courtesy of Eduardo Fierro, : BFP Engineers).

- Detailing at penetrations often involves several layers of material and finishes each of which require attention; penetrations through structural elements may involve both the engineer and the architect. For instance, a penetration through a masonry wall with interior plaster and exterior stucco will require detailing for all three of these materials. The damage shown in Figure 6.4.3.8–2 occurred because although the masonry penetration was oversized and filled with packing, the exterior stucco was placed flush with the pipe resulting in stucco damage during the earthquake.
