Reducing the Risks of Nonstructural Earthquake Damage – A Practical Guide

FEMA E-74 / December 2012

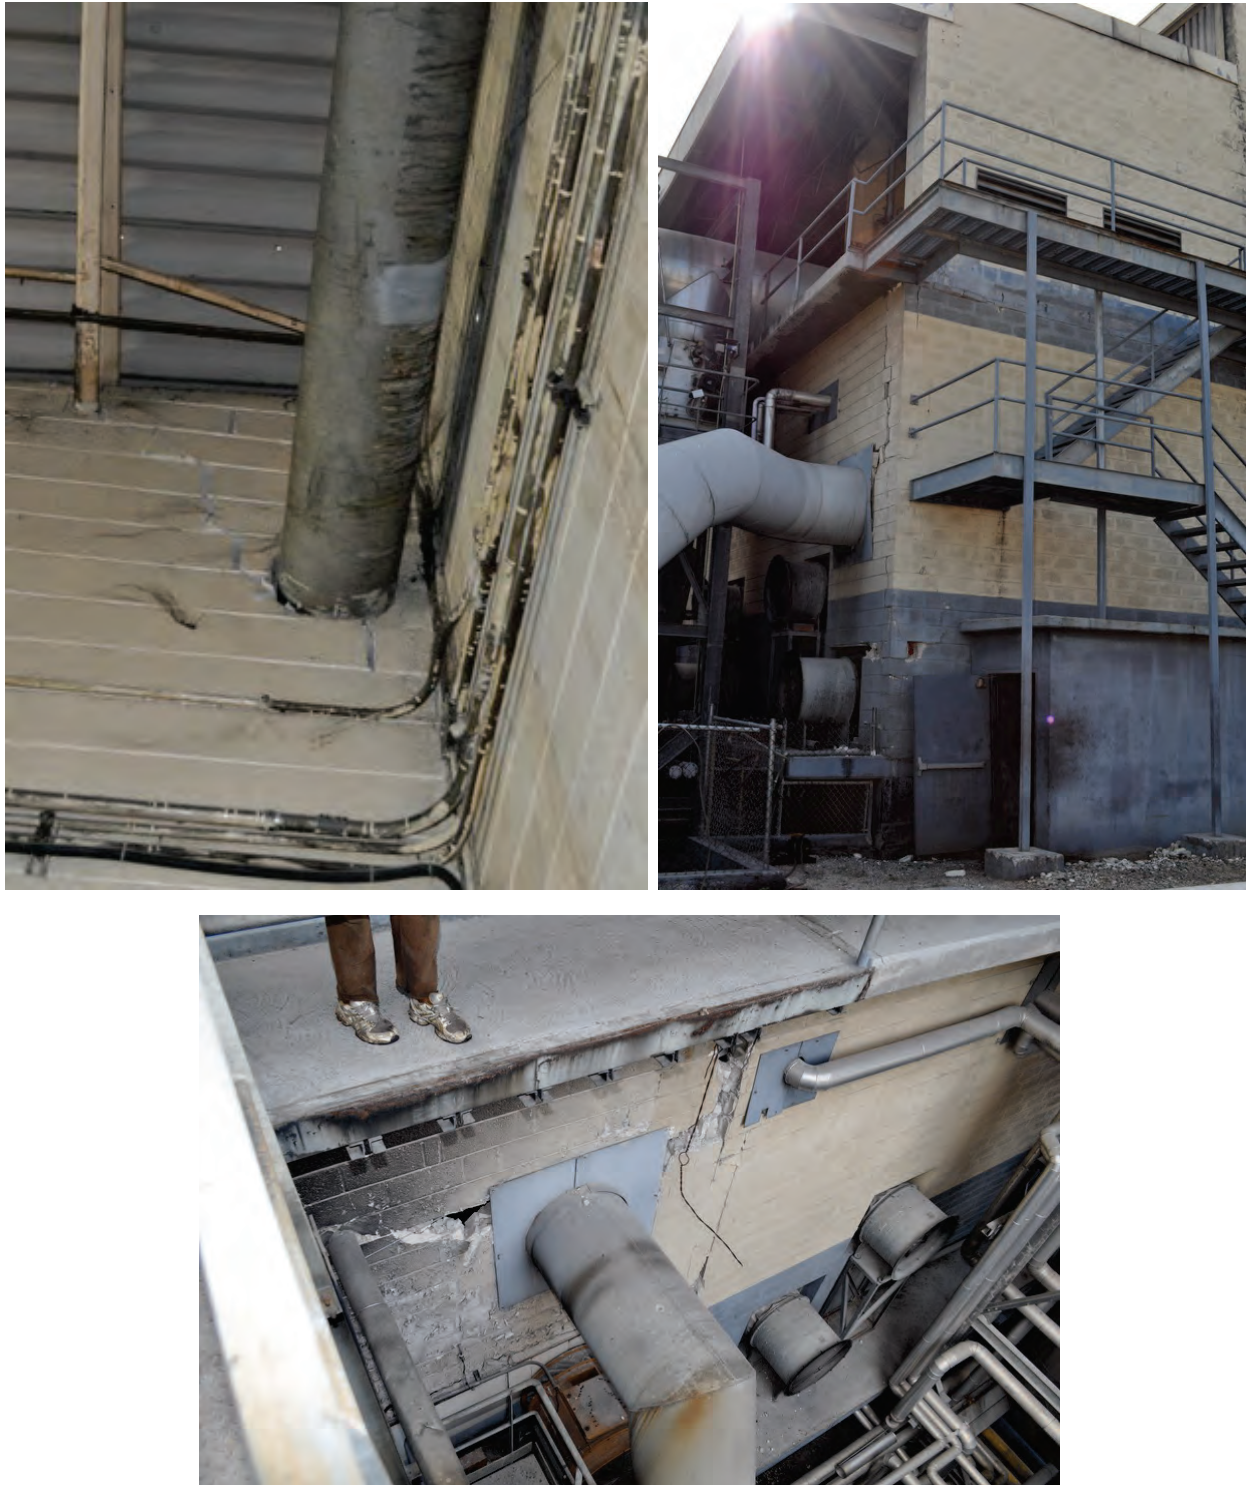
Figure 6.4.3.8-3 Wall penetrations for piping and ducts contributed to damage to unreinforced masonry walls at an industrial facility in the 2010 magnitude-7 Haiti Earthquake (Photos courtesy of Eduardo Fierro, BFP Engineers). The piping and ducts were not damaged but the walls cracked and will need to be repaired.

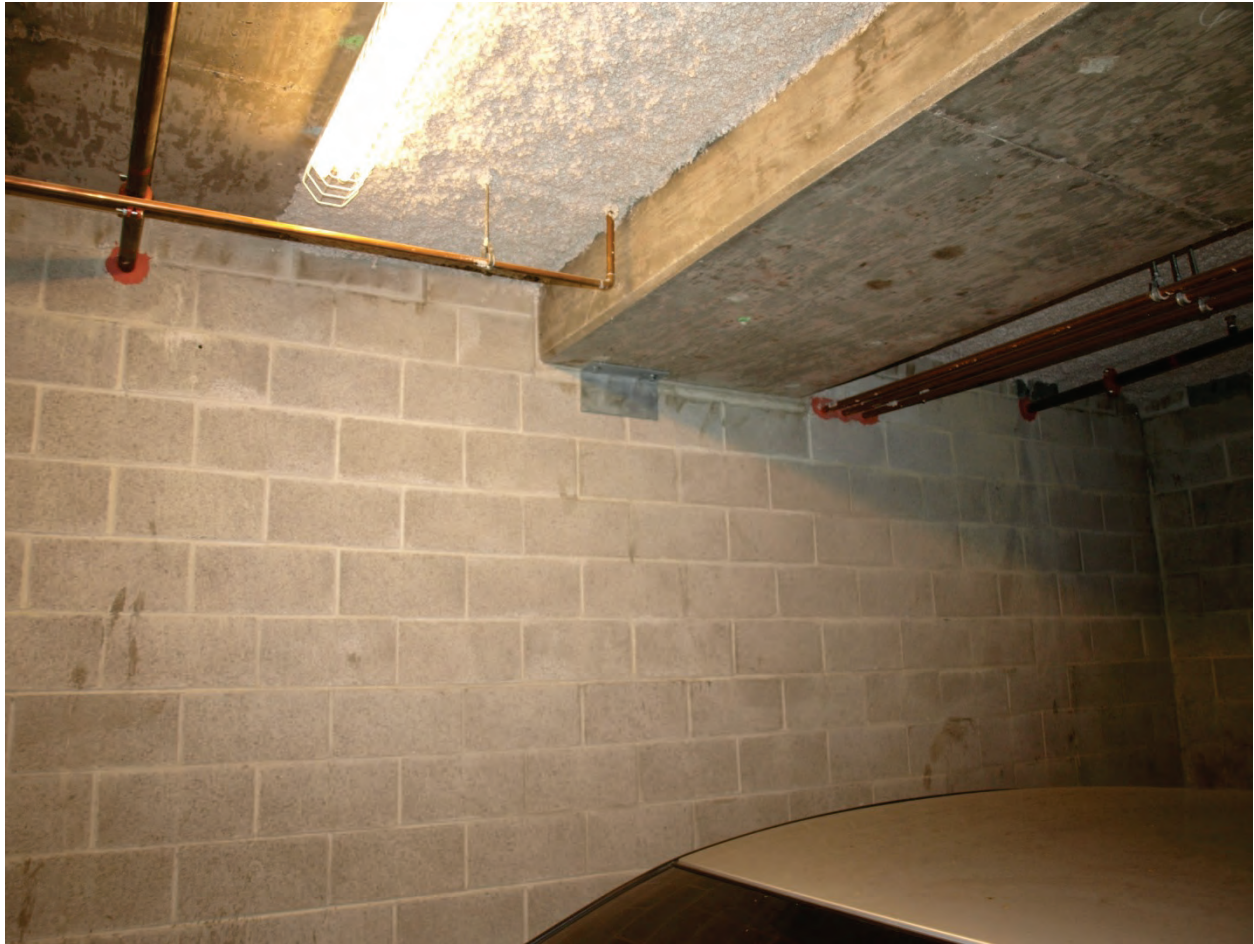
Figure 6.4.3.8-6 Series of pipe penetrations through a full-height CMU partition wall. Note pipe suspended from floor above; partition anchored to floor below and detailed with steel clip angles intended to provide lateral restraint for the wall but allow relative slip between the wall and slab above. The hangers will move with the floor above and the pipe at penetration will move with the wall. Lateral restraints are located immediately above floor (Photo courtesy Cynthia Perry, BFP Engineers).

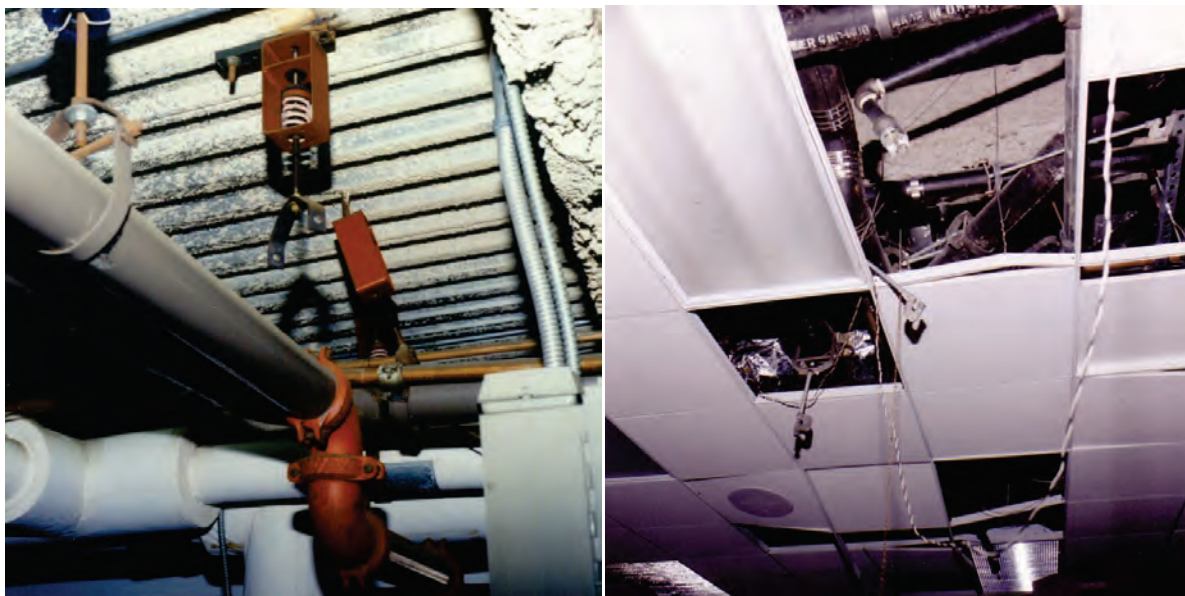
Figure 6.4.4.1-3 Damage to suspended fire protection piping from the 1994 Northridge Earthquake. Failed vibration isolators at left; failed C-clamps without beam clamp restraining straps shown at right (Photos courtesy of Mason Industries).

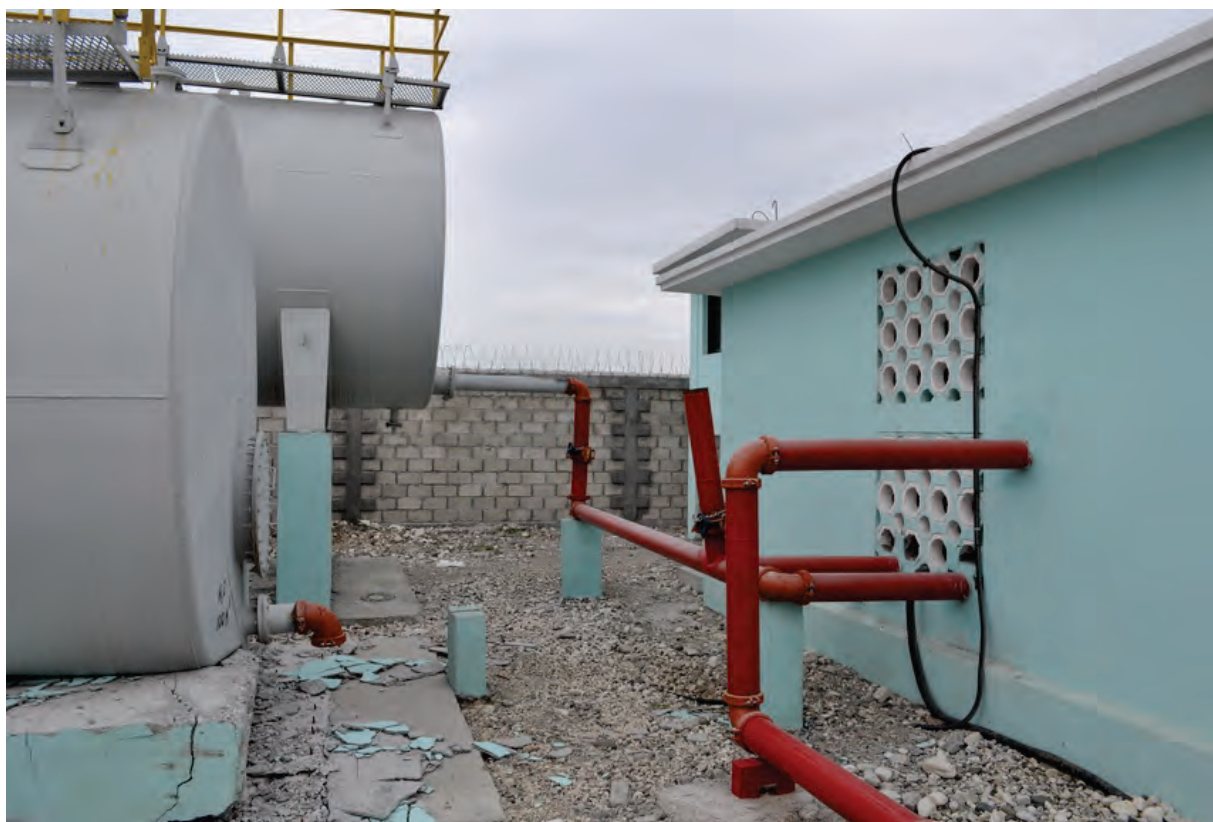
Figure 6.4.4.1-4 Collapse of water tank at left and broken piping disabled the fire protection system at this power plant in Port-au-Prince and led to the temporary plant closure in the 2010 magnitude-7 Haiti Earthquake (Photo courtesy of Eduardo Fierro, BFP Engineers).

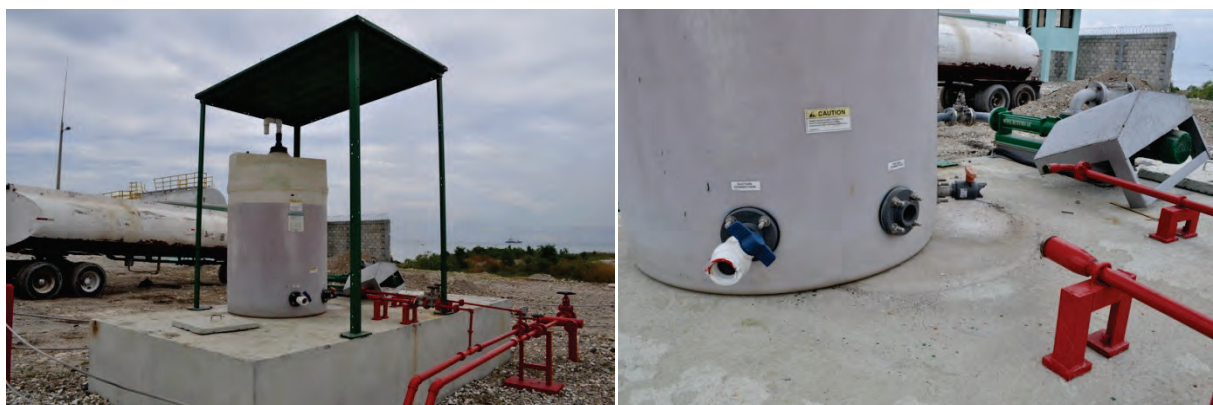
Figure 6.4.4.1-5 Unanchored holding tank slid on concrete pad, breaking fire protection piping and disabling the fire protection system in the 2010 Haiti Earthquake. In this case, the piping was well anchored but the tank was unrestrained (Photo courtesy of Eduardo Fierro, BFP Engineers).

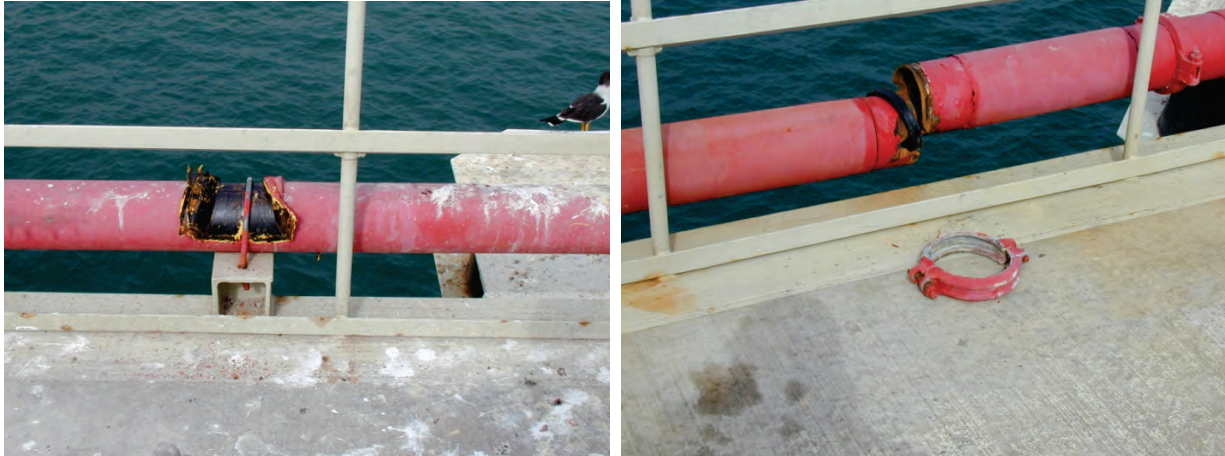
Figure 6.4.4.1-6 Damage to industrial fire protection piping located on jetty in 2001 Peru Earthquake. Longitudinal slip at U-bolt shown at left; this U-bolt still intact but other U-bolts broke and fell off the jetty. Failure of joint coupling and crushing of pipe shown at right (Photo courtesy Eduardo Fierro, BFP Engineers).

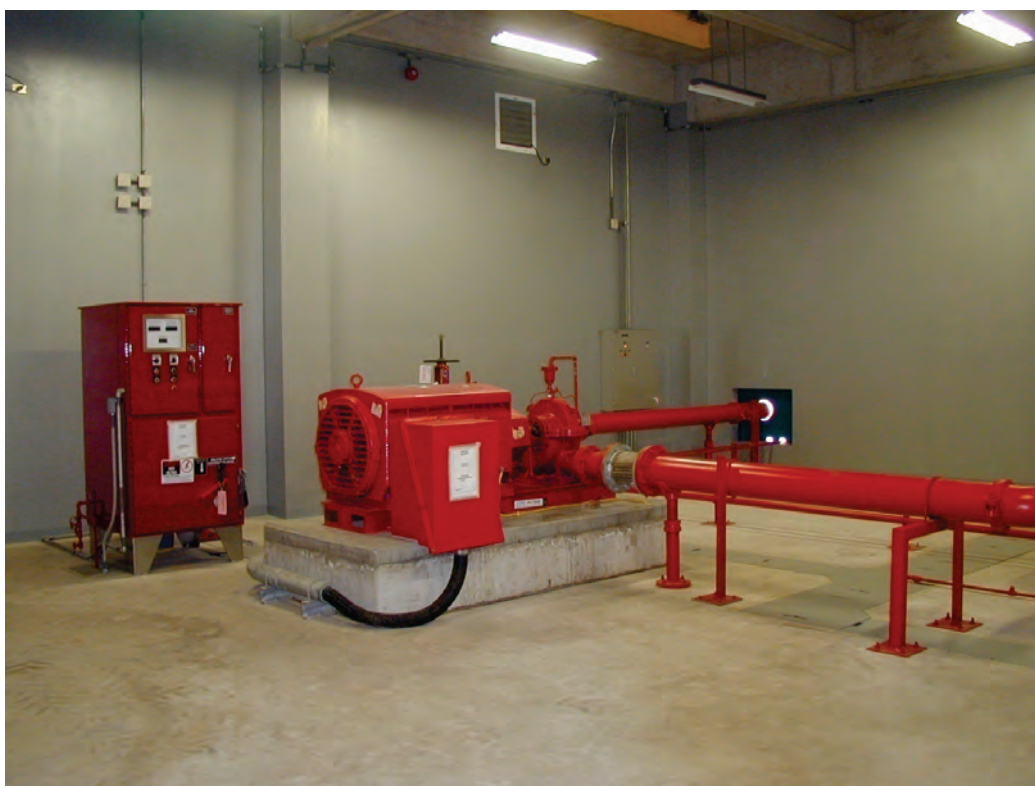
Figure 6.4.4.1-8 There was no damage to the *fire suppression equipment in this control room in the 2001 Peru Earthquake* because the pump and the control panel were well anchored and the piping had flexible connections with adequate sized wall penetration and no overhead falling hazards (Photo courtesy of Eduardo Fierro, BFP Engineers).

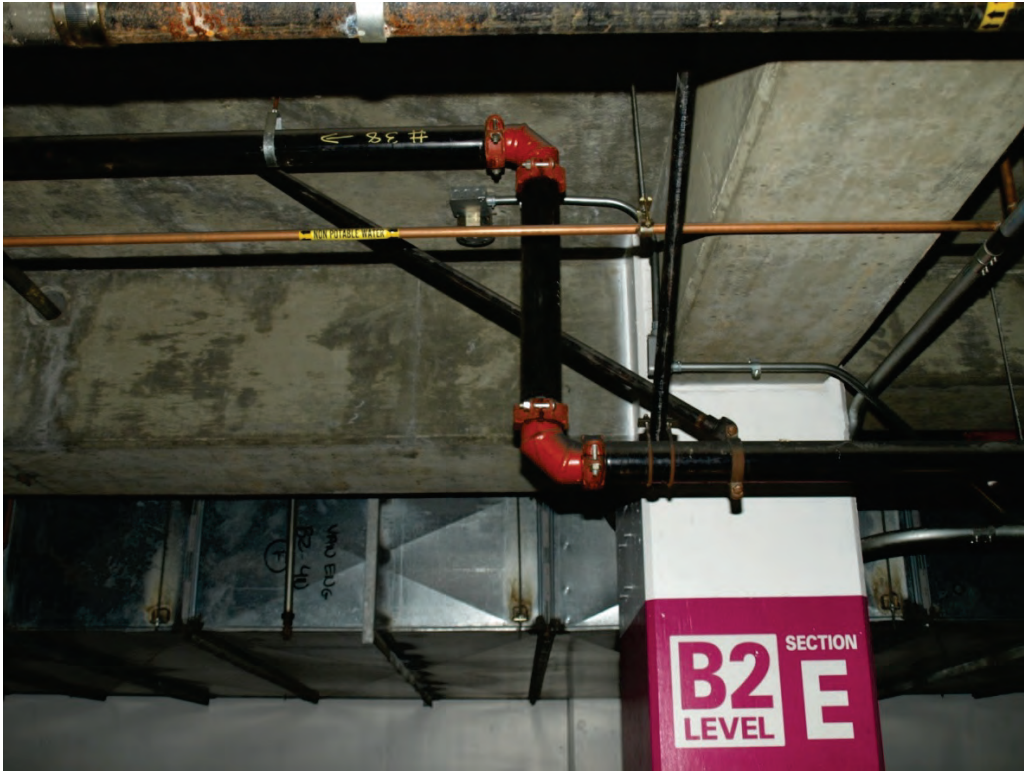
Figure 6.4.4.1-9 Transverse and longitudinal restraints on fire protection distribution line (Photo courtesy of Cynthia Perry, BFP Engineers).

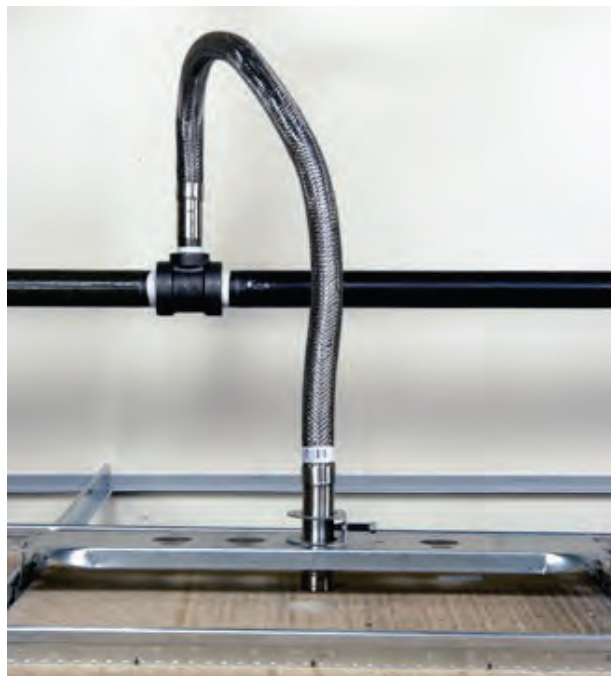
Figure 6.4.4.1-10 Flexible hose between sprinkler line and ceiling allowing the sprinkler head to move with the suspended ceiling without causing damage to the sprinkler system (Photo courtesy of Flexhead).

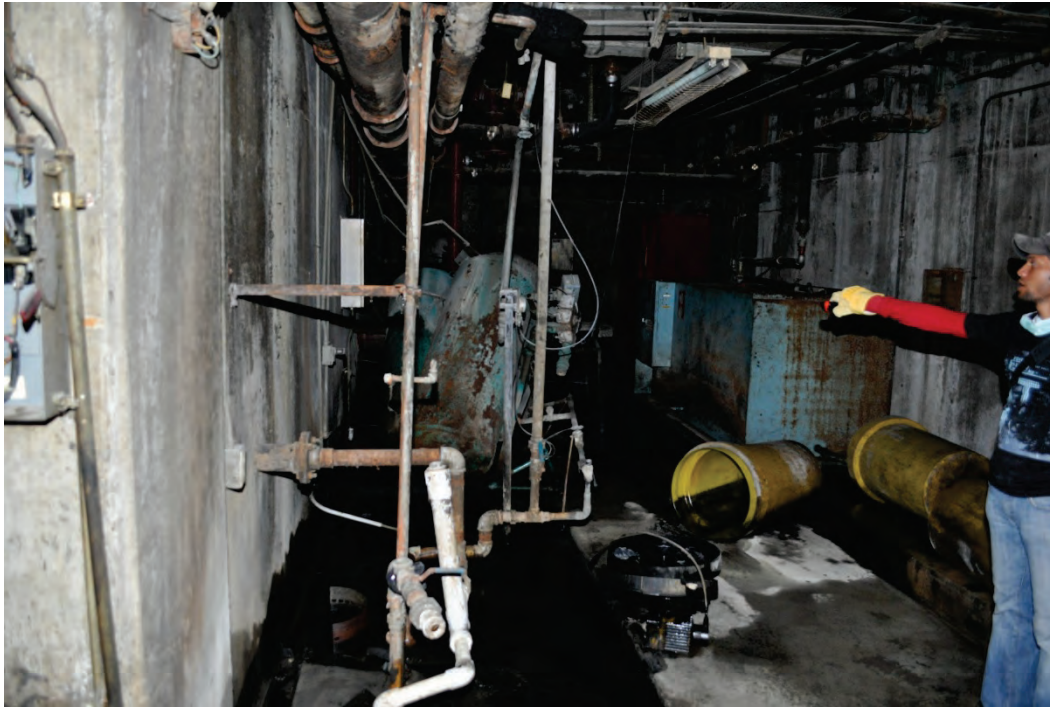
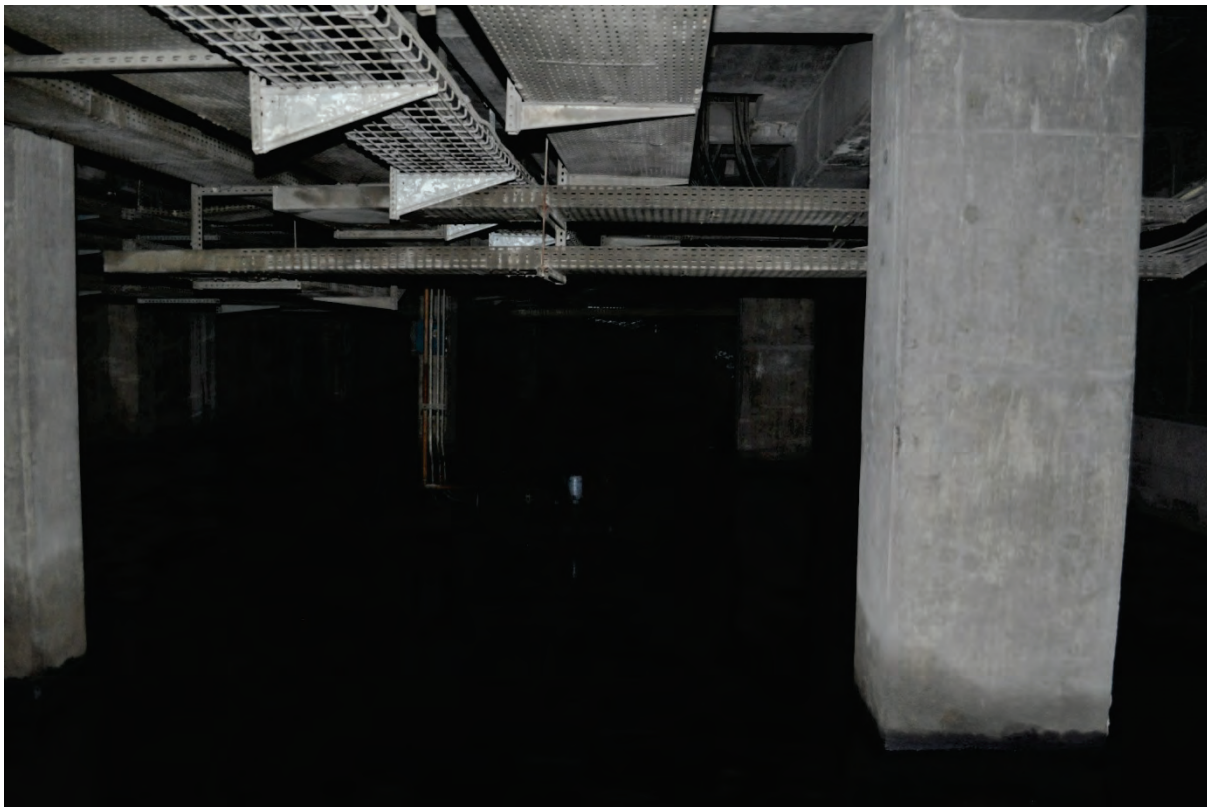
Figure 6.4.5.1-2 Basement level at power plant in Port-au-Prince flooded with oil and water in the 2010 magnitude-7 Haiti Earthquake creating hazardous conditions for inspection and clean-up (Photos courtesy of Eduardo Fierro, BFP Engineers).

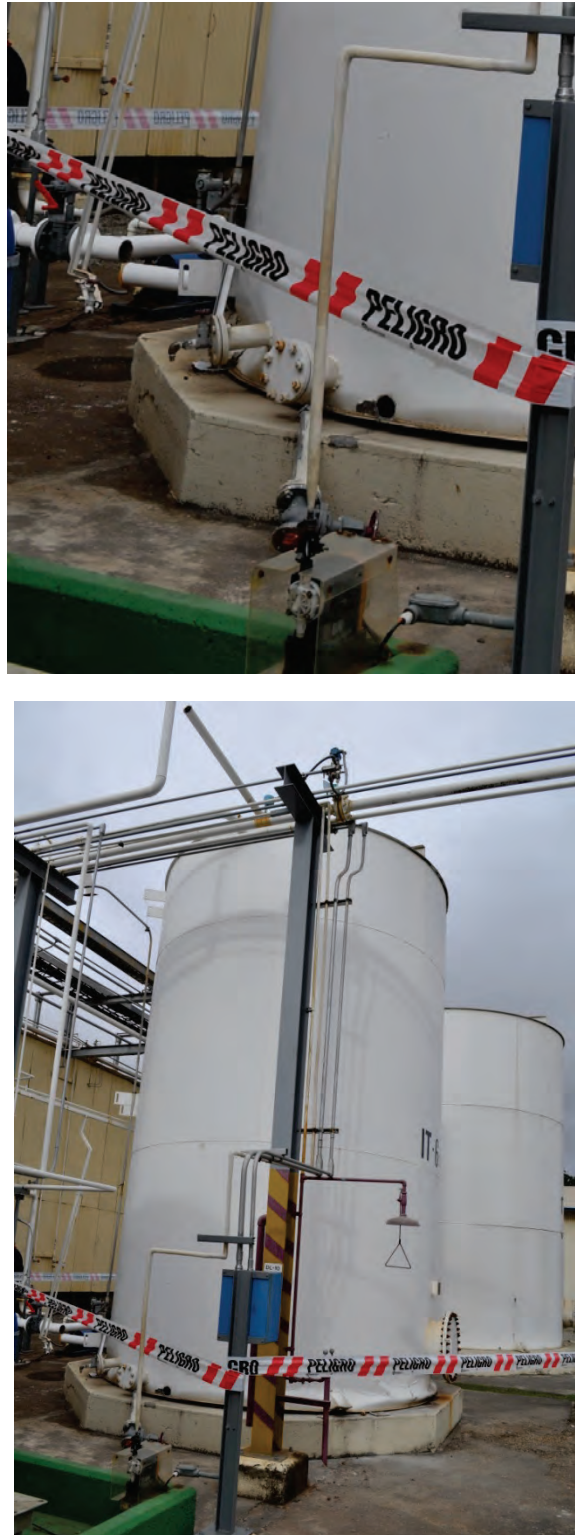
Figure 6.4.5.1-3 Elephant foot damage to inadequately anchored fuel tank in the 2010 Chile Earthquake also resulted in damage to fuel lines. Close-up photo shows failed pipe at welded joint (left) and pipe segment with attached valve (foreground) tore out of the tank wall (Photos courtesy of Eduardo Fierro, BFP Engineers).

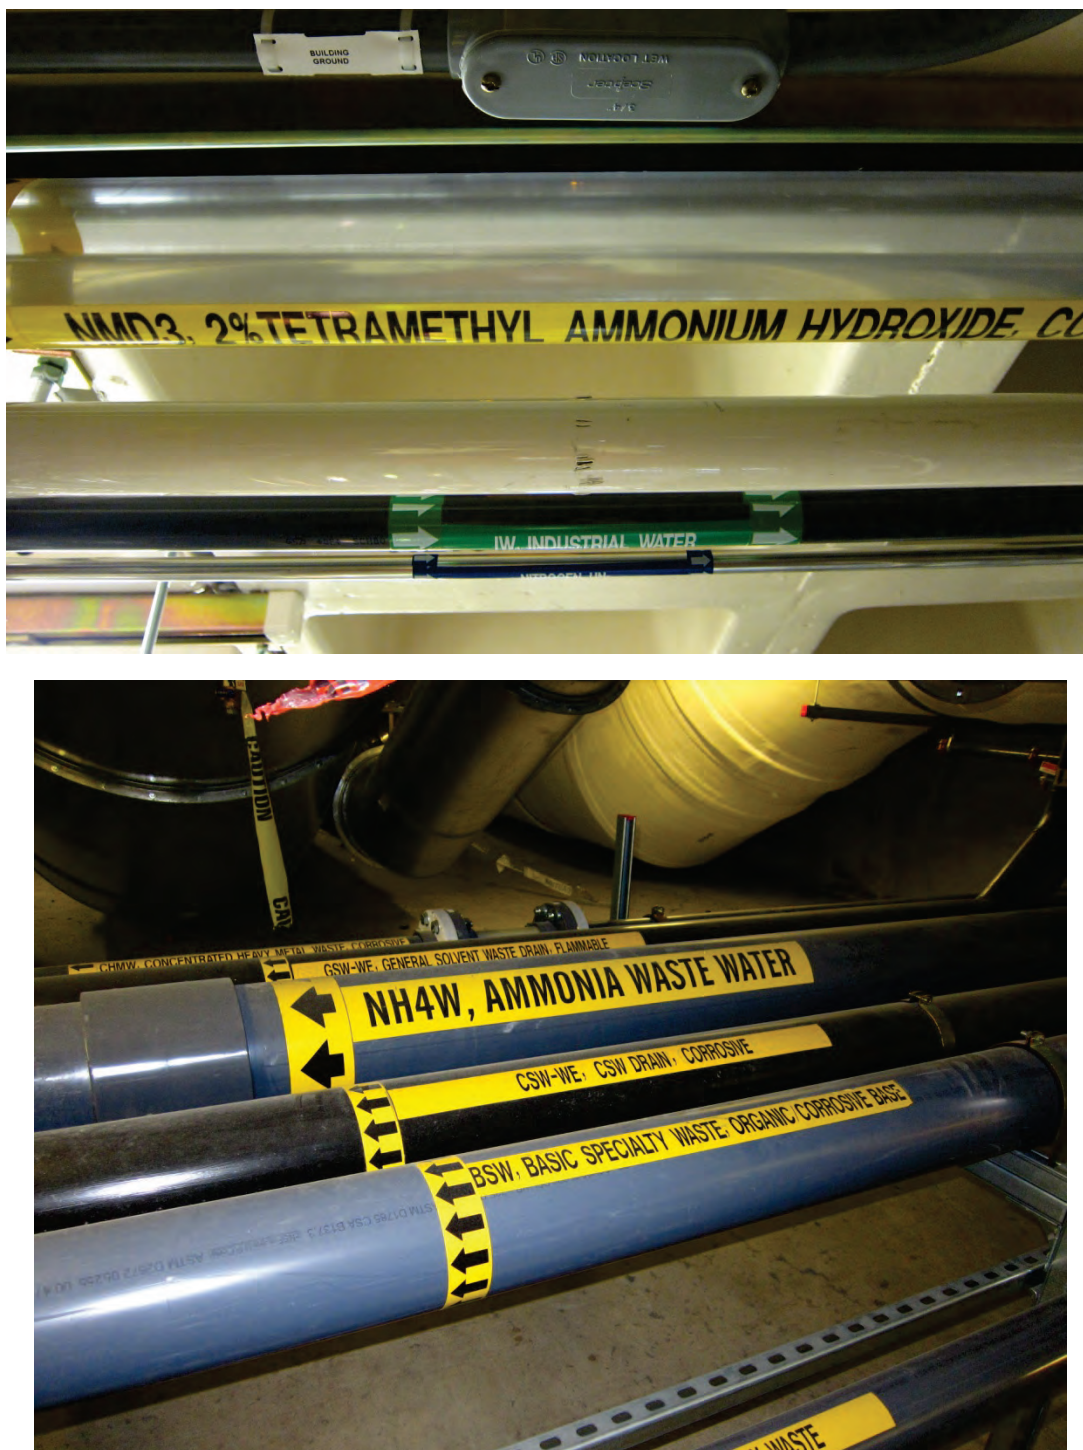
Figure 6.4.5.1-5 Two examples of double walled piping used for secondary containment of hazardous fluids. Preassembled double walled pipe with centering devices or spacers separating the inner and outer pipe is available commercially, but as shown here, the outer pipe was installed and leak tested prior to pulling the inner pipe through. Note the yellow color coded labels indicate reactive materials; flow direction also marked prominently (Photos courtesy of Jeffrey Soulages, Intel Corporation).

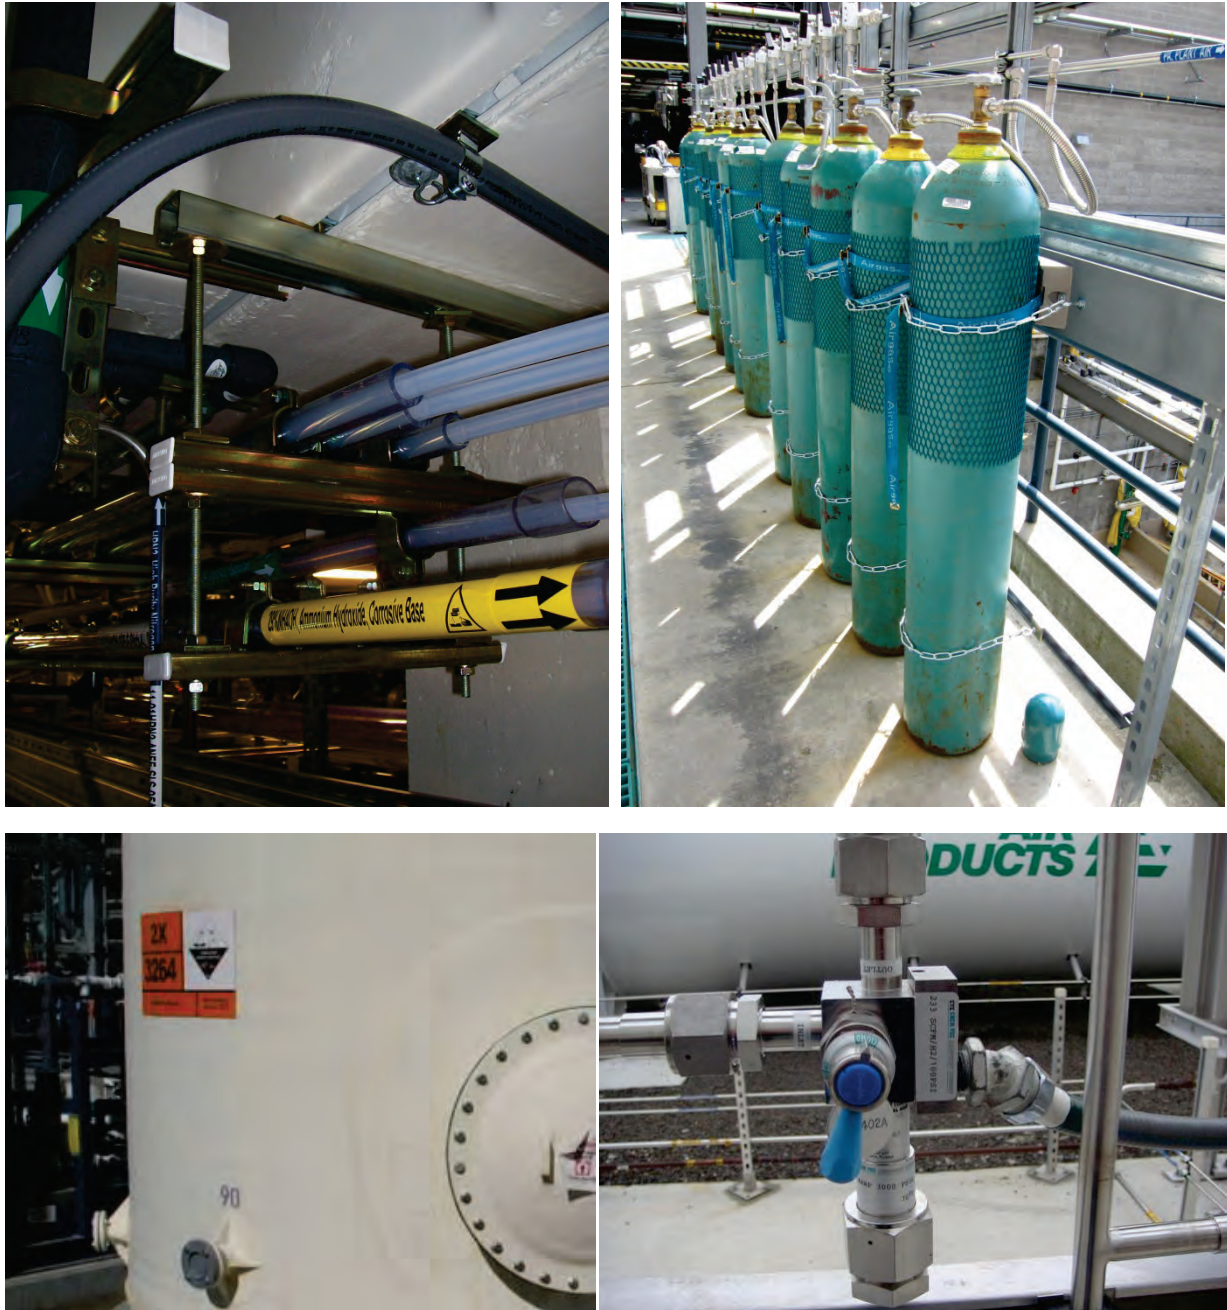
Figure 6.4.5.1-6 Clockwise from top: a) Sleeved pipe connections where seismic anchorage consists of cushioned pipe clamp attached around outer sleeve and inner pipe not restrained longitudinally. b) Airgas canisters chained and strapped to supports, fitted with flexible hose, stainless steel piping (note blue label), and a row of valves. c) Label on tank shows example of European ADR danger labeling scheme. d) Excess flow valve for large gas tank (Photos courtesy of Jeffrey Soulages, Intel Corporation).

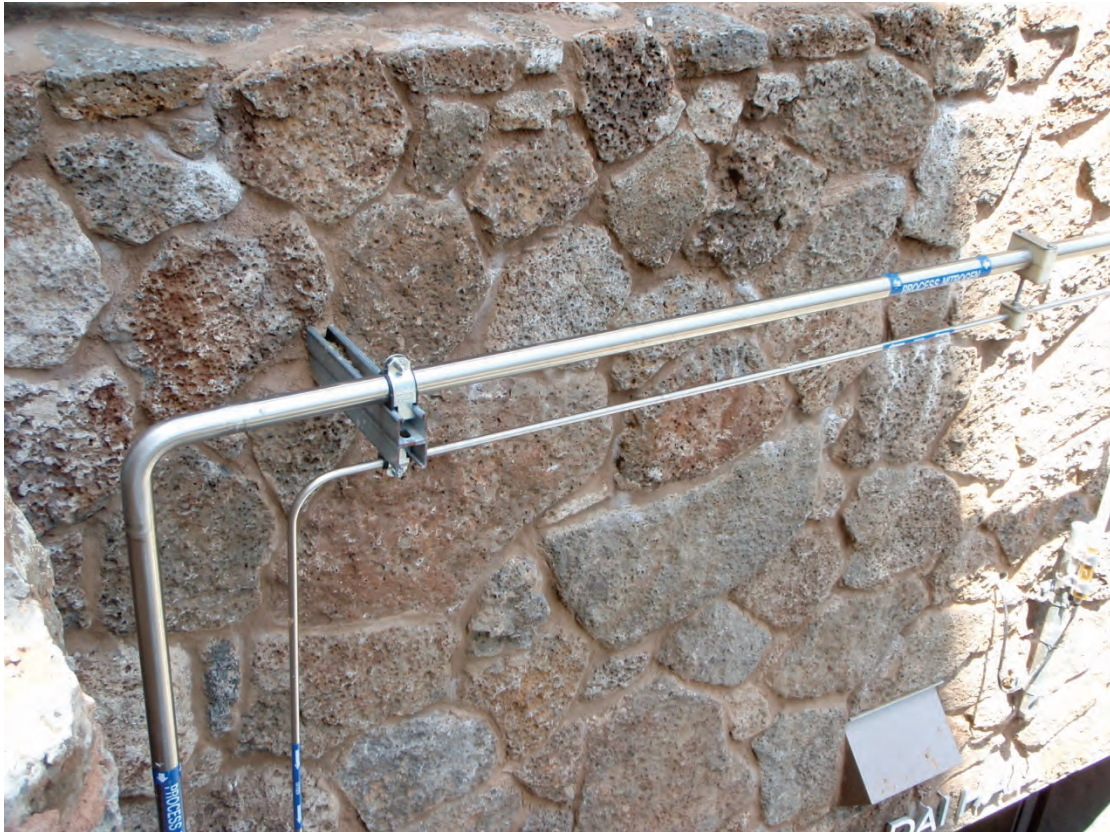
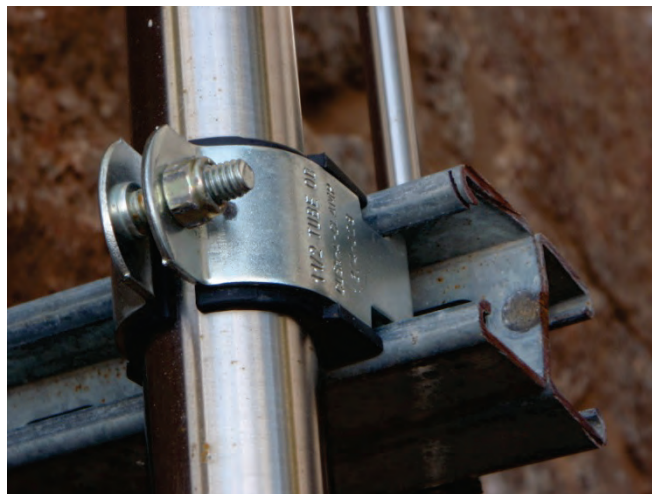
Figure 6.4.5.1-7 Process nitrogen piping outside engineering building on the UC Berkeley campus; strut clamp has rubber fittings to protect the stainless steel piping (Photos courtesy of Cynthia Perry, BFP Engineers).

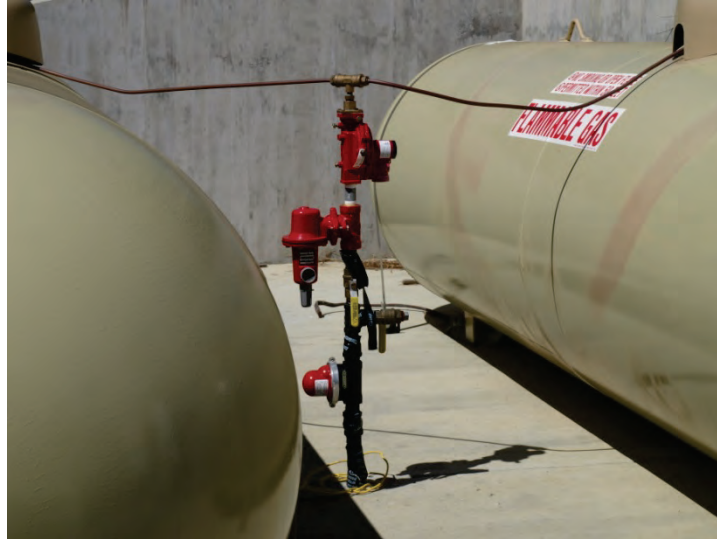
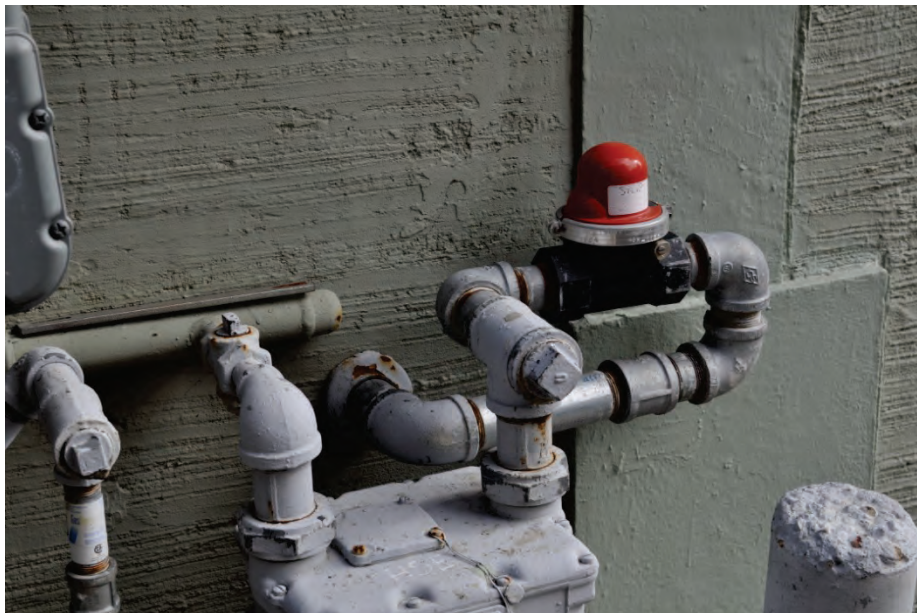
Figure 6.4.5.1-8 Two examples of seismic shut-off valves in San Francisco Bay Area. Top photo at Marine Mammal Center; lower photo at six unit apartment building in Oakland (Photos courtesy of Cynthia Perry, BFP Engineers).

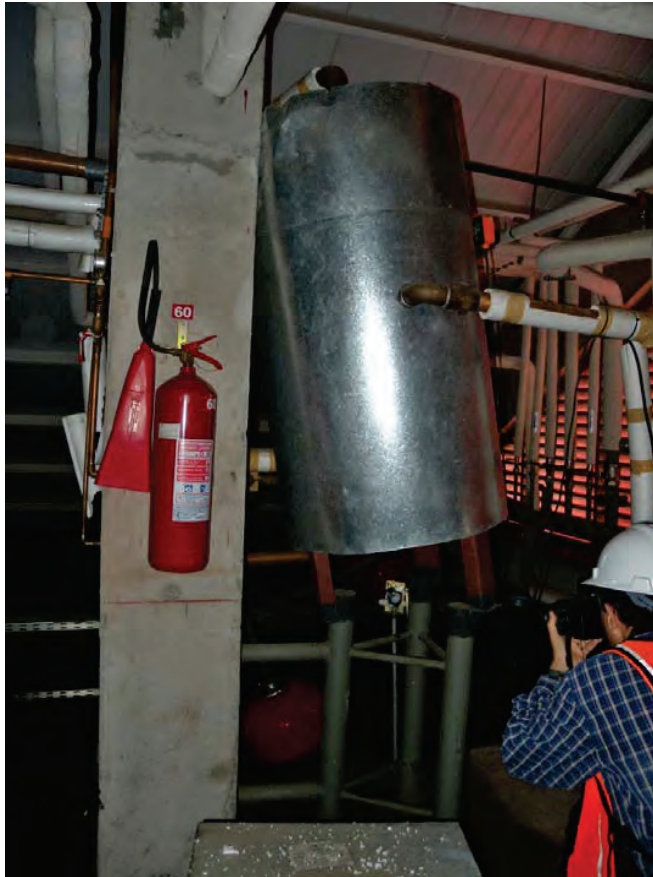
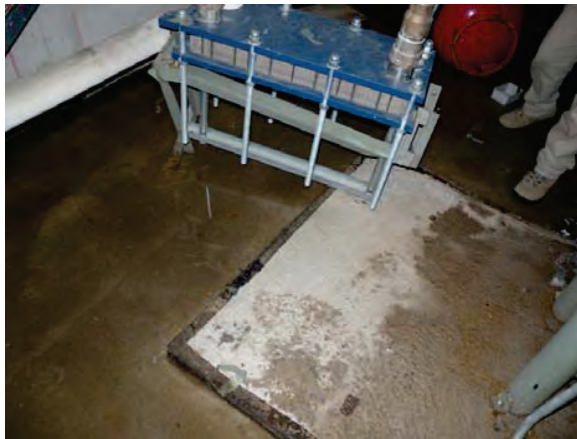
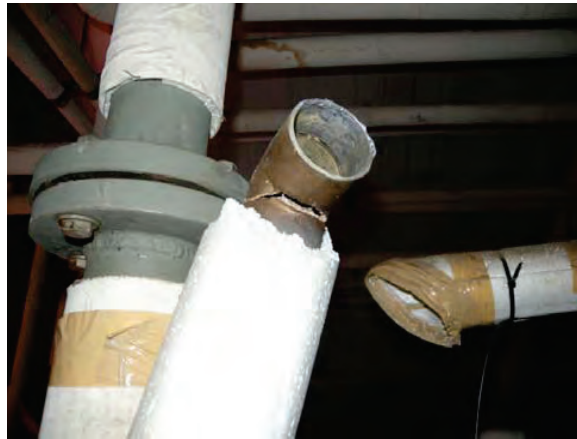
Figure 6.4.5.2-1 Broken copper hot water piping for at the San Carlos Hospital in the 2010 Chile Earthquake. Piping failure caused by movement of inadequately braced boiler shown at left (Photos courtesy of Gilberto Mosqueda, SUNY Buffalo).

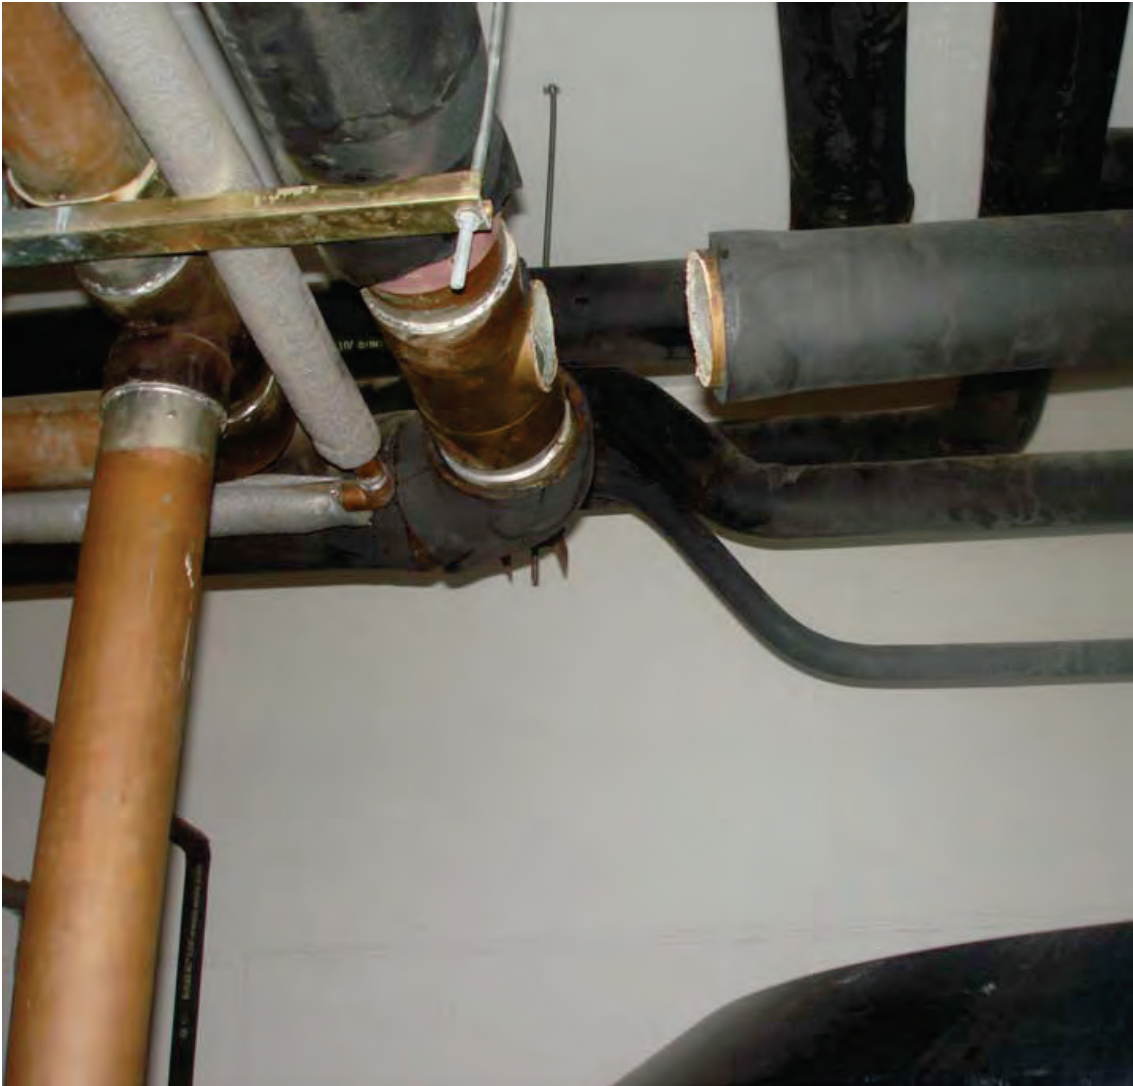
Figure 6.4.5.2-2 Broken copper piping for hot water supply in residential building in the 2010 Chile Earthquake. Trapeze shown not laterally braced but hangers appear to be less than 12" in length and may not have required lateral restraints per ASCE 7-10 (Photo courtesy of Gokhan Pekcan).

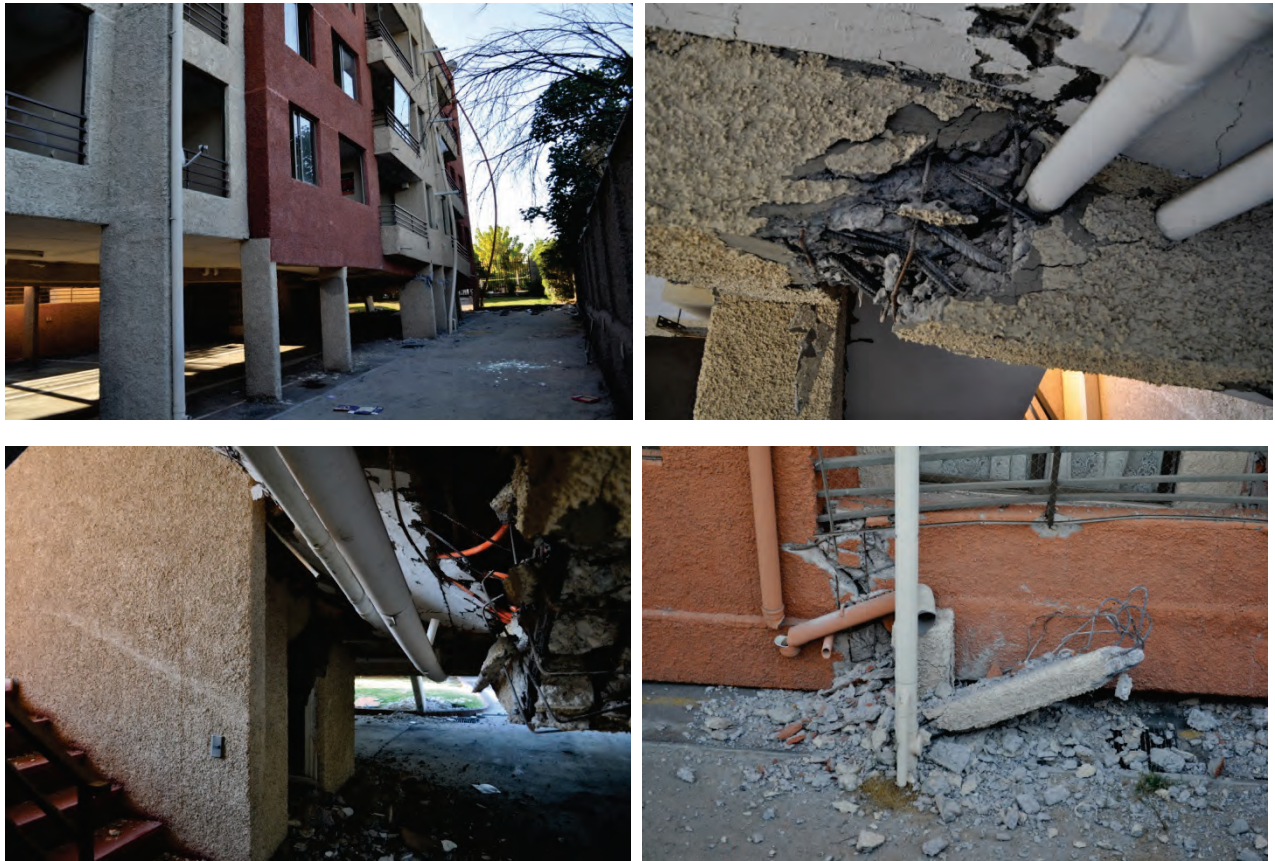
Figure 6.4.5.2-3 Photos displaying resilience of piping systems; this building suffered a partial structural collapse along one side in the 2010 Chile Earthquake. The only broken pipe (shown at lower right) was along the collapsed side; the other piping had broken pipe supports in some locations but the joints remained largely intact, even with these very large deformations (Photos courtesy of Eduardo Fierro, BFP Engineers).

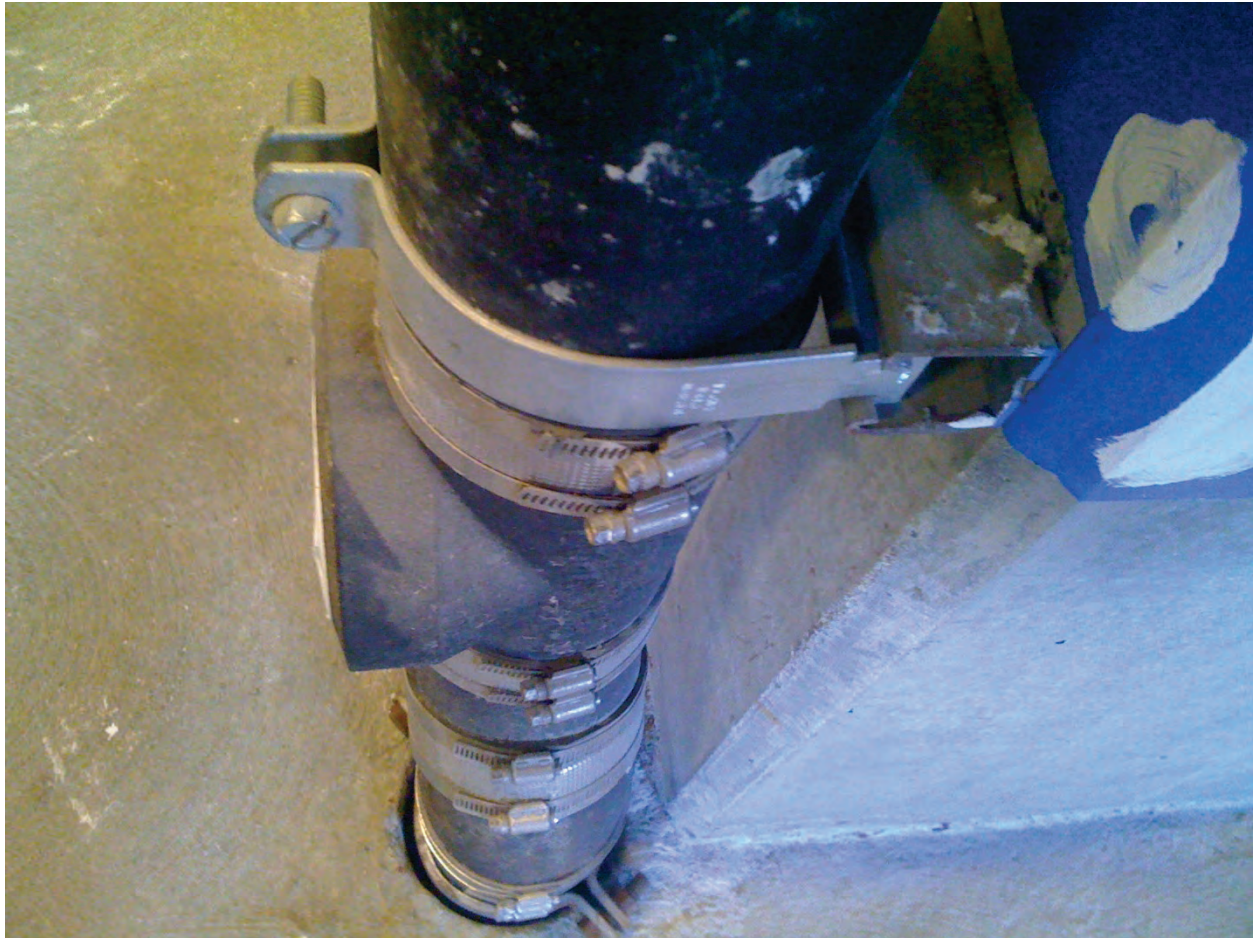
Figure 6.4.5.2-5 Poor example of sanitary sewer pipe support installed in San Francisco Bay Area in 2010; strut clamp has inadequate edge distance to end of strut and could slip off the end (Photo courtesy of Cynthia Perry, BFP Engineers).
