Reducing the Risks of Nonstructural Earthquake Damage – A Practical Guide

FEMA E-74 / December 2012

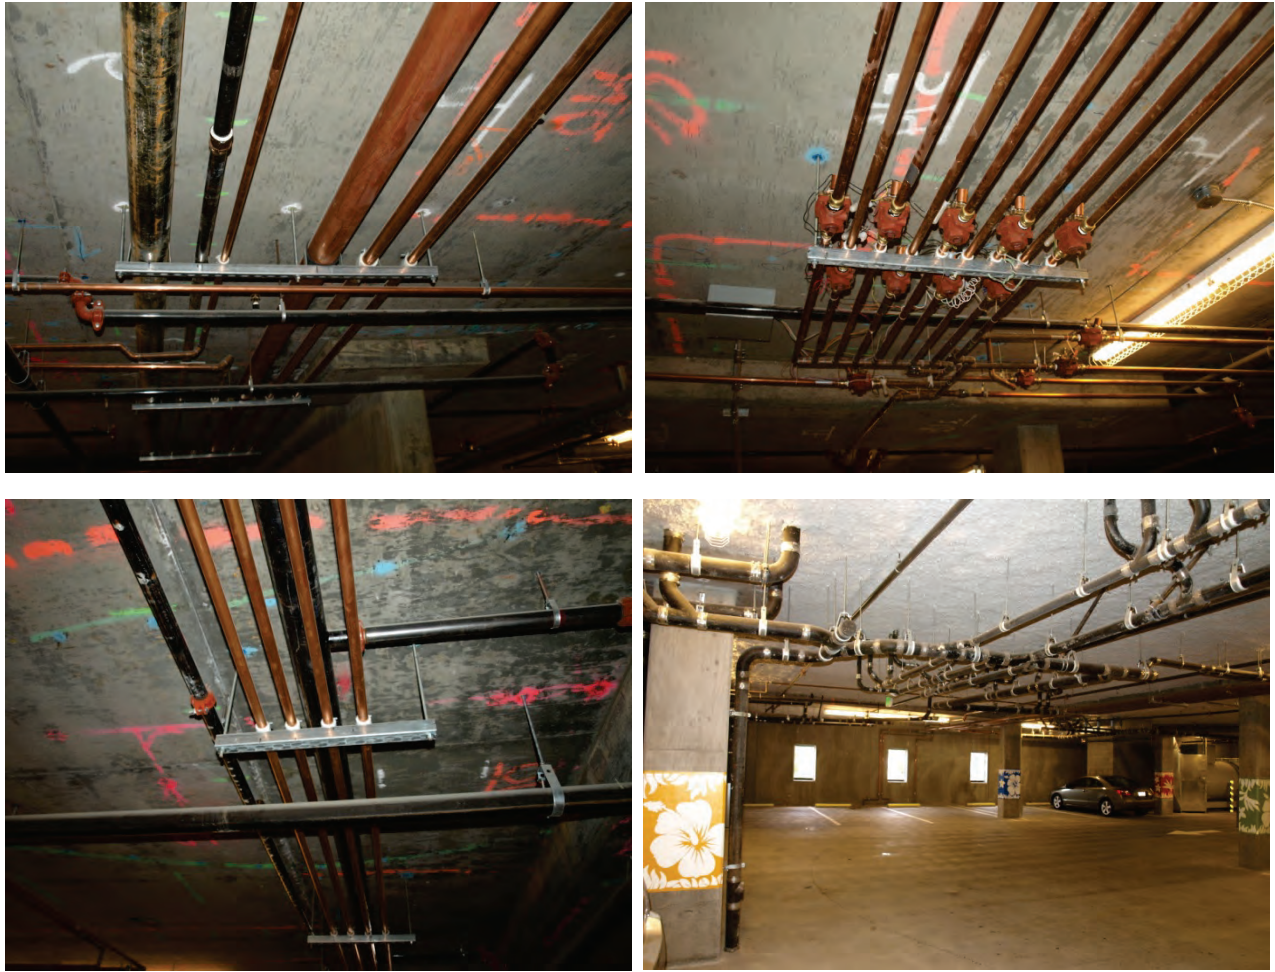
Figure 6.4.5.2-6 Piping installation in garage of mixed commercial/residential building San Francisco Bay Area completed in 2010. Note piping and trapeze supports do not have lateral restraints as all hangers were kept under 12" in length; only the sprinkler lines were laterally restrained. (Photo courtesy of Cynthia Perry, BFP Engineers).

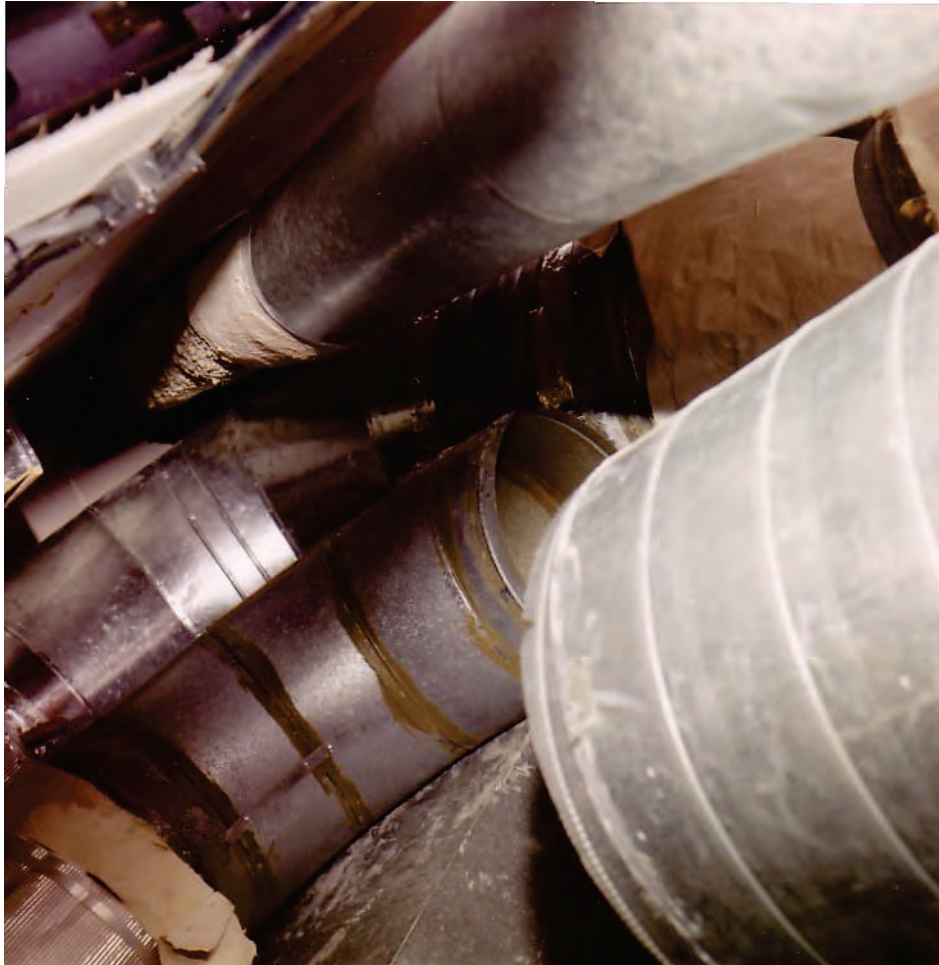
Figure 6.4.6.1-1 Unbraced ducts separated at bend in the 1994 magnitude-6.7 Northridge Earthquake (Photo courtesy of Mason Industries).

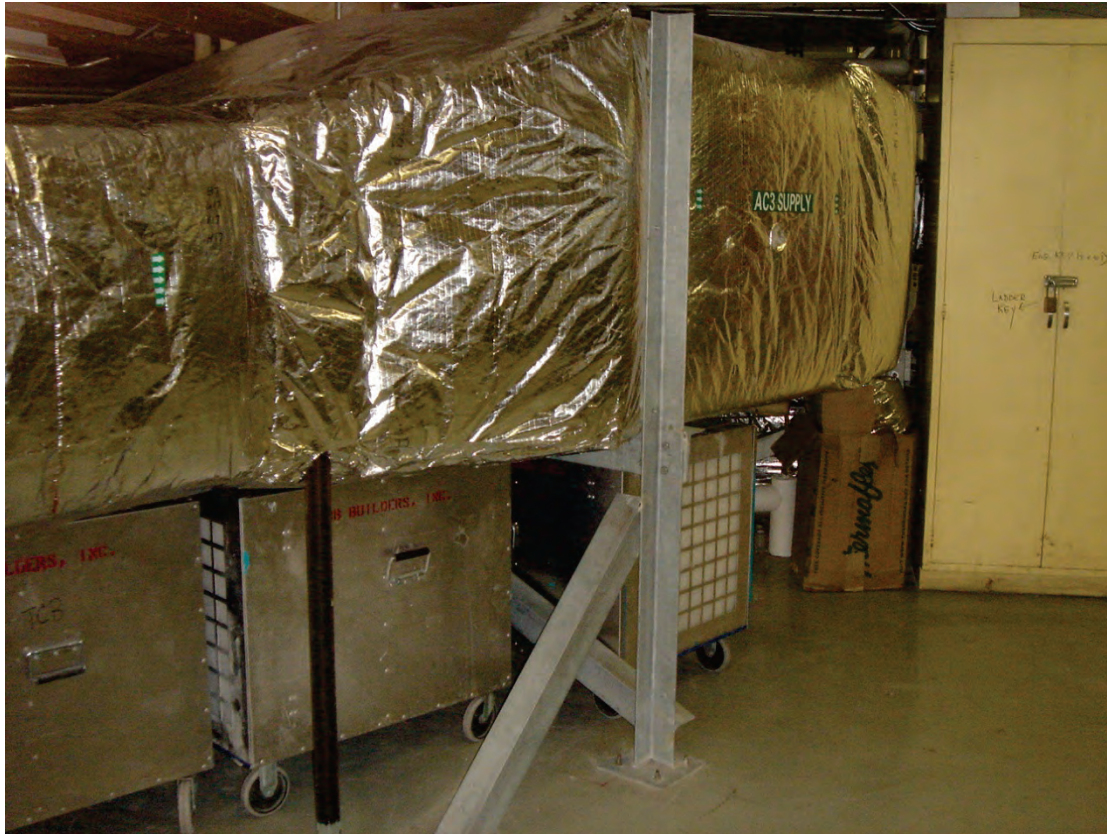
Figure 6.4.6.1-5 Floor-mounted rectangular duct supported on braced support stand built up from steel angles (Photo courtesy of Maryann Phipps, Estructure).

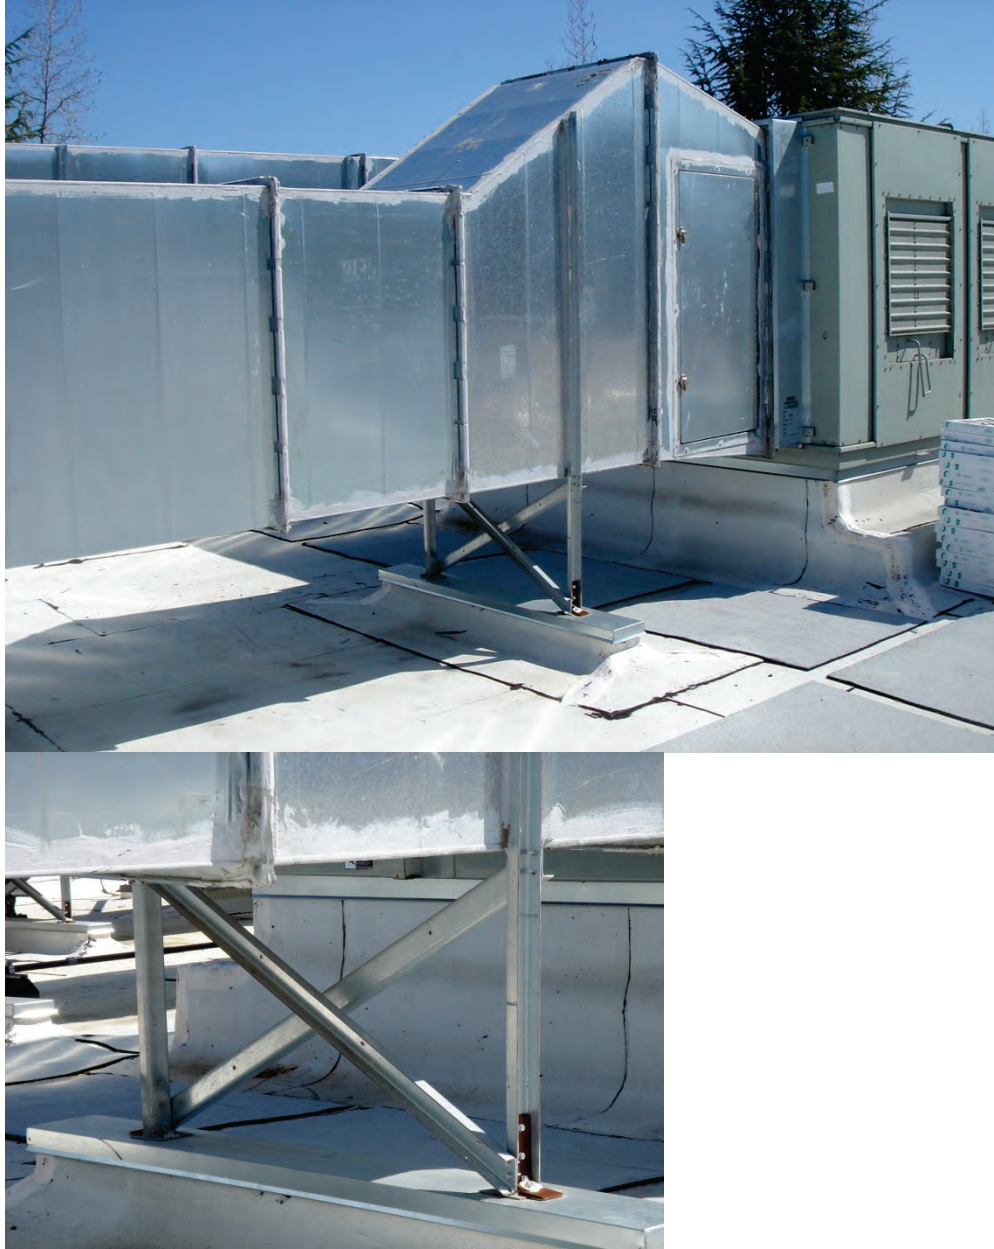
Figure 6.4.6.1-6 Roof-mounted rectangular duct supported on braced support stand built up from steel channels (Photo courtesy of Maryann Phipps, Estructure).

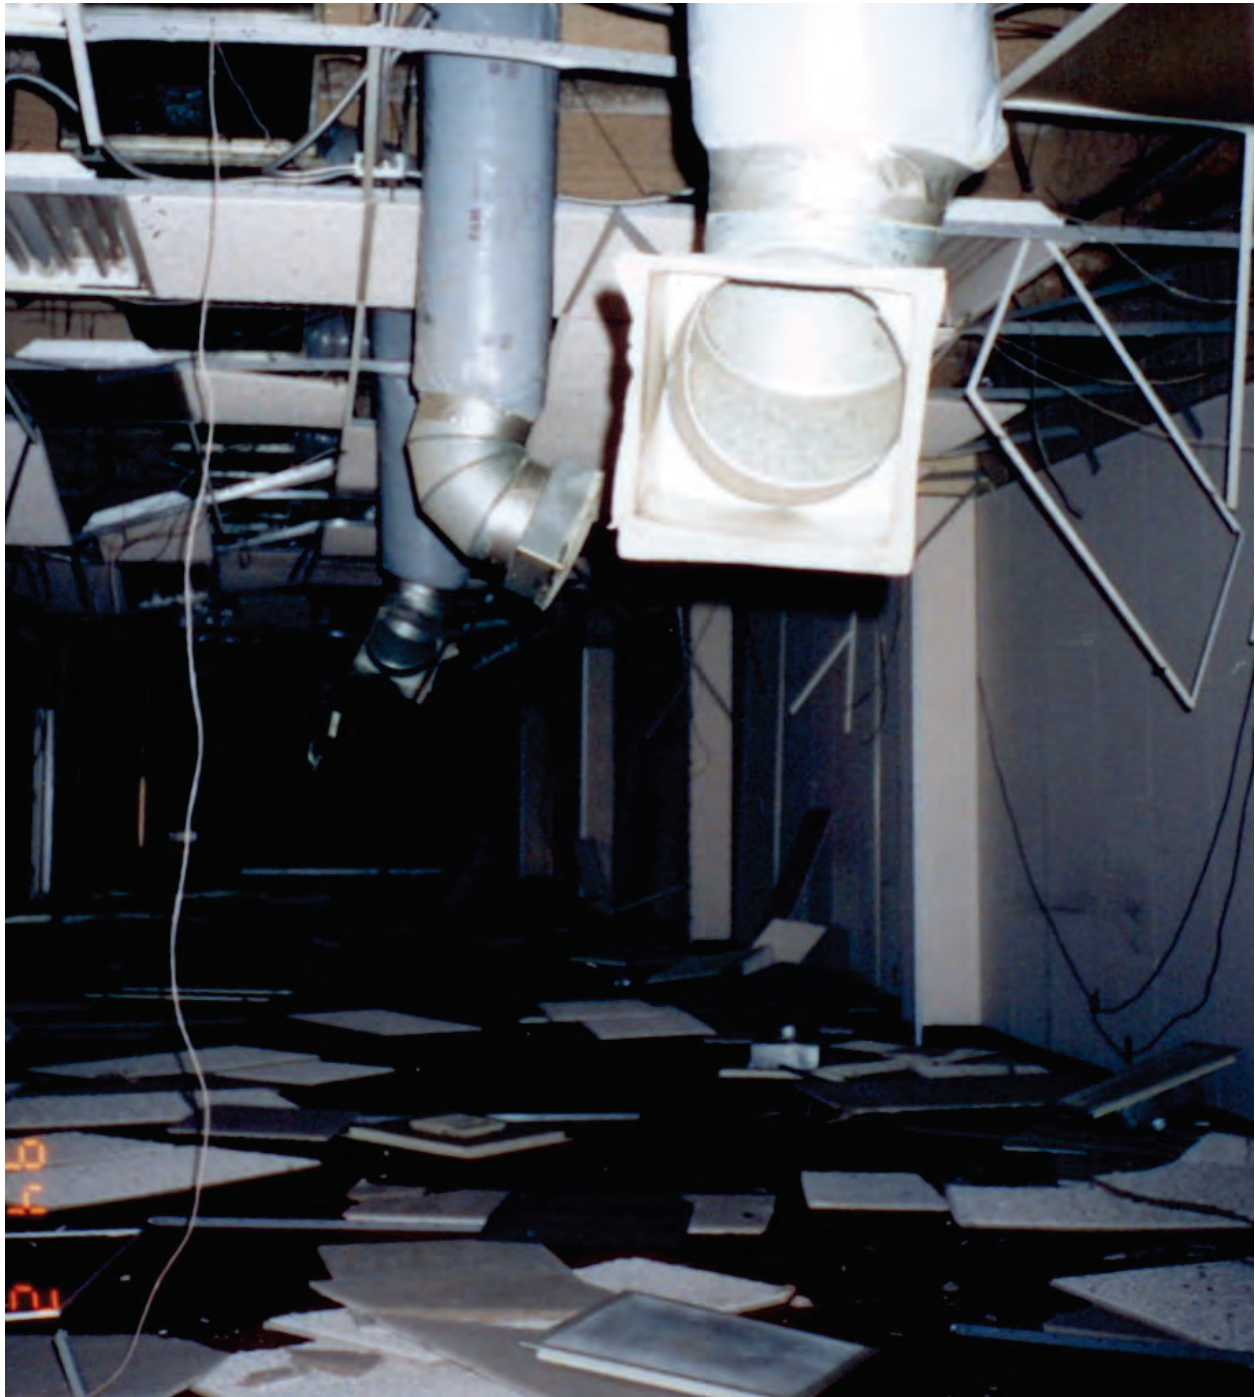
Figure 6.4.6.2-1 Air diffusers fell to the floor; ducts hanging through ceiling grid as a result of the 1994 Northridge Earthquake (FEMA 74, 1994).

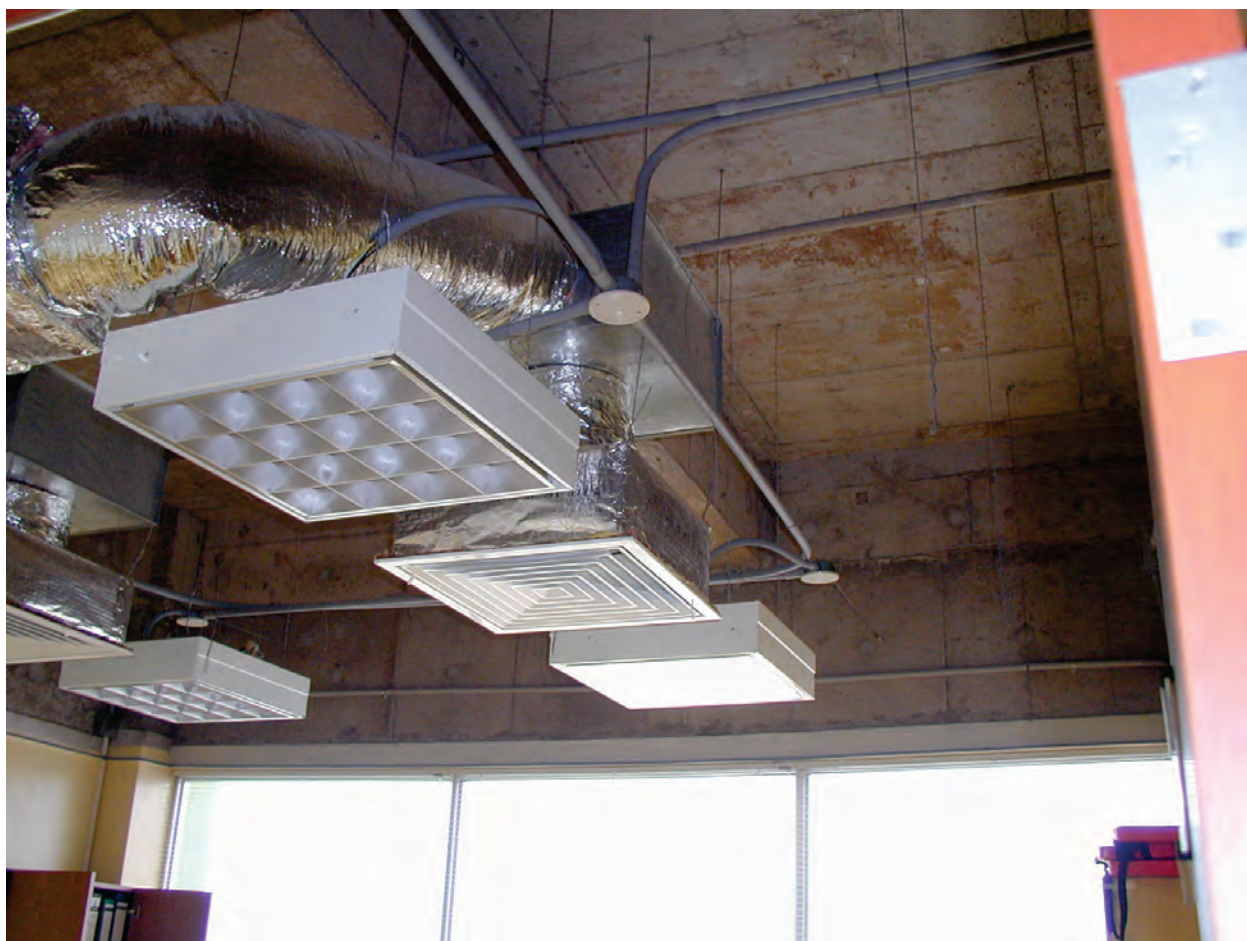
Figure 6.4.6.2-2 HVAC diffuser attached to the structure with four vertical hangers; ceiling system was damaged beyond repair in the 2001 Peru Earthquake but none of the diffusers or lights fell. Ceiling was demolished prior to photo (Photo courtesy of Eduardo Fierro, BFP Engineers).

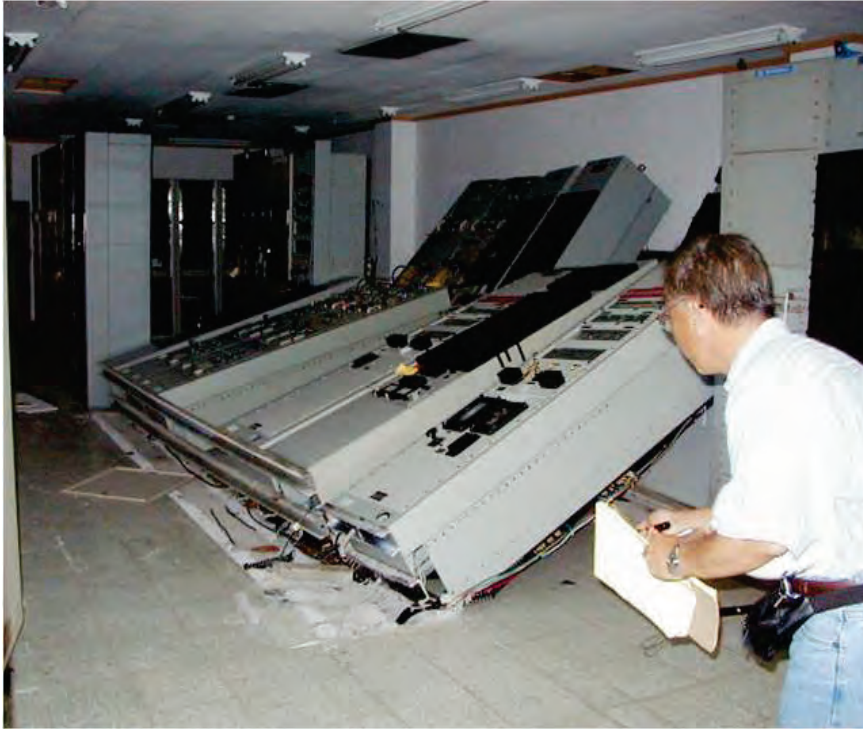
Figure 6.4.7.1-1 Overturned equipment in the 1985 magnitude-8 Mexico Earthquake, note absence of anchorage of equipment base to floor (Photo courtesy of Degenkolb Engineers).

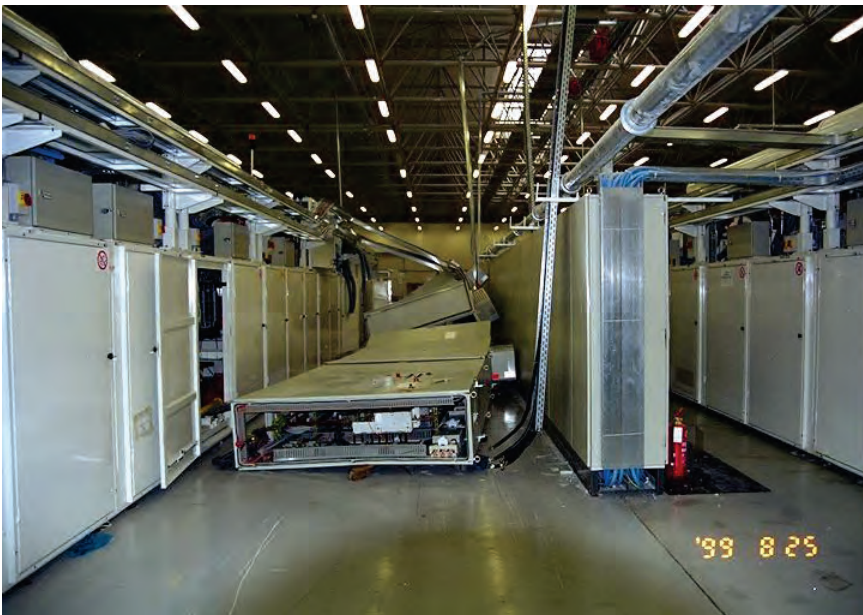
Figure 6.4.7.1-2 Unanchored electrical cabinets overturned in a paper products plant during the 1999 magnitude-7.4 Izmit, Turkey earthquake (Photo courtesy of NISEE Izmit Collection, No. IZT-682, photograph by Halil Sezen).

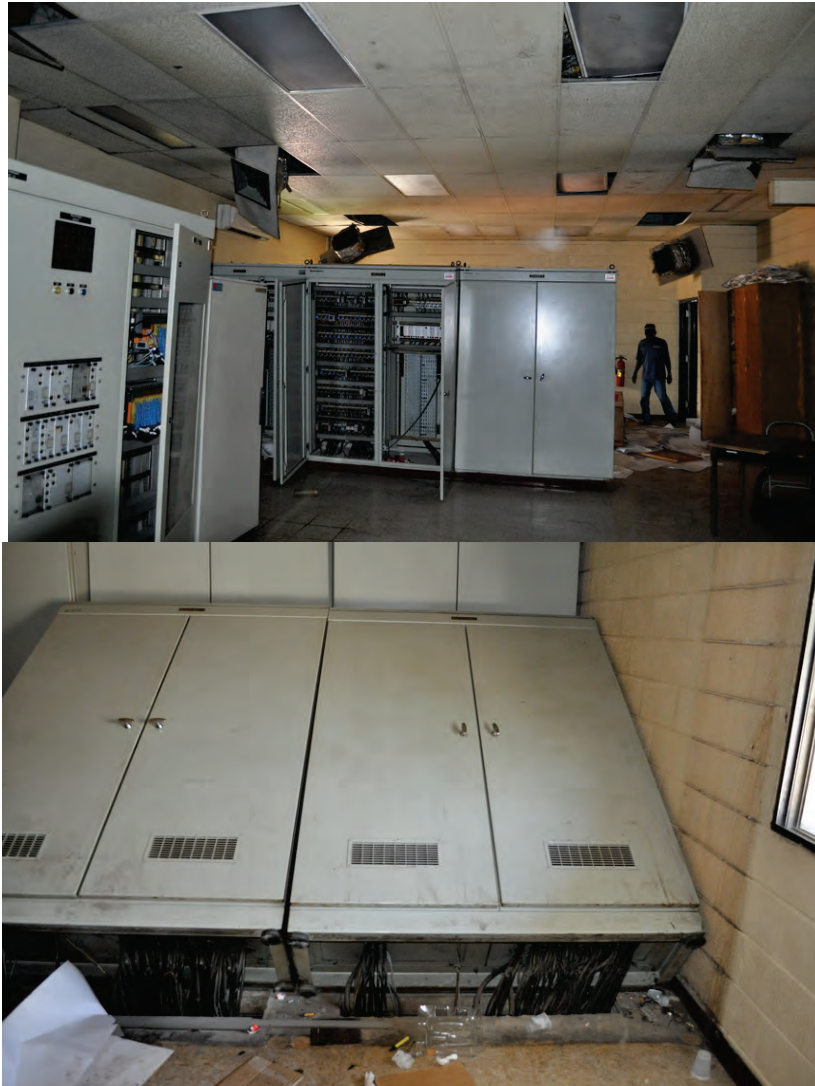
Figure 6.4.7.1-3 Damage to unanchored electrical cabinets at power plant in Port-au-Prince in the 2010 magnitude-7 Haiti Earthquake (Photos courtesy of Eduardo Fierro, BFP Engineers).

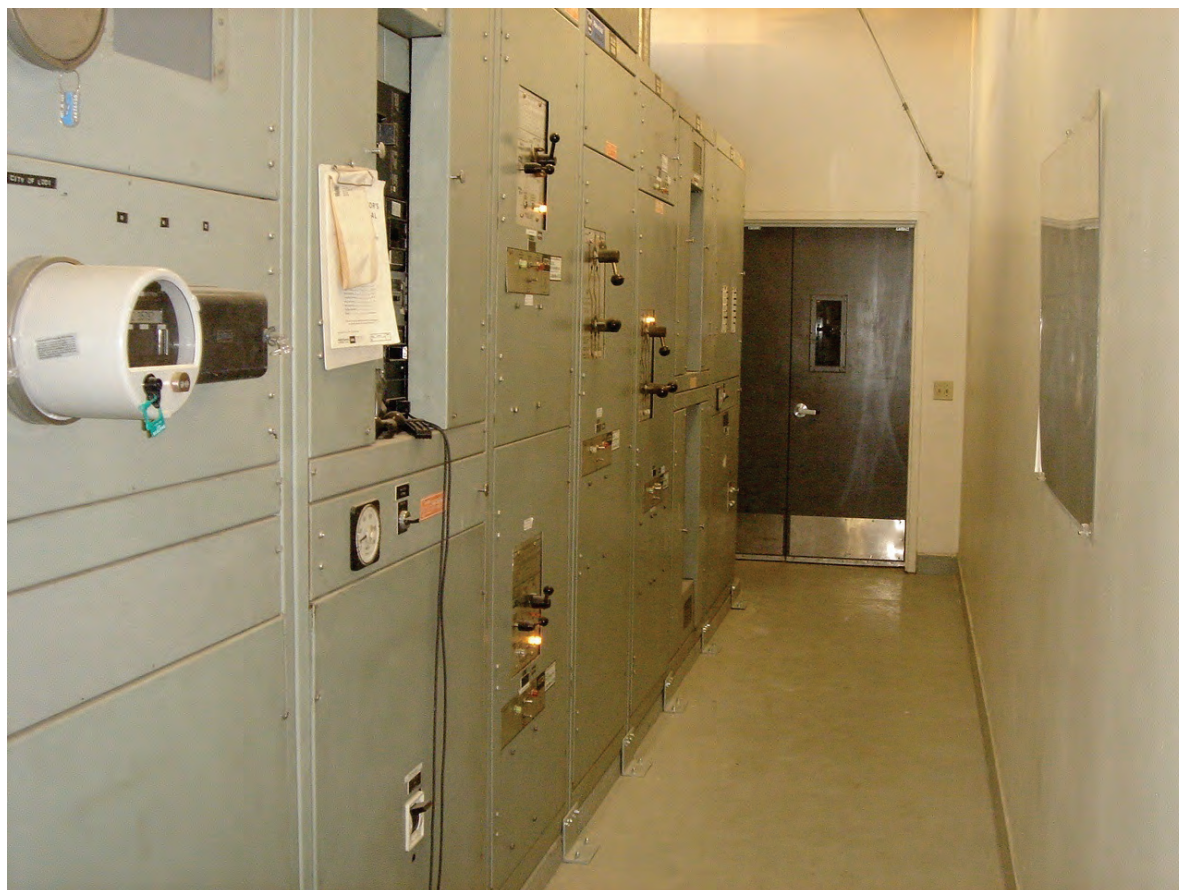
Figure 6.4.7.1-9 Anchorage for electrical cabinets. Anchorage to wall at top of cabinets is also present but not visible (Photo courtesy of Maryann Phipps, Estructure).

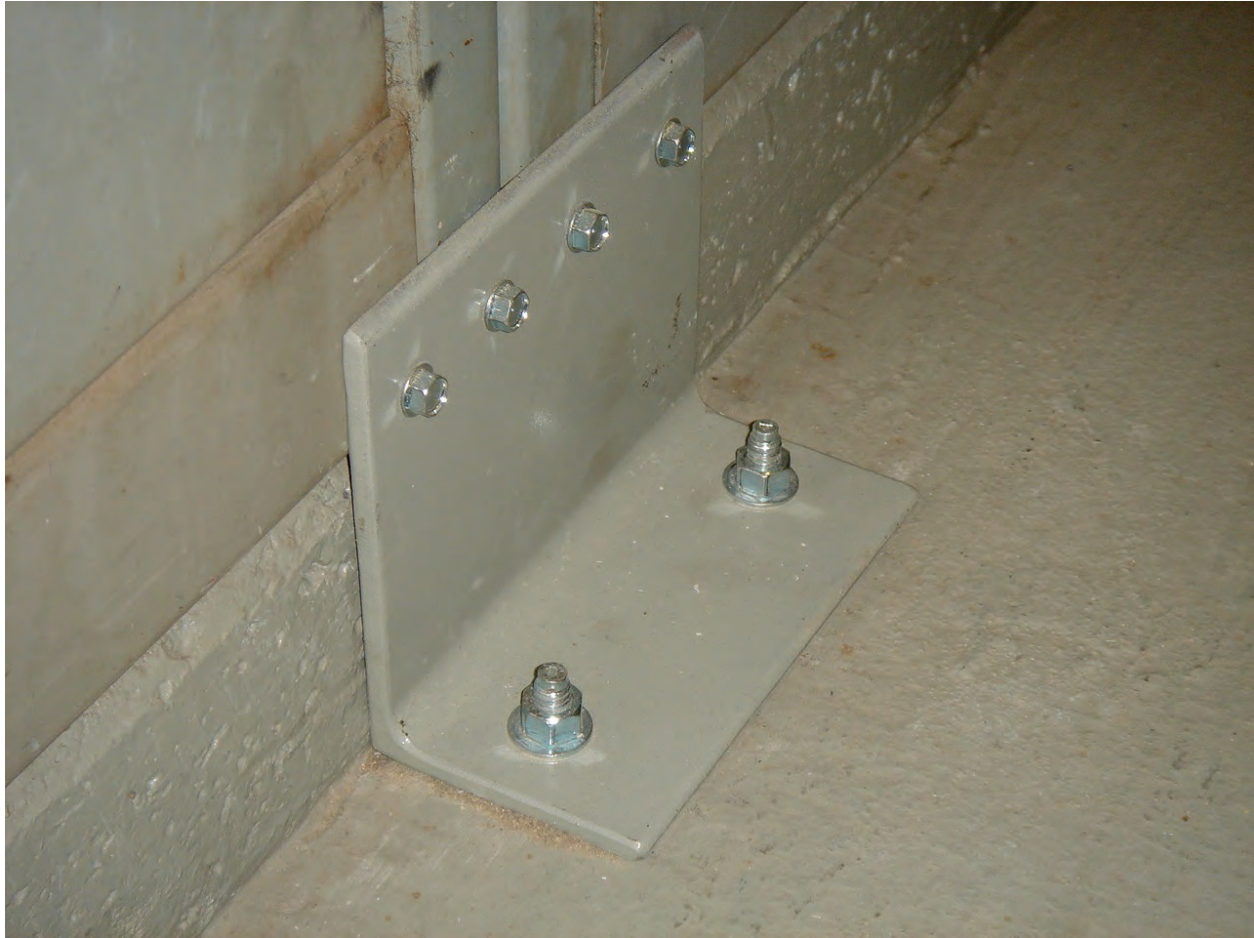
Figure 6.4.7.1-10 Detail of cabinet base anchorage (Photo courtesy of Maryann Phipps, Estructure).

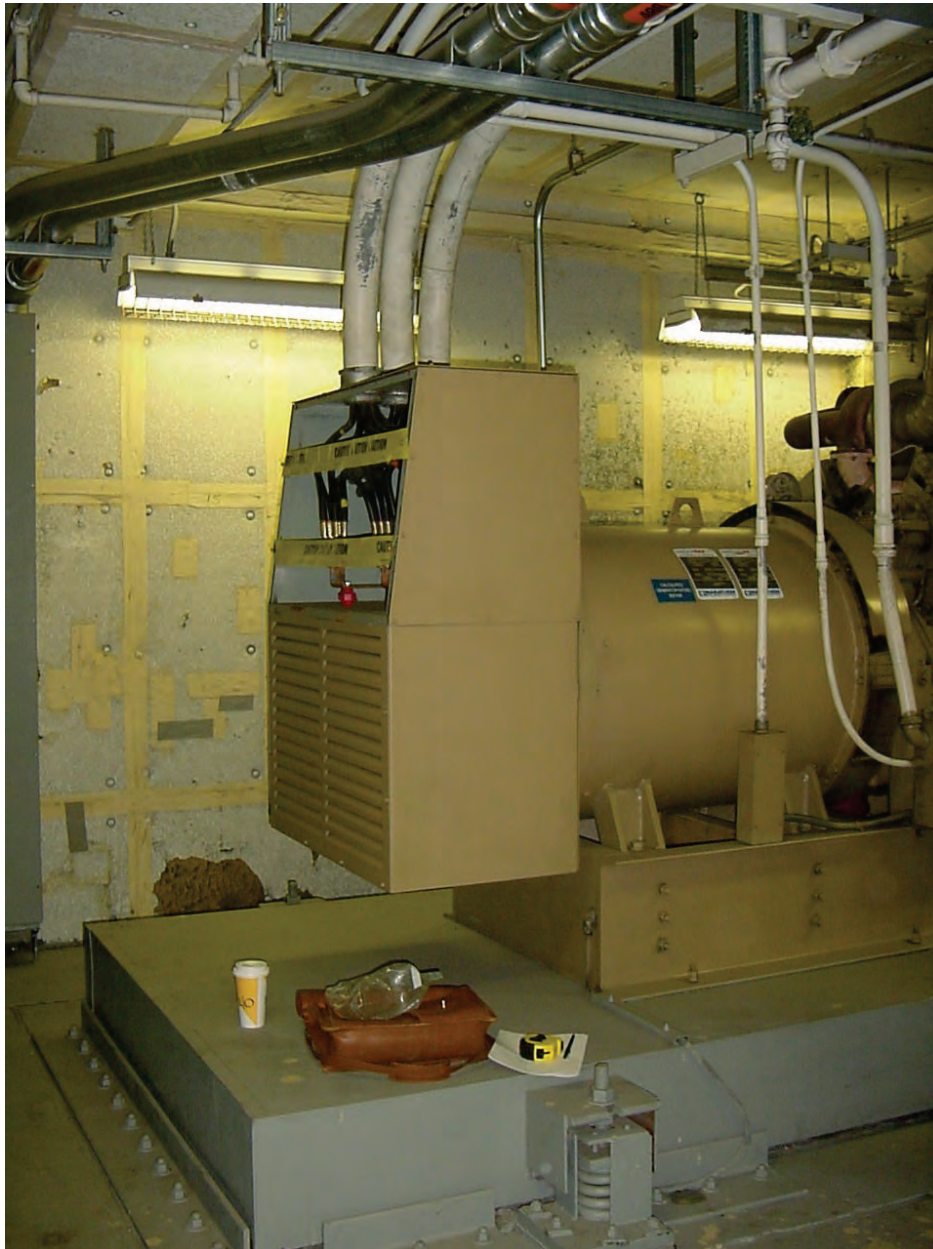
Figure 6.4.7.2-1 Emergency generator is anchored to a concrete inertia base. The inertia base is mounted on spring isolators and restrained by steel angle snubbers on all sides (Photo courtesy of Maryann Phipps, Estructure).

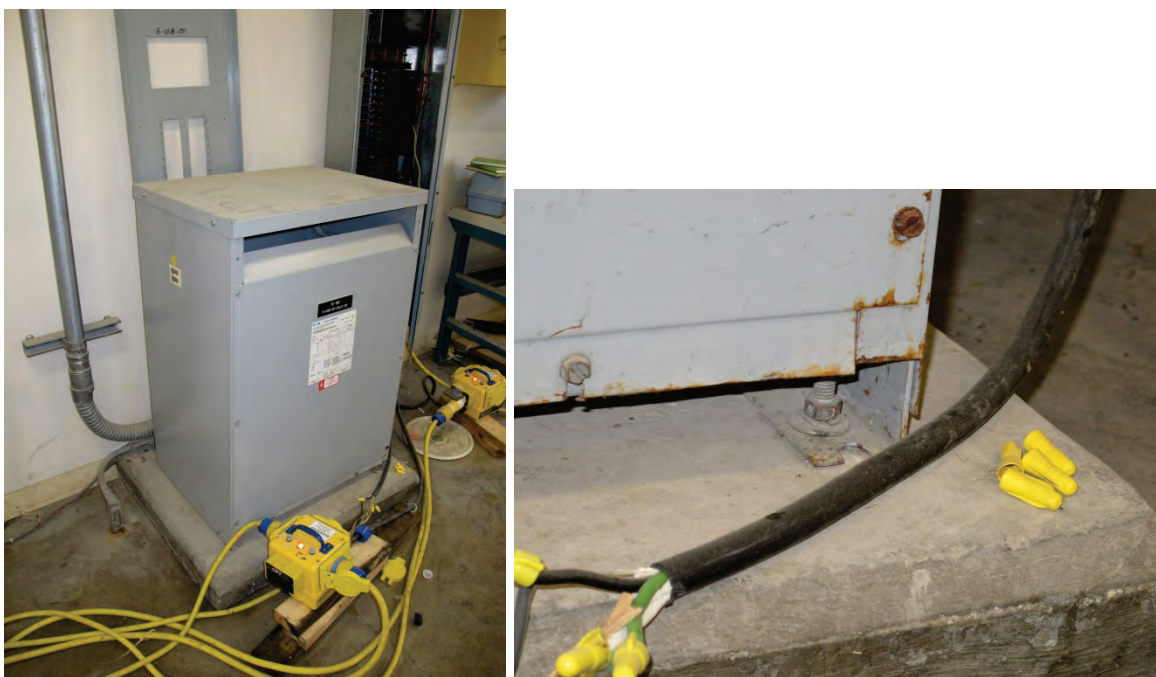
Figure 6.4.7.3-2 Typical electrical distribution dry type transformer. Note the use of manufacturer supplied anchor locations on base channels. Post earthquake photo from the 2010 Haiti M 7.0 Earthquake (photos courtesy of Philip J. Caldwell).

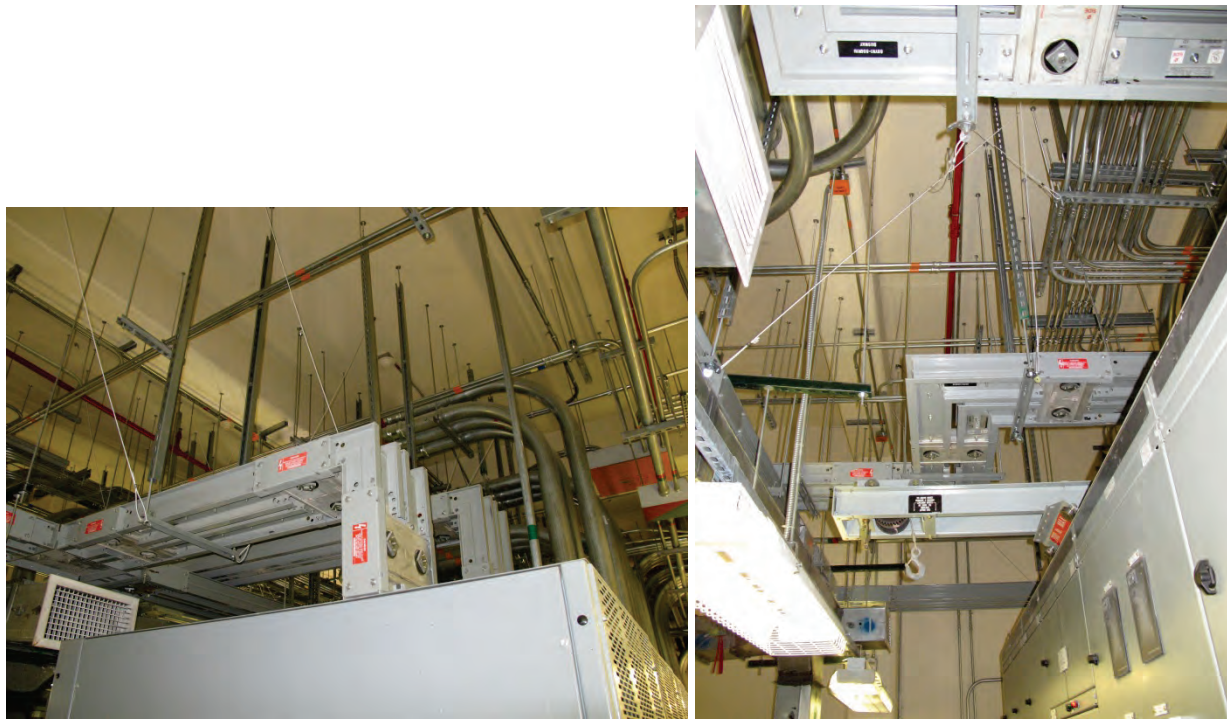
Figure 6.4.7.3-3 High ampacity power busway routing power from generator paralleling switchgear to facility. Note use of lateral restraints in addition to gravity hanger. Supplied uninterrupted power to critical facility during the 2010 M 7.0 Haiti earthquake. (photos courtesy of Philip J. Caldwell)

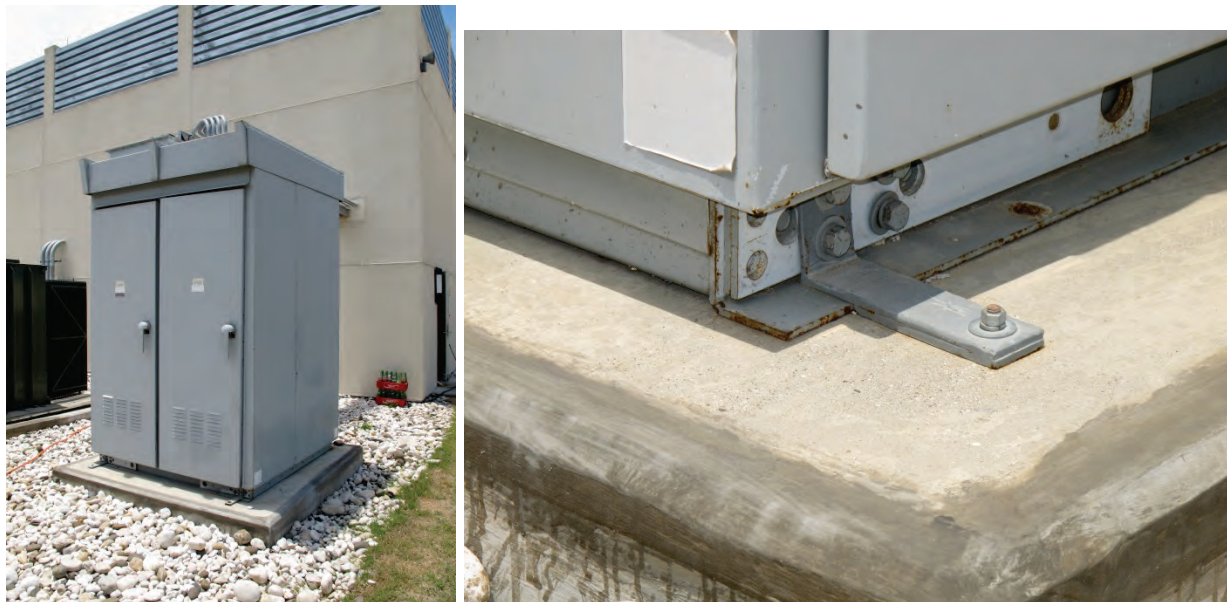
Figure 6.4.7.3-4 Outdoor low voltage switchgear supplying incoming utility power to critical facility. Note equipment frame seismic anchorage load path is bolted at both equipment frame and pad with a continuous rigid load path. Post earthquake photo from the 2010 M 7.0 Haiti earthquake. (photos courtesy of Philip J. Caldwell)

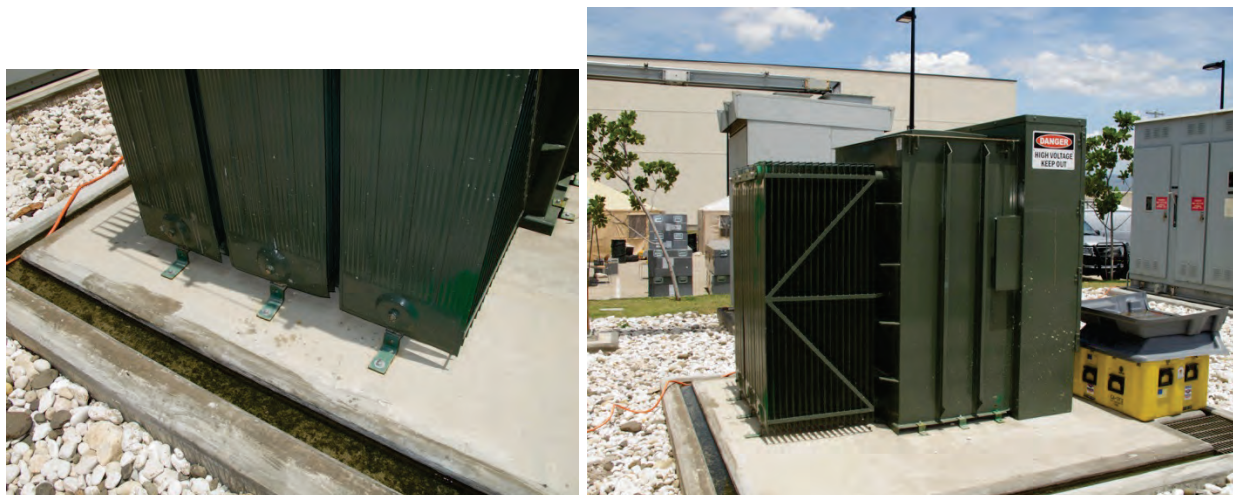
Figure 6.4.7.3-5 Outdoor liquid type electrical power transformer which converts incoming medium voltage to 480 volt utilization voltage for critical facility. Note use of manufacturer supplied diagonal elements on cooling fin assembly to minimize dynamic loading on liquid filled fin assembly which contains numerous welded connections. Post earthquake photo from the 2010 M 7.0 Haiti Earthquake (photos courtesy of Philip J. Caldwell).

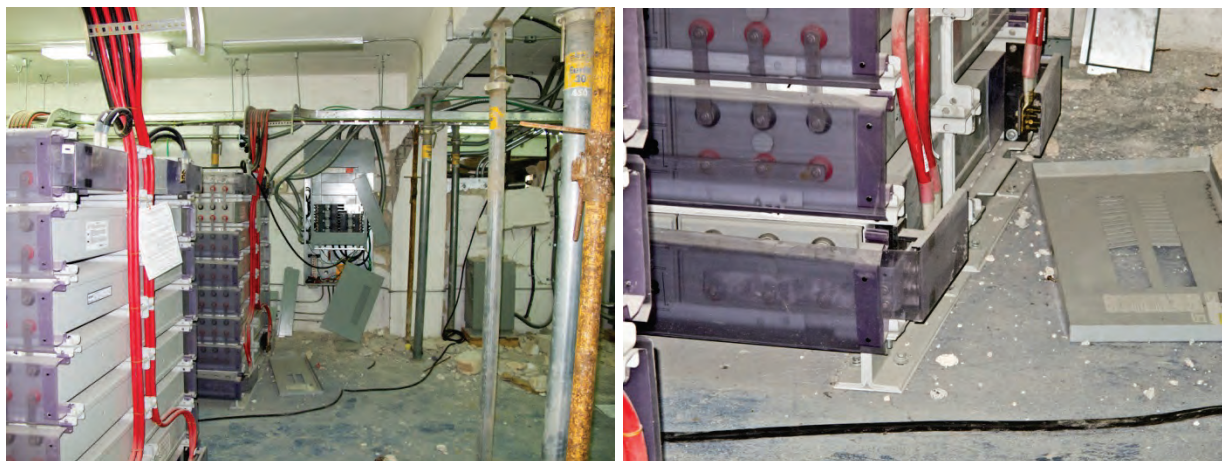
Figure 6.4.7.3-6 Battery room for central network cell phone carrier after 2010 M 7.0 Haiti Earthquake. Three-story building which contained the UPS (uninterruptable power supply) and battery room was newly constructed and suffered near collapse structural damage which required structural demolition and replacement. Note that high mass batteries with integral structural system was rigidly anchored and sustained no damage or loss of operation despite building structural system displacing enough to shear support columns. Cellular carrier representative advised that the central network support functionality was maintained during Earthquake (photos courtesy of Philip J. Caldwell).

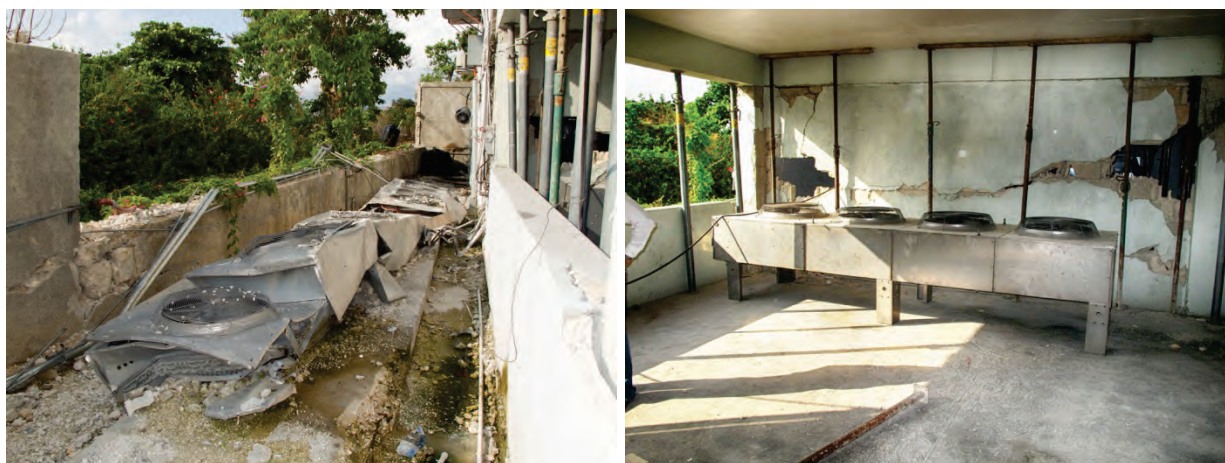
Figure 6.4.7.3-7 Heat rejection mechanical units which provide cooling for servers in cellular carrier central network facility (left photo). Collapsing security wall during the 2010 M 7.0 Haiti Earthquake crushed these units and resulted cyclical total failure of the cellular network as the servers hit temperature limits, shut down, rebooted and heated up again. System stability was restored by replacing the damaged units with temporary ones (right photo). Example of how the reliability of a critical facility essential system is both dependent upon adequate seismic restraints and a location which is free of structural and nonstructural falling hazards (photos courtesy of Philip J. Caldwell).

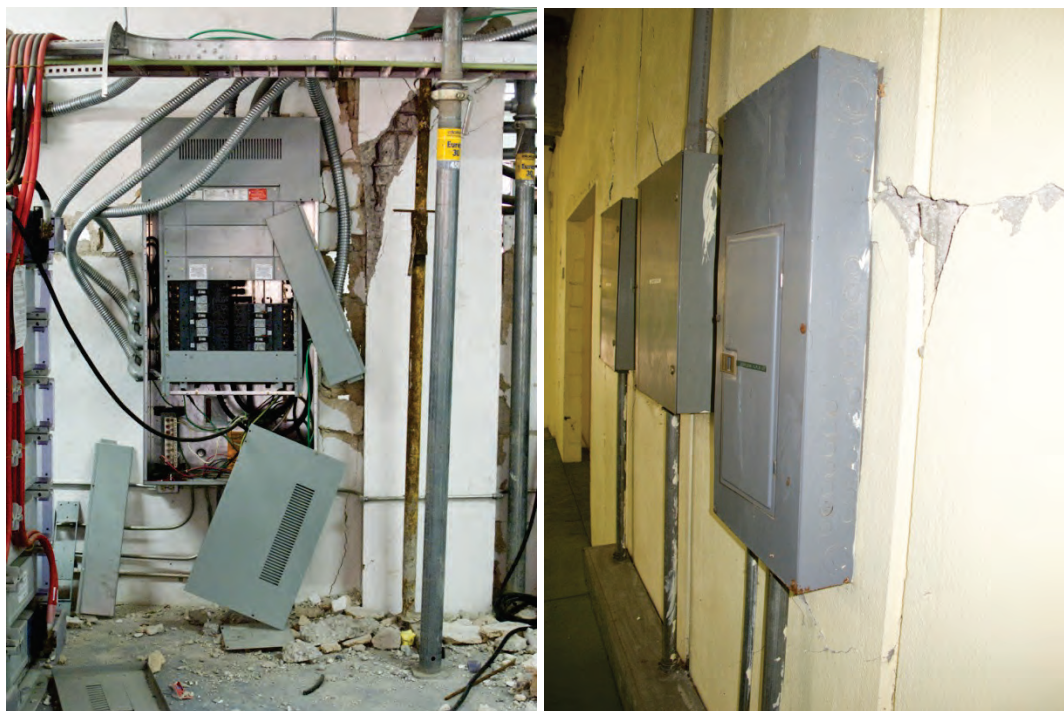
Figure 6.4.7.3-8 Example of rugged equipment. Post earthquake photos of two different essential facilities which sustained significant structural damage during the 2010 M 7.0 Haiti Earthquake. Wall mounted electrical power distribution panels were undamaged and remained functional even though the walls they were mounted to were severely damaged during the earthquake (photos courtesy of Philip J. Caldwell).

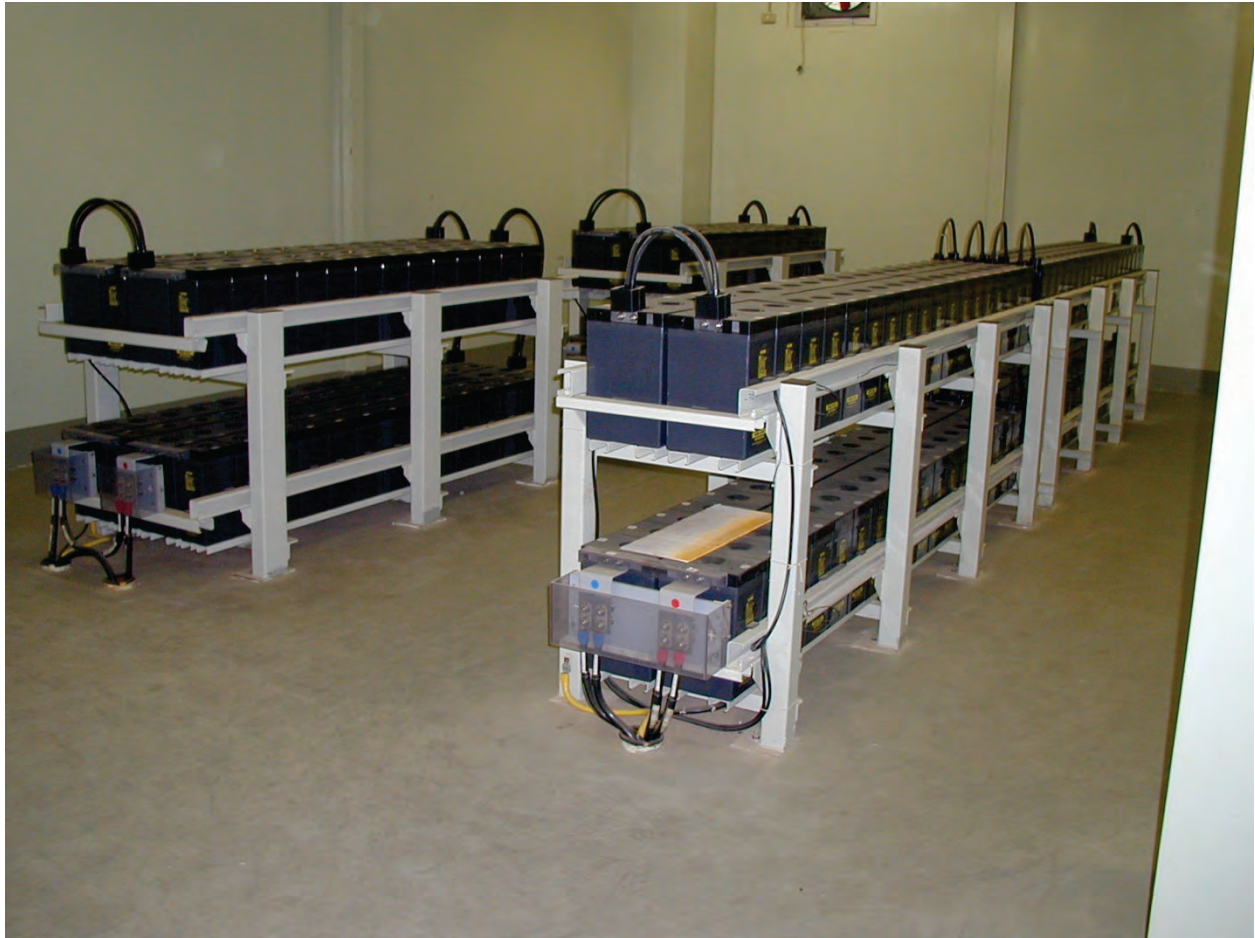
Figure 6.4.7.4-2 Anchored battery racks (Photo courtesy of Eduardo Fierro, BFP Engineers).

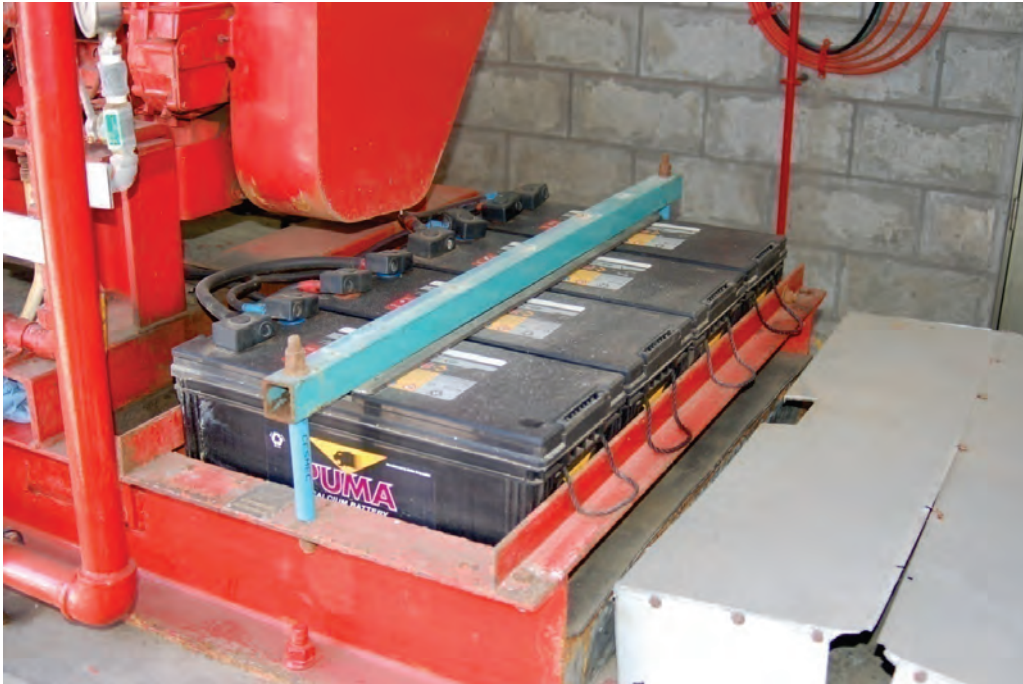
Figure 6.4.7.4-3 Batteries anchored with equipment skid (Photo courtesy of Eduardo Fierro, BFP Engineers).

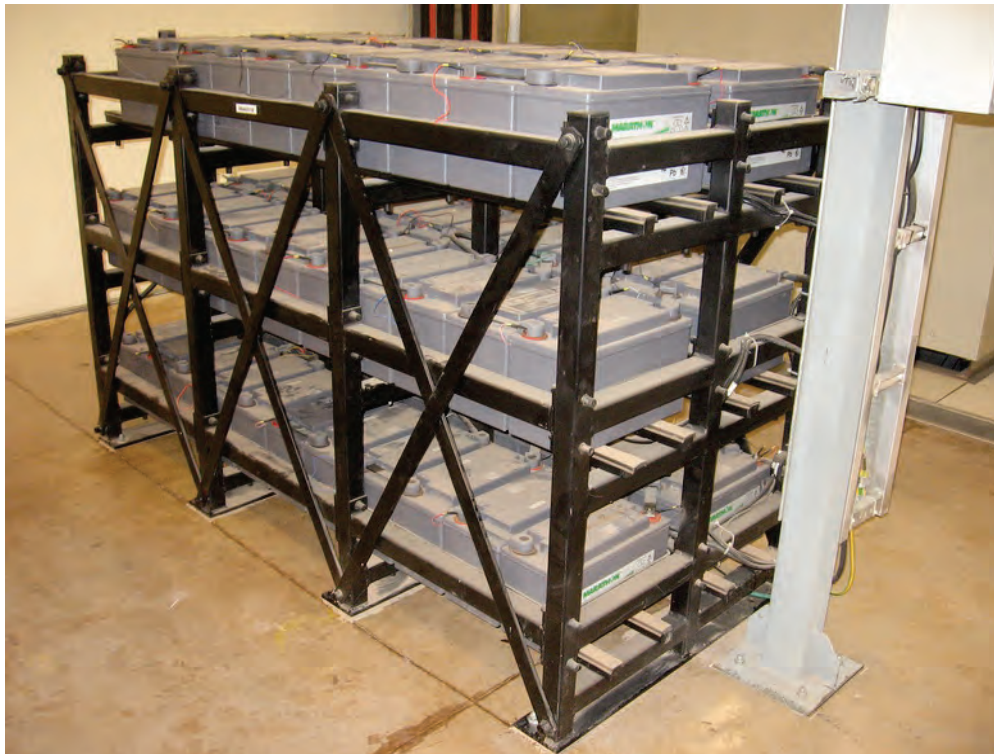
Figure 6.4.7.4-4 Battery rack that performed well in the 2010 magnitude-8.8 Chile Earthquake (Photo courtesy of Rodrigo Retamales, Rubén Boroschek & Associates).

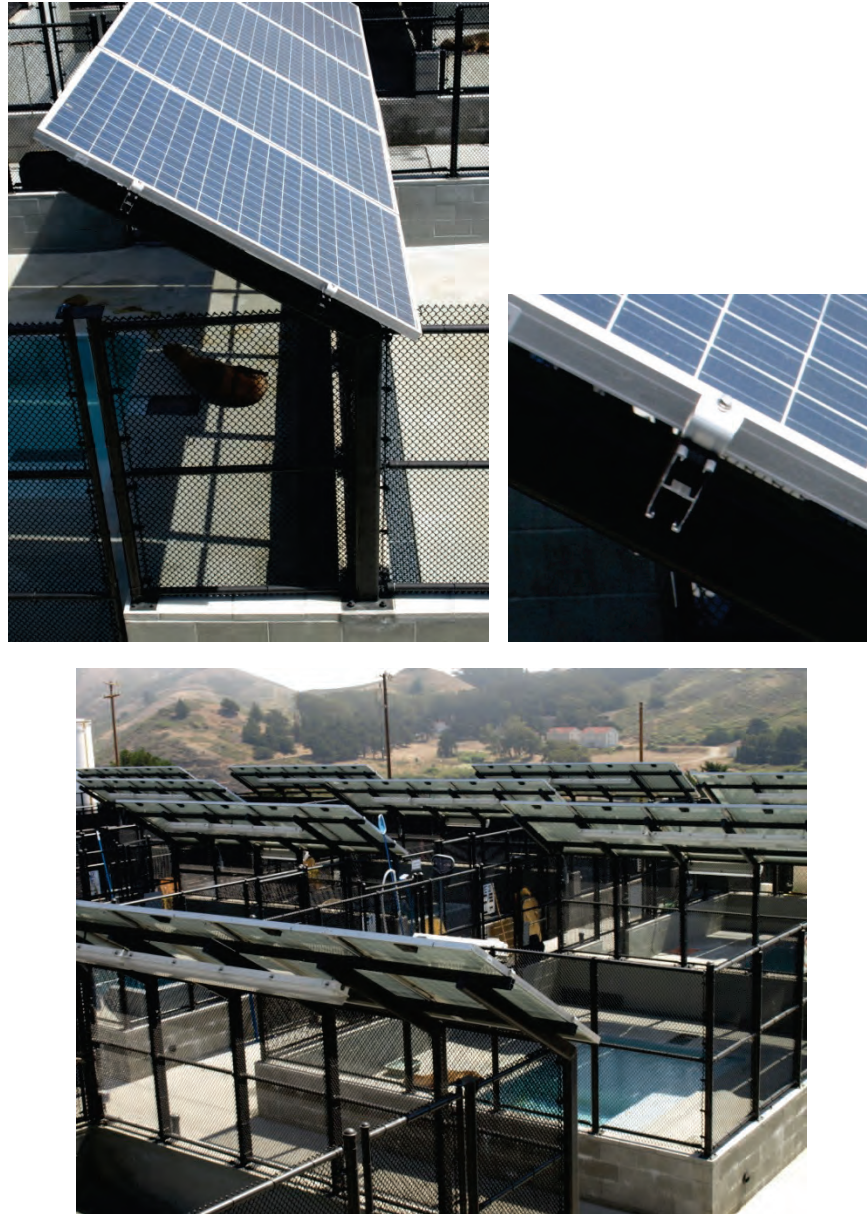
Figure 6.4.7.5-2 Ground mounted photovoltaic system that also provides shade to injured animals at the Marine Mammal Center in Sausalito, California (Photo courtesy of Cynthia Perry, BFP Engineers). Each solar panel is screwed to the strut at four locations; two rows of struts are bolted to 6 steel tubes which are anchored at the base with four bolts apiece.
