Reducing the Risks of Nonstructural Earthquake Damage – A Practical Guide

FEMA E-74 / December 2012

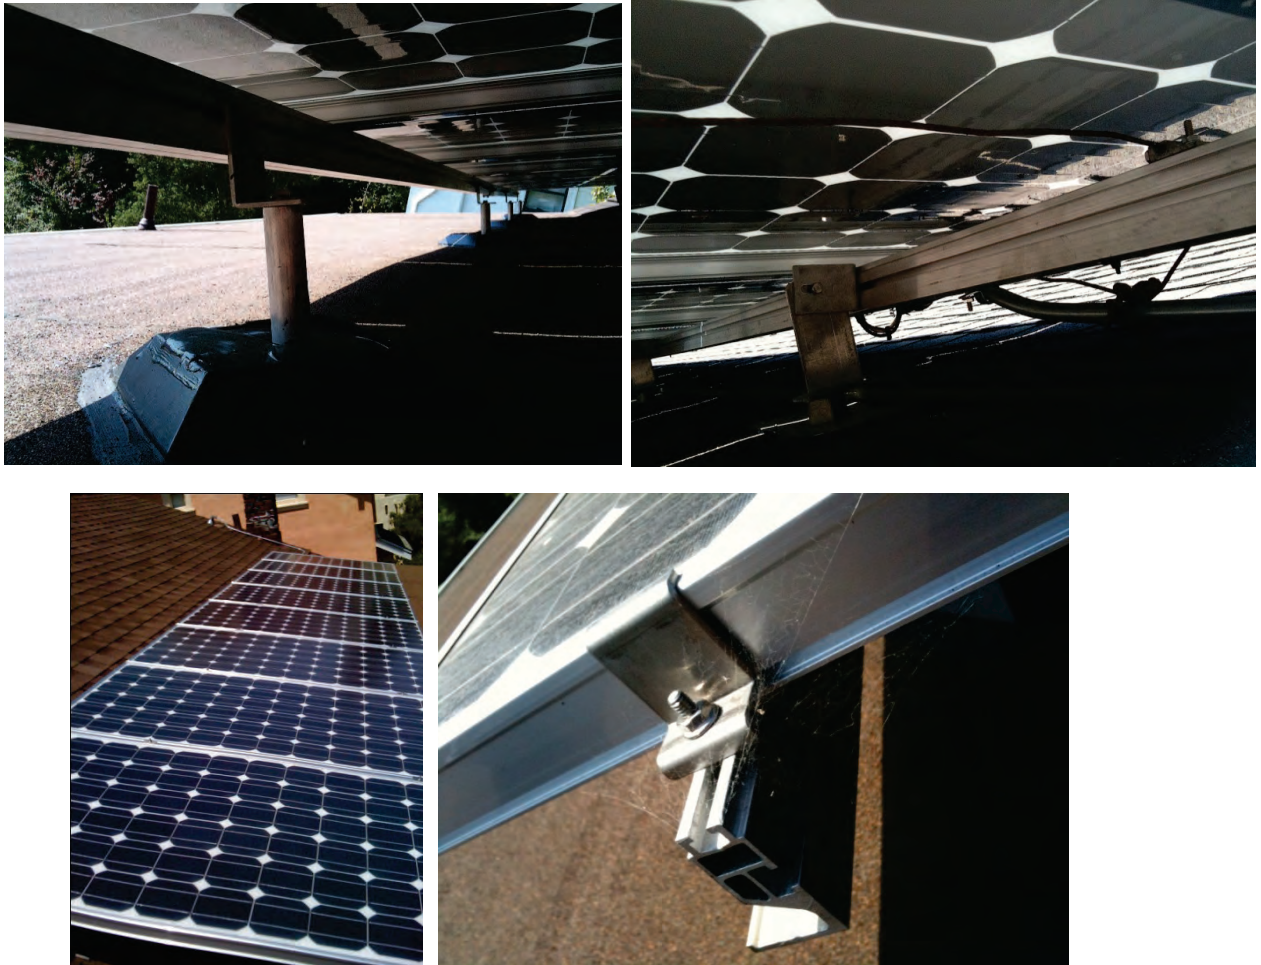
Figure 6.4.7.5-3 Residential photovoltaic system in Berkeley, California mounted over the transition between two different roof slopes (Photos courtesy of Heber Santos). Short standoff used on tar and gravel flat portion (upper left); aluminum flashing and mounting bracket used on sloped portion with composition tile roofing (upper right). The profile of one type of proprietary mounting track is seen at lower left.

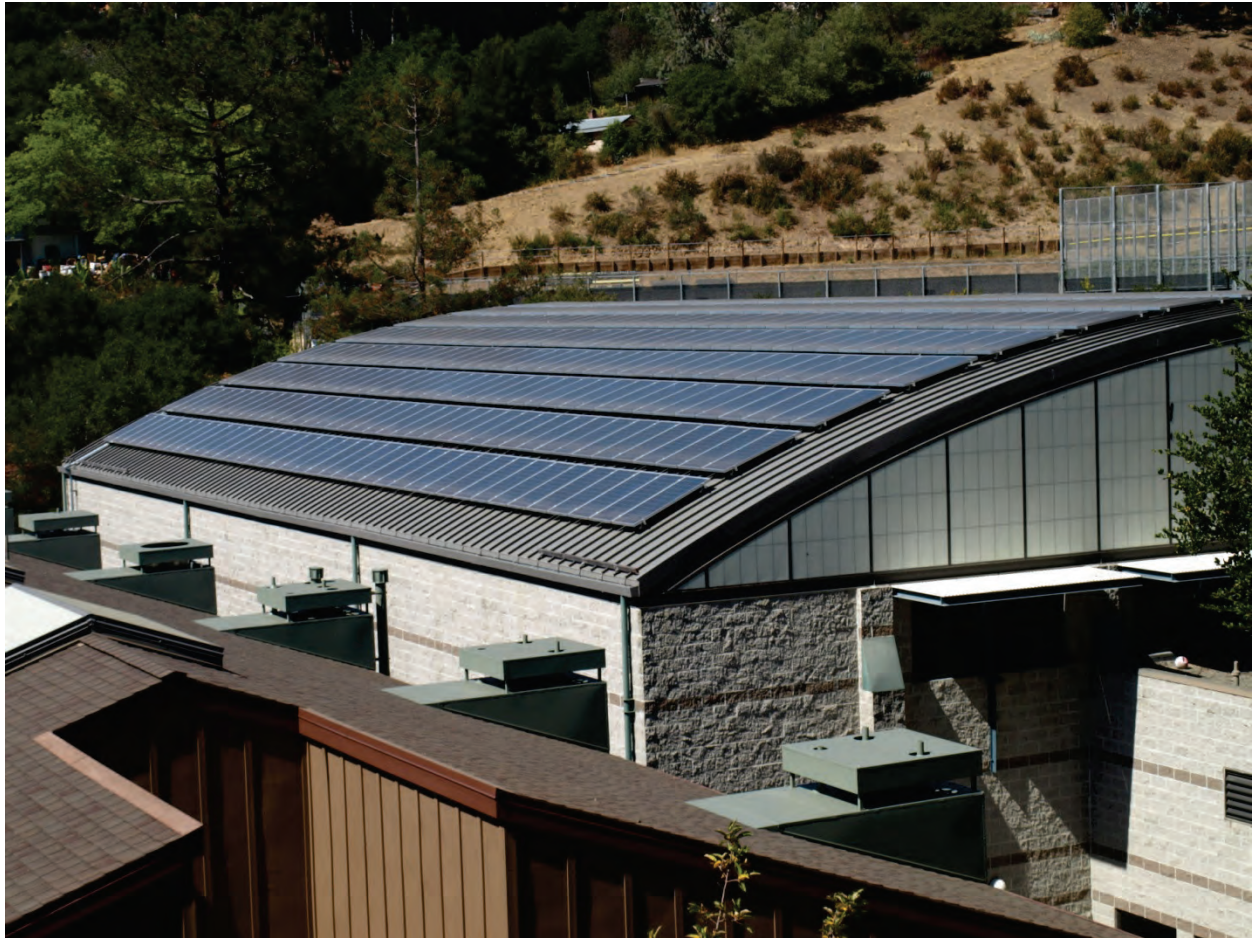
Figure 6.4.7.5-4 Flush mount photovoltaic system on barrel shaped roof of gymnasium at Head-Royce School, Oakland, California (Photo courtesy of Cynthia Perry, BFP Engineers).

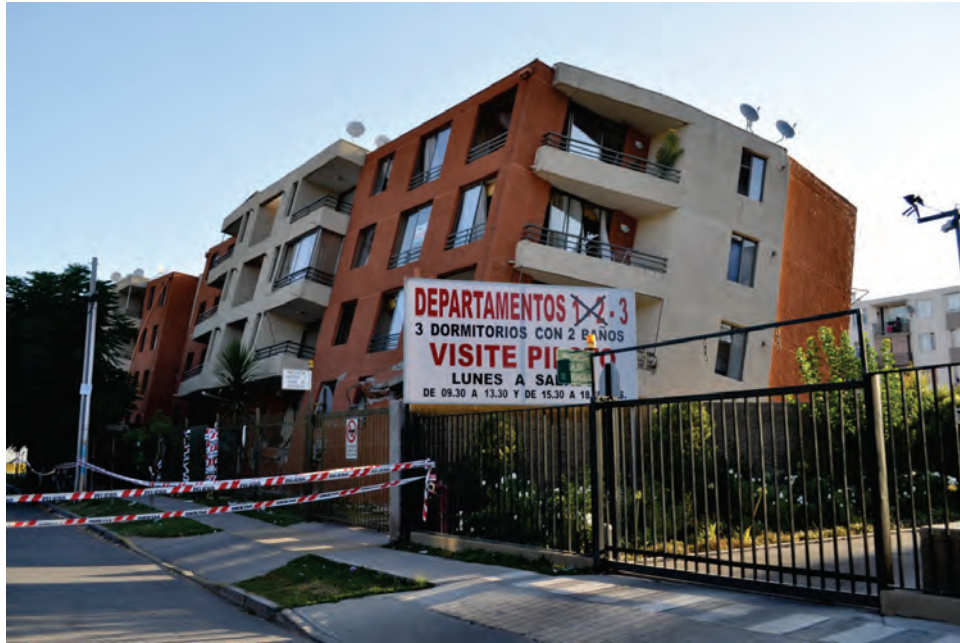
Figure 6.4.7.6-1 Most antennae are designed for wind and able to resist seismic loading. In spite of the collapse of the first story of this residential building complex, the roof-mounted antennae appear intact in the 2010 magnitude-8.8 Chile Earthquake (Photo courtesy of Eduardo Fierro, BFP Engineers).

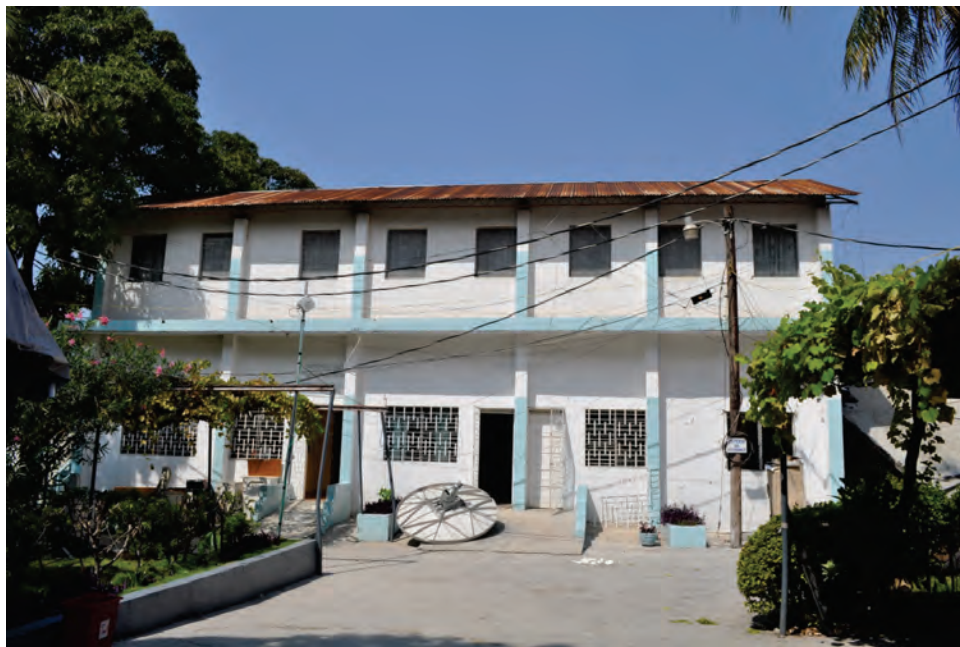
Figure 6.4.7.6-2 Antennae retrieved from roof of adjacent collapsed wing of the Hôpital Saint-François de Sales in the 2010 magnitude-7 Haiti Earthquake (not known if antenna suffered earthquake damage; photo courtesy of Ayhan Irfanoglu, Purdue University). Hospital communications depend on the functionality of antennae such as this.

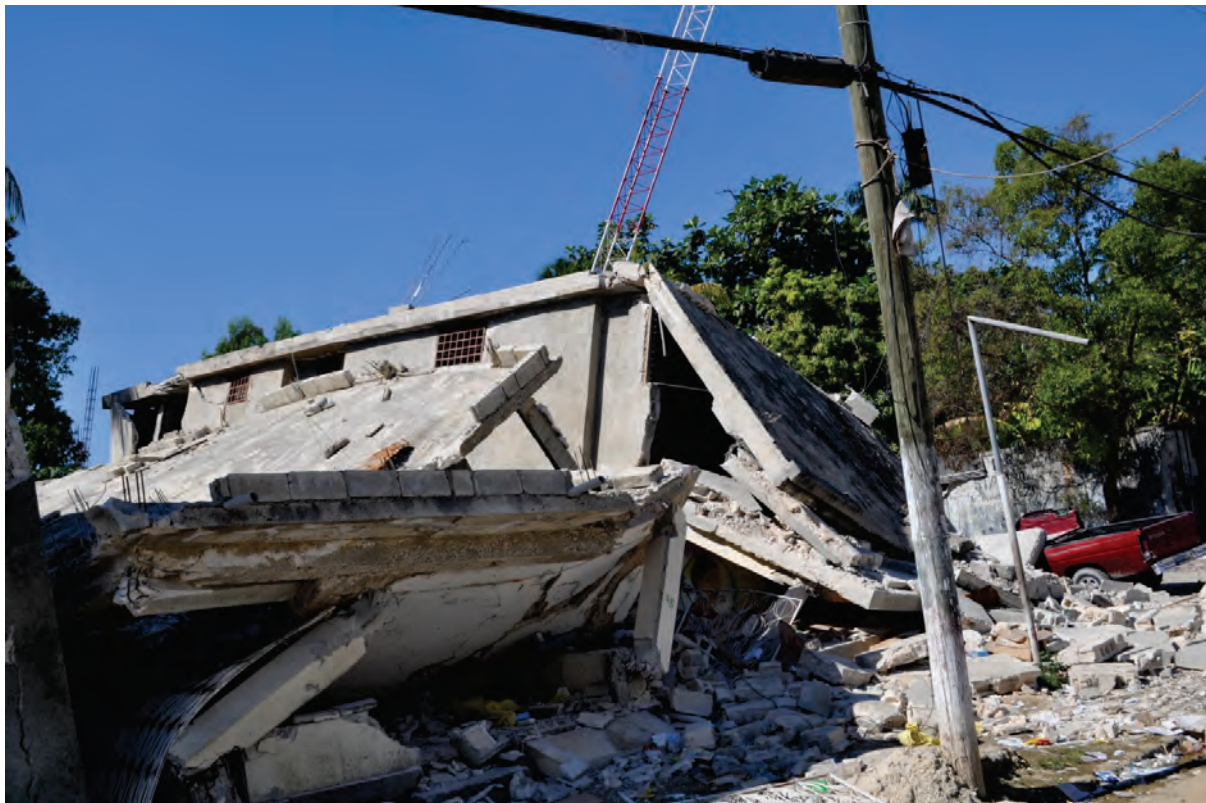
Figure 6.4.7.6-4 The antenna with guy wires remained upright atop a collapsed building in the 2010 Haiti Earthquake (Photo courtesy of Eduardo Fierro, BFP Engineers). Even though some of the guy wires went slack, the antenna did not fall into the street.

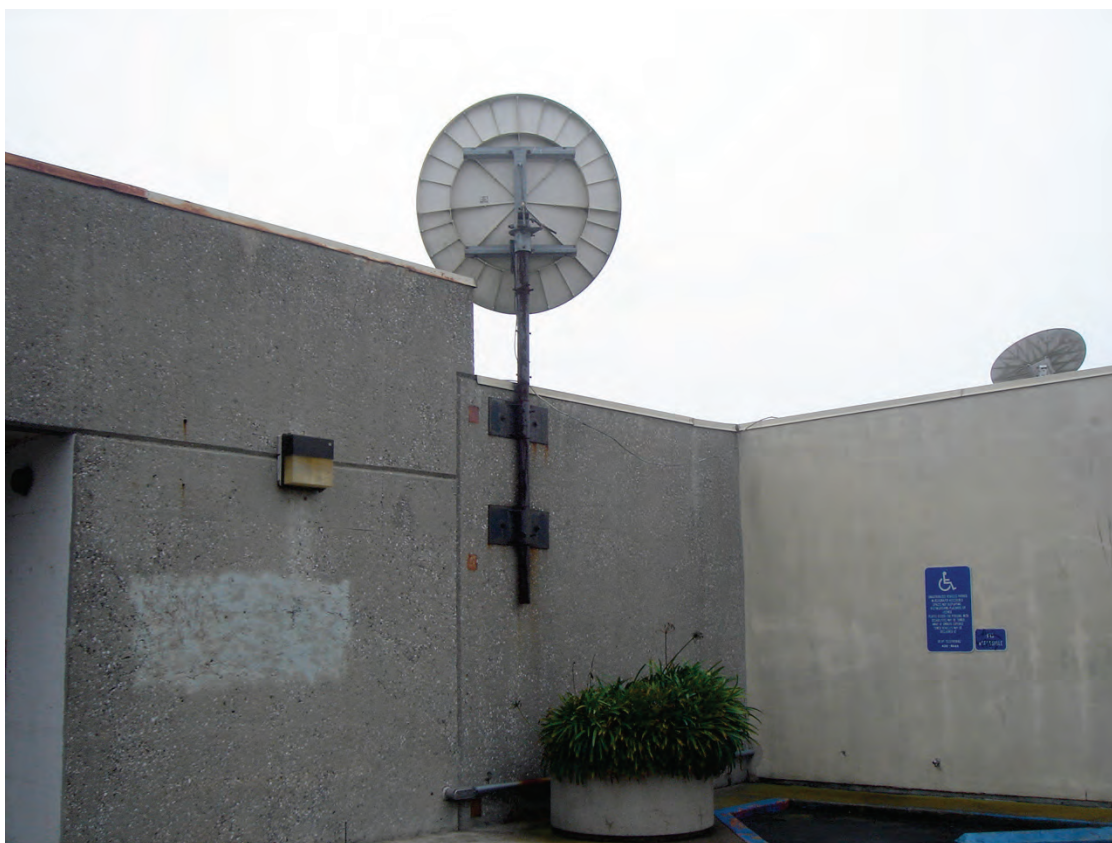
Figure 6.4.7.6-5 Antenna mast mounted to concrete wall surface at top floor of building (Photo courtesy of Maryann Phipps, Estructure). Note that two wall brackets are used to resist moments produced by wind or seismic forces. This antenna is larger than most standard residential versions.

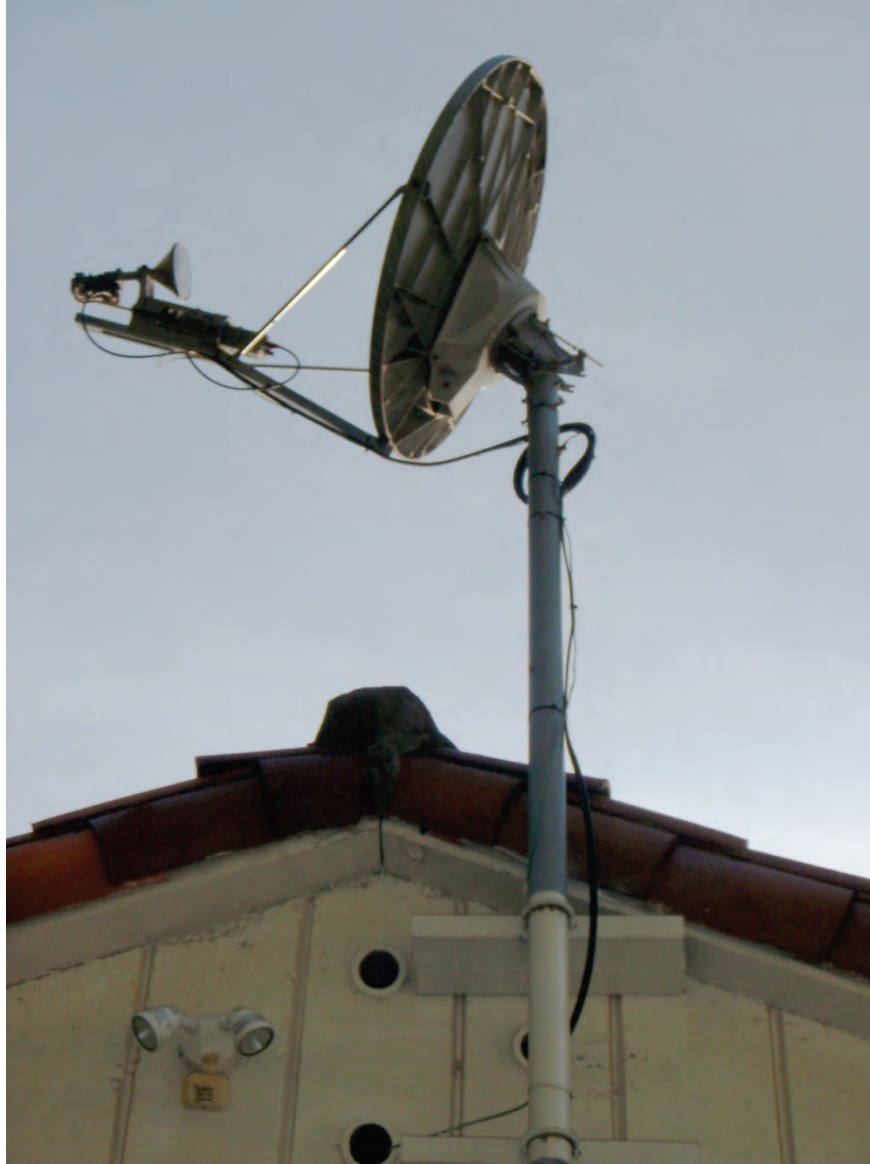
Figure 6.4.7.6-6 Antenna mast mounted to wood stud wall using blocking to clear eaves (Photo courtesy of Cynthia Perry, BFP Engineers).

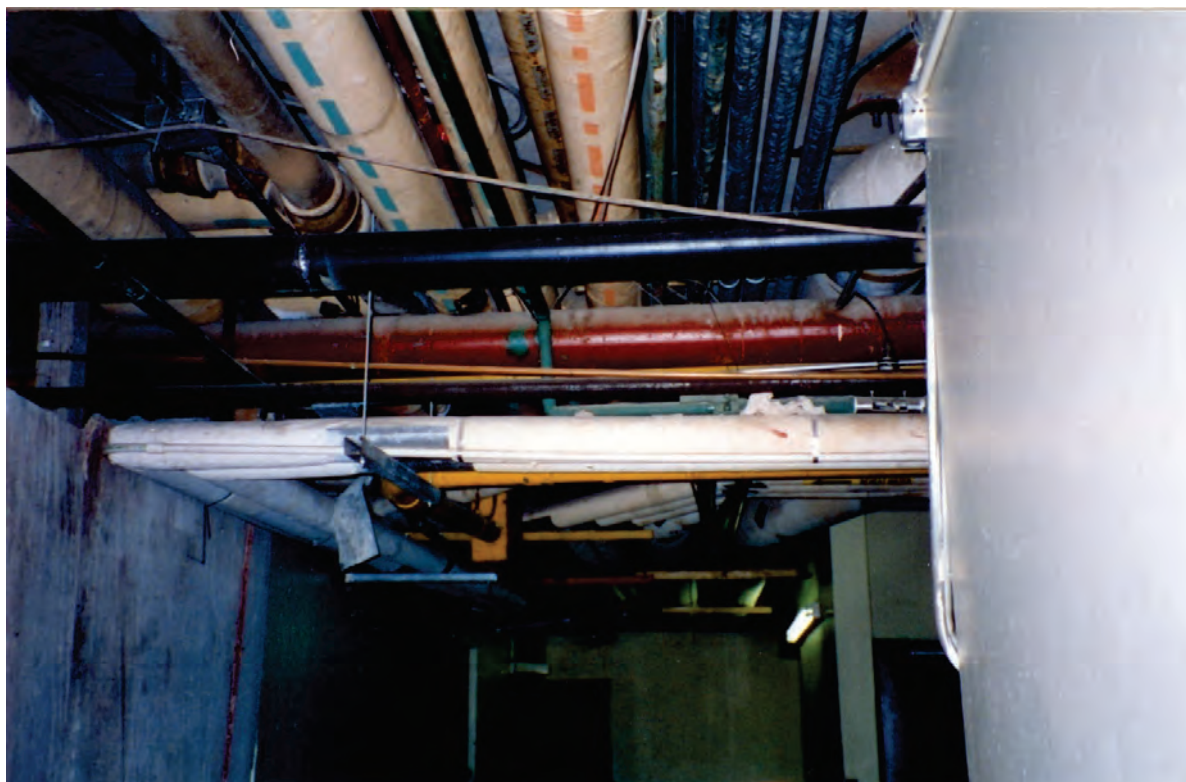
Figure 6.4.8.1-1 Unbraced suspended piping and conduit (Photo courtesy of Wiss, Janney, Elstner Associates).

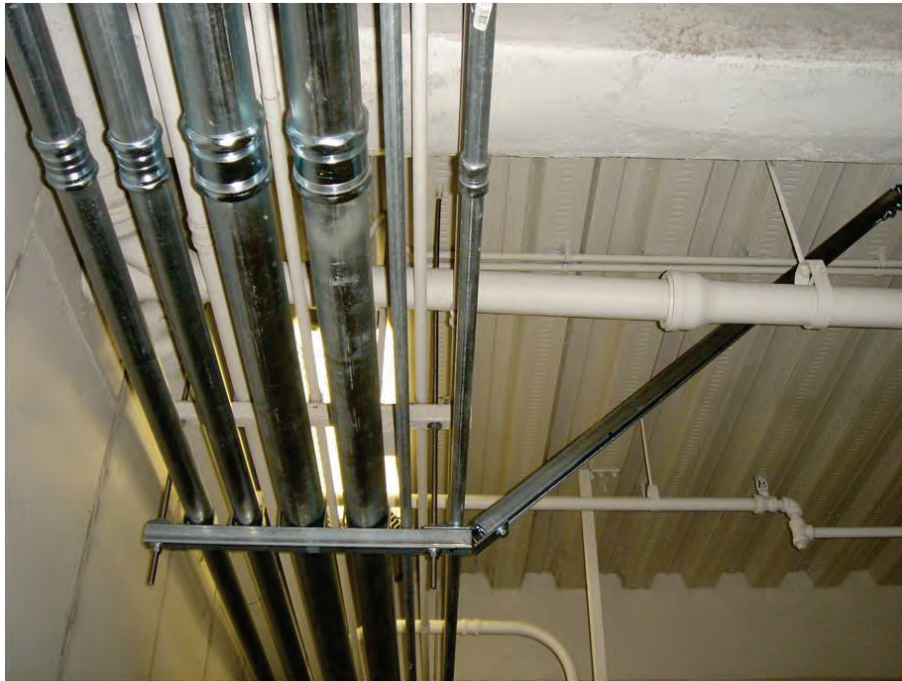
Figure 6.4.8.1-2 Rigid strut bracing provides restraint against earthquake forces perpendicular to the piping. Similar bracing is required in the direction parallel to the conduit (Photo courtesy of Maryann Phipps, Estructure).

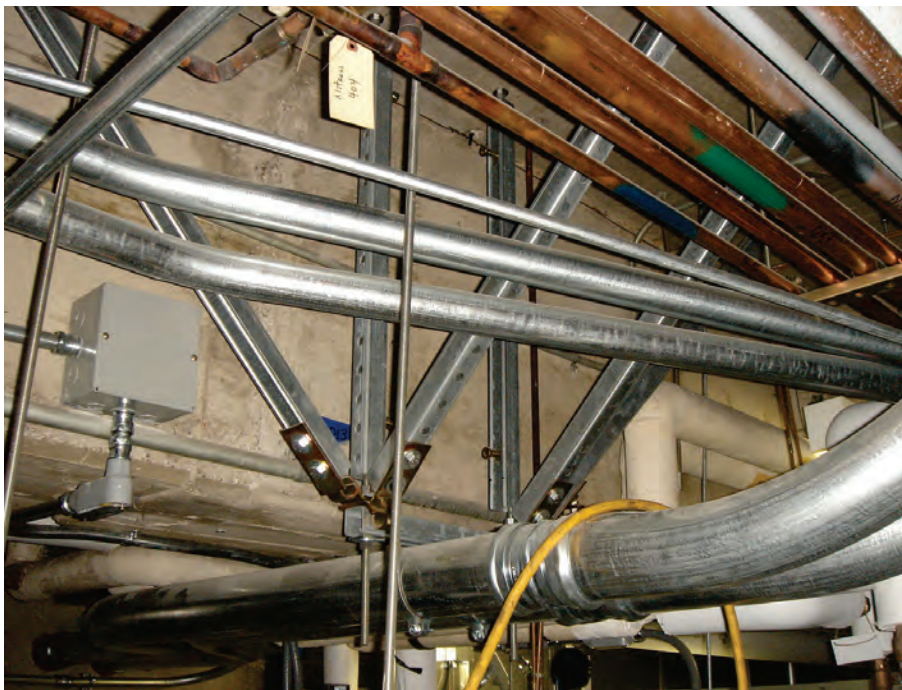
Figure 6.4.8.1-3 Rigid strut bracing for trapeze supporting electrical conduit; conduit attached to trapeze with conduit clamp that provides lateral and longitudinal restraint (Photo courtesy of Maryann Phipps, Estructure).

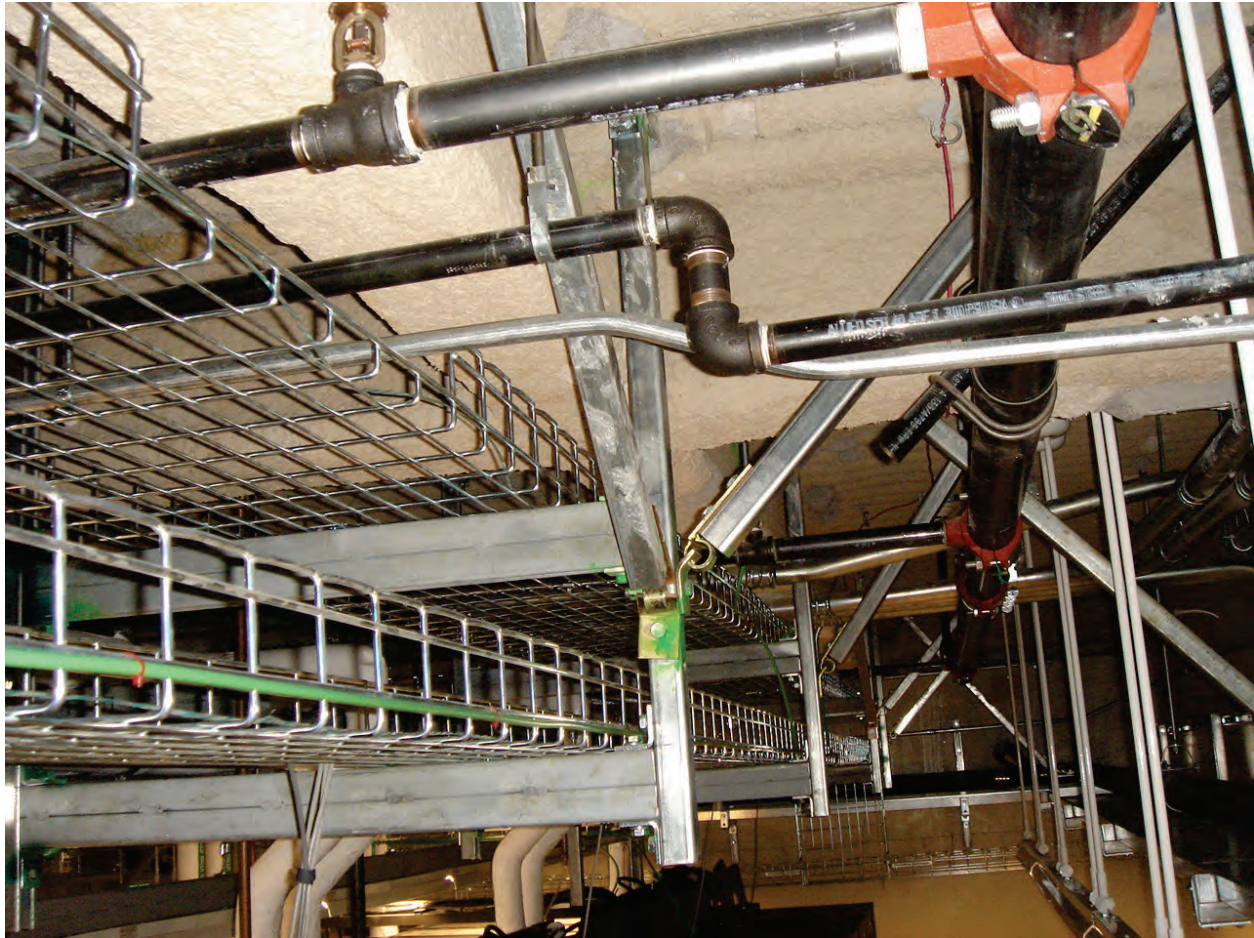
Figure 6.4.8.1-4 Lateral and longitudinal rigid strut bracing for trapeze supporting electrical raceways (Photo courtesy of Maryann Phipps, Estructure).

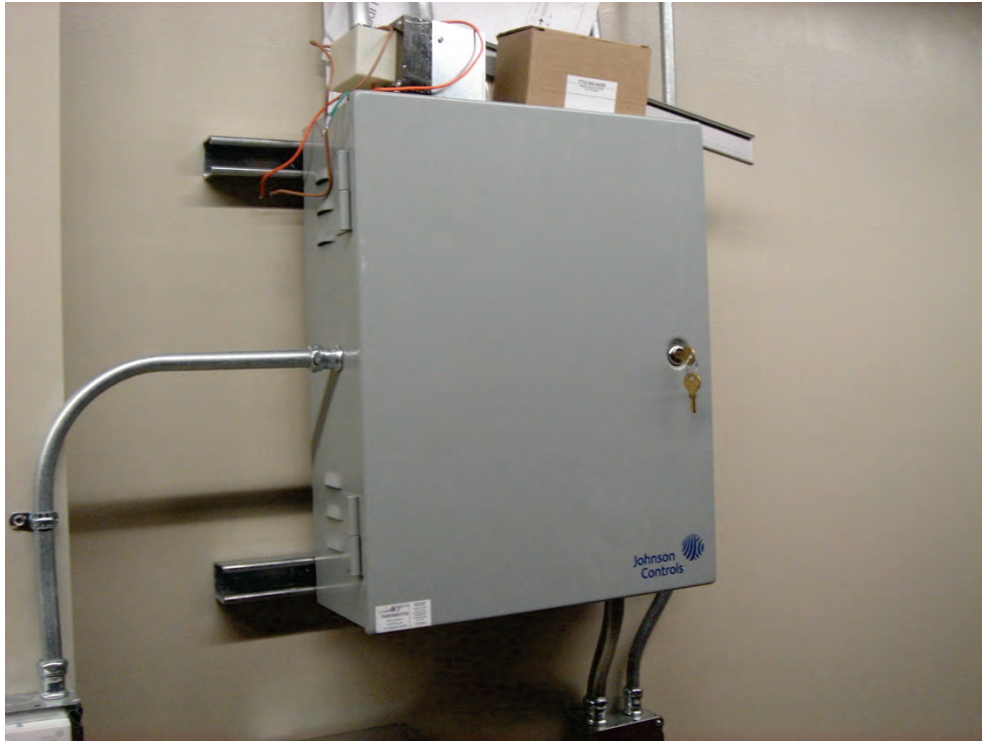
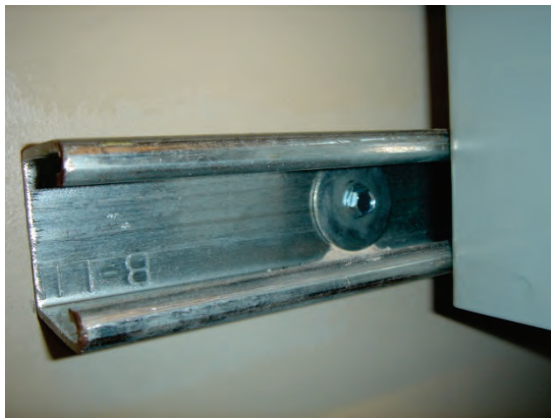
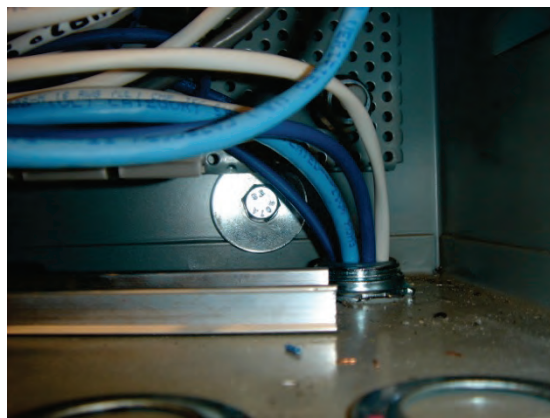
Figure 6.4.8.2-2 Wall anchorage for electrical panel; standard strut anchored to wall studs and panel anchored to strut (Photo courtesy of Maryann Phipps, Estructure).

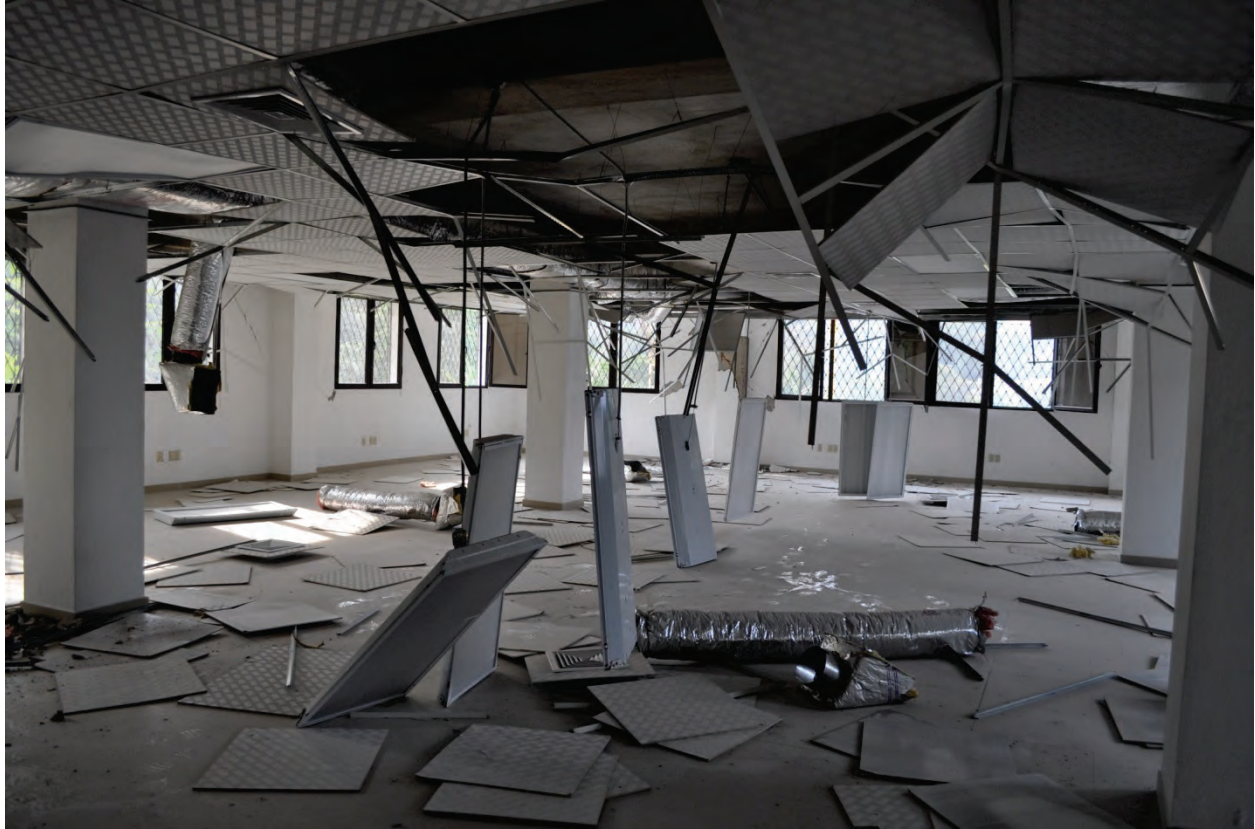
Figure 6.4.9.1-1 Numerous fluorescent fixtures dangling from electrical conduit; installed without safety wires in unbraced suspended acoustical ceiling and damaged in the 2010 magnitude-7 Haiti Earthquake. Loose bulbs, lenses, ceiling panels, diffusers and ducts also on the floor (Photo courtesy of Ayhan Irfanoglu, Purdue University).

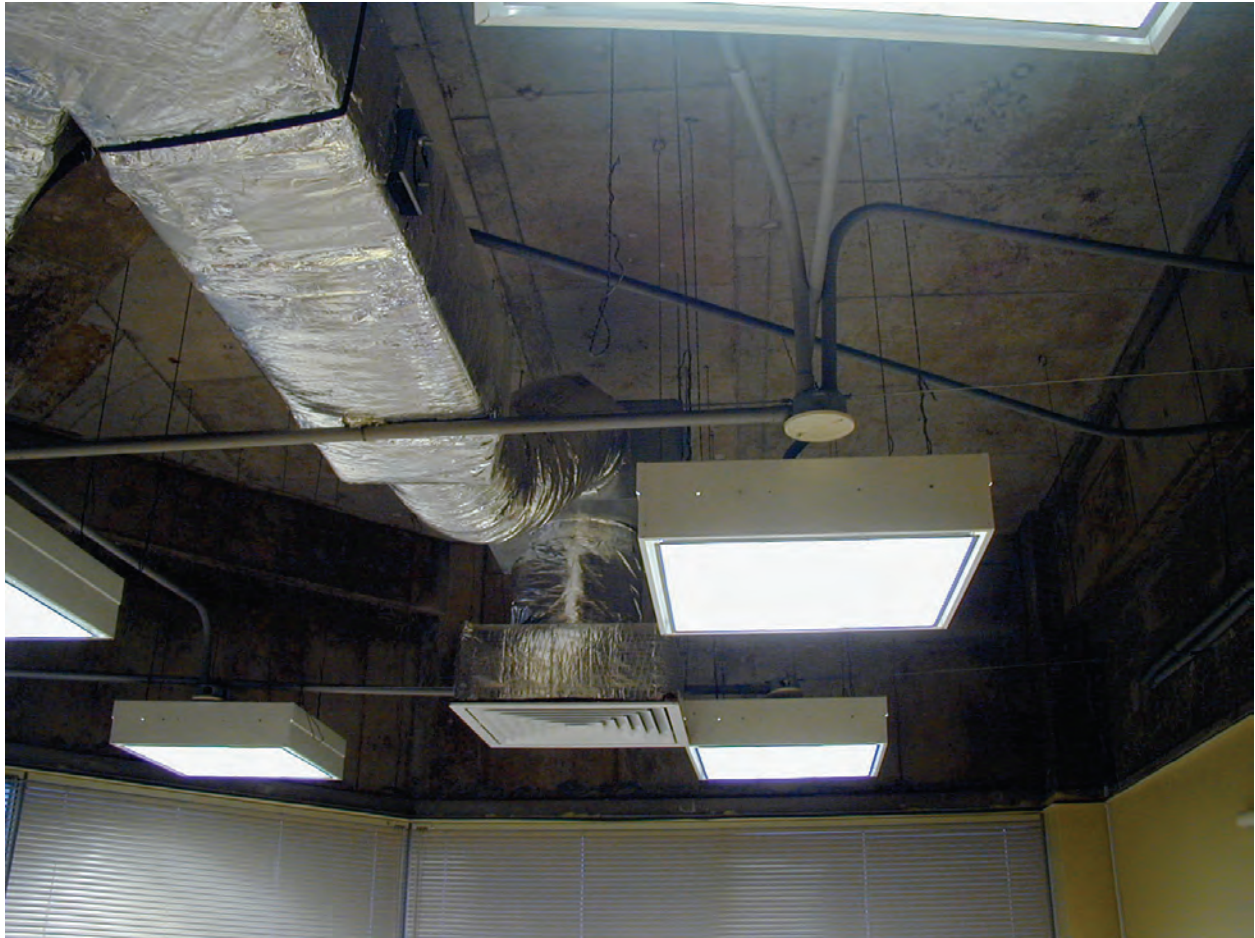
Figure 6.4.9.1-2 Overhead lights with four vertical hangers to the structure. Unbraced acoustic ceiling system was damaged beyond repair in the 2001 magnitude-8.4 Peru Earthquake but none of the diffusers or lights fell because they had independent supports. Ceiling was demolished prior to photo (Photo courtesy of Eduardo Fierro, BFP Engineers).

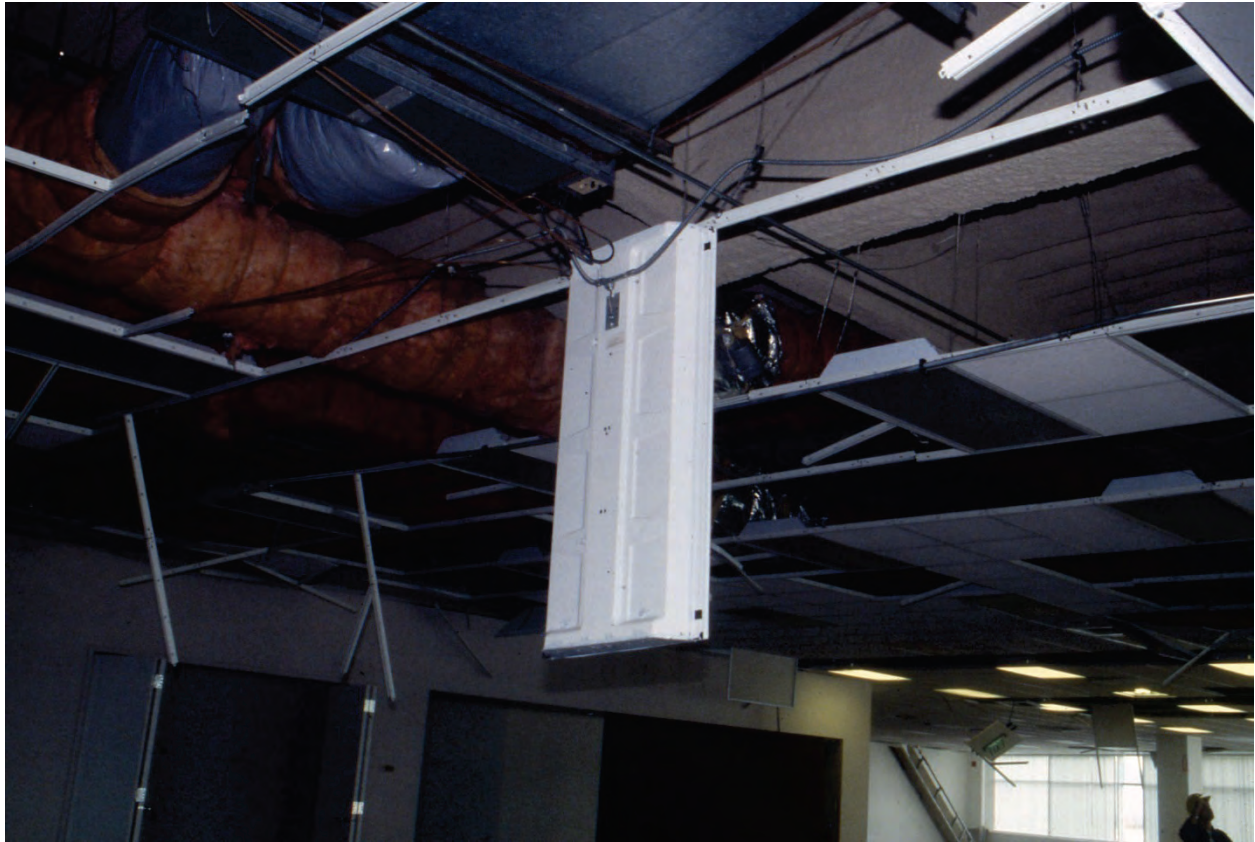
Figure 6.4.9.1-3 Light fixture without adequate independent support dangling along one edge from ceiling grid, damaged in the 1994 magnitude-6.7 Northridge Earthquake (Photo courtesy of Degenkolb Engineers).

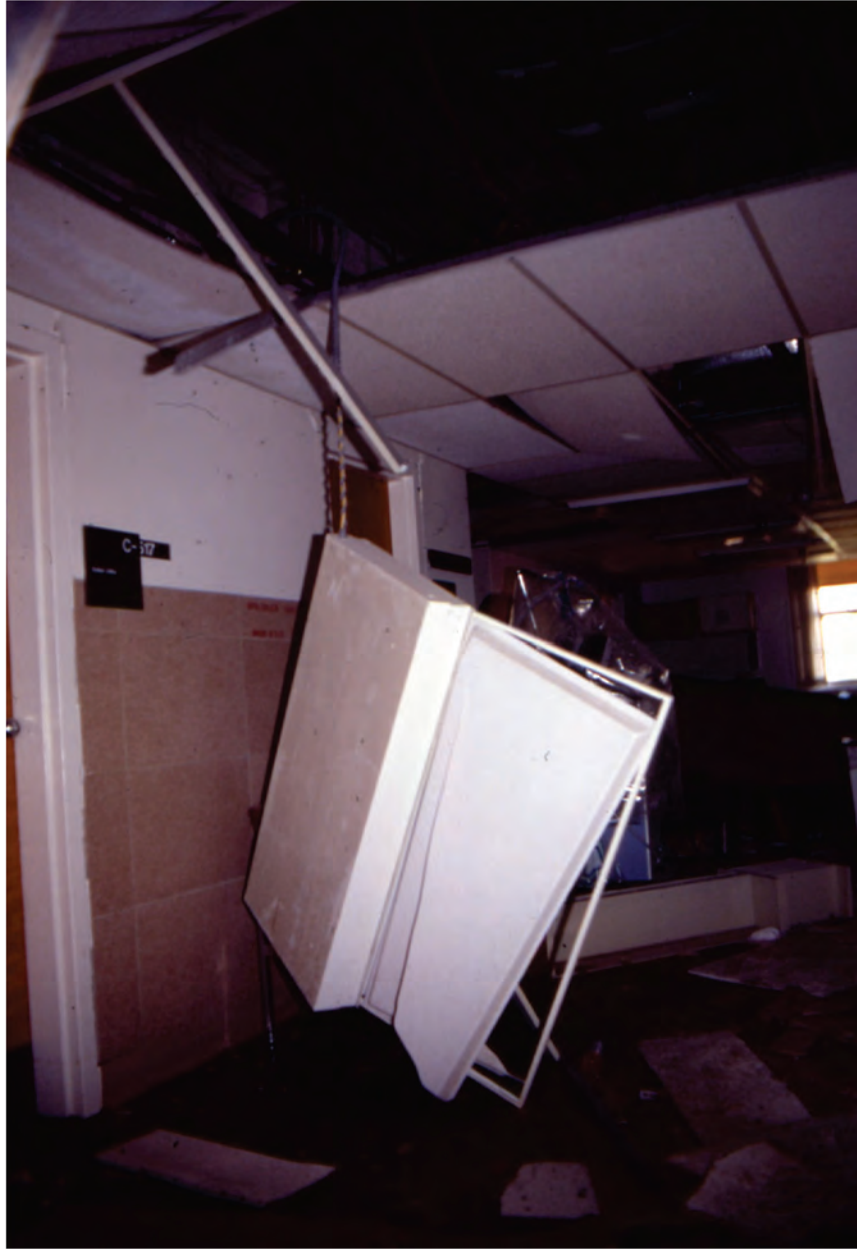
Figure 6.4.9.1-4 Light fixture without independent support dangling from conduit as a result of the 1994 Northridge Earthquake (Photo courtesy of Degenkolb Engineers).

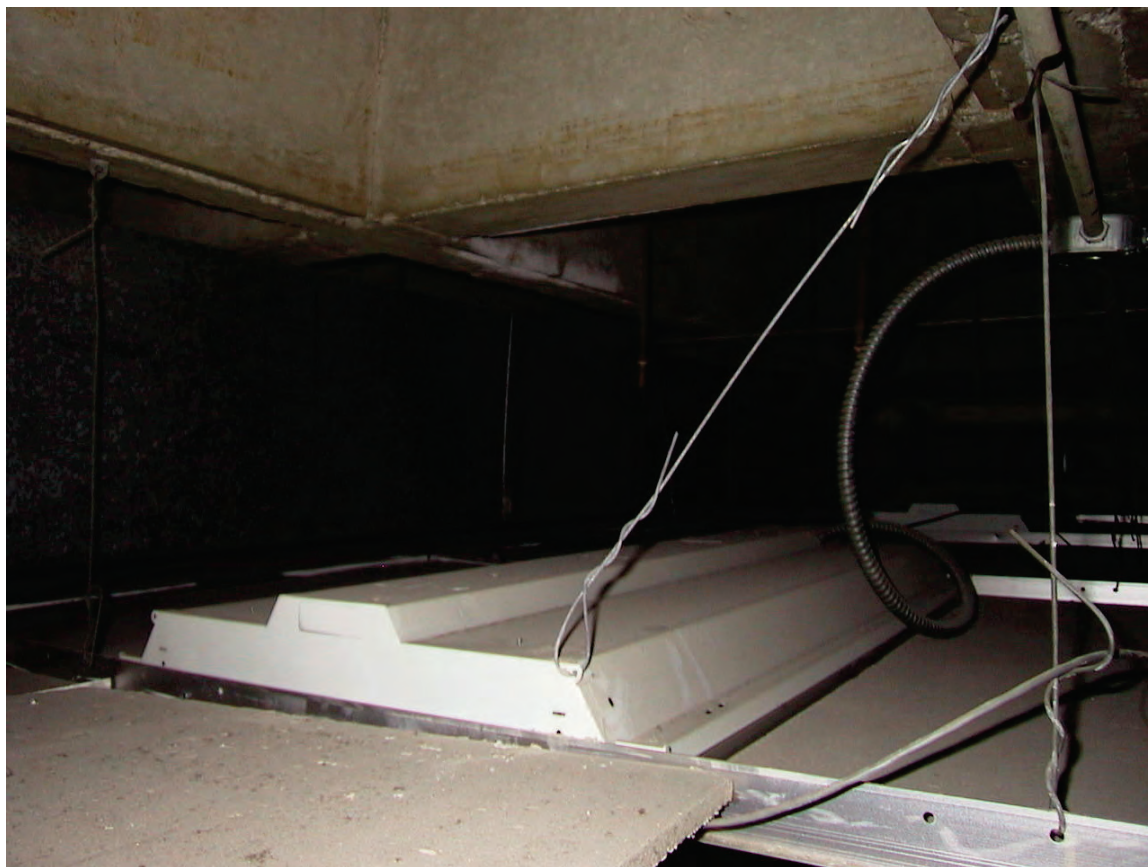
Figure 6.4.9.1-5 Example of light fixture with only one safety wire attached; the Salt Lake City schools require four wires for a fixture of this size and weight and also require tighter turns on the wire (Photo courtesy of Salt Lake City School District). Investigations in ceiling plenums often reveal missing wires.

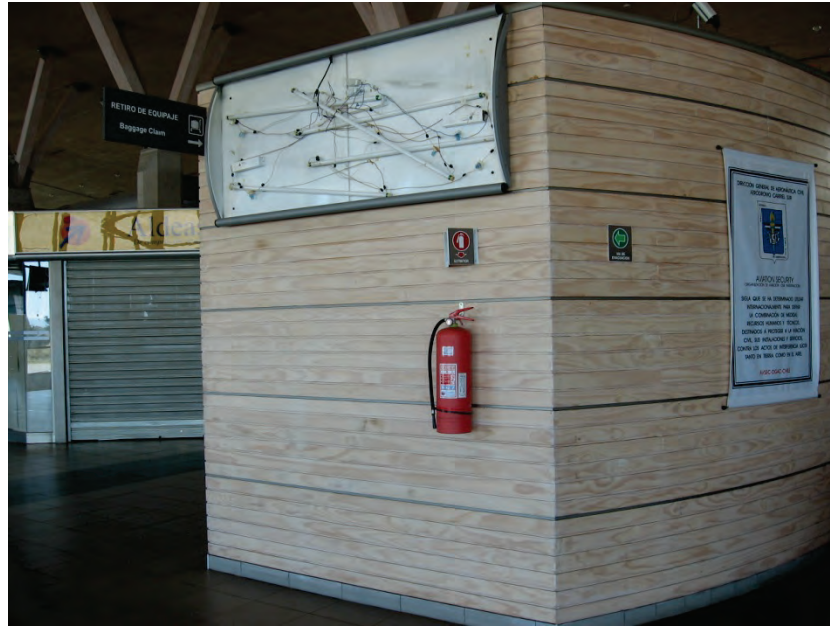
Figure 6.4.9.2-1 Numerous failures of ceilings and lights were observed at the Concepción airport in the 2010 magnitude-8.8 Chile Earthquake. Photo shows surface-mounted fixture on wall that remained in place but the lens fell and the bulbs were dislodged (Photo courtesy of Rodrigo Retamales, Rubén Boroscchek & Associates).

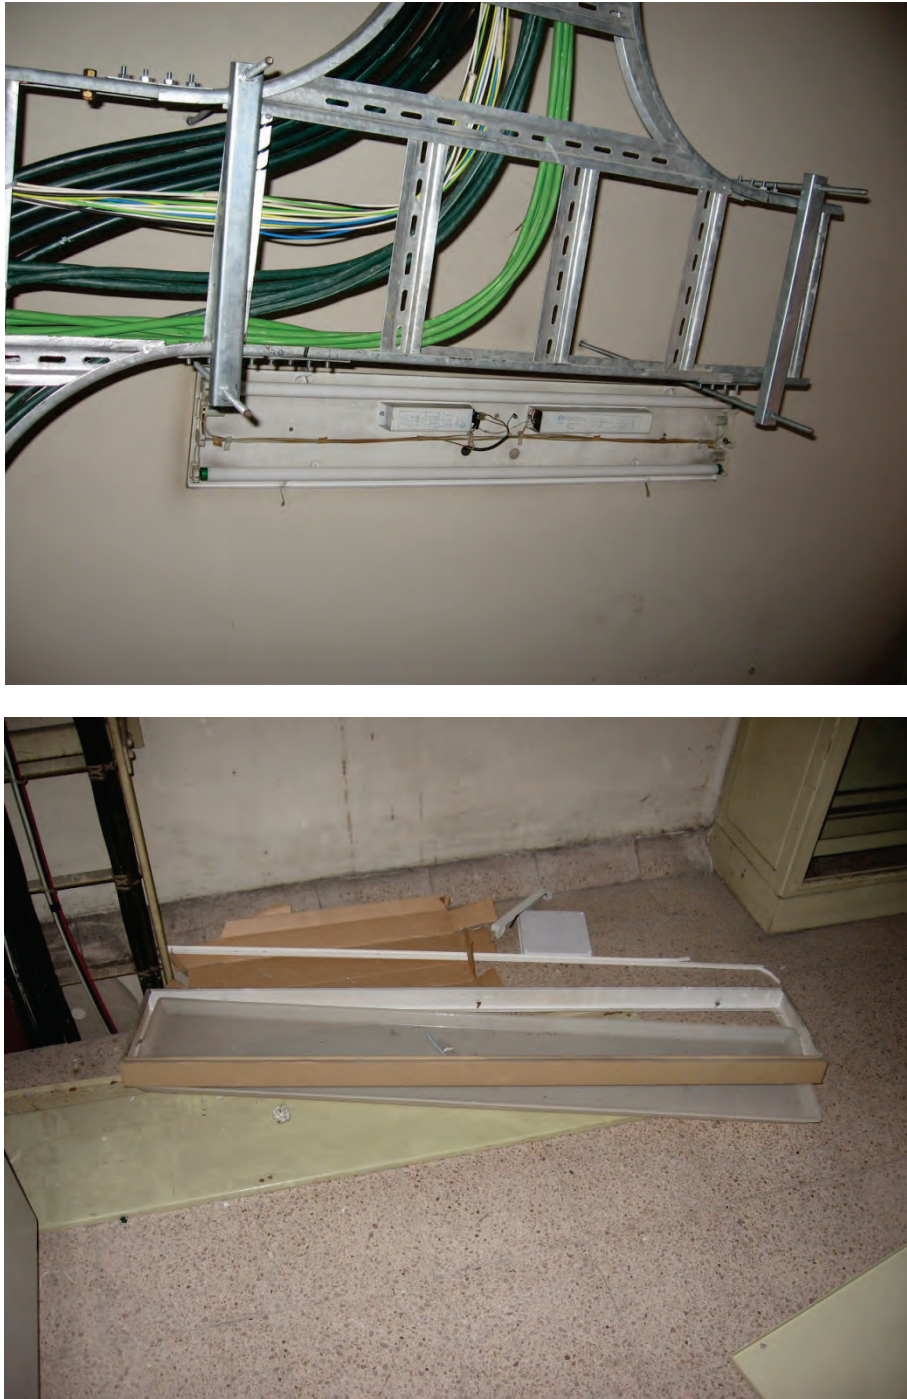
Figure 6.4.9.2-2 Overhead surface-mounted fixture anchored to underside of concrete slab damaged in the 2010 Chile Earthquake. Back of fixture housing remained anchored to the concrete slab above and the bulbs remained in place but the lens and sides of housing fell indicating that internal connections in the fixture were inadequate (Photos courtesy of Rodrigo Retamales, Rubén Boroschek & Associates).

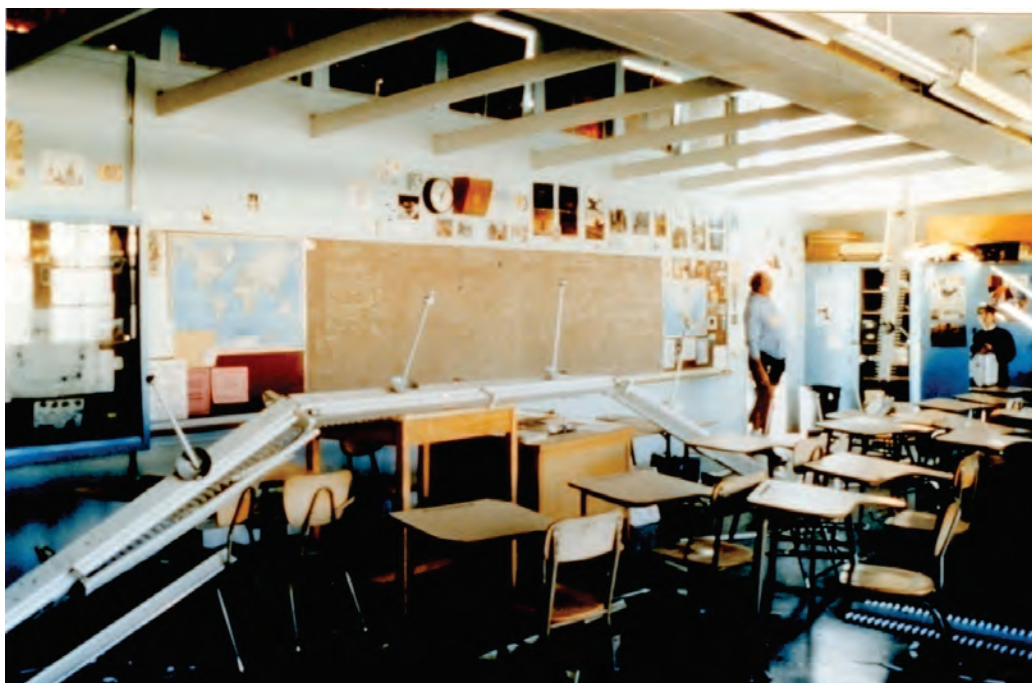
Figure 6.4.9.3-1 Failure of a strip of pendant light fixtures at Dawson Elementary School library as a result of the 1983 magnitude-6.4 Coalinga Earthquake. Note that in this case the support stems failed at the ceiling connection and the stem came down with the lights (Gary McGavin, NGDC, 2009).

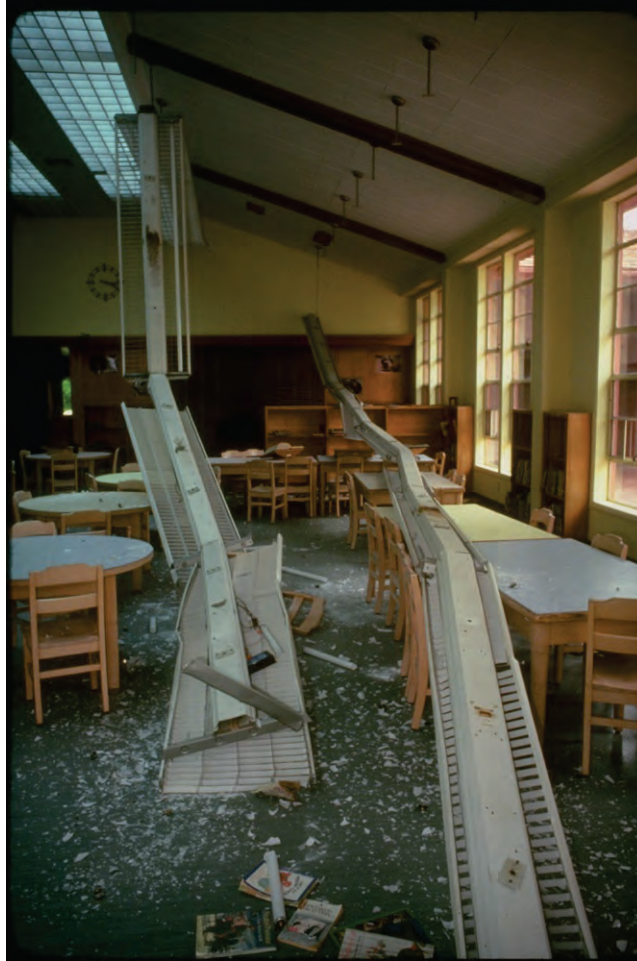
Figure 6.4.9.3-2 Failure of pendant light fixtures at Northridge Junior High School as a result of the 1994 Northridge Earthquake. In this example, the support stem failed at the fixture connection and the stem is still attached at the ceiling (Photo courtesy of Gary L. McGavin).

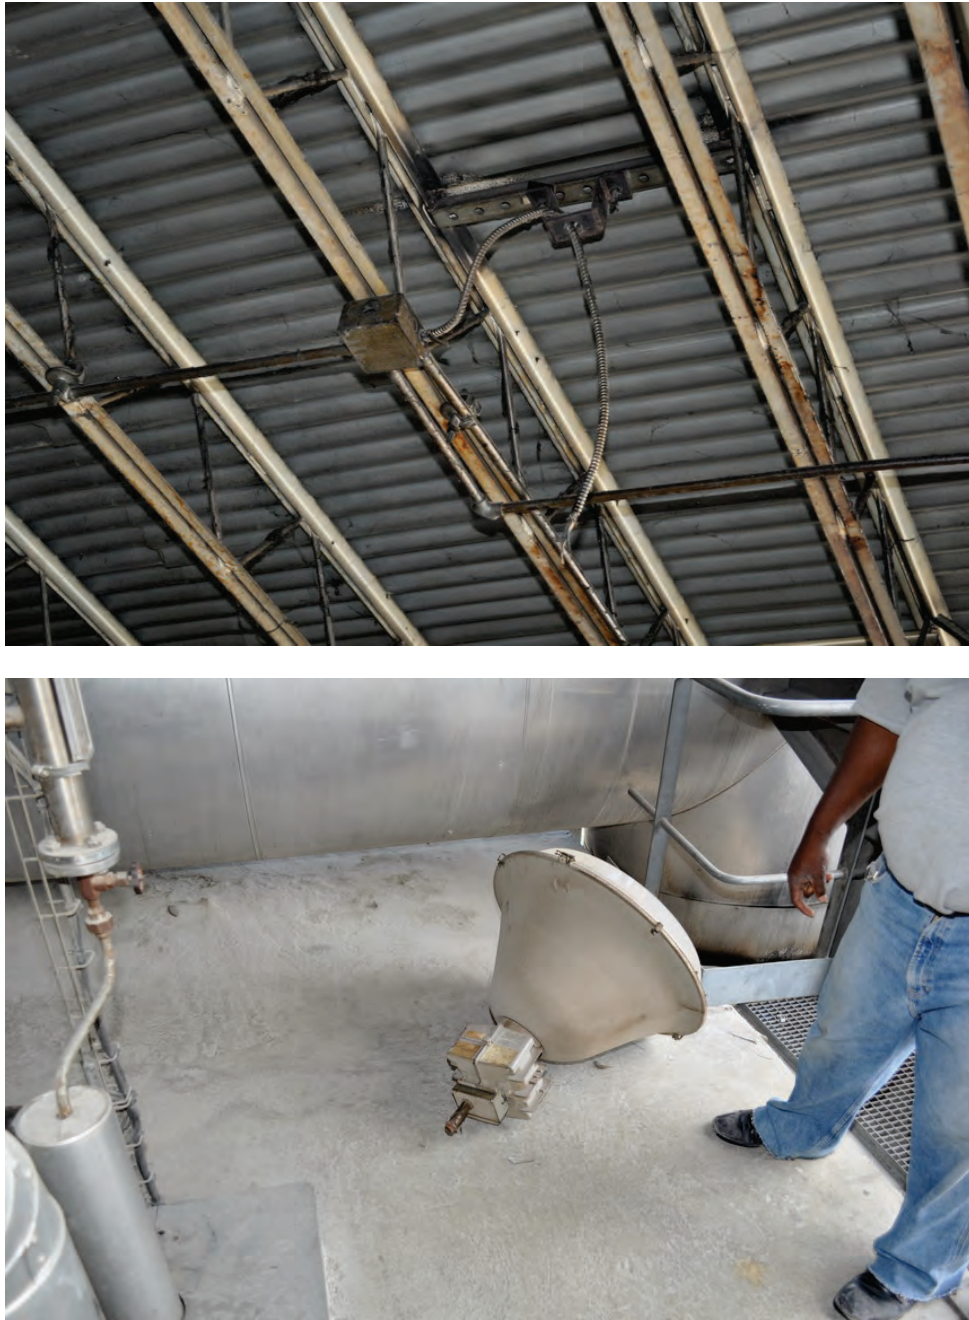
Figure 6.4.9.3-3 Failure of pendant light fixture in the 2010 magnitude-7 Haiti Earthquake; stem of fixture broke and conduit pulled loose (Photos courtesy of Eduardo Fierro, BFP Engineers).

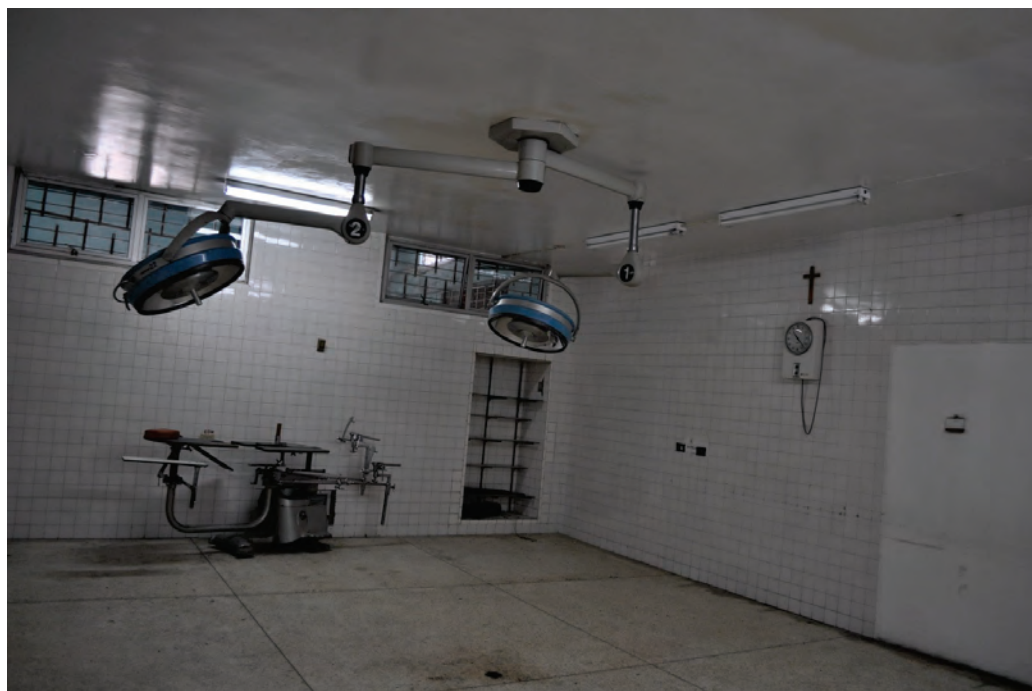
Figure 6.4.9.4-1 Operating room lights undamaged although hospital evacuated due to collapse of adjacent wing in the 2010 magnitude-7 Haiti Earthquake. Fixture anchored to underside of concrete slab (Photo courtesy of Ayhan Irfanoglu, Purdue University).
