Reducing the Risks of Nonstructural Earthquake Damage – A Practical Guide

FEMA E-74 / December 2012

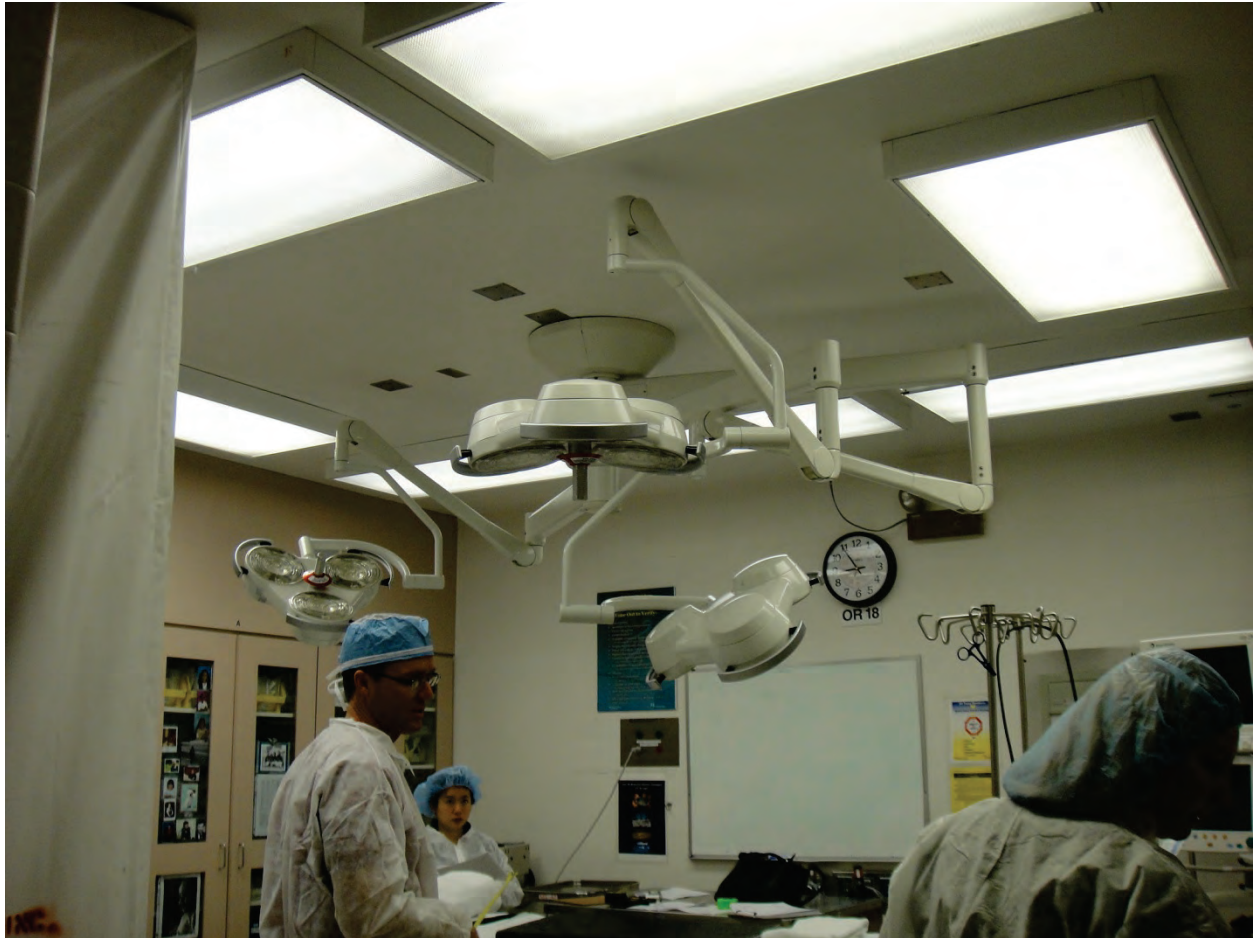
Figure 6.4.9.4-2 Engineered support and bracing are required for heavy operating room lights. The arms, joints, lenses and bulbs must be capable of resisting seismic forces. Hospital fixtures require certification. Photo also shows surface mounted fluorescent fixtures in a suspended gypsum board ceiling; each of these requires independent safety wires to the structure above; see Section 6.4.9.2 (Photo courtesy of Maryann Phipps, Estructure).

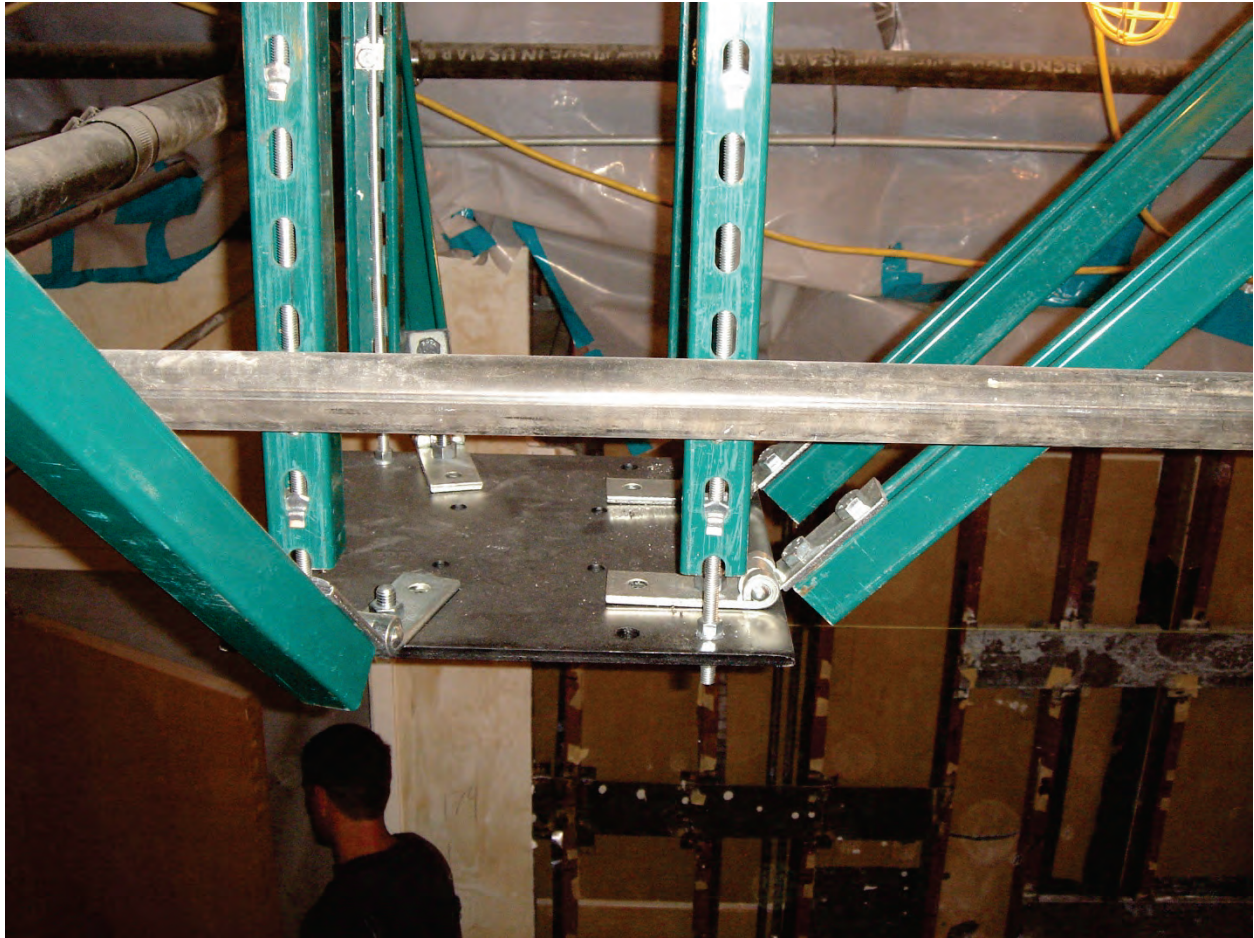
Figure 6.4.9.4-3 Engineered support and bracing for operating room lights located in California hospital. Steel plate has predrilled holes to receive fixture attachments (Photo courtesy of Maryann Phipps, Estructure).

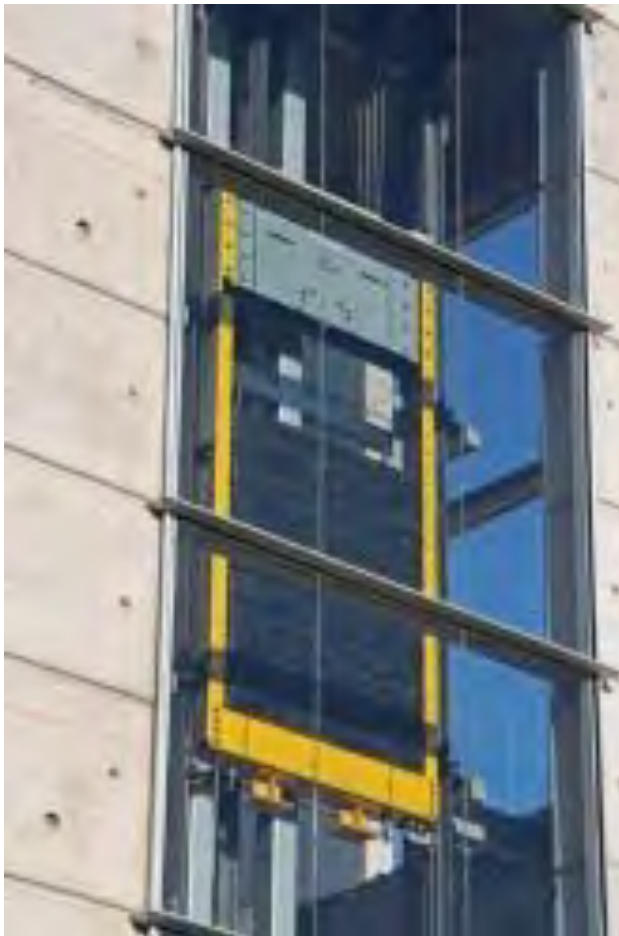
Figure 6.4.10.2-1 Examples of an elevator counterweight (Photo courtesy of Eduardo Miranda, Stanford University).

- Guide rails are attached to the structure by steel brackets. As shown in Figure 6.4.10.2–1 the rails are attached to the brackets by clamps that hold the flanges of the rail to the bracket. Both brackets and clamps are damaged as a result of the forces acting on the counterweight or car. The most common type of damage consists of bending of the brackets.

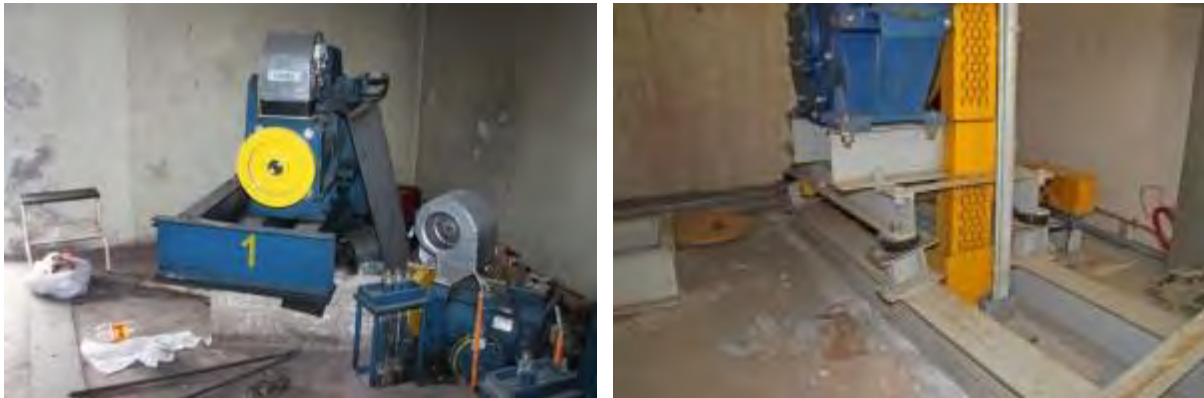
Figure 6.4.10.2-4 Examples of damage to elevator machines produced by inadequate anchorage to the structure (Photos courtesy of Eduardo Miranda, Stanford University).

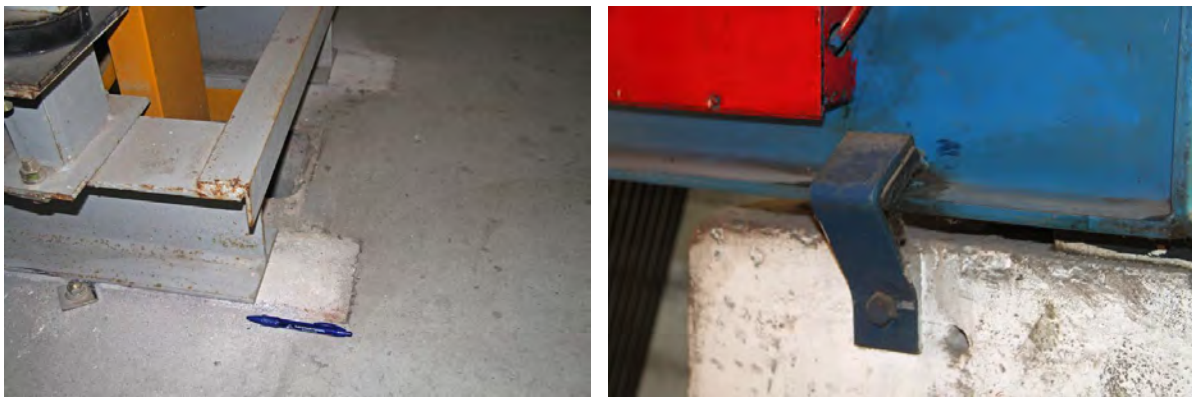
Figure 6.4.10.2-5 Details of bent bracket (left) and large displacement at the base of elevator machines (Photos courtesy of Eduardo Miranda, Stanford University).

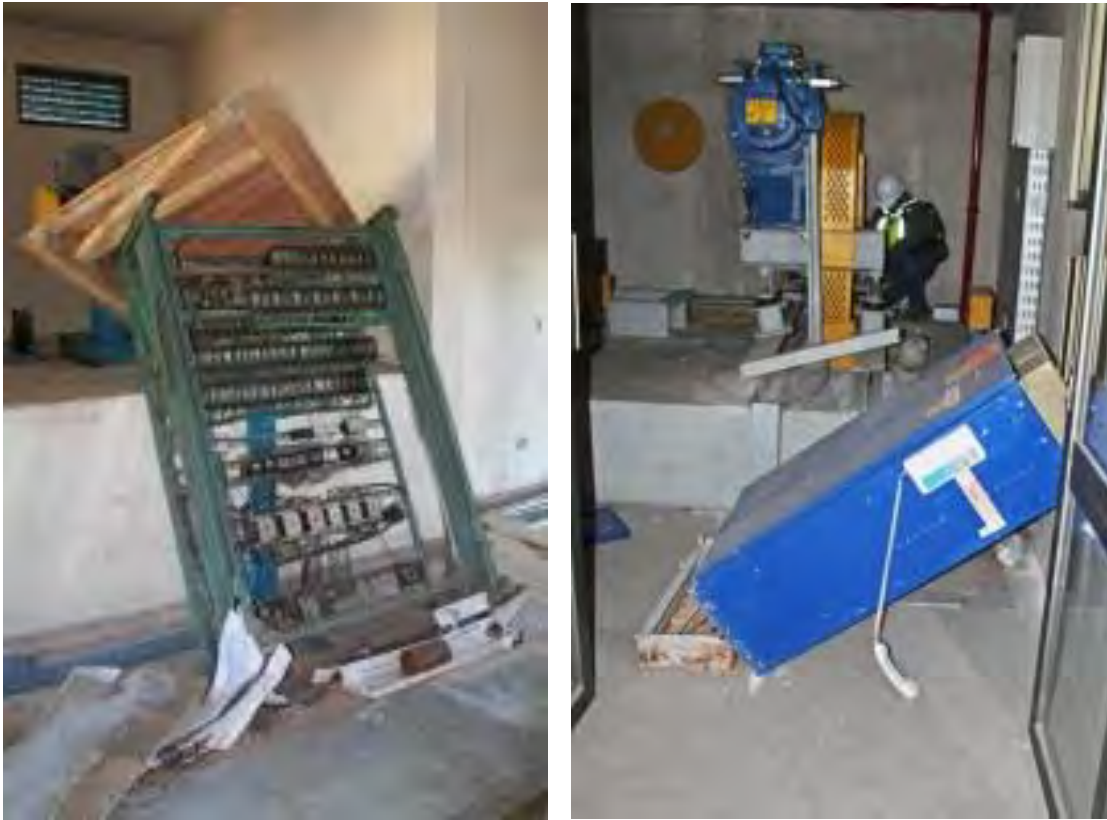
Figure 6.4.10.2-6 Overturned control panels in the 2010 Chile earthquake (Photos courtesy of Eduardo Miranda, Stanford University).

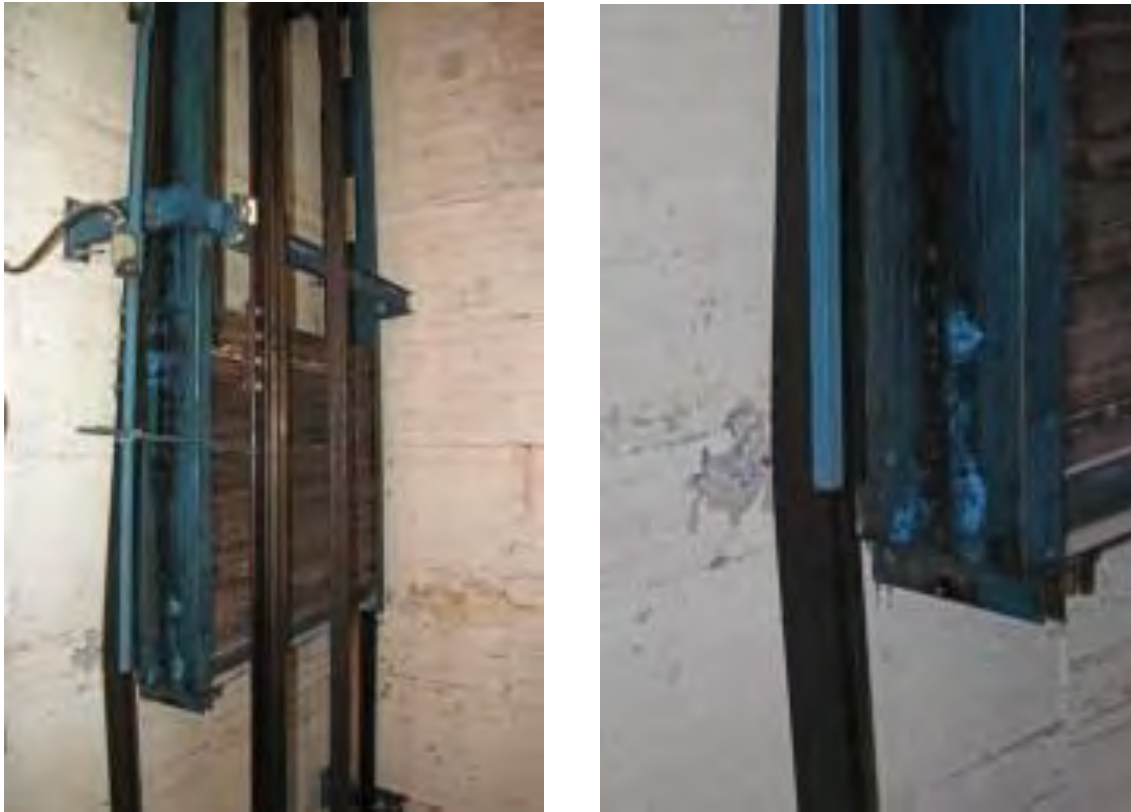
Figure 6.4.10.2-7 Damage to guide rails caused by derailment of the counterweight in a hospital in Chillan during the 2010 Chile earthquake (Photos courtesy of Eduardo Miranda, Stanford University).

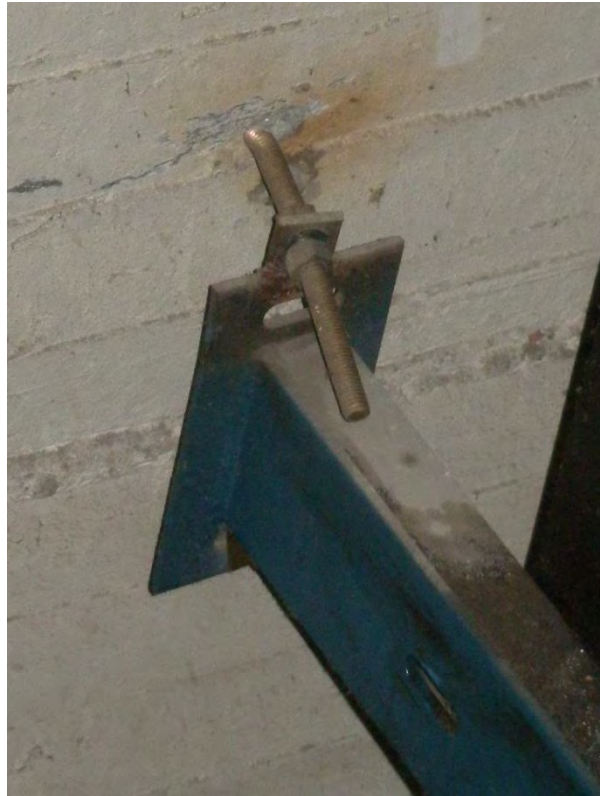
Figure 6.4.10.2-8 Damage to guide rail support brackets in the 2010 Chile Earthquake (Photo courtesy of Gilberto Mosqueda, SUNY Buffalo).

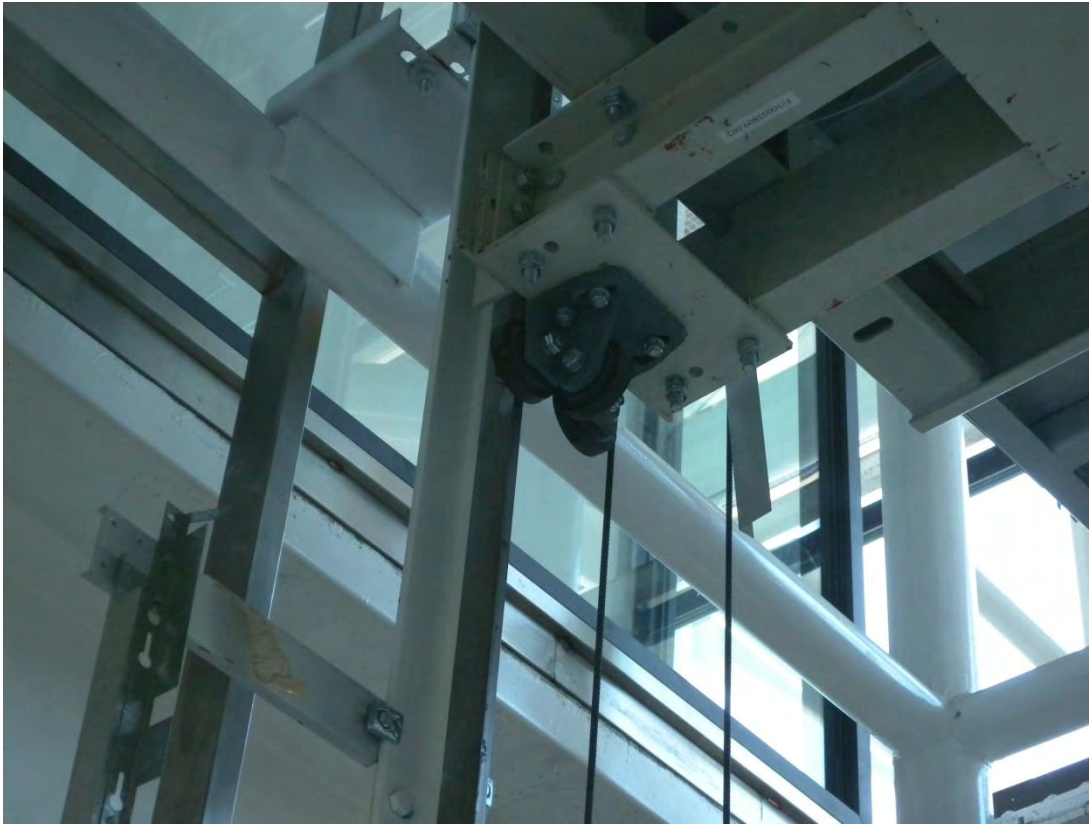
Figure 6.4.10.2-9 Derailed car roller assembly of the guide rail at the Santiago airport in the 2010 Chile Earthquake (Photo courtesy of Gilberto Mosqueda, SUNY Buffalo). The three rollers are supposed to travel along three sides of the stem of the T-shaped steel guide rail.

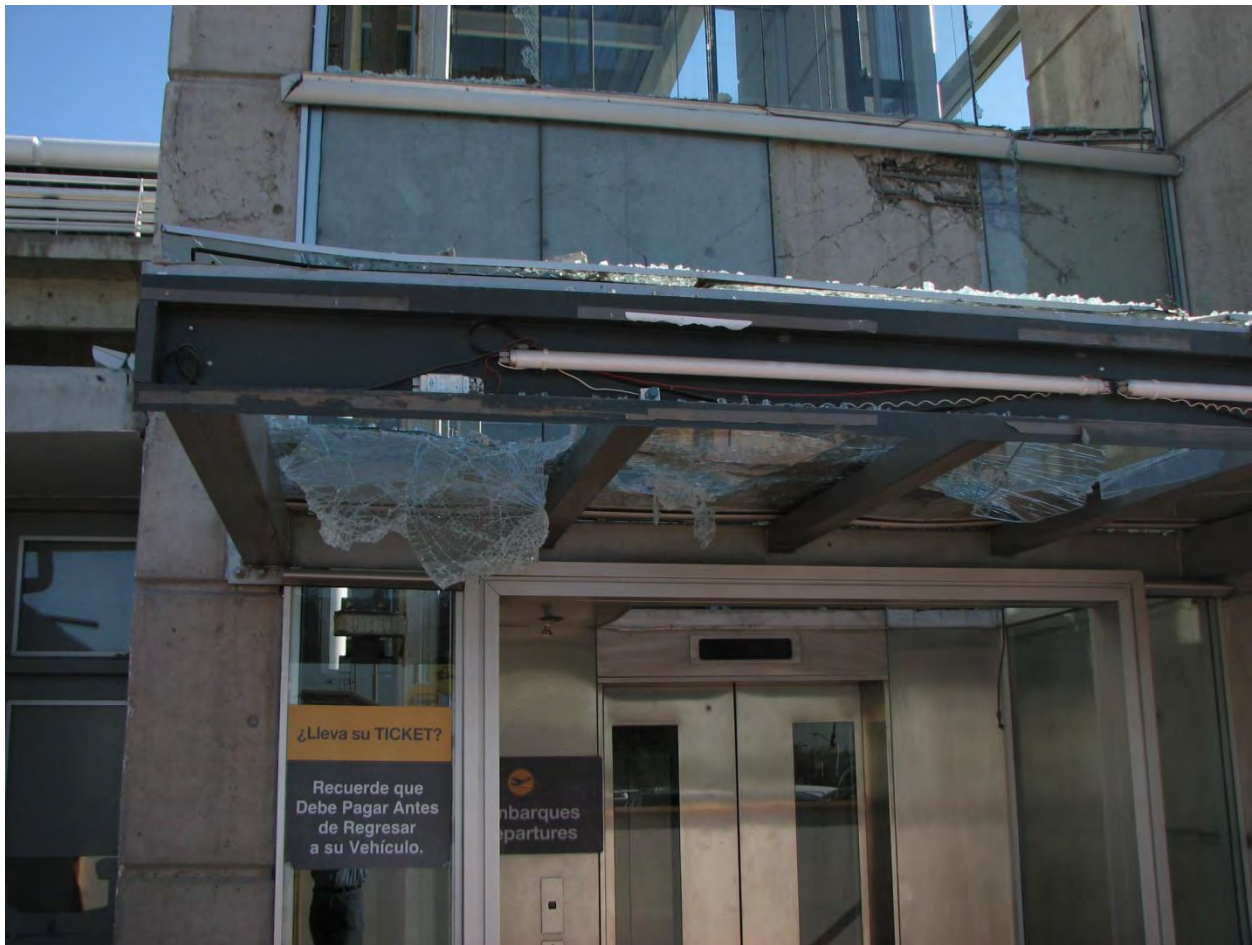
Figure 6.4.10.2-10 Glazing failures caused additional hazards at Santiago airport elevator in the 2010 Chile Earthquake (Photo courtesy of Antonio Iruretagoyena, Rubén Borsochek & Associates).

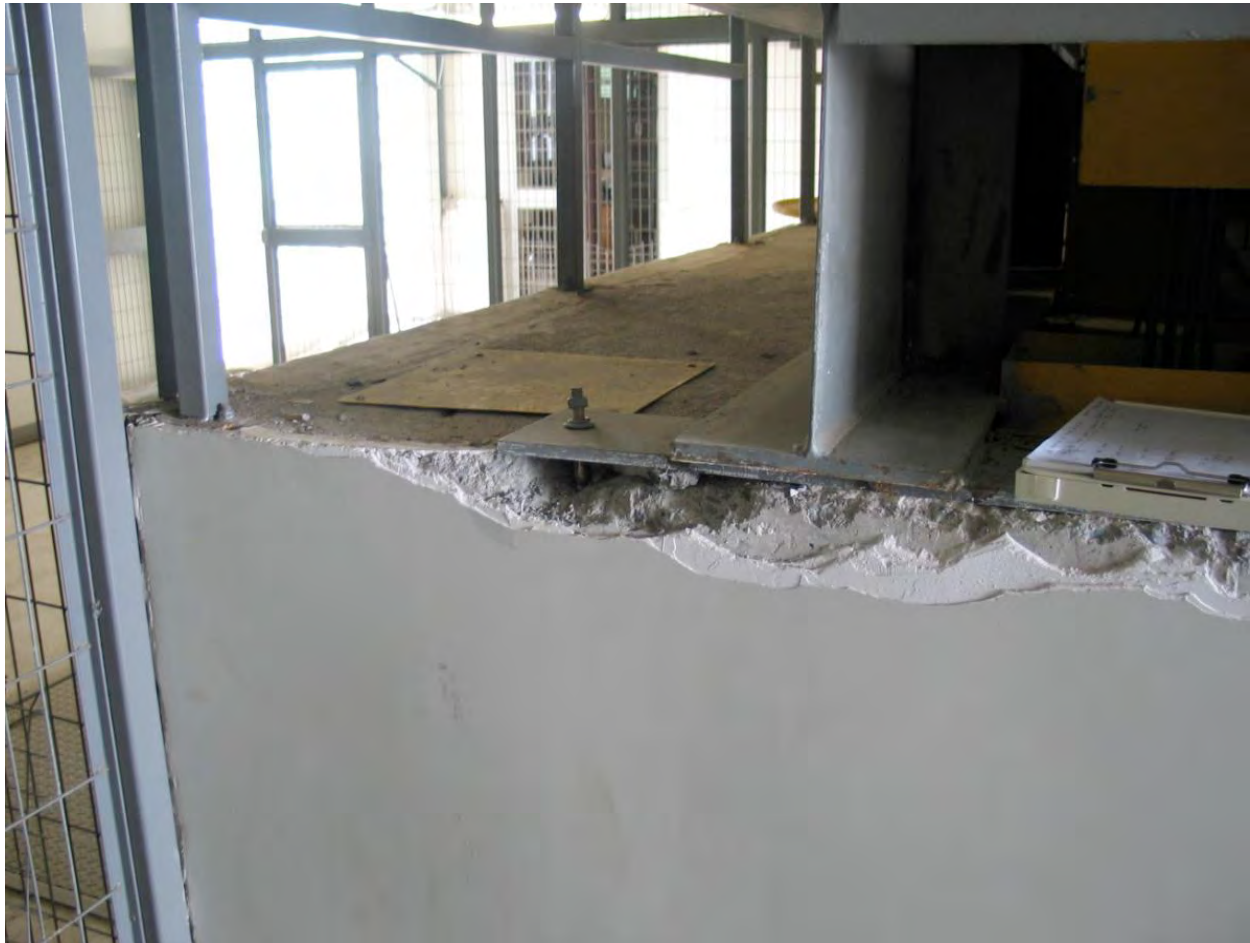
Figure 6.4.10.2-12 Anchor bolt failure of the elevator generator set due to inadequate edge distance for the bolts at the Los Angeles Regional Public Hospital in the 2010 Chile Earthquake (Photo courtesy of Bill Holmes, Rutherford & Chekene).

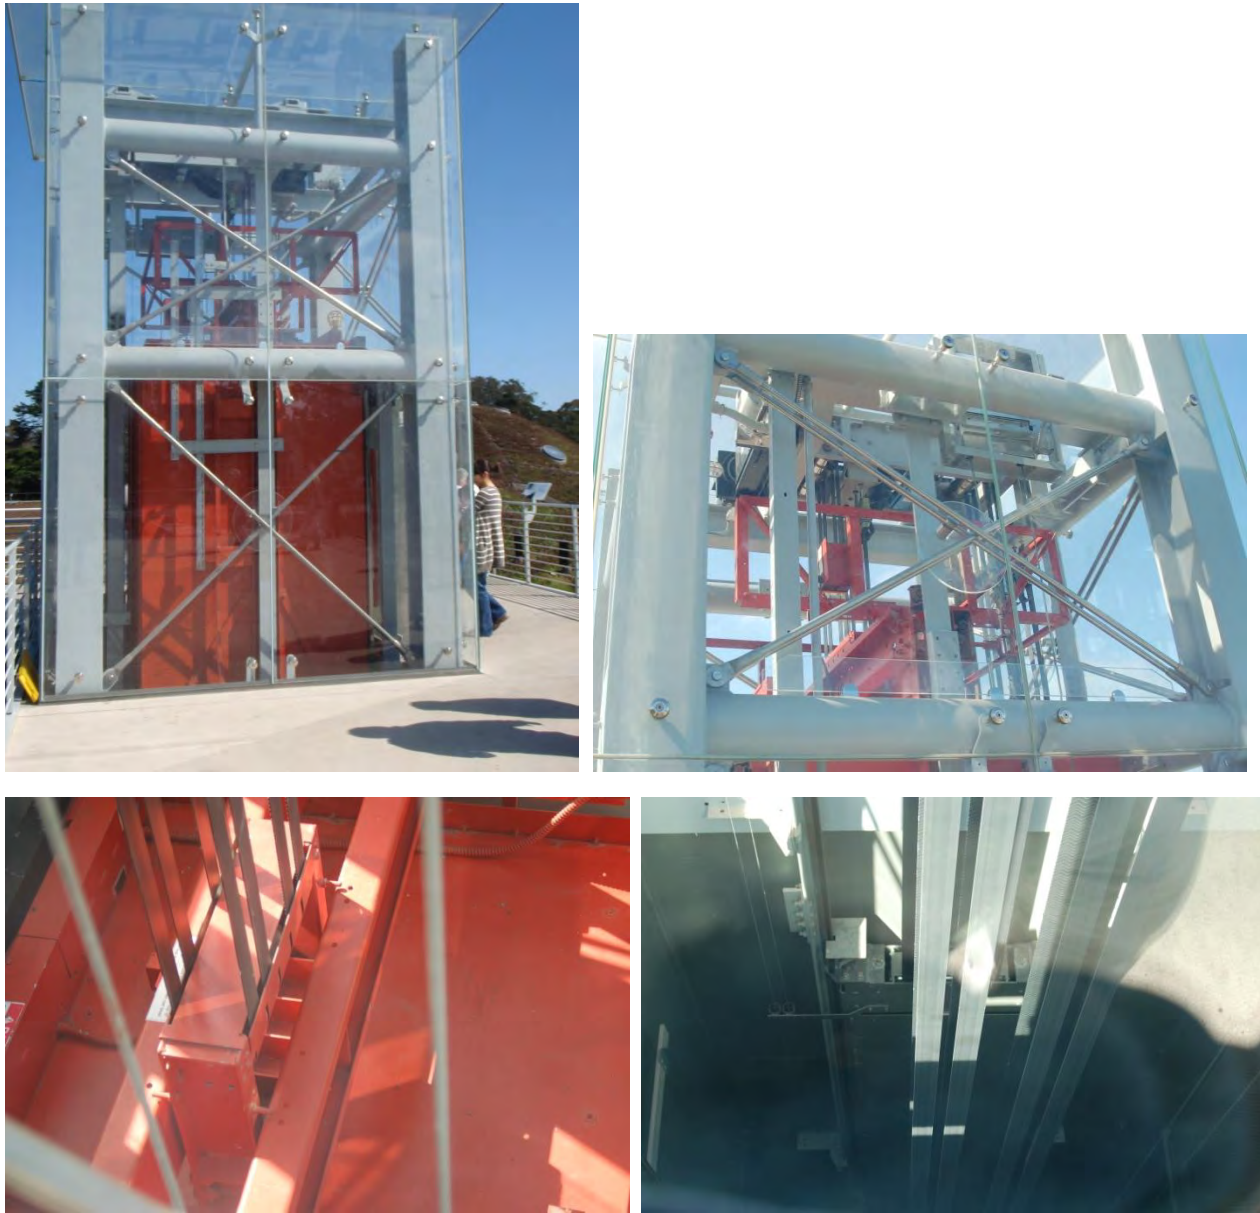
Figure 6.4.10.2-13 Small "machine-roomless" traction elevator with flat belts at the Academy of Sciences, San Francisco, California (Photos courtesy of Eduardo Fierro, BFP Engineers). Clockwise: Overview of elevator at roof; view of guide rails and sheaves; top of cab showing belts; view down shaft at belts, counterweight, guide rails and guide rail brackets.

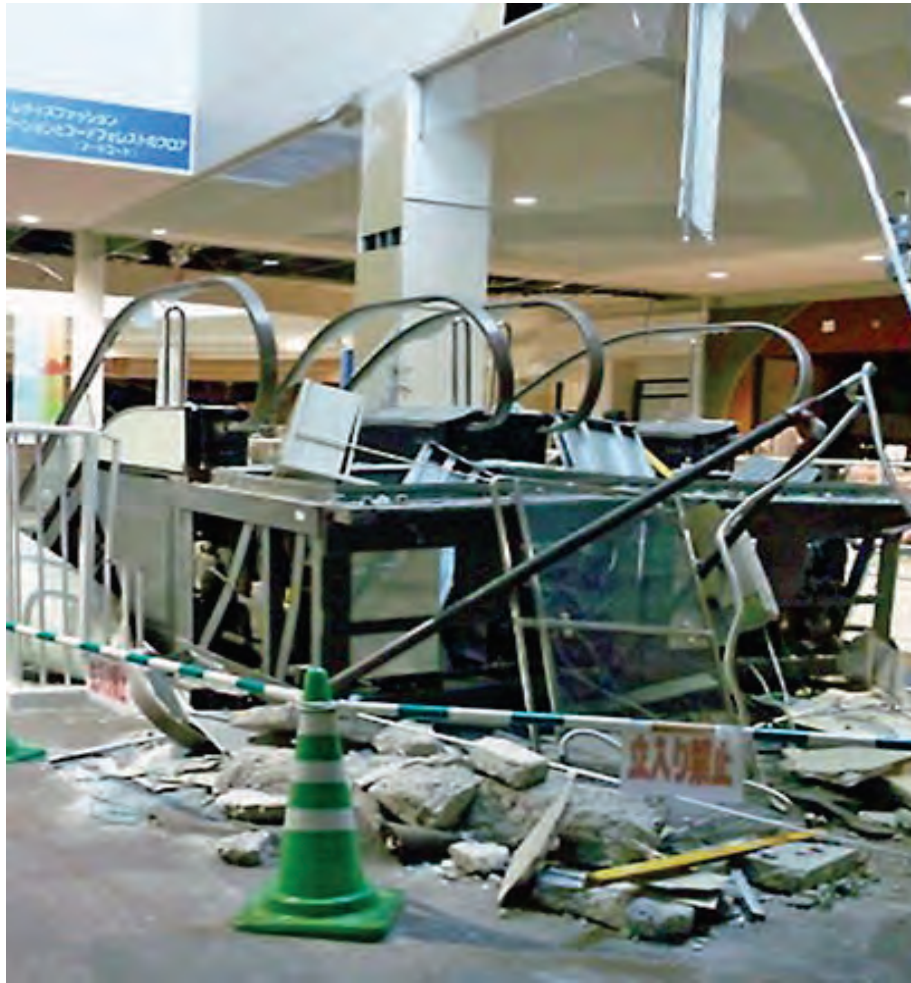
Figure 6.4.10.3-1 Photo of escalator, located in the Sendai area of Japan, which fell from the floor above onto the escalator on the floor below during the magnitude-9.0 Great Tohoku Earthquake of March 11, 2011. The probable cause of this collapse was that the relative displacements between floors exceeded the connection bearing width capacity of the escalator. This type of failure creates a serious life safety hazard (Photo source: Nekkei Architecture).

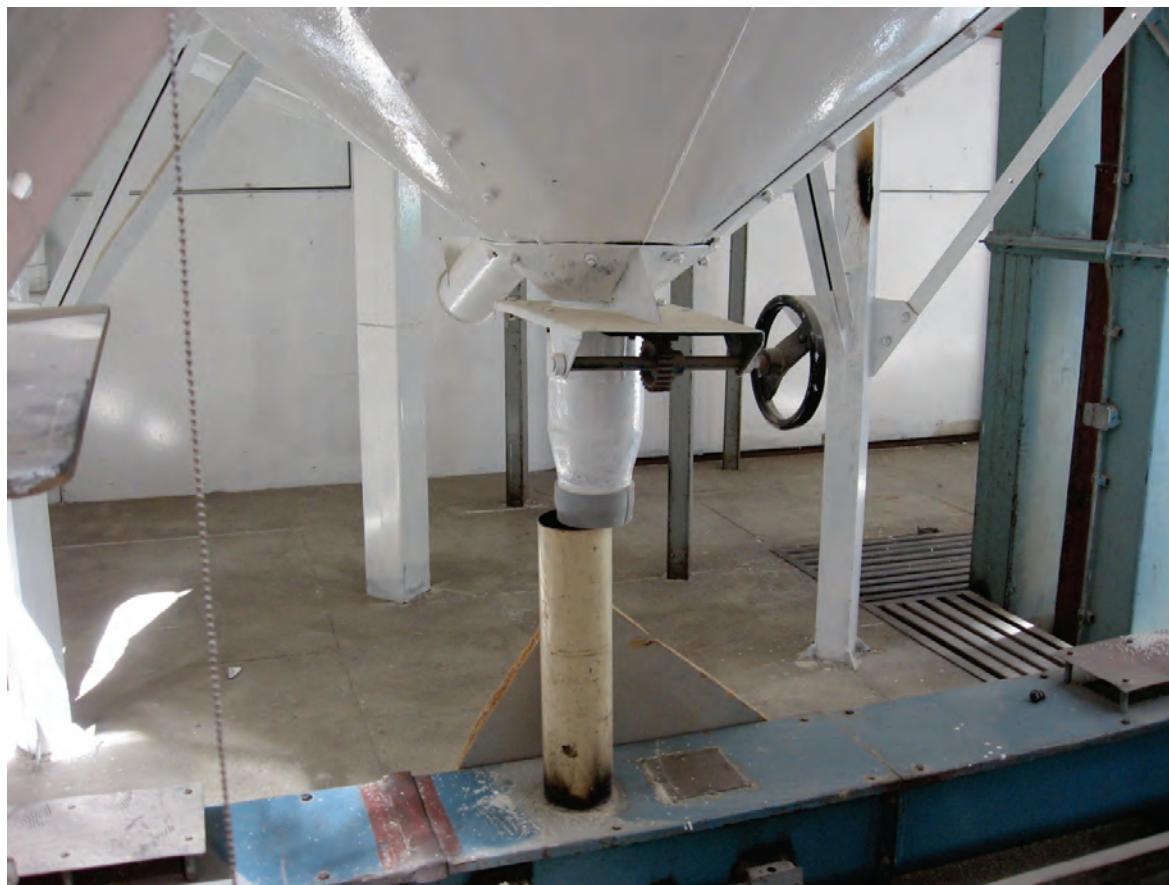
Figure 6.4.11.1-1 Misalignment between rice storage hopper and conveyor following the 2010 magnitude-8.8 Chile Earthquake (Photo courtesy of Rodrigo Retamales, Rubén Boroschek & Associates). Where various system components interface with a conveyor, the seismic restraints for the various parts should be coordinated to maintain alignment following an earthquake.

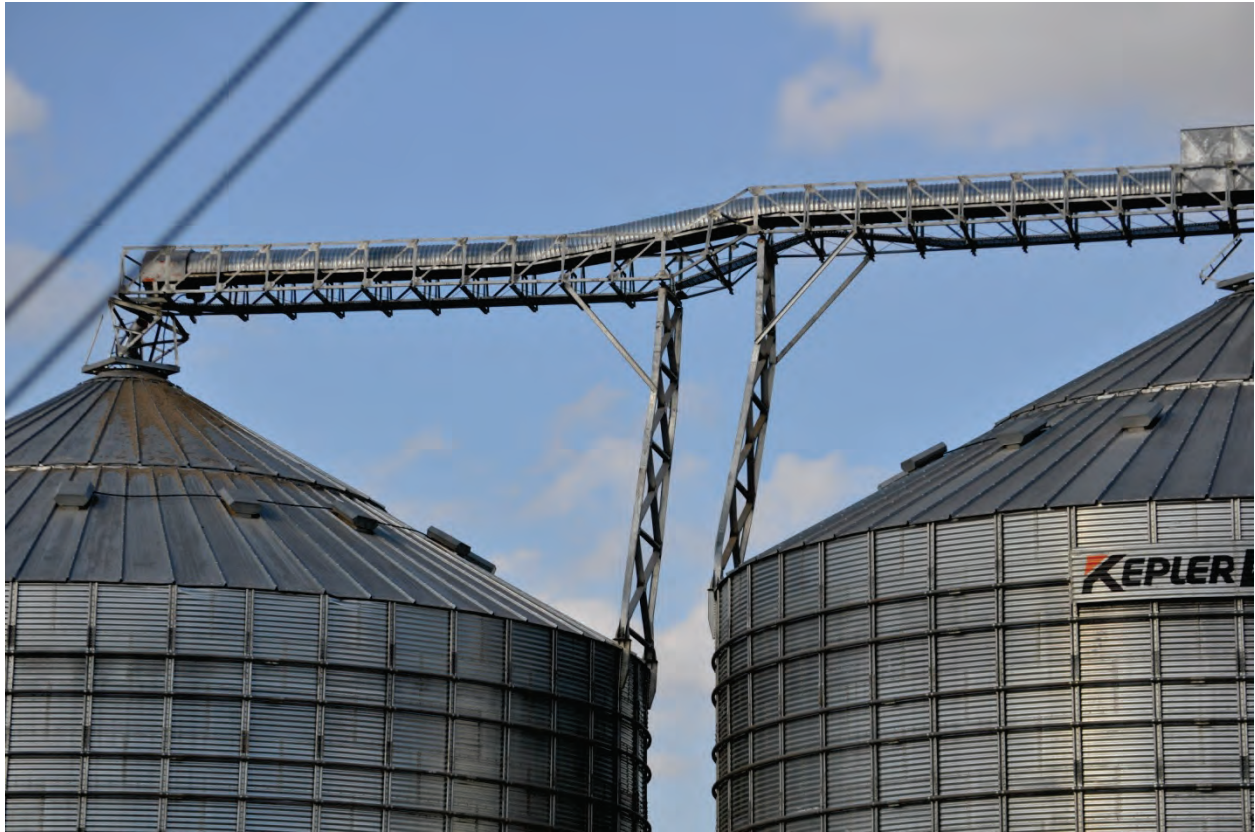
Figure 6.4.11.1-2 Damage to industrial conveyor used to feed grain silos in the 2010 Chile Earthquake (Photo courtesy of Eduardo Fierro, BFP Engineers).

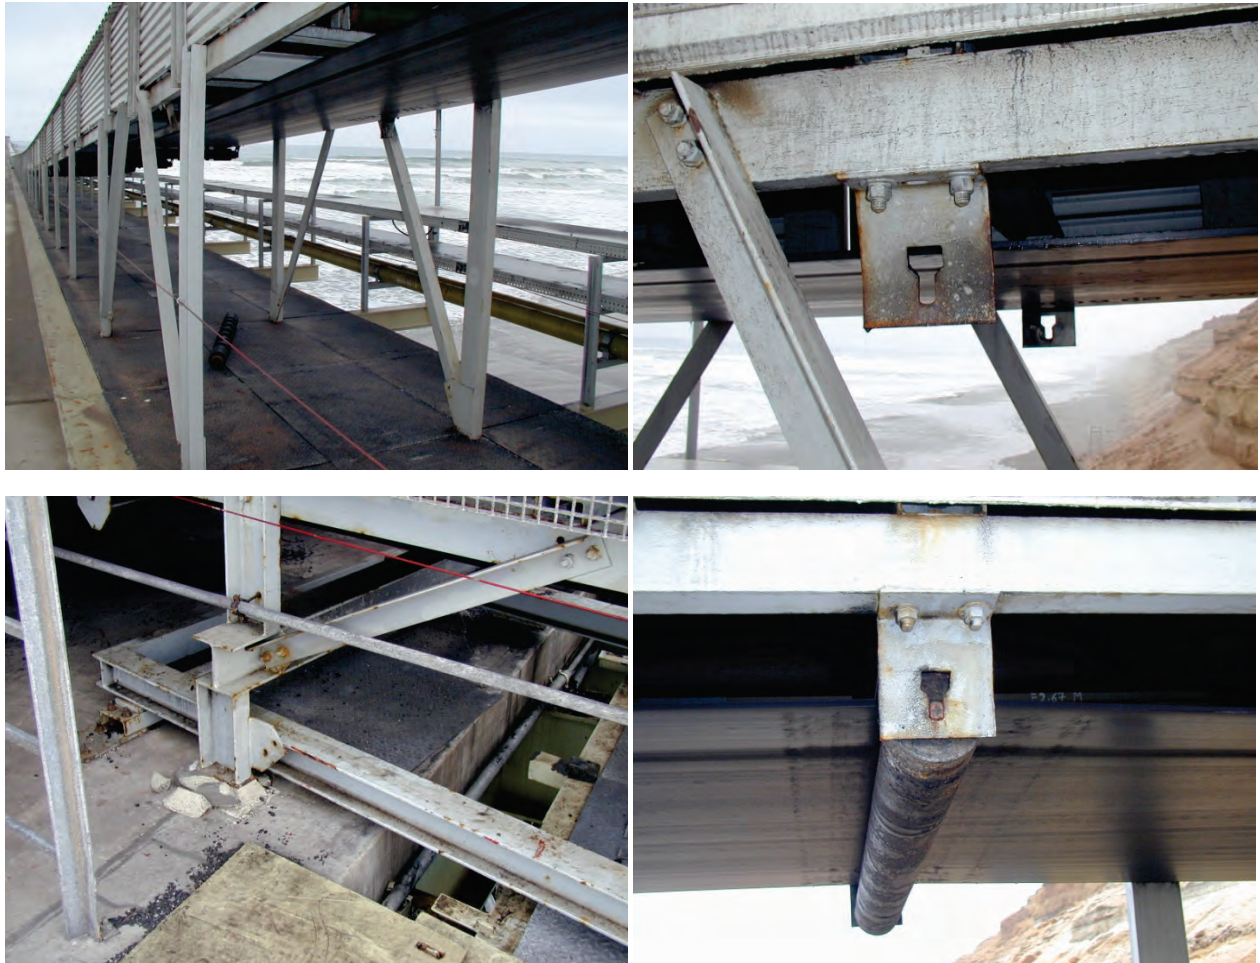
Figure 6.4.11.1-3 Damage to industrial coal conveyor on jetty in southern Peru in the 2001 magnitude-8.4 Peru Earthquake (Photos courtesy of Eduardo Fierro, BFP Engineers). Conveyor was well anchored along entire length but detailing at the seismic joint between the jetty and platform did not allow sufficient movement, resulting in misalignment at end of conveyor and damage to the supports as shown at lower left. Approximately 10% of the rollers fell; these were held in place with friction fittings and did not have positive connections.

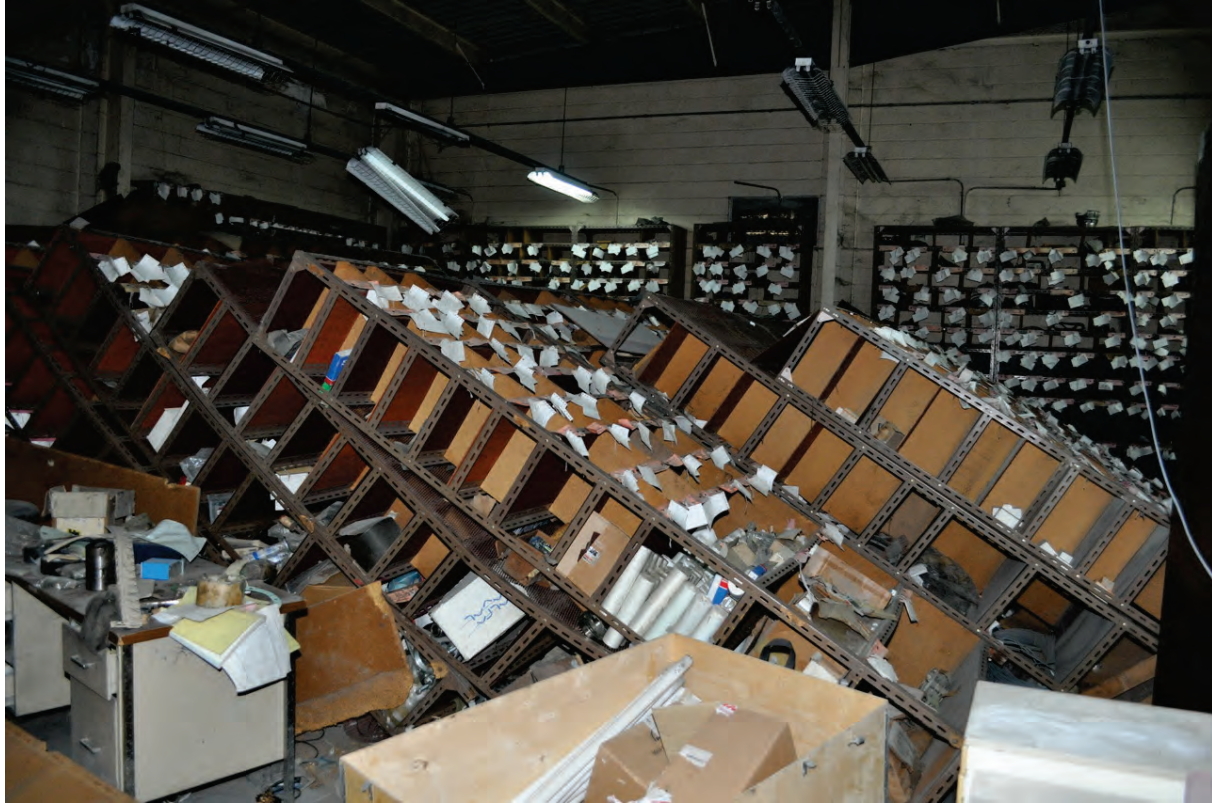
Figure 6.5.1.1-1 Collapse of row of unanchored freestanding shelving units containing spare parts at an electric power plant in Port-au-Prince in the 2010 magnitude-7 Haiti Earthquake (Photo courtesy of Eduardo Fierro, BFP Engineers).

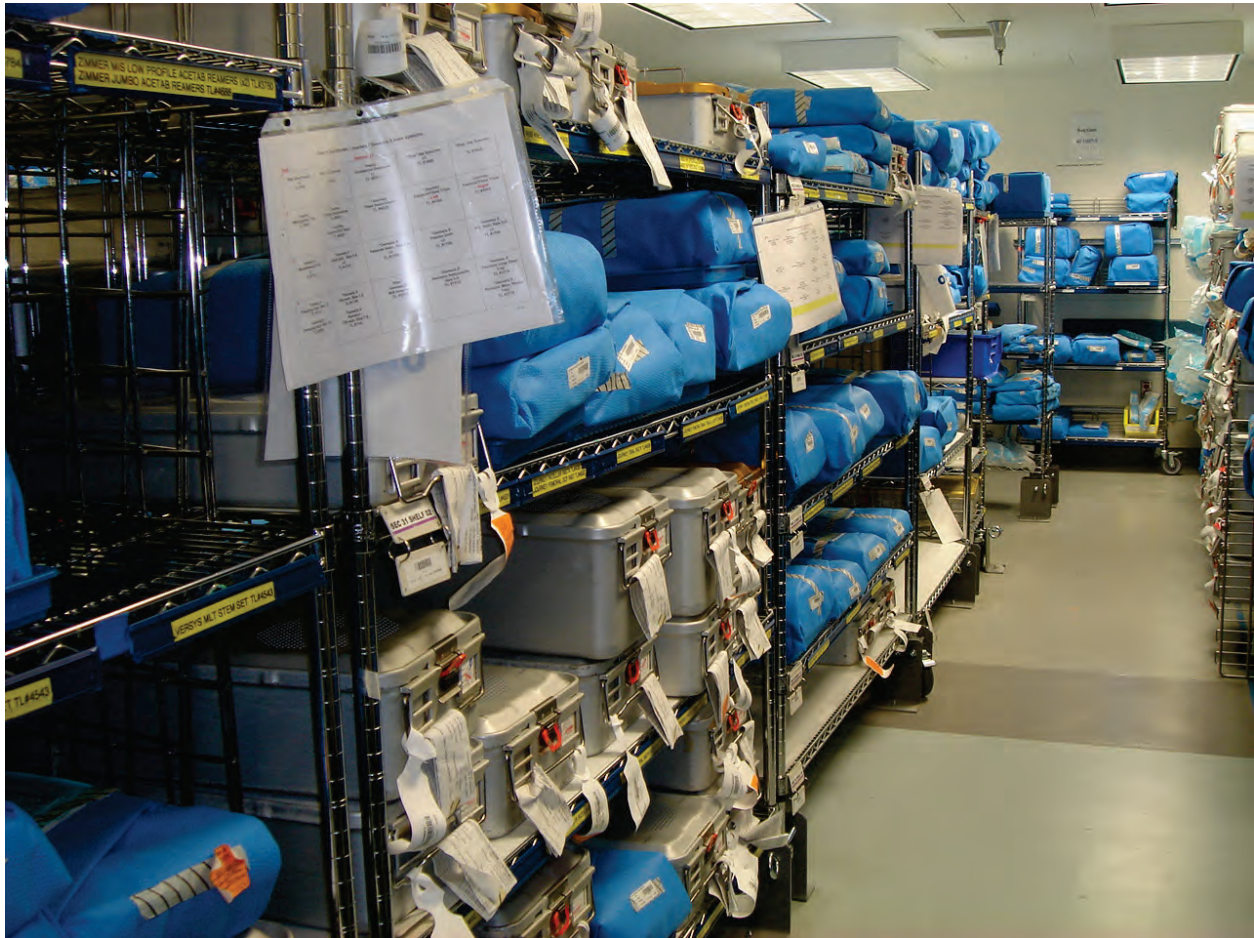
Figure 6.5.1.1-3 Mobile carts restrained at base with clip angles anchored to the floor and removable eyebolts attached from each cart to the angles (Photo courtesy of Maryann Phipps, Estructure).

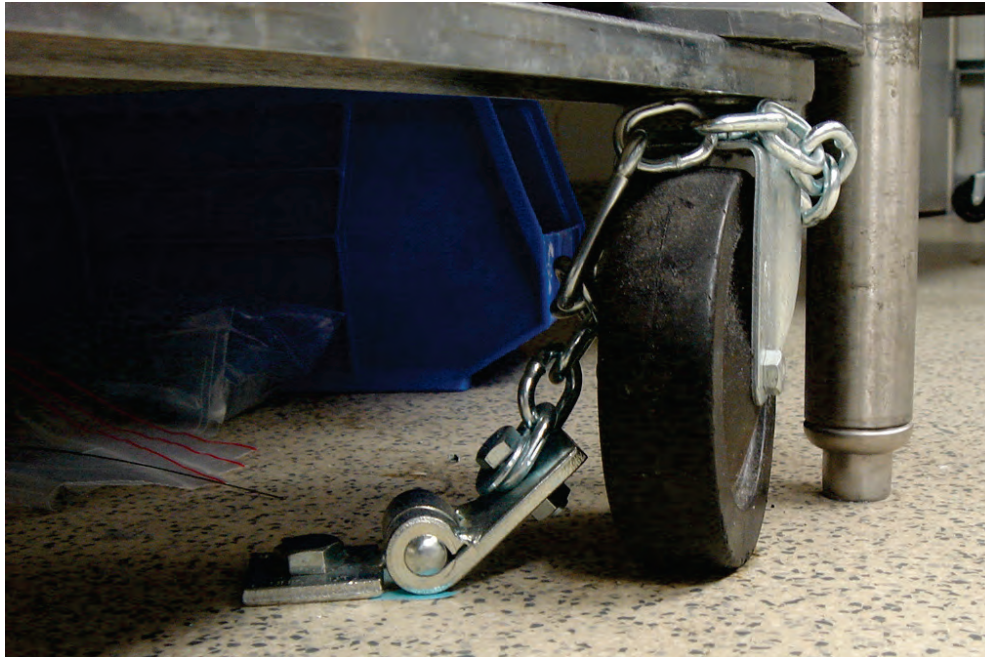
Figure 6.5.1.1-4 Alternate restraint at base of mobile shelving unit (Photo courtesy of Maryann Phipps, Estructure).

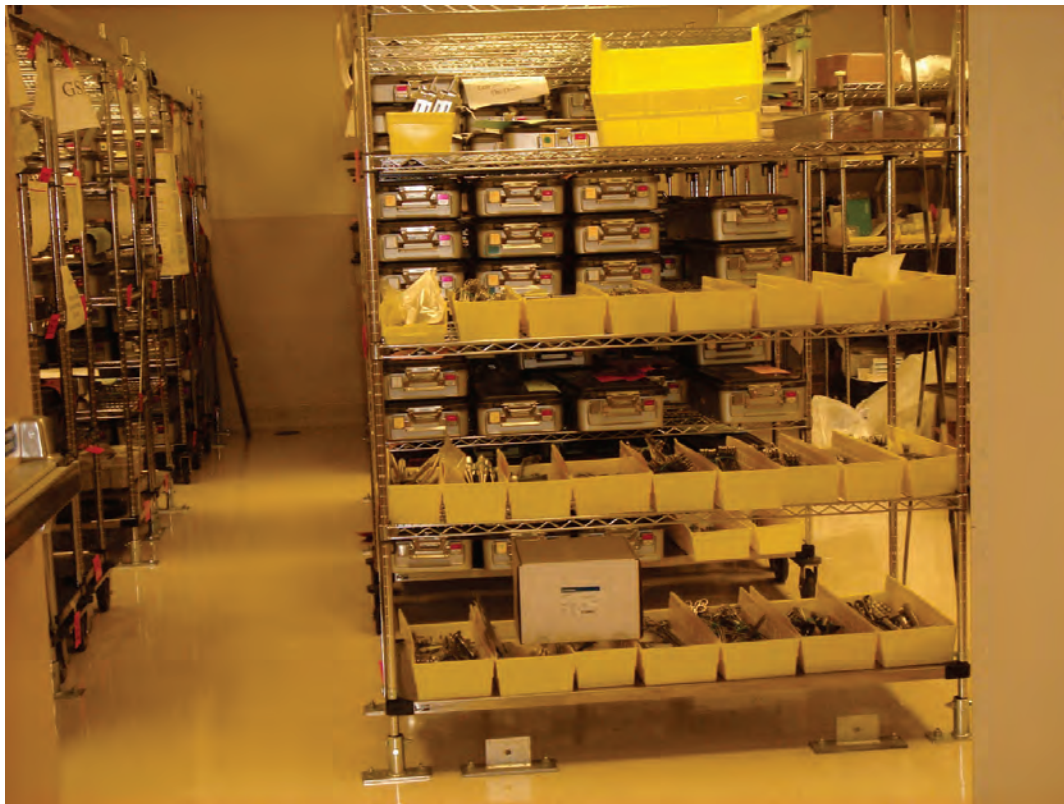
Figure 6.5.1.1-5 Fixed base shelving units anchored with optional seismic base plate offered by manufacturer (Photo courtesy of Maryann Phipps, Estructure).

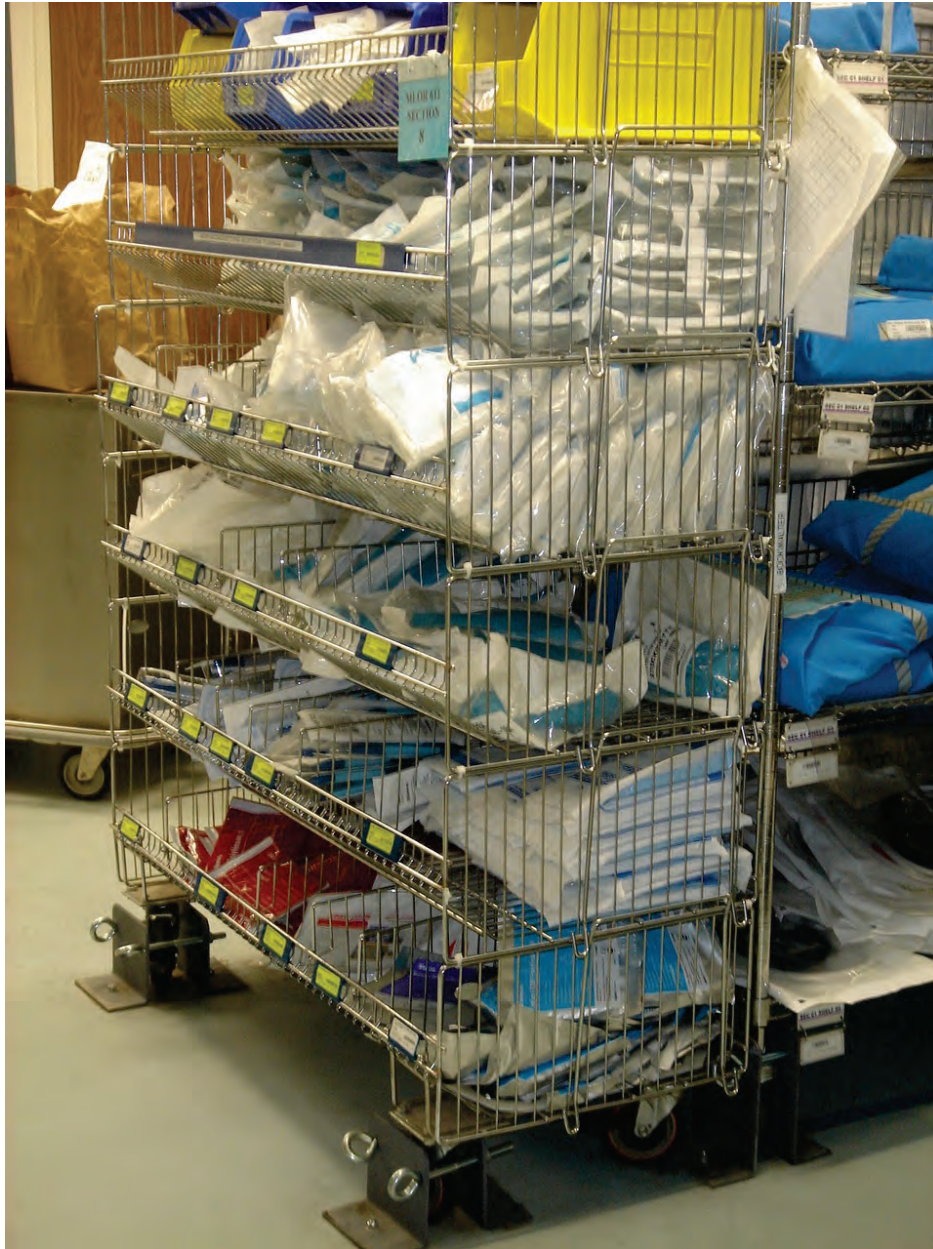
Figure 6.5.1.1-6 Mobile cart restrained at base with removable angles and eyebolts. Back-to-back units are interconnected (Photo courtesy of Maryann Phipps, Estructure).

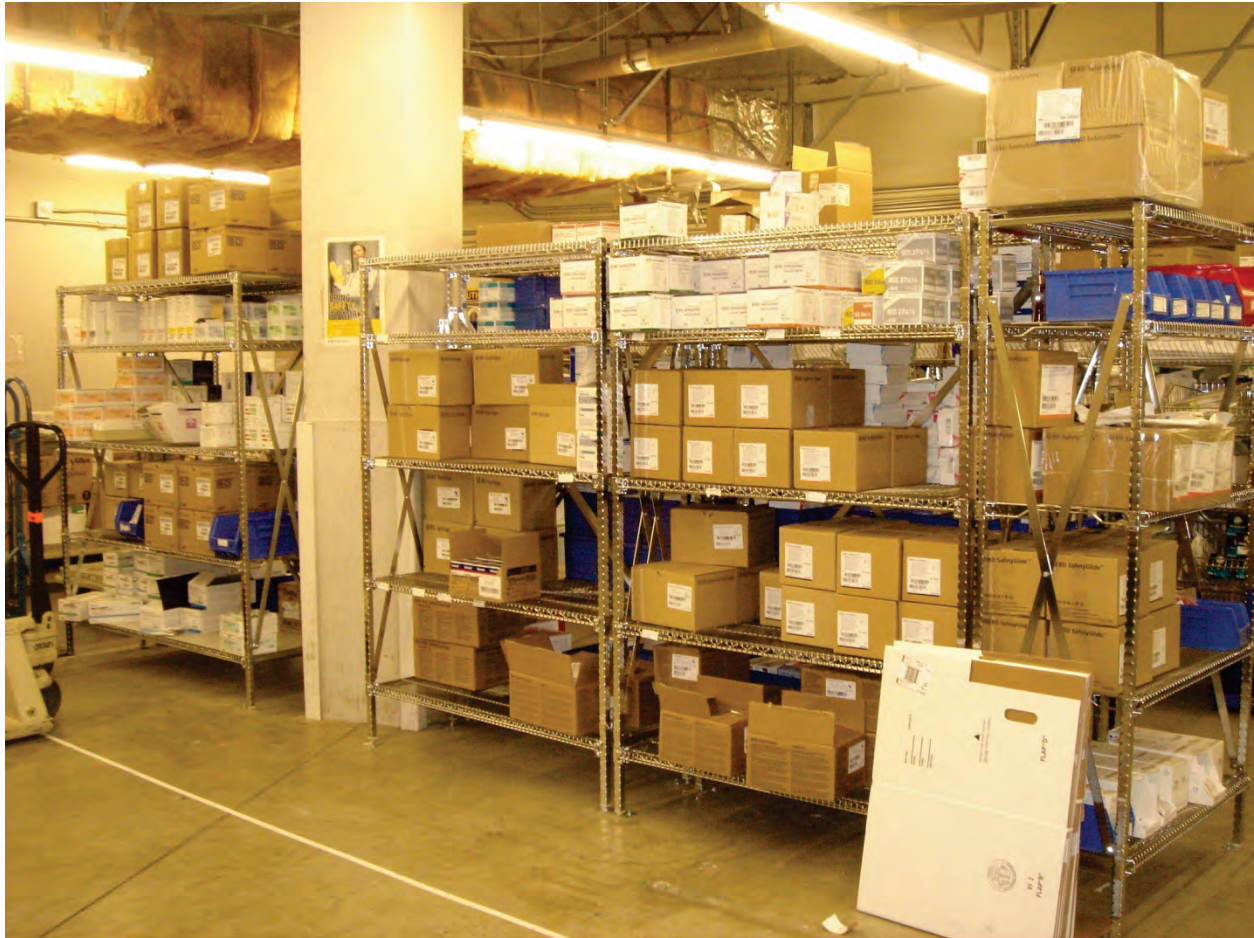
Figure 6.5.1.1-7 Fixed base shelving units anchored directly to concrete slab through base plate (Photo courtesy of Maryann Phipps, Estructure).
