Reducing the Risks of Nonstructural Earthquake Damage – A Practical Guide

FEMA E-74 / December 2012

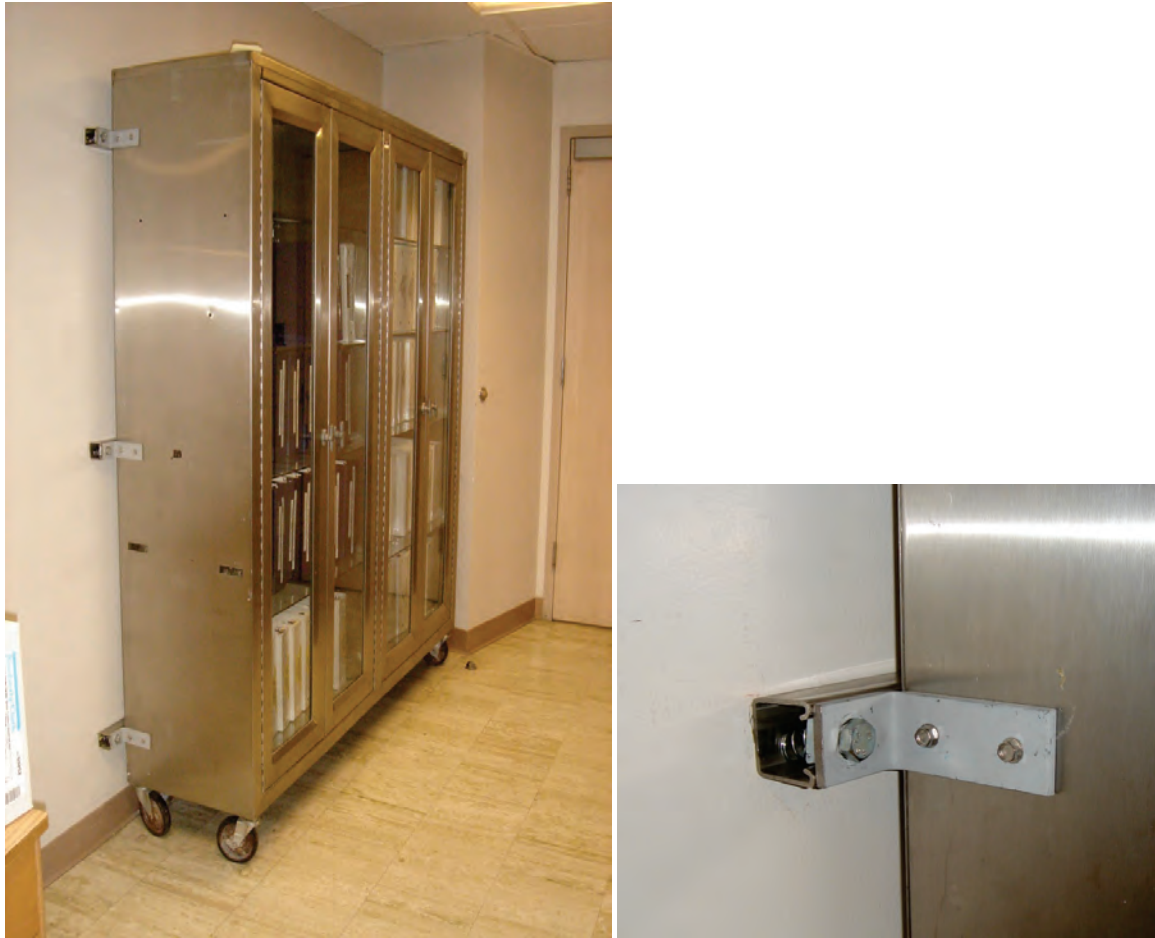
Figure 6.5.1.1-8 Mobile shelving unit restrained by connection to strut fastened to full height metal studs (Photo courtesy of Maryann Phipps, Estructure).

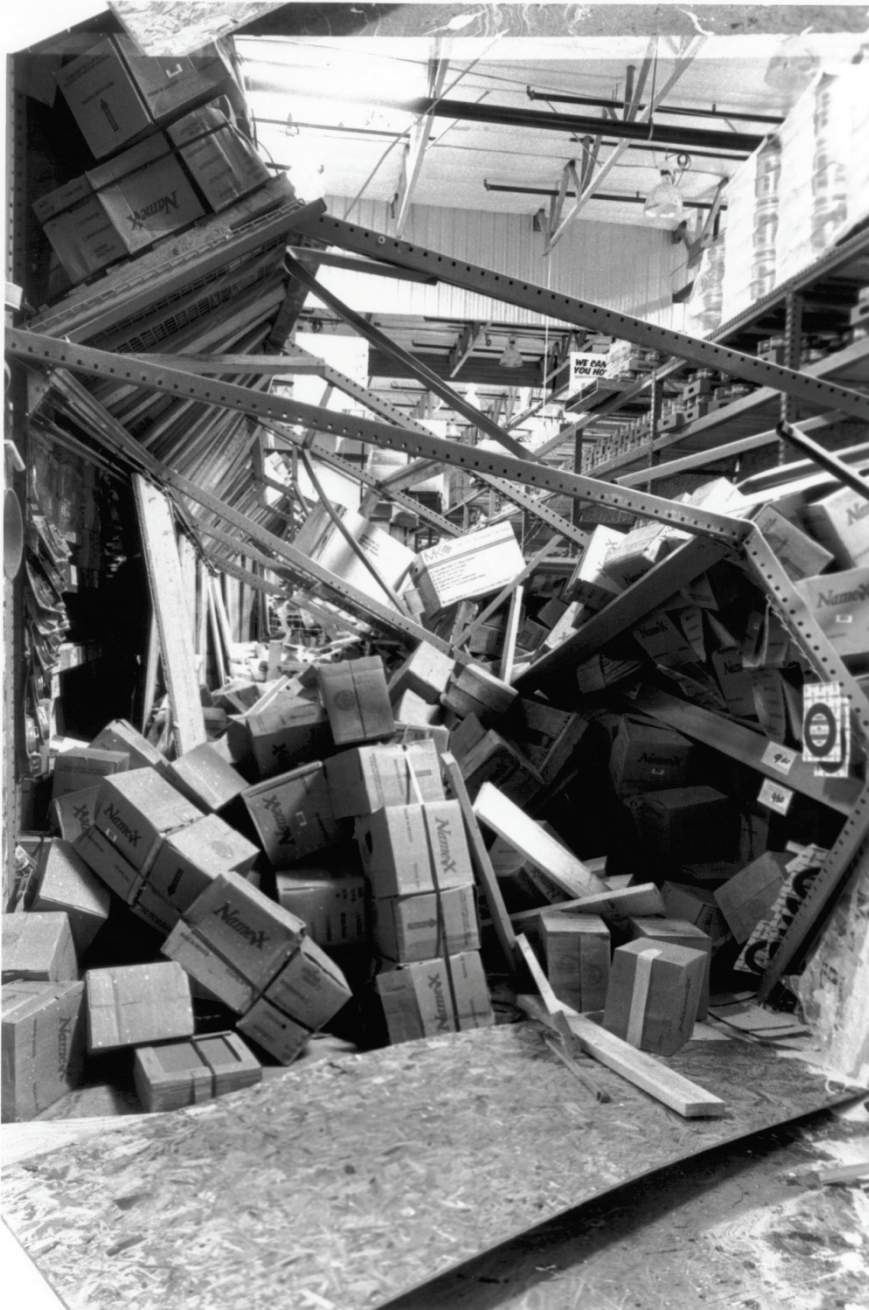
Figure 6.5.1.2-1 Damage to overloaded racks during the 1994 magnitude-6.7 Northridge Earthquake (FEMA 460, 2005).

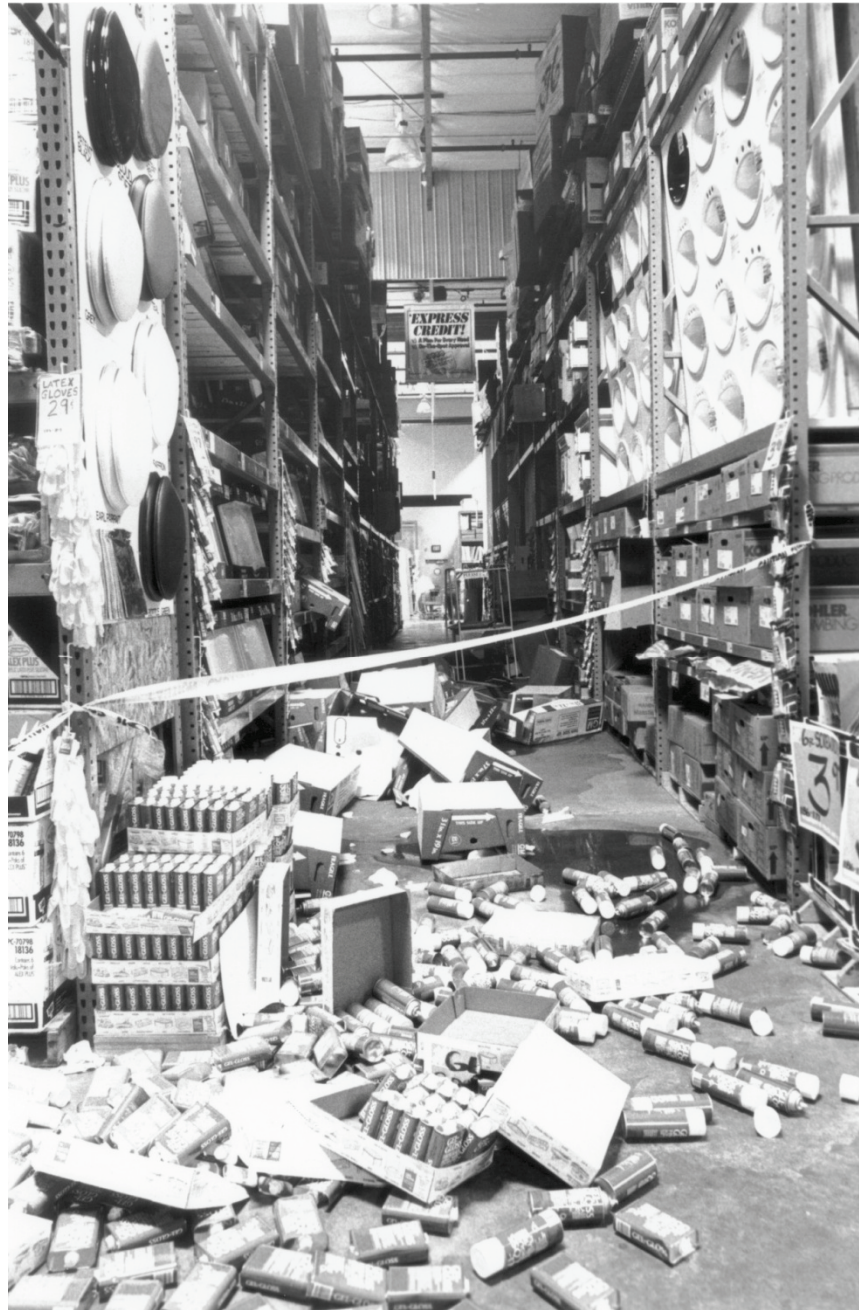
Figure 6.5.1.2-2 Spilled contents during the 1994 Northridge Earthquake (FEMA 460, 2005).

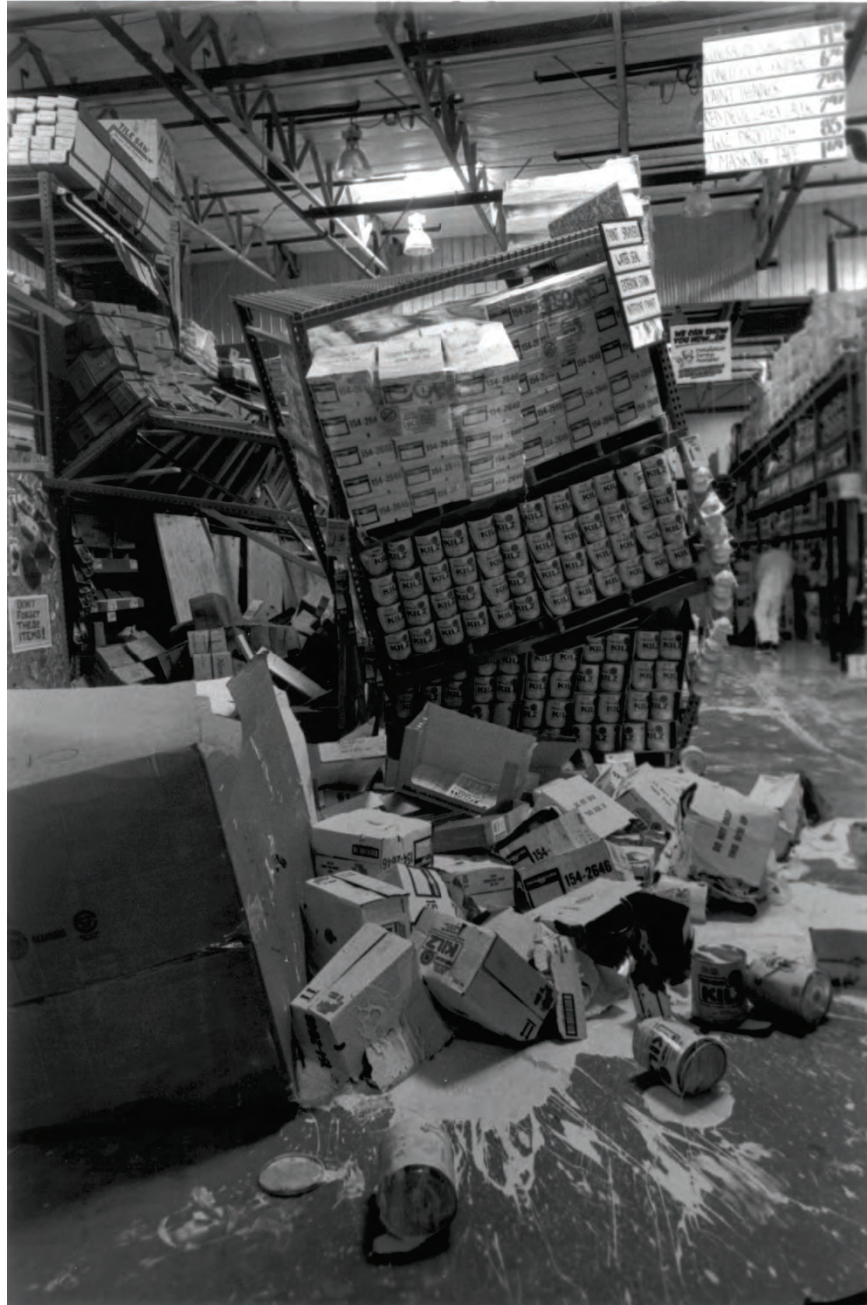
Figure 6.5.1.2-3 Rack collapse during the 1994 Northridge Earthquake. Note the minimal damage to shrink wrapped merchandise (FEMA 460, 2005).

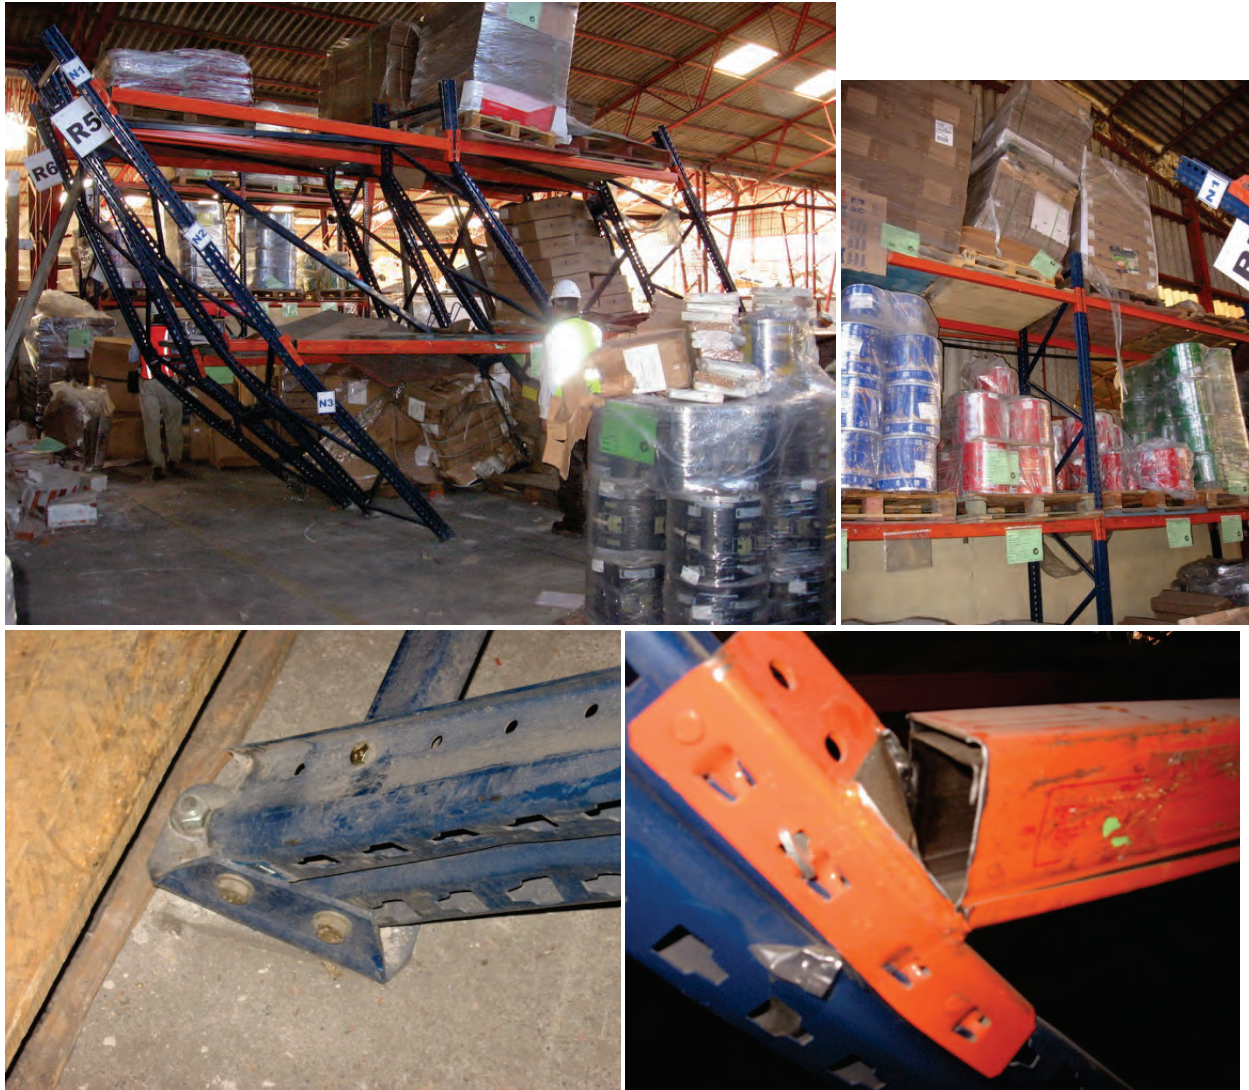
Figure 6.5.1.2-4 Failure of anchored racks in the 2010 magnitude-8.8 Chile Earthquake. The racks are leaning precariously due to inadequate bracing in the longitudinal direction and weak connections between the components. The welded fitting at the end of the beam failed at the weld in many places. Note that most items were shrink wrapped so merchandise did not scatter (Photos courtesy of Rodrigo Retamales, Rubén Boroschek & Associates).

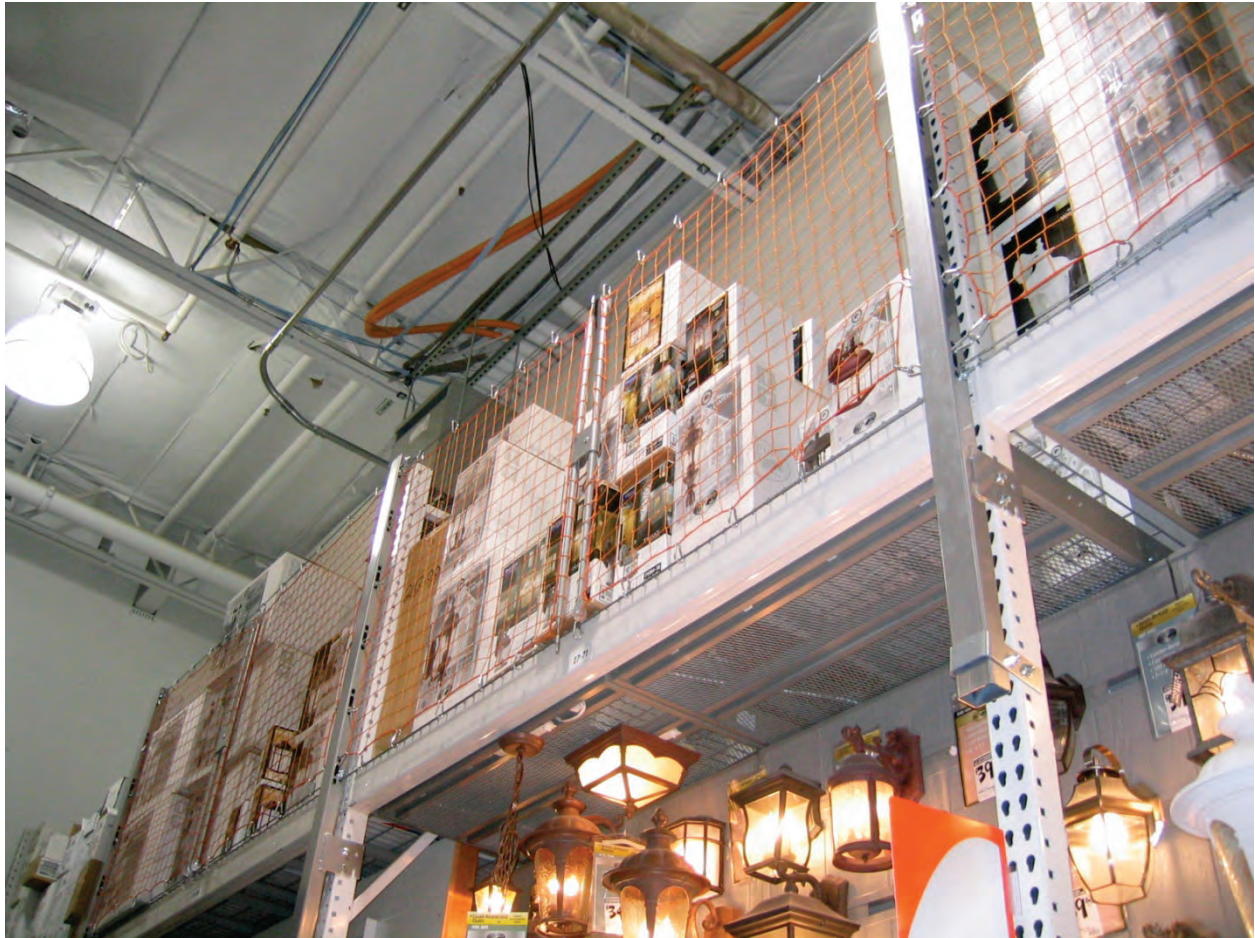
Figure 6.5.1.2-6 Photo showing netting used to keep storage on upper portions of steel storage racks in a big box hardware store (Photo courtesy of Mike Mahoney, FEMA).

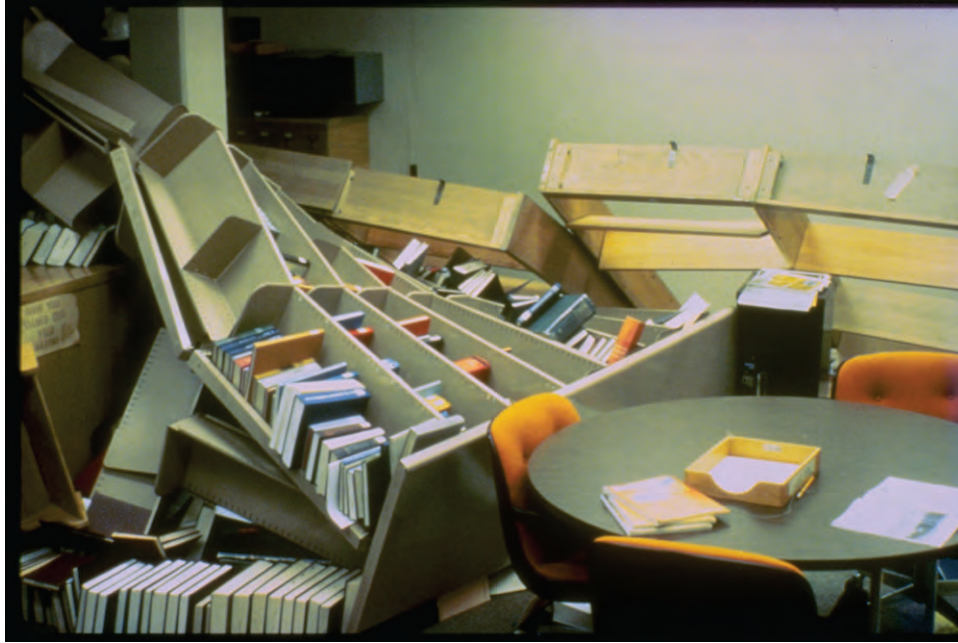
Figure 6.5.2.1-1 Failure of poorly anchored wood and metal book shelves at the Lawrence Livermore Laboratory, Livermore, California (NGDC, 2009).

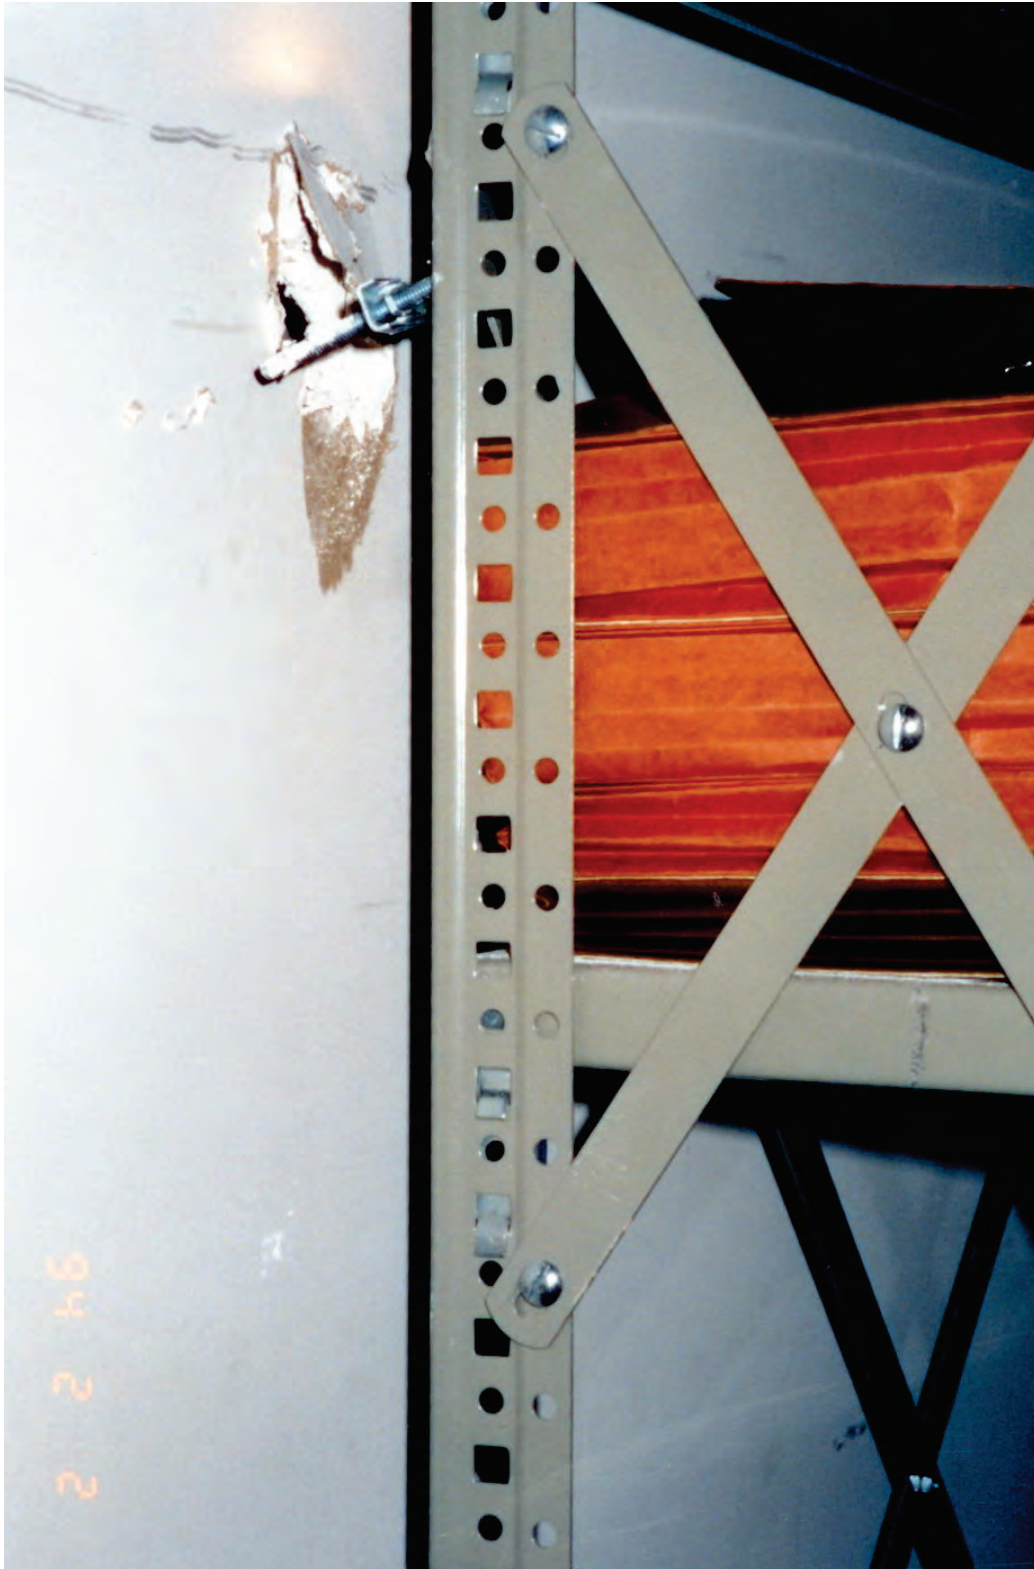
Figure 6.5.2.1-2 Failure of poorly anchored shelving; toggle bolt pulled out of gypsum board wall in the 1994 magnitude-6.7 Northridge Earthquake (Photo courtesy of Wiss, Janney, Elstner Associates).

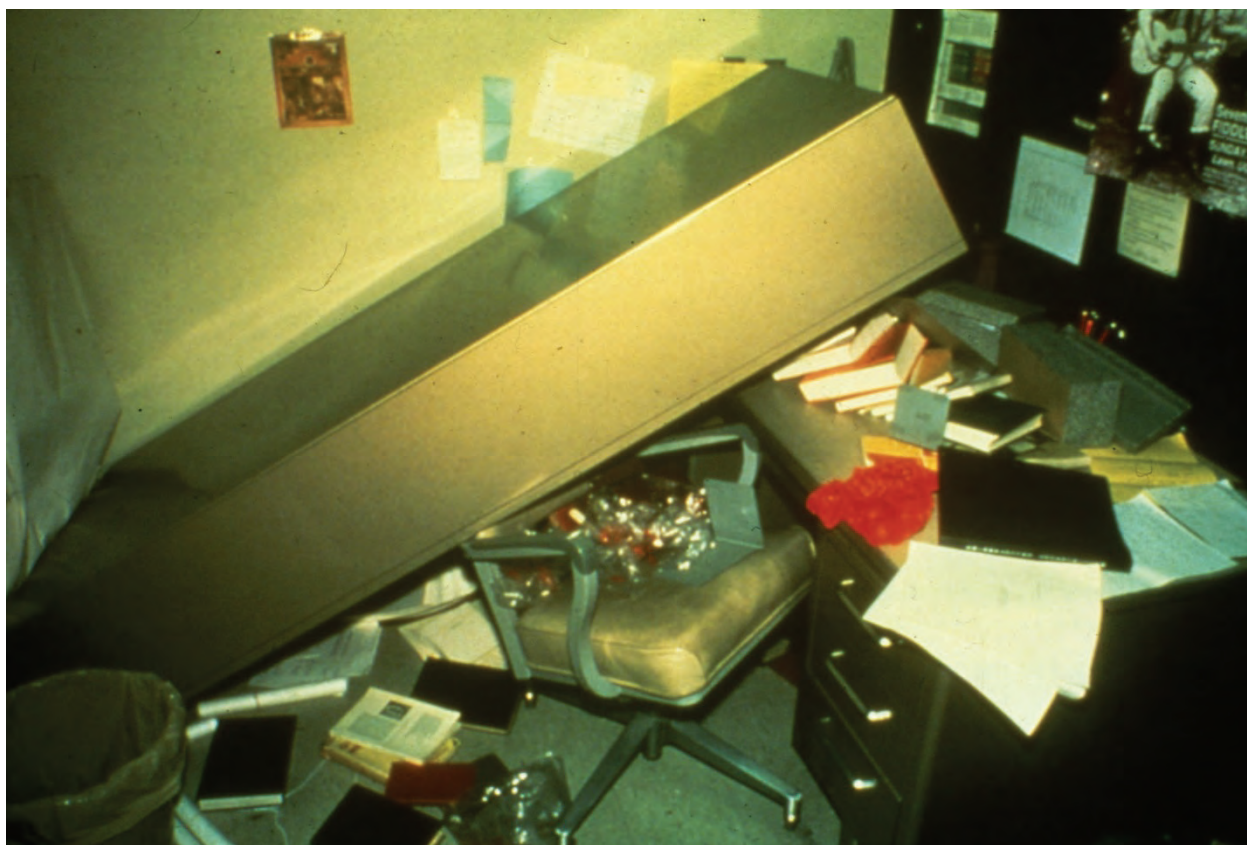
Figure 6.5.2.1-3 Bookcase overturned onto desk in the 1971 magnitude-6.6 San Fernando Earthquake (Photo courtesy of Degenkolb Engineers).

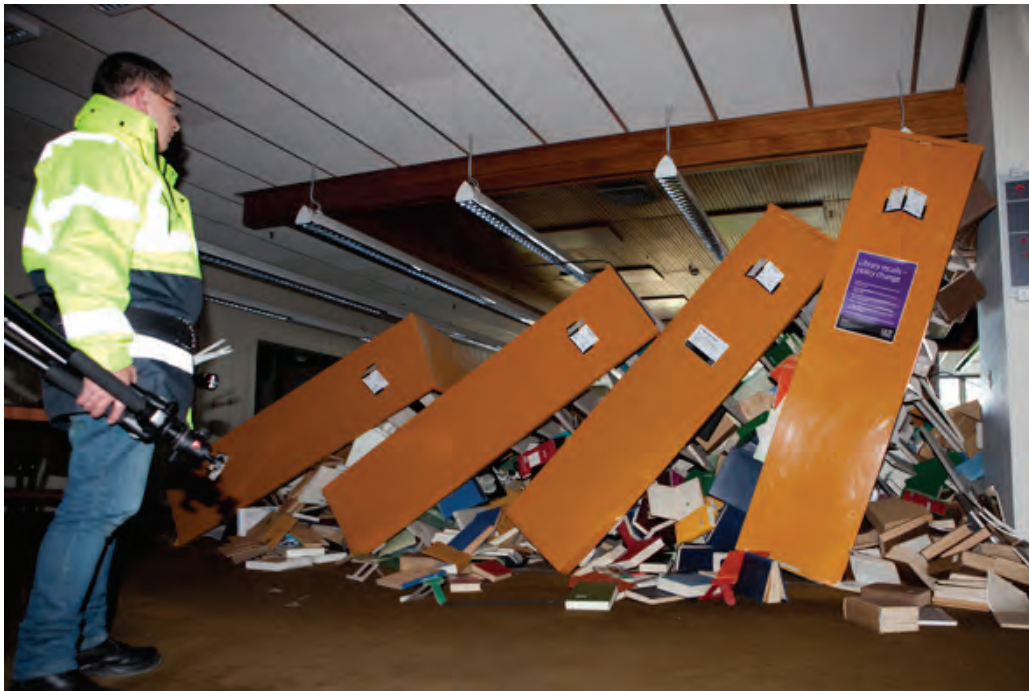
Figure 6.5.2.2-1 Photo showing collapsed library shelving in the 2010 magnitude-7.1 Canterbury New Zealand Earthquake (Photo courtesy of University of Canterbury).

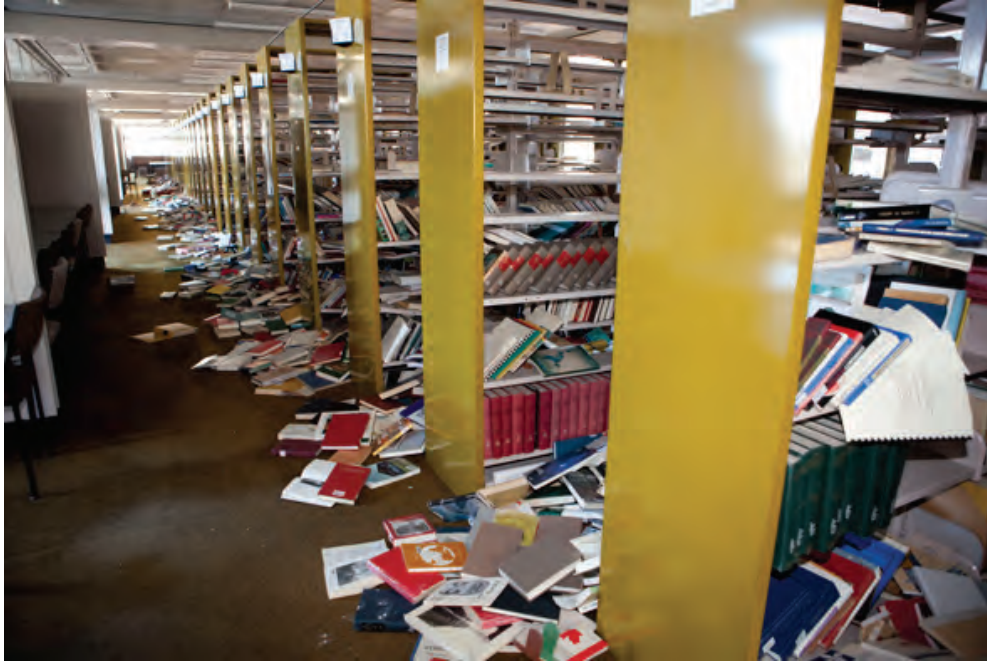
Figure 6.5.2.2-4 Shelving units with longitudinal ties did not fall over but all of the contents spilled to the floor in the 2010 Canterbury Earthquake. The use of lips or wires would have prevented the damage.(Photo courtesy of University of Canterbury).

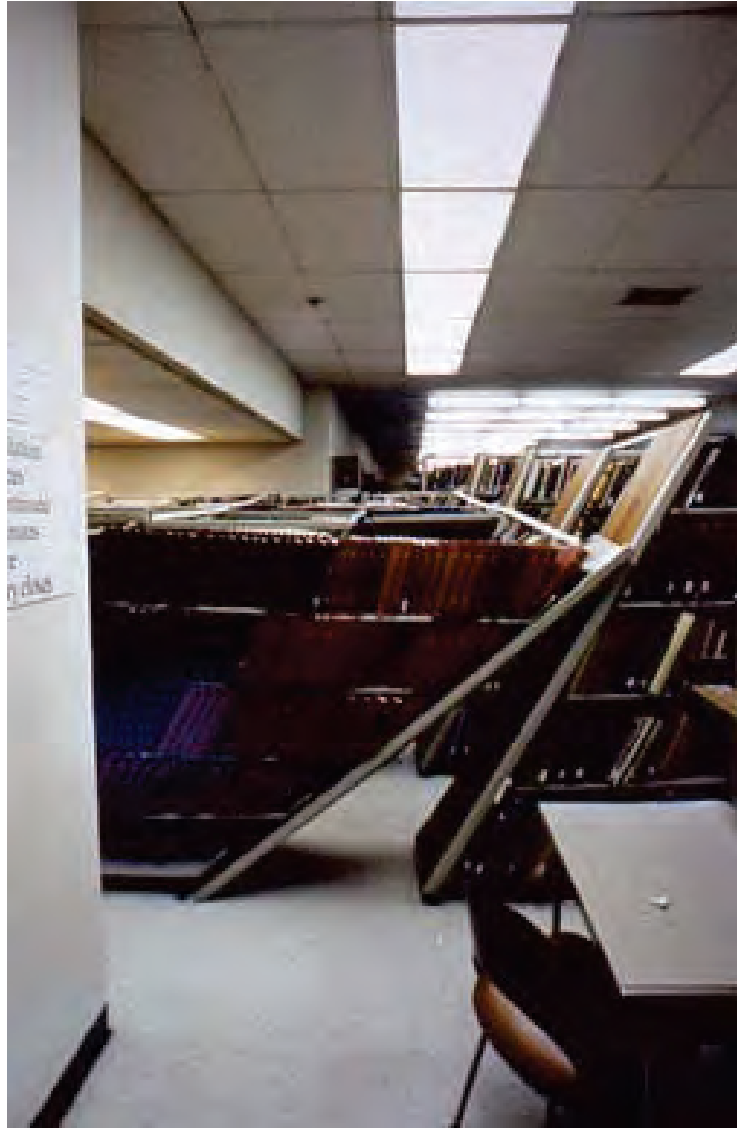
Figure 6.5.2.2-3 Longitudinal failure of library shelving units (Photo courtesy of NISEE-PEER, U.C. Berkeley). Transverse ties used to tie units together but this was not enough to prevent longitudinal failure.

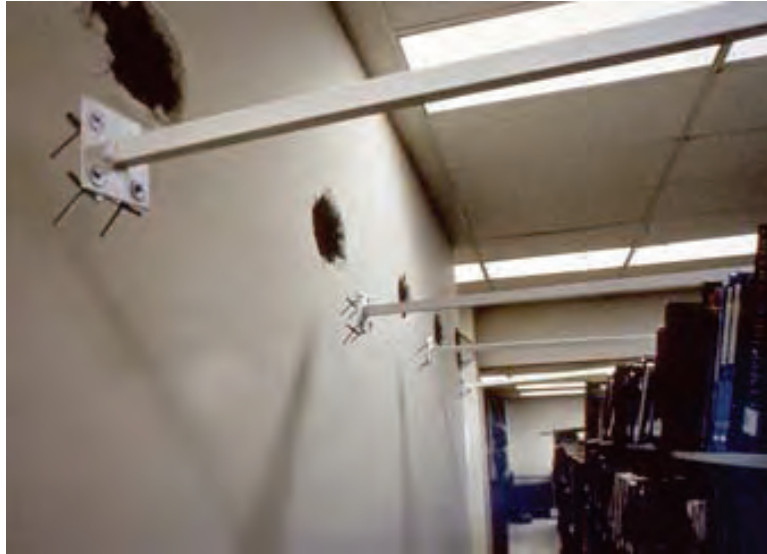
Figure 6.5.2.2-2 Failure of overhead transverse bracing for bookshelves were anchored to gypsum board partition in the 1984 magnitude-6.2 Morgan Hill Earthquake (Photo courtesy of Santa Clara County Office of Emergency Services). The anchors were not attached to wall studs, only to gypsum board.

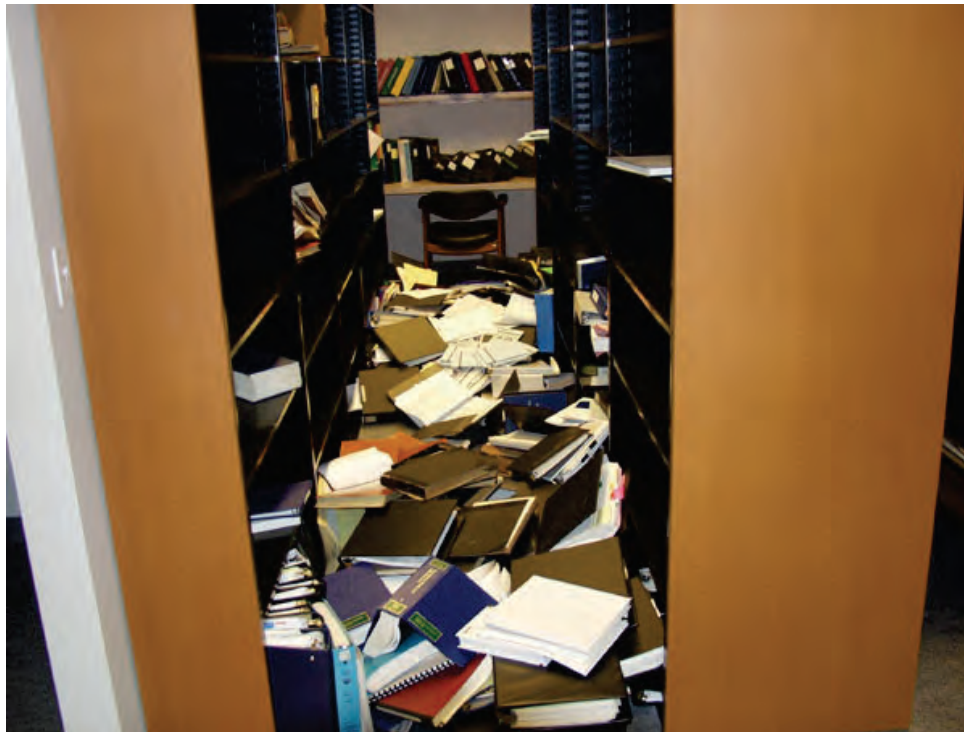
Figure 6.5.2.2-5 These shelving units remained in place but all of the contents spilled in the 2010 magnitude-6.5 Eureka, California Earthquake (Photo courtesy of Steve Mahin, PEER).

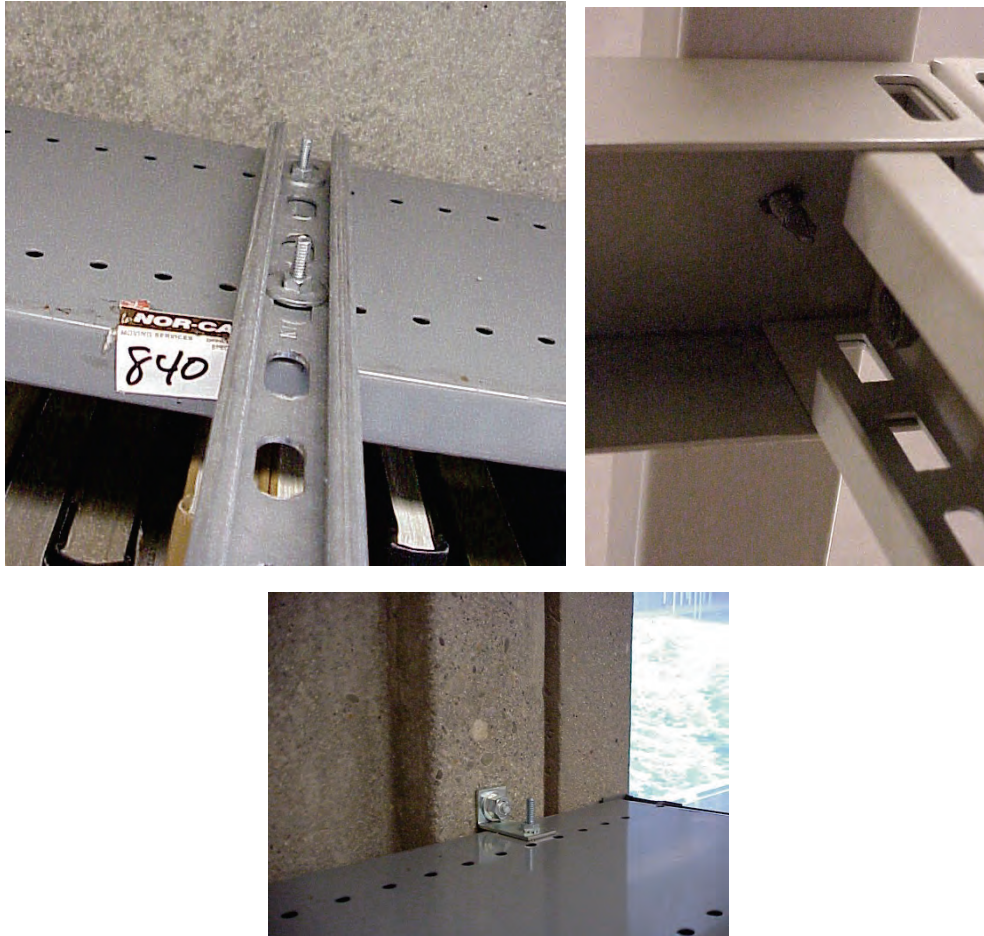
Figure 6.5.2.2-6 Examples of struts and hardware used to retrofit library shelving at the University of California, Berkeley (Photos courtesy of Mary Comerio, Dept. of Environmental Design, University of California Berkeley).

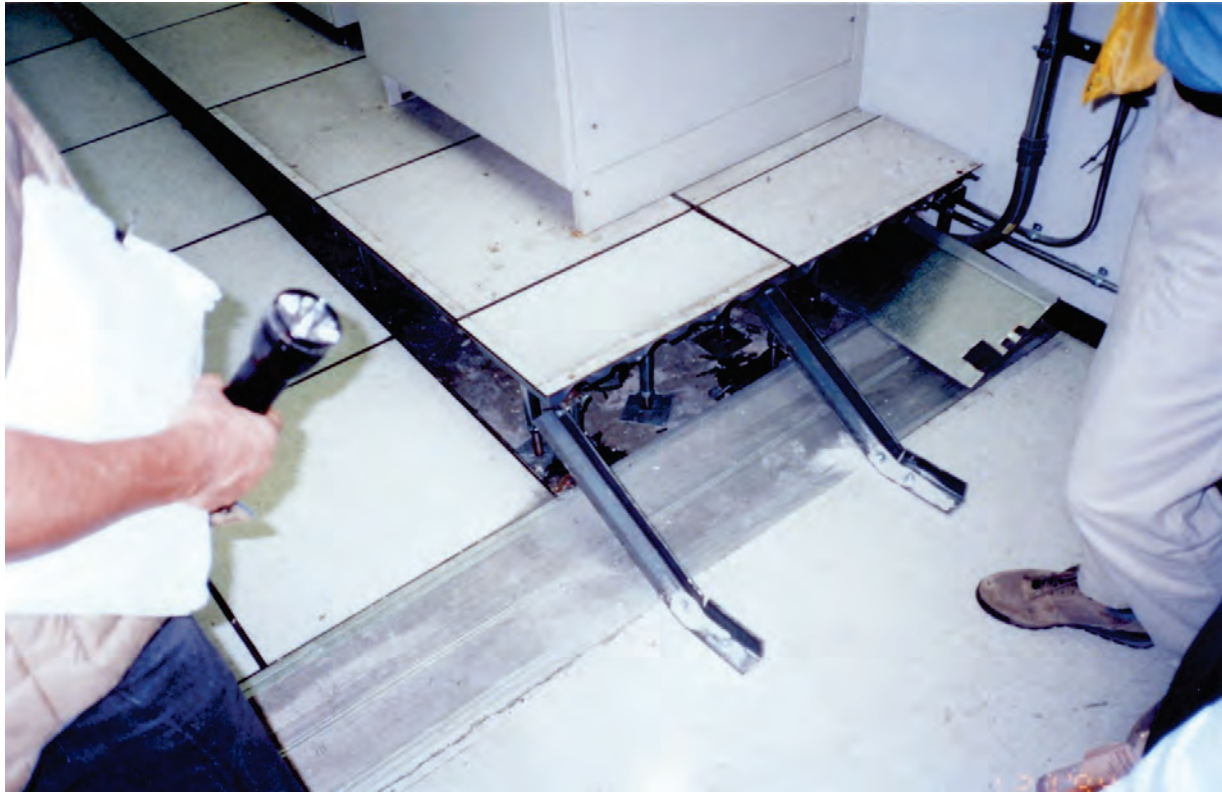
Figure 6.5.3.1-1 Temporary bracing for access floor collapsed in the 1994 magnitude-6.7 Northridge Earthquake (Photo courtesy of Wiss, Janney, Elstner Associates).

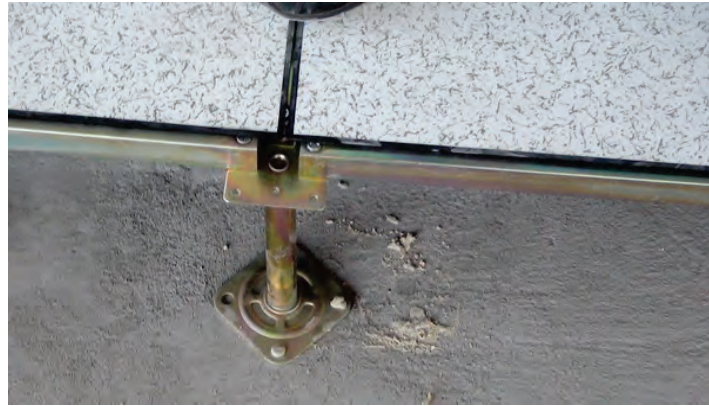
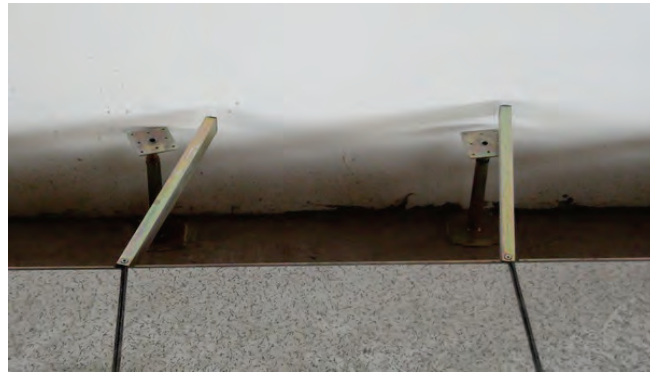
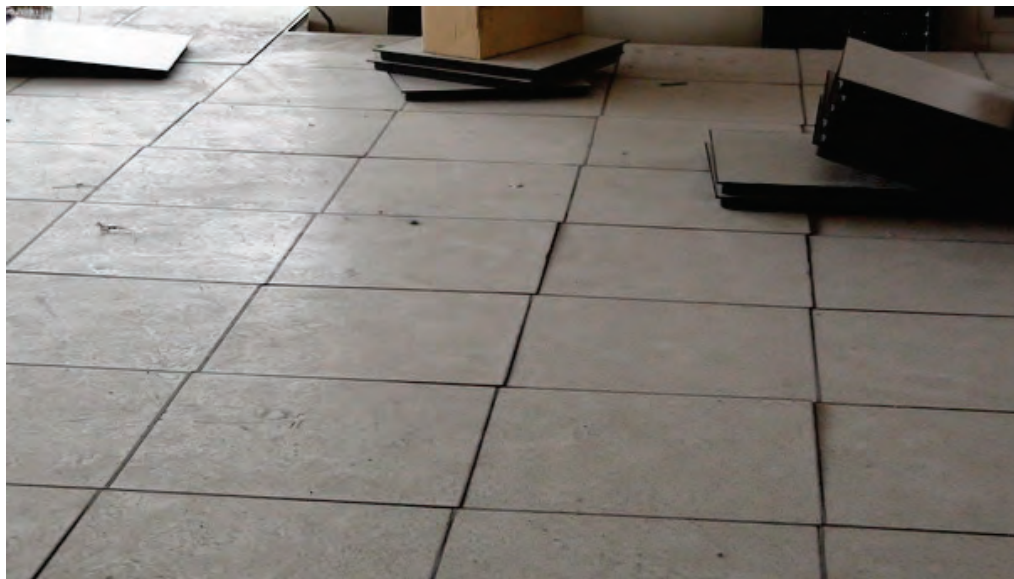
Figure 6.5.3.1-2 Damage to access floor with short anchored pedestals in the 2010 magnitude-6.7 Chile Earthquake; floor did not have lateral bracing. Note many tiles misaligned (Photos courtesy of Antonio Iruretagoyena, Rubén Boroschek & Associates).

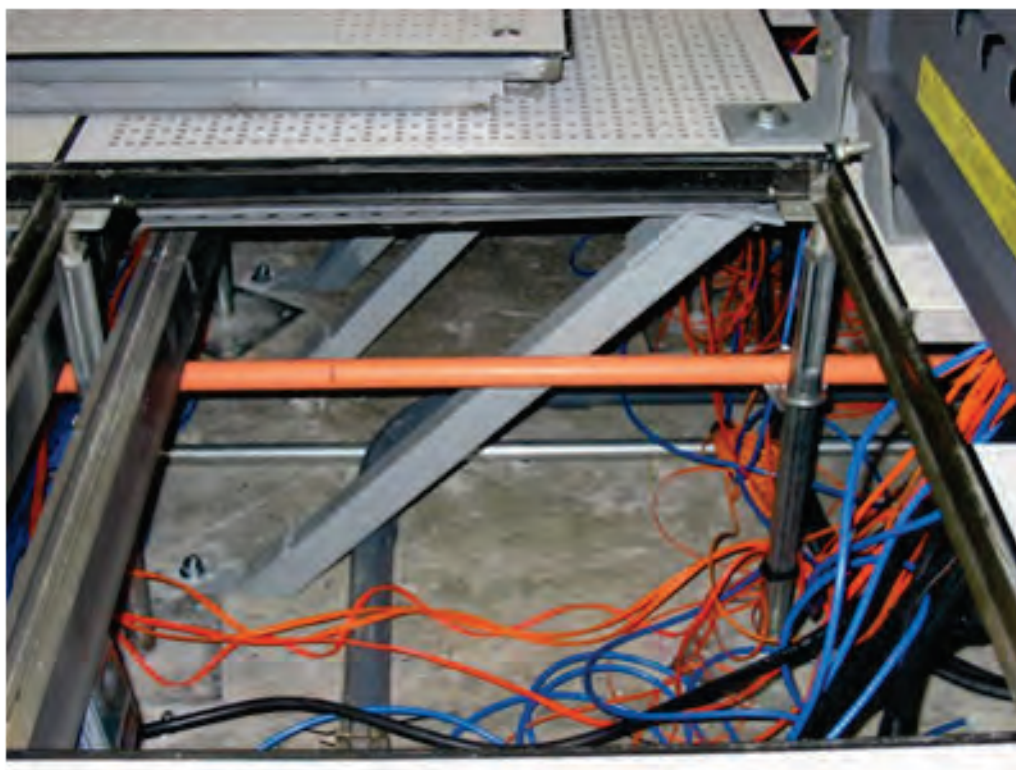
Figure 6.5.3.1-4 Raised floor braced with strut (Photo courtesy of Maryann Phipps, Estructure).

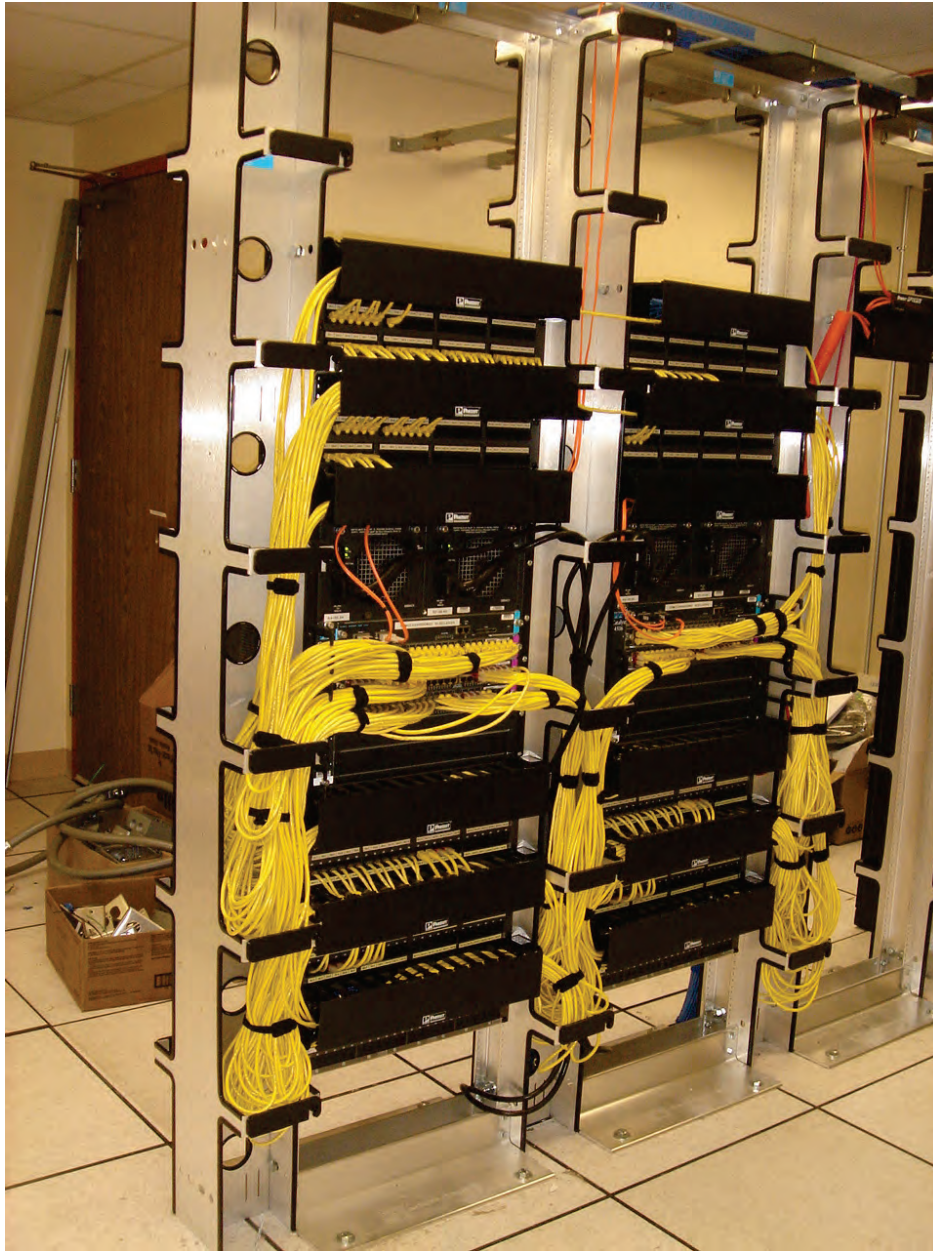
Figure 6.5.3.1-5 Data rack bolted through access floor to supplemental strut bracing below (Photo courtesy of Maryann Phipps, Estructure).

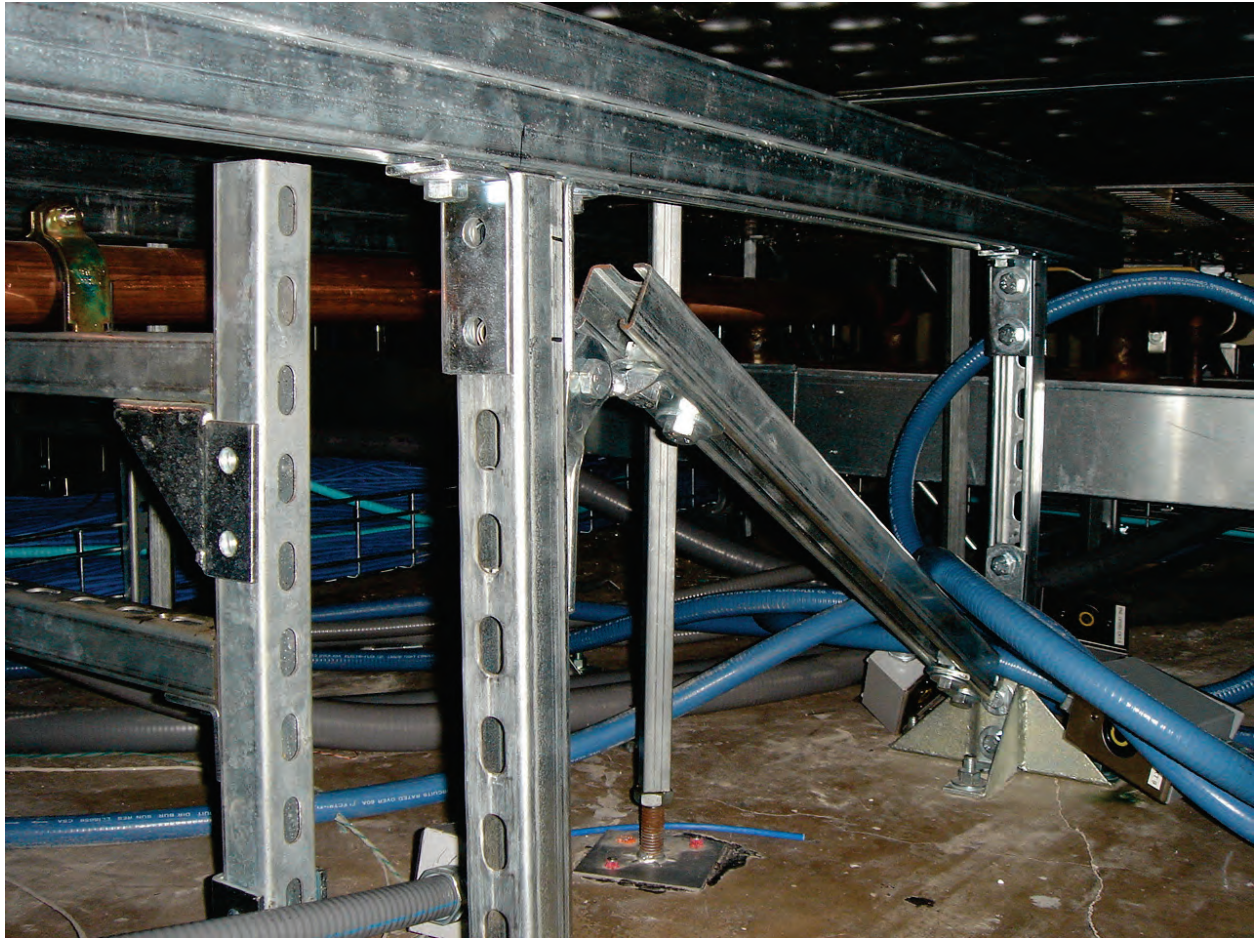
Figure 6.5.3.1-8 Strut framing added to brace data cabinet located on access floor. Bolts from angles above are connected to strut framing below (Photo courtesy of Maryann Phipps, Estructure).

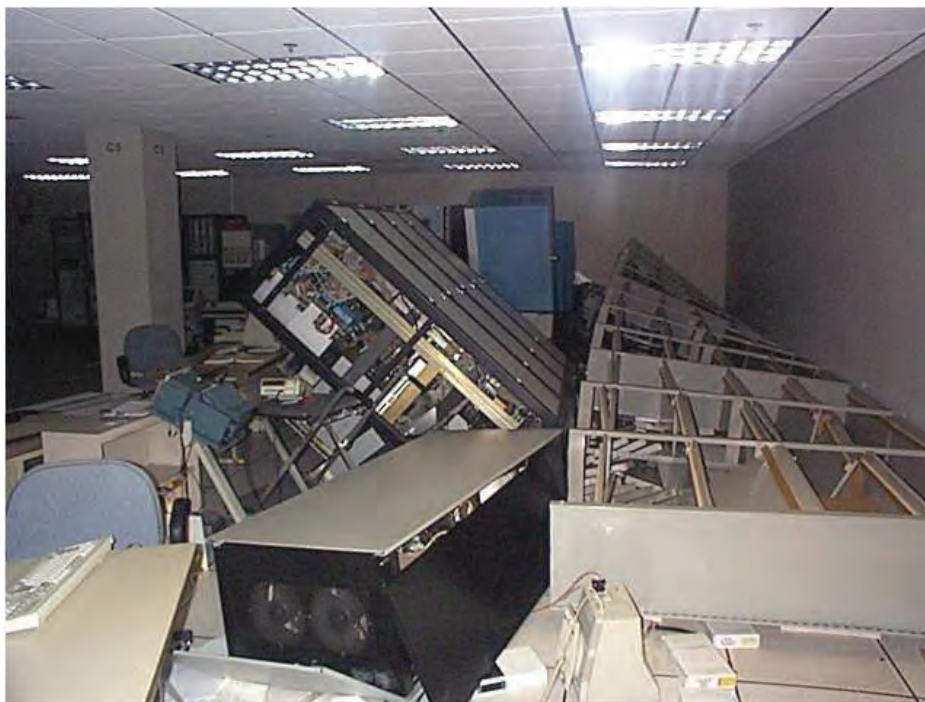
Figure 6.5.3.2-1 Damage to communication and computer racks (Photo courtesy of Degenkolb Engineers).

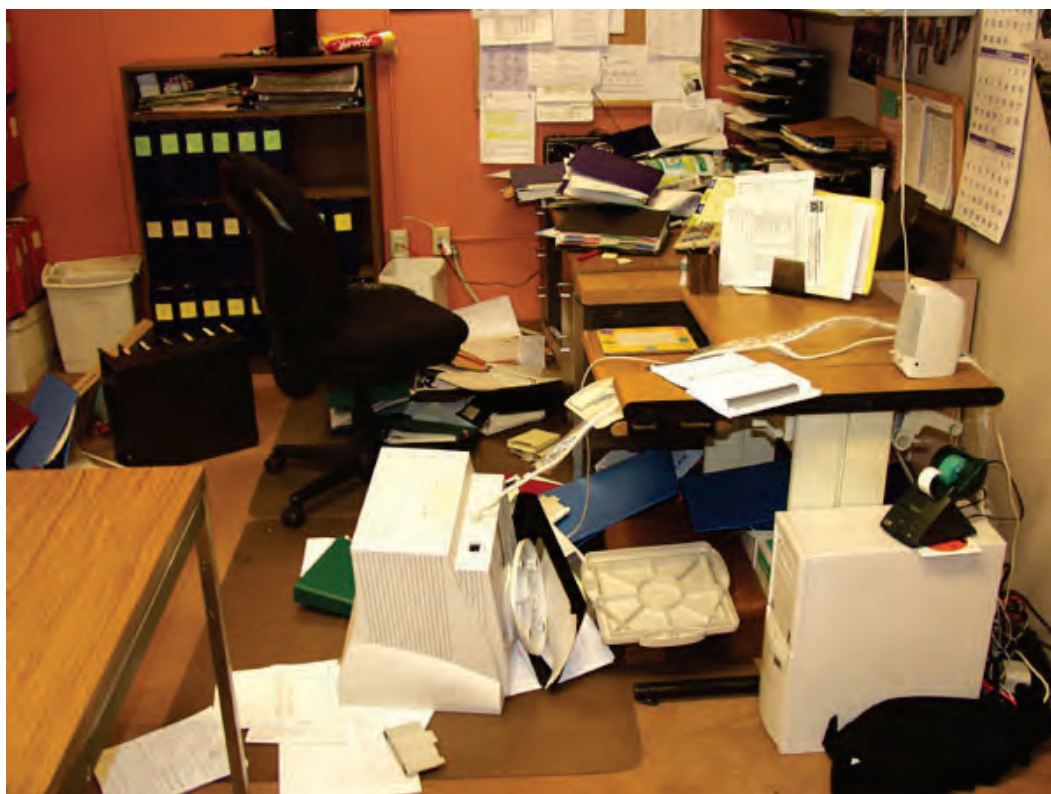
Figure 6.5.3.3-1 Computer monitor slid off desktop onto floor in the 2010 magnitude-6.5 Eureka, California Earthquake (Photo courtesy of Steve Mahin, PEER).

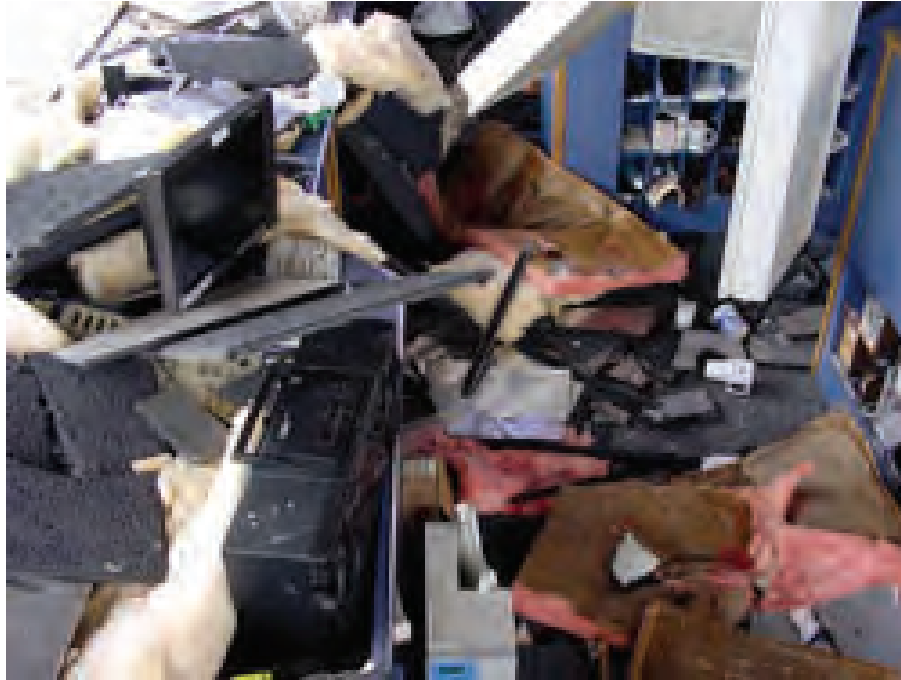
Figure 6.5.3.3-2 Damage to control tower at the SeaTac Airport in the 2001 Nisqually Earthquake (Photo courtesy of JCP Geologists).
